SUBJECT: Final Environmental Assessment (EA) for Conservation District Use Application (CDUA) MA-3633 for the Stable Road Beach Groins Project Located Upon Submerged Land Offshore of Spreckelsville, Maui, Makai of TMK:(2) 3-8-002:71, 74, 77 & 78

STABLE ROAD BEACH GROINS REPLACEMENT PROJECT

15 December 2012

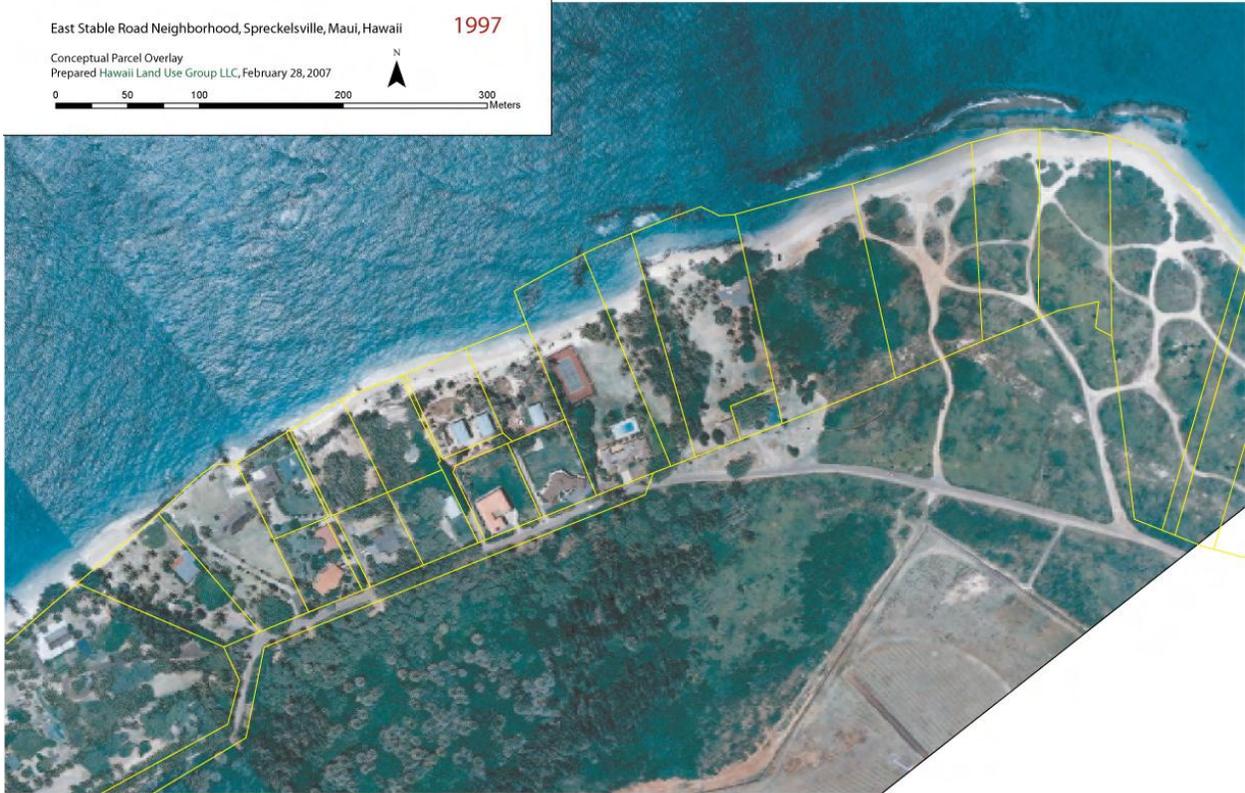
Photo 18 - Aerial View Showing No Beach in Front of Downdrift Lot 2 Seawall, May 1997

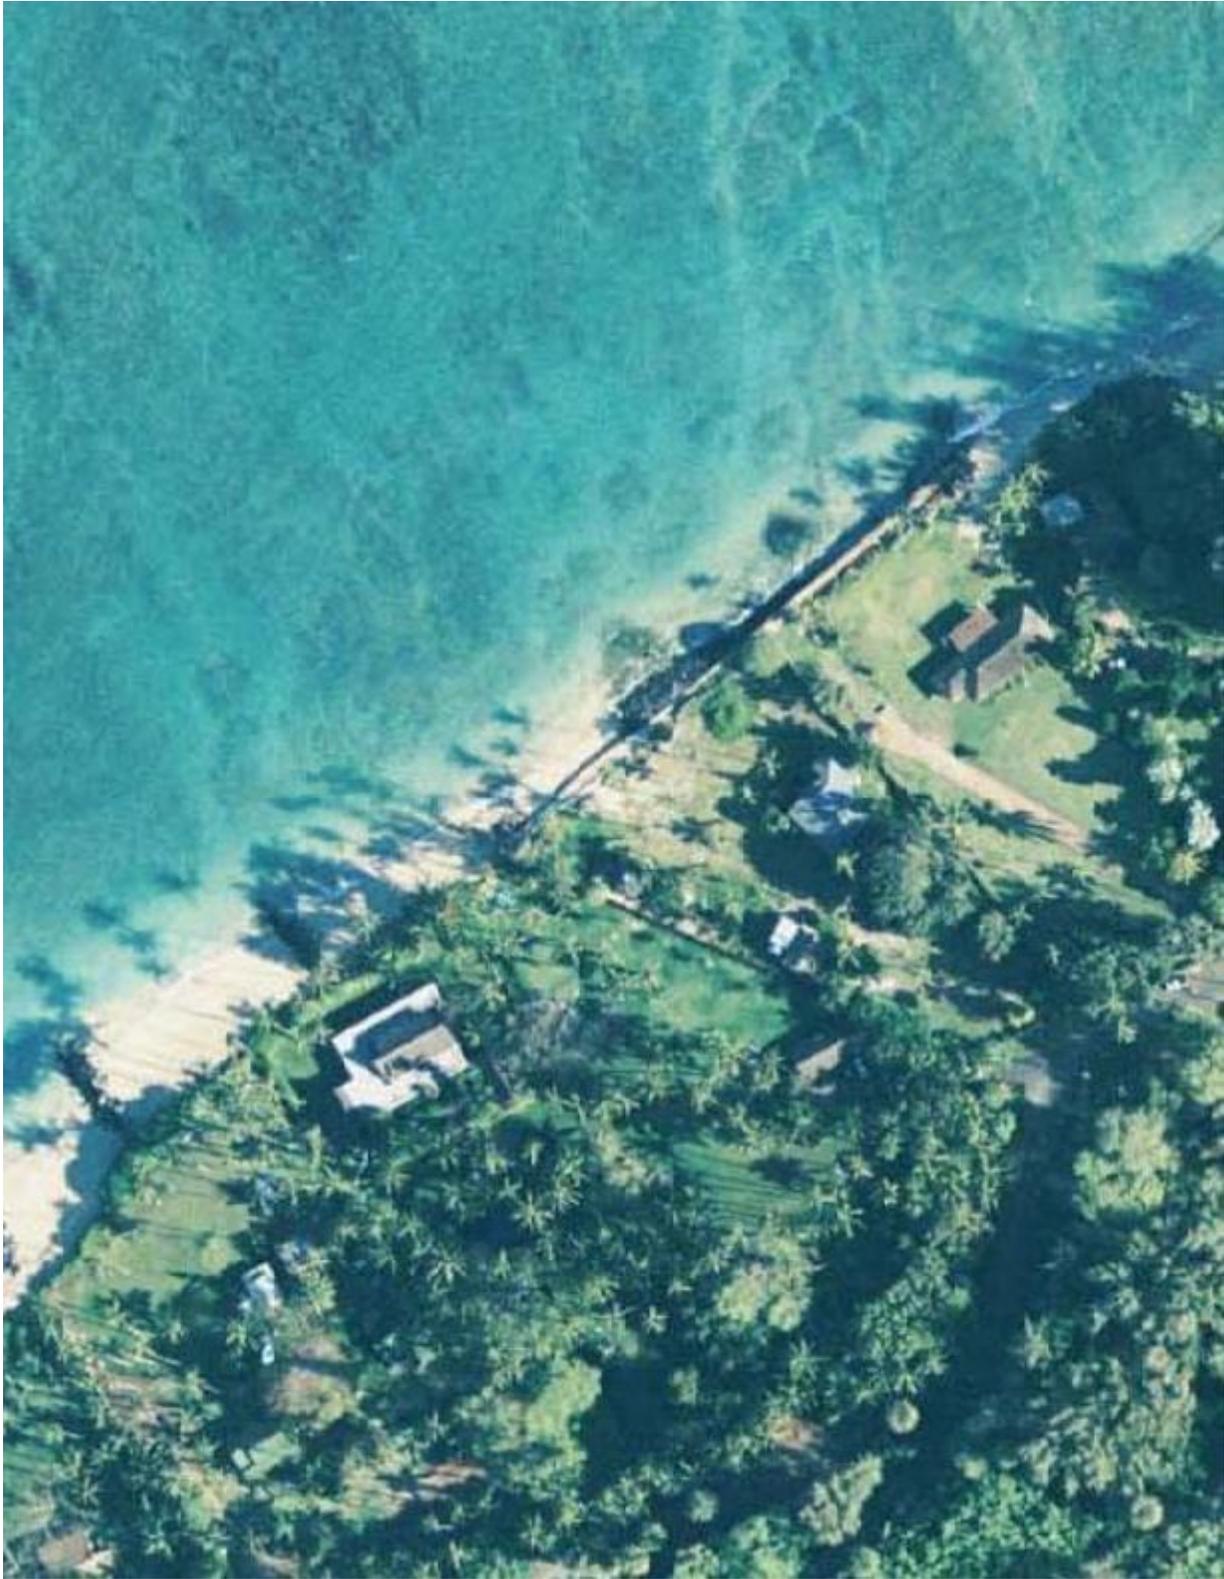
Photo 19 - Aerial View Showing Exposed Seawall Length, Height and Shadow in Front of Downdrift Lots 1 and 2, February 2002

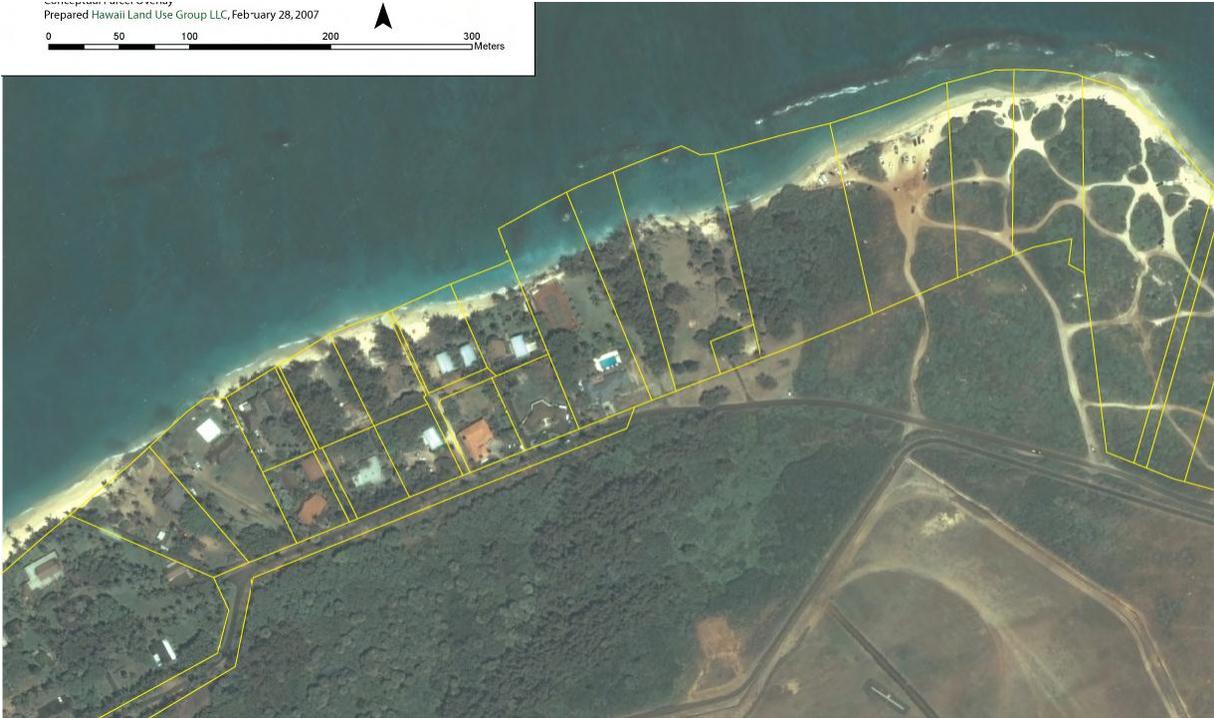
Photo 20 - Aerial View Showing No Beach at Downdrift Lot 2 and East Half of Lot 1, 2005

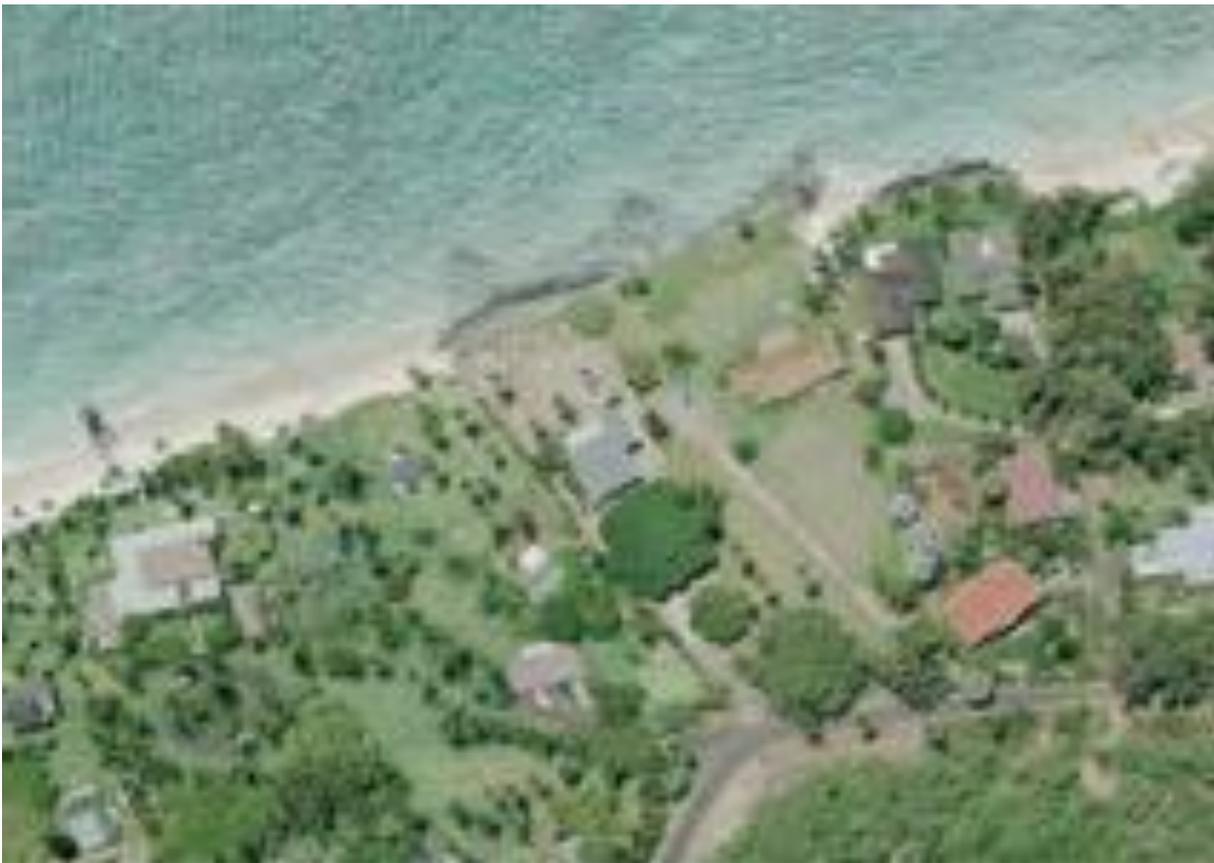
Photo 21 - Aerial View Showing No Beach at Downdrift Lot 2 and East Half of Lot 1, June 2007

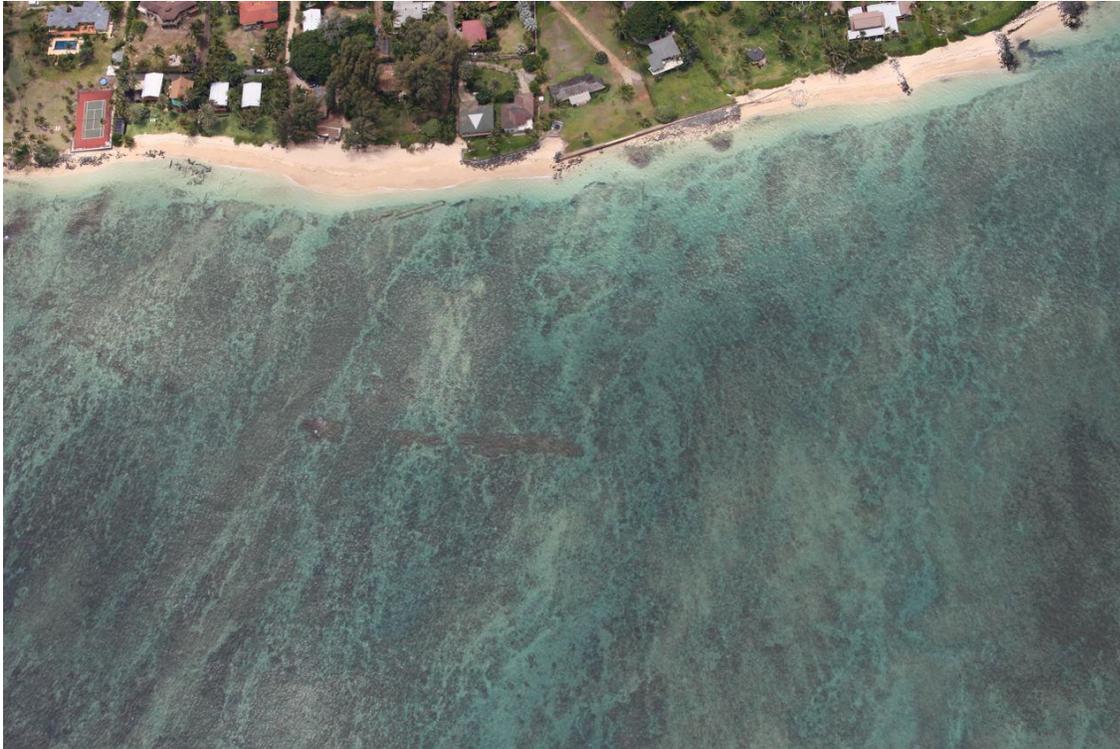
Photo 22 - Aerial View Showing Beach Beginning of Summer Season Erosion, Scouring, Exposed Seawall Portion in Front of Downdrift Lot 1 at Right, 19 July 2009

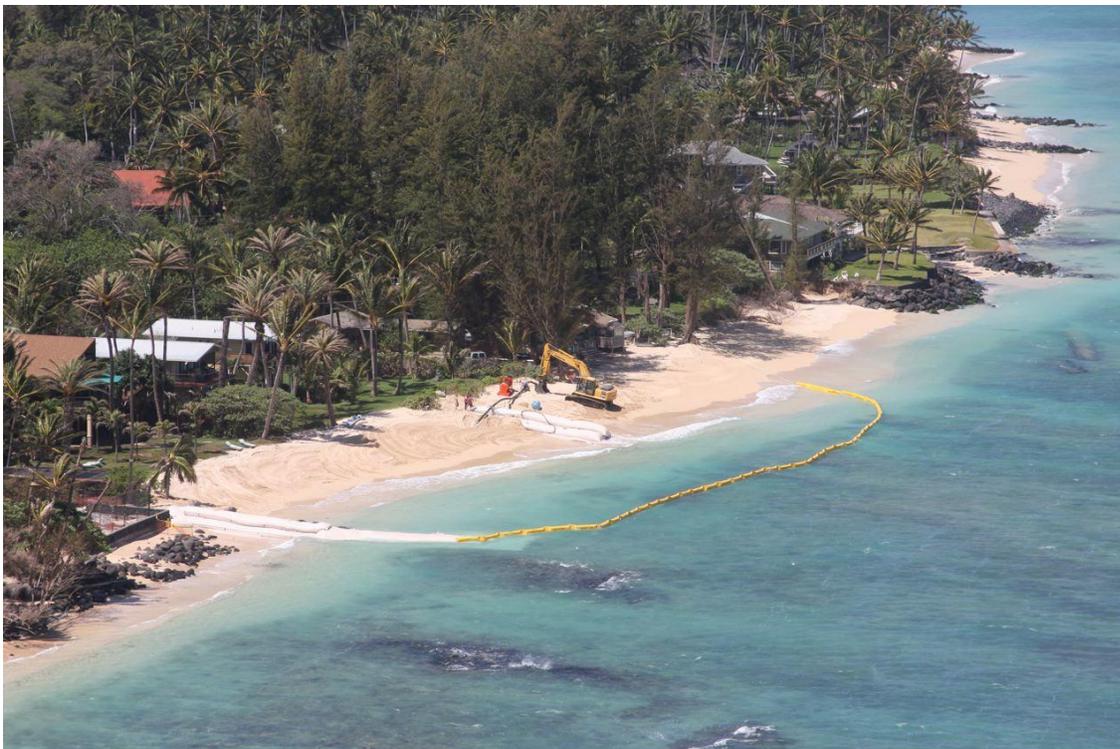
Photo 23 - Aerial View Showing Rock Piles Without Sand in Front at Downdrift Lots 1 and 2 Beyond on Second Day of Project Construction, 21 April 2010

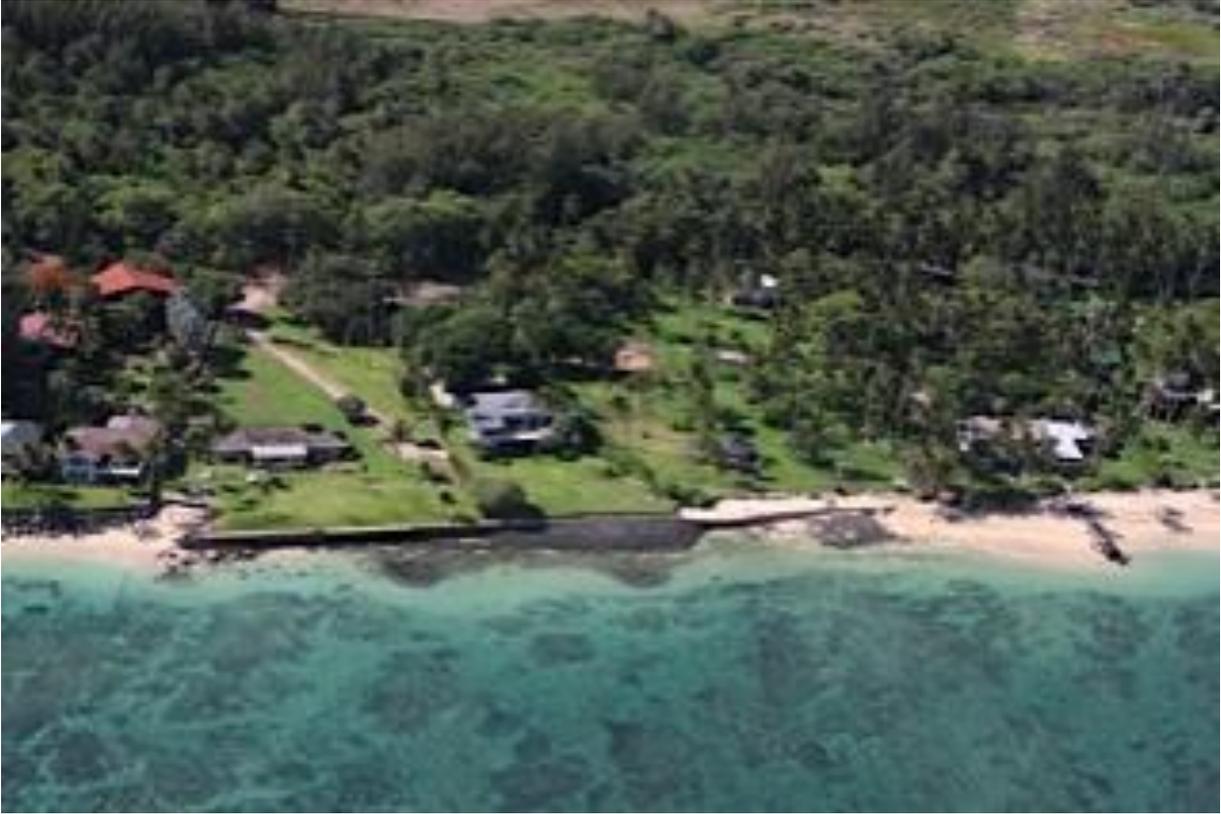
Photo 24 – Aerial View of Downdrift Area Post-Construction, 29 June 2011

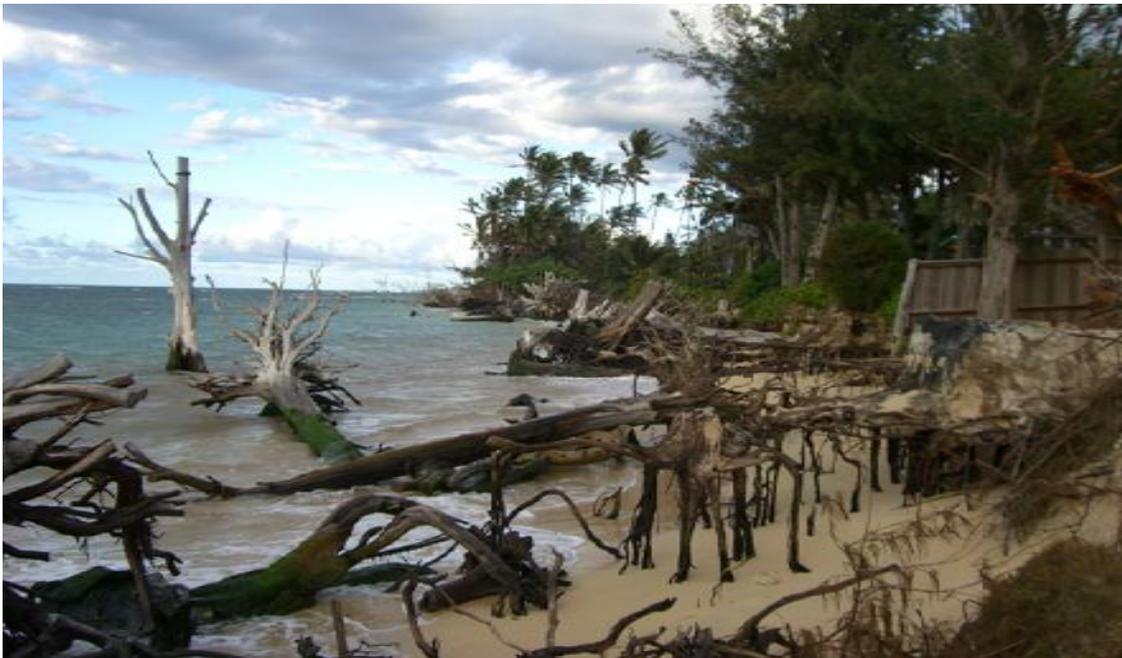
During the spring and summer seasons when strong trade winds typically occur, the east end of the Project Beach and land have eroded from northeasterly, short interval waves causing scouring and longshore sand transport to the west. The beach then has become unusable and unsafe (see Photo 1). This erosion is exacerbated by the adverse effects of the adjoining hardened shoreline to the east.

Photo 1 - Beach and Land Erosion Pre-Construction at Project Beach Looking East, 22 August 2006

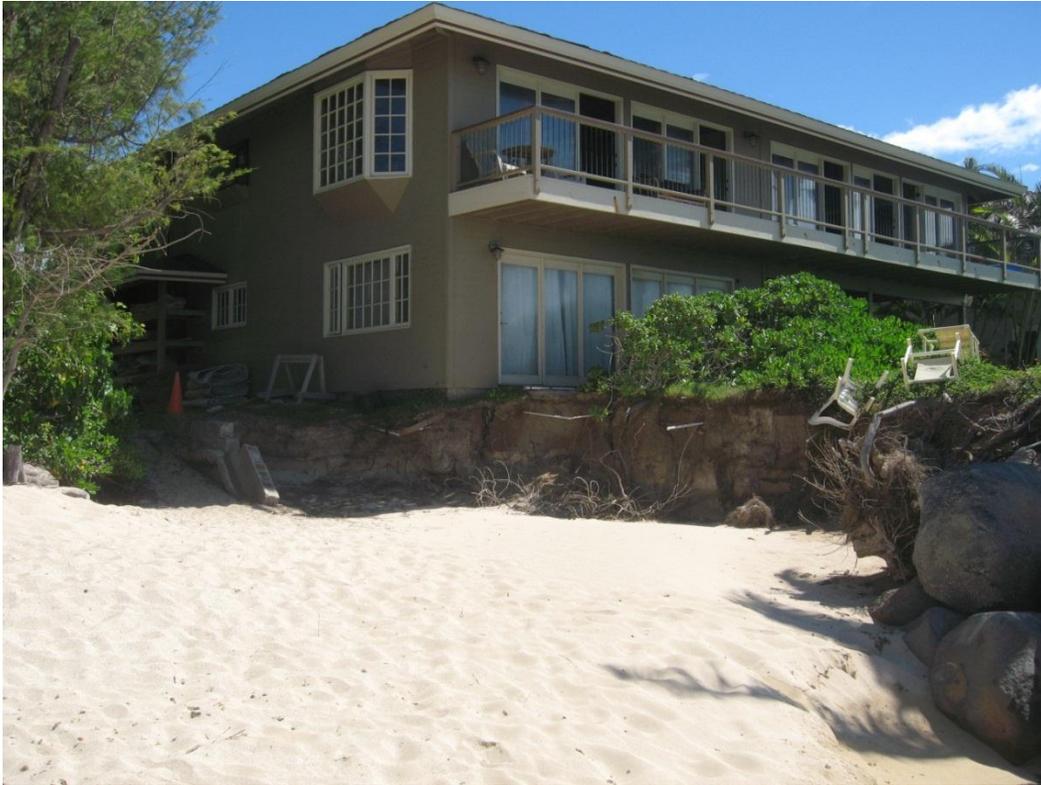
During the fall and winter seasons when large, north Pacific swells typically occur, the west end of the Project Beach and land have eroded from northwesterly, long interval waves causing cross shore sand transport and scouring exacerbated by adverse effects of the adjoining hardened shoreline to the west. The safety of the home on Lot 3 at the west end of the Project Beach is

Photo 2 - Land Loss at West End of Project Beach (Lot 3), 23 August 2010

threatened from this chronic erosion (see Photo 2).

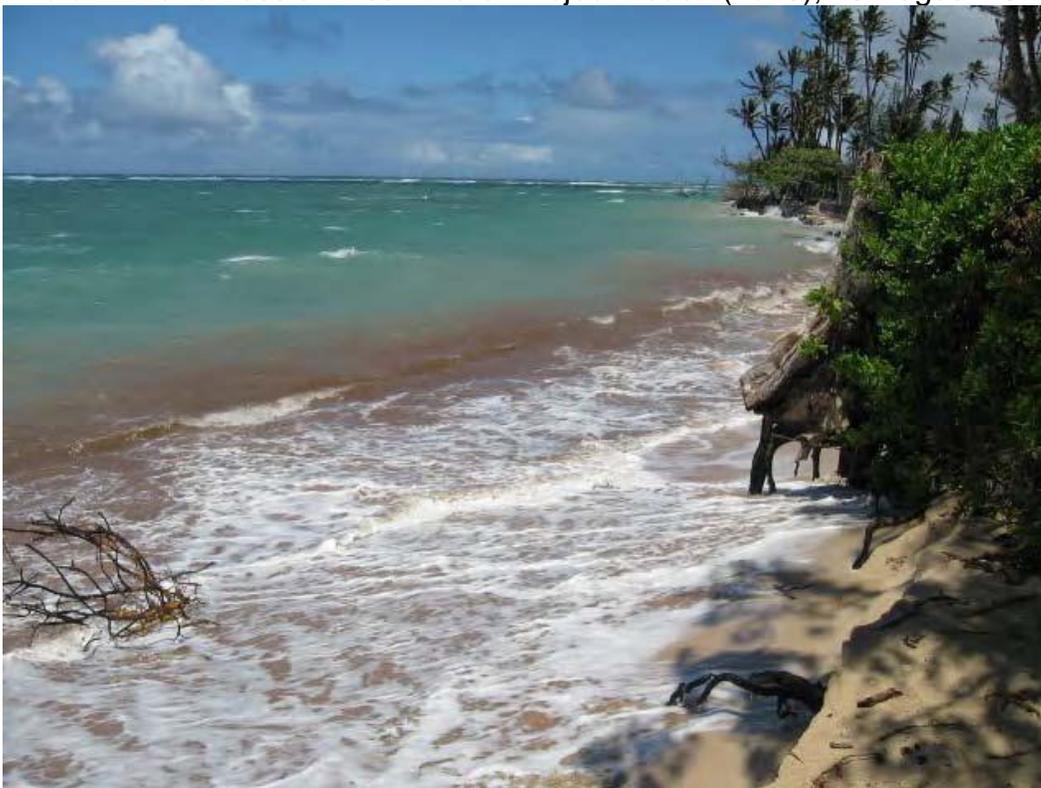
Photo 3 - Beach and Land Erosion, Beach Loss and Land Pollution at Project Beach, August 2008

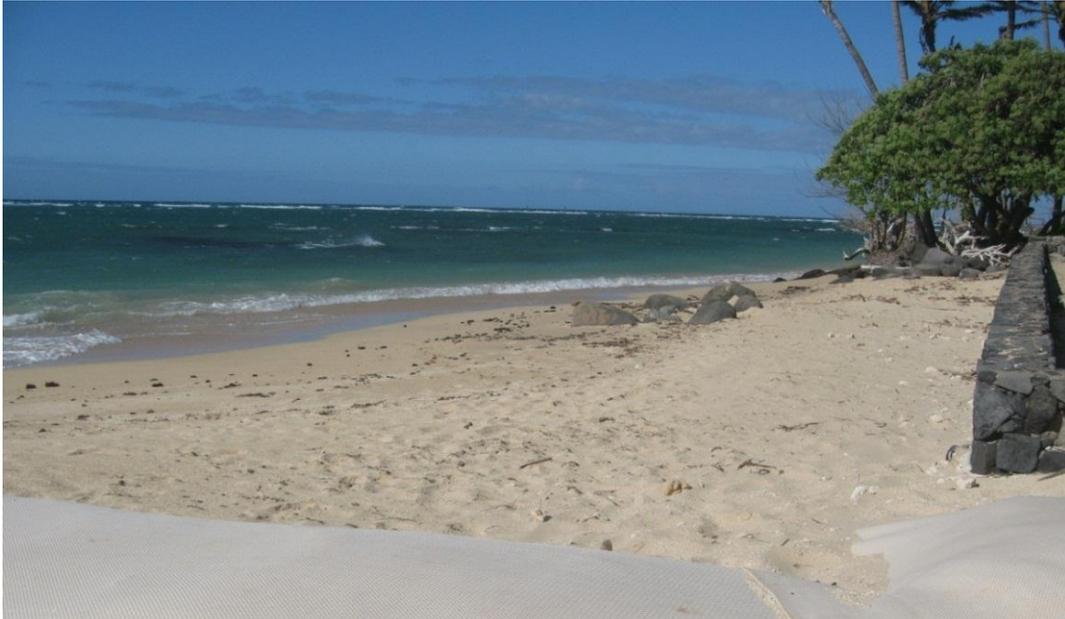
Beach Width and Beach Sand Volume - Updrift Area at Transect 12: There is a 70 foot long seawall in front of the tennis court on Lot A with rock piles in front of the seawall (see Appendix Photo 4 and Photos 18 and 19). Typically during the spring and summer seasons prior to the Project groins, the seawall had no beach in front due to beach scouring and sand loss from northeasterly trade wind waves and longshore sand transport currents. During previous years,

the bottom of the seawall footing became exposed and undermined during the spring/summer.

Photo 18 - Updrift Beach Area at Transect 12 Showing Seawall at Right and Rock Pile at Beach, 29 August 2010

Assessment: The Dry Beach Width measurements and Dry Beach Sand Volume calculations at transect 12 have varied seasonally with a 44% and 68% increase respectively after two and one half years per Figures 12 and 13, which are also confirmed by Photos 18 and 19. In the last two and one half years, there has been no exposed foundation and no significant erosion at transect 12; whereas the historic, Annual Erosion Hazard Rate from 1960 to 2001 at transect 12 was 1.5 feet per year (see Figure 15).

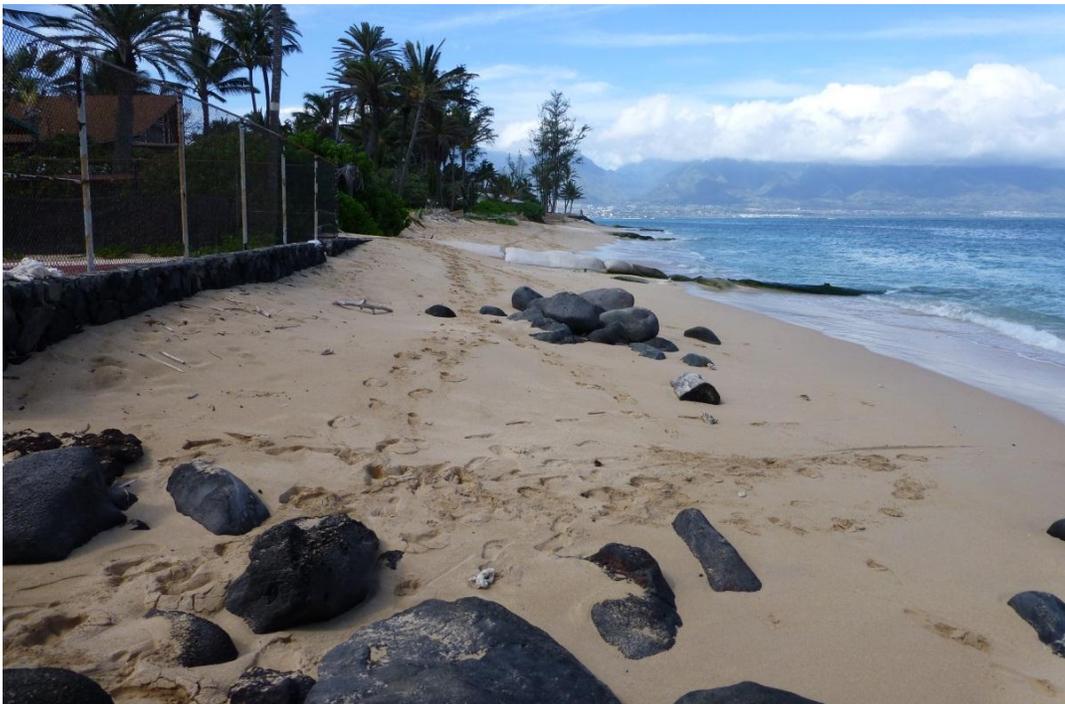
Photo 19 - Updrift Beach Area at Transect 12 Showing Seawall at Left and Top of Rock Pile at Beach, 3 October 2012

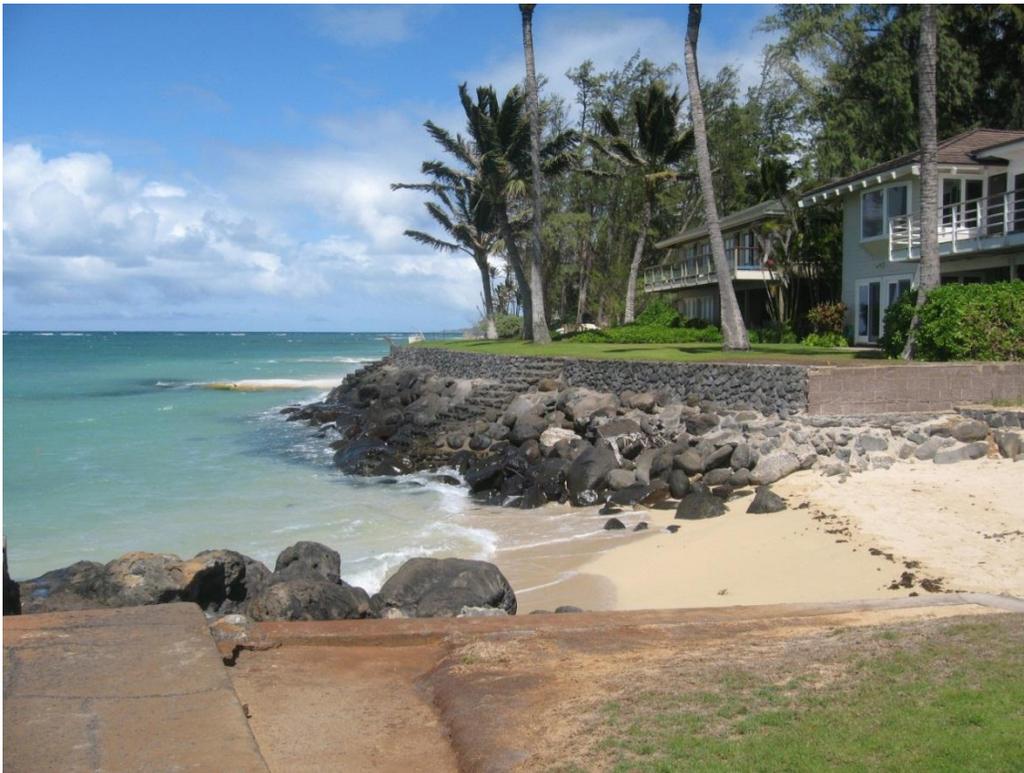
Photo 20 - At Transect 3 Near End of Seawall and Updrift Beach Cove With Perimeter Seawall, 17 August 2010

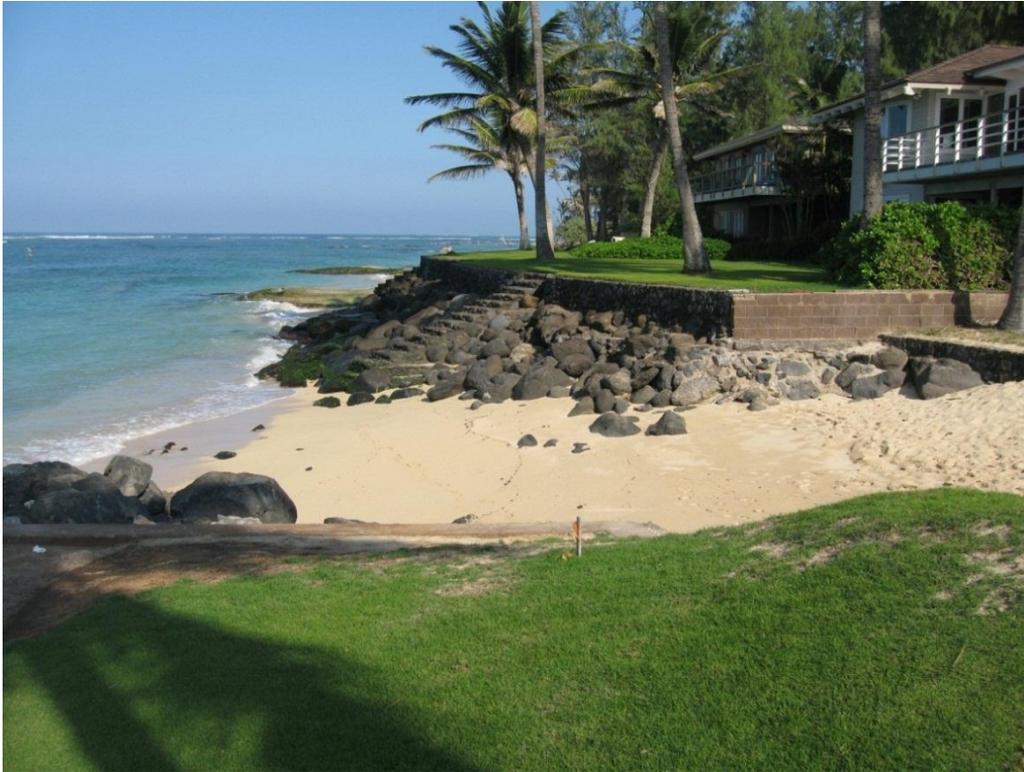
Photo 21 - At Transect 3 Near End of Seawall and Updrift Beach Cove With Perimeter Seawall, 13 December 2010

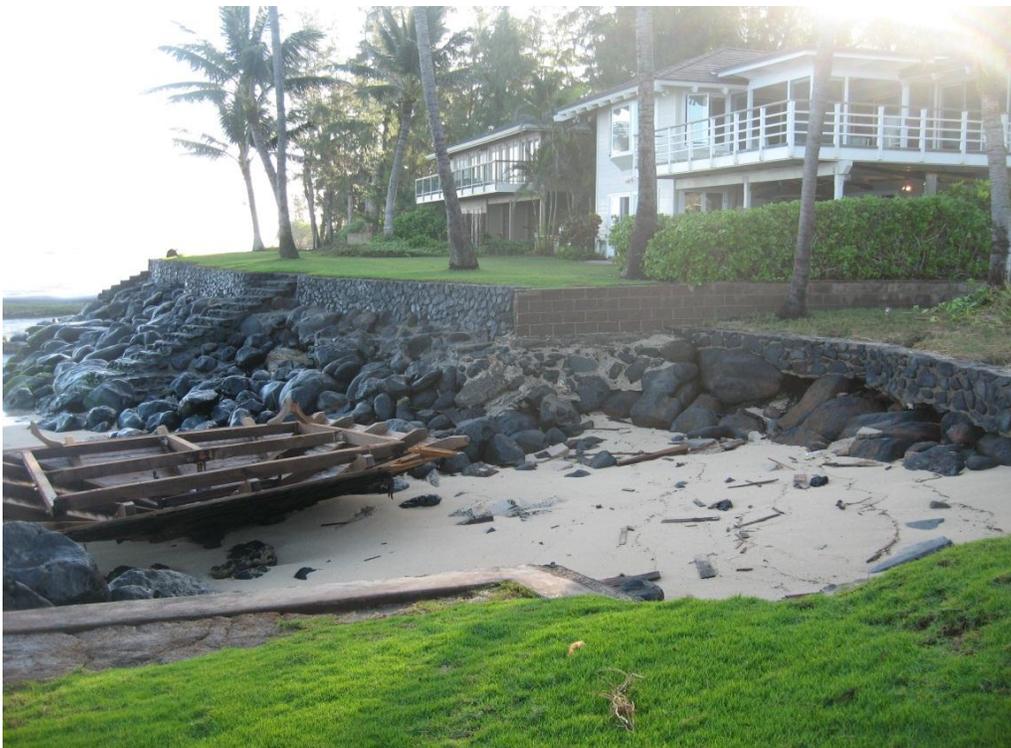
Transect 3 is located immediately downdrift of the Project Area and is approximately 160 feet from the nearest Project groin. Transect 3 is located approximately 20 feet west of the east end of a long seawall extending westerly, and there are rock piles in front, to the east and to the west of transect 3, which were formerly groins (see 1940 Appendix Photo 9). Immediately updrift of transect 3 to transect 4 is a small, sand beach cove approximately 50 feet wide with a perimeter seawall set back inland of the westerly seawall and the easterly revetment. This updrift beach cove did not significantly changed in its appearance of Beach Width and Beach Sand Volume during the 2010 summer and fall plus 2011 early winter seasons (see Photos 20 and 21), but it lost considerable Beach Sand Volume from the 11 March tsunami during the late 2011 winter season (see Photo 22). During the 2011 spring season, the beach cove re-gained considerable Dry Beach Width and Beach Sand Volume nearshore (see Photo 23); however, some ground under the perimeter seawall was still exposed, which was caused by the tsunami tidal waves undermining this wall upon impact and removing the sand below (see Photo 22). During the 2011

Photo 22 - At Transect 3 Near End of Seawall and Updrift Beach Cove with Perimeter Seawall, 11 March 2011- Immediately Post-Tsunami

There has been no Beach Width or Beach Sand Volume reduction post-construction at transects 3 and 4, and there has been an increase in Beach Width and Beach Sand Volume at transect 4 (see Tables 1 and 2). The beach cove lost considerable sand during the 11 March 2011 tsunami (see Photo 22), which was caused by cross shore tidal waves hitting the cove's perimeter seawall and reflecting back, thereby removing beach sand to the ocean in the process. The beach cove regained considerable sand volume during the normally erosive 2011 spring season (see Photo 23), thus indicating no adverse groin field effect on downdrift beach erosion.

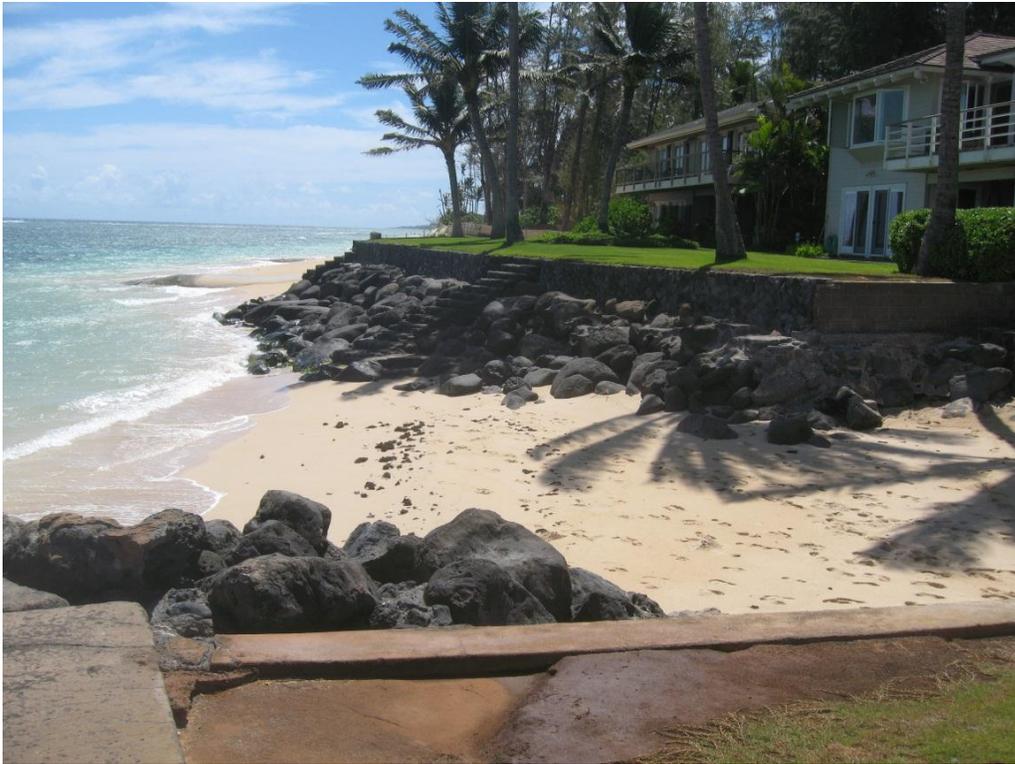
Photo 23 - At Transect 3 Near End of Seawall and Updrift Beach Cove with Perimeter Seawall, 29 June 2011

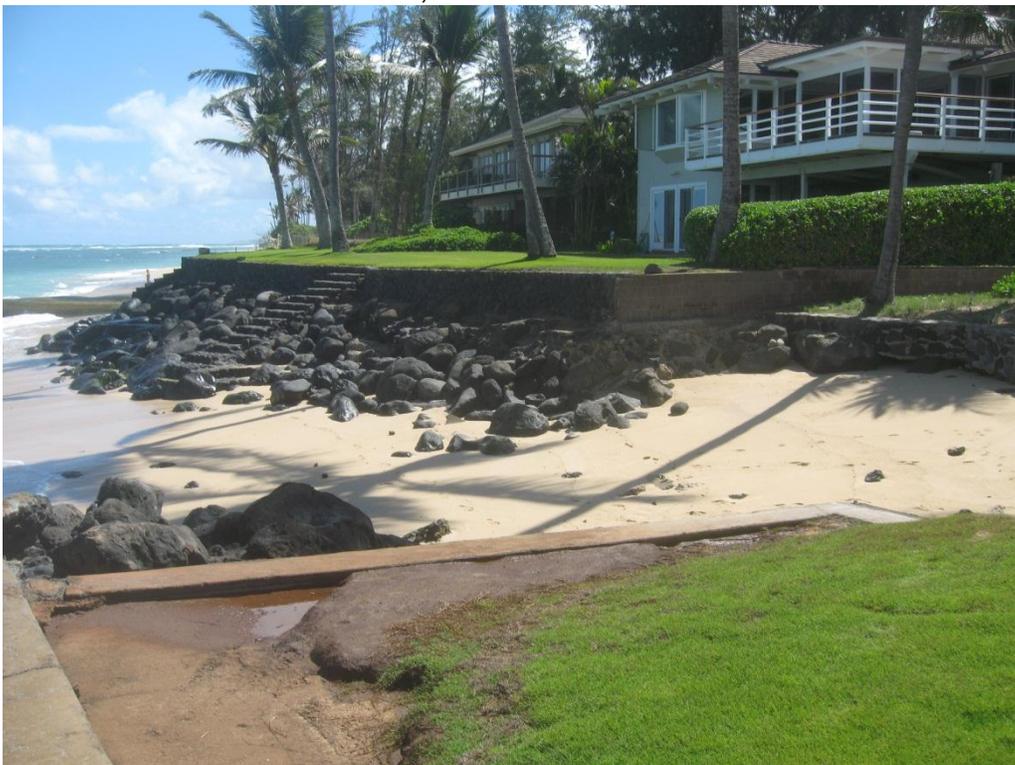
summer season, the beach cove gained sand initially and then lost sand in September with the return of a few north Pacific swells (see Photo 24). During the 2011 fall/ 2012 winter seasons, there was little change in the beach cove; however, sand returned to under the perimeter seawall (see Photos 25 and 26).

Photo 24 - At Transect 3 Near End of Seawall and Updrift Beach Cove with Perimeter Seawall, 1 October 2011

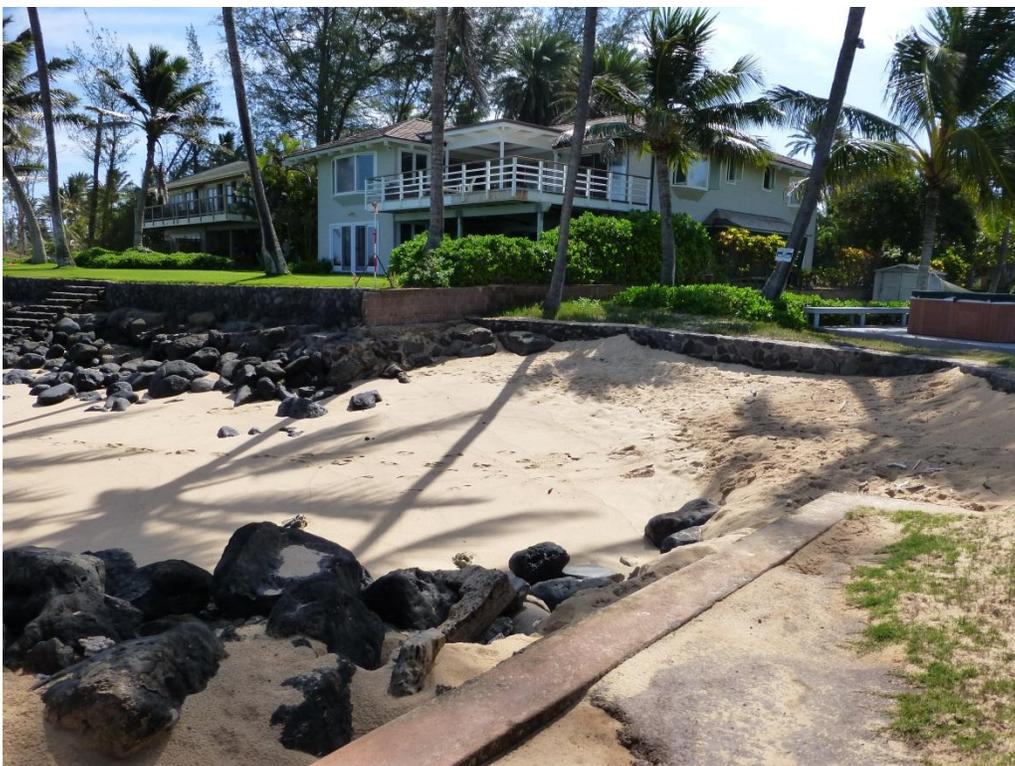
Photo 26 - At Transect 3 Near End of Seawall and Updrift Beach Cove with Perimeter Seawall, 3 October 2012

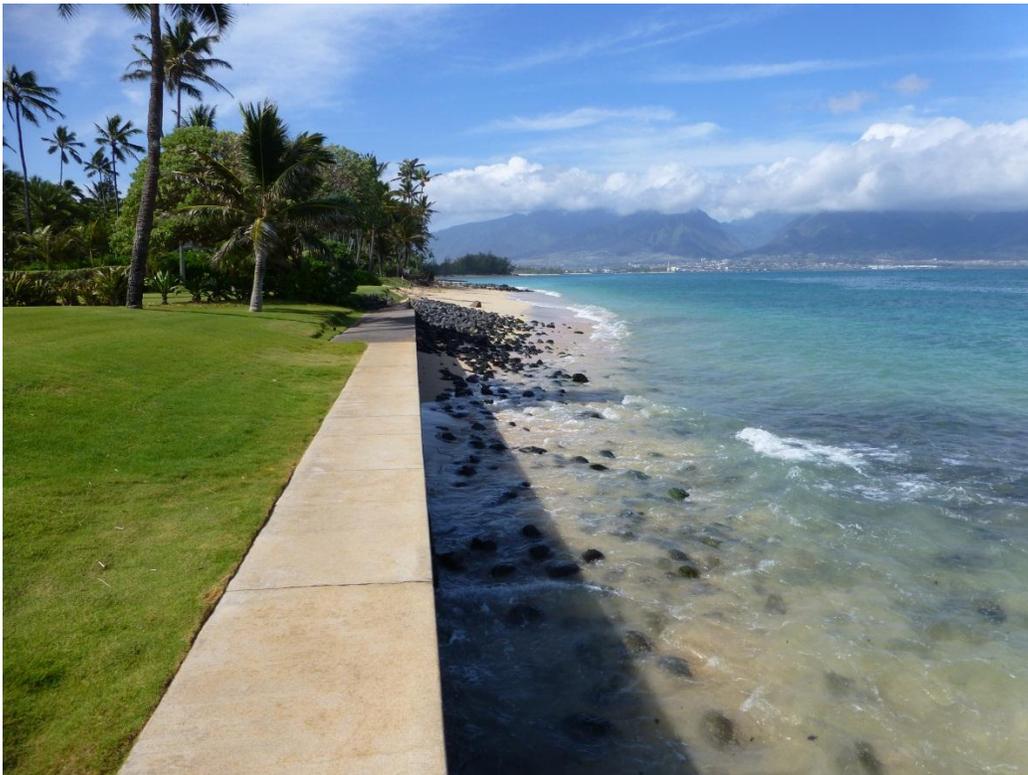
Transect 2 is located approximately 160 feet downdrift and east of transect 3 and 180 feet west of the seawall end with a continuous seawall in between to the east. There is another 280 feet of seawall downdrift and west of transect 2 to Parcel 25 (see Appendix Photo 5 plus Photos 27 and 28), so transect 2 is near the middle of a 460 foot long, continuous seawall. There are several rock piles in front of the long seawall including large revetment type piles both sides of transect 2 (see Appendix Photos 5 and 8), and the rock plies were formerly rock groins per the 1940 aerial photograph (see Appendix Photo 9).

Photo 27 - Near Transect 3 Looking West Along Continuous Seawall with Large Rock Pile/Revetment at Transect 2 Beyond, 3 October 2012

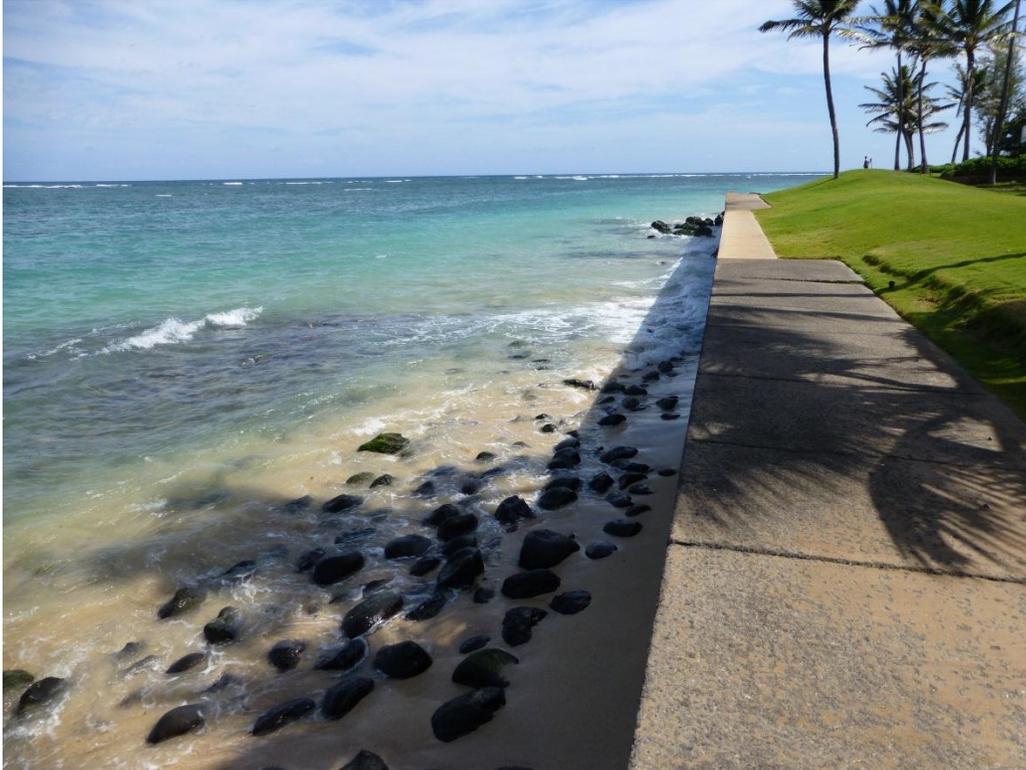
Photo 28 - Near Transect 2 Looking East Along Continuous Seawall with Large Rock Pile/Revetment Toward Transect 3 Beyond, 3 October 2012

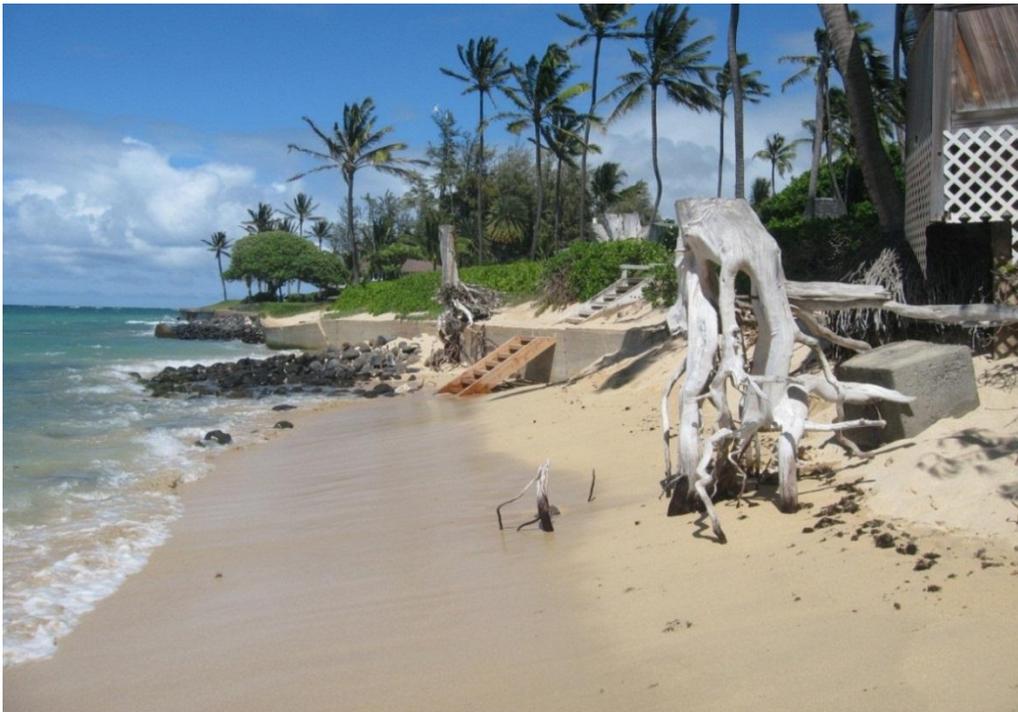
Photo 29 - Beach, Rock Groin and Seawall at West Half of Lot 1 and Parcel 25 (in Foreground) Near Transect 1 (at Stair), 17 August 2010

Photographic data visually shows the tsunami effect at transect 1. The most significant 2010 spring/summer beach sand loss at transect 1 in 2010 had occurred by mid-August, and the 17 August 2010 beach photograph (see Photo 29) shows 7 treads exposed at the lower stair located below the seawall at transect 1. Sand returned to this beach during the 2010 fall season, and as of 17 December 2010 only 2 treads were exposed at the same stair (see Photo 30). Also as of 17 December, sand was mostly covering the old rock groin

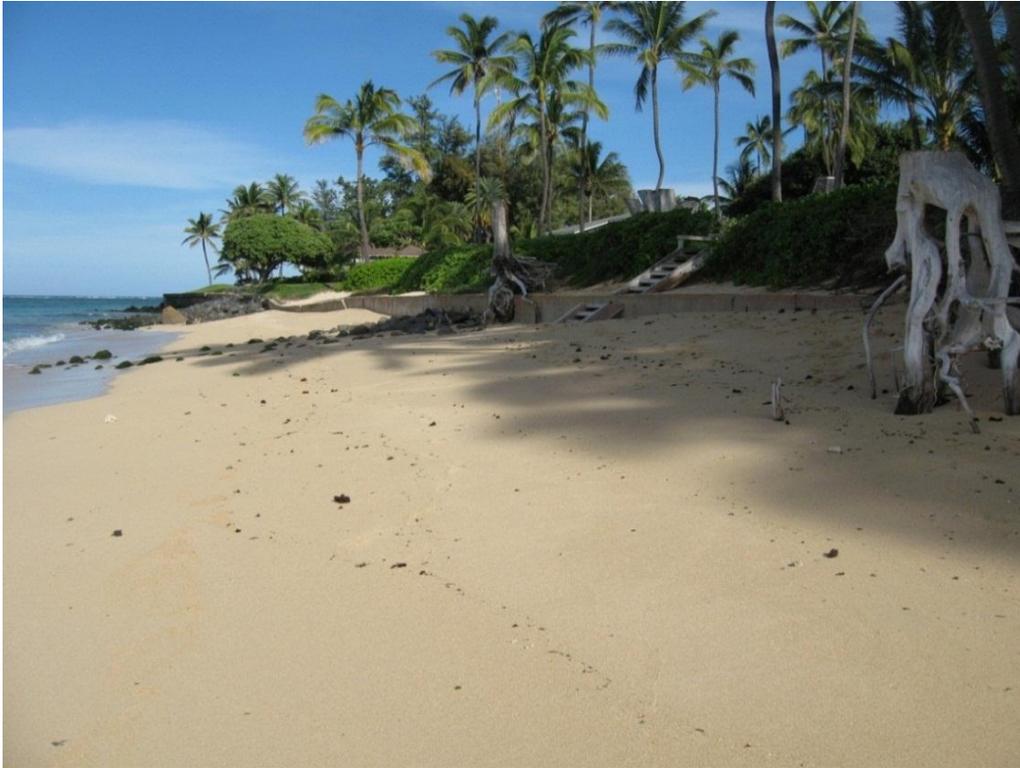
Photo 30 - Beach, Rock Groin and Seawall at West Half of Lot 1 and Parcel 25 (in Foreground) Near Transect 1 (at Stair), 17 December 2010

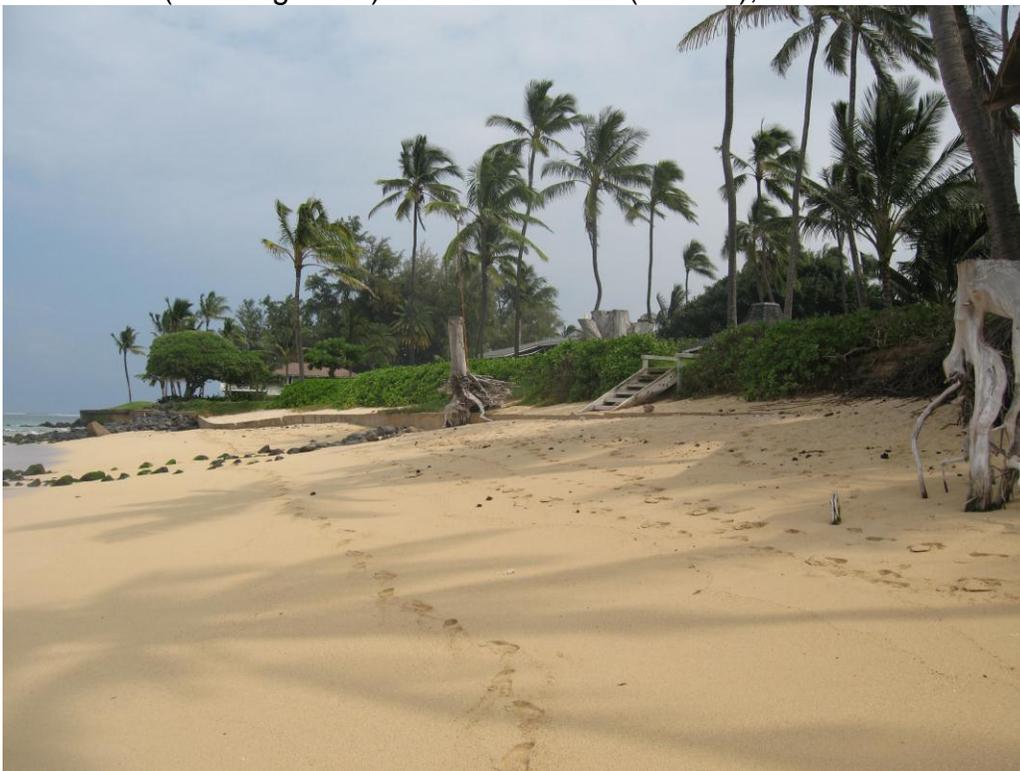
Photo 31 - Beach, Rock Groin and Seawall at West Half of Lot 1 and Parcel 25 Near Transect 1 (at Stair), 11 February 2011 - Pre-Tsunami

immediately east of transect 1 as well as the seawall portion to the east. Sand also returned to this beach during the first two months of the 2011 winter season by 11 February when no lower stair treads were exposed (see Photo 31), and the average height of the seawall across Lot 1 was approximately .75 feet. The subsequent 11 March tsunami removed sand from this beach when 3 treads of the lower stair were exposed on March 11 (see Photo 32); however, a significant volume of sand returned to the beach after the tsunami a month later by 9 April (see Photo 33) when the top of the seawall west of transect 1 and the lower stair were no longer exposed. The tsunami did not push much sand from this beach onto the land at this location as it did Within the Project Area, so the sand removed from the beach by the tsunami was dispersed in the ocean.

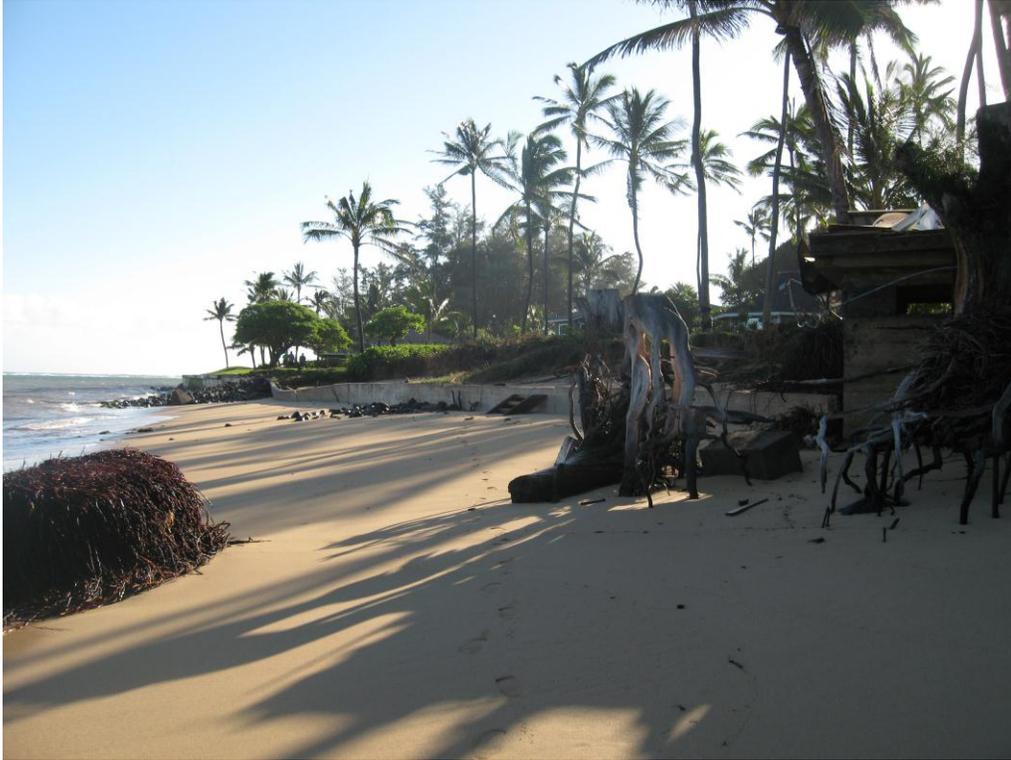
Photo 32 - Beach, Rock Groin and Seawall at West Half of Lot 1 and Parcel 2 Near Transect 1 (at Stair), 11 March 2011 Immediately Post-Tsunami
