SUBJECT: Final Environmental Assessment (EA) for Conservation District Use Application (CDUA) MA-3633 for the Stable Road Beach Groins Project Located Upon Submerged Land Offshore of Spreckelsville, Maui, Makai of TMK:(2) 3-8-002:71, 74, 77 & 78

STABLE ROAD BEACH GROINS REPLACEMENT PROJECT

15 December 2012

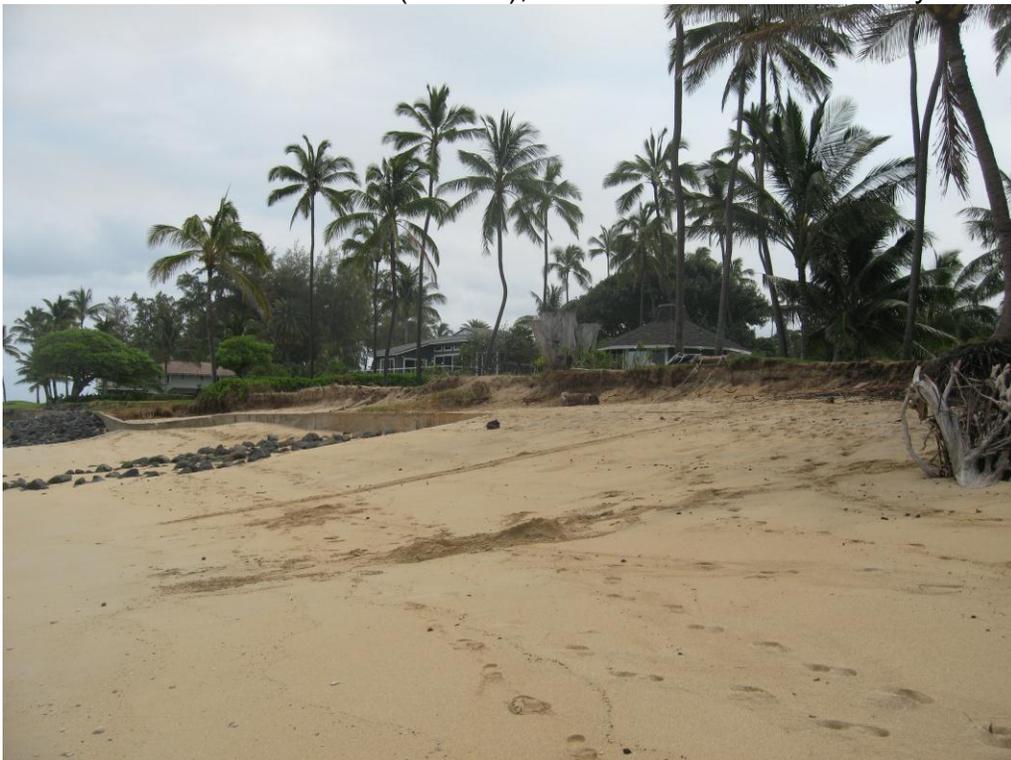
Photo 33 - Beach, Rock Groin and Seawall at West Half of Lot 1 and Parcel 25 Near Transect 1 (at Stair), 9 April 2011 - Post-Tsunami

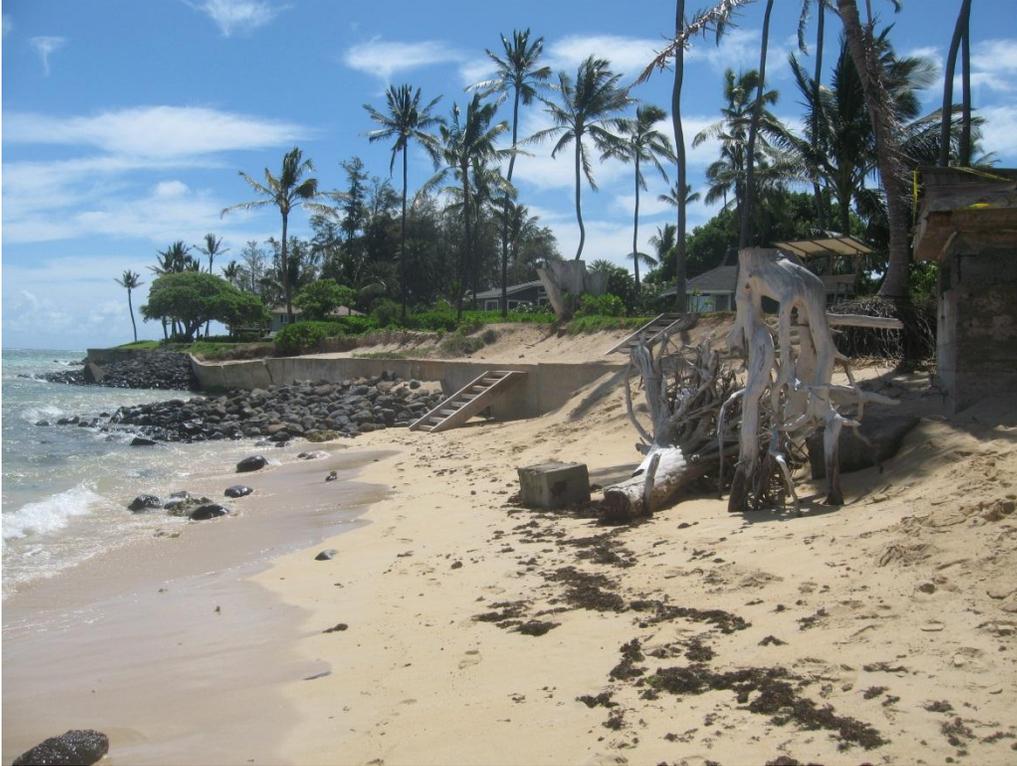
Photo 34 - Beach, Rock Groin and Seawall at West Half of Lot 1 and Parcel 25 Near Transect 1 (at Stair), 29 June 2011

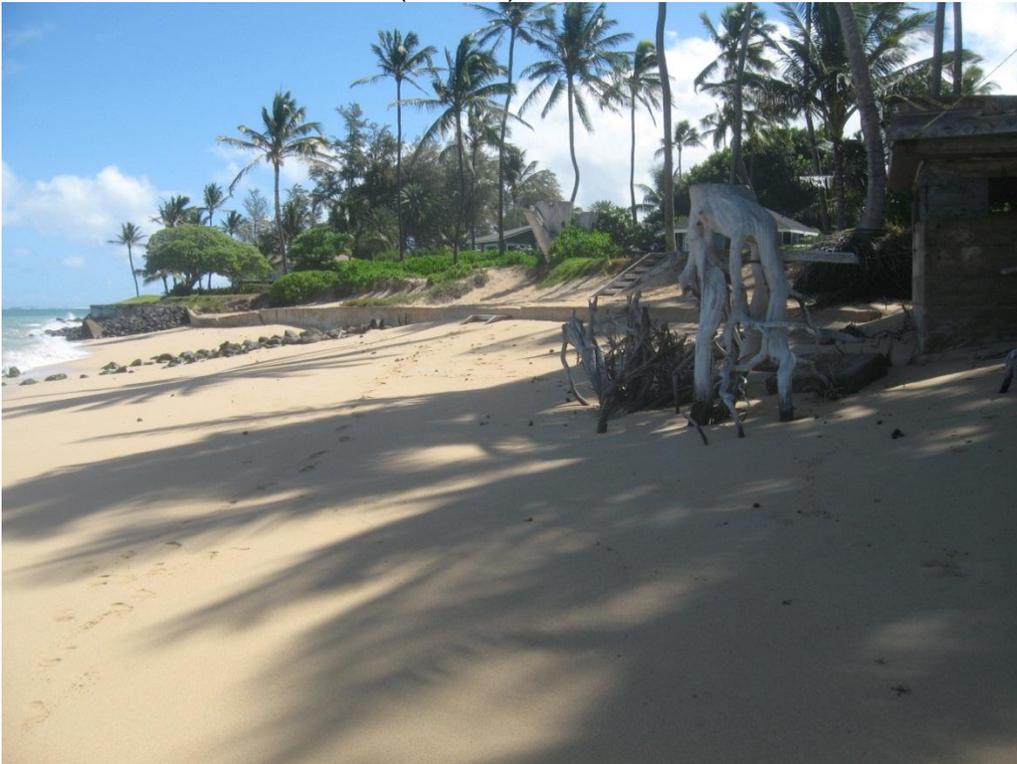
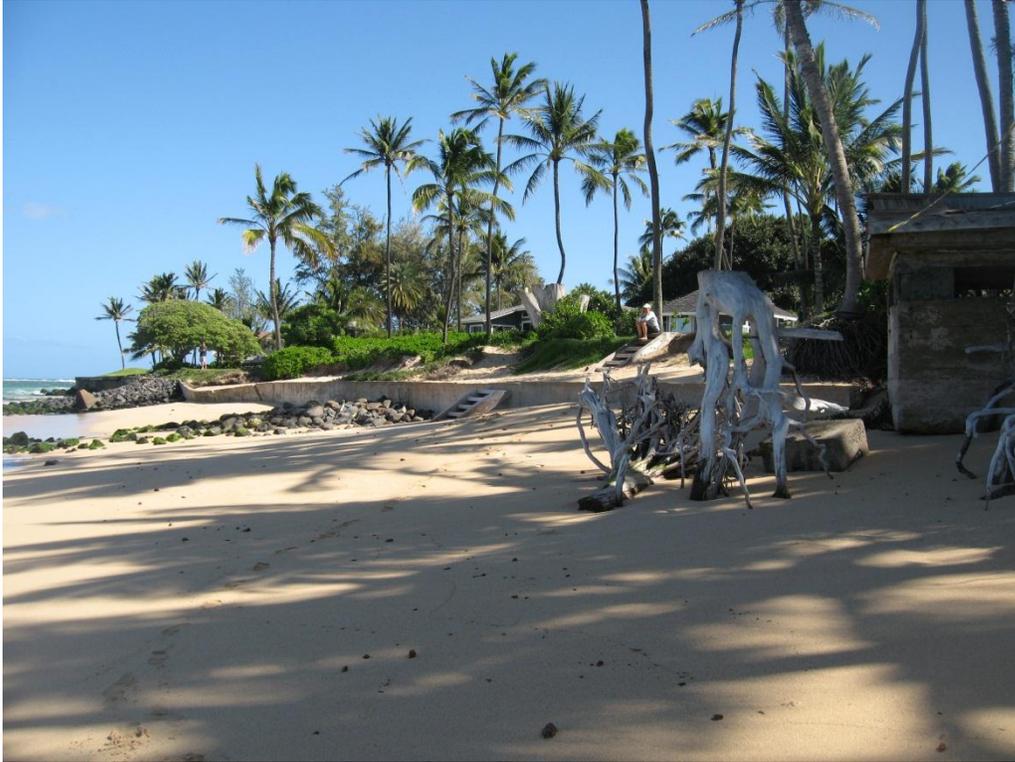
Photo 35 - Beach, Rock Groin and Seawall at West Half of Lot 1 and Parcel 25 Near Transect 1 (at Stair), 1 October 2011

Photo 36 - Beach, Rock Groin and Seawall at West Half of Lot 1 and Parcel 25 Near Transect 1 (at Stair), 29 December 2011

It was anticipated that during the 2011 fall/2012 winter seasons, north Pacific waves would again dominate light trade wind weather as they did during the last two fall/winter seasons, and the beach would gain sand; however, the weather fluctuated between periods of high trade winds causing erosion and periods of north Pacific waves causing accretion resulting in the beach at transect 1 to be generally unchanged and not gain sand during the 2011 fall/2012 winter seasons from the 2011 summer condition (see Photos 35 and 36).

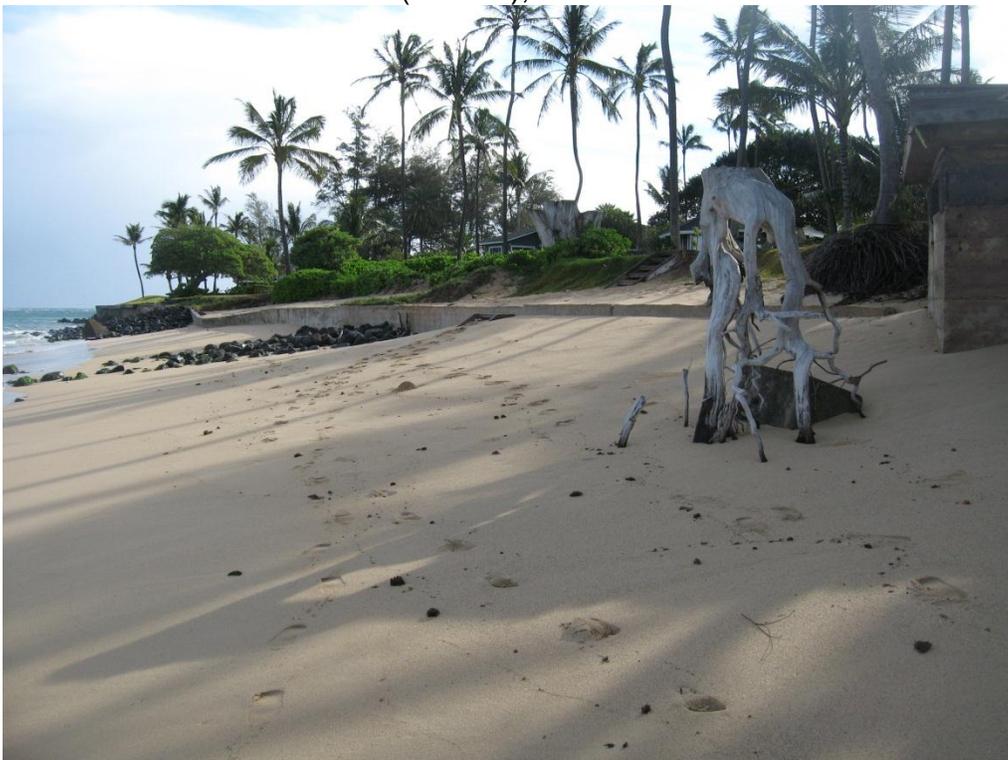
Photo 37 - Beach, Rock Groin and Seawall at West Half of Lot 1 and Parcel 25 Near Transect 1 (at Stair), 18 February 2012

Third Monitoring Year - During the 2012 spring/summer seasons, early, high trade winds started one month earlier than during the 2011 spring season; however, considerable sand returned to this beach during the 2012 spring and summer seasons (see Photos 38 and 39) with no lower stair tread exposed similar to the condition at the end of the 2012 winter season (see Photo 37).

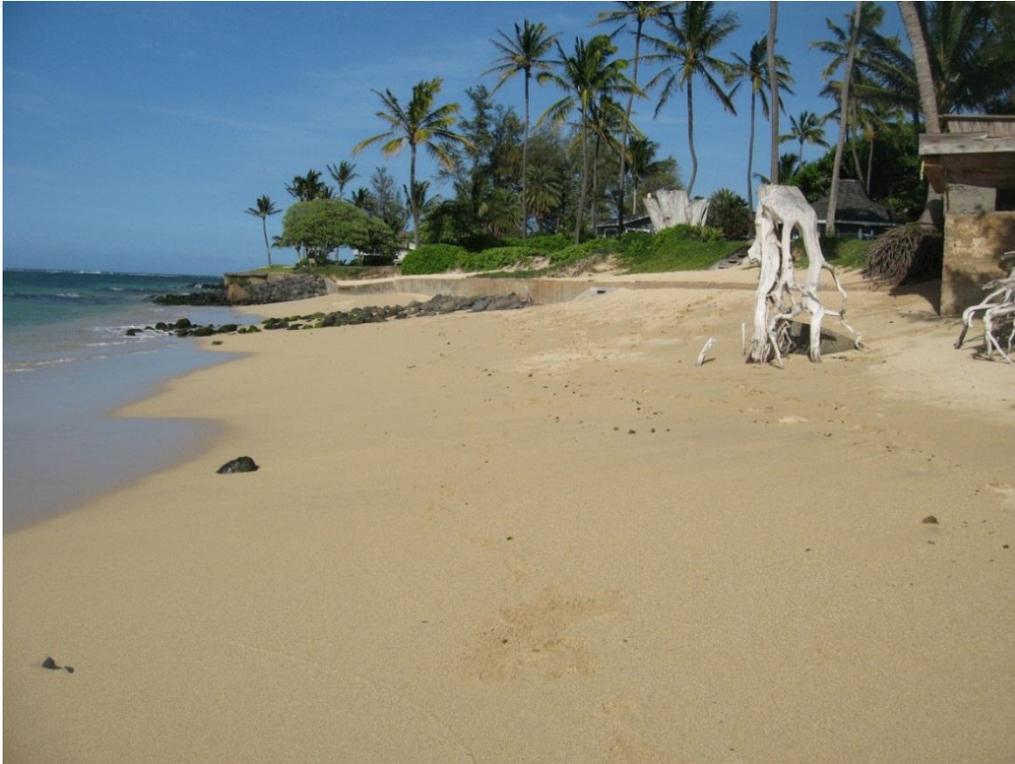
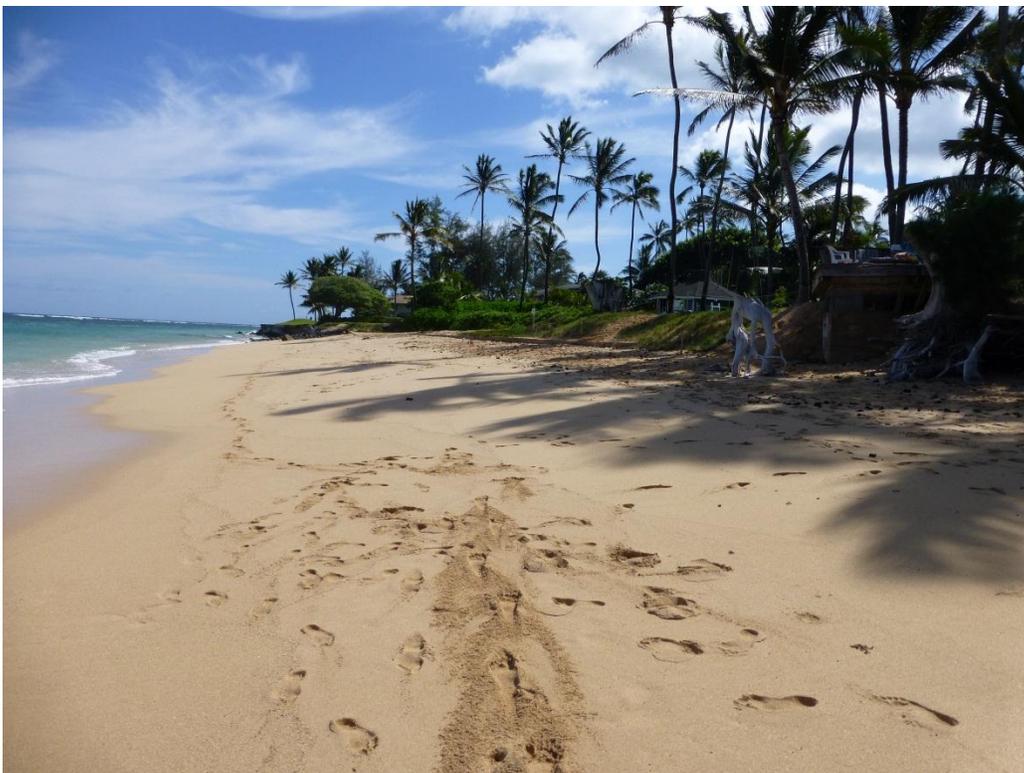
Photo 38 - Beach, Rock Groin and Seawall at West Half of Lot 1 and Parcel 25 Near Transect 1 (at Stair), 4 April 2012

Photo 39 - Beach, Rock Groin and Seawall at West Half of Lot 1 and Parcel 25 Near Transect 1 (at Stair), 3 October 2012

Recent photographs 29 through 39 show approximately 5 foot high, exposed roots of dead trees on the beach near transect 1 indicating a previously much higher beach with considerably more Dry Beach Width and Dry Beach Sand Volume historically in the past with a significant beach sand loss over time.

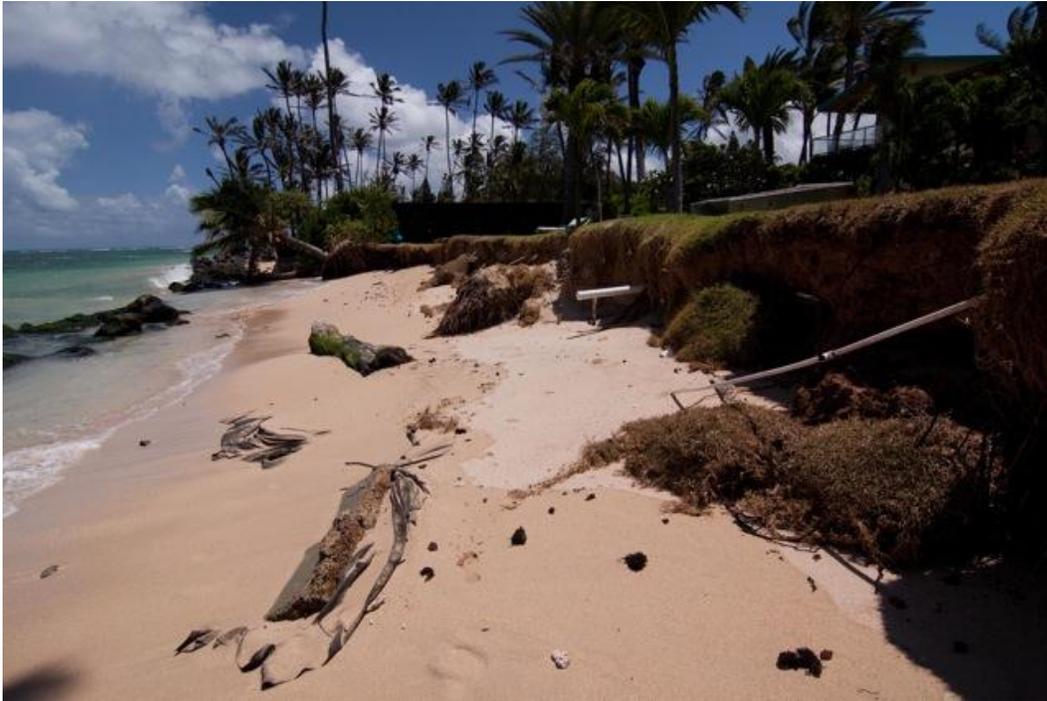
Photo 40 - East End of Project Beach, 4 August 2009

The Project Area pre-construction typically behaved as a littoral cell with spring/summer erosion starting at its east end from northeast trade winds (see pre-construction Photo 40), fall/winter erosion at its west end from north Pacific swells (see pre-construction Photo 2) and with sand migrating back and forth with seasonal weather changes. Post-construction during the 2010, 2011 and 2012 spring plus summer seasons, the east end of the Project Beach experienced minimal beach erosion and no land loss (see Photo 41), which is very unique compared to previous years of significant beach sand and land loss during the same time of year (see Photo 40).

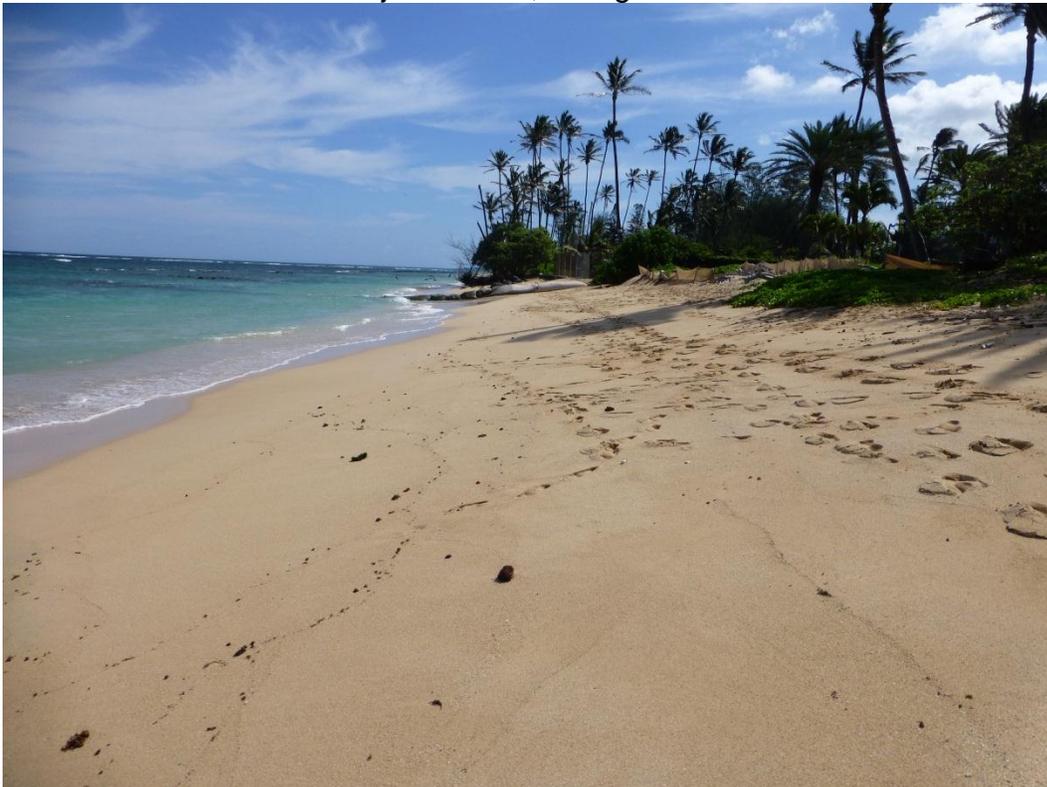
Photo 41 - East End of Project Beach, 3 October 2012

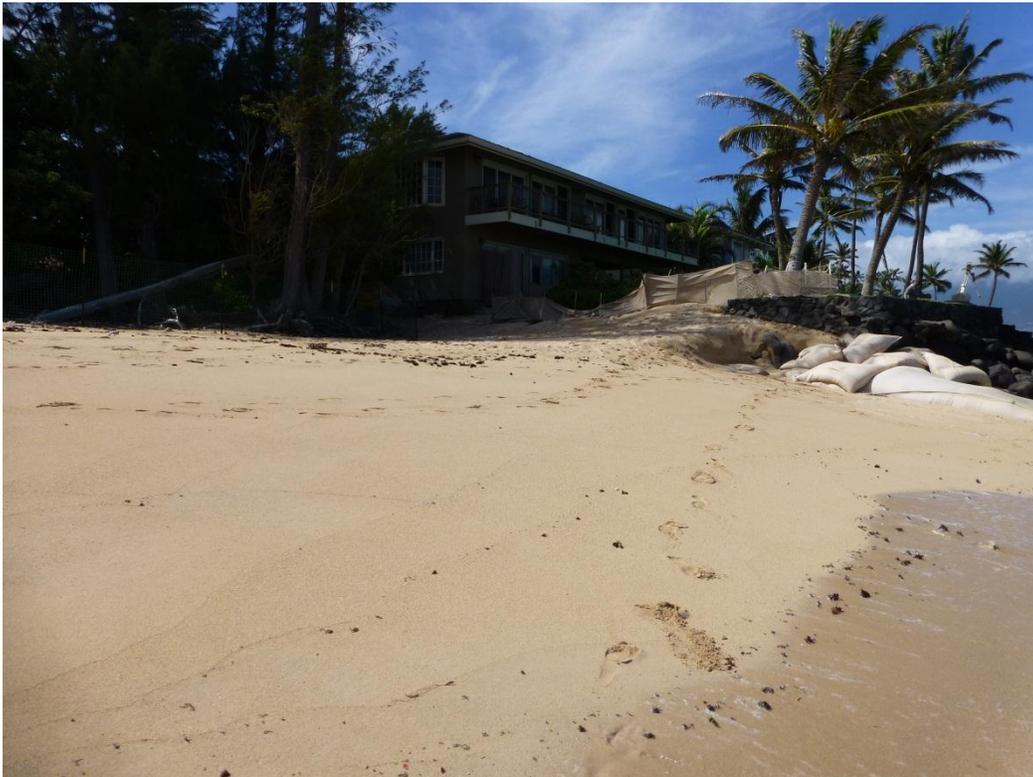
Photo 42 - West End of Project Beach, 3 October 2012

Post-construction during the 2010 fall and 2011 winter seasons, the west end of the Project Beach experienced minimal beach erosion and no land loss, except a minor amount from the 11 March tsunami, which is very unique compared to previous years of significant beach sand and land loss for the same time of year (see pre-construction Photo 2); plus it gained windblown sand during the 2011 spring and summer seasons (see Photo 42).

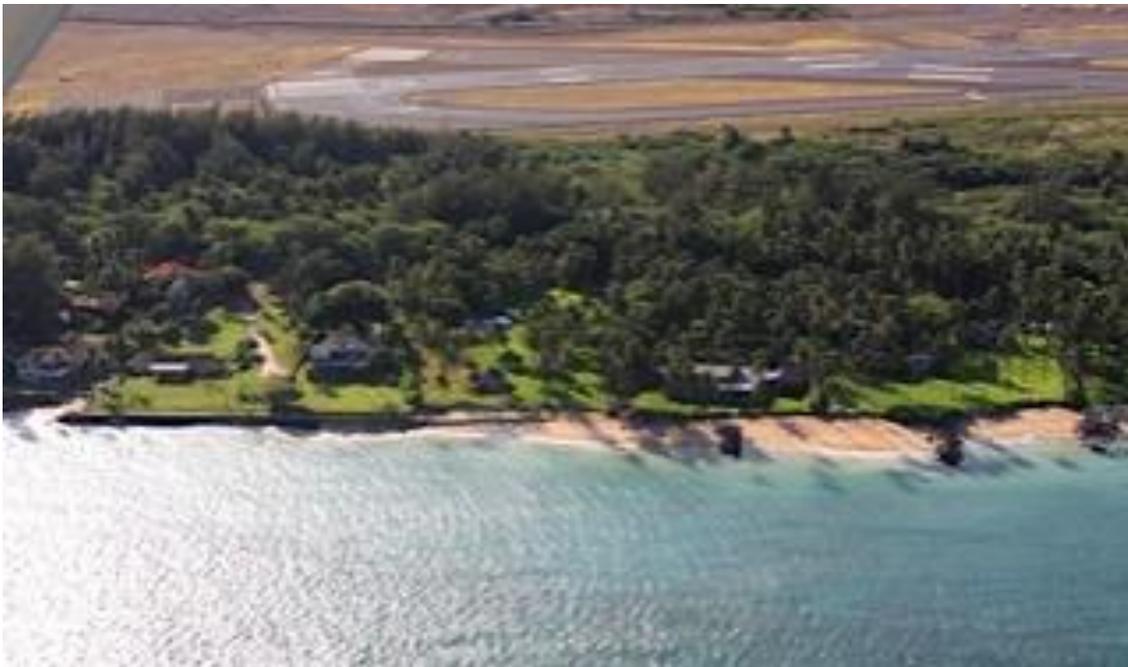
Photo 43 – Lot 2 Seawall Beach Loss and Beach Narrowing Immediately Downdrift at Transect 1, 5 October 2011

Seawall Effect on Beach Erosion Downdrift of Seawall - Seawalls have an increased erosion effect on immediate, downdrift beaches undergoing beach retreat, and the effect is more pronounced on beaches undergoing long-term retreat, due partly to a diminished beach width in front of the seawall and thus a decreased supply of sand sediment immediately updrift that may be transported longshore to downdrift beaches. The effect of the long seawall downdrift of the Project Area to the beach in front and downdrift of the seawall is a loss of beach in front of the seawall and a narrowing of the beach immediately downdrift of the seawall (see Photo 43).

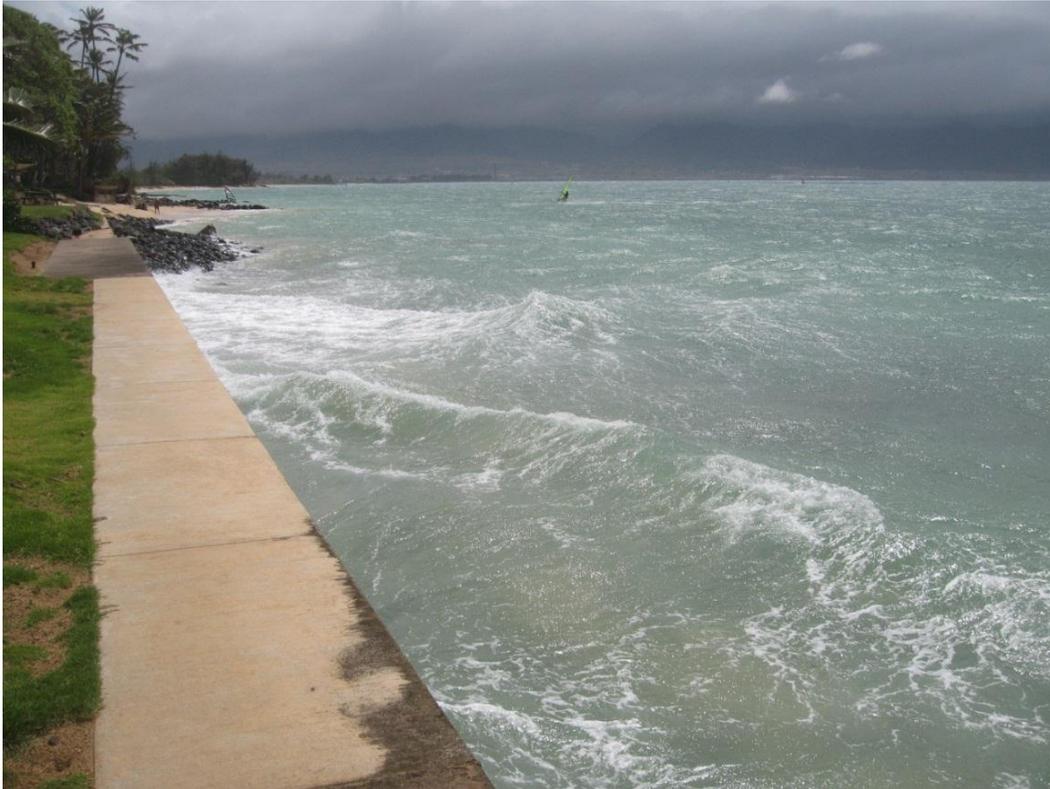
Photo 44 - Lot 2 Seawall Reflected Waves toward DOWNDRIFT BEACH at Transect 1, 10 June 2011

A contributing factor to downdrift beach loss is that the swash reflected by a seawall is directed seaward several seconds earlier than swash on the adjacent natural beach. This increases the backwash duration and velocity, which as a result increases the offshore transport of sand from the downdrift beach since the waves originate from updrift and reflect downdrift offshore (see Photo 44) (Tait

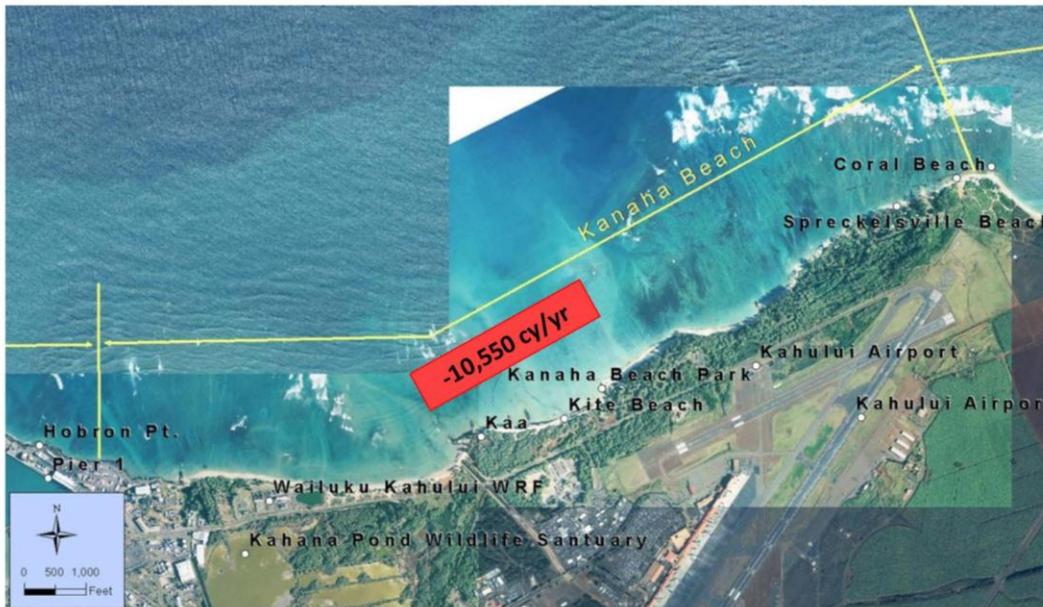
Figure 16 – Kanaha Littoral Cell Annual Beach Sand Volume Loss Map

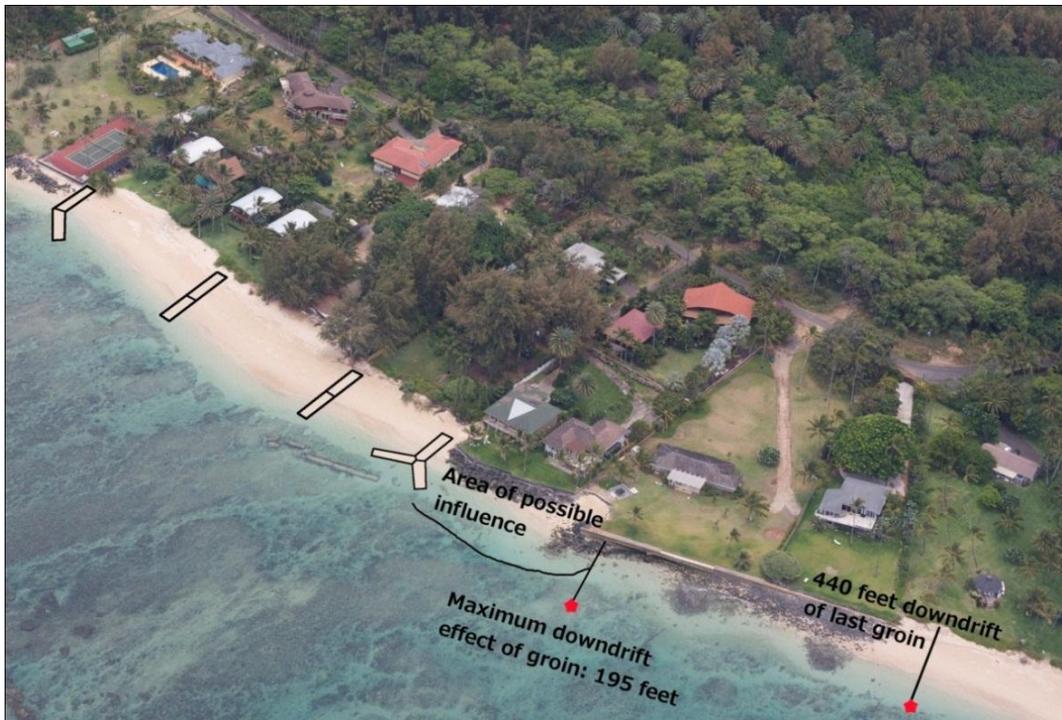
Figure 17 - Maximum Downdrift Effect of Project's Closest Groin

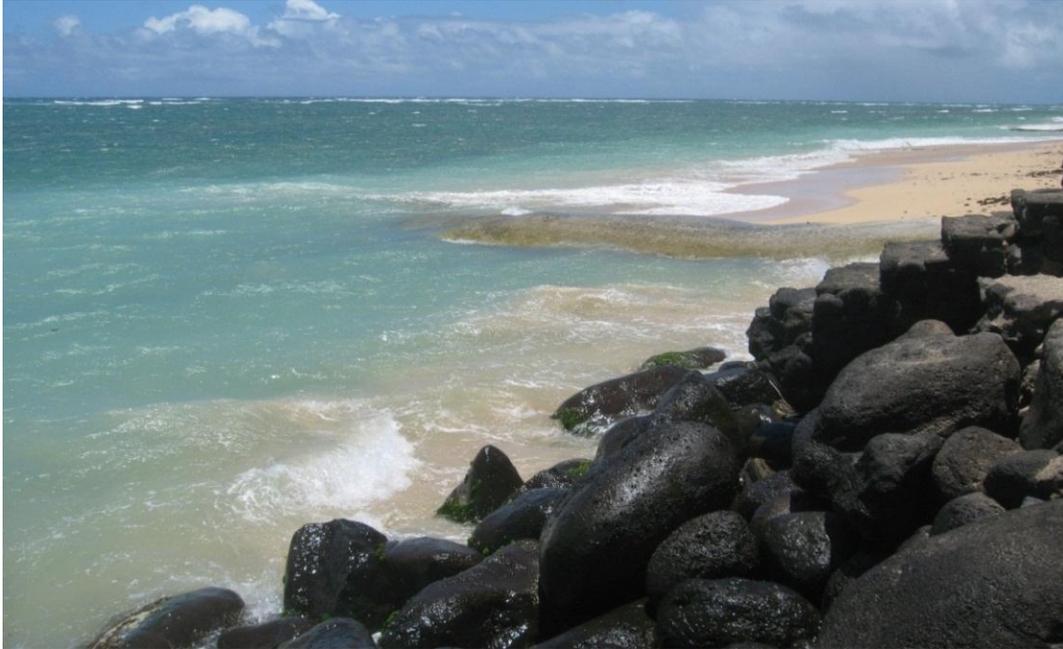
Photo 45 - Longshore Sand Transport Downdrift Over and Around Project's West End Groin, 10 June 2011

One of the downdrift residents claimed on 2 June 2011, the Project's west end terminal groin was trapping sand on the Project Beach and thus stopping longshore sand transport during the summer to the downdrift beaches. A photograph taken on 10 June shortly thereafter (see Photo 45) shows this groin and longshore sand transport with nearshore sand suspended in the water around, at the end and immediately downdrift of the groin near the rocks; the beach sand the same level as the top of the groin at its updrift side allowing water and sand to overflow the top of the groin; and the groin's easterly angled, seaward end totally submerged at a mean tide level. This is similar to the condition at the same location during the 2010 spring and summer seasons.

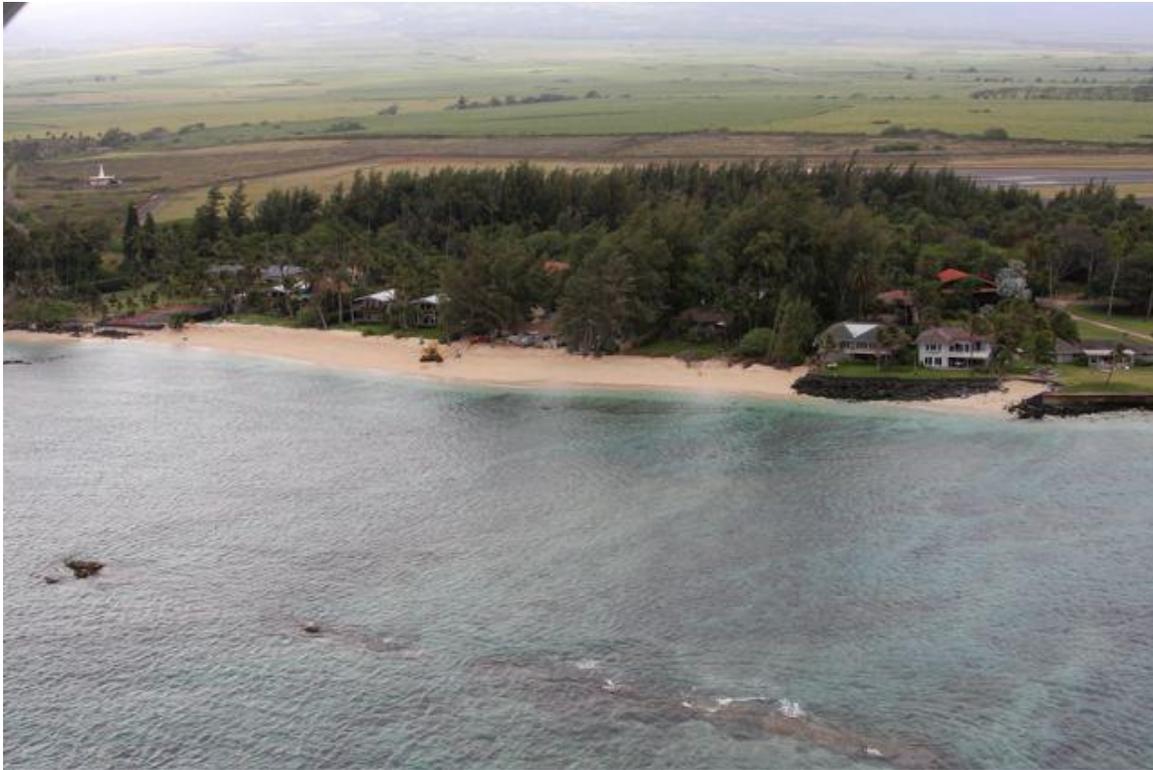
Photo 4 – Aerial View of Project and Updrift Areas Pre-Construction Showing Rock Pile in Front of Updrift Seawall at Left, 15 April 2010

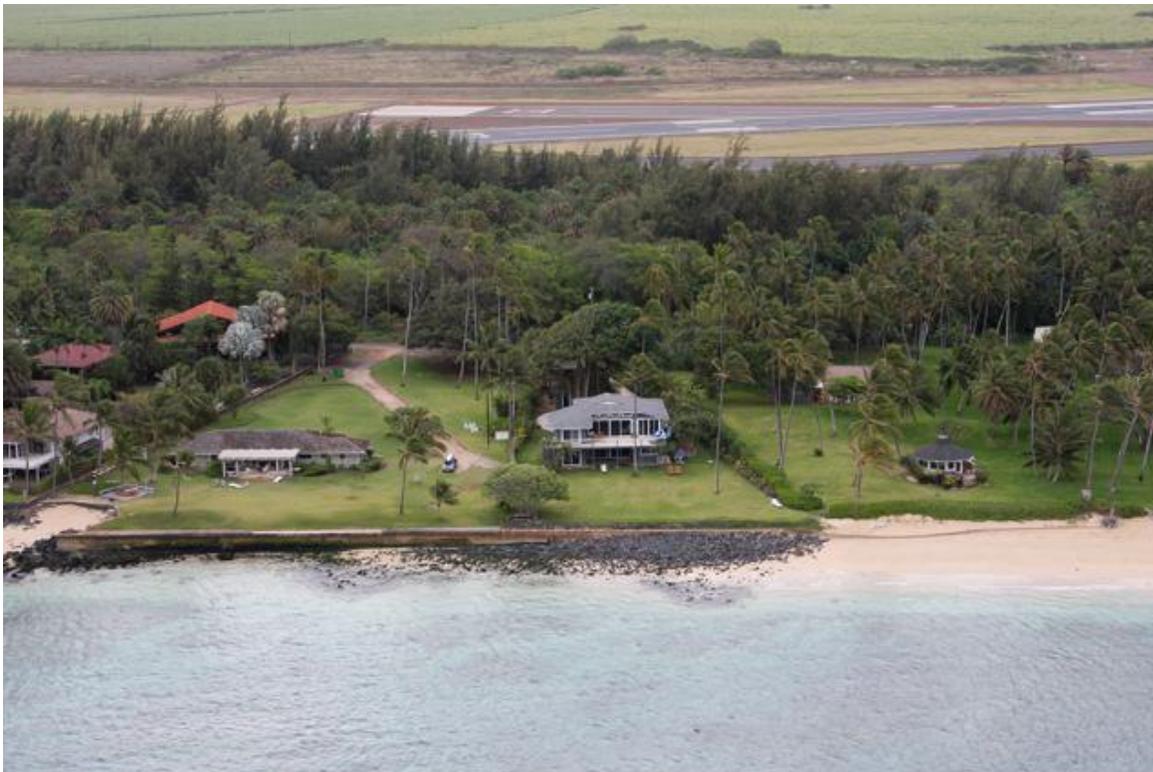
Photo 5 – Aerial View of Downdrift Area Pre-Construction Showing Lot 2 Seawall at Left, Lot 1 Seawall at Center and Transect 1 Beach at Right, 5 October 2010

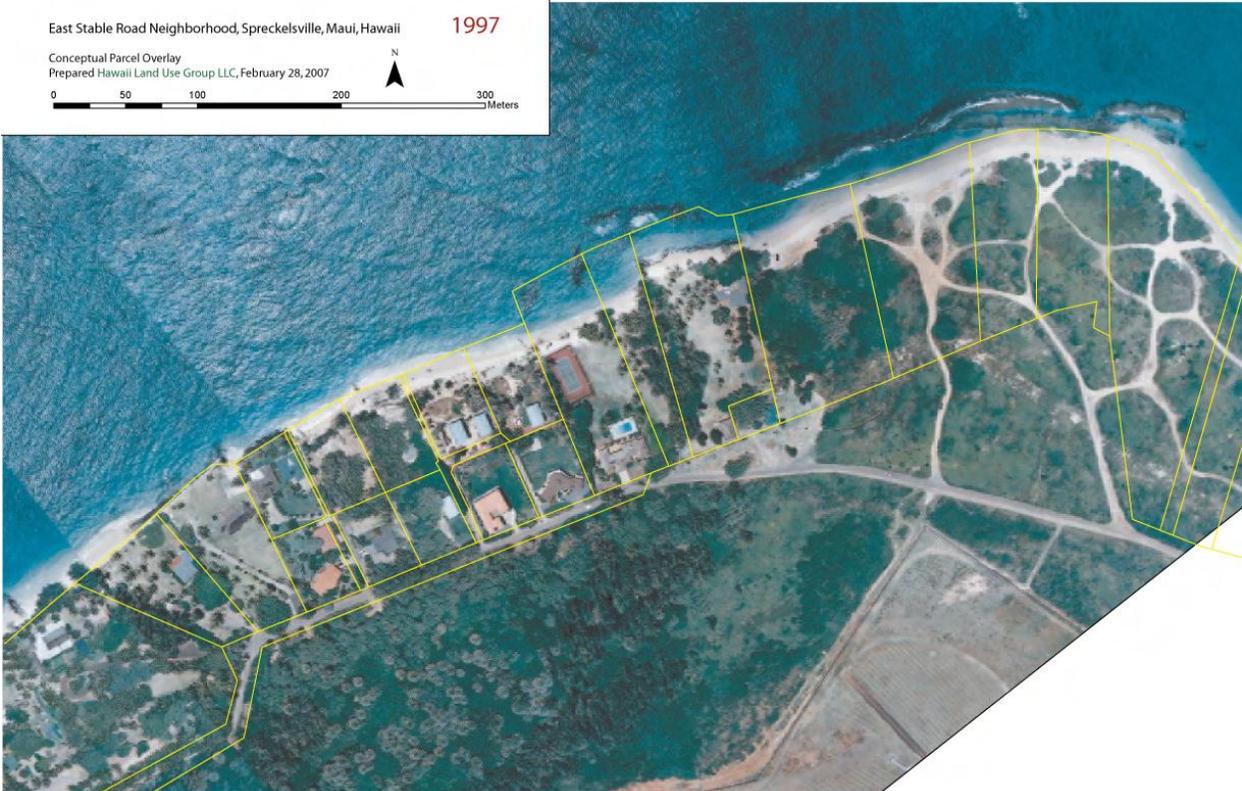
Photo 12 – Aerial View Showing No Beach in Front of Downdrift Lot 2 Seawall, May 1997

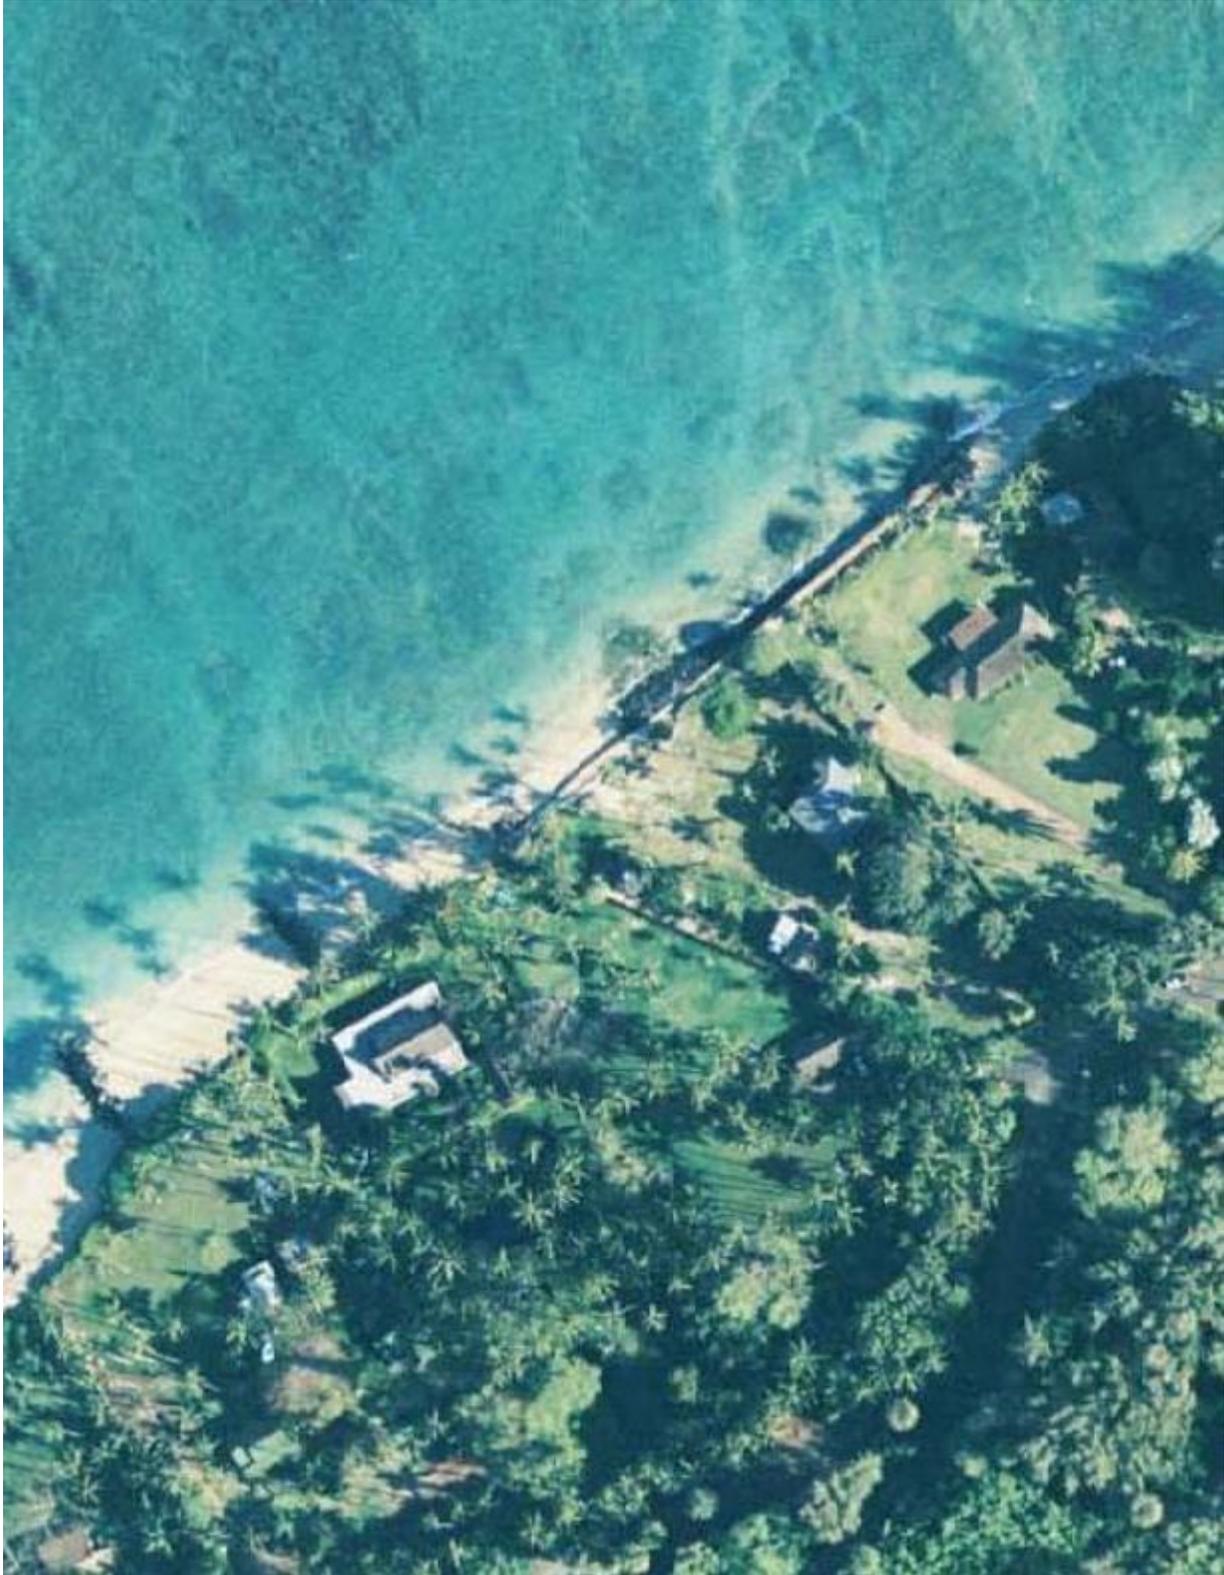
Photo 13 - Aerial View Showing Exposed Seawall Length, Height and Shadow in Front of Downdrift Lots 1 and 2, February 2002

The February 2002 aerial photograph (see Appendix Photo 13) taken at the end of the normal fall/winter accretion seasons, does show the exposure of the top of the seawall for its length across Lots 1 and 2 to Parcel 25 as evidenced by its shadow. The height of the seawall in front of easterly Lot 2 is approximately 7.2 feet above mean sea level. By comparing the scale of the height of the seawall shadow in front of Lot 1 to that of Lot 2, the seawall at Lot 1 was exposed approximately 1.5 to 2 feet in height during February 2002, which is historically and seasonally comparable to the beach condition post-construction during the 2011 and 2012 winter seasons in February (see Photos 31 and 37), especially considering the Annual Hazard Erosion Rate of .5 feet (see Figure 15). Exposure of the seawall indicates lower beach height and thus decreased Beach Sand Volume.

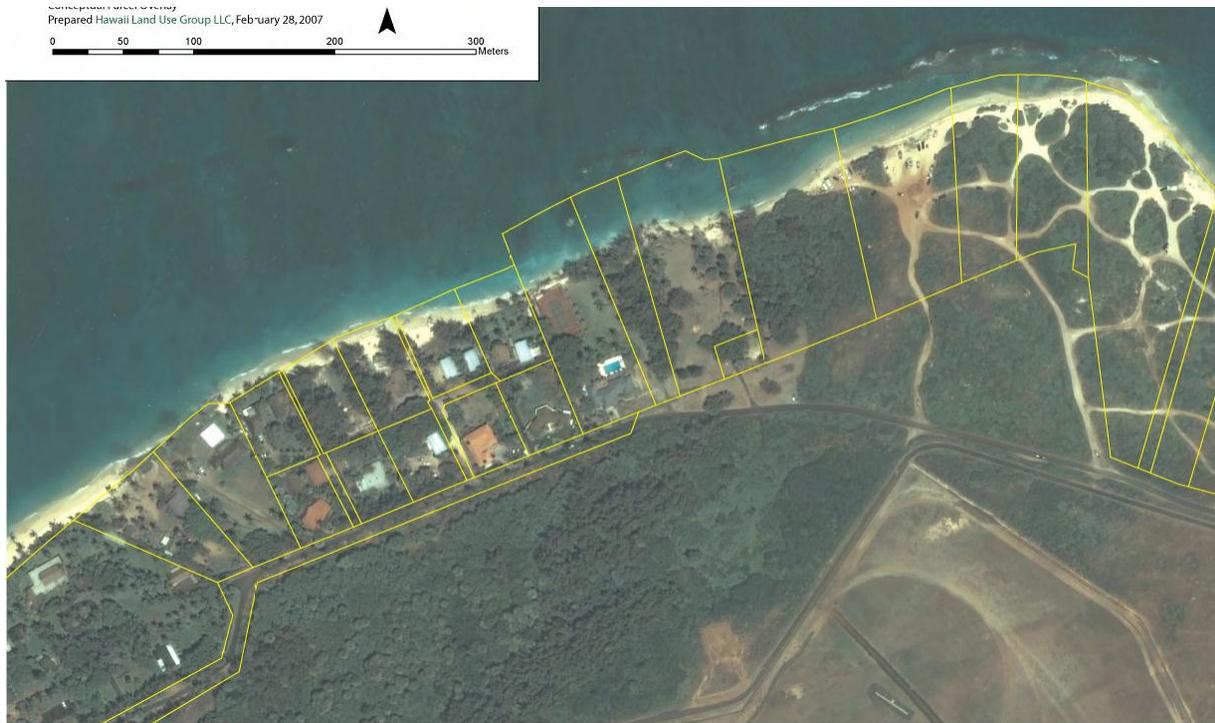
Photo 14 – Aerial View Showing No Beach at Downdrift Lot 2 and East Half of Lot 1, 2005

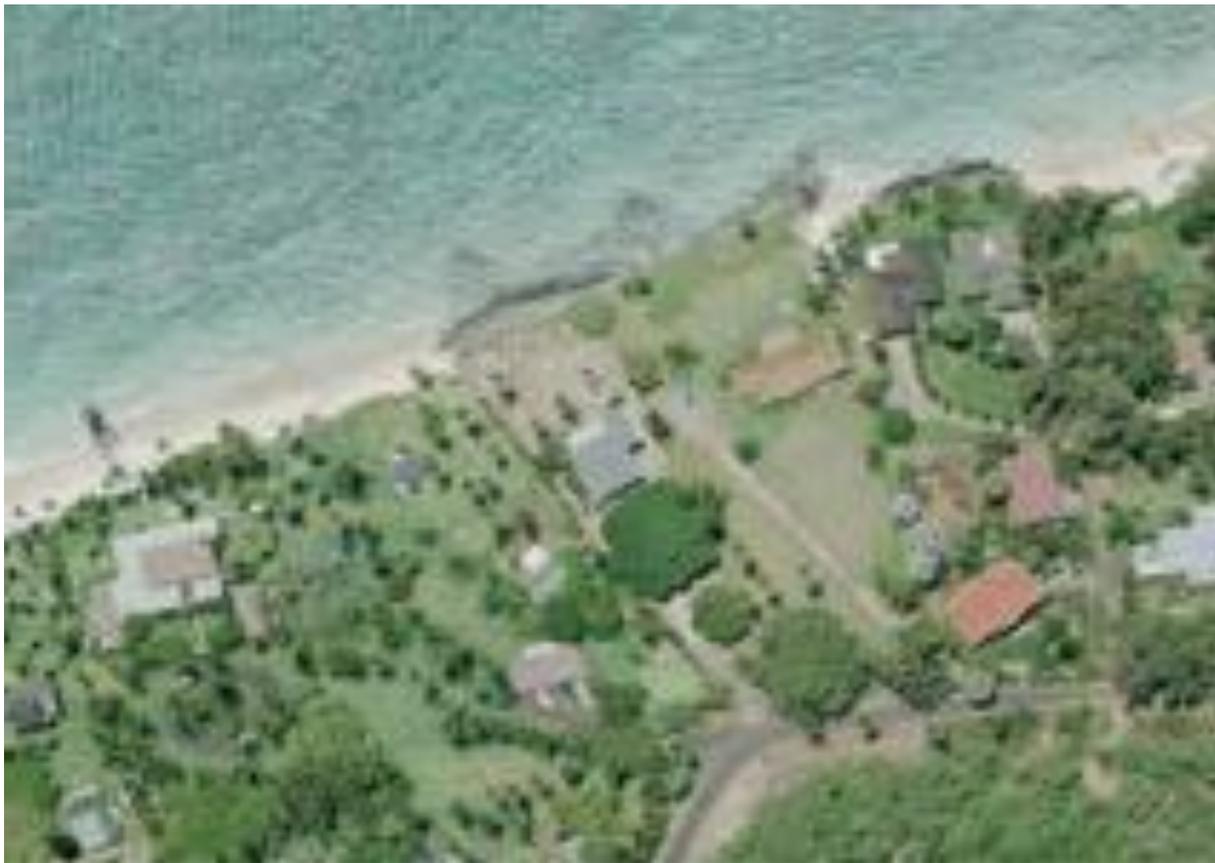
Photo 15 - Aerial View Showing No Beach at Downdrift Lot 2 and East Half of Lot 1, June 2007

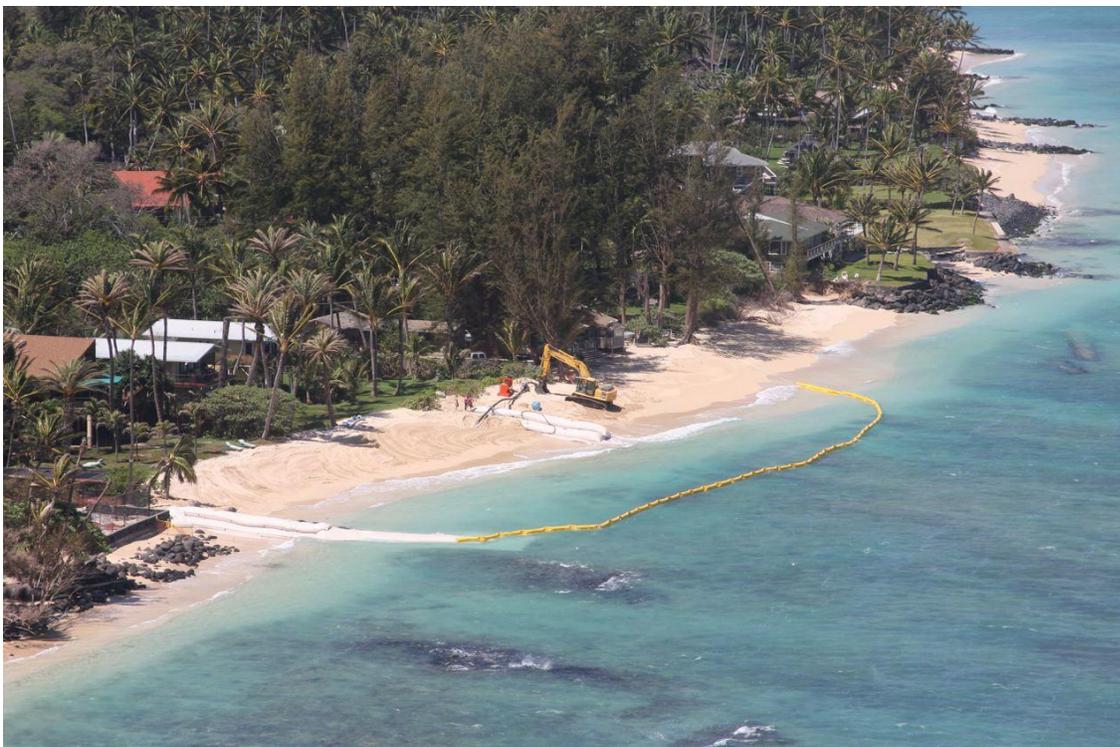
Photo 17 - Aerial View Showing Rock Piles Without Sand in Front at Downdrift Lots 1 and 2 Beyond on Second Day of Project Construction, 21 April 2010

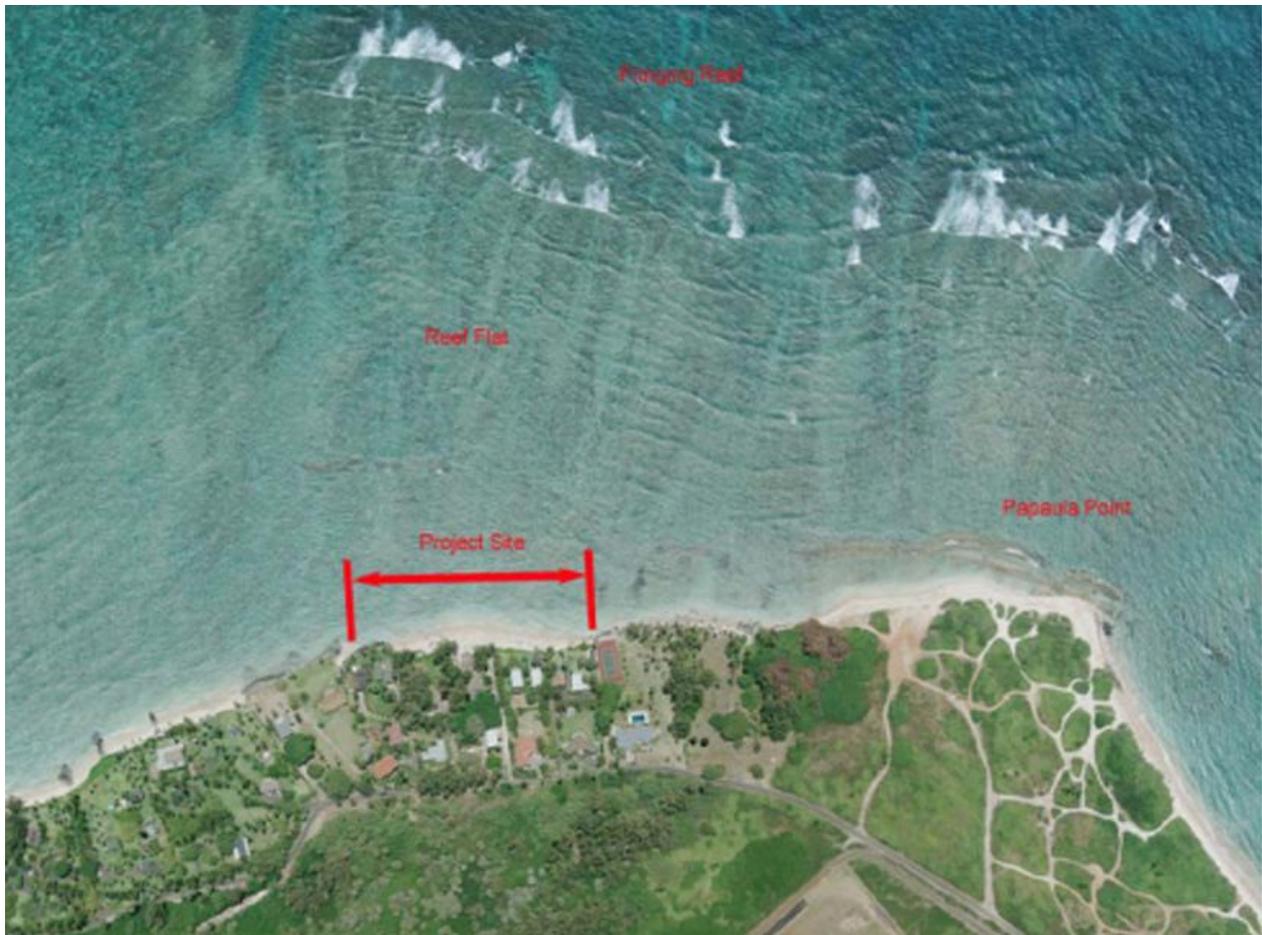
Figure 1 – Project Site Map Showing Reef Flat, Fringing Reef and Wave Patterns

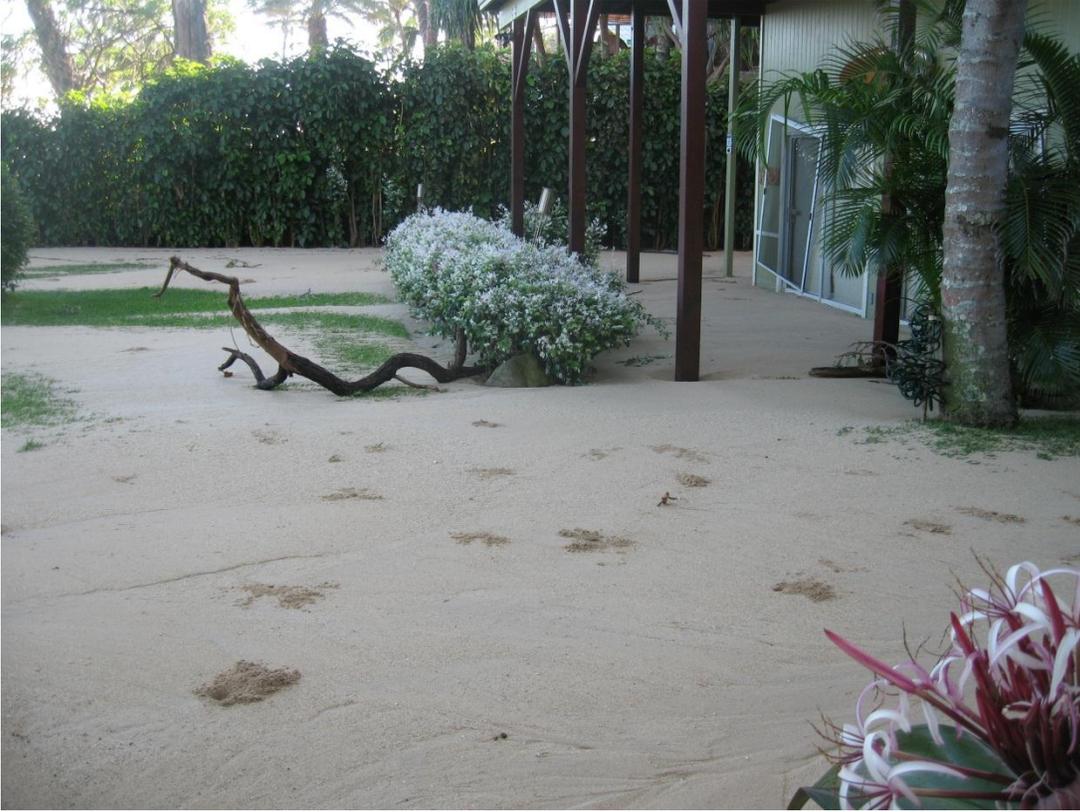
Photo 1 - Post-Tsunami Beach Sand on Ocean Front Property, 11 March 2011
