SUBJECT: Final Environmental Assessment (EA) for Conservation District Use Application (CDUA) MA-3633 for the Stable Road Beach Groins Project Located Upon Submerged Land Offshore of Spreckelsville, Maui, Makai of TMK:(2) 3-8-002:71, 74, 77 & 78

STABLE ROAD BEACH GROINS REPLACEMENT PROJECT

15 December 2012

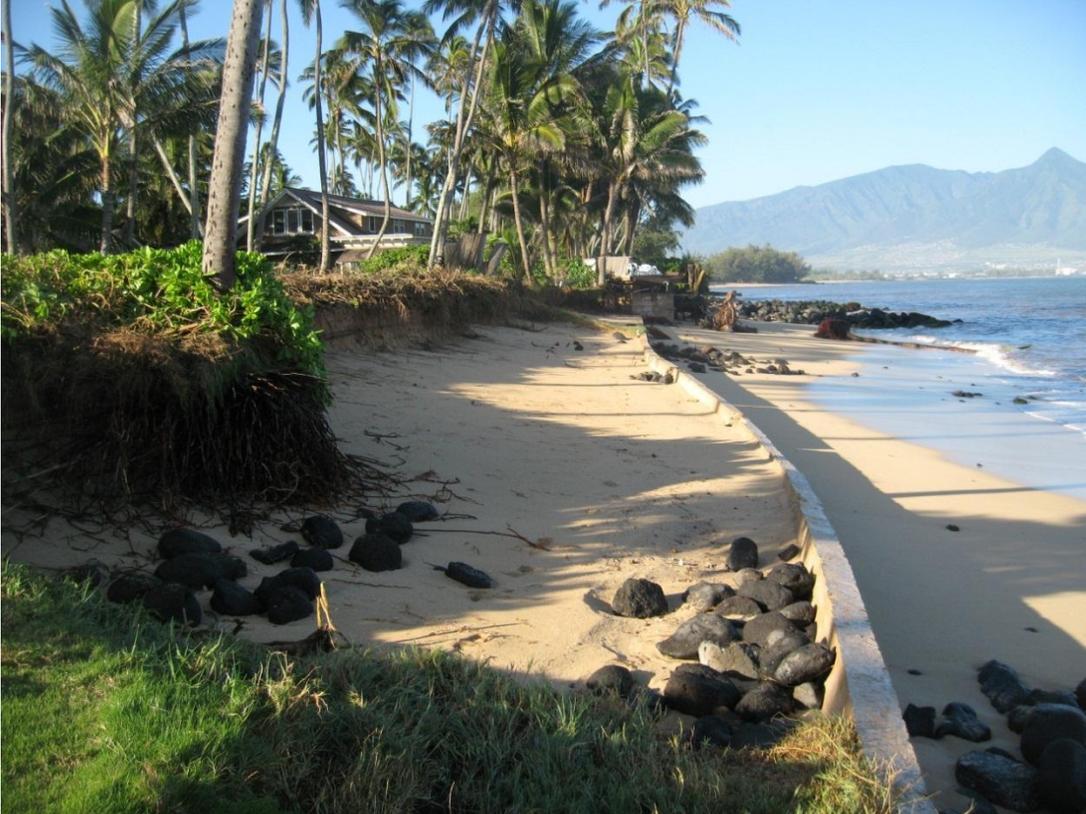
Photo 2 - Post-Tsunami Downdrift Land Erosion above Seawall, 11 March 2011

On 11 March 2011, tsunami waves from an earthquake near Japan hit the Hawaiian Islands with 9 foot high waves reported at Kahului Harbor. Tsunami waves deposited water beyond ocean front properties onto Stable Road at the project area. At the project beach, tsunami waves mostly rolled over the beach and transported beach sand onto adjoining properties (see Photo 1); and at nearby beaches, tsunami waves hit seawalls over-topping some and causing land loss beyond (see Photo 2).

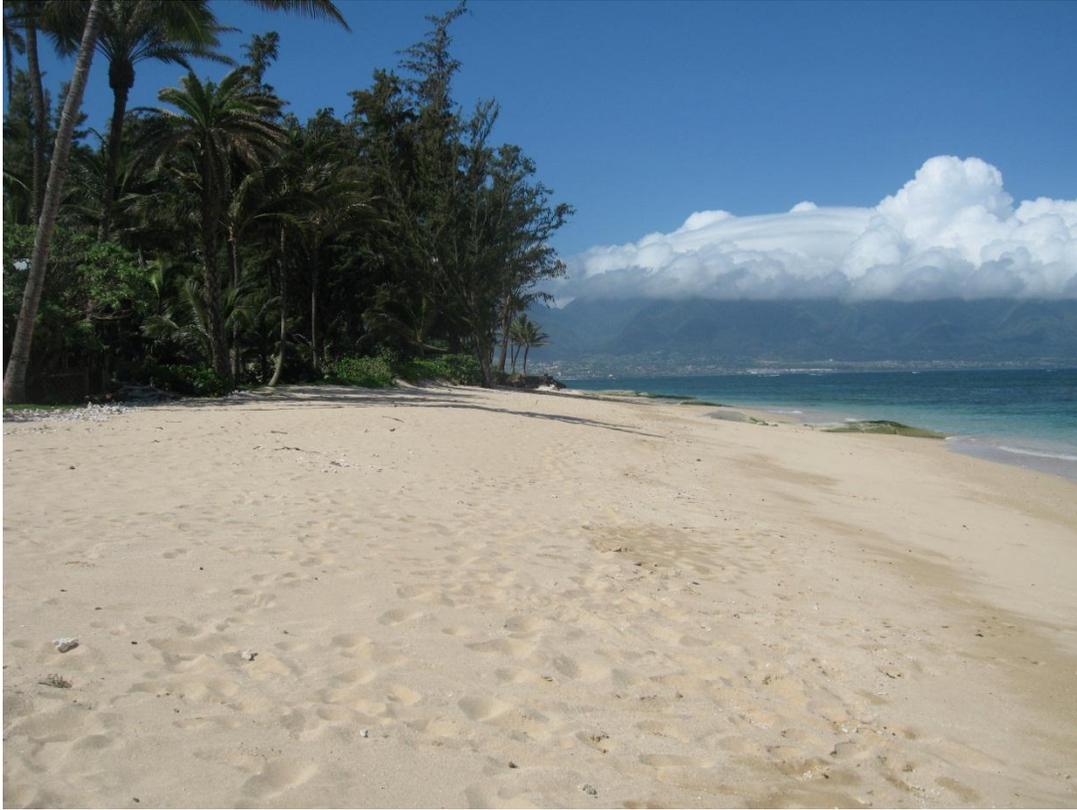
Photo 3 - Pre-Tsunami Project Beach Convex Profile, 8 March 2011

In early March 2011, the project beach and the updrift beach were full of sand (see Photo 3), which is typical late winter after the fall and winter seasons' natural accretion when light trade winds and north Pacific waves cause cross shore transport of sand from ocean deposits.

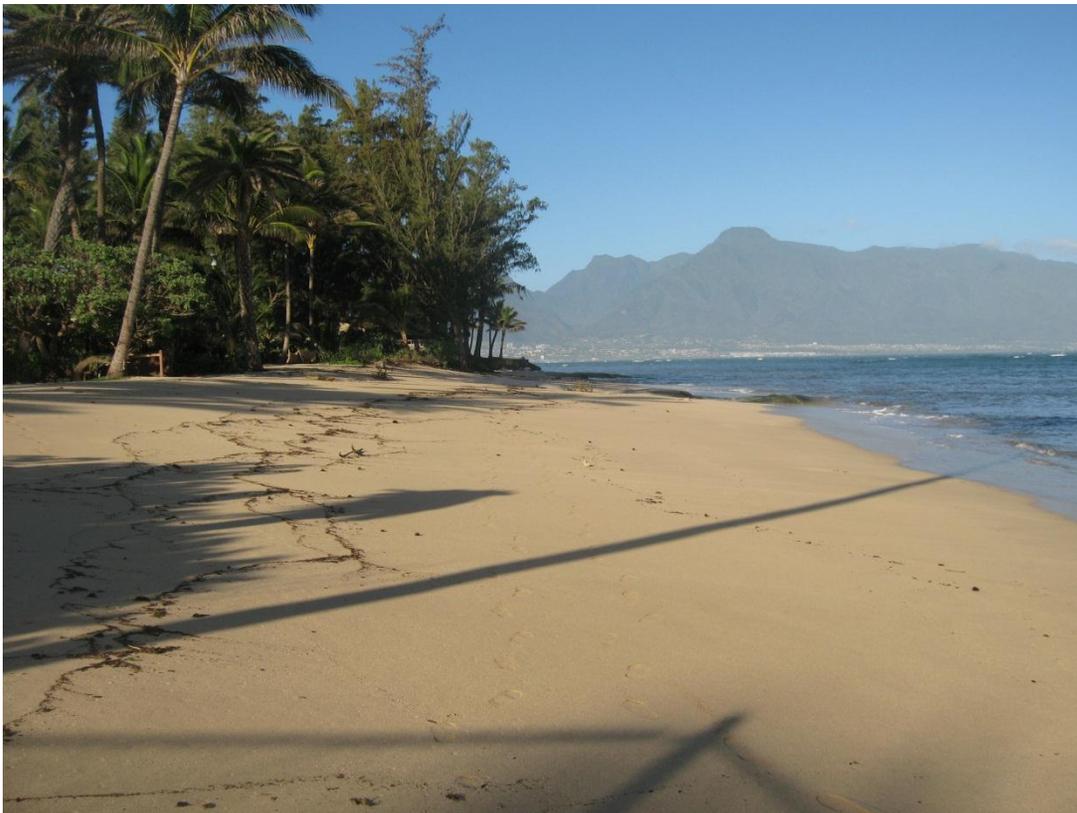
Photo 4 - Immediate Post Tsunami Project Beach Straight Profile, 11 March 2011

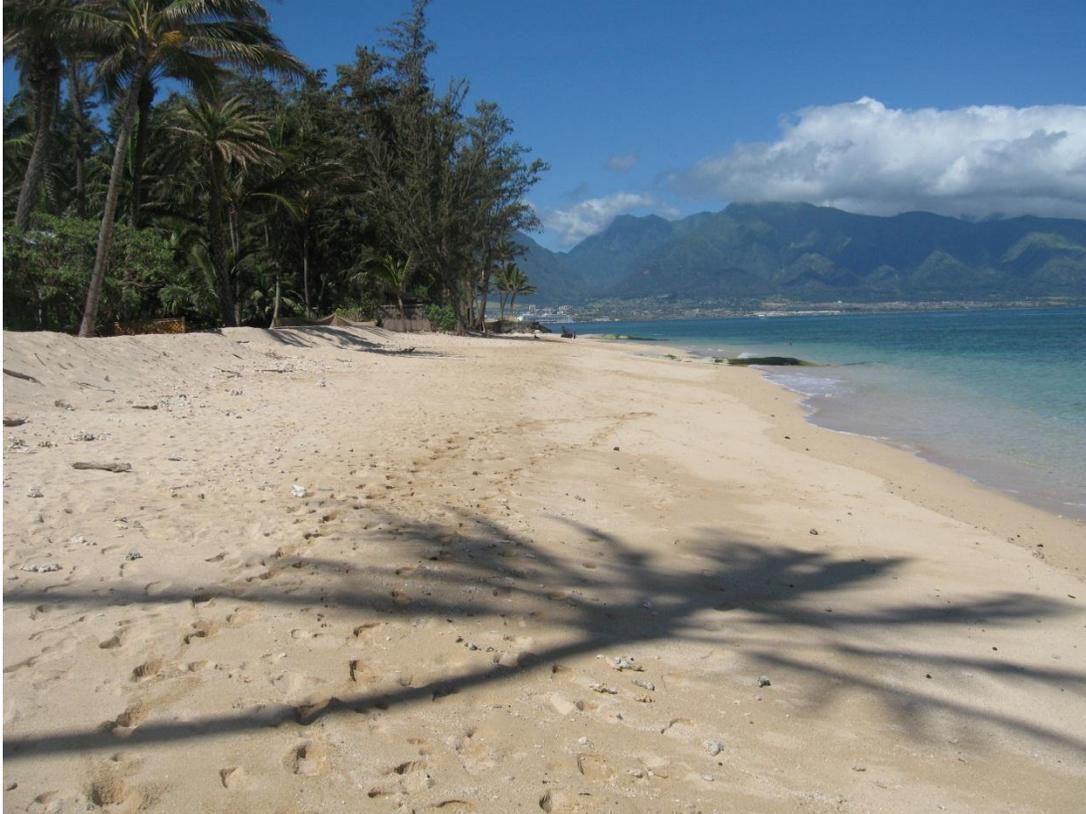
Photo 5 - Post Tsunami Project Beach Straight Profile with Dune, 3 April 2011

Approximately three weeks after the tsunami, the project beach profile remained straight and generally consistent with the immediate post tsunami condition (see Photo 5). Sand removed from 50% of the frontage properties can be seen as small dunes near the shoreline. Not all of the tsunami transported sand was able to be removed from these properties due to sand trapped in lawn and planter areas. Beach sand volume did not appear to change significantly during the three weeks post-tsunami at the project beach, except for the sand deposition from frontage properties.

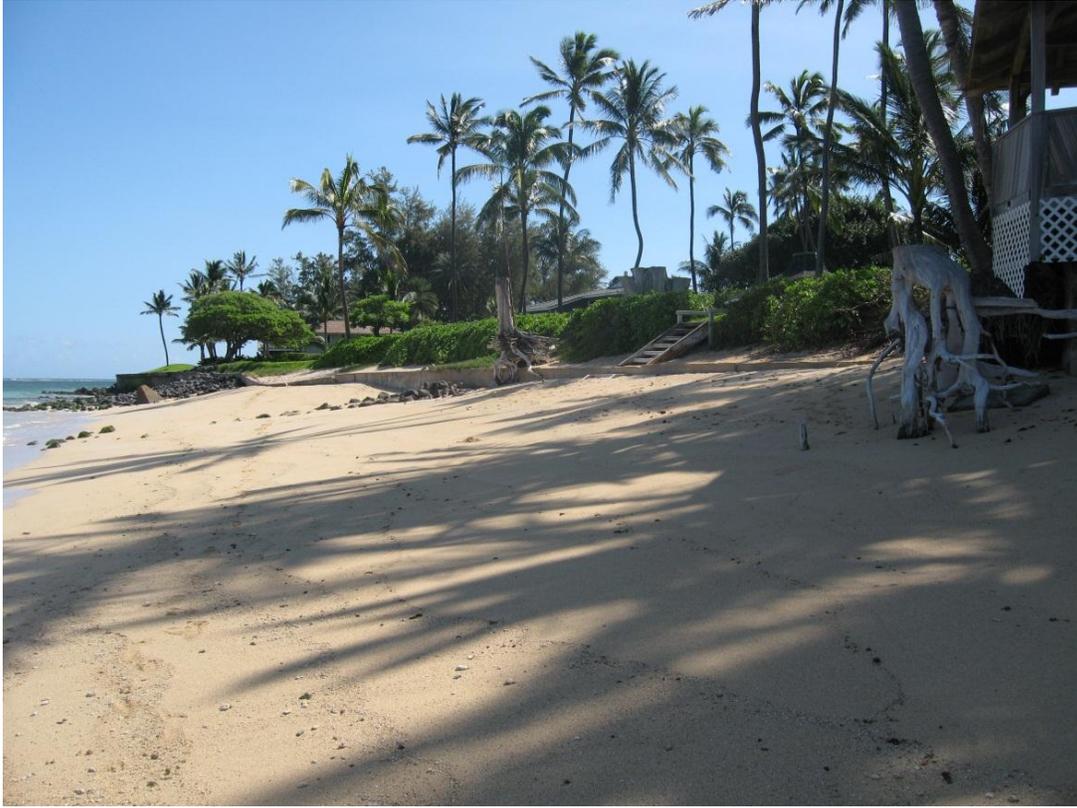
Photo 6 - Pre-Tsunami Downdrift Beach Sand Volume, 8 March 2011

In early March 2011, the downdrift beaches were also generally full of sand after accretion during the fall and winter seasons (see Photos 6 and 9).

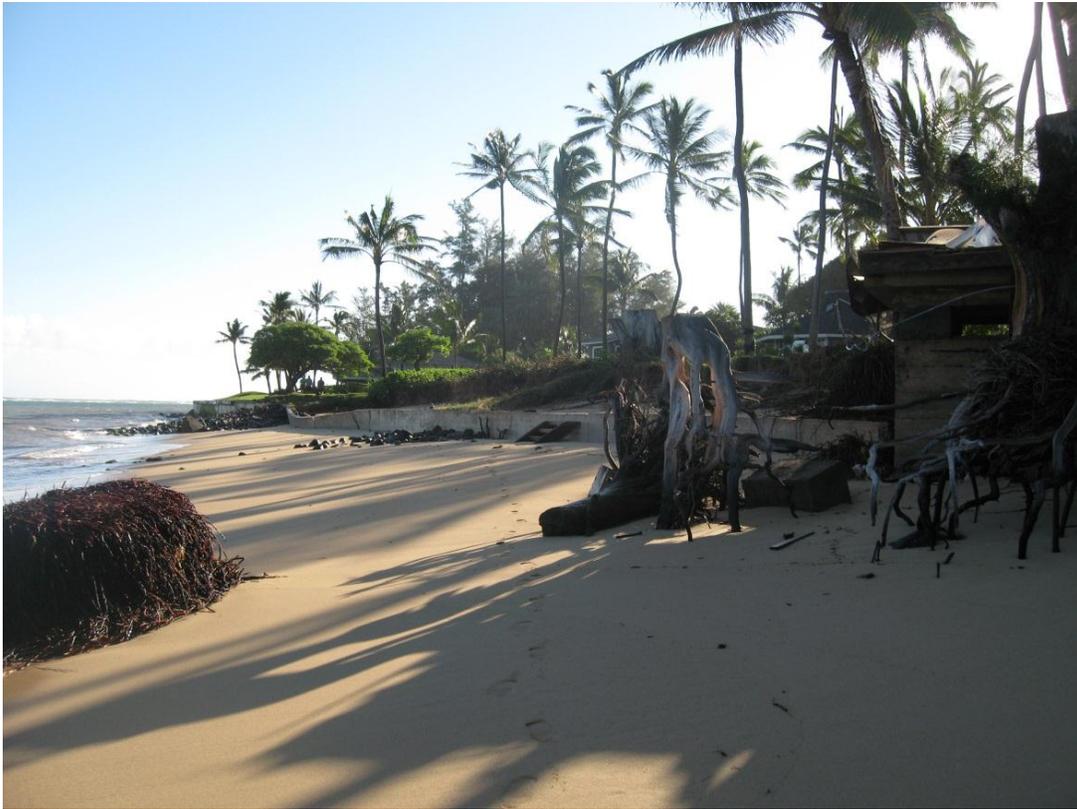
Photo 7 - Immediate Post-Tsunami Downdrift Beach Sand Volume, 11 March 2011

Immediate post-tsunami photos of the downdrift beaches (see Photos 7 and 10) indicate significant beach sand volume losses from the tsunami. There was no noticeable change of beach width and waterline location comparing photographs.

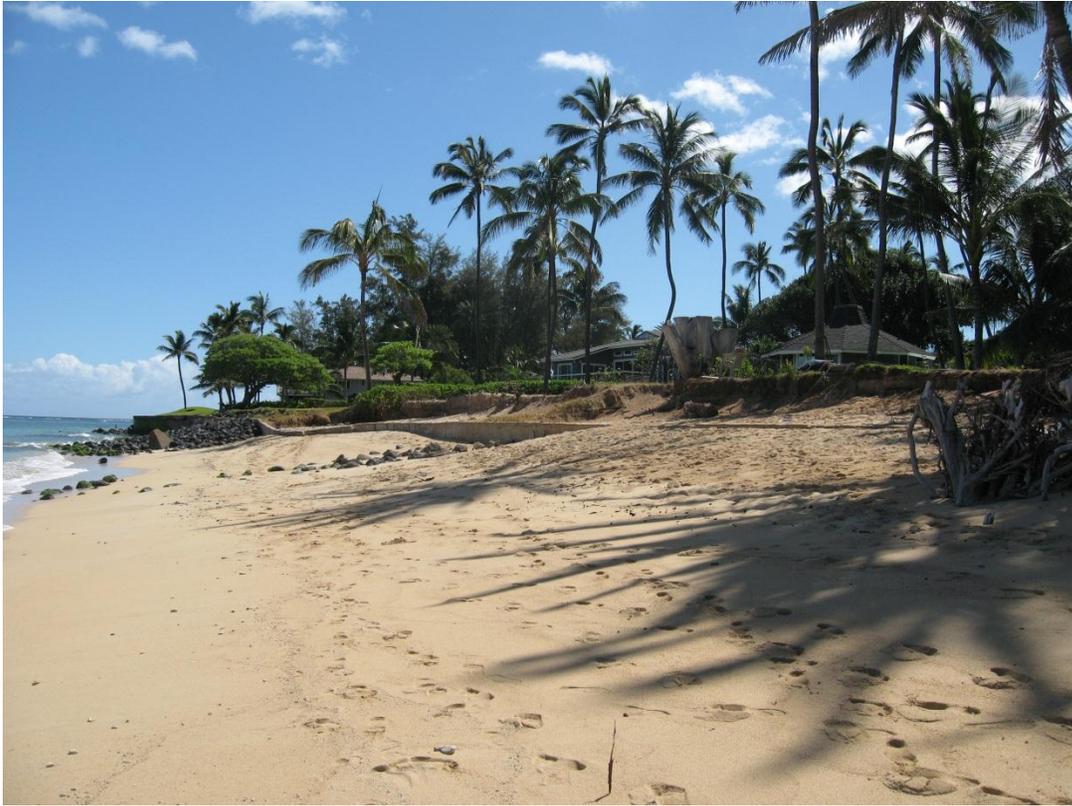
Photo 8 - Post-Tsunami Downdrift Beach Sand Volume, 3 April 2011

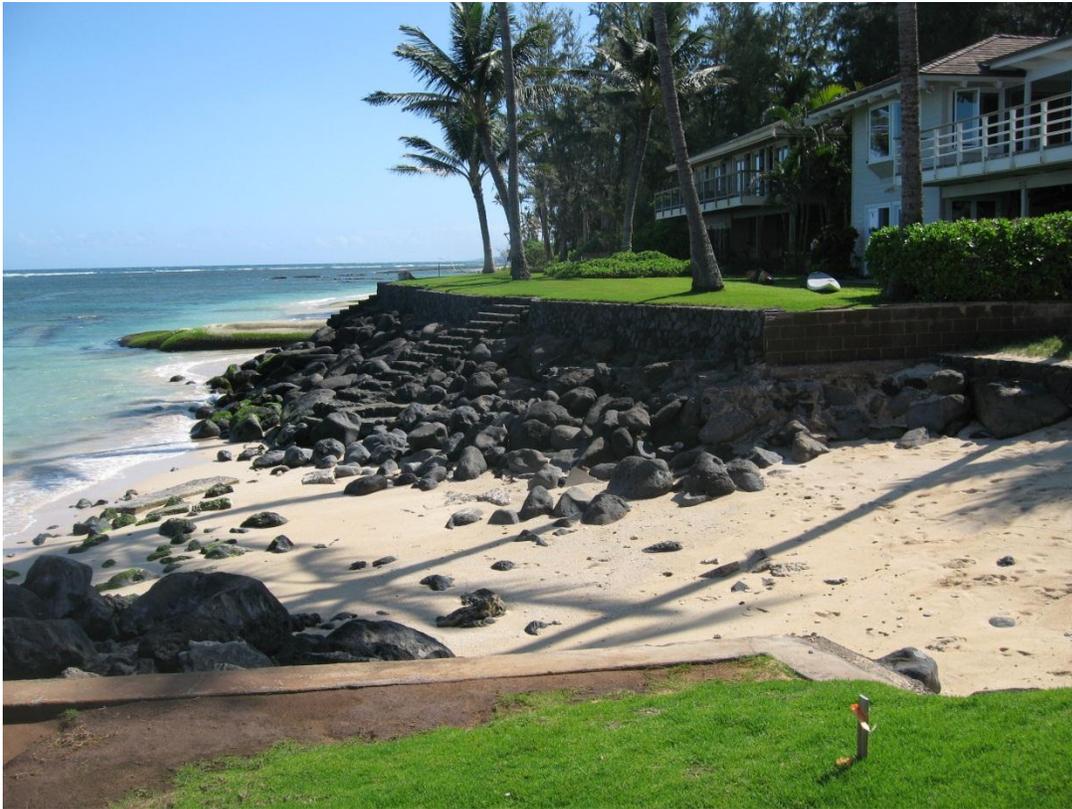
Photo 9 - Pre-Tsunami Downdrift Beach Sand Volume, 8 March 2011

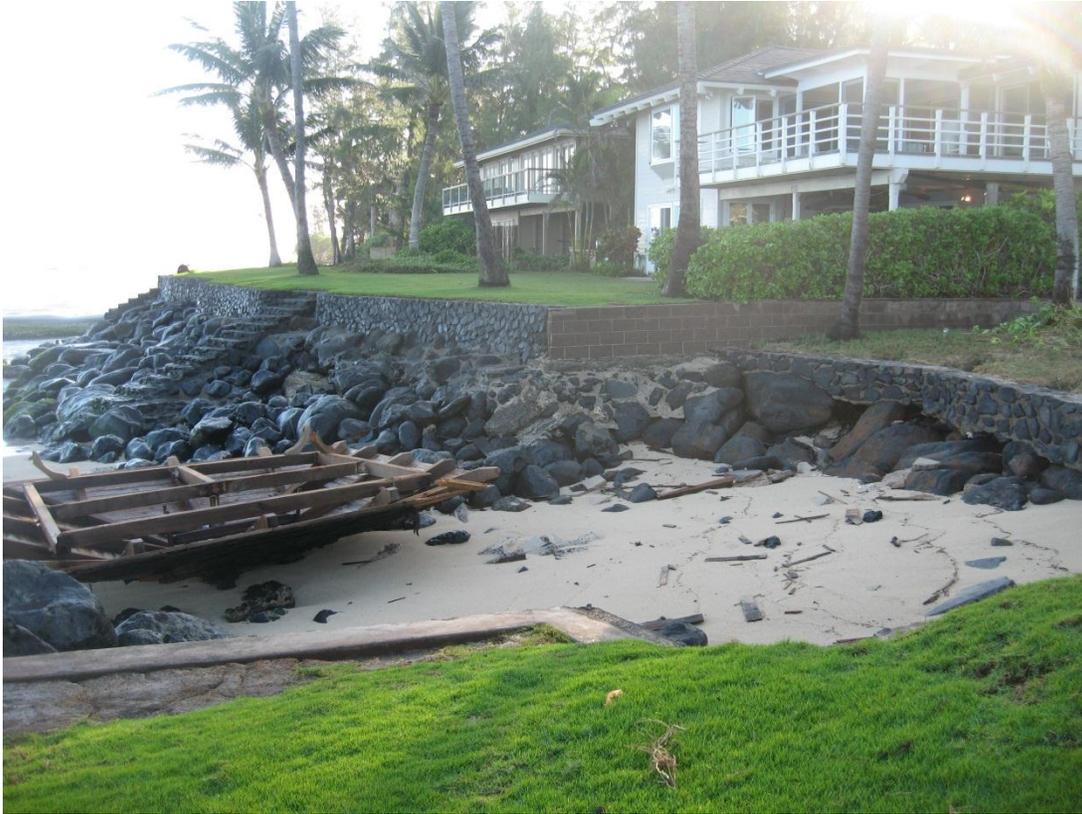
Photo 10 - Immediate Post-Tsunami Downdrift Beach Sand Volume, 11 March '11

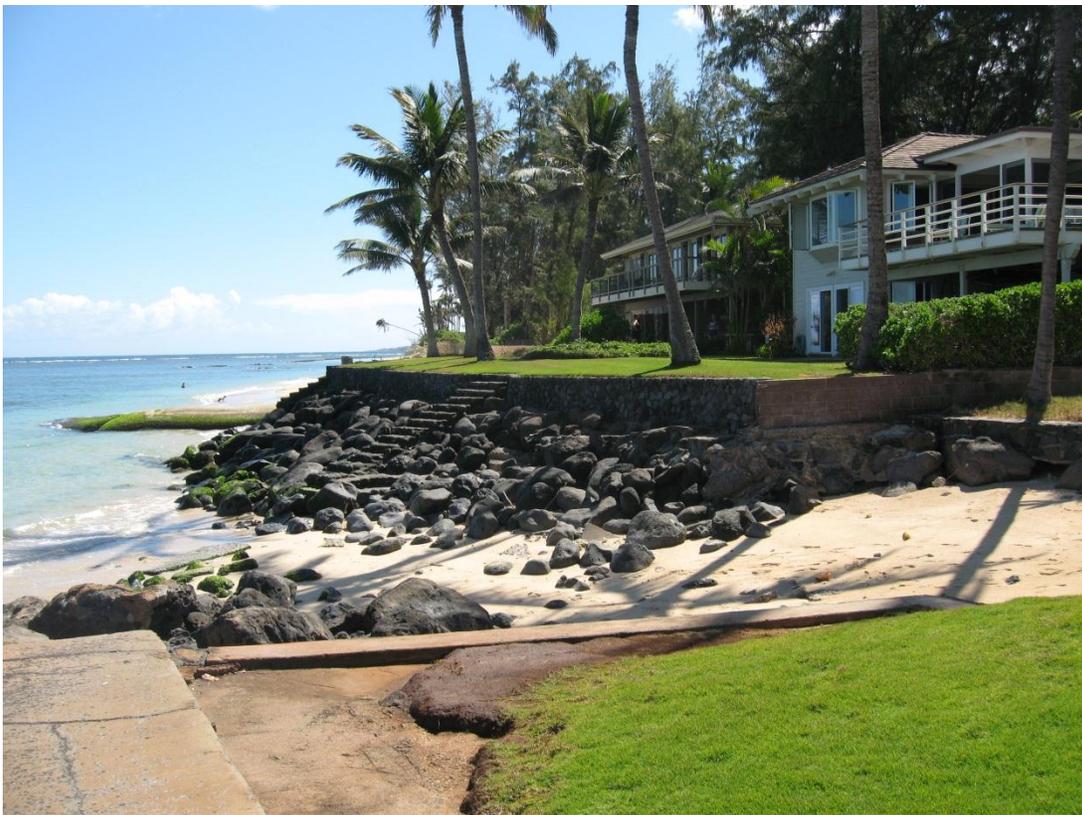
Photo 11 - Post-Tsunami Downdrift Beach Sand Volume, 3 April 2011

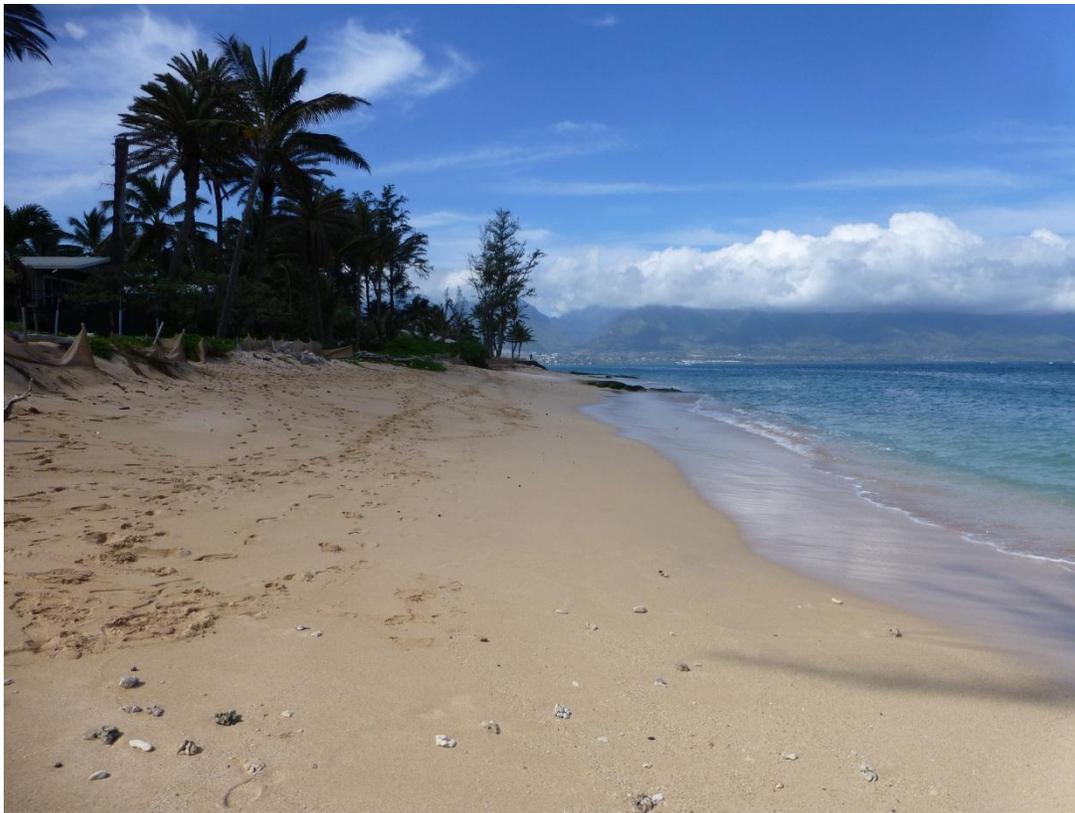
Photo 12 - Pre-Tsunami Project Beach Profile, 3 October 2012

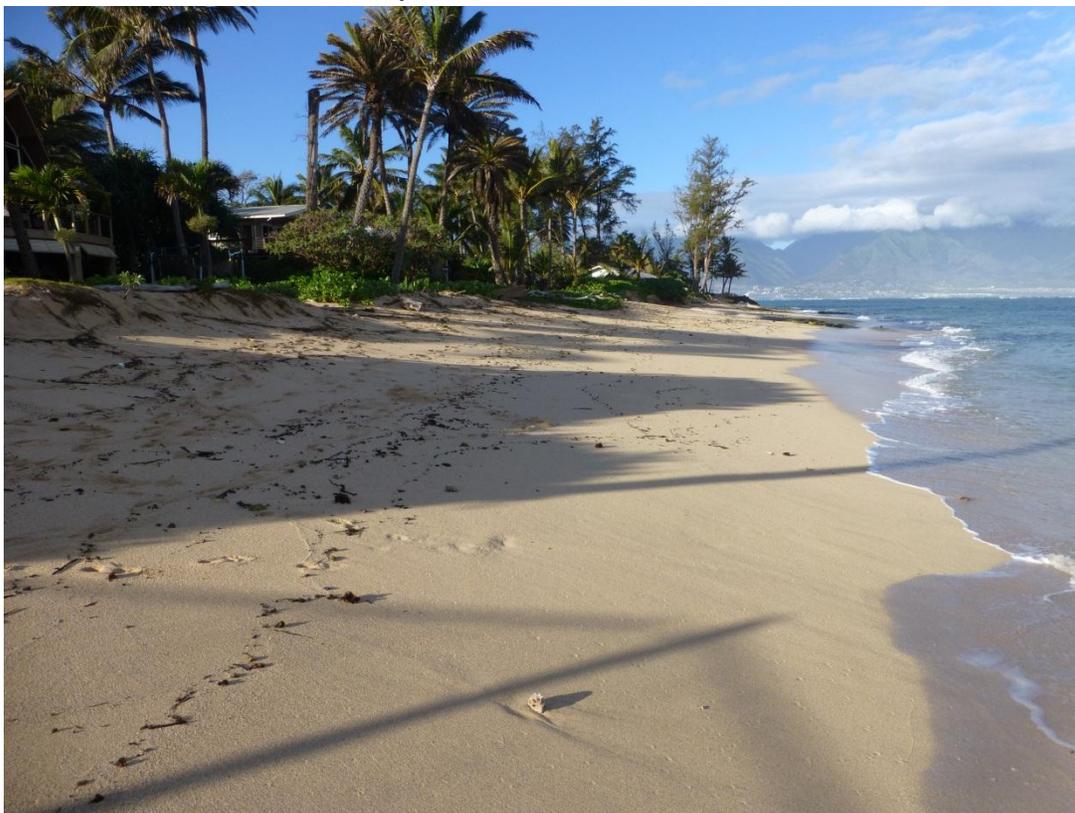
Photo 13 - Immediate Post-Tsunami Project Beach Profile, 27 October 2012

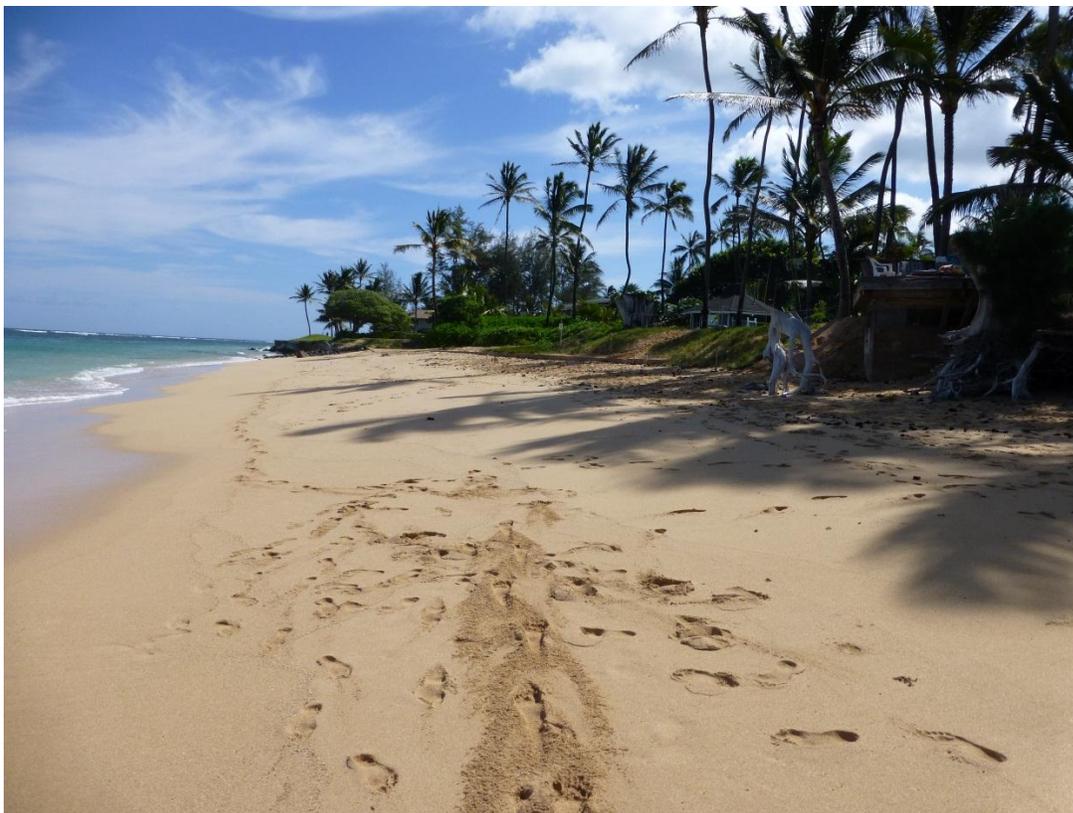
Photo 14 - Pre-Tsunami Downdrift Beach Profile, 3 October 2012

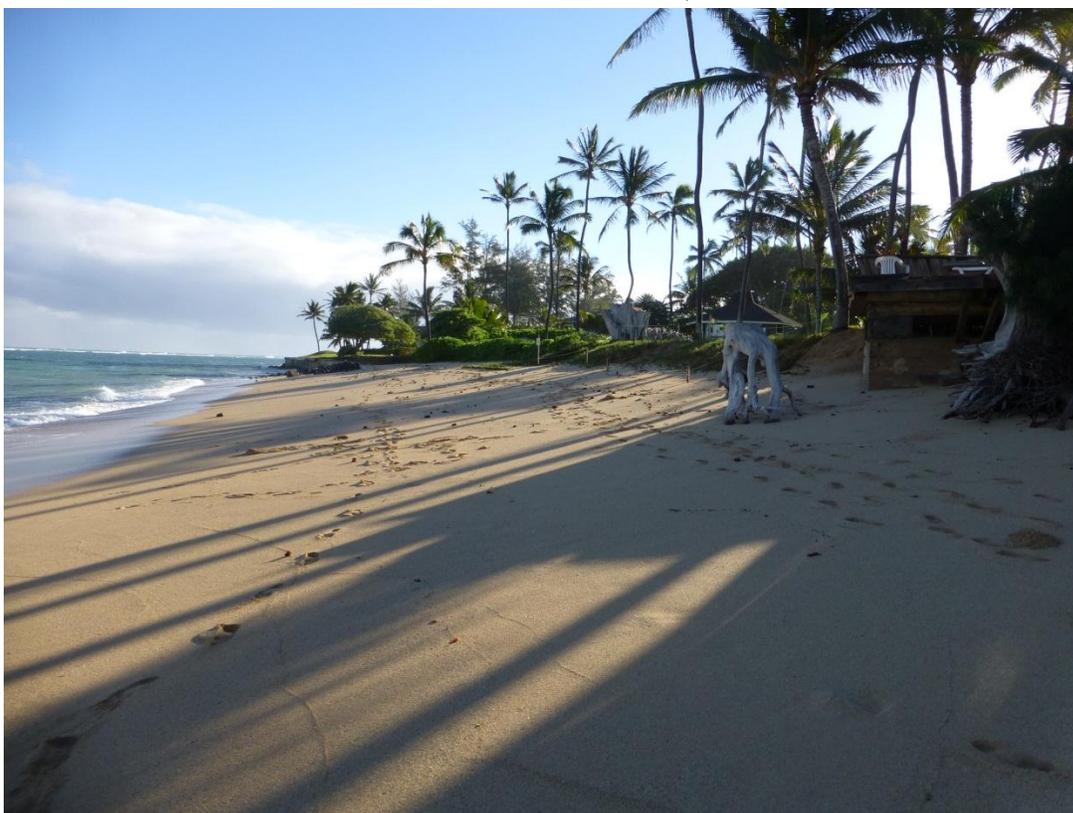
Photo 15 - Immediate Post-Tsunami Downdrift Beach Profile, 27 October 2012

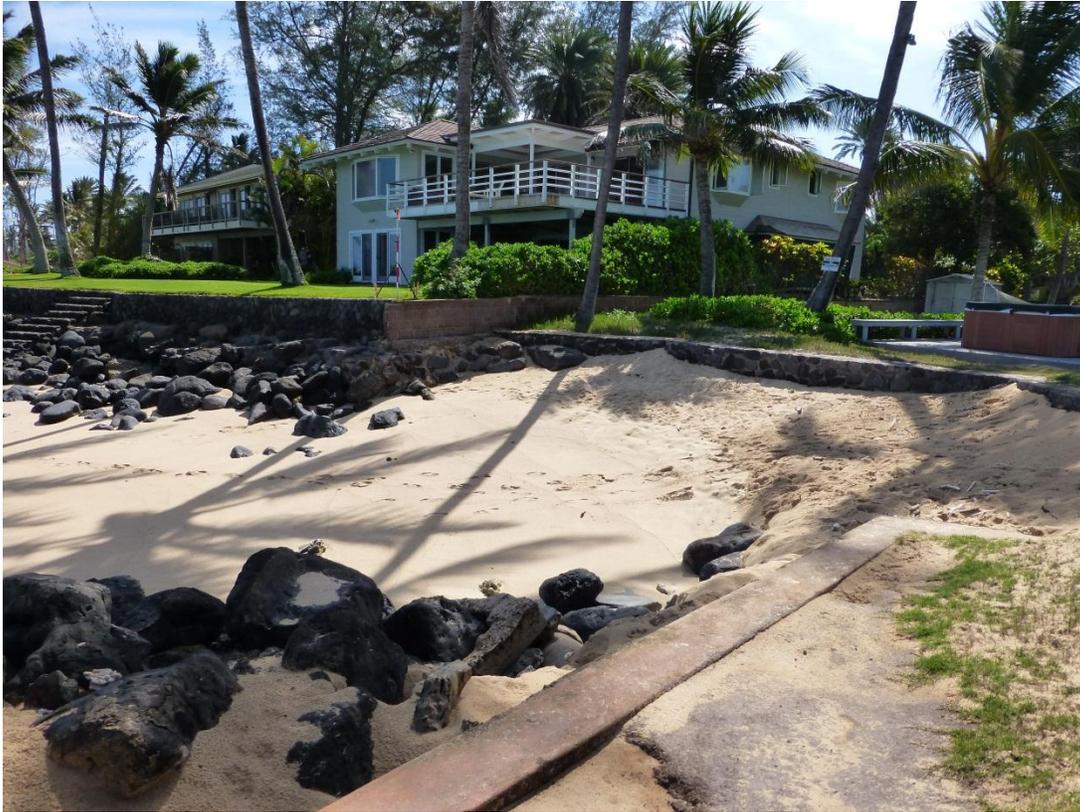
Photo 16 - Pre-Tsunami Downdrift Beach Cove Profile, 3 October 2012

Photos 16 and 17 of the downdrift beach cove indicate some decrease of beach sand volume from approximately 3 weeks pre-tsunami to immediately post-tsunami as evidenced by slightly more exposed rocks most likely due to north Pacific waves which can cause beach loss there this time of year.

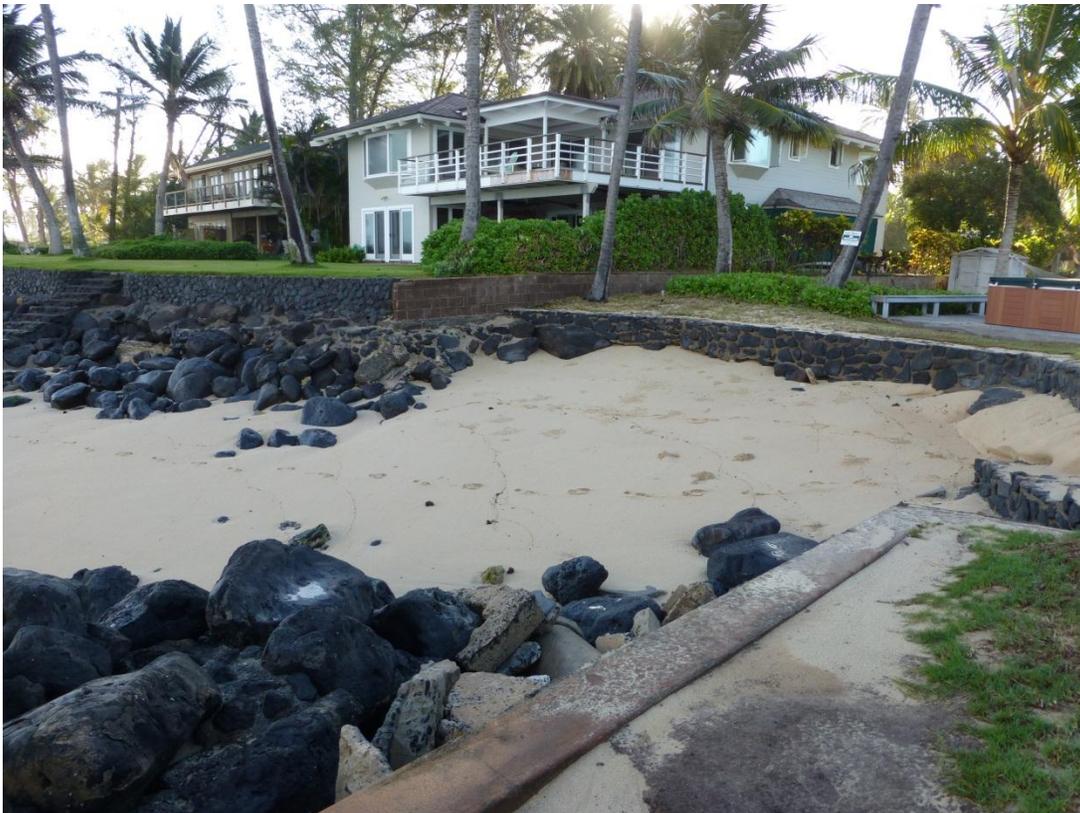
Photo 17 - Immediate Post-tsunami Downdrift Beach Cove Profile, 27 October '12

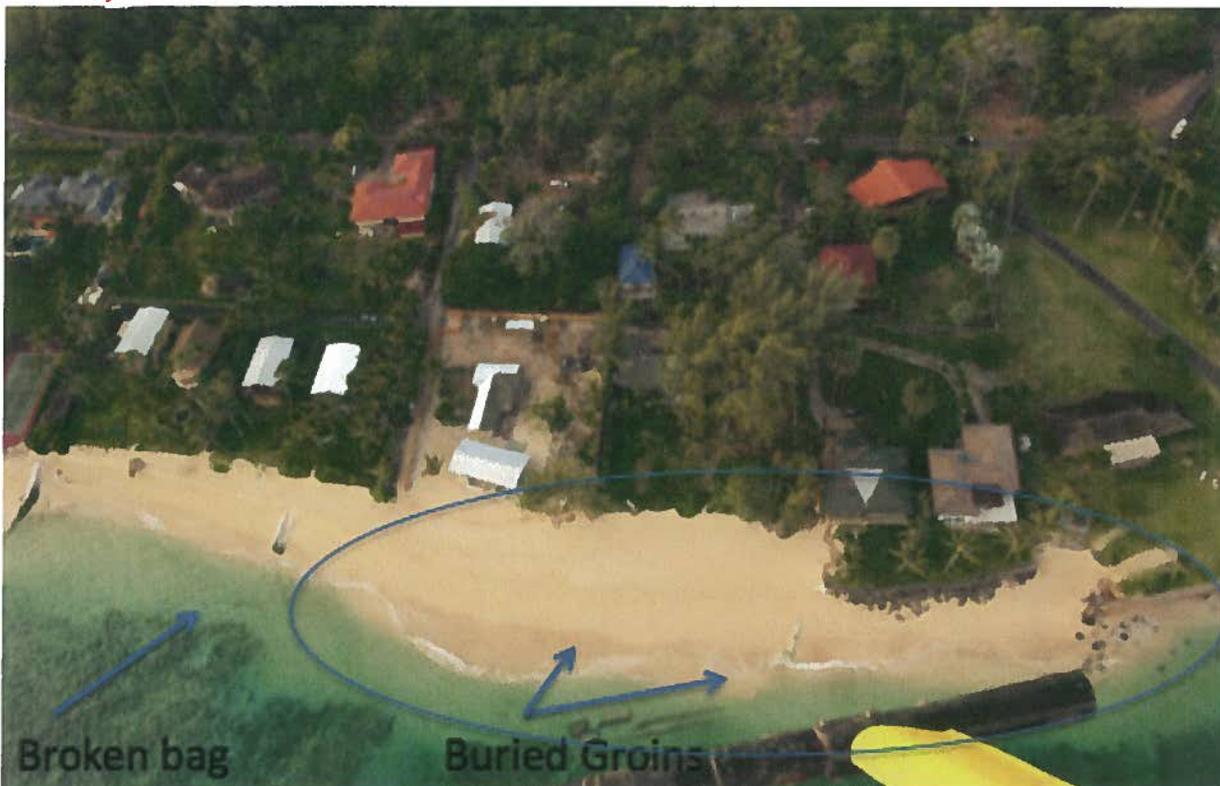
Photo 2

June 11, 2012 Approximately 1/2 length of Groin #2 releases 1000s of yds³ of sand.

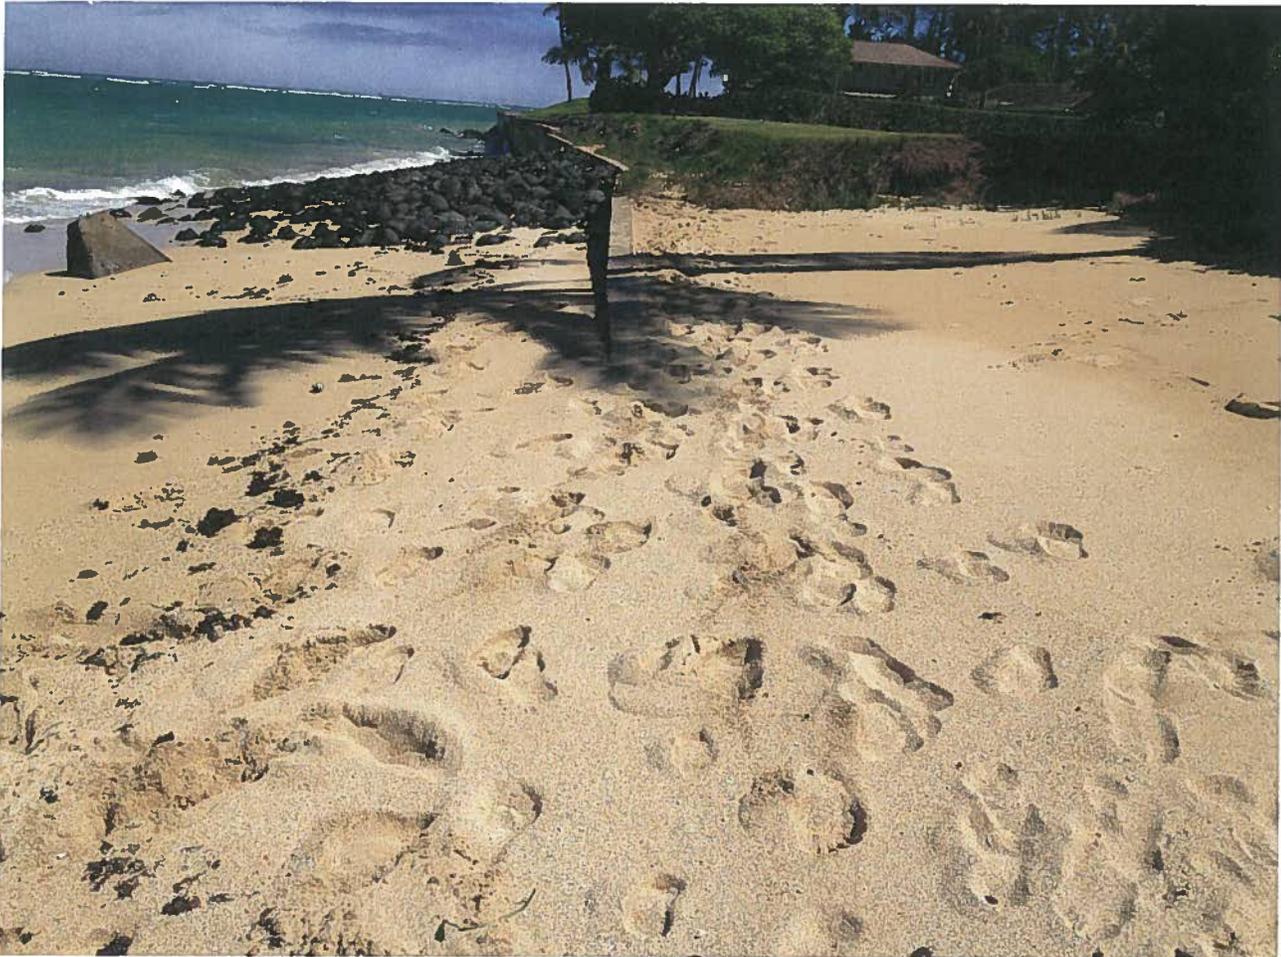
Photo 3

Immediately buries groin #3 and #4 as well as creating wide beach fronting the Riley/Martin revetment and burying groin remnant at Haines east boundary.

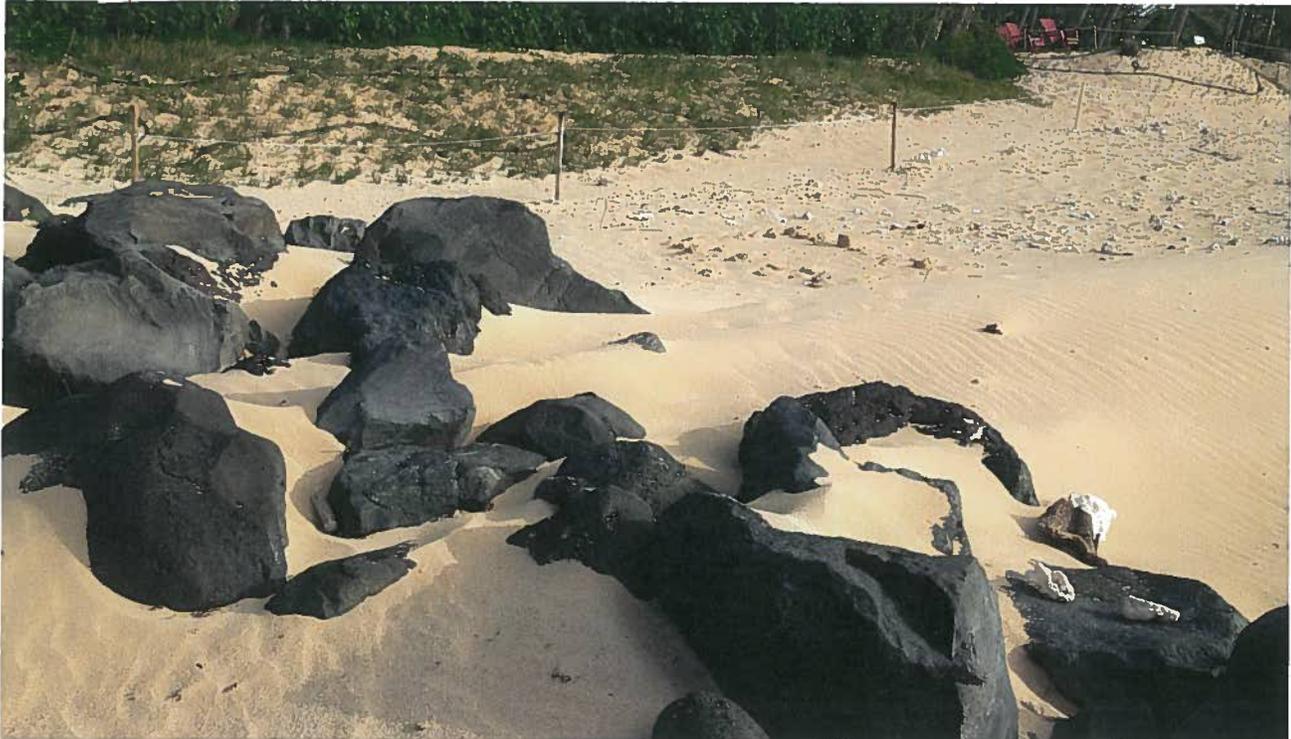
Photo 4

Over following days and weeks the sand continued migrating down current filling area fronting Kennedy and nearly burying the Golting eastward groin. This event clearly reveals more information, hitherto unknown, concerning the regional dynamics of the beaches at Stable Road East and West.
