**A CULTURAL APPROACH TO
SUSTAINABILITY**

A Cultural Approach to Sustainability

Prepared as a collaborative effort by
Turtle Bay Resort LLC, WCIT Architects, and Kuiwalu
October 2012

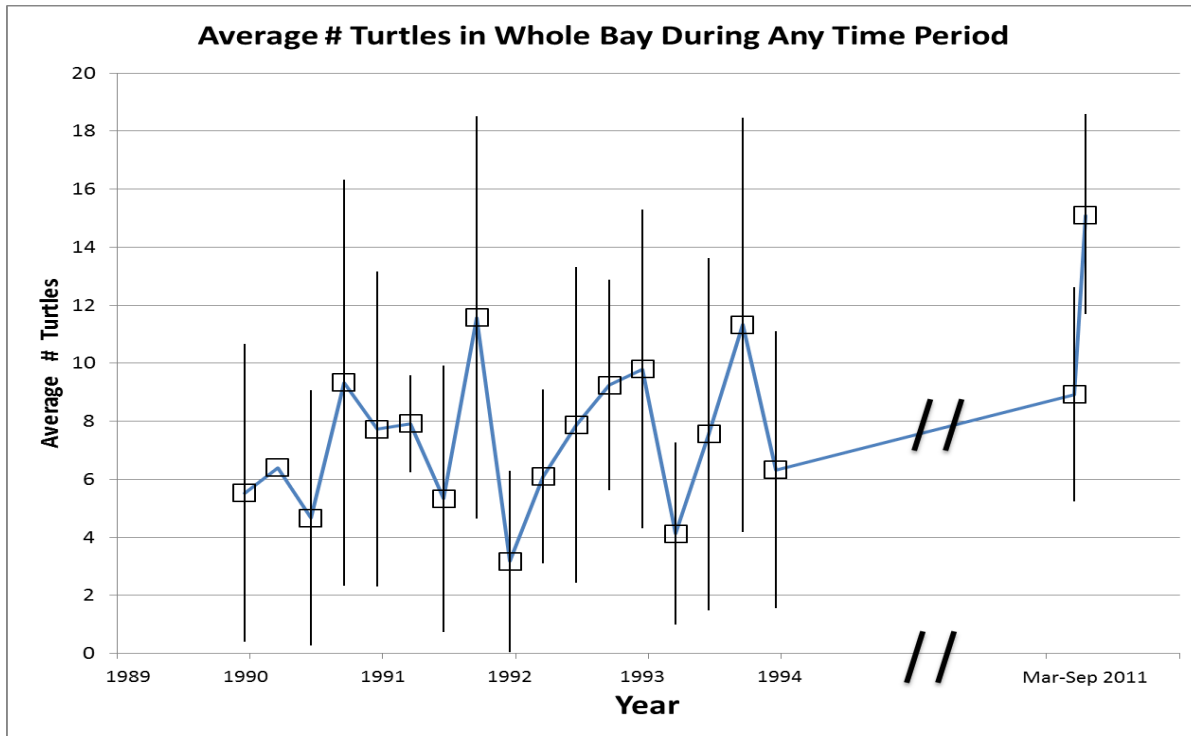
Figure 2-7. Average (+/- 1sd) number of turtles in Kawela Bay, per 2.5-hour observation period

Between 1989 and 1993 a total of 58 observation days (174 morning, noon, afternoon observation periods) recorded an average of 7.35 turtles in the bay at any given time with 68 percent of these observations (one standard deviation) falling between 1.96 and 12.75 turtles in the bay during any time period. During eighteen time periods (approximately 10 percent) no turtles were observed in the bay, with a maximum number of turtles (24) observed on the morning of September 14, 1991. During the five winter (March) days in 2011 (15 total observations, morning, noon, and afternoon) the average number of turtles observed at any given time was 8.93 with 68 percent of these observations (one standard deviation) falling between 5.24 and 12.63 turtles in the bay at any given time. The maximum number of turtles observed in the whole bay during a 2011 winter time period was 16, and the minimum was three turtles. During the five summer (September) days of observation in 2011 (fifteen observation periods) the number of turtles in the bay at any given time ranged from 10 to 22 with an average of 15.1. Sixty-eight percent of these observations fell between 11.7 and 18.6 turtles in the bay at any given time. The average number of turtles seen in the bay during 2011 (summer and winter) was twelve. The average number of turtles has increased from a daily average 7.35 in the early 1990's to 12.0 this past year between 1993 and 2011 and the number of periods when no turtles are observed in the bay has fallen from 10 percent to zero percent. This 50 percent increase in the turtle population in the bay is statistically significant at a 95 confidence interval. There does not appear to be any difference in turtle abundance between the five observation zones or between the times of day when observations were conducted.

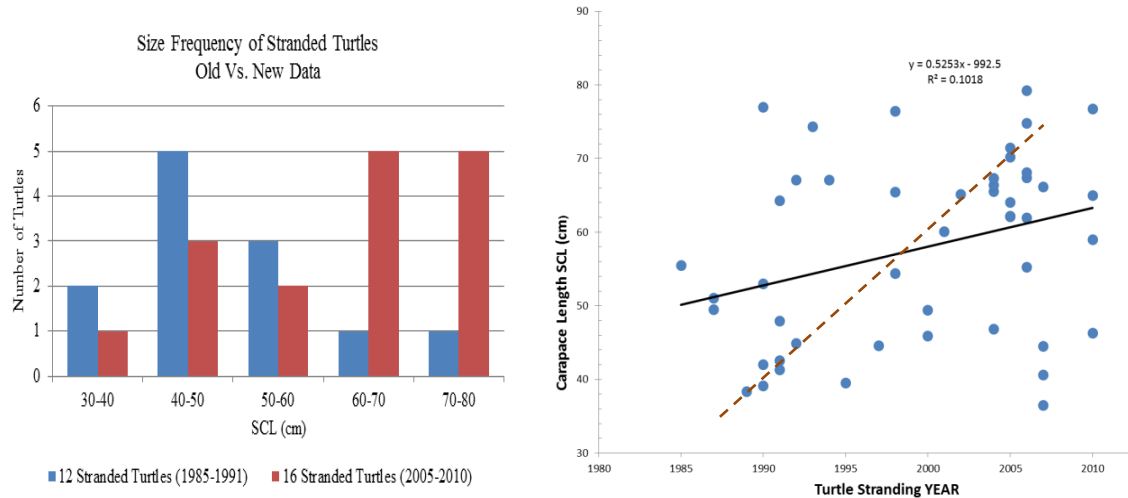
Figure 2-8. Data from NMFS turtle stranding database for project shoreline showing (left) increased prevalence of larger turtles in recent years, and (right) overall trend of increased size over entire time period. Dashed line is average growth rate of individual turtles (~ 2.1 cm/yr).

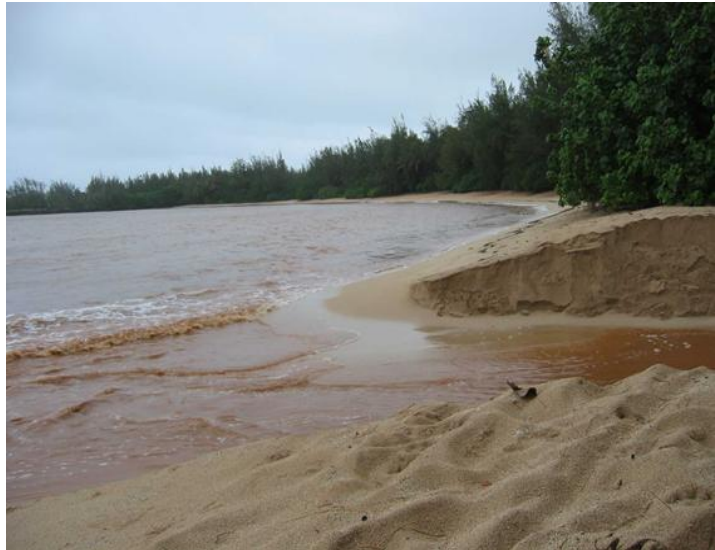
Figure 3-8. Kawela Stream flowing brown high turbidity water across beach into the bay.

For the large majority of days the flow of Kawela Stream terminates at the sand beach berm and percolates slowly through the berm to the bay. During the infrequent occasions (~3-4 times per year) when the stream flow is sufficient to break through the beach barrier the entire bay is usually extremely turbid for days. Following these stream flow events the water turbidity in the west end of the bay usually clears within a few days, while the east end of the bay often remains turbid for several weeks to a month. Following a very large storm event in March of 1991 that flooded most of Kahuku, turbidity within the bay ranged from 88 to 4,000 NTU. But even when the Kawela Stream is not flowing to the bay, the water quality of the bay rarely meets State Standards for open coastal waters. Samples taken in the early 1990's and

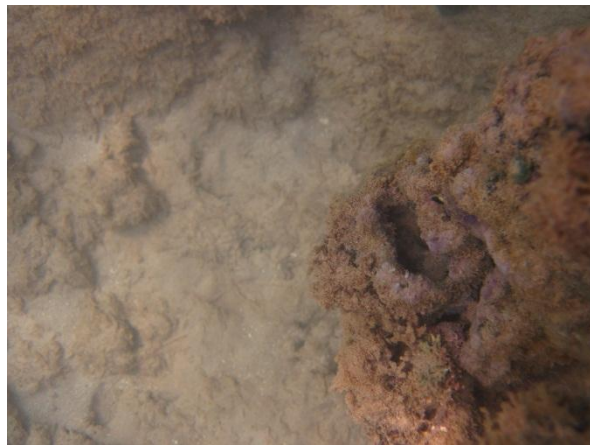
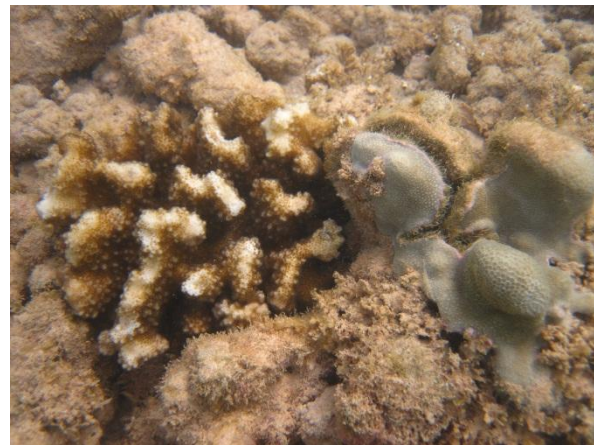
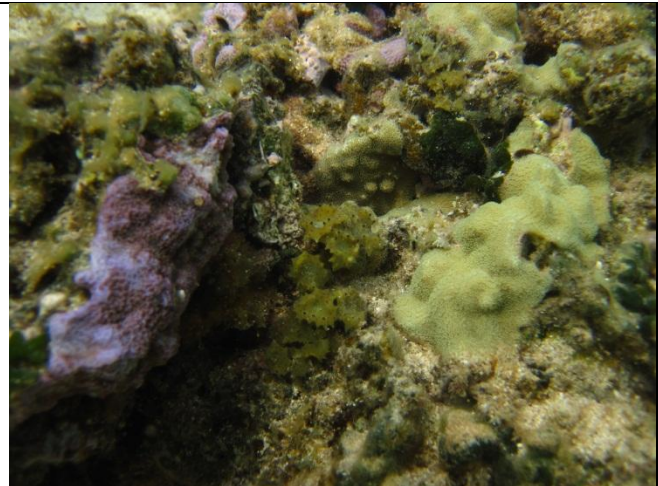
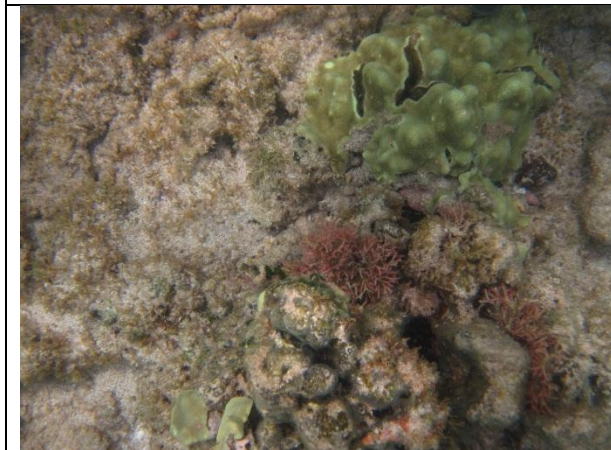
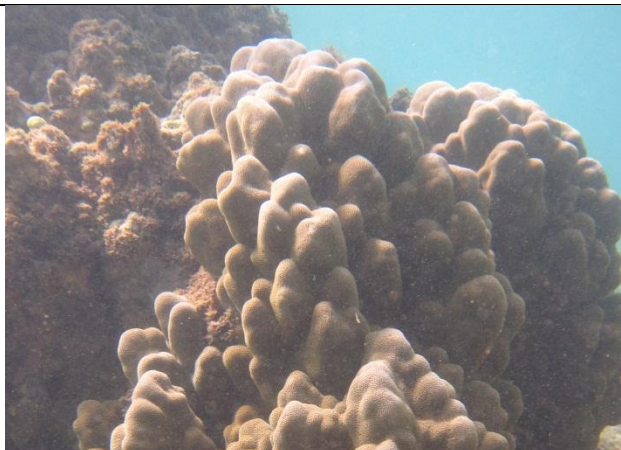
Figure 3-13. Representative photographs from three transects within Kawela Bay

1. Kawela Bay East Transect quadrant photo

1. Kawela Bay East transect detail photo

2.Kawela Bay Center Nearshore detail photo

3.Kawela Bay West quadrant photo

3.Kawela Bay West detail photo

Results of the 2011 benthic survey are presented in Table 3-2 with the fish surveys data presented in Table 3-2 and representative photographs from each transect in Figure 3-13. As would be expected from this very nearshore survey, most of the fish observed are small reef-dwelling species, primarily herbivores and omnivores. The most prevalent species seen are small wrasses, and surgeon fish. The lack of observed predatory fish is most likely due to the shallow water and relatively poor visibility. The benthic survey data shows that coral was not plentiful in this inner bay environment. At the K1 site (far right side – muddy water) there are numerous large (1-2m³) coral heads, but they are almost completely covered with algae. The small areas of live coral on these heads show obvious signs of stress, likely due to the very silt laden environment. The nearshore central bay (K2) is typical of shallow back-reef areas displaying low vertical profile with ample sand in pockets and small coral rocks and rubble mobilized across the surface by occasional storm waves. Coral cover is lowest in the area, likely due to the unstable substrate and fish count are also low likely in response to a lack of cover. Site K3 was selected primarily as a positive control as its location on the shelf at the west end of the bay typically provides it with ample surge and oceanic water. Corals at this site, while still not abundant, were by far the healthiest with no observed tissue stress. The quantitative data from these recent surveys are consistent with the findings of both the 1994 study (Oceanit) and the 1981 survey (Biengfang and Brock).

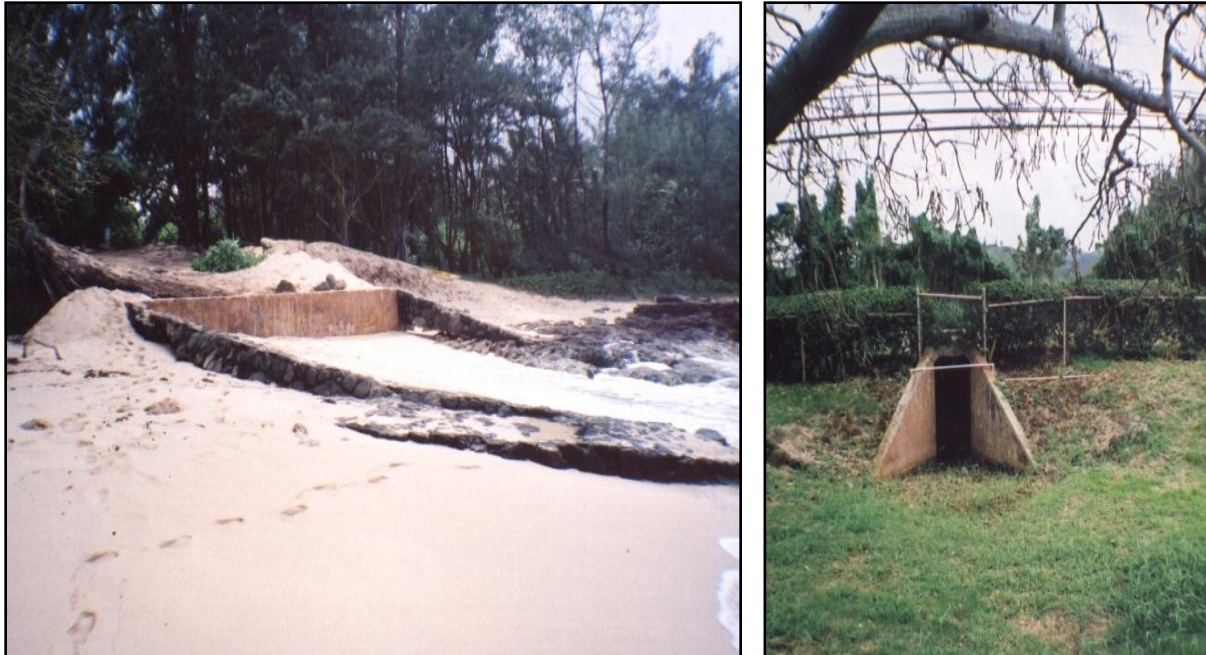
Figure 4-2. West Main Drain Outlet (above) to Turtle Bay is typically buried in sand when not actively flowing. The small channel under Kamehameha Highway (right) limits flow to the West Main Drain from mauka of the highway.

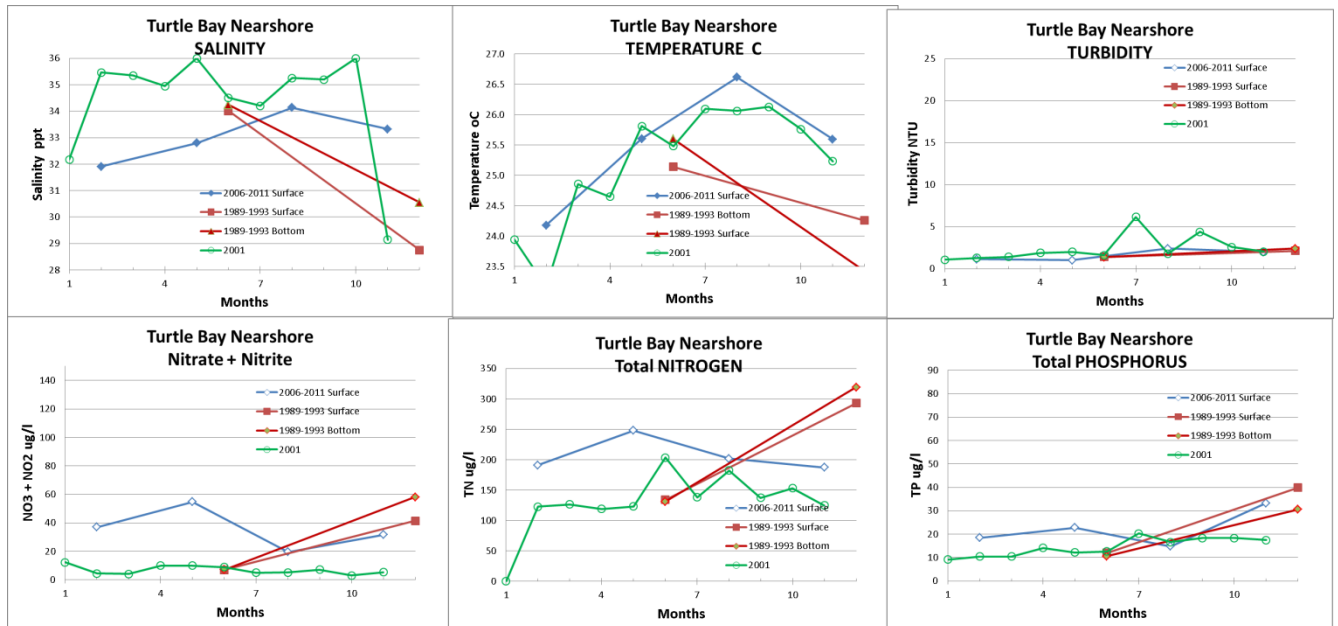
Figure 4-5. Graphic display of annualized averaged data from three studies conducted in Turtle Bay since 1989.

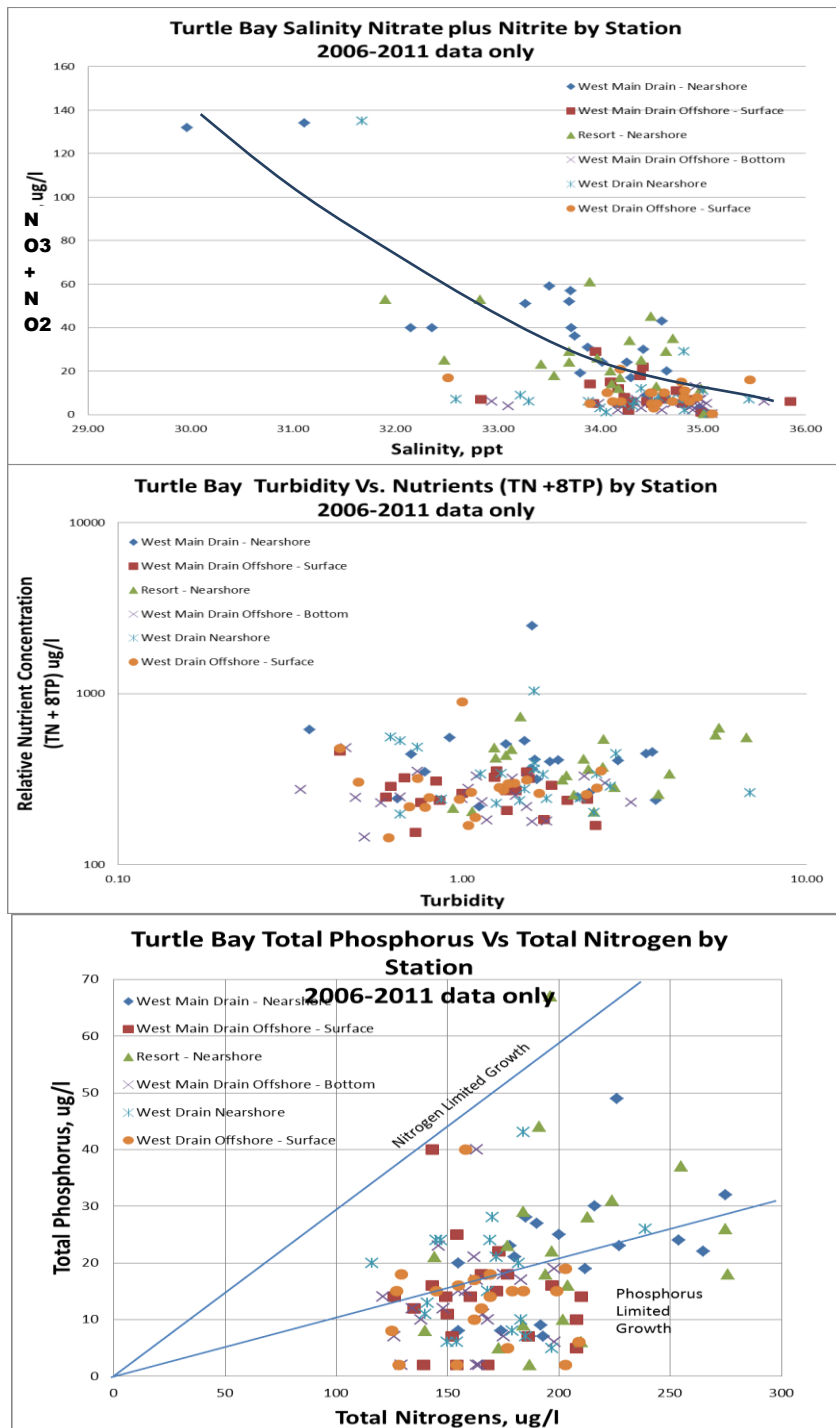
Figure 4-7. Top: Relation between Salinity and nitrate plus nitrite in Turtle Bay. Middle: Relationship between total nutrients (TN+8TP) and turbidity, and Bottom: TN Vs TP in Turtle Bay

2006-2011 data only. Compare to Figure 3-10

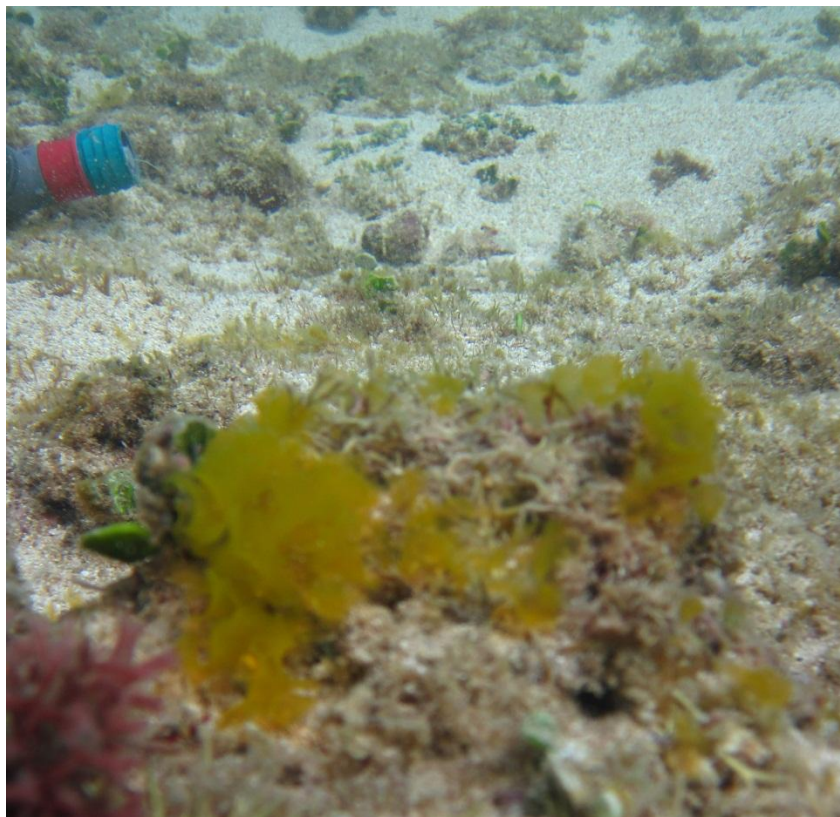
Figure 5-6. Much of the benthic substrate immediately off the East Main Drain in Kuilima Bay is dominated by sand and rubble with little vertical substrate

Benthic surveys were conducted over 100-foot long transects laid parallel to shore 25 feet, 100 feet and 150 feet off shore. A continuous string of 50 photographs was taken along one side of the transect line and the results tabulated by percent benthic substrate type, and then by percent of biological cover over the substrate (Table 5-2). These surveys are in good agreement with those conducted in 1989-1994 and again in 2002 by Oceanit and characterize these nearshore areas as being relatively low relief, highly mobile sand and gravel sediments, little habitat for fish (except at the shoreline), and low percent cover of either coral or fleshy algae.

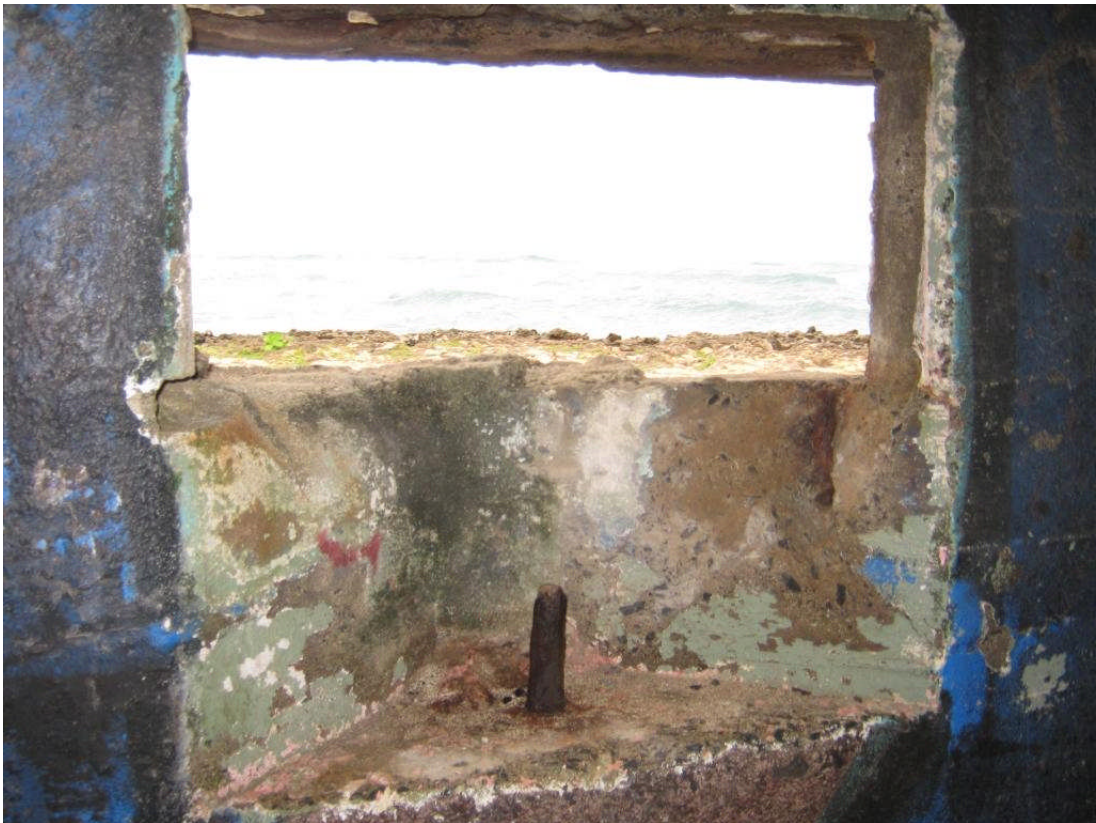
Figure 14. Site 7261 gun mount, view to north

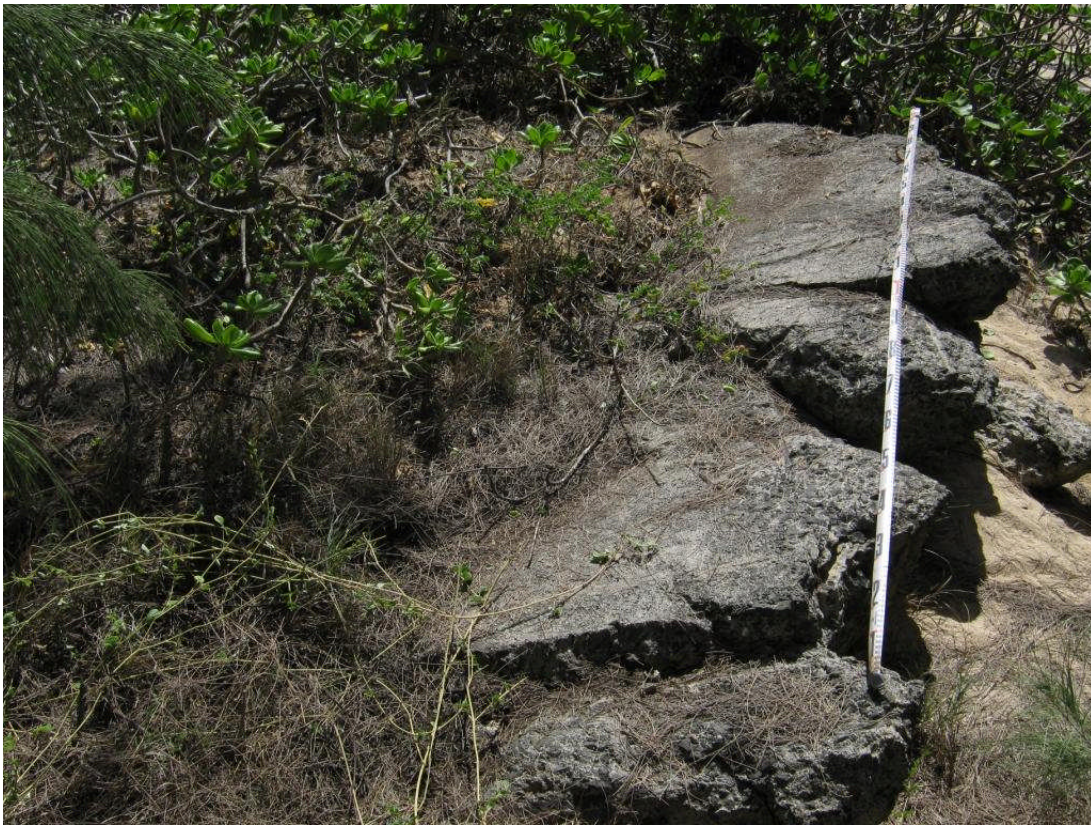
Figure 15. Site 7262 disturbed concrete slab, view to west

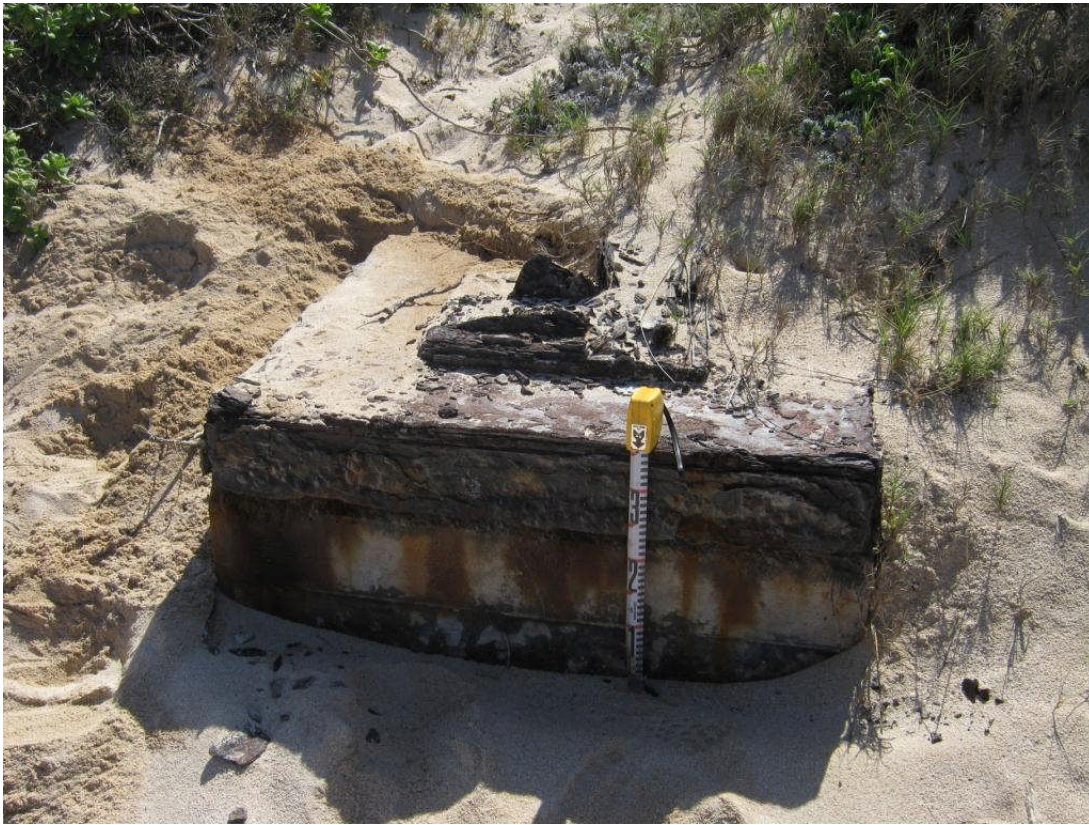
Figure 16. Site 7263 concrete block, view to south

Site 7263 is a concrete block located on the sand beach just inland from the coast along the seaward portion of the Kahuku Point Preserve. The block appears to be in place and intact. It is 36 ½" square and 15" in height above the sand surface (*Figure 16*). There is a metal plate 17" square by 2" high on the top. Two 6" metal bands extend around the upper edge of the plate, with a second band 7" below it. No associated artifacts were observed. The block is probably an anchor for a guy wire support for a tower of some type, potentially an antenna. It was likely used in conjunction with the WW II use of Kahuku Army Airfield. The block is in an upright position and probably in its original location. The site is in fair condition and retains limited physical integrity.

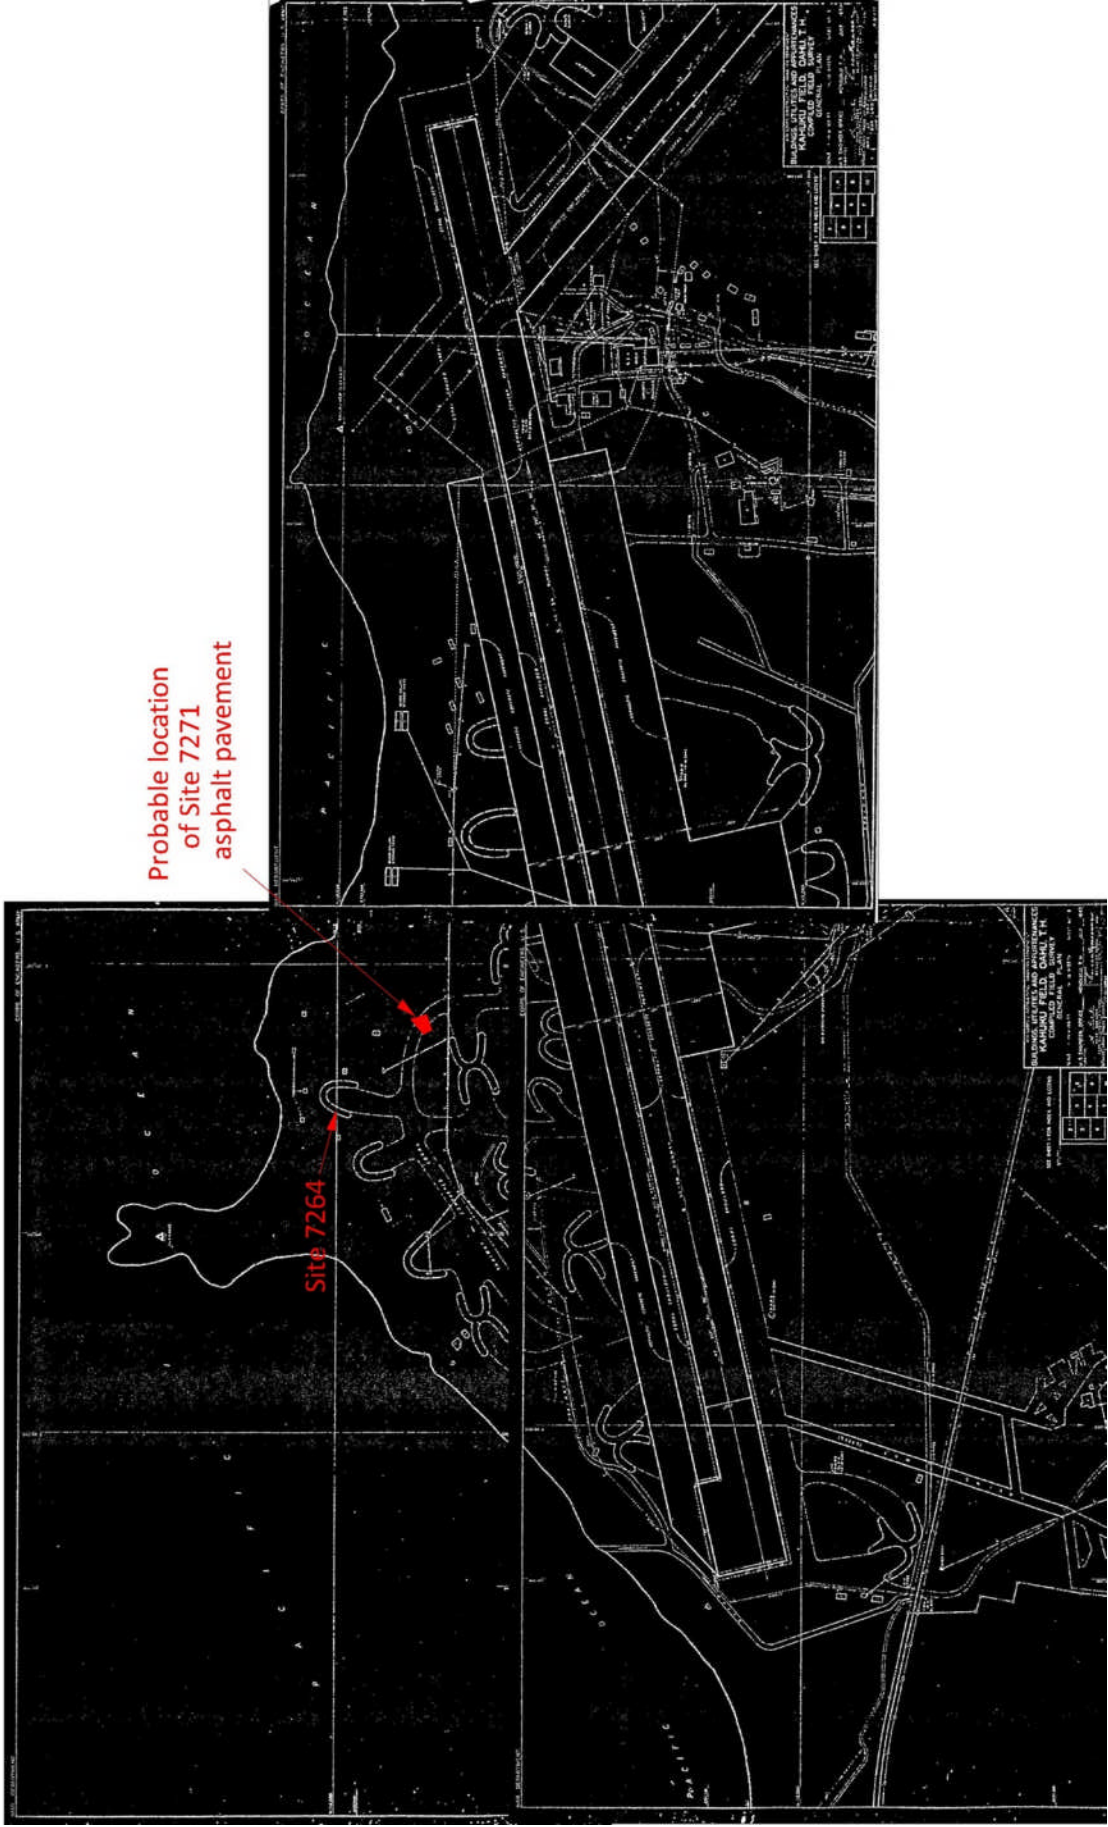
Figure 17. Composite plan map of Kahuku Army Airfield d

Site 7264 is a revetment located in the west part of the Kahuku Point Preserve and is one of twenty revetments formerly situated north of the Airfield runway (*Figure 17*). This revetment is also depicted as a crescent-shaped mound on the coast immediately east of the Kahuku Point on the USGS Kahuku Quadrangle (see *Figure 1*). The revetment is a U-shaped earthen mound, open to the south. It is 375' long (east-west) and 260' wide. The walls of the revetment vary from 49' to 75' wide with a maximum height of 6' 6" above the surrounding ground surface (*Figure 18*). The interior floor is level, reddish brown silty clay loam that was probably imported to the site. The revetment berm is covered with sand. There is a depression located in the interior northeast corner that is 8.35 m long by 4.9 m wide and 1.3 m deep, containing broken concrete slab fragments. No other cultural material was observed. Site 7264 is a WW II-era defensive storage area for aircraft. The site is in fair condition and retains substantial physical integrity.

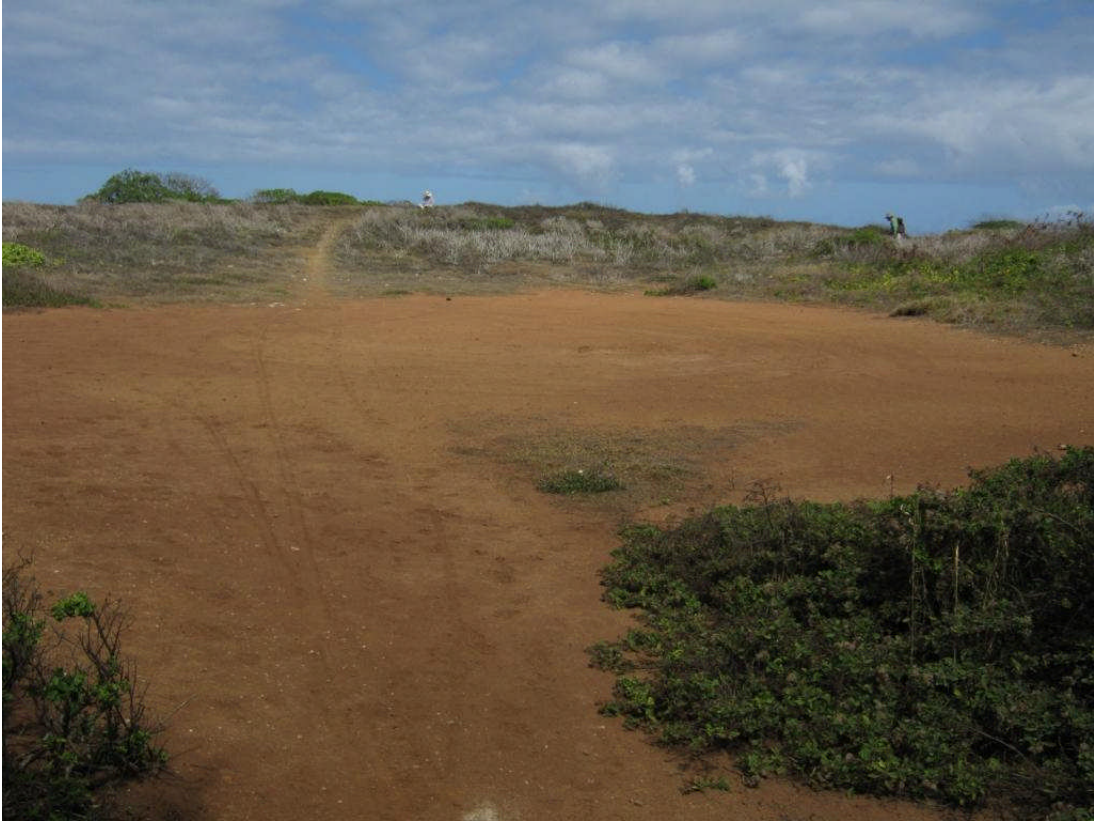
Figure 18. Site 7264 revetment, view to north

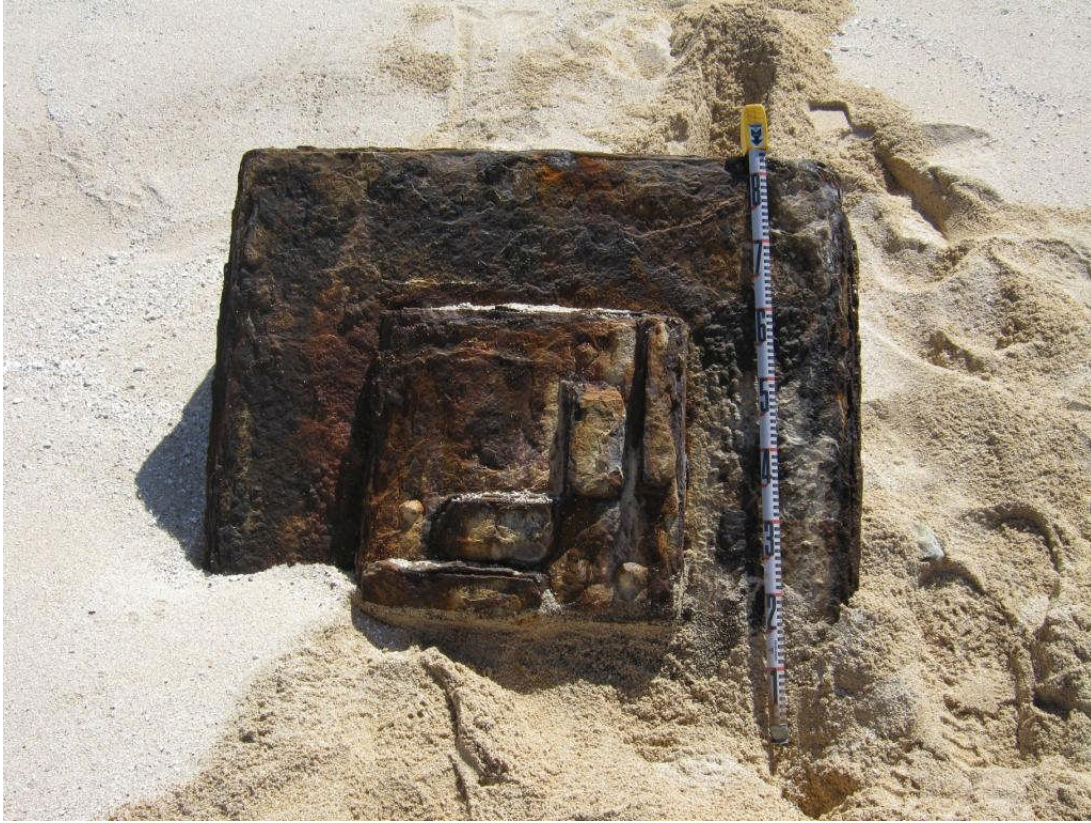
Figure 20. Site 7266, Feature A concrete block, view to south

Site 7266 consists of three concrete blocks located on the sand beach 100 m east-northeast of Site 7263 in the Kahuku Point Preserve (*Figure 19*). The apparently displaced blocks are exposed over an area 45' long (east-west) by 6' wide. The blocks are identical in size to the Site 7263 concrete block, measuring 36-½" square. The Feature A block (located at the eastern end) is buried in the sand at an angle with the upper surface exposed and extends 30" above the surface of the sand (*Figure 20*). The rusted remnants of metal plates are visible on the weathered upper surface of Feature A and a 6" wide metal band extends around the upper sides. The Feature B and C blocks are upside-down, possibly displaced by the 1946 or 1957 tsunami, with an irregular bottom surface exposed. This uneven surface indicates that the blocks were likely formed and poured in place on the ground surface. These blocks vary in height from 12" to 15" above the sand surface. No other cultural material was observed in association with the blocks. The Site 7266 blocks are displaced and likely served the same function as the Site 7263 block, interpreted as a guy wire anchor. The site is in poor to fair condition and retains limited physical integrity.

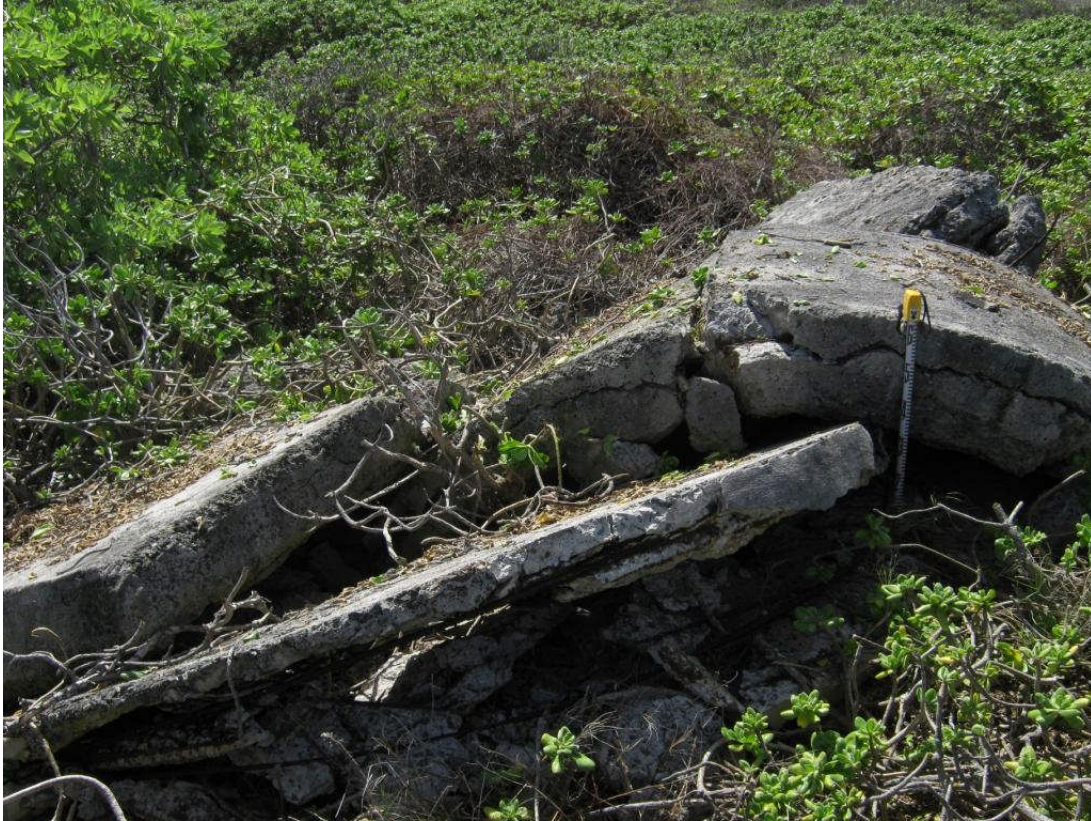
Figure 21. Site 7268 concrete structural remnant, view to south

Site 7268 is the displaced remnant of a concrete structure located in a dense thicket of *naupaka* in the coastal portion of the Kahuku Point Preserve. The concrete material is located in a pile that is 5.0 m long (northwest by southeast) and 3.6 m wide (*Figure 21*). The remnants include what appear to be a domed roof and wall with an opening in it. The walls and roof are 1' in width. Rebar reinforcing is visible in the broken edges. No artifacts were observed in association with the structural remnant. *Figure 22* is a sketch depicting the estimated original shape and dimensions of the structure based on the fragmentary remnants. The structure was approximately 10' 4" long, 7' wide and 6'8" in height. There is a low opening on one side that is 48" in height and 43" wide. There are two 4" diameter ceramic inserts in the ceiling. Site 7268 is located on the coastal side of a military revetment (see *Figure 11*). The site is the probable remnant of a World War II era structure. The specific function of the structure is undetermined; however, the thick, reinforced concrete walls and roof indicate it was likely part of a defensive position, probably a bunker. The site is in poor condition and no longer retains physical integrity.

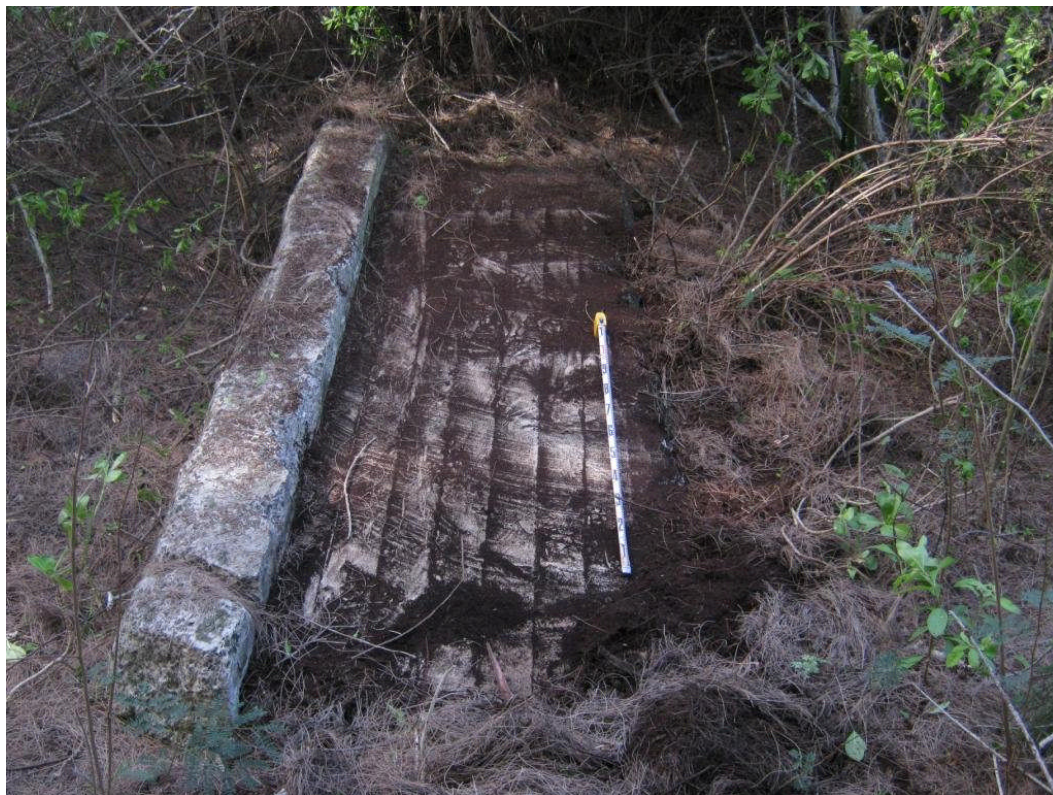
Figure 23. Site 7269 concrete structural remnant, view to east

7269 is the tsunami-displaced remnant of a concrete structure located on the crest of a sand dune, in the central portion of the Kahuku Point Preserve. The remnant is partially buried by sand. The exposed portion is 10' long (east-west) and 4'2" wide (*Figure 23*). The impressions of 5" wide form boards are visible on the side of the structure. No artifacts were observed in association with the structure. The appearance and condition of the concrete indicates the structure likely dates to the World War II use of the area; however, its original size, shape and function are undetermined. The site is in poor condition and lacks physical integrity.

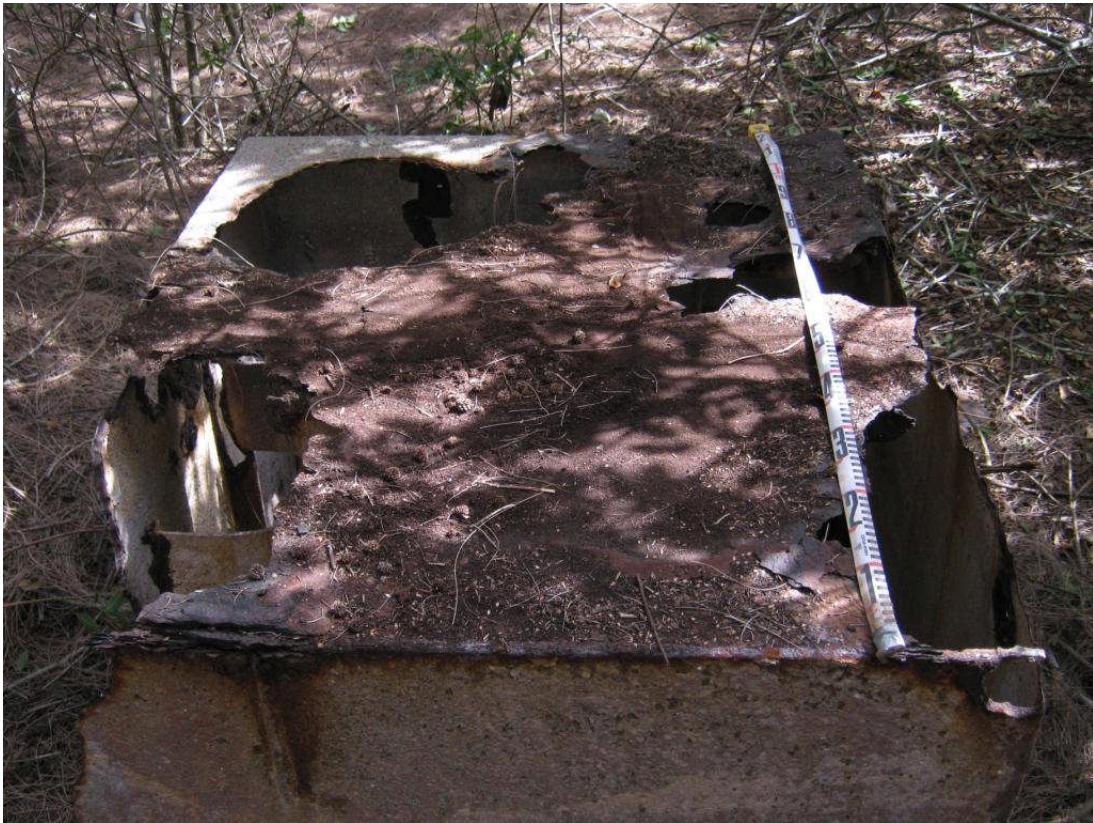
Figure 24. Site 7270 metal box, view to west

Site 7270 is a rusted rectangular metal container, or tank, located on a level soil deposit on the inland side of the Kahuku Point Preserve. The tank is 47" long, 39¼" wide and 34½" in height (*Figure 24*). It is constructed of ¼"-thick sheets of steel that are welded together. The tank interior is divided into compartments by metal sheets perforated with 6" diameter holes (*Figure 25*). There is a 1 ½" diameter hole present near the top of the tank and a 3" diameter metal drainpipe at the base. No artifacts were observed in association with the container. The tank is probably a fuel storage tank based on the compartmentalized interior, which served to reduce fluid movement during transportation. Its condition and appearance suggests it was utilized during World War II. The site is in poor condition and lacks physical integrity.

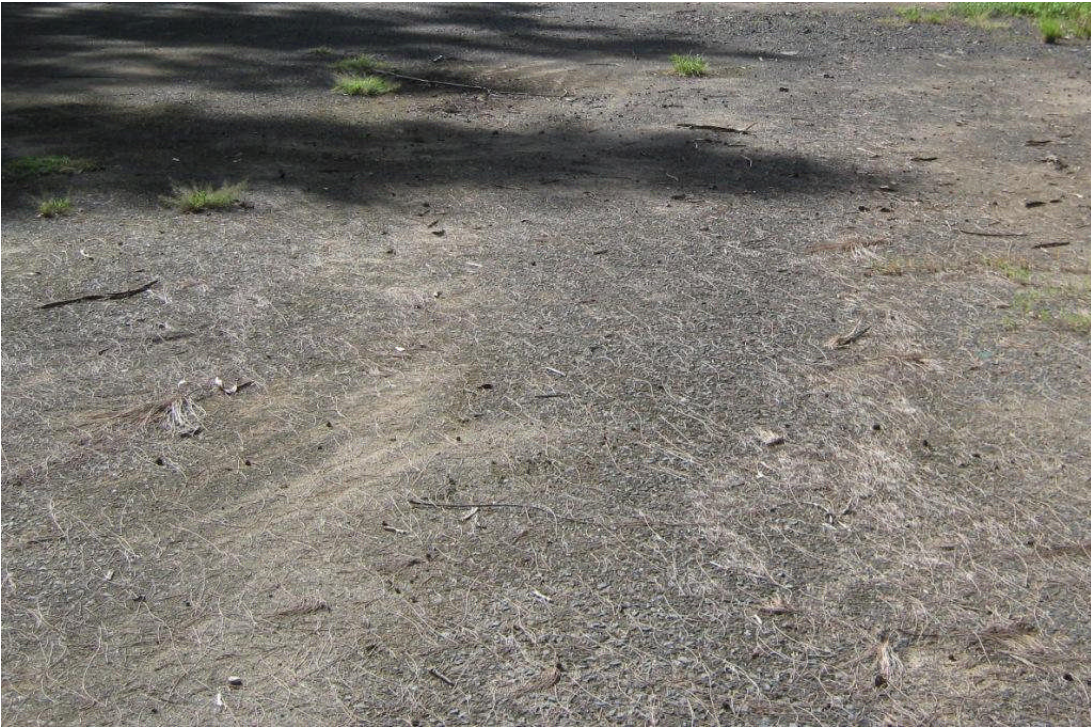
Figure 26. Site 7271 asphalt area, view to east

Site 7271 is a level segment of asphalt pavement located in an ironwood grove along the south side of the Kahuku Point Preserve. The exposed pavement is 76' 6" in length (north-northwest by south-southeast) and 72'10" wide. The sides of the asphalt pavement are disturbed, with jagged edges. A section is buried beneath mechanically piled berms of soil and stone. The pavement surface is level and covered with scattered leaves and ironwood needles (*Figure 26*). Recent aluminum cans and golf balls are scattered on the surface. The Site 7271 pavement is located in an area of aircraft revetments on the north of the main Kahuku Army Airfield runway. The location of the site on *Figure 17* indicates that the pavement probably is a remnant of a road that connected the revetments to the airfield. The site is in poor condition and retains limited physical integrity.

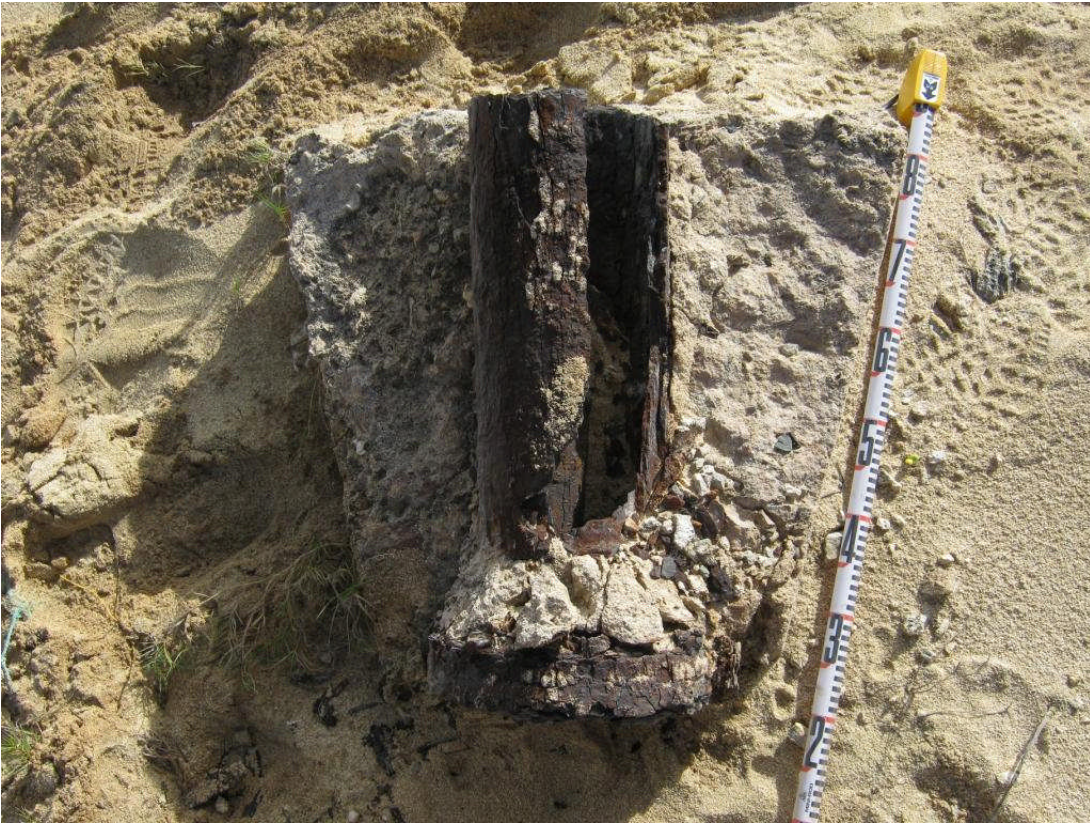
Figure 28. Site 7273 concrete block, view to south

Site 7273 is a tsunami-displaced concrete block located on the seaward slope of a coastal sand dune, in the eastern portion of the Kahuku Point Preserve. The block is trapezoidal and measures 28" wide at the base, 16" wide at the top with sides that vary in length from 25" to 26" (*Figure 28*). The block is lying on its side. There is an 8" diameter pipe embedded in the block with a 1' diameter flange at one end. The concrete has basalt aggregate inclusions. No artifacts were observed in association with the block. Site 7273 likely dates to the World War II use of the area based on the appearance of the concrete. The flanged pipe indicates it potentially had a plumbing-related function. The site is in poor condition and no longer retains physical integrity.

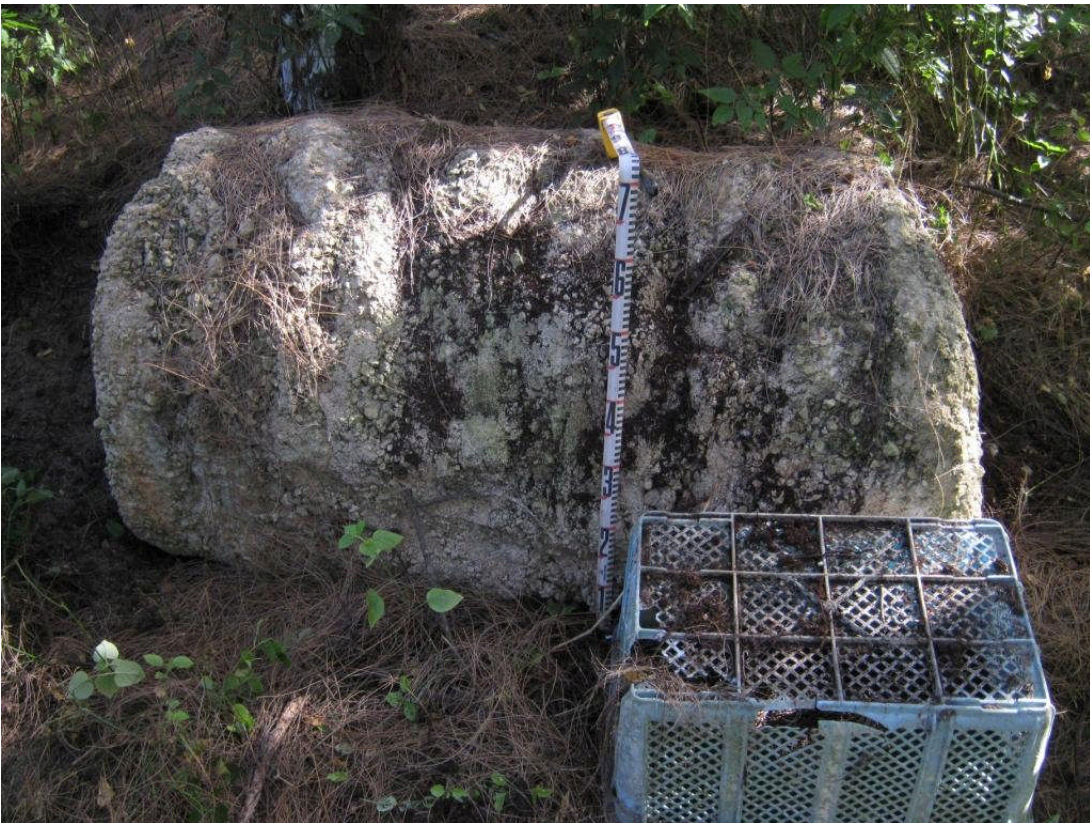
Figure 29. Site 7274 concrete cylinder, view to north

Site 7274 is a tsunami-displaced concrete cylinder exposed on level terrain on the south side of the Kahuku Point Preserve. The cylinder is 55" long by 27" in diameter (*Figure 29*). The concrete is rough and contains limestone gravel aggregate. A copper cable extends out of one end of the cylinder. A plastic milk crate is located adjacent to the cylinder. The shape of cylinder suggests it was originally set in a vertical position and the copper wire indicates

an electrical function, perhaps a support for a light fixture. The site is located within an area of former revetments adjacent to the north side of the Kahuku Army Airfield runway (see *Figure 11*), potentially lending support to a light fixture support function. Site 7274 is poor condition and no longer retains physical integrity.
