**A CULTURAL APPROACH TO
SUSTAINABILITY**

A Cultural Approach to Sustainability

Prepared as a collaborative effort by
Turtle Bay Resort LLC, WCIT Architects, and Kuiwalu
October 2012

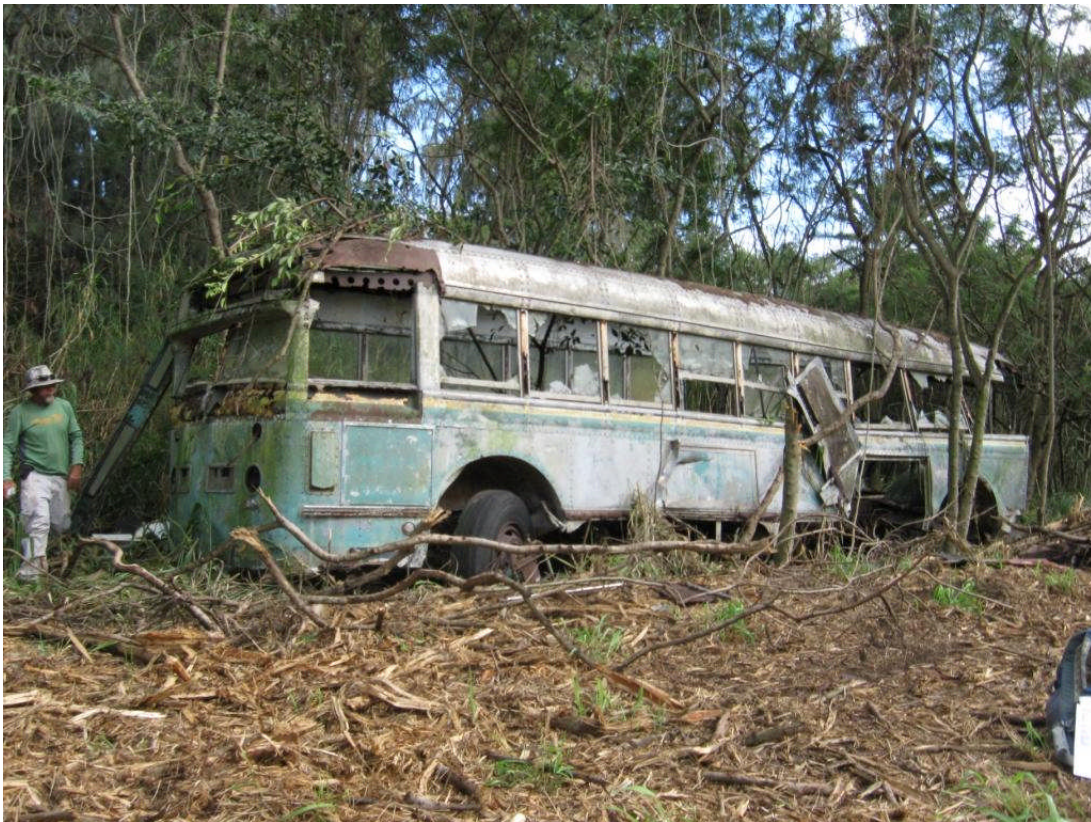
Figure 32. Site 7267 transit bus, view to south

by the City and County of Honolulu (*Figure 34*). The bus was probably sold by the CCHONO, repurposed as a temporary dwelling or farm crew vehicle and abandoned in place. The vehicle is completely deteriorated and lacks physical integrity.

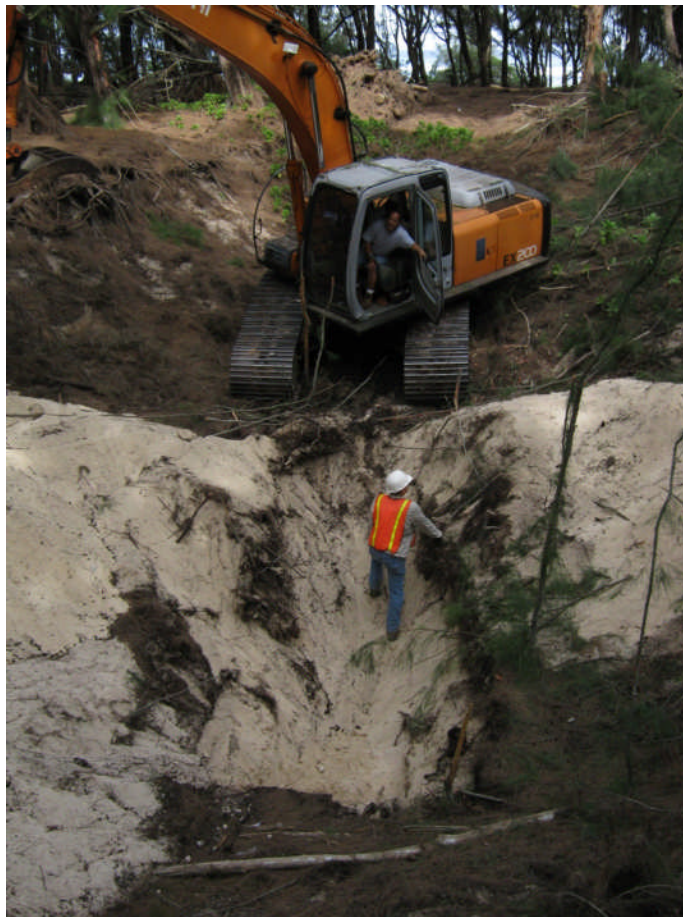
Figure 39. Area C, Sand Pit 1 showing mechanical excavation, view to south

approximately 0.5 to 6.0 m (*Figure 38*). A secondarily deposited human metatarsal (toe bone) was identified on the surface of Sand Pit 7, displaced during previous sand mining activity from a subsurface burial. Two sand pits are illustrated in *Figures 39* and *40*. A grove of Norfolk pines trees is planted in a rectangular 0.71-acre area in the central portion of Area C, and was formerly part of a nursery. A series of dirt roads, paths and a paved golf cart road cross the area.

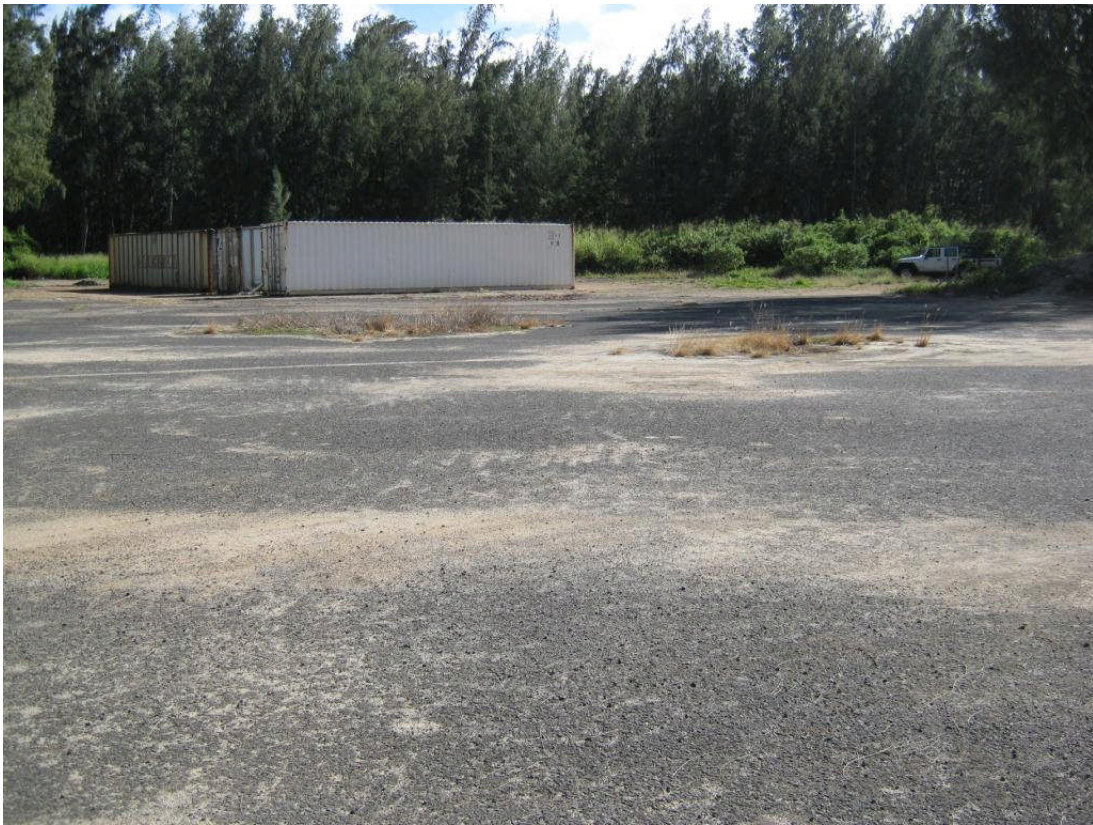
Figure 45. Site 7275 runway with shipping containers, view to east

Site 7275 consists of an exposed asphalt pavement located at the northwestern end of Area E. The pavement is a portion of the main Kahuku Army Airfield runway (see *Figure 43*). The extant pavement is 717' long (east-northeast by west-southwest) and from 104' to 138' wide. Originally, the runway was 6,500' in length; however, large portions were destroyed during golf course construction (Trojan n.d.). The pavement is currently used as storage for sand and soil stockpiles and five metal shipping containers (*Figure 45*). No artifacts associated with the World War II era use of the runway were identified. The site retains limited physical integrity, representing only a portion of the former extent of the runway, and is in fair condition.

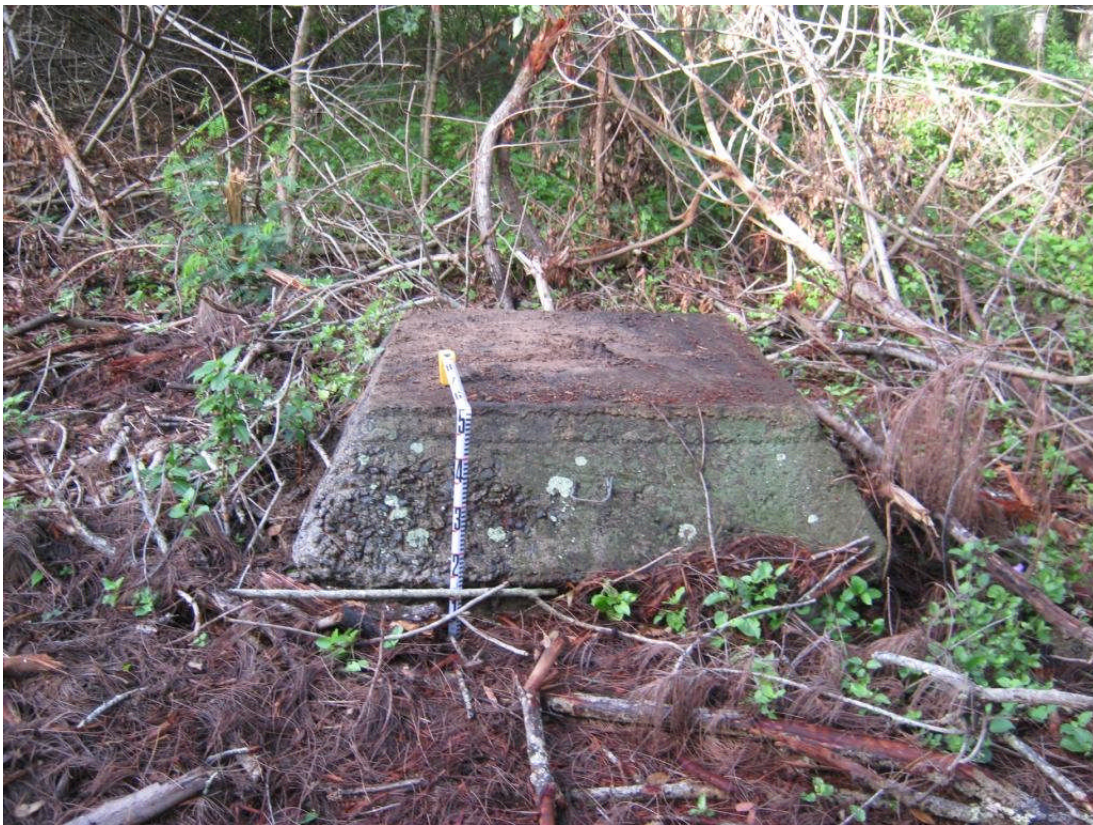
Figure 46. Site 7276 concrete block, view to west

Site 7276 is a concrete block located in the approximate center of Area E. The block is 4' square at the base and 3' square at the top, with 1.2' high tapering sides (*Figure 46*). Form board impressions are visible on the sides and a projection on the base indicates it was poured in place. Braided wire loops are embedded on each side of the block and a rusted metal remnant of a possible hook or eye protrudes from the top. Fragments of asphalt are scattered around the block. Site 7276 is a probable anchor, potentially used to secure guy wires. It is unclear if the block is in its original location and is in fair condition.

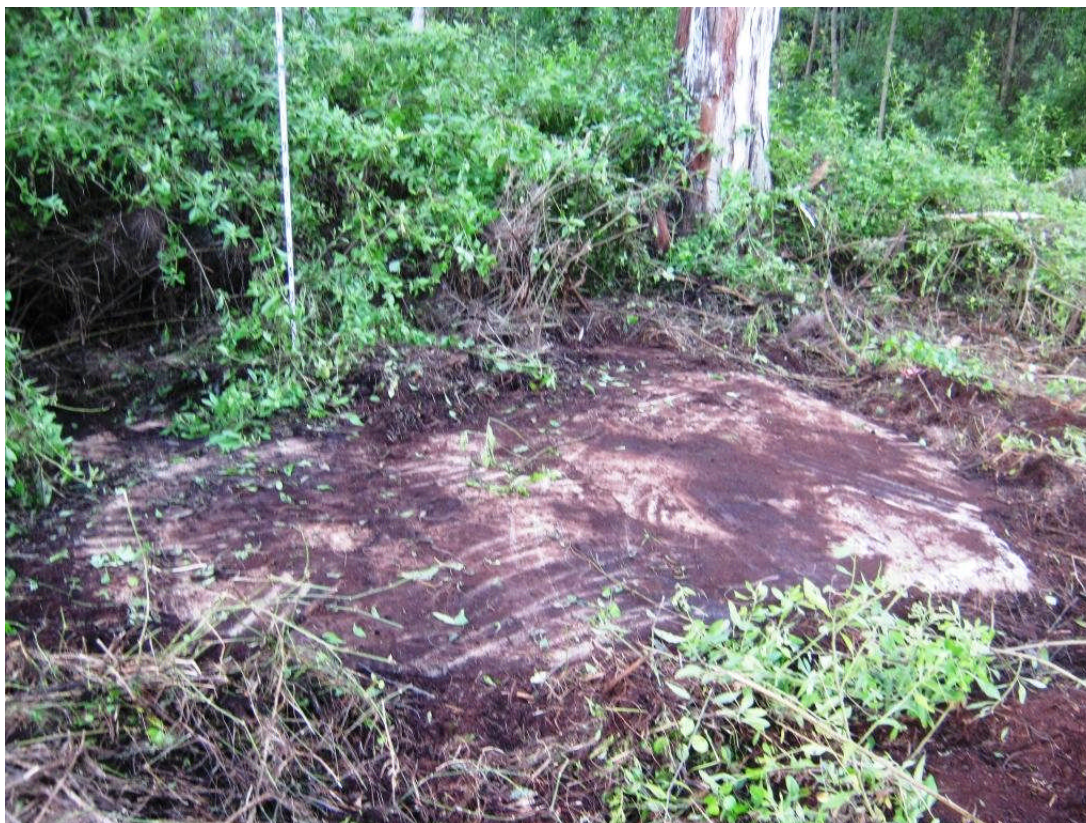
Figure 47. Site 7277 concrete slab, view to southwest

Site 7277 is a rectangular concrete slab located on the northwest side of Area E. The slab is 10' 9 ¼" long (north-south) and 9' 8¼" wide (*Figure 47*). The sides are mostly broken although linear, intact edges are present along each of the four sides. The slab is formed concrete and the surface is level and smooth. Modern debris is scattered throughout the area although no remains were in direct association with the slab. The slab presumably served as a foundation likely associated with the Kahuku Army Airfield. It is altered and in fair condition.

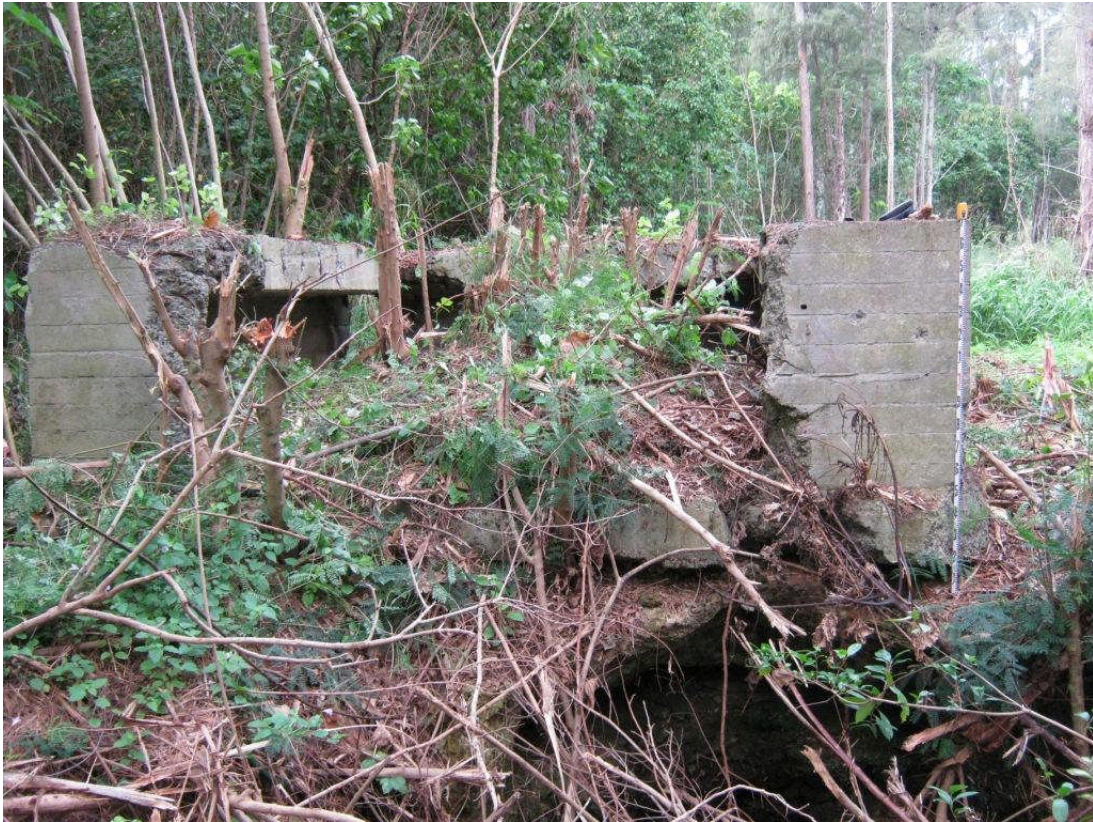
Figure 49. Site 7278 concrete structure, view to northwest

Site 7278 is an intact U-shaped concrete structure located in the southeast portion of Area E, north of the barracks and south of the revetment bordering the main runway (see *Figure 43*). The structure is 15'10" long (northeast-southwest) by 14'2" wide and open to the southeast (*Figure 48*). The walls are 4'2" to 4'7" high and 1' thick, with impressions from 6" form boards. The walls were constructed with reinforcing steel bars visible in broken edges. The top of the structure is open with eave-like overhanging sections 2'10" wide on the interior (*Figure 49*). Two linear, parallel grooves 1" wide and ¾" deep are located on the underside of the overhanging sections; remnants of wood are still visible in the grooves. The floor of the structure is covered with soil and displaced concrete slab fragments. The structure is extensively damaged. Damage to the north and west corners resulted in the complete destruction of the exterior corners and in holes through the concrete to the interior of the structure (*Figure 50*), a pattern that might be the result of an explosive charge detonated in an attempt to destroy the structure. A water

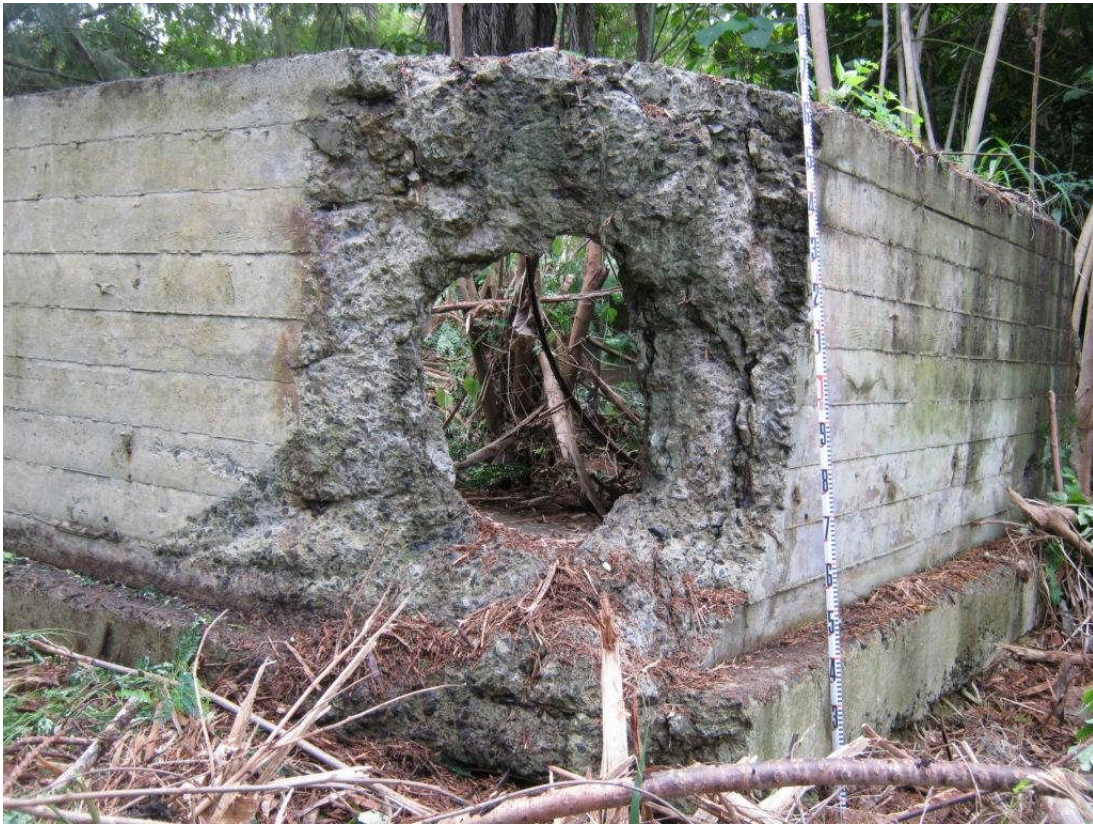
Figure 50. Site 7278 blown out corner of concrete structure, view to southwest

filled sinkhole roughly 13' square and 6' deep is located adjacent to the southeast side of the structure. No artifacts were observed in association with the structure. Site 7278 is interpreted as a World War II era facility based on formal type and condition. Its specific function is undetermined, but its peripheral location and thick reinforced concrete walls might indicate use as a defensive structure, perhaps a gun position, or an ordnance storage facility. Site 7278 is in poor condition and lacks substantial physical integrity.

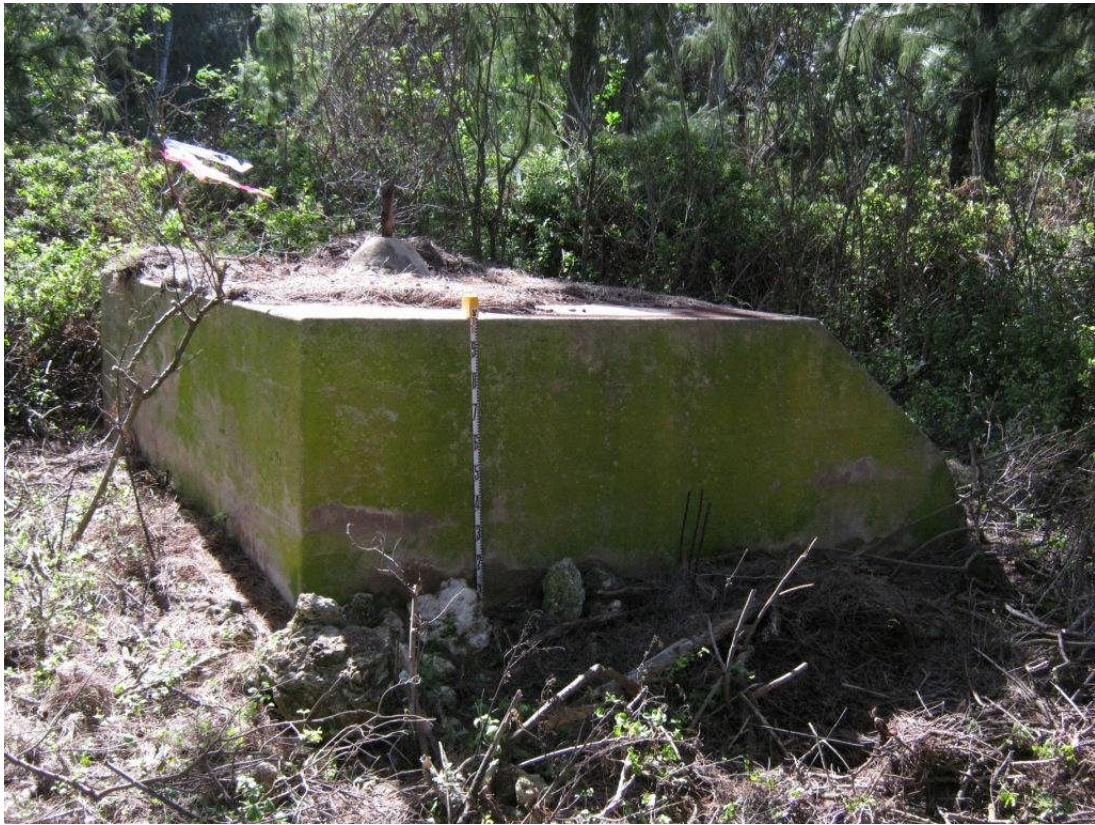
Figure 52. Site 7279 concrete block, view to south

Site 7279 is a square concrete block located on level ground on the east side of Area E. The block is intact and measures 9'10" on each side (*Figure 51*). The east two-thirds of the block has a level upper surface 2'9" high. The west side slopes to the ground surface (*Figure 52*). An 8" wide metal strap is imbedded in the sloping surface (*Figure 53*). A conical concrete mound on the upper surface of the block is 1'7" in diameter and 1' high. A 2" rusted metal pipe extends vertically from the center of the mound. Two inscriptions are present on the sides of the mound: "Station 232" is inscribed on the east side (*Figure 54*) and "JBM 1933" is inscribed on the west side (*Figure 55*). A purple glass bottle is present on the ground surface east of the block and a pile of concrete rubble is located adjacent to the north side of the block.

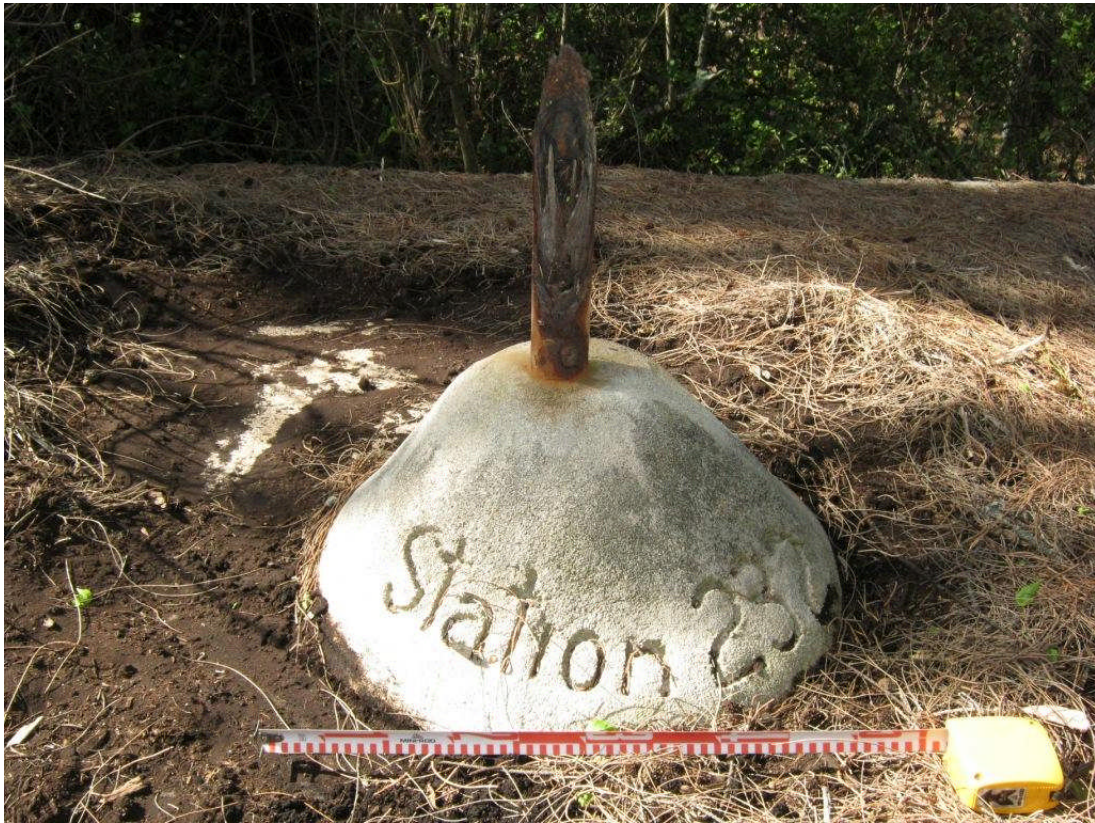
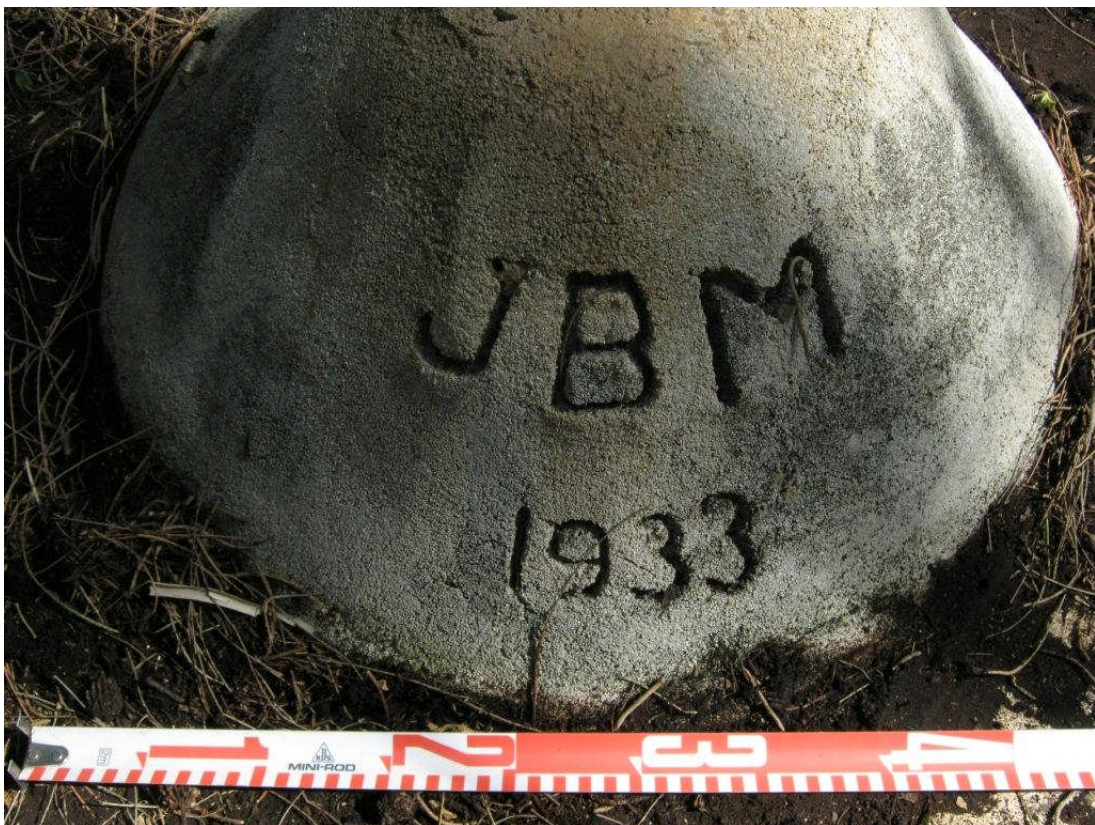
Figure 54. Site 7279 concrete mound with inscription, view to east

Figure 55. Site 7279 concrete mound with inscription, view to west

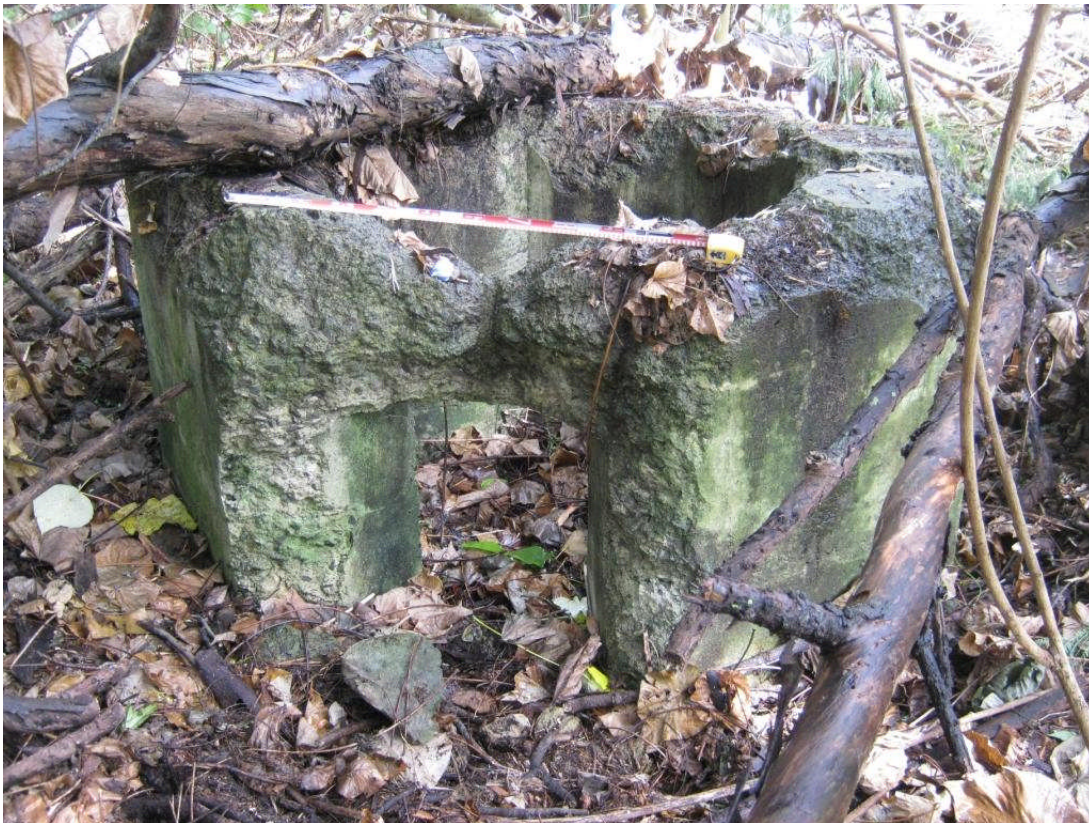
Figure 59. Site 7280 concrete structure, view to northeast

Site 7280 is a low, octagonal concrete structure 6' 3" wide and open on the top, located on a level ground surface in the east portion of Area E (*Figure 58*). The walls are formed concrete, 1' thick and 2'2" to 2'8" high. A tapered opening in the southwest side is 1'9" wide on the exterior and 1'1" wide on the interior (*Figure 59*). The corners and upper edges of structure are broken, exposing the interior wall surfaces, where steel rebar is exposed. The floor is level soil. No artifacts were observed in association with the feature. Site 7280 appears to be in its original location, but is severely damaged. The site is in fair condition and retains limited physical integrity.

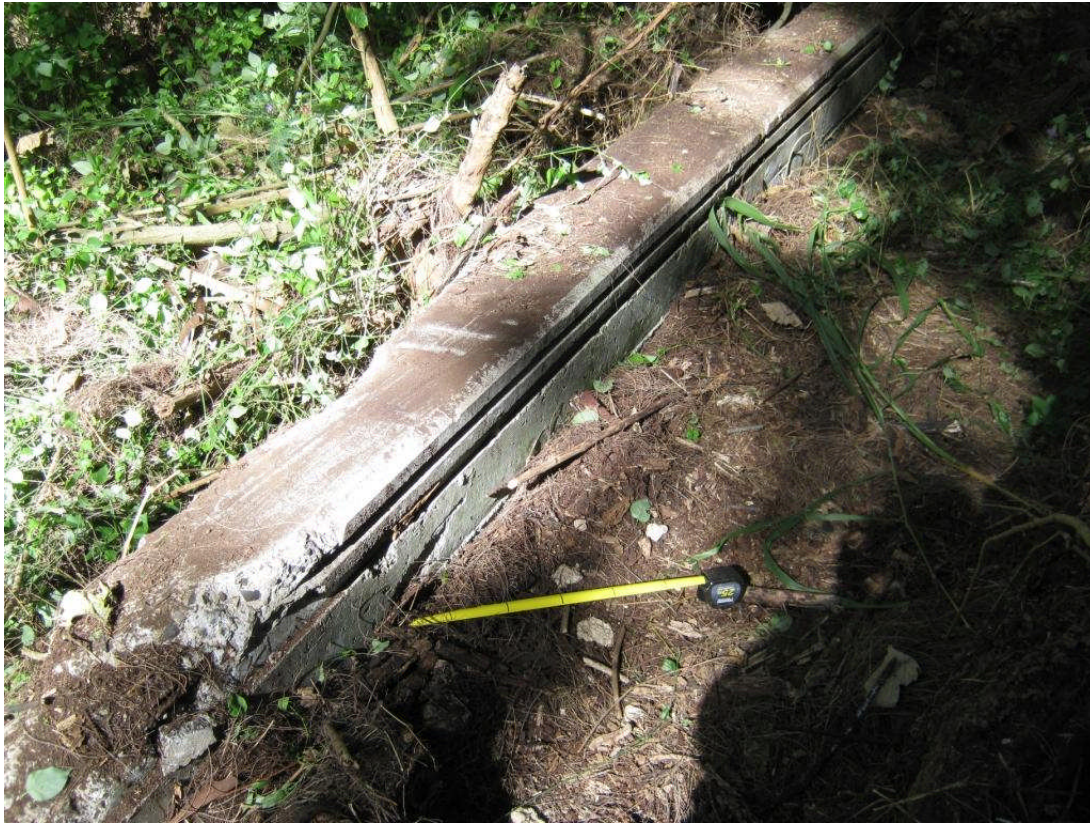
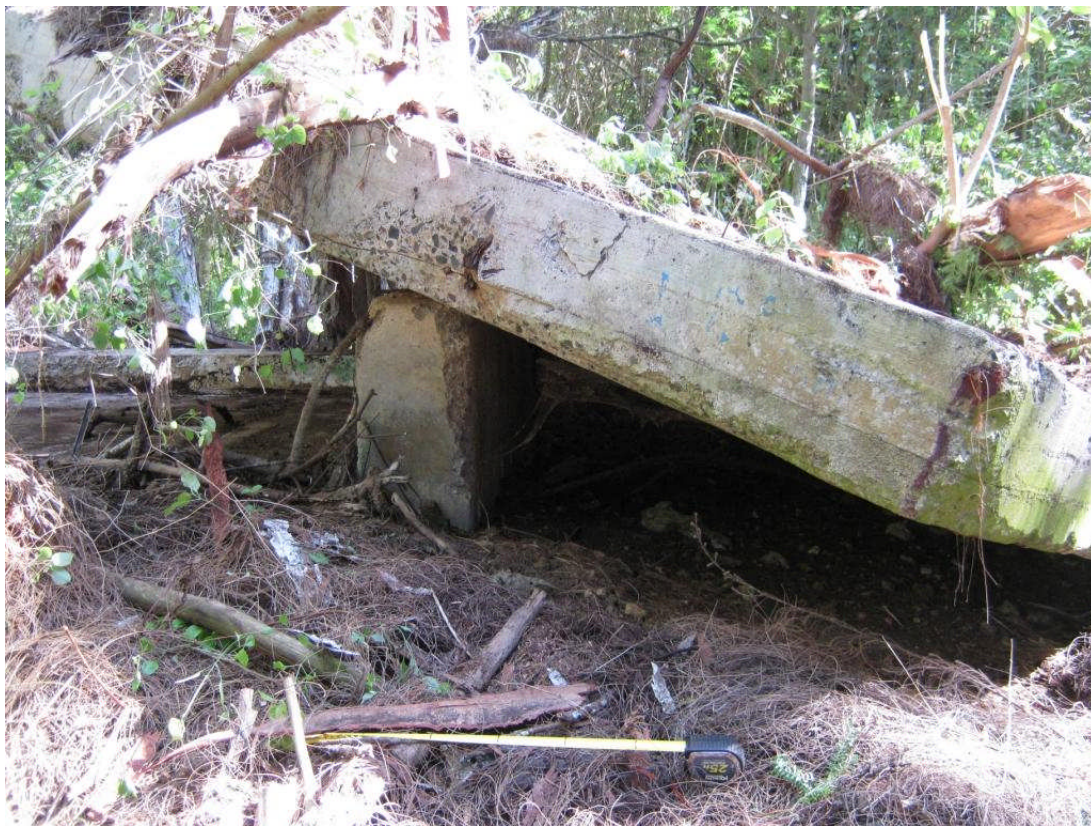
Site 7281 consists of a predominantly buried pile of concrete structural elements in an area 16 m long (north-northwest by south-southeast) by 4 m wide. The debris pile is located adjacent to a dirt road on level ground in the south portion of Area E. Some concrete structural elements are similar in form and appearance to the standing concrete structure documented at Site 727. Visible elements consist of three wall segments 1' thick with the same 2'10" wide overhanging interior eaves as those at Site 7278, and the same two parallel grooves on the underside of the overhanging eave-like projections (*Figure 60*). The broken walls vary in length from 13' to 14'. A displaced concrete slab is positioned on top of one of the disturbed walls adjacent to the dirt road. The slab is 12' square and 1' 4" thick, with reinforcing rebar visible along the edges (*Figure 61*). A similar slab was not present at Site 7278, which suggests it could represent a displaced element of a second structure.

Figure 60. Site 7281 concrete structural remnant, view to northeast

Figure 61. Site 7281 concrete structural remnant, view to south

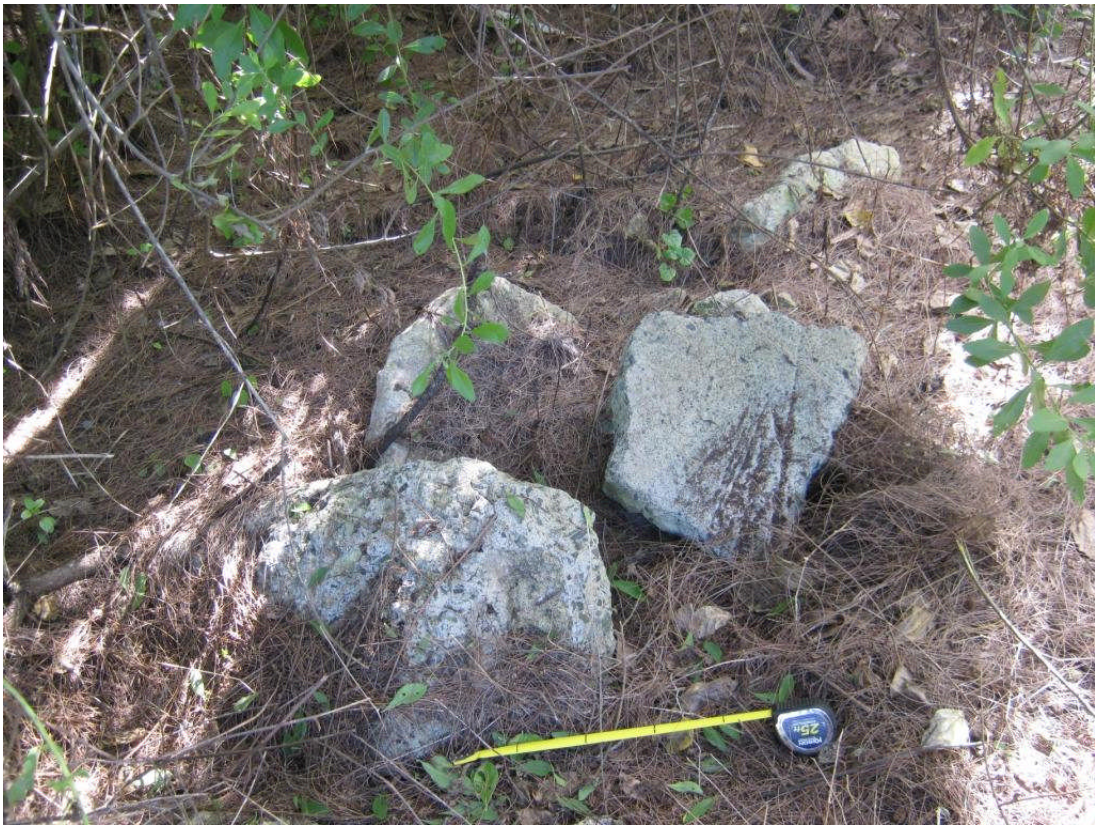
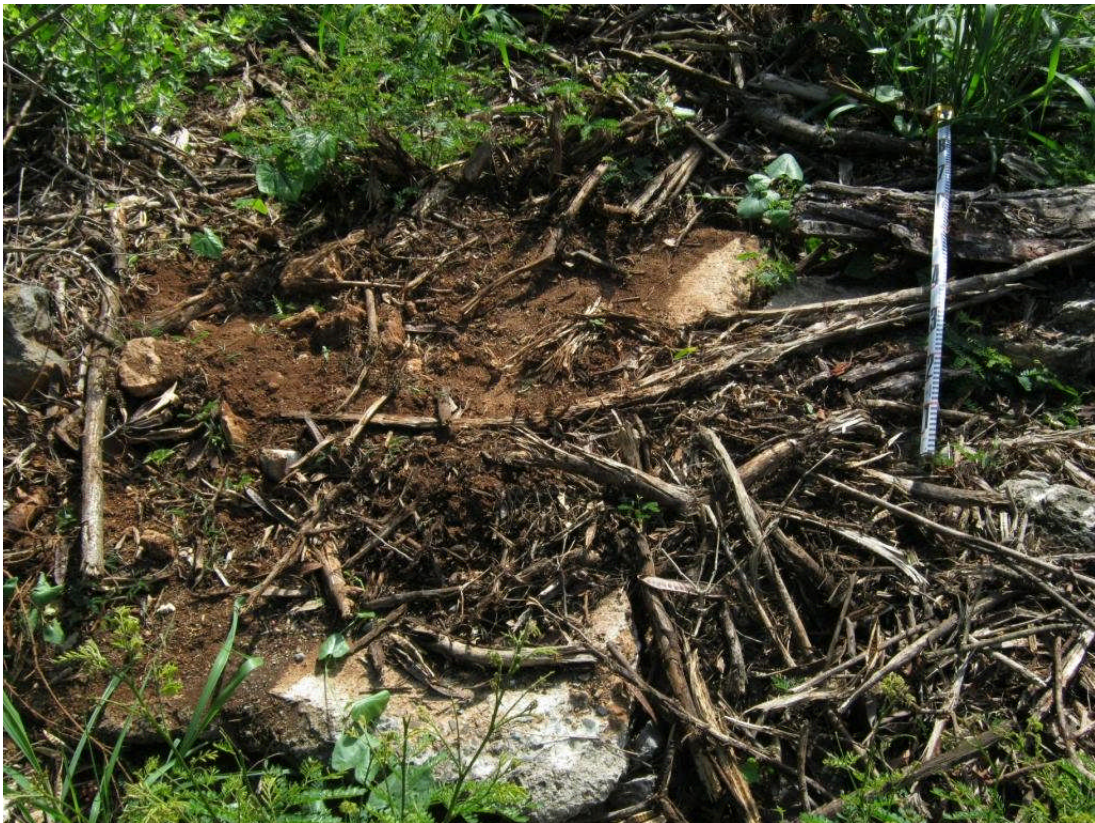
Figure 65. Push piles with concrete debris, view to south

Figure 66. Push piles with concrete debris, view to southwest

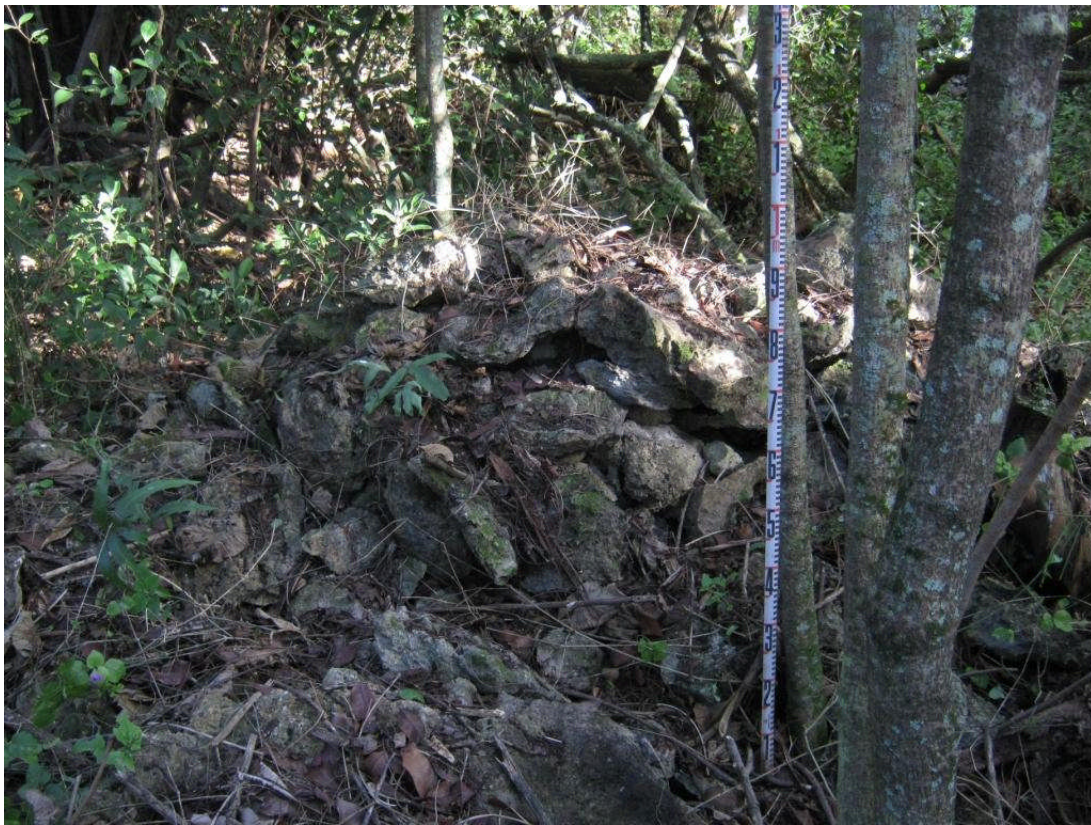
Figure 68. Site 7283 stone mound, view to north

Site 7283 is an irregularly shaped stone mound located on the eastern periphery of Area F, 5.0 m north of a dirt road. The mound is built of roughly stacked and piled weathered limestone boulders and cobbles on a surface of undulating terrain characterized by limestone outcrops (*Figure 68*). The mound is 3.0 m long (east-west) by 2.6 m wide and 0.95 m high with an uneven irregular surface. No artifacts were observed in association with the feature. The mound is interpreted as possible agricultural clearing feature based on its formal type and informal construction. It is in poor to fair condition and retains limited physical integrity.

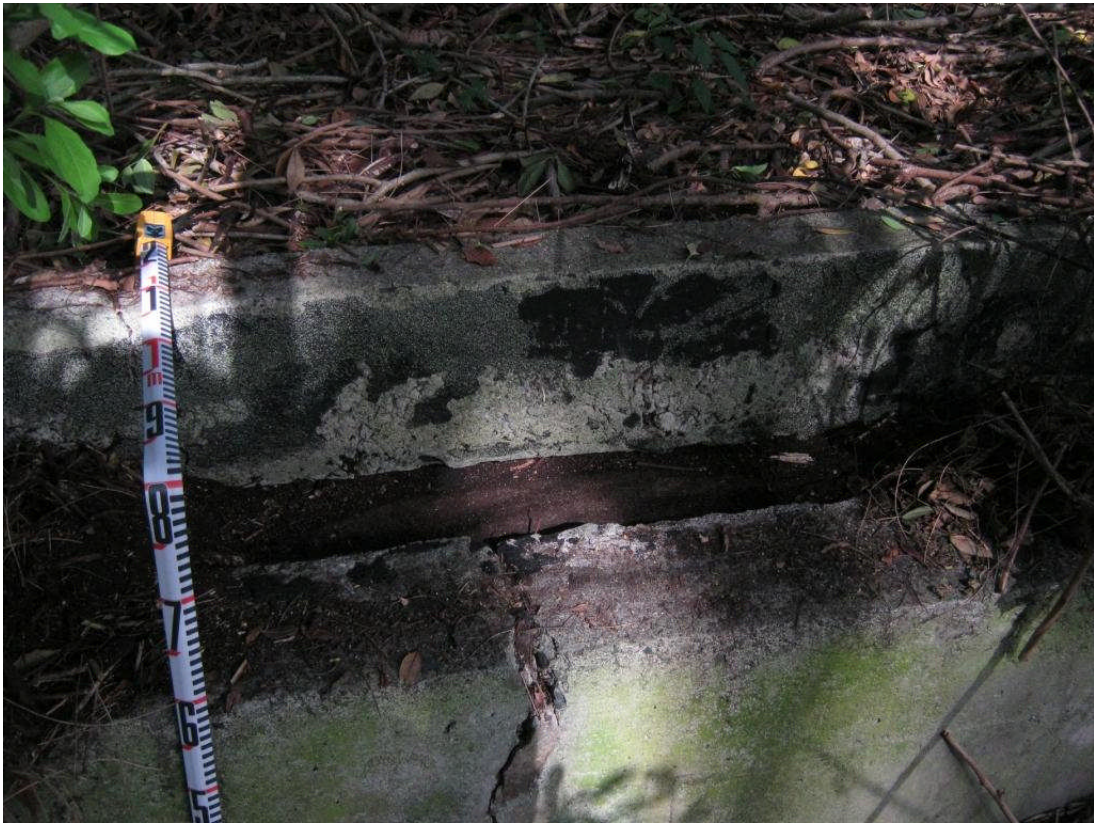
Figure 71. Site 7284, Feature A channel, view to northeast

Feature A is a rectangular concrete slab 73'6" long (northwest by southeast) and 40' wide, located at the southeast end of the site (*Figure 70*). The sides vary in height from 1'11" to 3'8" above the surrounding ground surface. The northwest quarter of the slab is raised 4" above the rest of the surface. A second, 10" high raised surface is located in the eastern corner. Two ½" bolts are present in the north and east corners, while two ¾" bolts are present at the south and west corners. A recessed channel 3 5/16" wide extends along the southwest side and portions of the northwest and southeast sides. A dense stand of Christmas berry covers and obscures the slab surface; it is possible that the channel continues but is obscured. The surface of the main slab is 10" above the channel (*Figure 71*). A second set of recessed channels extends at least 16' toward the center of the slab, but is buried beneath soil and Christmas berry so its full extent might be greater. A 1 ¾" metal pipe is suspended from the side of the slab along the northwest side. One-half inch diameter steel rebar is visible in broken edges of the slab. A mound of soil and a large boulder are located on the southwest side of the large slab. A smaller concrete slab adjoins the west-central side of the main structure and is 25' long (northwest by southeast) by 6'4" wide and 1" above the surrounding ground surface. The surface of the main slab is 2'6" higher than the surface of the smaller slab. A large displaced slab fragment is present on the east end of the surface of the lower slab. A backhoe trench was excavated on the southwest side of Feature A. Excavation of BT-F-9-1, a 5.0 m long trench, documented 0.2 m of fill over weathered limestone (see *Figure B-320* in **Appendix B**). A 2" galvanized metal pipe in the northwest wall of the trench likely originated at the slab. No other cultural remains were present.

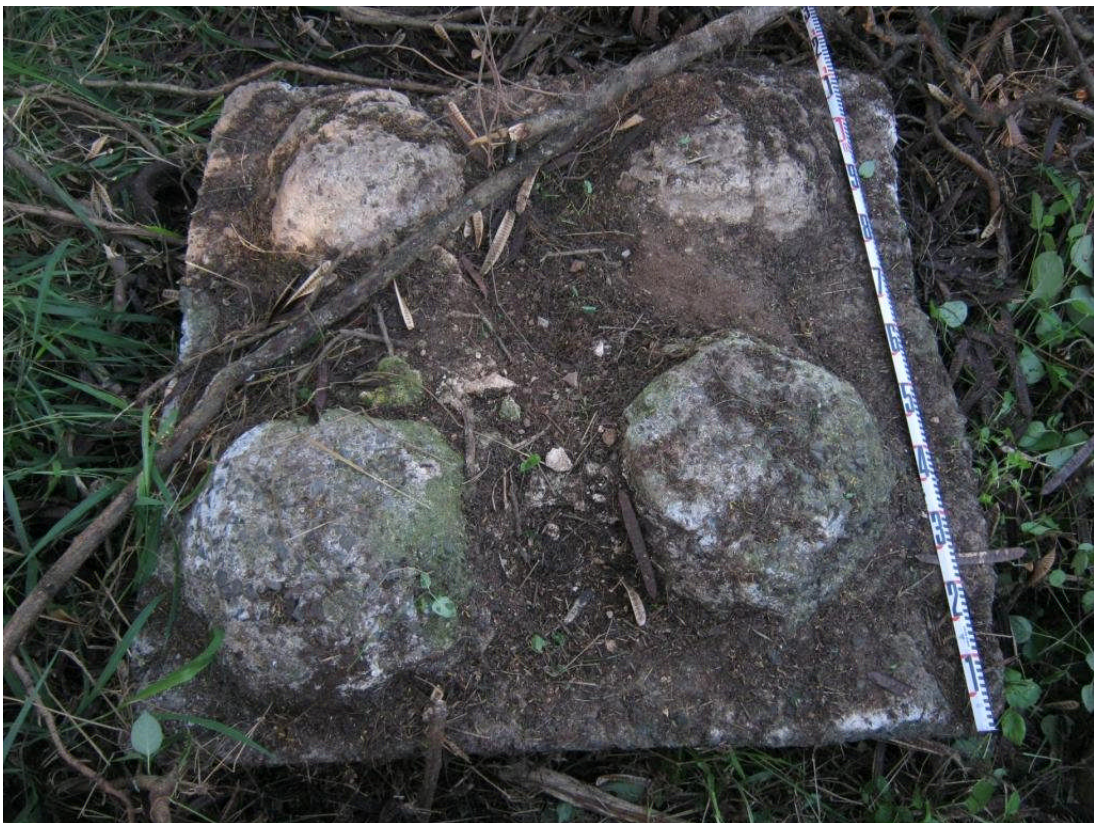
Figure 72. Site 7284, Feature B concrete pad with projections, view to northwest

Feature B is a concentration of discarded historic structural elements, predominantly fragments of concrete, located 18 m northeast of Feature A (see *Figures 69-70*). A large bulldozed push pile of soil, stones, asphalt and concrete fragments separates Feature B and Feature A. Debris is scattered over an area 7 m long (north-northwest by south-southeast) by 4 m wide. Feature B consists of two concrete pads (each is 4'3" long by 3'1" wide), a cluster of twisted metal pipes, a concrete block with a 4" metal pipe extending from the top (3' long by 2'8" wide) and two small concrete pads with four raised, roughly hemispherical projections (*Figure 72*). The pads at the north end of the concentration are 4' square and 10" thick with the projections averaging 1'4" in diameter and 5" in height. The broken pad with projections is 4' long and 2'9" wide. A large basalt boulder is located on the northwest edge of the discarded structural elements.

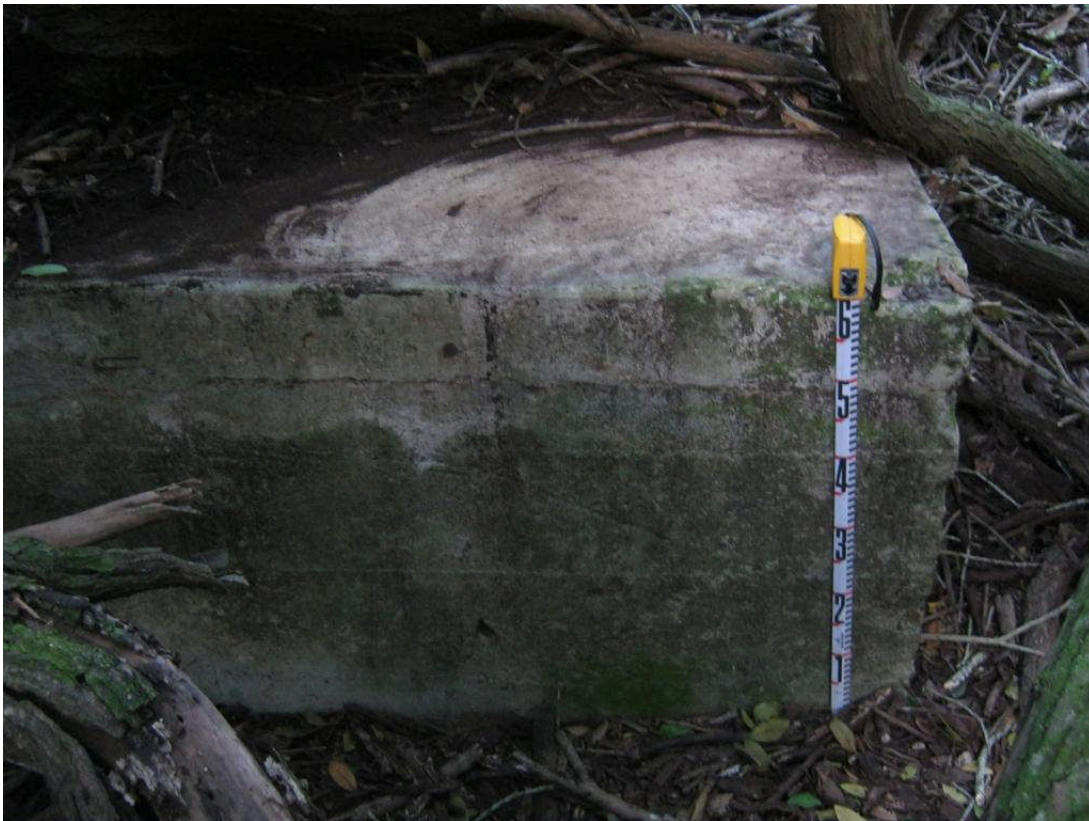
Figure 74. Corner of Site 7284, Feature C showing form board marks, view to northeast

Feature C is a rectangular concrete slab 70'2" long (northwest by southeast) and 37'6" wide, located 15 m northwest of Feature A (*Figure 73*). The slab is 1'10" to 2'6" high and was constructed using 7" wide form boards (*Figure 74*). The northeast side of the slab is raised 4" above the rest of the slab surface. A recessed (10" deep) channel, identical to one at Feature A, frames the lower portion of the slab. A series of ½" threaded metal bolts spaced 4' apart extend from the northeast side of the raised portion of the slab (*Figure 75*). Numerous Anchor Hocking brown and colorless glass bottles are scattered around the slab.

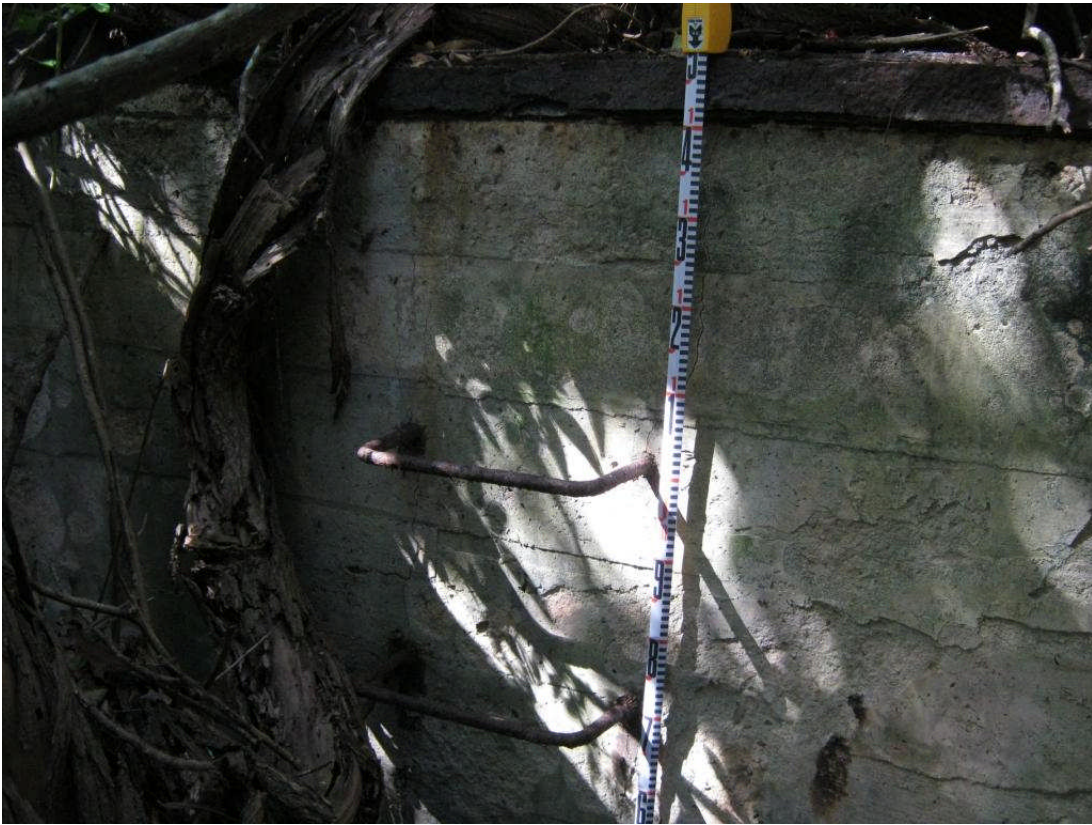
Figure 77. Metal ladder at Site 7284, Feature D, view to west

Feature D is a complex concrete structure situated 22 m northwest of Feature C. The structure is densely overgrown with Christmas berry and is composed of three adjoining rooms. The overall structure is 44'2" long (west-northwest by east-southeast) and 19'8" to 40'8" wide (*Figure 76*). The walls are 1' thick and were constructed using 7" wide form boards. Broken edges reveal metal reinforcing rods. The smallest room on the east side is 19'8" long by 10'9" wide with a concrete floor, but no roof or obvious entrance. Half-walls are present on the north and east sides, 2'3" to 2'6" high. A metal ladder is attached to the southwest interior wall of the smallest room (*Figure 77*). The central room is 33' 4" long by 19'10" wide; wall heights vary from 5'4" to 5'7" and the floor is concrete (*Figure 78*). The floor and the lower half of the interior walls are coated with tar. The central room also lacks a roof and obvious entrance. A northern extension of the central room consists of a rectangular concrete slab that adjoins the north side of the central room. The northern extension is 26'11" long by 20'10" wide and is only partially walled, but not roofed. A half-wall, 1' thick and 1'11" to 2' high, extends along the east side and northeast corner. A raised concrete platform in the center of the slab has two levels (*Figure 79*). The lower level is 3'11" long, 2'8" wide and 6" high, with a metal bracket at both ends. The upper level is 4' long, 2'6" wide and 1'5" high. A metal electrical panel is located on the wall near the southeast corner. Modern trash is scattered within and adjacent to the structure.

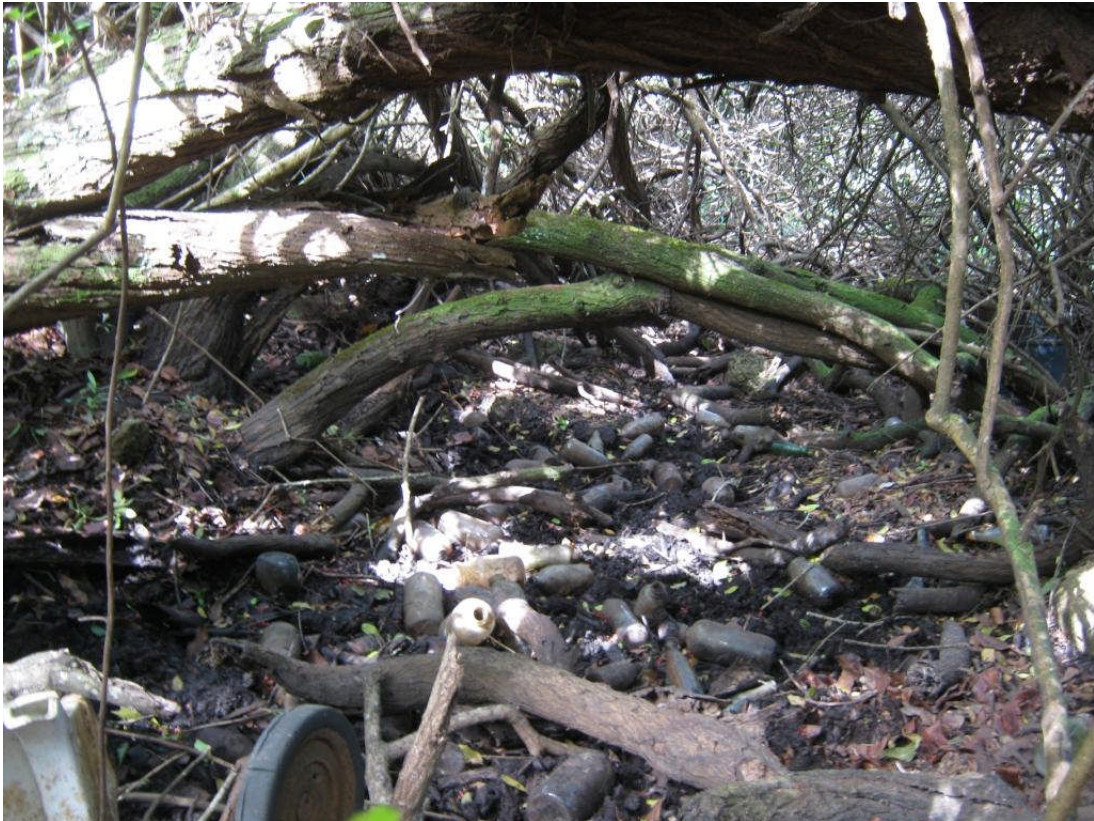
Figure 80. Site 7284, Feature E artifact scatter, view to north

Feature E is trash dump of historic and modern debris covering an area 8.5 m long (east-west) by 3 m wide, c. 3.5 m northwest of Feature D (see *Figures 69* and *76*). The oldest items are colorless glass containers, Anchor Hocking bottles and jugs, brown glass beer bottles, and rusted metal cans (*Figure 80*). Modern debris includes a lawn mower, plastic bottles, a small refrigerator, an enamel sink and two porcelain toilets.
