**A CULTURAL APPROACH TO
SUSTAINABILITY**

A Cultural Approach to Sustainability

Prepared as a collaborative effort by
Turtle Bay Resort LLC, WCIT Architects, and Kuiwalu
October 2012

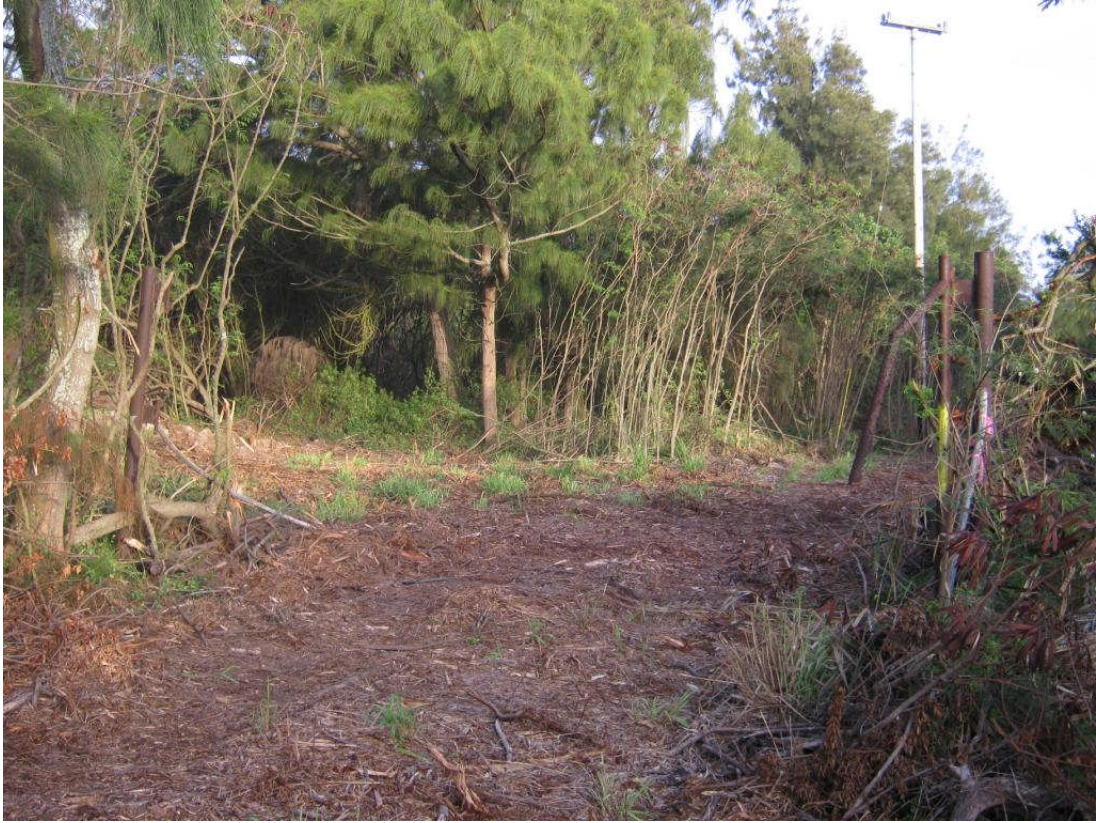
Figure 81. Site 7285 metal gateposts, view to south

Site 7285 consists of a pair of metal posts located on opposite sides of a dirt road in the northeast portion of Area F. The posts are 4" in diameter and are set vertically in the ground, spaced 21' apart (*Figure 81*). Each post has two hinges fabricated from 4" by 3" metal plates with 1" rods welded to the sides. The remnants of a gate frame are attached to the hinges on the southeastern post. The posts are set in concrete and are supported by two 2" galvanized pipes welded to the sides. No artifacts were observed in association with the site. Site 7285 is located within the former barracks area of the Kahuku Army Airfield (see *Figure 64*) and could represent the remains of a gate used to control access to the barracks complex. Site 7285 is in poor condition and lacks physical integrity.

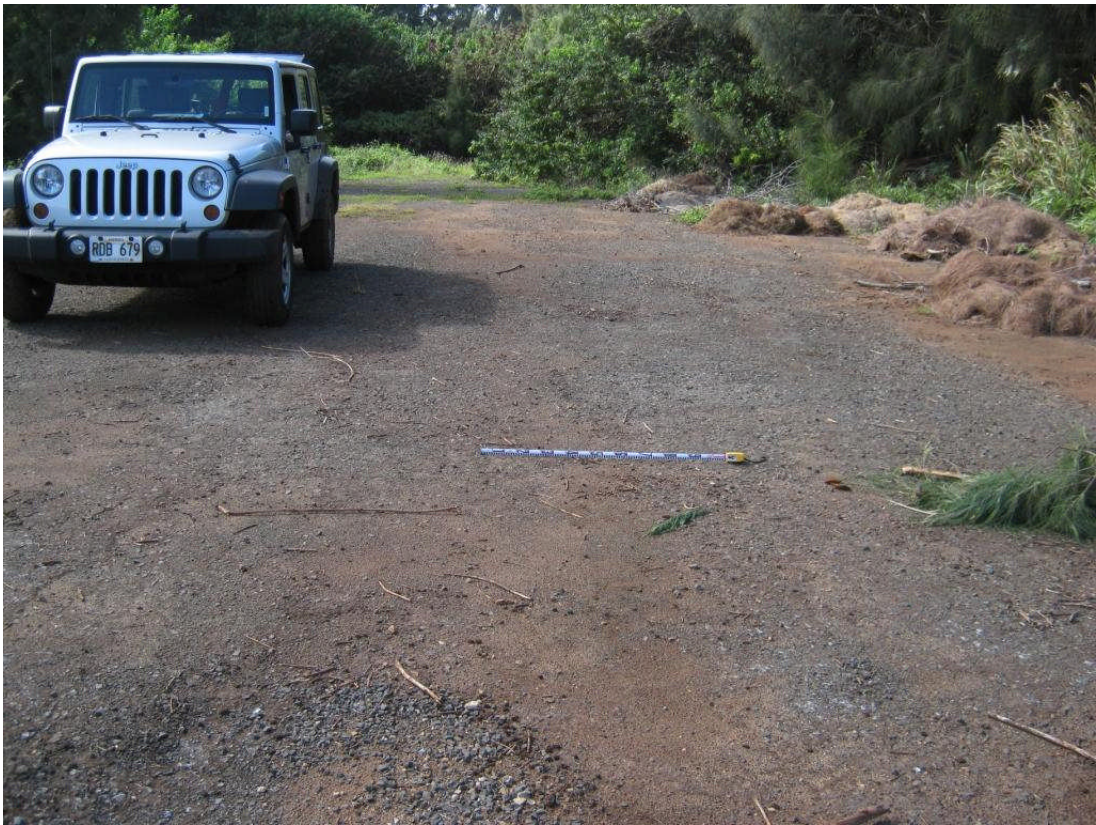
Figure 82. Site 7286 asphalt pavement, view to west

Site 7286 is a roughly rectangular section of asphalt pavement located on the east boundary of Area F. The exposed portion of pavement is 134'6" long (east-west) by 67' wide (*Figure 82*). A dirt road borders southwest side of the pavement along; low berms of soil and stone frame the other sides. A second dirt road, which leads to the Site 7285 gateposts, is located on the north side of the berm framing the north end of the pavement. A barbed wire fence is located adjacent to the east side of the pavement and parallels Marconi Road. Modern trash is scattered on and around the pavement. Site 7286 is located within the former Kahuku Army Airfield barracks area, 40 m south of the Site 7285 gateposts. The location of the asphalt pavement at an intersection of two roads potentially indicates that it may be a paved intersection. The site is in poor condition and retains limited physical integrity.

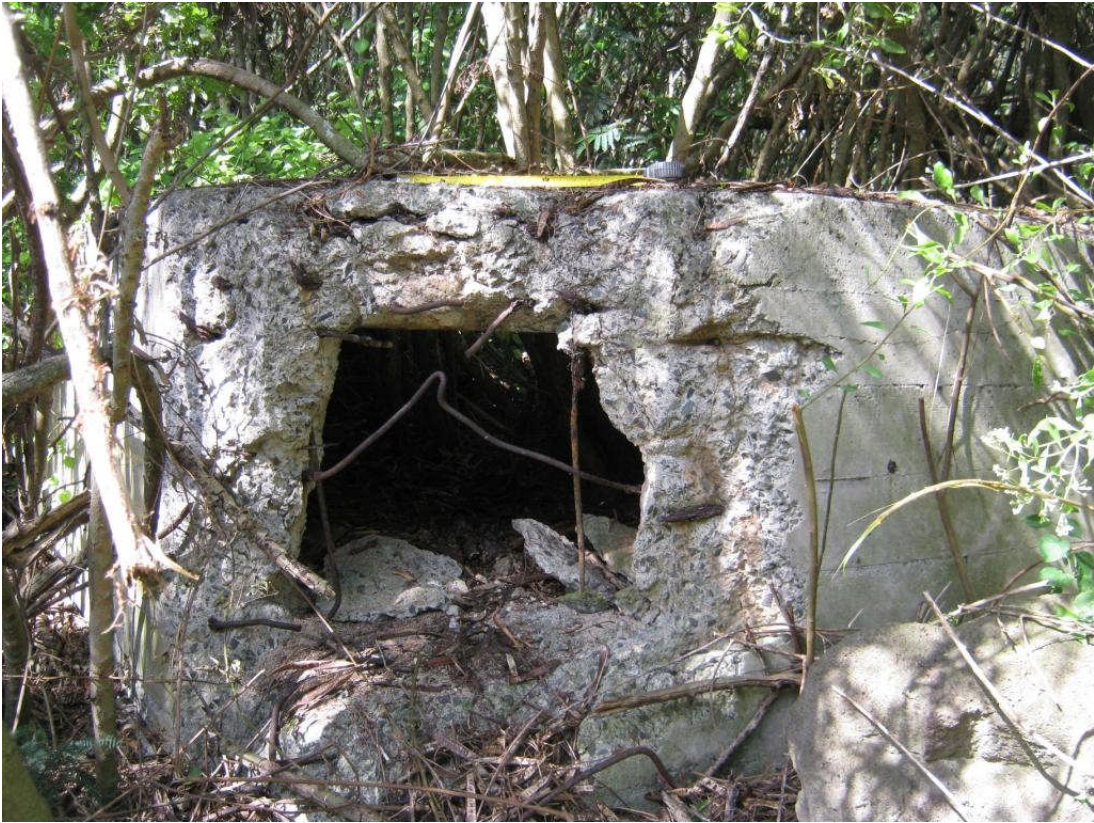
Figure 83. Site 7287 displaced concrete structure remnant, view to northeast

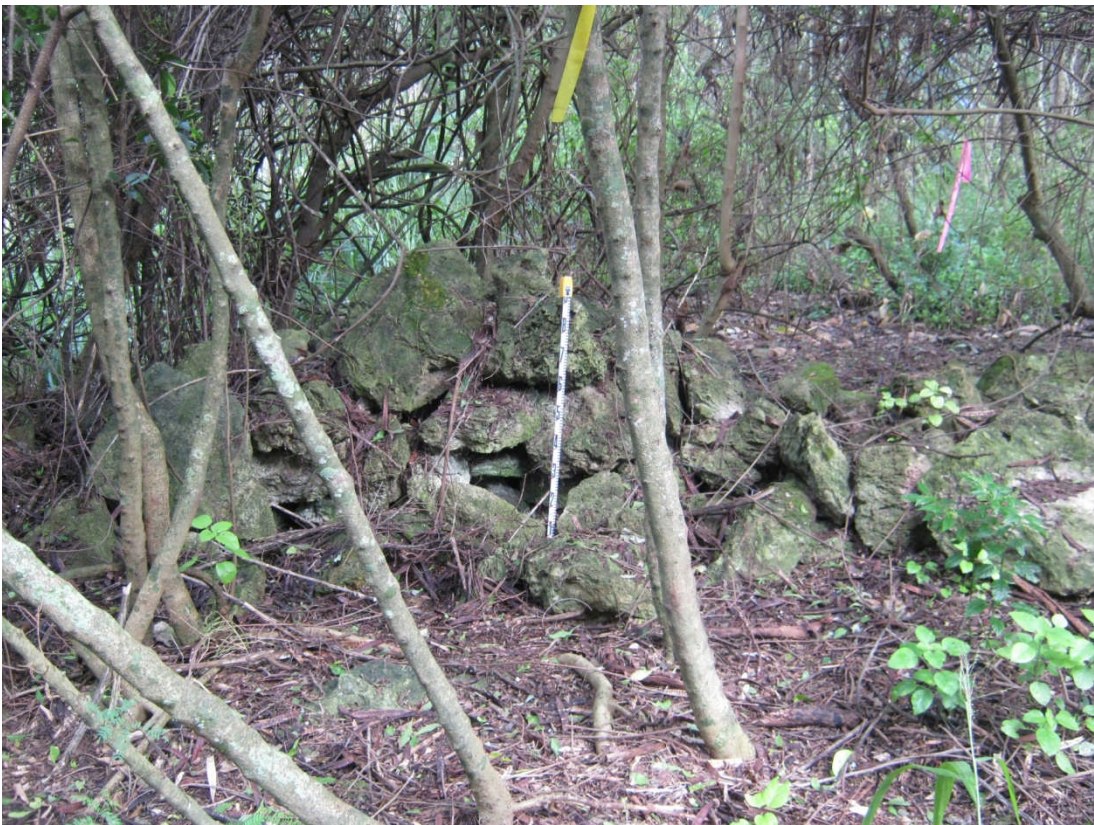
Figure 84. Site 7299 wall, view to northwest

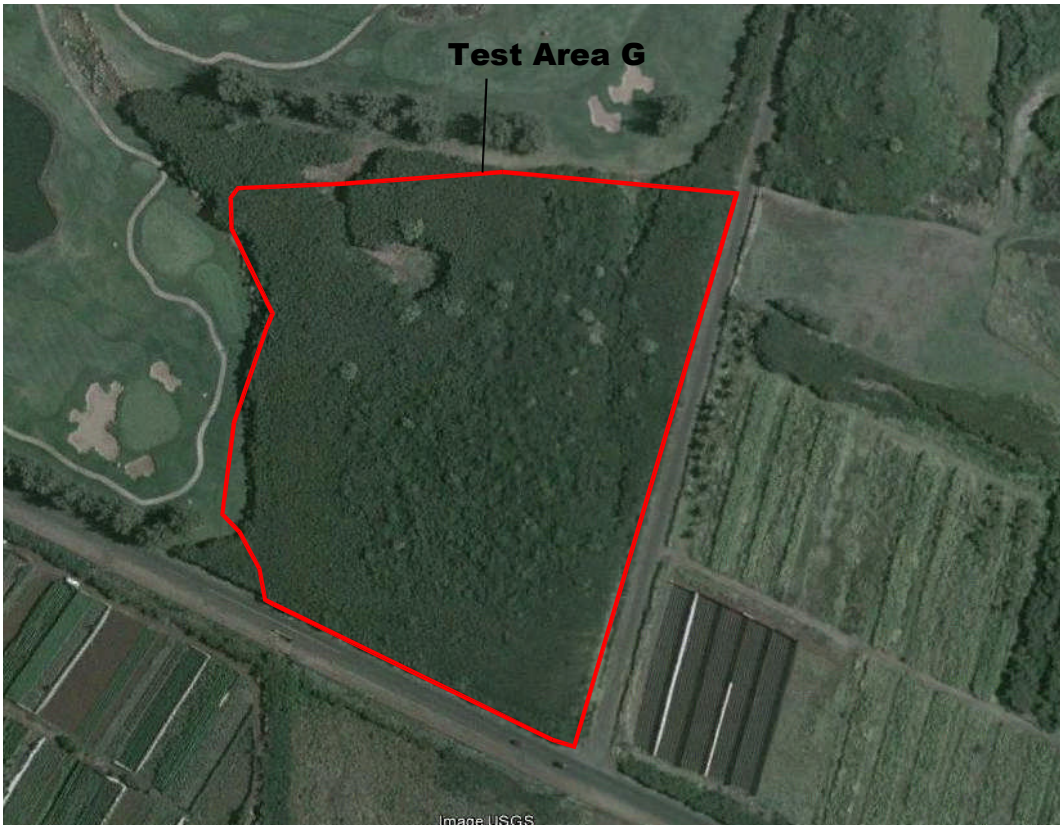
Figure 85. Aerial view of Test Area G (from Google Earth)

No surface sites were identified in Area G. This area encompasses 9.9-acres and is located at the southeast corner of the TBR property. It is bordered by golf course to the north and west, by Kamehameha Highway to the south and by Marconi road to the east (*Figure 85*). This area is located south of the boundary of the Kahuku Army Airfield barracks complex (*Figure 86*). The surface of Area G has been extensively disturbed by historic and modern agricultural activity. A bulldozed push pile of soil, stones and concrete rubble, probably created during the construction of the adjacent golf course, is located near the northwest edge of Area G.

Test Area G is located in gently sloping terrain and is covered by an invasive *haole koa* forest (see *Figure 85*). Marconi Road forms the east boundary, Kamehameha Highway the south, and by the 4th, 5th, and 6th holes of the Palmer Golf Course on the north and west. A single push pile was noted on the surface of Test Area G, but otherwise, the area did not contain surface evidence of 20th Century disturbance, except for agricultural use. No surface sites were identified in Test Area G and no LCAs were located in this part of the property. The former location of the Kahuku Army Airfield barracks is located north of Test Area G.

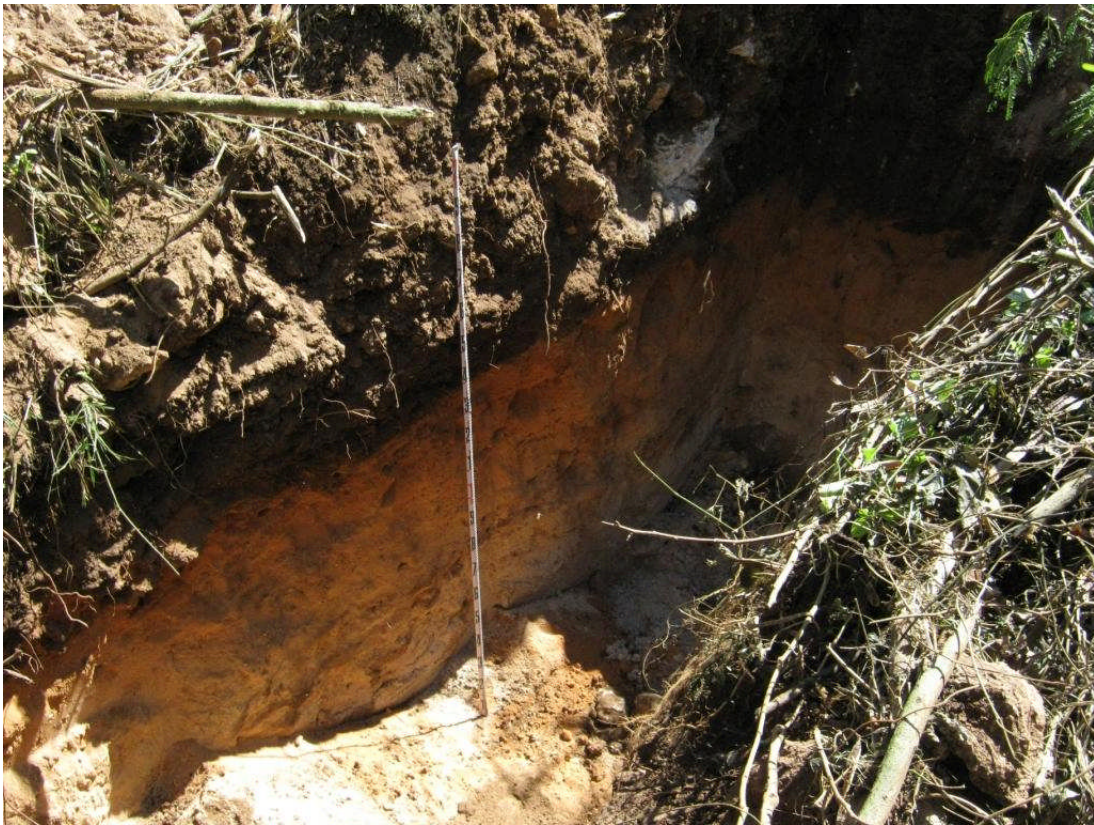
Figure 88. Photograph of BT-A-1-3 showing typical Test Area A stratigraphy, view to west

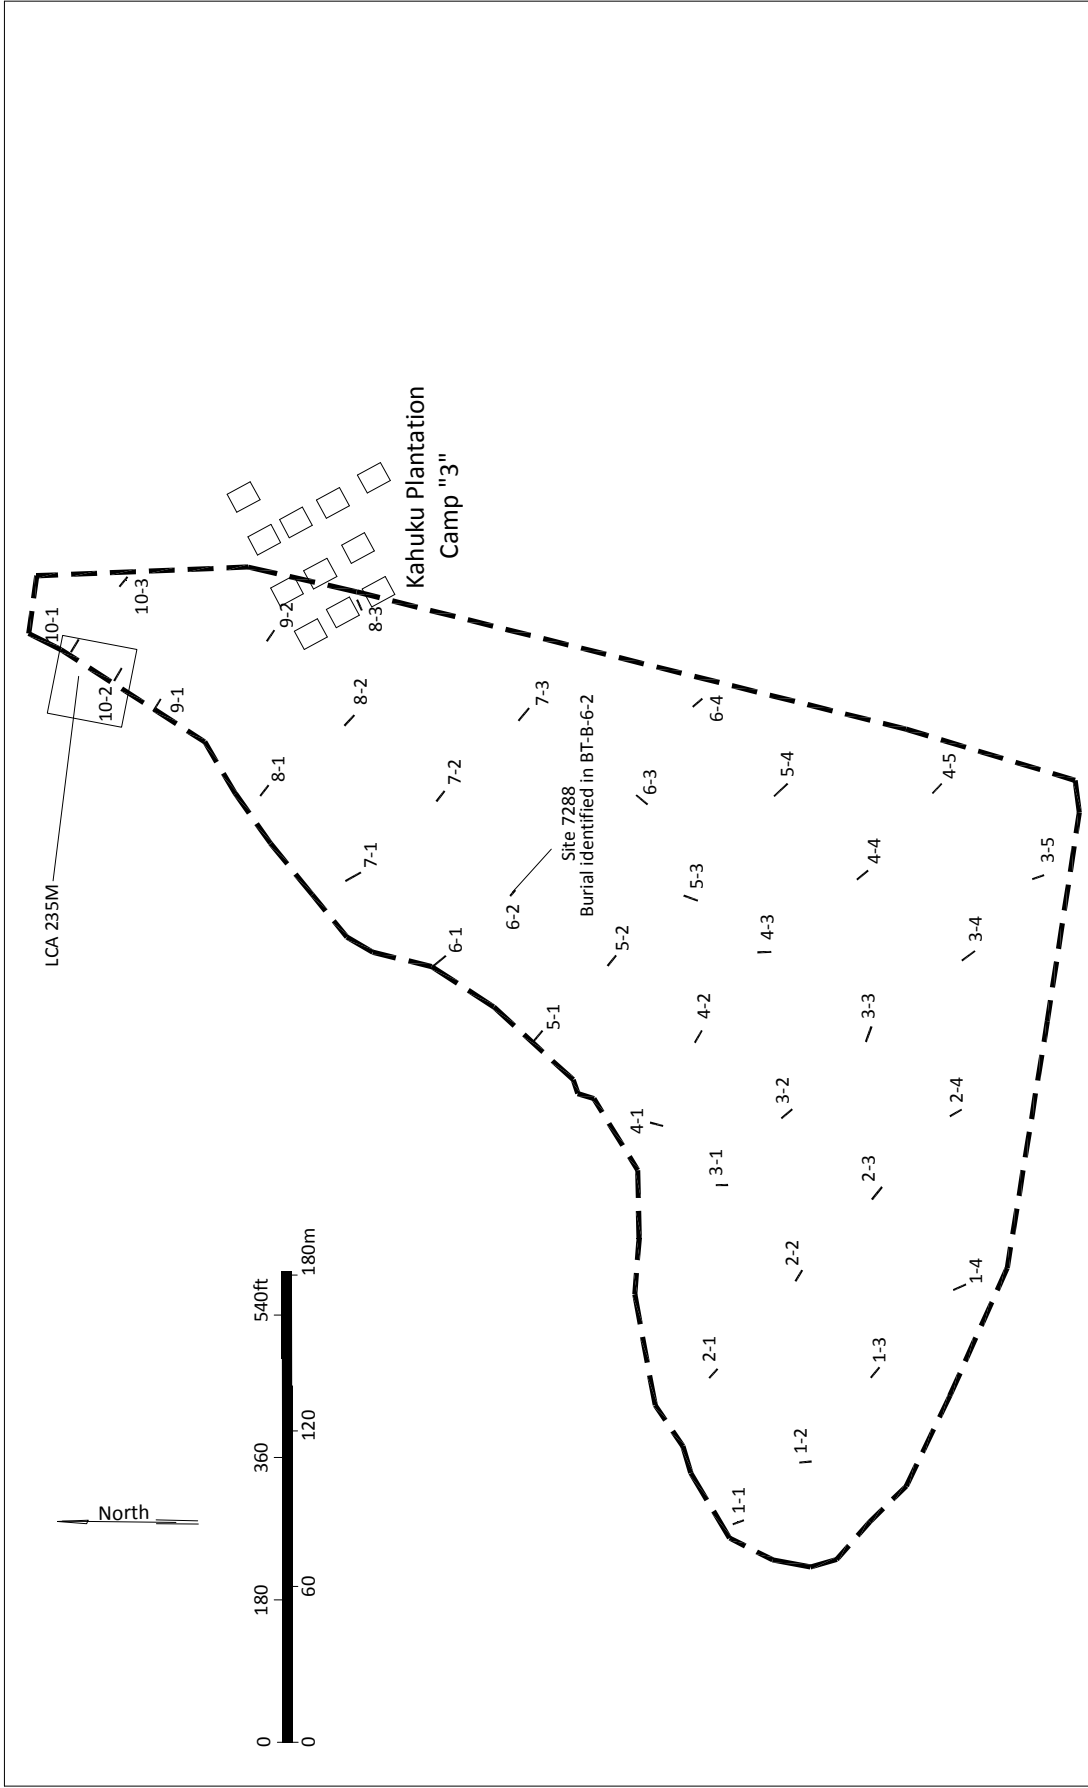
Figure 93. Location of trenches in Test Area B

LCA 235M is located at the north end of Area B (see *Figure 93*). This land claim of 0.41-acres was awarded to Kaili (Waihona 'Aina 2000). A house lot and 5 *kalo* patches are described in the claim testimony. Kaili died in 1849 and left his property to his daughter Nahuli. Two trenches (BT-B-10-1, B-10-2) were excavated in the vicinity of the LCA. In BT-B-10-1, 0.1 m of imported fill overlies an aeolian sand layer and in BT-10-2 two layers of aeolian sand were documented. No cultural materials were recovered from either trench.

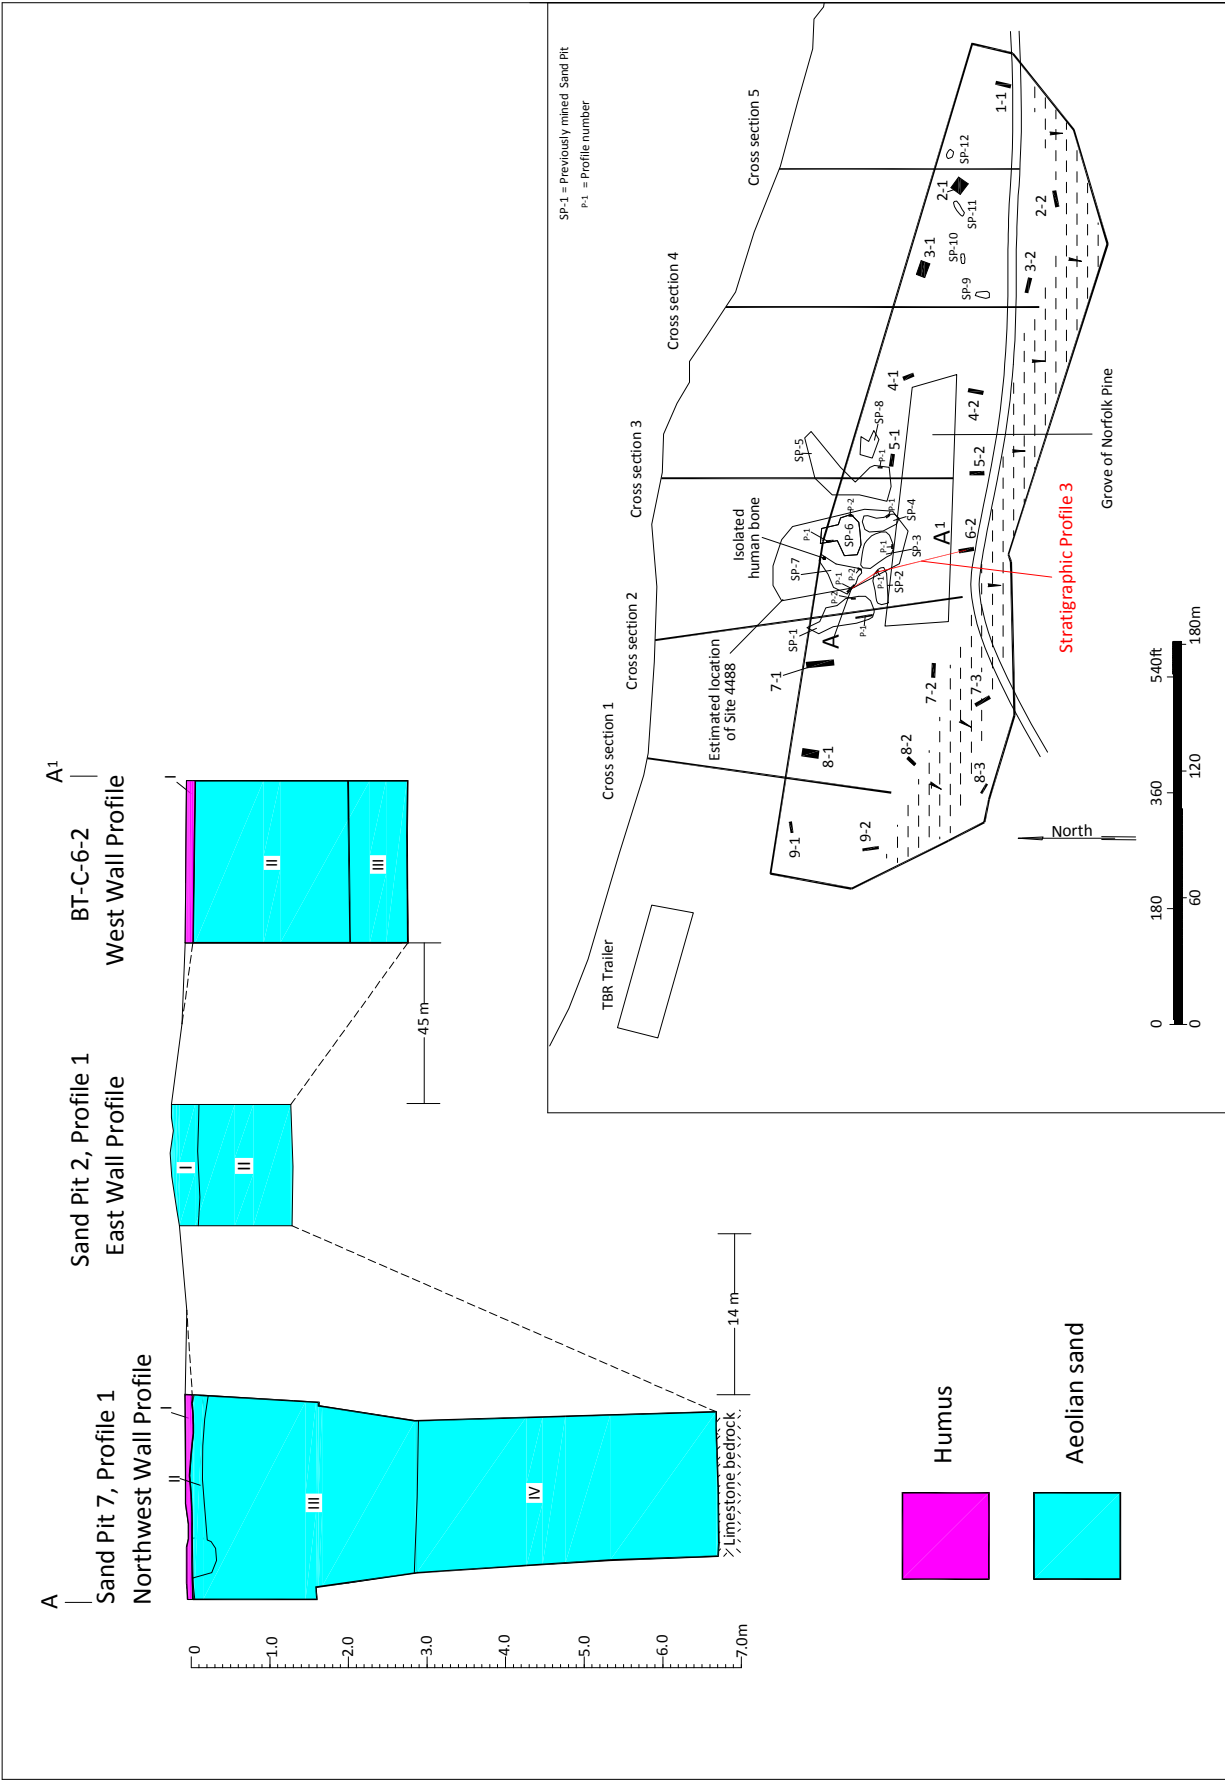
Figure 120. Test Area C stratigraphic profile 3

Figure 120 is the last of three stratigraphic profiles (Profile 3) and illustrates a composite north-south transect across the approximate center of Area C, where intact deposits across the dune show the humic duff differentially overlying sequential aeolian deposition. Stratigraphic Profile 3 shows SP-7, at the north end of the composite transect, encountered the limestone substrate at 6.7 m below the ground surface. Layer II in SP-7 consists of aeolian sand containing semi-lithified sand chunks and discontinuous calcium carbonate lenses at the interface with Layer III. The calcium carbonate horizon probably resulted from seawater inundation from either the 1946 or 1957 tsunami, or both; the semi-lithified sand chunks could result from super compaction or, less probably from secondary deposition of fossilized dunal remnants from an exposure closer to the shoreline. The 10-cm thick Layer II aeolian sand in SP-7 could represent a severely eroded and truncated aeolian deposit. In contrast, Layer IV in SP-7 is a 4.0 m deposit of semi-lithified aeolian sand that is the fossilized dune over which the upper dunal deposit (Layer III) coalesced.

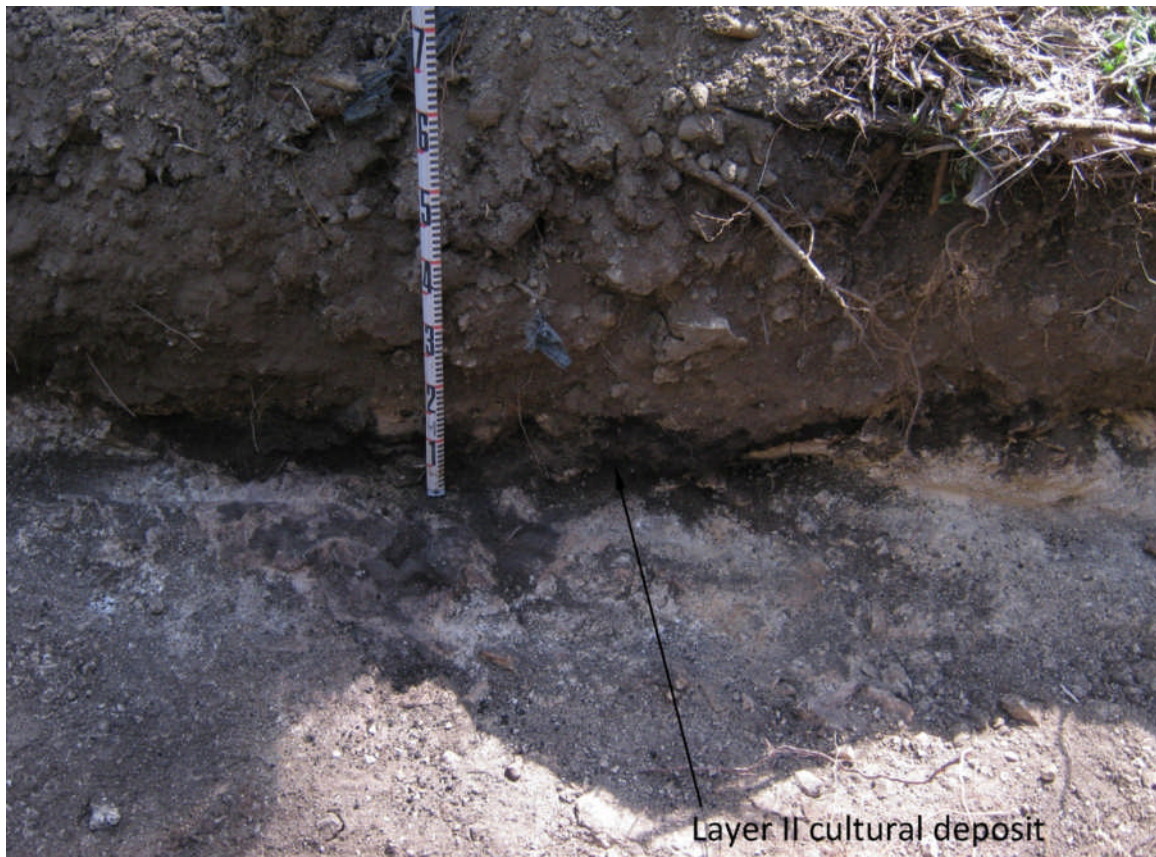
Figure 142. Site 7293 subsurface deposit in BT-E-10-2

Site 7293 is a subsurface prehistoric cultural deposit identified in BT-E-10-2 situated in the northwestern portion of Area E, 225 m southeast of Site 7292 (*Figure 142* and *Figure B-166*). No discretionary trenching was conducted because the deposit was not encountered in other systematically placed trenches, and appears to be restricted in areal extent. A large artificial pond borders BT-E-10-2 on the southeast and it is located on the southwest edge of former location of the Kahuku Army Airfield runway (Site 7275). The subsurface cultural deposit (Layer II) underlies 40-45 cm of redeposited fill (Layer I) associated with construction of the east extension of the pond in Fairway 11. During pond construction the overlying Kahuku Army Airfield deposits associated with Site 7275 and the upper surface of the prehistoric deposit were removed during mass grading to recontour the ground surface around the pond. In BT-E-10-2 only a remnant of the prehistoric cultural deposit remains, where it overlies a depression in the limestone substrate. The basin-shaped deposit is 1.50 m long and a maximum of 14 cm thick, and consists of black to brown very fine friable clay loam and clayey sand, containing urchin, charcoal and heat-altered rock, none of which was collected. The limited horizontal extent of the deposit suggests that the associated site has largely been obliterated during construction of the golf course. Subsurface evidence of Site 7293 was encountered in only one trench. The site is estimated to encompass a maximum area of approximately 1,768 sq m; however, it is likely that its actual extent is much smaller. Site 7293 is interpreted as a prehistoric habitation site, based on the associated subsistence debris. The subsurface deposit has been truncated during late 20th Century development activities and retains limited physical integrity.

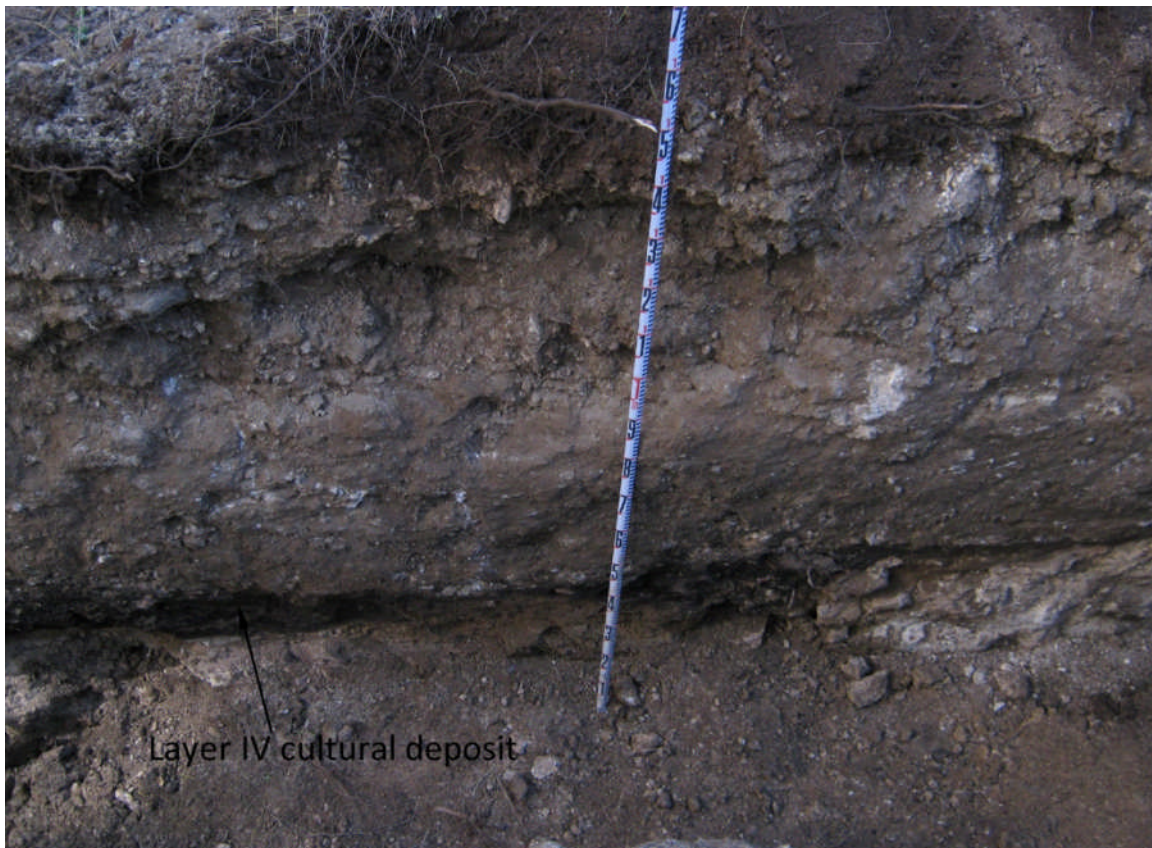
Figure 147. Site 7296 subsurface deposit in BT-E-22-4

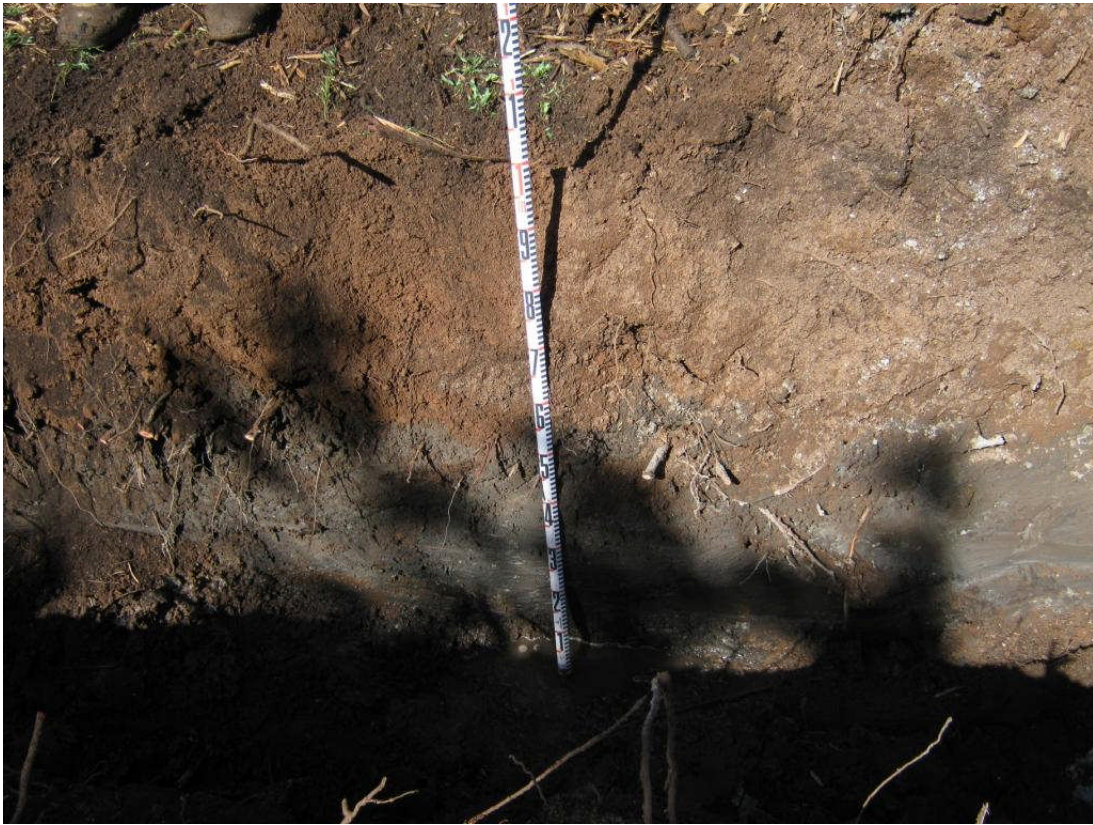
Figure 154. Gley deposit in BT-F-2-3, view to southeast

encountered in trenches where the water table overlies the limestone substrate (*Figure 154*) and a single deposit of tropical peat was encountered in BT-F-2-2 (*Figure 155*).

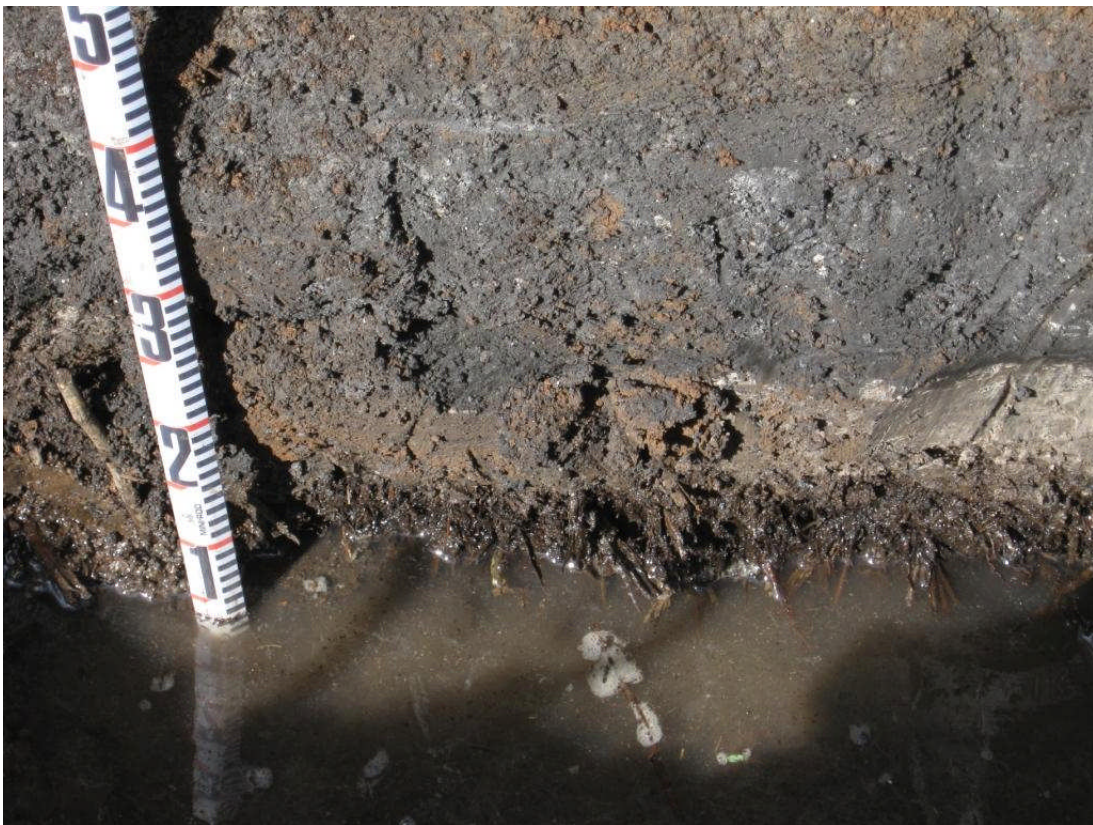
Figure 155. Tropical peat deposit in BT-F-2-2, view to northwest

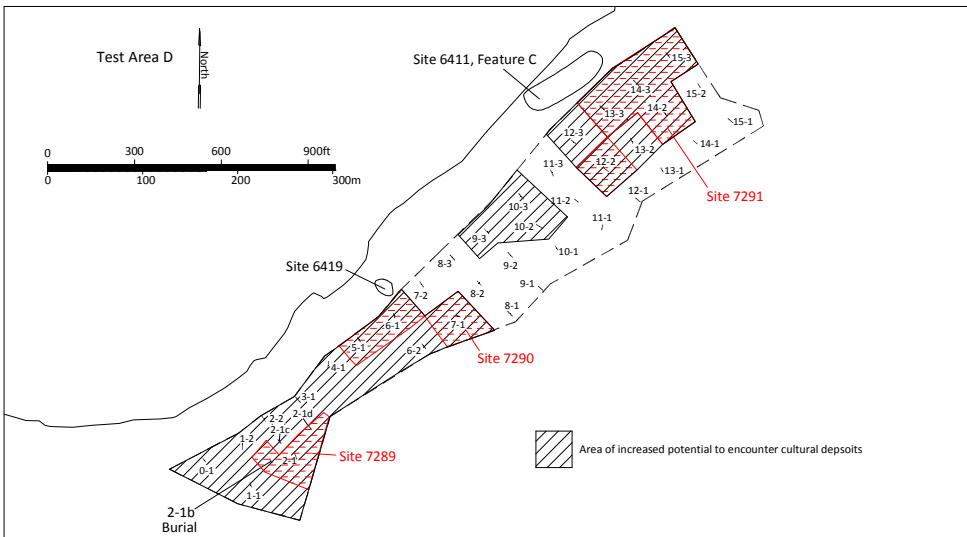
Figure 163. Areas of increased potential for encountering cultural deposits in Test Areas B-D
