SUBJECT: Chapter 343, Hawaii Revised Statutes
Final Environmental Assessment (EA)

Landowner/
Applicant: Jason D. Seymour
Agent: Janine K. Seymour
Location: 61-357 Kamehameha Highway – Kawaihoa
Tax Map Key: 6-1-12: 21
Proposal: Final EA for a Shoreline Setback Variance (SSV) to allow (retain)
a rock retaining wall, stairs, and landing within the 40-foot
shoreline setback area.

Project Name: Seymour Moss Rock Retaining Wall
Island: Oahu
District: Waialua
TMK: 6-1-012:0021
Permits: Building Permit, Shoreline Setback Variance,
Shoreline Certification

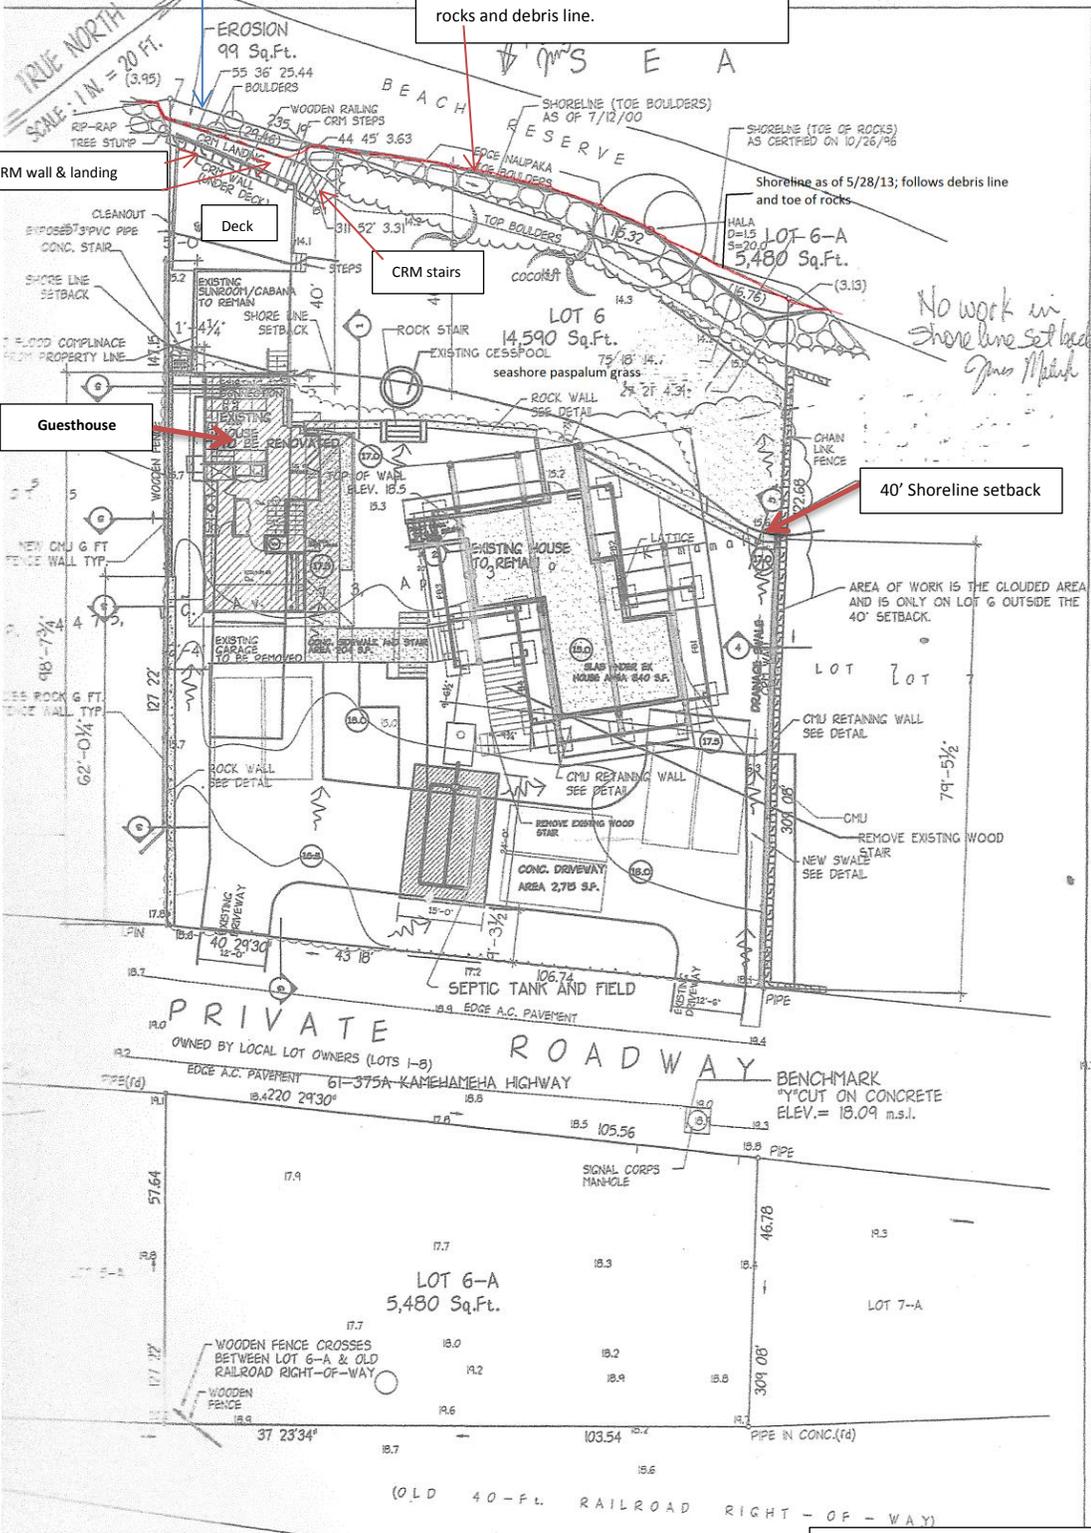
Figure 2: Scaled Architectural Site Plan showing all structures on the property along with the Shoreline Surveys as of 1996, 2000 and 2013

Shoreline as of 5/28/13; Follows toe of rocks and debris line.

40' Shoreline setback

No work in shoreline setback zone

Figure 2 is the site plan drawn by the architect James Matichuk that was approved by DPP in 2000 for renovation of the legal non-conforming house on the property. A full copy of the drawing will be included in Appendix B. The current 2013 shoreline has been added by surveyor Jim Thompson to indicate the most recent assumed shoreline in relation to the other structures. The structure on the south side of the property that from now on will be designated as 'guesthouse' was built in 1924. (Figure 2) The front part of the guesthouse and the attached deck are legal nonconforming structures, as they are located within the shoreline setback area. The appropriate building permit (#520250) was obtained by the previous owner and the legal non-conforming house was remodeled in 2001. At that time the floor of the portion of the house within the shoreline setback was raised to 19 feet above mean sea level (msl) to conform to the FEMA flood zone VE **base flood elevation** of 18 feet. (Figure 3) The moss rock retaining wall is located directly below the deck supporting it. Attached and adjacent to the retaining wall are the CRM stairway and landing. The foundation of the house is within 12.9 feet of the retaining wall on one side and 13.9 feet on the other. According to the shoreline survey done by James R. Thompson in 2000 and 2013, the moss rock retaining wall, CRM stairway and landing are mauka (landward) of the shoreline. The second house on the property which was built in 1970 (permit #93730) is behind the 40 foot setback according to the 2000 and 2013 shoreline survey. (Figure 2)

changes in vegetation, sand and erosion from 1949 to 1975. As the title would suggest, he used historic aerial photographs to chart this change. The applicant's property is in transect 10 within Kawaioloa Beach. (photomap 7, p.20 Hwang, 1981). Overall this area has shown accretion of vegetation +5 and sand +4, however in 1969 when there was a very large storm with waves in excess of 50 feet, there was "erosion of the vegetation and much structural damage on Kawaioloa Beach". (Table 2) In 1969, the guesthouse did sustain some damage due to the high surf, as there was no retaining wall at that time. Since that time, shoreline certification maps have shown pockets of erosion that occurred from 2000-2013, 91 square feet by the landing. (Figure 2)

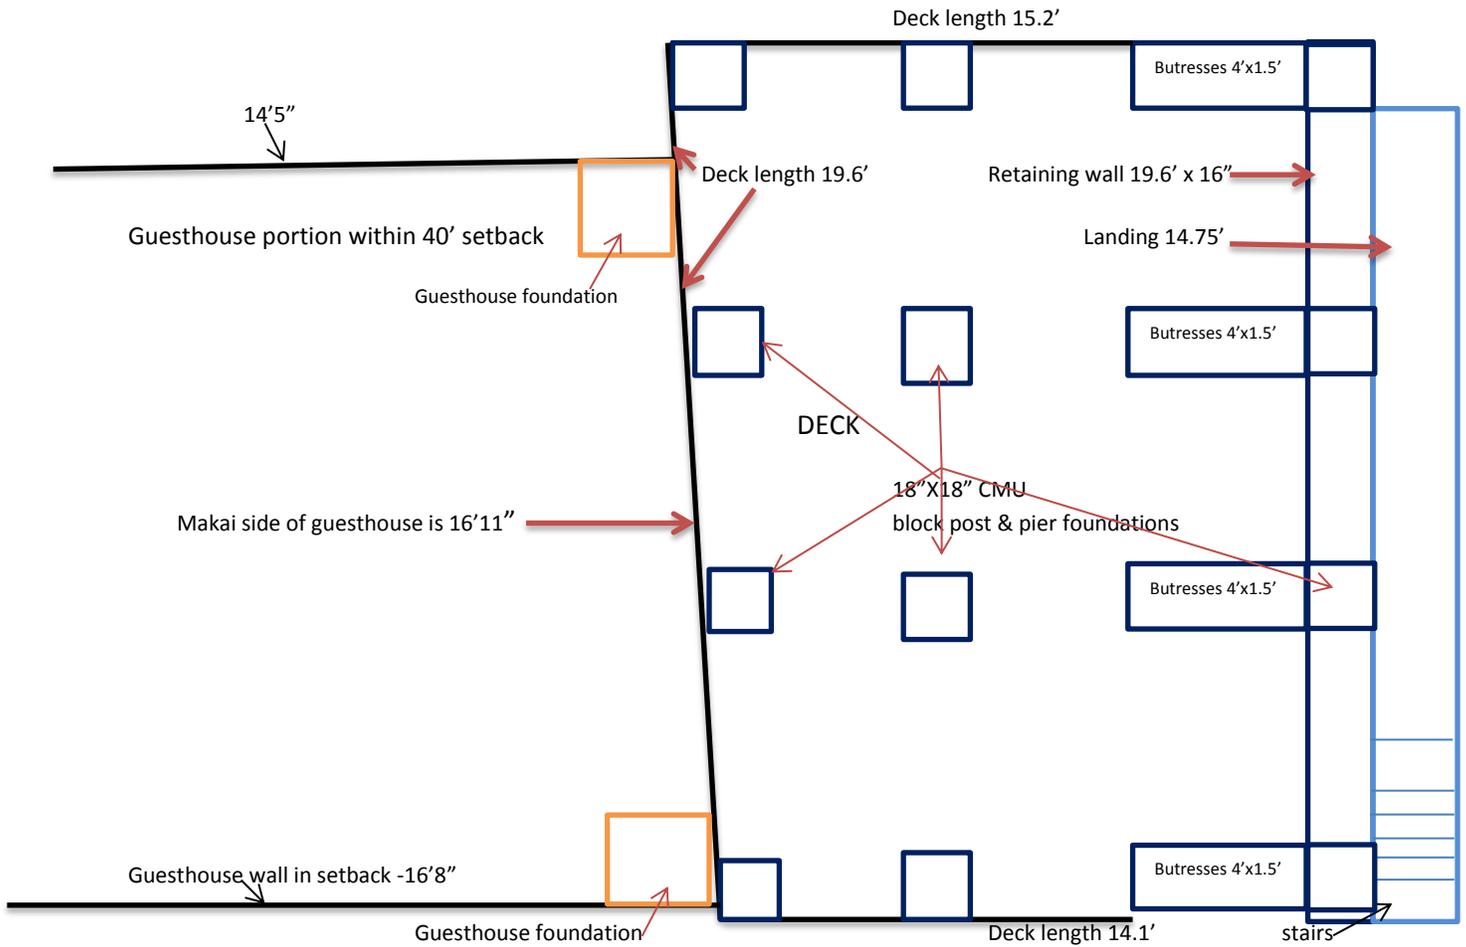
Figure 4A: Cross Section Schematic of Retaining Wall with Post and Pier Foundation and Buttresses

Scale: ¼ inch = 1.0 foot

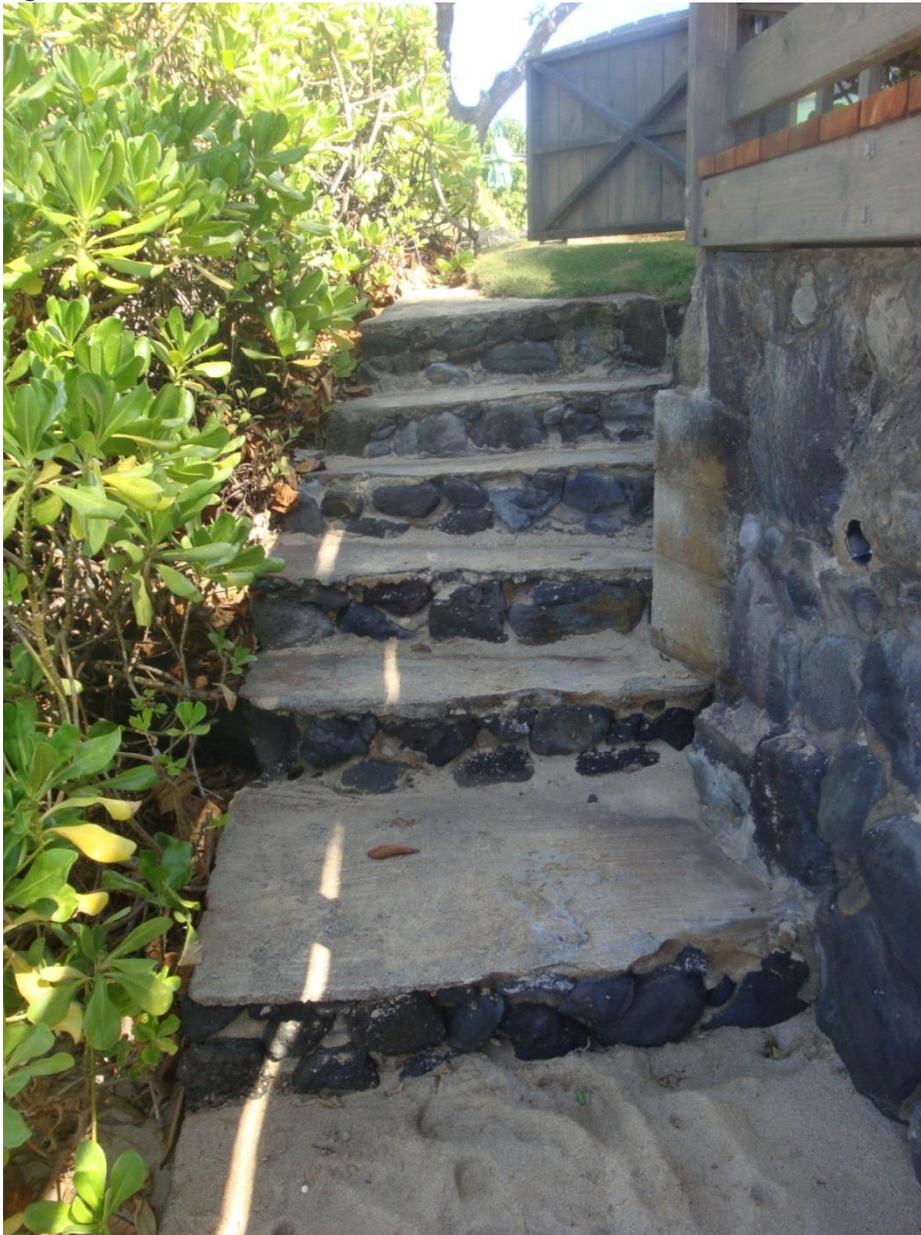
Figure 5: Photo of CRM stairs

Figures 5-7 are photographs of the CRM stairs, landing and retaining wall. The photographs were taken from the beach looking back at the property to show clearly the stairs, retaining wall and landing. The area included in the photos is the ocean side of the red box on the first diagram in Appendix B. At the toe of the retaining wall is the CRM landing which spans the length of the retaining wall and is 12 inches high, 33-44 inches wide, 177 inches long and is 9 feet above msl at its base. (Figure 6) The landing is connected to the stairs which are also constructed of rock and mortar. There are 6 stairs each with a rise of 7.75 inches. This includes the concrete cap. (Figure 5) The treads on stairs 1-5 are 12-15 inches and the tread on stair 6 is 29 inches. The stairs are 15.5 feet above mean sea level at their start and 11 feet 4.5 inches above mean sea level at the lowest stair. The stairs are 36 inches wide. The continuous horizontal landing provides additional sliding resistance at the base of the retaining wall and helps protect against possible damage to the wall due to scour and undercutting of the toe. Wave forces would be dissipated if they hit the raised rock landing. Because of the close proximity of the 'guesthouse' and deck to the shoreline, protection from erosion is essential. Undermining of the foundation of the guesthouse and damage to the deck by high surf events could create a potentially

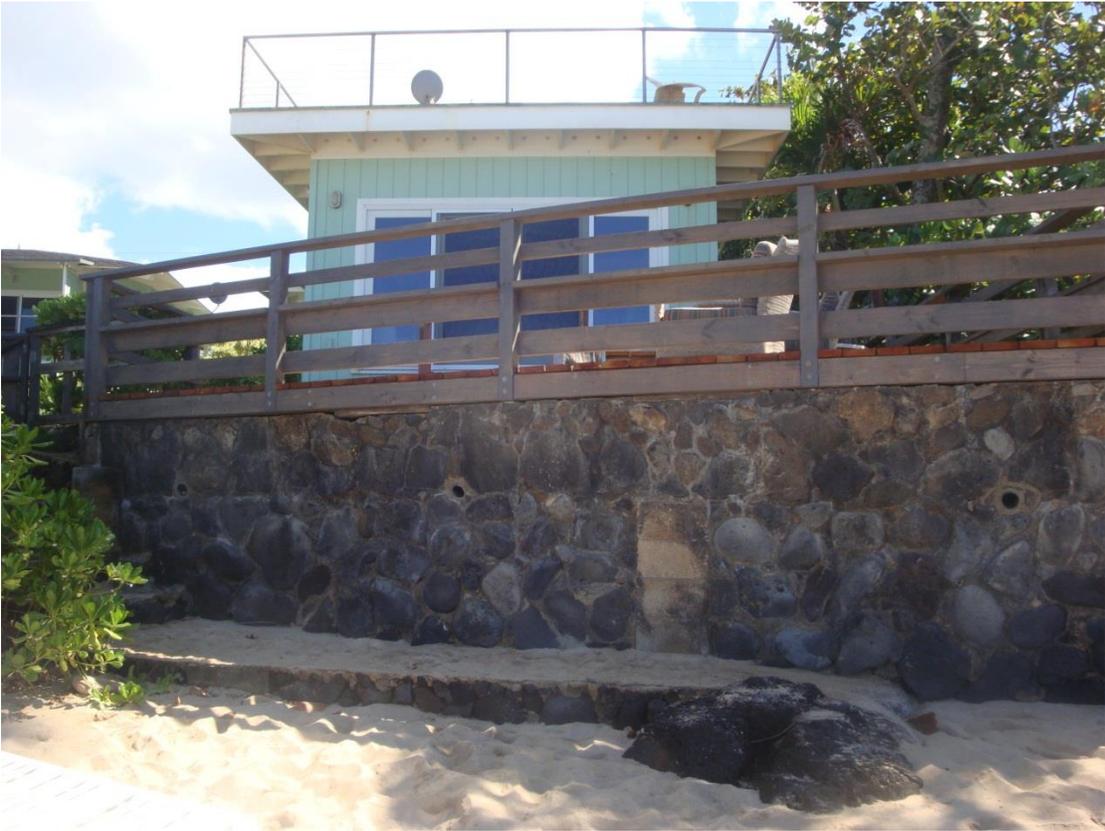
Figure 6: Photo of Retaining wall and CRM landing

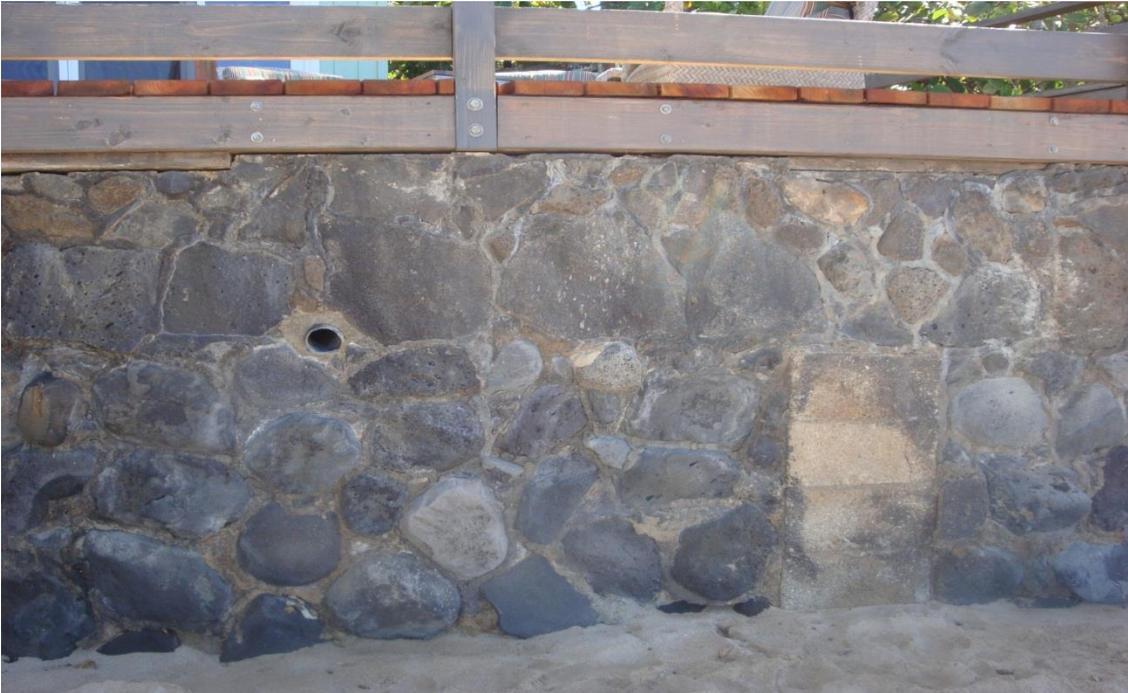
Figure 7: Close up of Moss Rock Retaining Wall

The retaining wall stairs and landing are constructed of dark black basalt rock which is consistent with the color and type of beach rock found on this stretch of Kawailoa Beach. Aesthetically these structures blend in with the naturally occurring rocks on the beach. If they were to be removed, debris, trash and would accumulate under the legal nonconforming deck and would be less attractive to look at. In addition, erosion and dirt debris would color the beach and affect the natural resource if these structures were removed.

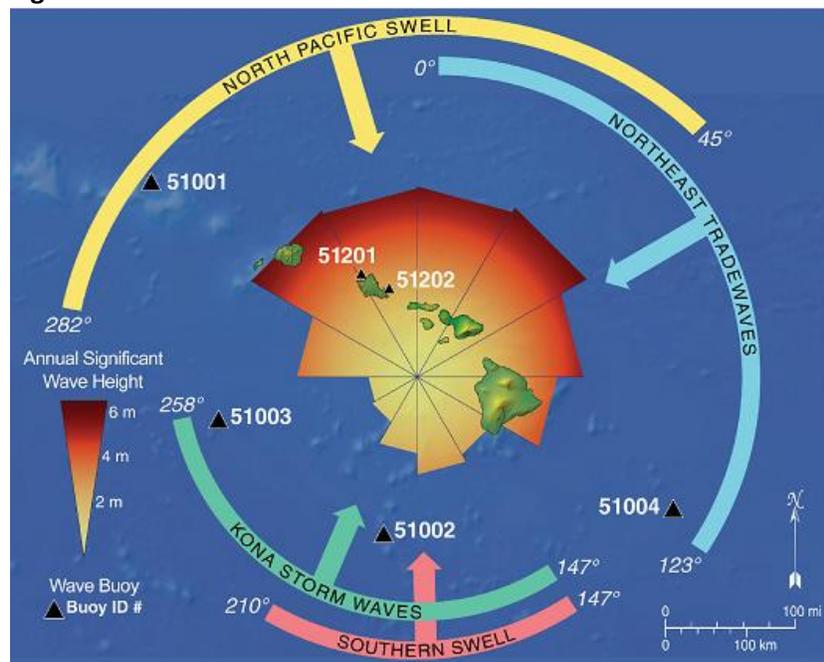
Figure 9 Wave Patterns in the Main Hawaii Islands

Waves: Hawaii is known for its year round surfing. Waves are created by wind blowing across the water. Swells from all directions reach Hawaii's shores, but there are only four basic swell sources: east-northeast trade winds, North Pacific lows, South Pacific lows and Kona storm waves. (Haraguchi 1979; Fletcher 2012) (Figure 9) The most important waves for the applicant's property are the Northwesterly swells. These waves occur mainly in the winter season October through March. The waves are generated by North Pacific lows, storms or gales with very large, strong northwest winds. Swells generated in the 'fetch area' travel hundreds of miles before reaching Hawaii. The northern and western coastlines are affected by these waves, particularly Oahu's north shore. The applicant's property is less affected by waves generated by trade winds or Kona winds and is completely unaffected by waves generated from South Pacific lows that occur predominantly in the summer season.

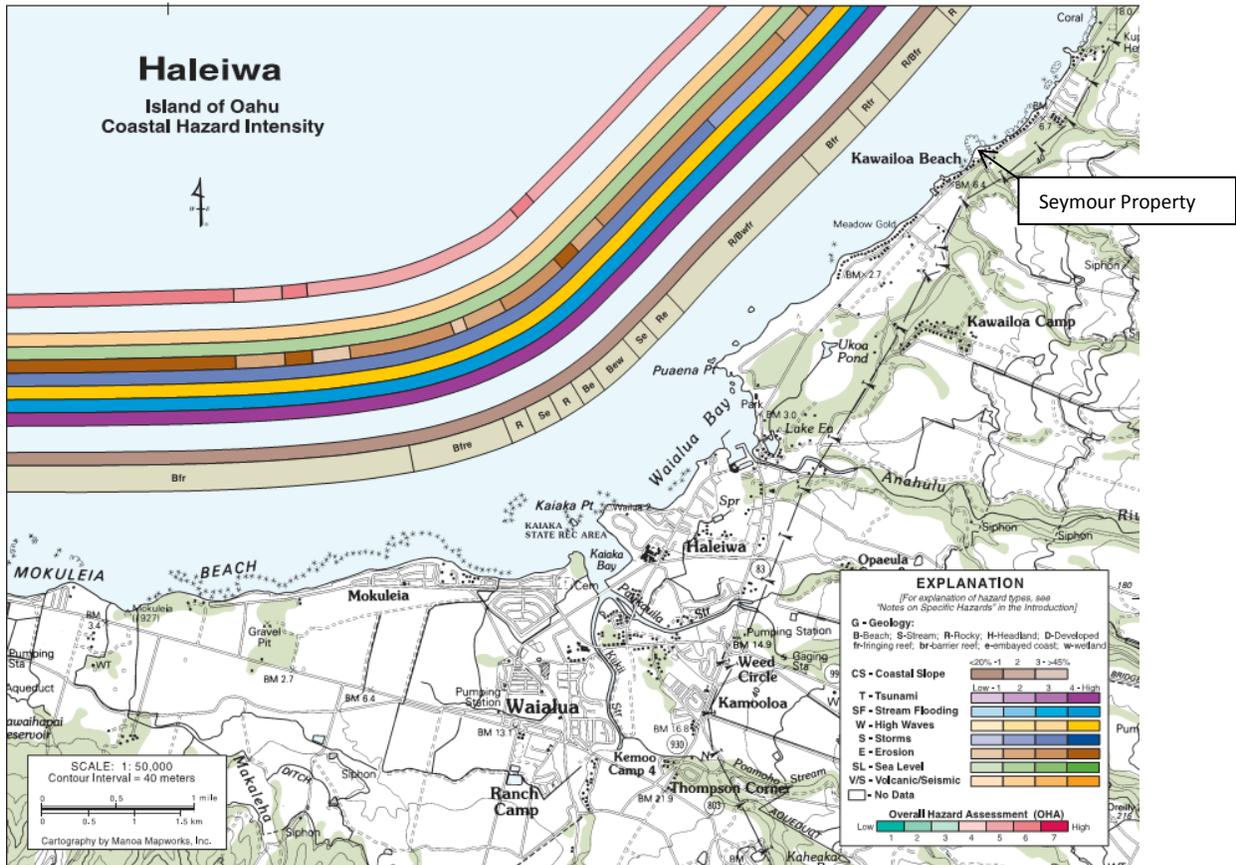
Figure 10: Coast Hazard Intensity Map

Coastal Hazards include floods, hurricanes, high waves, tsunamis and erosion. The coastline at Kawaiioa Beach consists mostly of interspersed sand beaches and 3-6ft. rocky escarpments of basalt or limestone. This is a high wave-energy coastline that receives some of the largest breaking waves in the state. According to the USGS coastal hazard intensity, the coastline in front of the applicant's property has an Overall Hazard Assessment (OHA) of 5-moderately high. (Figure 10: Map of Coastal Hazard Intensity). The overall hazard assessment (OHA) is calculated using a mathematical formula which takes into account more dynamic hazards (volcanism, seismicity, coastal stream flooding, seasonal high waves, marine over wash, tsunami inundation and high winds) versus lesser hazards (sea level rise and beach erosion). The dynamic hazards constitute a greater risk and thus are given more weight in the formula. The result of the calculations is then used to assign a nominal overall hazard rank on a scale of 1-7 with 1 being very low overall hazard assessment (OHA) to 7 being a very high overall hazard assessment. The greatest risk to the applicant's property is from seasonal high waves and tsunami inundation. (USGS Oahu Atlas of Natural Hazards)

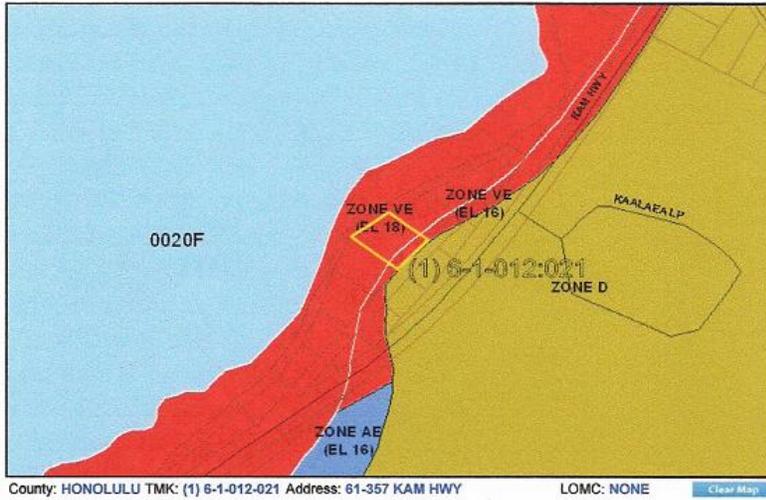
Figure 11: Flood Zone Map of the Seymour's Property

The applicant's property is zoned VE per FEMA flood designation. "Areas along coasts subject to inundation by the 1-percent-annual-chance flood event with additional hazards due to storm-induced velocity wave action."

Please refer to figure 11 in EA which shows the FEMA flood map for the applicant's property which is zoned VE which corresponds to level of base flood elevation of 18 feet above sea level. "The floor of the legal nonconforming portion of the 'guesthouse' was raised to 19 feet above sea level when renovations were done in 2000 to conform to FEMA flood standards. The base of the moss rock retaining wall is 11 feet above msl and the base of the landing is 10 feet above msl. The stairs range from 11'1" above msl to 15'6" above msl. The legal non-conforming deck is 16 feet above msl. (Figures 3,4)"

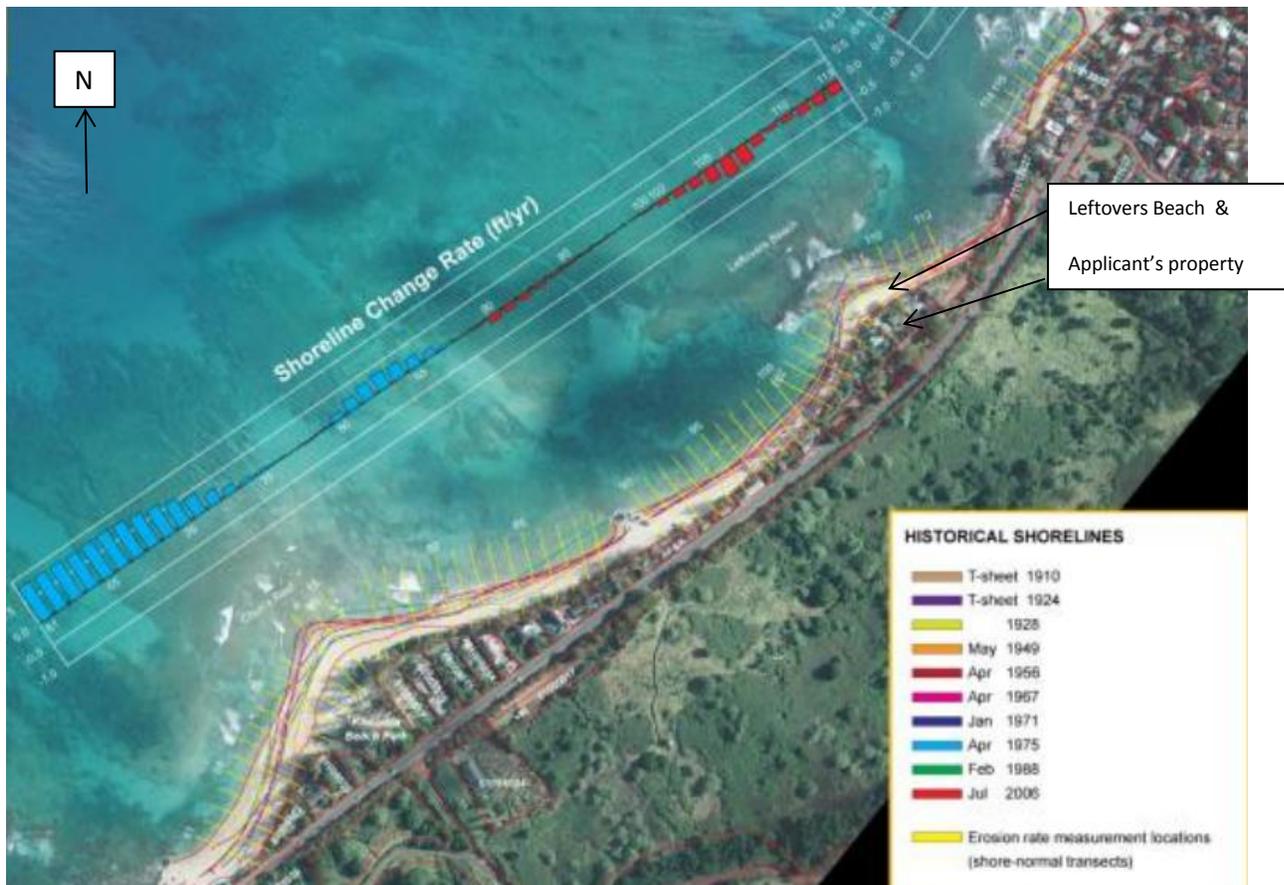
Figure 14: Erosion Map of Kawaiiloa Beach

swells are from a predominantly more westerly direction, then sand migrates to the north end of the beach. This occurred in 2012-2013. When the swells are more predominantly from the north, the sand migrates to the south end of the beach at Chun's as was the case in 2006. Overall, there have been no long term changes in Kawaiiloa Beach due to erosion since 1910, however, there can be quite dramatic short-term seasonal changes in sand movement and shoreline position caused by large winter swells. Short-term erosion can be a significant hazard to beach-front homes, especially in the winter with run-up from large waves. (<http://www.soest.hawaii.edu/coasts/erosion/oahu/index.php>)

The most recent published long-term (1910-2006) shoreline change rates at Kawaioloa are low on average, less than 1 foot per year. (SOEST 2011) However rates at Kawaioloa have high uncertainty due to short-term (seasonal to daily) variations in shoreline position caused by large winter swells from the north and northwest and persistent tradewind waves year round. Though long term rates are low, short-term erosion is a significant hazard to beach-front homes especially in winter with run up from large waves. According to the most recent published data by SOEST, "Chun's and Leftovers Beaches (transects 61-113) have been approximately stable since 1910 at an average of 0.1ft/yr. Some long-term accretion may be occurring in the south of Chun's Beach (see transect 61) but uncertainty with these rates is high and may be influenced by seasonal accretion in the July 2006 shoreline." Also, "previous studies by Hwang(1981) and Sea Engineering (1988) found little net change in the vegetation line at Kawaioloa 1949-1988 but Hwang found the water line varied by over 100 feet." The shoreline in front of the applicant's property corresponds to between transects 108 and 109 in figure 14. The most recent map shows a slight loss of the shoreline -0.1 - 0.2 feet in front of the applicant's property.

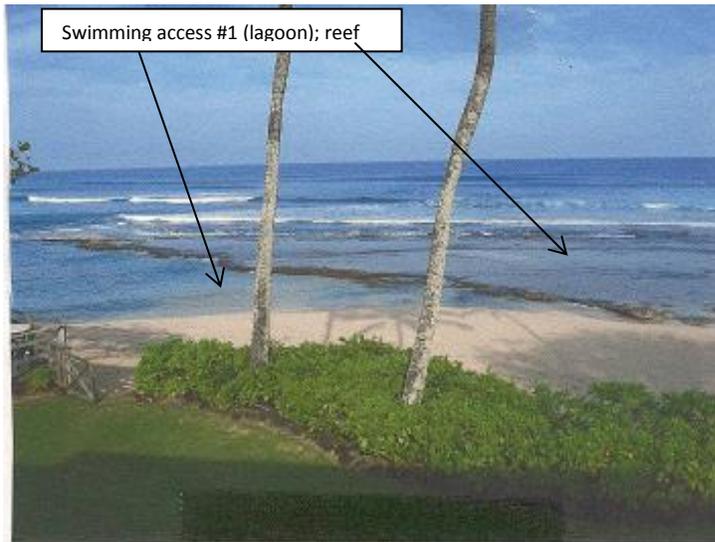
Figure 15: Swimming Access #1 (lagoon) & Reef

north of the property .(Figure 15,16). Both areas are protected by the shallow, limestone, rock reef, and this beach has been nicknamed locally as 'baby beach' given the protection from waves and pounding shore break by the reef. The bottom of the lagoon is sand bottom with numerous scattered rock boulders. The shoreline is quite protected by this reef in this area except for high energy storm waves greater than 30 ft. which occur occasionally during the winter season. Towards the south of the property where the flat, limestone reef ends, the shoreline is much more exposed to breaking waves and erosion.

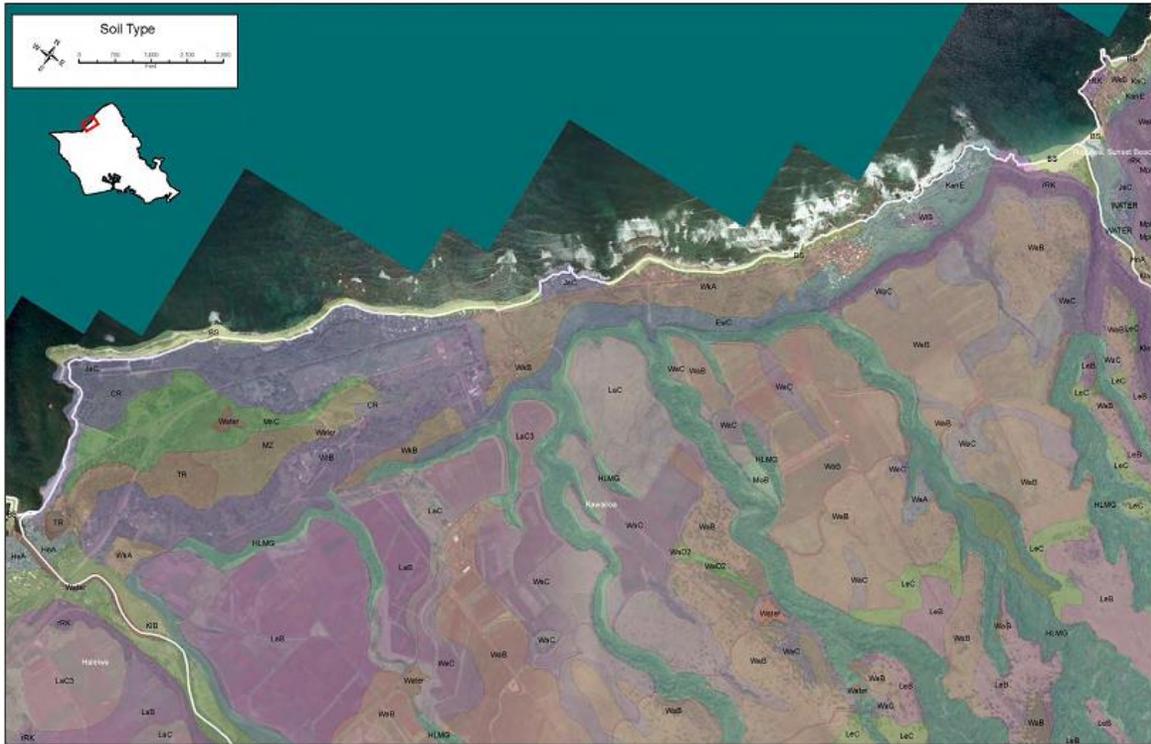
Figure 20: Map of Soils from USDA Survey

Figure B-24. Soils in the Kawaiiloa Area
Source: Hawaii Statewide GIS Program

There is a layer of Waialua silty clay under the sand. Under typical conditions, this layer of clay is covered with a layer of sand. Waialua silty clay is present on smooth coastal plains. The surface layer is dark reddish-brown silty clay about 12 inches thick and the sub layer is about 26 inches thick in a sub angular blocky structure. (USDA Soil Survey 1972) (Figures 19, 20) Because of difficulties during construction to dredge through the clay, the retaining wall is anchored directly to the clay with dowels and mortar. The moss rock retaining wall is made up of blue rock weighing about 25 to 150 pounds (median weight of 80) and is 6' high from the north end of the wall to the south end. Full height CRM buttresses spaced approximately 5' on center behind the wall provide additional support from horizontal forces induced from high waves. Backfill behind the wall is approximately 3' to 4' above the foot of the wall. The 16"-wide moss rock wall supports the beach-side edge of the exterior, open deck located at the rear of the dwelling while the exterior deck is supported on posts and piers at interior bays. This moss rock wall protects the existing deck and house structure from tidal forces during periods of high wave action. Weep holes are present in the moss rock wall to allow any water collected behind the wall to be discharge to the beach. At the toe of the moss rock wall is a CRM landing (approximately 2-foot high and 3-feet wide) connected to a stair also constructed of rock, rebar and mortar. This built-up landing, coupled with an existing large lava rock bed in front of the wall, provides additional sliding resistance at the base of the moss rock wall. This continuous horizontal landing helps protect against possible damage to the wall due to scour and undercutting of the toe. Wave forces are dissipated when it hits raised rock landing. (Figure 18)

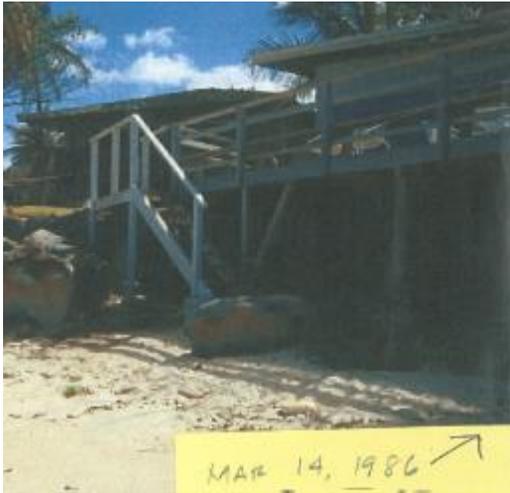
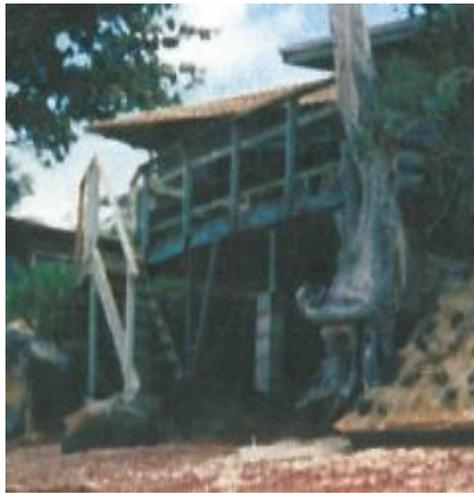
12.2.4 Photographs of stairs from 1986 and 1996

March 14, 1986

November 18, 1996

The applicant purchased the property in 2004 and was given architectural plans, site plans and a 2000 shoreline survey that were all approved by Department of Planning and Permitting and Board of Land and Natural Resources showing the moss rock retaining wall, CRM stairs and landing. In a meeting with Art Challacomb and Steve Cheung on November 1, 2006, a photograph from November 18, 1996 documenting a set of wooden stairs from the deck to the beach was given to the applicant. The stairs were thus constructed by the previous owner, Mr. George Suman, sometime between 1996 and 2000. The applicant does not have the specific date, however the structures in question were built between November 1996 and 2000. Please refer to figure 2 and the 2000 certified shoreline survey (Appendix B).

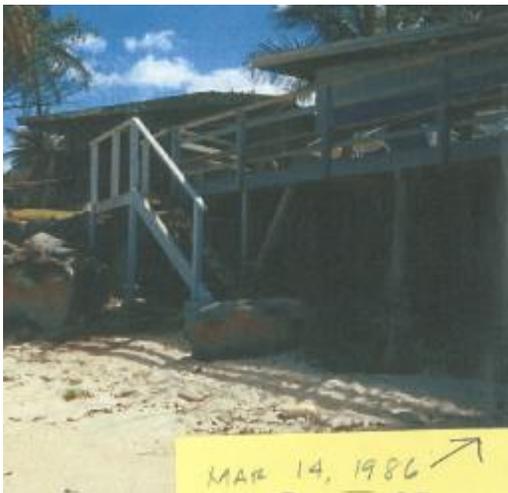
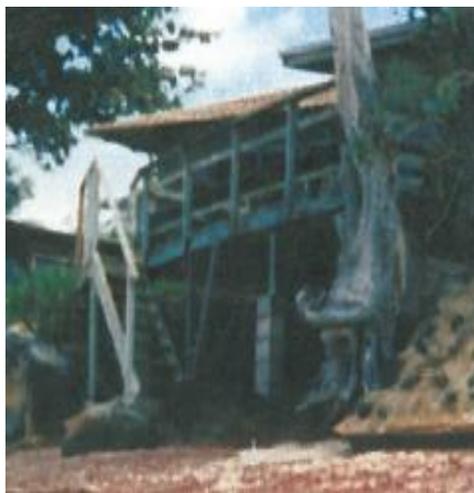
March 14, 1986

November 18, 1996

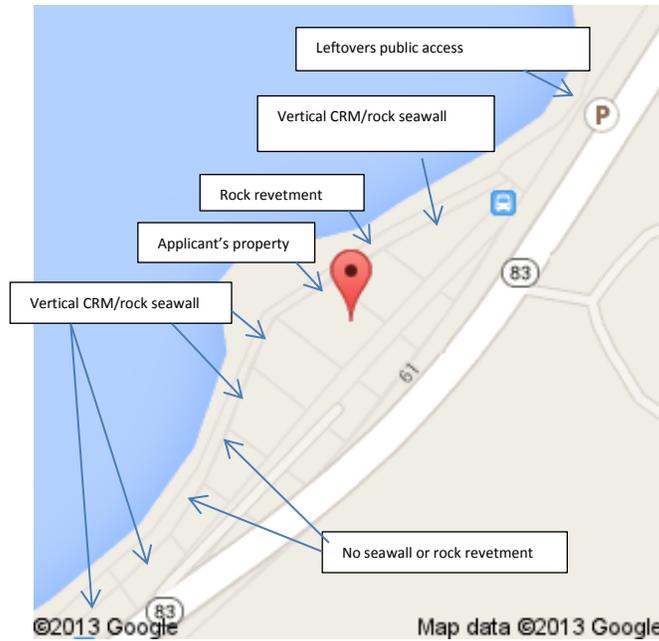
Map of shore protection devices in the proximity of the applicant's property

TMK	SHORE PROTECTION
61012025	Vertical CRM/rock seawall
61012023	Rock Revetment
61012021	Applicant's property
61012019	Vertical CRM/rock seawall
61012017	Vertical CRM/rock seawall
61012015	No seawall or revetment
61012013	No seawall or revetment
61012012	Vertical CRM/rock seawall
61008001	Vertical CRM/rock seawall
