SUBJECT: MODIFICATION TO THE IAO STREAM FLOOD CONTROL PROJECT WAILUKU, MAUI, HAWAII

DRAFT ENVIRONMENTAL ASSESSMENT

**Project Name:** Modification to the 'Jao Stream Flood Control Project

The United States Army Corps of Engineers (USACE) is proposing to implement engineering designs to address existing flood hazards and provide the authorized level of reduced flood risk along 'Tao Stream, Wailuku, Maui, Hawai'i. Implementation of the Proposed Action is needed to restore the reliability of the existing flood control strucutures and to protect the health and well-being of the Wailuku Community. The Proposed Action consists of features intended to reconnect the main channel with the floodplain to reduce damaging flows along the main channel and right bank levees. The reconnection would be accomplished by lowering a portion of the left bank, grading the overflow area, and construcing a diversion wall to force flood flows to enter the existing floodplain on the left bank. A portion of the left bank would be raised downstream to contain the overflow within the floodplain. Further downstream, the left bank would be lowered to allow the return of the overflow into the main channel. The P

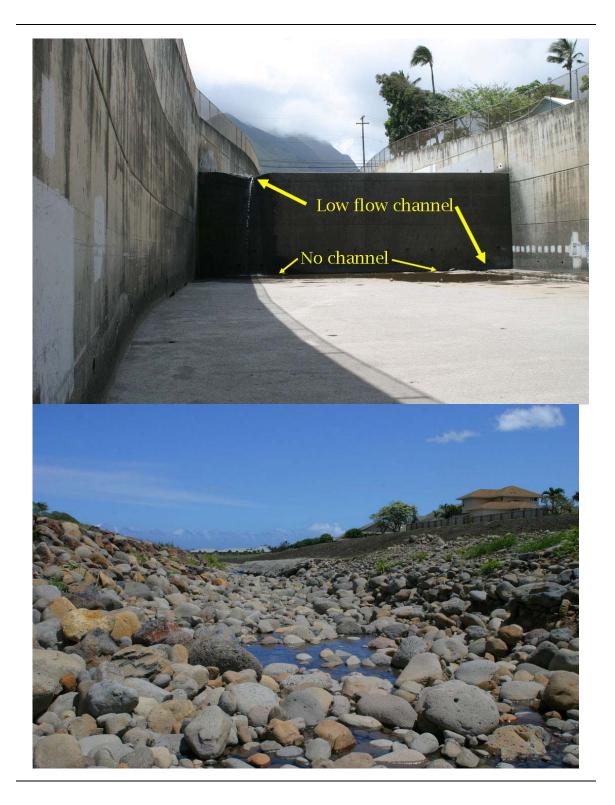
Figure 4a (top). In places, the low-flow channel is not continuous. Figure 4b (bottom). An unlined stream section in the Project area.

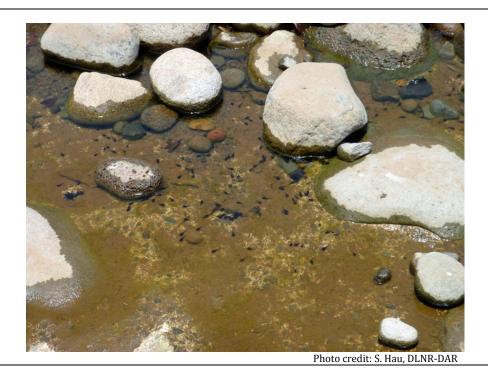
Figure 8. Cane toad tadpoles dominate semi-permanent pools in flood control channel.

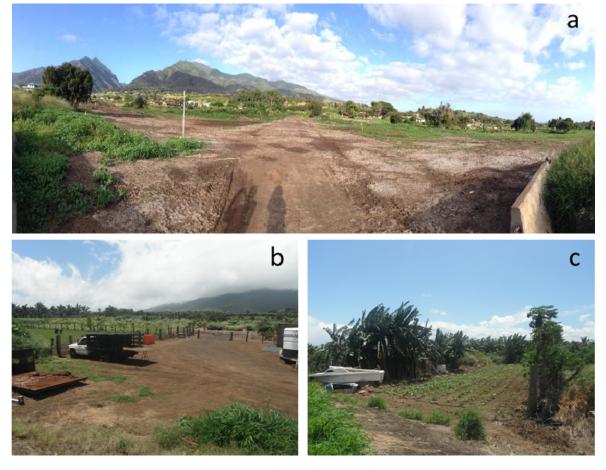
Figure 1. Current vegetated condition of the overflow area: a) looking west from Imi Kala bridge, b,c) views from Levee F looking into the overflow area.

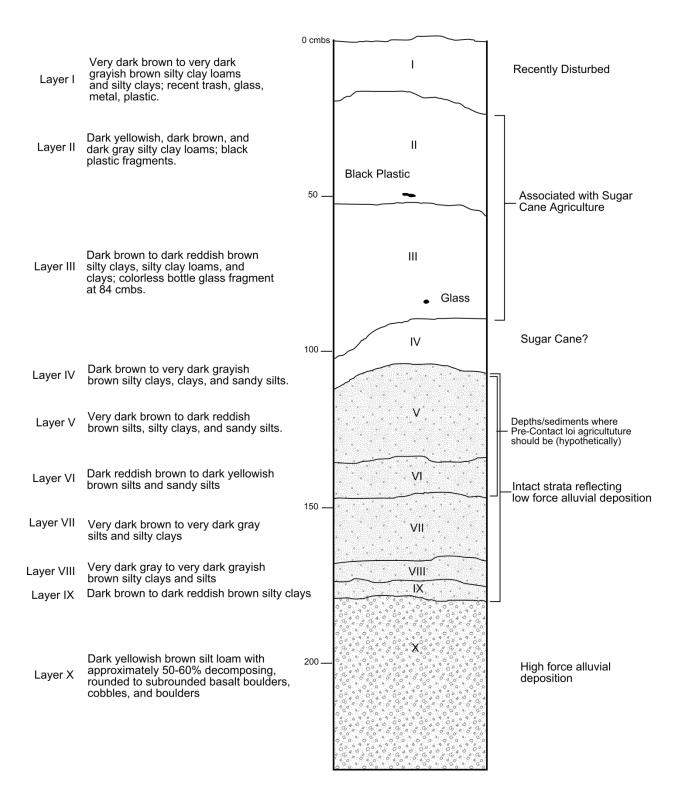
Figure 10. Composite Stratigraphic Sequence.

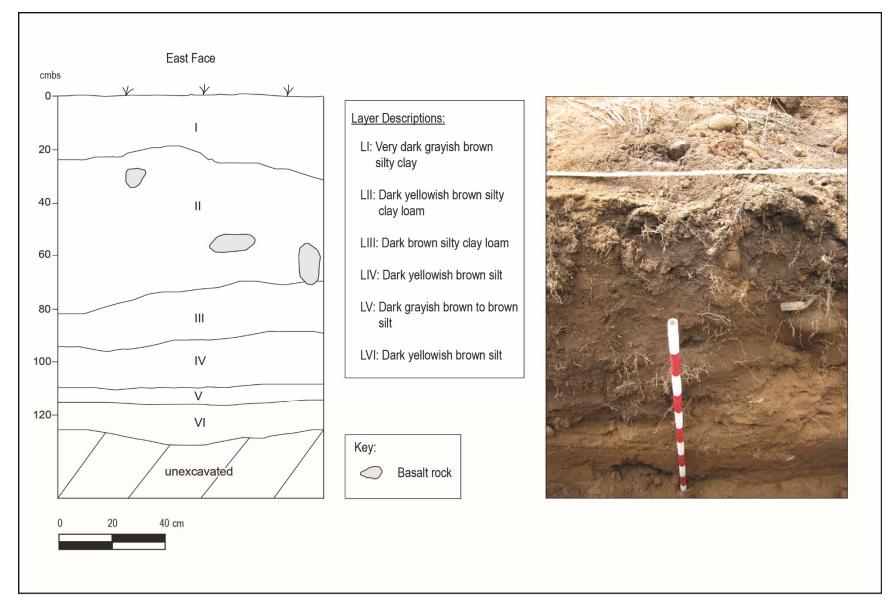
Figure 12. Profile and Photograph of East Face of Trench 1 at PL1.

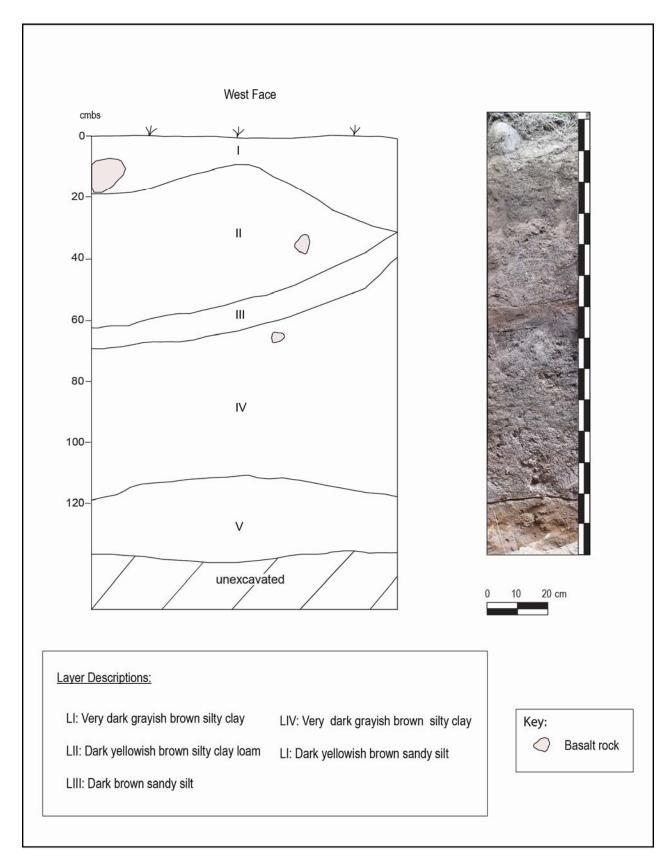
Figure 13. Profile and Photograph of West Face of Trench 1 at Profile Locale 2.

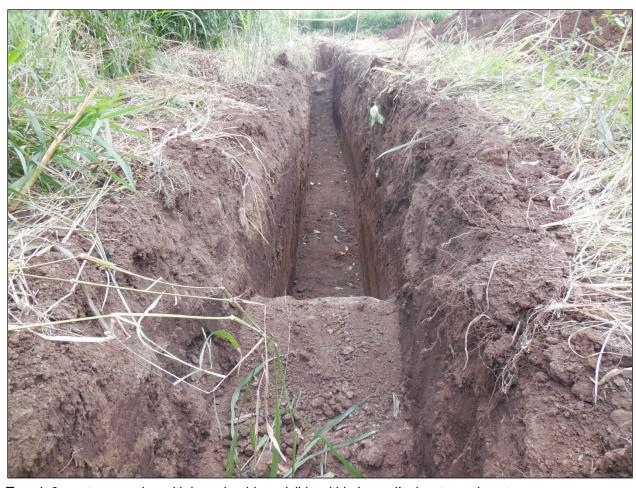
Trench 3, post-excavation with large boulders visible within Layer II; view to northeast.

Figure 17. Overview Photograph of Trench 3.

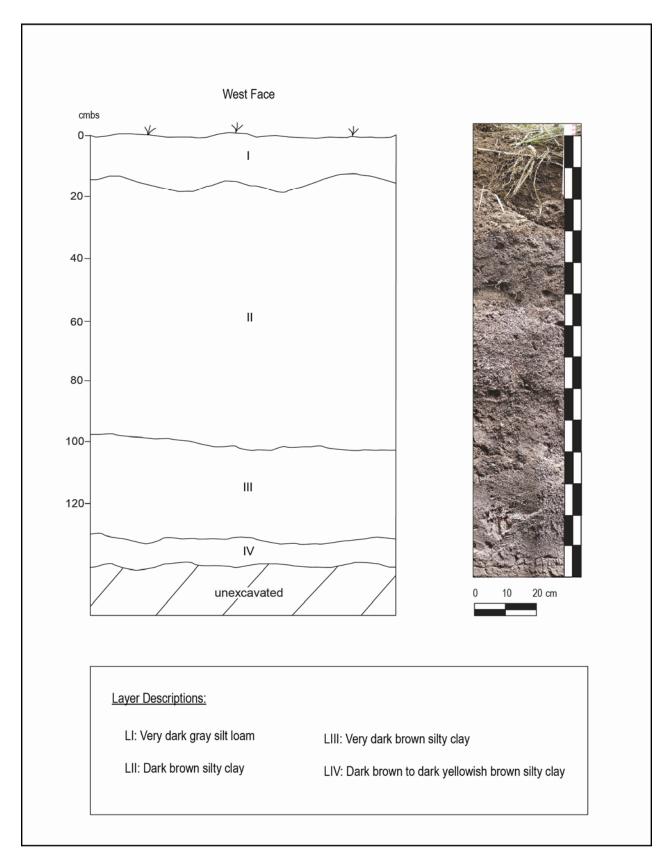
Figure 18. Profile and Photograph of West Face of Trench 3 at Profile Locale 12.

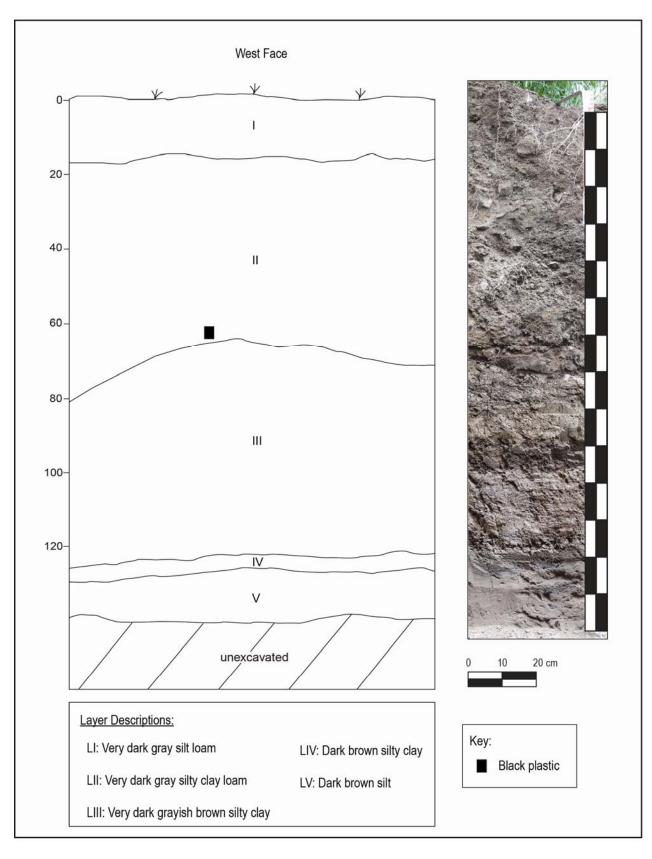
Figure 19. Profile and Photograph of West Face of Trench 3 at Profile Locale 13.

A total of five stratigraphic layers were identified at PL13, and designated as Layers I-V. Table 11 presents the maximum layer depths (top/bottom) and stratigraphic layer descriptions for these layers. Figure 19 presents the profile drawing at PL13 and a photograph. Layer V at PL13 is a silt deposit. A piece of black plastic, the type of material frequently observed in sugar cane fields, was found at the base of Layer II in this locale. Samples of Layer IV had strong brown (10YR 5/8, moist) staining on ped surfaces. No archaeological materials or features were encountered in Layers I-V at PL13.
