Subject: Proposed Department of Hawaiian Home Lands Kapa'akea Flood Mitigation Improvements

With this letter, the State of Hawai'i, Department of Hawaiian Home Lands (DHHL) hereby transmits the Final Environmental Assessment and Finding of No Significant Impact (FEA-FONSI) for the Proposed Kapa'akea Flood Mitigation Improvements Project, situated on five (5) DHHL Homestead lots identified by TMKs (2)5-4-007:009(por.), (2)5-4-007:010(por.), (2)5-4-007:011(por.), (2)5-4-007:024(por.), and (2)5-4-007:025(por.), within the Kapa'akea Ahupua'a near Kaunakakai on the island of Molokai for publication in the next available edition of the Environmental Notice.

Project Name:	Proposed Department of Hawaiian Home Lands Kapa'akea Flood Mitigation Improvements
Project Short Name:	Kapa'akea Flood Mitigation Improvements
HRS §343-5 Trigger(s):	Use of State Lands and State Funds
Island(s):	Moloka'i
Judicial District(s):	Moloka'i
TMK(s):	(2)5-4-007:009 (por.), (2)5-4-007:010 (por.), (2)5-4-007:011 (por.), (2)5-4-007:024 (por.), (2)5-4-007:025 (por.)
Permit(s)/Approval(s):	National Pollutant Discharge Elimination System (NPDES) Permit, as applicable; Community Noise Permit, as applicable; Building

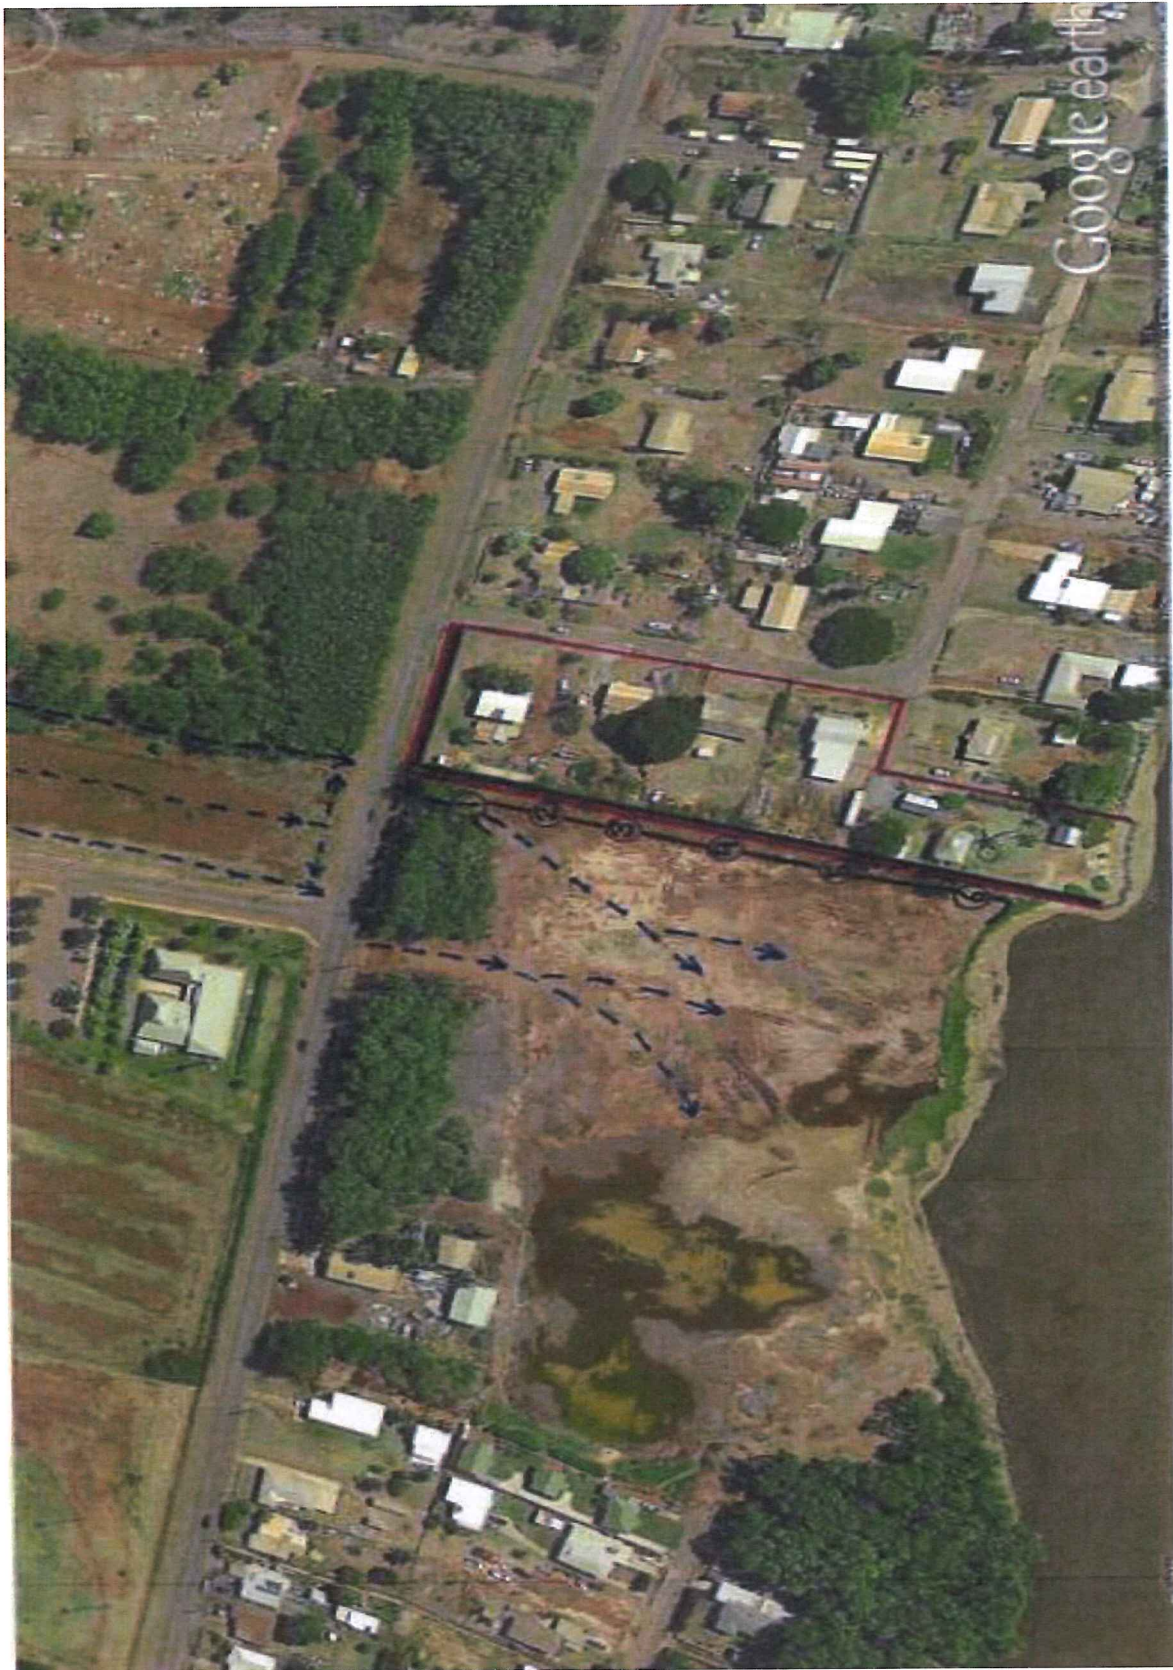
Figure 2.

- DHHL Kapa'akea Flood Mitigation Project boundary
- Proposed concrete wall along west and north boundaries of project area.
- - - - - > Runoff flow pattern of unnamed drainage along west boundary of project area.
- ③ — ④ — ⑤ Numbered sampling points and proposed wetland boundary

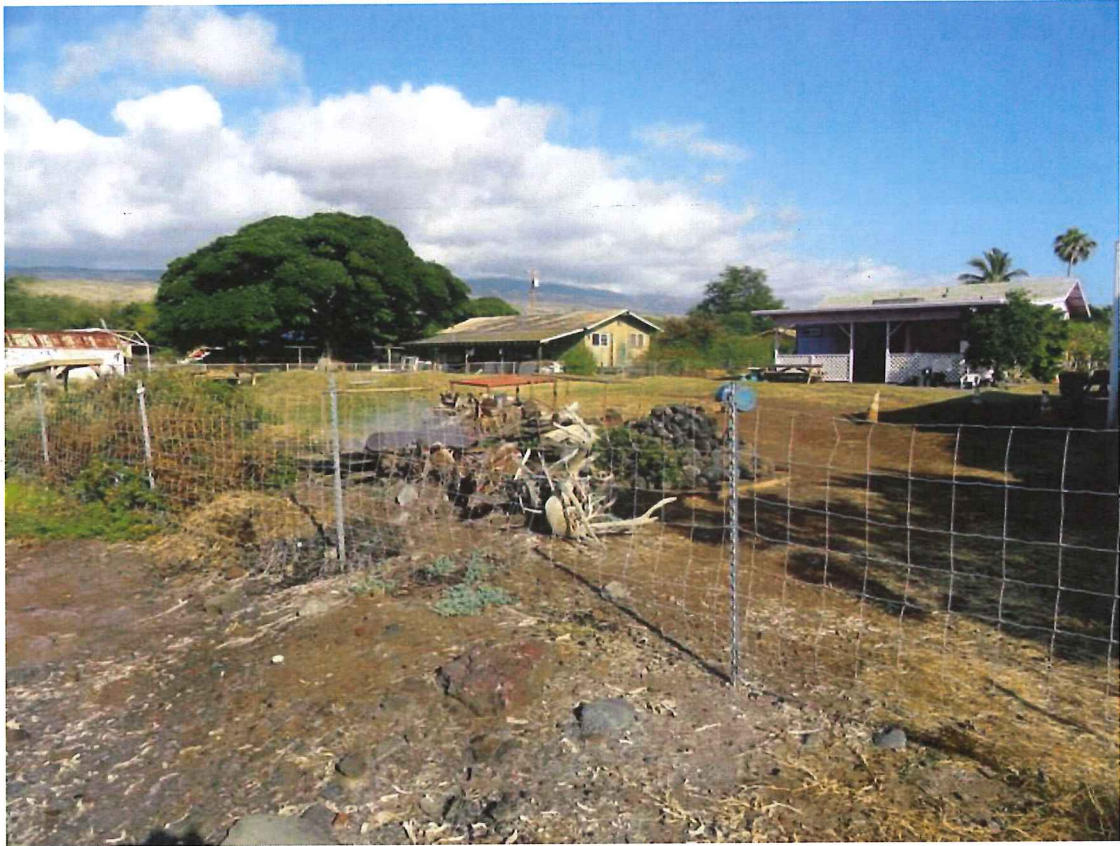
Figure 4. View northeast across the project boundary into the DHHL Lots, showing their developed residential character.

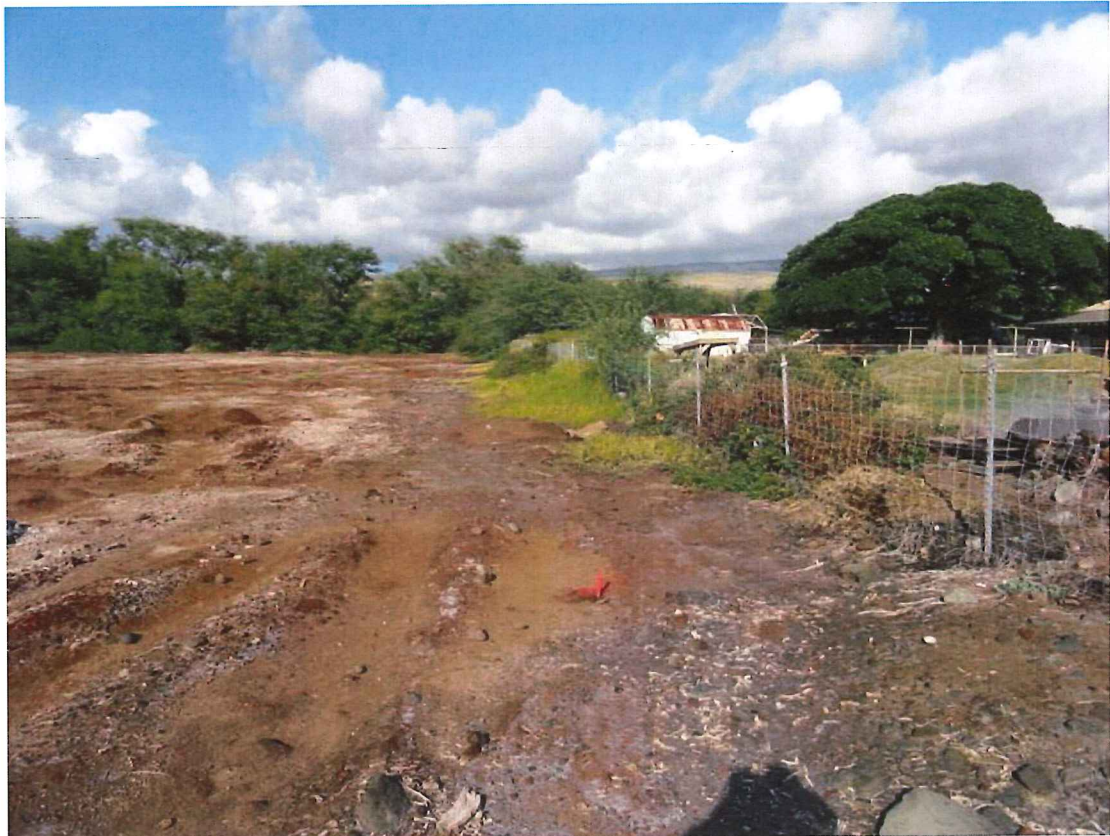
Figure 5. View north along project boundary. The proposed wetland boundary is indicated by red stakes which are located near the toe of the slope below the elevated DHHL lots.

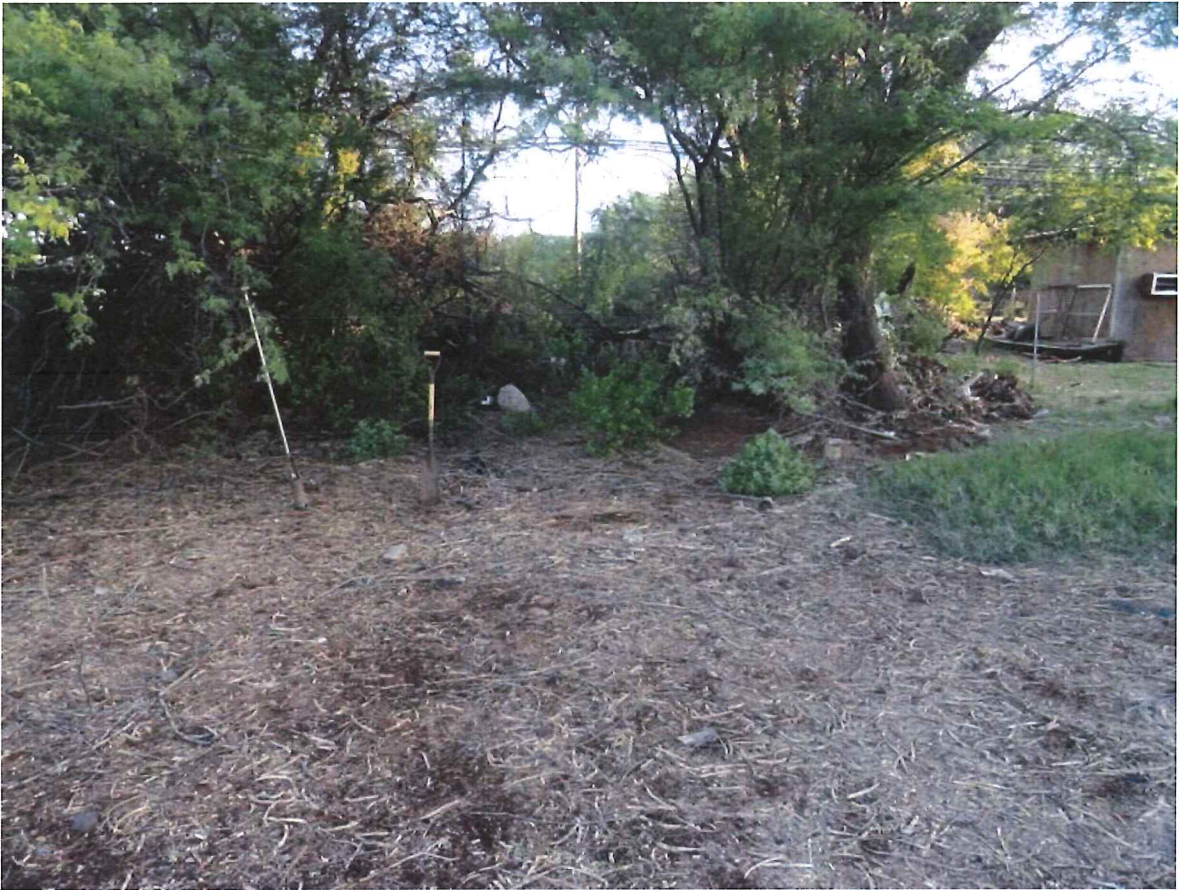
Sampling Point 1A. Upper edge of wetland. Inflow from the Kamehameha V Highway is aligned with the telephone pole. The elevated DHHL project boundary is along the fenceline on the right

Remarks:  
 This site floods for short periods following heavy rainfall events but groundwater levels retreat to depths that prevent the development of positive indicators of wetland hydrology.

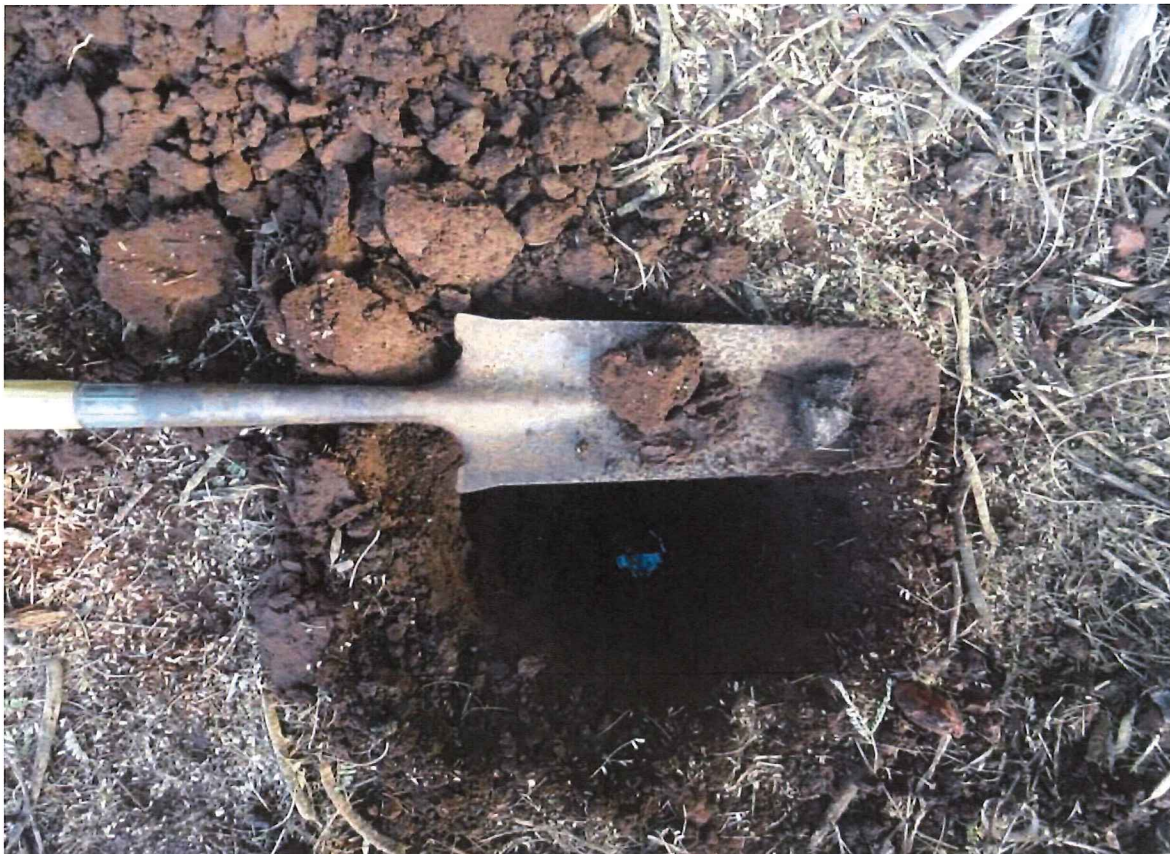
Sampling Point 1B. Dark reddish-brown silt loam over dark reddish gray clay loam.  
Soil saturated at 18 inches, water table at 22 inches.

Depth (inches)	Matrix		Redox Features				Testers	Remarks
	Color (moist)	%	Color (moist)	%	Type <sup>1</sup>	Loc <sup>2</sup>		
0-18	2.5YR 3/4	100	-	-	-	-	silt loam	dark reddish brown moist
18-24	2.5YR 4/1	100	-	-	-	-	clay loam	dark reddish gray saturated

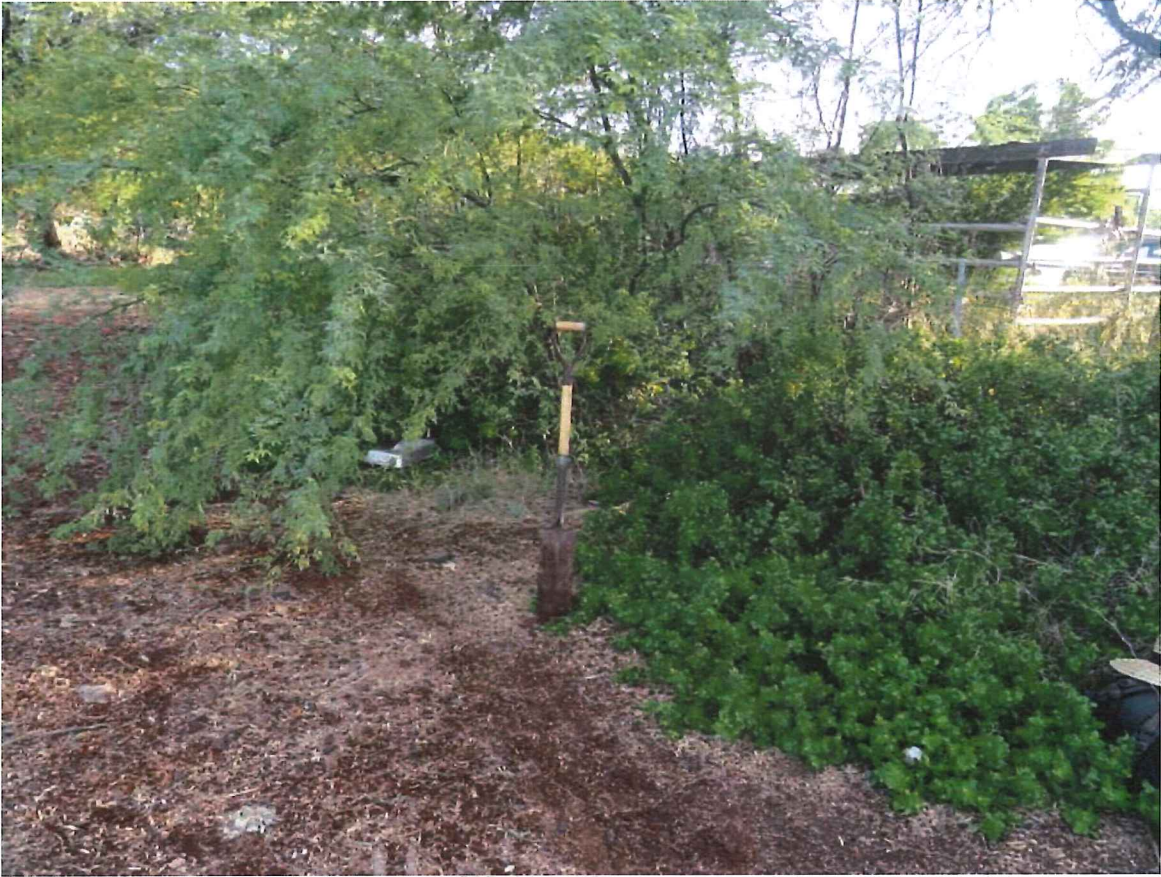
Sampling Point 2A. Located near the bottom of the slope below the DHHL lot boundary.

Remarks:  
 While close to the wetland boundary, this sampling point does not have any positive signs of wetland hydrology.

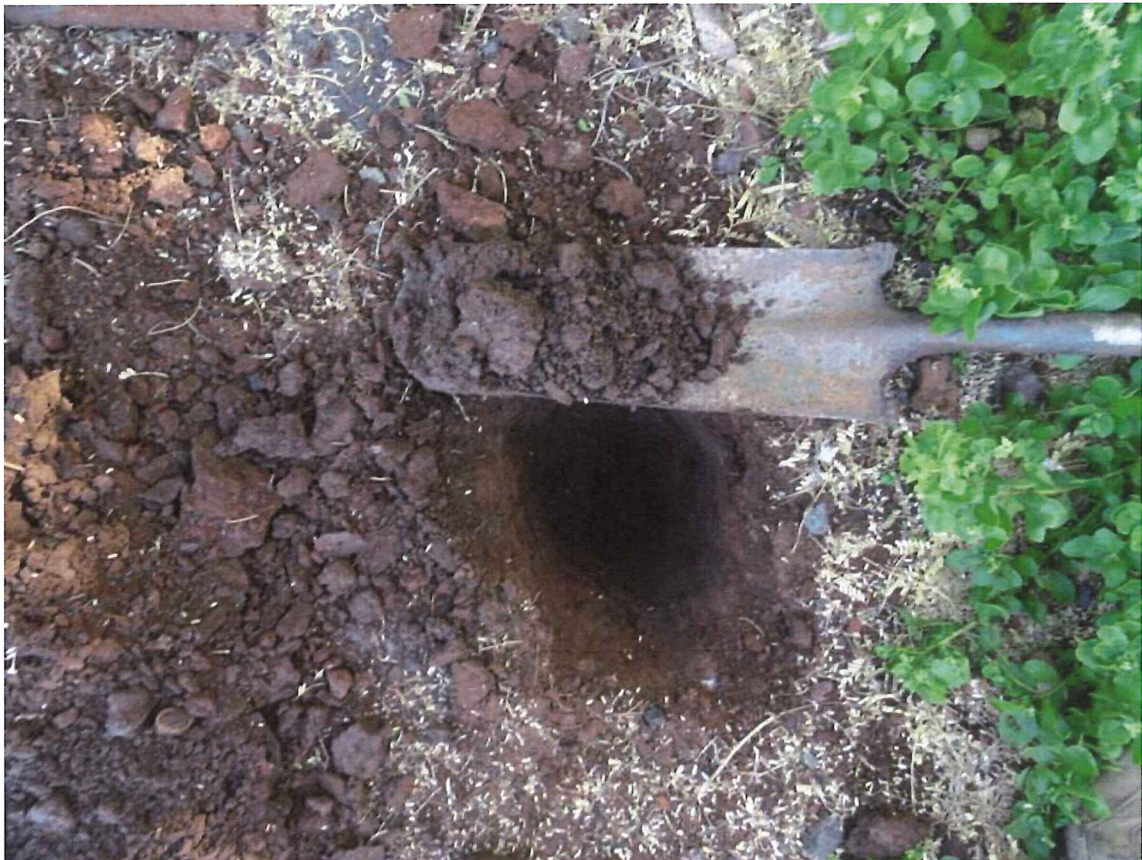
Sampling Point 2B. Dark reddish-brown silt. Loam to 18 inches depth.  
Did not reach saturation or water table depths.

Depth (inches)	Matrix		Redox Features				Texture	Remarks
	Color (moist)	%	Color (moist)	%	Type <sup>1</sup>	Loc <sup>2</sup>		
0-18	2.5YR3/4	100	—	—	—	—	silt loam	dark reddish brown UNS 7.0YR 3/4

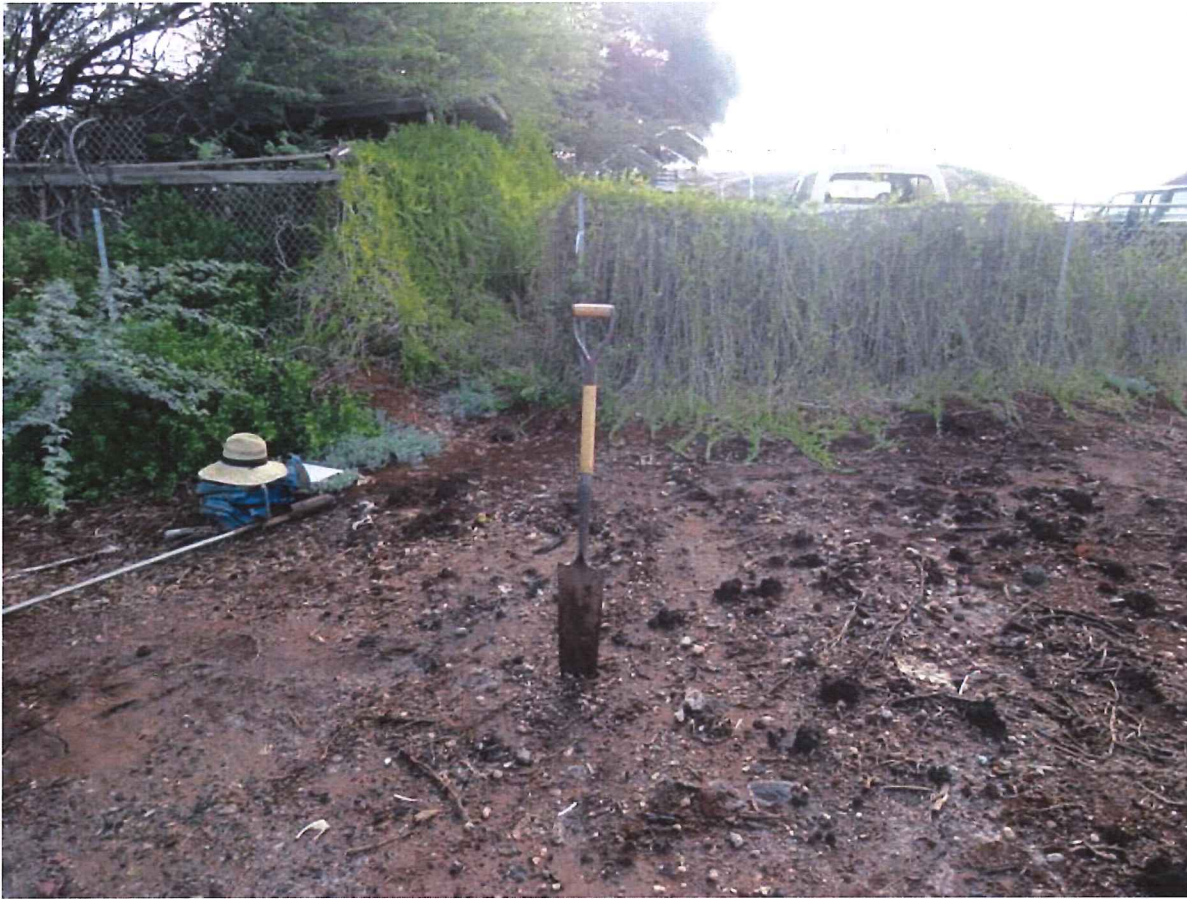
Sampling Point 3A. Located near the bottom of the slope below the DHHL lot boundary.

Remarks: While close to the wetland boundary, this sampling point does not have any positive indicators of wetland hydrology.

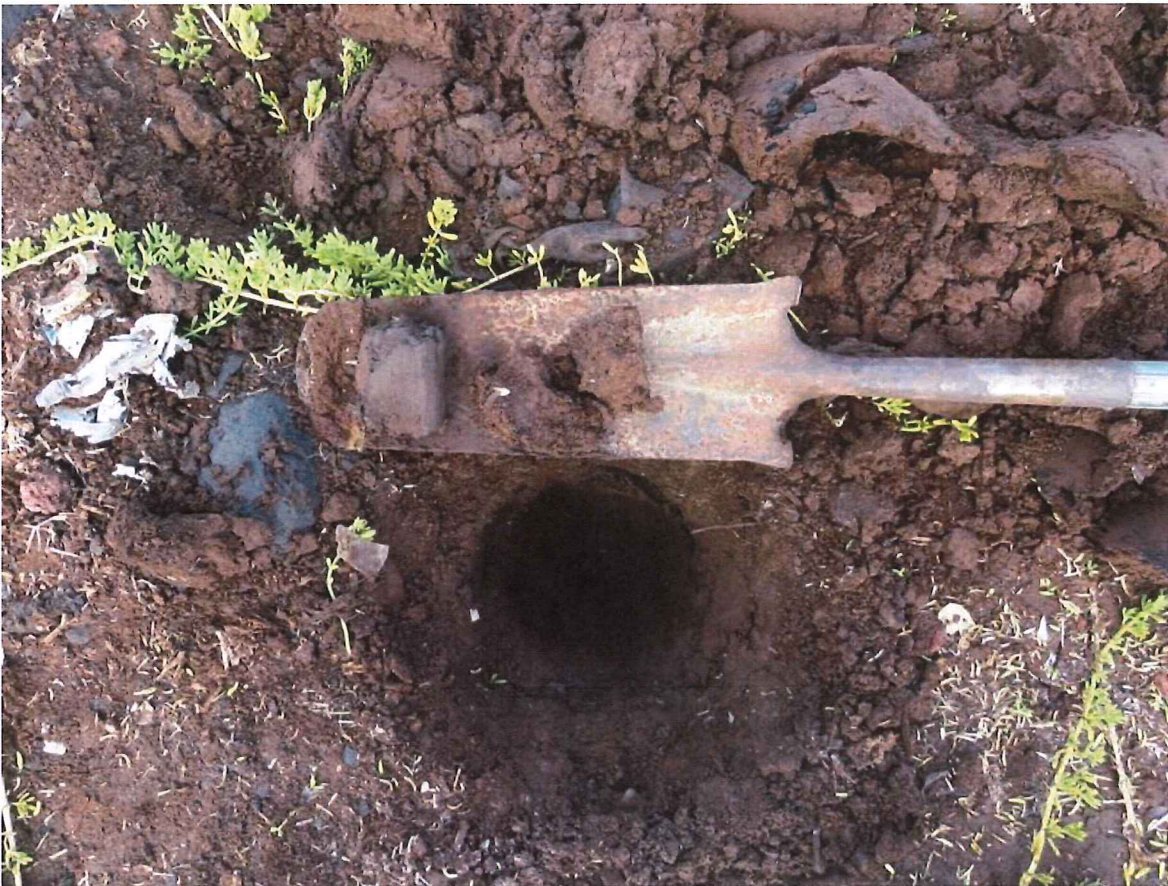
Sampling Point 3B. Dark reddish-brown silt loam over dusky red silty clay loam. Saturation at 17 inches. Water table at 20 inches.

Depth (inches)	Matrix		Redox Features				Texture	Remarks
	Color (moist)	%	Color (moist)	%	Type	Loc <sup>2</sup>		
0-17	2.5YR 3/4	100	-	-	-	-	Silt loam silty clay	dark reddish brown with stratified red
17-20	2.5YR 3/3	100	-	-	-	-	loam	dark red, saturated

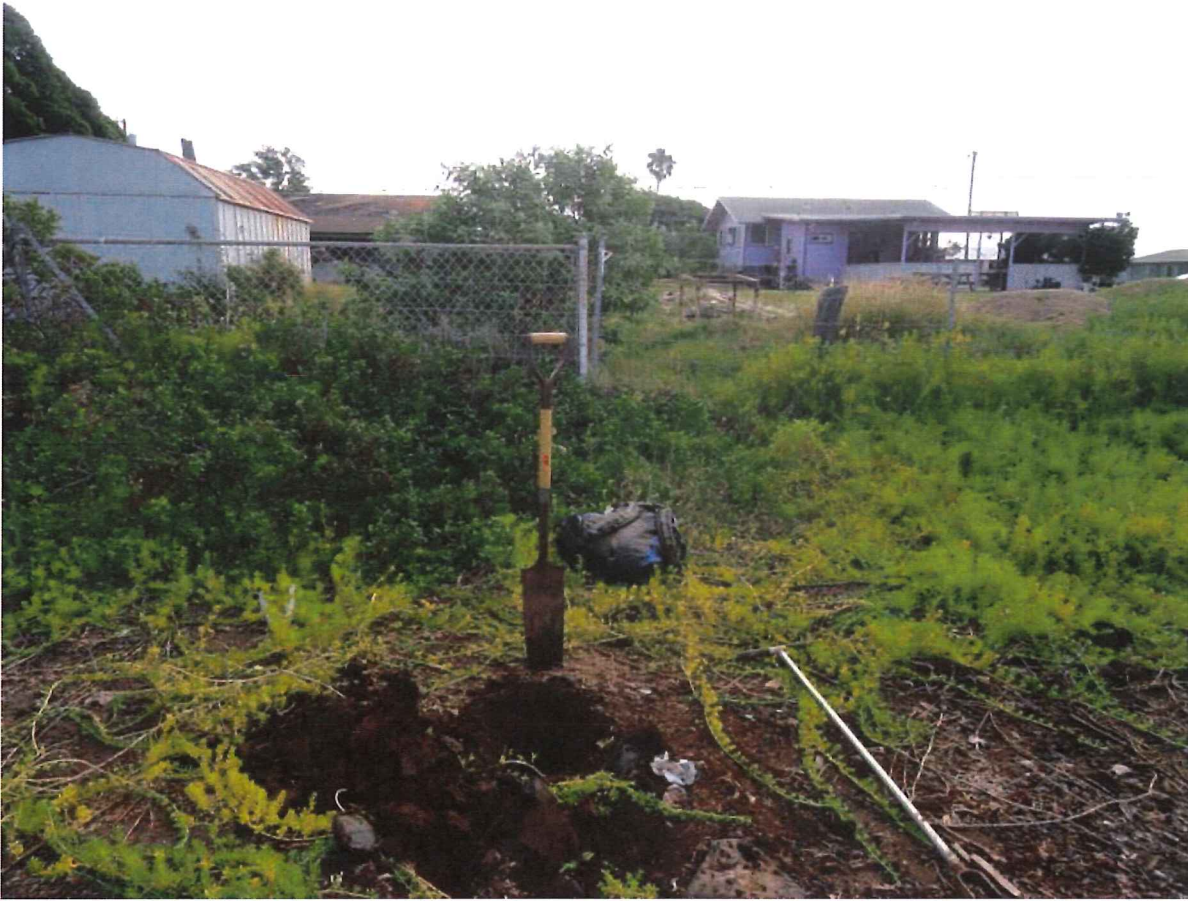
Sampling Point 4A. Located near the bottom of the slope below the DHHL lot boundary.

Remarks: While close to the wetland boundary, this sampling point does not have any positive indicators of wetland hydrology.

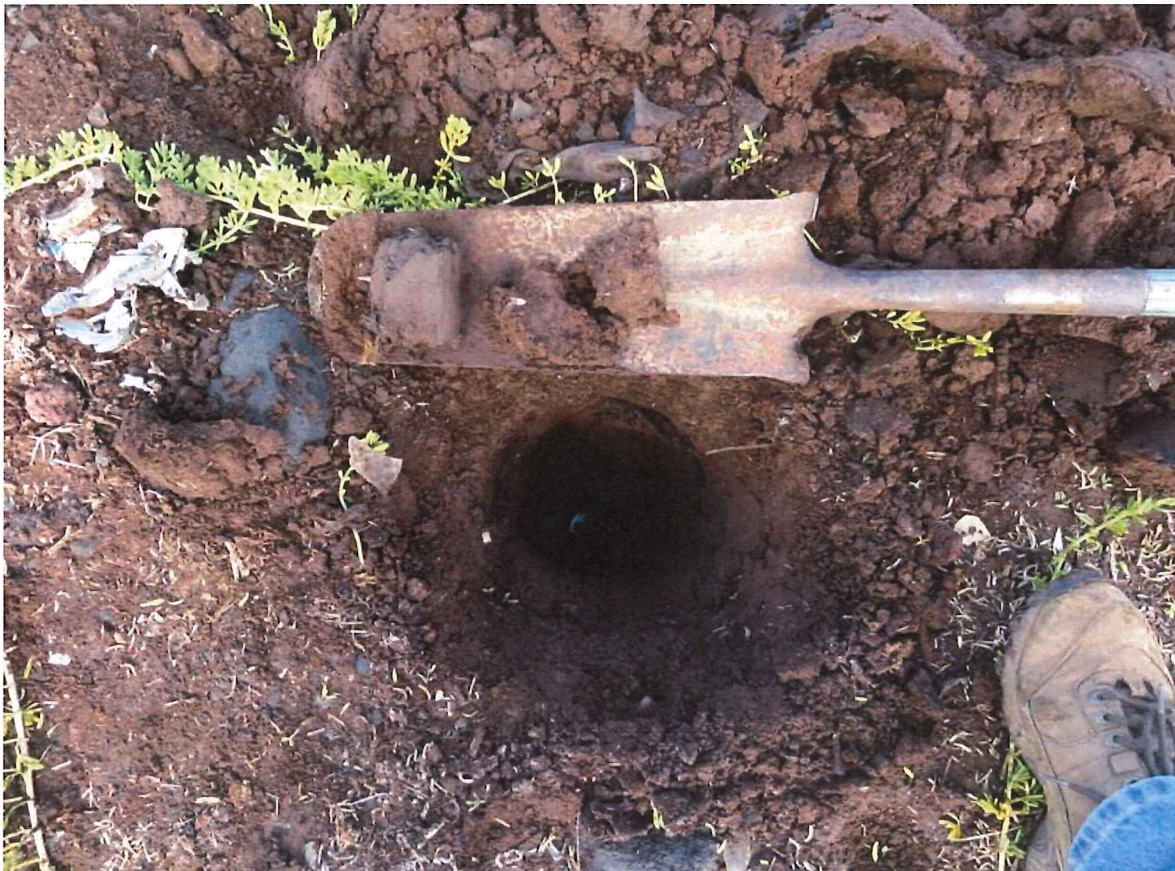
Sampling Point 4B. Dark reddish-brown silt loam over dusky red silty clay loam.  
Saturation at 19 inches. Water table at 23 inches.

Depth (Inches)	Matrix		Redox Features				Texture	Remarks
	Color (moist)	%	Color (moist)	%	Type <sup>1</sup>	Loc <sup>2</sup>		
0-19	2.5YR 3/4	100	-	-	-	-	Silt loam	dark reddish-brown unstratified
19-23	2.5YR 3/4	100	-	-	-	-	silty clay loam	dusky red, saturated

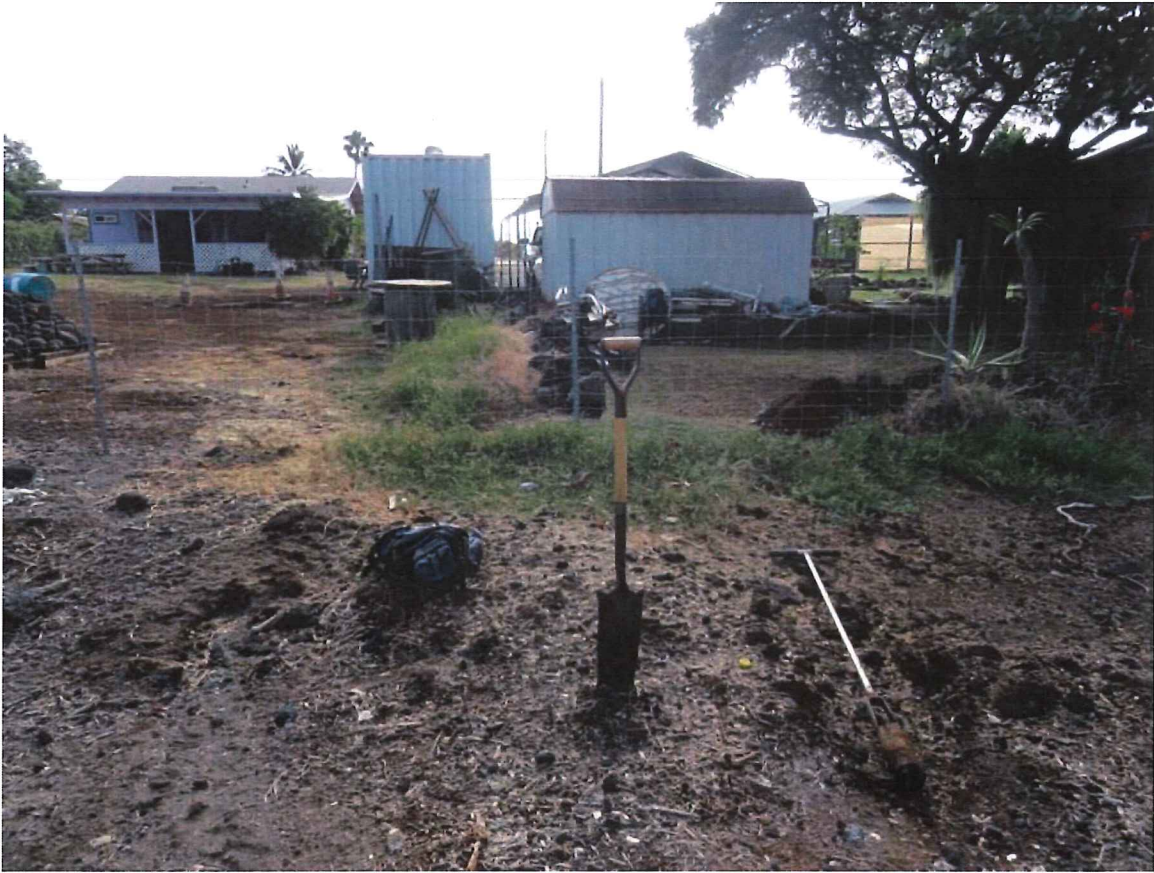
Sampling Point 5A. Located near the bottom of the slope below the DHHL Lot boundary.

Remarks: While close to the wetland boundary, this sampling point does not have any positive indicators of wetland hydrology.

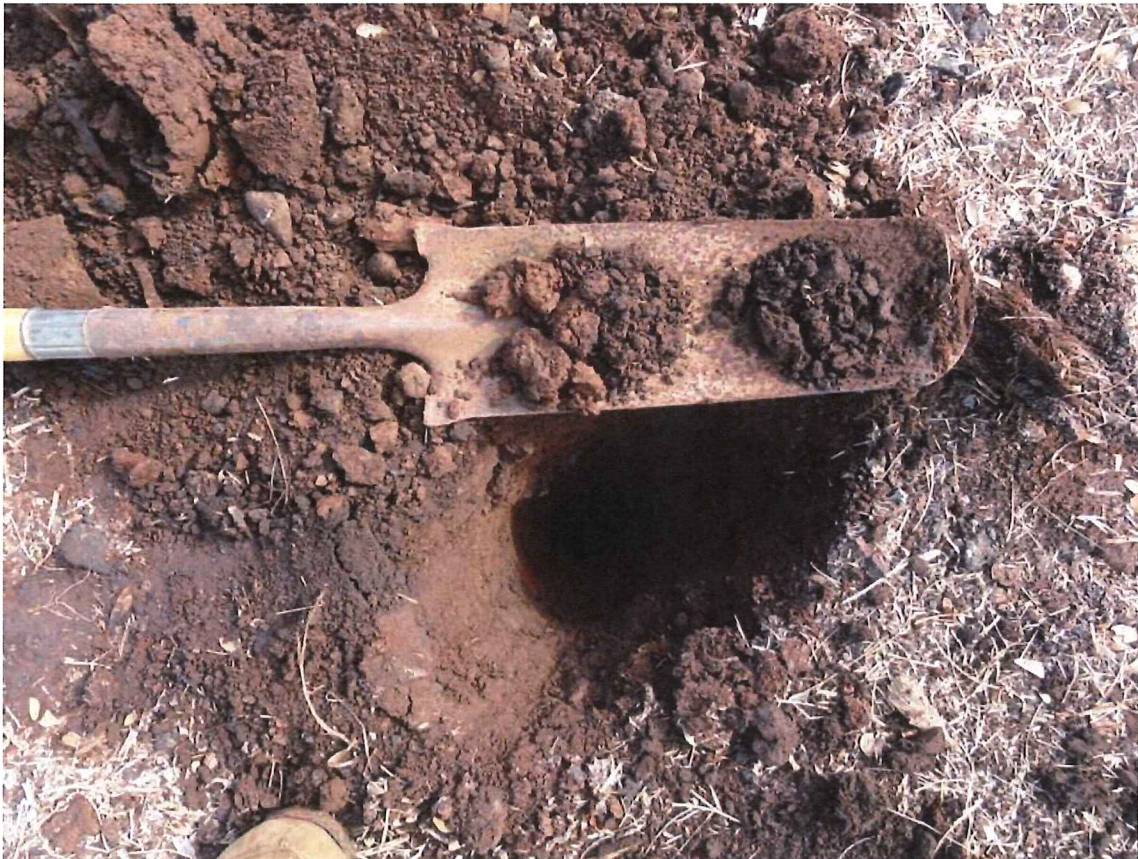
Sampling Point 5B. Dark reddish-brown silt loam over dark reddish-gray clay loam. Saturation at 17 inches. Water table at 20 inches.

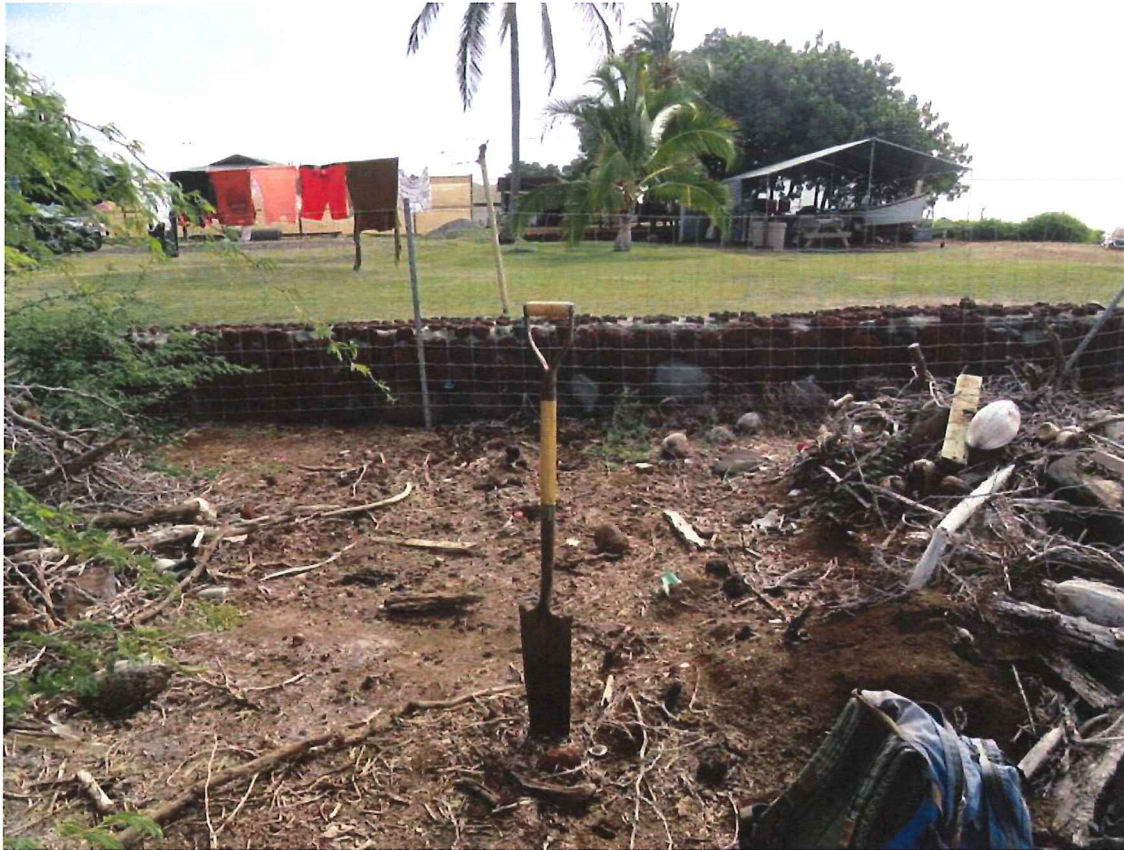
Sampling Point 6A. Located at the bottom of the slope below the DHHL lot boundary within the margin of the wetland.

Remarks:  
 This sampling point had salt deposits and shallow saturation and water table - it had wetland hydrology.

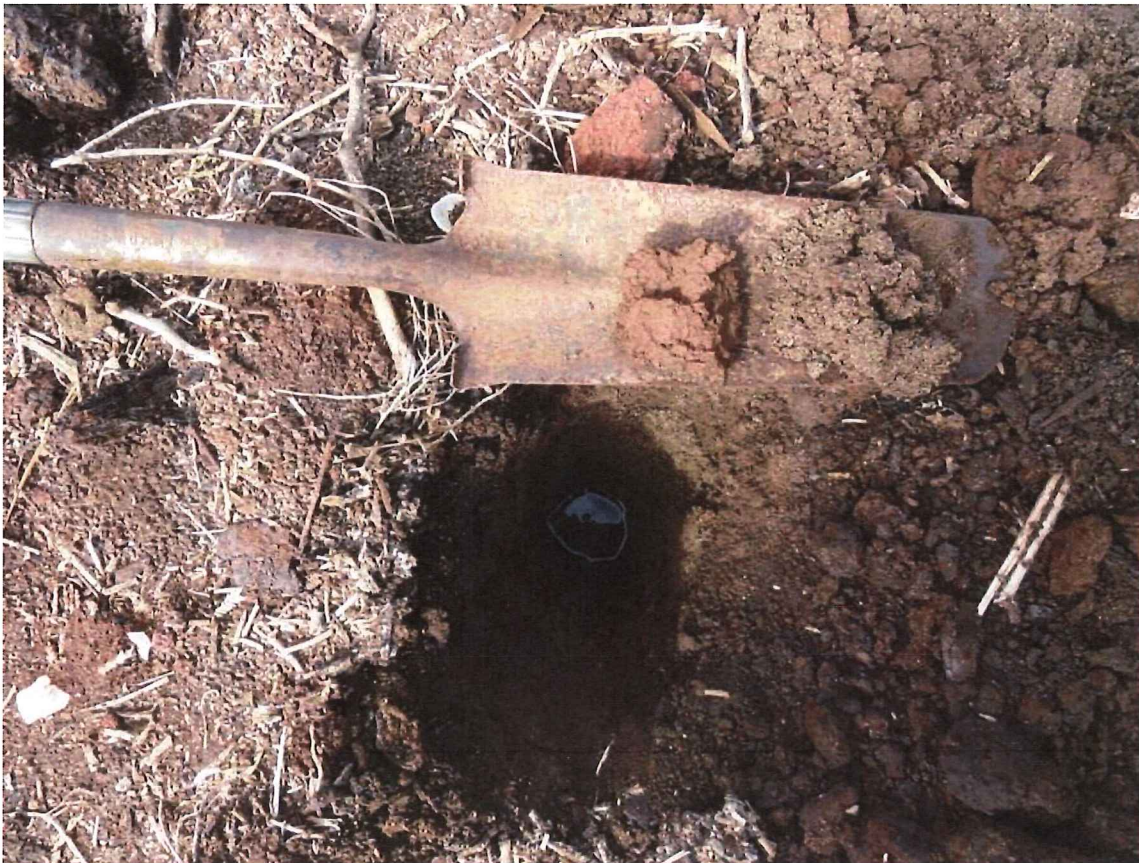
Sampling Point 6B. Reddish-brown silt loam over weak red, saturated silty sand. Saturation at 8 inches. Water table at 12 inches.

Depth (Inches)	Matrix		Redox Features				Texture	Remarks
	Color (moist)	%	Color (moist)	%	Type	Loc		
0-A	2.5YR 5/3	100	-	-	-	-	silt loam	Redox horizon unstratified
A-20	2.5YR 5/3	100	-	-	-	-	silty sand	Weak red sand saturated water table at 12 in.

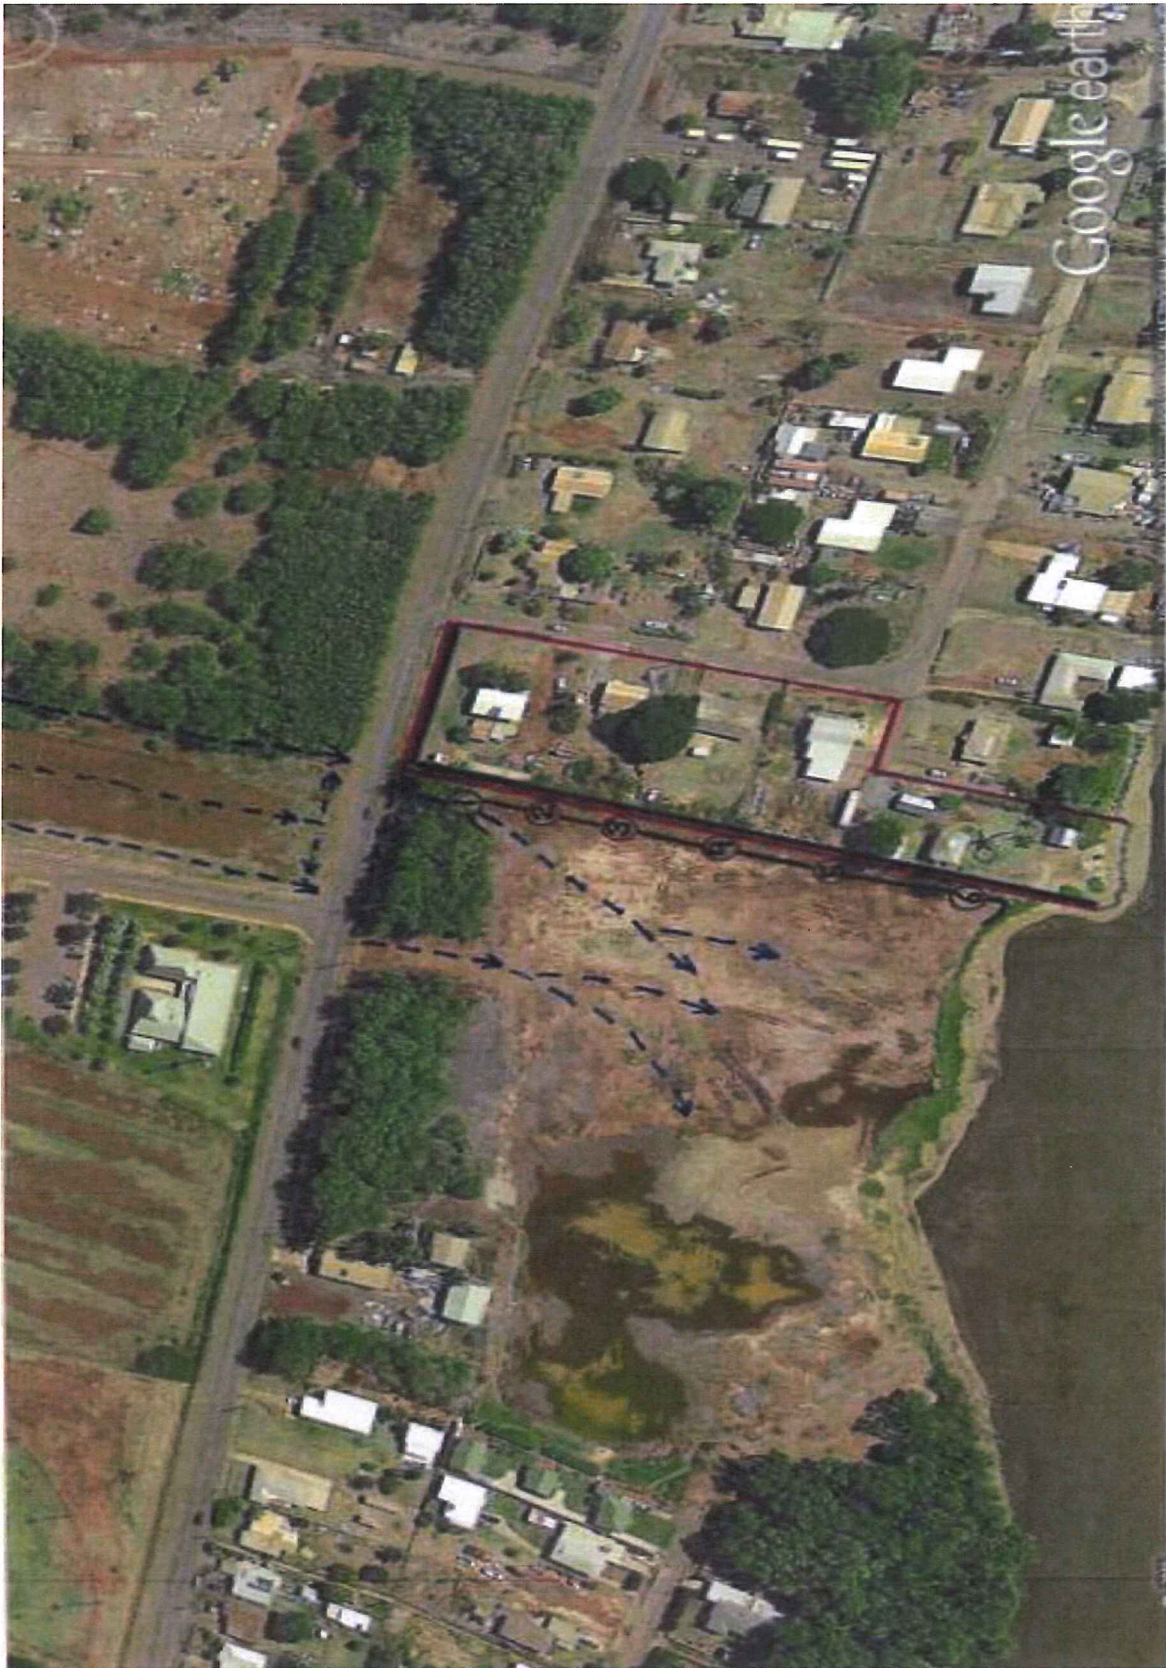
Figure 2.

- DHHL Kapa'akea Flood Mitigation Project boundary
- Proposed concrete wall along west and north boundaries of project area.
- - - - - > Runoff flow pattern of unnamed drainage along west boundary of project area.
- ③ — ④ — ⑤ — Numbered sampling points and proposed wetland boundary

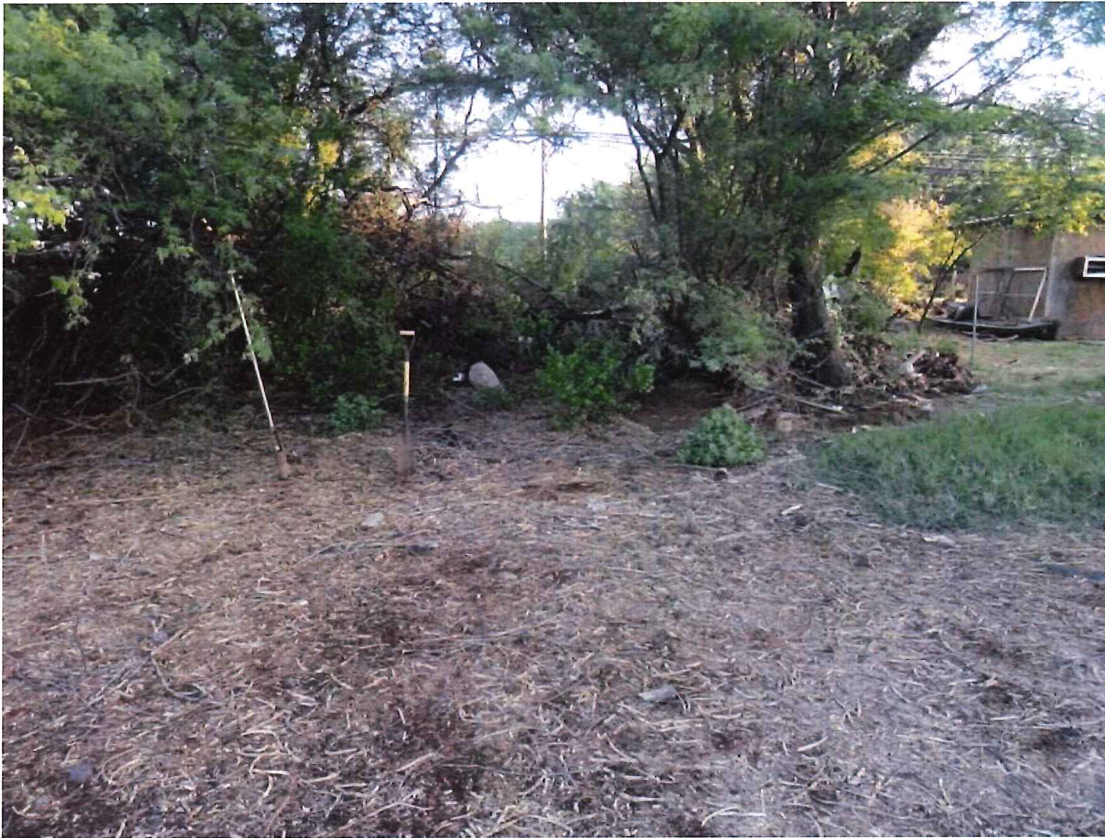
Sampling Point 1A. Upper edge of wetland. Inflow from the Kamehameha V Highway aligns with the telephone pole. The elevated DHHL project boundary is along the fenceline on the right.

Remarks:  
**THIS SITE FLOODS FOR SHORT PERIODS FOLLOWING HEAVY RAINFALL EVENTS BUT GROUND WATER LEVELS RETREAT TO DEPTHS THAT PREVENT THE DEVELOPMENT OF POSITIVE INDICATORS OF WETLAND HYDROLOGY.**

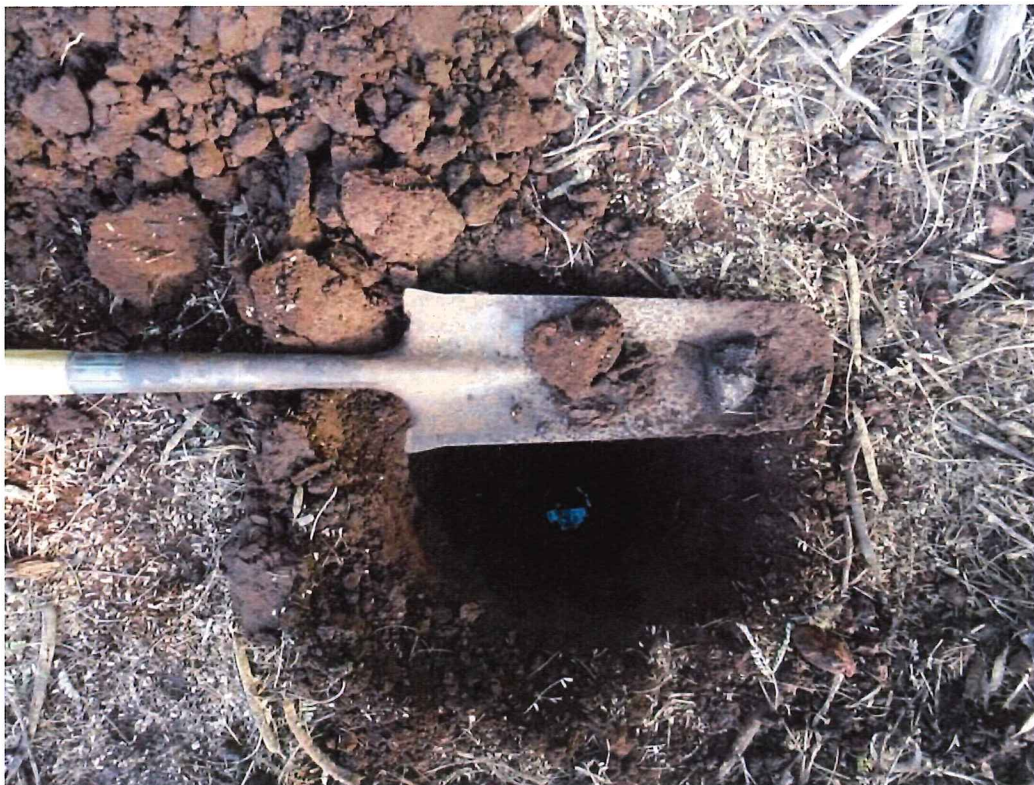
Sampling Point 1B. Dark reddish-brown silt loam over dark reddish gray clay loam. Soil saturated at 18 inches, water table at 22 inches.

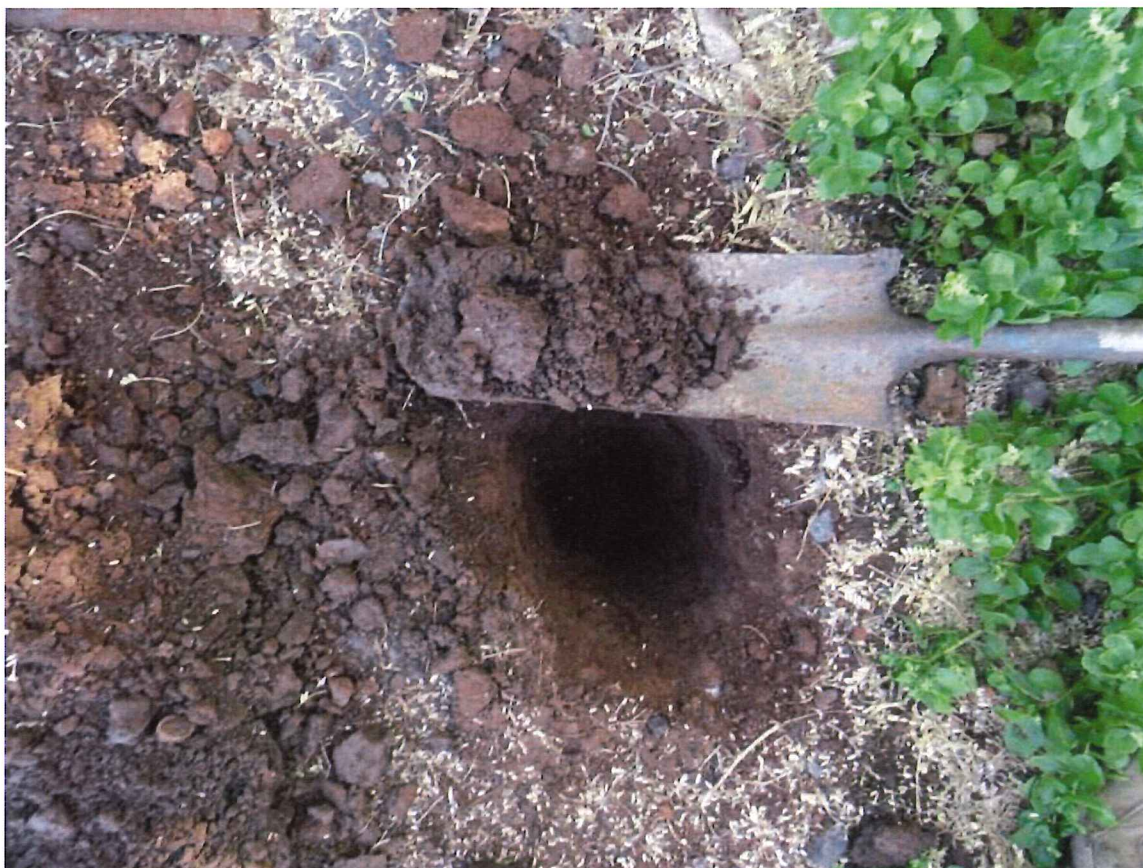
Sampling Point 2B. Dark reddish-brown silt. Loam to 18 inches depth. Did not reach saturation or water table depths.
