Subject: Proposed Department of Hawaiian Home Lands Kapa'akea Flood Mitigation Improvements

With this letter, the State of Hawai'i, Department of Hawaiian Home Lands (DHHL) hereby transmits the Final Environmental Assessment and Finding of No Significant Impact (FEA-FONSI) for the Proposed Kapa'akea Flood Mitigation Improvements Project, situated on five (5) DHHL Homestead lots identified by TMKs (2)5-4-007:009(por.), (2)5-4-007:010(por.), (2)5-4-007:011(por.), (2)5-4-007:024(por.), and (2)5-4-007:025(por.), within the Kapa'akea Ahupua'a near Kaunakakai on the island of Molokai for publication in the next available edition of the Environmental Notice.

Project Name:	Proposed Department of Hawaiian Home Lands Kapa'akea Flood Mitigation Improvements
Project Short Name:	Kapa'akea Flood Mitigation Improvements
HRS §343-5 Trigger(s):	Use of State Lands and State Funds
Island(s):	Moloka'i
Judicial District(s):	Moloka'i
TMK(s):	(2)5-4-007:009 (por.), (2)5-4-007:010 (por.), (2)5-4-007:011 (por.), (2)5-4-007:024 (por.), (2)5-4-007:025 (por.)
Permit(s)/Approval(s):	National Pollutant Discharge Elimination System (NPDES) Permit, as applicable; Community Noise Permit, as applicable; Building

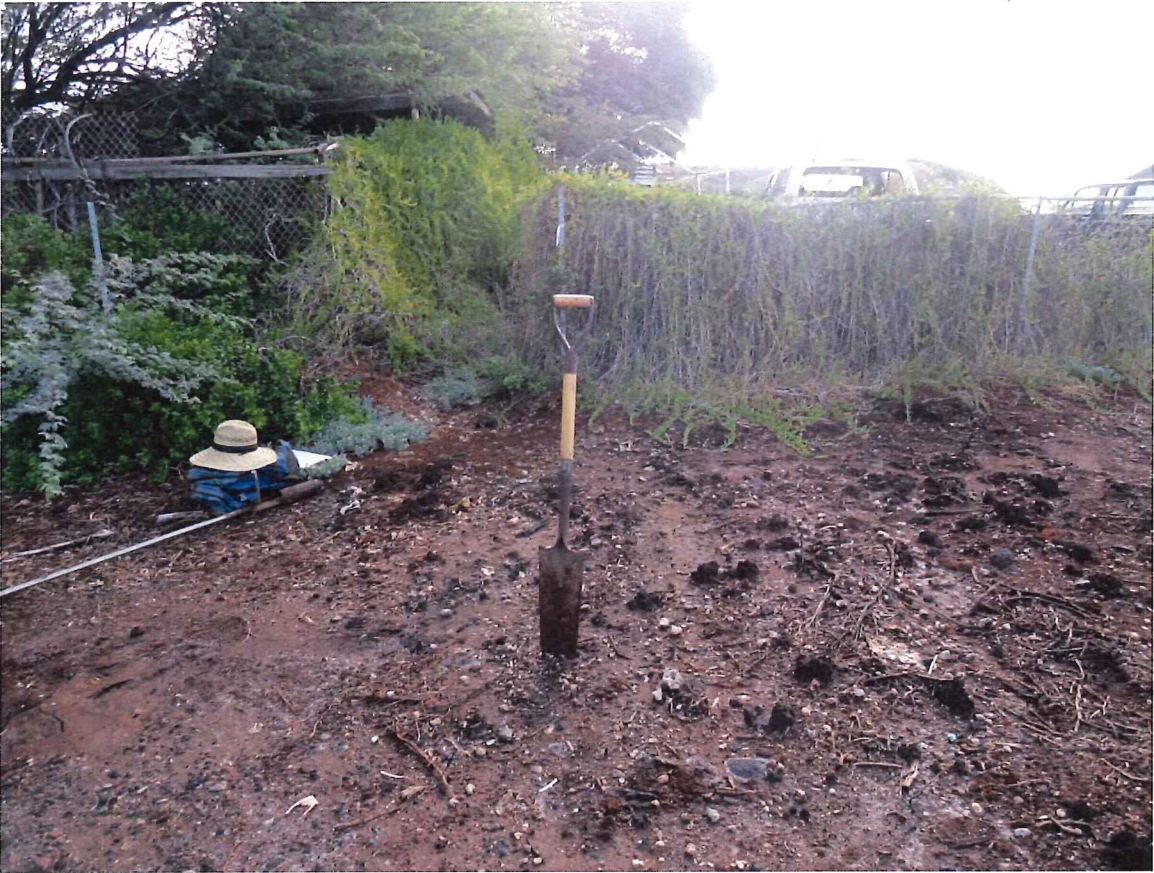
Sampling Point 3A. Located near the bottom of the slope below the DHHL lot boundary.

WHILE CLOSE TO THE WETLAND BOUNDARY, THIS SAMPLING POINT DOES NOT HAVE ANY POSITIVE INDICATORS OF WETLAND HYDROLOGY.

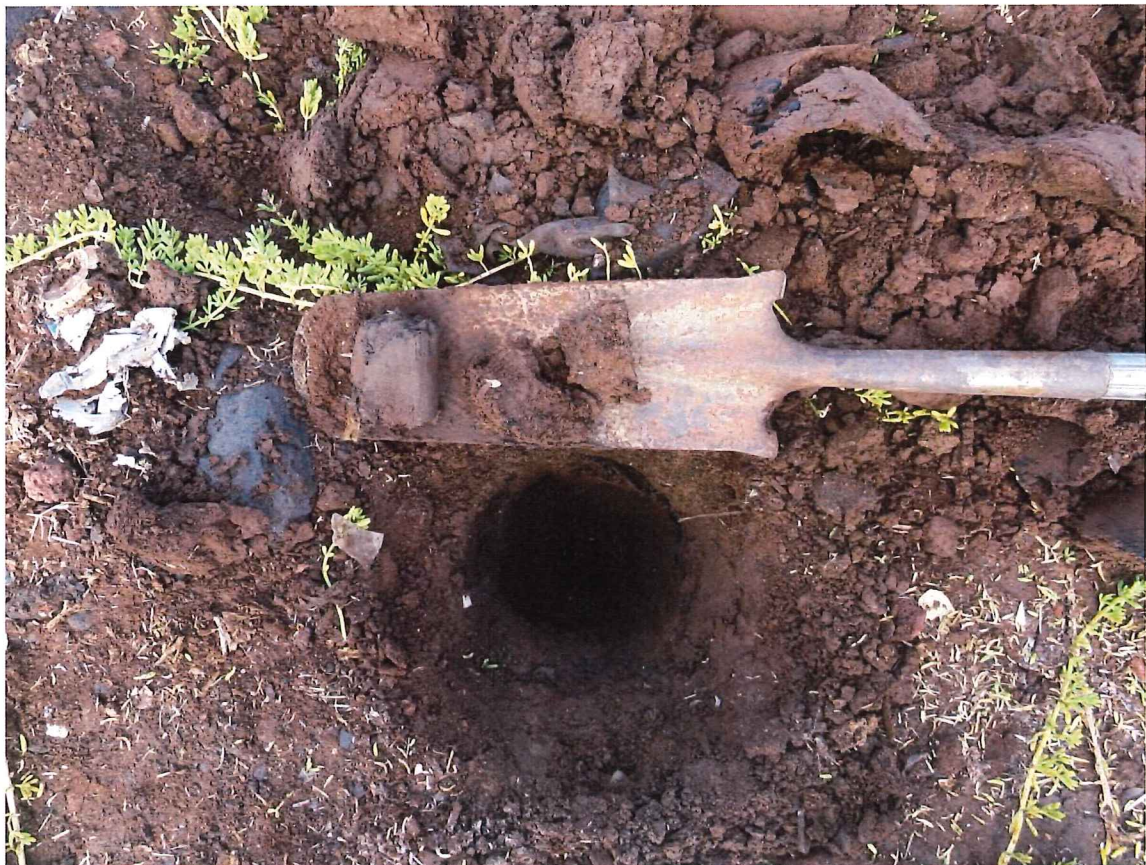
Sampling Point 3B. Dark reddish-brown silt loam over dusky red silty clay loam. Saturation at 17 inches. Water table at 20 inches.

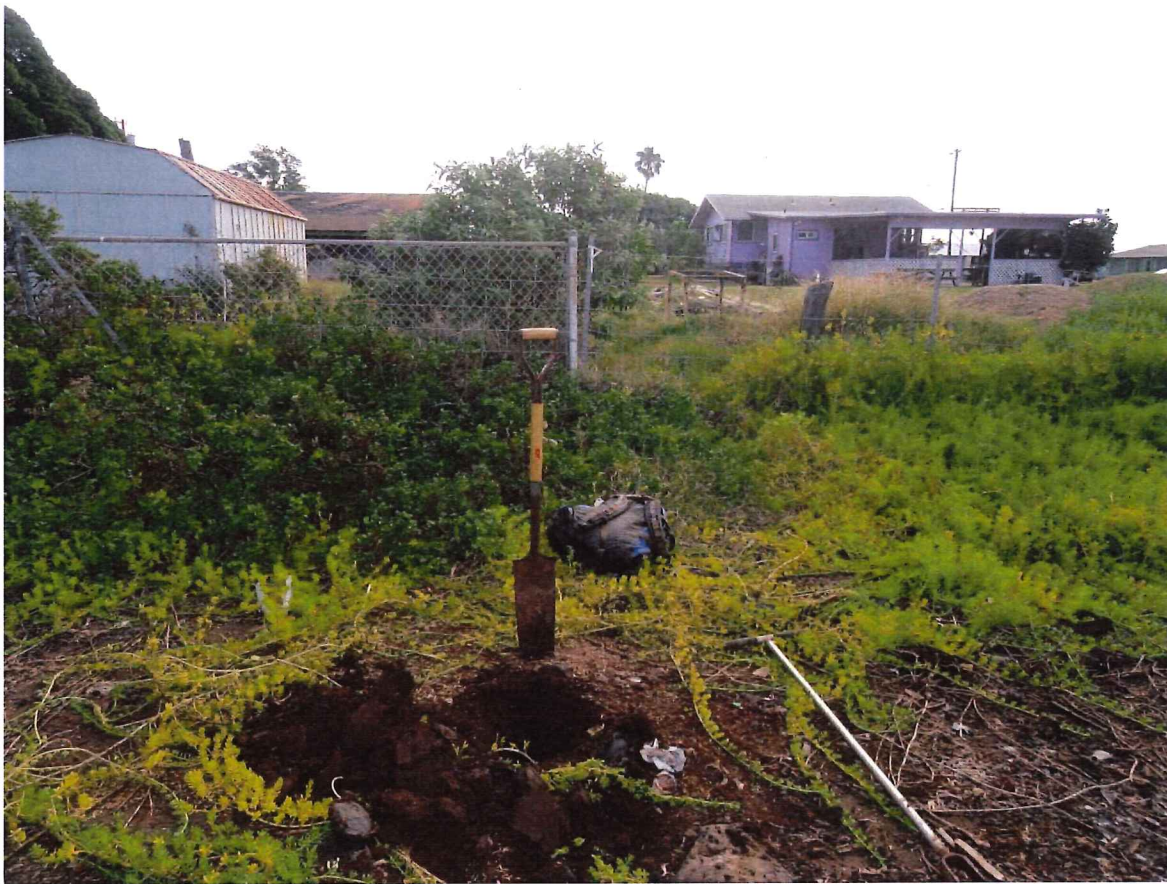
Sampling Point 4A. Located near the bottom of the slope below the DHHL lot boundary.

WHILE CLOSE TO THE WETLAND BOUNDARY THIS SAMPLING POINT DOES NOT HAVE ANY POSITIVE INDICATORS OF WETLAND HYDROLOGY.

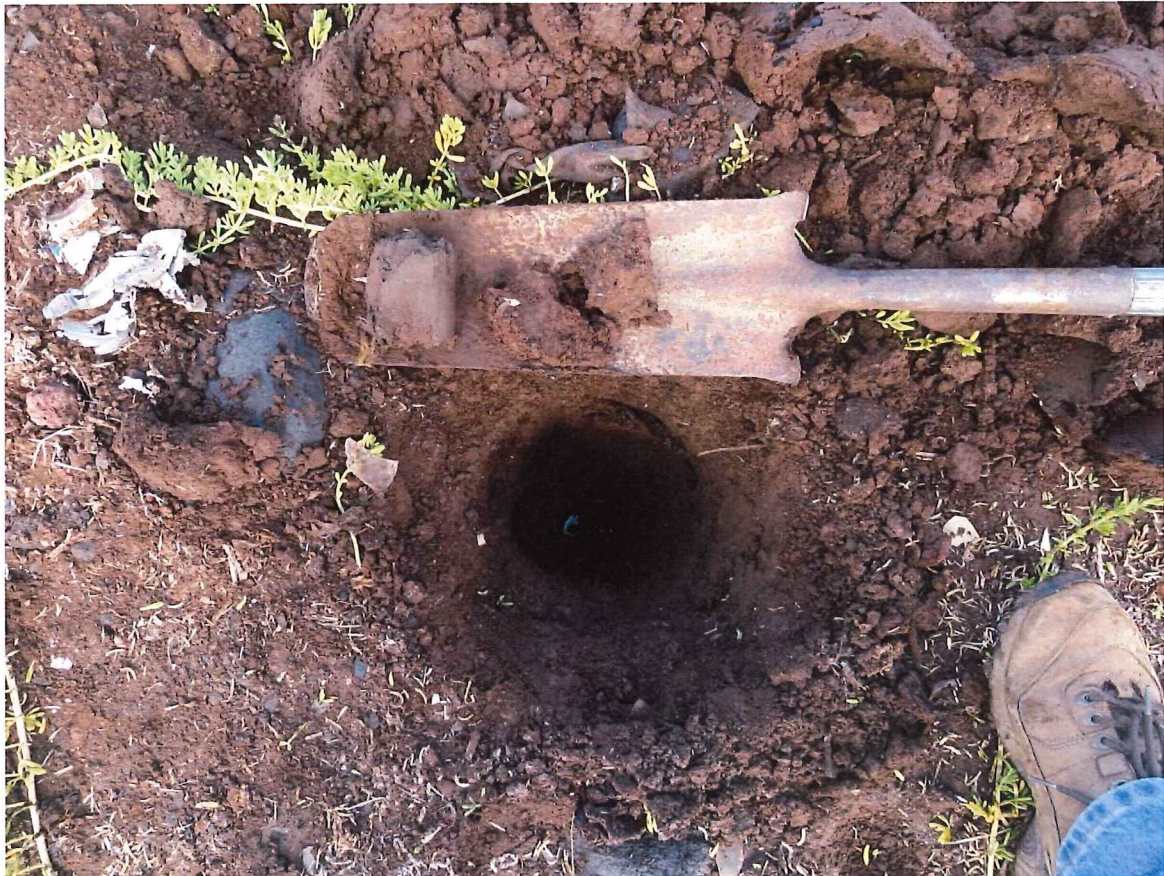
Sampling Point 4B. Dark reddish-brown silt loam over dusky red silty clay loam. Saturation at 19 inches. Water table at 23 inches.

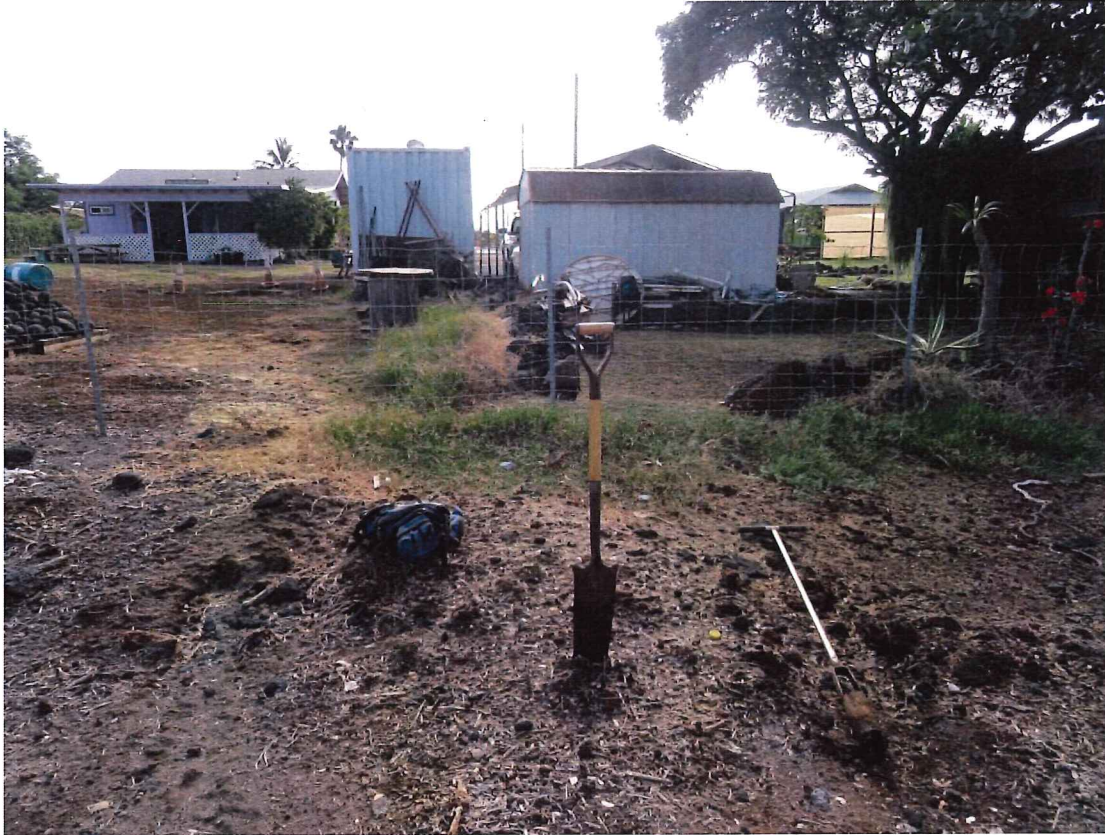
Sampling Point 5A. Located near the bottom of the slope below the DHHL lot boundary.

Remarks:  
**WHILE CLOSE TO THE WETLAND BOUNDARY THE SAMPLING POINT DOES NOT HAVE ANY POSITIVE INDICATORS OF WETLAND HYDROLOGY.**

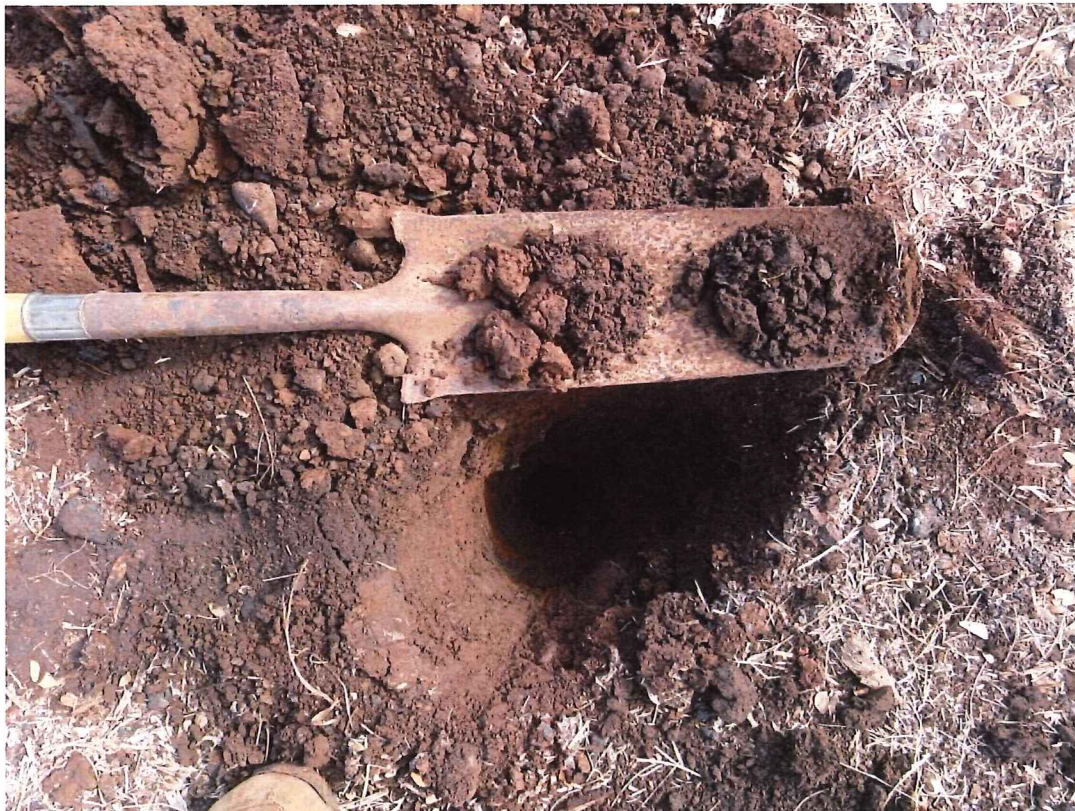
Sampling Point 5B. Dark reddish-brown silt loam over dark reddish-gray clay loam. Saturation at 17 inches. Water table at 20 inches.

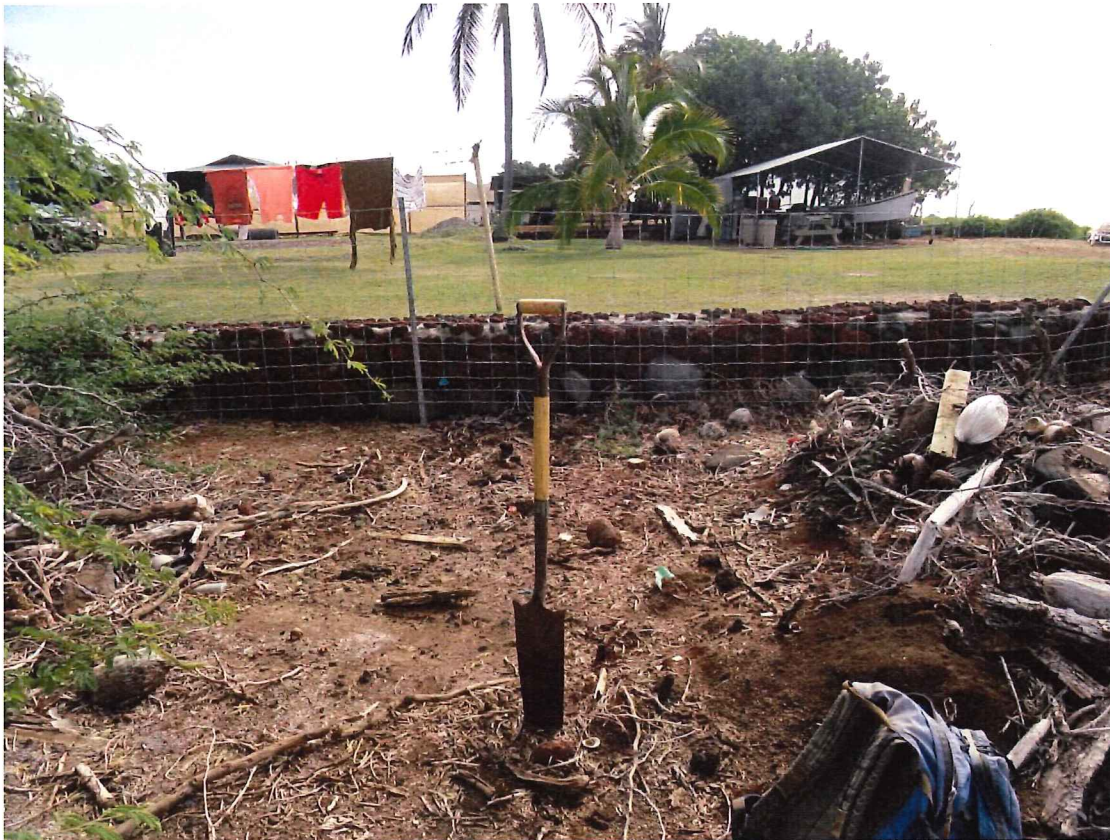
Sampling Point 6A. Located at the bottom of the slope below the DHHL lot boundary within the margin of the wetland.

THIS SAMPLING POINT HAD SHALLOW SATURATION AND WATER TABLE LEVELS AND SURFACE SALT DEPOSITS. IT HAD WETLAND HYDROLOGY.

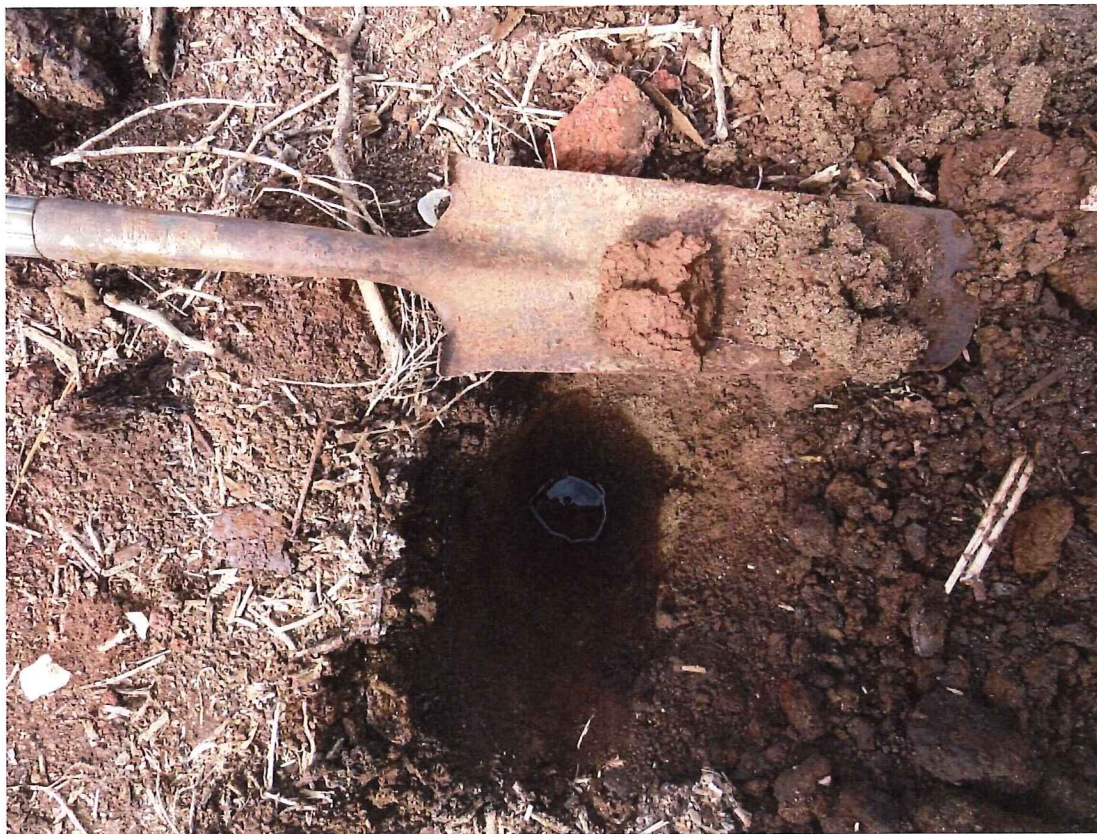
Sampling Point 6B. Reddish-brown silt loam over weak red, saturated silty sand. Saturation at 8 inches. Water table at 12 inches.

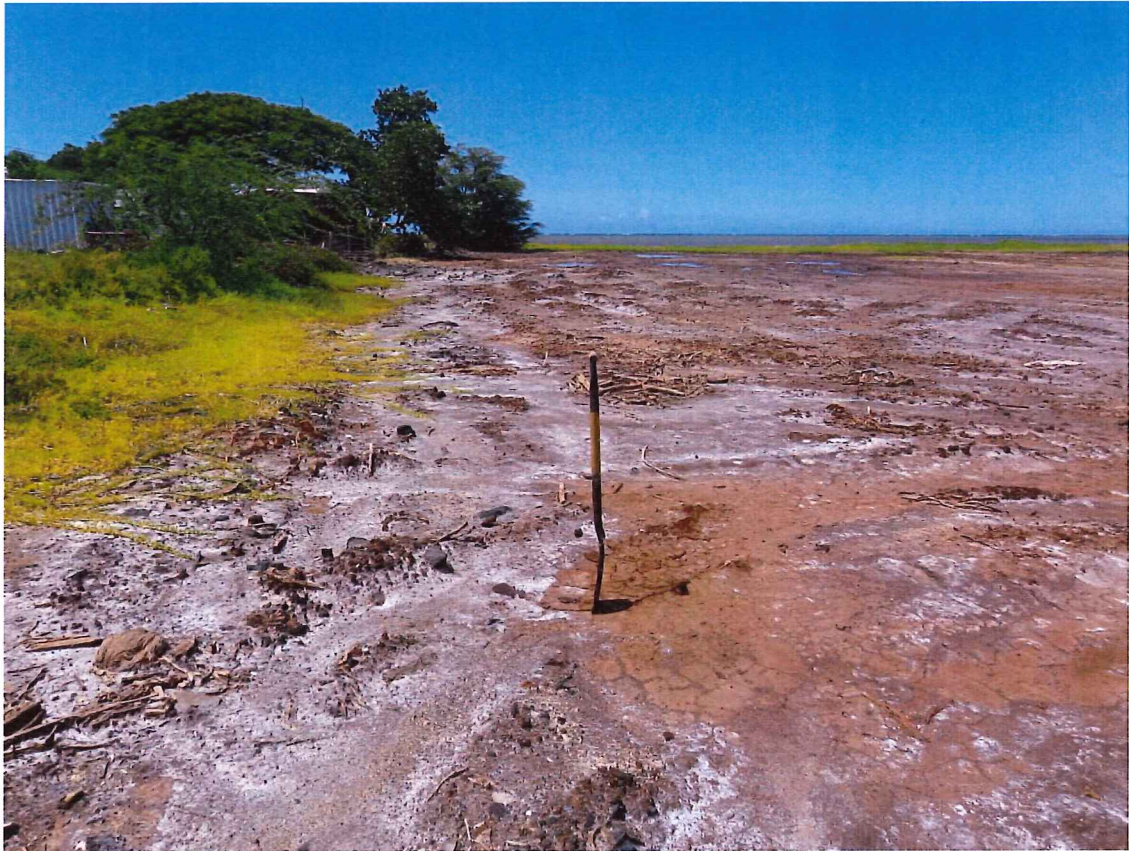
**Remarks:**  
 THIS SAMPLING POINT HAS HIGH SATURATION AND WATER TABLE LEVELS. THUS HIGH SALT CONTENT IN THE SOIL HAS A HYDROPHYTIC EFFECT THAT HOLDS SOME MOISTURE ALL THE WAY TO THE SURFACE.

Sampling Point 7A. This plot lies 24 feet to the west of the DHHL boundary and about 5 feet within the wetland boundary.

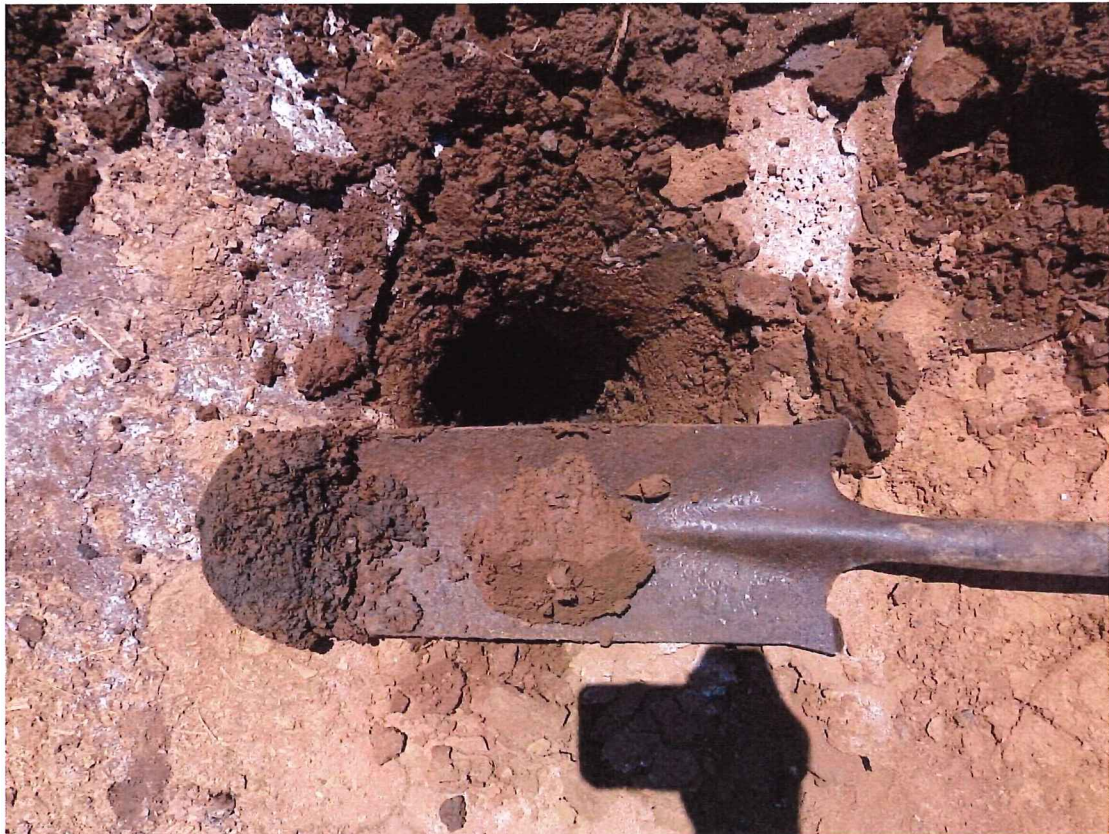
Sampling Point 7B. This soil is saturated to within 12 inches of the surface and has a water table at 22 inches.

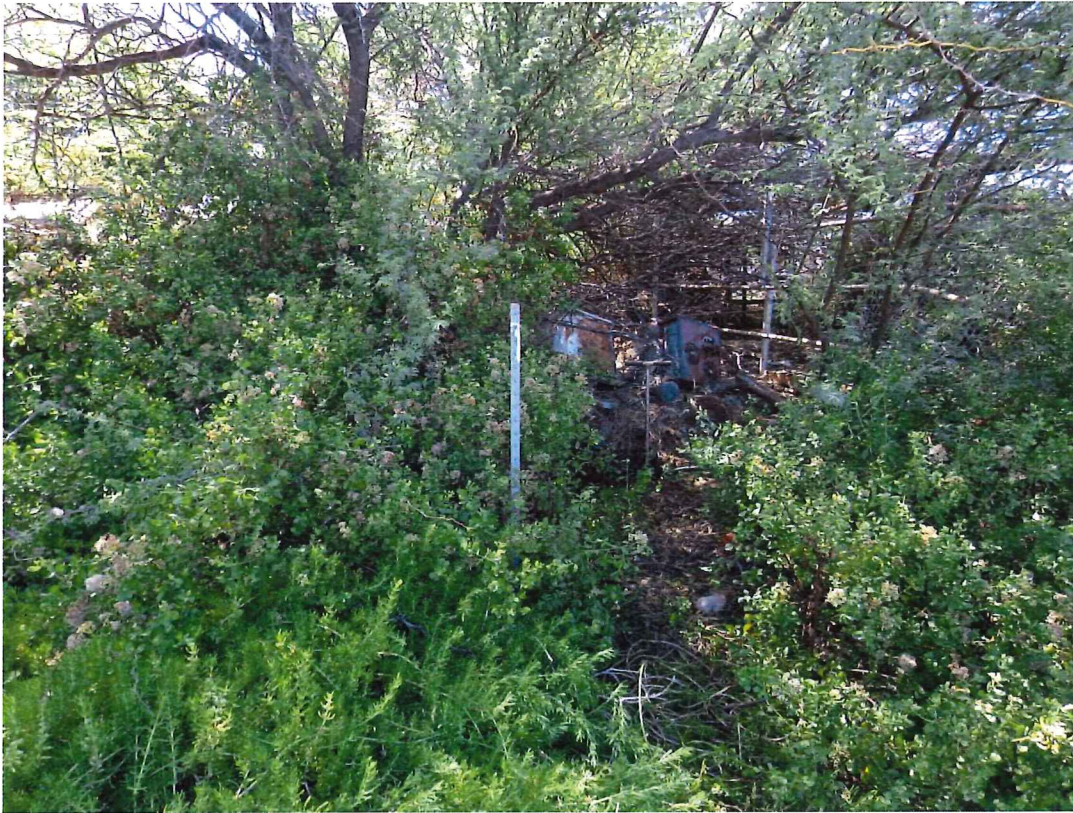
Sampling Point 8A. This plot lies on the elevated DHHL project corridor. Vegetation consists of kiawe (*prosopis pallida*) FACU, Indian fleabane (*Pluchea indica*) FAC and pickleweed (*Batis maritima*) OBL.

NO WETLAND HYDROLOGY INDICATORS OCCUR CLOSE ENOUGH TO THE SURFACE TO EXPRESS THE CHARACTER OF A WETLAND ENVIRONMENT.

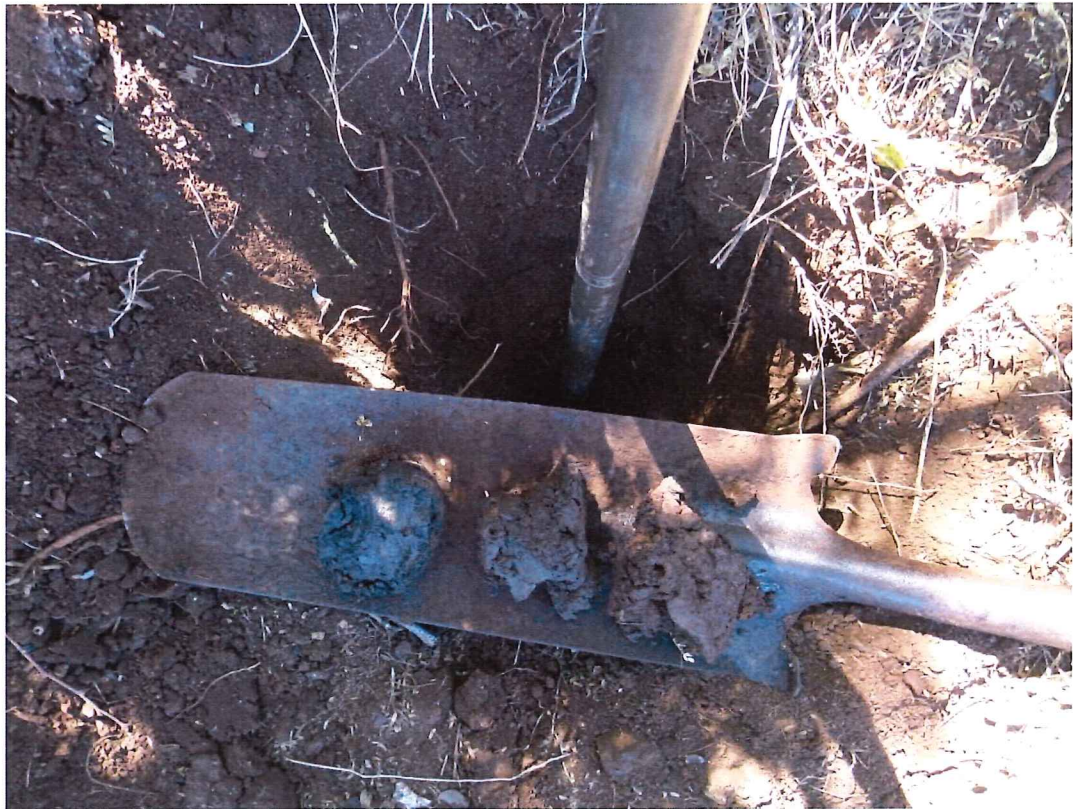
Sampling Point 8B. Saturated soil lies at 29 inches below the surface and the water table is at a depth of 32 inches.

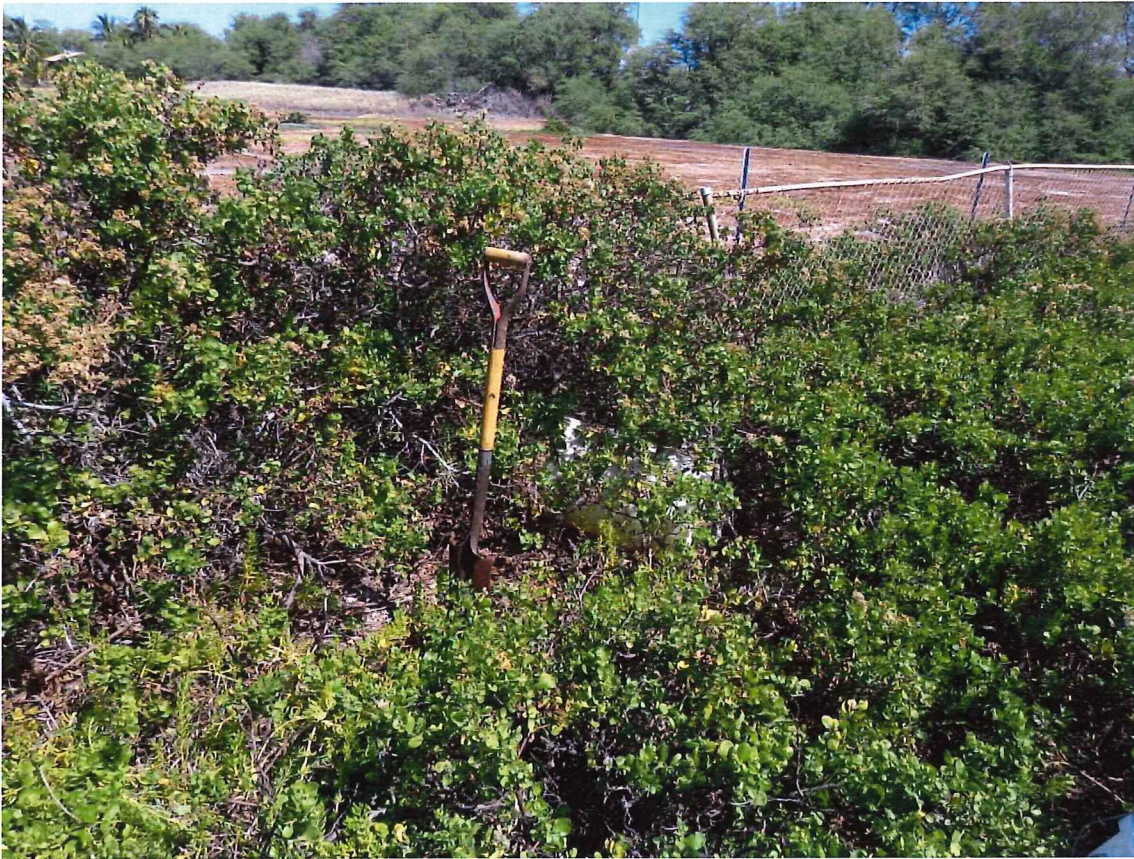
Sampling Point 9A. This plot lies on the DHHL project corridor on an elevated houselot parcel.

**Remarks:**  
 NO WETLAND HYDROLOGY INDICATORS OCCUR CLOSE ENOUGH TO THE SURFACE TO EXPRESS THE CHARACTER OF A WETLAND ENVIRONMENT.

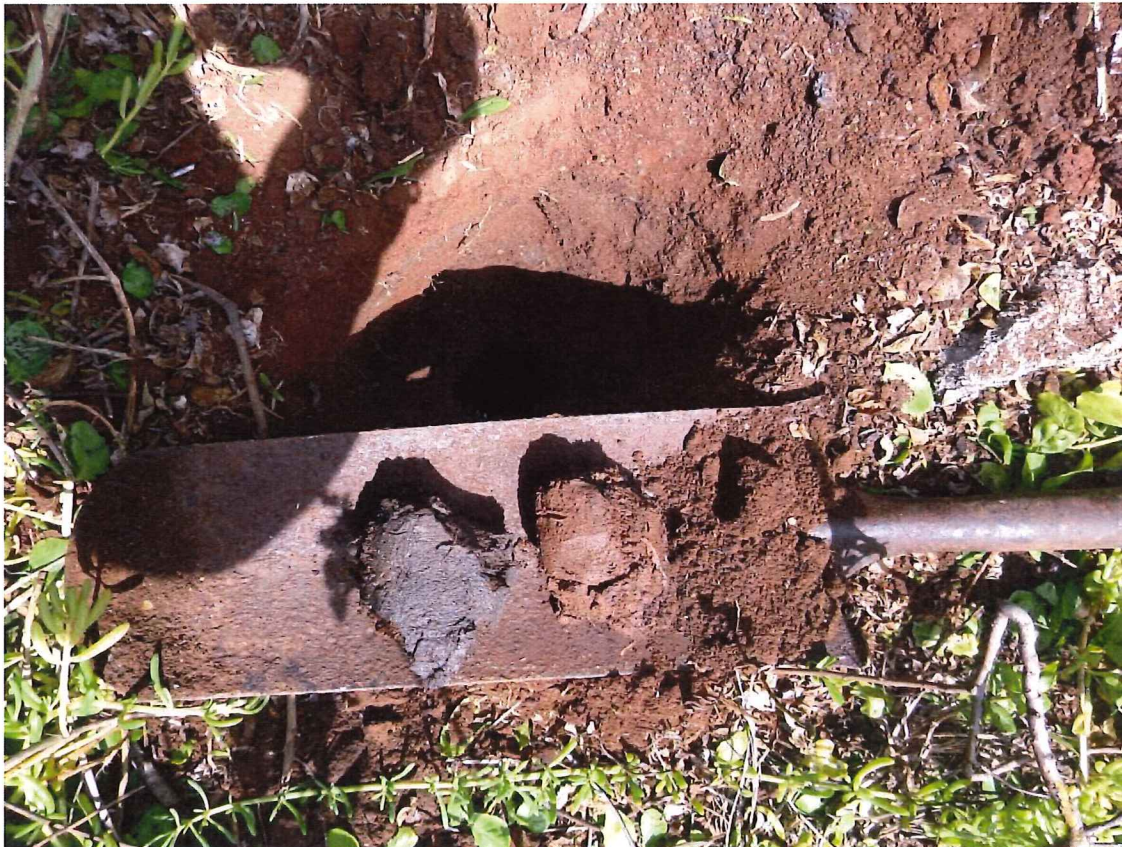
Sampling Point 9B. The soil here is saturated at a depth of 33 inches and the water table is at a depth of 38 inches.

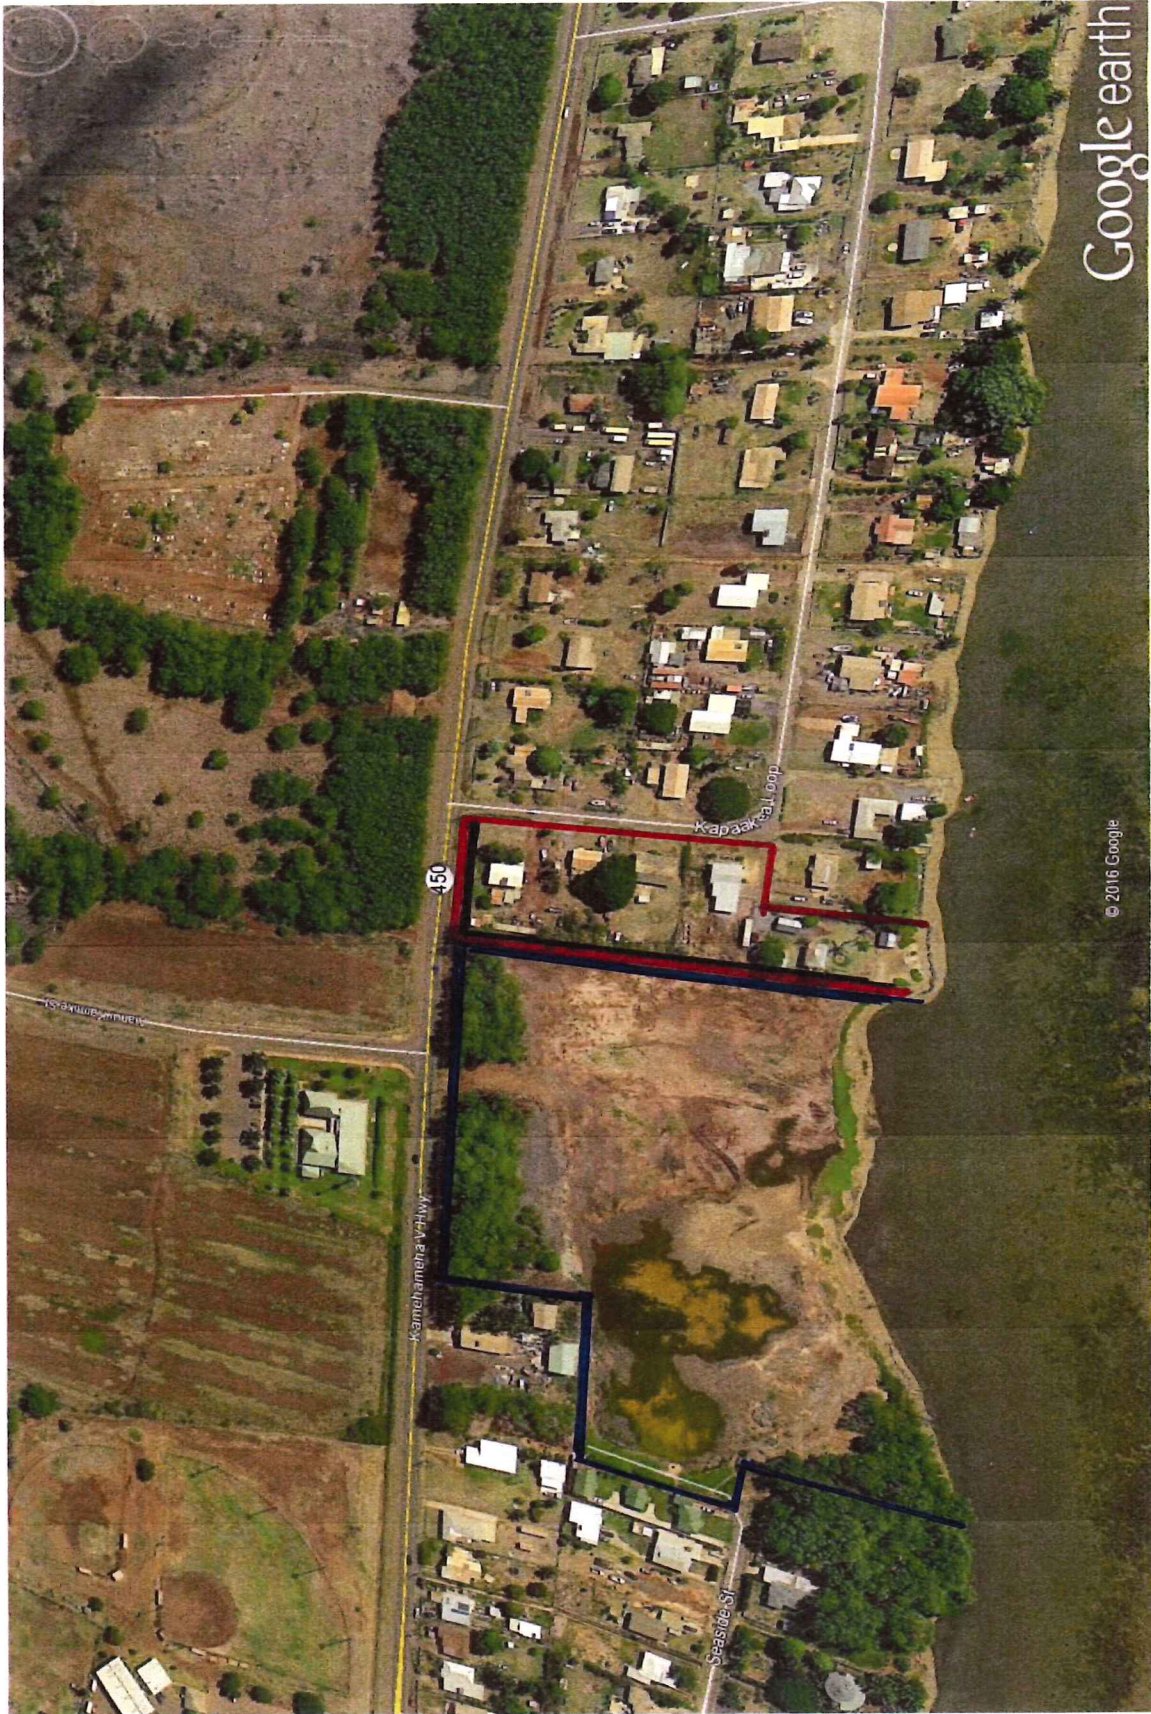
Figure 2.

**DHHL Kapa'akea Flood Mitigation Project boundary**  
**Proposed concrete wall along the west and north project boundaries**  
**Kōheo Wetland – Goodfellow Brothers, Inc.**

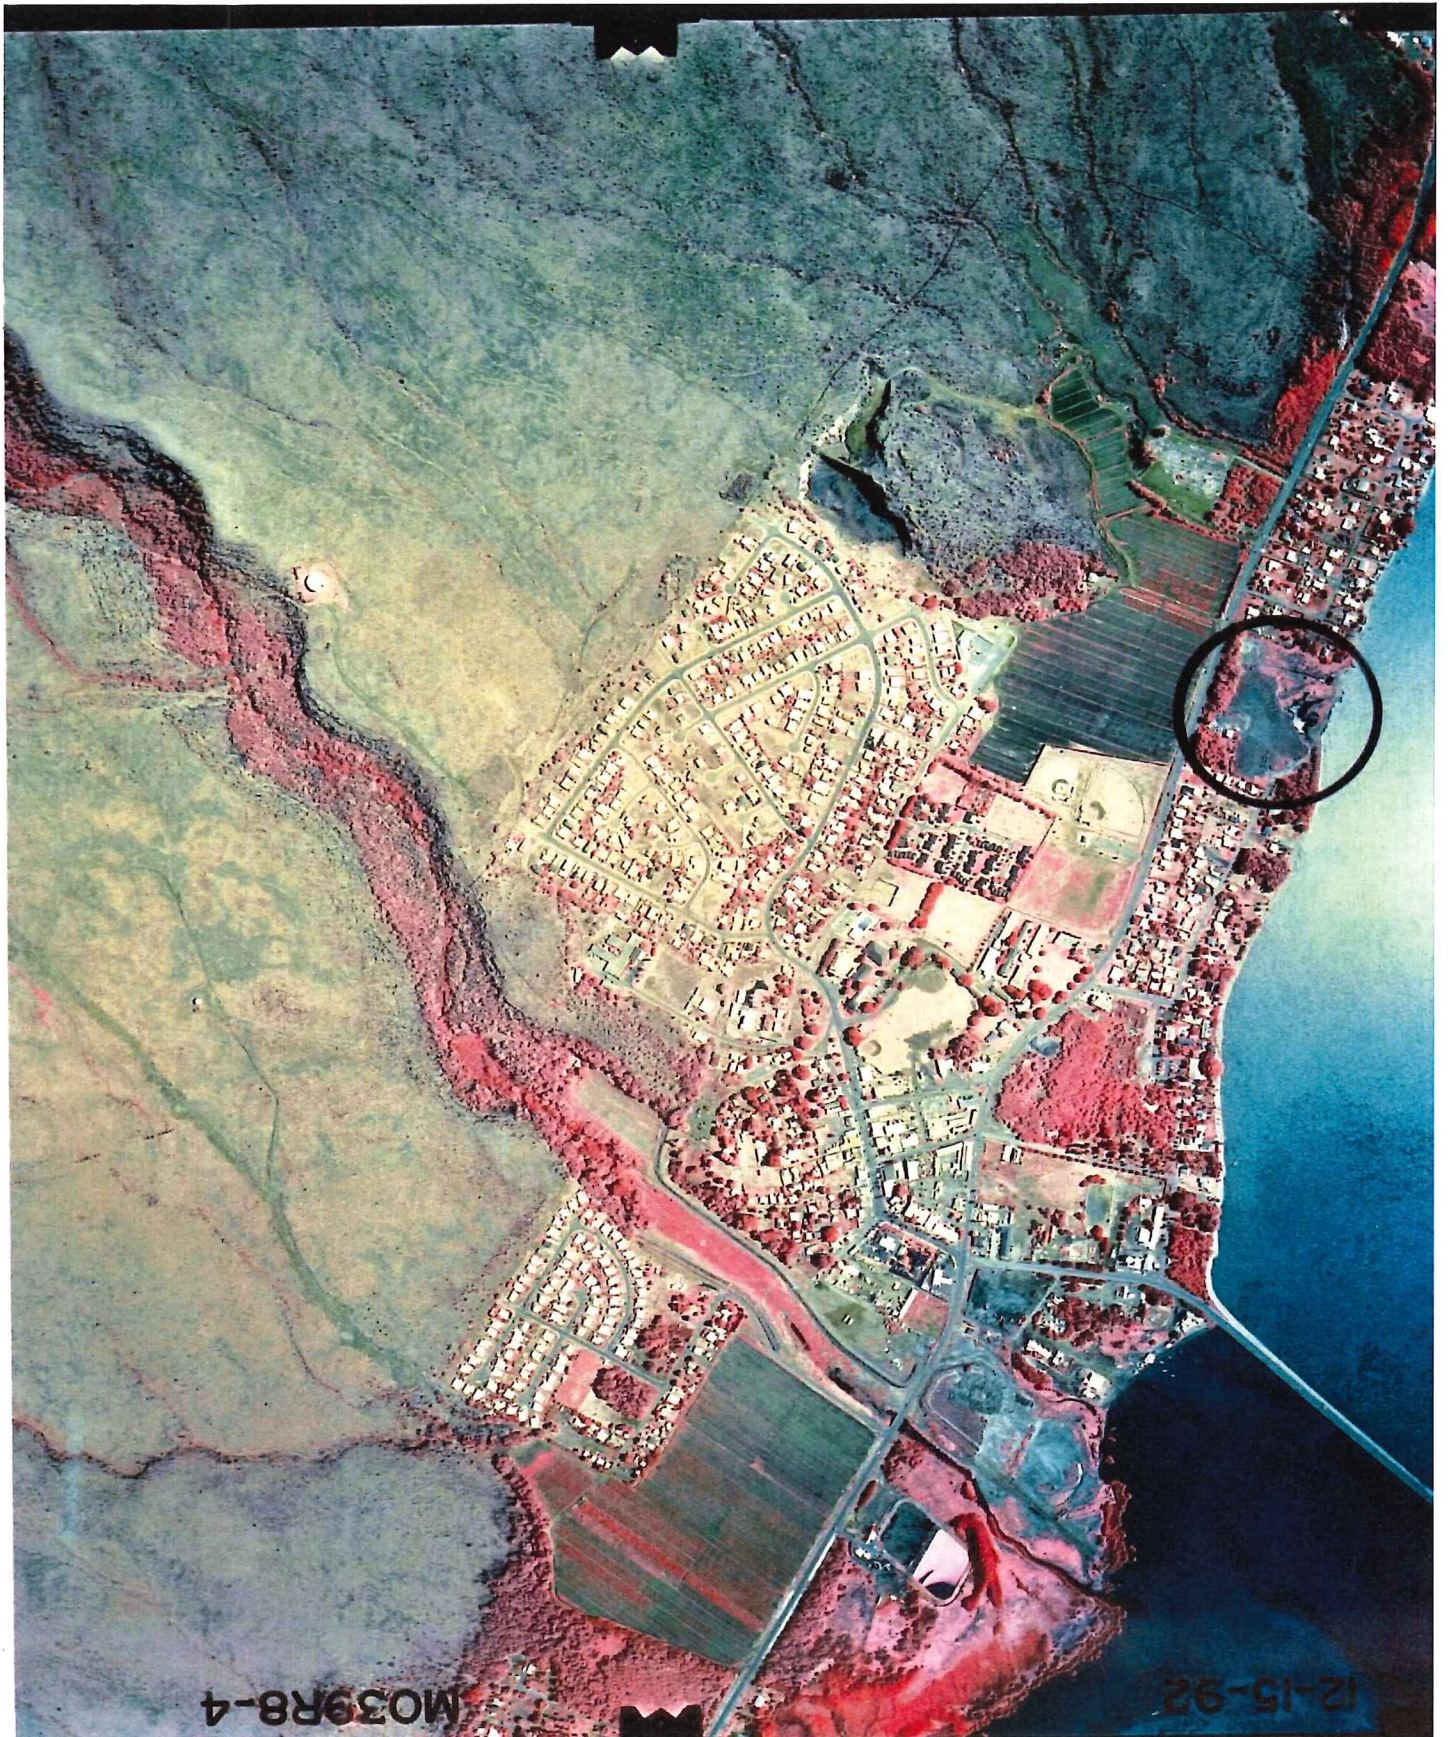
Figure 8. 1992 Infrared aerial photograph showing Kōheo pond with fill material in place.

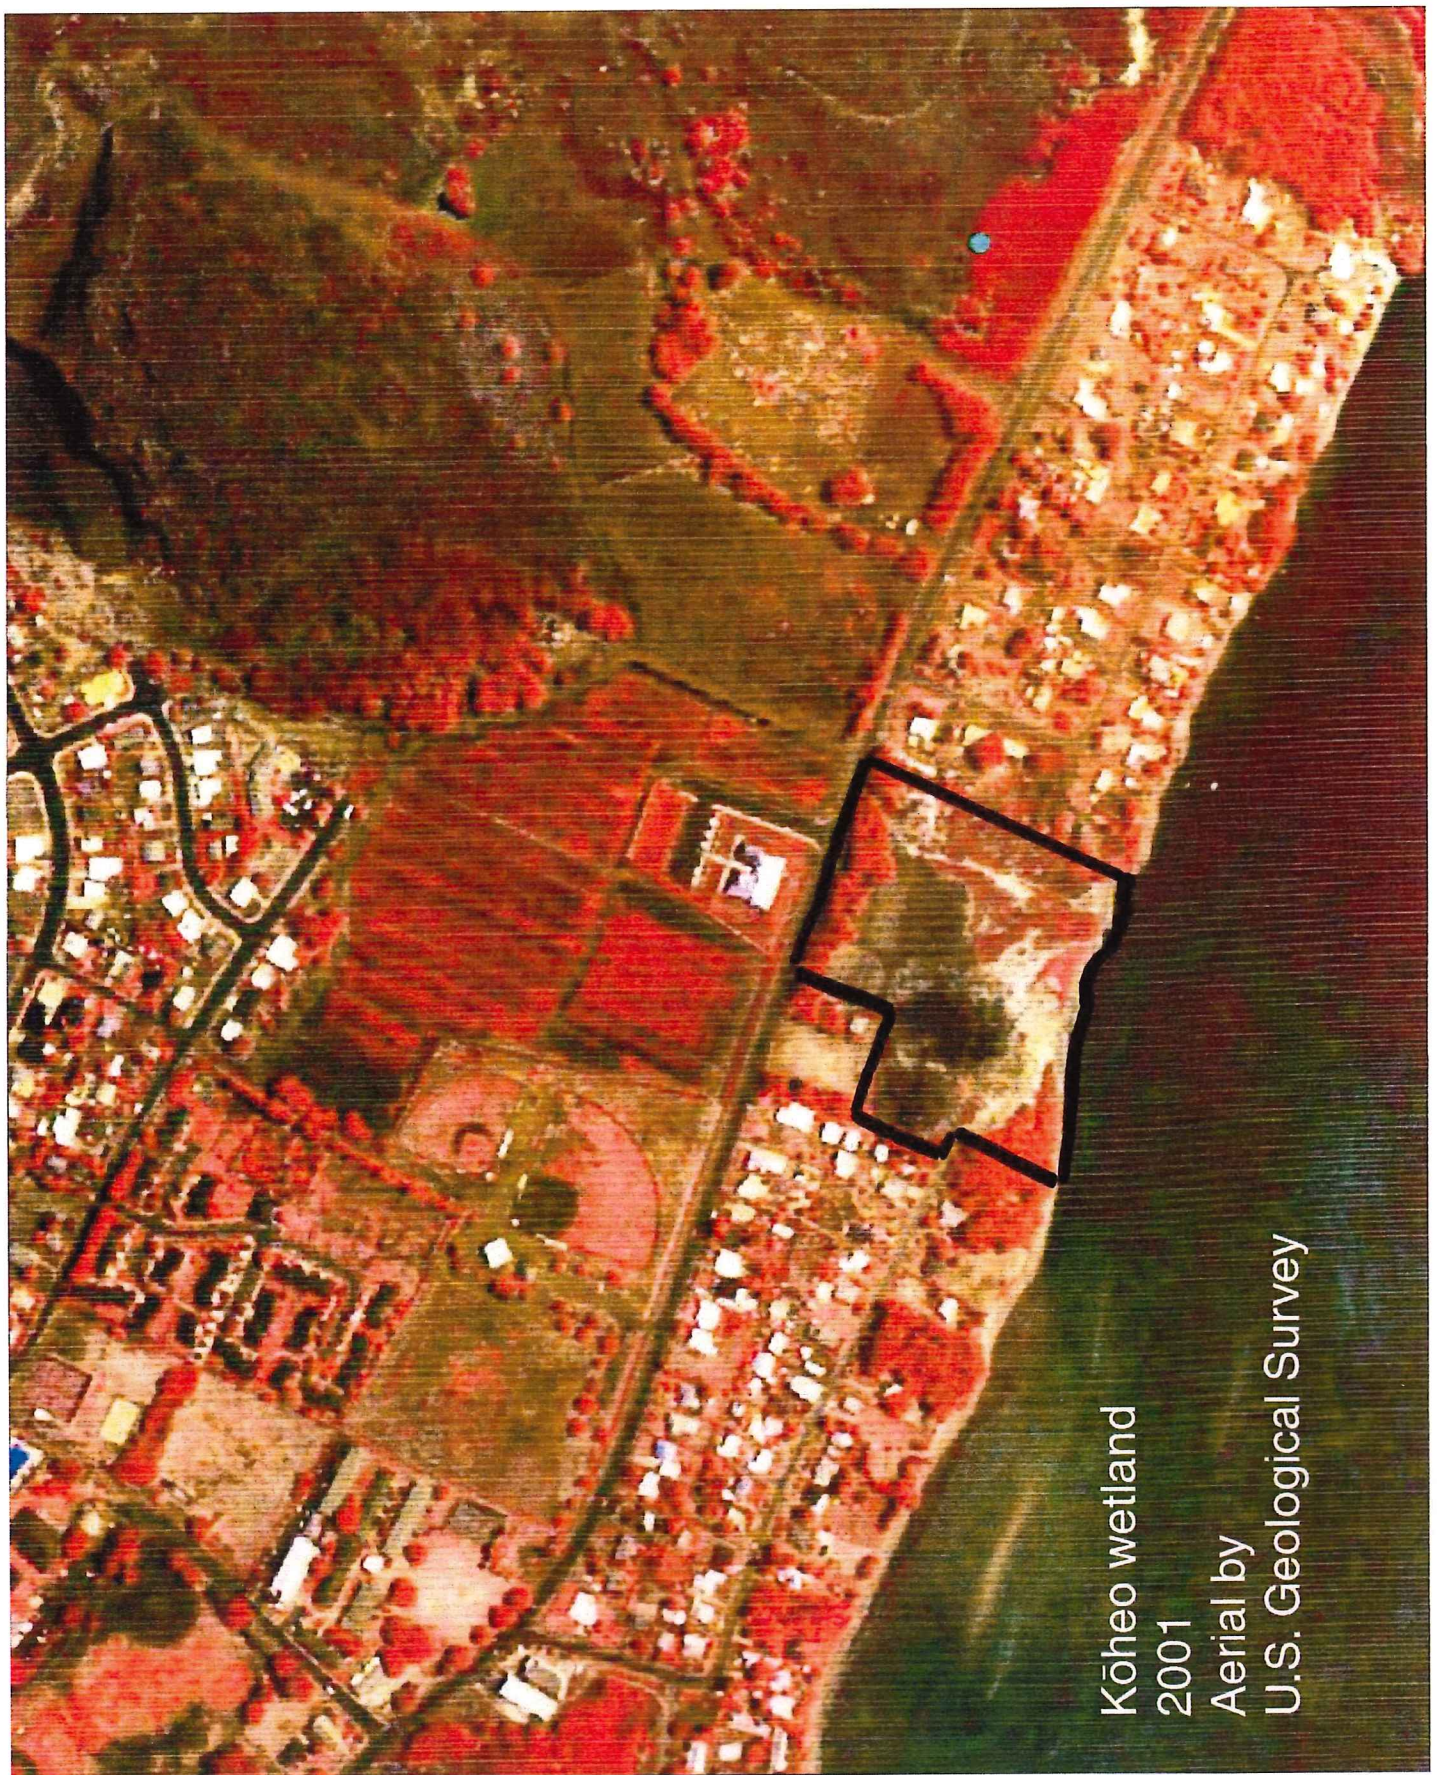
Figure 9. 2001 U.S.G.S. aerial photograph with fill material removed.

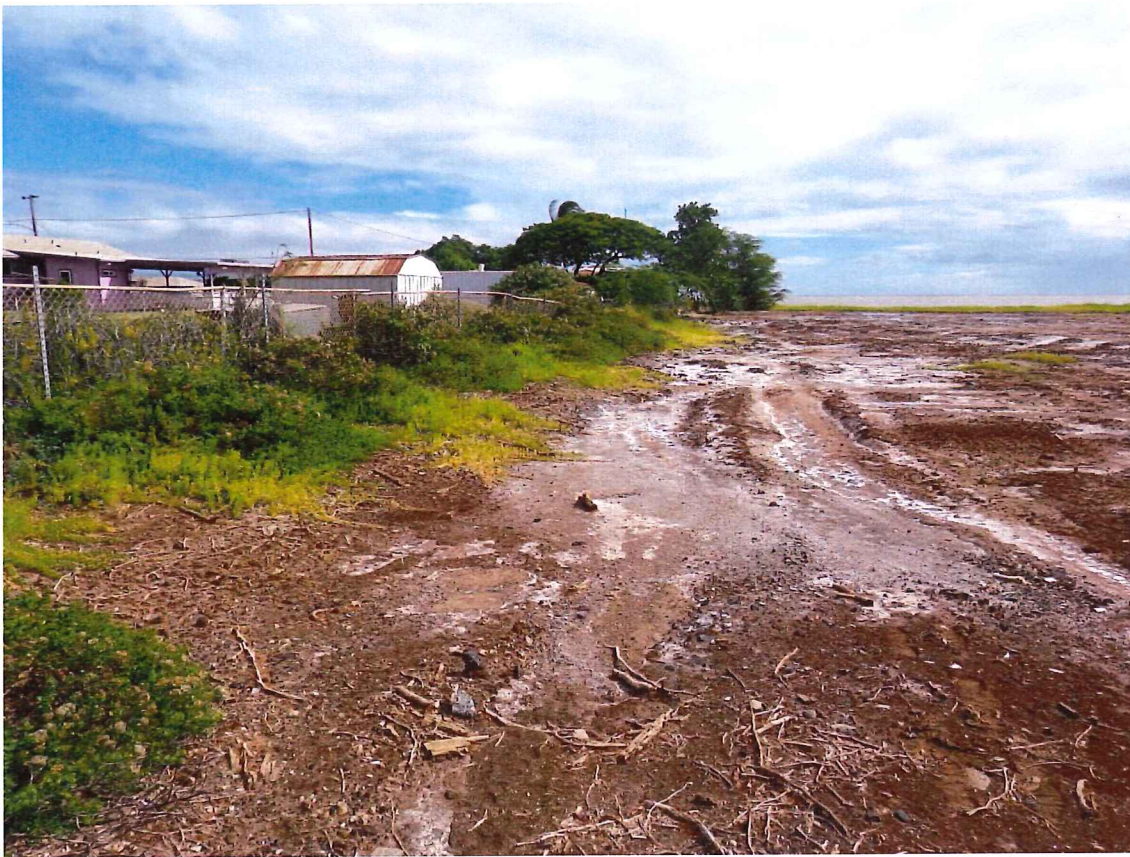
Figure 13. Kōheo wetland margin on right. Elevated DHHL boundary (fenceline) at left.

Figure 13. Kōheo wetland margin on right. Elevated DHHL boundary (fenceline) at left.
