Subject: Proposed Department of Hawaiian Home Lands Kapa'akea Flood Mitigation Improvements

With this letter, the State of Hawai'i, Department of Hawaiian Home Lands (DHHL) hereby transmits the Final Environmental Assessment and Finding of No Significant Impact (FEA-FONSI) for the Proposed Kapa'akea Flood Mitigation Improvements Project, situated on five (5) DHHL Homestead lots identified by TMKs (2)5-4-007:009(por.), (2)5-4-007:010(por.), (2)5-4-007:011(por.), (2)5-4-007:024(por.), and (2)5-4-007:025(por.), within the Kapa'akea Ahupua'a near Kaunakakai on the island of Molokai for publication in the next available edition of the Environmental Notice.

Project Name:	Proposed Department of Hawaiian Home Lands Kapa'akea Flood Mitigation Improvements
Project Short Name:	Kapa'akea Flood Mitigation Improvements
HRS §343-5 Trigger(s):	Use of State Lands and State Funds
Island(s):	Moloka'i
Judicial District(s):	Moloka'i
TMK(s):	(2)5-4-007:009 (por.), (2)5-4-007:010 (por.), (2)5-4-007:011 (por.), (2)5-4-007:024 (por.), (2)5-4-007:025 (por.)
Permit(s)/Approval(s):	National Pollutant Discharge Elimination System (NPDES) Permit, as applicable; Community Noise Permit, as applicable; Building

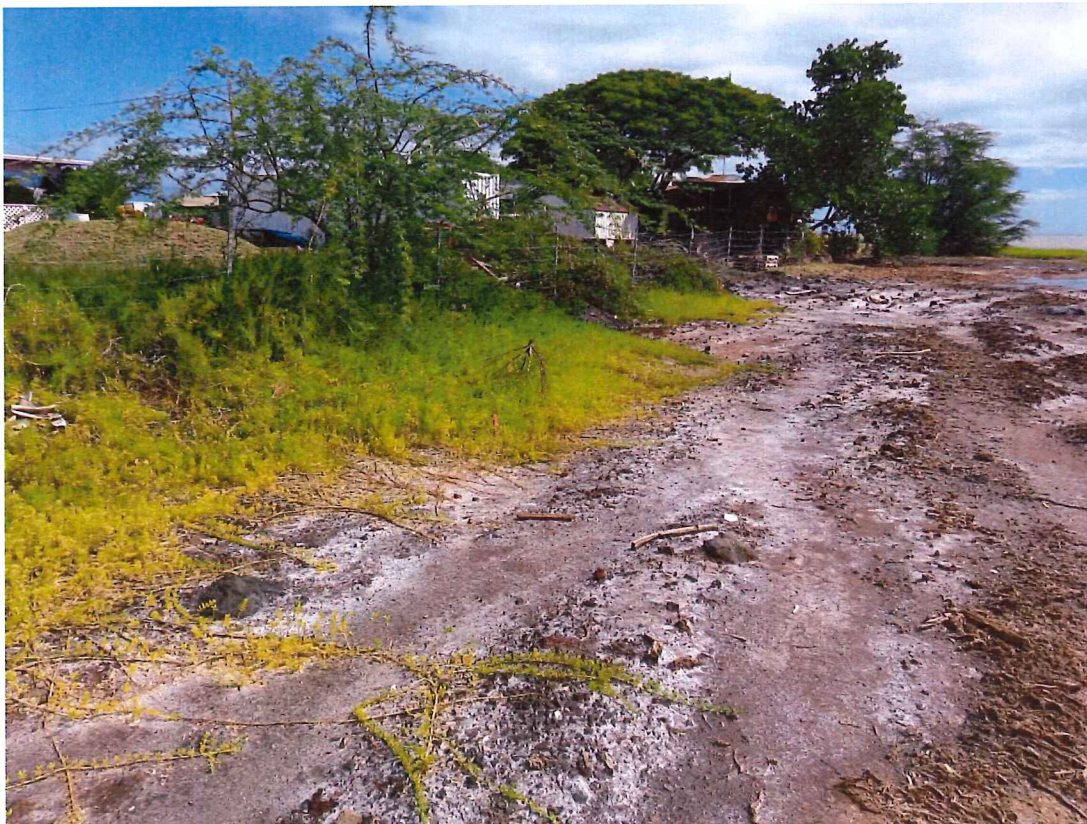
Figure 14. Kōheo wetland margin on right with an abundance of crystalized surface salt. Grounds slope up to the DHHL house lots on the left. Slope retains a remnant cover of *Batis maritima*.

Figure 14. Kōheo wetland margin on right with an abundance of crystalized surface salt. Grounds slope up to the DHHL house lots on the left. Slope retains a remnant cover of *Batis maritima*.

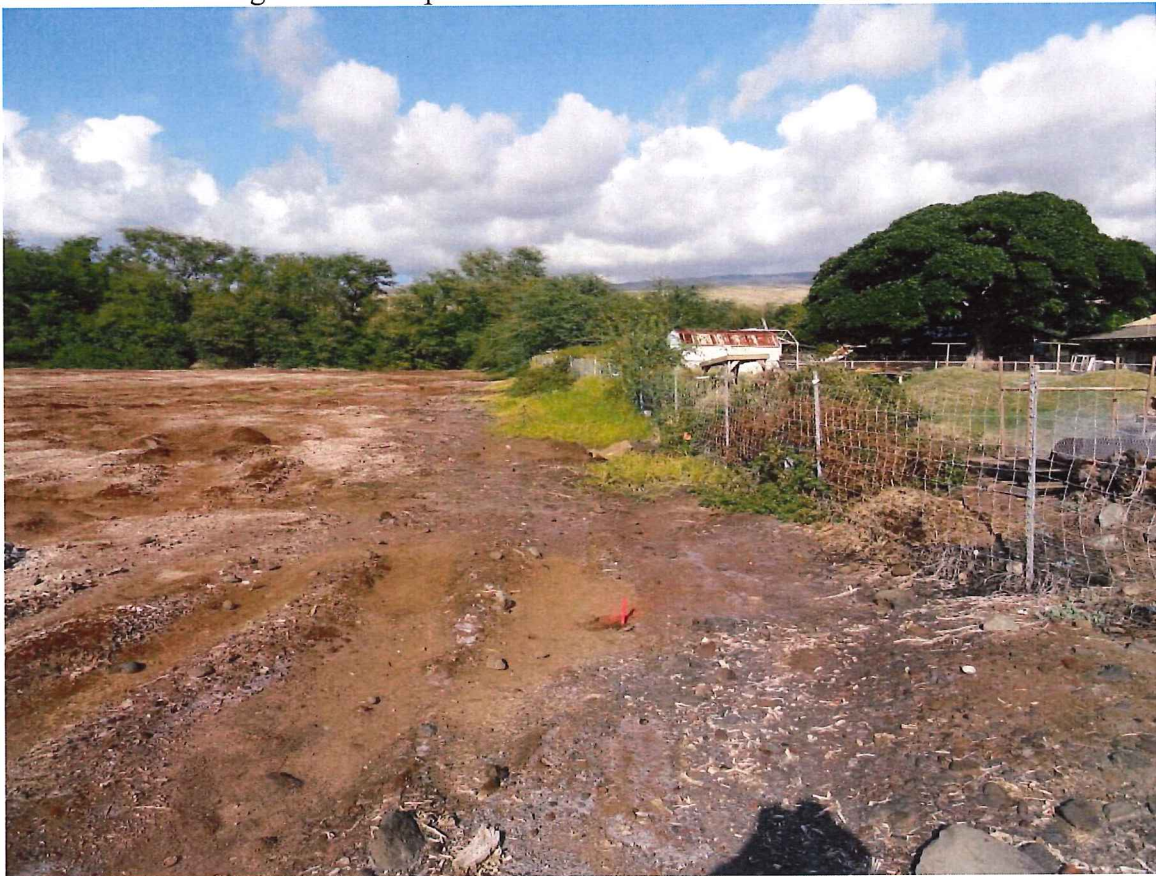
Figure 16. View north along the project boundary. The proposed wetland boundary is indicated by red stakes which are located near the toe of the slope below the elevated DHHL houselots.

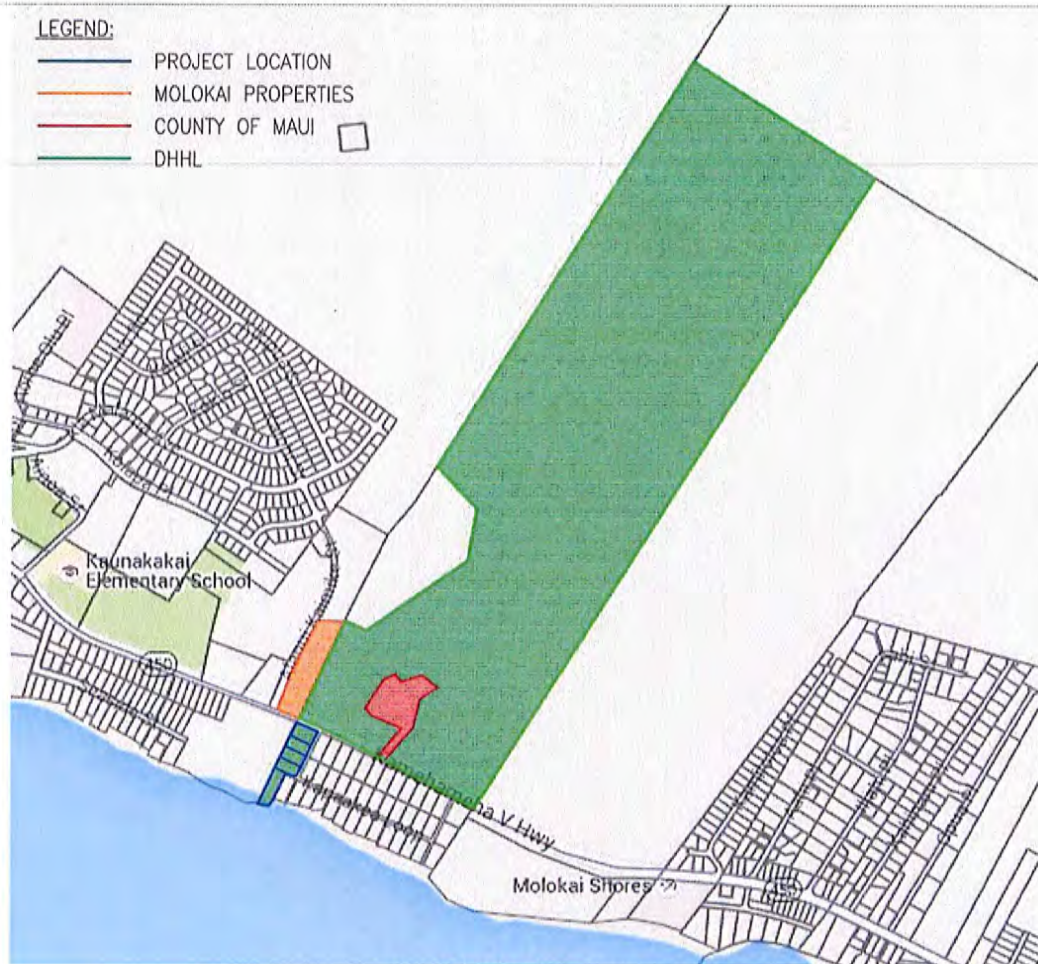
Figure 3 – Mauka Property Owners

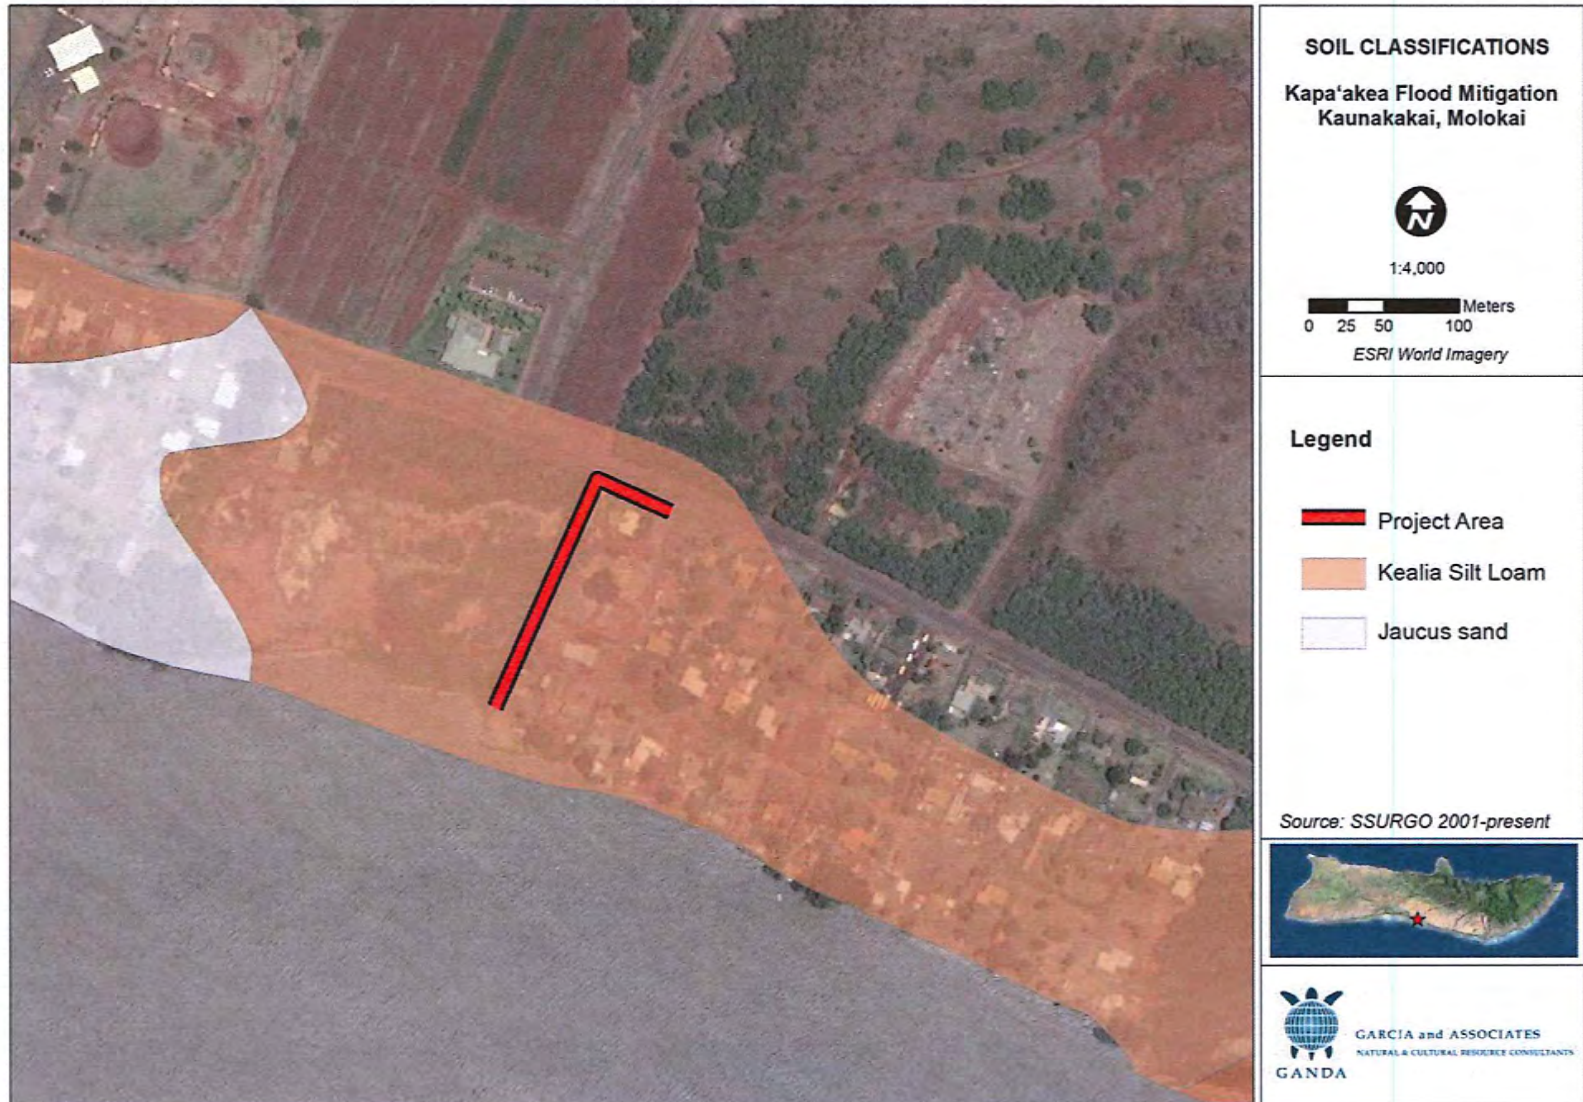
Figure 4. Project area soils.

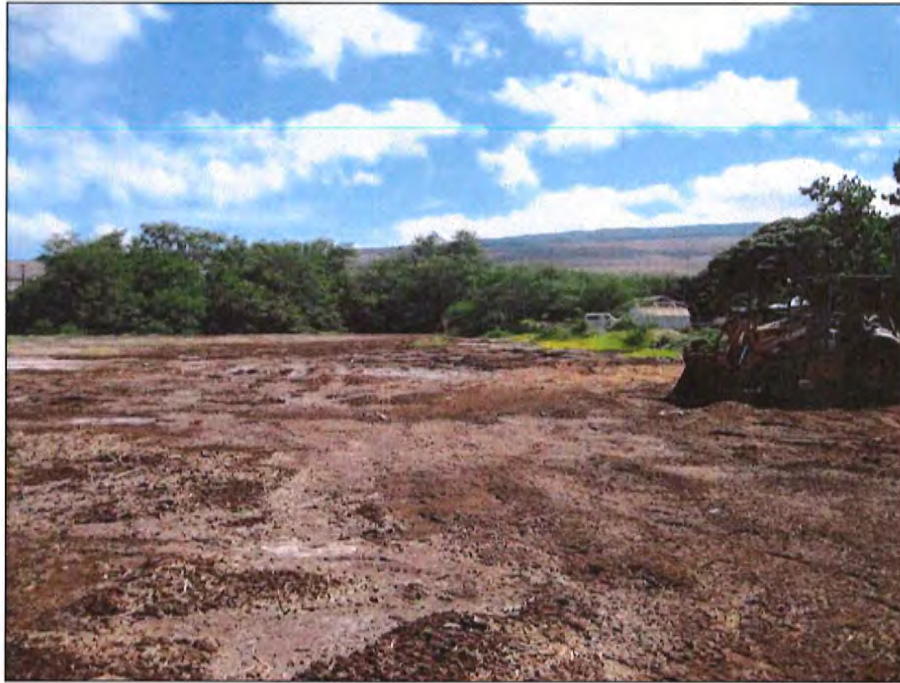
**Figure 11. Coastal mud flat west of project area, facing northwest.**

Section 1 is relatively flat and consists of exposed soft muddy soils with little vegetation (Figure 11). Much of this portion of the project area is subject to regular tidal flooding and salt left from evaporated seawater was present on the ground surface. The project area also runs along a modern wire fence that marks the western boundary of five house lots of the subdivision and the boundary between the *ahupua‘a* of Kaunakakai and Kapa‘akea. Some of the owners of these houses have built modern rock walls and berms on the eastern side of this fence to keep their yards from flooding (Figure 12). No features were found in this portion of the project area and a lot of modern refuse including cans, bottles, and other small bits of rubbish was common on the ground surface.

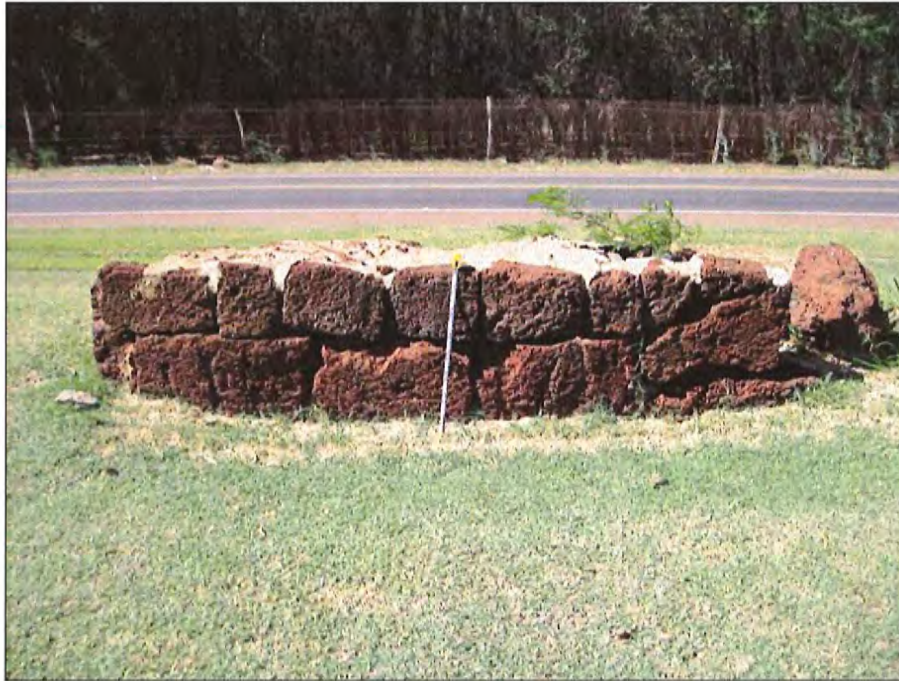
**Figure 13. Rock and concrete wall, facing north.**

Section 2 runs along the southern edge of Kamehameha V Highway (Route 450) and is on relatively flat ground covered by cut grass. There is a degraded wall built from roughly quarried red lava rock blocks held together with concrete mortar (Figure 10 and Figure 13). A small valve box is present along the north side of the wall indicating the presence of a buried utility line (Figure 14). Portions of this wall have been knocked down and the stones were moved and restacked forming a wall along the eastern boundary of the house lot along the west side of Kapa‘akea Loop Road (Figure 15). According to local informants and residents of the subdivision, this wall is modern and was built within the last 20 years.

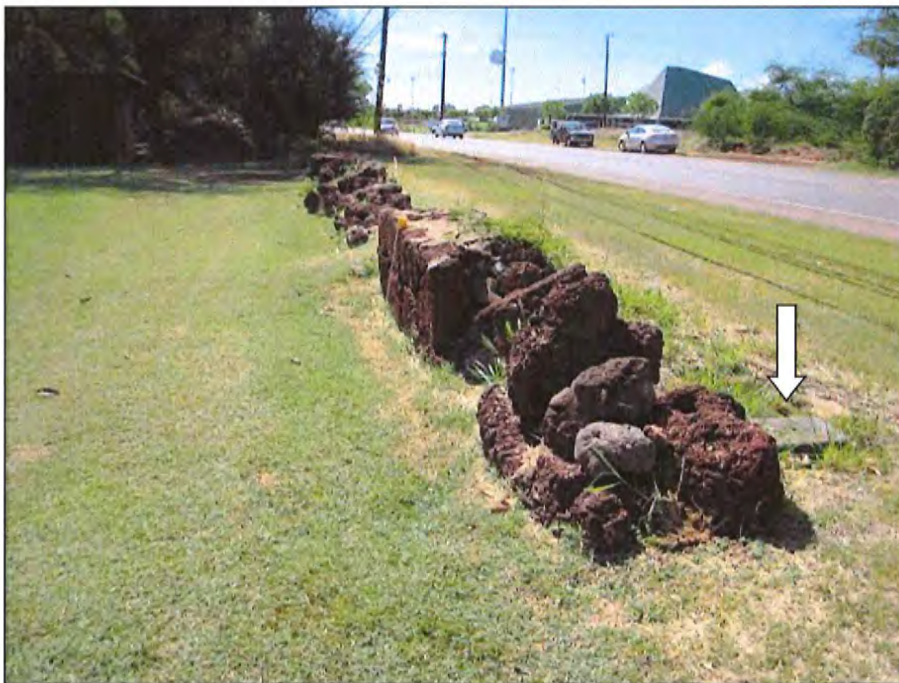
**Figure 14. Degraded section of wall in project area, facing west. Arrow indicates location of valve box.**

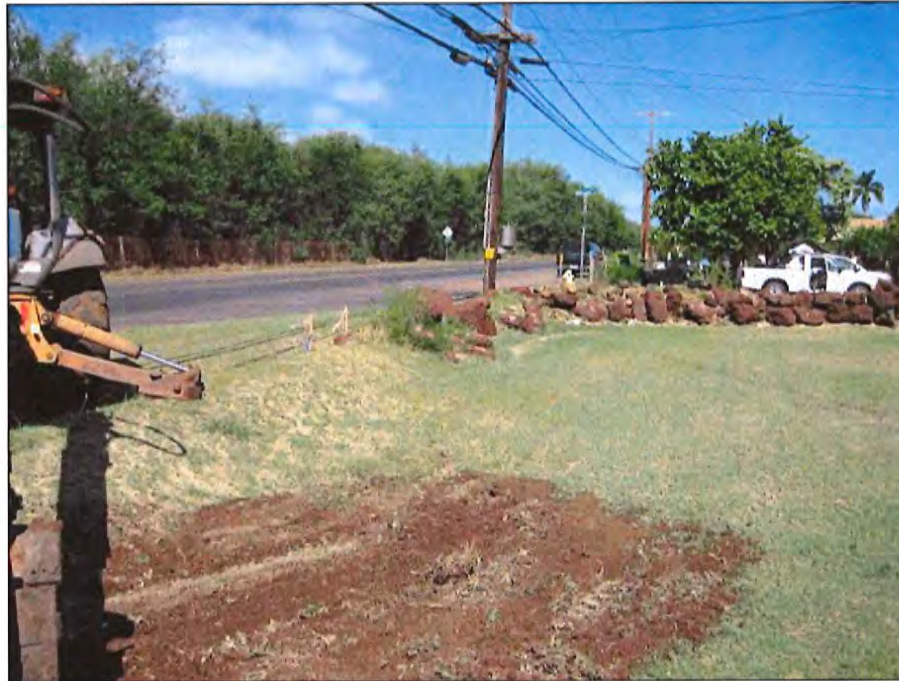
Figure 15. Section of restacked wall along Kapa'akea Loop Road, facing east.

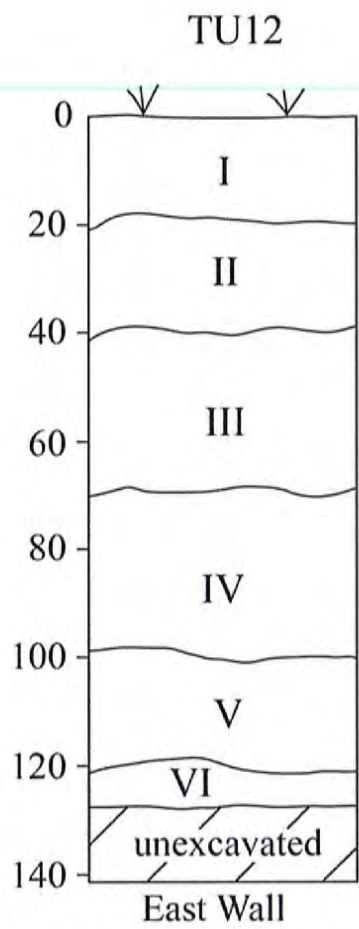
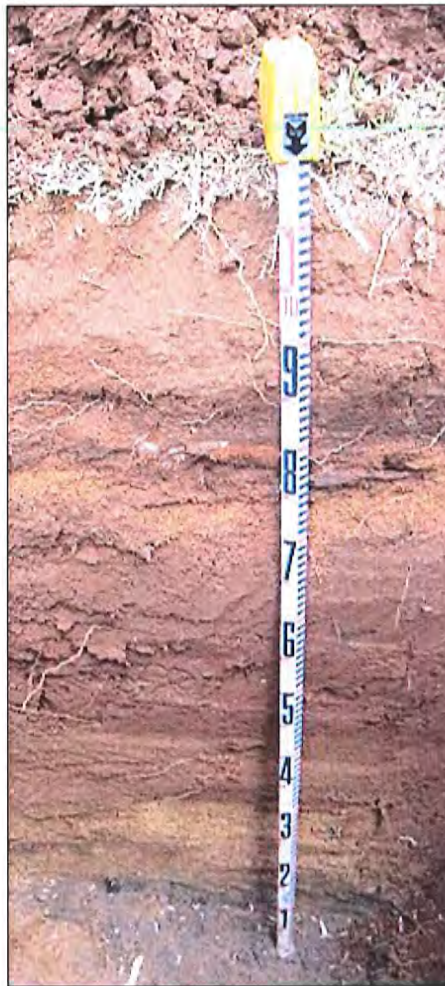
IV	120-125 (base of test unit)	Dark olive gray (5Y 3/2) to black (5Y 2.5/2) calcareous sand with natural shell, wet consistence, and nonsticky.	Undisturbed beach sand

Figure 20. Profile and photograph of east wall of TU-12.

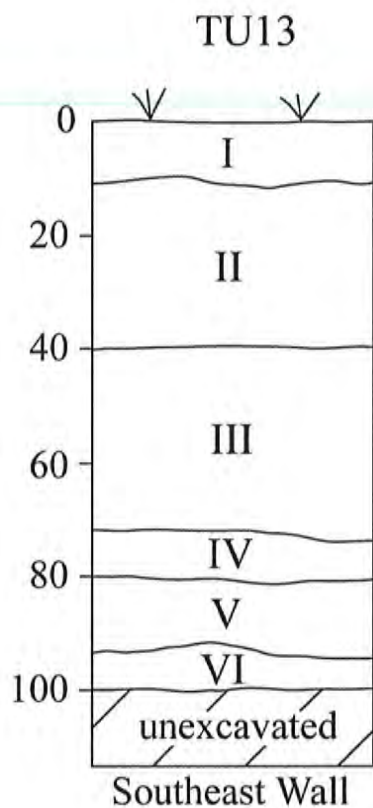
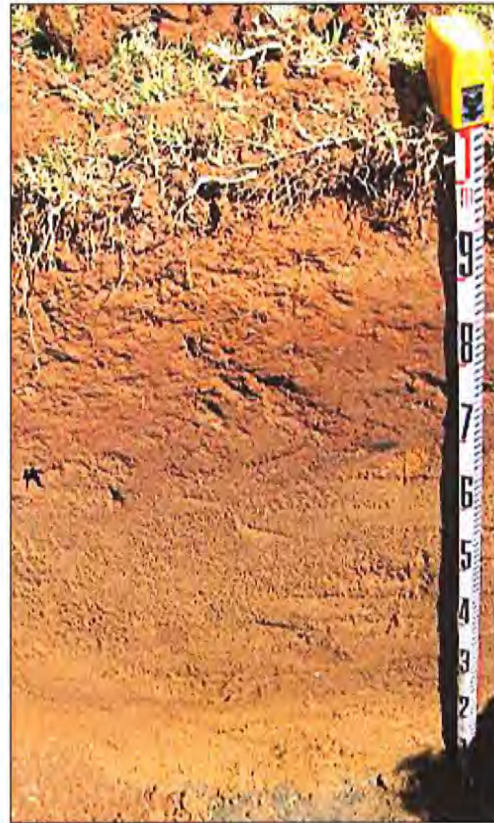
Figure 21. Profile and photograph of southeast wall of TU-13.

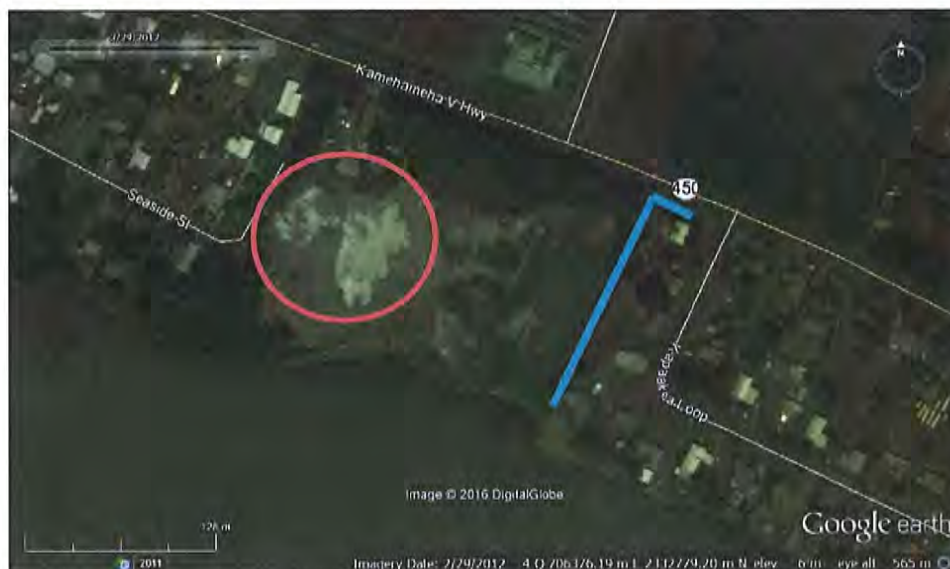
Figure 10. Aerial image from 2012 showing salt deposits (red circle) near the project area (blue L-shaped line).

Given the former presence of a salt marsh adjacent to and possibly within the fill area that is now Kapa‘akea Homesteads, consultants were asked specifically about salt collecting in the vicinity as a current cultural practice. The answer was negative. Although salt deposits are clearly visible on the parcel adjacent to the proposed flood control wall (Figure 11), these have been recently created as part of a “wetlands” bird preserve by a private landowner and are not exploited by the Hawaiian community. Traditional salt gathering likely ended when the land was filled, if not earlier. Consultants did note that the former Kapa‘akea salt flats were likely harvested and controlled by the *ali‘i* who also maintained Kapa‘akea Fishpond.

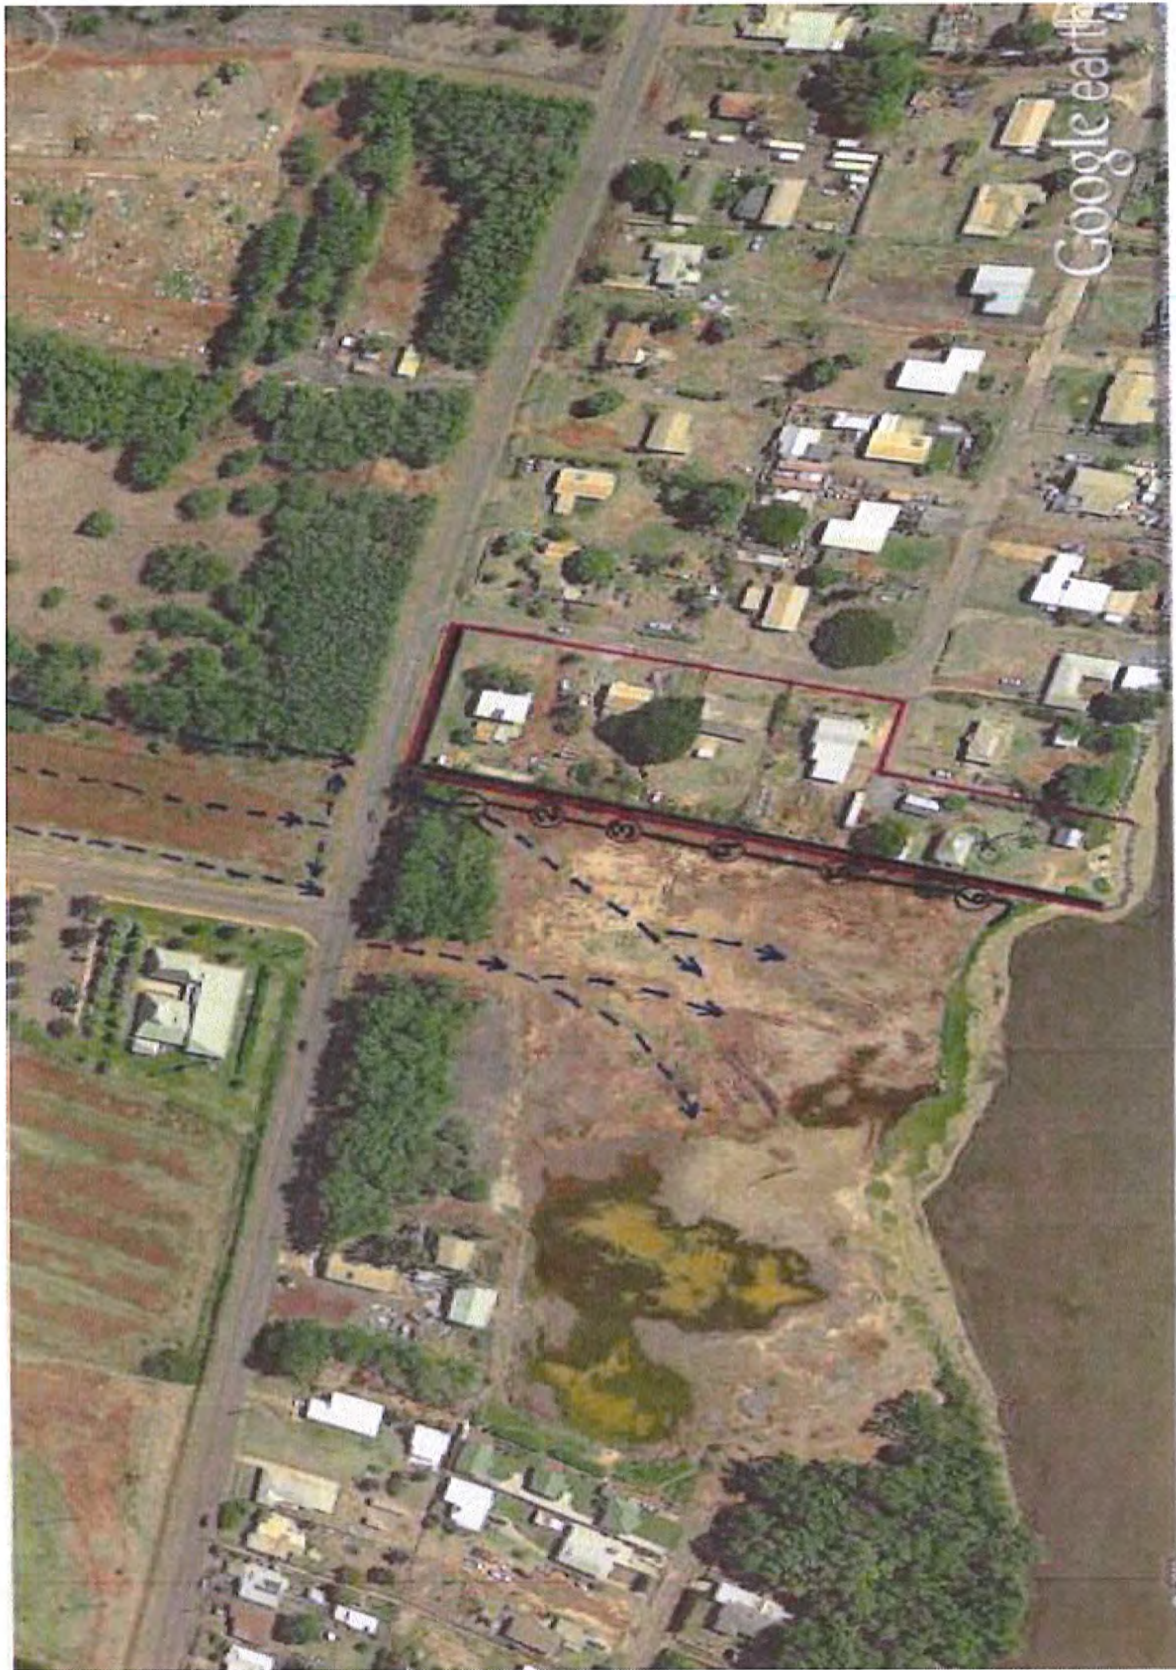
Figure 2.

- DHHL Kapa'akea Flood Mitigation Project boundary
- Proposed concrete wall along west and north boundaries of project area.
- - - - - > Runoff flow pattern of unnamed drainage along west boundary of project area.
- ③ — ④ — ⑤ Numbered sampling points and proposed wetland boundary

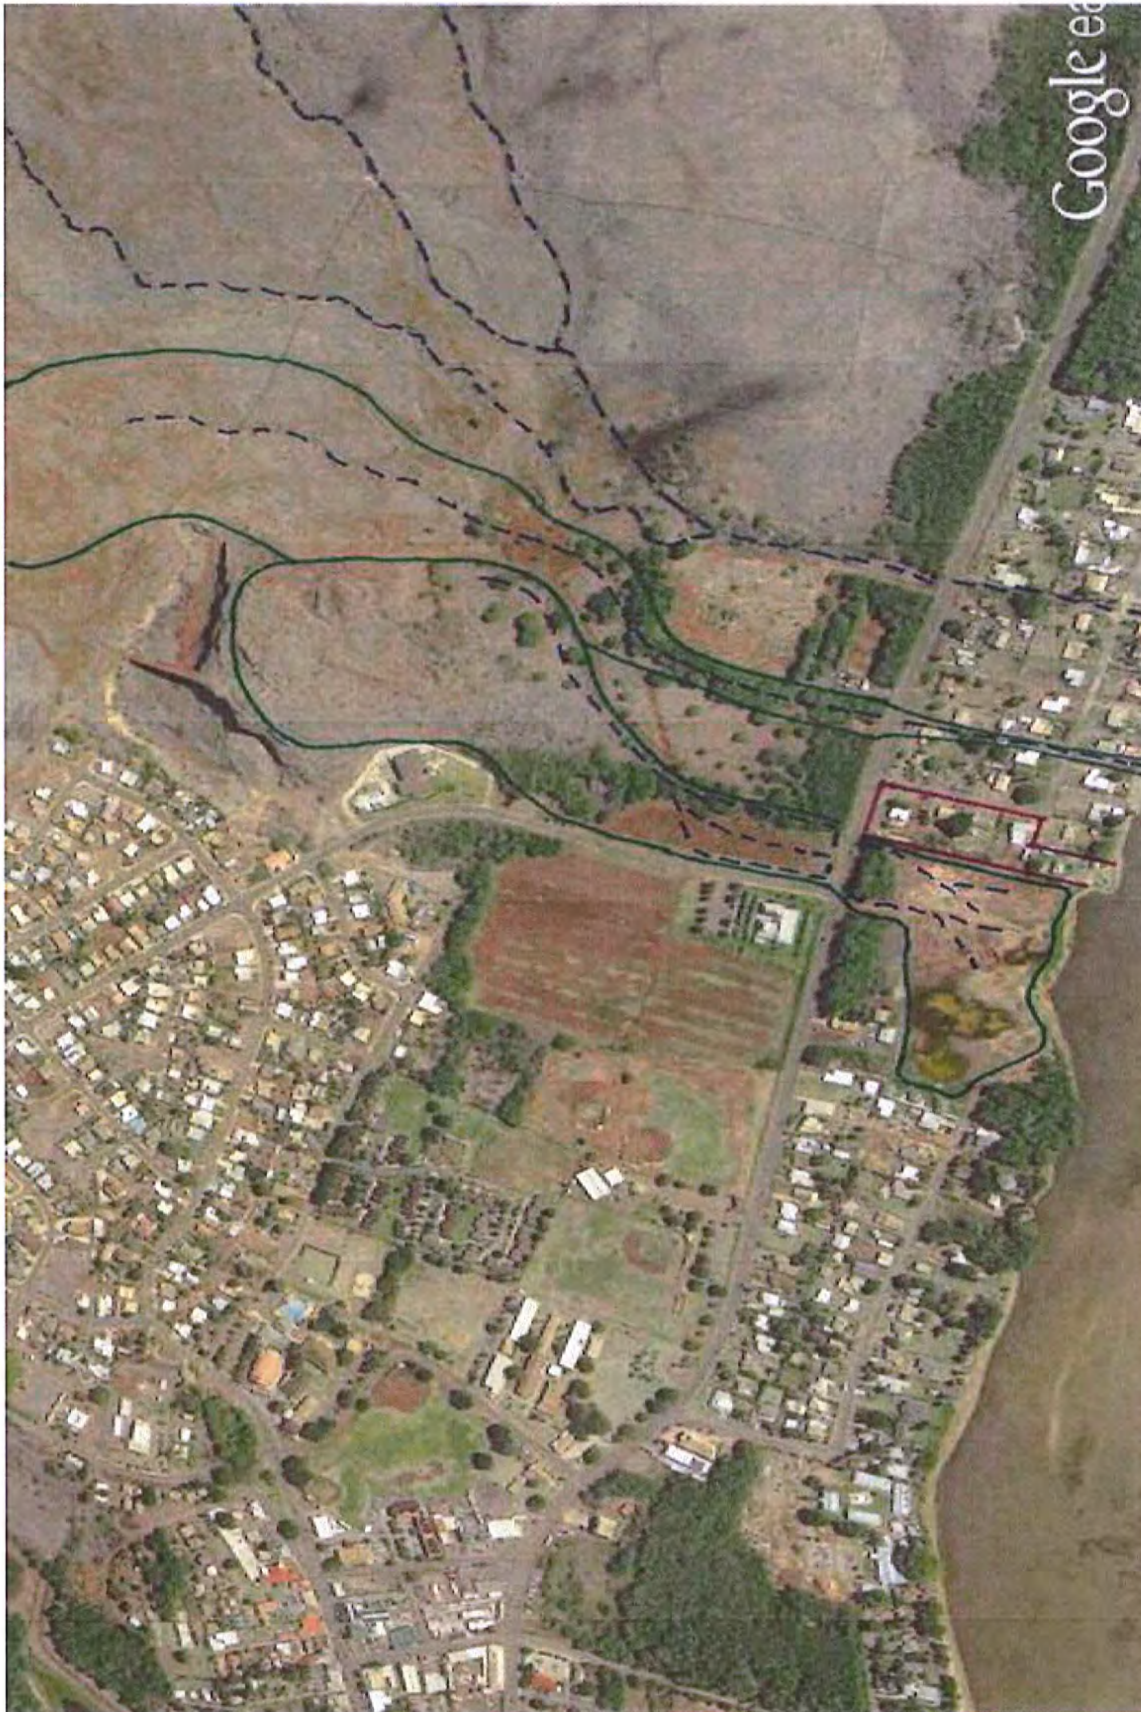
Figure 3

- DHHL Kapa'akea Flood Mitigation Project Area
- Ephemeral stream storm water flow from adjacent unnamed gullies
- Watershed boundaries of adjacent unnamed gullies

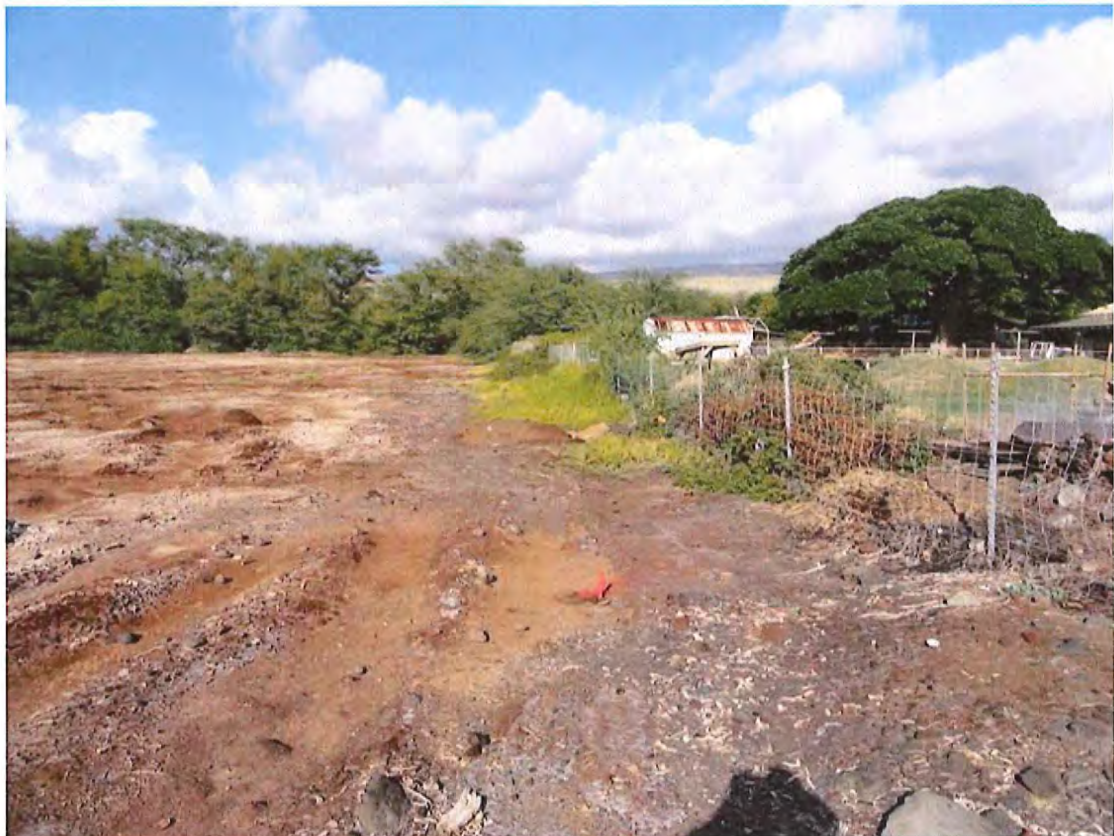
Figure 5. View north along project boundary. The proposed wetland boundary is indicated by red stakes which are located near the toe of the slope below the elevated DHHL lots.

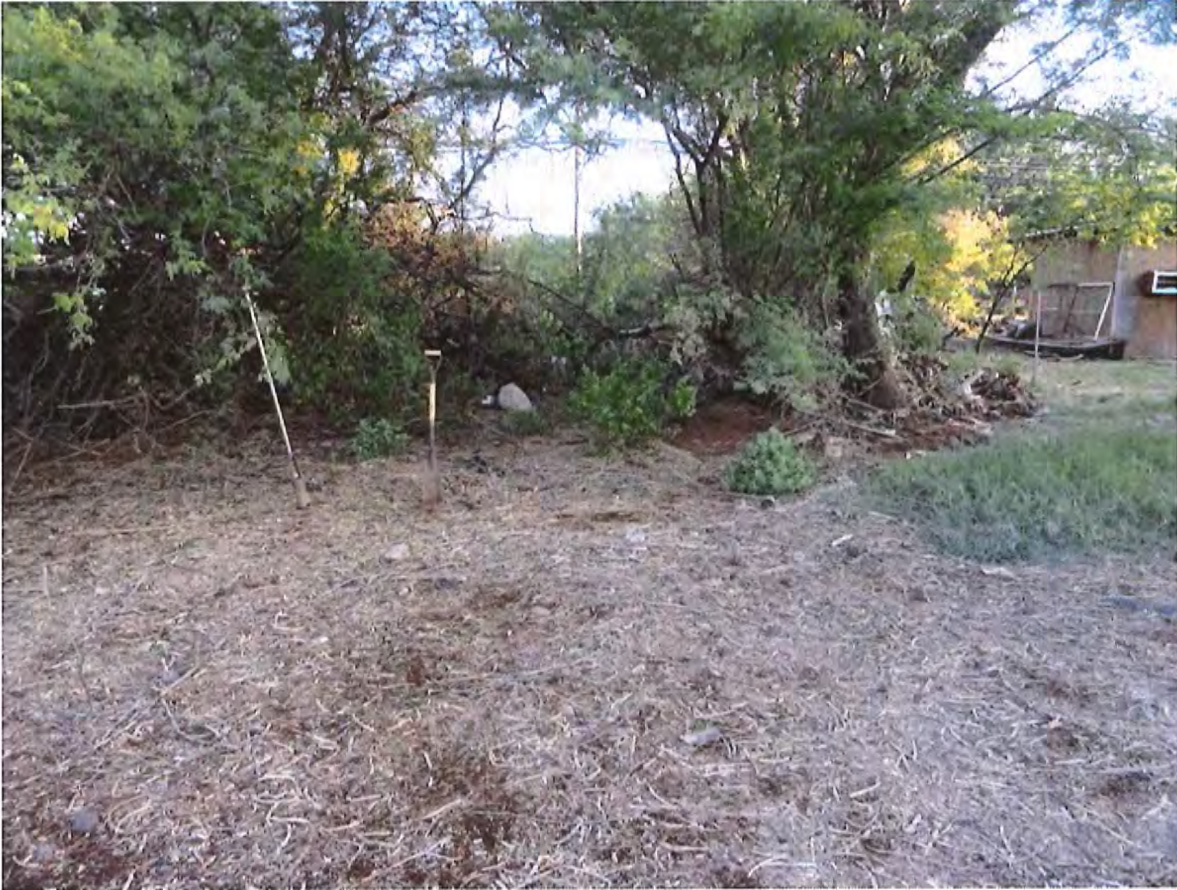
Sampling Point 1A. Upper edge of wetland. Inflow from the Kamehameha V Highway is aligned with the telephone pole. The elevated DHHL project boundary is along the fenceline on the right

Remarks:  
 This site floods for short periods following heavy rainfall events but groundwater levels retreat to depths that prevent the development of positive indicators of wetland hydrology.

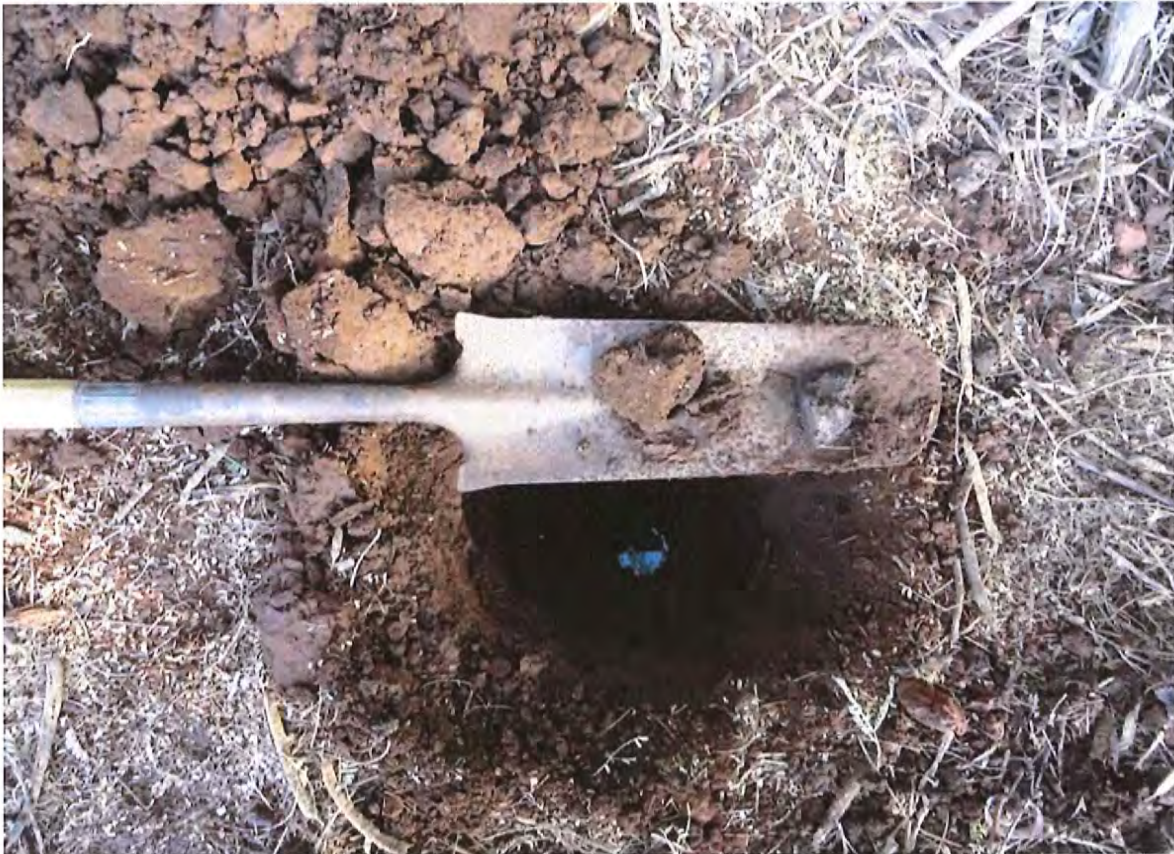
Sampling Point 1B. Dark reddish-brown silt loam over dark reddish gray clay loam. Soil saturated at 18 inches, water table at 22 inches.

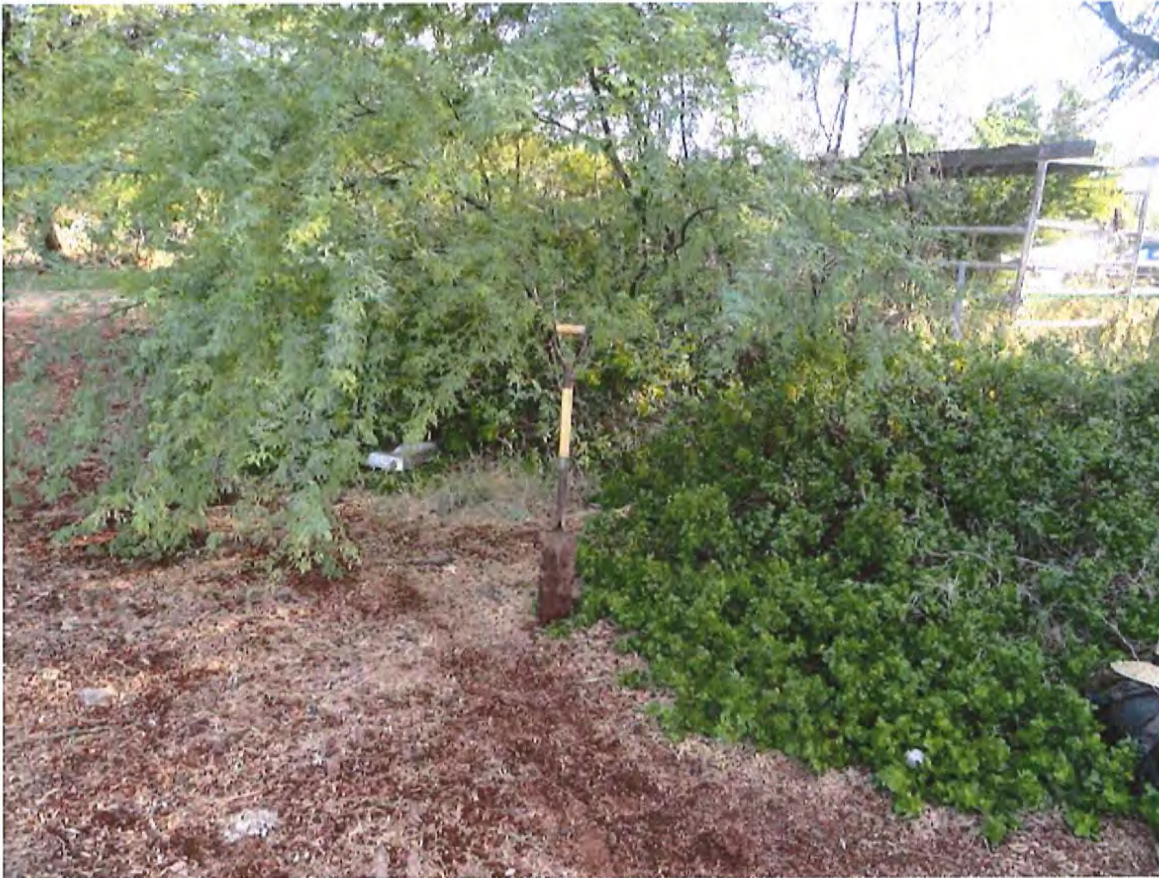
Sampling Point 2A. Located near the bottom of the slope below the DHHL lot boundary.

Remarks:  
 While close to the wetland boundary, this sampling point does not have any positive signs of wetland hydrology.

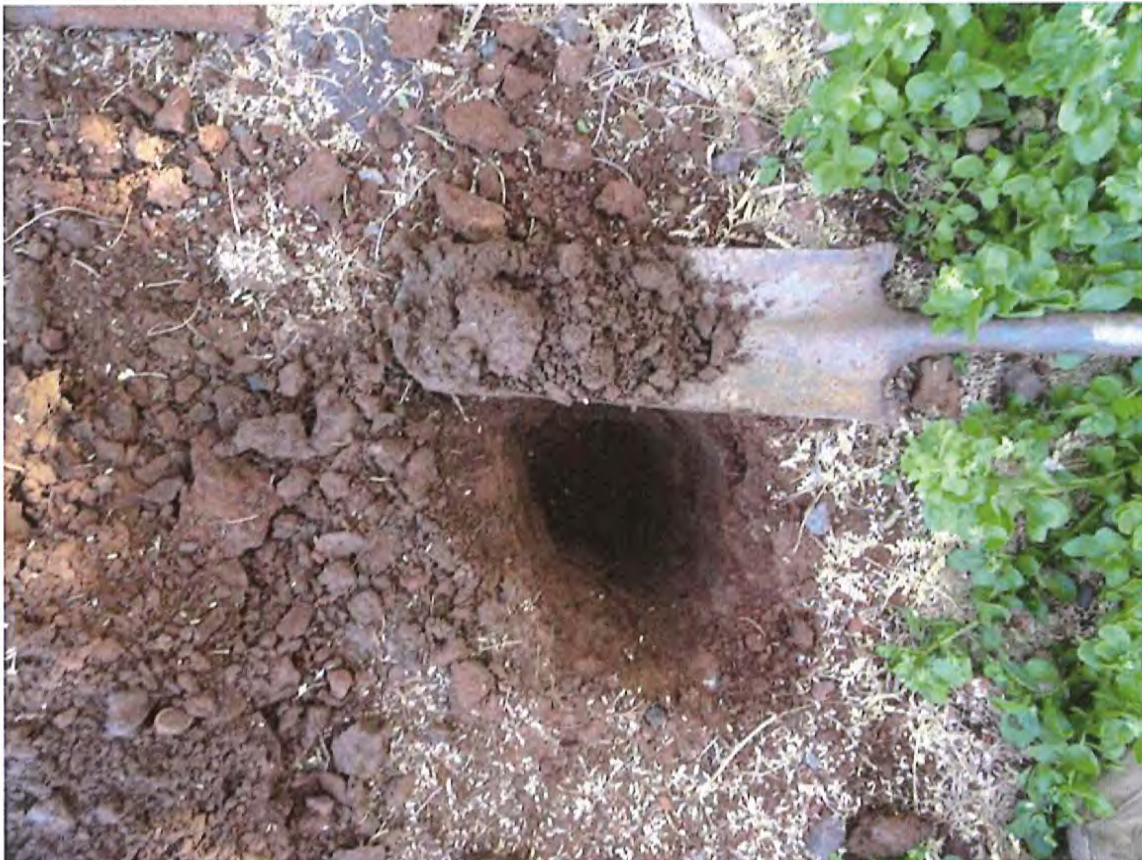
Sampling Point 2B. Dark reddish-brown silt. Loam to 18 inches depth.  
Did not reach saturation or water table depths.

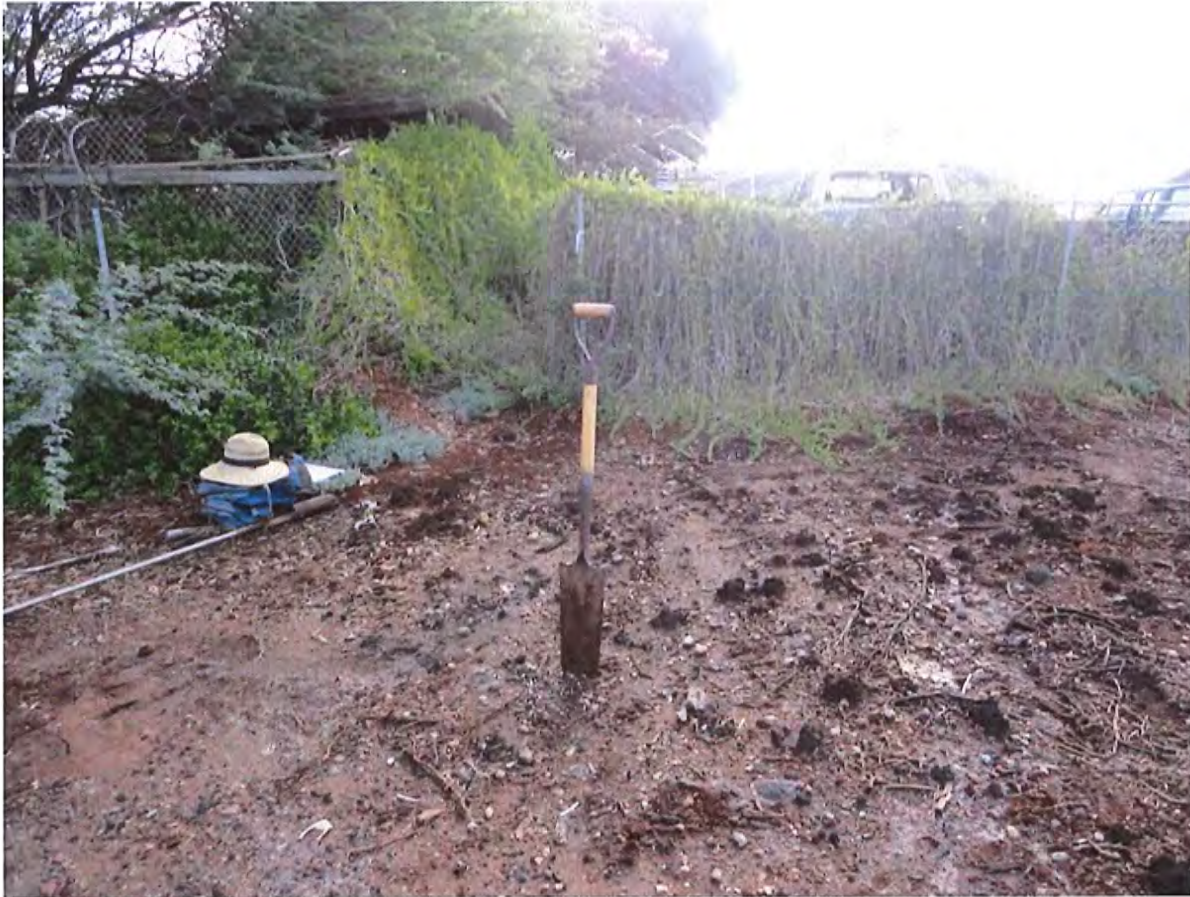
Sampling Point 3A. Located near the bottom of the slope below the DHHL lot boundary.

While close to the wetland boundary, this sampling point does not have any positive indicators of wetland hydrology.

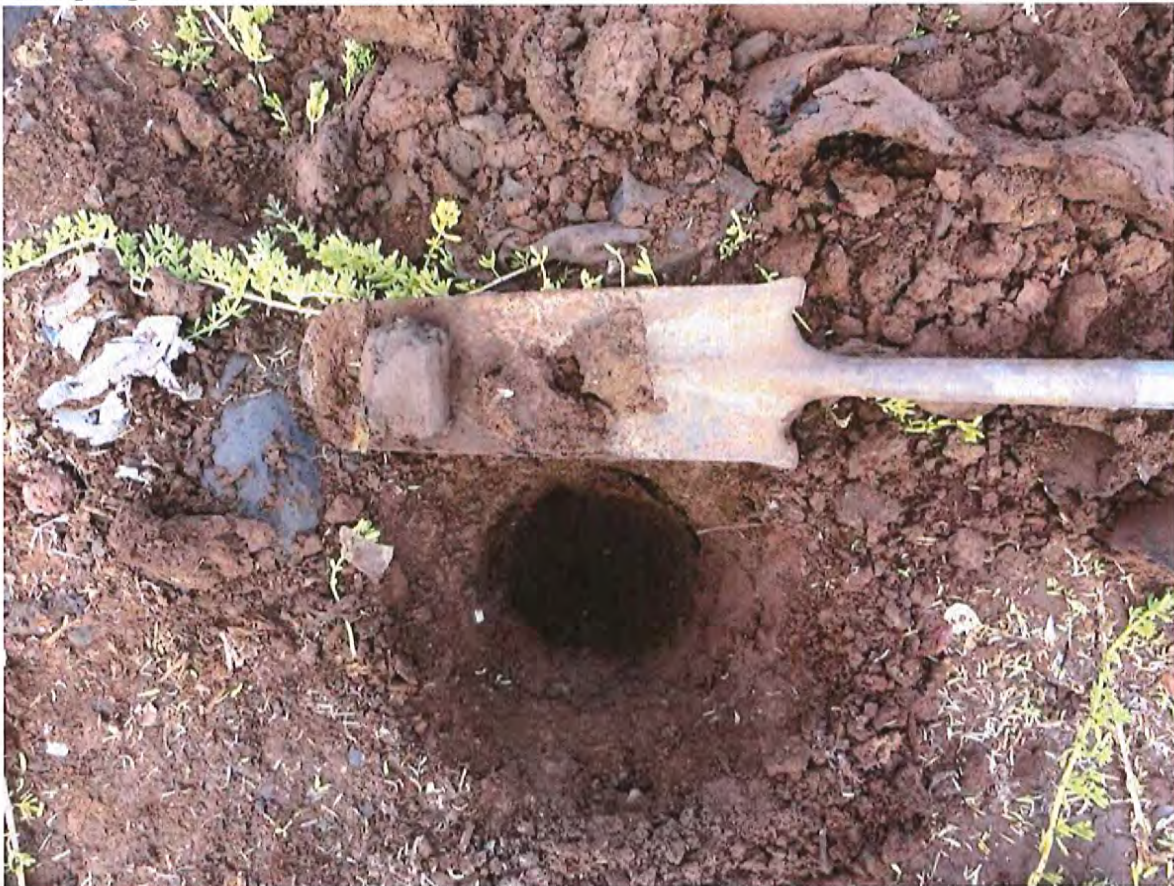
Sampling Point 3B. Dark reddish-brown silt loam over dusky red silty clay loam. Saturation at 17 inches. Water table at 20 inches.

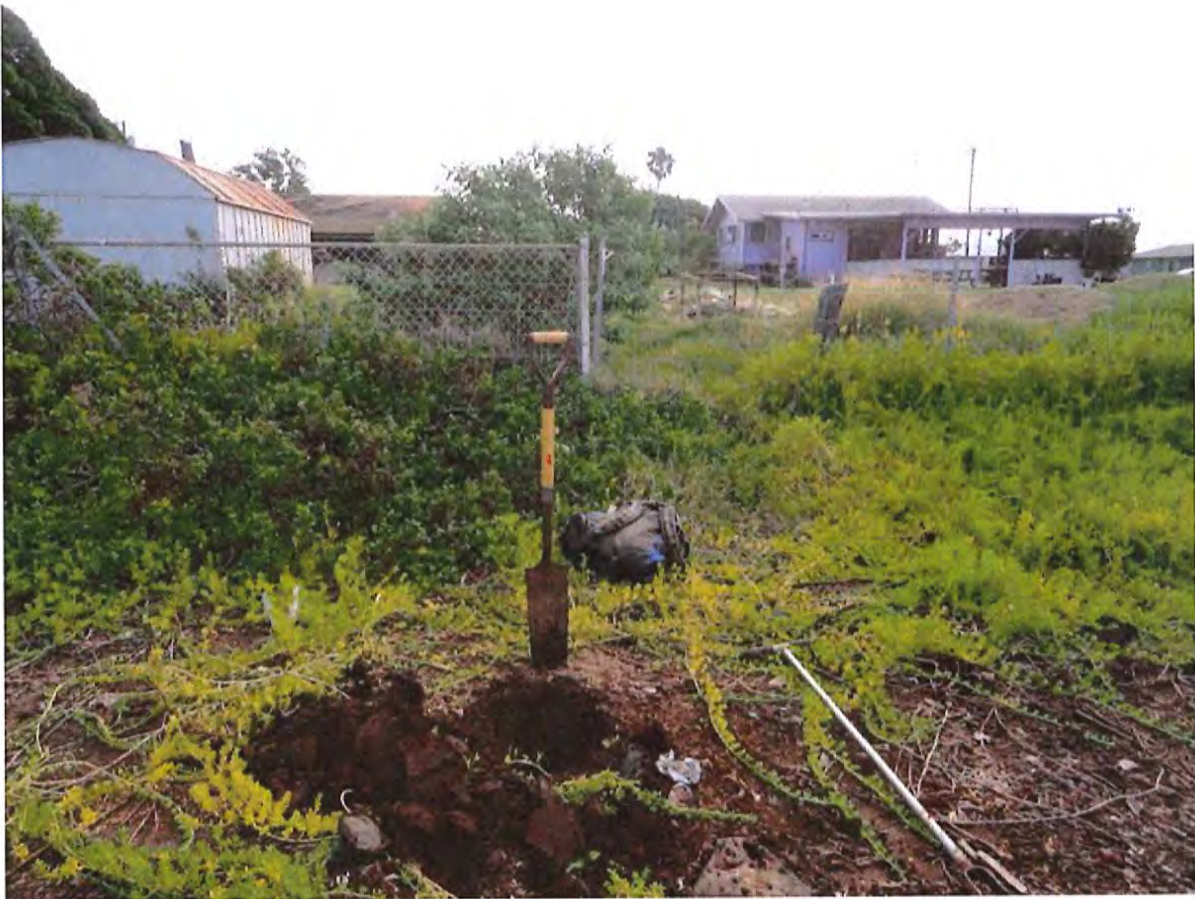
Sampling Point 4A. Located near the bottom of the slope below the DHHL lot boundary.

Remarks: While close to the wetland boundary, this sampling point does not have any positive indicators of wetland hydrology.
