Subject: Proposed Department of Hawaiian Home Lands Kapa'akea Flood Mitigation Improvements

With this letter, the State of Hawai'i, Department of Hawaiian Home Lands (DHHL) hereby transmits the Final Environmental Assessment and Finding of No Significant Impact (FEA-FONSI) for the Proposed Kapa'akea Flood Mitigation Improvements Project, situated on five (5) DHHL Homestead lots identified by TMKs (2)5-4-007:009(por.), (2)5-4-007:010(por.), (2)5-4-007:011(por.), (2)5-4-007:024(por.), and (2)5-4-007:025(por.), within the Kapa'akea Ahupua'a near Kaunakakai on the island of Molokai for publication in the next available edition of the Environmental Notice.

Project Name:	Proposed Department of Hawaiian Home Lands Kapa'akea Flood Mitigation Improvements
Project Short Name:	Kapa'akea Flood Mitigation Improvements
HRS §343-5 Trigger(s):	Use of State Lands and State Funds
Island(s):	Moloka'i
Judicial District(s):	Moloka'i
TMK(s):	(2)5-4-007:009 (por.), (2)5-4-007:010 (por.), (2)5-4-007:011 (por.), (2)5-4-007:024 (por.), (2)5-4-007:025 (por.)
Permit(s)/Approval(s):	National Pollutant Discharge Elimination System (NPDES) Permit, as applicable; Community Noise Permit, as applicable; Building

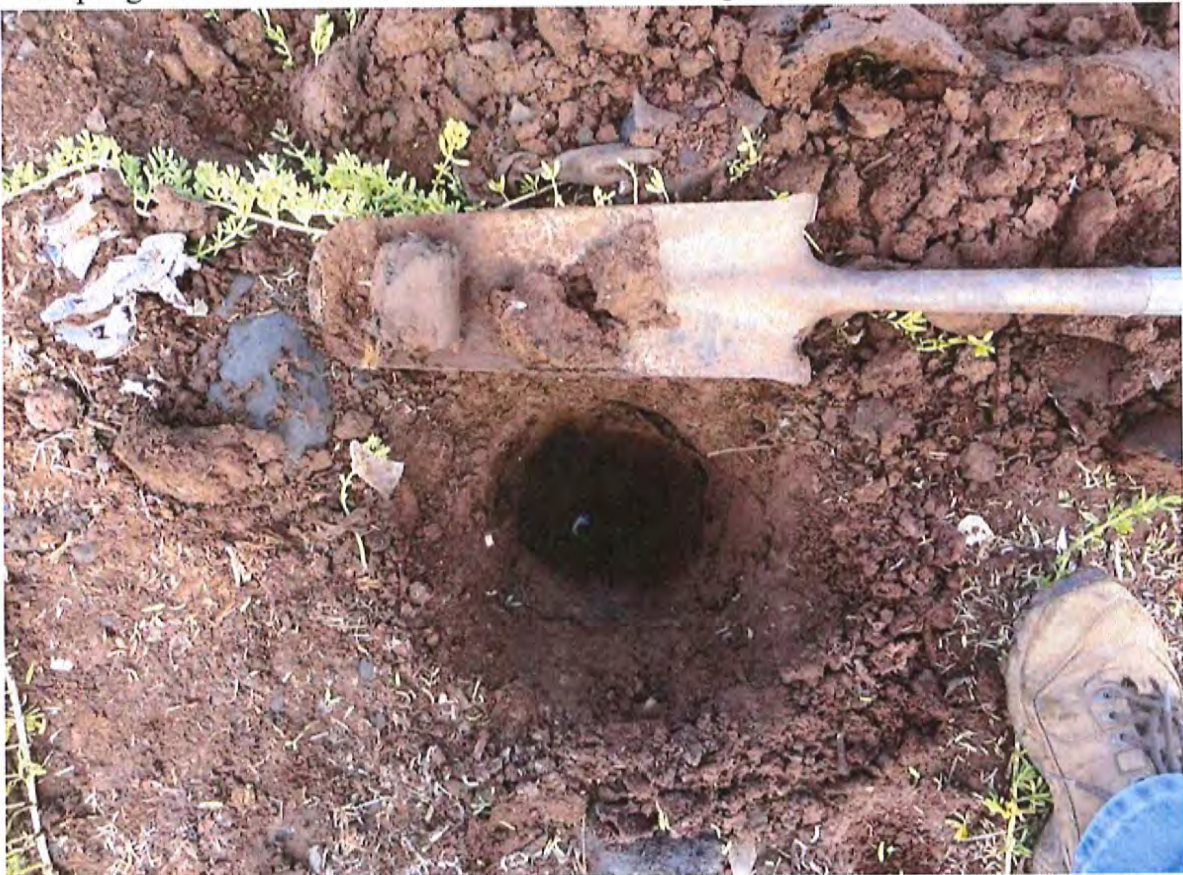
Sampling Point 4B. Dark reddish-brown silt loam over dusky red silty clay loam.  
Saturation at 19 inches. Water table at 23 inches.

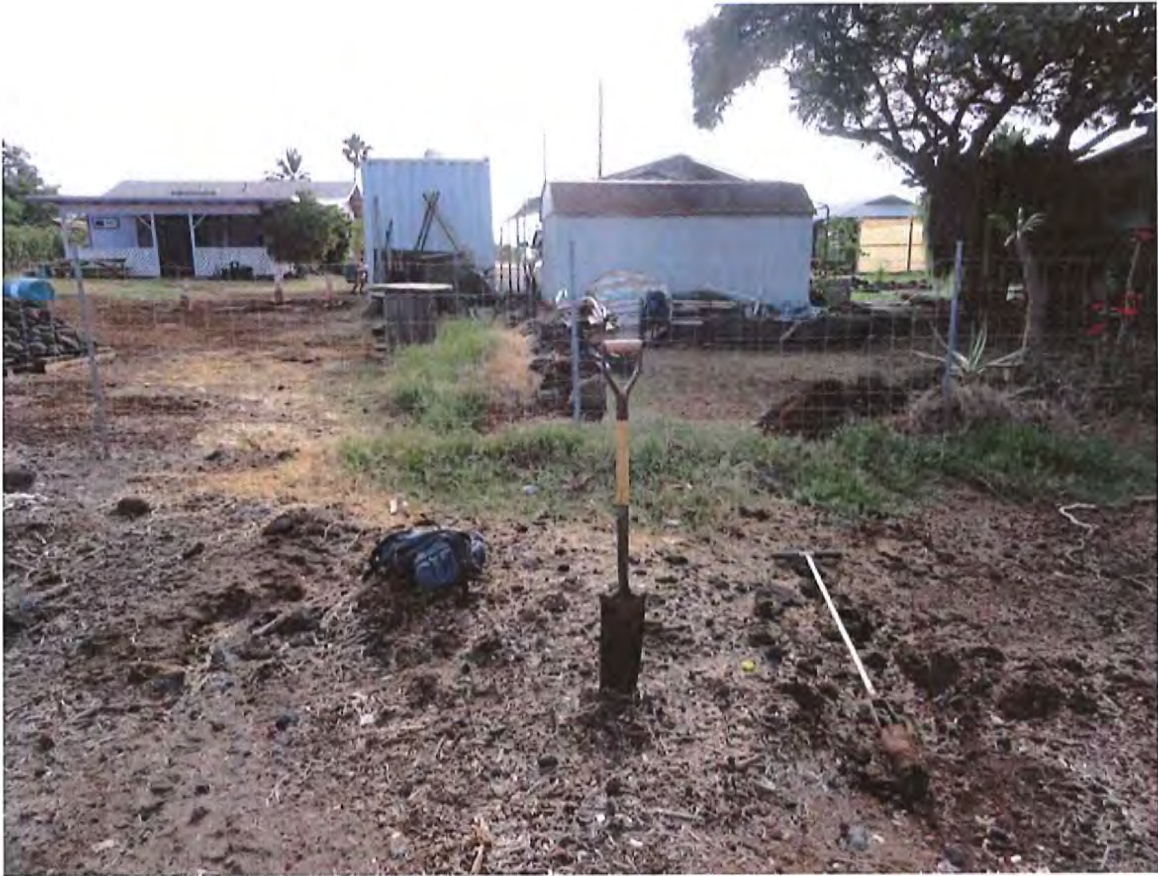
Sampling Point 5A. Located near the bottom of the slope below the DHHL Lot boundary.

Remarks: While close to the wetland boundary, this sampling point does not have any positive indicators of wetland hydrology.

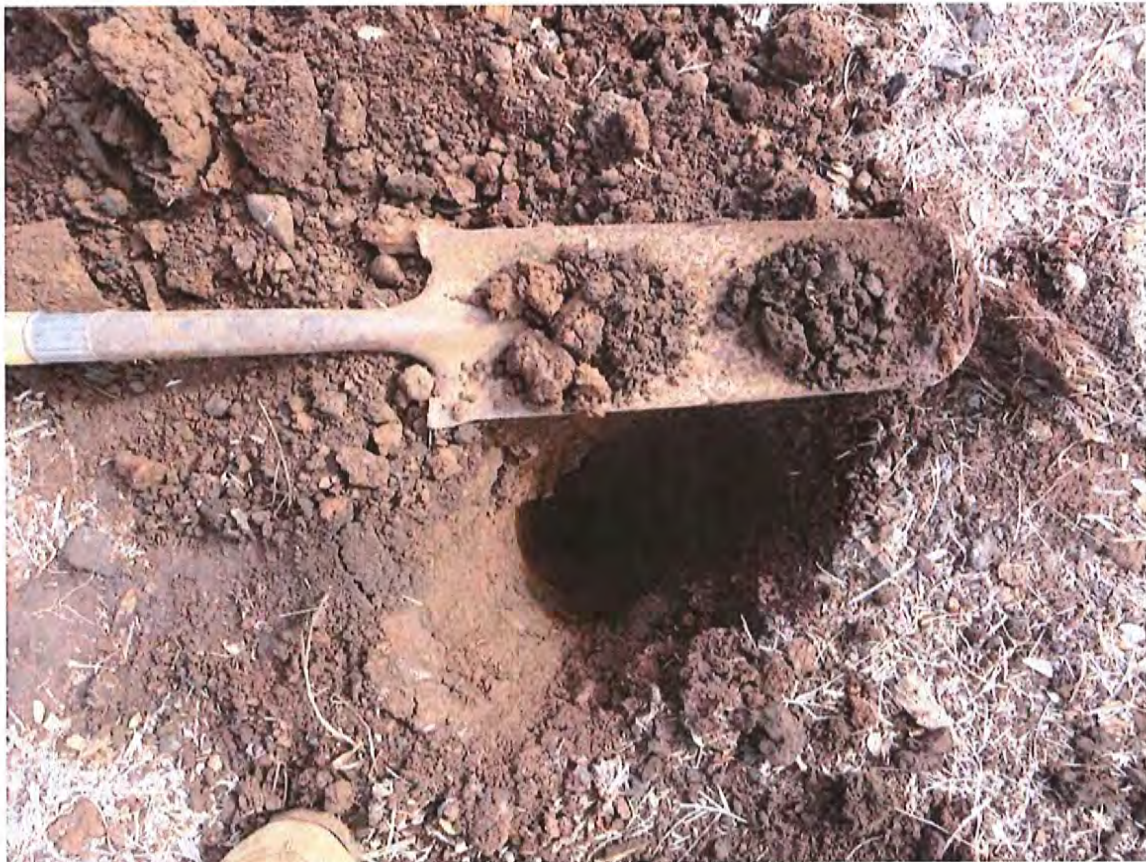
Sampling Point 5B. Dark reddish-brown silt loam over dark reddish-gray clay loam. Saturation at 17 inches. Water table at 20 inches.

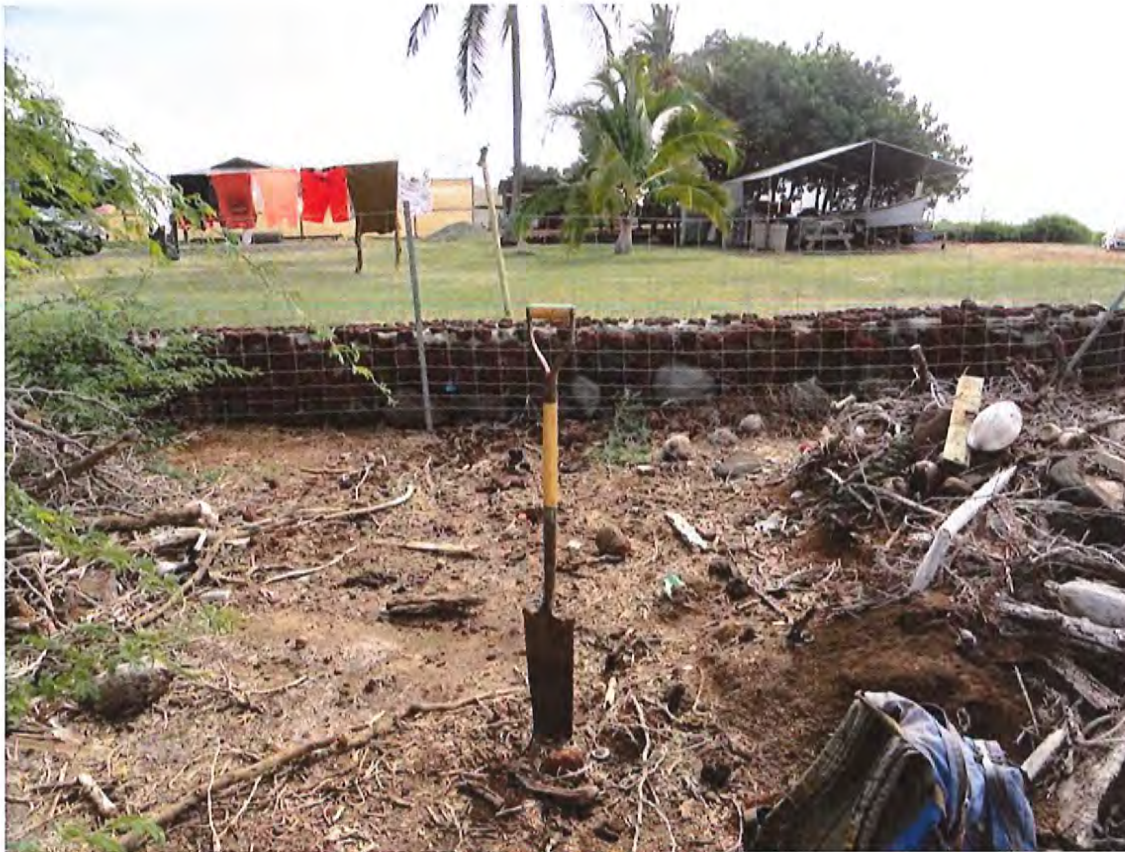
Sampling Point 6A. Located at the bottom of the slope below the DHHL lot boundary within the margin of the wetland.

Remarks:  
 This sampling point had salt deposits and shallow saturation and water table - it had wetland hydrology.

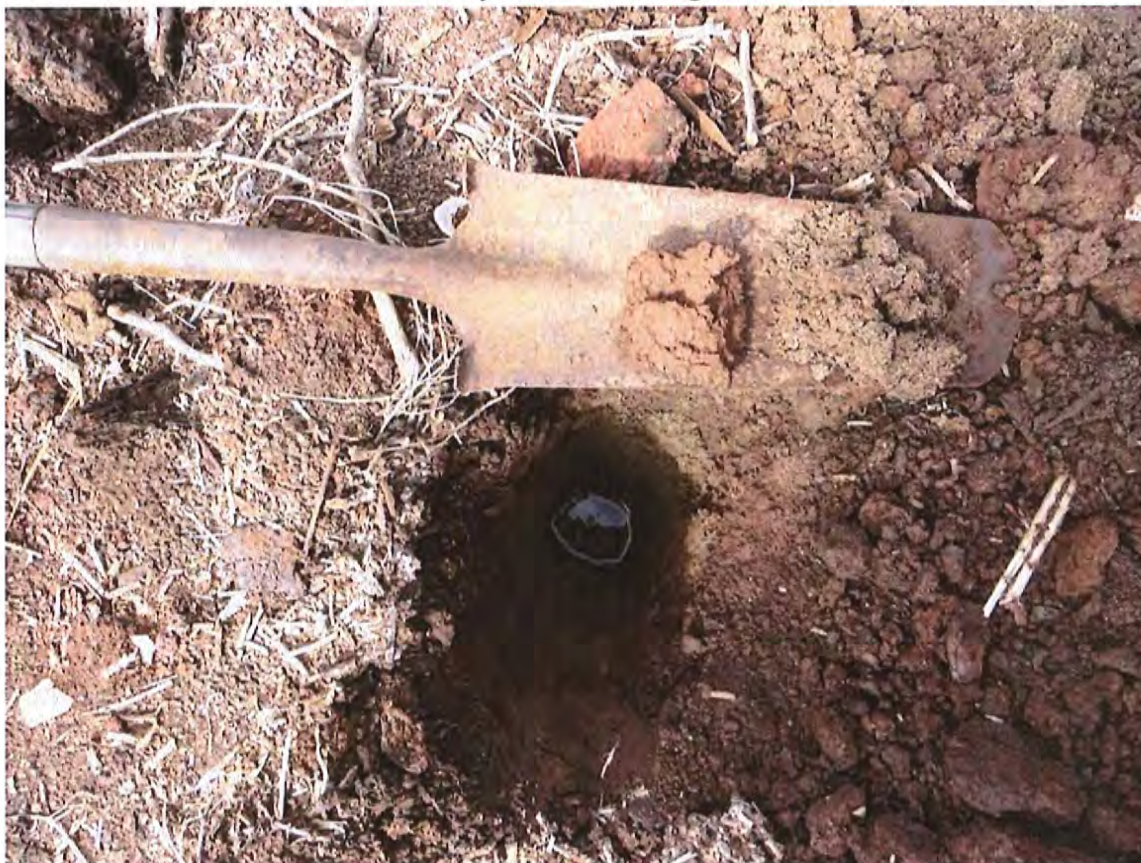
Sampling Point 6B. Reddish-brown silt loam over weak red, saturated silty sand. Saturation at 8 inches. Water table at 12 inches.

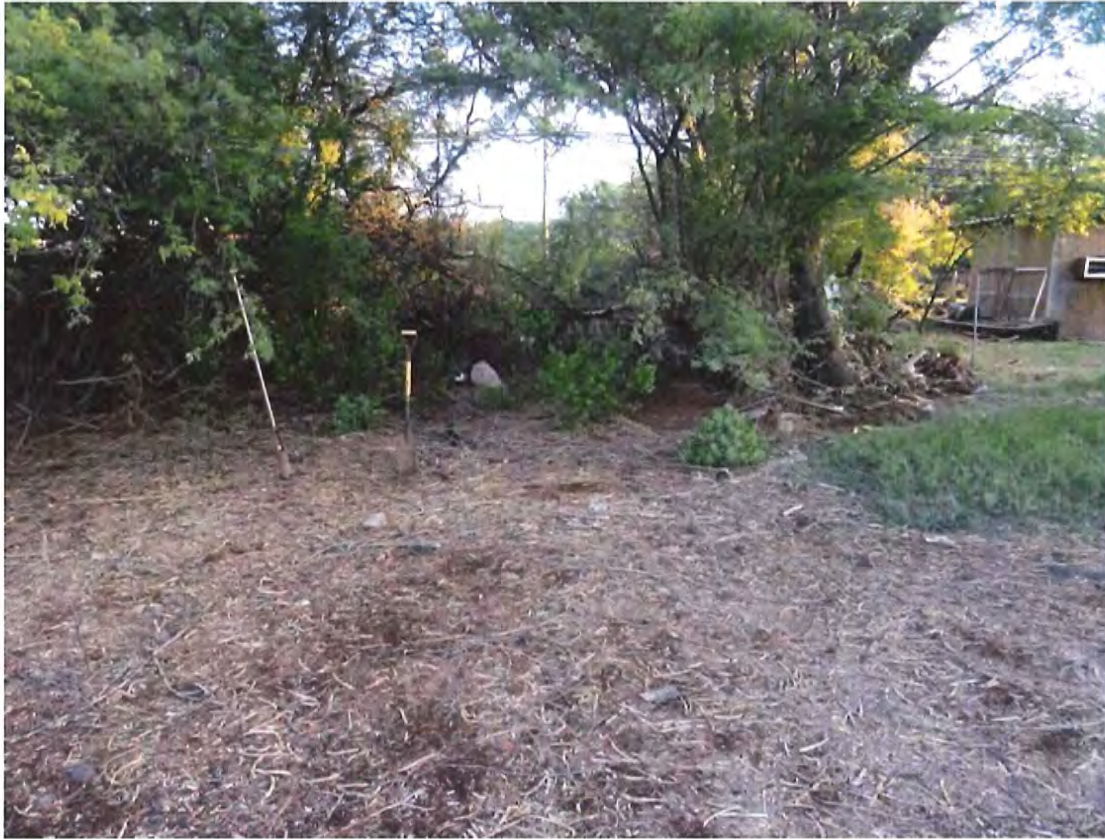
Sampling Point 1A. Upper edge of wetland. Inflow from the Kamehameha V Highway aligns with the telephone pole. The elevated DHHL project boundary is along the fence line on the right.

Remarks:  
**THIS SITE FLOODS FOR SHORT PERIODS FOLLOWING HEAVY RAINFALL EVENTS BUT GROUND WATER LEVELS RETREAT TO DEPTHS THAT PREVENT THE DEVELOPMENT OF POSITIVE INDICATORS OF WETLAND HYDROLOGY.**

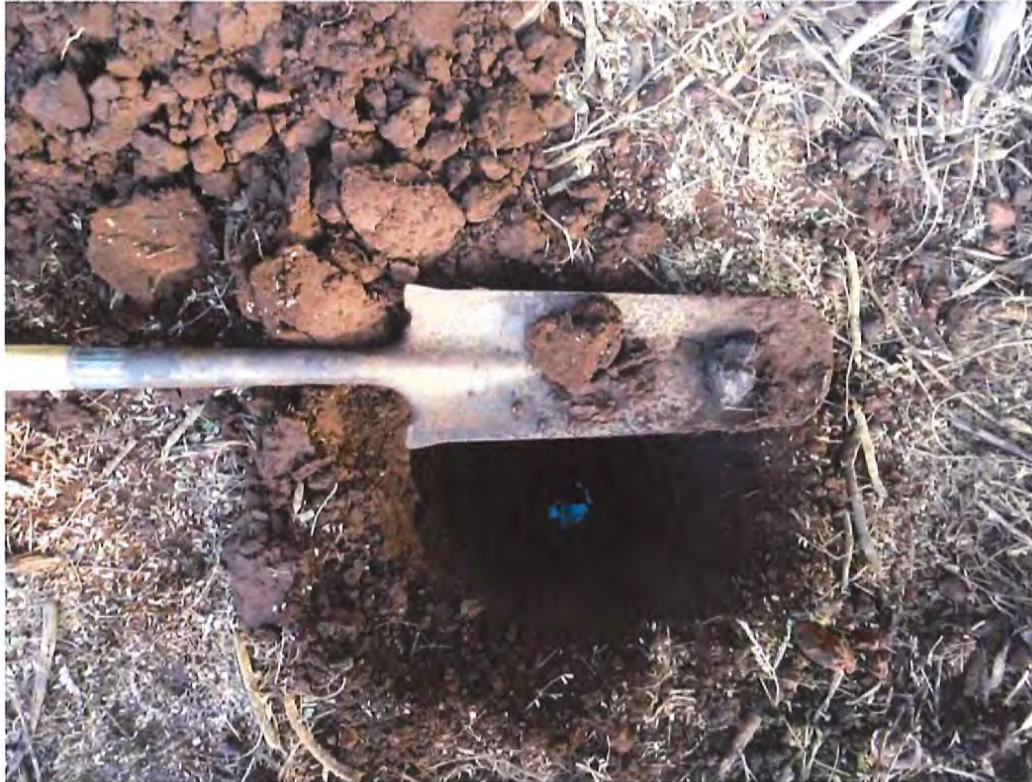
Sampling Point 1B. Dark reddish-brown silt loam over dark reddish gray clay loam. Soil saturated at 18 inches, water table at 22 inches.

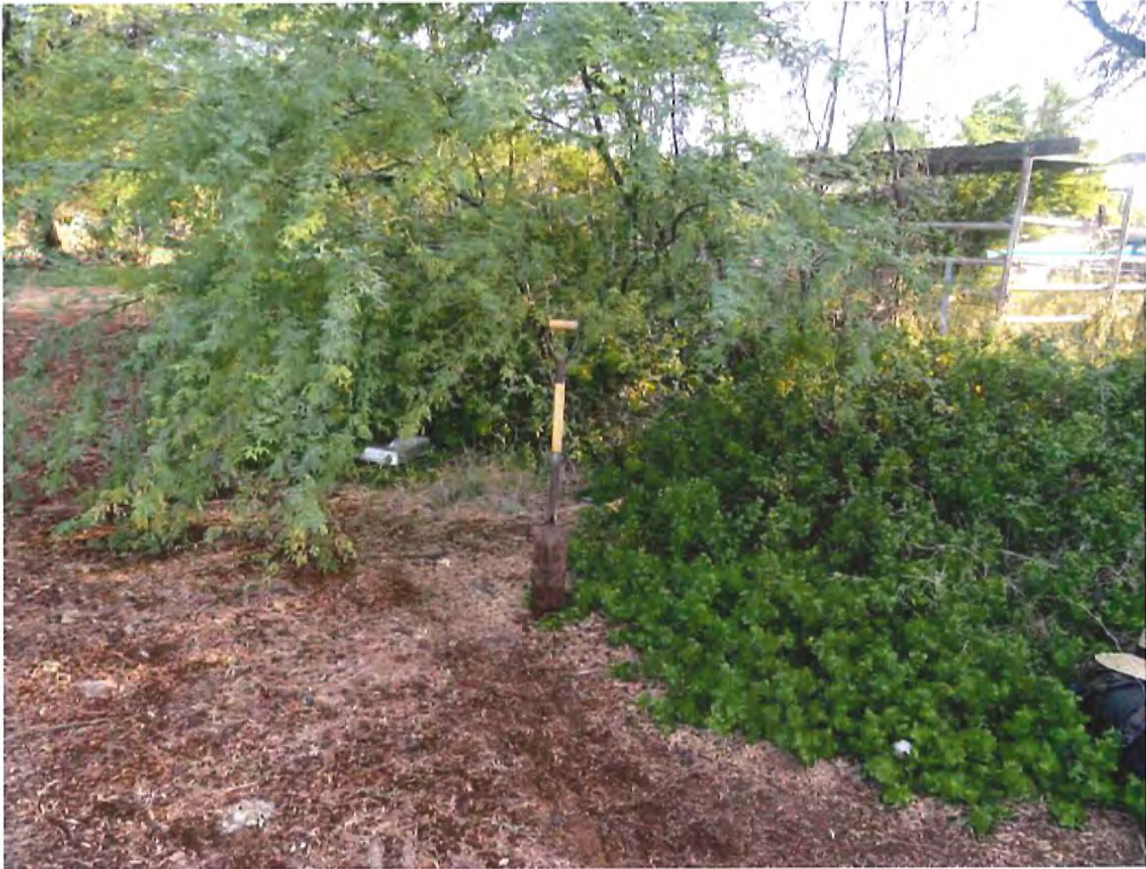
Sampling Point 2A. Located near the bottom of the slope below the DHHL lot boundary.

Remarks:  
 WHILE CLOSE THE WETLAND BOUNDARY, THIS SAMPLING POINT DOES NOT HAVE ANY POSITIVE SIGNS OF WETLAND HYDROLOGY.

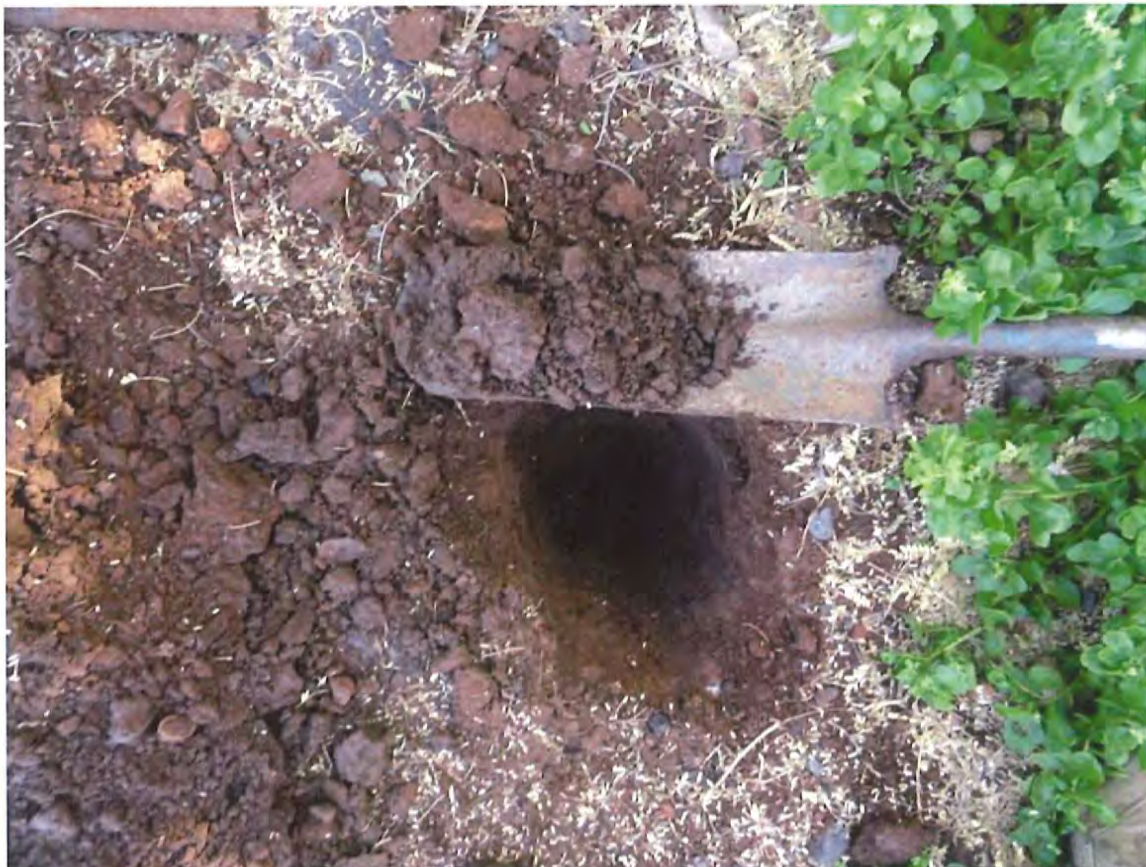
Sampling Point 2B. Dark reddish-brown silt. Loam to 18 inches depth.  
Did not reach saturation or water table depths.

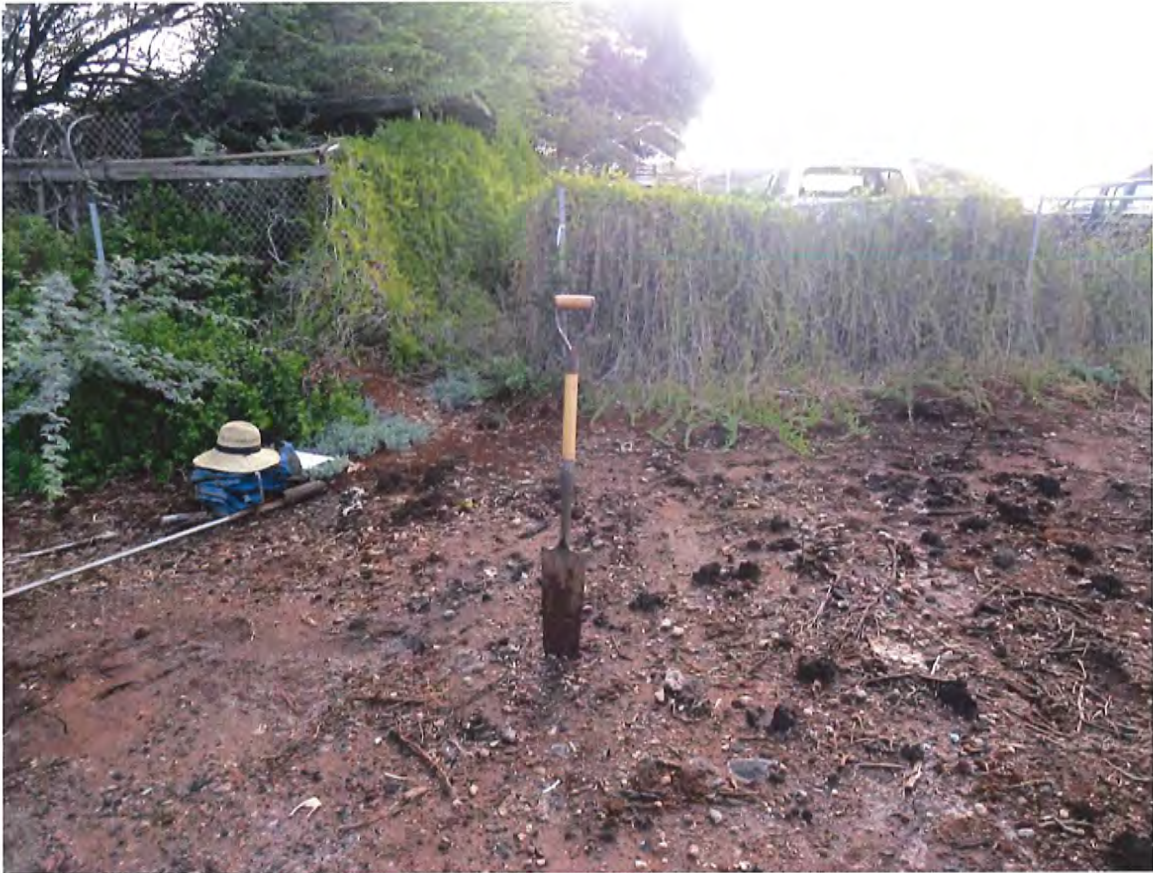
Sampling Point 3A. Located near the bottom of the slope below the DHHL lot boundary.

**Remarks:**  
 WHILE CLOSE TO THE WETLAND BOUNDARY, THIS SAMPLING POINT DOES NOT HAVE ANY POSITIVE INDICATORS OF WETLAND HYDROLOGY.

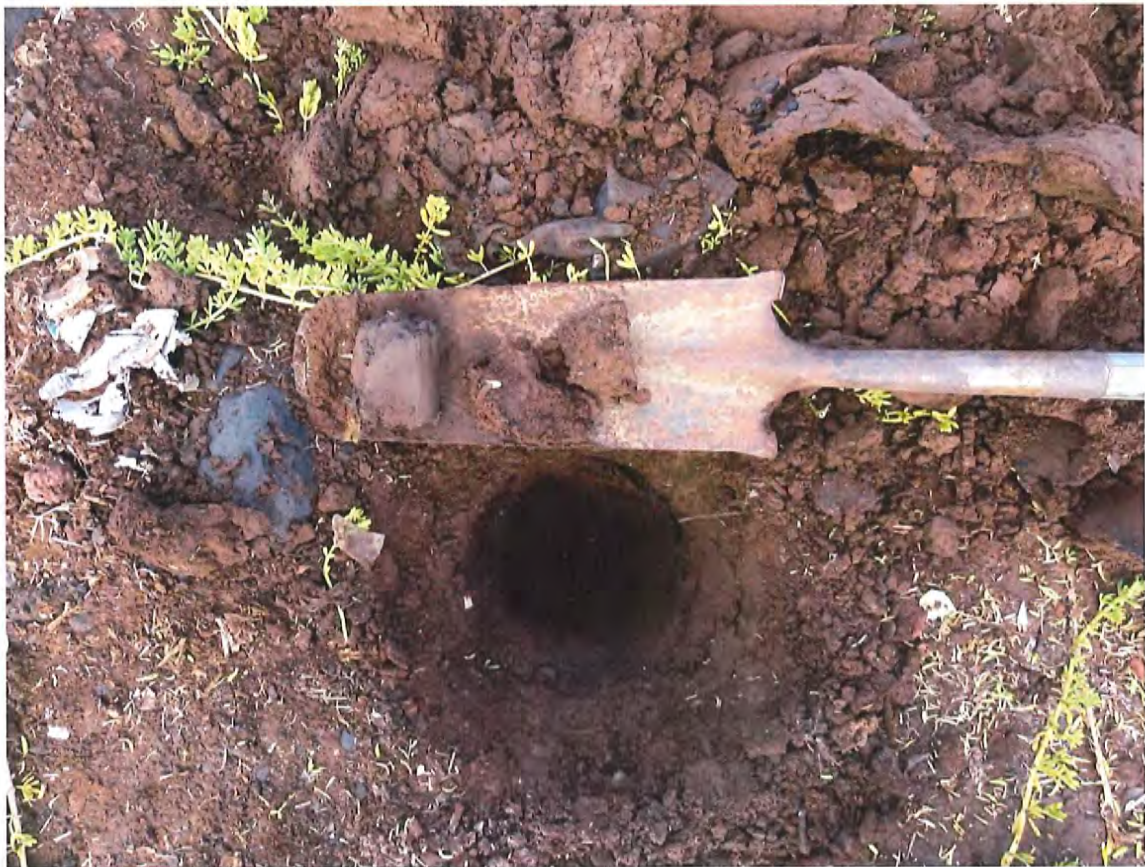
Sampling Point 3B. Dark reddish-brown silt loam over dusky red silty clay loam. Saturation at 17 inches. Water table at 20 inches.

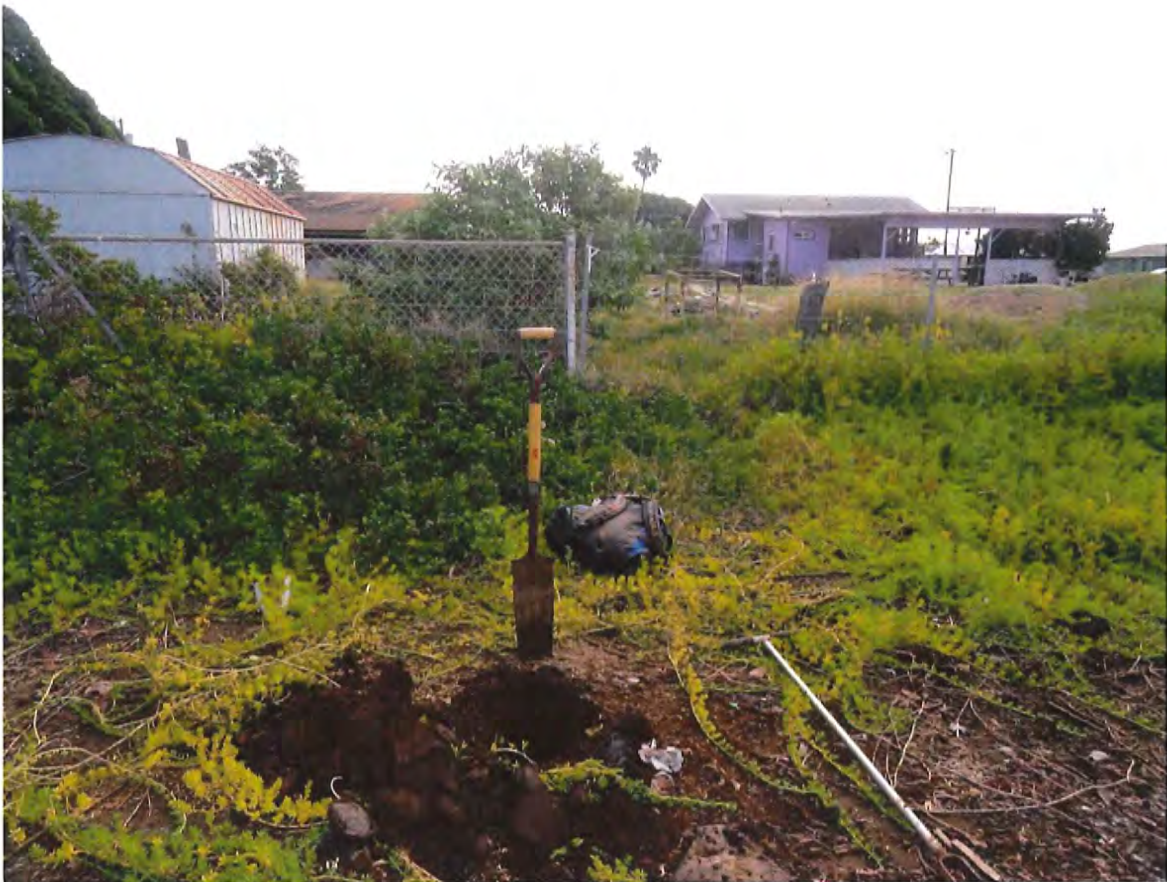
Sampling Point 4A. Located near the bottom of the slope below the DHHL lot boundary.

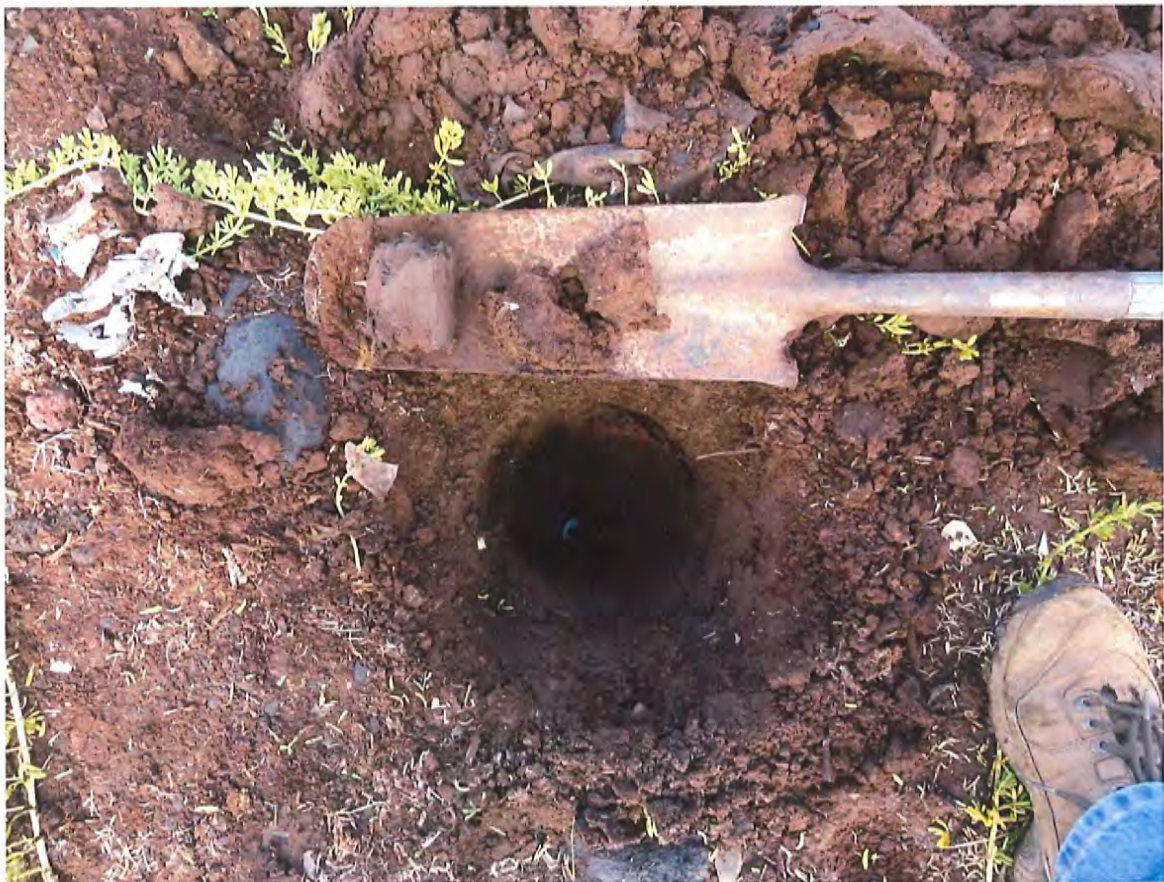
WHILE CLOSE TO THE WETLAND BOUNDARY THIS SAMPLING POINT DOES NOT HAVE ANY POSITIVE INDICATORS OF WETLAND HYDROLOGY.

Sampling Point 4B. Dark reddish-brown silt loam over dusky red silty clay loam. Saturation at 19 inches. Water table at 23 inches.

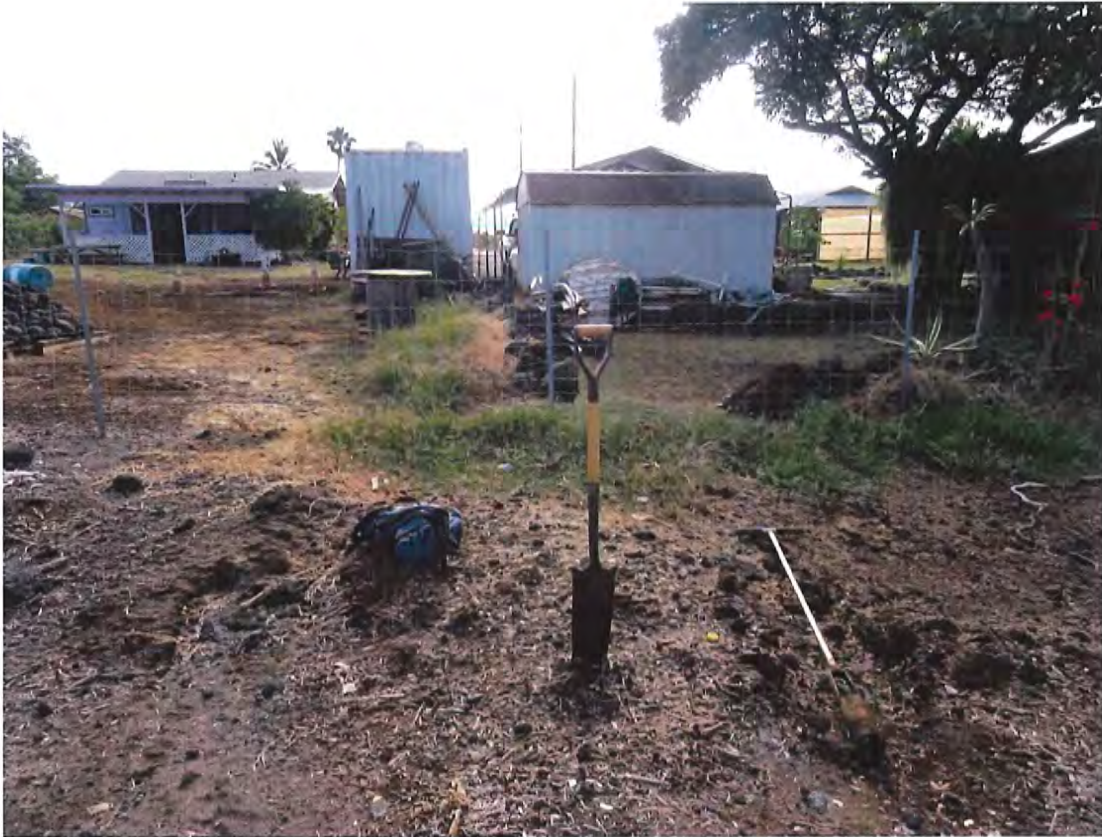
Sampling Point 5A. Located near the bottom of the slope below the DHHL lot boundary.

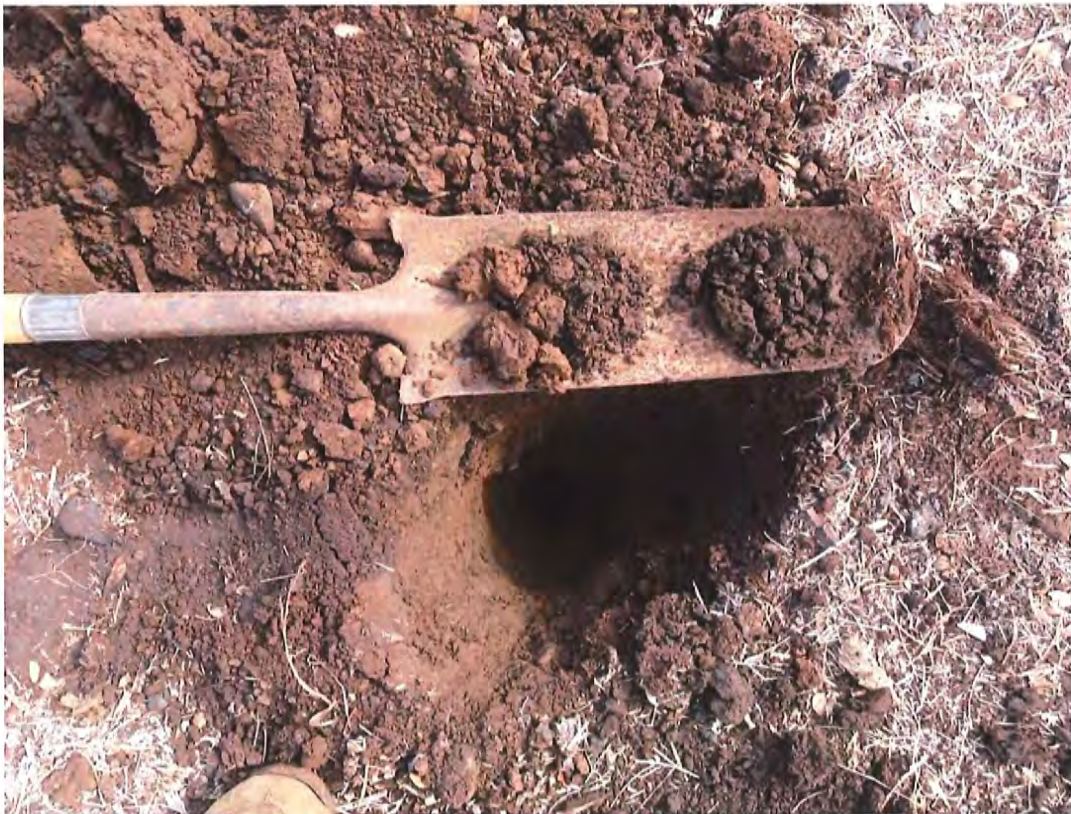
Remarks:  
**WHILE CLOSE TO THE WETLAND BOUNDARY THE SAMPLING POINT DOES NOT HAVE ANY POSITIVE INDICATORS OF WETLAND HYDROLOGY.**

Sampling Point 5B. Dark reddish-brown silt loam over dark reddish-gray clay loam. Saturation at 17 inches. Water table at 20 inches.

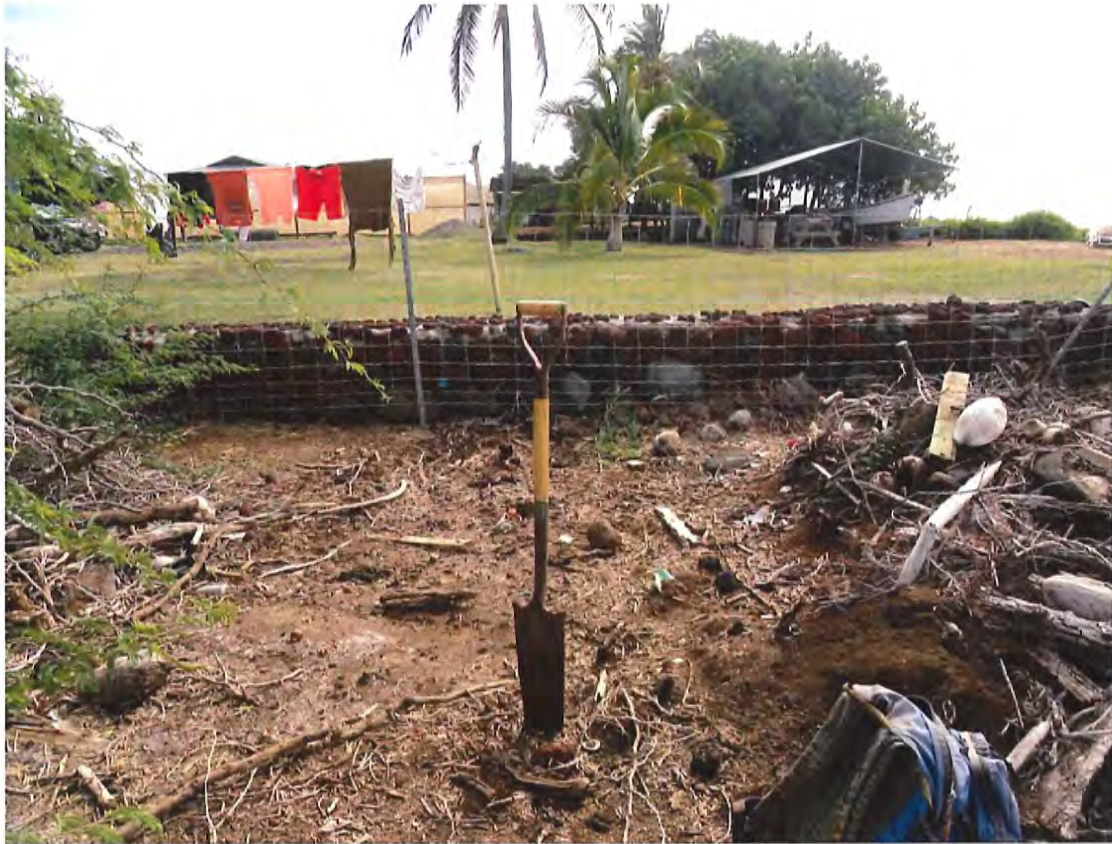
Sampling Point 6A. Located at the bottom of the slope below the DHHL lot boundary within the margin of the wetland.

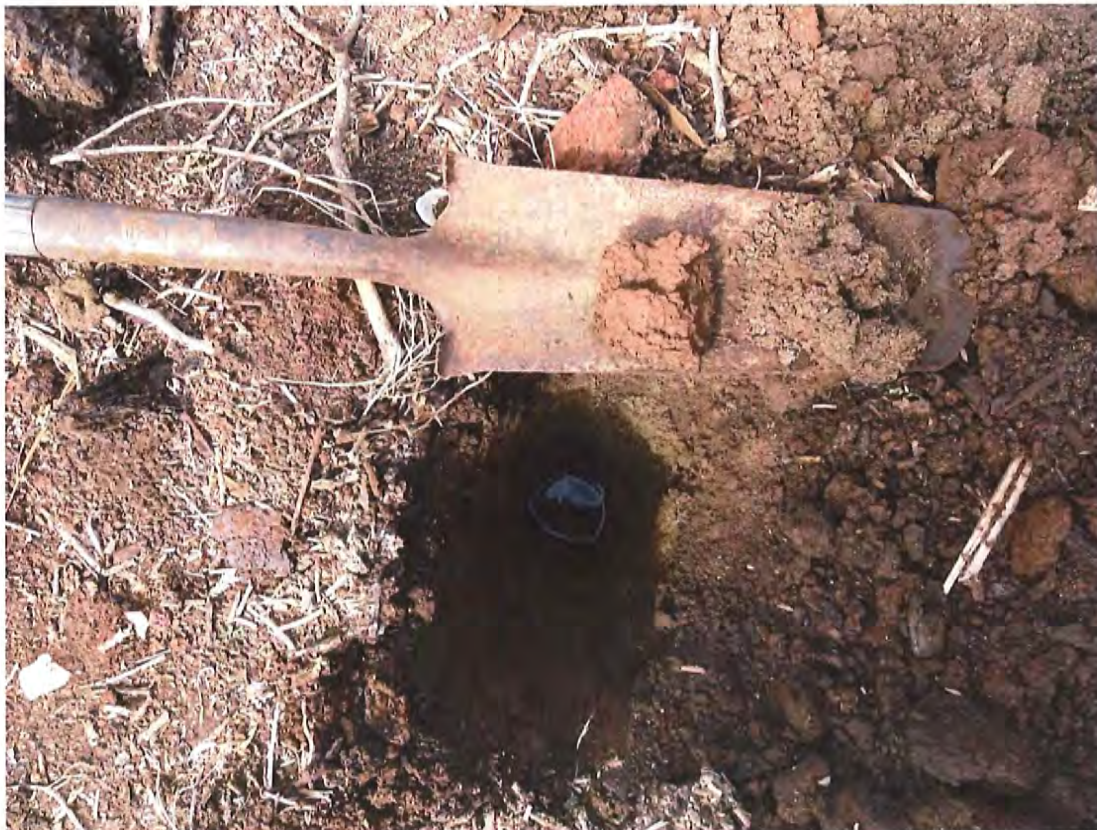
**THIS SAMPLING POINT HAD SHALLOW SATURATION AND WATER TABLE LEVELS AND SURFACE SALT DEPOSITS. IT HAD WETLAND HYDROLOGY.**

Sampling Point 6B. Reddish-brown silt loam over weak red, saturated silty sand. Saturation at 8 inches. Water table at 12 inches.

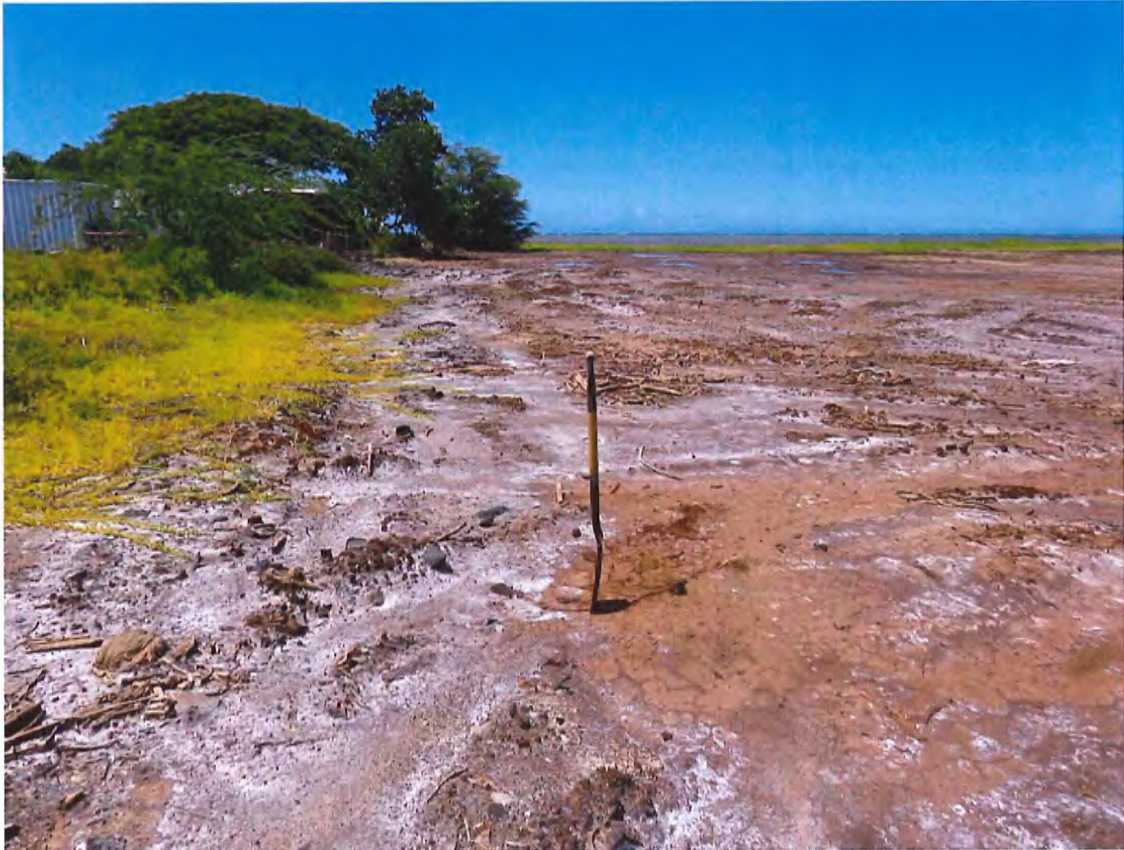
Sampling Point 7A. This plot lies 24 feet to the west of the DHHL boundary and about 5 feet within the wetland boundary.

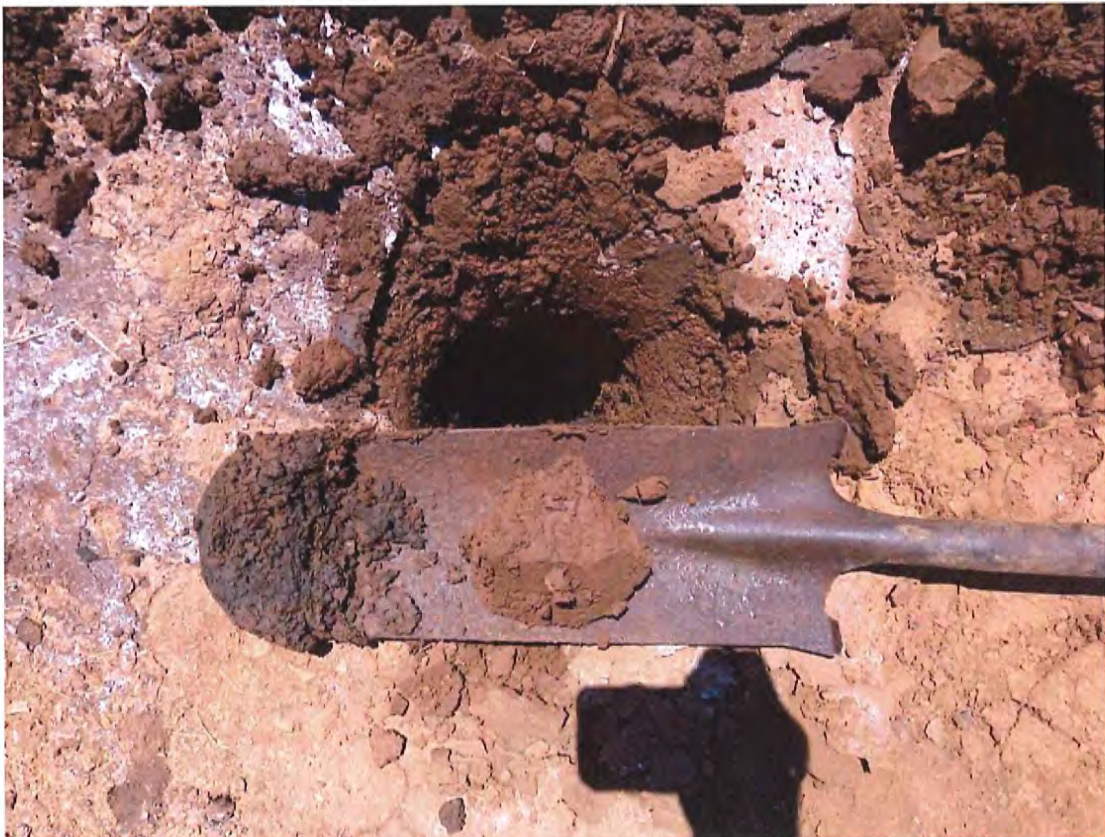
Remarks:  
**THIS SAMPLING POINT HAS HIGH SATURATION AND WATER TABLE LEVELS. THUS HIGH SALT CONTENT IN THE SOIL HAS A HYDROPHYTIC EFFECT THAT HOLDS SOME MOISTURE ALL THE WAY TO THE SURFACE.**

Sampling Point 7B. This soil is saturated to within 12 inches of the surface and has a water table at 22 inches.

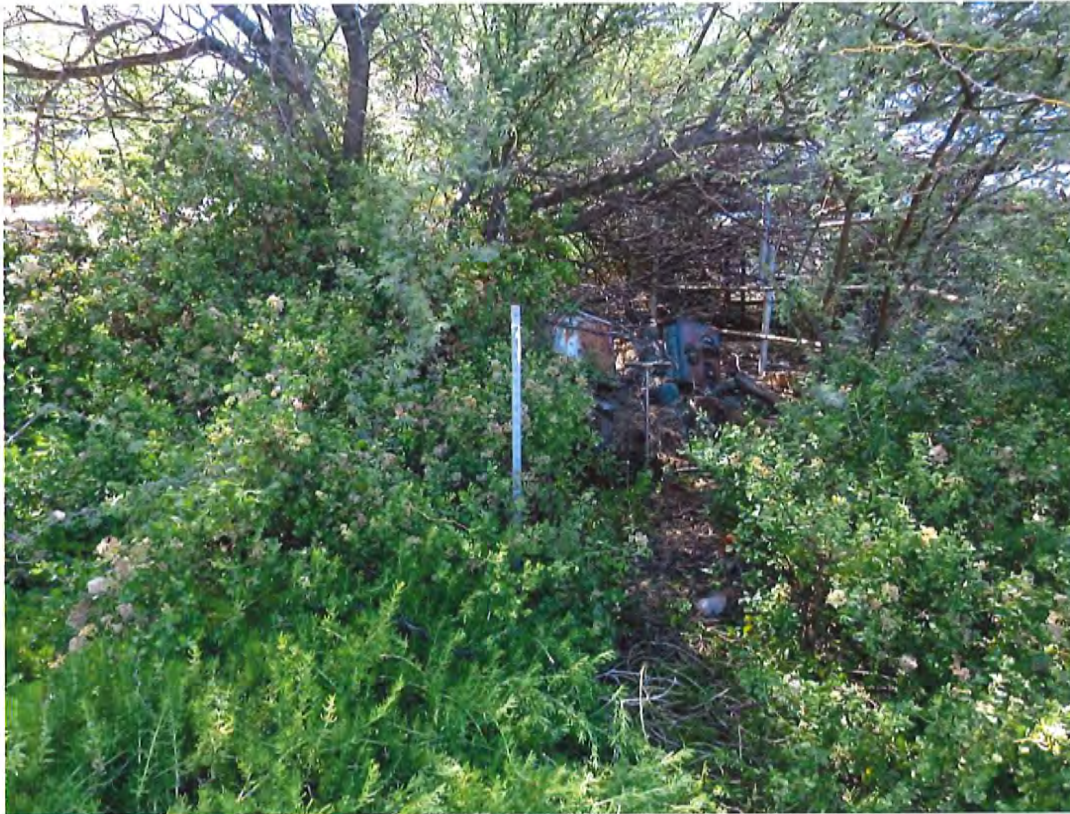
Sampling Point 8A. This plot lies on the elevated DHHL project corridor. Vegetation consists of kiawe (*prosopis pallida*) FACU, Indian fleabane (*Pluchea indica*) FAC and pickleweed (*Batis maritima*) OBL.

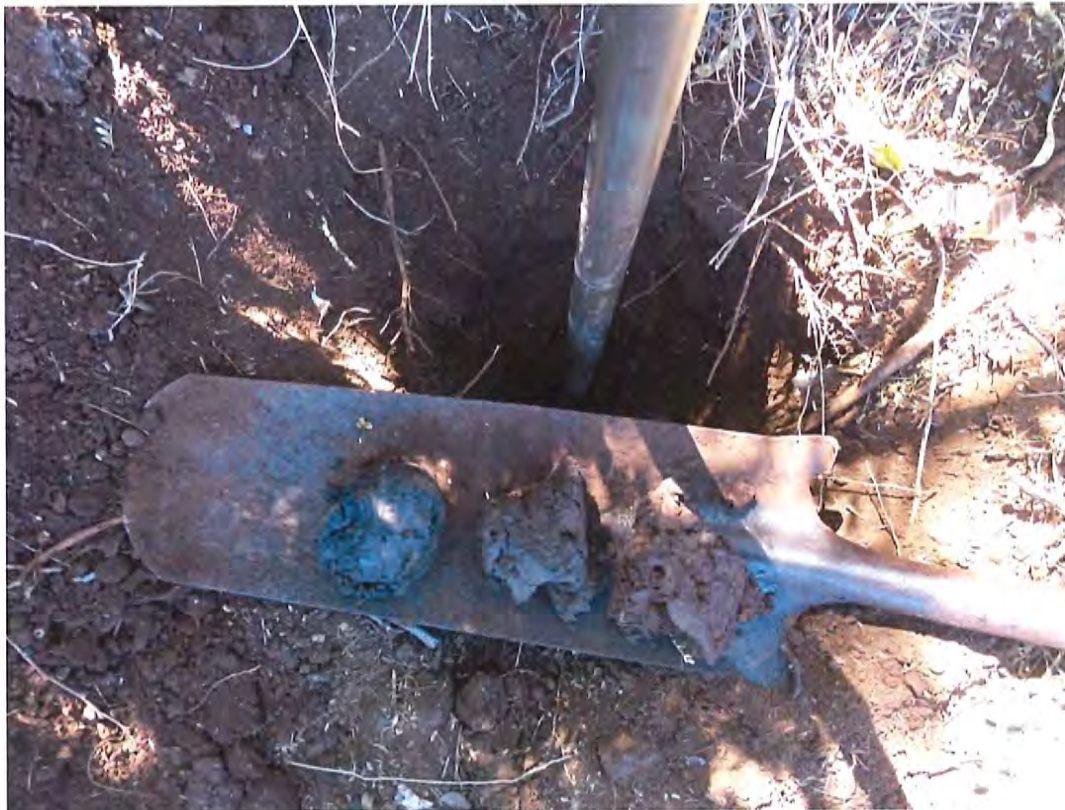
Remarks:  
**NO WETLAND HYDROLOGY INDICATORS OCCUR CLOSE ENOUGH TO THE SURFACE TO EXPRESS THE CHARACTER OF A WETLAND ENVIRONMENT.**

Sampling Point 8B. Saturated soil lies at 29 inches below the surface and the water table is at a depth of 32 inches.

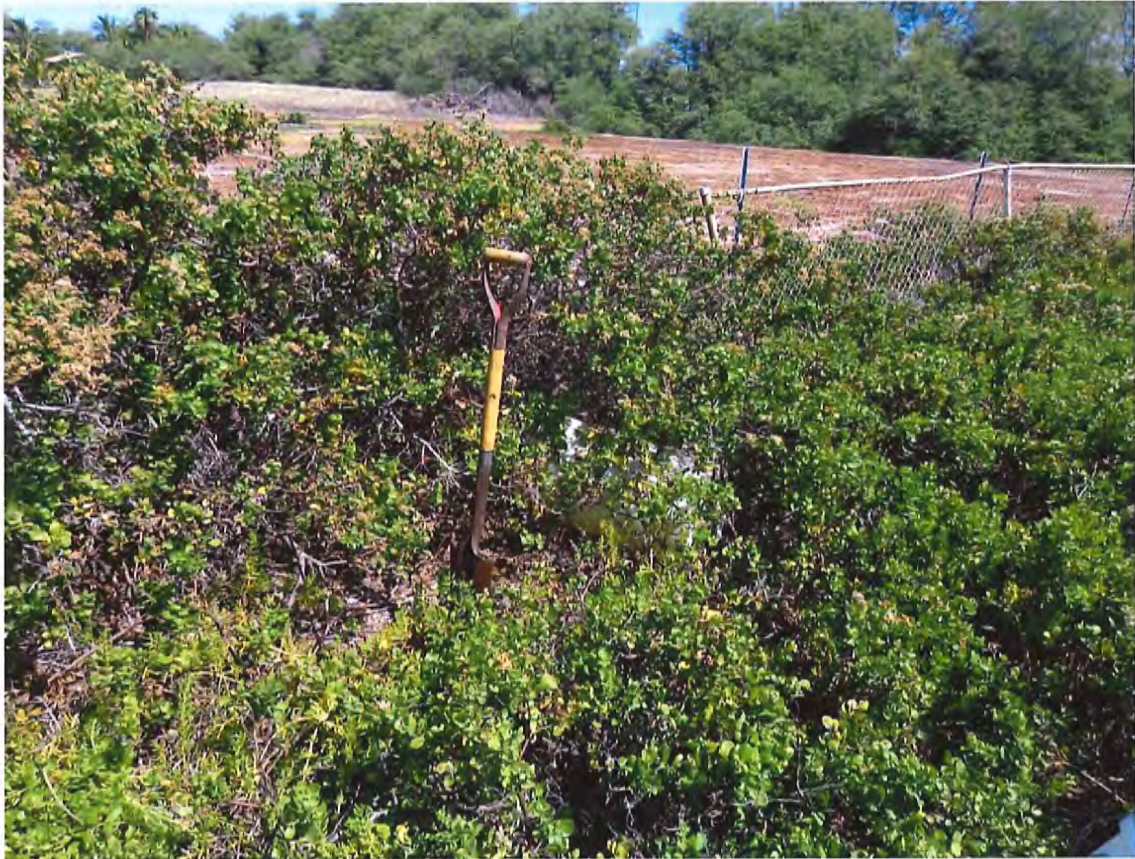
Sampling Point 9A. This plot lies on the DHHL project corridor on an elevated houselot parcel.
