Subject: Proposed Department of Hawaiian Home Lands Kapa'akea Flood Mitigation Improvements

With this letter, the State of Hawai'i, Department of Hawaiian Home Lands (DHHL) hereby transmits the Final Environmental Assessment and Finding of No Significant Impact (FEA-FONSI) for the Proposed Kapa'akea Flood Mitigation Improvements Project, situated on five (5) DHHL Homestead lots identified by TMKs (2)5-4-007:009(por.), (2)5-4-007:010(por.), (2)5-4-007:011(por.), (2)5-4-007:024(por.), and (2)5-4-007:025(por.), within the Kapa'akea Ahupua'a near Kaunakakai on the island of Molokai for publication in the next available edition of the Environmental Notice.

Project Name:	Proposed Department of Hawaiian Home Lands Kapa'akea Flood Mitigation Improvements
Project Short Name:	Kapa'akea Flood Mitigation Improvements
HRS §343-5 Trigger(s):	Use of State Lands and State Funds
Island(s):	Moloka'i
Judicial District(s):	Moloka'i
TMK(s):	(2)5-4-007:009 (por.), (2)5-4-007:010 (por.), (2)5-4-007:011 (por.), (2)5-4-007:024 (por.), (2)5-4-007:025 (por.)
Permit(s)/Approval(s):	National Pollutant Discharge Elimination System (NPDES) Permit, as applicable; Community Noise Permit, as applicable; Building

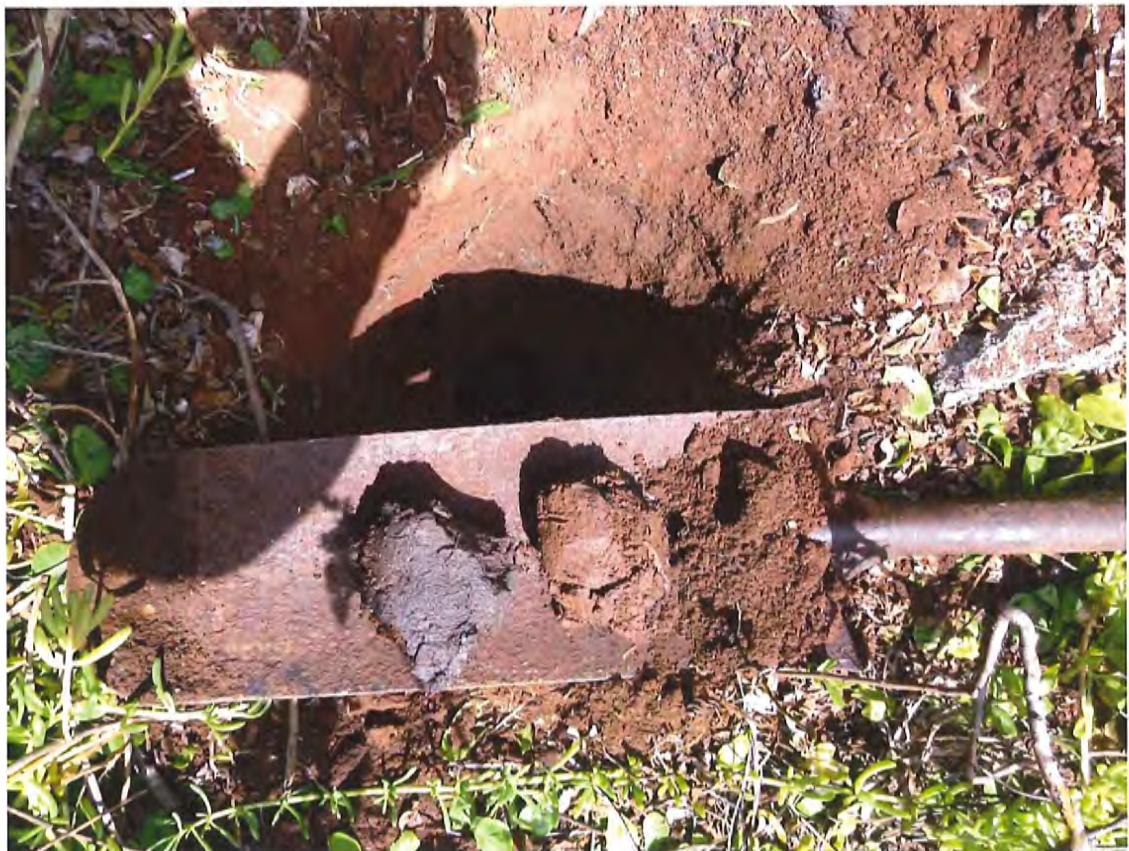
**NO WETLAND HYDROLOGY INDICATORS OCCUR CLOSE ENOUGH TO THE SURFACE TO EXPRESS THE CHARACTER OF A WETLAND ENVIRONMENT.**

Sampling Point 9B. The soil here is saturated at a depth of 33 inches and the water table is at a depth of 38 inches.

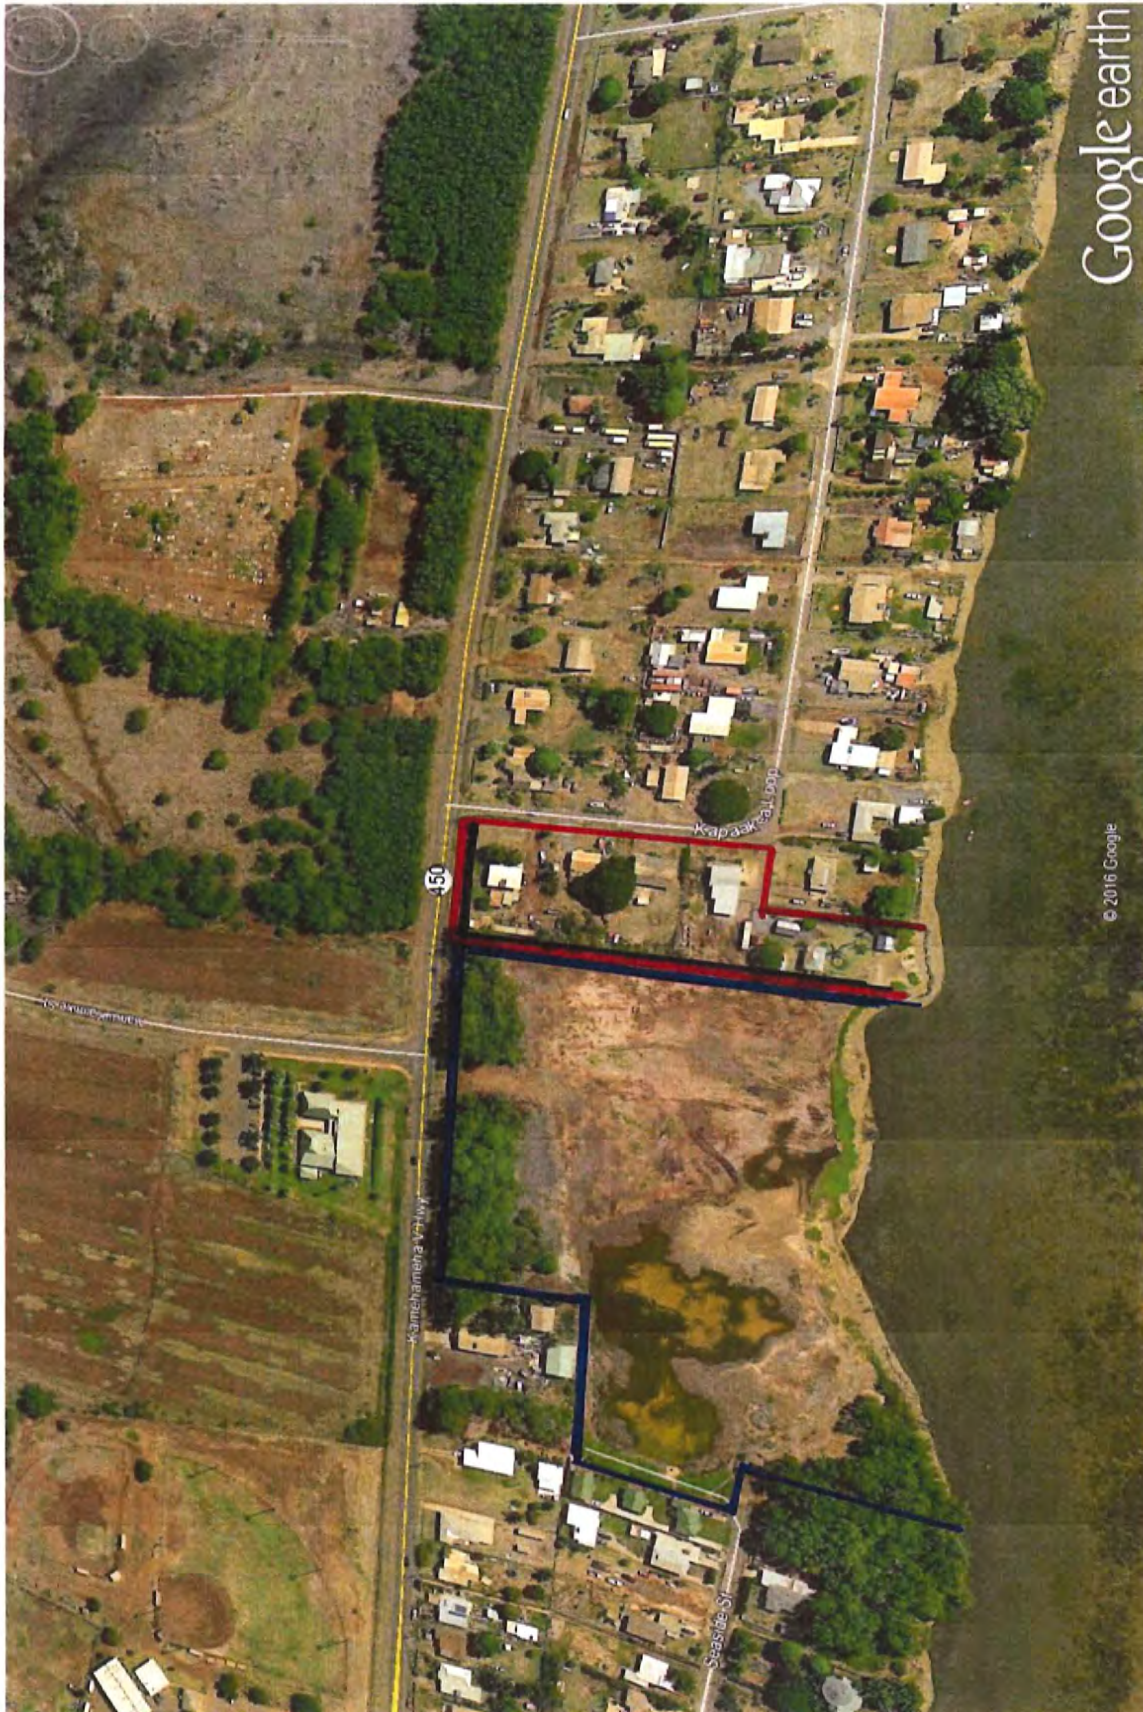
Figure 2.

**DHHL Kapa'akea Flood Mitigation Project boundary**  
**Proposed concrete wall along the west and north project boundaries**  
**Kōheo Wetland – Goodfellow Brothers, Inc.**

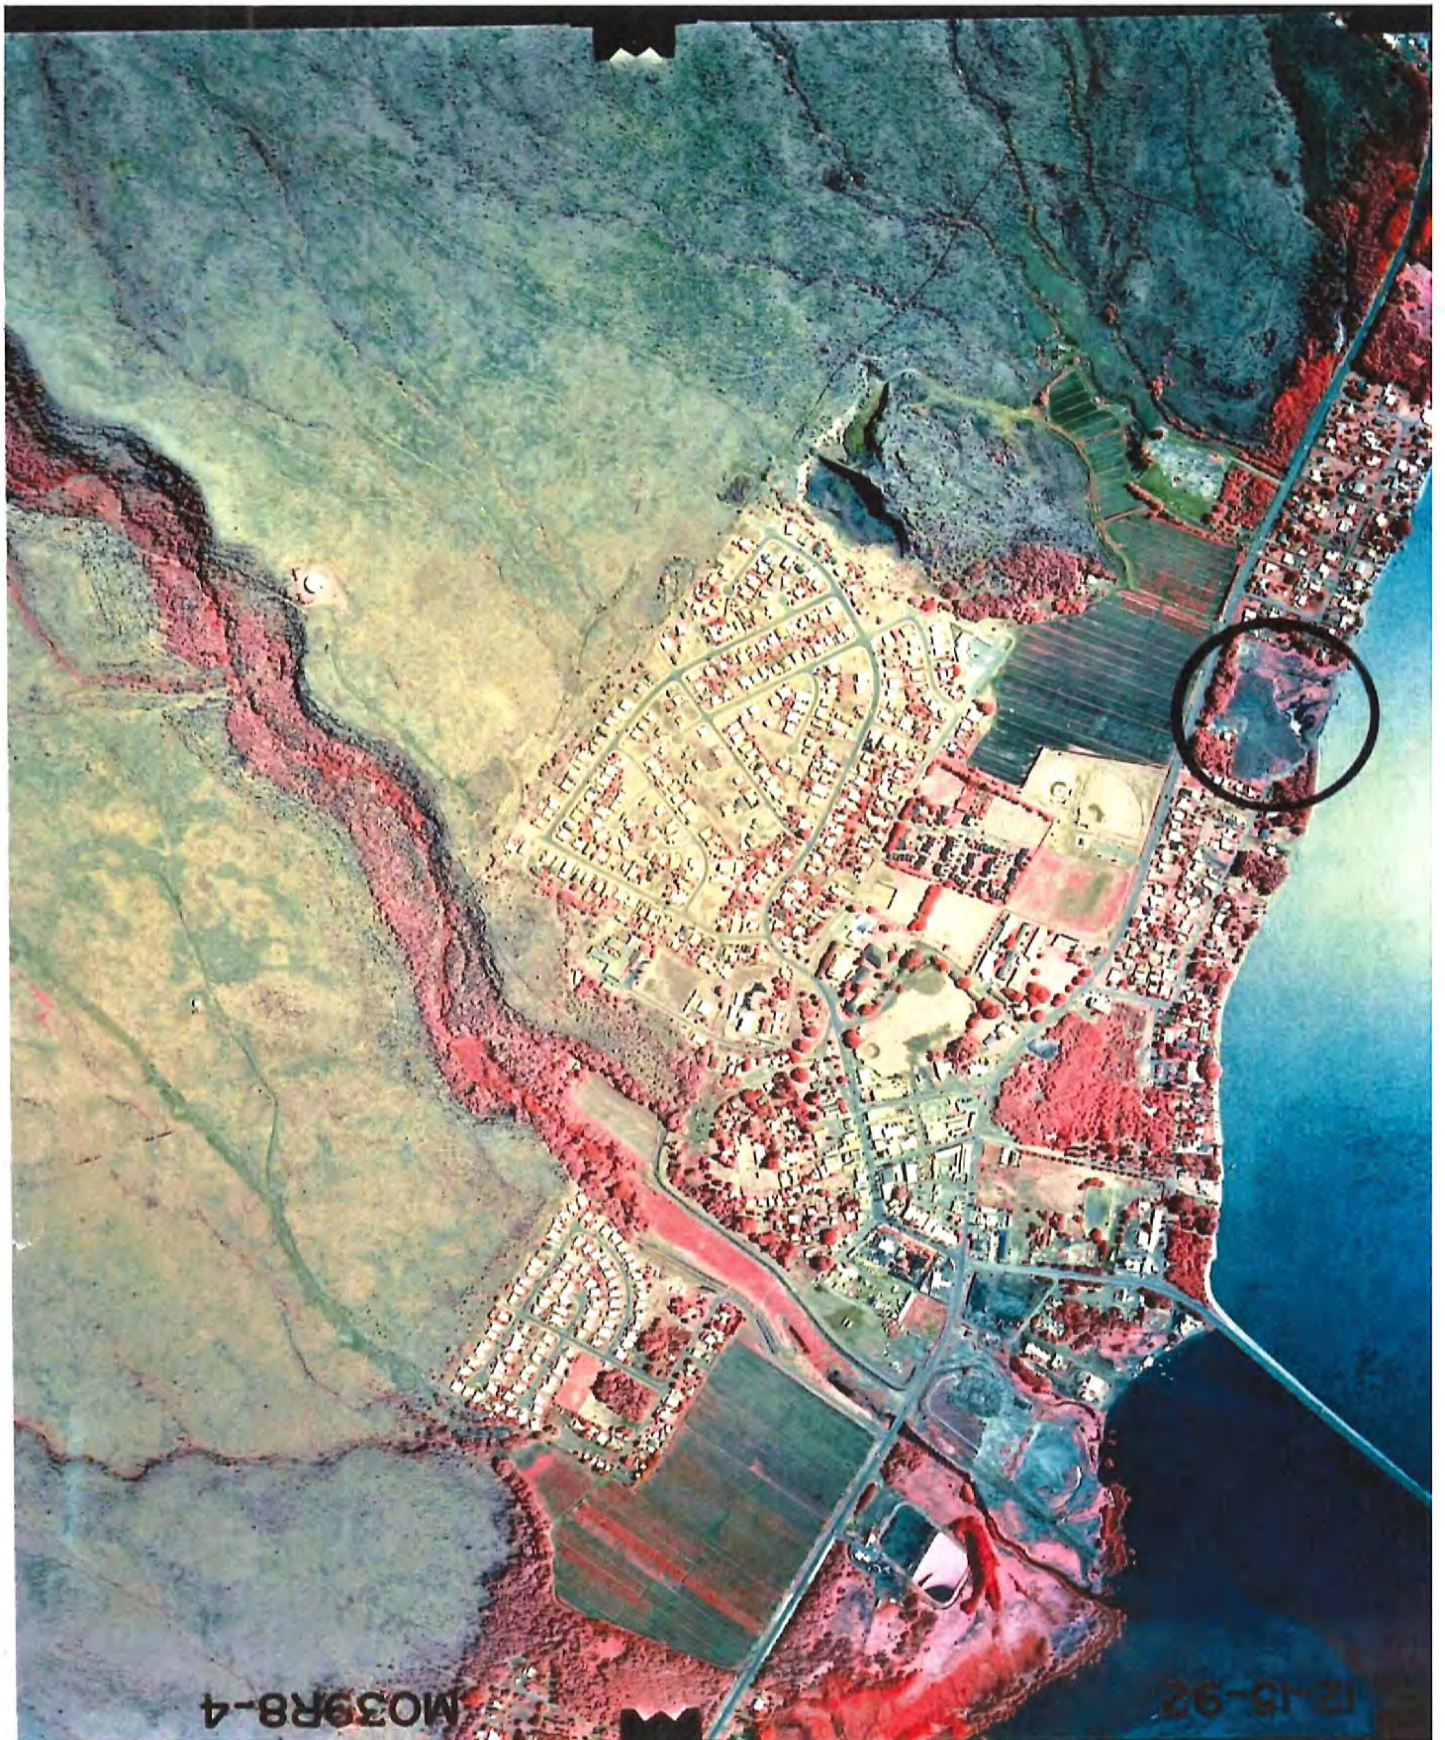
Figure 8. 1992 Infrared aerial photograph showing Kōheo pond with fill material in place.

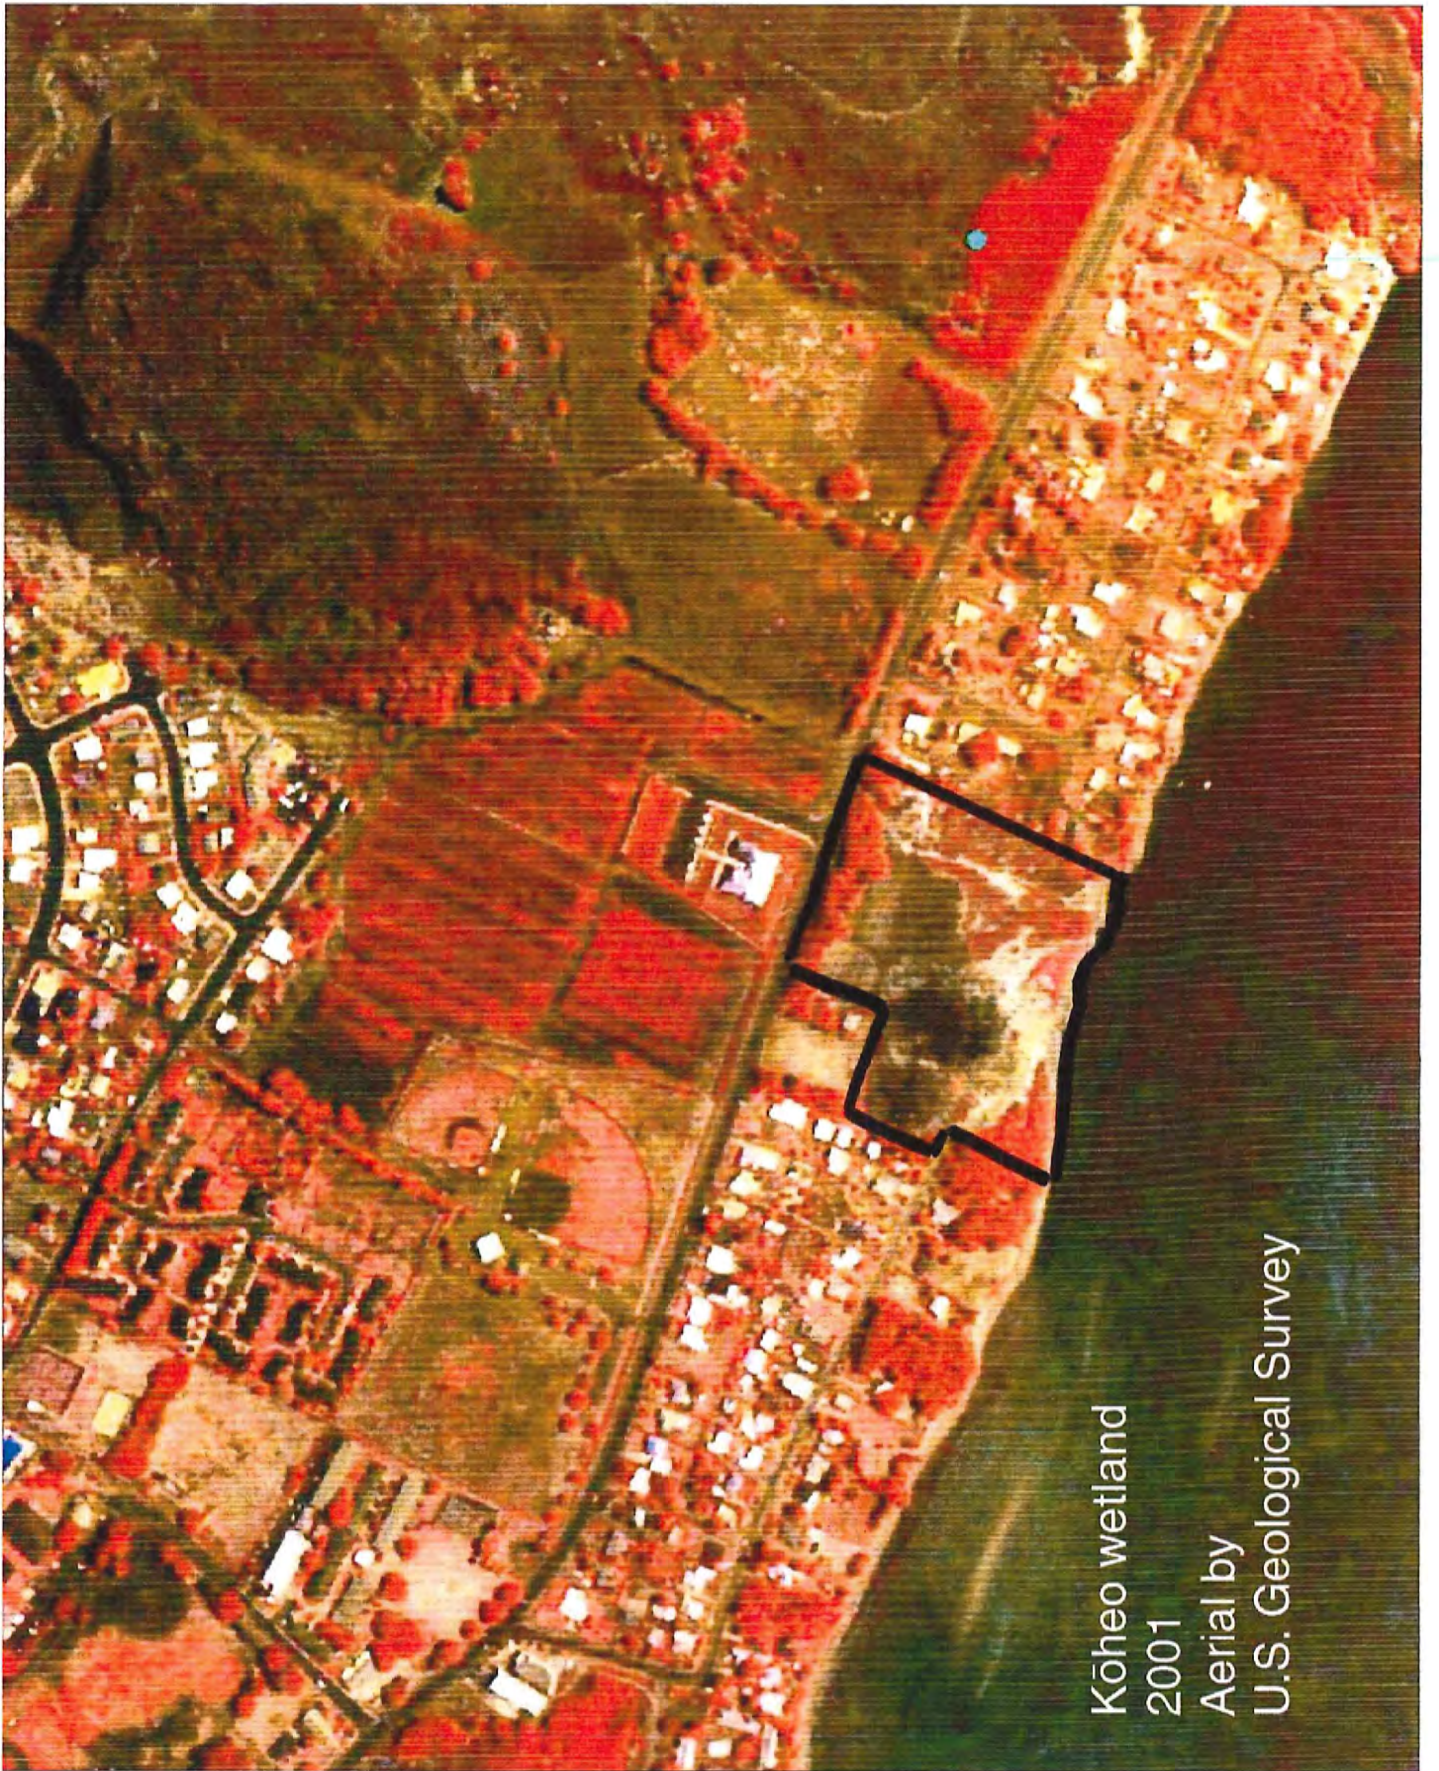
Figure 9. 2001 U.S.G.S. aerial photograph with fill material removed.

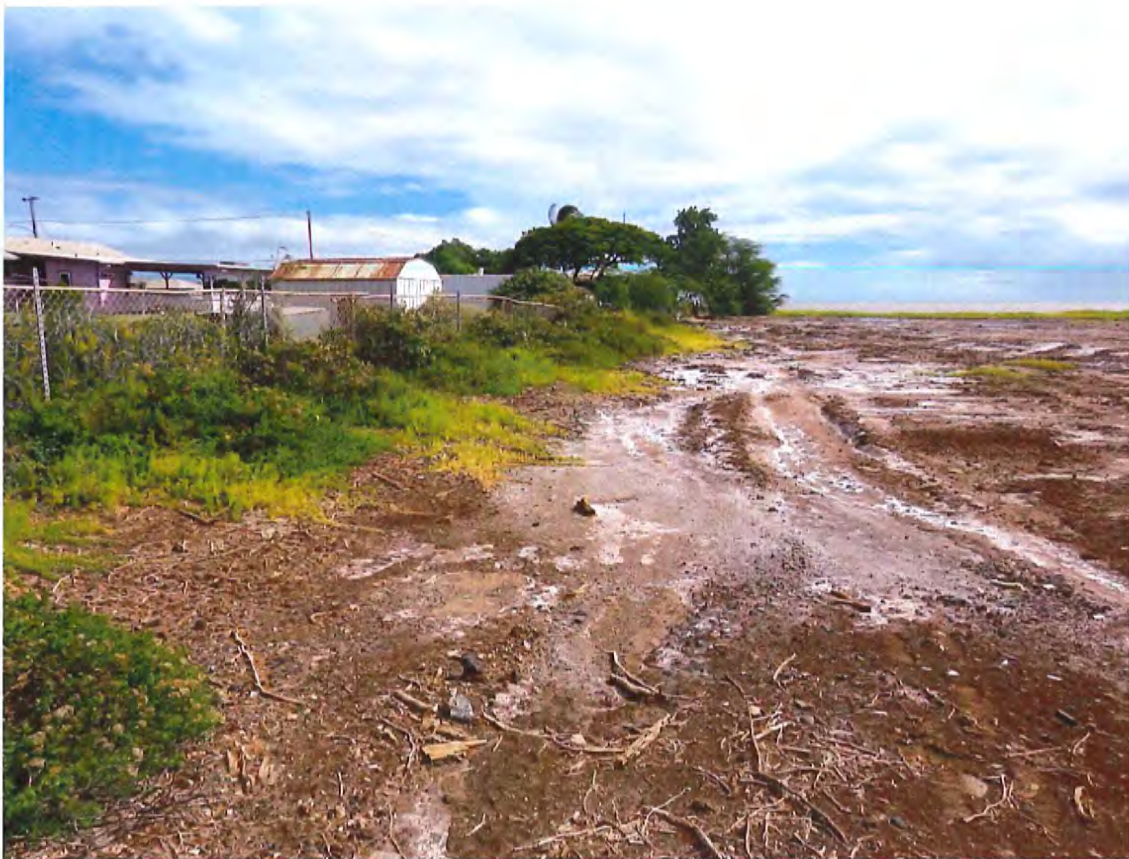
Figure 13. Kōheo wetland margin on right. Elevated DHHL boundary (fenceline) at left.

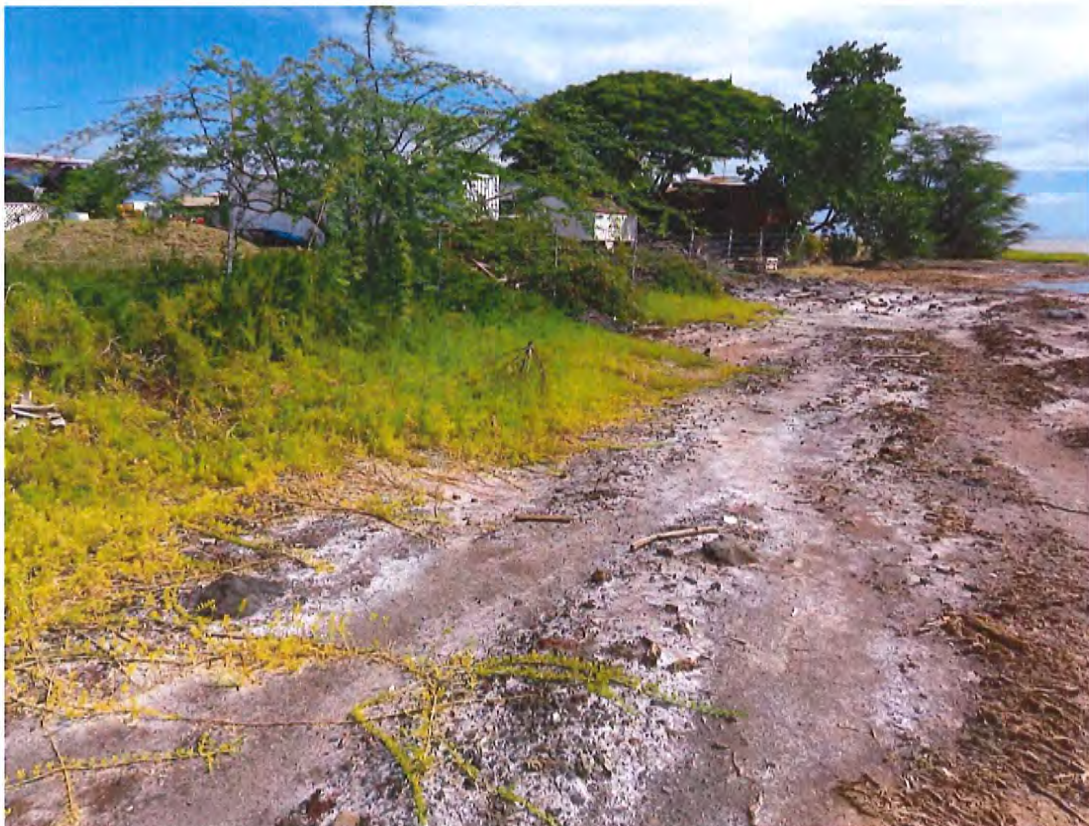
Figure 14. Kōheo wetland margin on right with an abundance of crystalized surface salt. Grounds slope up to the DHHL house lots on the left. Slope retains a remnant cover of *Batis maritima*.

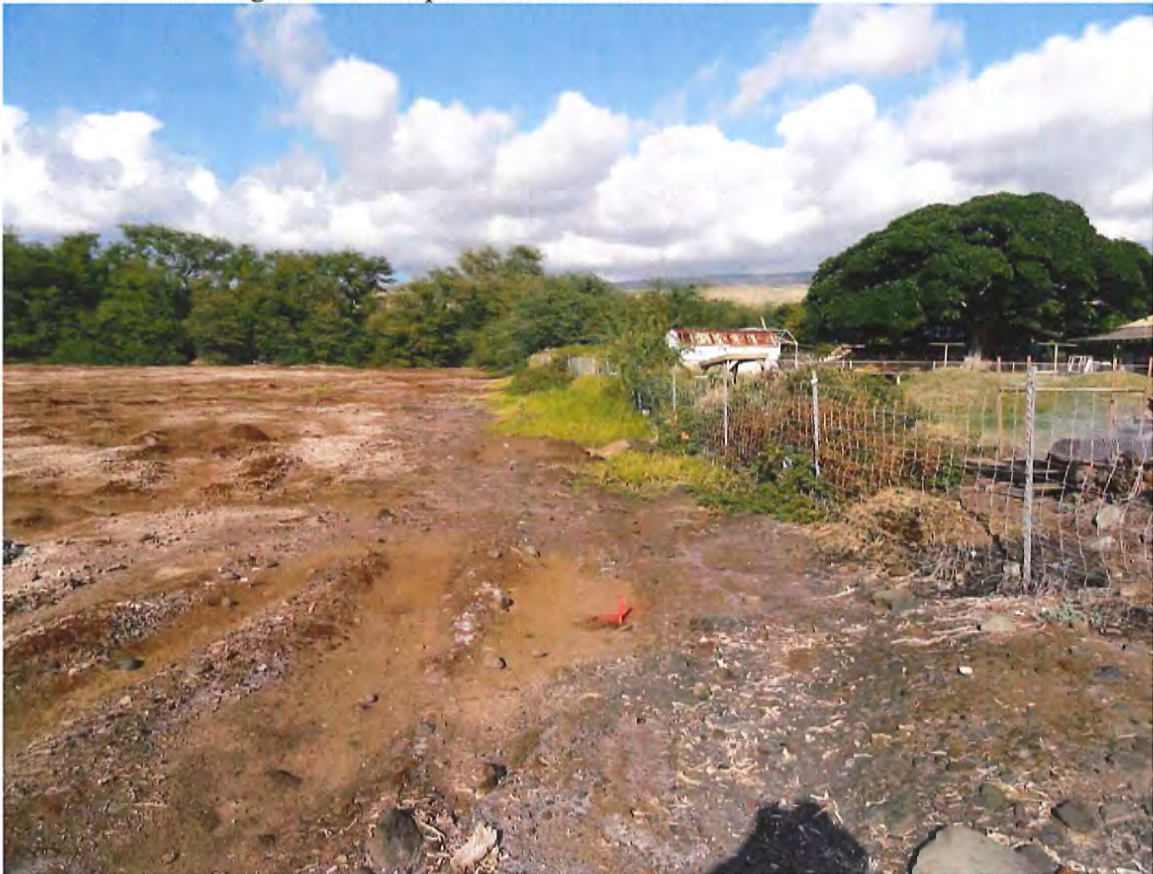
Figure 16. View north along the project boundary. The proposed wetland boundary is indicated by red stakes which are located near the toe of the slope below the elevated DHHL houselots.
