SUBJECT: Chapter 343, Hawaii Revised Statutes (HRS)  
Draft Environmental Assessment (DEA)

Project: Mark Button and Heidi Snow Seawall  
Applicants: Mark Button and Heidi Snow  
Agent: Gundaker Works LLC (Mark Ticonni)  
Location: 68-505 and 68-511 Crozier Drive – Waialae  
Tax Map Keys: 6-8-004: 018 and 031  
Request: After-the-fact Shoreline Setback Variance (SSV)  
Chapter 23, Revised Ordinances of Honolulu  
Proposal: To allow (retain) a continuous concrete and timber seawall  
along two residential lots.

With this letter, the Department of Planning and Permitting hereby transmits the DEA and anticipated finding of no significant impact (DEA-AFONSI) for the retention of an reconstructed timber and concrete seawall and backfill within the 40-foot shoreline setback of the above-referenced parcels in the Koolauloa District on the island of Oahu, for publication in the next edition of "The Environmental Notice."

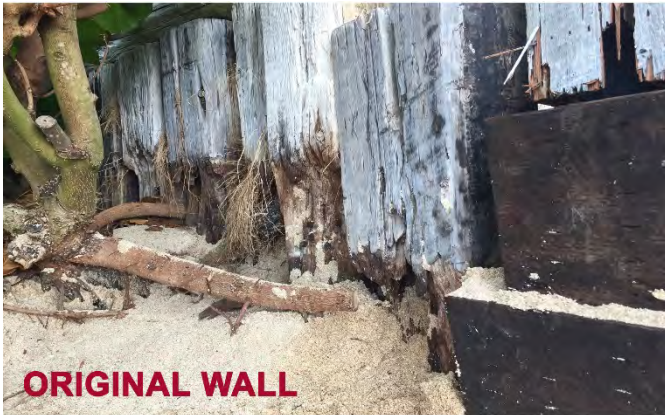
**Figure 3A.1**

(1) TMK 6-8-004:018

Photo Above: October 2016

Photo Below: December 2017

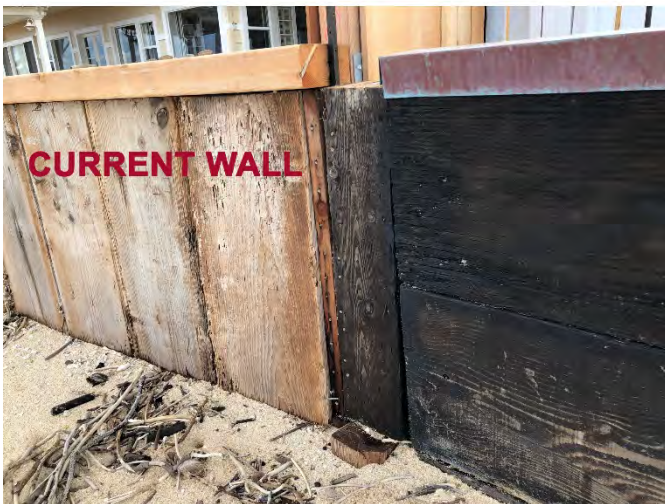
**Figure 3A.2**

(1) TMK 6-8-004:018

Photo Right: December 2017

Description: Although photo was taken during low tide, High tide of ocean swell is shown clearly by the positioning of the drift wood in the photo.

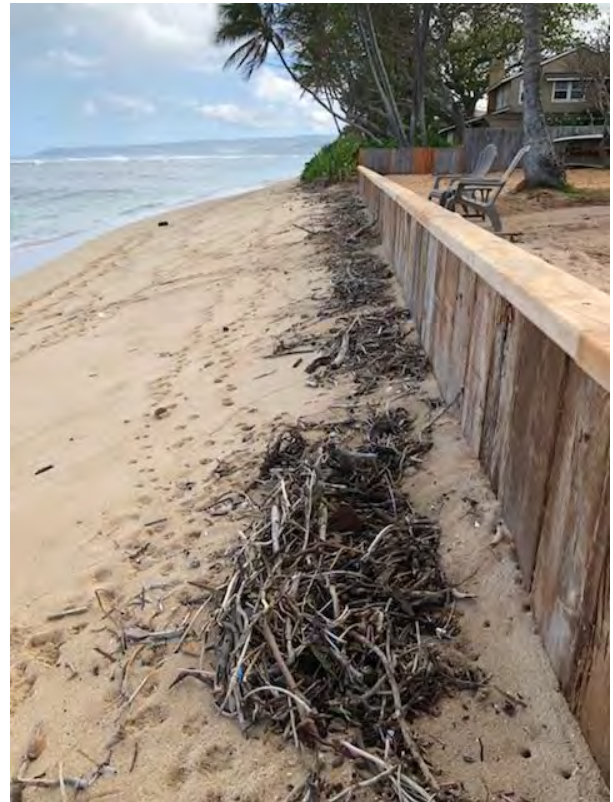
**Figure 3A**

**SUBJECT SEAWALL (1) TMK: 6-8-004:018**

**68-505 CROZIER DRIVE, Waialua, Hawaii 96791**

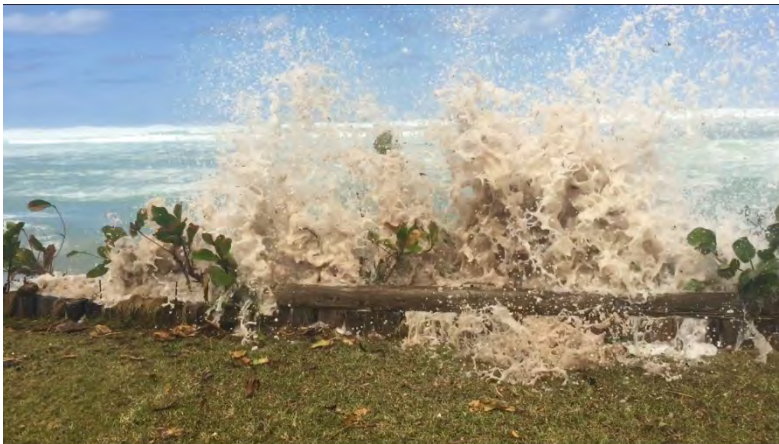
Figure **3B.2**

(1) TMK 6-8-004:018

Description: Incoming Ocean Swells clearly making contact with Subject property's wooden seawall.

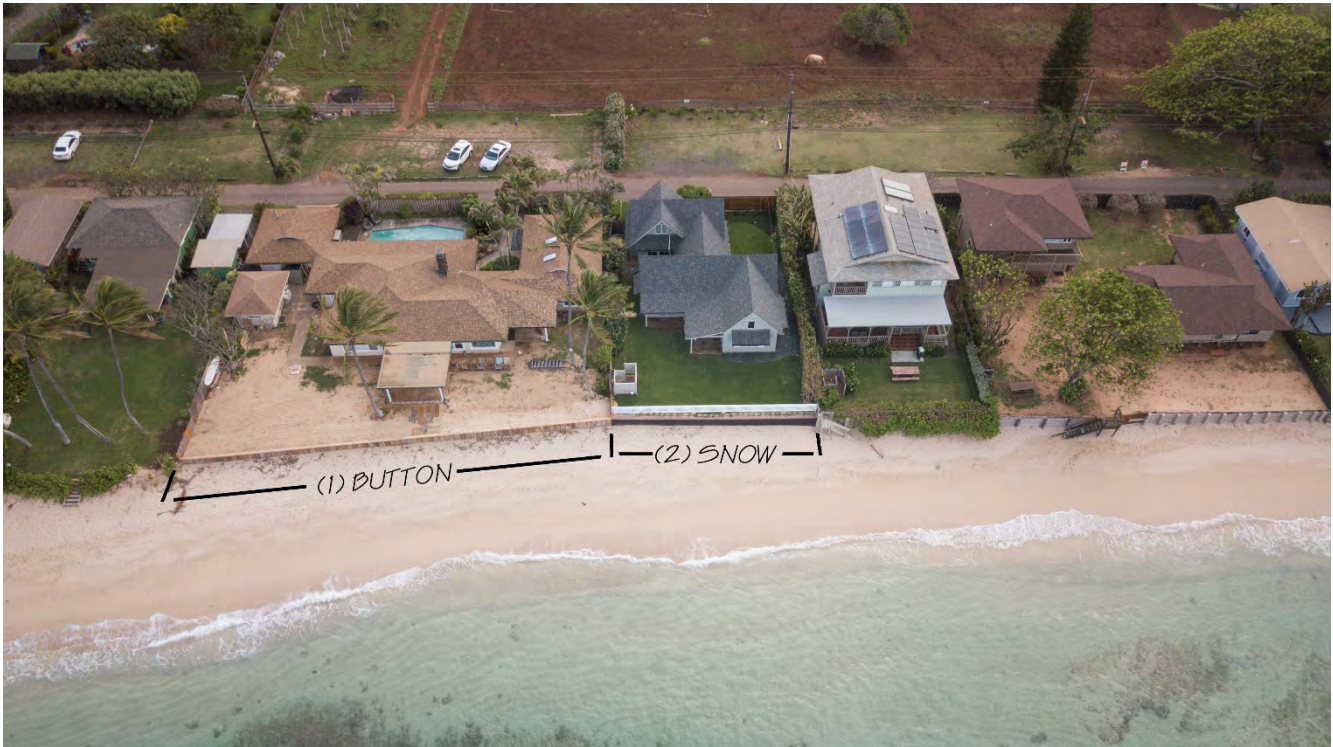
Figure **3C.1**

Photo Left: February 2016

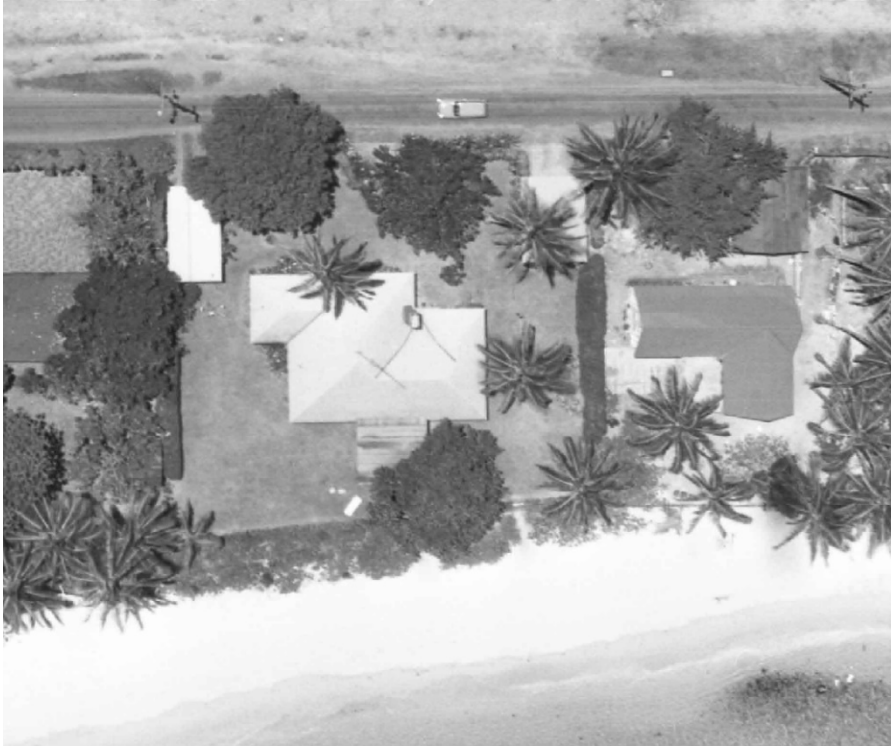
Figure **5.1**  
Historical Aerial photo  
April 22, 1967

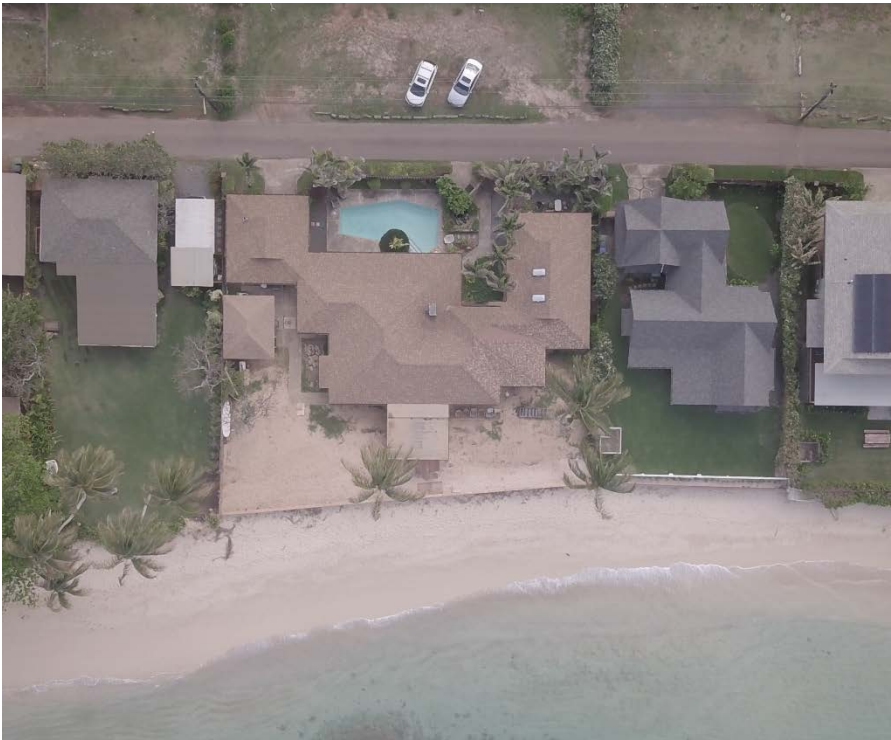
Figure **5.2**  
Modern Aerial Photo  
January 2018

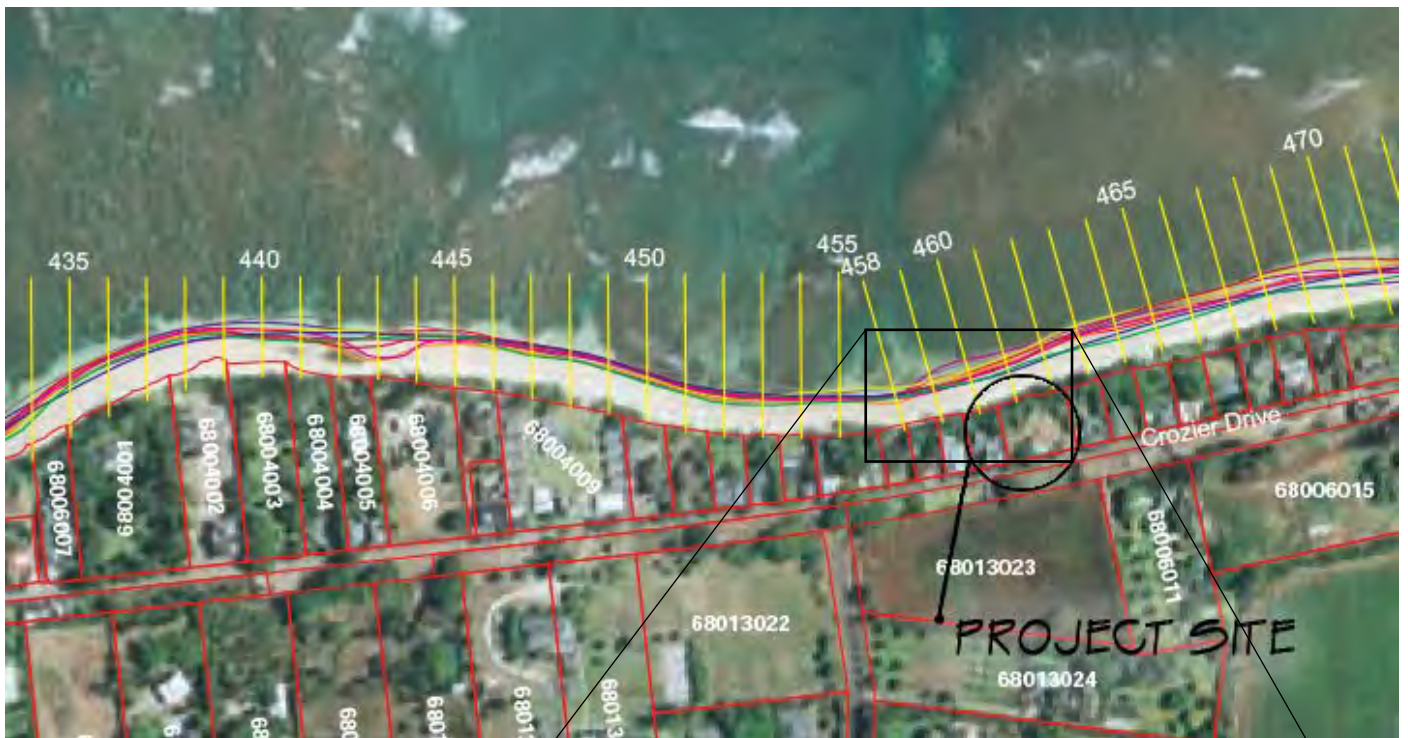
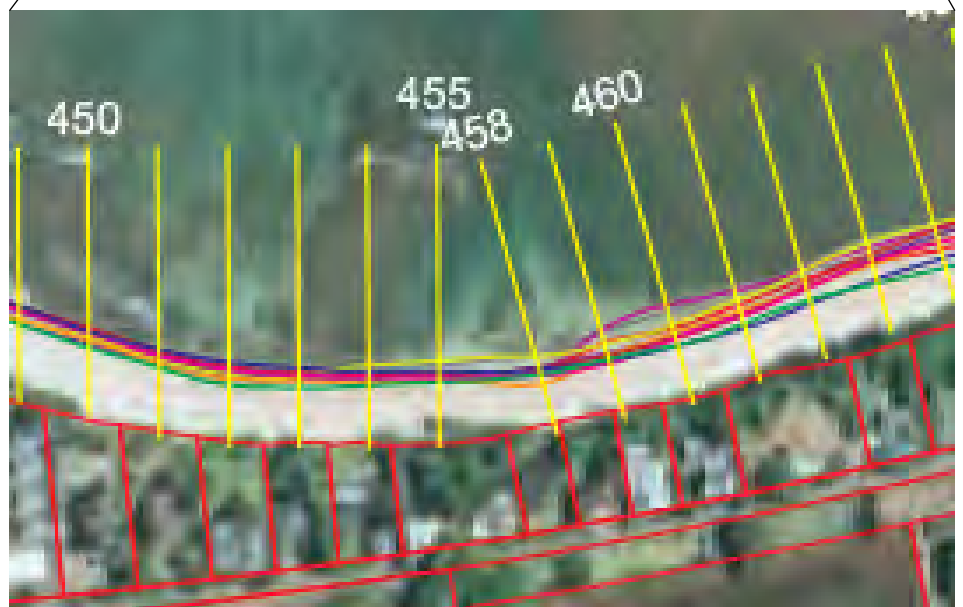
**Figure 7**

**BEACH LOSS – Historical Aerial Graphic**

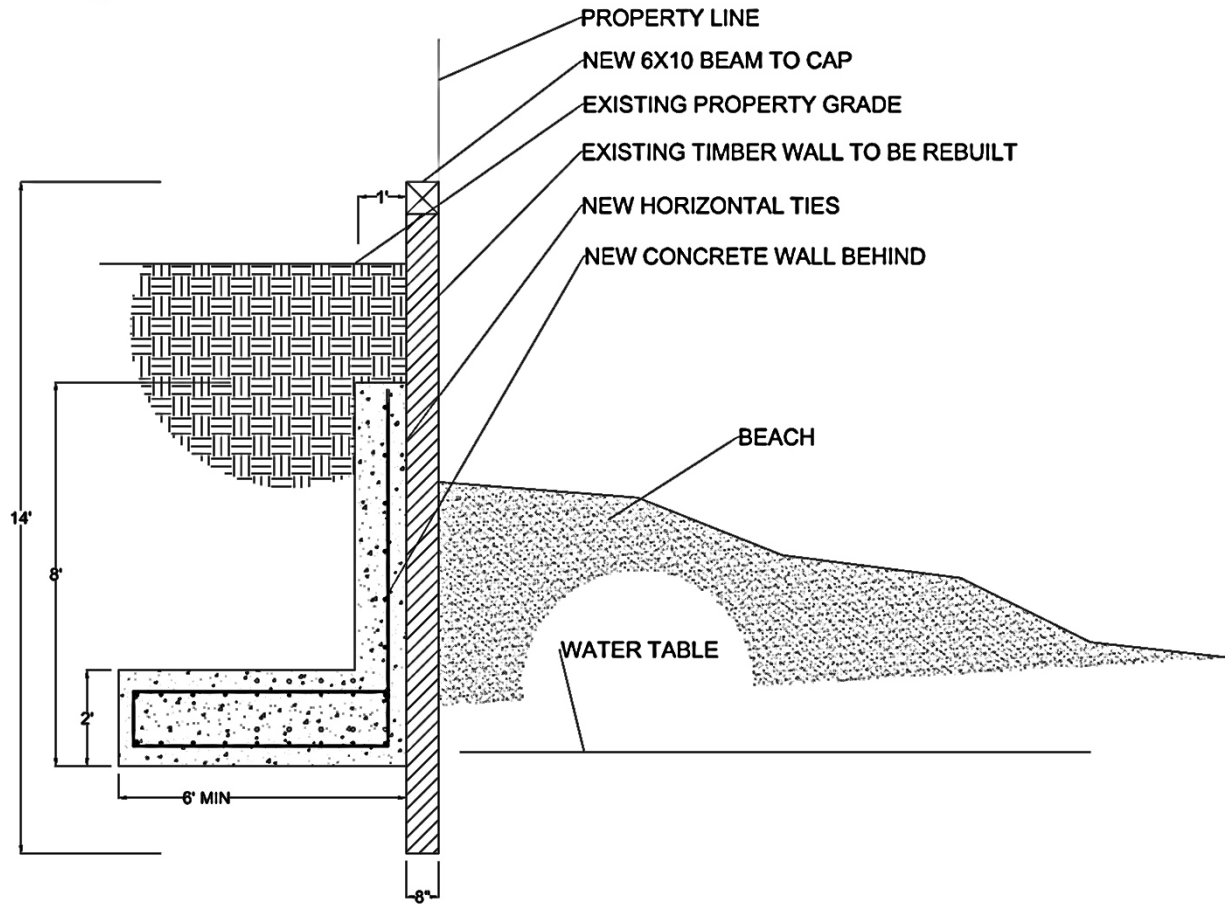
1 EXISTING SEAWALL SECTION  
001 AS BUILT ALTERATIONS

NEW CONCRETE WALL TO HAVE MMFX REBAR  
 #4 @ 12" O.C. EACH WAY BEHIND TIMBER WALL AND  
 #5 @ 8" O.C. ON BOTH THE TOP AND BOTTOM ROW OF FOUNDATION  
 WALL TO BE 12" IN WIDTH, 8' IN HEIGHT AND STRETCH THE LENGTH OF THE OCEAN FRONT

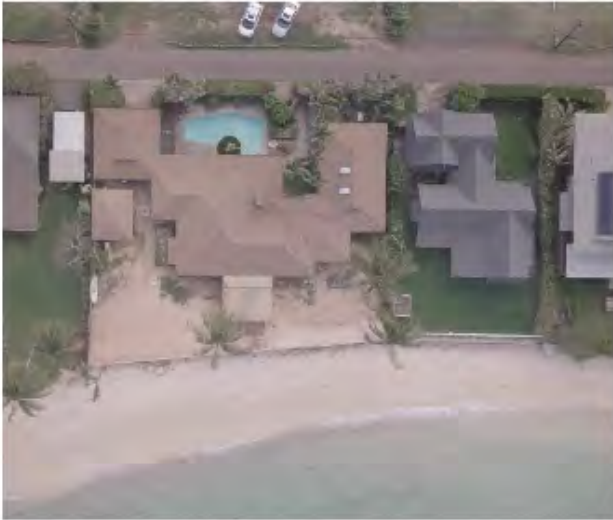
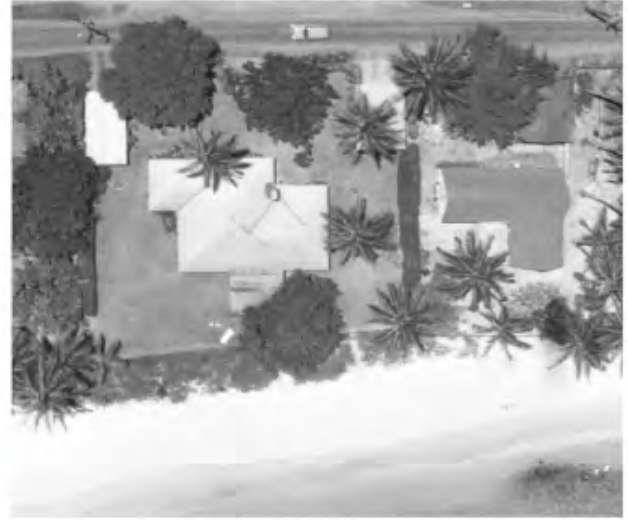
The beach profile in the area is rather constant and varies with slopes between 10% and 30% depending on the status of the littoral system. Where the normal water level intersects the beach profile and seaward of this line, there is the foreshore. The foreshore has about 4 feet in elevation change resulting in about 8-12 feet of lateral distance into the water. The bottom at the toe of the foreshore is crushed coral and is at about the same elevation as reported in previous geotechnical investigations in the yard that terminate at this depth. The following photos demonstrate the normal beach profile at the two properties. The backshore upto the existing sea wall is sand with deposits of vegetation and driftwood that have washed up. This area is consistent with the highest reach of the waves as modeled using combine STWAVE source calculations as well as the USACE method for estimating run up on smooth impermeable slopes such as the near shore reef. The foreshore and backshore are both comprised of the uniformly graded calcium carbonate sand. For more details on the sand composition reference the previous geotechnical investigation. The historical photos below are undisputable evidence that the beach profile has not changed over 51 years.

Figure B. 2017 and 2018 Aerial Photograph Comparison  
(Photos are generally to the same scale +/-2%)

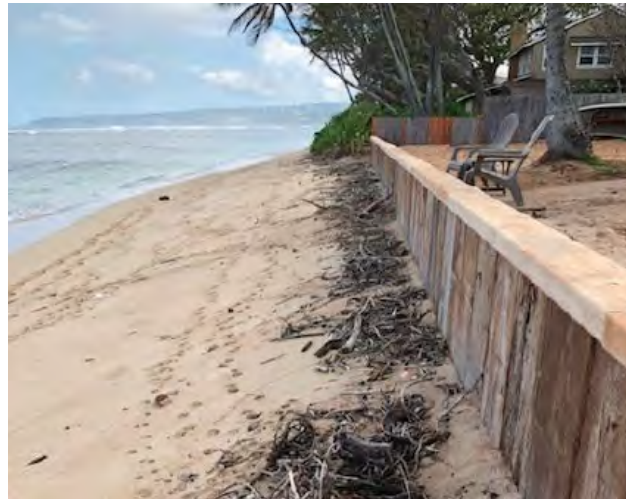
Figure C. Photo of Shoreline – Backshore

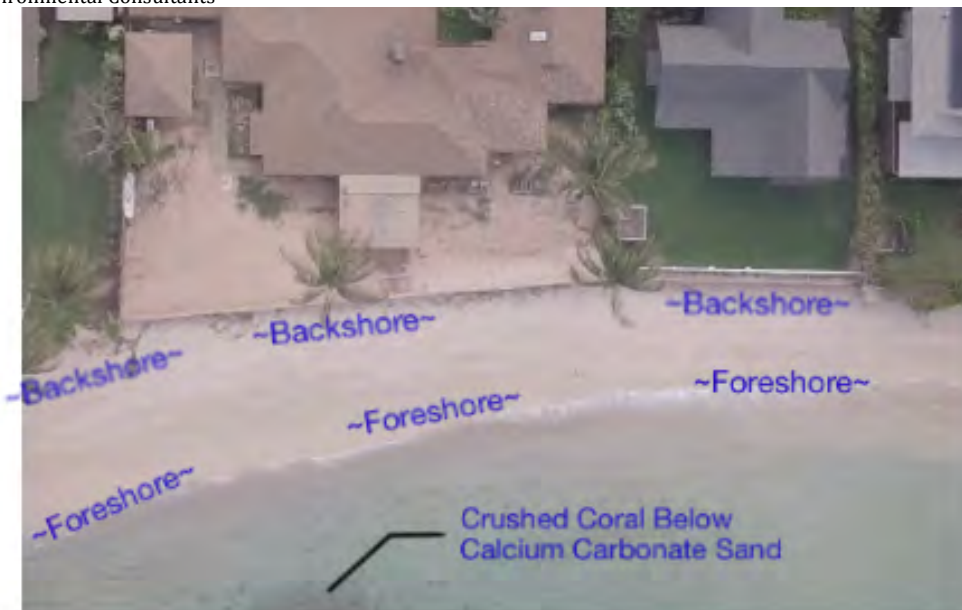
Figure D. Foreshore and Backshore Denoted on Aerial Photograph

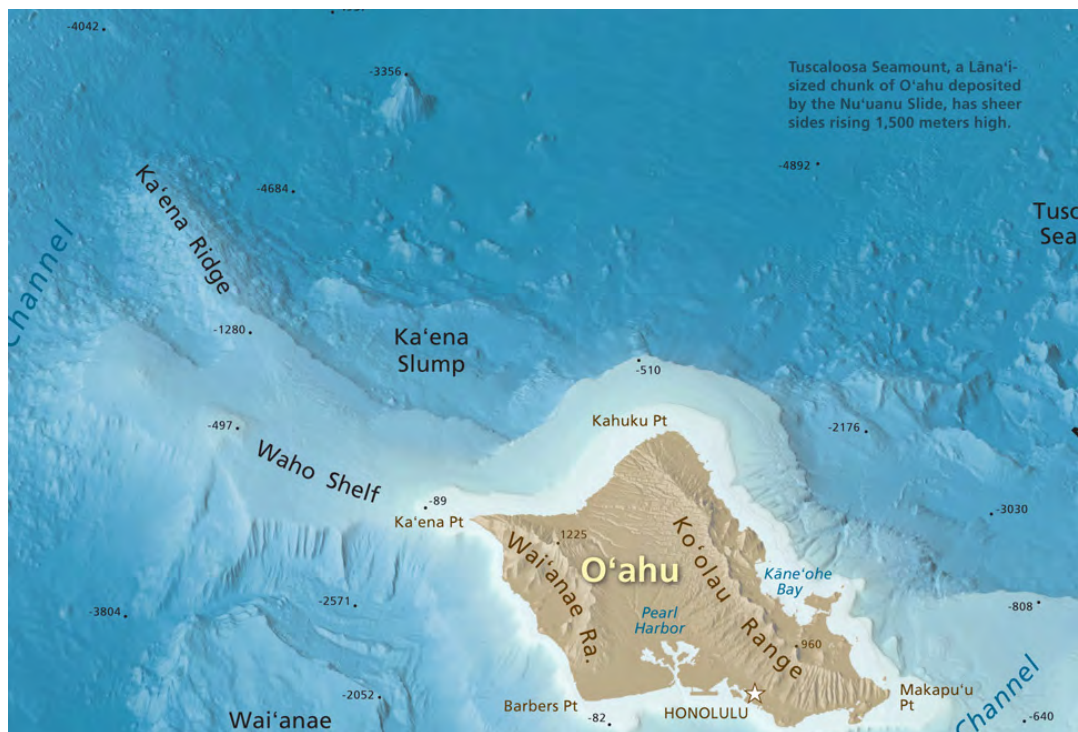
Figure G. USGS Data 2003

Littoral transport driven primarily by swell and wind waves dominates the coastal sand transport processes in the area offshore and affronting the properties of consideration. The reef structures also play a role in the balance of the sand transport. Given the primary direction of swell from the north west, waves are set-up and split by the reefs in random patterns. The withdrawal of the waves through submerged trenches and propagation of waves over these trenches creates a stirring and mixing effect that allows sand to be taken from the shoreline and also redeposited along the shoreline. The figure below outlines the littoral transport as well as the conveyance of sand from offshore and along the reef. Given the minimal to no net change of the shoreline since 1967 it is reasonable to assume the system is at littoral equilibrium and while cyclical erosion may occur of the sectional area identified in the beach profile, (figure e) further erosion is not anticipated except during discrete events. These discrete events are rare and improbable. that are not reasonably probable. The maintenance of the front face of the sea wall and backing seawall is therefore dually recommended without exception.

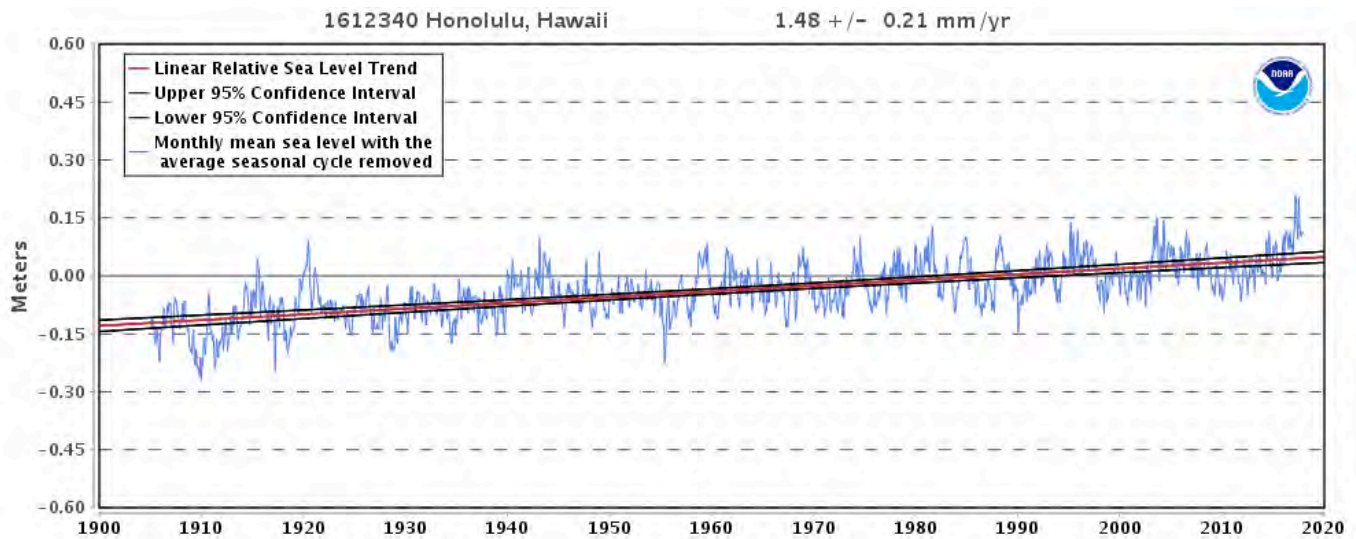
the water level in the bay just offshore. Sea Level rise associated with climate change and/or melting ice caps has been a common concern of the public. The figure below shows mean sea levels along with confidence intervals. Over the design life of the structure for the next 20 years, if a direct positive trend of 1.2mm rise per annum is continued, this would result in about a 1 inch rise in mean sea level rise. Given the location of the property relative to the reef, this would have negligible effects on the wave run-up and anticipating no change in the distribution of wave from various directions would have no significant effect on the current balance of the littoral drift.

Figure I. Sea Level Rise Extrapolation

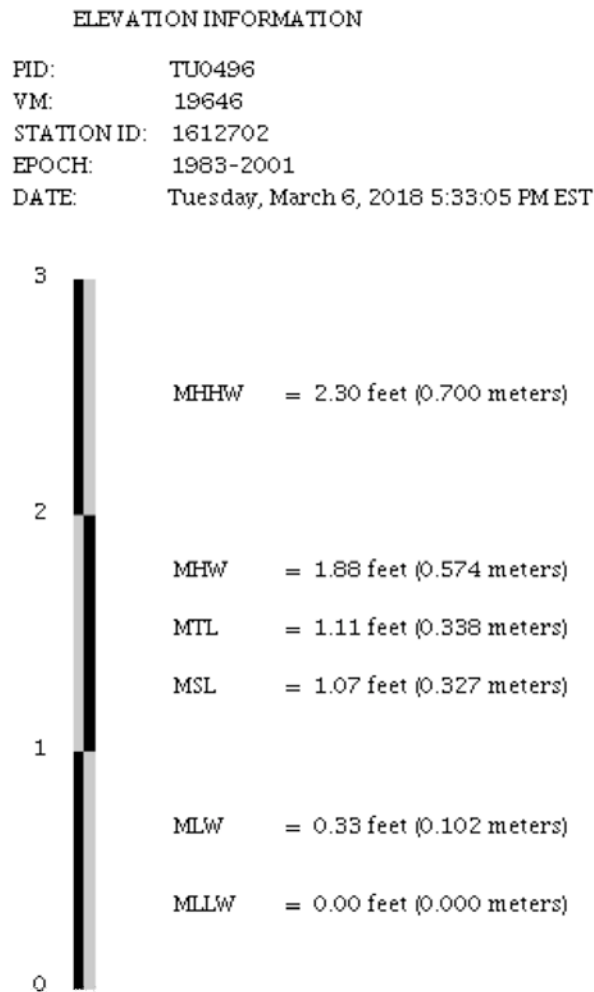
Figure J. Tidal Datum Variances (National Geodetic Survey)

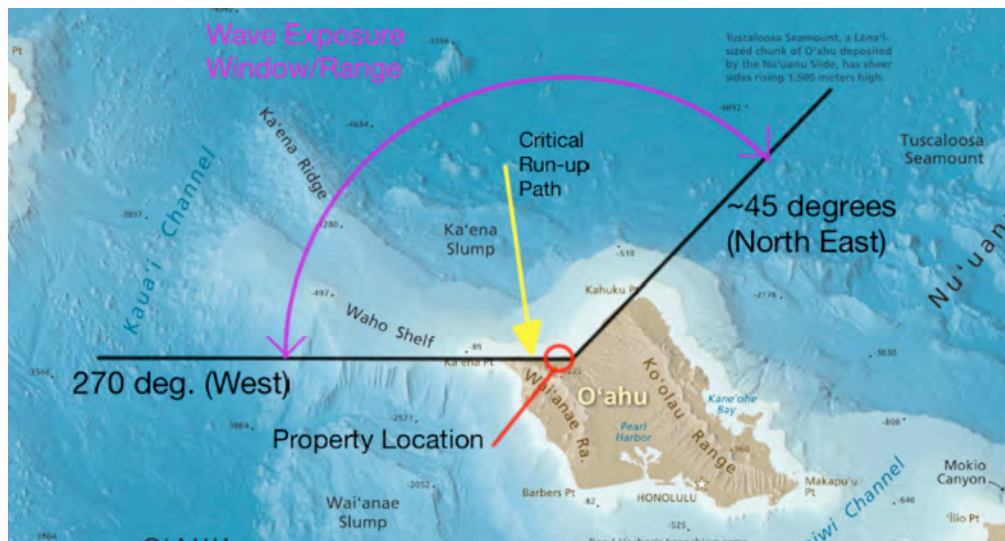
wave heights have the potential to result in large wave setup or surge atop the reef and may push the run up of the wave to the higher extents of the backshore. Wave Run-up will not substantially affect this structure unless the foreshore is eroded in ultra rare improbable instances.

Figure K. Figure Showing Critical Run up Path

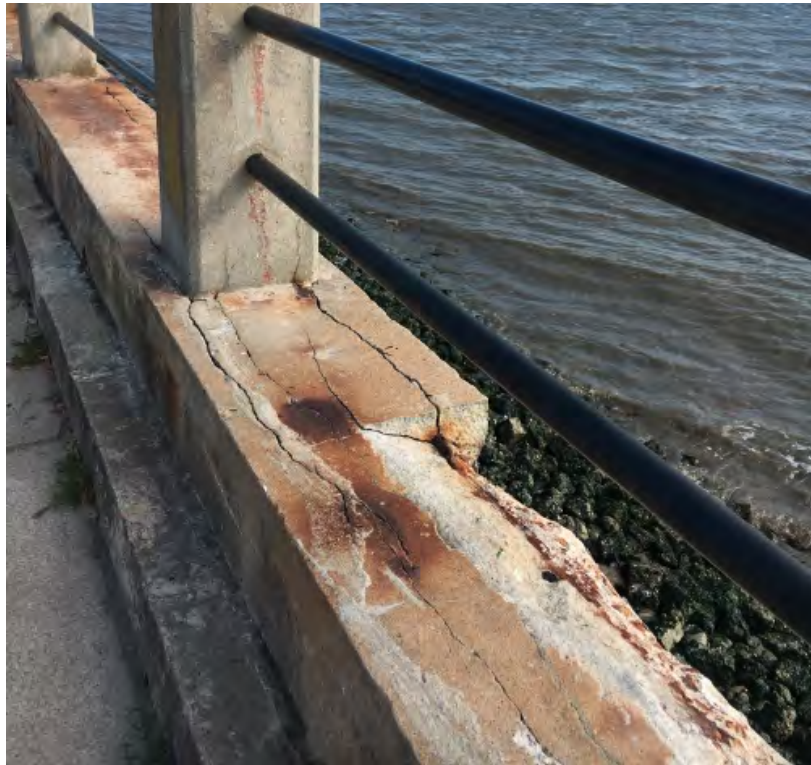
The sea wall upgrade will have a 20 year service life. The wall will be limited in performance by corrosion or the deleterious effects of the materials to withstand salt degradation. An example figure is provided below for a sea wall that has met its final life by means of corrosion failure. The life of the sea wall may be extended in the future by means of additional maintenance.

Figure L. Example End of Service Life of Sea Wall Due to Rebar Corrosion

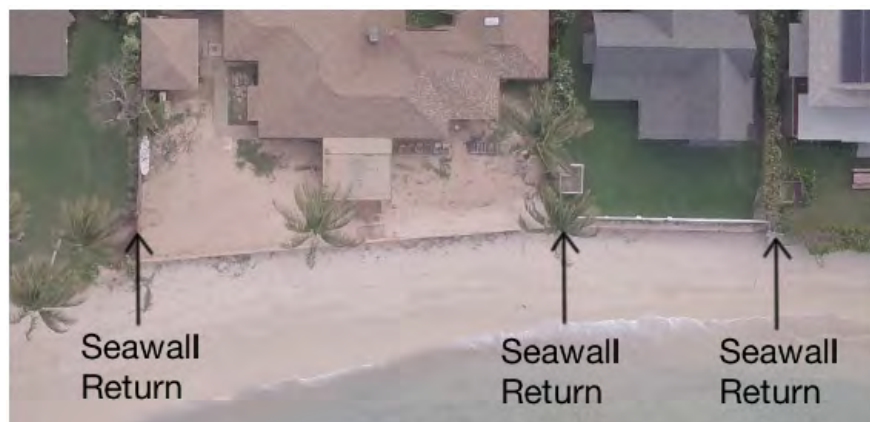
Both properties currently include flank protection. While these current wall returns provide protection, they are ultimately there in contingency should an adjacent seawall fail. Given the continuous nature of this shoreline as well as the minimal variance in littoral sand drift/onshore-offshore sand exchange, flank protection is unnecessary. The offshore reef also provides significant protection from flanking as the wave travel distance along approach angles near to parallel to the shore resulting in hydraulic resistance and dissipation capability such that wave energy is almost completely abated. Upgrades to the sea wall will not include returns as the wall will be designed to settle should and event of such occur. This relies on the fact that flanking by waves around the sea wall would only occur in the event the beach was completely eroded. Given this has not occurred in 50 years, the event is not reasonable or cost justified to account for.

Figure M. Current Seawall Returns

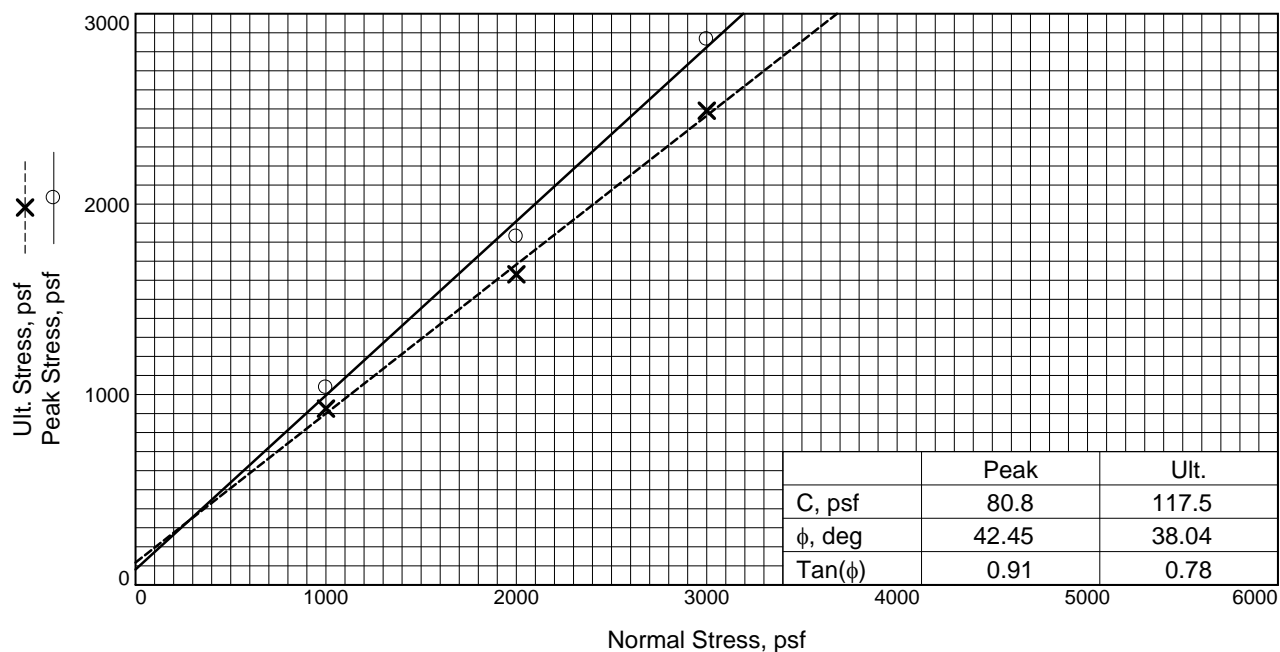
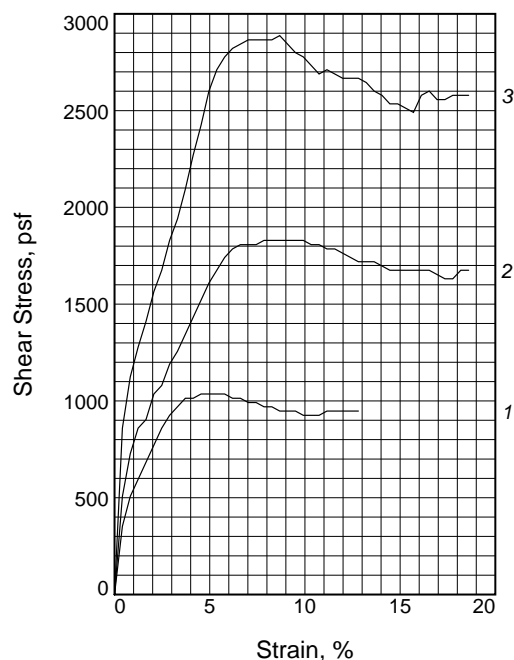
Sample No.		1	2	3
Initial	Water Content, %	N/A	N/A	N/A
	Dry Density, pcf	N/A	N/A	N/A
	Saturation, %	N/A	N/A	N/A
	Void Ratio	N/A	N/A	N/A
	Diameter, in.	2.420	2.420	2.420
	Height, in.	1.000	1.000	1.000
At Test	Water Content, %	N/A	N/A	N/A
	Dry Density, pcf			
	Saturation, %			
	Void Ratio			
	Diameter, in.			
	Height, in.			
Normal Stress, psf		1000.0	2000.0	3000.0
Peak Stress, psf		1035.9	1829.3	2865.2
Strain, %		4.5	7.9	7.0
Ult. Stress, psf		925.7	1631.0	2490.5
Strain, %		10.3	17.4	15.7
Strain rate, in./min.		N/A	N/A	N/A

**Sample Type:** SP  
**Description:** SAND

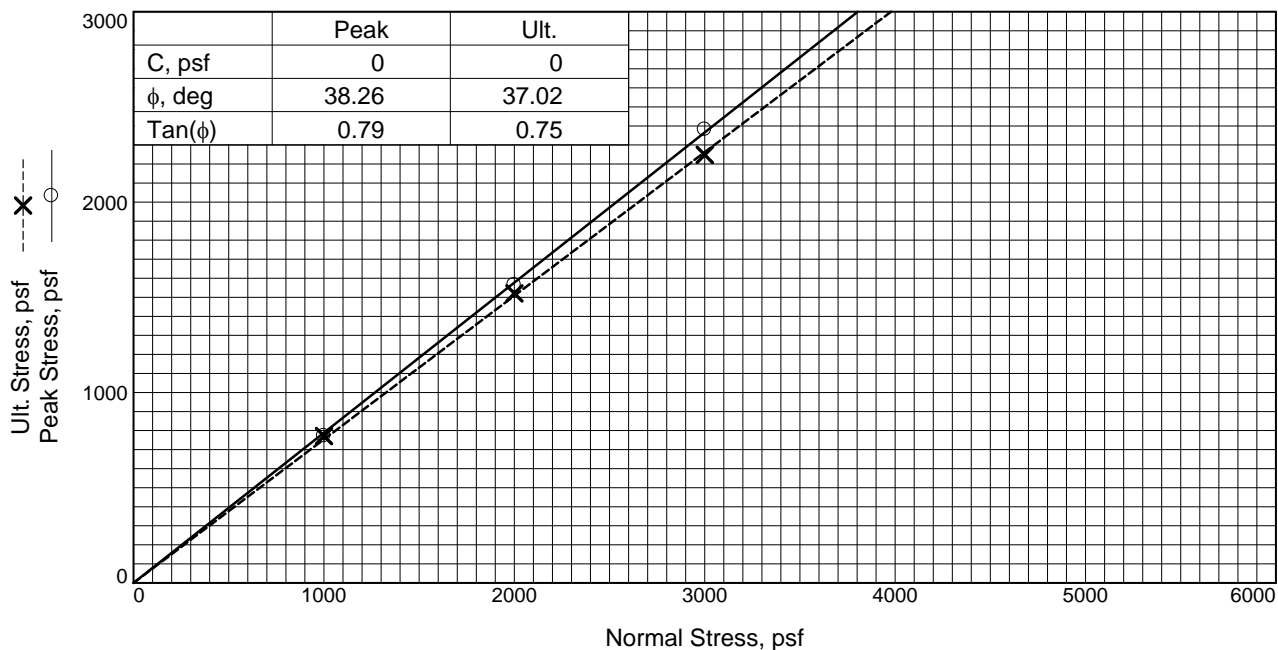
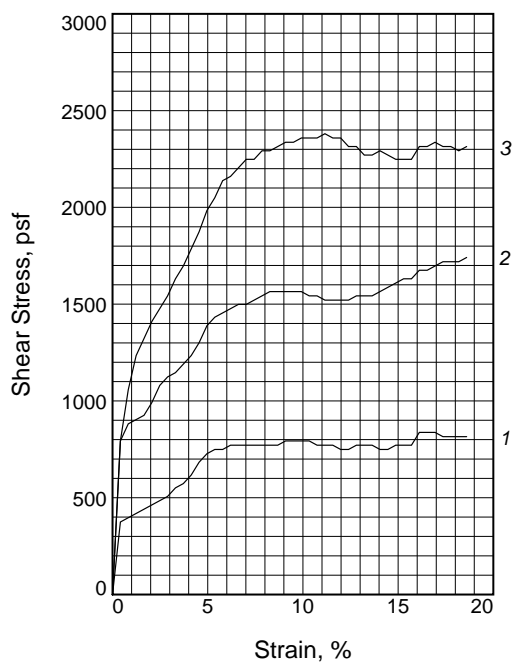
Sample No.		1	2	3
Initial	Water Content, %	N/A	N/A	N/A
	Dry Density, pcf	N/A	N/A	N/A
	Saturation, %	N/A	N/A	N/A
	Void Ratio	N/A	N/A	N/A
	Diameter, in.	2.420	2.420	2.420
	Height, in.	1.000	1.000	1.000
At Test	Water Content, %	N/A	N/A	N/A
	Dry Density, pcf	N/A	N/A	N/A
	Saturation, %	N/A	N/A	N/A
	Void Ratio	N/A	N/A	N/A
	Diameter, in.	N/A	N/A	N/A
	Height, in.	N/A	N/A	N/A
Normal Stress, psf		1000.0	2000.0	3000.0
Peak Stress, psf		771.4	1564.9	2380.3
Strain, %		6.2	8.3	11.2
Ult. Stress, psf		771.4	1520.8	2248.1
Strain, %		6.2	11.2	14.9
Strain rate, in./min.		N/A	N/A	N/A

**Sample Type:** SP  
**Description:** SAND

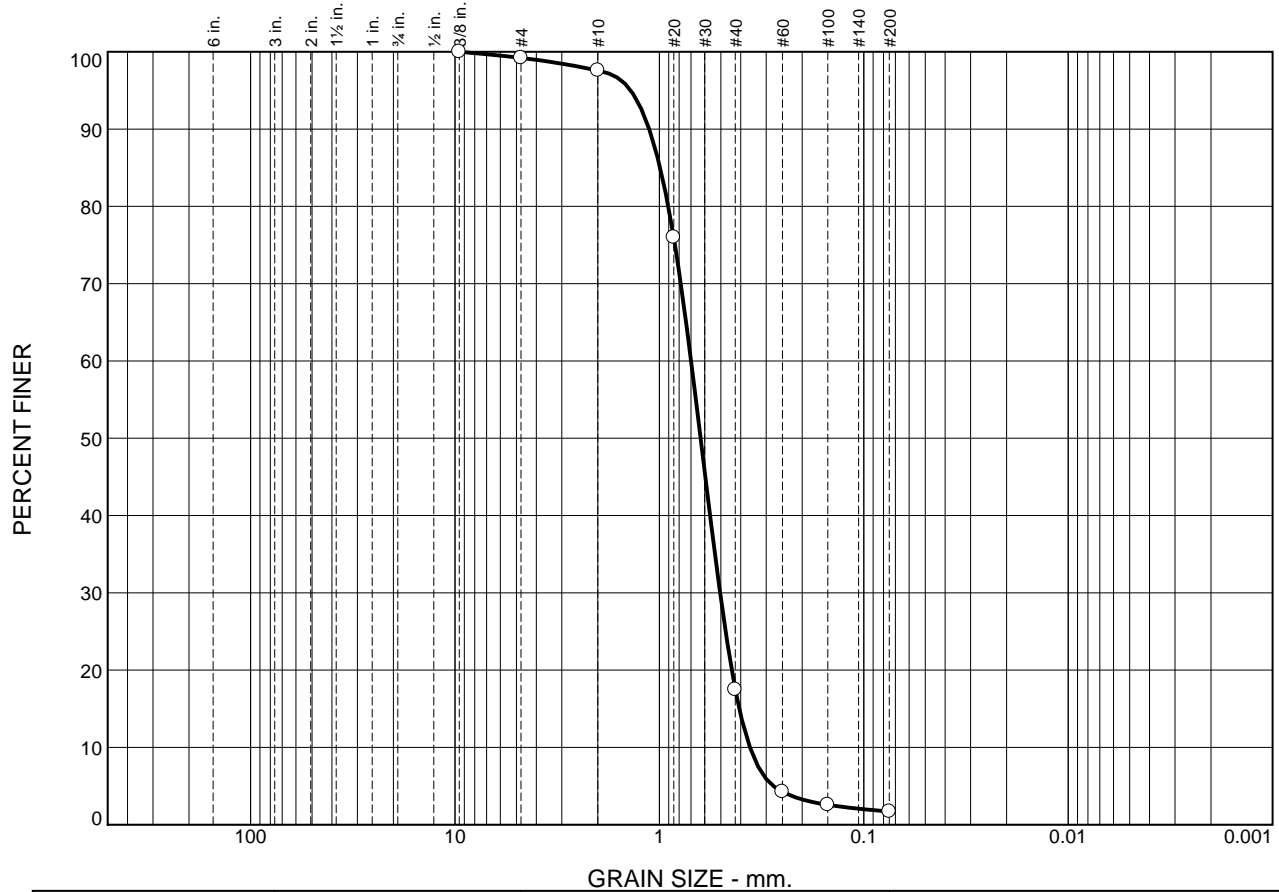
# Particle Size Distribution Report

% +3"	% Gravel		% Sand			% Fines	
		Coarse	Fine	Coarse	Medium	Fine	Silt	Clay
○	0	0	1	1	81	15	2

SOIL DATA					
SYMBOL	SOURCE	SAMPLE NO.	DEPTH (ft.)	Material Description	USCS
○	4	2	4	SAND	SP
