# WAIKĪKĪ WAR MEMORIAL COMPLEX

## Transportation Impact Assessment Report

September 2018

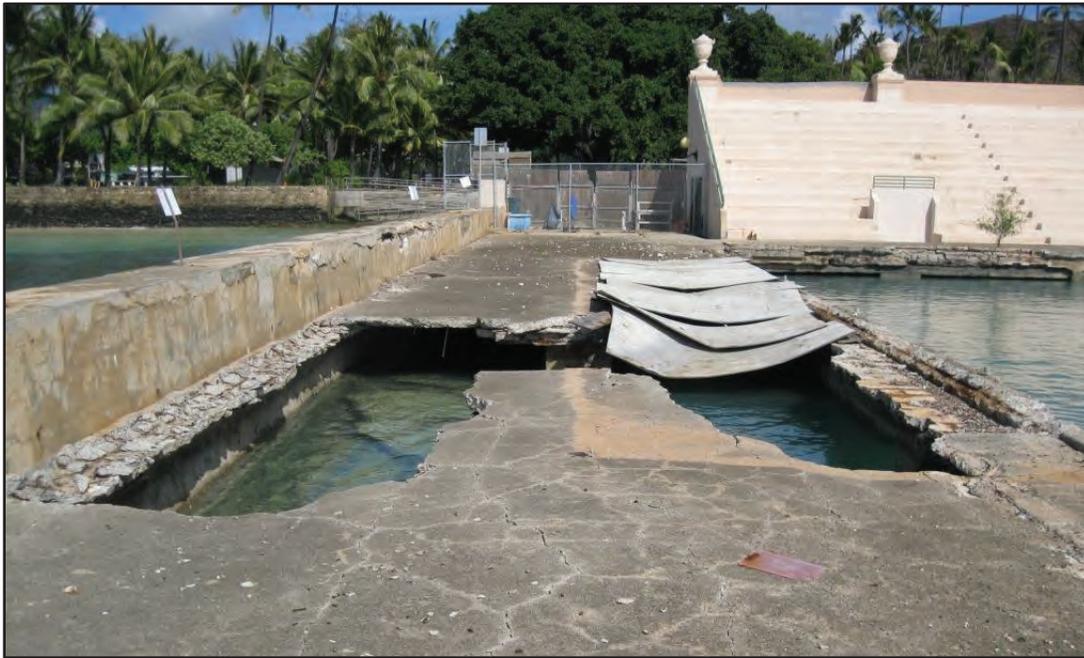
Figure 2-3. Collapsed pool deck.
