Draft Environmental Assessment (DEA)

Wailehua I Single-Family Residences

With this letter, the Department of Planning and Permitting hereby transmits the DEA and Anticipated Finding of No Significant Impact for the Wailehua I Single-Family Residences Project, located on Wailehua Road in Kahaluu, Oahu, for publication in the January 23, 2022, edition of *The Environmental Notice*.

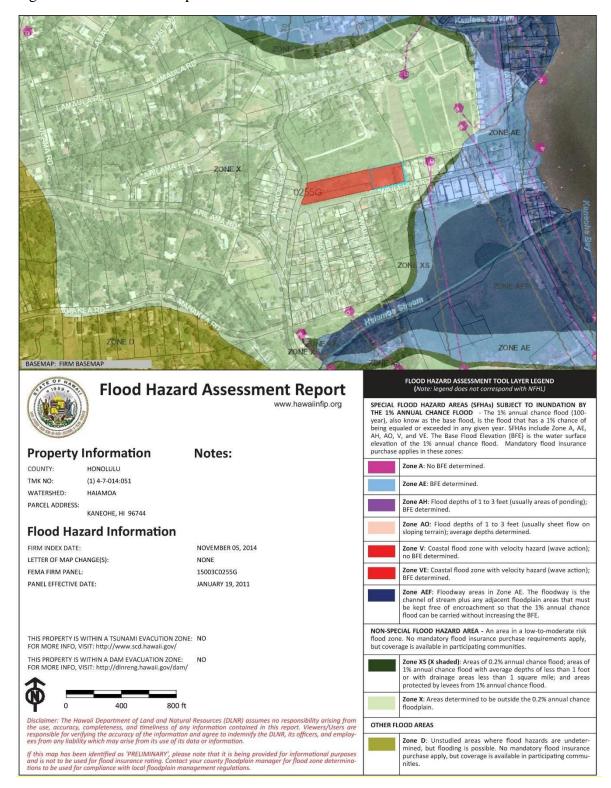
Figure 13. Flood Zone Map

The FEMA National Flood Hazard Layer (NFHL) viewer (FEMA 2021) shows that the proposed project site is entirely located in Flood Zone X, areas determined to be outside the 0.2% annual chance floodplain, as mapped on FEMA FIRM panel 15003CO255G (Figure 13). The proposed project site is not located within the tsunami evacuation zone but is located within the extreme tsunami evacuation zone (State of Hawaii, 2021).

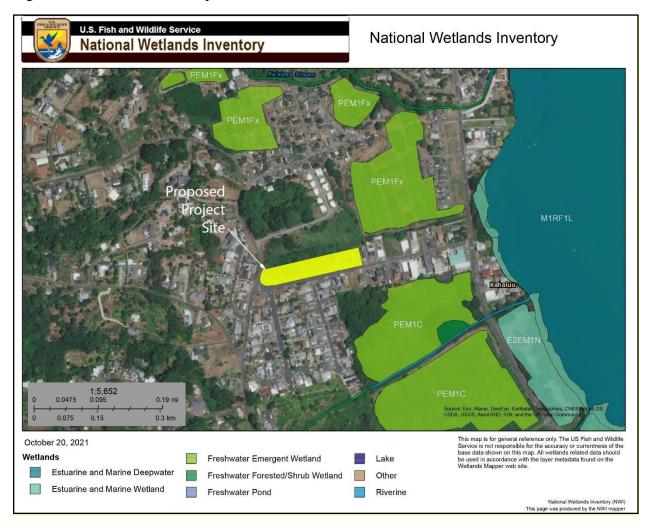
Figure 14. FWS Wetlands Map

There are no potential wetlands impacts from the proposed project as determined by the U.S. Army Corps of Engineers in a jurisdictional determination on December 21, 2020 (Appendix B). Figure 14 shows the U.S. Fish and Wildlife Service National Wetlands Inventory for the proposed project site and vicinity. This finding was issued after wetlands were delineated on the proposed project site under a previous study in 2015 (Paahana 2015) and was associated with a notice of violation dated February 14, 2017 for placement of fill in waters of the U.S. by the Applicant on a portion of the proposed project site. The change in jurisdictional determination is due to the halting of implementation of the Navigable Waters Protection Rule, which essentially rolled back interpretation of the definition of "waters of the United States" to the pre-2015 regulatory status. In the December 21, 2021 jurisdictional determination, the U.S. Army Corps of Engineers determined that the "Wailehua 1 drainage feature" was created by excavation for the purpose of drainage of stormwater and, furthermore, conveys flow only ephemerally, and is therefore not a water of the United States as per 33 CFR Section 328(b)(10). This determination is fixed for a period of five years, meaning that another rule change would not affect the determination for this term.

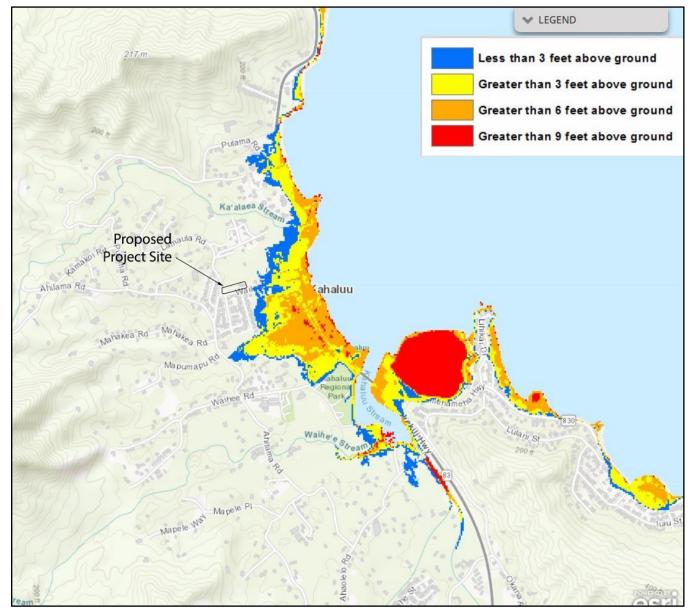
Figure 17. The SLOSH Model for Storm Surge from a Category 4 Hurricane.

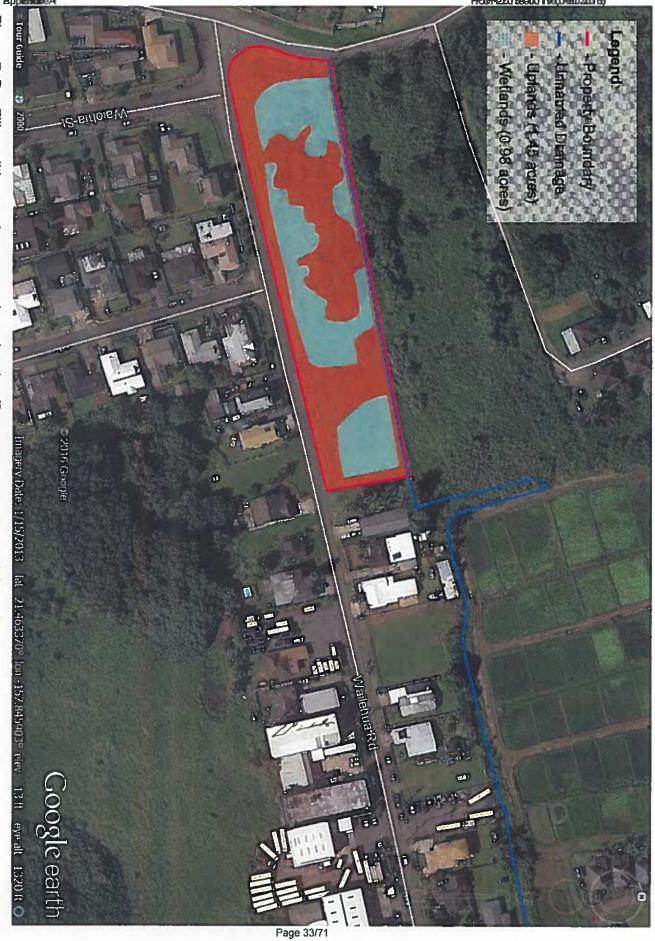
Figure 7: Pre-Fill conditions and resources based on in-office assessment as overlain and quantified in Google Earth

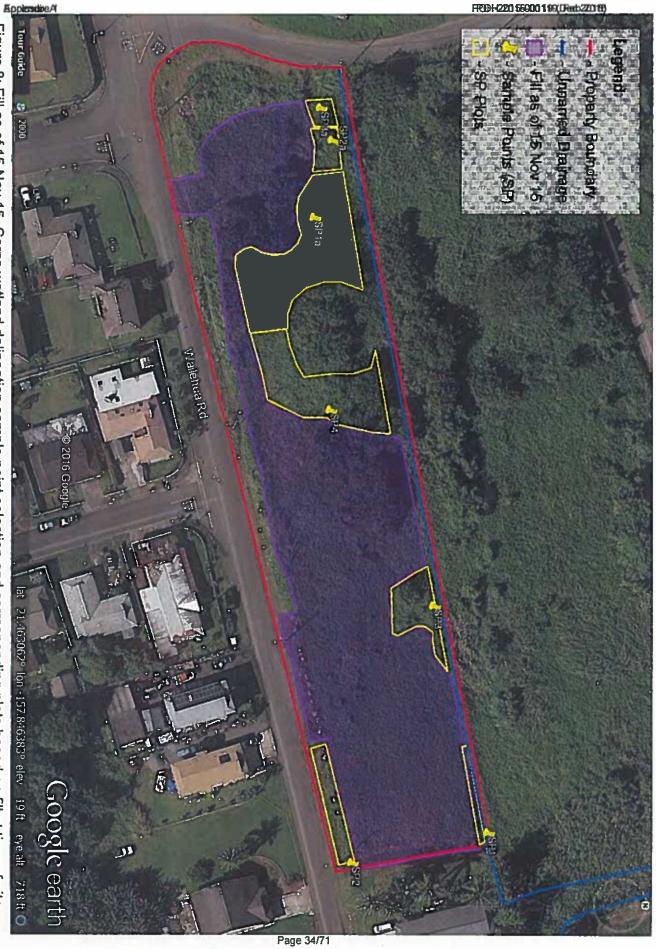
visit as overlain and quantified in Google Earth Figure 8: Fill as of 15 Nov 15. Corps wetland delineation sample point selection and corresponding plots based on fill at time of site

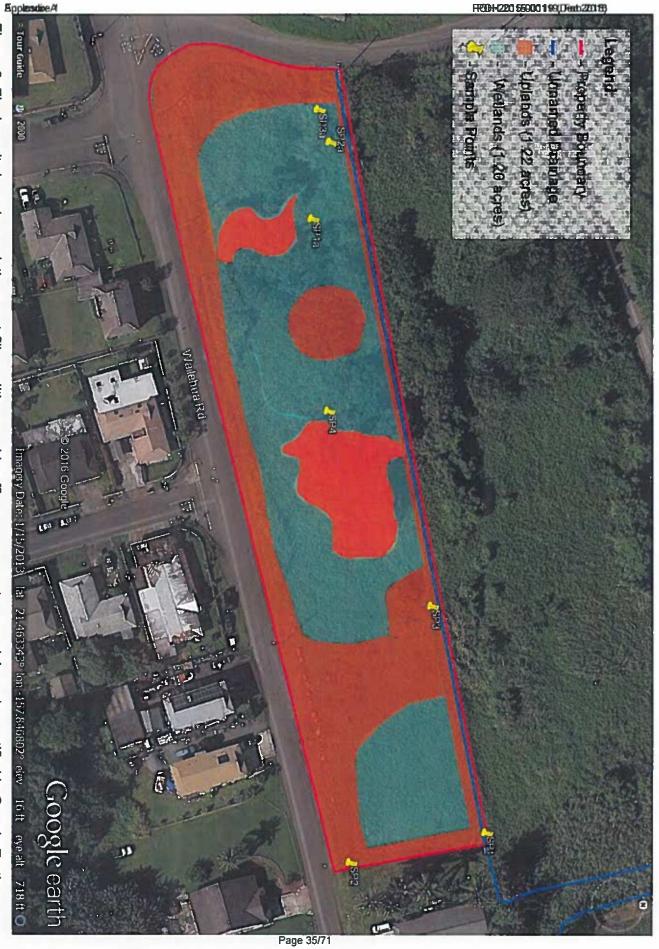
Figure 9: Final results based on existing, post-fill conditions and in-office assessment as overlain and quantified in Google Earth

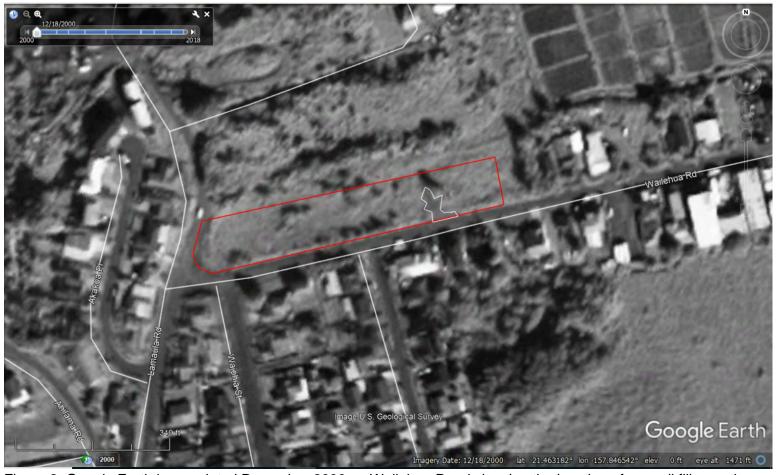
Figure 2. Google Earth image dated December 2000 on Wailehua Road showing the location of a small fill near the center of the property (white polygon), allegedly used as an unauthorized parking area. Red polygon illustrates the boundaries of the proposed project. Map source: Google Earth Pro.

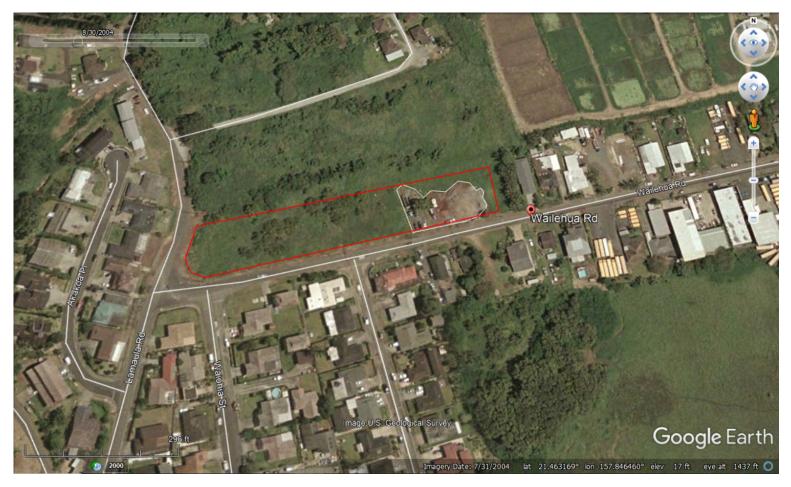
Figure 3. Google Earth image dated August 2004 illustrating an approximately .40-acre expanse of fill (white polygon) on Wailehua Road associated with the unauthorized parking area. Large vehicles can be seen parked at the site. Red polygon illustrates the location of the proposed project. Map source: Google Earth Pro.

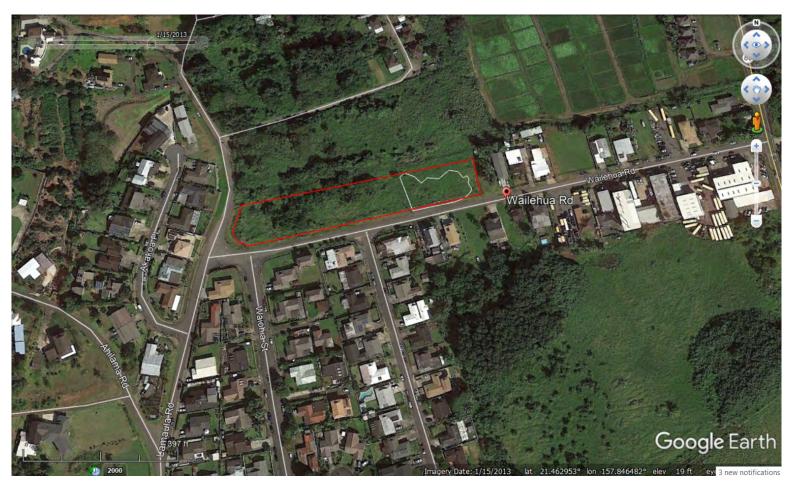
Figure 4. Google Earth image dated January 2013 illustrates that the fill associated with the unauthorized parking area (white polygon) has been completely overgrown by grasses and shrubs. This condition persisted through 2014. Red polygon illustrates the location of the proposed project. Map Source: Google Earth Pro.

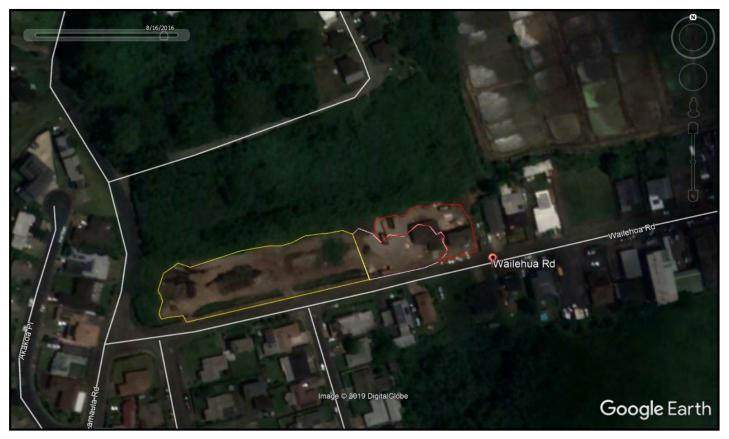
Figure 5. Google Earth image dated August 2016 illustrates the 1.16 acres of grubbing and grading (yellow outline), and 0.40 acres of fill over the previous unauthorized parking area (white outline), and 0.31 acres of grading, grubbing and fill associated with the two existing house lots at Wailehua I. Values are approximate based upon Google Earth area calculations. Map source: Google Earth Pro.

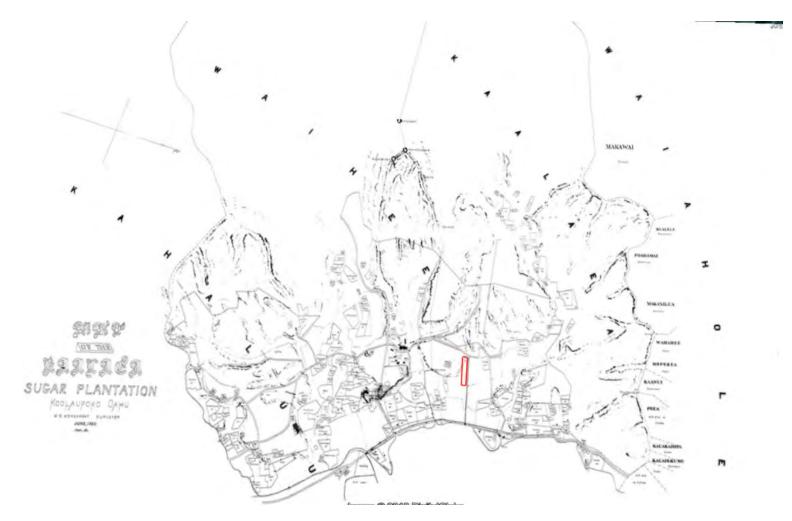
Figure 8. A map of the Kaalaea Sugar Company published in 1880 by M.D. Monsarrat illustrates the presence of the unnamed drainage ditch running from Lamaula Road into Kaneohe Bay, and an irrigation auwai that flows through the area occupied today by Wong Village that drains into the unnamed ditch just seaward of the project area. Red polygon illustrates the approximate location of the project site. Map source: Hawaii State Archives.

The unnamed drainage ditch that plays a key role in the hydrology of the project site today was apparently constructed by the Kaalaea Sugar Plantation sometime during the mid- to late-1870's to drain adjoining wetlands for sugar cultivation. This ditch, running in a straight line from Lamaula Road to Kaneohe Bay along the northern boundary of the project site, first appears in a map of the Kaalaea Sugar Company published in 1880 by M.D. Monsarrat (Figure 8). The Monsarrat map also shows another drainage that flows from the Kaalaea watershed through the area occupied today by Wong Village an drains into the unnamed ditch just makai of the project area. Mello (2019) identified this drainage as an auwai that carries water for taro irrigation from Kaalaea Stream.

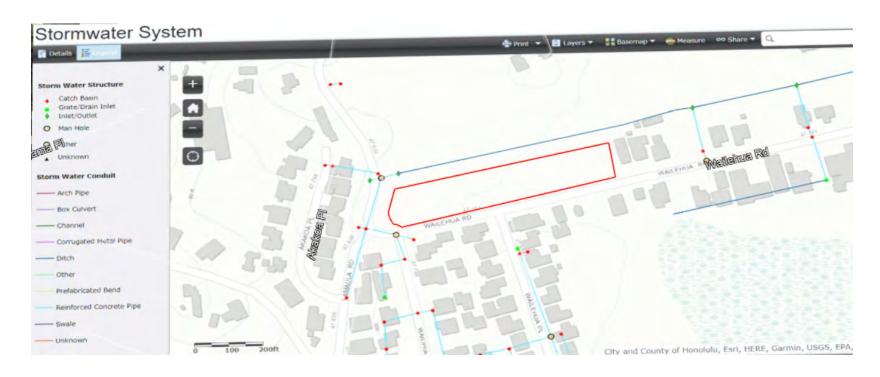
Figure 9. A map from the City and County of Honolulu's online GIS system showing that the drainage feature in "Drainage Easement A" that forms the northern boundary of the project site is clearly a component of the stormwater system within the Haiamoa watershed, and is not a perennial stream. Red polygon illustrates the footprint of the project site. Map source: http://cchnl.maps.arcgis.com/apps/OnePane/basicviewer/.

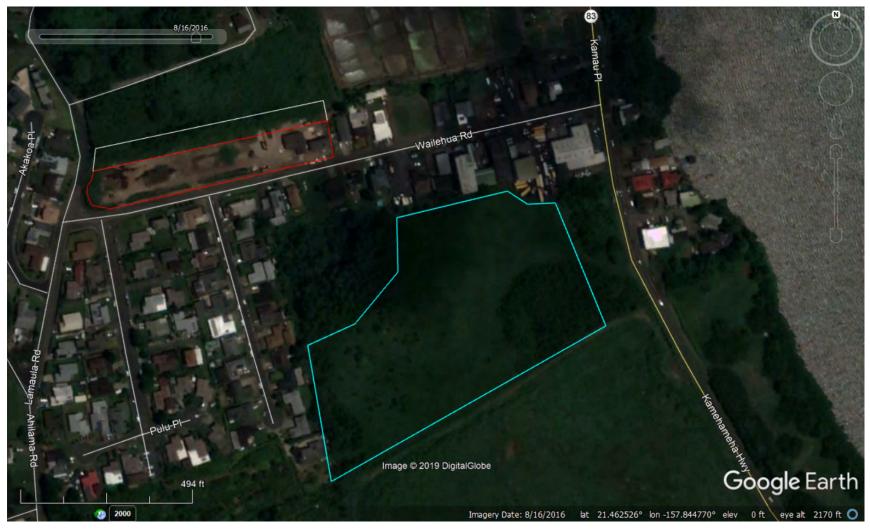
Figure 12. Draft conceptual compensatory mitigation proposal for Wailehua I (red polygon) involving both on- and off-site wetland preservation. A perpetual conservation easement (white polygon) abutting "Drainage Easement A" on Wailehua Road; and area within Waihee Marsh where additional preservation may be located (blue polygon).

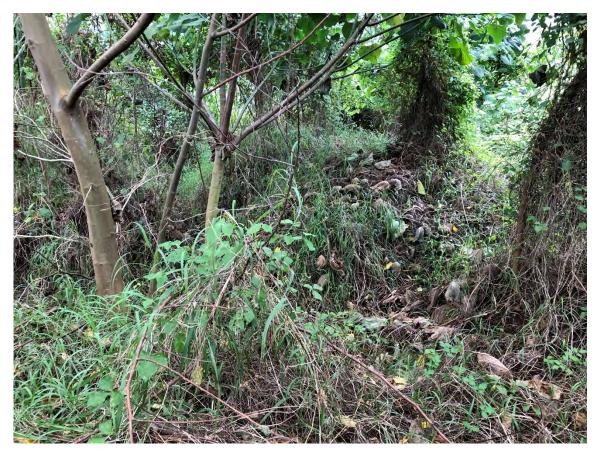
Photo 1. Several mounds consisting of boulders, asphalt, gravel, and broken concrete from the previous parking lot fill and illegal dumping are found scattered within the project site where they had been moved during initial grubbing and grading of the project site that occurred in 2015.

US Geological Survey 7.5-minute quadrangle maps from the mid- to late-1950's reveal widely scattered buildings and dwellings throughout the region. The housing subdivision at the intersection of Lamaula Road and Wailehua Road appears to have been developed in the 1970's, and is illustrated in historical aerial photographs dating from 1975 (Environmental Risk Analysis LLC 2014). Paahana (2015) noted that the project site had not been previously developed for residential purposes or formally managed. Aerial photos of the project site prior to 1978 demonstrate that the parcel was undeveloped and completely covered with dense vegetation. Aerial photos available from Google Maps support anecdotal accounts that the center of the project site had previously been used as an undesignated parking lot for a commercial bus company, additional parking for area residents, and as an undesignated dumping ground by the former landowner (Paahana 2015). Between 1978 and 2008, marginal fills can be seen in aerial photos at differing locations within the project site immediately adjacent to Wailehua Road. A fill of roughly 2,398 square feet is visible in an August 2000 image of the site (Appendix C, Figure 2) and was expanded in subsequent years. The largest of these fills appears in an August 2004 Google Earth image to be approximately 0.40 acres in size (Appendix C, Figure 3); and vehicles can be seen parked there. Aerial images collected in Jan 2013 show that the filled area had been totally overgrown with dense vegetation (Appendix C, Figure 4). The full extent of clearing, grubbing and filling associated with the Wailehua I project can be seen in the 16 August 2016 aerial image (Appendix C, Figure 5). The area shown in white outline in Figure 5 represents the greatest extent of fill associated with the bus parking lot. The uneven elevated lands at the center of the project site, which appear as dark spots in Figure 5, appear to be mounds of rubble created by grubbing and grading of the site for Wailehua 1 as well as grading/filling for the bus parking area in the early 2000s. Irregular blocks of broken asphalt, concrete and gravel, previously used as fill for the bus parking lot, are evident under the heavy mats of grass at the project site (Appendix C, Photo 1).

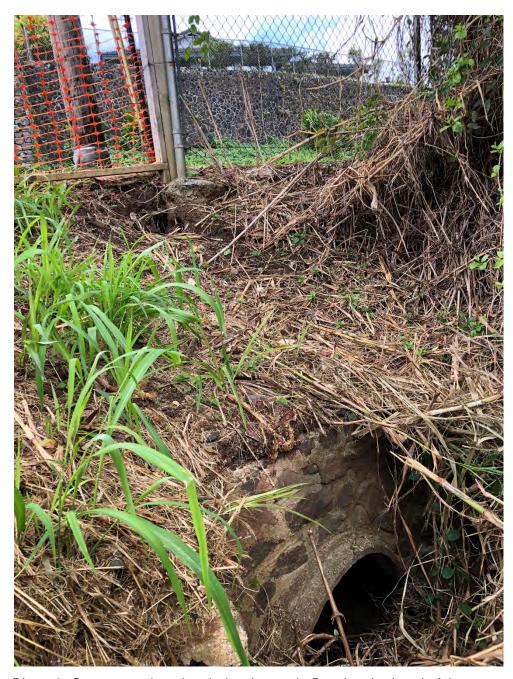
Photo 2. Concrete culvert just below Lamaula Road at the head of the unnamed ditch that runs along the northern boundary of the project site.

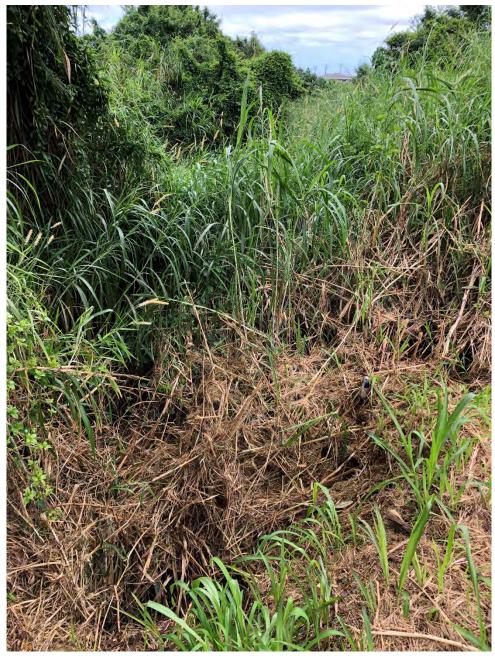
Photo 3. View towards Kaneohe Bay within the unnamed ditch immediately downstream of the Lamaula Road culvert. No water was seen flowing in this portion of the ditch during field visits in the first quarter of 2019. Note the dense vegetation.

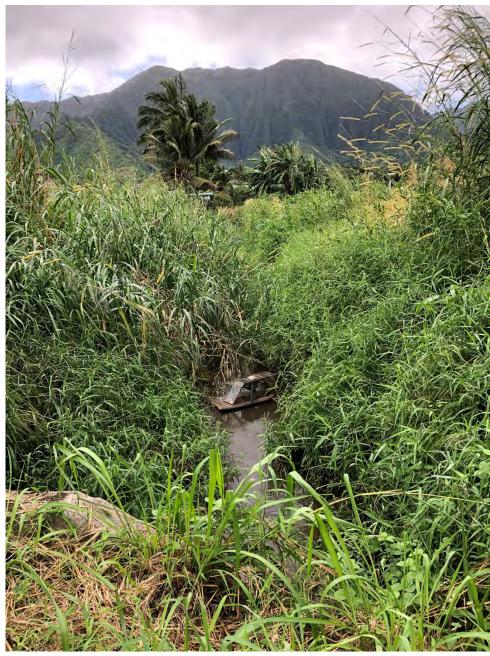
Photo 4. View toward Lamaula Road of the unnamed ditch taken from the Kamehameha Highway culvert, below the project site. Note the fish trap and dense vegetation. The ditch appears to have perennial flow at this location, fed by the auwai that carries water from Kaalaea watershed through Wong Village to the north, and perhaps by spring flow.

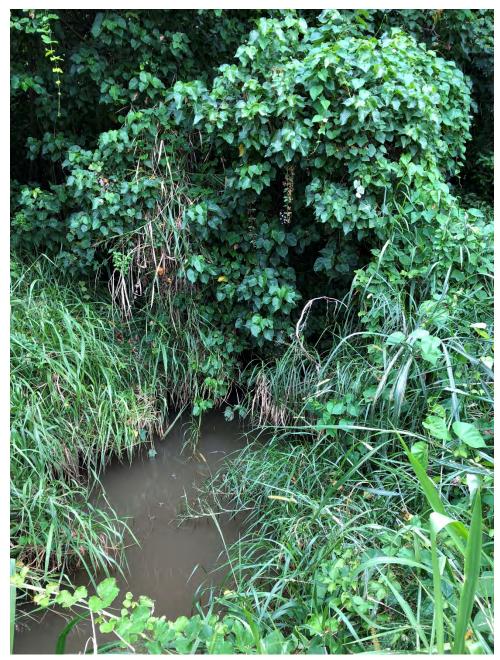
Photo 5. View downstream from the Kamehameha Highway bridge culvert of the muliwai (estuarine portion) of the unnamed ditch. Here, the drainage reaches a depth of 4-5 feet and flows through hau and mangrove trees before reaching Kaneohe Bay.

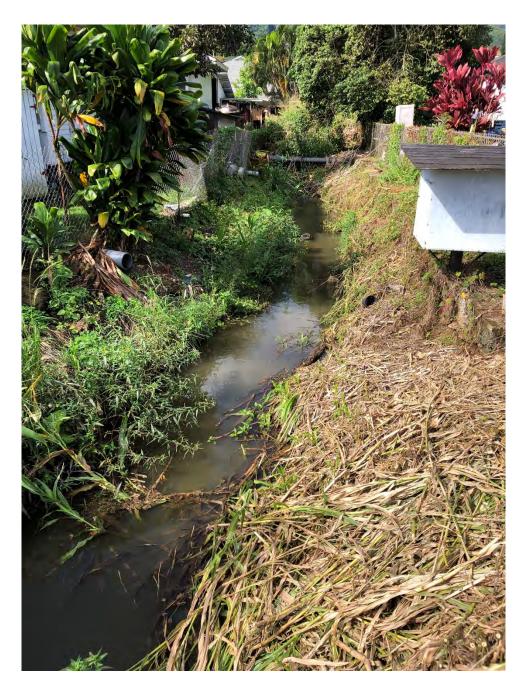
Photo 6. View upstream of the irrigation auwai that carries flow from the neighboring Kaalaea watershed into the unnamed ditch just below the project site. Note the stream gauge on the bank at right. Also note other PVC pipes that apparently stormwater discharge from neighboring properties into the auwai. The auwai consistently carried surface flow during site visits in the first quarter of 2019. No records of the stream gauge have been located as yet.
