MACZAC Hotspots 6/2015

Haena's "Temporary" Sandbag Revetment

RE: Cattle Damage to Conservation District and Shoreline Management Area,
Moloa`a Bay Ranch, TMK (4) 4-9-011: 001, Kaua`i

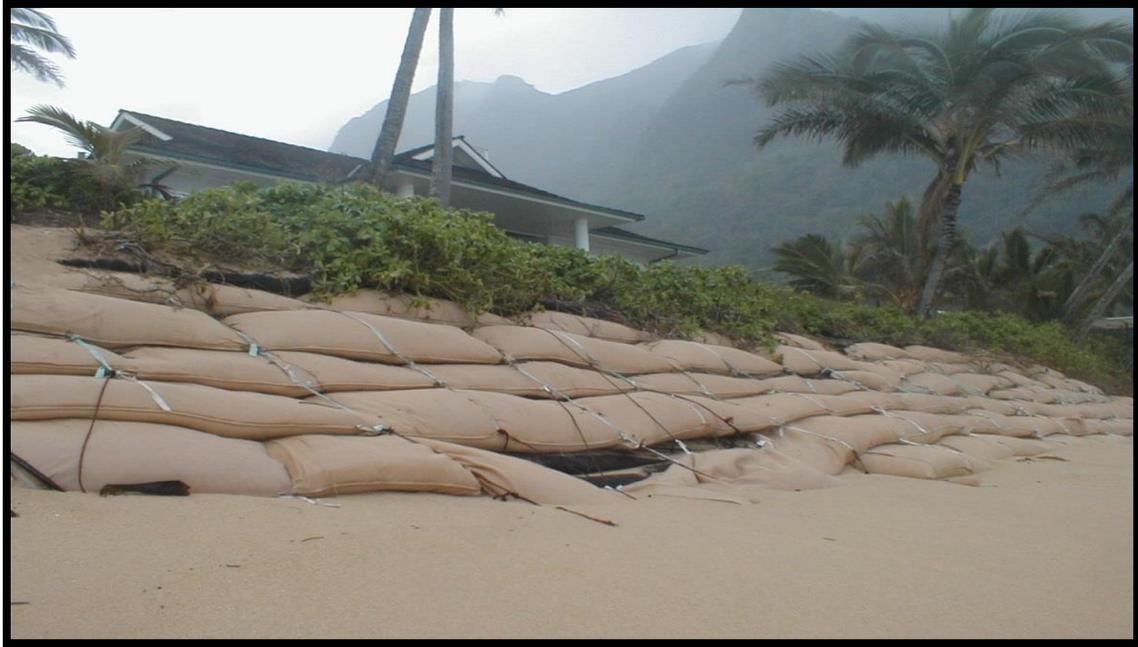
The sandbag revetment is located seaward of five (5) contiguous lots in the Conservation District in Ha'ena, Kauai; TMK 5-9-5: 23, 24, 25, 26, and 27. Temporary emergency erosion control measures were issued to protect habitable structures that were in jeopardy of being destroyed by erosion forces in the winter of 1996.

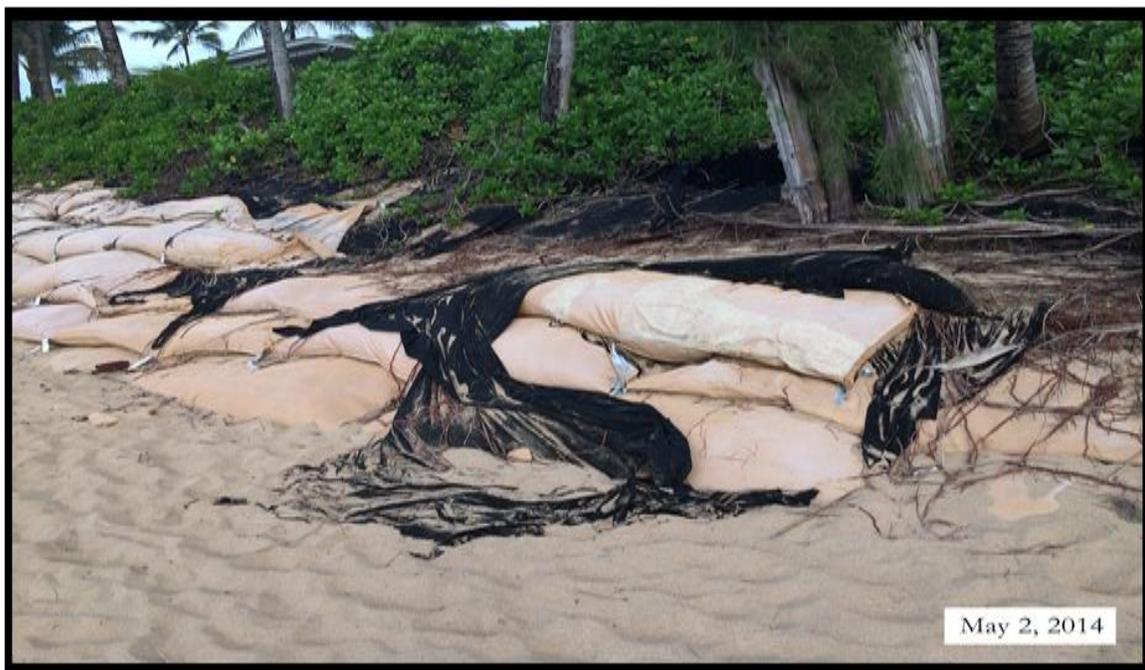
The "temporary" sandbag revetment diminishes the public beach, and has prevented the natural littoral processes from establishing the natural shoreline for over 18 years adversely affecting the surrounding public beach. The "temporary" structures are causing harm to the public beach, have exceeded the timeframe allowed in the Emergency permit, are degrading into beach trash and should be required to be removed.

We are advocating for the temporary revetment to be removed before additional degradation to Haena's beaches, coastal waters and reef occurs from the sandbags. The sandbag revetment that fronts these properties has exceeded its authorized life, is detrimental to the public interest and should be removed. After 18 years, the temporary emergency sandbag revetment should be removed and the natural beach processes be allowed to restore the beach.

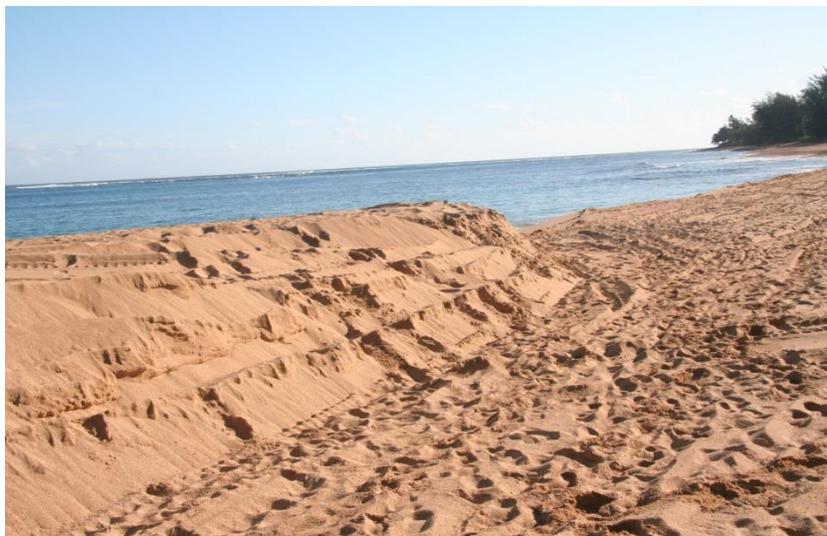
8/15/06 the sand on the public beach was taken and pushed mauka with a bulldozer to cover the sandbag revetment across 5 Conservation District lots.

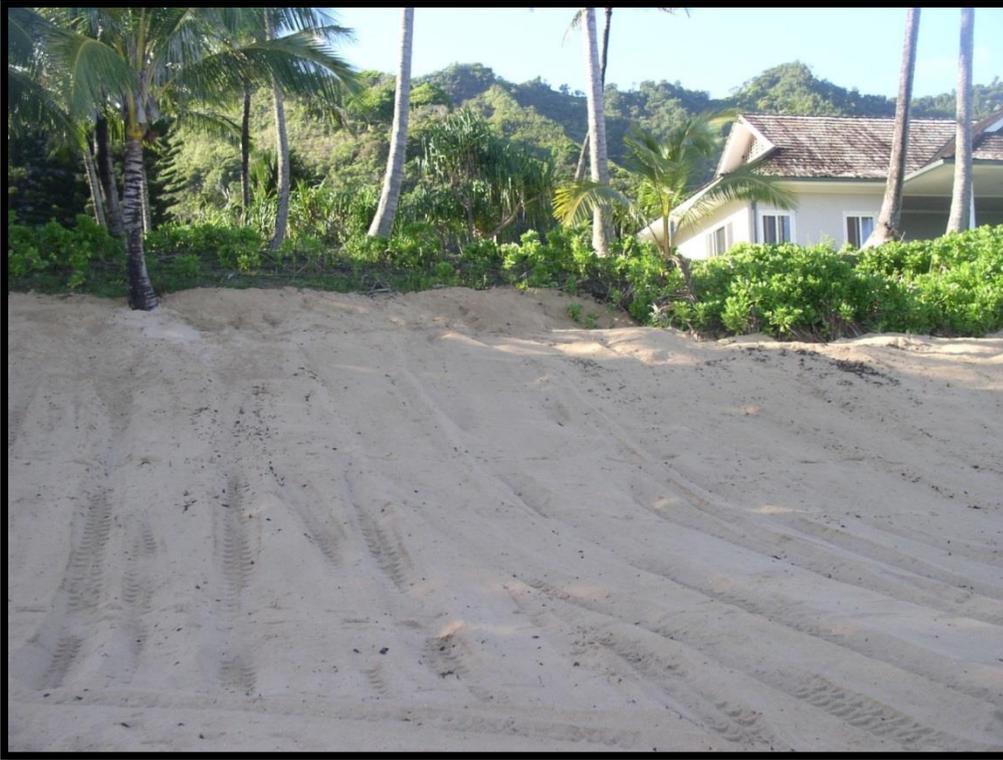
Sand pushing in the summer of 2006, the bulldozer tracks in the sand show the sand that was taken from the beach and pushed mauka to cover the sandbags.

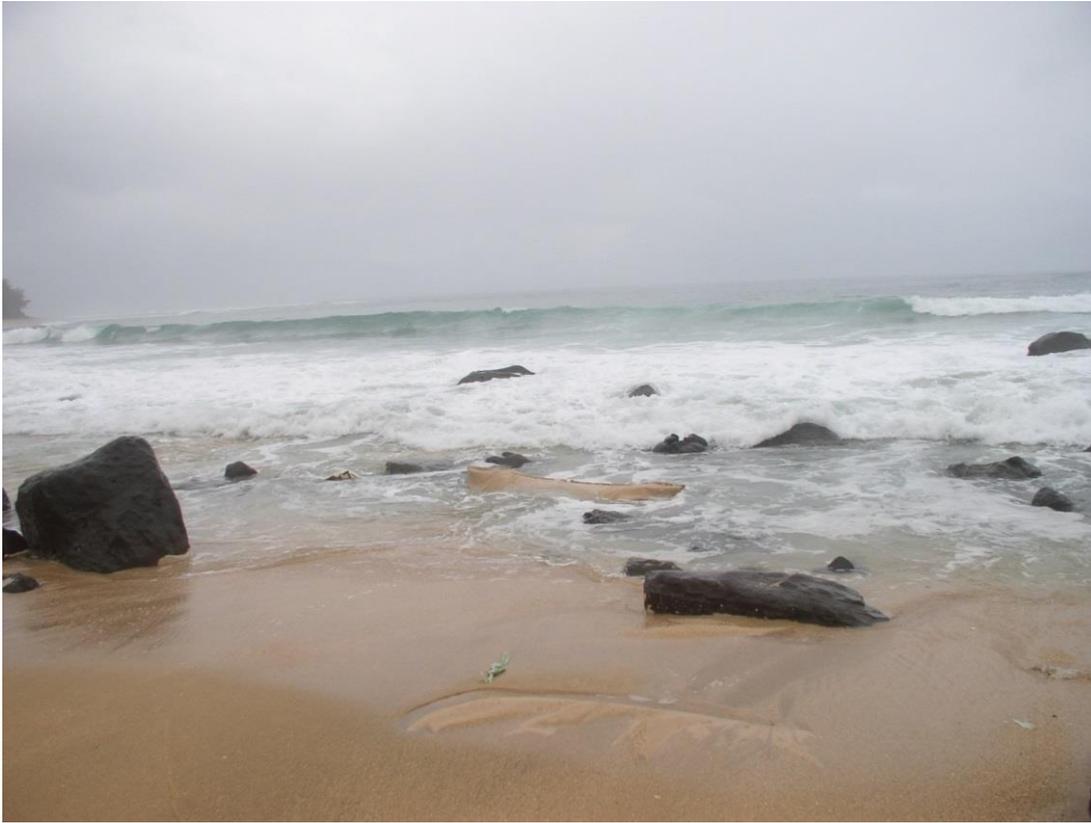
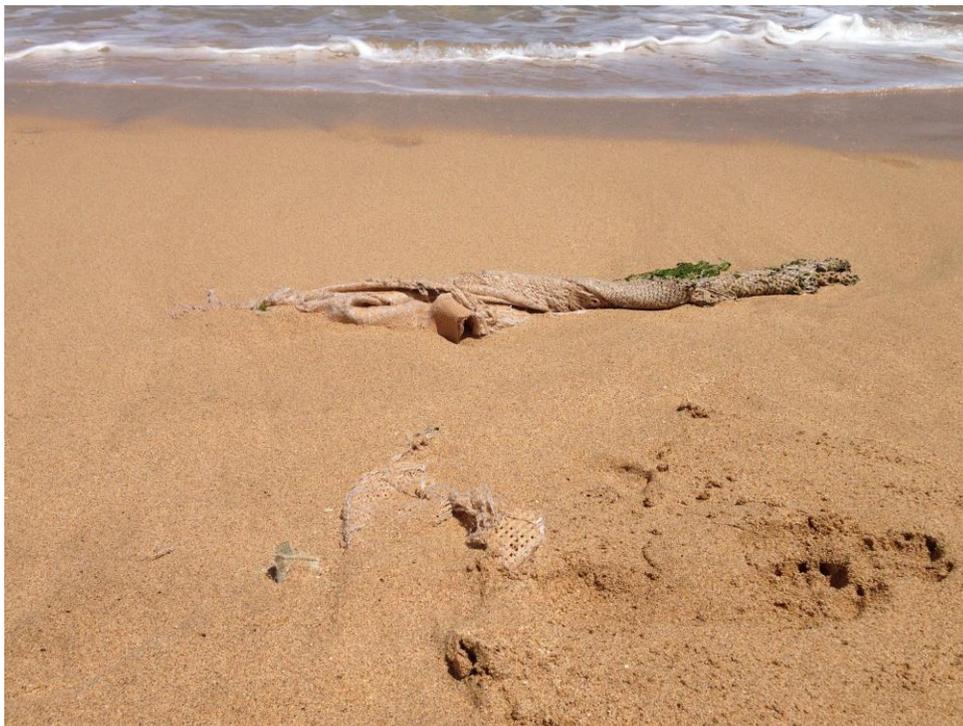
In the last 7 years, adverse impacts have occurred as the sandbags have deteriorated, broken apart and lodged in the pristine reef and rocks here in the Class AA waters.

Over the years, the sandbags break apart, littering the beach, reef and rocks, get repaired and replaced and fail again.

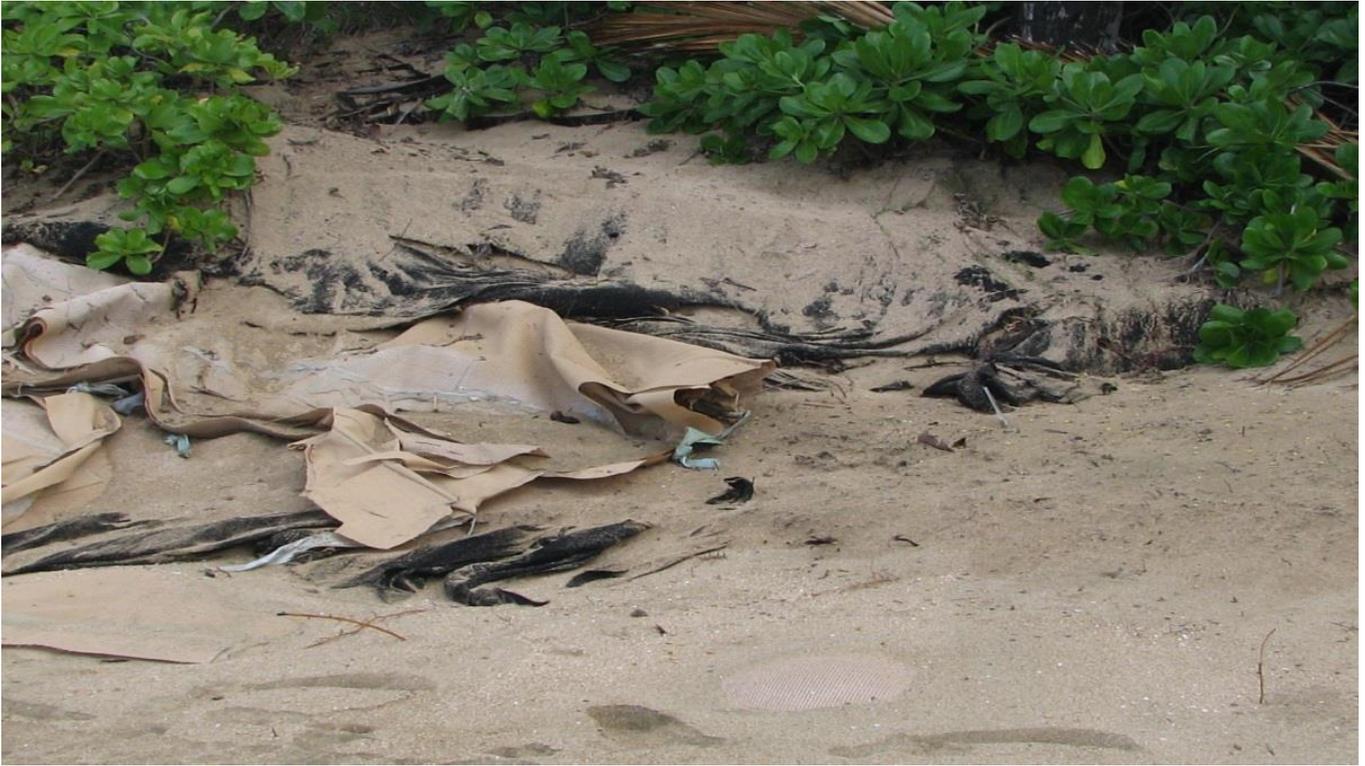
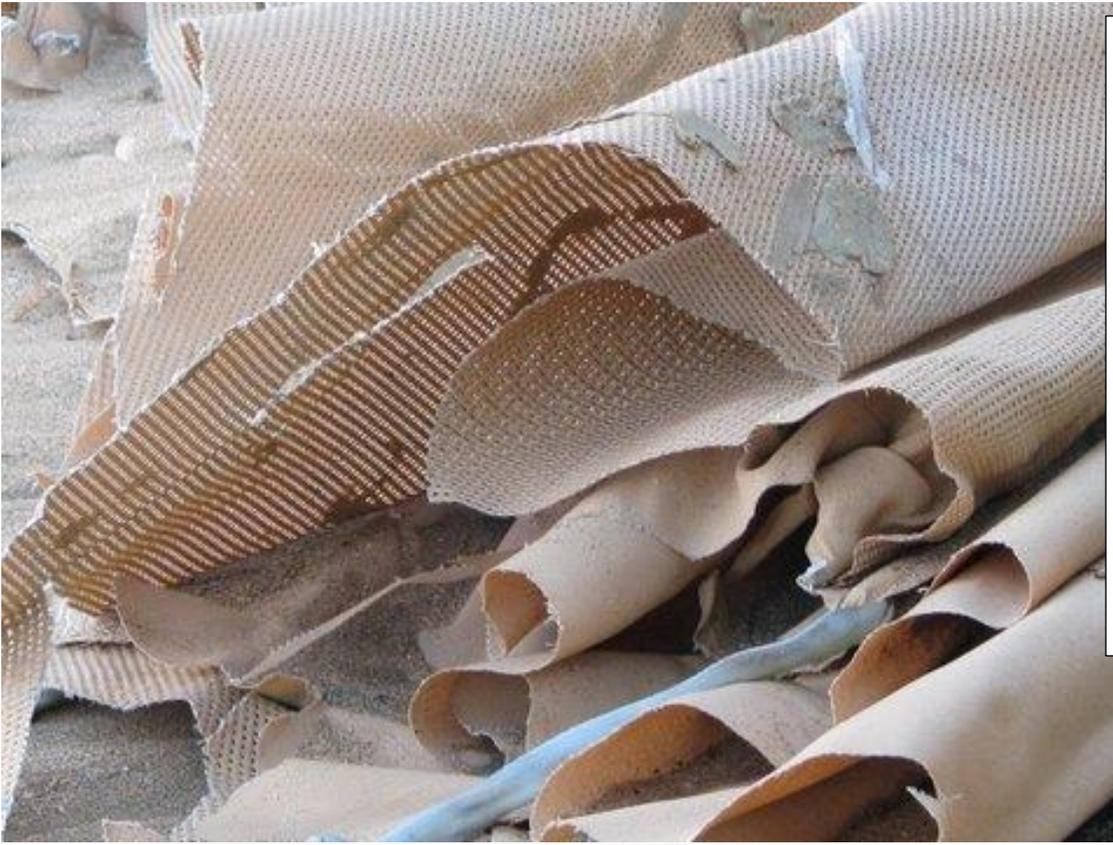
Each winter for the last 7 years, parts of the revetment broke up during winter swells, with sandbags dislodged from the revetment and trapped within the reef and rocks and in the ocean resulting in environmental degradation of Haena's Conservation District.

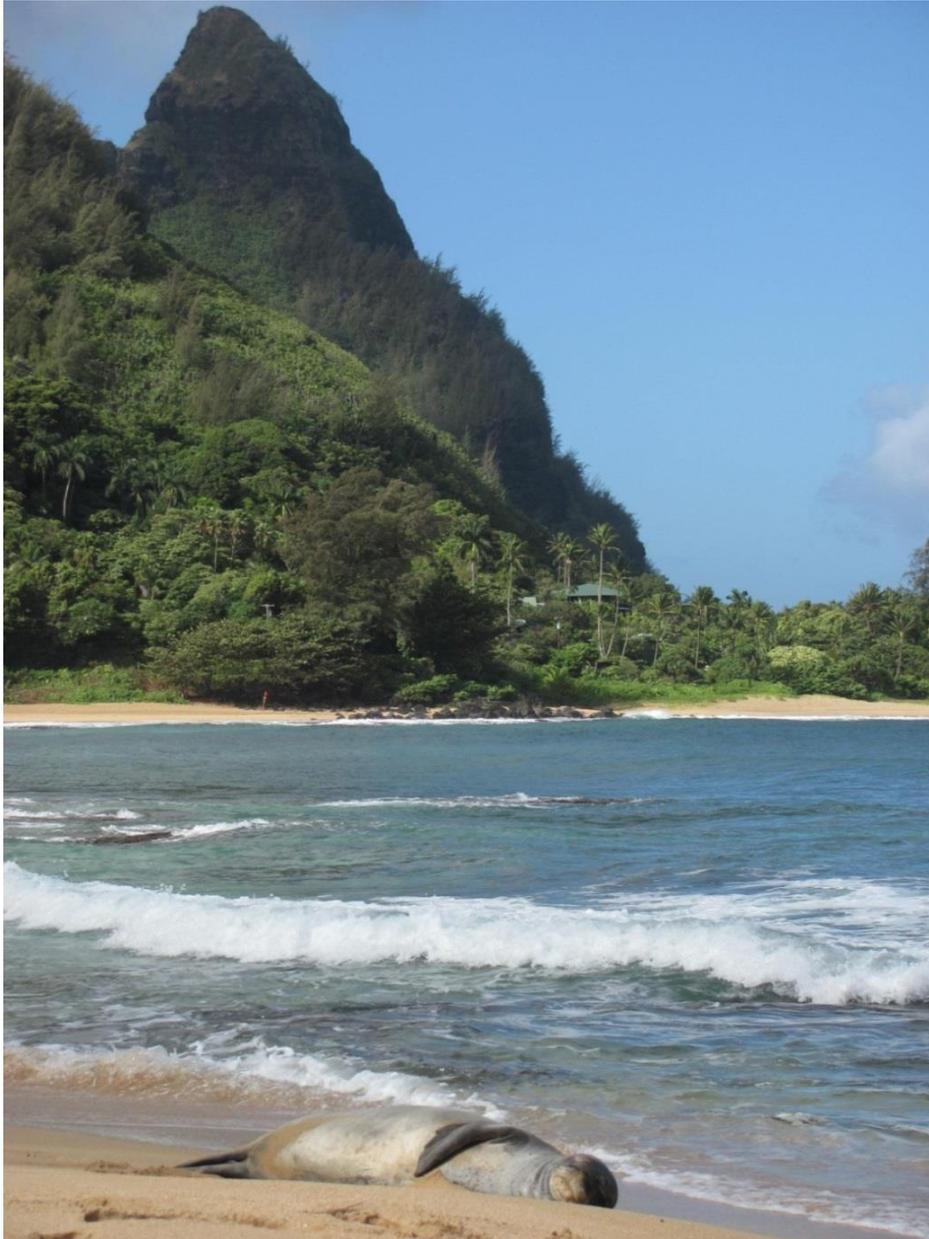
The project area is critical habitat for endangered Hawaiian Monk Seals that rely on this area for survival. The "temporary "sand bag revetment" here interferes with this critical habitat. The beach fronting the revetment has diminished since the sandbag revetment has been in place, with the beach profile becoming steeper and steeper, making it harder for Monk seals to haul out and rest.

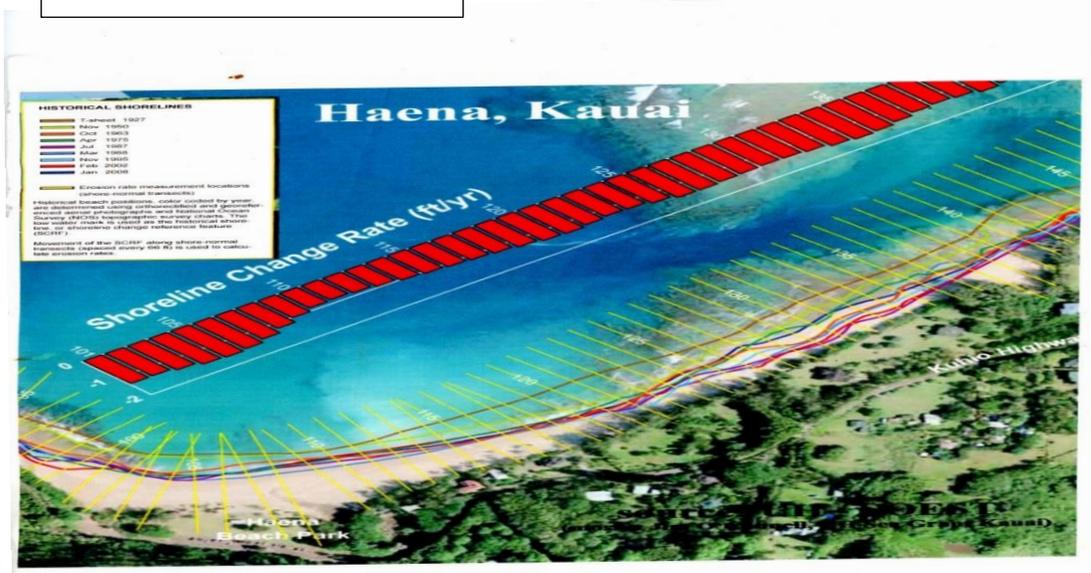
SOEST Shoreline Change Rate is 1 foot a year

- *The long-term average annual rate of change shows an erosion rate of approximately 1 foot per year fronting the property. As the shoreline continues to erode and move mauka toward the revetment, the beach will narrow and along-shore public access will be adversely affected more frequently by wave uprush, and eventually access will be prohibited (or unsafe) when the high (and low) water line reaches the structures.*

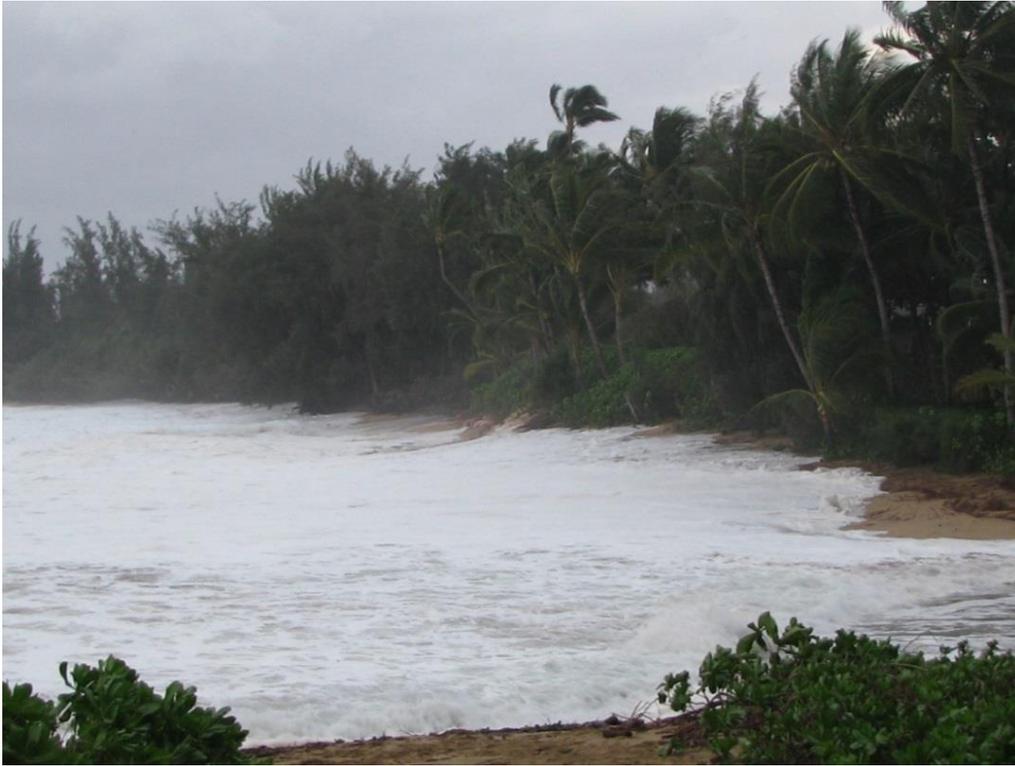
Photo taken January 22, 2014 at 6:19 AM

Sandbags covered with Naupaka. No lateral access.

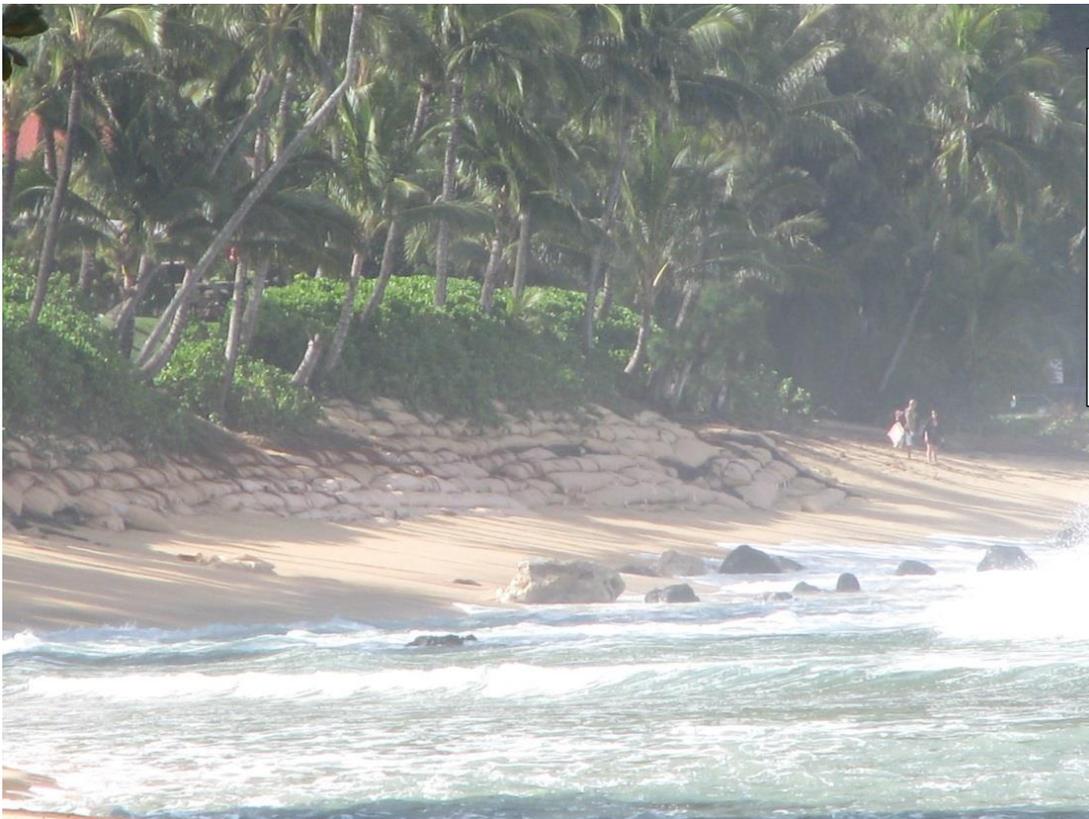
Same place, January 22, 2014 at 10:44 AM, all the naupaka has been washed away by the waves, exposing the sandbag revetment.

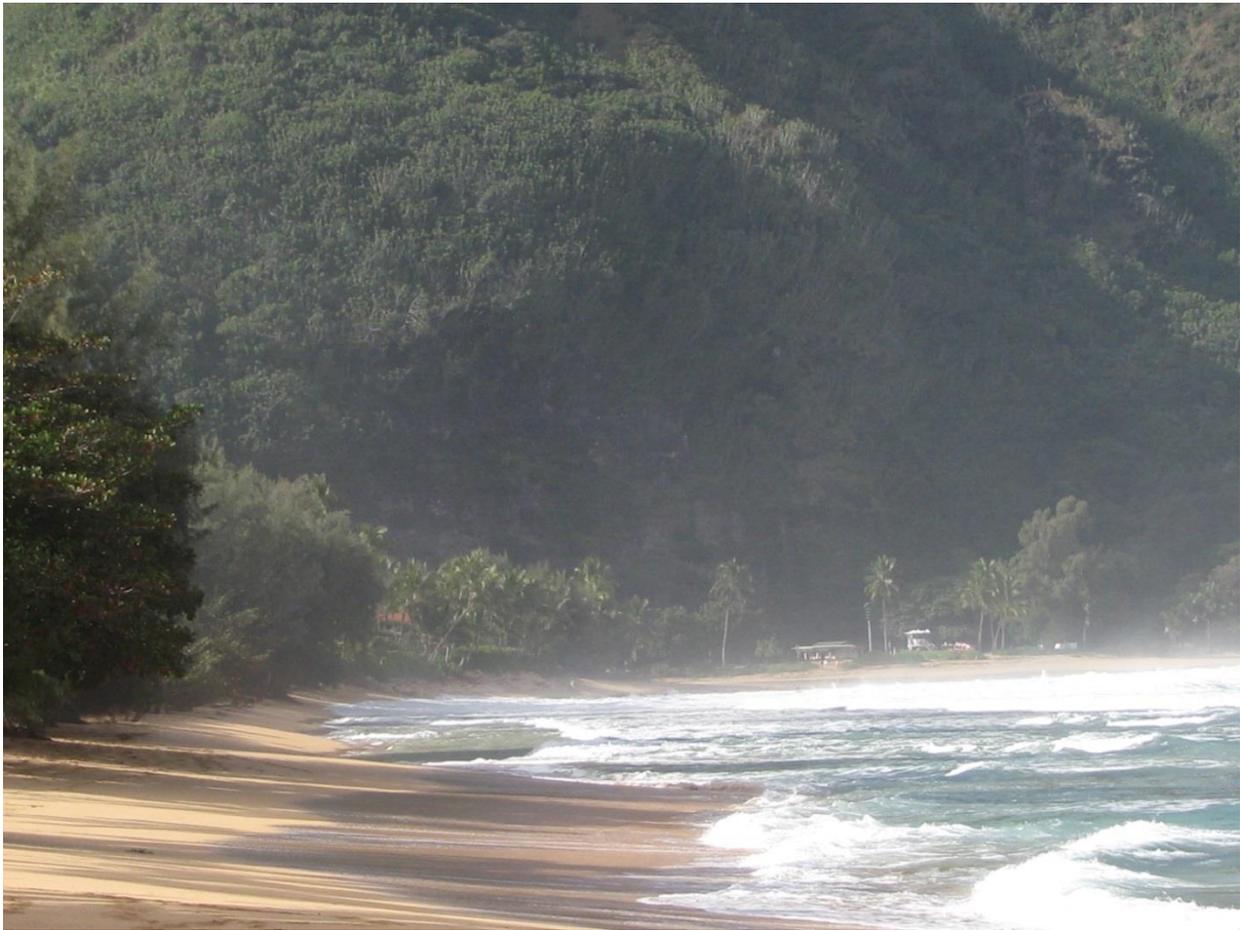
In the 1990's, according to the County's Kauai Shoreline Erosion Management Study, the beach width at nearby Ha'ena County Park was 200 feet, and was significantly wider than anywhere else along this reach. The width of the beach park has diminished greatly in recent years. The sandbags have altered the natural sand movement of this area and contributed to the diminished public beach. The five (5) properties with the temporary sandbag revetment have increased in value; all the while being protected by a temporary emergency revetment that has adversely impacted the public beach in Haena's conservation district.

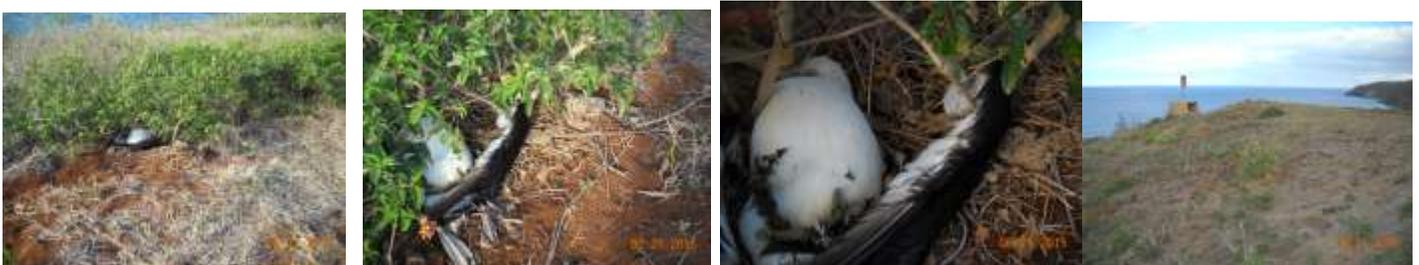
1 Dead Laysan Albatross on Moloa`a Bay Ranch Conservatin District Lands.

Right now, there are nesting albatross and wedge-tailed shearwaters that are imminently threatened by being trampled by cattle. There is a dead albatross in the CD. There is cattle feces on the Na Ala Hele alaloa segment of Moloa`a Bay Ranch Coastal Trail, creating a public nuisance and impacting the water quality of a popular sustenance fishing and limu gathering area.

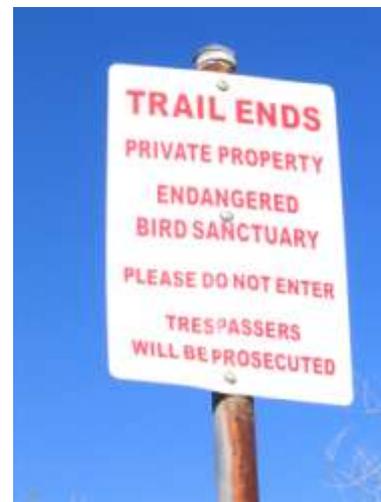
Open access was recommended, but a contiguous property owner has created a bird sanctuary for the migratory Laysan albatross.

There is a barbed wire fence blocking access to the reef resources at Ka`aka`aniu.

Open public access along the shoreline of the project area should be maintained at all times. Individuals should have the right to access these areas for traditional cultural practices, which include the gathering of marine resources. It is important that the landowner observe and maintain the State shoreline setback for public access.

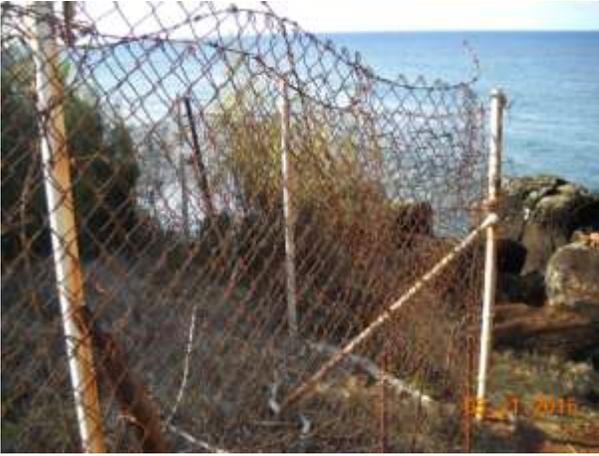
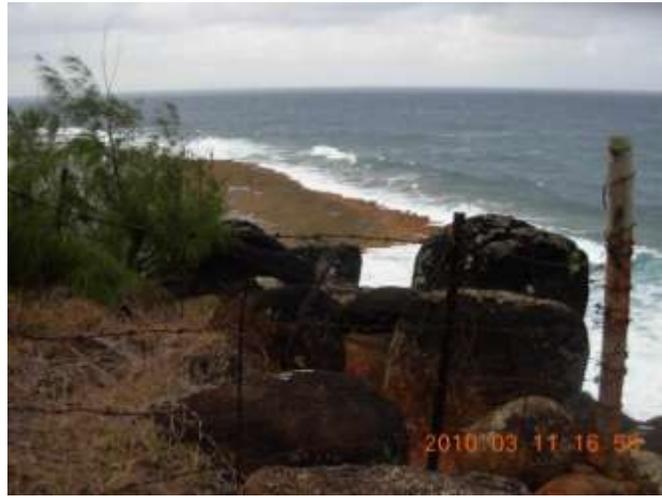
This "Trail to Nowhere" is an insult to cultural practitioners and creates a public safety hazard. The coastal alaloa does not end; it circumnavigates the entire island of Kaua`i. Please address the blockage of this cultural trail before someone gets hurt.

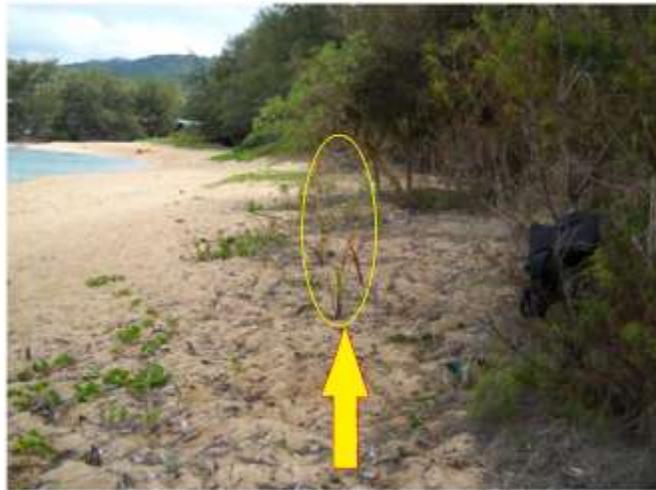
The public beach, within the State and County setback area is being systematically reduced by vegetative plantings. There is a row of newly planted coco palms planted in the sand.
