Report on 'Ōhi'a Stream Maui, Hawaii

August 2009

State of Hawai'i
Department of Land and Natural Resources
Division of Aquatic Resources

Prepared for
Commission on Water Resource Management
Department of Land and Natural Resources
State of Hawai‘i

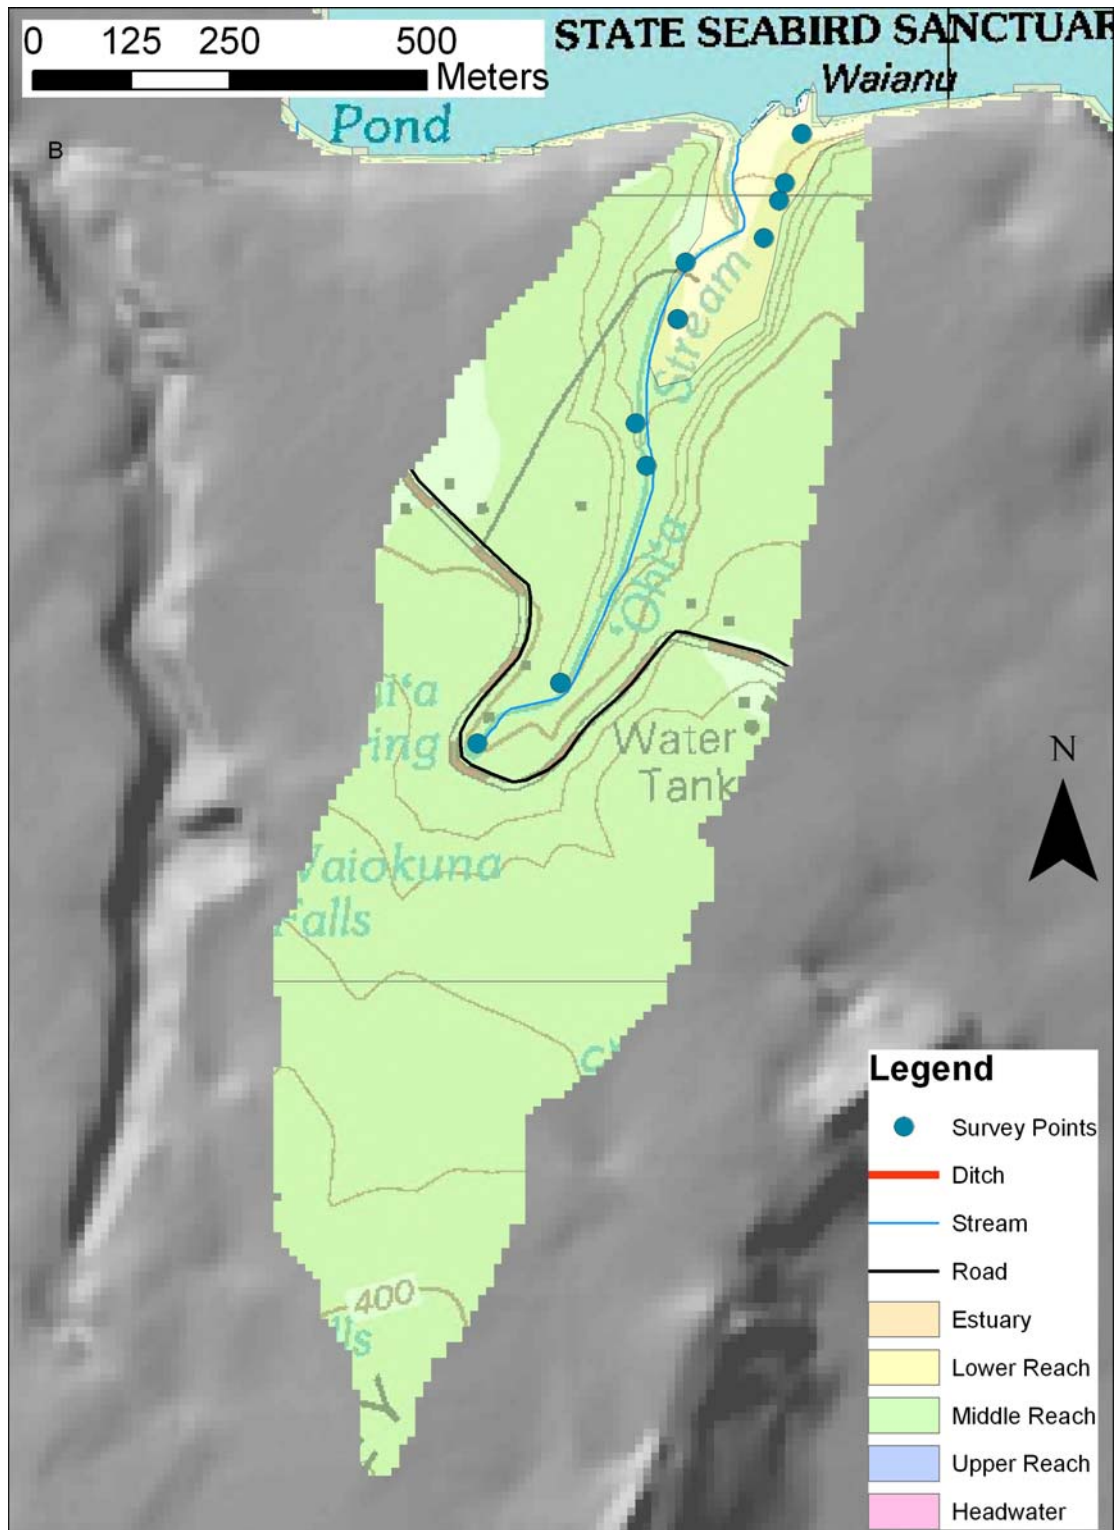
Figure 3-1. Locations of point quadrat surveys conducted in ‘Ōhi‘a Stream.

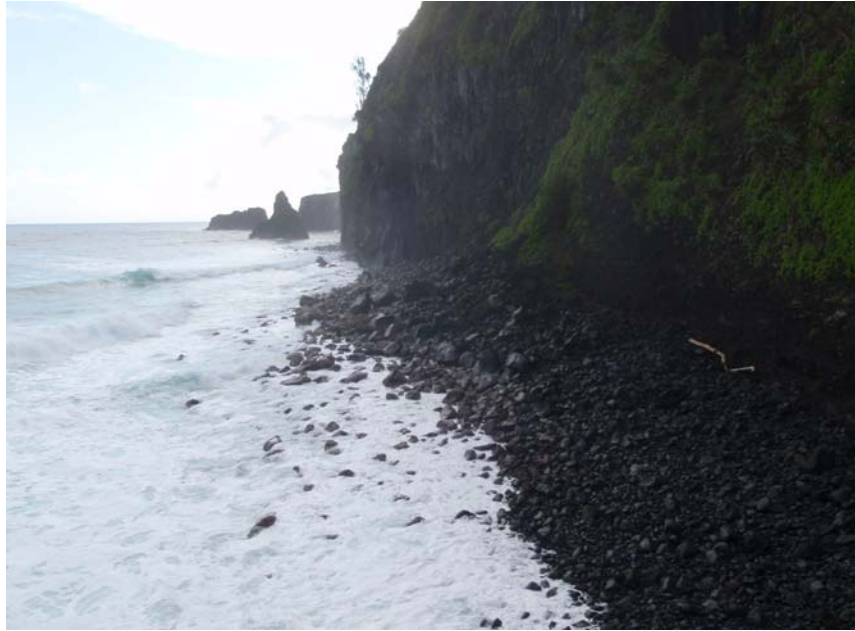
Figure 4-2. Photo shows the beach at the mouth of the stream. (3/11/2009; Tributary name: ‘Ōhi‘a (64012001); PBN: dk001p-004-031109; Surveyor: Kuamo‘o, D.; Habitat type: No Water; SBN: dk001r-031109; Lat. (DD): 20.85797, Long. (DD): -156.13806).

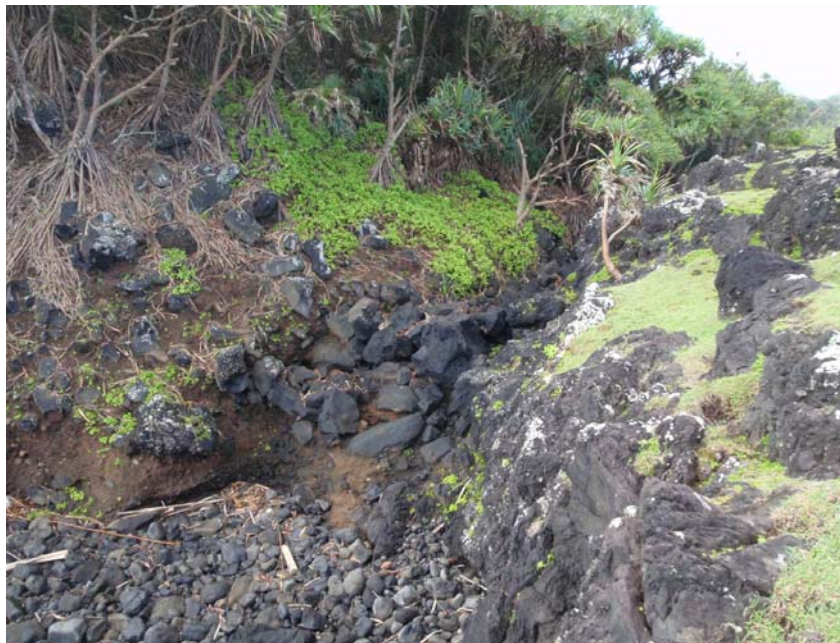
Figure 4-3. Photo of survey site 1, showing short drop to the cobble beach from stream mouth. Photo is taken in an upstream direction. (3/11/2009; Tributary name: ‘Ōhi‘a (64012001); PBN: dk001p-006-031109; Surveyor: Kuamo‘o, D.; Habitat type: No Water; SBN: dk001r-031109; Lat. (DD): 20.85797, Long. (DD): -156.13806).

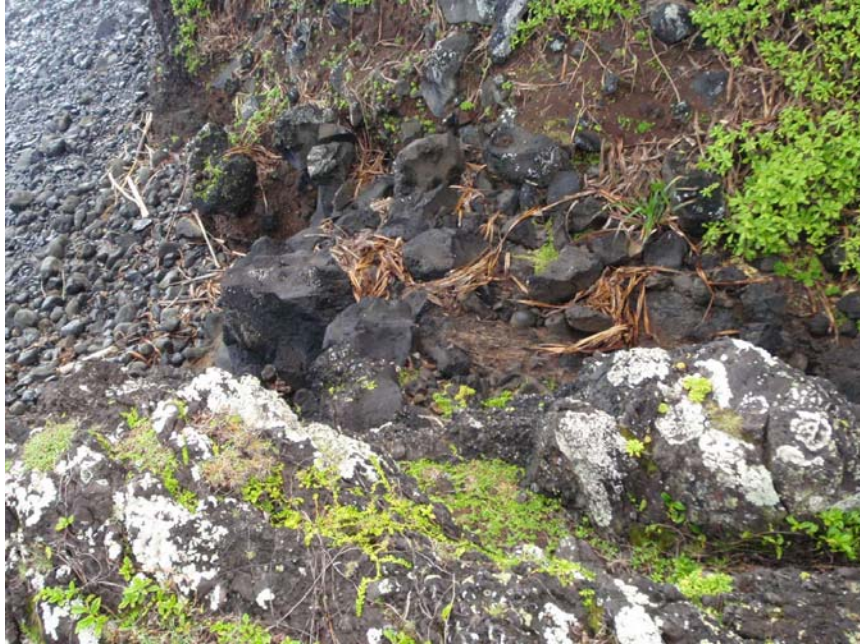
Figure 4-4. Photo from survey site 1 looking down at the cobble beach and ocean. (3/11/2009; Tributary name: ‘Ōhi‘a (64012001); PBN: dk001p-009-031109; Surveyor: Kuamo‘o, D.; Habitat type: No Water; SBN: dk001r-031109; Lat. (DD): 20.85797, Long. (DD): -156.13806).

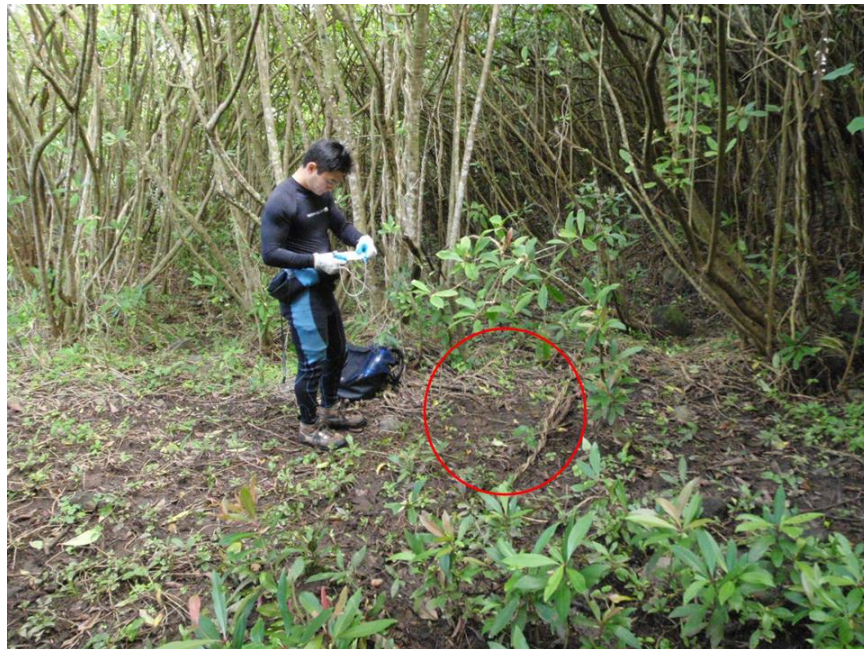
Figure 4-5. DAR staff surveying site 2 with no water. (3/11/2009; Tributary name: ‘Ōhi‘a (64012001); PBN: tss002p-013-031109; Surveyor: Sakihara, T.; Habitat type: No Water; SBN: tss002r-031109; Lat. (DD): 20.85741, Long. (DD): -156.13828).

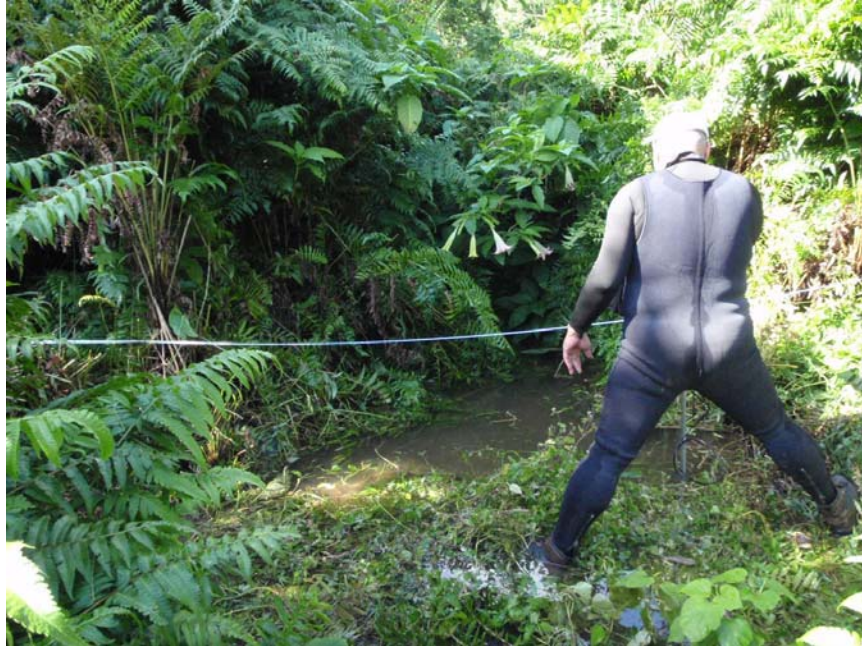
Figure 4-6. Photo of DAR staff conducting flow measurements near survey site 5. (3/11/2009; Tributary name: ‘Ōhi‘a (64012001); PBN: tss005p-016-031109; Surveyor: Sakihara, T.; SBN: 92; Lat. (DD): 20.85652, Long. (DD): -156.13951).

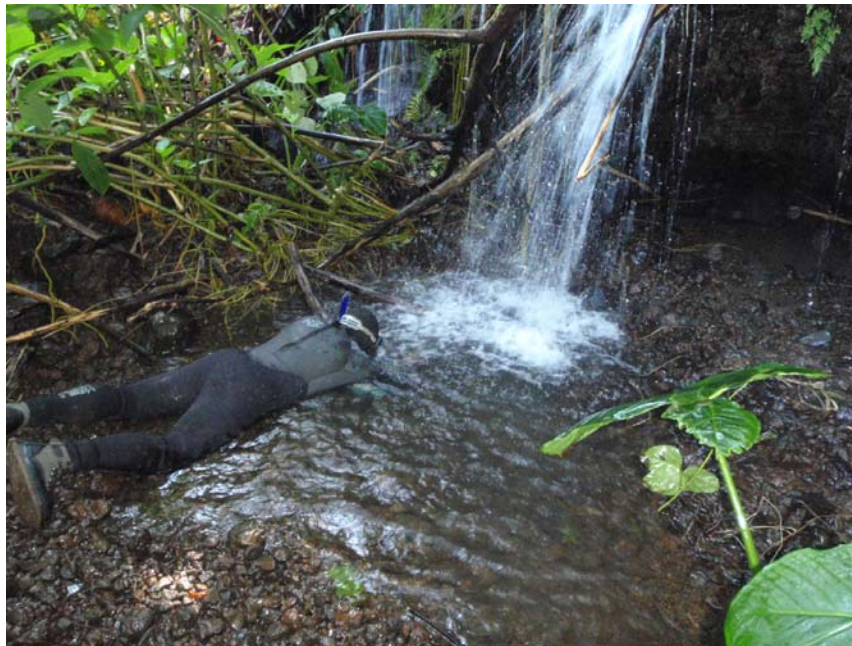
Figure 4-7. Photo of DAR staff surveying stream under a waterfall at survey site 6. (3/11/2009; Tributary name: ‘Ōhi‘a (64012001); PBN: sh006p-020-031109; Surveyor: Hau, S.; Habitat type: Plunge Pool; SBN: sh006n-031109; Lat. (DD): 20.85587, Long. (DD): -156.13962).

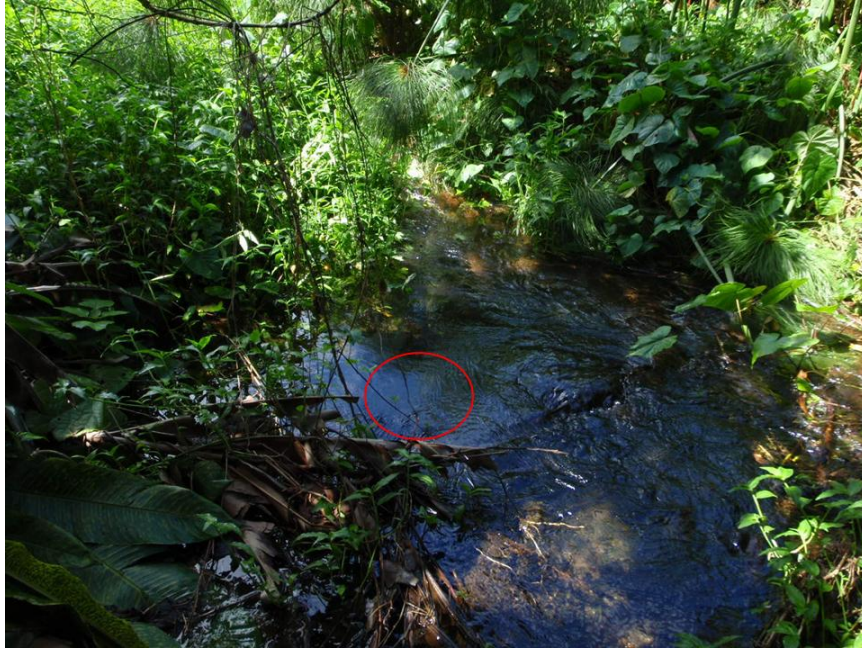
Figure 4-9. Photo of survey site 9. (3/11/2009; Tributary name: ‘Ōhi‘a (64012001); PBN: sh009p-025-031109; Surveyor: Hau, S.; Habitat type: Run; SBN: sh009n-031109; Lat. (DD): 20.85172, Long. (DD): -156.14113).

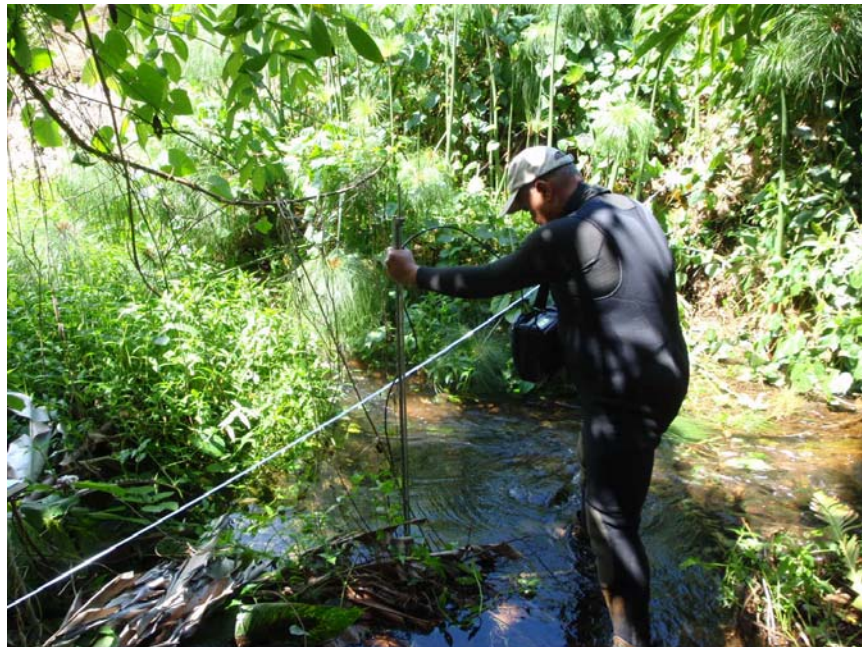
Figure 4-10. Photo showing DAR staff taking flow measurements near survey site 9. (3/11/2009; Tributary name: ‘Ōhi‘a (64012001); PBN: sh009p-027-031109; Surveyor: Hau, S.; Habitat type: Run; SBN: 91; Lat. (DD): 20.85172, Long. (DD): -156.14113).

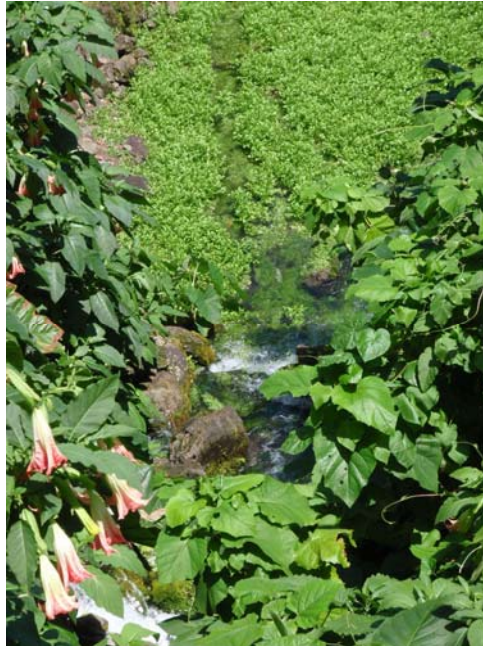
Figure 4-11. Photo showing the spring above the ponds near survey site 10. (3/11/2009; Tributary name: ‘Ōhi‘a (64012001); PBN: sh010p-044-031109; Surveyor: Hau, S.; Habitat type: Riffle; SBN: sh010n-031109; Lat. (DD): 20.85104, Long. (DD): -156.14215).

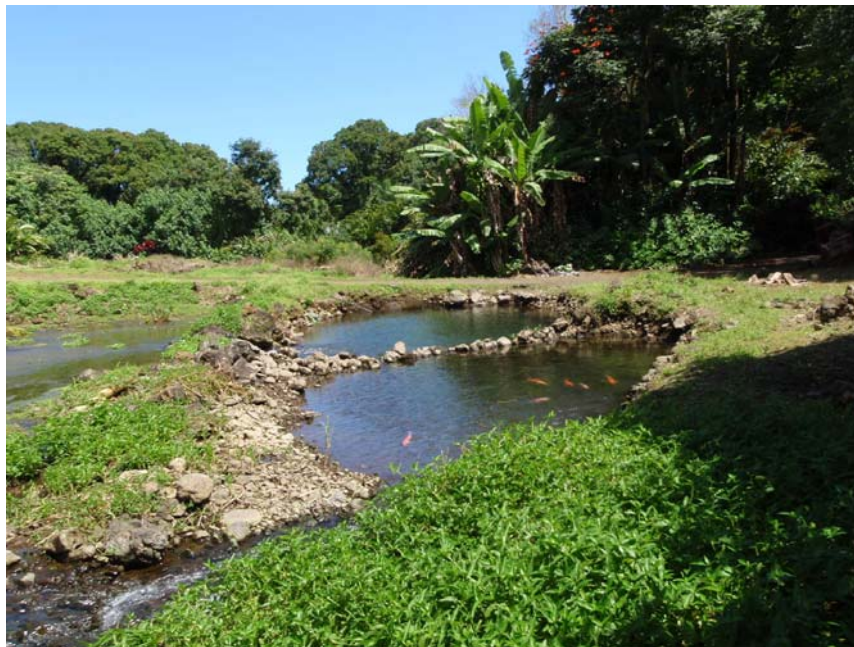
Figure 4-12. Photo of ponds below the springs near survey site 10. (3/11/2009; Tributary name: ‘Ōhi‘a (64012001); PBN: sh010p-040-031109; Surveyor: Hau, S.; Habitat type: Riffle; SBN: sh010n-031109; Lat. (DD): 20.85104, Long. (DD): -156.14215).

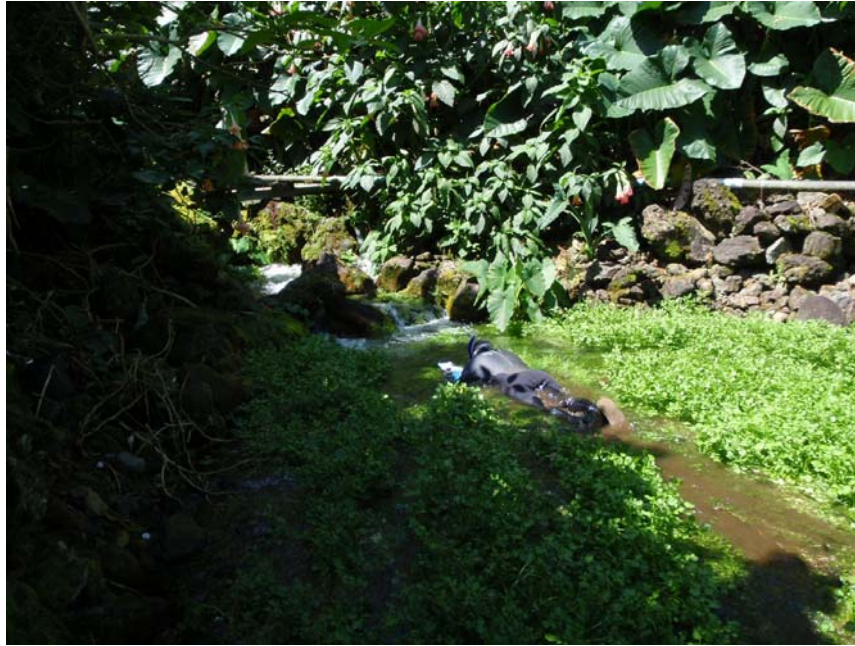
Figure 4-13. Photo shows survey site 10 which is located upstream of the ponds and below the springs. (3/11/2009; Tributary name: ‘Ōhi‘a (64012001); PBN: sh010p-036-031109; Surveyor: Hau, S.; Habitat type: Riffle; SBN: sh010n-031109; Lat. (DD): 20.85104, Long. (DD): -156.14215).
