Report on Waiohue Stream Maui, Hawaii

August 2009

State of Hawaiⁱ
Department of Land and Natural Resources
Division of Aquatic Resources
and
Bishop Museum

Prepared for
Commission on Water Resource Management
Department of Land and Natural Resources
State of Hawai'i

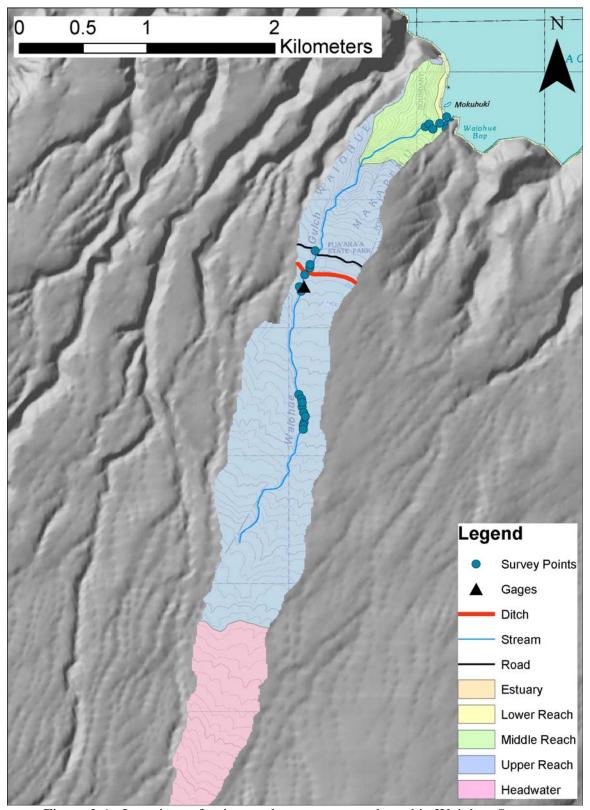
Figure 3-1. Locations of point quadrat surveys conducted in Waiohue Stream.

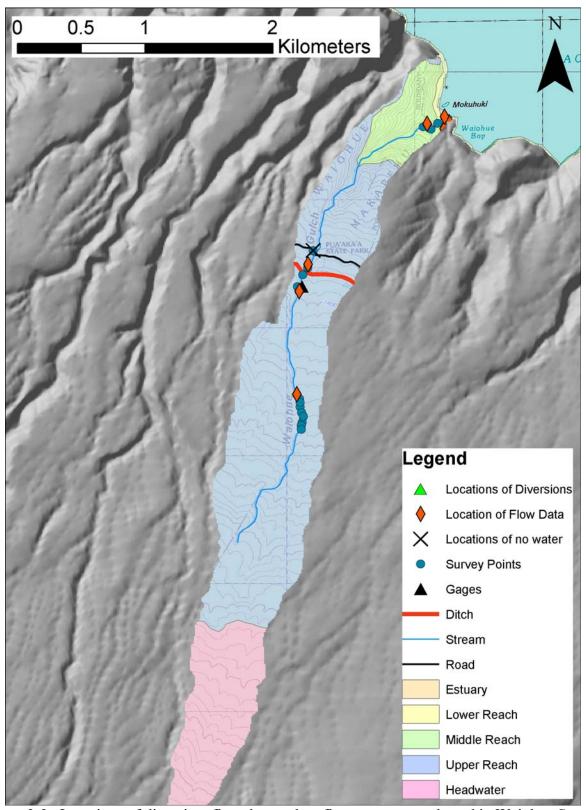
Figure 3-2. Locations of diversion, flow data and no flow surveys conducted in Waiohue Stream.

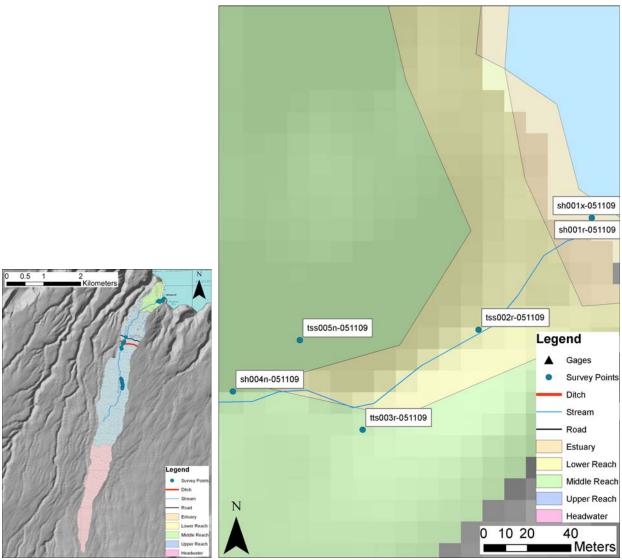
Figure 3-3. Point quadrat survey locations in the estuary, lower, and middle reaches of Waiohue Stream.

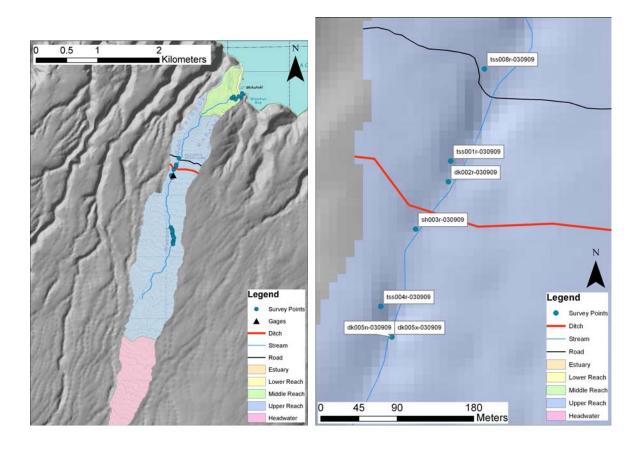
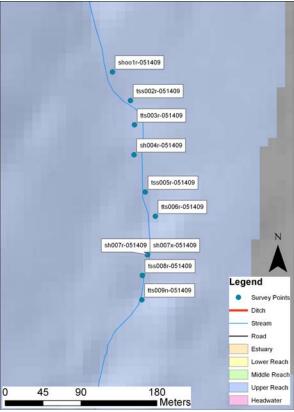
Figure 3-4. Point quadrat survey locations in the upper reach of Waiohue Stream.

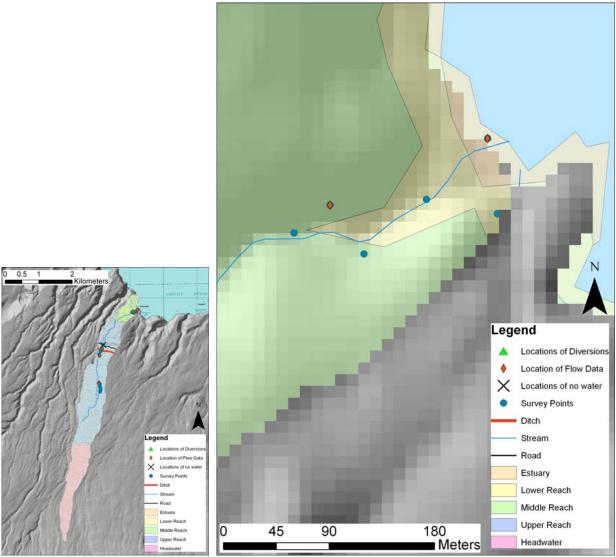
Figure 3-5. Locations of diversions, flow data and no water conditions in the estuary, lower, and middle reaches of Waiohue Stream.

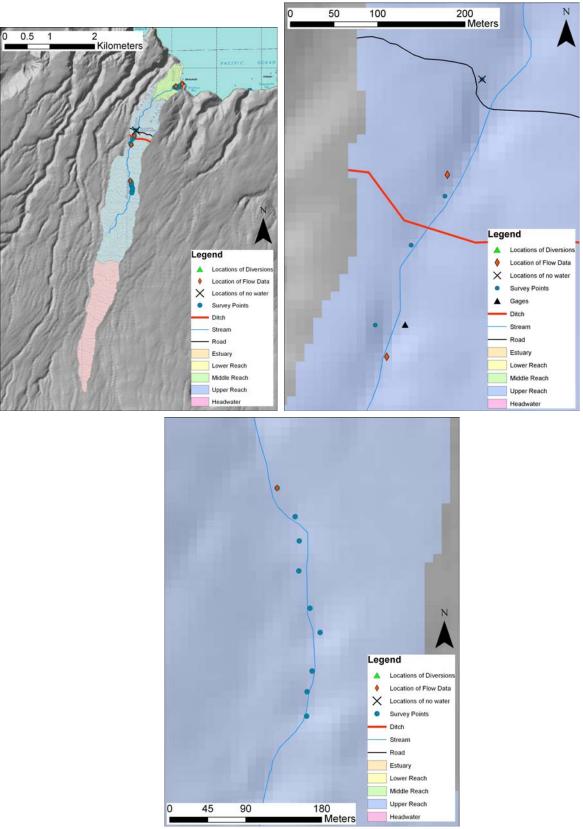
Figure 3-6. Locations of diversions, flow data, and no water conditions in the upper reach of Waiohue Stream.

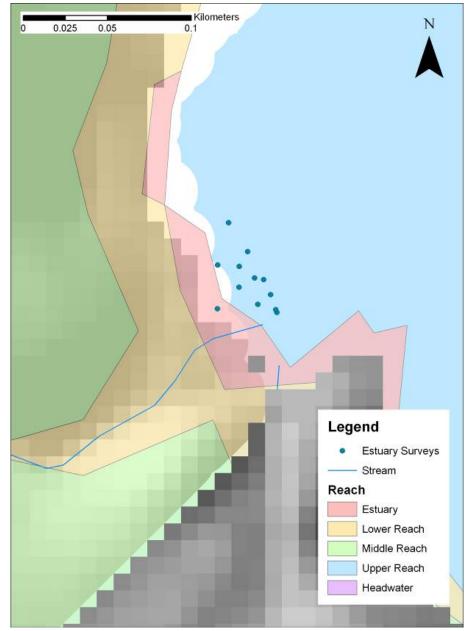
Figure 4-1. Location of estuary surveys conducted in Waiohue.

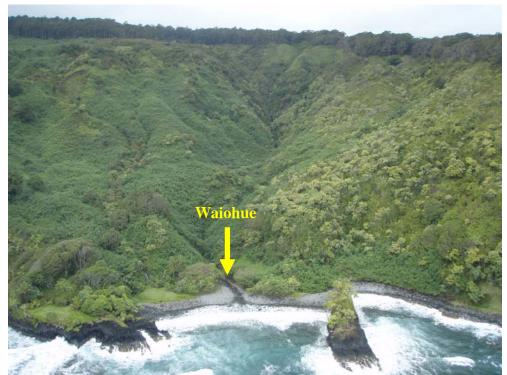
The physical characteristics of Waiohue estuary consisted of boulder terrain, white water and high surge in a small coastal embayment, typical of East Maui. The mouth of Waiohue Stream had minimal flow entering the ocean which may be due to the effects of diversions upstream.

Figure 5-2. Photo of Waiohue stream entering the ocean. (4/8/2009; Tributary name: Waiohue (64018001); PBN: dk64018001p-004-040809; Surveyor: Kuamoʻo, D.).

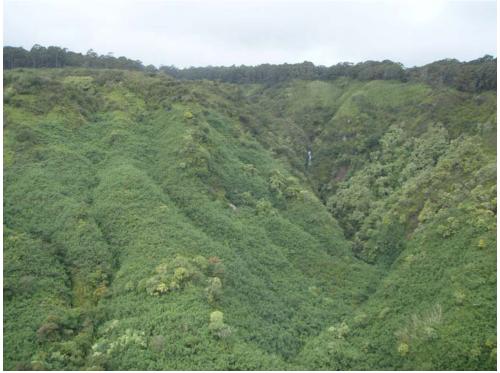
Figure 5-3. Upstream view of Waiohue stream. (4/8/2009; Tributary name: Waiohue (64018001); PBN: dk64018001-001-040809; Surveyor: Kuamoʻo, D.).

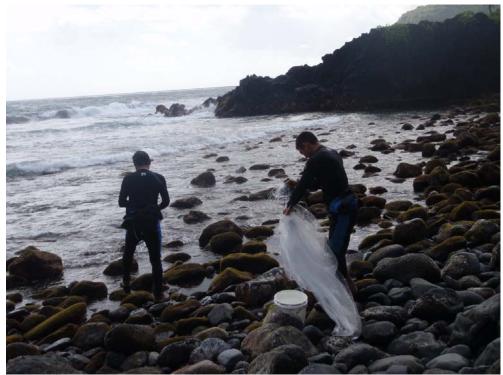
Figure 5-4. Eastward view of the stream mouth. (5/11/2009; Tributary name: Waiohue (64018001); PBN: tts64018001p-054-051109; Lat. (DD): 20.82667, Long. (DD): -156.11554).

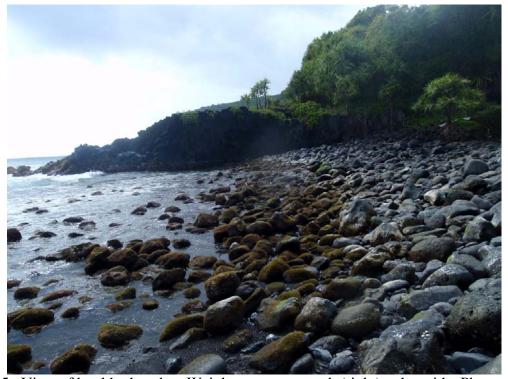
Figure 5-5. View of boulder beach at Waiohue stream mouth (right) at low tide. Photo taken eastward. (5/11/2009; Tributary name: Waiohue (64018001); PBN: tts64018001p-064-051109; Lat. (DD): 20.82667, Long. (DD): -156.11554).

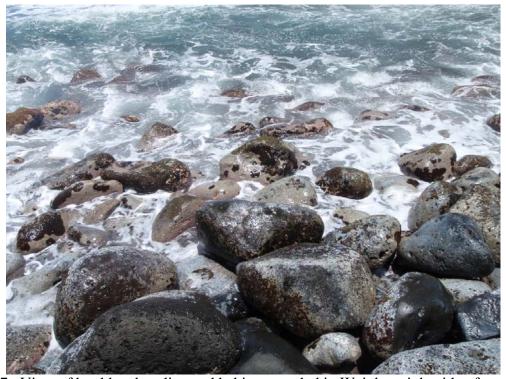
Figure 5-7. View of boulder shoreline and habitat sampled in Waiohue right side of stream mouth. (5/11/2009; Tributary name: Waiohue (64018001); PBN: tts64018001p-098-051109; Lat. (DD): 20.82667, Long. (DD): -156.11554).

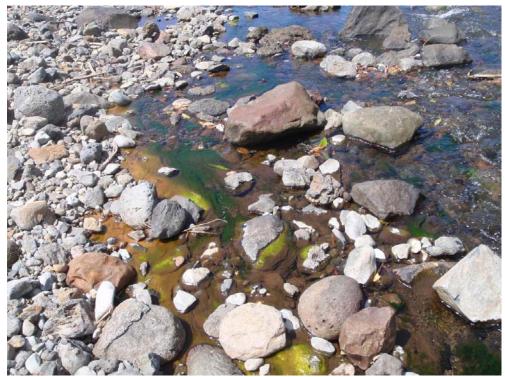
Figure 5-12. Photo of stream bed with algal mats near site 1 at stream mouth in Waiohue Stream. (5/11/2009; Tributary name: Waiohue (64018001); PBN: sh001p-145-051109; Surveyor: Hau, S.; Habitat type: Riffle; SBN: sh001r-051109; Lat. (DD): 20.82666, Long. (DD): -156.11543).

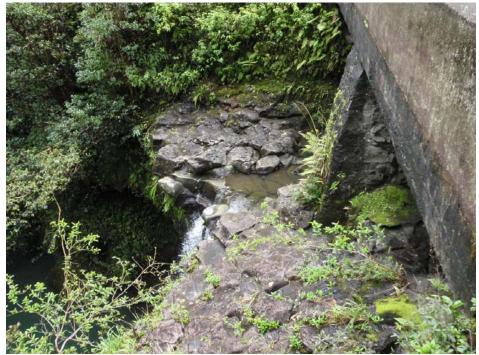
Figure 5-14. Photo of waterfall at the intersection of Hāna Highway Bridge and Waiohue at survey site 8. Below diversion showing the low flow in the stream. (3/9/2009; Tributary name: Waiohue (64018001); PBN: tss008p-080-030909; Surveyor: Sakihara, T.; Habitat type: No Water; SBN: tss008r-030909; Lat. (DD): 20.81737, Long. (DD): -156.12547).

Lower Waiohue Stream had a number of native amphidromous animals, with an abundance of *A. bisulcata* in the upper stream section. Flow restoration could improve the downstream habitat and provide better connection between upstream habitats with the ocean. Water restoration may also benefit the stream mouth and estuarine communities, although not a lot of habitat exists here in the best of conditions.

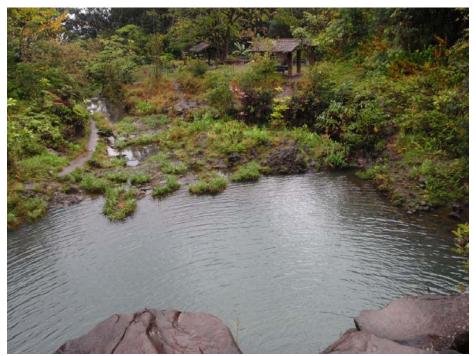
Figure 5-15. Photo taken at the intersection of Hāna Highway bridge (above highway) and Waiohue Stream at survey site 8. Image is taken in an upstream direction. (3/9/2009; Tributary name: Waiohue (64018001); PBN: tss008p-081-030909; Surveyor: Sakihara, T.; Habitat type: No Water; SBN: tss008r-030909; Lat. (DD): 20.81737, Long. (DD): -156.12547).

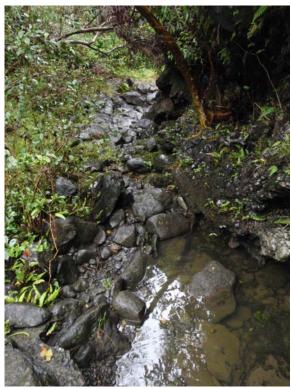
Figure 5-18. Photo of dry downstream channel below diversion intake. showing where the natural stream exits from the pool. Note the low flow due to the diversion. (3/9/2009; Tributary name: Waiohue (64018001); PBN: sh003p-019-030909; Surveyor: Hau, S.; Habitat type: Pool; SBN: sh003r-030909; Lat. (DD): 20.81567, Long. (DD): -156.12628).

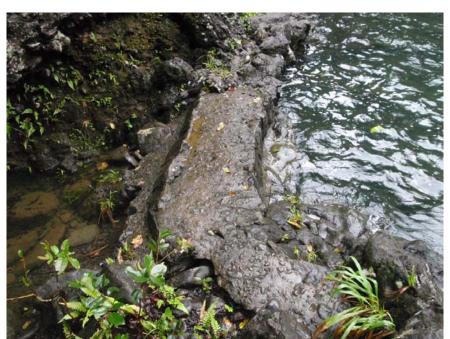
Figure 5-19. Photo of concrete wall damming water for diversion intake above survey site 3. (3/9/2009; Tributary name: Waiohue (64018001); PBN: sh003p-016-030909; Surveyor: Hau, S.; Habitat type: Pool; SBN: sh003r-030909; Lat. (DD): 20.81567, Long. (DD): -156.12628).

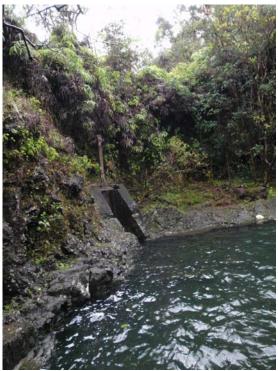
Figure 5-20. Photo of the intake where the water exits the dammed pool into the ditch system diverting 100% of flow. (3/9/2009; Tributary name: Waiohue (64018001); PBN: sh003p-018-030909; Surveyor: Hau, S.; Habitat type: Pool; SBN: sh003r-030909; Lat. (DD): 20.81567; Long. (DD): -156.12628).

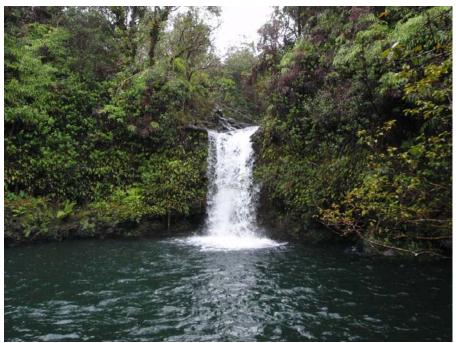
Figure 5-21. Photo of dammed waterfall plunge pool where diversion intake (to the left) is located above survey site 3. (3/9/2009: Tributary name: Waiohue (64018001); PBN: sh003p-017-030909; Surveyor: Hau, S.; Habitat type: Pool; SBN: sh003r-030909; Lat. (DD): 20.81567, Long. (DD): -156.12628).

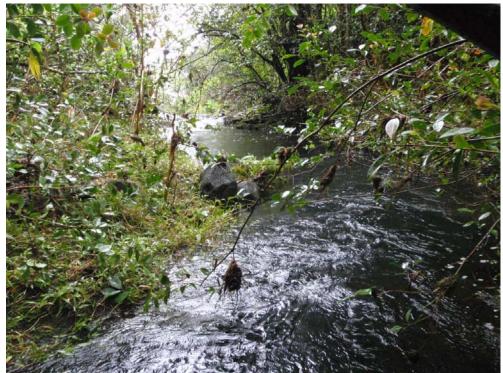
Figure 5-22. Flow measurement site. (3/9/2009: Tributary name: Waiohue (64018001); PBN: dk005p-025-030909; Surveyor: Kuamoʻo, D.; Habitat type: Run; SBN: dk005n-030909; Lat. (DD): 20.81452, Long. (DD): -156.12657).

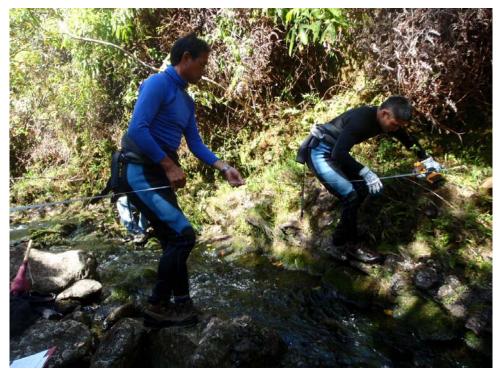
Figure 5-24. Photo shows DAR staff conducting flow measurements. (5/14/2009; Tributary name: Waiohue (64018001); PBN: sh001p-024-051409; Surveyor: Hau, S.; SBN: 118; Lat. (DD): 20.80724, Long. (DD): -156.12689).

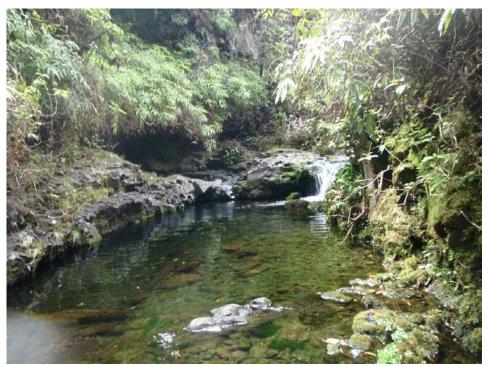
Figure 5-25. Photo shows a pool upstream of survey site 2 with algal patches. (5/14/2009; Tributary name: Waiohue (64018001); PBN: tss002p-033-051409; Surveyor: Sakihara, T.; Habitat type: Pool, SBN: tss002r-051409; Lat. (DD): 20.80693, Long. (DD): -156.12669) *Atyoida bisulcata* present - water dripping from stream walls.
