STATE OF HAWAII  
DEPARTMENT OF LAND AND NATURAL RESOURCES  
**COMMISSION ON WATER RESOURCE MANAGEMENT**  
P.O. BOX 621  
HONOLULU, HAWAII 96809

November 7, 2016

## Introduction

This serves as the written testimony summarizing the supplemental data requested from the Commission on Water Resource Management (CWRM) by the Hearings Officer, Dr. Lawrence Miike, for the re-opened contested-case hearing (CCH-MA13-01) addressing the 27 Petitions to Amend the Interim Instream Flow Standards in East Maui, filed by Native Hawaiian Legal Corporation (NHLC) on behalf of Na Moku 'Aupuni o Koolau Hui (Na Moku), Beatrice Kepani Kekahuna, and Marjorie Wallet. The Hearings Officer wanted CWRM staff to identify how much of the natural stream flow and/or regulated stream flow above certain diversions in each hydrologic unit was being diverted before establishment of an interim instream flow standard (IIFS), how much stream flow occurred below the diversion before establishment of an IIFS, how much stream flow was being diverted at the identified diversion, the percent of habitat at the regulated flow relative to the natural median baseflow (BFQ<sub>50</sub>), and the flow value which restored 90%

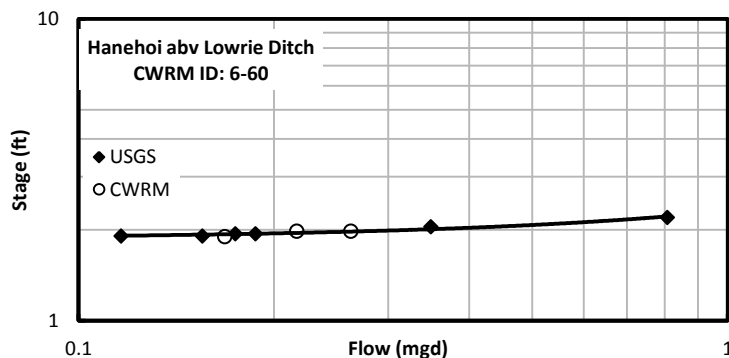
**6-60 Hanehoi abv Lowrie Ditch**

Gage 6-60 monitors stream flow in Hanehoi Stream above the Lowrie Ditch. The USGS made six measurements at this location from 2009-2010. The streambed is dominated by bedrock in this reach and the control is maintained by bedrock before water spills over a waterfall. From 2011-2015, CWRM staff made three measurements verify that the rating curve is still accurate. Gage 6-60 is challenging to get to and data are infrequently downloaded.

Because of its location and the wet conditions during 2015 and 2016, the site on Hanehoi above Lowrie Ditch was only visited once and the range of data presented is limited. Data for East Wailuaiki (CWRM ID 6-66) and Waiohue (CWRM ID 6-64) were graphed but no summary statistics have been calculated due to the malfunctioning DLNR server.

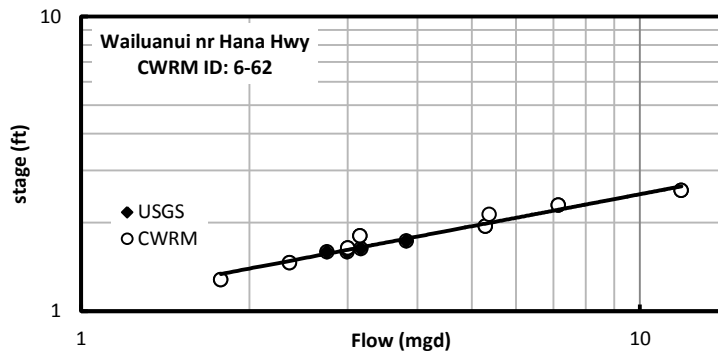
**6-62 Wailuanui nr Hana Hwy**

Gage 6-62 monitors stream flow in Wailuanui Stream at Hana Highway below the confluence of the east and west branches. Diversions on both streams take water for the Koolau Ditch. The USGS made four measurements at this location from 2009-2010. The control is maintained by bedrock and some large boulders in the stream channel below the bridge. From 2011-2015, CWRM staff made nine additional measurements to improve the rating curve.

In 2015, the median flow at 6-62 was 4.17 mgd, and the IIFS met on 279 of 365 days (76.4%). In 2016 (through October 25), the median flow was 8.33 mgd, and the IIFS was met on 259 of 299 days (86.6%).

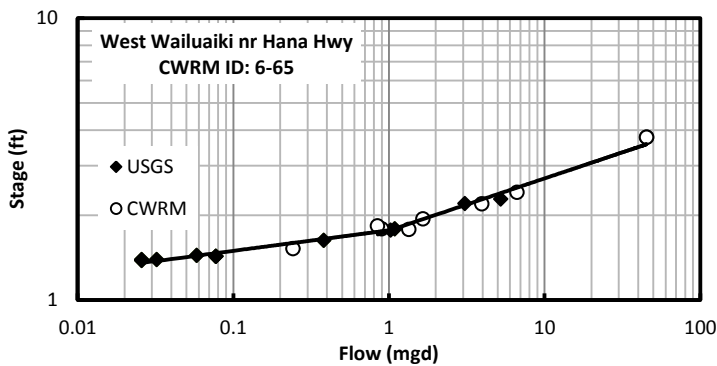
**6-65 West Wailuaiki nr Hana Hwy**

Gage 6-65 monitors stream flow in West Wailuaiki Stream at Hana Highway below the Koolau Ditch diversion. The USGS made nine measurements at this location from 2009-2011. The control is maintained by bedrock and boulders at the highway bridge pier. From 2011-2016, CWRM staff made eight measurements to improve the rating curve. There is currently a seasonal IIFS of 2.46 mgd during the wet season and 0.26 mgd during the dry season.

In 2015, the median flow at 6-62 was 1.29 mgd, and the IIFS met on 180 of 365 days (49.3%). During the wet season in 2015, the median flow was 1.44 mgd and the IIFS was met on 83 of 181 days (45.9%). During the dry season in 2015, the median flow was 0.59 mgd and the IIFS was met on 97 of 184 days (52.7%). In 2016 (through October 25), the median flow was 1.73 mgd, and the IIFS was met on 198 of 301 days (65.8%). During the wet season, the median flow was 0.19 mgd and the IIFS was met 18 of 121 days (14.9%) in 2016.
