**Preliminary Demolition Assessment
for the
Former Pagoda Hilo Bay Hotel,
Country Club Condominium/Hotel,
and Reeds Bay Hotel**

Island of Hawai'i, State of Hawai'i

VOLUME 1 OF 2

February 2018

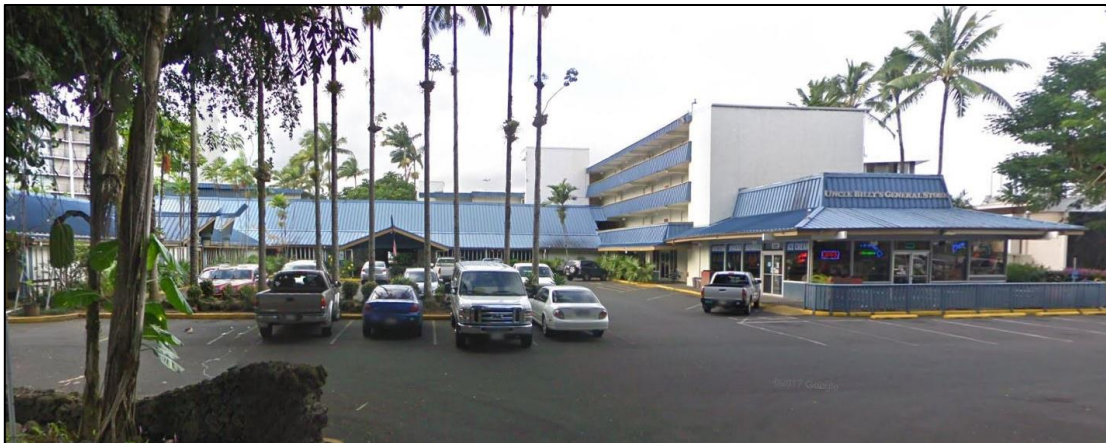
Photograph 1 Former Pagoda Hilo Bay Hotel

The former Pagoda Hilo Bay Hotel is situated on 1.7 acres, which includes 146 hotel rental units, former restaurant and retail uses, other associated buildings constructed from 1966 to 1970, parking, swimming pool, and landscaped grounds. Constructed in 1969, the Country Club Condominium/Hotel is situated on 1.2 acres which includes one, six-story building with 152 hotel rental units, meeting facilities, restaurant, parking, swimming pool, and landscaped grounds. The Reeds Bay Hotel is situated on 1.05 acres, including three structures, a total of 65 hotel rental units, parking, swimming pool, and landscaped grounds. The original construction date is unknown; however, building permit records indicated that the building has undergone various alterations since 1969. See **Photographs 1 through 3**.
