**Field Survey Report**

**East Maui Irrigation Ditch System**

**East Maui, Hawaii - Stream Diversion Abandonments**

**Native Damselfly Baseline Survey - Endangered Species Act**

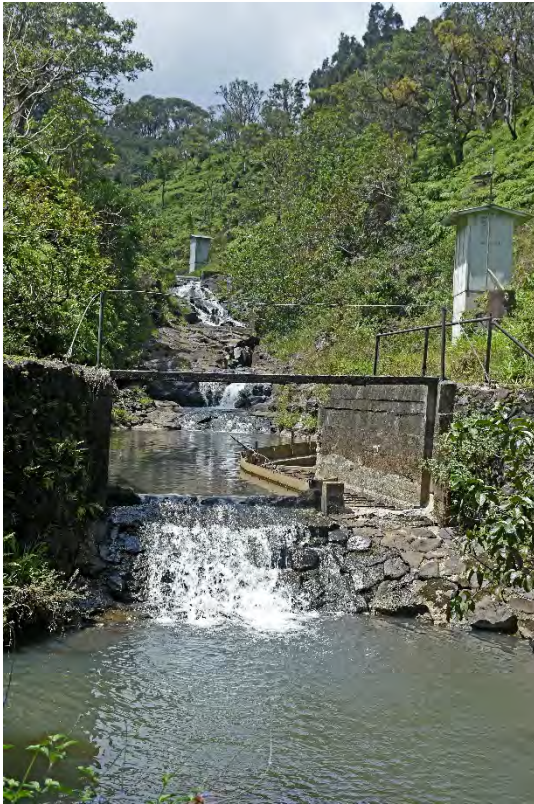
*Comments* – The point of diversion lies at a sloping cascade over bedrock (Fig. 3), which represented suitable habitat for the large native damselfly *M. blackburni*, but this species was not in evidence despite the good weather. The indigenous dragonfly *Pantala flavescens* was seen hovering above a shallow pool just downstream where the ditch maintenance road crosses via a ford. Immediately east of this ford, water was seeping into the stream channel from leaks in the masonry of an old ditch spillway, creating small side pools in bedrock that represented potentially excellent habitat for other *Megalagrion* damselflies. Despite a diligent search, however, none were seen here. Other stream invertebrates present at this site were the native prawn *Atyoides bisulcata*, and the introduced prawn *Macrobrachium lar*.

**Fig. 3.** Station 1a. Honopou Stream looking upstream at New Hamakua Ditch intake NH-22.

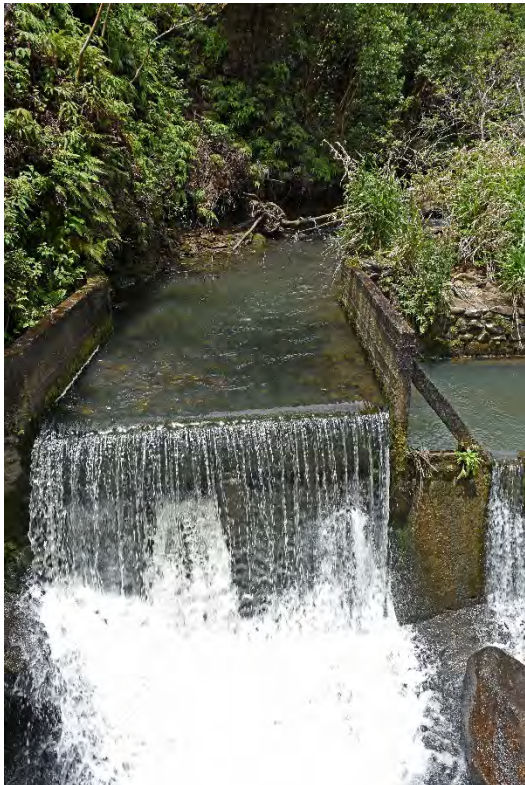
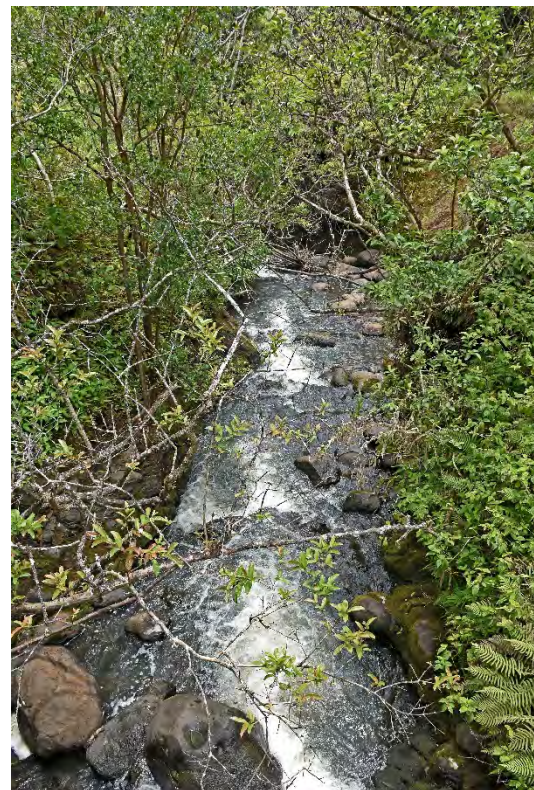
*Comments* – The brief stop at this site was only sufficient to allow photographs of the substantial discharge emerging from this catchment. Future surveys should be made here, at and above the Wailoa Ditch point of diversion (W-21, Lupi Small Intake), in order to determine

**Fig. 5.** Station 3. West Hoolawanui Stream tributary looking upstream at New Hamakua intake NH-20.

**Fig. 6.** Station 3. West Hoolawanui Stream tributary looking downstream at New Hamakua intake NH-20.

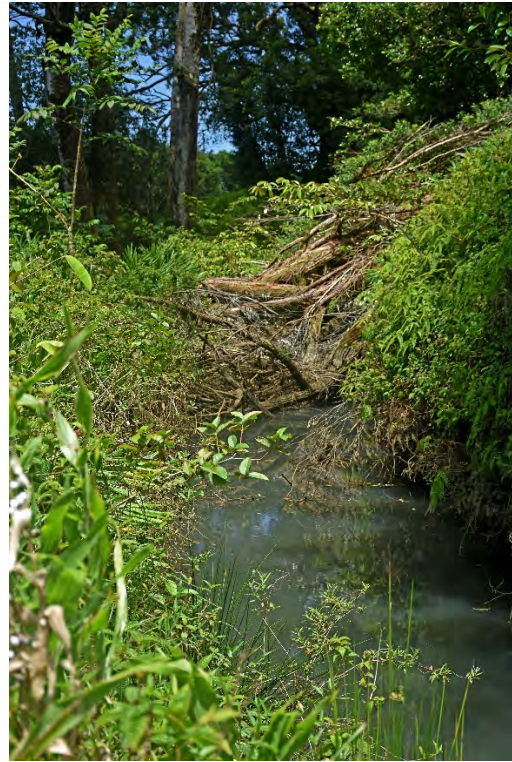
*Comments* – The stream channel here was small, and heavily overgrown, and as such difficult to discriminate as an actual drainage (Figs. 9, 10). No surface flow was observed. A large, tangled treefall was blocking the New Hamakua Ditch upstream of this point (Fig. 8).

**Fig. 8.** New Hamakua Ditch east of Intake NH-17a, showing significant blockage by fallen trees.

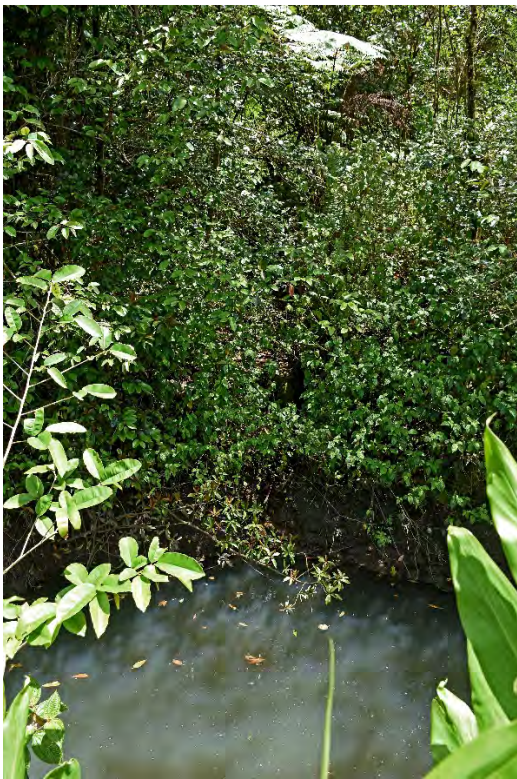
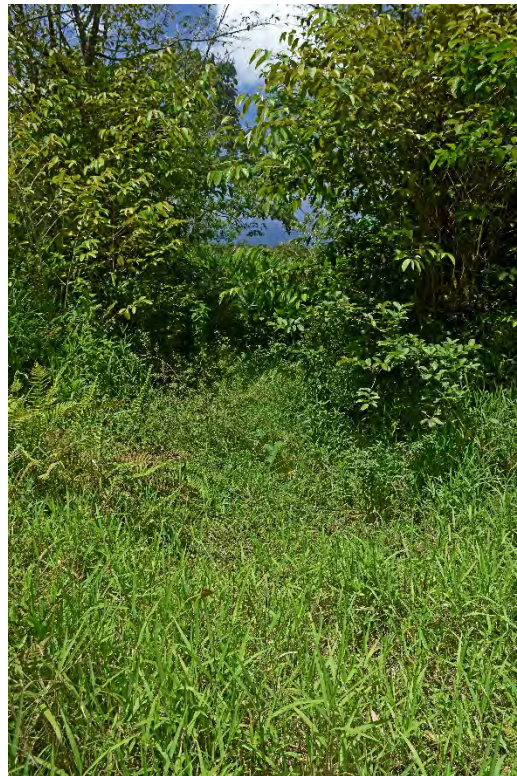
**Fig. 9.** Station 5, New Hamakua Ditch at intake NH-17a, looking upstream across the ditch

**Fig. 10.** Station 5, New Hamakua Ditch at intake NH-17a, looking downstream along weedy channel.

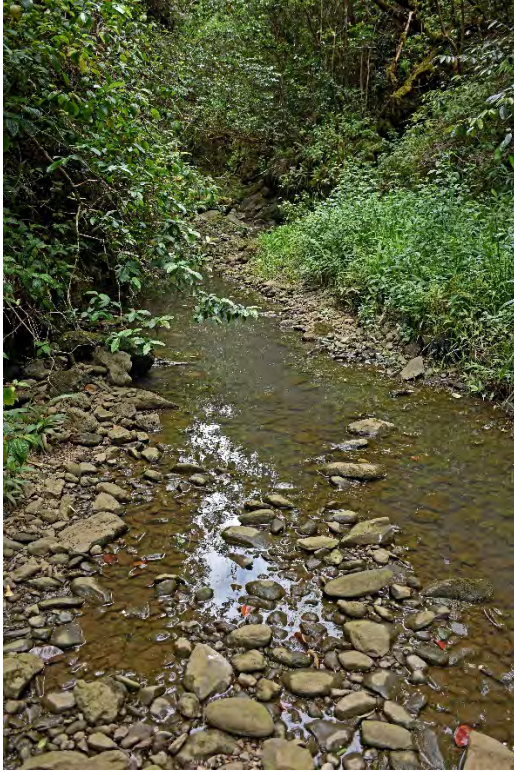
*Comments* – The ESA-listed native damselfly *M. pacificum* was abundant here in the partially de-watered reach lying downstream from Wailoa Ditch intake W-17 and upstream of New Hamakua Ditch intake NH-17 (Figs. 11, 15). At least 20 individual males were observed at various times, perching on prominent midstream rocks and on vegetation bordering the stream channel (Fig. 12) where they defended mating territories. Additional individuals were also seen along the undiverted reach immediately above intake W-17. The presence of *M. pacificum* at this site had been previously confirmed during surveys undertaken in 2008 (Higashi et al. 2008b).

**Fig. 11.** Station 6a. Hanehoi Stream looking upstream at New Hamakua Ditch intake NH-17, *Megalagrion pacificum* habitat.

**Fig. 12.** Station 6a. Hanehoi Stream above New Hamakua Ditch intake NH-17, *Megalagrion pacificum* perching beside stream.

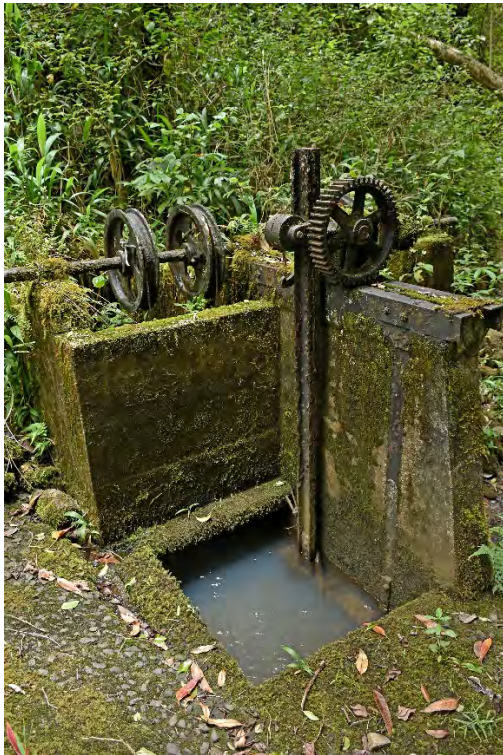
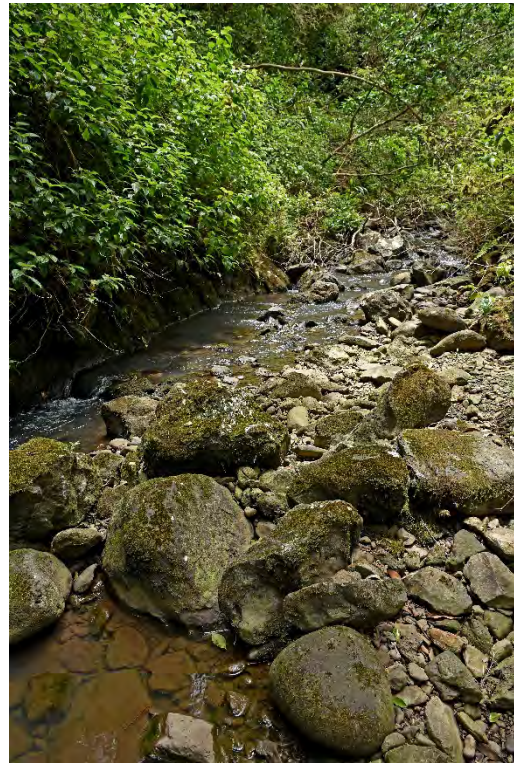
*Comments* – See comments above. The ESA-listed native damselfly *M. pacificum* was present here, and also along the freely flowing, undiverted reach immediately upstream, although time constraints did not permit extensive upstream reconnaissance. Stream corridor vegetation at this site consisted of guava, uluhe fern, Job's tear and *Clidemia*, with a single native *Cyrtandra* growing from the mossy concrete of the diversion structure. Other native aquatic insect species observed at this location included the water bug *Microvelia vagans* (Heteroptera), and the water skating fly *Campsinemus truncatus* (Diptera).

**Fig. 13.** Station 6b. Active Wailua Ditch intake W-18 along Hanehoi Stream.

**Fig. 14.** Station 6b. Hanehoi Stream looking upstream at Wailua Ditch intake W-18.

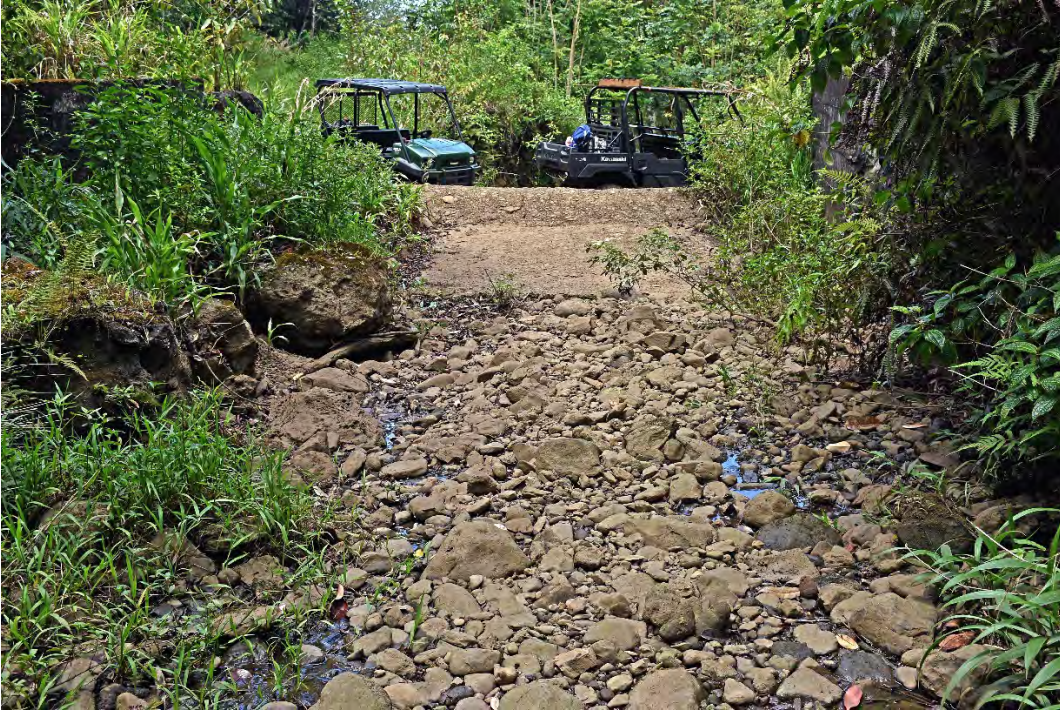
**Fig. 15.** Station 6a, Hanehoi Stream looking downstream to New Hamakua Ditch intake NH-17. The stream channel is nearly dry downstream of the concrete weir. All diversion at this site is being accomplished via the Wailoa Ditch intake W-18 further upstream.

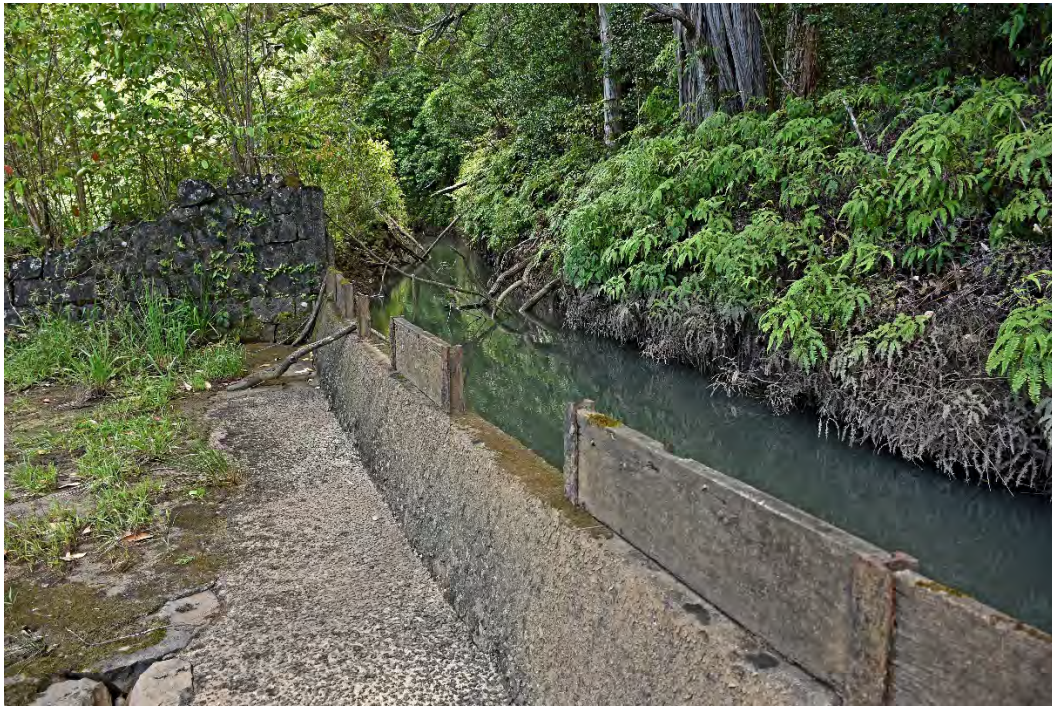
**Fig. 16.** Spillway along New Hamakua Ditch, emptying into a tributary to upper Huelo Stream northeast of New Hamakua Ditch intake N-17a. Note the fallen trees in the ditch, which is not flowing at this point, and missing flash boards along the spillway, indicative of disrepair.

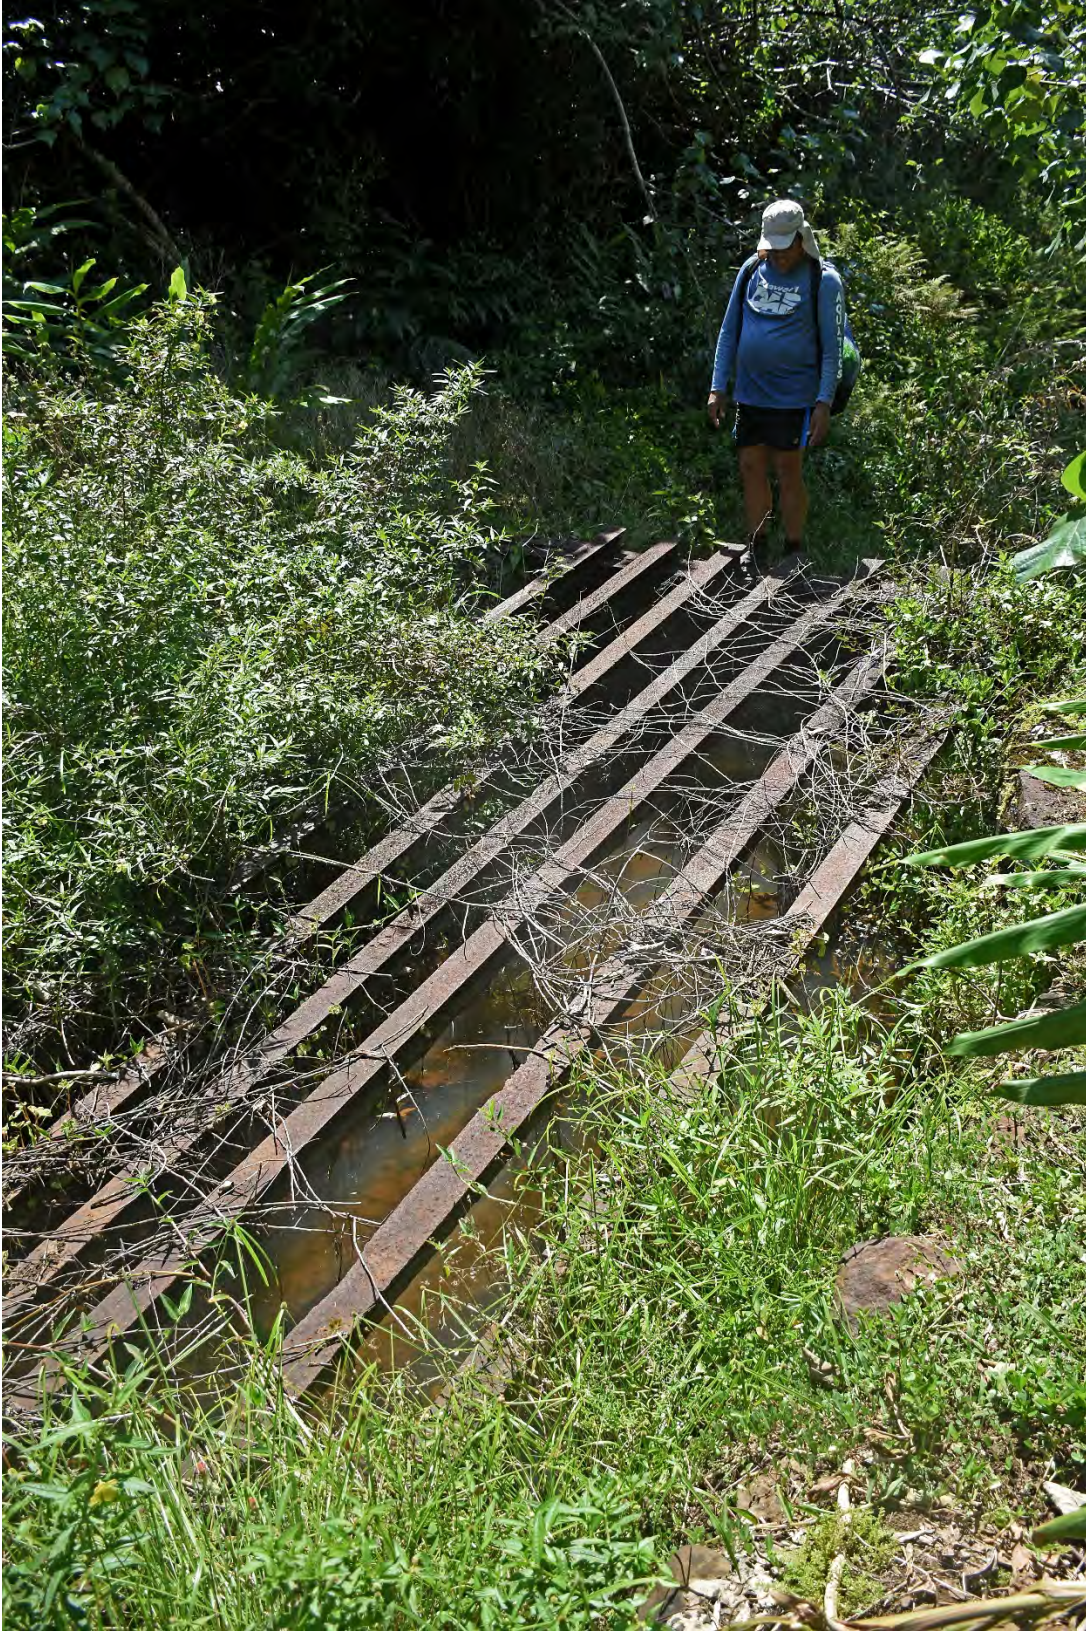
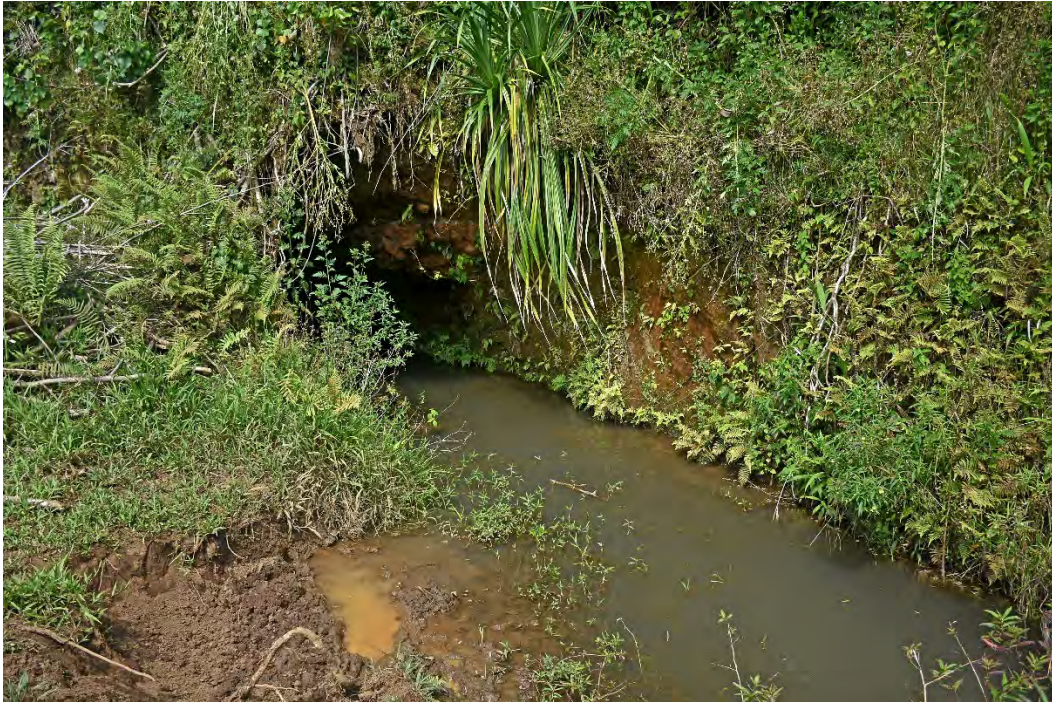
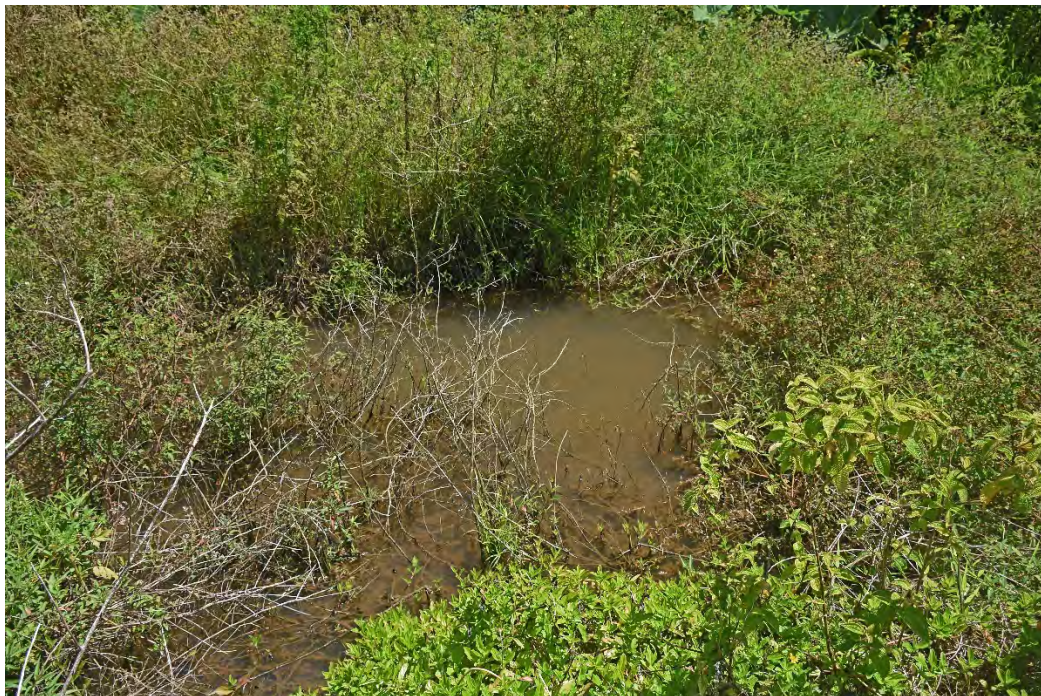
*Comments* – The Lowrie Ditch at this point was not flowing, and consisted of stagnant reaches partially overgrown by invasive weeds (Figs. 17-19). The surrounding vegetation consisted of scattered koa and ohia trees with an understory of introduced ferns, weeds and *Clidemia*. No Odonata were seen.

**Fig. 17.** Station 2, Lowrie Ditch at the Long Strainer and intake L-15, along an eastern tributary to Honopou Stream. The ditch in this area is not flowing, and is heavily overgrown with weeds.

**Fig. 18.** Station 2, Lowrie Ditch and associated tunnel a short distance east of the Long Strainer and intake L-15.

**Fig. 19.** Station 2, Standing water along the Lowrie Ditch immediately east and upstream of the Long Strainer and intake L-15. In its current condition this ditch does not appear suitable for water transport. No native damselflies were seen in this area.

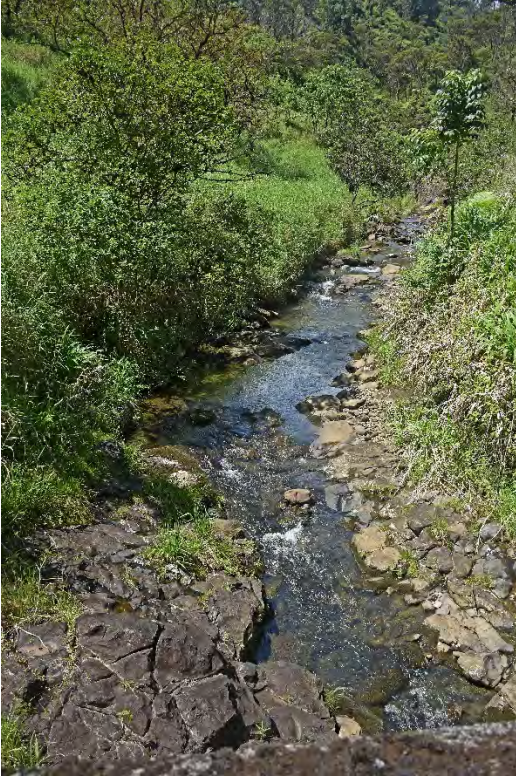
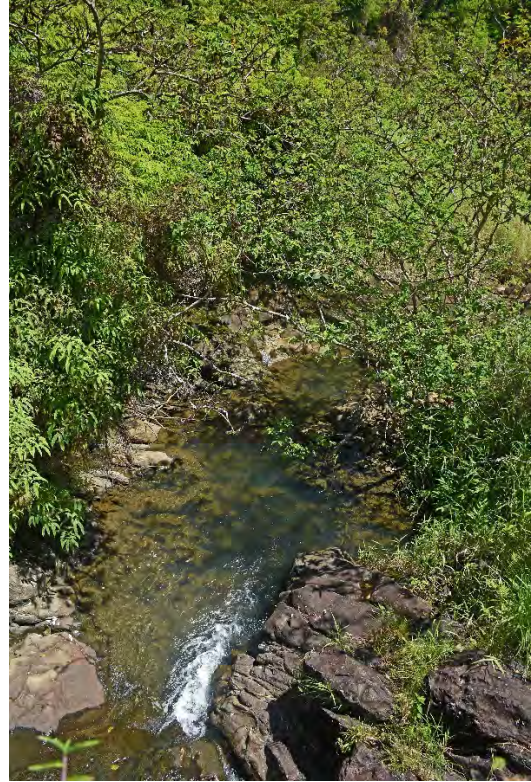
*Comments* – East Wailuanui stream along the reach surveyed was a clear, moderately swift stream flowing in a rocky, unshaded bed lined by introduced grasses and scattered guava trees (Figs. 20, 21). A tandem pair of the native damselfly *Megalagrion nigrohamatum nigrohamatum* was observed in the vicinity of the K-18 diversion structure, indicating a breeding population in this area, and a single individual of *Megalagrion hawaiiense* flew across the road as the party was crossing this stream on the return trip later in the day. No ESA-listed *Megalagrion* species were seen at this location.

**Fig. 20.** Station 7, East Wailuanui Stream, looking upstream below Koolau Ditch intake K-18.

**Fig. 21.** Station 7, East Wailuanui Stream, looking downstream below Koolau Ditch intake K-18.

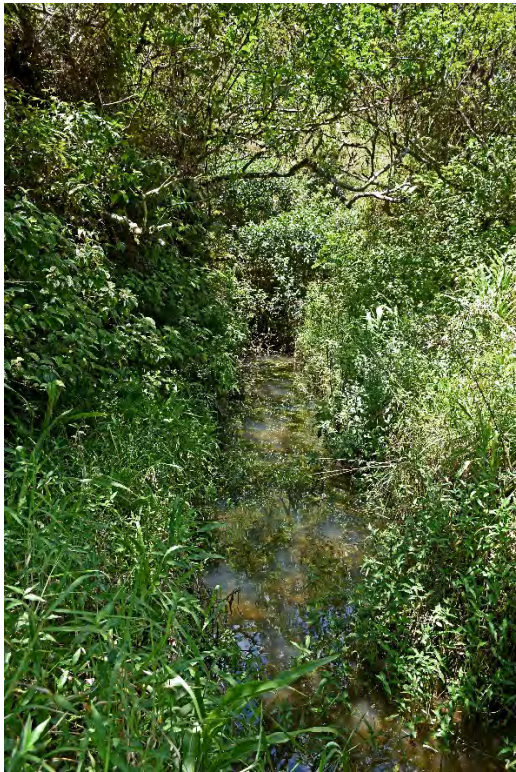
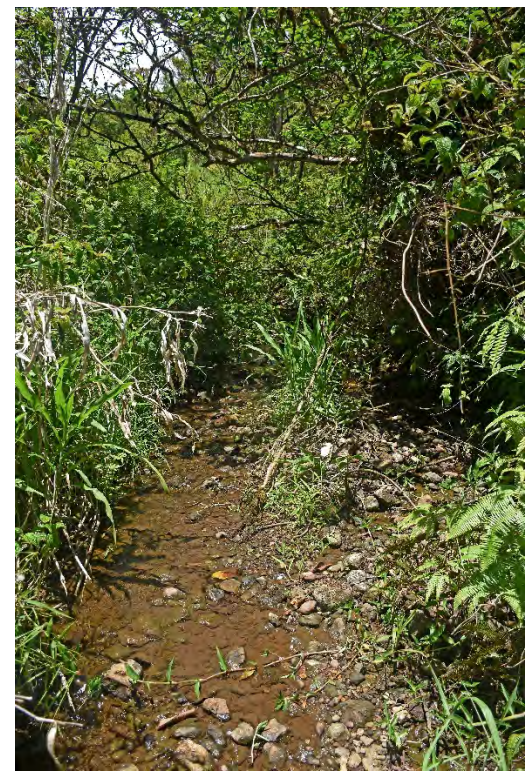
*Comments* – This site presented several types of freshwater habitats, including standing pools in the currently inactive Koolau Ditch (Figs. 22), and a small, shallow stream flowing in a rocky, partially shaded bed lined by grasses and guava trees (Figs. 23). No Odonata were seen at the pools along the ditch, but the small stream, a tributary to East Wailuanui Stream, supported a moderately rich assemblage of damselfly species, including the native *Megalagrion blackburni* and *Megalagrion nigrohamatum nigrohamatum*, and the introduced *Ischnura posita*. No ESA-listed *Megalagrion* species were seen at this location.

**Fig. 22.** Station 8, Koolau Ditch at Intake K-19, on a tributary to East Wailuanui Stream.

**Fig. 23.** Station 8, tributary to East Wailuanui Stream above Koolau Ditch intake K-19.

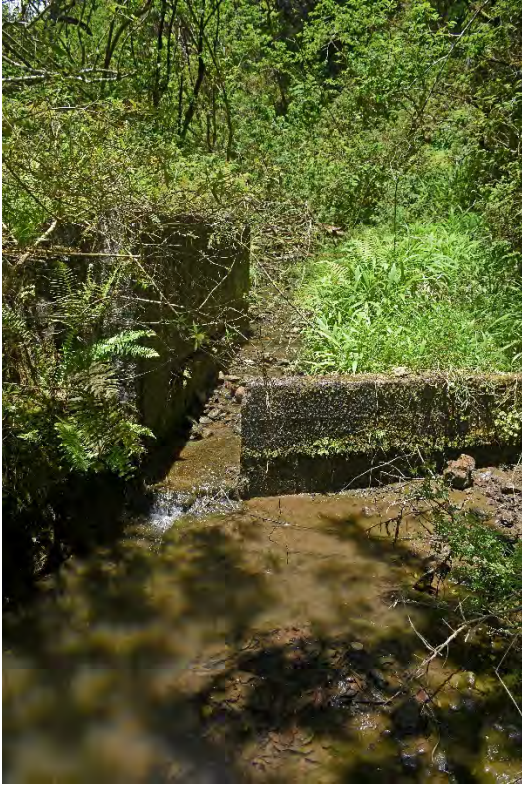
*Comments* – At this site a small, shallow tributary to East Wailuanui Stream passed through a slot in a low weir at intake K-20 (Fig. 24). The channel above the diversion was overtopped by a tangle of introduced guava and other low trees that made transit along it difficult, and no Odonata were seen there. The adjacent Koolau Ditch was masonry-lined at this point, and

though carrying no water, still retained moist walls and bottom, creating artificial seep habitat. One individual of the native damselfly *Megalagrion hawaiiense* was seen briefly here, and it is assumed that this seep-breeding species is utilizing the habitat provided by the de-watered ditch. No ESA-listed *Megalagrion* species were seen at this location.

**Fig. 24.** Station 9, tributary to East Wailuanui Stream at Koolau Ditch intake K-20.

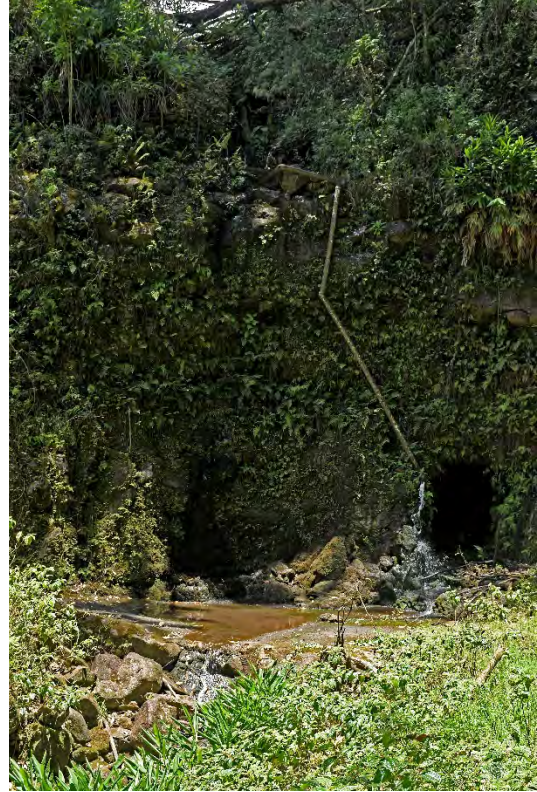
*Comments* – This site consisted of a pipe which diverts a tributary of East Wailuanui Stream at the head of a waterfall face and conveys the water downward into a bulkhead leading to intake 20A on the Koolau Ditch (Fig. 25). The diversion does not appear to be currently active, and water was being released from a valve into the streambed, forming a broad, shallow pool where the EMI ditch maintenance road crosses. The bedrock faces to either side of the pipe were seeping and wet, supporting lush riparian vegetation. Although this appeared to be potentially good habitat for certain native *Megalagrion* damselfly species such as *M. hawaiiense* or *M. nesiotetes*, no Odonata of any type were seen at this location, even under excellent weather conditions.

**Fig. 25.** Station 10, tributary to East Wailuanui Stream at Koolau Ditch intake K-20a.

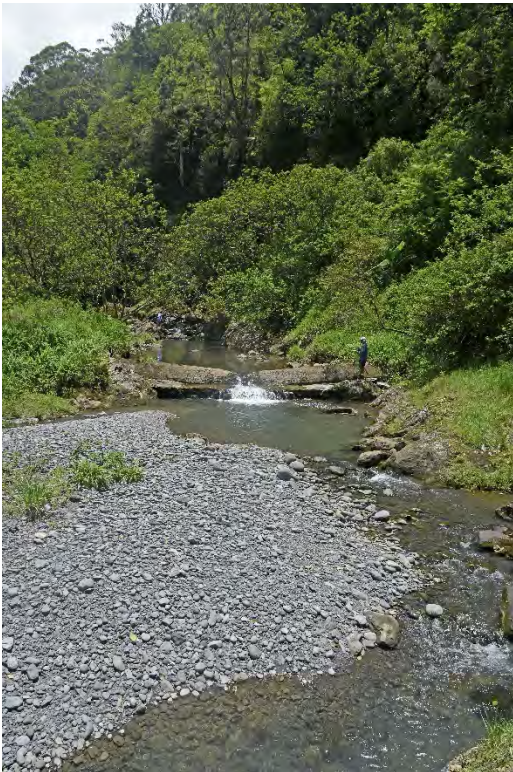
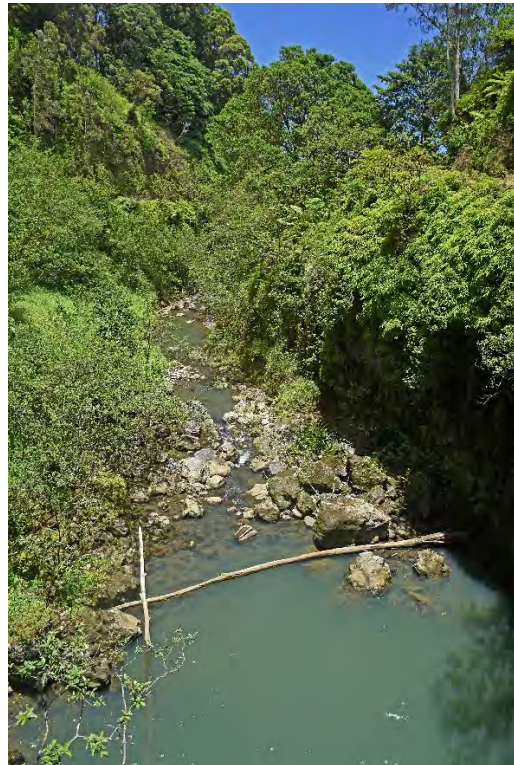
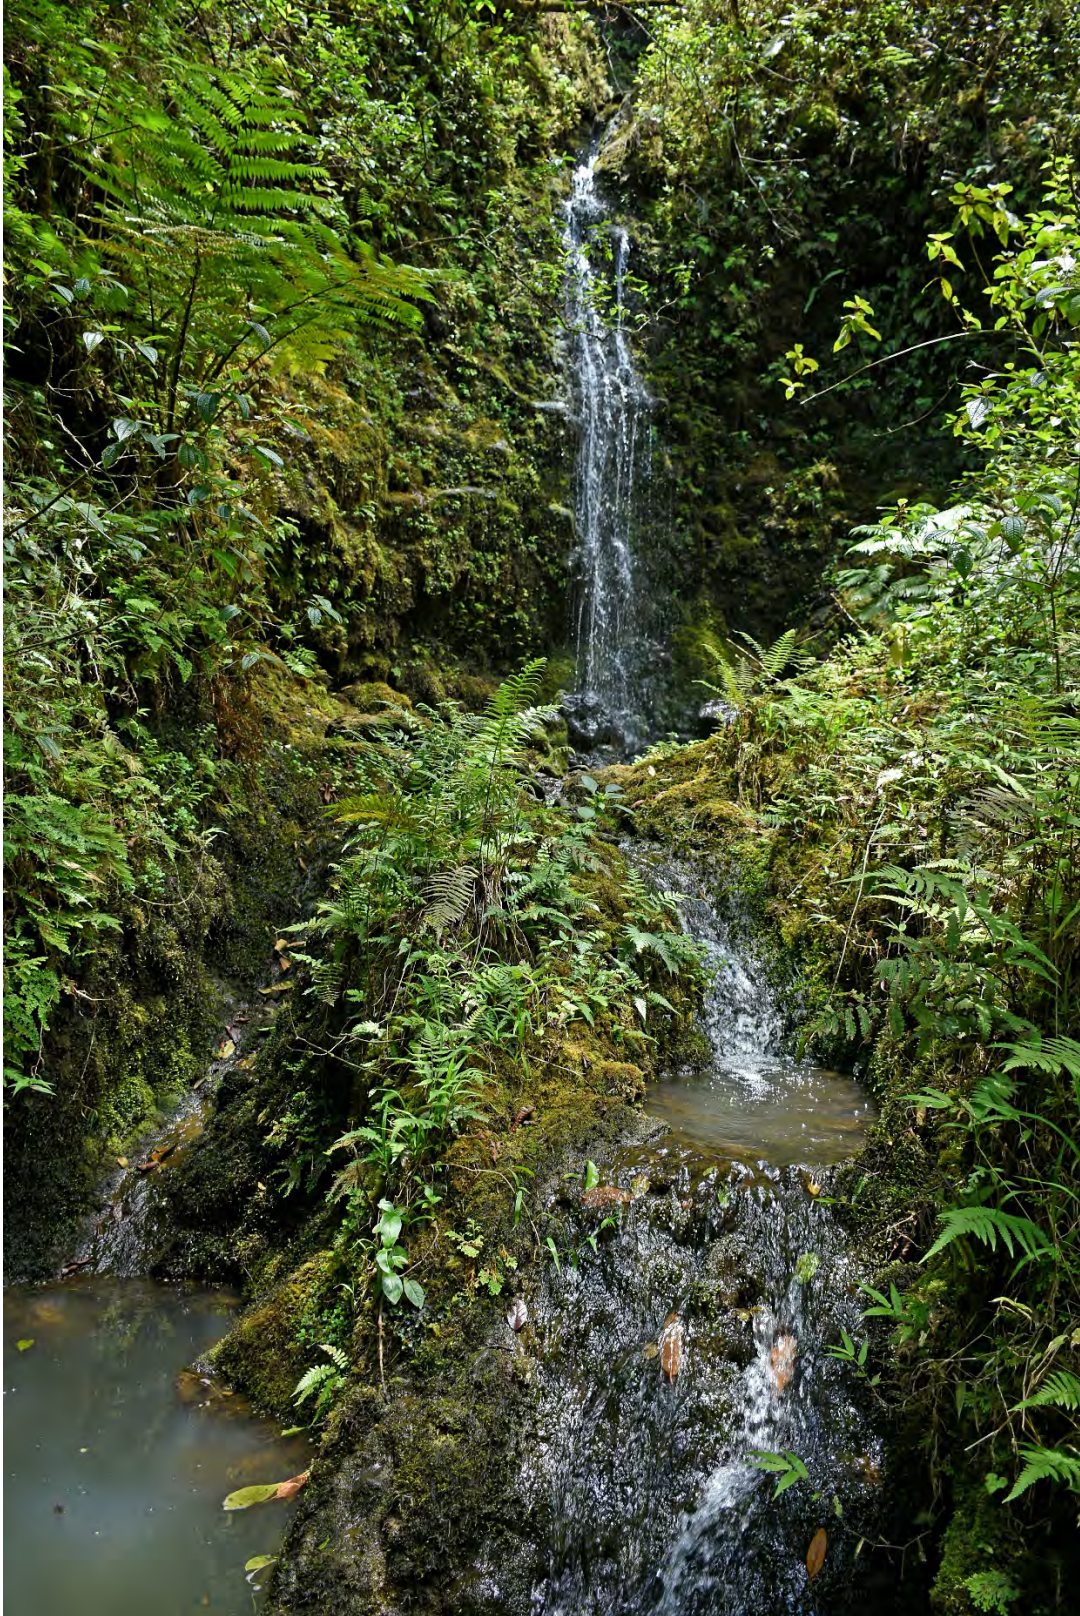
*Comments* – West Wailuanui Stream at this site is a large, high-volume catchment that clearly experiences wide fluctuations in discharge rate, as shown by the clean, scoured nature of the channel and the deposition of extensive cobble berms. The stream above the road crossing and associated intake K-21 lie at the lip of a high waterfall, with a deep gorge below containing a deep plunge pool (Fig. 27). This area was not accessible. Above the bridge, the stream occupies a broad, unshaded bed of gentle gradient, which may be traversed for several hundred feet before another high waterfall is reached (Fig. 26). A small tributary with lush riparian vegetation also enters from the east bank just upstream of the road crossing (Fig. 30), and the bedrock walls next to the waterfall supported seeps with numerous ferns and hydrophytes. Despite this diverse array of habitats, coupled with sunny weather, no *Megalagrion* damselflies were seen along the stream at this location, although the native dragonflies *Anax strenuus* and *Pantala*

**Fig. 26.** Station 11, West Wailuanui Stream, looking upstream above Koolau Ditch Intake K-21.

**Fig. 27.** Station 11, West Wailuanui Stream, looking downstream from Koolau Ditch Intake K-21.

**Fig. 30.** Station 11, tributary to West Wailua Iki Stream a short distance upstream of Koolau Ditch intake K-21. Although this is a very picturesque habitat, no native damselflies were seen here.

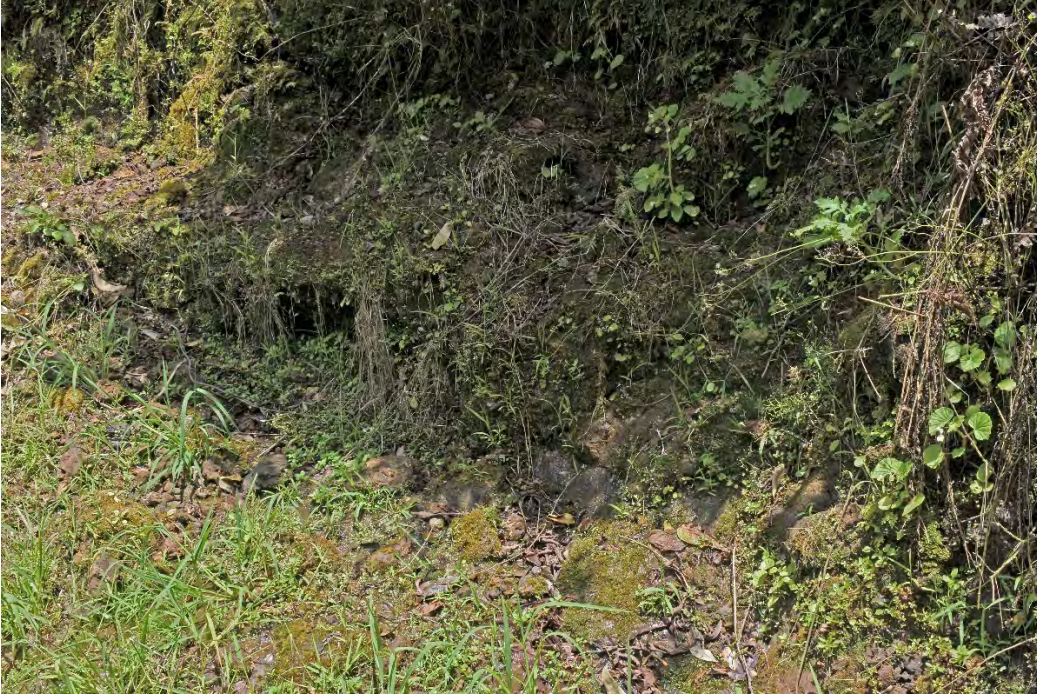
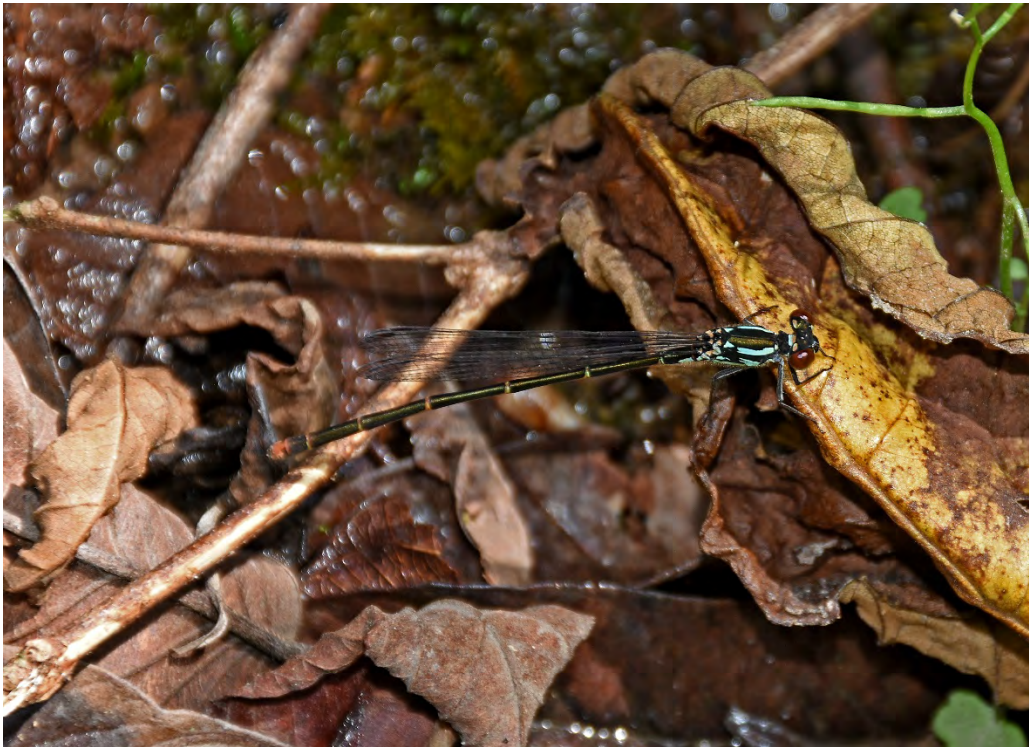
*flavescens* were both present in low numbers. A female of the seep-breeding species *Megalagrion hawaiiense* was eventually observed ovipositing at the base of seeping bedrock walls formed by a road cut to the east of the bridge (Fig. 28); this female exhibited the blue thoracic striping characteristic of *M. hawaiiense* populations occurring at lower elevations on windward Haleakala (Fig. 29). No ESA-listed *Megalagrion* species were seen at this location. Other native aquatic insect species observed here included the water bug *Microvelia vagans* (Heteroptera), and the water skating fly *Campsinemus truncatus* (Diptera). The predominant riparian vegetation at this site consisted of guava and introduced grasses.

**Fig. 28.** Station 11a, roadside seeps just to the northeast of Koolau Ditch intake K-21, which provided habitat for the native damselfly *Megalagrion hawaiiense*.

**Fig. 29.** A female of the native damselfly *Megalagrion hawaiiense*, photographed while ovipositing at the base of the seeps shown above.
