# Report on Kapā'ula Gulch Maui, Hawaii

**August 2009**

State of Hawai'i  
Department of Land and Natural Resources  
**Division of Aquatic Resources**

Prepared for  
Commission on Water Resource Management  
Department of Land and Natural Resources  
State of Hawai‘i

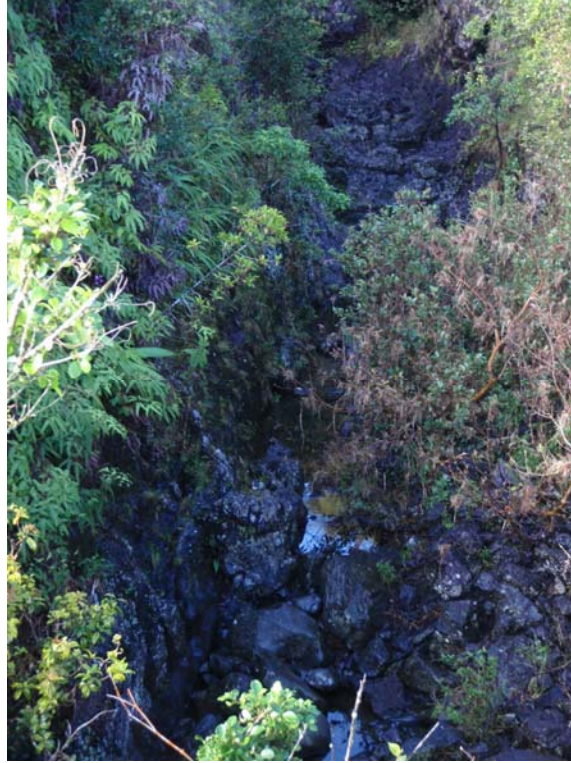
Figure 4-2. Dry stream bed with rain-fed pools in Kapā'ula Gulch just below site 1. (2/10/2009; Tributary name: Kapā'ula(64021001); PBN: dk001p-003-021009; Surveyor: Kuamo'o, D.; SBN: dk001n-021009; Lat.(DD): 20.81134, Long.(DD): -156.11473).

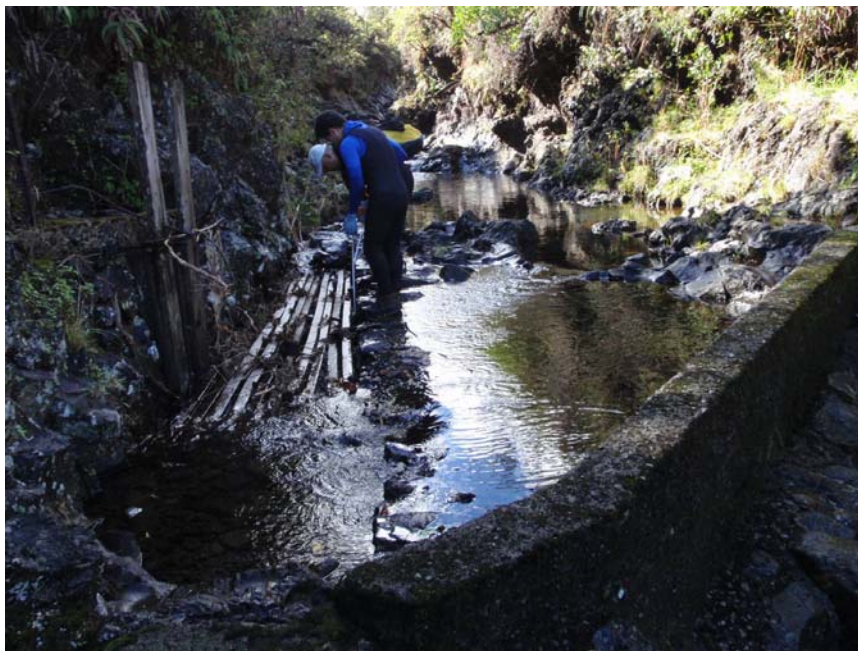
Figure 4-3. Concrete weir next to survey site 6. Photo is taken in the upstream direction. (2/11/2009; Tributary name: Kapā'ula (64021001); PBN: ts006p-123-021109; Surveyor: Shimoda, T.; Habitat type: Riffle; SBN: ts006n-021109; Lat. (DD): 20.80955, Long. (DD): -156.11530).

Point quadrat surveys were conducted in the upper reach of Kapā'ula Gulch upstream from Hāna Highway. DAR surveyors accessed the stream by following a polyvinyl chloride (PVC) pipe up a dry wash and found an old tunnel that led to the stream, which could have been an older diversion that no longer collects water but was not dismantled. The streambed consisted mainly of cobble, bedrock and boulders and standing water with no flow. A second diversion was found upstream, which was taking 100% of stream flow, sending water into the ditch through metal grating (Figure 4-3). The stream had moderate flow above the second diversion where flow was measured.

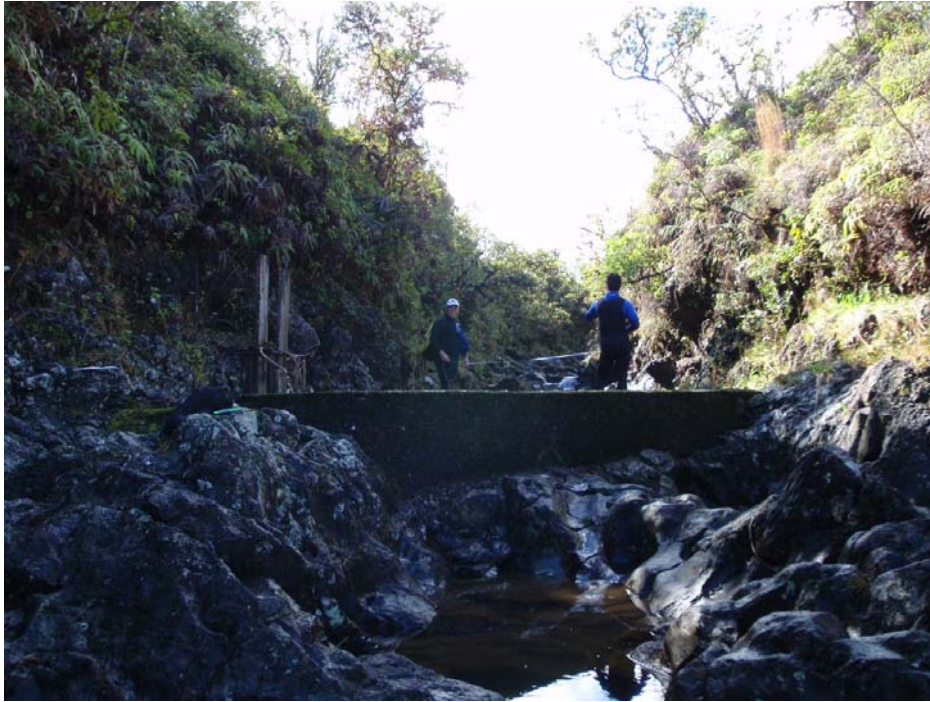
Figure 4-4. Photo is looking upstream towards the survey site 6 and the diversion. (2/11/2009; Tributary name: Kapā'ula (64021001); PBN: ts006p-124-021109; Surveyor: Shimoda, T.; Habitat type: Riffle; SBN: ts006n-021109; Lat. (DD): 20.80955, Long. (DD): -156.11530).

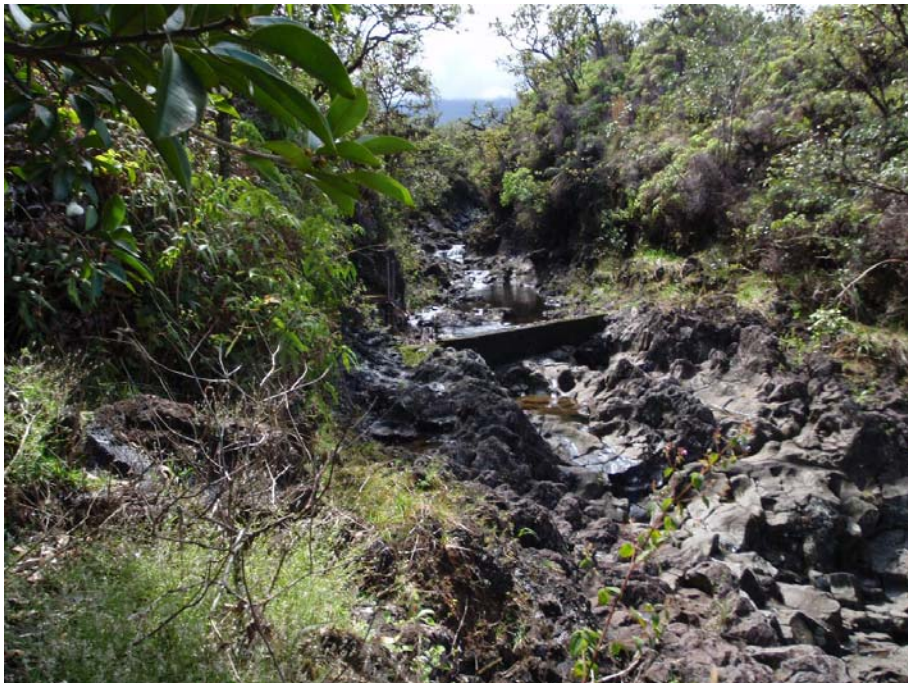
Figure 4-5. Photo is taken looking upstream towards the diversion and survey site 6. (2/11/2009; Tributary name: Kapā'ula (64021001); PBN: ts006p-141-021109; Surveyor: Shimoda, T.; Habitat type: Riffle; SBN: ts006n-021109; Lat. (DD): 20.80955, Long. (DD): -156.11530).

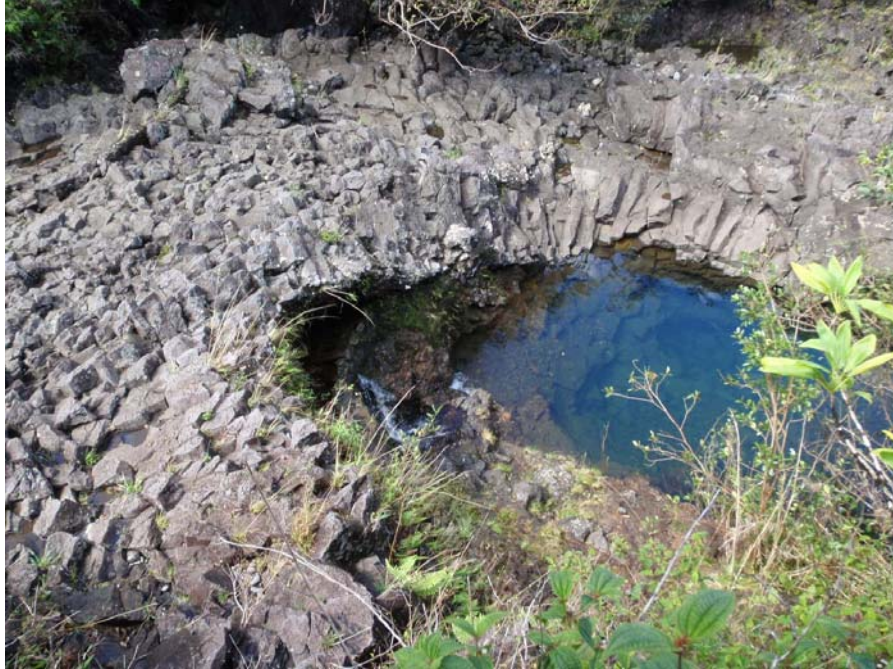
Figure 4-6. A pool in a dry stream bed downstream of concrete weir and westward of site 6 in Kapā'ula Gulchi. (2/11/2009; Tributary name: Kapā'ula (64021001); PBN: ts006p-139-021109; Surveyor: Shimoda, T.; Habitat type: Riffle; SBN: ts006n-021109; Lat. (DD): 20.80955, Long. (DD): -156.11530).

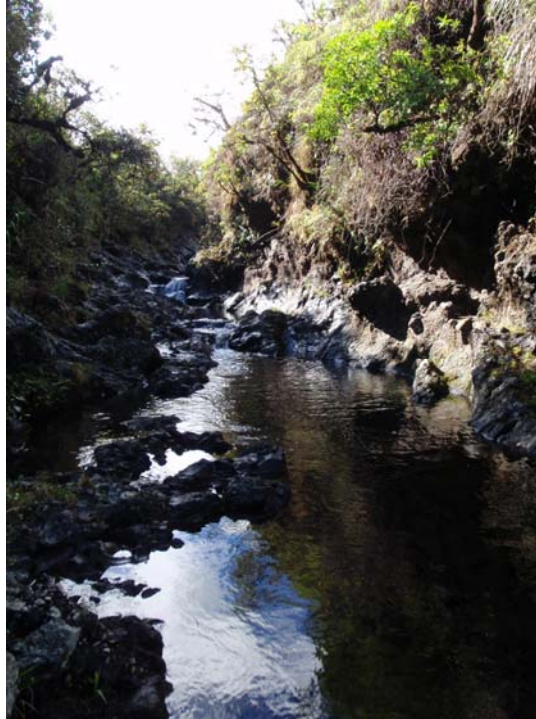
Figure 4-7. Photo is taken upstream from survey site 6 and the diversion. (2/11/2009; Tributary name: Kapā'ula (64021001); PBN: ts006p-128-021109; Surveyor: Shimoda, T.; Habitat type: Riffle; SBN: ts006n-021109; Lat. (DD): 20.80955, Long. (DD): -156.11530).

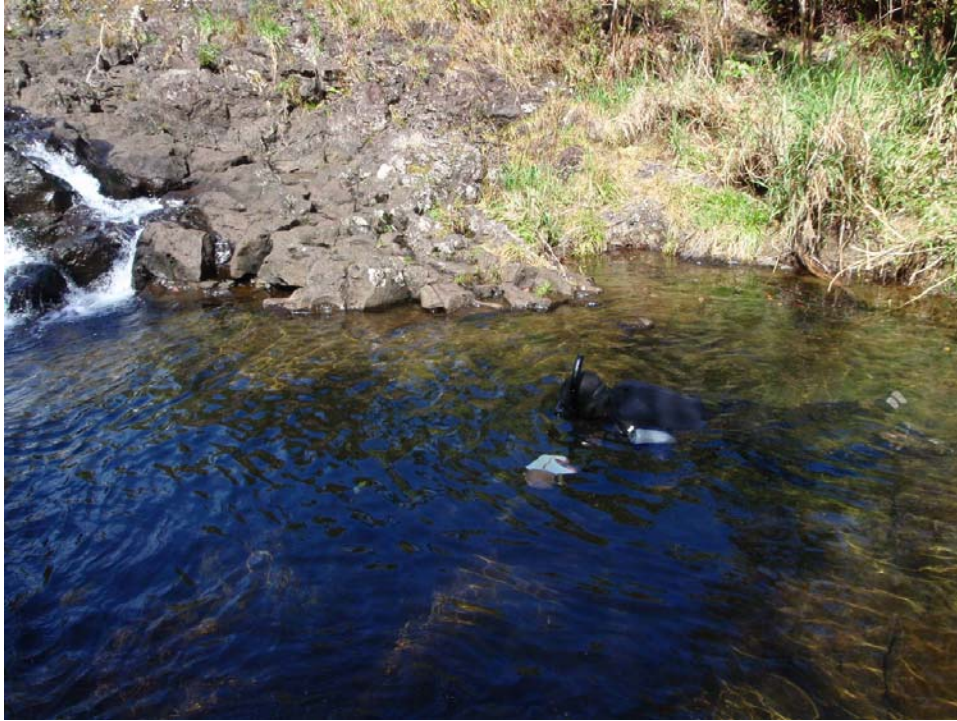
Figure 4-8. DAR staff conducting survey at site 7 (2/11/2009; Tributary name: Kapā'ula (64021001); PBN: dk007p-132-021109; Surveyor: Kuamo'o, D.; Habitat type: Run; SBN: dk007r-021109; Lat. (DD): 20.80854, Long. (DD): -156.11565).

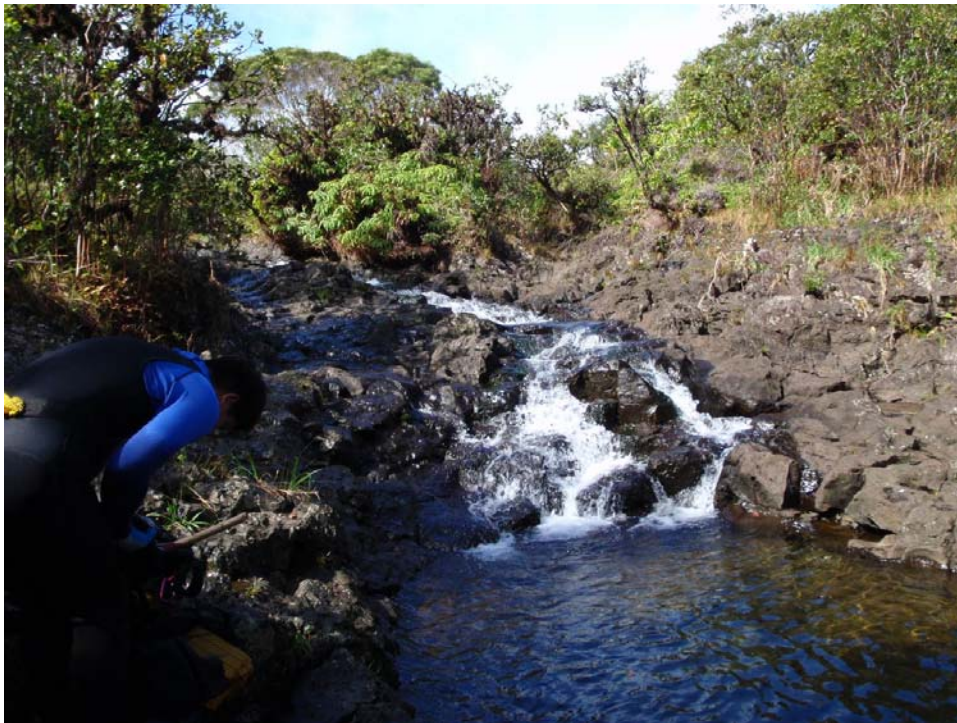
Figure 4-9. Photo taken above survey site 7 in an upstream direction. (2/11/2009; Tributary name: Kapā'ula (64021001); PBN: dk007p-131-021109; Surveyor: Kuamo'o, D.; Habitat type: Run; SBN: dk007r-021109; Lat. (DD): 20.80854, Long. (DD): -156.11565).

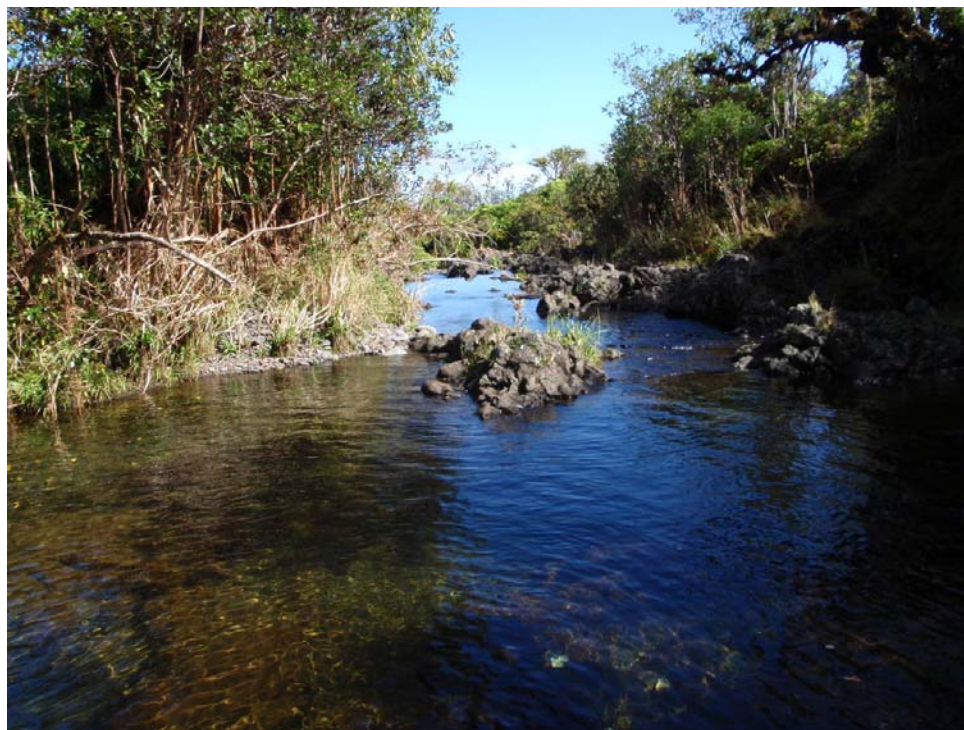
Figure 4-10. Photo of a pool taken downstream at site 7 in upper reach above the diversion. (2/11/2009; Tributary name: Kapā'ula (64021001); PBN: dk007p-133-021109; Surveyor: Kuamo'o, D.; Habitat type: Run; SBN: dk007r-021109; Lat. (DD): 20.80854, Long. (DD): -156.11565).
