SUBJECT: Comments on Alexander and Baldwin, Inc. applications for stream diversion works permits for abandonment.

## Attachment B

### Specific comments

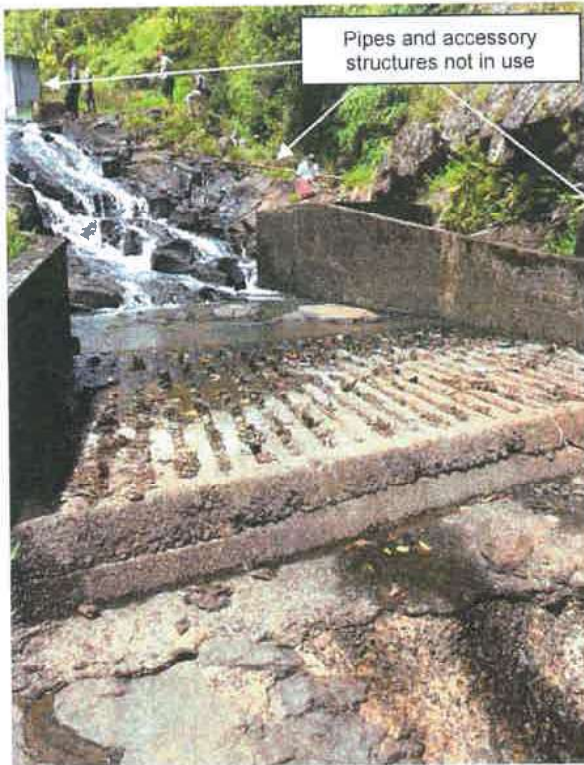
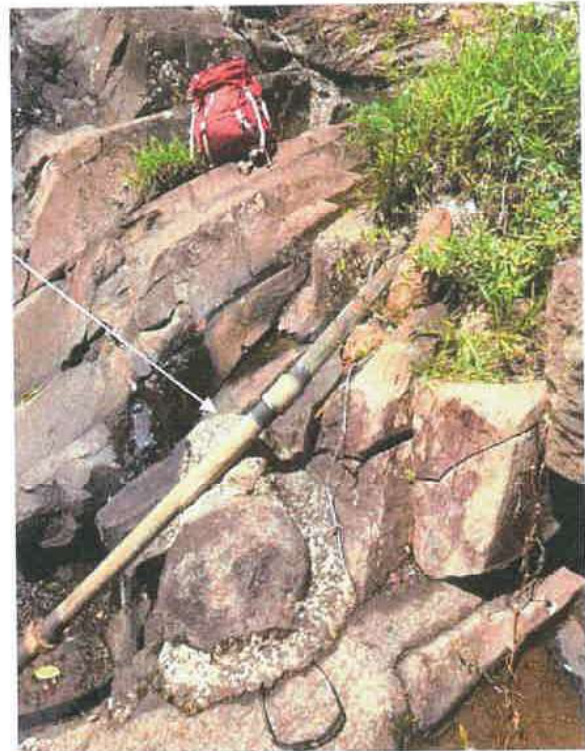
(b) Grate captures water diverting it to the Wailoa ditch. Application proposes to seal grate to allow stream to flow. Accessory pipes were found in the diversion area.

Figure 1. Wailoa ditch intake (W-22). Collection grate (left) and accessory pipes (right).

(a) Remove any pipes and accessories not in use.

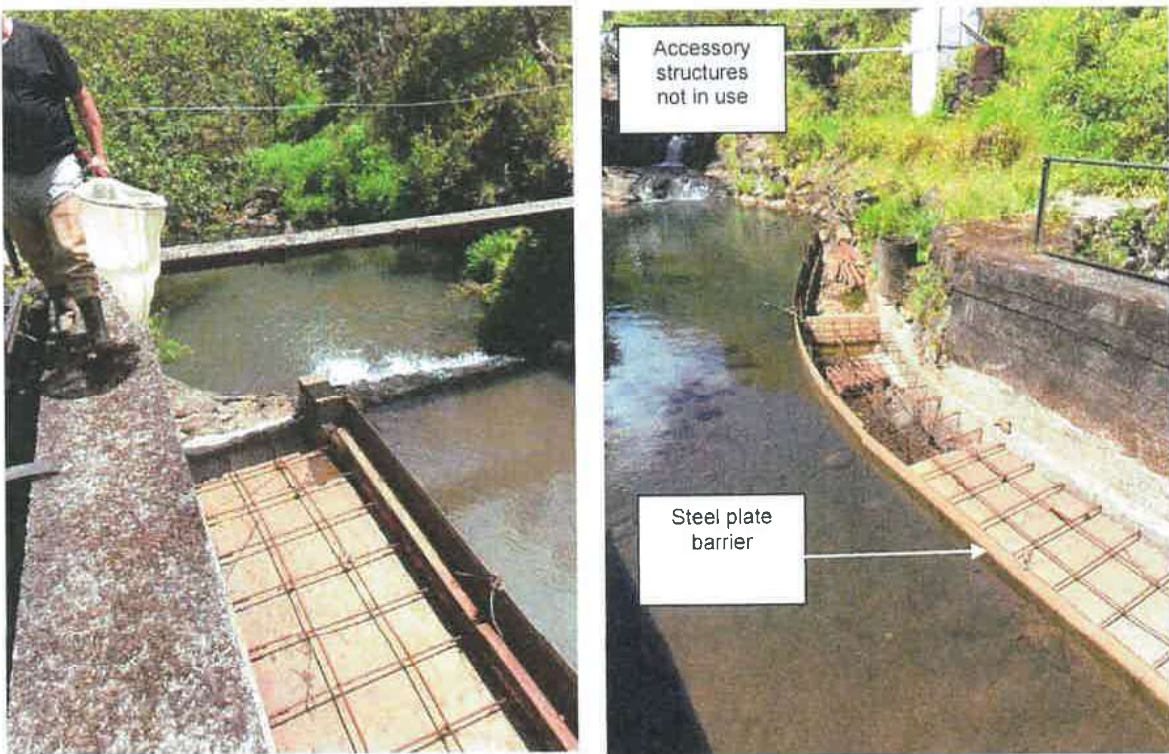
- (a) Diversion located in Koolau FR
- (b) Grate on the west side of stream captures water for diversion. Application proposes to seal grate by filling with concrete.

Figure 2. Grate to be sealed (left). Accessory pump house above grate (right).

- (a) After the grate is sealed, the steel plate should be removed and sufficient concrete should be used to ensure that stream flow is continuous over the grate area and water cannot become trapped and stagnant, creating breeding sites for mosquitoes.
- (b) Remove any accessory structures not in use, such as the pump house shown in the figure below.

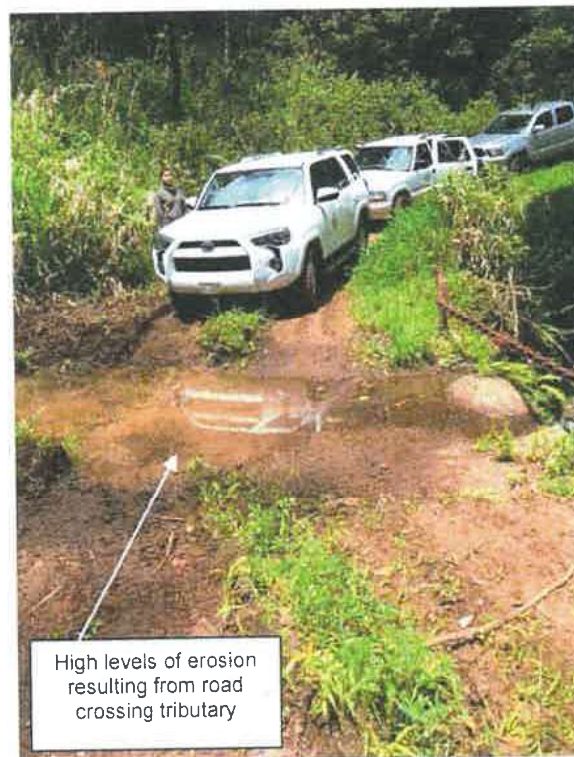
- (a) This diversion is on EMI lands.
- (b) The tributary feeds Honopou stream, which runs through the Koolau Forest reserve.
- (c) The road crossing this tributary to Honopou stream appears to be prone to high levels of erosion.

Figure 3. Road crossing tributary would appear to be prone to high levels of erosion.

- (a) Please assess erosion and impacts to water quality resulting from this location and consider installation of a concrete swale or other measures to control erosion.

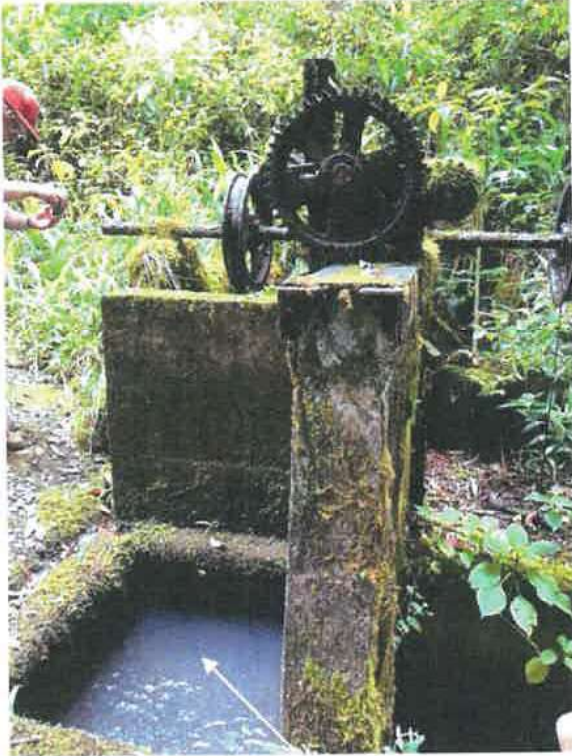
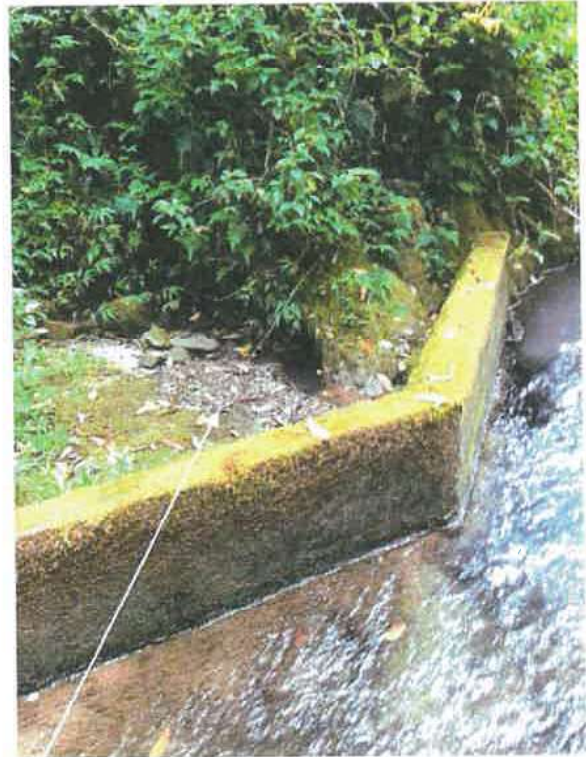
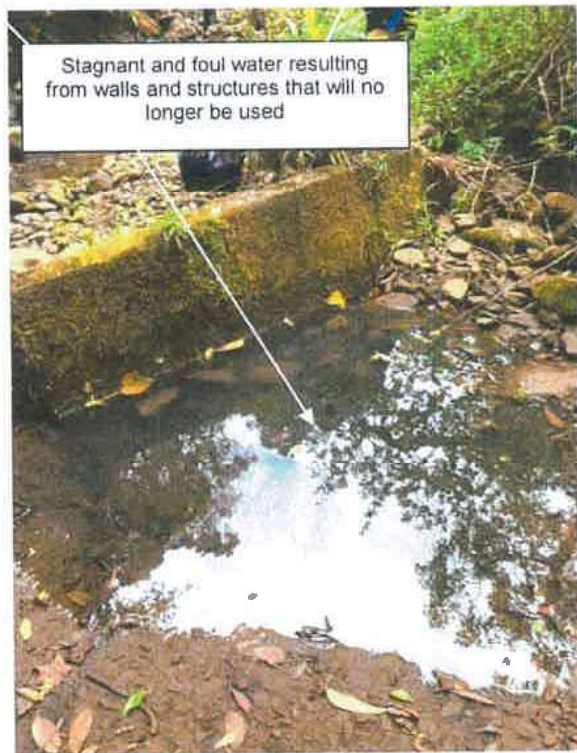
(b) Walls on both sides of the stream prevent the stream water from taking its natural course. The walls create sections where water stands and cause pooling of water, which becomes stagnant and creates breeding sites for mosquitoes.

(c) Water is also standing and foul in the sluice basin or catchment entry structure where the gate is located.

Figure 4. Stagnant water standing in depressions created by the walls and the gate structure.

(a) In addition to the measures identified in the application to seal the grate, remove the walls to restore the natural stream flow and eliminate mosquito breeding sites.

(b) Prevent stagnant water and mosquito breeding sites sealing the sluice basin or other measures to avoid water standing in the structure.

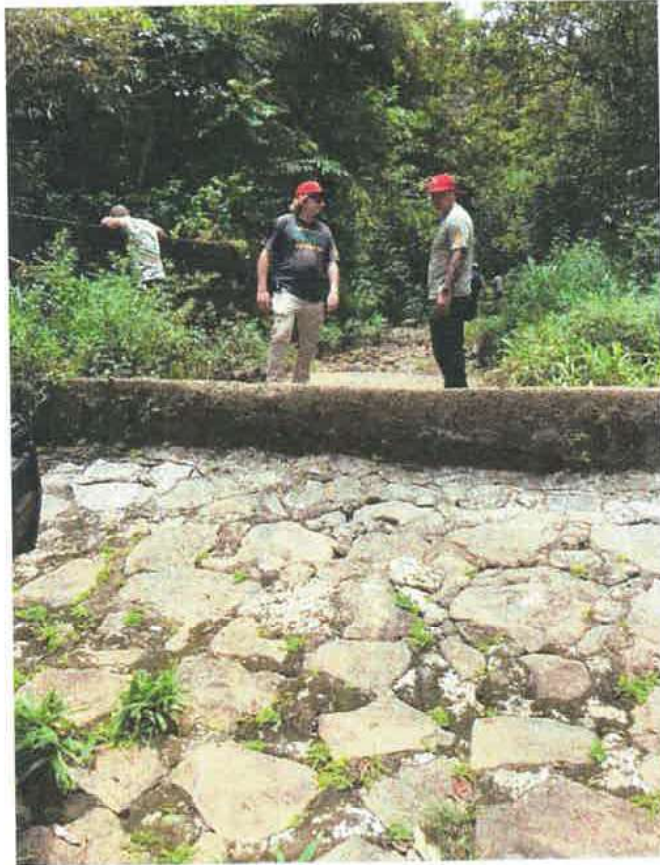
(a) The wall across the stream bed creates a dam that obstructs the natural course of the stream.

Figure 5. Wall across stream bed creates a dam that that alters flow and creates standing water.

(a) In addition to the measures identified in the application to seal the grate, please remove the wall across the stream bed to restore the natural stream flow.

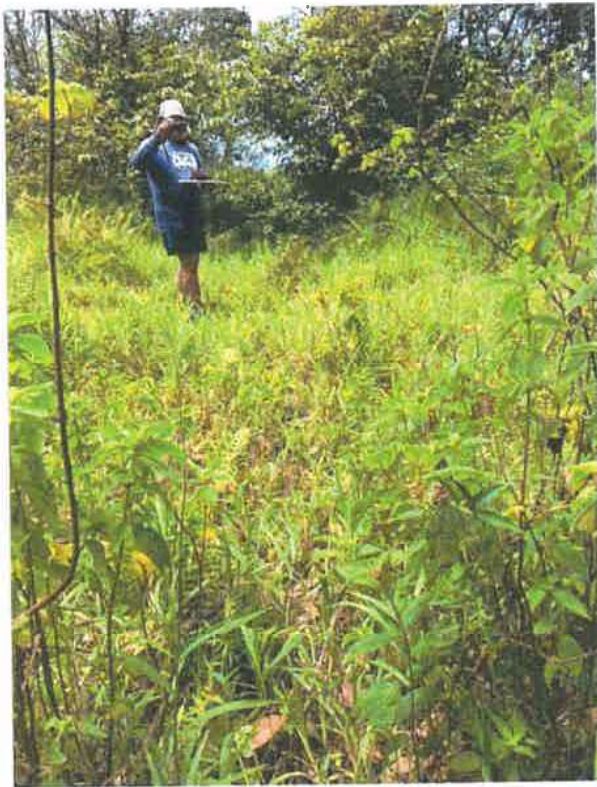
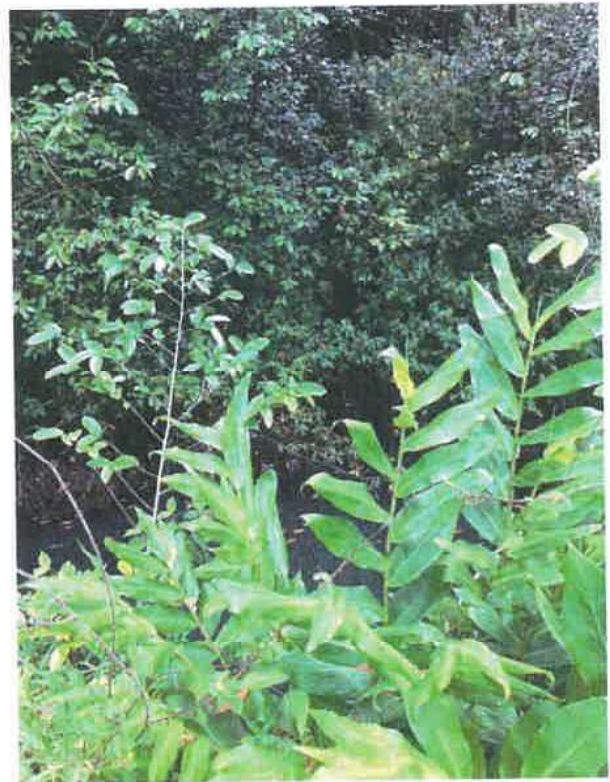
(b) This tributary enters the New Hamakua ditch where the access road runs along and makai of the ditch. The application proposes to install a stream bypass to enable the tributary to cross over the ditch.

(c) The stream must also cross the road and the application does not describe how that will be constructed.

Figure 6. Location where tributary will cross the access road.

(a) The methods employed to enable the stream to cross the road should ensure that erosion of the road is avoided. This may be done by installing a concrete swale or by installation of a culvert of appropriate diameter under the road.

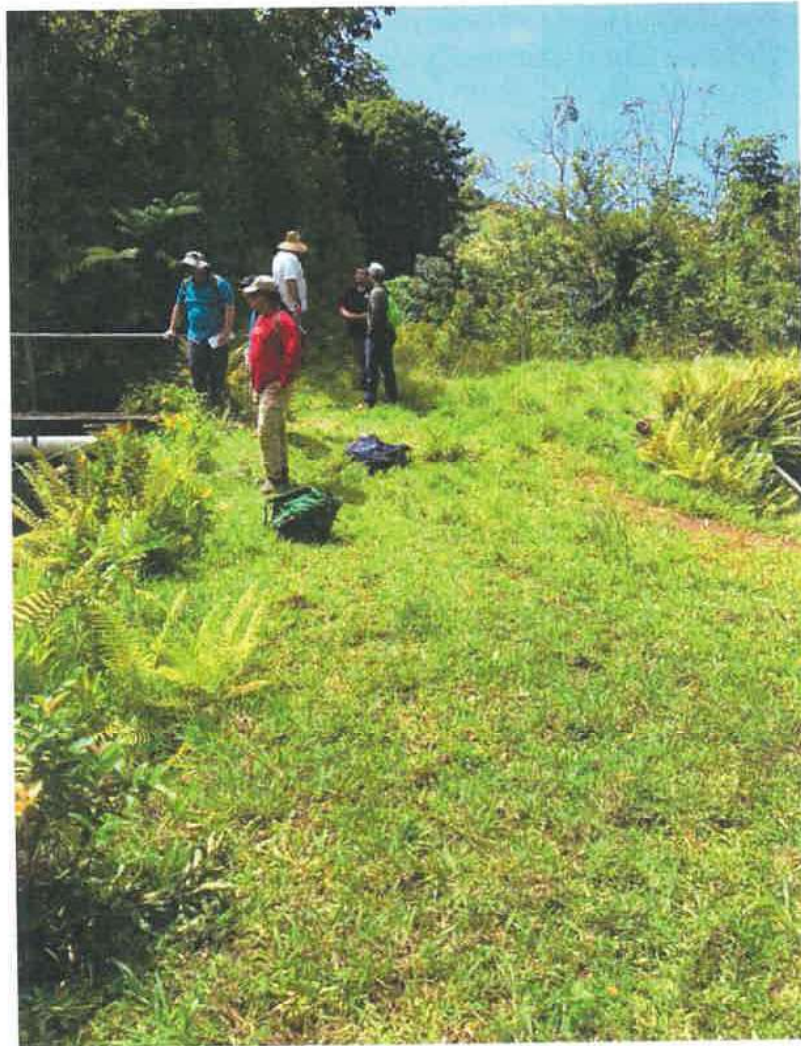
(a) The application proposes to construct an overpass that will allow the stream to cross the ditch. Since the access road runs parallel to the ditch at this location, the stream will also need to cross the road.

Figure 7. Location where stream will cross access road.

(a) A concrete swale should be constructed across the road at this location to avoid erosion of the road, which appears to be currently comprised of soil only.

(b) A culvert should not be used at this site since this stream is a fish corridor and fish are not expected to cross through culverts.

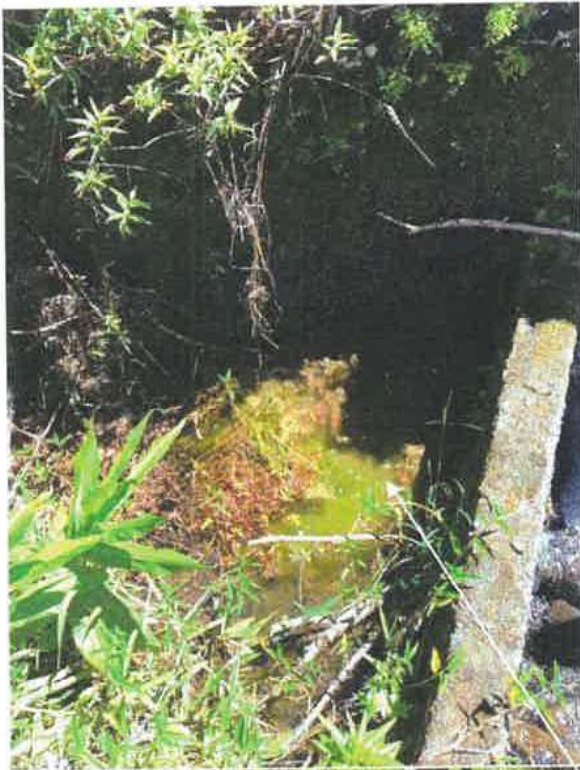
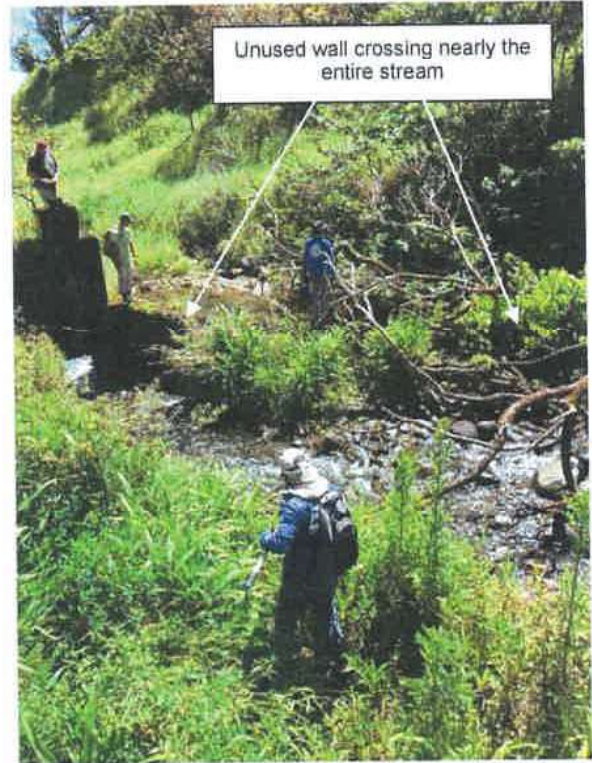
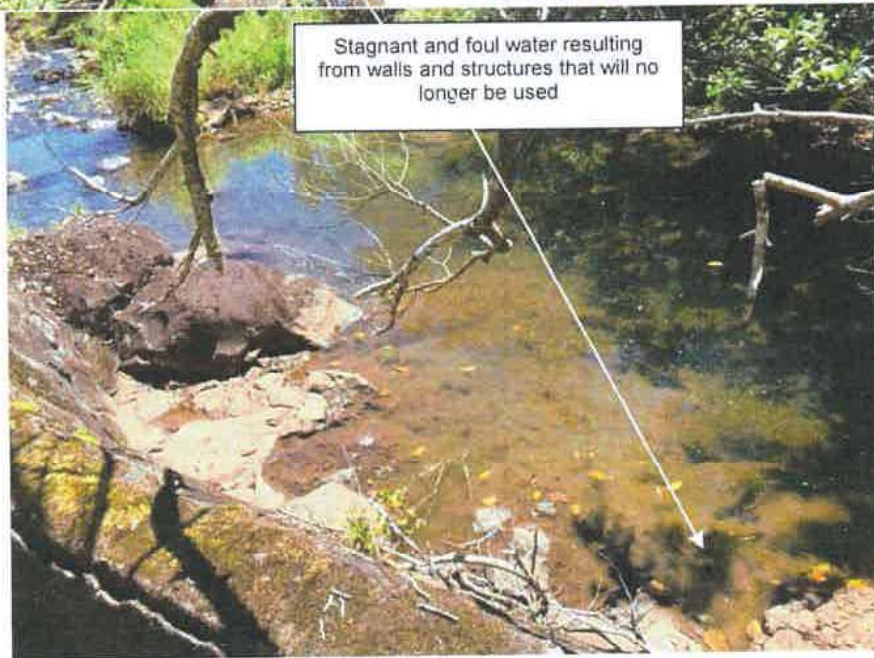
(a) This diversion consists of walls on both sides of the stream that divert the stream into the ditch on the west side of the stream. The east wall crosses nearly the entire stream bed to divert the water to the west.

(b) The walls trap standing water on both sides of the stream, as well as in the intake, which we found to be very stagnant, creating breeding sites for mosquitoes. The application proposes to permanently remove the sluice gate to restore stream flow and to fill the intake with concrete.

Figure 8. East Wailuanui at Koolau ditch (K-18). Stagnant water outside the west wall (top left), wall crossing stream (top right), stagnant water on the east side of the stream.

(a) Remove the walls on the east and west side of the stream in their entirety. Those walls will no longer be used for diversion purposes and their presence creates large areas of stagnate water that creates breeding sites for mosquitoes.

(b) Ensure that sufficient fill material is used for the intake to ensure that water does not become stagnant in the intake.

(c) Remove the pillar and structures at the intake since they will no longer be used for water diversion purposes.

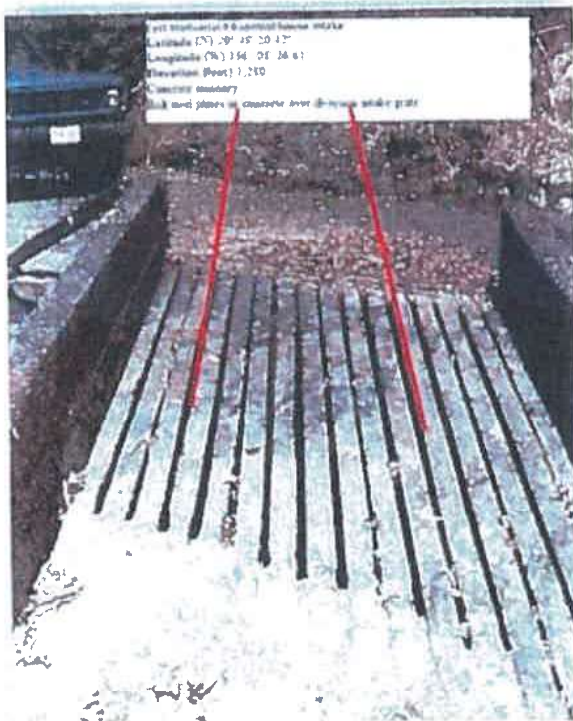
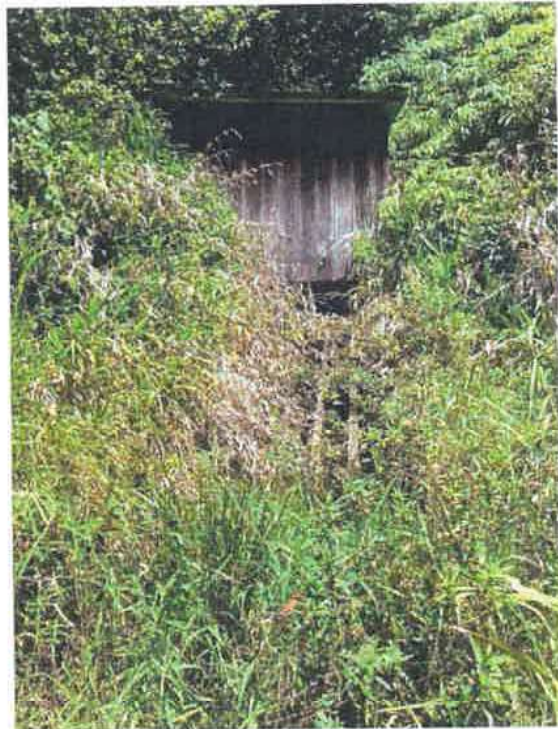
- (a) Diversion consists of walls that channel the stream flow over the ditch where a collection grate allows the water to fall into the ditch.
- (b) The application proposes to cover and seal the grate so that water will continue downstream.

Figure 9. Channel to enable stream to cross ditch (left). Control house at K-19 (right).

- (a) The channel that is created by the walls is relatively narrow and low. It is unknown whether it may should be monitored regularly to ensure that it does not become obstructed by debris.
- (b) The control house and related structures should be removed if they are no longer in use.

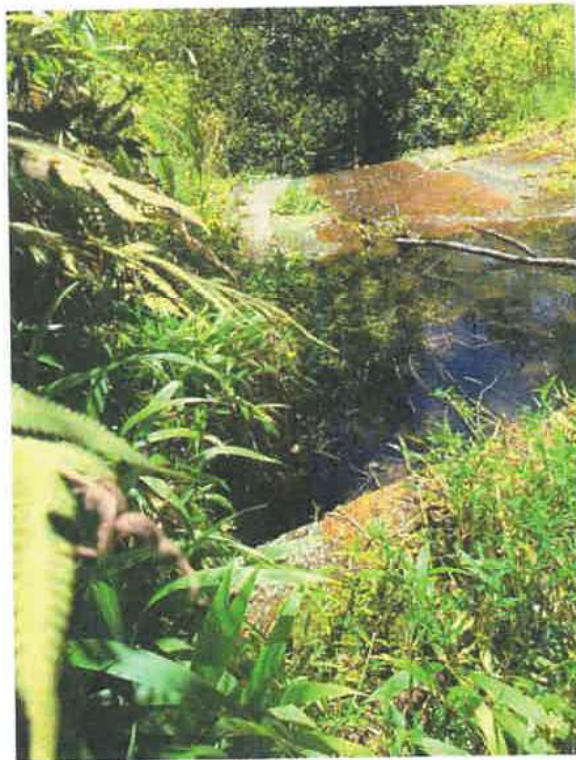
- (a) Diversion at a tributary that consists of a wing wall on the west side of the stream that directs flow into a set of slots in a wall on the east side.
- (b) Application proposes to fill the collection slots to enable stream to flow down. Where the stream crosses the access road, a pipe under the road directs water under the road. The road has a concrete swale.
- (c) The wing wall appears to be creating pooling of stagnant water and the pipe was found to be clogged. The pipe obstructs movement of fish upstream.

Figure 10. Wing wall causing pooling of stagnant water at K-20.

- (a) Remove the wing wall to prevent standing water
- (b) Seal the pipe so that water will flow freely over the swale and enable fish movement upstream.

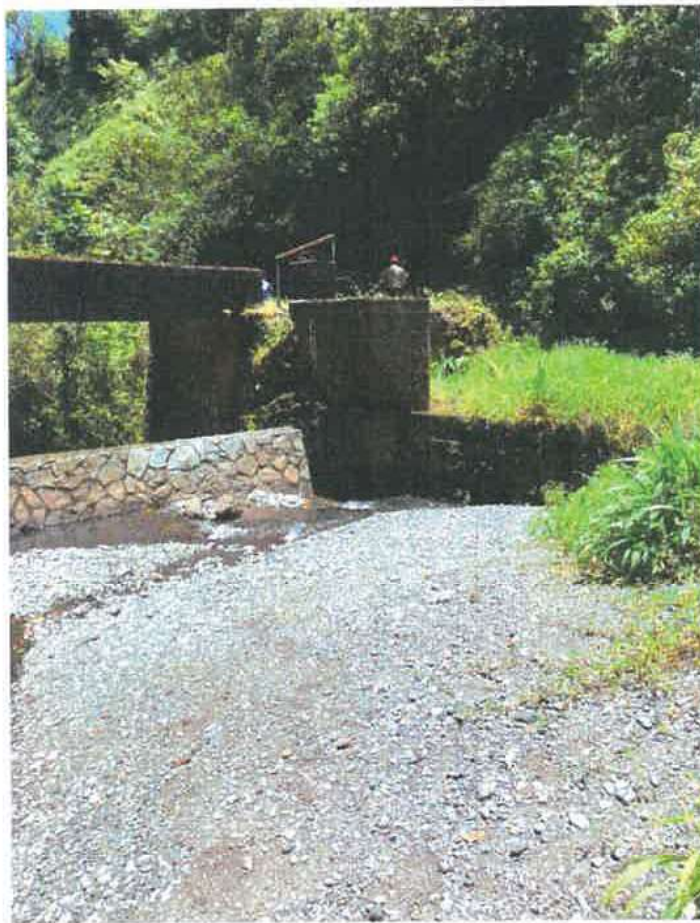
- (a) Diversion consists of a large dam that directs the stream flow into collection slots on the east side of the stream.
- (b) The dam is fitted with a sluice and gate to enable water to flow downstream when it is not being diverted.
- (c) The application proposes to cover the collection slots and permanently remove the gate.

Figure 11. Dam, gate, and control structure at K-21.

- (a) The sluice is relatively narrow and may become clogged. Monitoring is recommended to ensure it does not become clogged.
- (b) If the gate house structure is no longer used it should be removed.
- (c) The dam will also not be used. However, since it is of substantial size and mass, we recommend that consideration of its disposition be deferred until further assessments can be conducted to determine the best course of action.
