**STATE OF HAWAI‘I
DEPARTMENT OF LAND AND NATURAL RESOURCES
OFFICE OF CONSERVATION AND COASTAL LANDS
Honolulu, Hawai‘i**

REGARDING: Conservation District Enforcement File MA 09-54
Alleged Unauthorized Seawall and Stairs

BY: Henry and Diane Schweitzer
4885 Lower Honoapi‘ilani Road
Lahaina, Hawai‘i 96761

**LOCATION/
Tax Map Key:** Keonenui Beach, ‘Alaeloa, Island of Maui
(2) 4-3-015:001

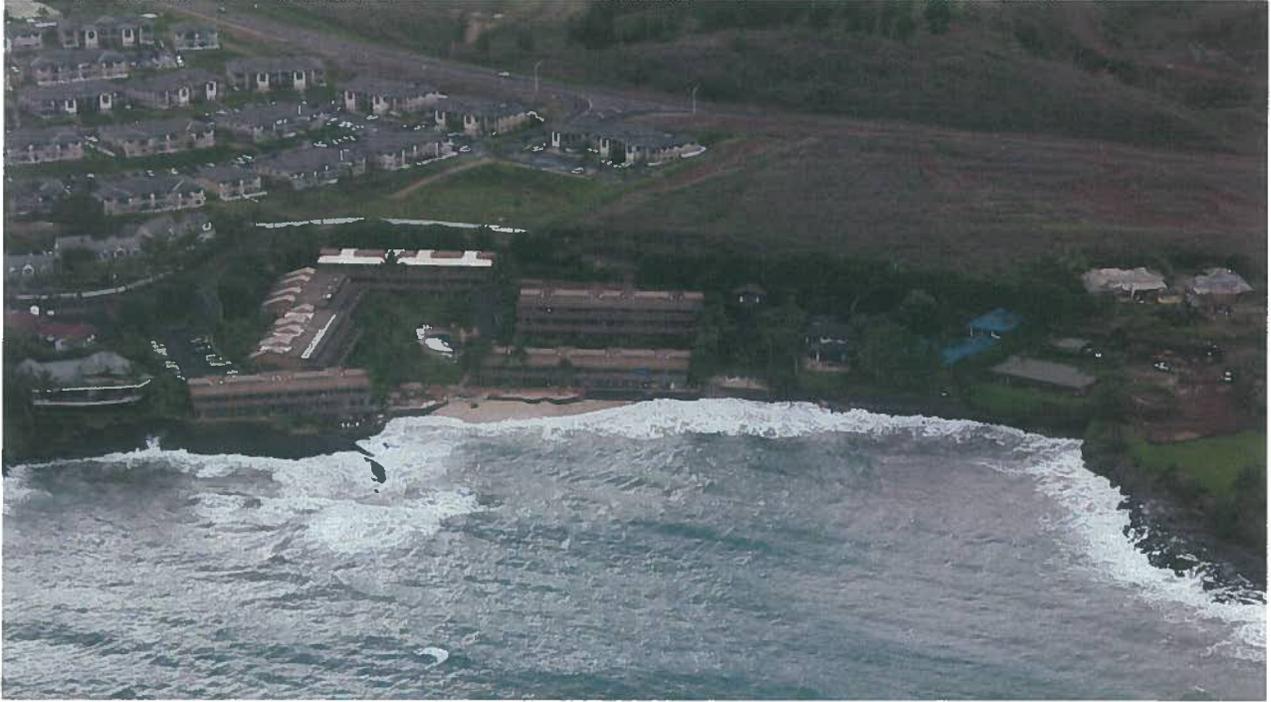
EXHIBIT 6

Keonenui Beach has a narrow, wet beach with a low slope in the middle section of the bay. The beach shows signs of long-term erosion and has disappeared at the north end of the bay. The shoreline is eroding at a rate of around 1.15 feet per year in front of the subject parcel (**Exhibit 5**). The middle and south end of the bay has a transient, wet beach, which is submerged at high tide (**Exhibit 6**).

2003 Oblique Photo

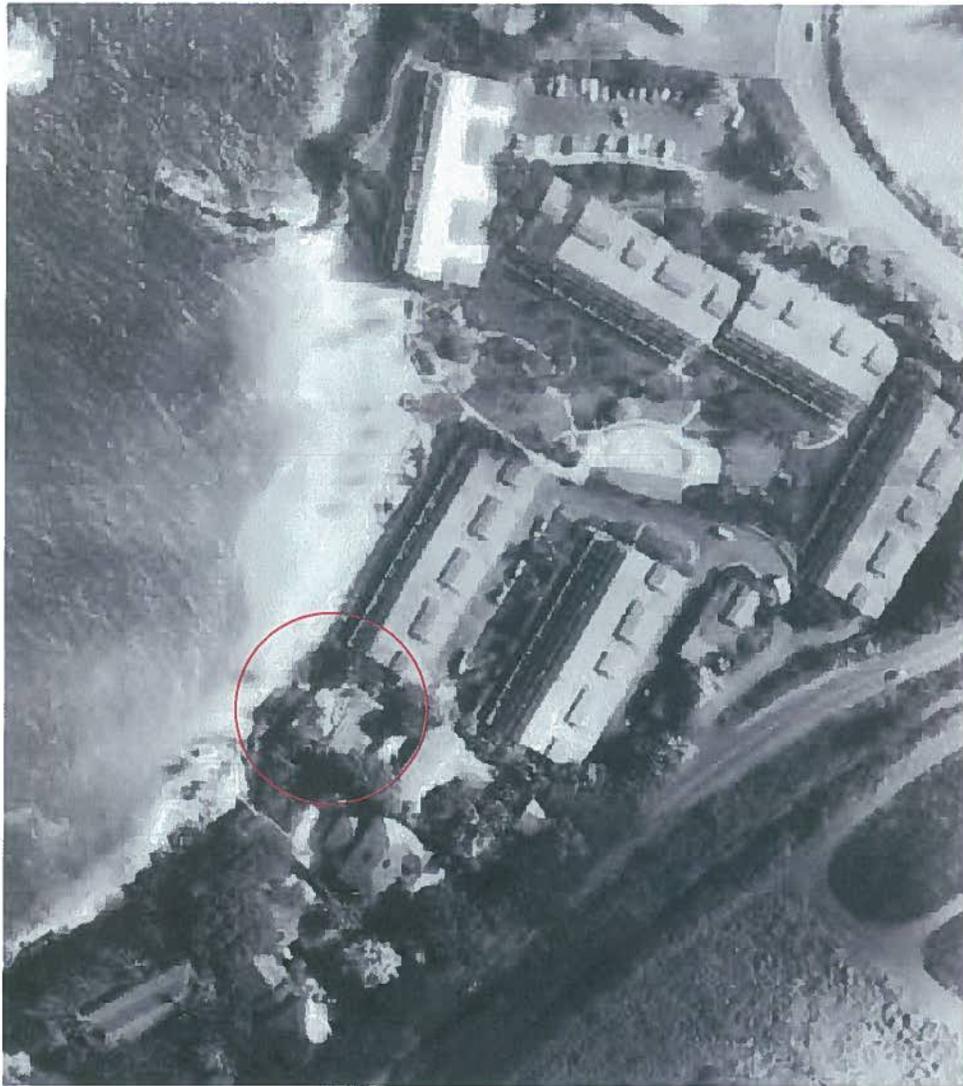
AERIAL PHOTOGRAPH: 1987

1987 – An aerial photograph of the subject shoreline documents the existence of a seawall (**Exhibit 8**).

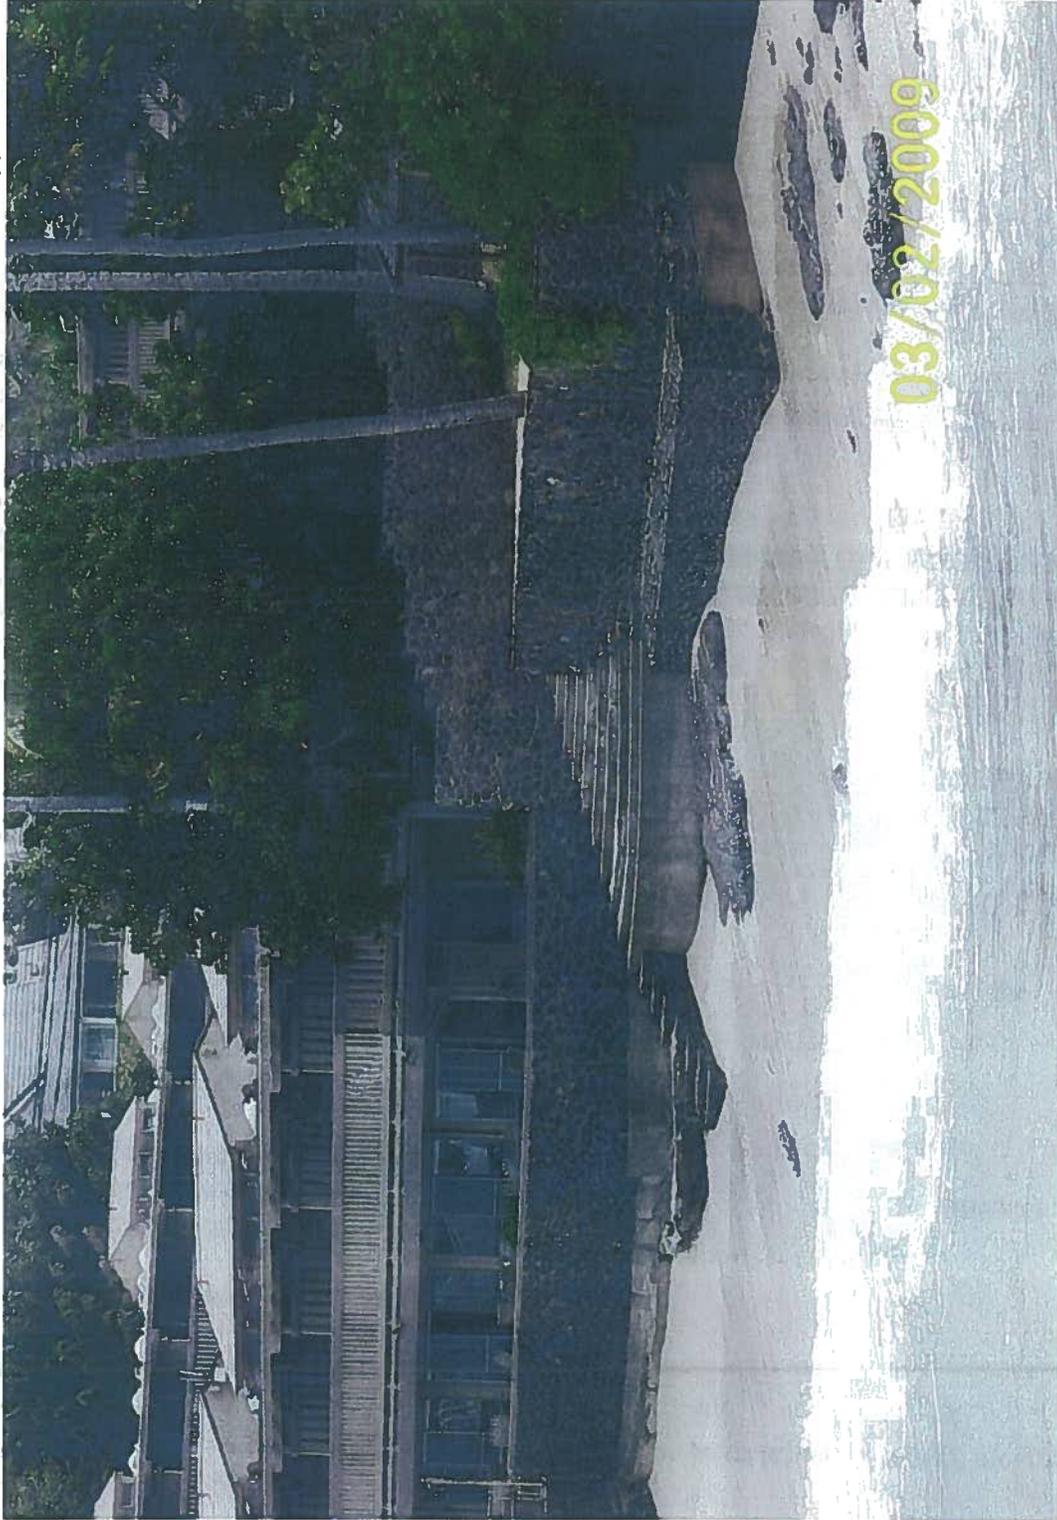
Shoreline area fronting the Schweitzer property at TMK: (2) 4-3-015:001. Possible encroaching stairway onto the sand shoreline.

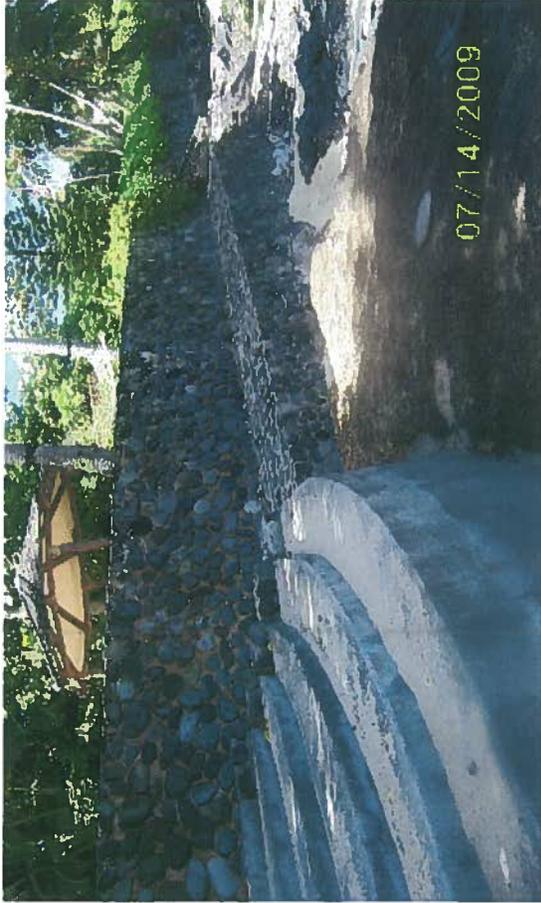
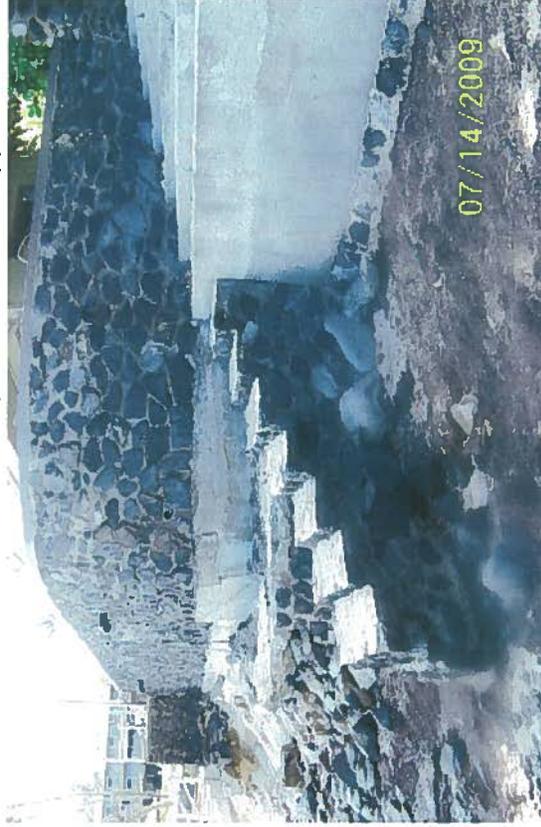
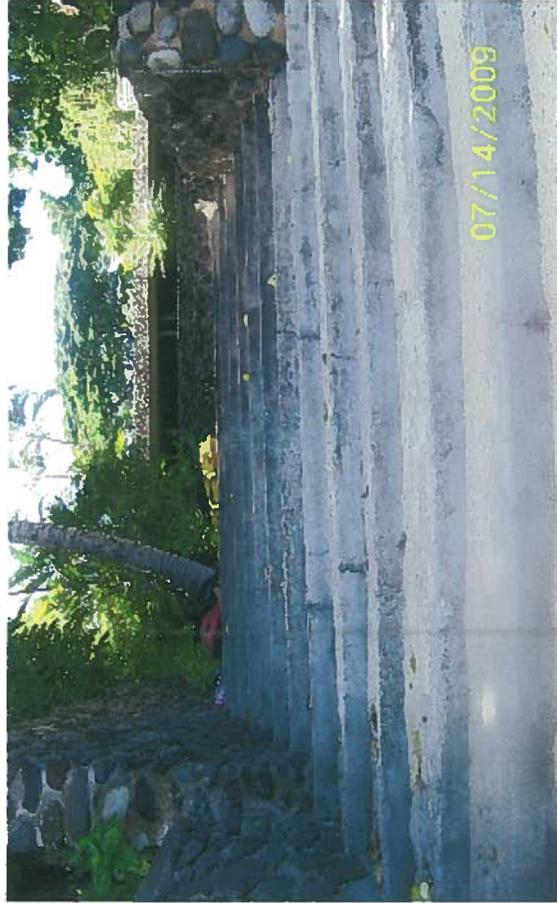
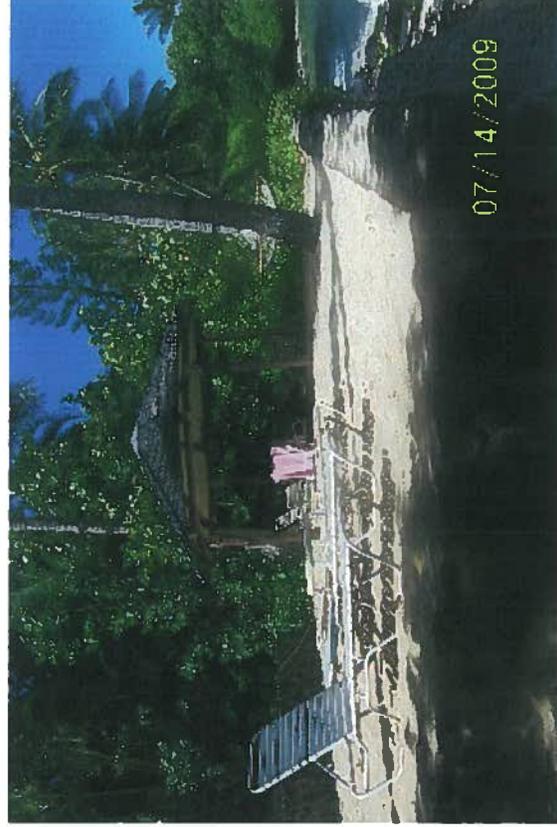
July 14, 2009 – MDLO conducted another site inspection and attempted to locate the owner; however, there was no response at the doorbell. MDLO noted additional observations: 1) Concrete stairway leading to a smaller concrete and rock stairs, which leads down to the shoreline; 2) Terraced rock walls within the SMA area; and 3) A construction gazebo within the first terraced area that has also been filled with sand (**Exhibit 11**).

Photos of improvements made along the shoreline and within the SMA area at the Schweitzer property at 4885 Lower Honoapiilani Road, Lahaina HI.

Concrete stairway leading to the shoreline line of Kahana Bay.

Terraced area filled with sand with a wood gazebo.

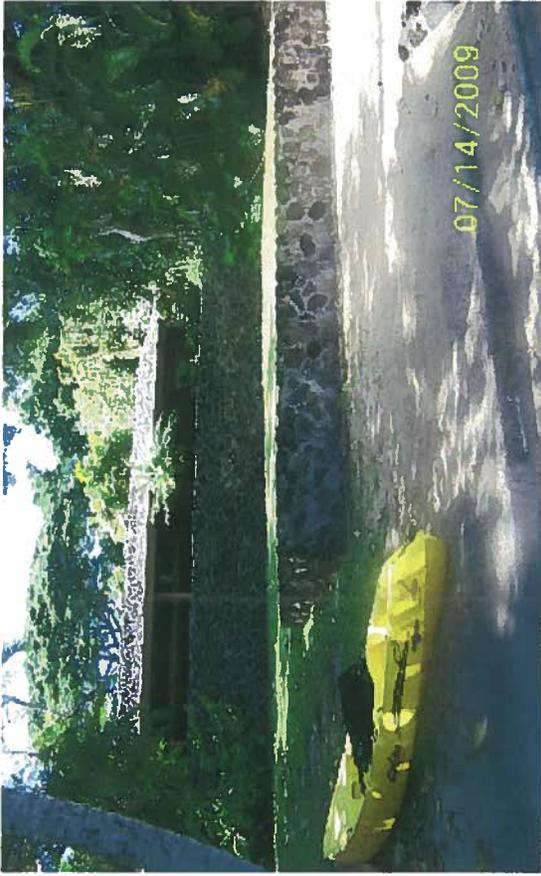
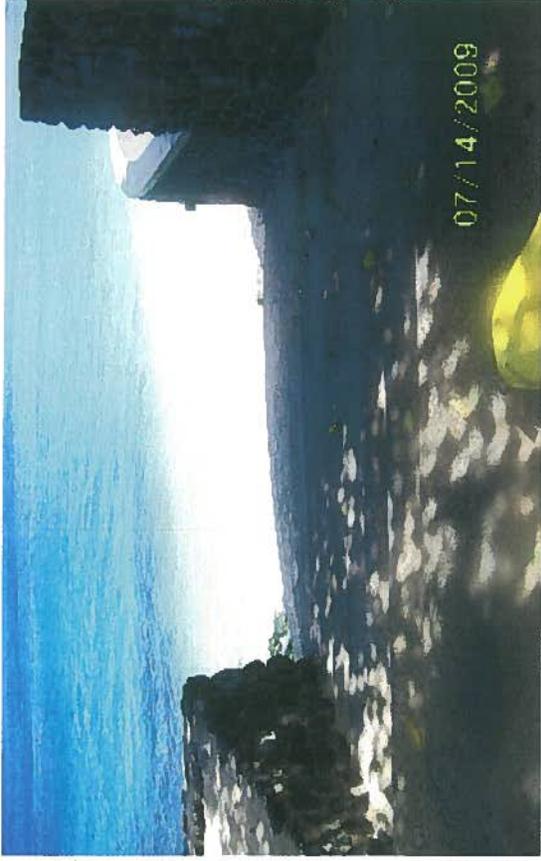
Improvements at the makai side of the Schweitzer property. Property overlooks Kahana Bay.
