**STATE OF HAWAI'I
DEPARTMENT OF LAND AND NATURAL RESOURCES
OFFICE OF CONSERVATION AND COASTAL LANDS
Honolulu, Hawai'i**

REGARDING: After-The-Fact Conservation District Use Application (CDUA-MA3689)
for a Seawall and Stairs

BY: Henry and Diane Schweitzer
4885 Lower Honoapi'ilani Road
Lahaina, Hawai'i 96761

**LOCATION/
Tax Map Key:** Keonenui Beach, 'Alaehoa, Island of Maui
(2) 4-3-015:001

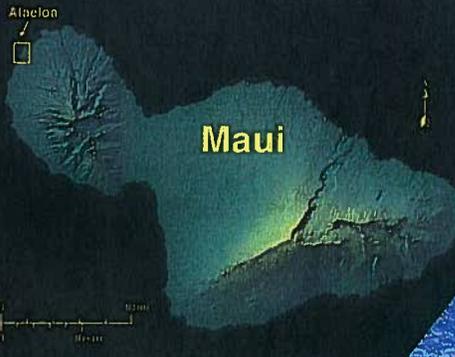
Smoothed Erosion Rates

The Alaeloa study area extends from Hauko Point in the south to Namalu Bay in the north. This area is a series of bays and coves with small white sand and cobble pocket beaches interspersed. Offshore is basaltic hard bottom and sand.

As a whole, the area has experienced moderate to high erosion since 1912 with an average AEHR of -0.9 ft/yr. Keonenui Beach (transects 1 - 14) is partially backed by a revetment constructed prior to 1980 to protect private property. The beach has experienced moderate erosion over time with an average AEHR of -1.0 ft/yr. To the north, Alaeloa Beach (transects 17 and 18) occupies a small cove and has experienced moderate erosion with an average AEHR of -1.0 ft/yr. Honokaaia Bay (transects 25 - 28) is comprised primarily of cobble beach. It has experienced moderate erosion with an average AEHR of -0.8 ft/yr. Napili Bay (transects 32 - 47) has experienced moderate erosion over time with an average AEHR of -0.8 ft/yr. Kapalua Bay (transects 53 - 62) has experienced moderate erosion since 1912 with an average AEHR of -1.2 ft/yr.

Erosion rates are measured every 20 m along the shoreline. These sites are denoted by yellow shore normal transects. The Annual Erosion Hazard Rate (AEHR) is a spatially smoothed center weighted average of calculated erosion rates. Five contiguous transects are incorporated in the smoothing process. The transects are weighted: 1-3-5-3-1 with the smoothed rate assigned to the center transect. The AEHRs are shown on the shore-normal histogram graph. Colored bars on the graph correspond to shore-normal transects; approximately every fifth transect and bar are numbered. Where necessary, some transects have been purposely deleted during data processing; as a result, transect numbering is not consecutive everywhere. Where complete beach loss has occurred, erosion rate calculations apply only to the time period when a beach existed.

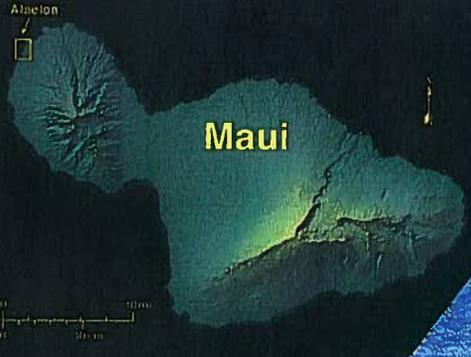
Smoothed Erosion Rates

The Alaeloa study area extends from Hauko Point in the south to Nāmālu Bay in the north. This area is a series of bays and coves with small white sand and cobble pocket beaches interspersed. Offshore is basaltic hard bottom and sand.

As a whole, the area has experienced moderate to high erosion since 1912 with an average AEHR of -0.9 ft/yr. Keonenui Beach (transects 1 - 14) is partially backed by a revetment constructed prior to 1960 to protect private property. The beach has experienced moderate erosion over time with an average AEHR of -1.0 ft/yr. To the north, Alaeloa Beach (transects 17 and 18) occupies a small cove and has experienced moderate erosion with an average AEHR of -1.0 ft/yr. Honokēana Bay (transects 25 - 28) is comprised primarily of cobble beach. It has experienced moderate erosion with an average AEHR of -0.8 ft/yr. Napili Bay (transects 32 - 47) has experienced moderate erosion over time with an average AEHR of -0.8 ft/yr. Kapalua Bay (transects 53 - 62) has experienced moderate erosion since 1912 with an average AEHR of -1.2 ft/yr.

Erosion rates are measured every 20 m along the shoreline. These sites are denoted by yellow shore normal transects. The Annual Erosion Hazard Rates (red), is a spatially smoothed center weighted average of calculated erosion rates. Five contiguous transects are incorporated in the smoothing process. The transects are weighted: 1-3-5-3-1 with the smoothed rate assigned to the center transect. The AEHRs are shown on the shore-normal histogram graph. Colored bars on the graph correspond to shore-normal transects; approximately every fifth transect and bar are numbered. Where necessary, some transects have been purposely deleted during data processing; as a result, transect numbering is not consecutive everywhere. Where complete beach loss has occurred, erosion rate calculations apply only to the time period when a beach existed.

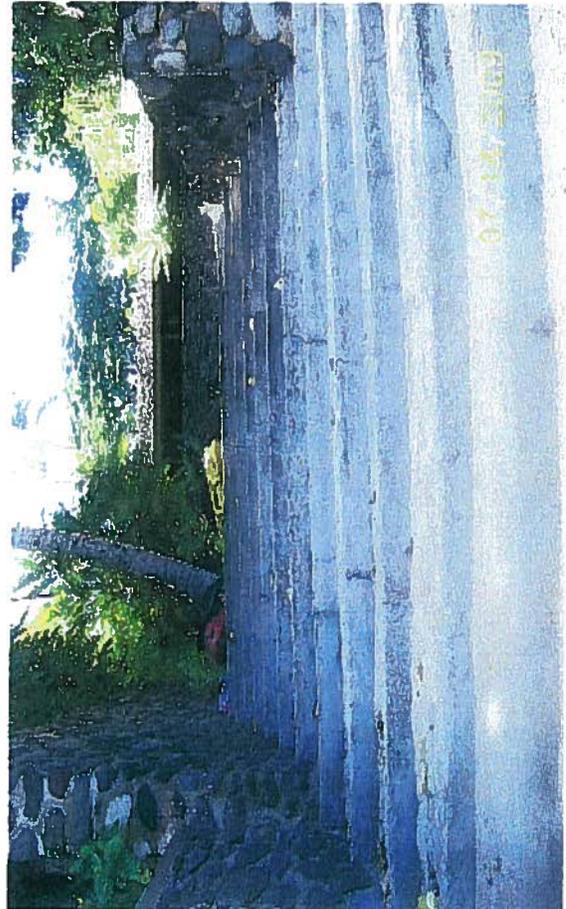
Concrete stairway leading to the shoreline line of Kahana Bay.

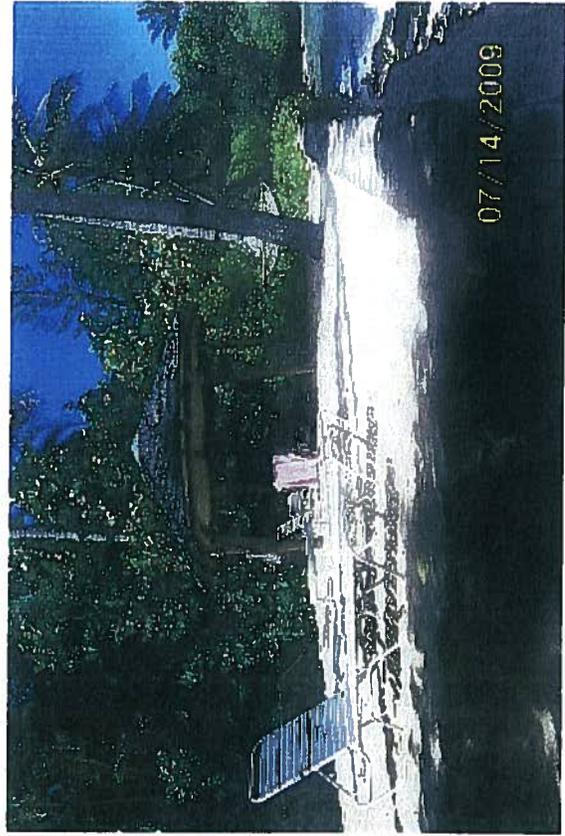
Terraced area filled with sand with a wood gazebo.

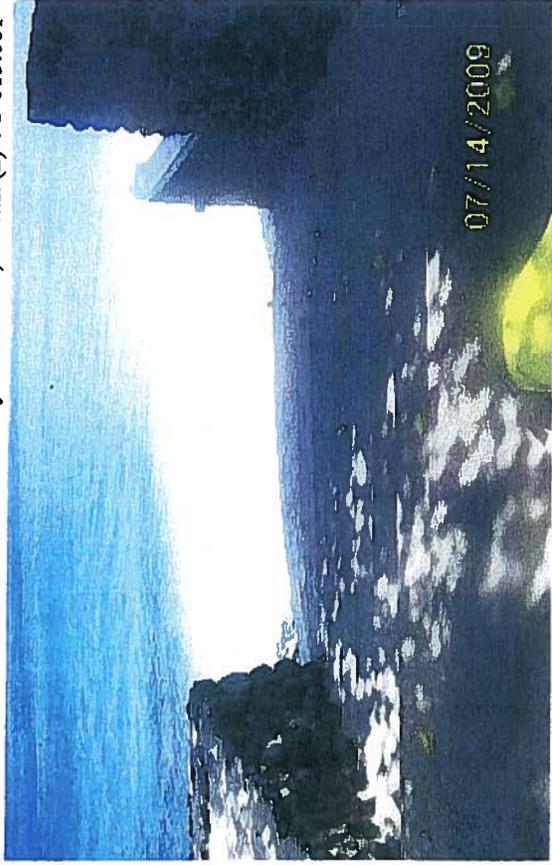
Henry Schweitzer, TMK: (2) 4-3-015:001

Improvements at the makai side of the Schweitzer property. Property overlooks Kahana Bay.
