SCS Project Number 681-1

**AN ARCHAEOLOGICAL INVENTORY SURVEY REPORT
ON 48.117 ACRES LOCATED IN,
KEALAHOU AHUPUA`A, KULA, MAKAWAO DISTRICT,
MAUI ISLAND, HAWAII
[TMK: 2-3-001:174]**

Prepared by:
**Leann McGerty
Jennifer Hunt
and
Robert L. Spear, Ph.D.**
April 2006

Scientific Consultant Services, Inc. (SCS) conducted Archaeological Inventory Survey on 48.117 acres of land in Kealahou Ahupua`a, Makawao District, Maui Island (TMK: 2-3-001:174). A total of 18 archaeological sites consisting of 32 individual features were documented during the Inventory Survey. Identified sites included agricultural and habitation features represented by terraces, alignments, walls, modified outcrops, a rock mound, and an enclosure. Eighteen archaeological sites (50-50-11-5970 to 50-50-11-5987) were assessed as significant under Criterion D of Hawaii's State Historic Preservation criteria. All 18 sites have yielded sufficient information and no additional archaeological work is recommended.

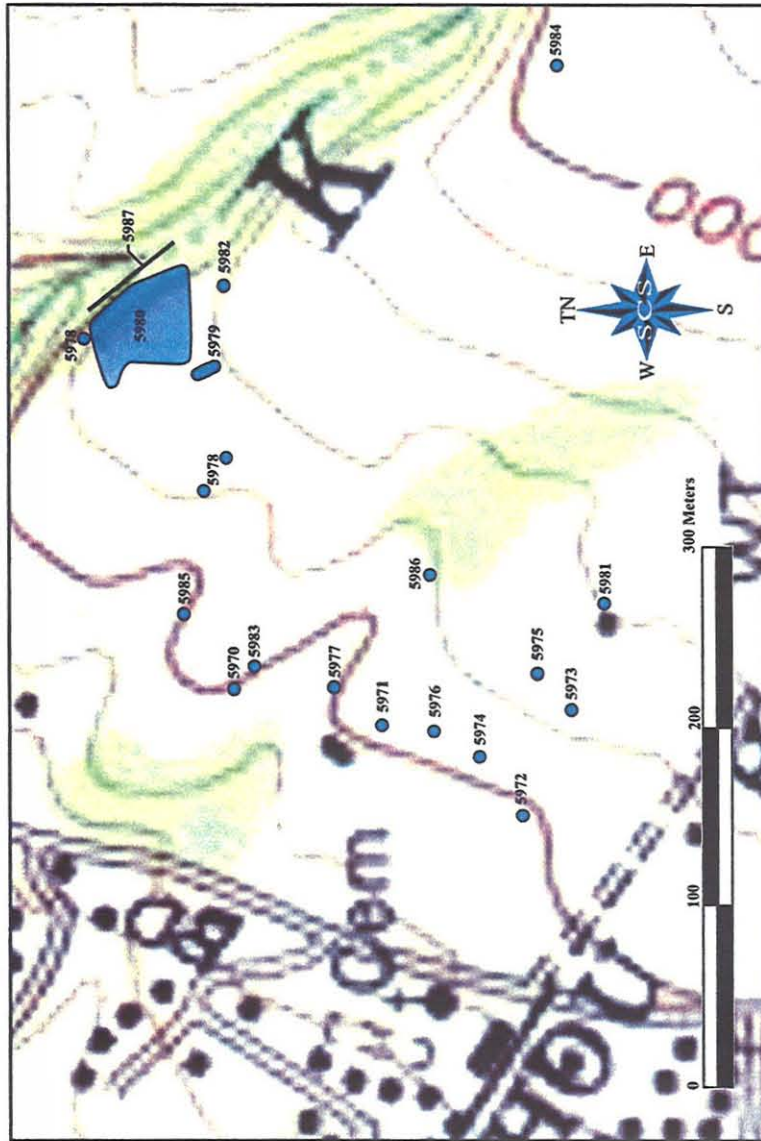
Figure 3: Map of Archaeological Sites Within the Project Area.

Site #	# of Fe.'s	Type	Function	Age
50-50-11-				
5970	1	Wall	Ranching	Historic
5971	1	Wall	Ranching	Historic
5972	1	Alignment/wall	Agriculture	Pre-Historic
5973	3	Ag Complex	Agricultural	Early Historic
5974	1	Modified Outcrop	Agriculture	Undetermined
5975	1	Terrace	Agricultural	Pre-Historic
5976	1	Modified Outcrop	Undetermined	Undetermined
5977	1	Platform	Habitation	Pre-Historic
5978	4	Terraces	Agricultural	Pre-Historic
5979	2	Terraces	Agricultural	Pre-Historic
		Modified Outcrop/Terrace/en-		
5980	8	closure	Agriculture/Habitation	Pre-Historic
5981	1	Wall	Ranching	Historic
5982	1	Terraces	Agriculture	Pre-Historic
5983	1	Mound	Activity Area	Pre-Historic
5984	1	House	Habitation	Historic
5985	2	Enclosure/Wall	Activity Area/Ranching	Historic
5986	1	Modified Outcrop, Rock Mound	Undetermined	Undetermined
5987	1	Wall	Ranching	Historic

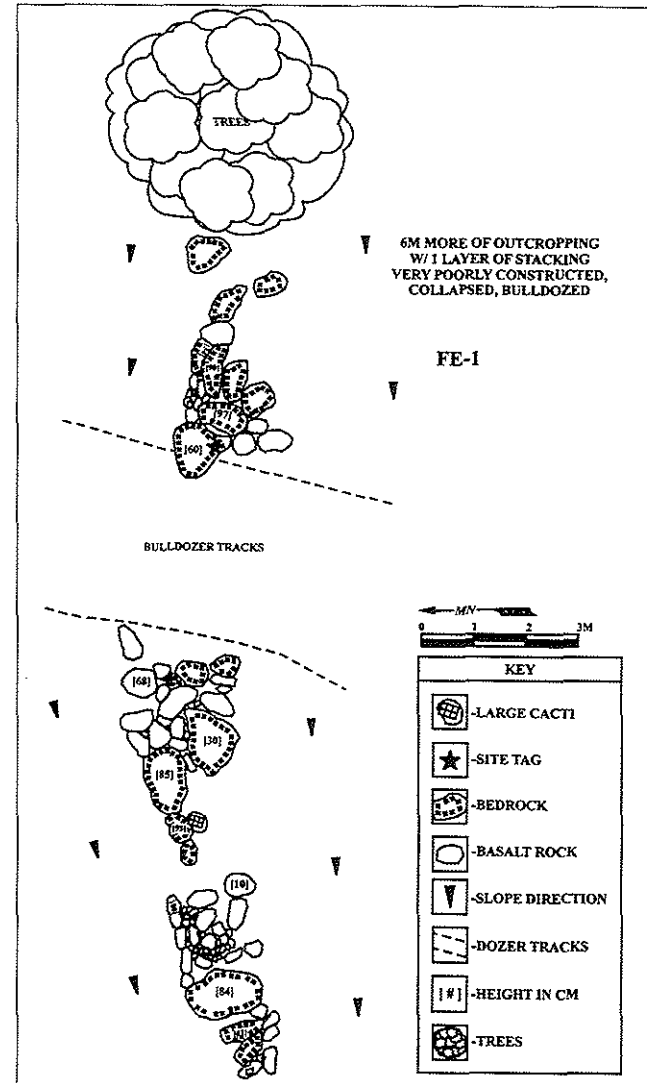
Figure 4: Site 5970, Feature 1 Plan View.

Feature 1 was a low-lying core-filled rock wall extending *mauka/makai*, incorporating *in situ* boulders and standing three courses high. It measured approximately 22.00 by 2.20 by 0.15/0.90 m high (Figure 4). The feature was in poor condition and had been severely altered by at least one bulldozed road that bisected the feature, as well as damage from cattle. The function of Feature 1 was interpreted as a ranching wall.

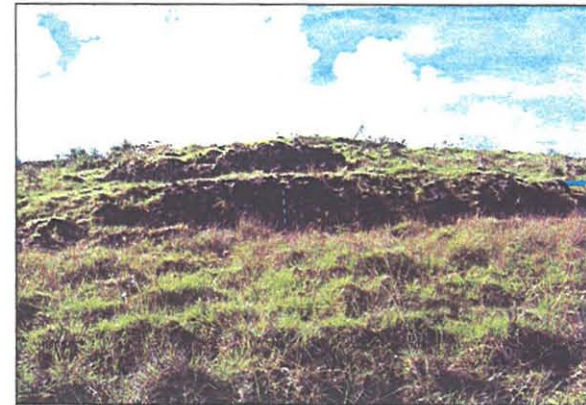
Figure 15: Site 5979, Feature 2 To East.

Feature 2 was a partially soil-surfaced and partially paved, rock-faced terrace constructed with medium to large cobbles and large boulders (Figures 15 and 16). It measured 14.40 m long by 1.08 m high with a terrace facing thickness of 0.60 m wide. The terrace was three to six courses high.

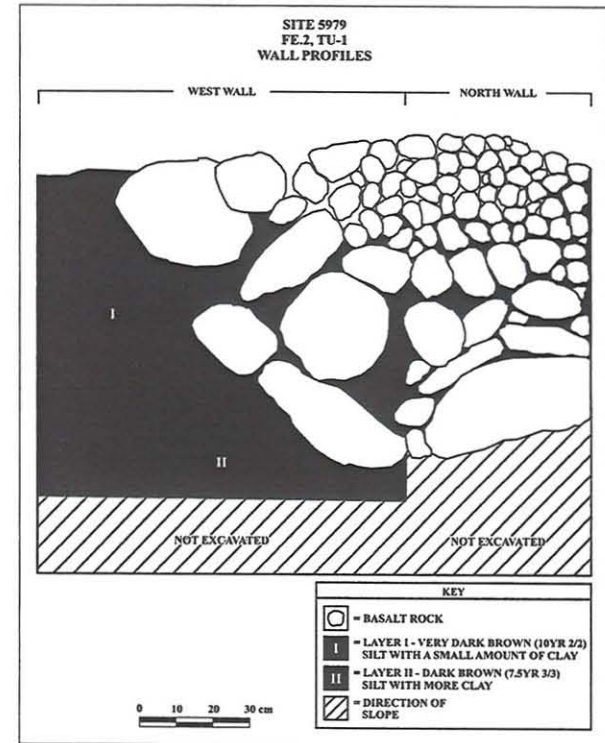
Figure 17: Site 5979, Feature 2, TU-1 North And West Wall Profiles.

TU-1 (1.00 by 0.50 m) was placed in the center of the terrace interior. The excavated fill was screened through 3 mm mesh screen. Two stratigraphic layers were identified in the exposed section (Figure 17).

Layer I (0-80 cmbs) consisted of a very dark brown (10YR 2/2) silty-clay containing no cultural material.

Layer II (80-100 cmbs) consisted of a dark brown (7.5YR 3/3) clay-silt containing no cultural material.

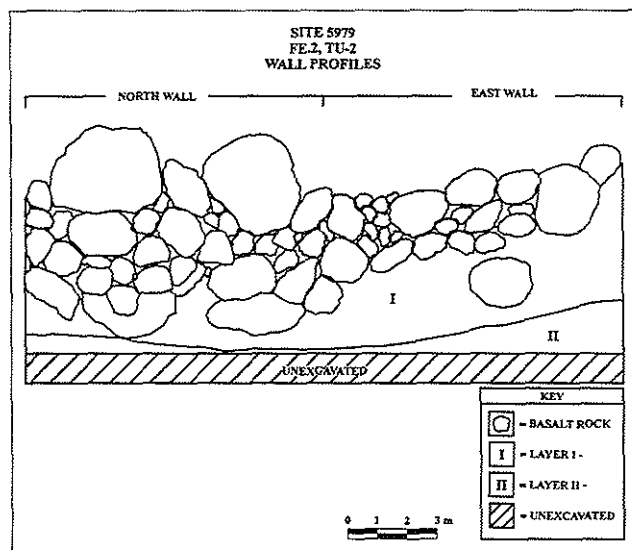
Figure 18: Site 5979, Feature 2, TU-2 North and East Wall Profiles.

TU-2 (1.00 by 1.00 m) was placed in the northeast corner of the terrace. The excavated fill was screened through 3-mm mesh screen. Two stratigraphic layers were identified in the exposed section (Figure 18).

Layer I (0-60 cmbs) consisted of a very dark brown (10YR 2/2) silty-clay containing charcoal flecks and the base of the facing.

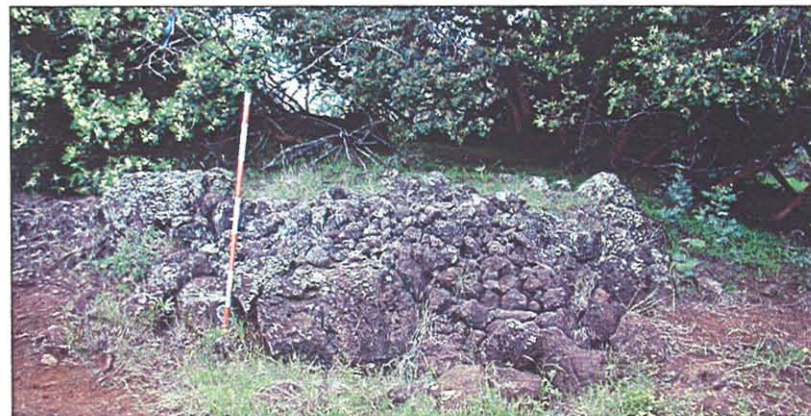
Feature 1 was a modified outcrop forming an enclosure that became a soil-surfaced terrace with a stacked and piled rock facing (Figures 19 and 20). It measured 5.60 by 5.60 by 1.30 m high.

Figure 20: Site 5980, Feature 1 To Northeast.

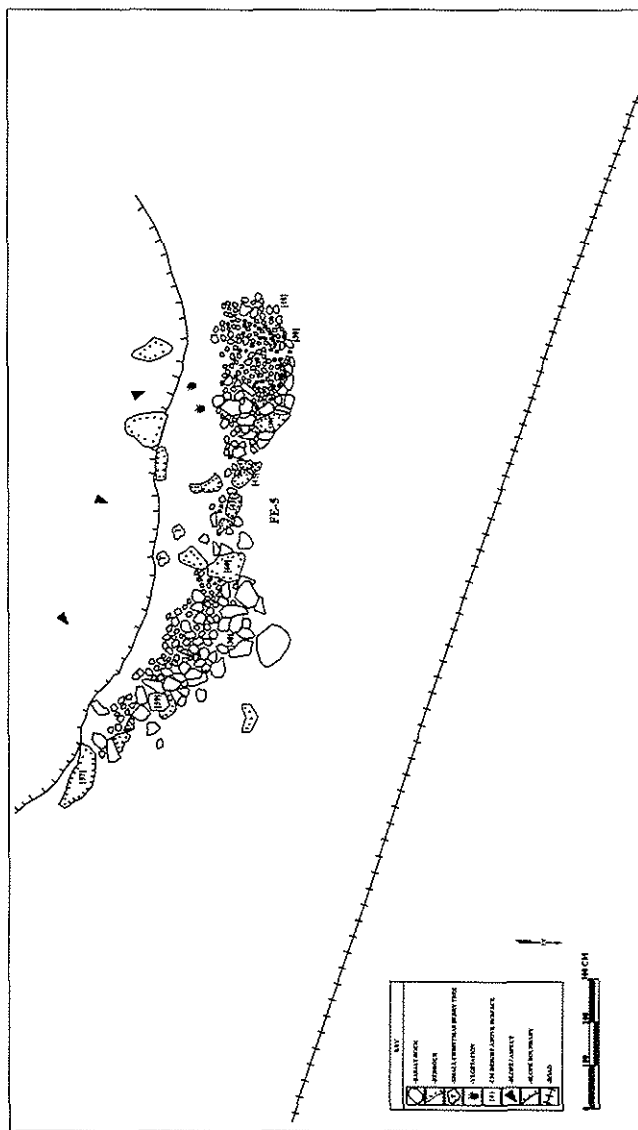
Figure 24: Site 5980, Feature 5 Plan View.

Feature 5 was located on a south spur of a *pu`u* and consisted of cobbles and boulders stacked along a bedrock outcrop (Figure 24). It measured 13.00 by 0.50/2.00 by 0.75 m high and stood two to three courses high at its north end.

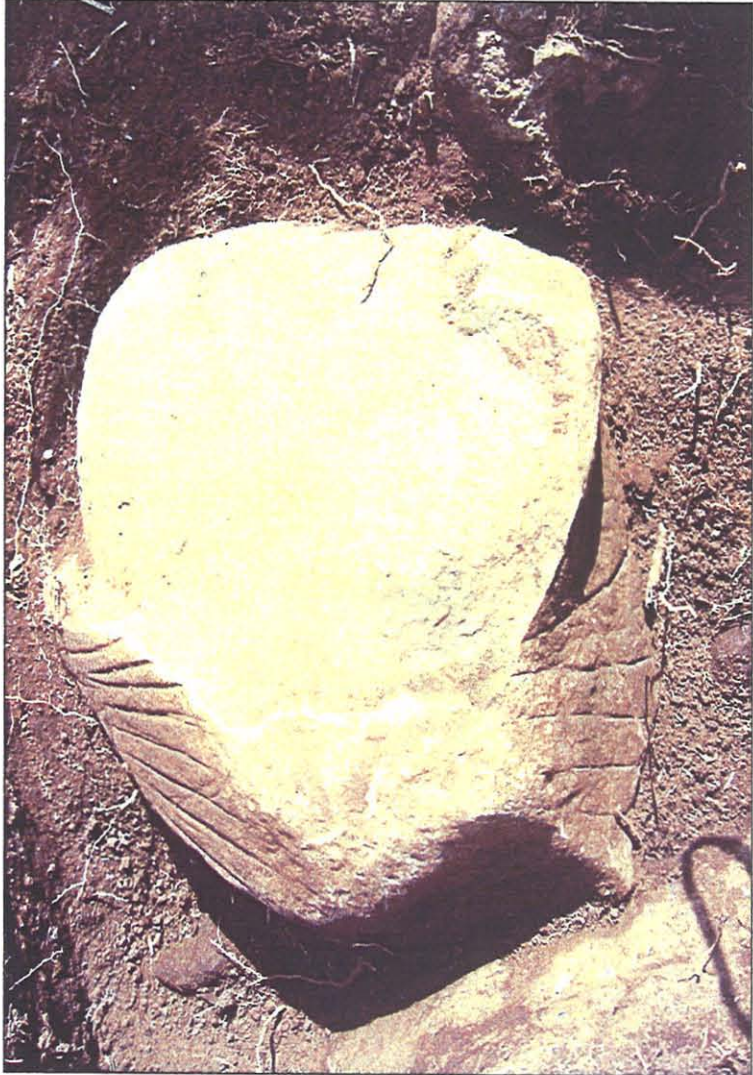
The incised rock may represent the results of what was traditionally known as a *hoana* stone which was often used for sharpening pointed tools, such as bone picks and needles, rather than a polishing or whetstone used most frequently on flat surfaces of larger tools (Figure 28).

Figure 28: Site 5980 Incised Boulder From Feature 6, TU-1.

Feature 6 was located on a west spur of a *pu'u* and consisted of a soil-surfaced, rock-faced terrace constructed with cobbles and boulders stacked three courses high (Figures 25 and 26). It measured 14.00 by 2.40 by 1.00 m high. A possible re-worked large basalt flake was identified on the surface.

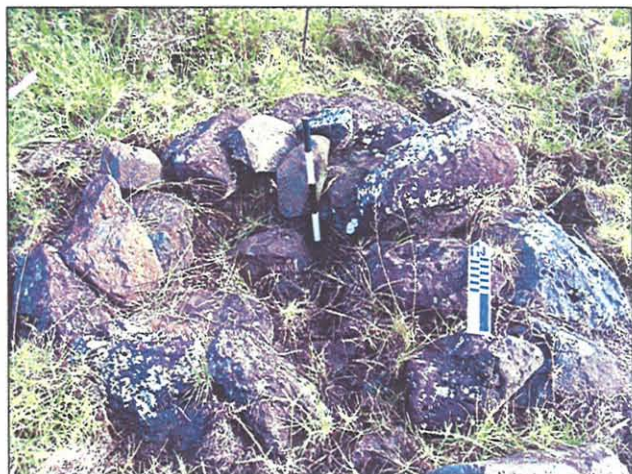
Feature 8 was an enclosure constructed with basalt boulders stacked two to three courses high (Figures 30 and 31). It measured 2.40 by 2.25 by 0.47 m high. Both features had been impacted by animal activity. This site was interpreted as an agricultural/habitation complex.

Figure 31: Site 5980, To North.

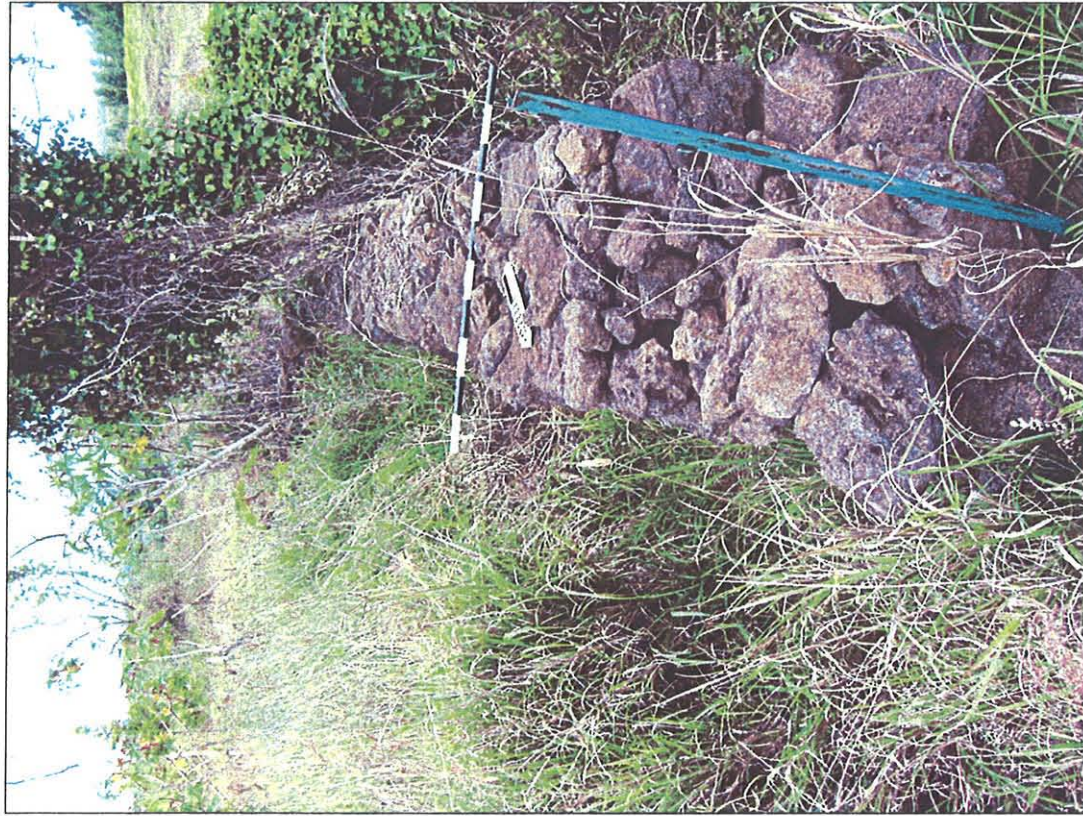
Figure 32: Site 5981, Feature 1. View to Southeast.

Feature 1 was a double-faced, cobble-filled, roughly L-shaped wall constructed with boulders and cobbles, and stacked three to six courses high (Figure 32). It measured 26.20 by 0.80 by 0.90 high to the north-south and 7.50 by 0.80 by 0.90 m high in the east-west jog. This feature was interpreted as an historic ranching wall.

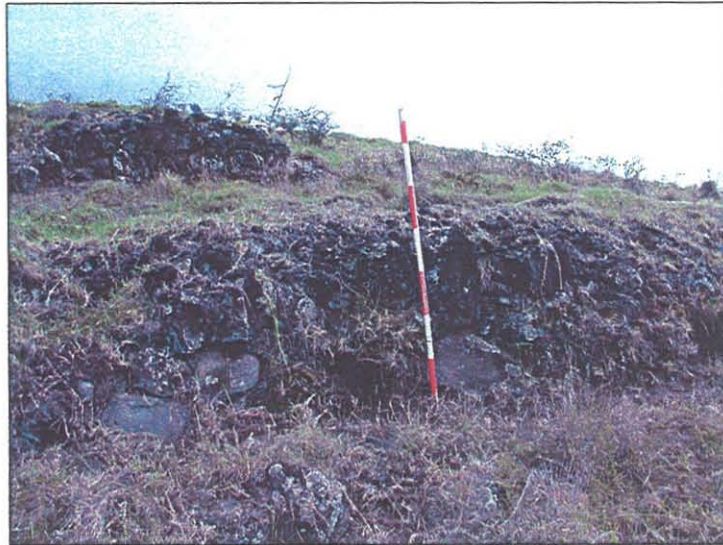
Feature 1 consisted of a three-tiered, rock-faced terrace, three to five courses high in the middle and one to two courses high at the bottom terrace (Figures 33 and 34). The top terrace measured 9.00 by 1.40 by 1.30 m high and has been impacted by bulldozer activity. The lower terrace measured 11.00 by 0.75 by 0.62 m high.

Figure 34: Site 5982, Feature 1. View to South.

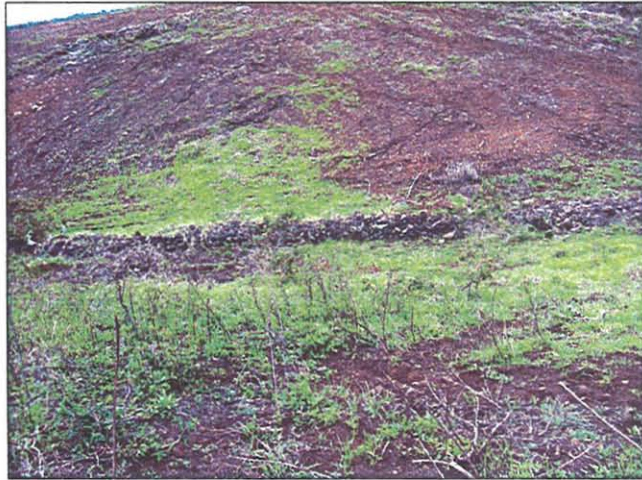
Figure 42: Site 5985, Feature 2. View to North.

Feature 2 was located at the bottom of the nearby gulch and consisted of a core-filled, wall, with a stacked basalt rock facing four to six courses high (Figure 42). It measured 49.00 by 1.00 by 0.69 m high. This site was interpreted as agriculture and ranching.
