Lanai City Expansion - 200 Housing Units

Awalua Avenue

Lanai City, HI 96763

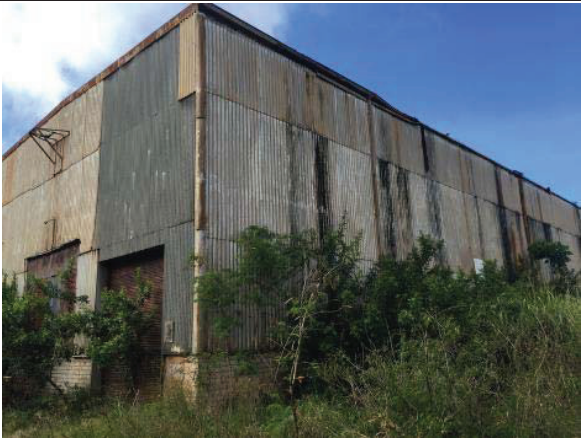
Description: North corner of the power plant			
Photo No. 2	Date 06/01/2016

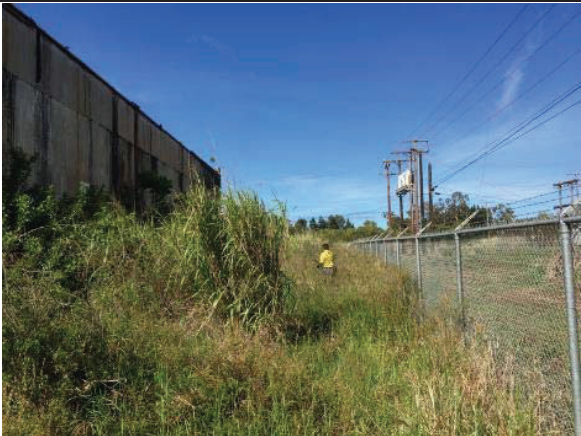
Description: North corner of the power plant looking east; overgrown vegetation

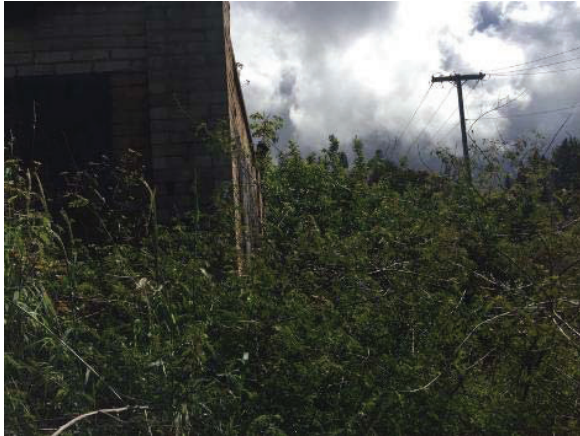
3	06/01/2016		
<b>Description:</b> South corner of the power plant looking east; overgrown vegetation

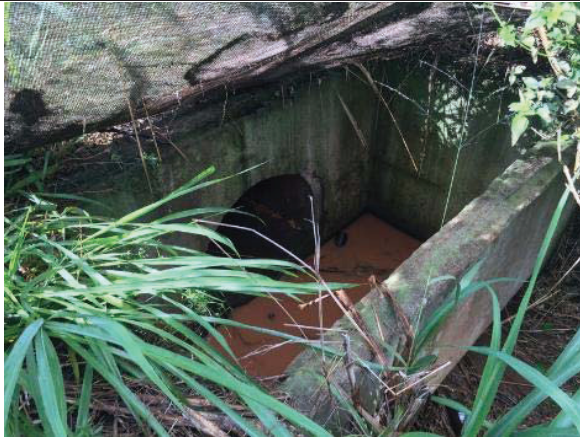
4	06/01/2016	
<b>Description:</b> Drain inlet for Site runoff located at the south side of the power plant

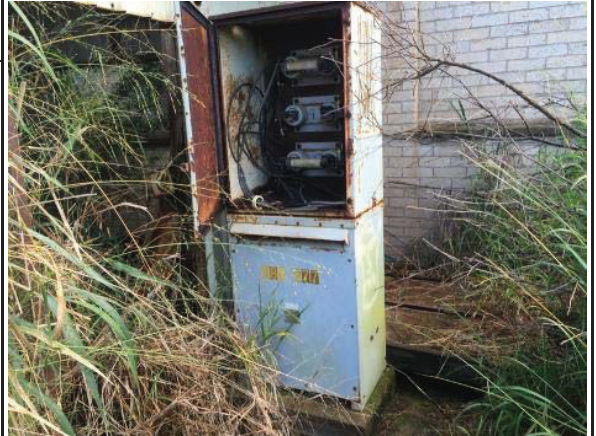
5	06/01/2016		
<b>Description:</b> Equipment located at the south side of the power plant

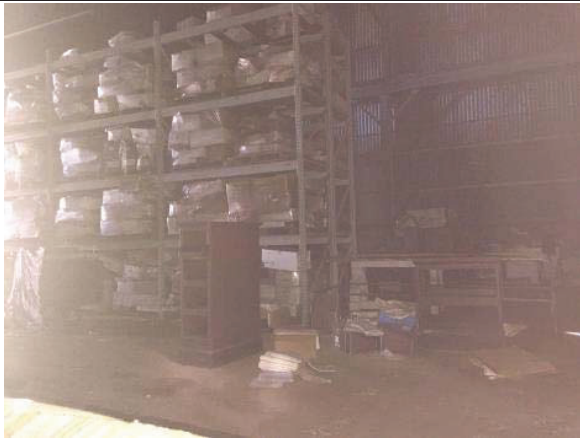
7	06/01/2016		
<b>Description:</b> Items stored inside the power plant building (as viewed through a hole in the side of the building)

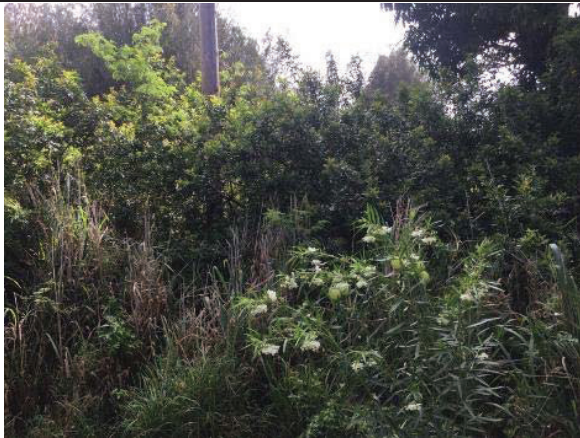
8	06/01/2016		
<b>Description:</b> East of the power plant looking east across the Site; overgrown vegetation

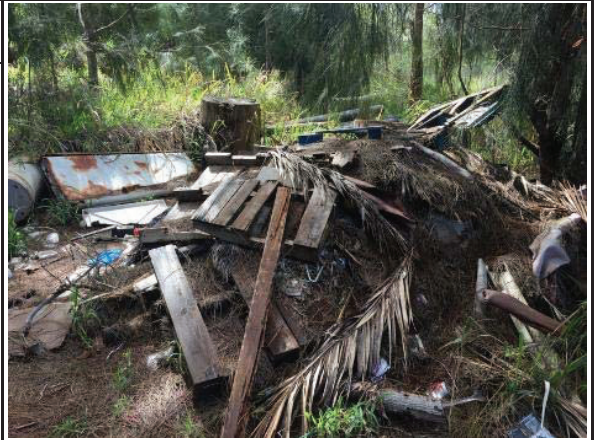
9	06/01/2016		
<b>Description:</b> Debris pile located southeast of the power plant (Typical throughout the Site)

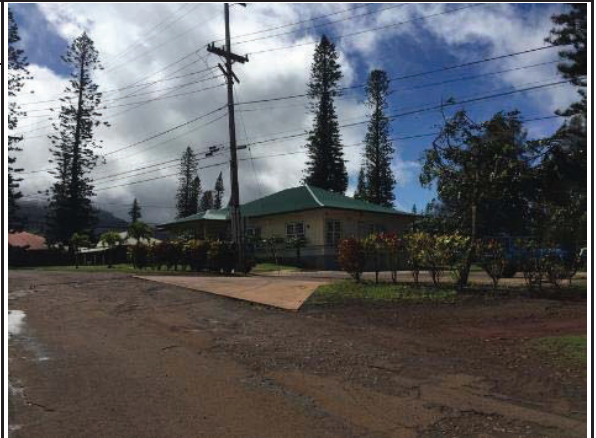
10	06/01/2016		
<b>Description:</b> Northeast corner of the Site looking southeast to the adjoining site – Church leased from Pulama Lanai

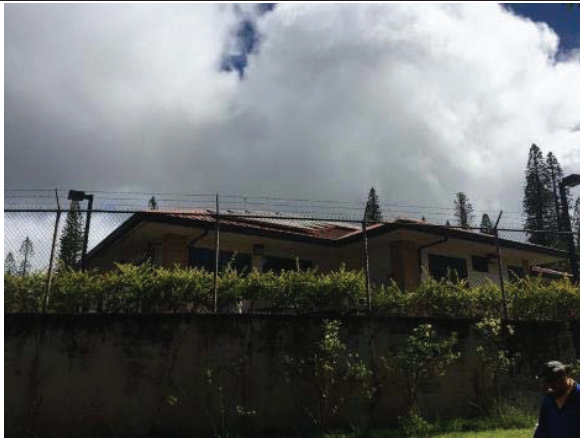
Client Name:		Site Location:	Project No.:
Pulama Lanai		Lanai City Expansion – 200 Housing Units	258407
Photo No.	Date		
11	06/01/2016		
<b>Description:</b> Northeast corner of the Site looking north to the adjoining site – Police Station

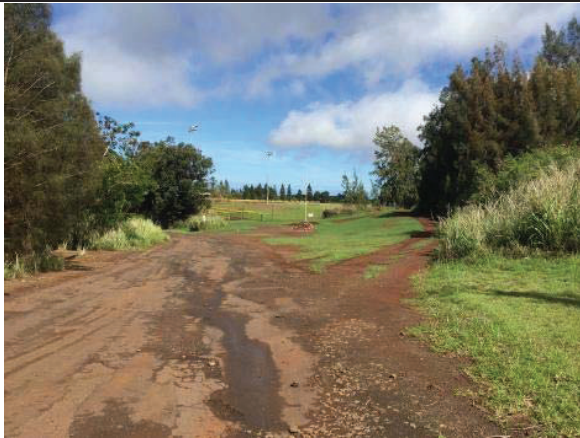
Photo No.	Date		
12	06/01/2016		
<b>Description:</b> Northeast corner of the Site looking west down 9 <sup>th</sup> Street to the adjoining property – Baseball field

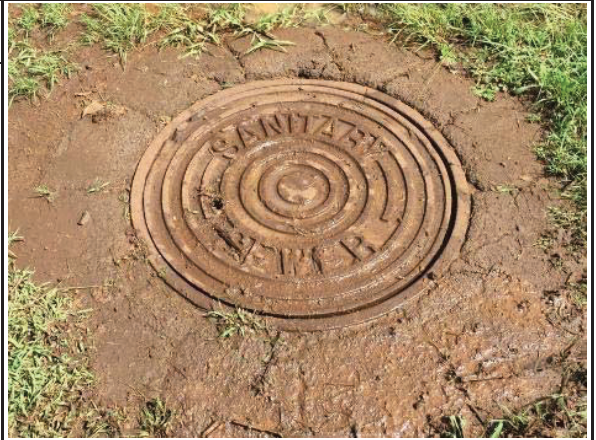
Client Name:		Site Location:	Project No.:
Pulama Lanai		Lanai City Expansion – 200 Housing Units	258407
Photo No.	Date		
13	06/01/2016		
<b>Description:</b> Sewer manhole located on 9 <sup>th</sup> Street (one of two sewer lines that run from the north portion of the Site to the southeast corner of the Site)

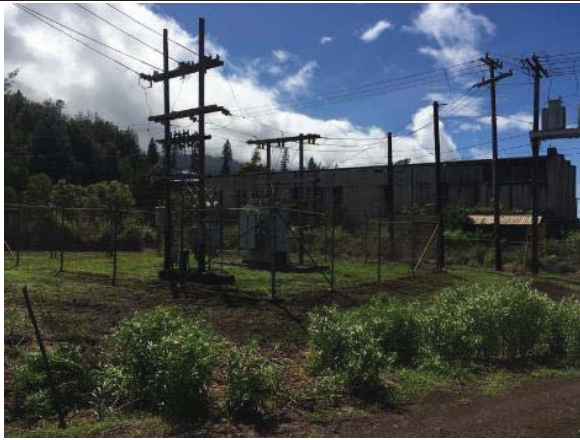
Client Name:		Site Location:	Project No.:
Pulama Lanai		Lanai City Expansion – 200 Housing Units	258407
Photo No.	Date		
15	06/01/2016		
<b>Description:</b> MECO substation located north of the power plant – currently operational

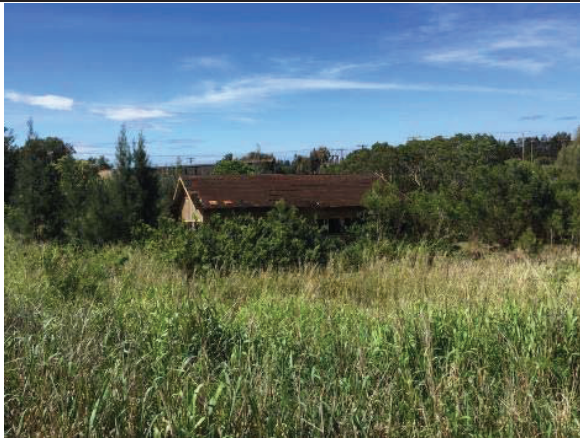
Photo No.	Date		
16	06/01/2016		
<b>Description:</b> Former Boy Scout Hall located north of the power plant – View of the structure from 9 <sup>th</sup> Street looking south across the Site; overgrown vegetation

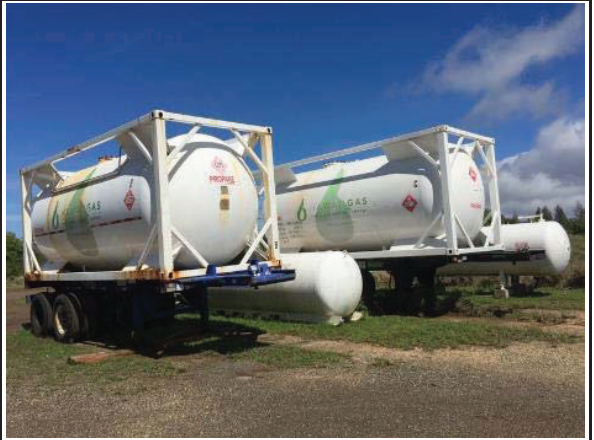
Client Name:		Site Location:	Project No.:
Pulama Lanai		Lanai City Expansion – 200 Housing Units	258407
Photo No.	Date		
17	06/01/2016		
<b>Description:</b> Hawaii Gas ASTs located in the northwest portion of the Site – Reportedly a temporary location for Hawaii Gas and will be moved to a new location off of the Site

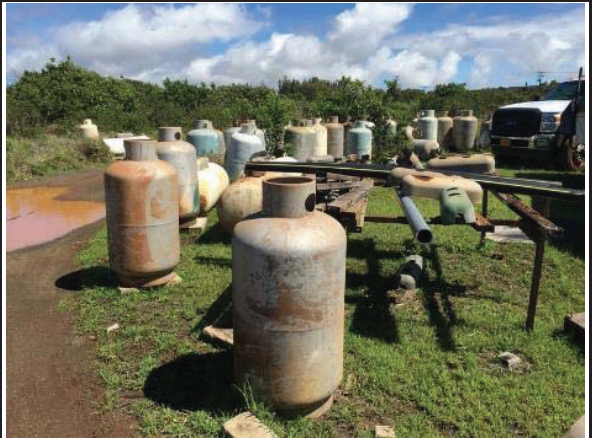
Photo No.	Date		
18	06/01/2016		
<b>Description:</b> Hawaii Gas upright, residential propane tanks located in the northwest portion of the Site

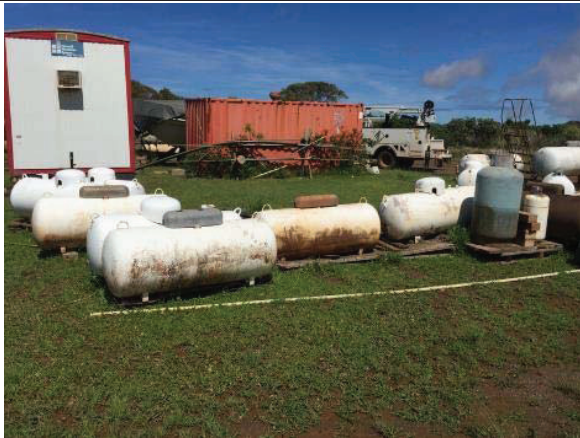
19	06/01/2016		
<b>Description:</b> Hawaii Gas oblong, residential propane tanks with storage container beyond located in the northwest portion of the Site

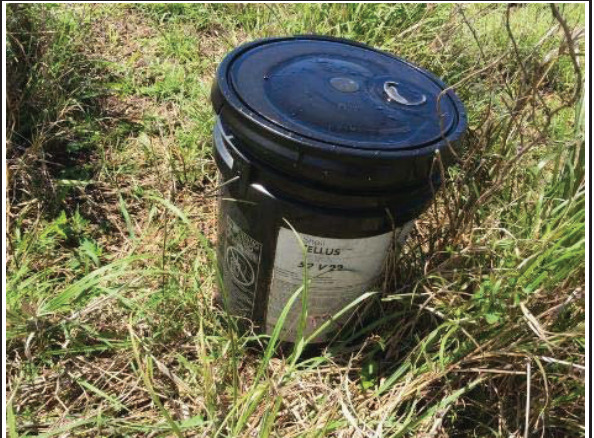
21	06/01/2016		
<b>Description:</b> 5 gallon bucket of hydraulic fluid located in the northwest portion of the Site currently occupied by Hawaii Gas

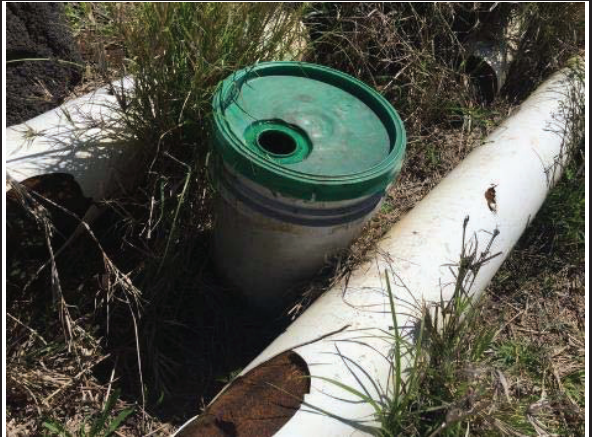
22	06/01/2016		
<b>Description:</b> 5 gallon bucket of unknown substance and aboveground PVC pipe over foam (reportedly used as a boundary marker) located in the northwest portion of the Site currently occupied by Hawaii Gas

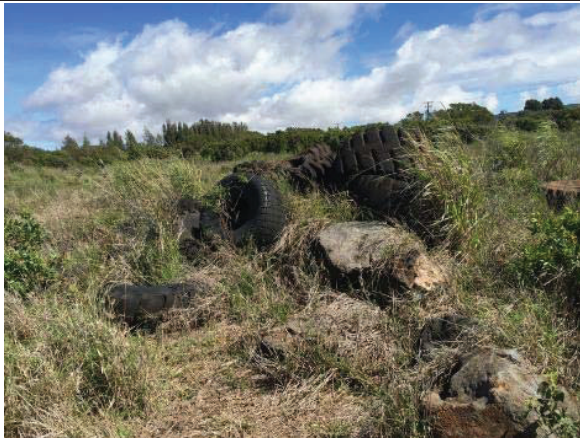
Client Name:		Site Location:	Project No.:
Pulama Lanai		Lanai City Expansion – 200 Housing Units	258407
Photo No.	Date		
23	06/01/2016		
<b>Description:</b> Tires dumped on the Site (typical throughout the Site)

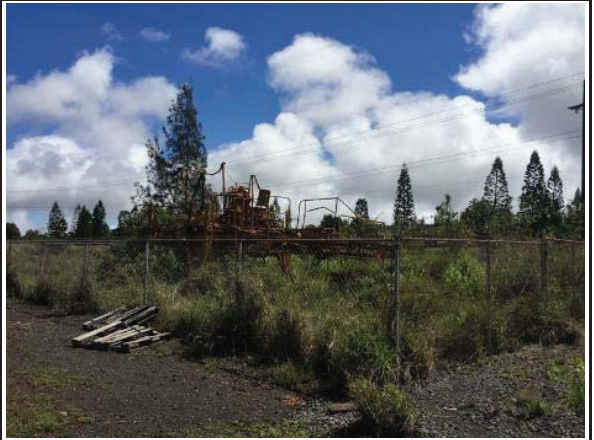
Client Name:		Site Location:	Project No.:
Pulama Lanai		Lanai City Expansion – 200 Housing Units	258407
Photo No.	Date		
25	06/01/2016		
<b>Description:</b> Broken down pineapple harvester located in the northwest portion of the Site

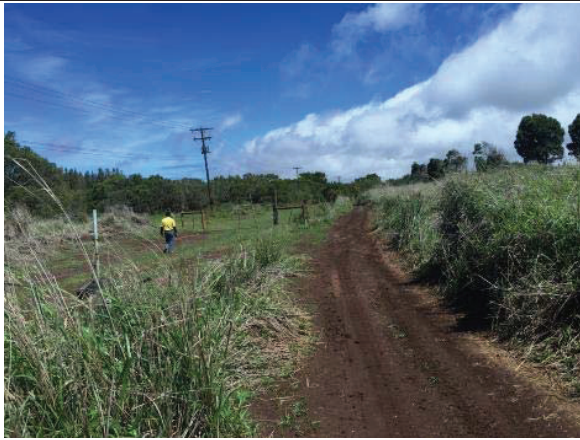
Client Name:		Site Location:	Project No.:
Pulama Lanai		Lanai City Expansion – 200 Housing Units	258407
Photo No.	Date		
27	06/01/2016		
<b>Description:</b> North Site boundary looking north across gated, County owned property

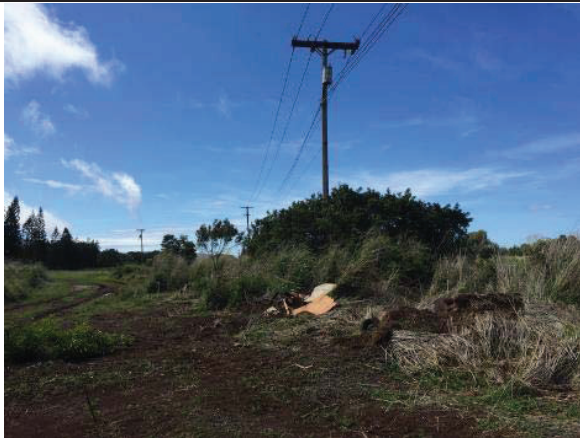
Photo No.	Date		
28	06/01/2016		
<b>Description:</b> North Site boundary looking south across the Site and the electrical easement and pole mounted transformers

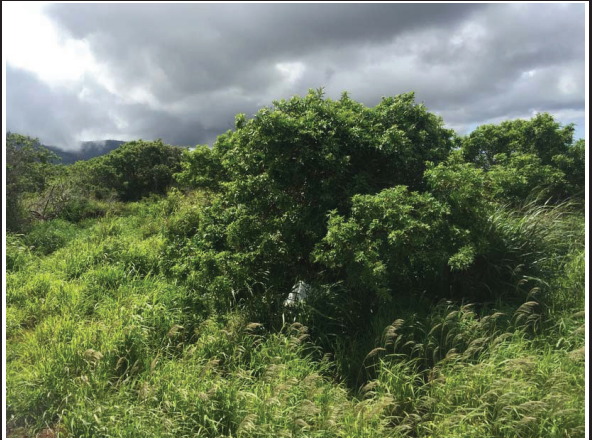
Client Name:		Site Location:	Project No.:
Pulama Lanai		Lanai City Expansion – 200 Housing Units	258407
Photo No.	Date		
29	06/21/2016		
<b>Description:</b> Northwest Site boundary looking south across the site; overgrown vegetation

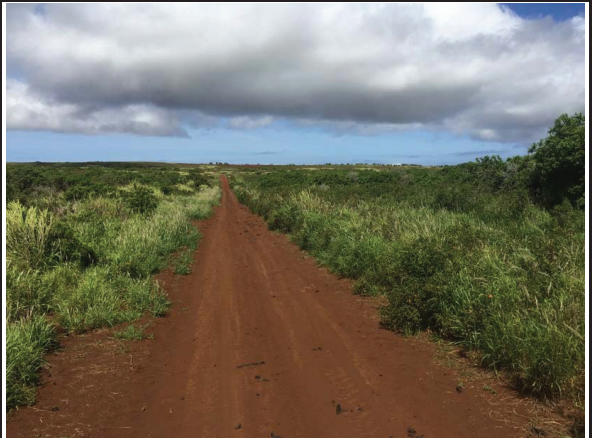
Photo No.	Date		
30	06/21/2016		
<b>Description:</b> Northwest Site boundary looking west to adjoining property – Undeveloped, agricultural land (The roadway in the photo is reportedly going to be 9 <sup>th</sup> Street once it is extended.)

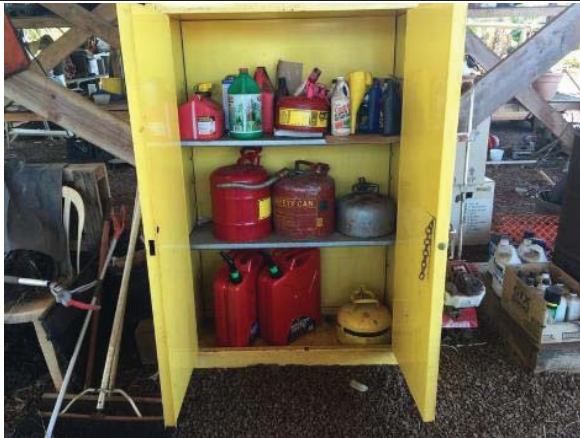
35	06/01/2016		
<b>Description:</b> Flammable cabinet located on the east portion of the Nursery

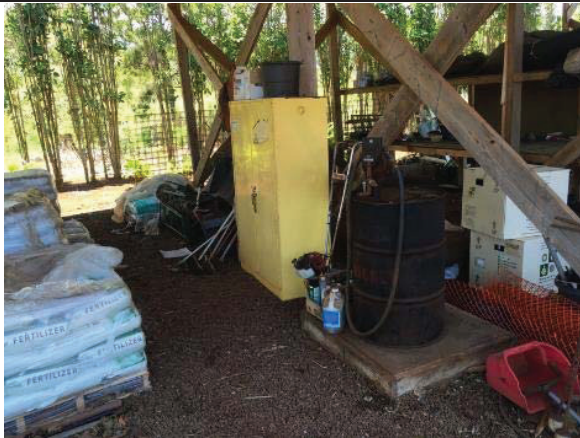
36	06/01/2016		
<b>Description:</b> 55-gallon drum of diesel with staining on the gravel below located in the east portion of the Nursery

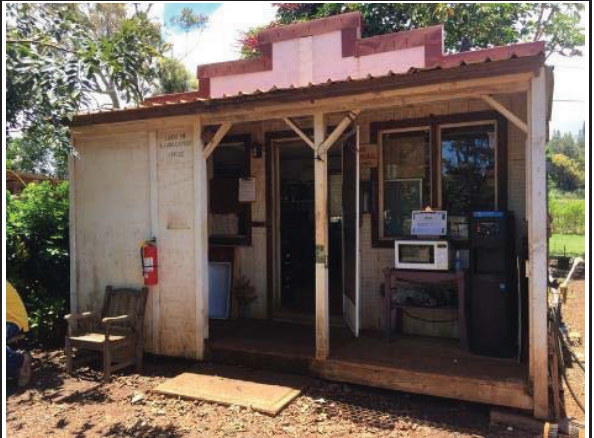
37	06/01/2016		
<b>Description:</b> Nursery office located in the northeast portion of the Nursery

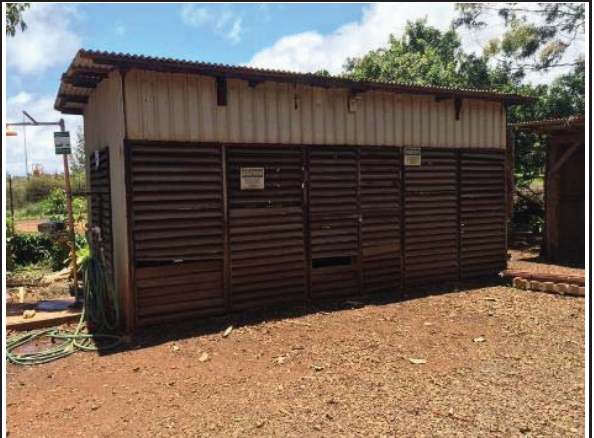
38	06/01/2016		
<b>Description:</b> Pesticide and chemical storage shed located in the northeast corner of the Nursery

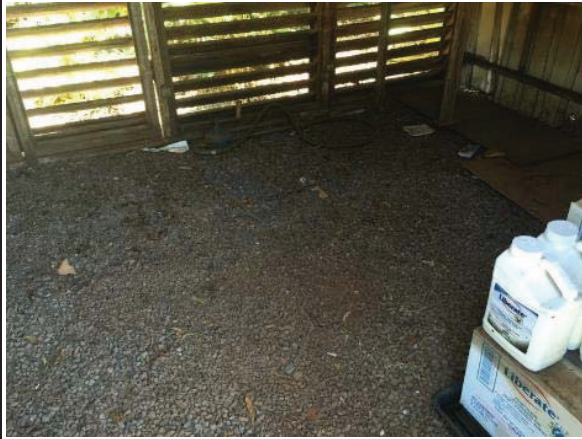
Client Name:		Site Location:	Project No.:
Pulama Lanai		Lanai City Expansion – 200 Housing Units	258407
Photo No.	Date	Description:	
39	06/01/2016		
		Gravel floor of the pesticide and chemical storage shed located in the northeast corner of the Nursery

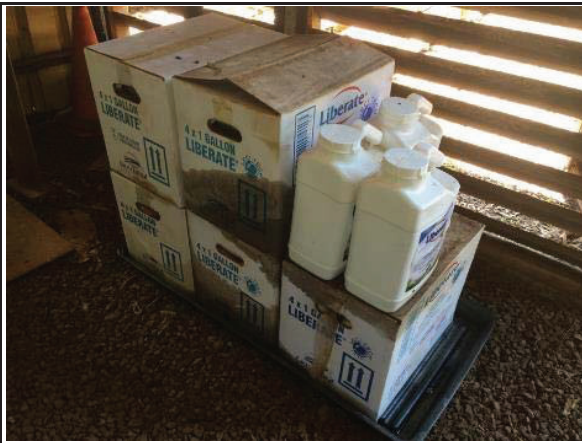
Photo No.	Date	Description:	
40	06/01/2016		
		Liberate® Penetrant (Drift Control Agent) in the pesticide and chemical storage shed located in the northeast corner of the Nursery

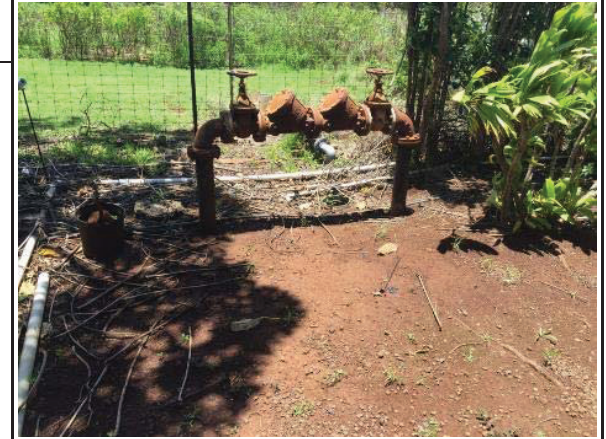
Client Name:		Site Location:	Project No.:
Pulama Lanai		Lanai City Expansion – 200 Housing Units	258407
Photo No.	Date	Description:	
41	06/01/2016		
		Water pipes located behind the Nursery office in the northeast portion of the Nursery

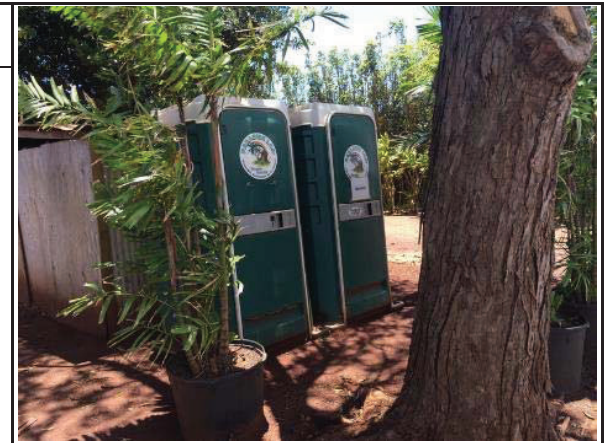
Photo No.	Date	Description:	
42	06/01/2016		
		Porta Potties servicing the Nursery

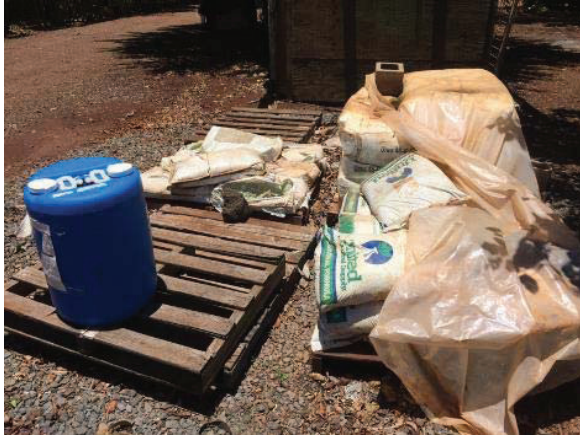
Client Name:		Site Location:	Project No.:
Pulama Lanai		Lanai City Expansion – 200 Housing Units	258407
Photo No.	Date		
43	06/01/2016		
<b>Description:</b> Fertilizer on pallets and a 15-gallon container of Pendulum Aquacap Herbicide located near the entrance of the Nursery

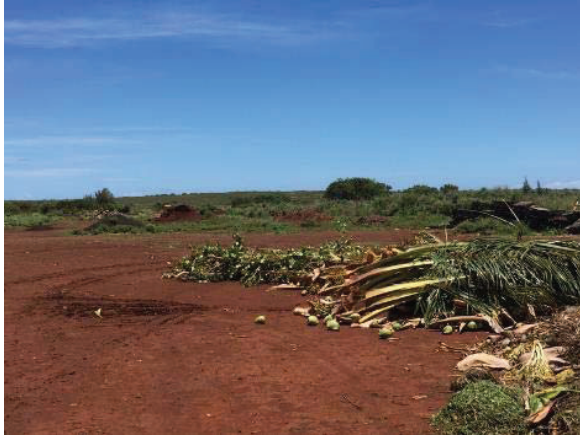
Photo No.	Date		
44	06/01/2016		
<b>Description:</b> Green waste pile with compost piles beyond located to the northwest of the Nursery

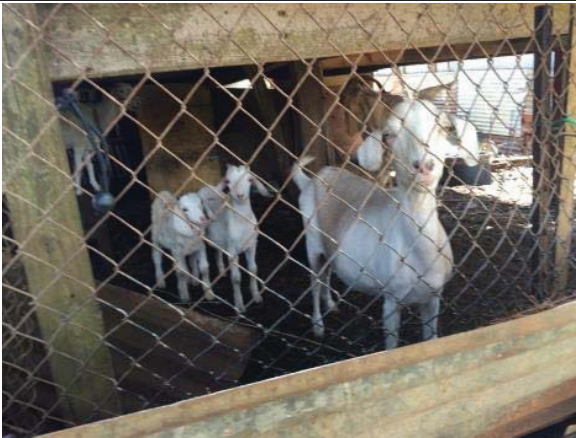
Description: Community garden plot with goats

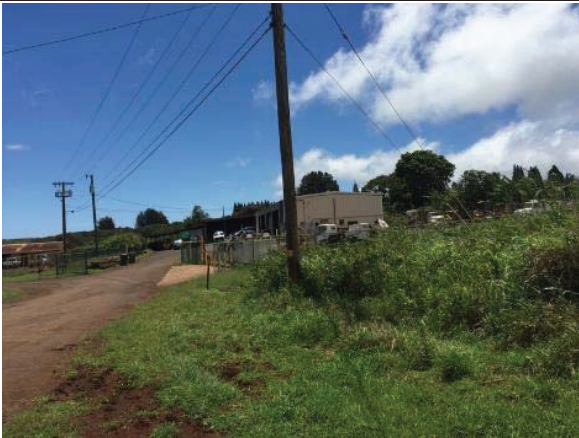
Description: County Highway Department located southwest of the Site

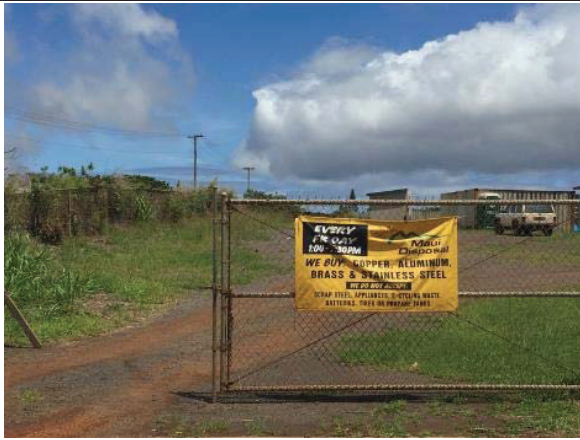
Client Name:		Site Location:	Project No.:
Pulama Lanai		Lanai City Expansion – 200 Housing Units	258407
Photo No.	Date		
55	06/01/2016		
<b>Description:</b> South Site boundary (12 <sup>th</sup> Street) looking south to the light industrial adjoining the Site

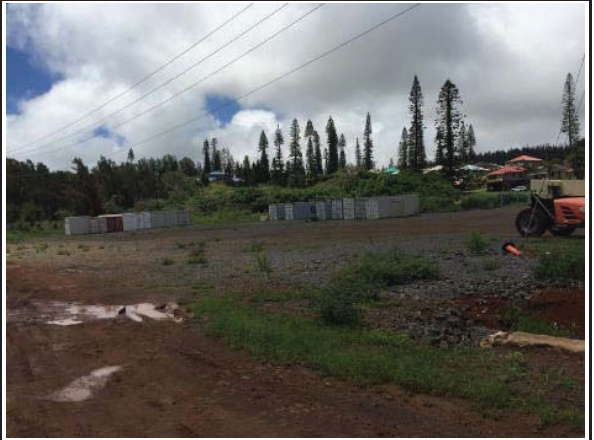
Client Name:		Site Location:	Project No.:
Pulama Lanai		Lanai City Expansion – 200 Housing Units	258407
Photo No.	Date		
57	06/01/2016		
<b>Description:</b> Southeast Site boundary (12 <sup>th</sup> Street and Awalua intersection) looking northeast to the parking lot and storage containers adjoining the Site (Former Emulsion Plant Site)

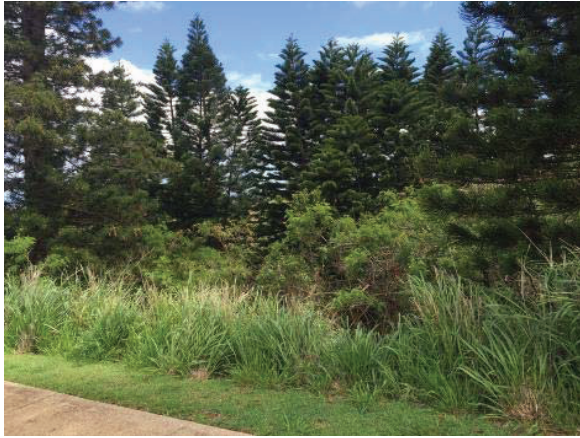
Client Name:		Site Location:	Project No.:
Pulama Lanai		Lanai City Expansion – 200 Housing Units	258407
Photo No.	Date		
59	06/01/2016		
<b>Description:</b> East Site boundary (from Fraser Avenue) looking east across the Site; overgrown vegetation

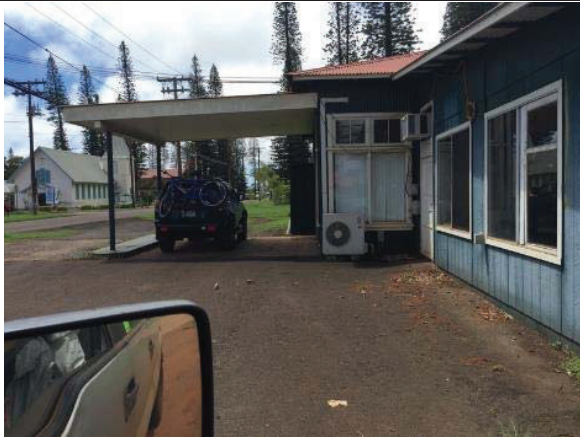
Photo No.	Date		
60	06/01/2016		
<b>Description:</b> Former Oshiro gas station located to the north-northeast of the Site (LUST listing with NFA)

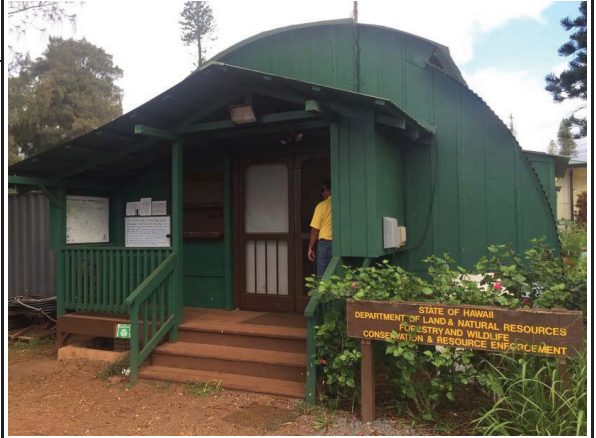
Client Name:		Site Location:	Project No.:
Pulama Lanai		Lanai City Expansion – 200 Housing Units	258407
Photo No.	Date		
61	06/21/2016		
<b>Description:</b> Quonset Shed

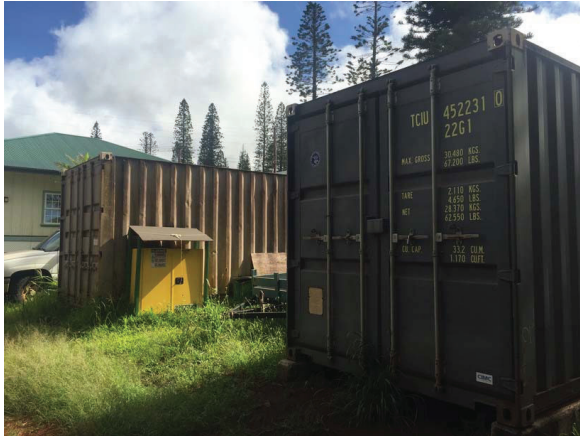
Client Name:		Site Location:	Project No.:
Pulama Lanai		Lanai City Expansion – 200 Housing Units	258407
Photo No.	Date		
63	06/21/2016		
<b>Description:</b> Quonset shed, storage containers located west of the shed. Locked and reportedly storing equipment

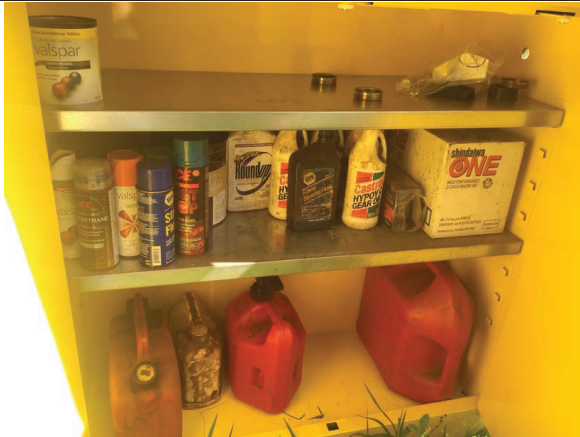
Photo No.	Date		
64	06/21/2016		
<b>Description:</b> Quonset shed, contents of flammable cabinet in good condition

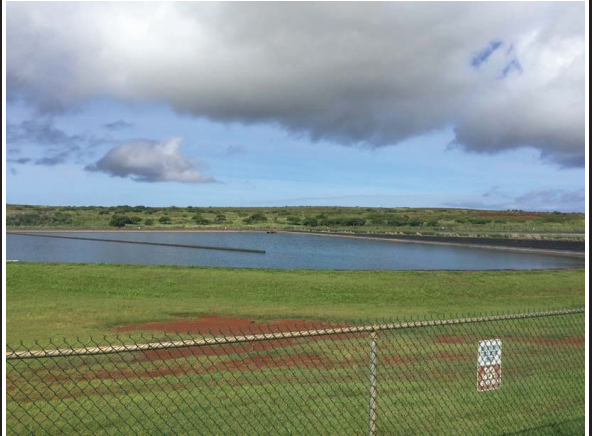
Client Name:		Site Location:	Project No.:
Pulama Lanai		Lanai City Expansion – 200 Housing Units	258407
Photo No.	Date		
65	06/21/2016		
<b>Description:</b> West Site boundary looking west-northwest across Waste Water Treatment Plant northmost ponds (ponds are lined)

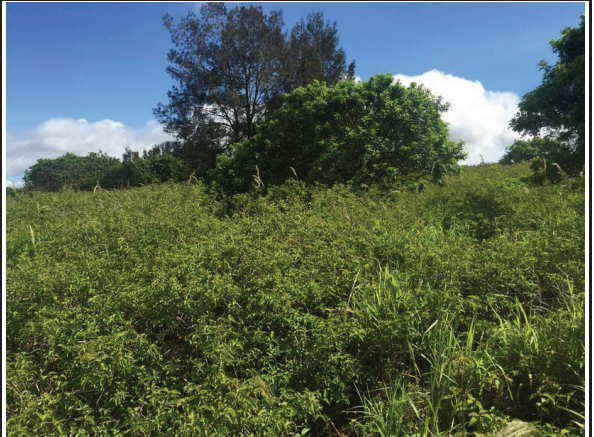
Photo No.	Date		
66	06/21/2016		
<b>Description:</b> West Site boundary looking North across the Site, overgrown vegetation

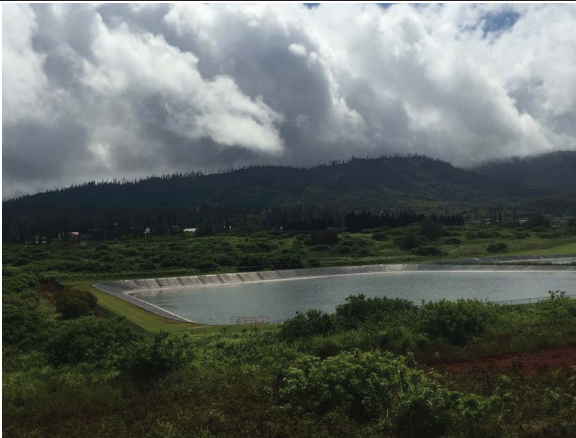
Description: Upper elevation beyond the Site overlooking the Waste Water Treatment Plant with the Site beyond.
