**ARCHAEOLOGICAL INSPECTION, ARCHIVAL AND MAP RESEARCH,  
AND ORAL INTERVIEWS OF HISTORIC HŌLUALOA HUI  
ACCESS EASEMENTS MAUKA (EAST) OF THE ROYAL VISTAS  
PROJECT AREA, HŌLUALOA 1<sup>ST</sup> AHUPUA‘A,  
NORTH KONA DISTRICT, HAWAI‘I ISLAND, HAWAI‘I  
[TMK: (3) 7-6]**

**Glenn G. Escott, M.A.  
&  
Suzan Escott, B.A.**

**2024  
FINAL**

**SCIENTIFIC CONSULTANT SERVICES Inc.**

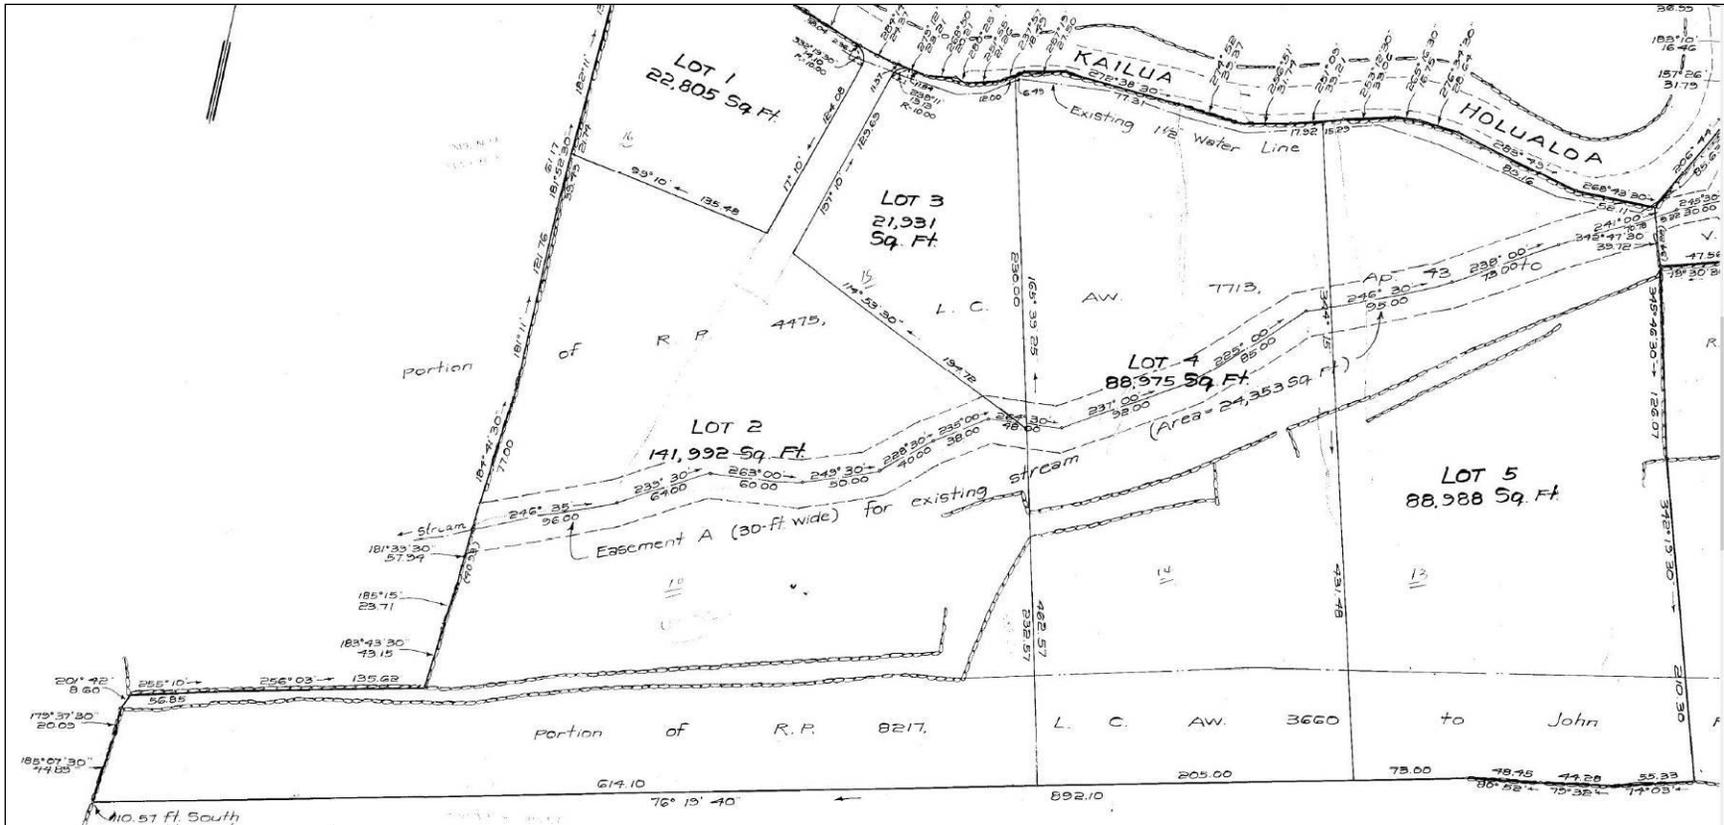
**Figure 5: Subdivision #2915 Plan (1970) Showing Lots, LCA 3660 North Boundary, and Rock Walls along the North and South Edges of Way #4.**

Way #4 is labeled 12 feet wide on the map. The rock walls on either side of the trail were surveyed and mapped on the Subdivision #2915 Plan (1970) (Figure 5). The trail easement is not depicted on the plan and the omission shows the trail to be within Lots #2, #4, and #5. The west terminus of the trail is labeled 8.6 feet wide, and the overall width of the trail appears to be between 8.0 and 10.0 feet wide.

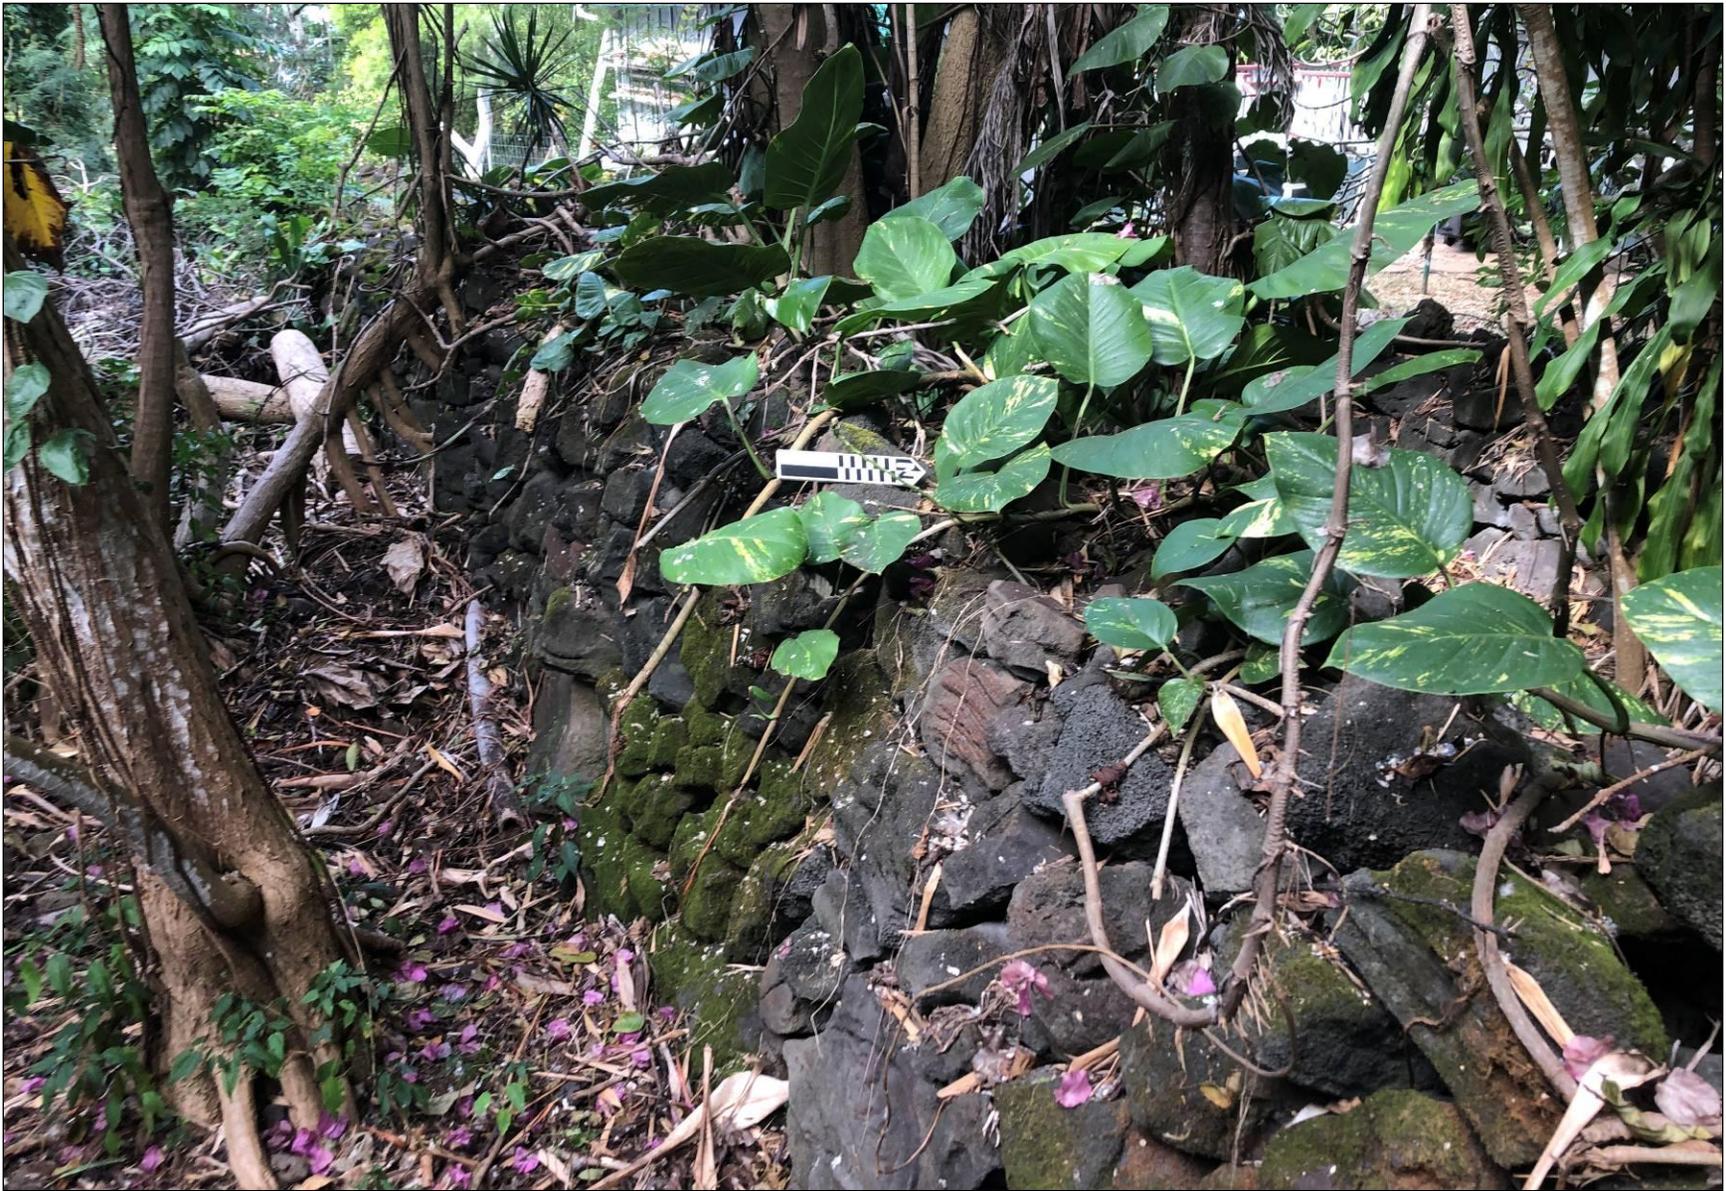
**Figure 7: Photograph of Way #4 North Wall Taken Near the East Terminus, Looking West.**

The wall construction style and dimensions are typical of Historic era and early modern walls documented on Hawai'i Island. The eastern ends of the walls have been bulldozed near the east boundary of Parcel 032 (see Figure 6) and are no longer present. Roughly 100 ft of the two walls near the eastern terminus are partially tumbled (Figure 8), though the middle and the western portions of the walls are in good condition.

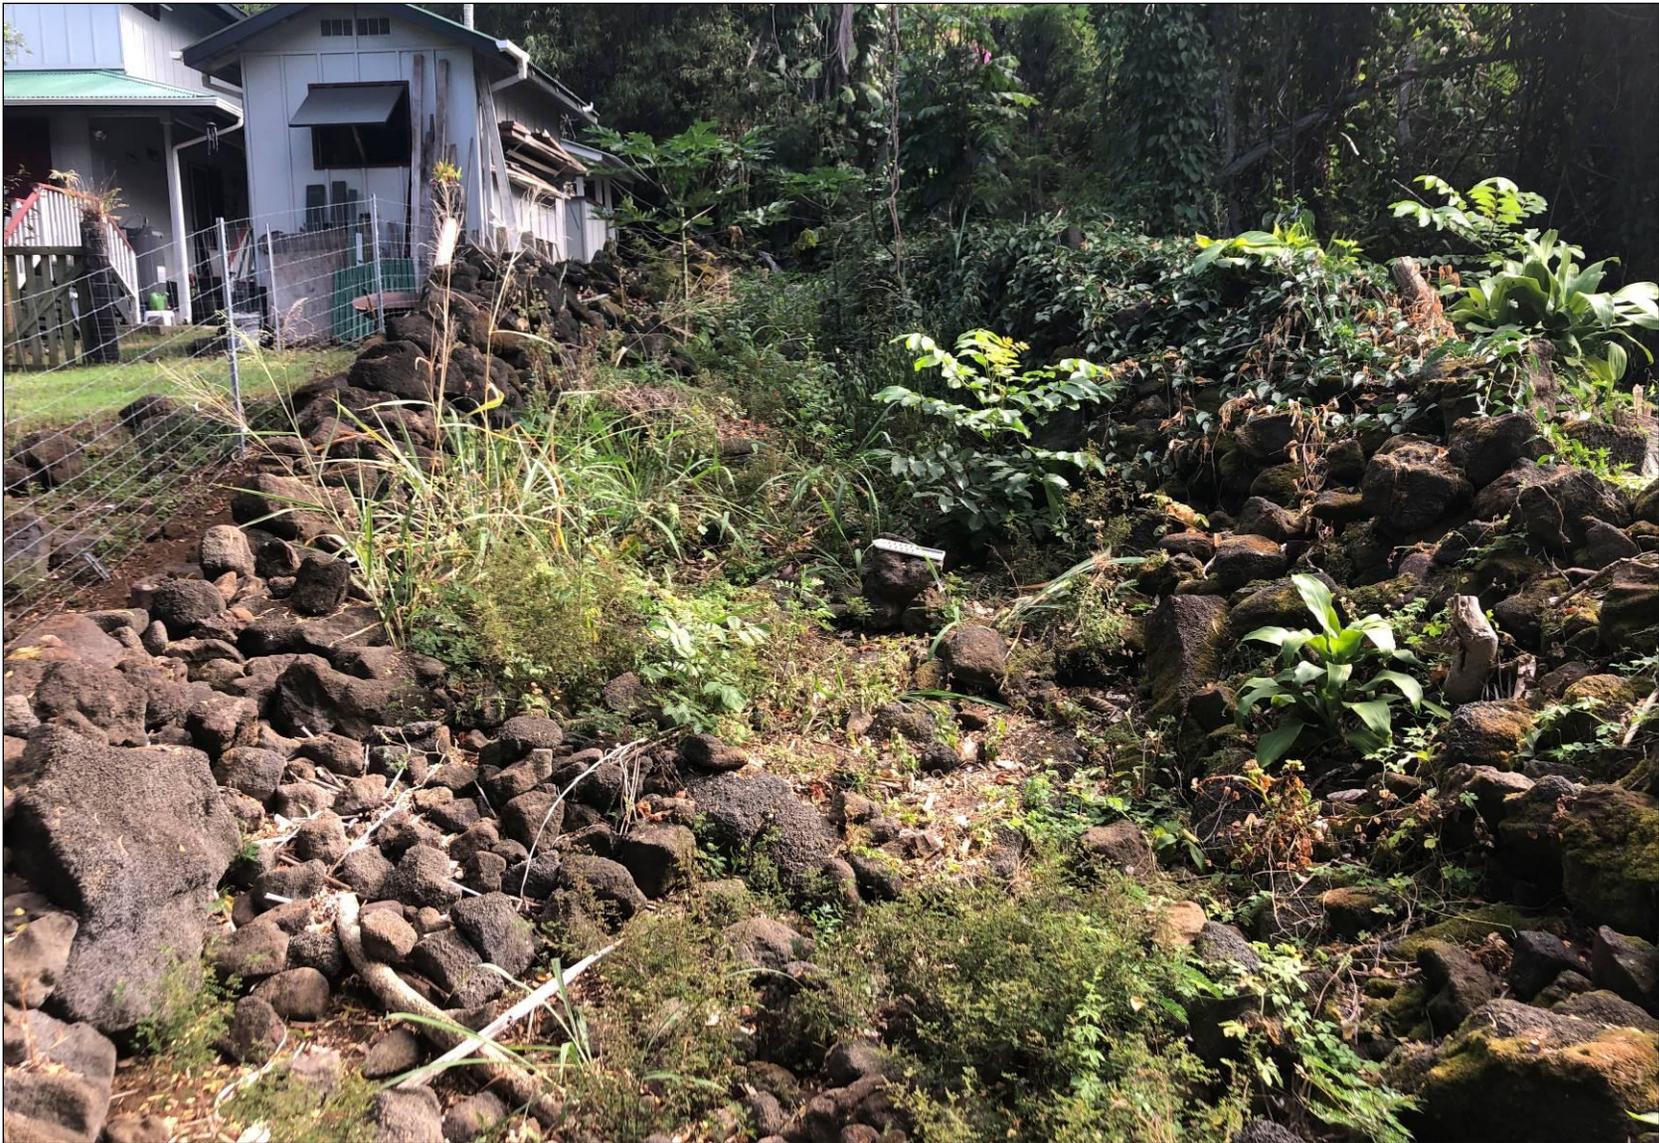
**Figure 8: Photograph of Way #4 Corridor and Walls Showing Tumble 100 Feet from the East Terminus, Looking East.**

Way #4 was located within TMK: (3) 7-6-011:032 (Figure 6). The trail walls begin at the *mauka* edge of the railroad bed and continue east/northeast for approximately 350.0 feet (107 meters). The corridor between the walls ranges from 8.0 to 11.0 ft (2.44-3.35 m). The walls are between 2.3 and 3.3 ft (0.7 and 1.0 m) in height. They are constructed of stacked angular and subangular basalt large cobbles and small boulders (Figure 7). The rocks are tightly fitted, the walls are bi-faced, and the wall faces slope slightly inward from their base to their top.

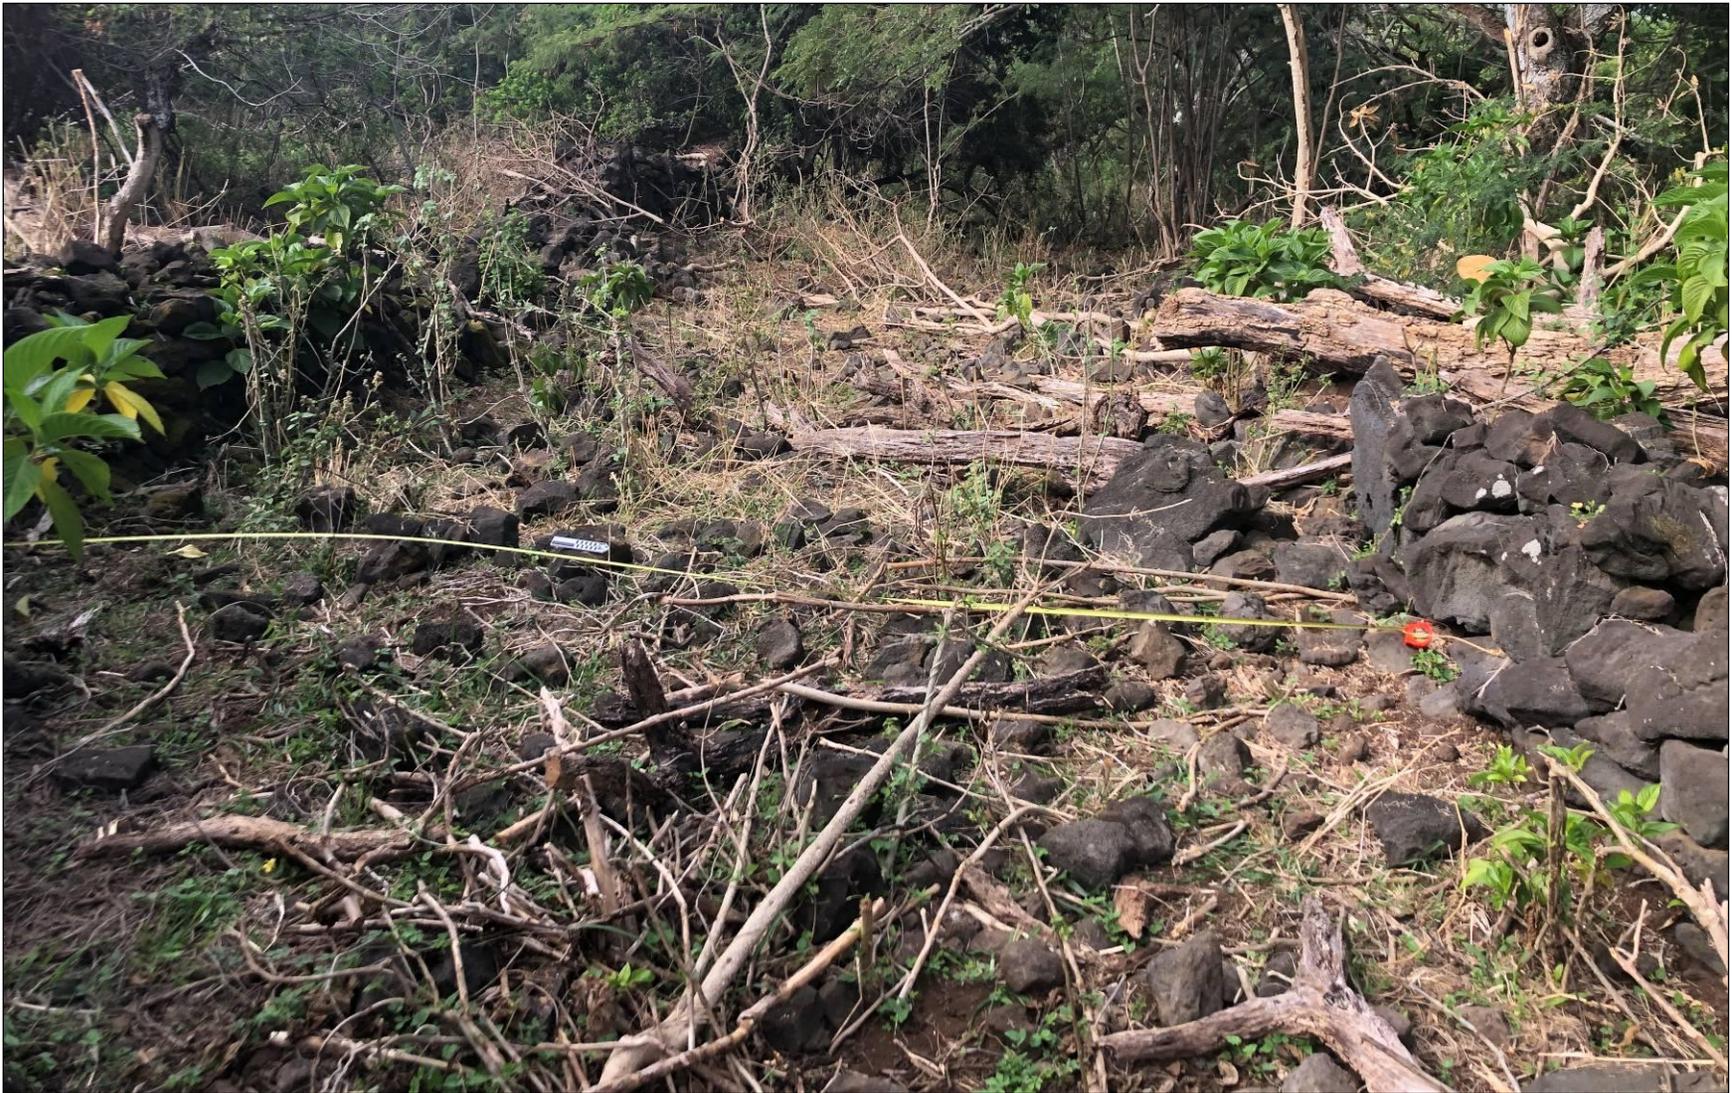
**Figure 10: Photograph of Site 31182 Feature 2 and Feature 3 Walls Near Their Eastern Termini, Looking West.**

**Site 31182, Feature 2 and Feature 3** are *mauka-makai* rock walls with eastern termini at the *makai* edge of the railroad bed (see Figure 6, and Figure 9 through Figure 11). Feature 2 continues west to the west boundary of the Royal Vistas project area, with a gap where there is a seasonal gulch. Feature 3 continues west to the edge of a seasonal gulch, though remnant line footing stones from the wall were identified *makai* of the gulch.

The two walls are approximately 20.5 ft (6.25 m) apart from each other at their eastern ends and become wider apart as they continue west. They are approximately 80 ft (24.4 m) apart from each other at the western terminus of Feature 3. At the eastern end, the exterior sides of the two walls are almost 30 apart from each other.

The walls are between 2.62 and 2.95 ft (0.8-0.9 m) wide by 2.95 to 4.26 ft (0.9-1.3 m) in height. The walls are constructed of stacked angular and subangular large cobbles and small boulders (see Figure 10). The rocks are somewhat fitted and are bi-faced. The walls are collapsed in places near their eastern termini and are in poor condition (see Figure 11). The wall construction style and dimensions are typical of Historic era ranch and property boundary walls documented on Hawai'i Island.

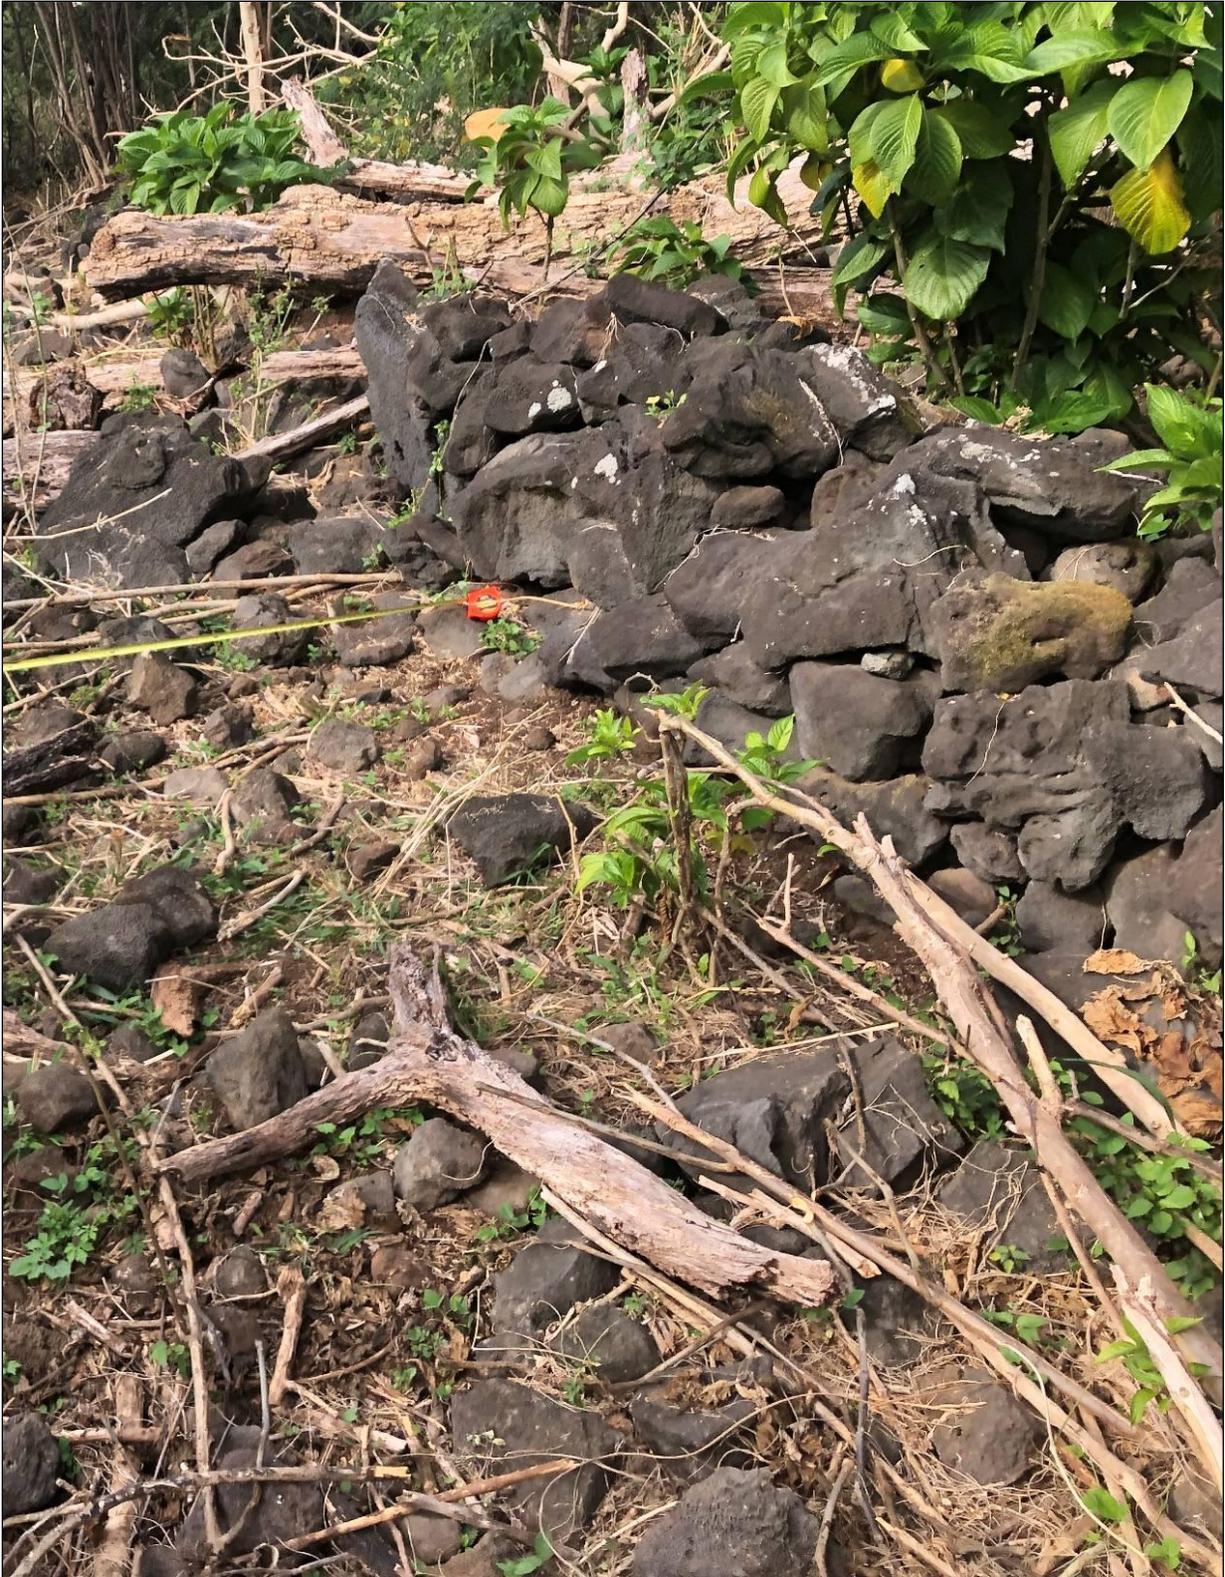
**Figure 11: Photograph Site 31182 Feature 2 Wall Construction and Collapse, Looking Northeast.**

The Site 31182 Feature 2 and Feature 3 wall construction is not similar to the Way #4 wall construction. The Way #4 walls are built much better. The rocks are tightly fitted, the facing is much finer, and they slope inward slightly from base to top. The construction style is closer to late Historic to early modern wall construction. The Feature 2 and Feature 3 walls are more roughly constructed and are more similar to early Historic era ranch and property boundary walls.

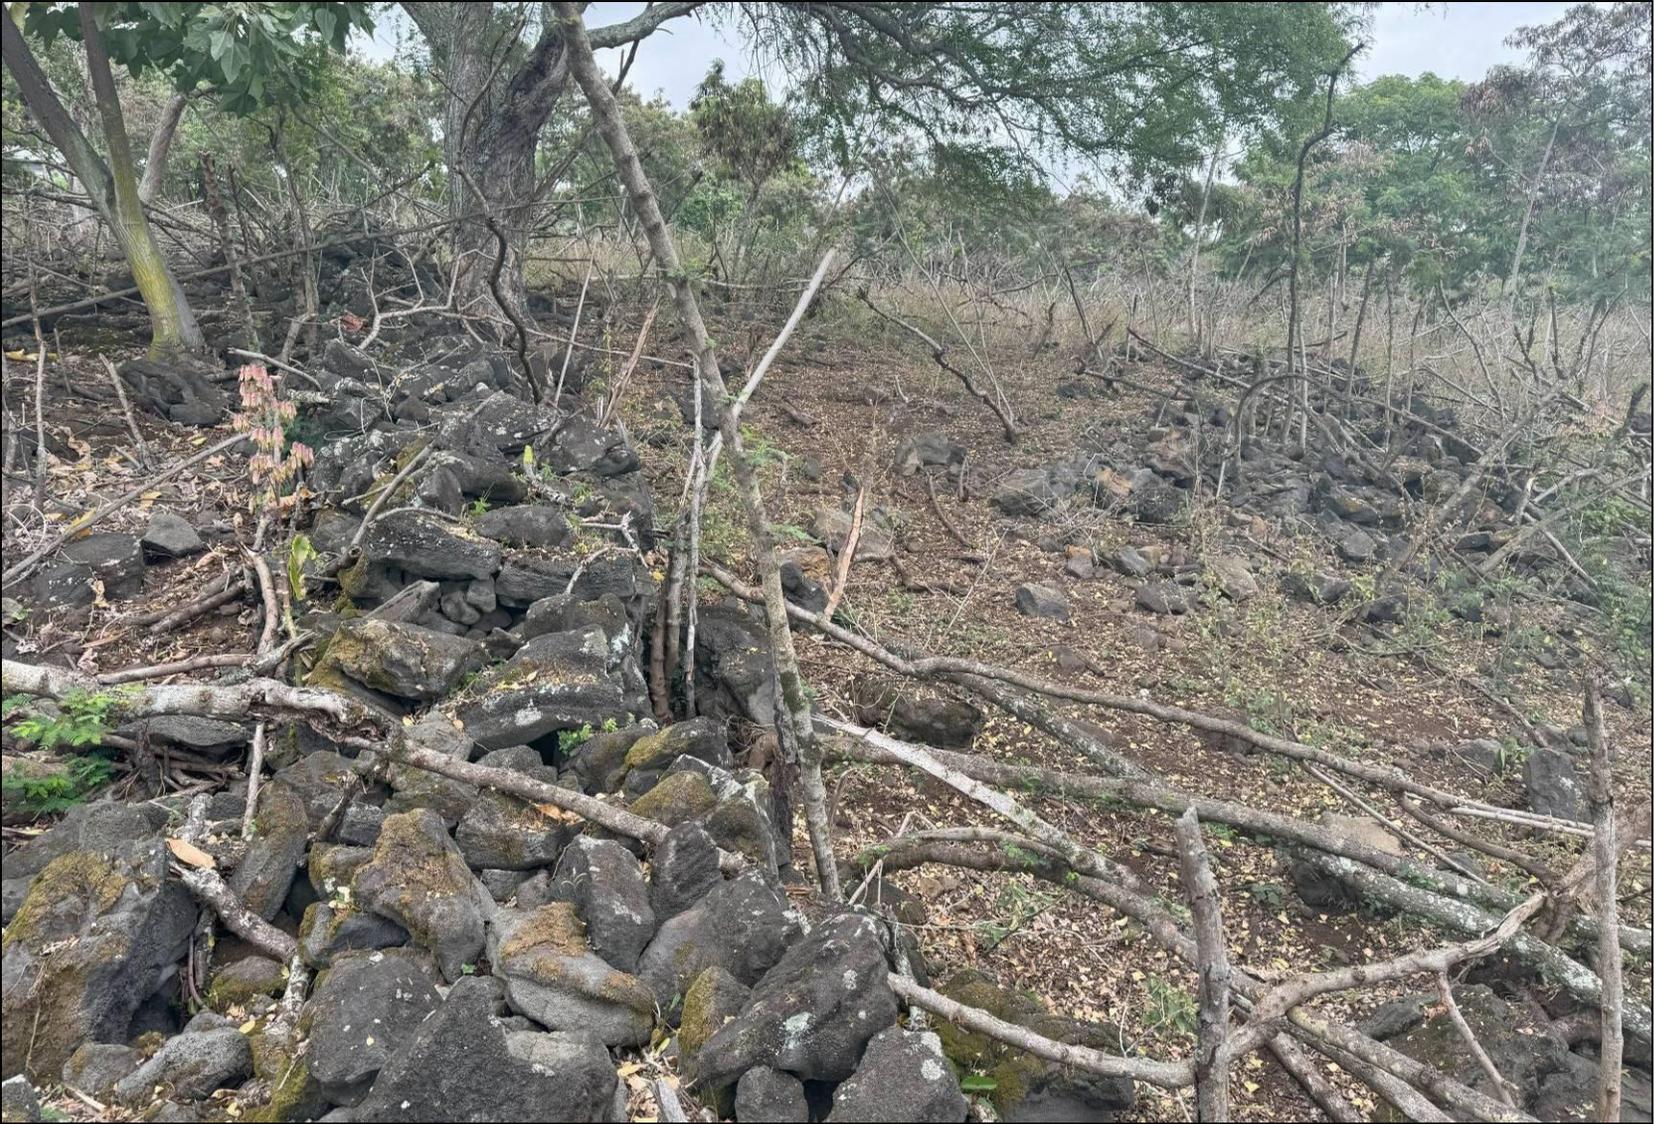
**Figure 25: Photograph of South Wall Overview Showing Wall Construction, Wall Condition and Even Ground on South Side of Wall, Looking East.**

The construction and condition of Site 30595 (south wall) and Site 30601 (north wall) are dissimilar (Figure 25 and Figure 26). The south wall is not as substantial as the north wall. The south wall is roughly constructed and is shorter in height than the north wall. Both walls are dry stacked, bi-faced and core filled in places. The construction method and dimensions are similar to Historic era ranch walls documented on the Island of Hawai‘i. The south wall is collapsed in several places and is in poor condition. The north wall is taller, is in good condition and is better faced. It is likely that the north wall was constructed sometime after the south wall and was repaired/maintained whereas the south wall was not.

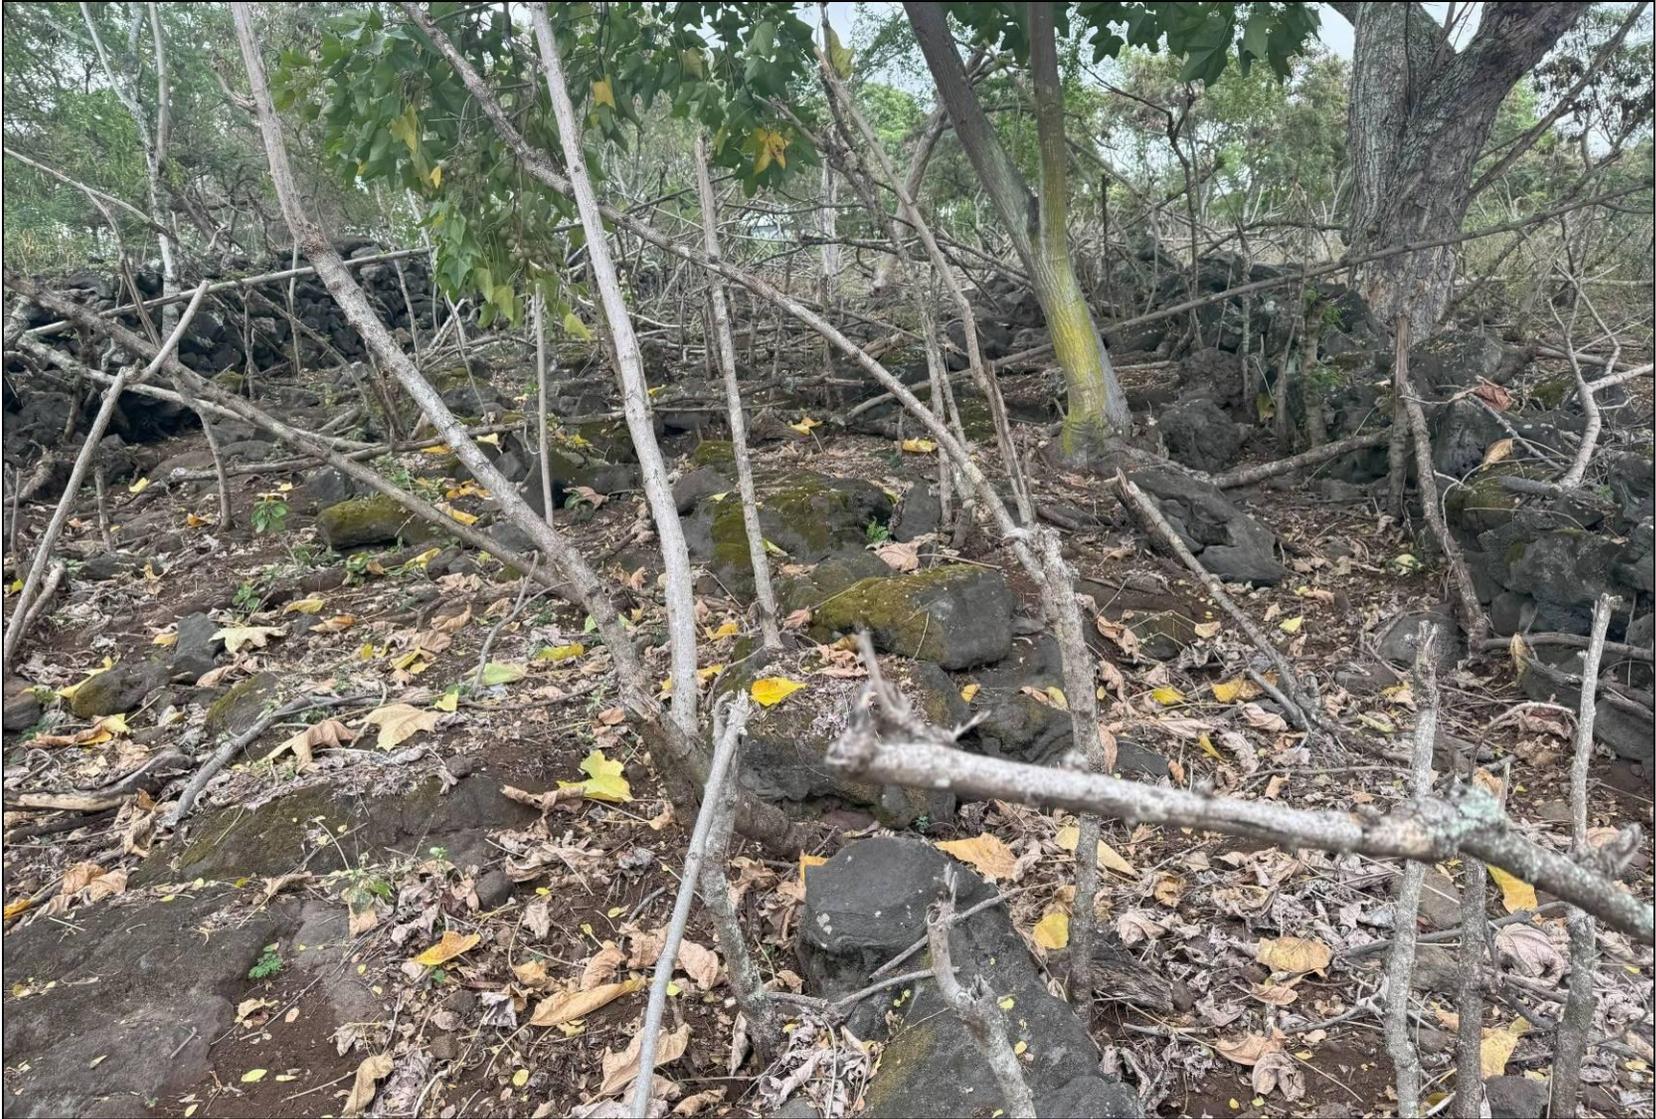
**Figure 27: Photograph of North Wall (Left), South Wall (Right), and Uneven Bedrock Outcrop Ground Surface Between Them, Looking East.**

The ground surface between the two walls slopes to the south and is made uneven in places by the presence of raised bedrock outcrops and boulders (Figure 27 and Figure 28). The ground surface north of the north wall and south of the south wall is even soil on either side of the uneven bedrock surface between the two walls (see Figure 25 south wall photograph). The early 1970s plat map shows a waterline along the south side of the south wall (see Figure 21). There is also a roughly L-shape enclosure (Site 30603) constructed along the south side of the south wall (see Figure 21 and Figure 22, and Figure 29 and Figure 30). A roughly 35.0 m segment of the Site 30595 rock wall forms the north boundary of the enclosure. The enclosure walls are constructed in the same manner as the south wall, of stacked angular and subangular basalt cobbles and small boulders and are bi-faced and cobble core filled. Based on the enclosure construction, size, level soil interior and the 1970s plat map depiction of the water line, it is possible that the enclosure interior was the location of redwood or metal water tanks between springs further *mauka* and cattle water troughs further *makai* (see oral interviews below).

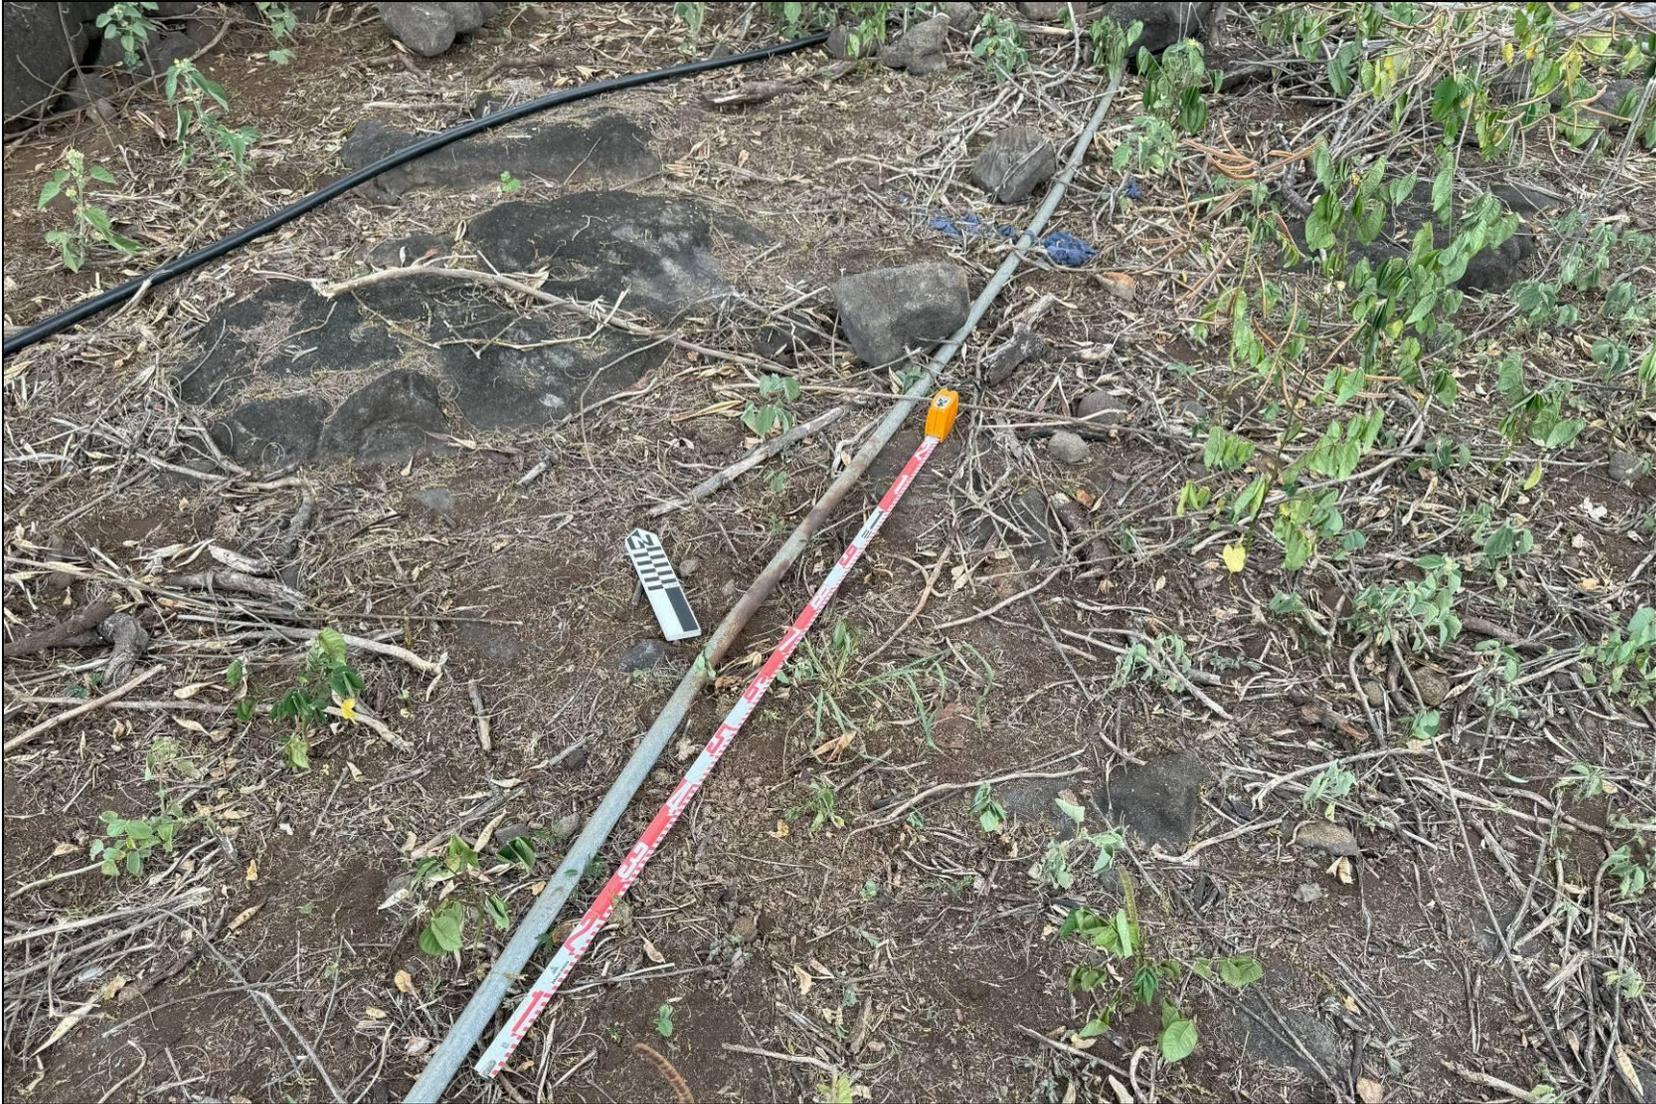
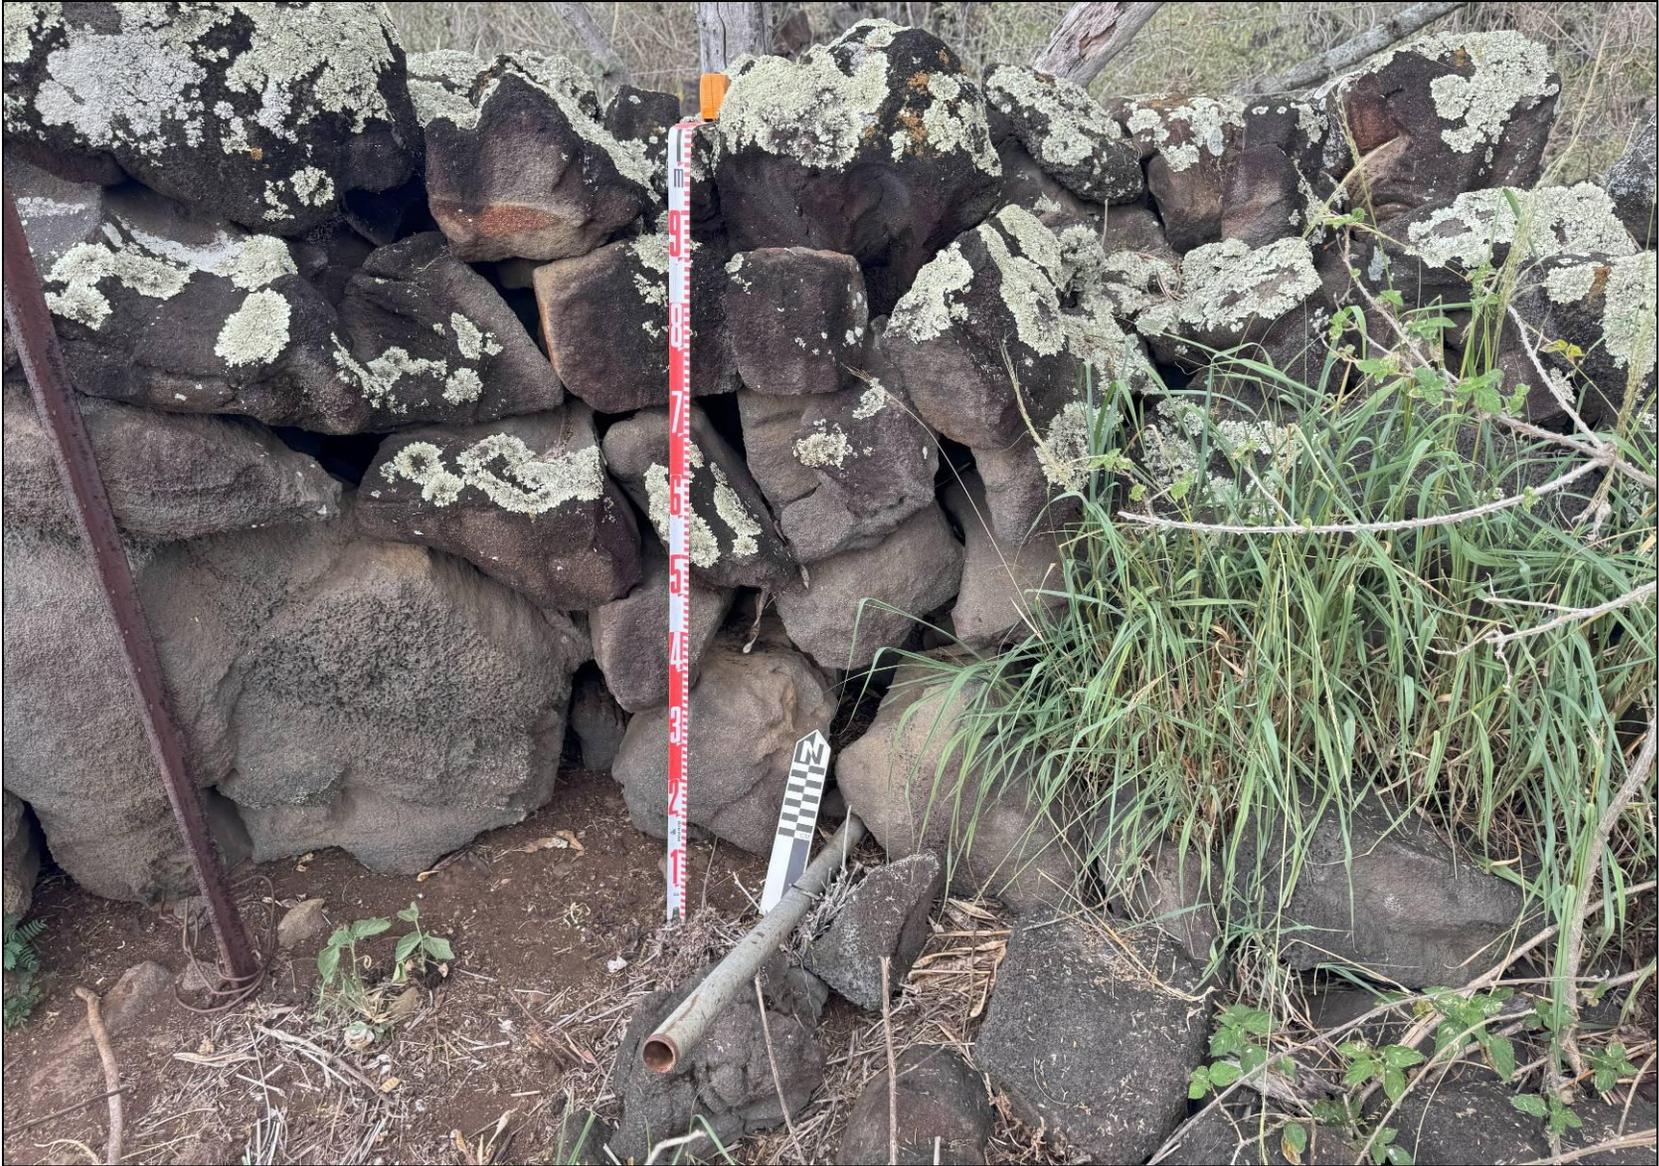
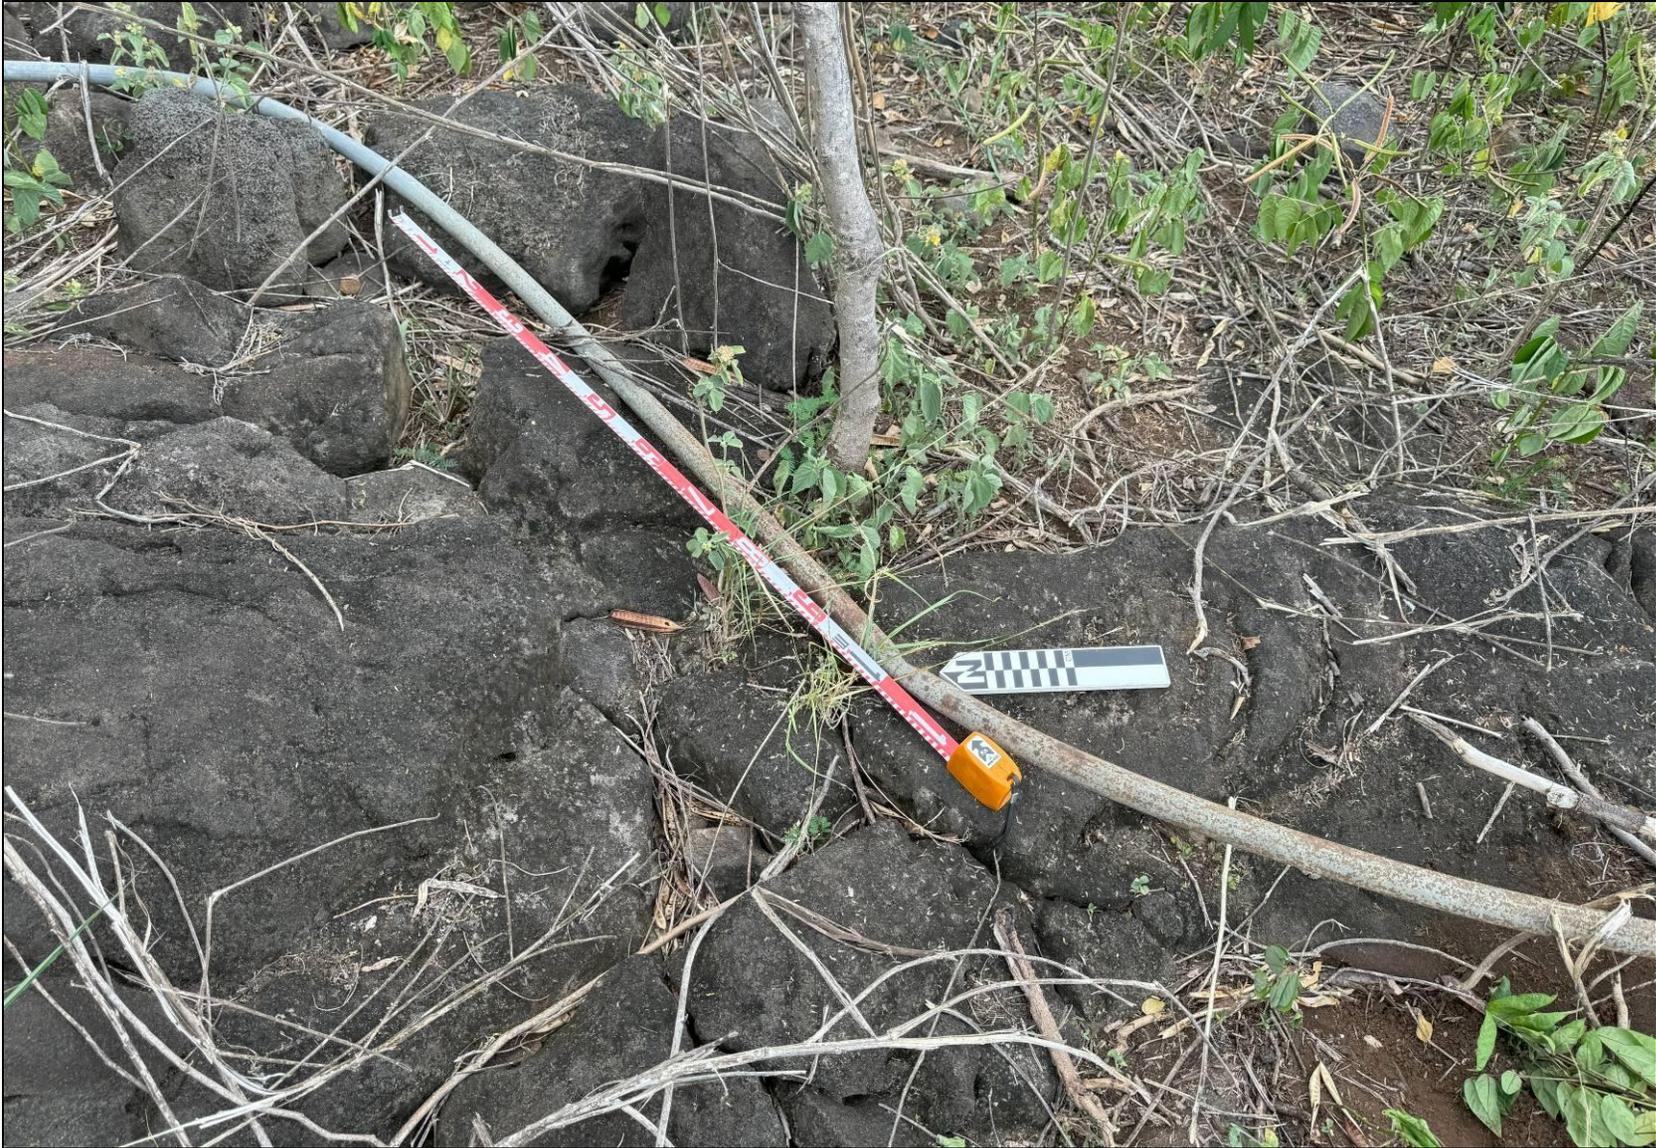
A north-south ranch road branches off of the *mauka-makai* ranch road at an enclosure about midway down the project area. The north-south ranch road crosses the gulch at the north end of modern day Kekuanaoa Place. The waterline is no longer present on the ground surface between the L-shape enclosure (Site 30603) and the middle enclosure. Two sections of one inch galvanized iron water pipe and a roll of two inch black PVC water pipe were identified along the south wall at the mid-elevation enclosure (Figure 33). It appears that the metal pipe was removed when the newer PVC pipe was installed. The PVC pipe was removed from above the mid-elevation enclosure and was rolled up and stored at the enclosure. The PVC pipe is still present along the south side of the south wall from the mid-elevation enclosure to the Gouveia enclosure and several sections of bent galvanized metal pipe were also identified on the ground between the two enclosures (Figures 34 through 36).

**Figure 34: Photograph of Galvanized Iron Water Pipe and Black PVC Pipe along South Wall Near Gouveia Enclosure, Looking Northeast.**

**Figure 35: Photograph of Galvanized Iron Water Pipe along South Wall Near Gouveia Enclosure, Looking North.**

**Figure 36: Photograph of Galvanized Iron Water Pipe Near South Wall Next to Gouveia Enclosure, Looking East.**
