**ARCHAEOLOGICAL INSPECTION, ARCHIVAL AND MAP RESEARCH,  
AND ORAL INTERVIEWS OF HISTORIC HŌLUALOA HUI  
ACCESS EASEMENTS MAUKA (EAST) OF THE ROYAL VISTAS  
PROJECT AREA, HŌLUALOA 1<sup>ST</sup> AHUPUA‘A,  
NORTH KONA DISTRICT, HAWAI‘I ISLAND, HAWAI‘I  
[TMK: (3) 7-6]**

**Glenn G. Escott, M.A.  
&  
Suzan Escott, B.A.**

**2024  
FINAL**

**SCIENTIFIC CONSULTANT SERVICES Inc.**

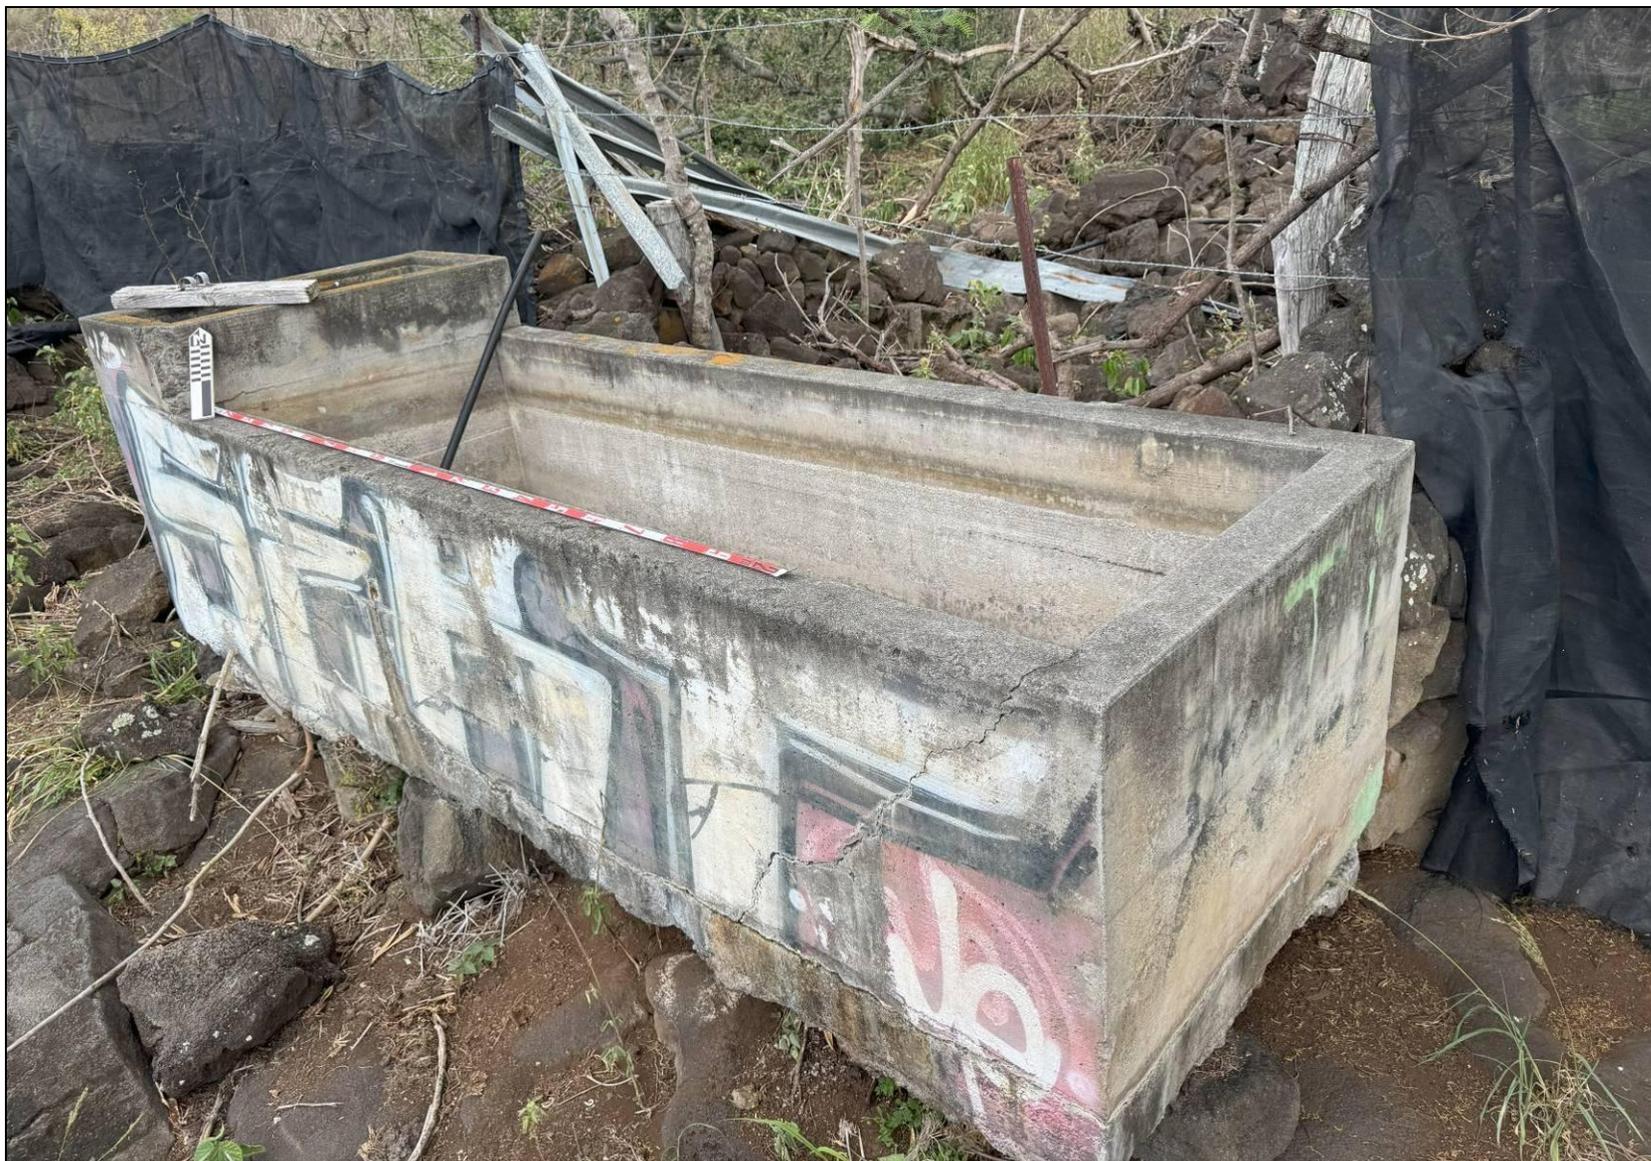
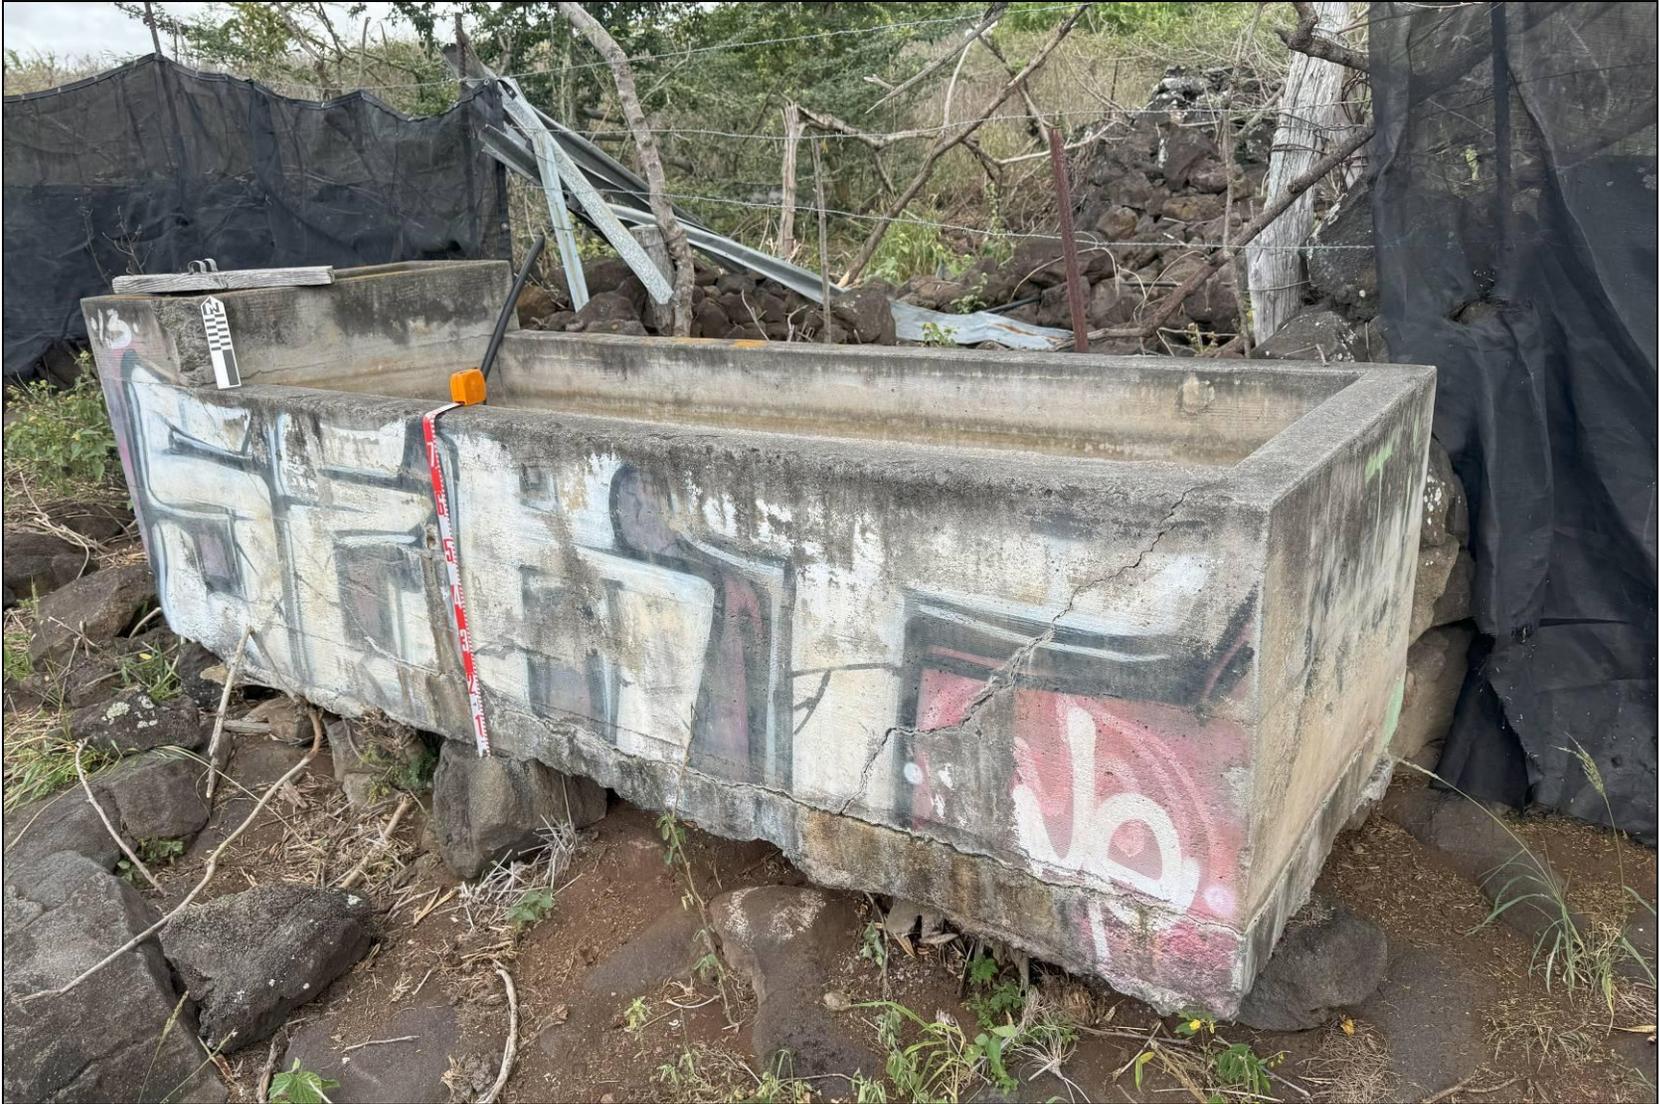
A concrete water trough, black PVC water pipe, a section of 1 ¼ inch galvanized iron water pipe, and a Stockham galvanized iron globe valve were identified within the northeast quadrant of the Gouveia enclosure (Figures 37 through 39). Stockham Valves & Fittings Inc., originally Stockham Pipe & Fittings Company, was a manufacturer of cast iron products, predominantly large valves and pipe fittings founded in 1903 in Birmingham, Alabama ([https://bhamwiki.com/w/Stockham\\_Valves\\_%26\\_Fittings](https://bhamwiki.com/w/Stockham_Valves_%26_Fittings)). Stockham products are still manufactured today by the Crane Company of Stamford, Connecticut. Based on the basket handle on top of the globe valve, it is not of more recent manufacture, as newer models have a flat handle.

**Figure 37: Photograph of Concrete Water Trough Within the Gouveia Enclosure, Looking North.**

**Figure 38: Photograph of Concrete Water Trough Within the Gouveia Enclosure, Looking Northeast.**

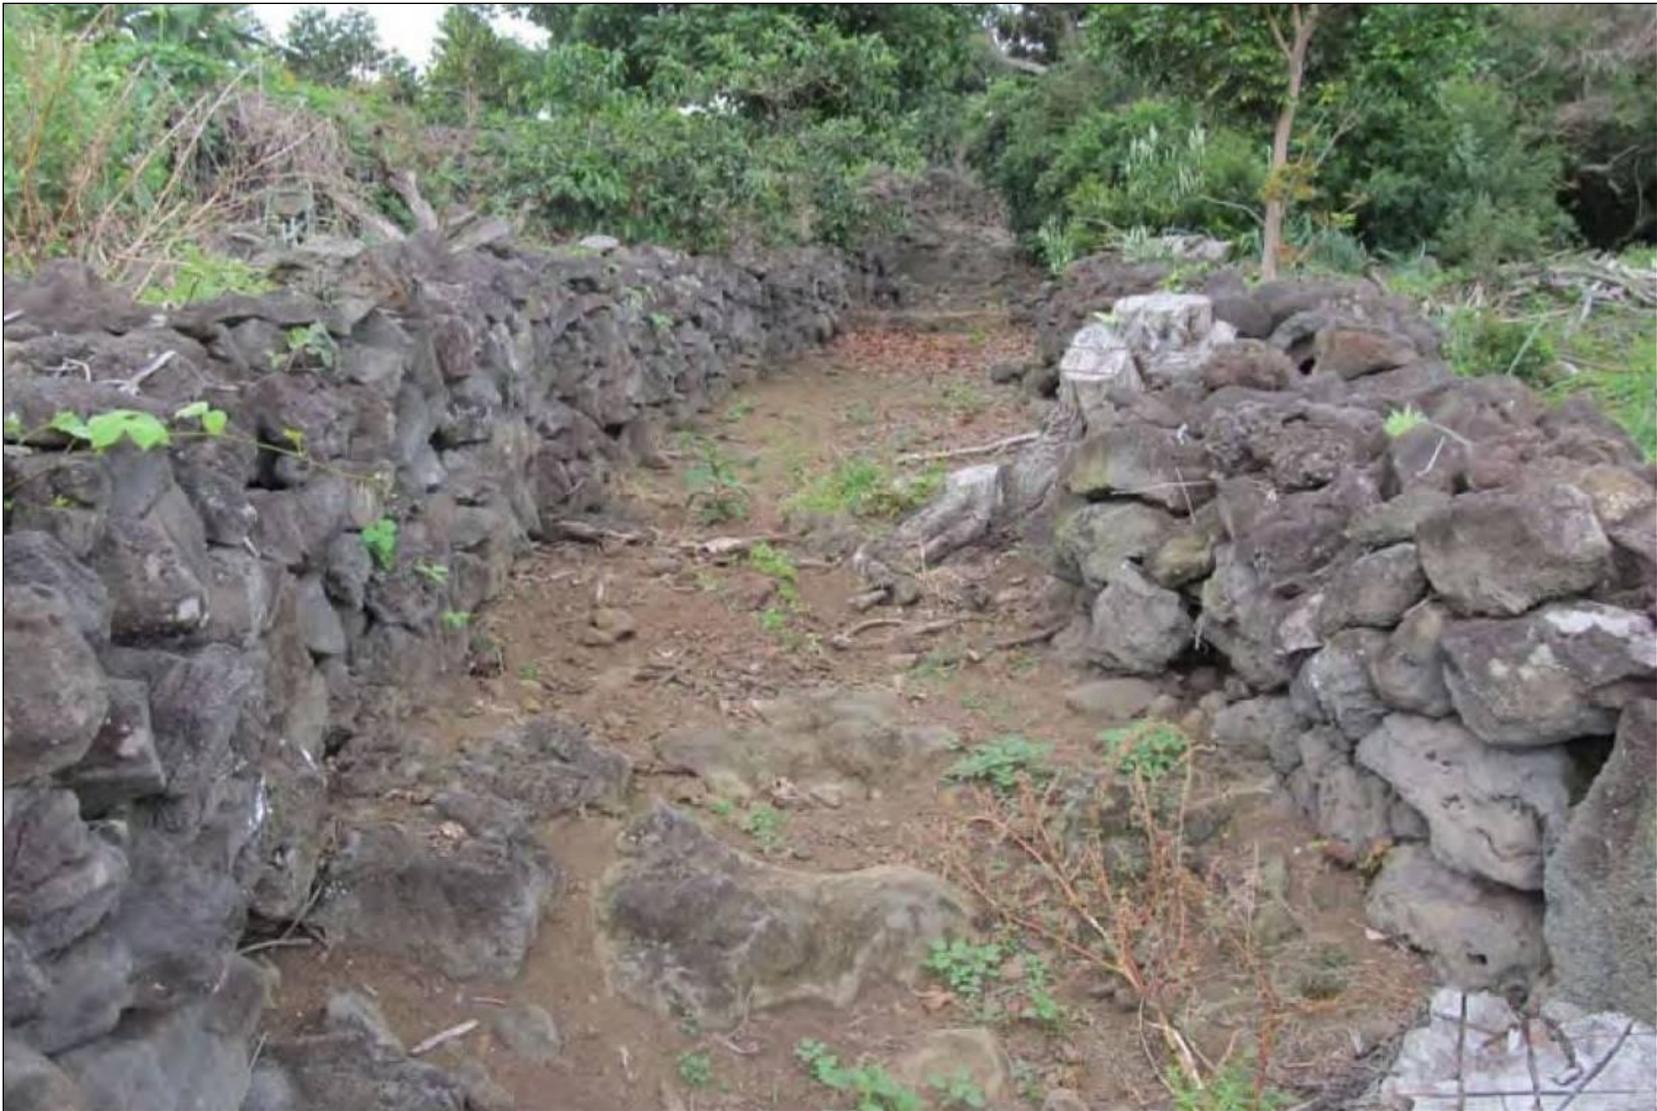
**Figure 40: Photograph of Site 24211 Historic Road and Rock Walls, Showing Trail Ground Surface, Looking East (Rechtman 2013:24).**

Between 1887 and 1914, a series of roads were constructed to provide grantees access to their lands. A historic road, coterminous with the current study area, appears on the first surveyed map of the Hōlualoa grant allotments. This road is also present on maps later drafted in 1928, 1955, and 1957. The 1950s maps, in particular, show stone walls on either side of the road for most of its length.

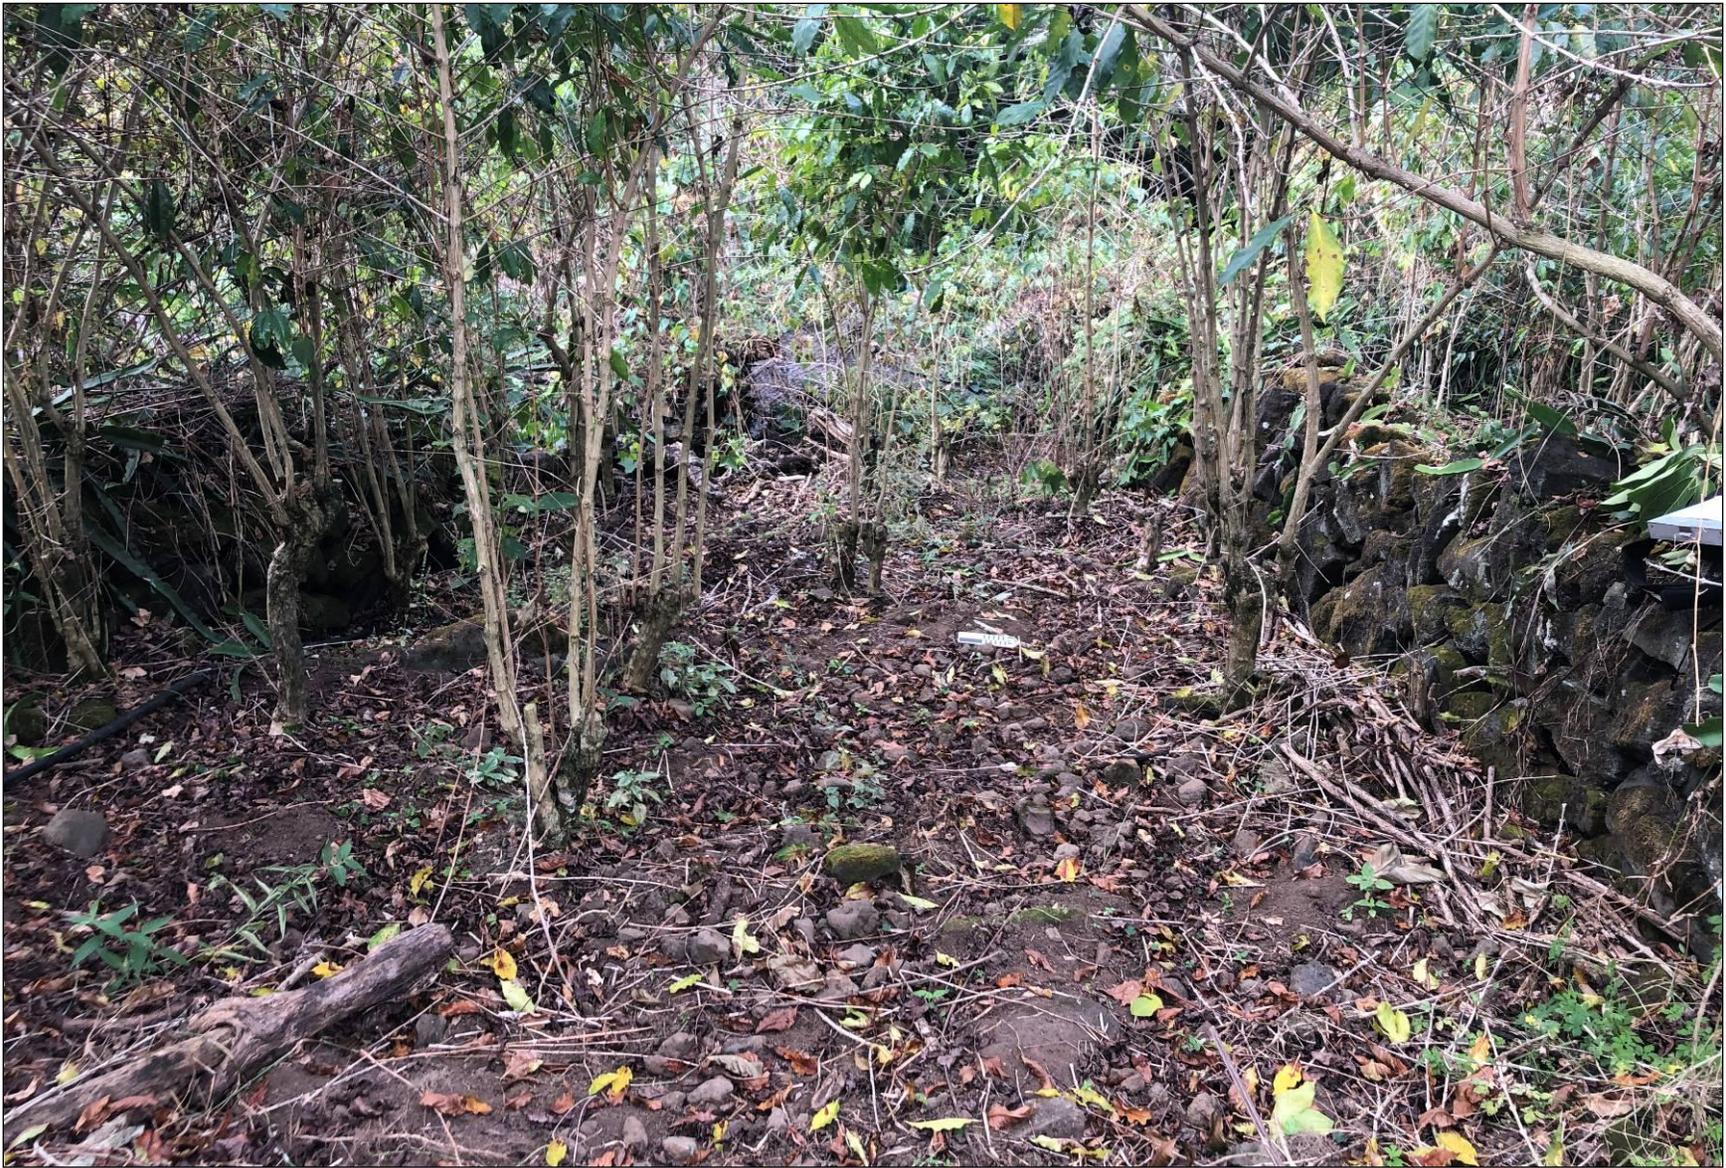
**Figure 41: Photograph of Site 24211 Historic Road and Rock Walls Immediately East of Hualālai Road, Looking West.**

The western terminus of Way #5, where it meets Hualālai Road, was inspected (see Figure 4). The trail corridor at this location is 14 ft (4.32 m) wide and consists of dirt with loose scattered cobbles (Figure 41). There are rock walls on either side of the trail corridor. The walls are 0.70 m thick and are 0.85 m high. The walls are constructed of angular and subangular large cobbles and small boulders stacked five to six courses high. The walls are bi-faced and slope slightly inward toward their tops.

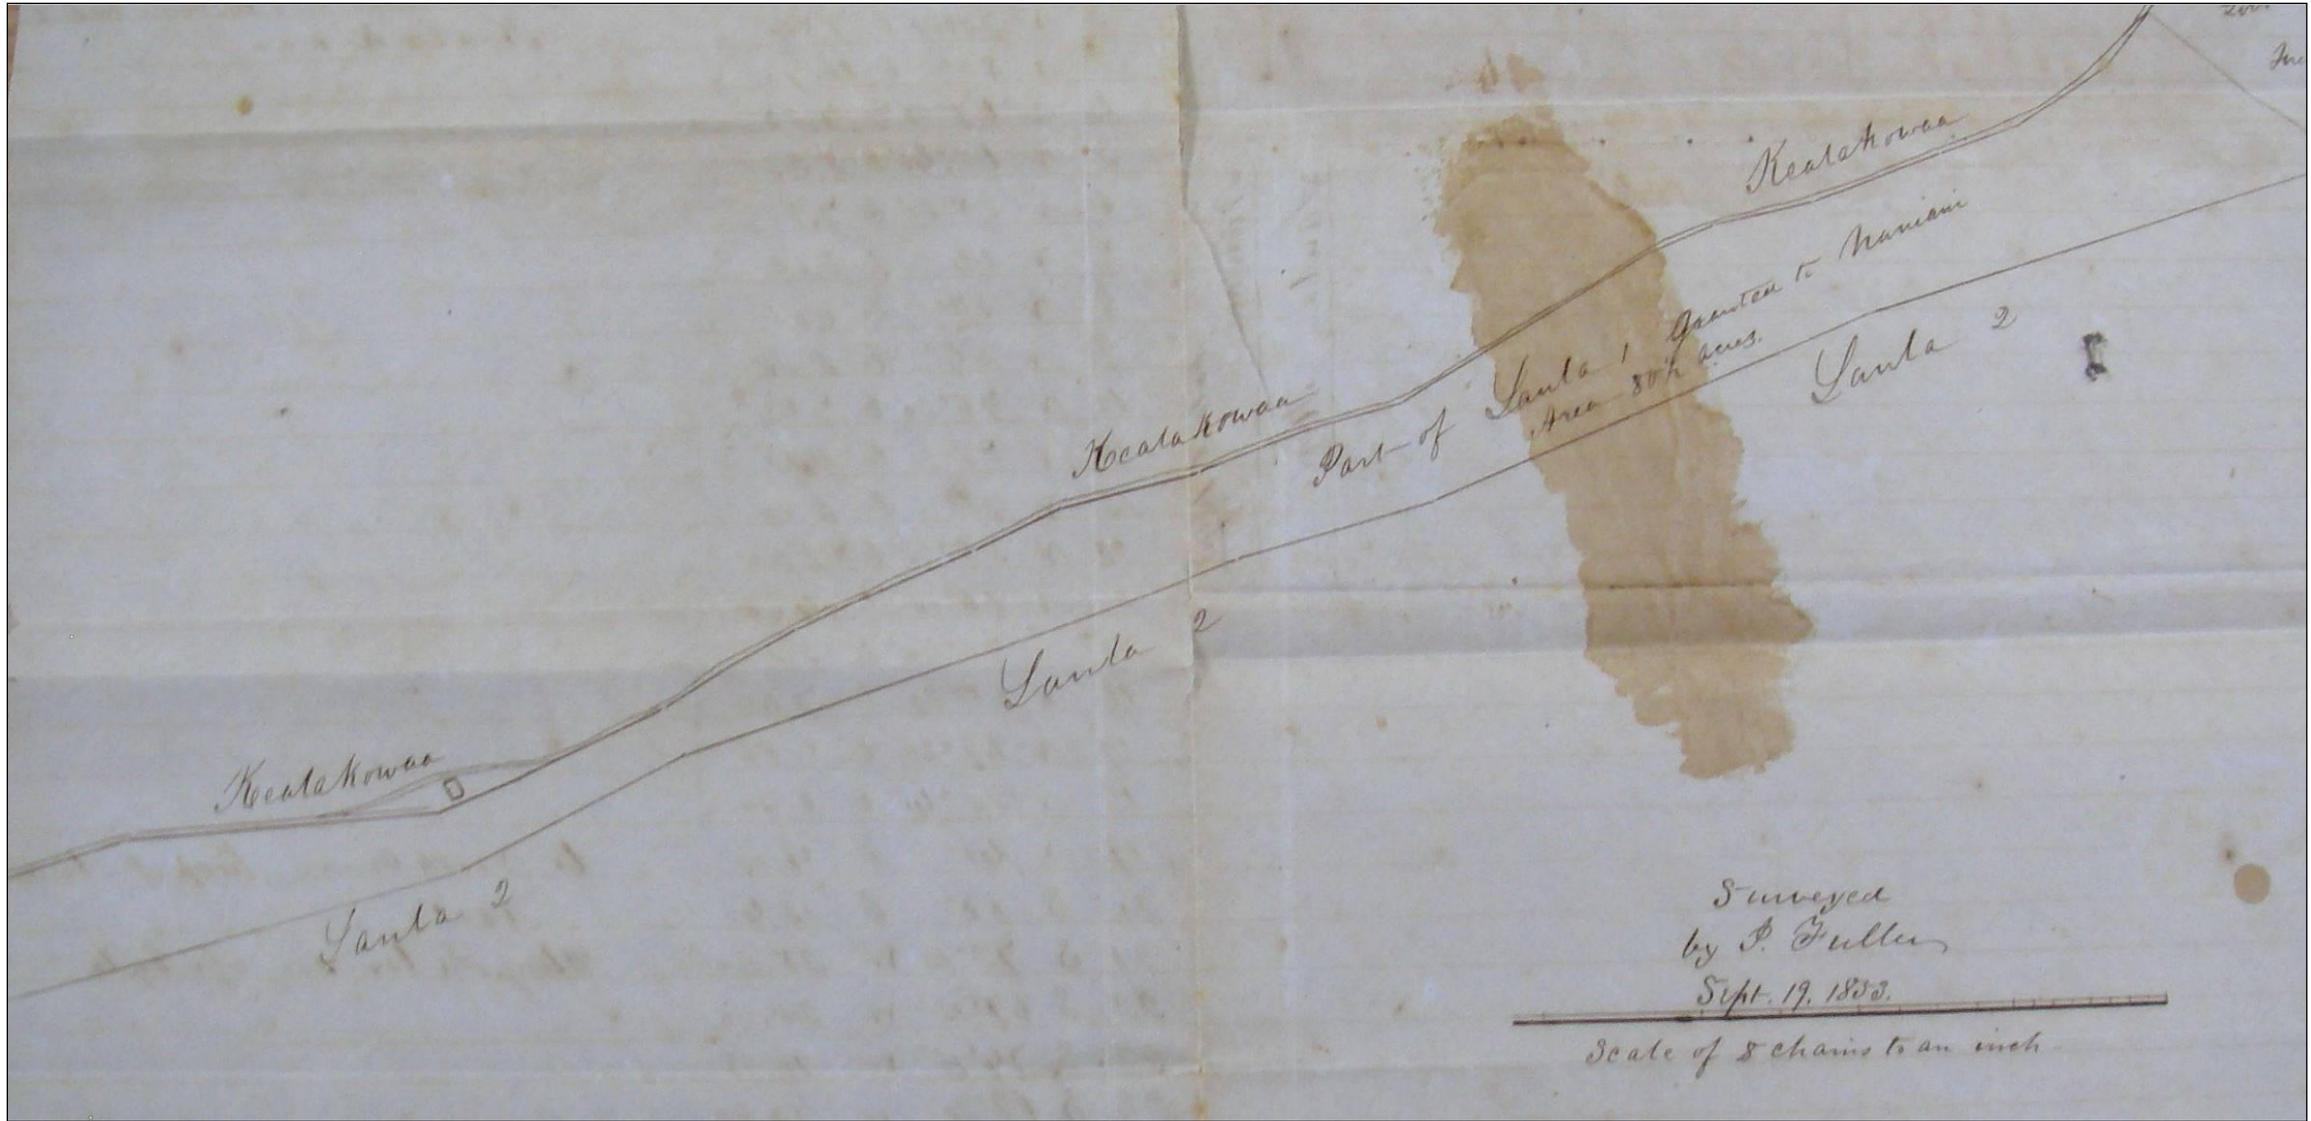
A Part of the Pi (Aula) granted to Maniani situated  
in the District of North Kona Island of Hawaii and bounded  
as follows: Beginning at a heap of stones at S.W. Corner on  
the Manka road leading through North Kona and running  
1 N 3° 30' E 6.56 chains along said road to N.W. Corner <sup>stones</sup>  
2 N 73° 30' E 7.84 " " Keala Kowaa  
3 N 83° E 16.70

Figure 45: Portion of Land Grant 1593 Property Boundaries Description, Referencing Kealakowa'a Trail along the North Boundary.

The boundary description for Land Grant 1593 (Figure 44), sold to Naniani in 1855, describes the north boundary of the property running along Kealakowa‘a (Figure 45), and the survey map shows a trail/road labeled Kealakowa‘a along the north boundary (Figure 46). The boundary description and survey map for Land Grant 1592, adjacent to and west of LG 1593, shows the Kealakowa‘a trail but it is labeled Road to the Sea (Figure 47).

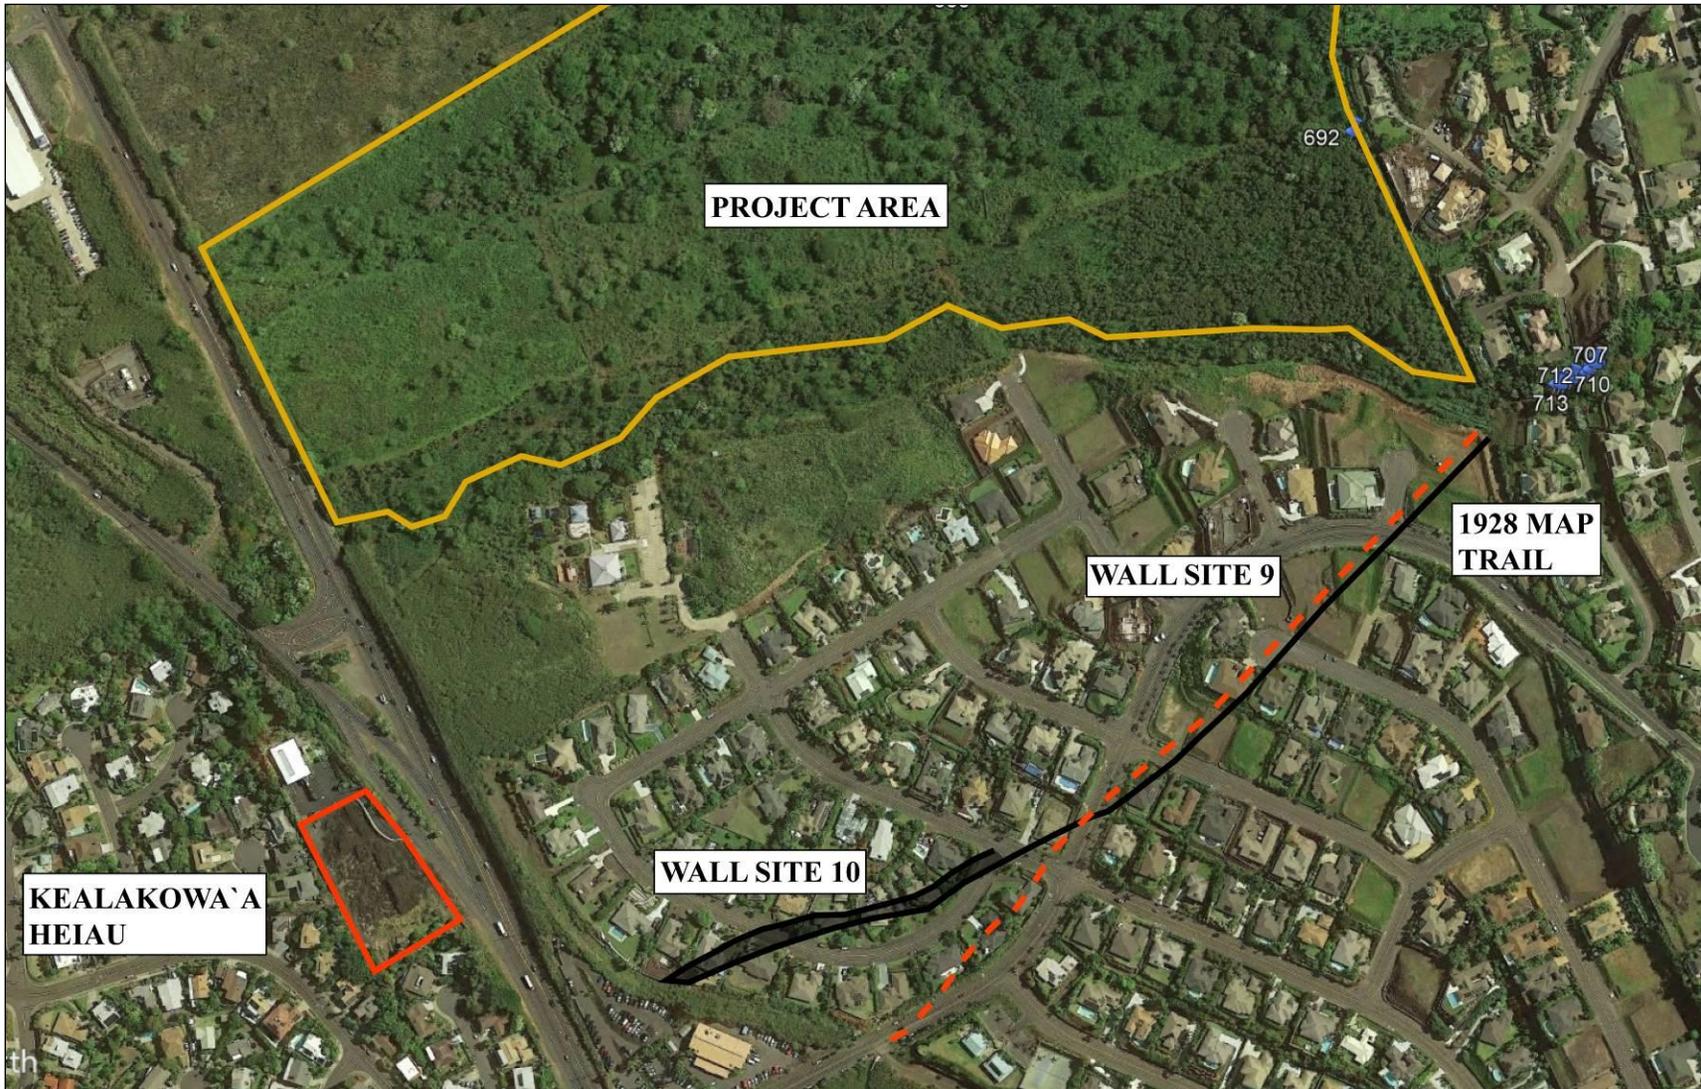
**Figure 50: Aerial Photograph Showing the Royal Vistas Project Area (Orange), Way #8 Wall Segment GPS Points (Blue Numbered Pins), Wall Site 9, Wall Site 10, and Kealakowa'a Heiau.**

The rock wall segment identified and GPS plotted along the north bank of the gulch is along a portion of the northern boundary of LG 3630 depicted on the 1914 Hui Partition map (see Figure 3) and the 1928 Strip Map (Figure 48). The Cultural Surveys Hawai'i (CSH) AIS (Hammatt et al. 1992) project area sites map for the Kona Vistas project area shows the rock wall, labeled Wall Site 9 (Figure 49). There is a second wall, Wall Site 10, just west of Wall Site 9 above the old Kailua-Keauhou Road. The map shows a double walled bulldozed road there. The road is a little north of where the 1928 map shows the trail alignment. However, the Wall Site 9 and Wall Site 10 location matches Henry Kekahuna's descriptive notes that the Kealakowa'a passed about 100 feet south of the *heiau* (Figure 50).

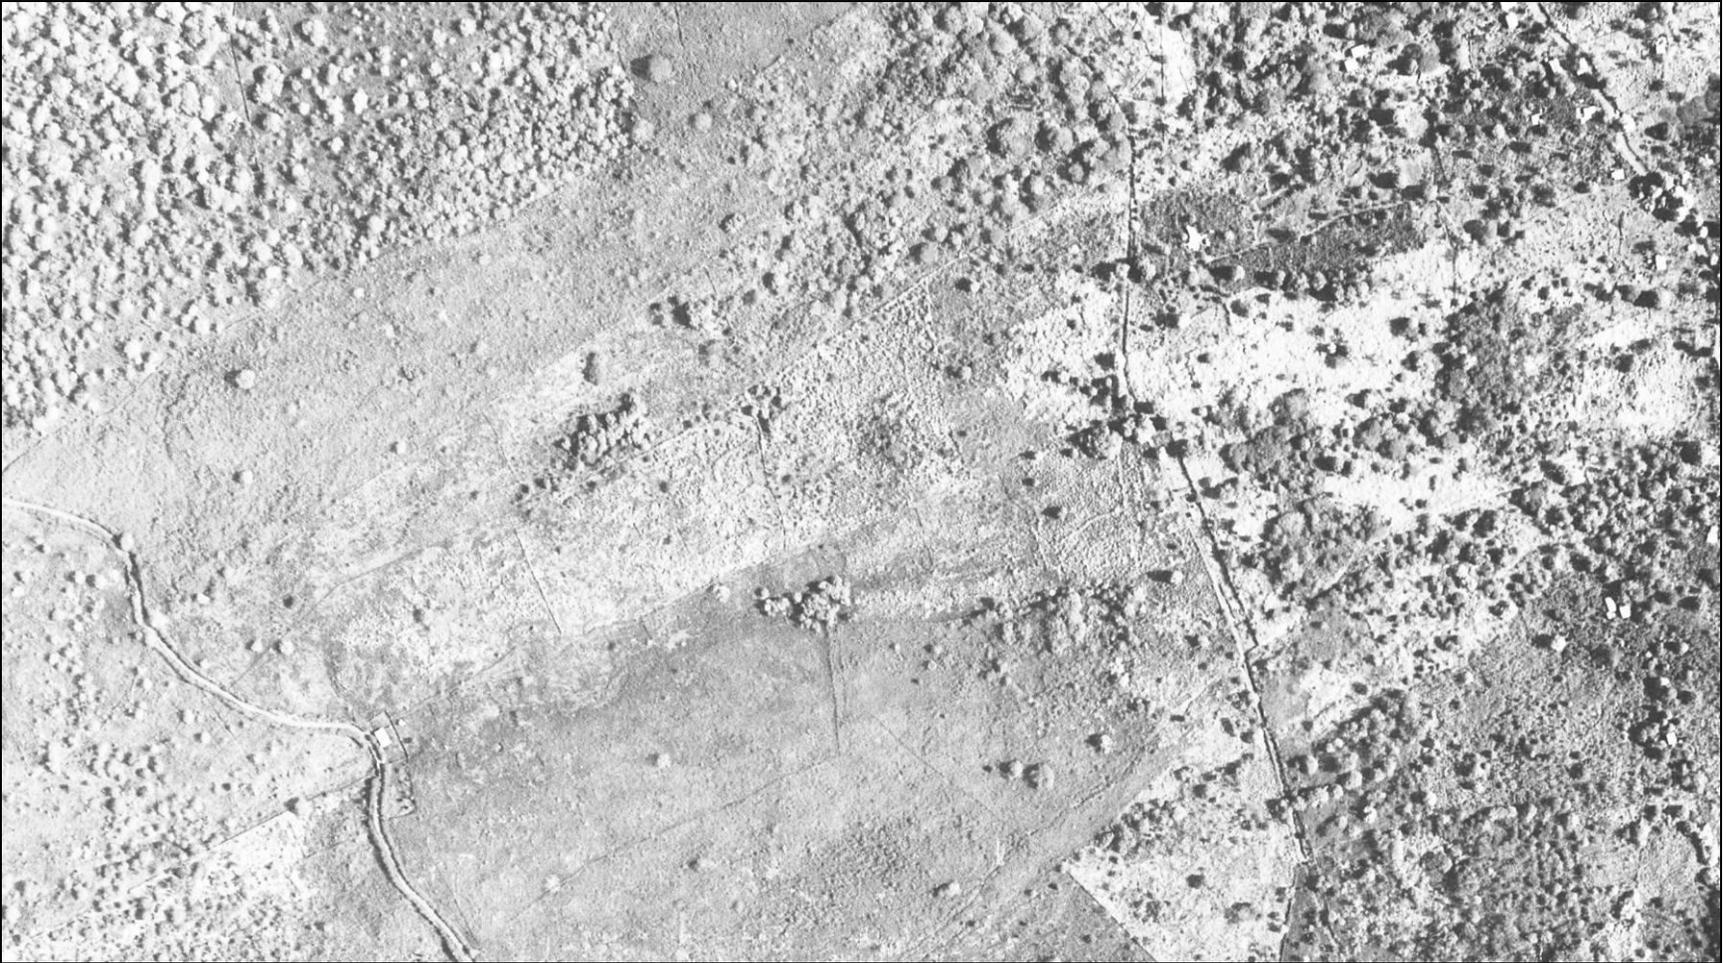
**Figure 52: 1950 Aerial Photograph Showing Project Area Lands and Man-Made Features.**

Minoru also worked at the sisal mill in Kailua after he graduated school. When he worked at the sisal mill, he would “get up, 3:00 o’clock in the morning, get on a donkey from Hōlualoa, go all the way to Keopu (along the road), and go down the trail [Figure 52]. You see the sisal mill used to be on Palani Road” c. It took him three hours to get to the sisal mill for work.

Based on oral interviews of longtime residents, Historic era to modern *mauka-makai* travel was primarily along government roads and not on trails across private property. A study of three high resolution aerial photographs of the Hōlualoa area dated 1950, 1958, and 1972 do not show trails crossing the project area (Figure 52 through Figure 54). They do show rock walls, cattle chutes, corrals, pens, and government roads. The only visible trail in all three aerial photography is the Kealakowa‘a Trail south of the project area.

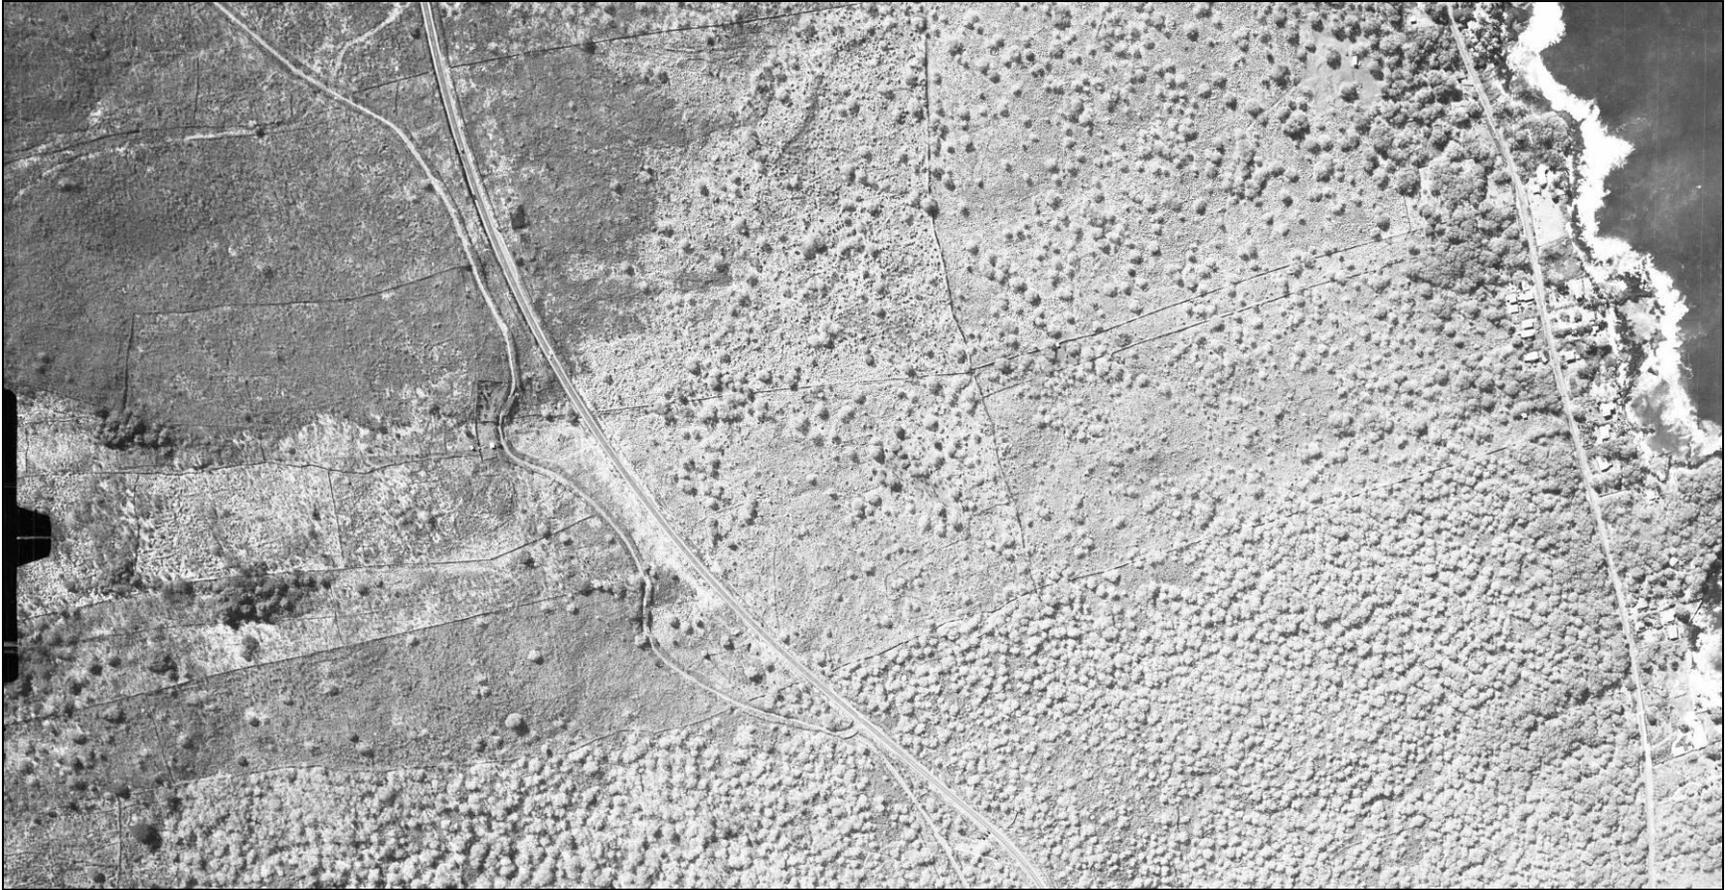
**Figure 53: 1958 Aerial Photograph Showing Project Area Lands and Man-Made Features.**

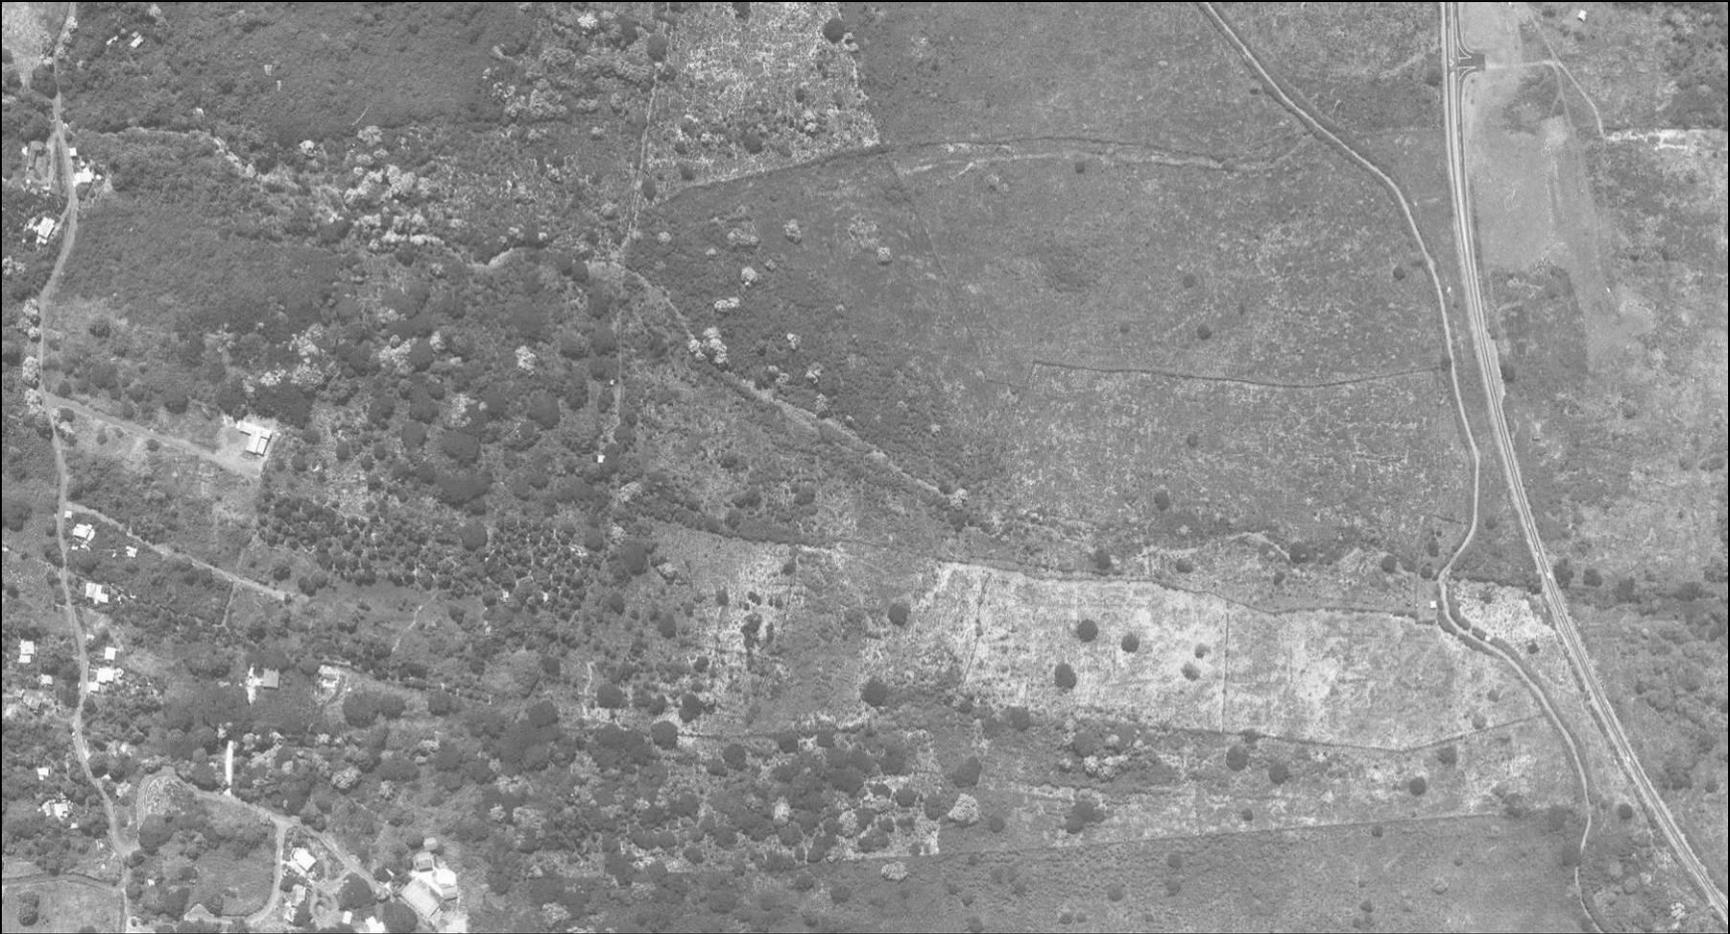
**Figure 54: 1972 Aerial Photograph Showing Project Area Lands and Man-Made Features.**
