Reconnaissance Level Survey for the Royal Kunia II Development Project

AHUPUA'A OF HŌ'AE'AE, 'EWA DISTRICT, ISLAND OF O'AHU
CITY AND COUNTY OF HONOLULU TAX MAP KEY PARCELS
(1) 9-4-002:070, (1) 9-4-002:071, AND (1) 9-4-002:078

REVISED DRAFT

SWCA Project No. 80814
SWCA Cultural Resources Report No. 23-570

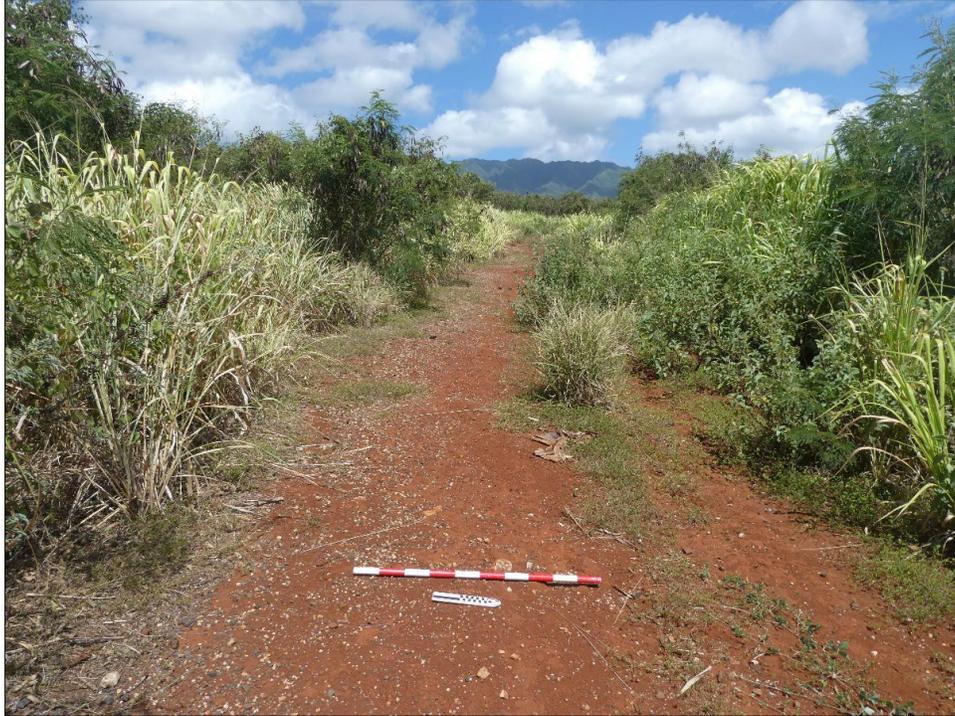
Figure 5. Vegetation alongside a dirt road within the project area; view to the west.

The natural vegetation and topography within the project area have been heavily altered by at least 100 years of intensive sugar cane agriculture. The vegetation observed within the project area is comprised of invasive species, including small groves of koa haole (*Leucaena leucocephala*), dense stands of California grass (*Brachiaria mutica*), and vines such as *Passiflora foetida* and *Neonotonia wightii* (Figure 5 and Figure 6).

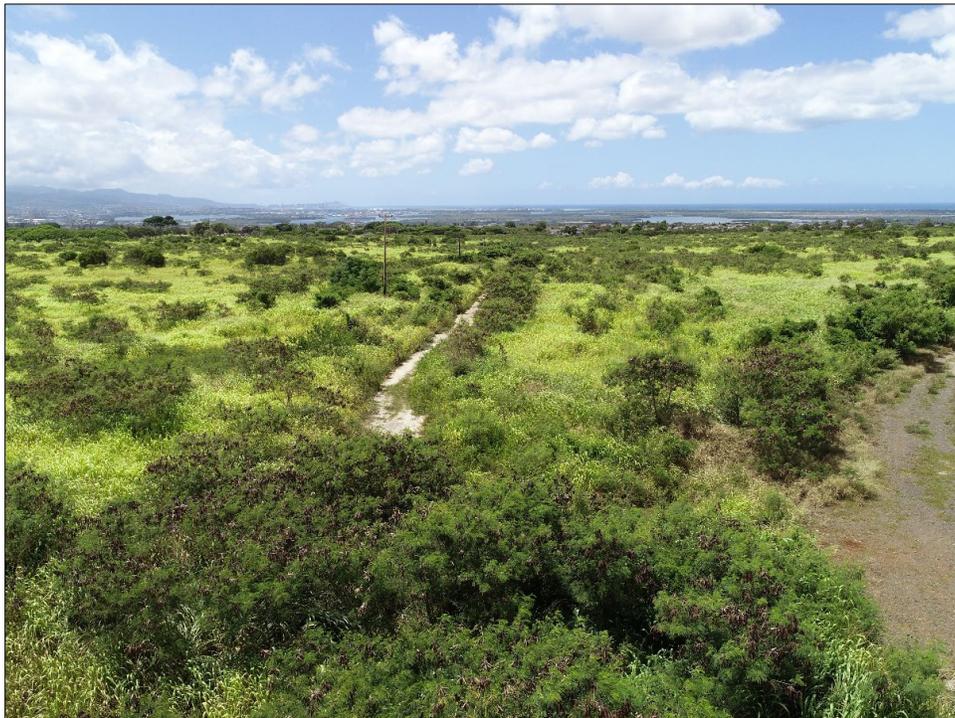
Figure 6. Overview of the project area showing density of vegetation; view to the south.

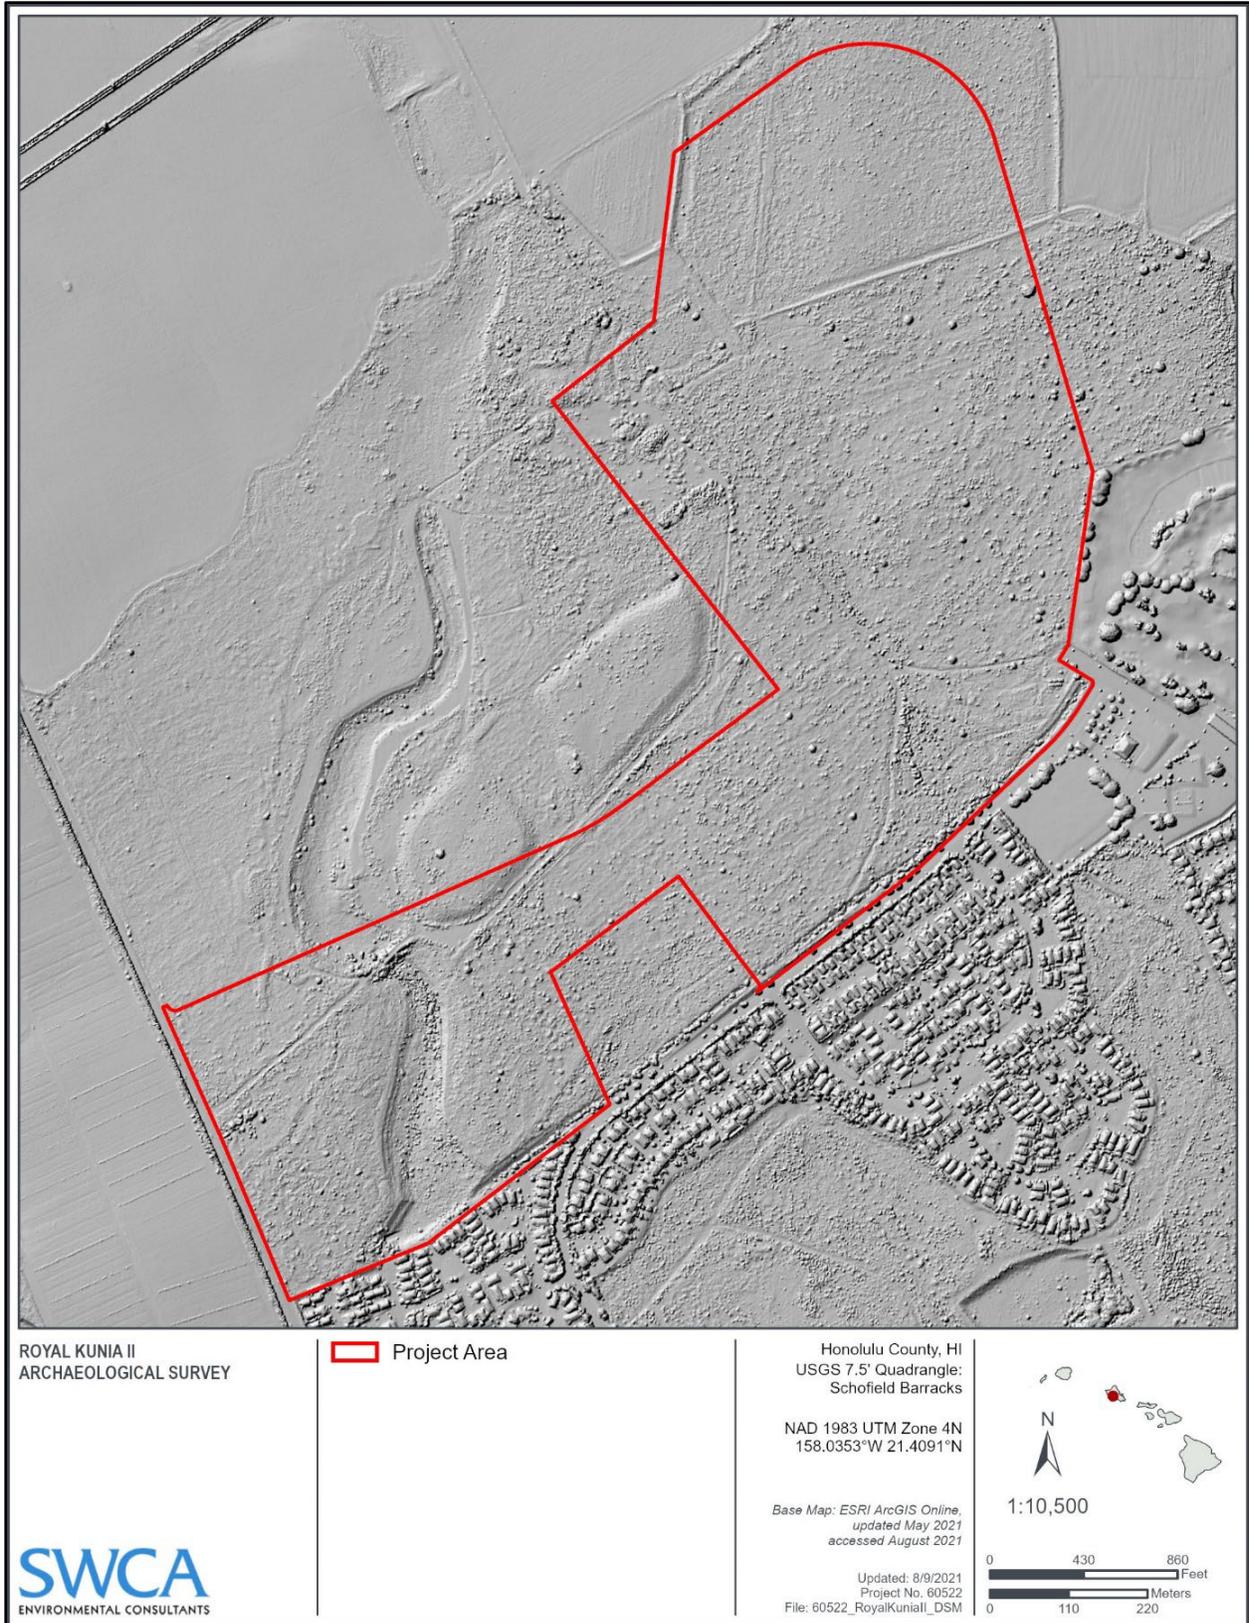
Figure 15. DSM of the project area (data from the Hawai'i Statewide GIS Program), from Gerrish et al. (2021:52).

During the Gerrish et al. (2021) study, a detailed orthomosaic image of the entire project area was created using images taken by a UAV (Figure 14). The UAV flew predetermined transects at an elevation of 150 feet to create a georeferenced orthomosaic with a resolution of 0.5 inch. The Gerrish et al. (2021) study also used a DSM image created using publicly available LiDAR, to identify potential surface features beneath the vegetation cover. The DSM layer clearly shows the course of roads and irrigation ditches dating from the plantation era (Figure 15).

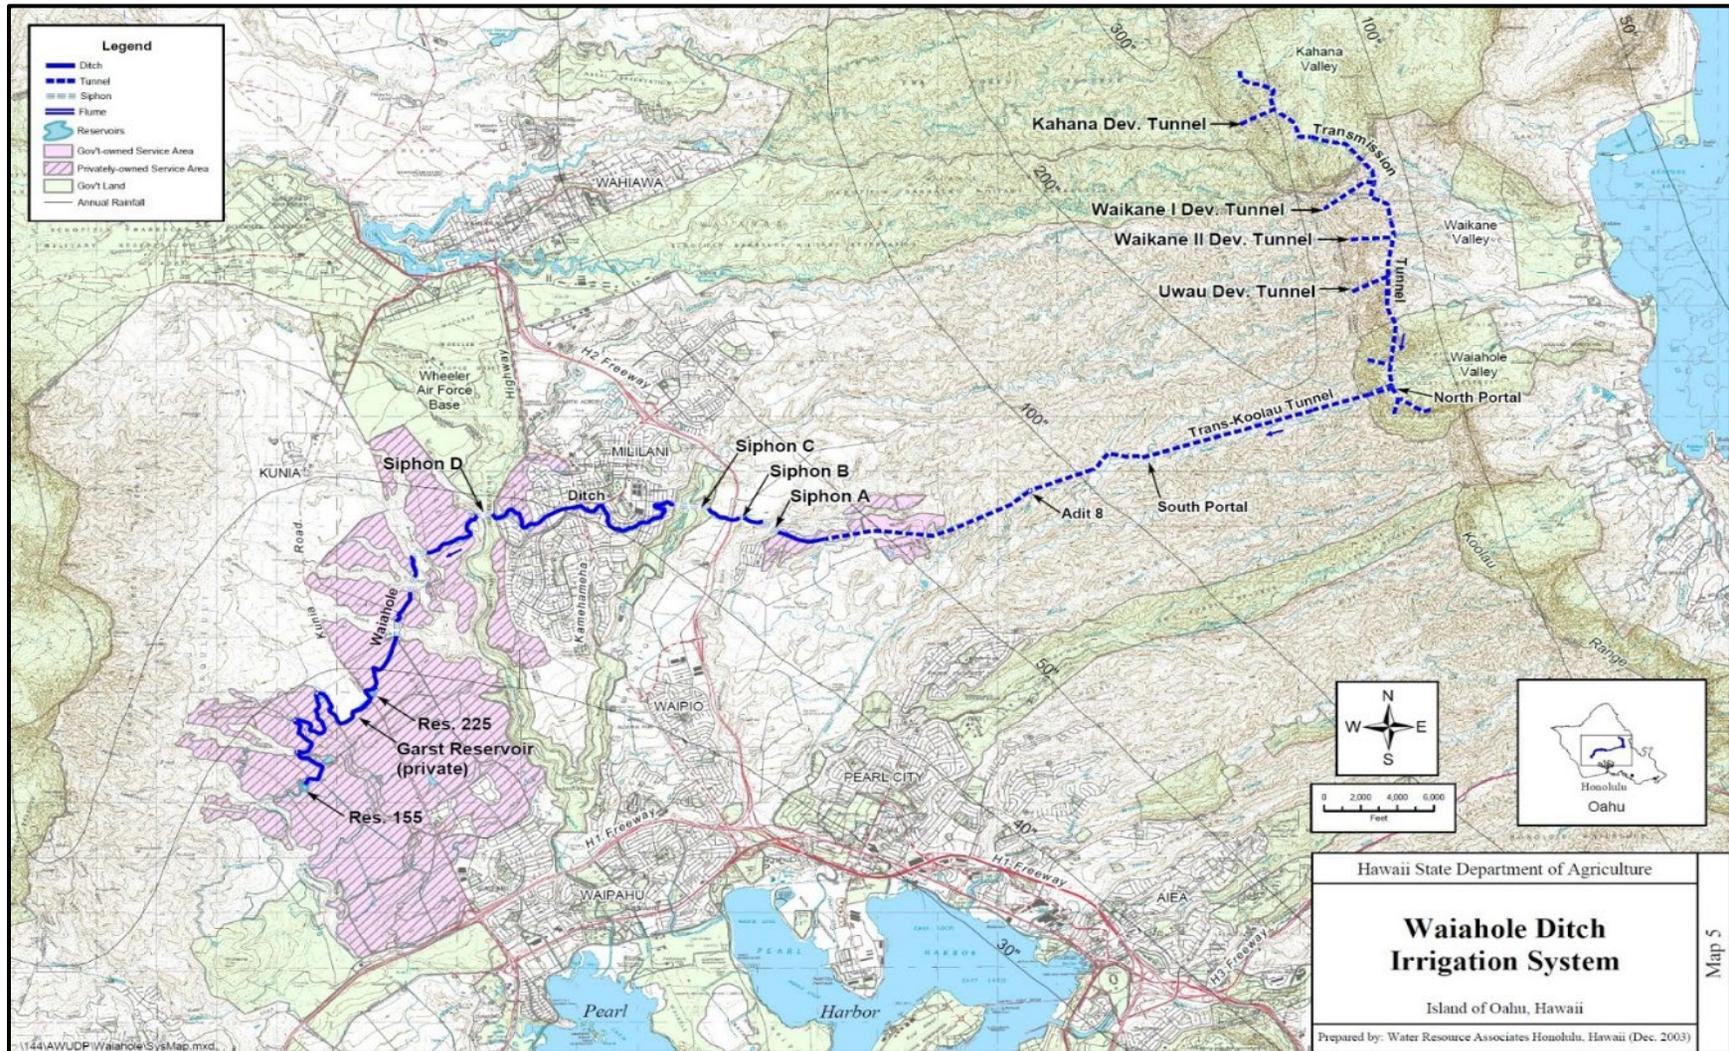
Figure 16. Waiāhole Ditch Irrigation System depicted on Hawai'i State Department of Agriculture (2003) map. The ditches identified within the project area are located south of the blue ditches depicted on this map.

As the irrigation features located within the current project area appear to be ancillary elements associated with the Waiāhole Ditch Irrigation System, they were assigned to SIHP Site 50-80-09-02268 as Features RK1 and RK2 (Goodman and Nees 1991; Gerrish et al. 2021). As discussed in Section 2.2.1, the lands cultivated by the Oahu Sugar Company were irrigated by a combination of artesian wells and water carried from the Waiāhole Ditch, which drew water from windward O‘ahu and channeled it through the Trans-Ko‘olau tunnel to the ‘Ewa plain (Figure 16). From there, the water was channeled through ditches to a series of reservoirs at the foothills of the Wai‘anae Range. The water from these reservoirs was then carried by smaller irrigation ditches to feed the lands planted in sugar cane. Those areas crosshatched in pink in Figure 16 indicate the extent of the lands irrigated by the ancillary ditch network, which includes the project area.

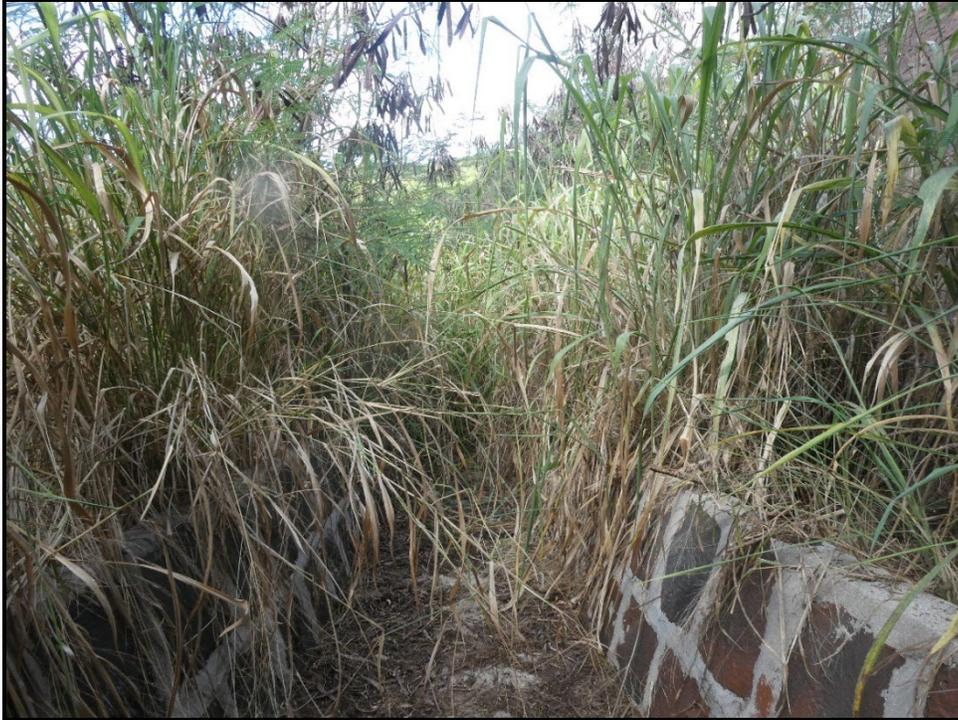
Figure 17. Abandoned ditch segment obscured by dense vegetation.

Different types of concrete were observed in the ditch segments within the project area. Some contained aggregate, while others appeared to be more modern mortar mixes. This appears to indicate maintenance and repair over a long period as concrete mixes improved through the twentieth century. Overall, the ditch segments are in good condition, having fallen into disuse recently in the mid-1990s.

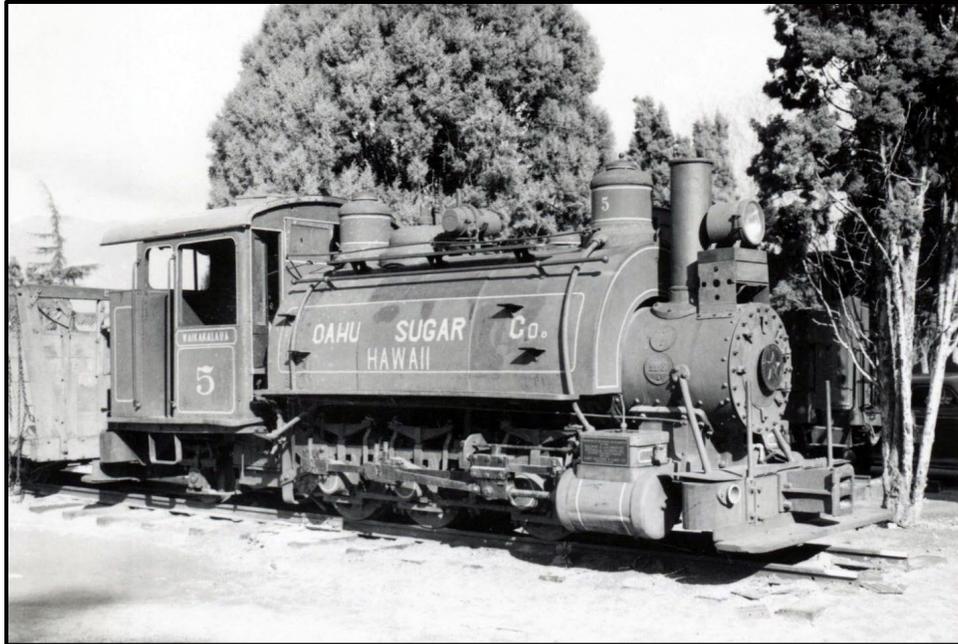
Figure 19. Oahu Sugar Company narrow-gauge railway locomotive (Kalis 2017).

For much of its operation, the Oahu Sugar Company relied upon a narrow-gauge railway to transport cane from the fields to the mill (Figure 19). In 1939, the Oahu Sugar Company railway covered 60 miles of 3-foot-gauge track plus an unspecified amount of portable track. In total, 939 plantation cars (860 4-ton cane cars, 50 flat cars, and 29 other cars) were in operation. In the late 1950s, the railway system was removed, and the rail alignment was converted to use by large cane haul trucks (Kalis 2017).

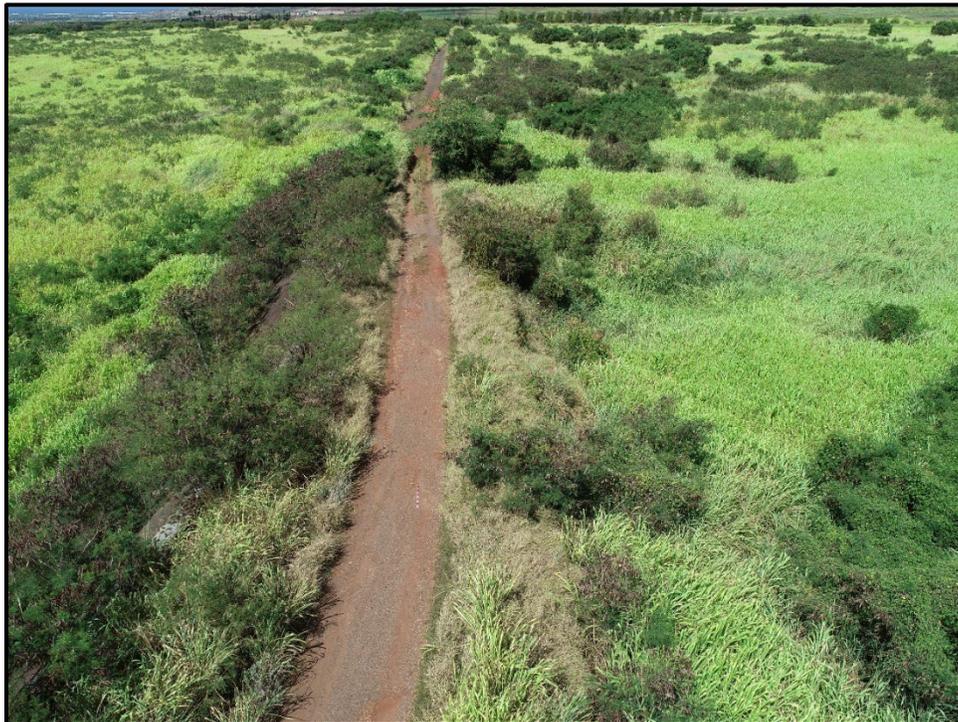
Figure 20. Railway alignment trending towards the terminus at Kunia Road, showing dam segment in foreground, view to the west.

At an unknown date (historic maps suggest sometime between 1943 and 1953), the rails, ballast, ties, and track were removed from the rail line segments within the project area. Since then, the former railway bed has primarily been used as a dirt cane haul road, though remnant, deteriorated sections of paving are still present. These surface segments are irregularly paved with more modern asphalt surfacing, compacted crushed coral aggregate and/or gravel, and macadam, indicating a long period of use, maintenance, and repair. There are no other improvements, such as shoulder, grading, drainage, or formal engineering (Figure 20 through Figure 22).

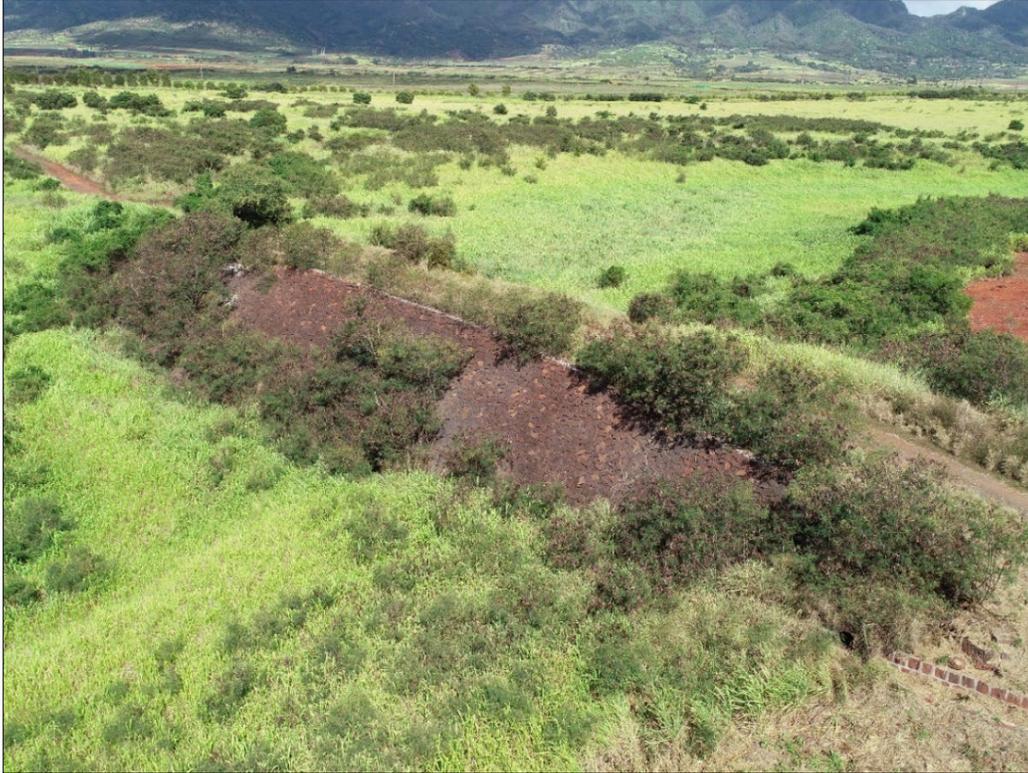
Figure 23. Aerial view of SIHP Site 50-80-08-07671 showing the dam with the former rail line crossing (Feature 4) and reservoir (SIHP Site 50-80-08-09385) in upper right of frame; view to the west.

Located in the western portion of the project area is an earth-filled and stone-faced dam (Feature 4 of SIHP Site 50-80-08-07671). The crest of the dam also supported the rail line, which has subsequently been converted to a road (see Section 3.3.2.1 above). Feature 4 extends approximately 230 feet in total length, blocking a shallow gully that runs from north to south through the project area. During the plantation era, the dam impounded a reservoir (SIHP Site 50-80-08-09385) on the northern side of the structure that was used as part of the plantation's irrigation system. The dam is slightly curved and is roughly 25 feet tall from the base to the crest. The length along the bottom width of the dam could not be determined because dense vegetation prevented measurement. The dam's width at its crest measures 22 feet. Both the north and south sides of the dam are faced with locally sourced, dry-laid stone (Figure 23). The dam crest features a low, dry stacked stone wall on the south side, topped by sharp stone fragments facing upward and set in concrete (Figure 24). The make-up of the core is unknown but appears to be earth fill (Figure 25). The other elements of the dam include a sluice gate which was controlled by a wheel-operated screw valve located at the base of the dam's downstream side (Figure 26). The valve connects to a pipe, which passes through the structure connecting to a pipe inlet on the north (reservoir-facing) side.

The railway alignment and dry-stacked rock dam (Feature 3 and Feature 4, respectively, of SIHP Site 50-80-08-07671) are not candidates for preservation, conservation, reconstruction, or rehabilitation as part of the residential development proposed for the project site. As noted in Table 4, architectural recordation is considered to be the most appropriate mitigation for the project’s effect on SIHP Site 50-80-08-07671. Plans for the mitigation measures are described in further detail below.

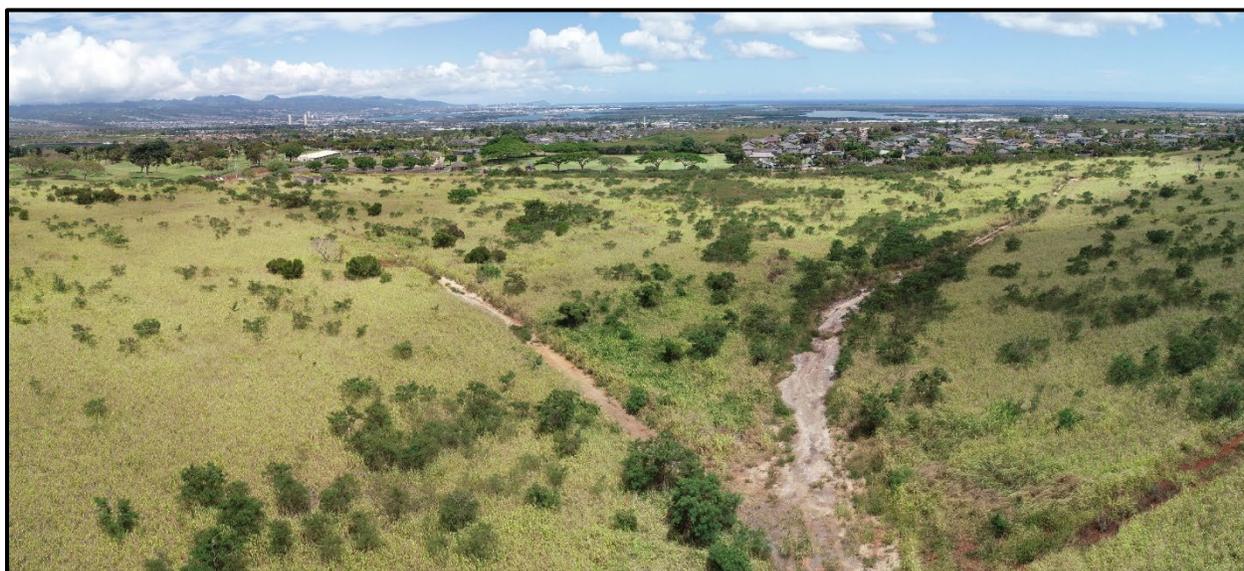
Figure 27. Southern segment of SIHP Site 50-80-08-07758 showing fork, view to the southeast.

Feature 6 enters the project area from the northern boundary (see Figure 13) and trends southeast before forking to the east and south (Figure 27). The southern fork terminates at the southern project area boundary where it trends parallel to Anoiki Street, while the eastern fork ends in the southeastern corner of the project area, aligning with Anonui Street. The feature represents additional remnant plantation-era routes of travel that were used to transport harvested cane. The road is irregularly paved with more modern asphalt surfacing, crushed coral aggregate, and macadam, indicating a long period of use, maintenance, and repair. Several utility poles were observed along the alignment (Figure 28).

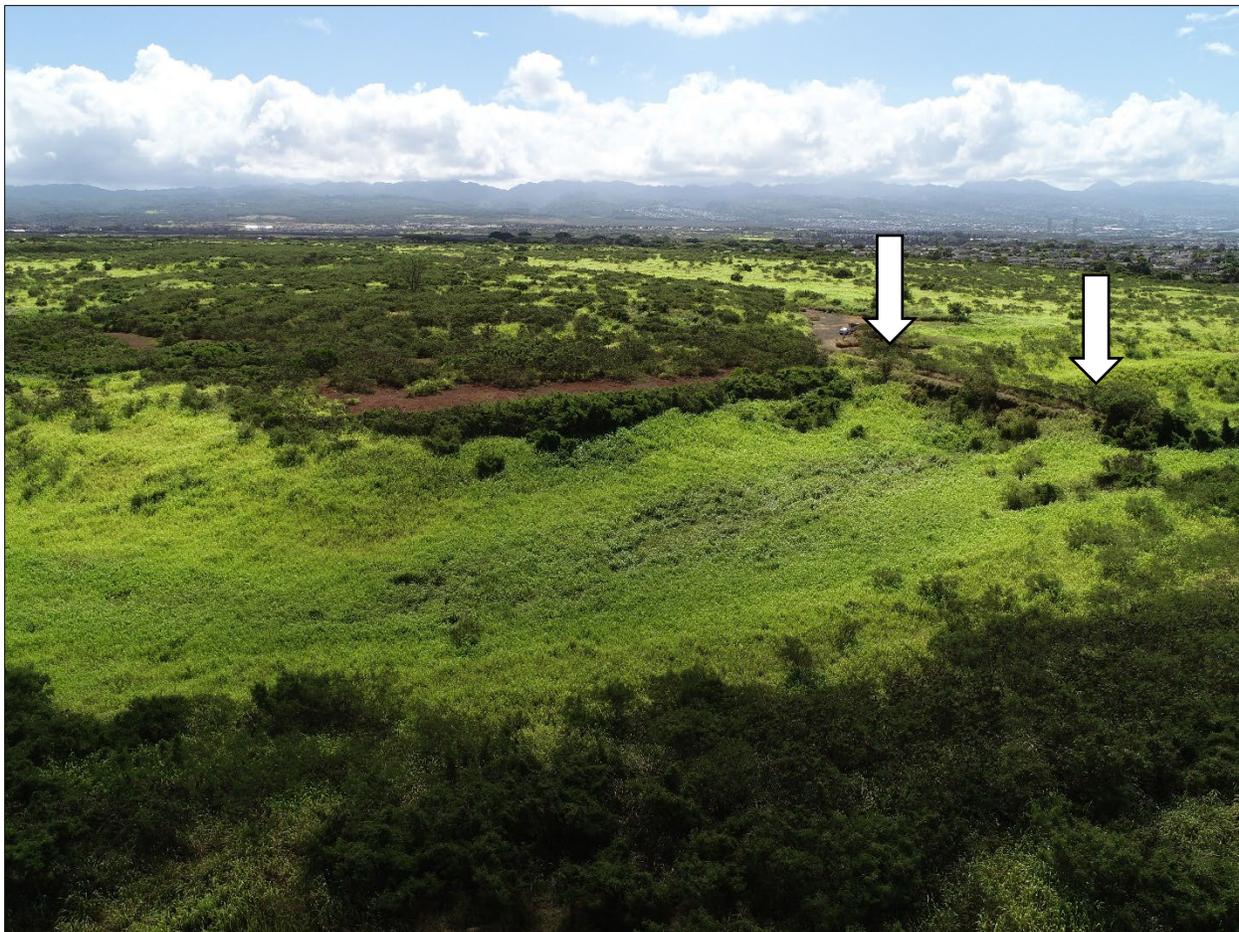
Figure 29. Aerial image of SIHP Site 50-80-08-09385 (reservoir) with the ends of the dam indicated by white arrows, view to the southeast from outside the northern project area boundary.

SIHP Site 50-80-08-09385 represents the site of a former plantation-era water reservoir (see Figure 13) initially identified by Gerrish et al. (2021) (Figure 29). The reservoir is clearly delineated on historic maps and aerials and was photo documented in the field. Due to the high density of vegetation within the feature, however, access during the pedestrian survey was not possible. The reservoir was not formally constructed but utilized a natural gully on the landscape, similar to other plantation-era reservoirs in the region (see Figure 9 to Figure 11). The surface acreage and capacity of the reservoir would have been dependent on the amount of water impounded behind the dam (Feature 4 of SIHP Site 50-80-08-07671). As depicted on the historic maps in Section 2.3, most of the reservoir is situated outside the northern project area boundary.
