WARNING LETTER

SUBJECT: Inspections at Waimanalo Gulch Sanitary Landfill
Solid Waste Management Permit No. LF-0054-02
Kapolei, Oahu

INSPECTION REPORT

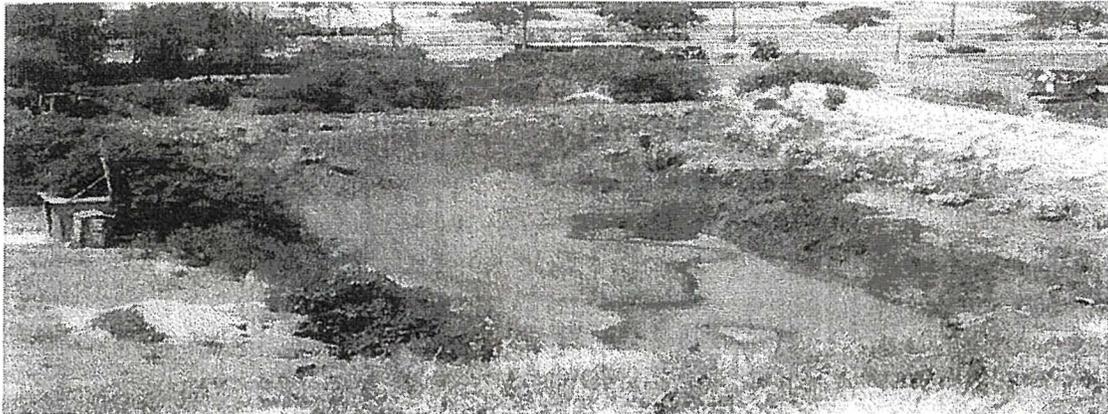
Photograph 1

Site Name: Waimanalo Gulch MSWLF and Ash Monofill
Location: 92-460 Farrington Highway, Kapolei, Hawaii 96707
Date Taken: August 2, 2006
Photographer: JRuiz
Description: View of the siltation pond from top of the ash berm buttress and located on the southeast portion of the landfill adjacent to Farrington Highway.

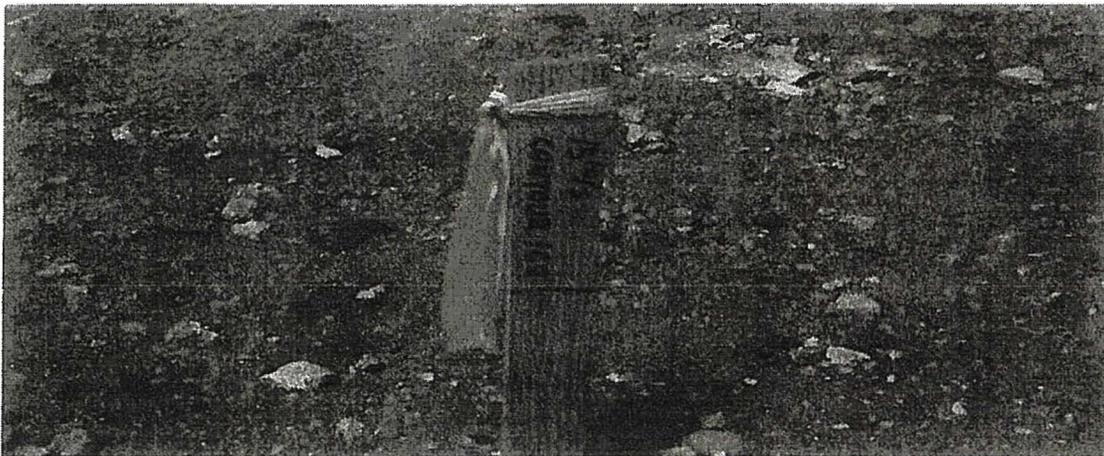
Photograph 2

Site Name: Waimanalo Gulch MSWLF and Ash Monofill
Location: 92-460 Farrington Highway, Kapolei, Hawaii 96707
Date Taken: August 2, 2006
Photographer: JRuiz
Description: Present height at the ash monofill ash buttress is at 162' msl.

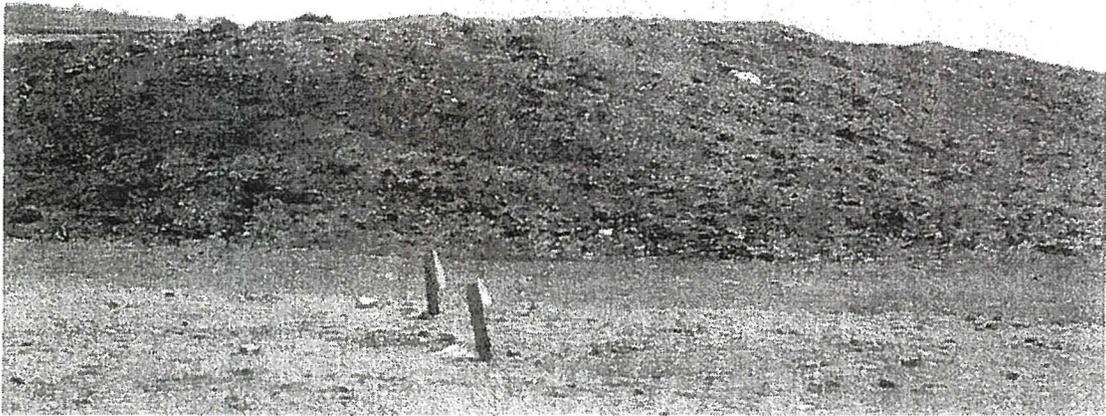
Photograph 3

Site Name: Waimanalo Gulch MSWLF and Ash Monofill
Location: 92-460 Farrington Highway, Kapolei, Hawaii 96707
Date Taken: August 2, 2006
Photographer: JRuiz
Description: Placement of ash covered with intermediate soil near the buttress area in Ash Cell 8 with stakes indicating present height at 162 ft msl.

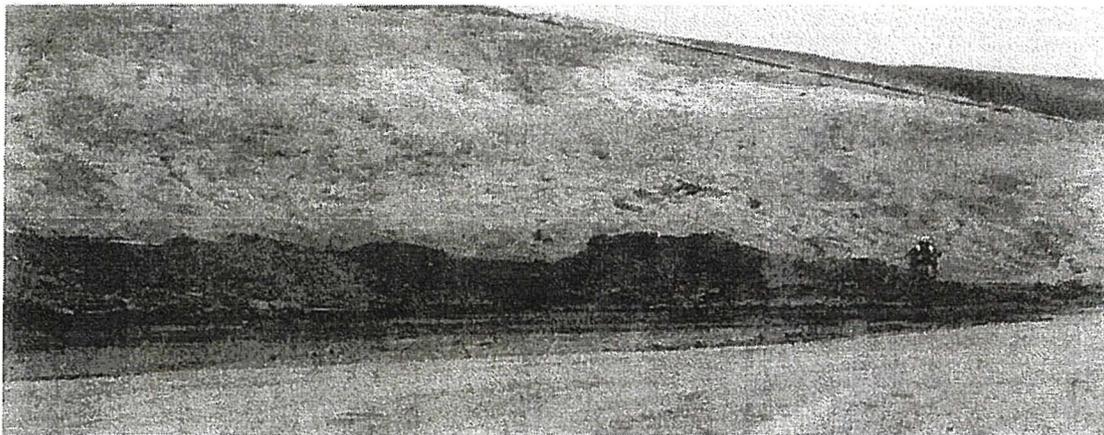
Photograph 4

Ash Monofill landfill: Based on documents provided by WMH, Environmental Compliance Officer, and an inspection of the ash monofill shows that ash is covered with intermediate soil every seven days. Ms. Pankenier said that the active ash workforce is covered every Tuesday. A few small stockpiles of ash were noted on the active workforce, now located on the northeast end along the main road to the landfill in Ash Cell 4 (see photograph 4). WMH received a total of 55 tons of ash the same day of the inspection.

Site Name: Waimanalo Gulch MSWLF and Ash Monofill
Location: 92-460 Farrington Highway, Kapolei, Hawaii 96707
Date Taken: August 2, 2006
Photographer: JRuiz
Description: Active ash monofill workforce area located on the north end of Ash Cell 4.

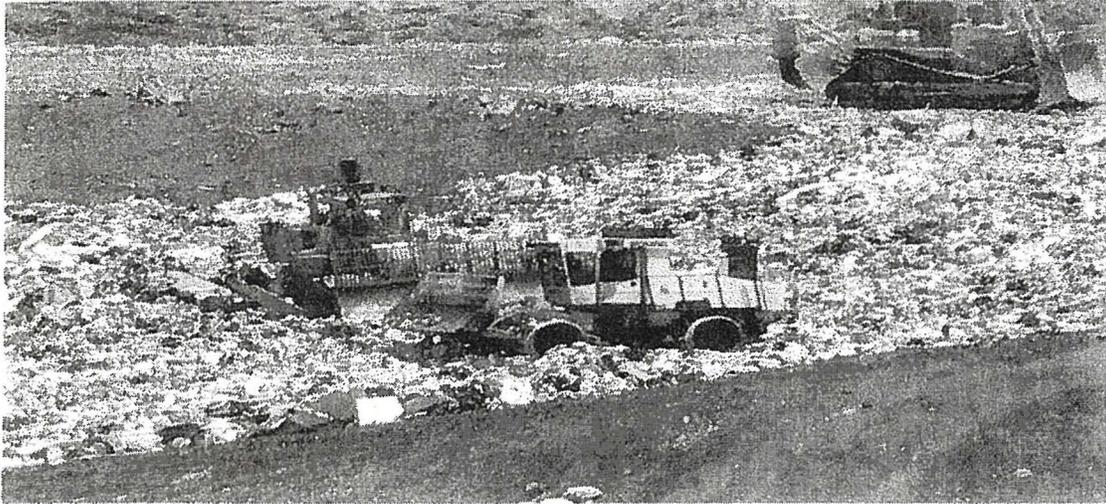
Photograph 5

On August 2, 2006, SWS inspectors observed a D-9 dozer and Bomag and Caterpillar compactors working a large active workforce area, located topside of MSW Cell-10 on the northwest portion of the landfill (see photographs 5 & 13). Litter fences were observed and placed on the east and west side of MSW Cell 10. Litter fences seem to be effectively placed for flying litter. At the time of inspection, active cell geometry appears to be fairly good with narrow deep cells to limit exposed waste. Surrounding areas are covered with soil and litter and odor are controlled. From daily photos submitted by WMH to SWS, the MSW cell appears to have been covered with daily soil at the end of each day.

Site Name: Waimanalo Gulch MSWLF and Ash Monofill
Location: 92-460 Farrington Highway, Kapolei, Hawaii 96707
Date Taken: August 2, 2006
Photographer: JRuiz

Description: Compactor operators are working the MSW at the active workforce area in Cell 10. Operators were running 3 to 5 passes for compaction. H-Power is down for maintenance and daily tonnage is about 3,000 tons per day.

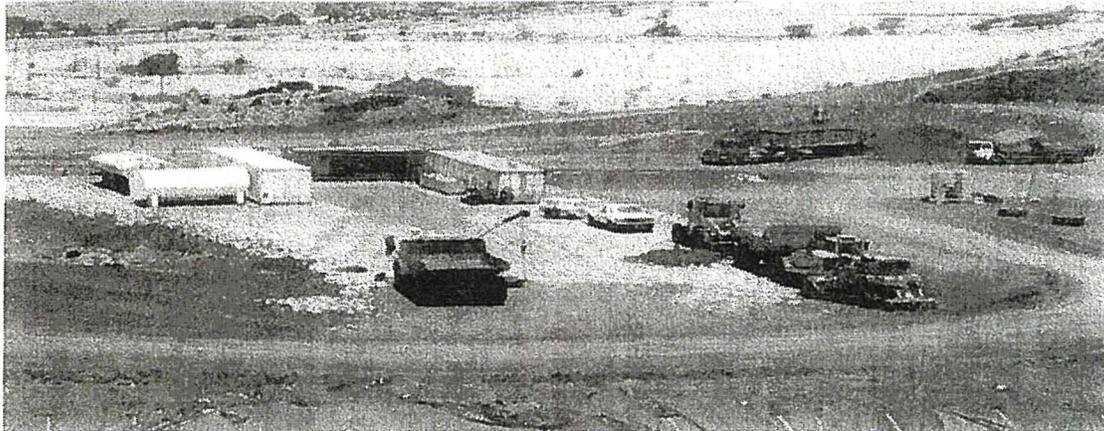
Photograph 6

The equipment maintenance yard is now located on top of MSW Cell 4-C. The top of the landfill has been covered with crushed concrete material for wet weather conditions (see photograph 6). Other types of heavy equipment utilized for the construction of the new cells are being stored on top of MSW Cell 1.

Site Name: Waimanalo Gulch MSWLF and Ash Monofill
Location: 92-460 Farrington Highway, Kapolei, Hawaii 96707
Date Taken: August 2, 2006
Photographer: JRuiz
Description: Equipment maintenance yard located on top of MSW Cell 4C.

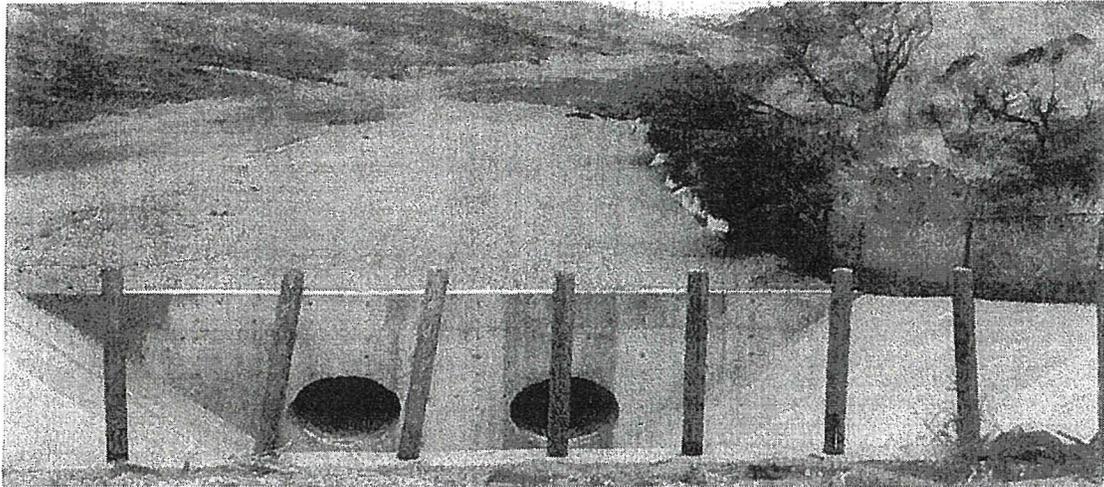
Photograph 7

Site Name: Waimanalo Gulch MSWLF and Ash Monofill
Location: 92-460 Farrington Highway, Kapolei, Hawaii 96707
Date Taken: August 2, 2006
Photographer: JRuiz
Description: Newly installed two 48 inch corrugated metal pipes to channel stormwater under the northwest berm located from the topside of MSW Cell 11 to MSW Cell 7. The pipes are located on the former concrete channel for stormwater runoff.

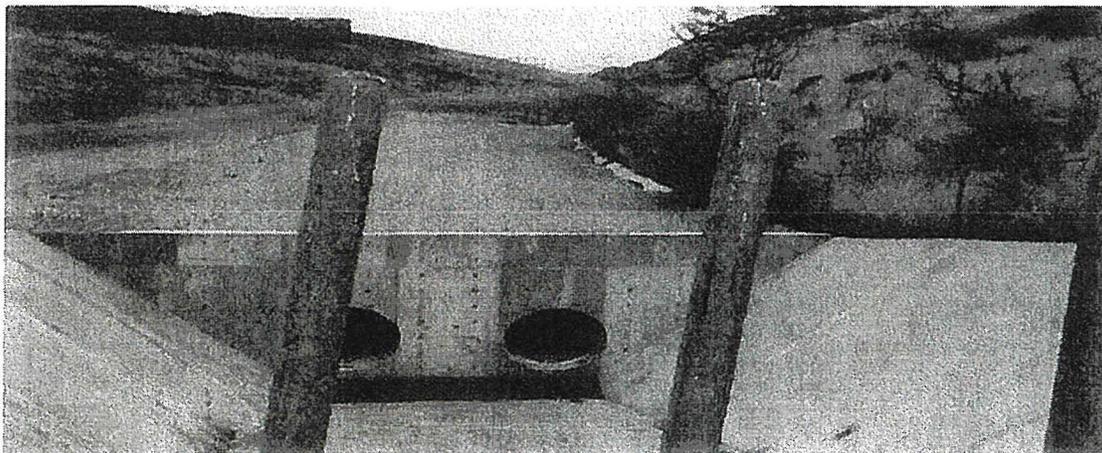
Photograph 8

Site Name: Waimanalo Gulch MSWLF and Ash Monofill
Location: 92-460 Farrington Highway, Kapolei, Hawaii 96707
Date Taken: August 2, 2006
Photographer: JRuiz
Description: Another view of the newly installed two 48 inch corrugated metal pipes to channel stormwater under the northwest berm located from the topside of MSW Cell 11 to MSW Cell 7.

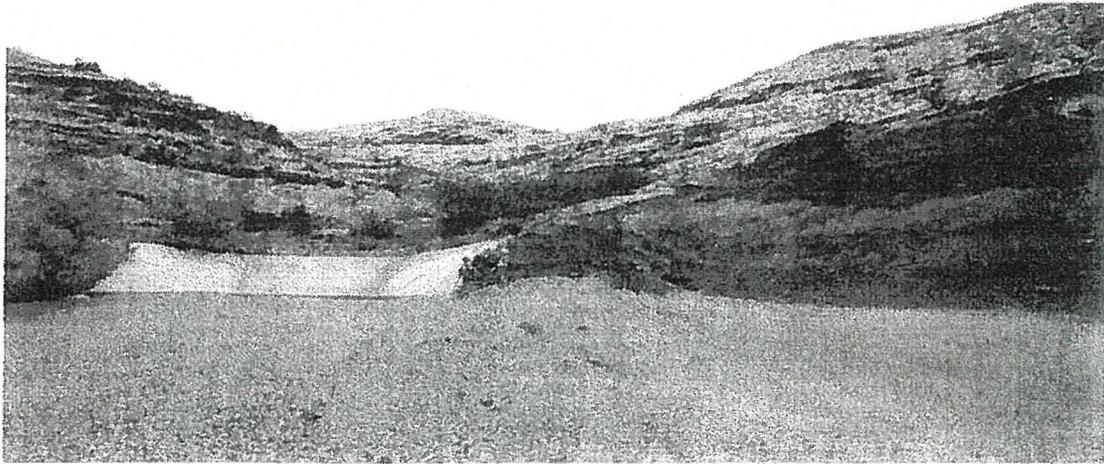
Photograph 9

The installation of two 48-inch corrugated metal stormwater drainpipes inside the drainage channel through the northwest area berm, along the length of MSW Cell-11 to MSW Cell 7 has been completed (see photograph 12). The pipes were installed to pass stormwater under the northwest berm (see photographs 7 & 8). A fence or similar structure was not provided to provide safety along the perimeter of the inlet area (see photograph 9).

Site Name: Waimanalo Gulch MSWLF and Ash Monofill
Location: 92-460 Farrington Highway, Kapolei, Hawaii 96707
Date Taken: August 2, 2006
Photographer: JRuiz
Description: Wide view of the stormwater channel located at the topside of MSW Cell 11 to divert run on water during inclement weather.

1. The recent modification of the stormwater channel, where two 48-inch corrugated metal pipes were placed in the concrete channel to pass stormwater under the recently constructed berm lacks safety devices. WMH and the City should consider constructing a fence or similar structure along the perimeter of the inlet area as a safety measure.

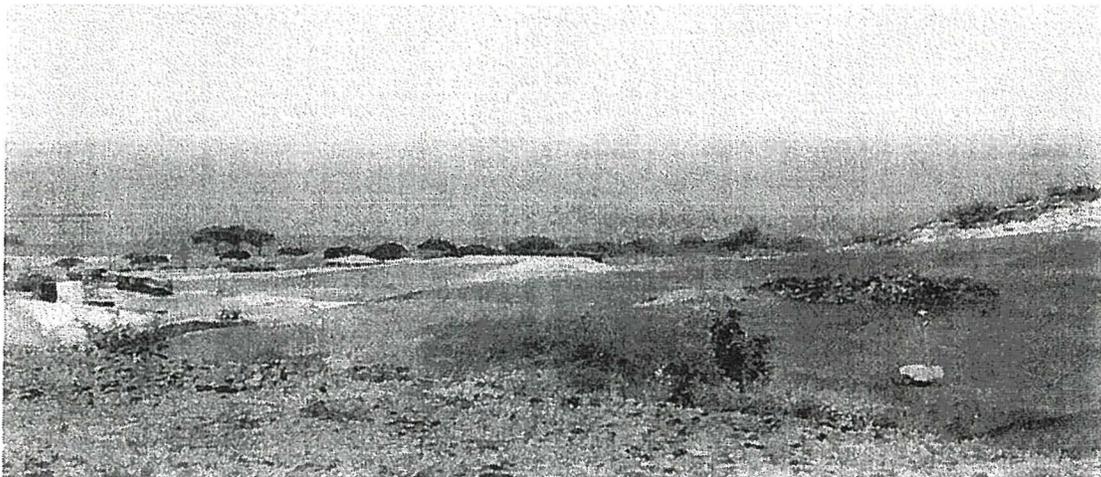
Photograph 10

The inspectors noted large stockpiles of concrete material stored on the top deck of Ash Cell 4 & 5, for the construction of wet weather deck for MSW cells (see photograph 10). Facility's permit condition does not allow for the storage of material on the ash landfill area. WMH must have the stockpiled materials removed from the ash monofill area.

Site Name: Waimanalo Gulch MSWLF and Ash Monofill
Location: 92-460 Farrington Highway, Kapolei, Hawaii 96707
Date Taken: August 2, 2006
Photographer: JRuiz
Description: View of the ash monofill from top of E-Cell berm. To the right of the photo, WMH is stockpiling concrete material for construction of wet weather deck for MSW Cell 10.

1. The facility stored wet weather construction material for MSW cells on ash monofill Cell 4, in violation of Special Condition IIIB, Item 5.

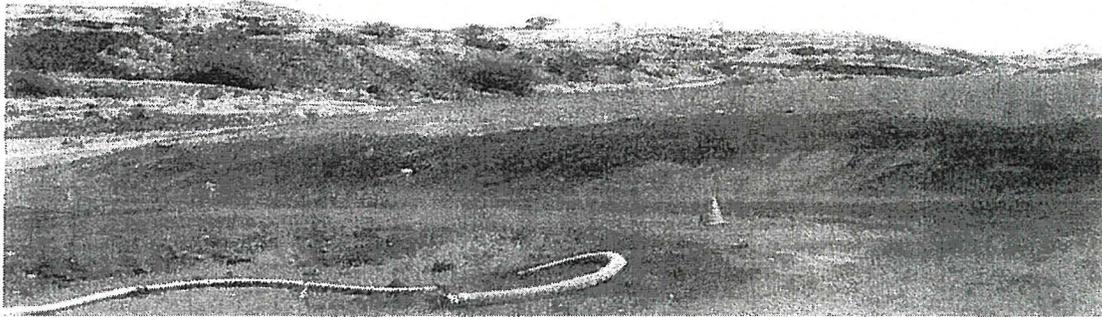
Photograph 11

Ms. Pankenier informed the inspectors that the west end of the ash monofill area continues to be overcapacity and filled with ash beyond the 2003 permit grades (see photograph 11). On the top deck of Ash Cell 1 & 8, near the recently built ash buttress berm and adjacent to the ash leachate sump, the inspectors noticed a large amount of ash placement (approx. 14,000 cubic yards) covered with intermediate soil (see photograph 3). Ms. Pankenier was asked if the ash pile is allowed to be placed on top of the ash buttress berm and she said that the stockpile is within 2003 permit grades.

Site Name: Waimanalo Gulch MSWLF and Ash Monofill
Location: 92-460 Farrington Highway, Kapolei, Hawaii 96707
Date Taken: August 2, 2006
Photographer: JRuiz
Description: View of the overfilled ash monofill Cells 5 through 8 located on the west portion of the landfill.

2. The facility continues to violate Special conditions III, Item 9 by exceeding permit grades on the placement of ash and MSW. While WMH and the City and County of Honolulu (City) submitted an application to modify its permit grades after the fact, the application remains incomplete.

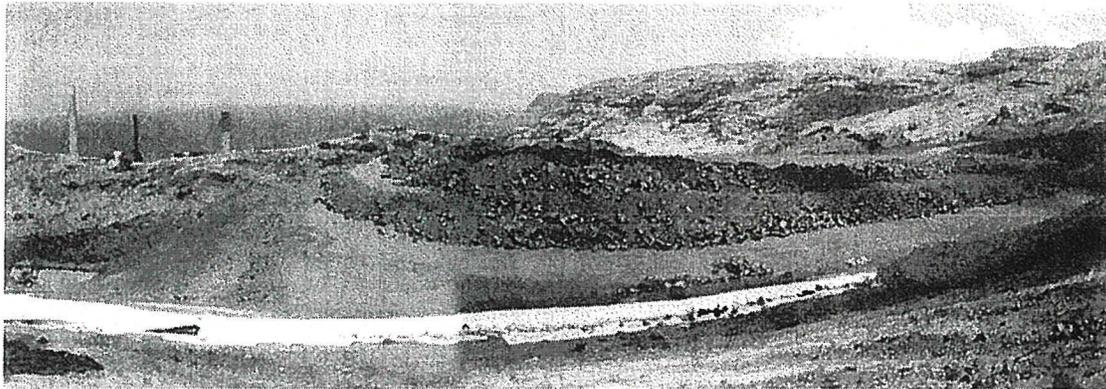
Photograph 12

Site Name: Waimanalo Gulch MSWLF and Ash Monofill
Location: 92-460 Farrington Highway, Kapolei, Hawaii 96707
Date Taken: August 2, 2006
Photographer: JRuiz
Description: Panoramic view of the northwest berm under construction on top of MSW Cells 7 thru 11 and inside the concrete stormwater channel. The contractor installed two 48 inch corrugated metal pipes through the berm (former concrete channel) to pass stormwater.

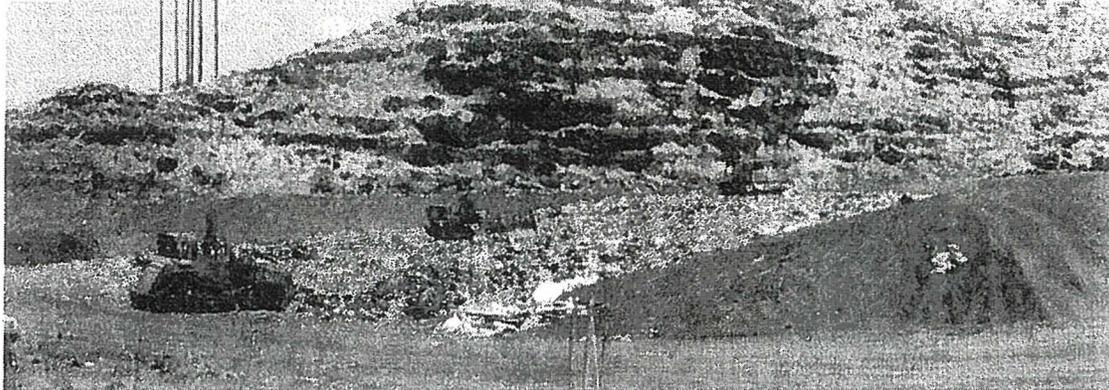
Photograph 13

Site Name: Waimanalo Gulch MSWLF and Ash Monofill
Location: 92-460 Farrington Highway, Kapolei, Hawaii 96707
Date Taken: August 2, 2006
Photographer: JRuiz
Description: Panoramic view of MSW Cell-10 workface area during H-Power shutdown.

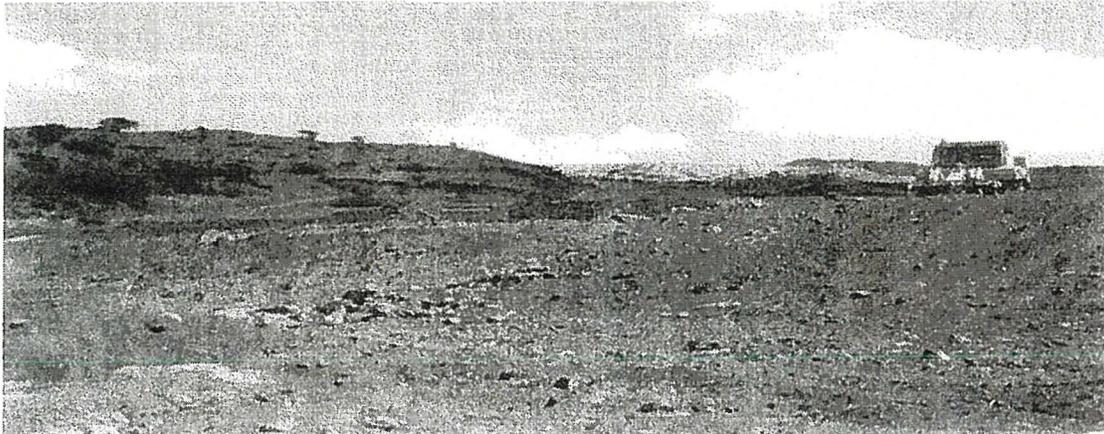
Photograph 1

Ash Monofill landfill: Based on documents provided by WMH, Environmental Compliance Officer, and an inspection of the active ash workface area in cell-8 (see photograph 1), ash is graded daily and covered with intermediate soil every seven days. Other cells of the monofill were covered with intermediate soil except for a large part of ash cell 6 (see photographs 6, 7, & 8) which was estimated to be a little less than ½ acre. Ms. Pankenier said that the ash would be covered during the coming weekend.

Site Name: Waimanalo Gulch MSWLF and Ash Monofill
Location: 92-460 Farrington Highway, Kapolei, Hawaii 96707
Date Taken: September 29, 2006
Photographer: JRuiz
Description: Active ash workface located in cell 8

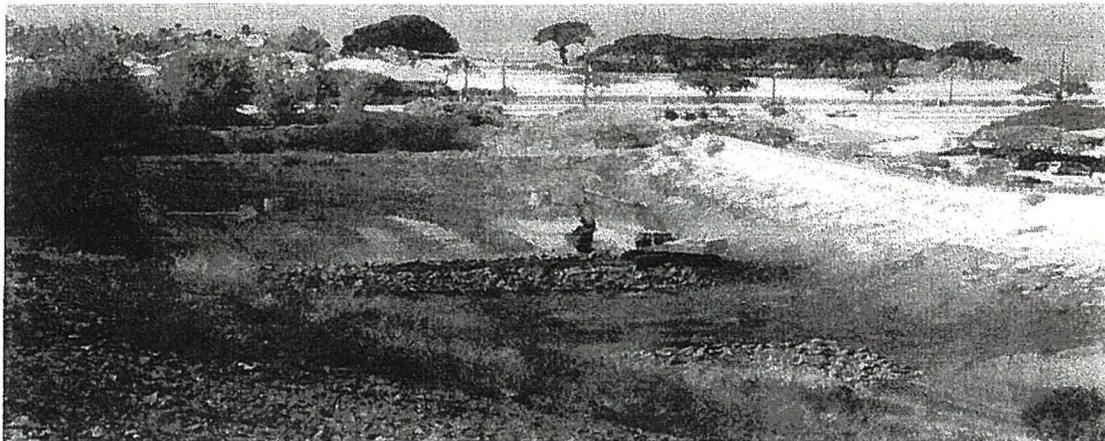
Photograph 2

Site Name: Waimanalo Gulch MSWLF and Ash Monofill
Location: 92-460 Farrington Highway, Kapolei, Hawaii 96707
Date Taken: September 29, 2006
Photographer: JRuiz
Description: Contractor placing rocks to separate the siltation pond area and on the background (red arrows) shows two new risers for installation.

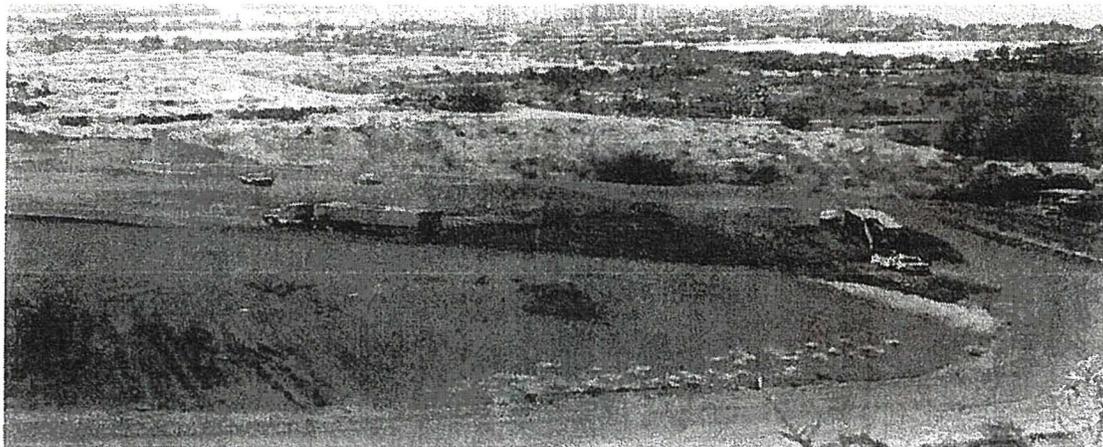
Photograph 4

Site Name: Waimanalo Gulch MSWLF and Ash Monofill
Location: 92-460 Farrington Highway, Kapolei, Hawaii 96707
Date Taken: September 29, 2006
Photographer: JRuiz
Description: View of the active ash workspace area located in cell 8.

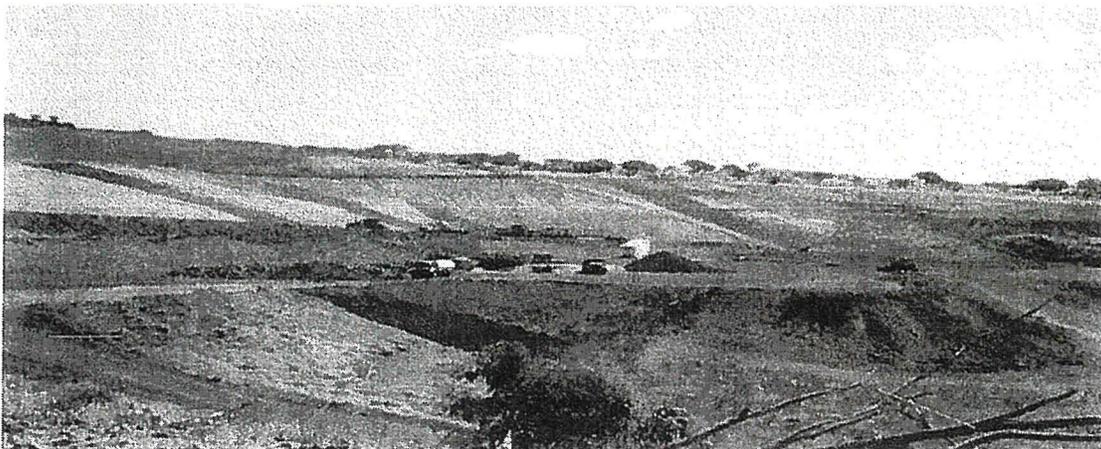
Photograph 6

Site Name: Waimanalo Gulch MSWLF and Ash Monofill
Location: 92-460 Farrington Highway, Kapolei, Hawaii 96707
Date Taken: September 29, 2006
Photographer: JRuiz
Description: Part of the monofill area (red arrows) located on the west of cell 6 was noted without intermediate soil cover.

4. Portions of Ash Cell 6 requires intermediate cover. Based on the growth of vegetation in this area and visual observation, ash has not been covered within 7 days of placement, in violation of the facility's Permit Special Condition IIIB, Item 2.

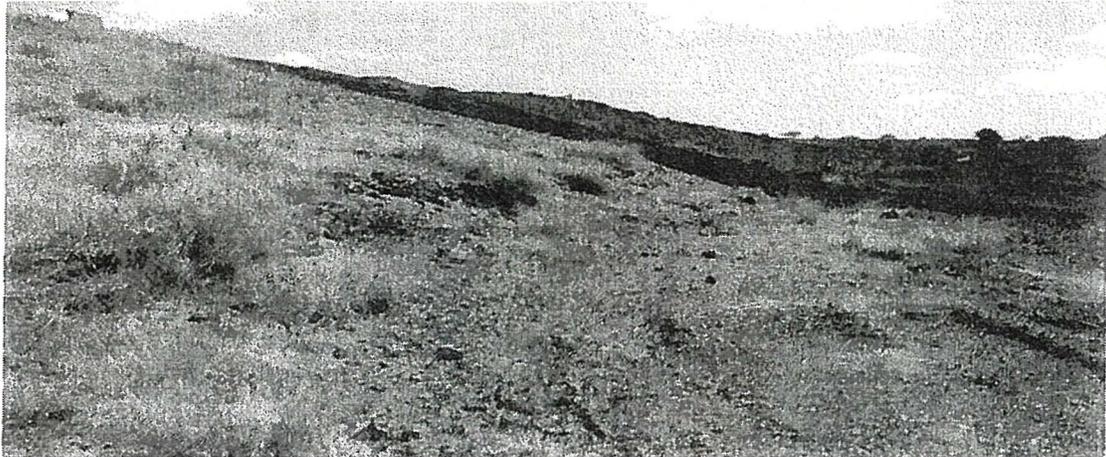
Photograph 7

Site Name: Waimanalo Gulch MSWLF and Ash Monofill
Location: 92-460 Farrington Highway, Kapolei, Hawaii 96707
Date Taken: September 29, 2006
Photographer: JRuiz
Description: Close-up look of ash cell 6 without intermediate soil cover.

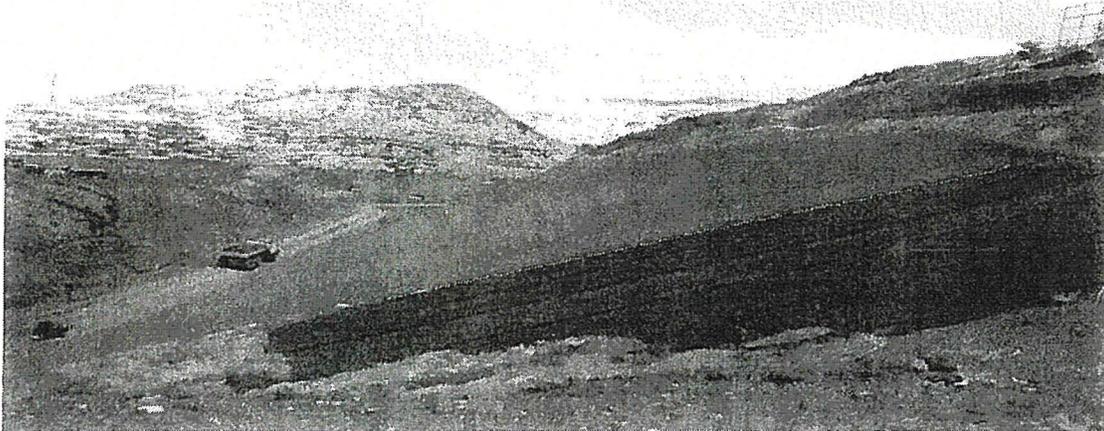
Photograph 9

The new MSW Cell E-3 is almost ready to be lined (see photograph 9) and plans are to lined the cell by mid October 2006. Contractor was observed at the bottom edge of MSW Cell E-2 with a backhoe (see photograph 10) uncovering the edge of the existing liner and exposing the waste of MSW Cell E-2 for connection to the new cell liner. The stormwater management system for the E-Cell expansion is still under construction. WMH is constructing swales along the perimeter of the road adjacent to the MSW landfill area to divert storm water. The swales should be completed by the first week of October 2006. Contractor continues to build the buttress on the west side of MSW Cells 8 & 9. Prior to the placement of the rock wall/partition in the pond, the contractor had excavated 2500 cubic yards of dirt. The contractor was observed isolating the pond by placing a layer of rocks on the upper portion of the pond to separate the fines before it gets into the second phase of the pond. New risers were also observed in place on the second portion of the pond area (see photograph 2).

Site Name: Waimanalo Gulch MSWLF and Ash Monofill
Location: 92-460 Farrington Highway, Kapolei, Hawaii 96707
Date Taken: September 29, 2006
Photographer: JRuiz
Description: The lined cell area (blue arrow) is part of MSW Cell E-2 and on the background (red arrow) is the newly constructed MSW Cell E-3 not yet lined.

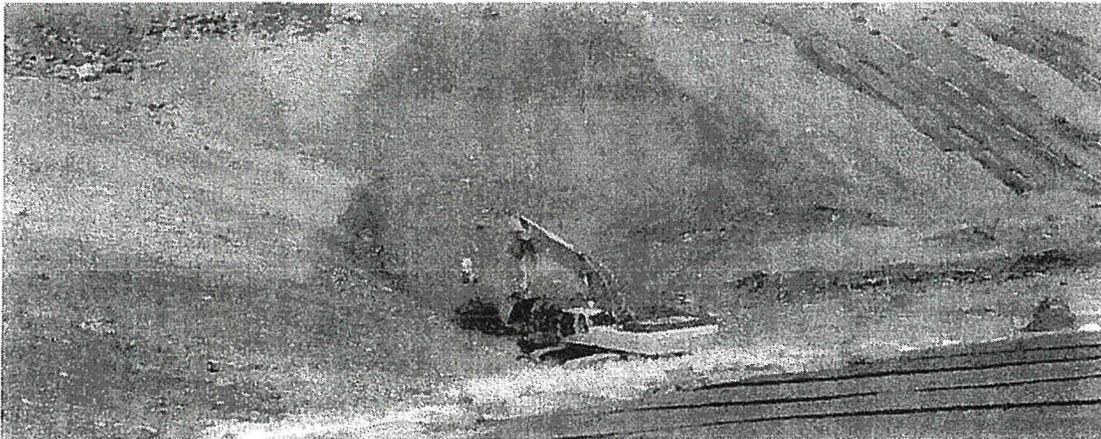
Photograph 10

Site Name: Waimanalo Gulch MSWLF and Ash Monofill
Location: 92-460 Farrington Highway, Kapolei, Hawaii 96707
Date Taken: September 29, 2006
Photographer: JRuiz
Description: Goodfellow Company is using a backhoe to expose the liner from MSW Cell E-2 for future addition of MSW Cell E-3 liner.

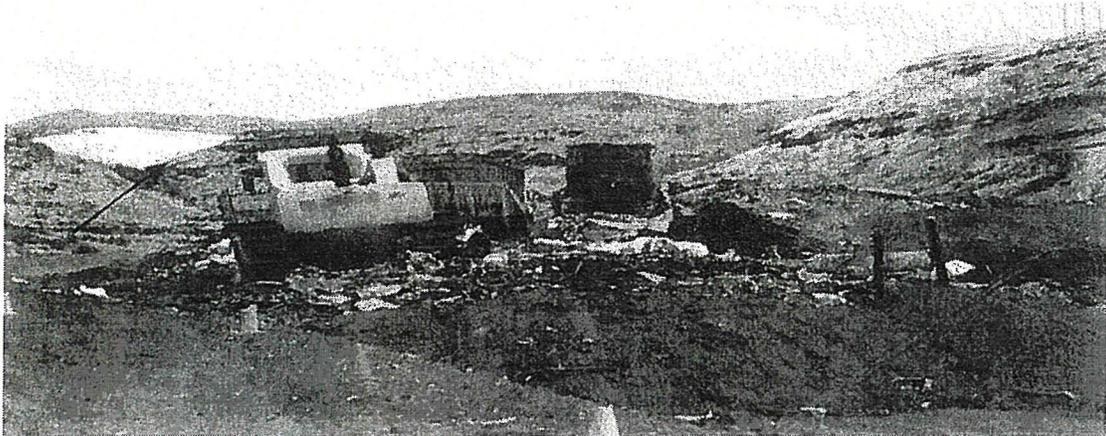
Photograph 11

Site Name: Waimanalo Gulch MSWLF and Ash Monofill
Location: 92-460 Farrington Highway, Kapolei, Hawaii 96707
Date Taken: September 29, 2006
Photographer: JRuiz
Description: Active workspace area is located in MSW Cell 10 with a bomag compactor making passes on the trash for compaction.

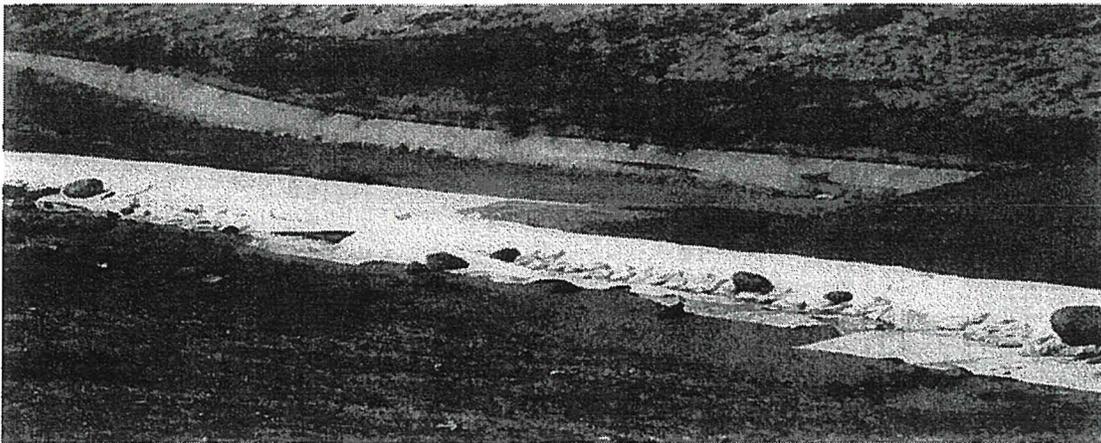
Photograph 12

Site Name: Waimanalo Gulch MSWLF and Ash Monofill
Location: 92-460 Farrington Highway, Kapolei, Hawaii 96707
Date Taken: September 29, 2006
Photographer: GSiu
Description: Composite liner system under northwest berm on cells 8 & 9 interface. White liner is flexible member liner (FML).

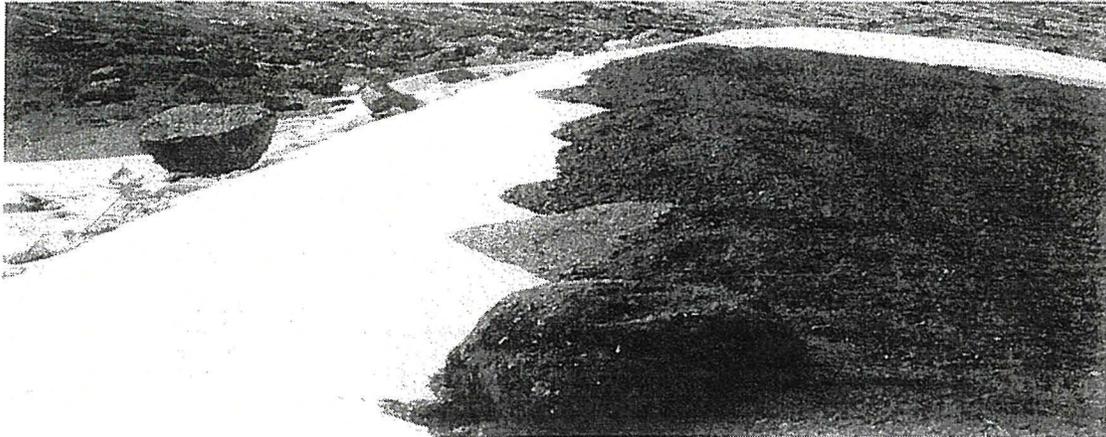
Photograph 13

Site Name: Waimanalo Gulch MSWLF and Ash Monofill
Location: 92-460 Farrington Highway, Kapolei, Hawaii 96707
Date Taken: September 29, 2006
Photographer: GSiu
Description: Another view of the composite liner under northwest berm. Note boulder on top of liner (red arrow).

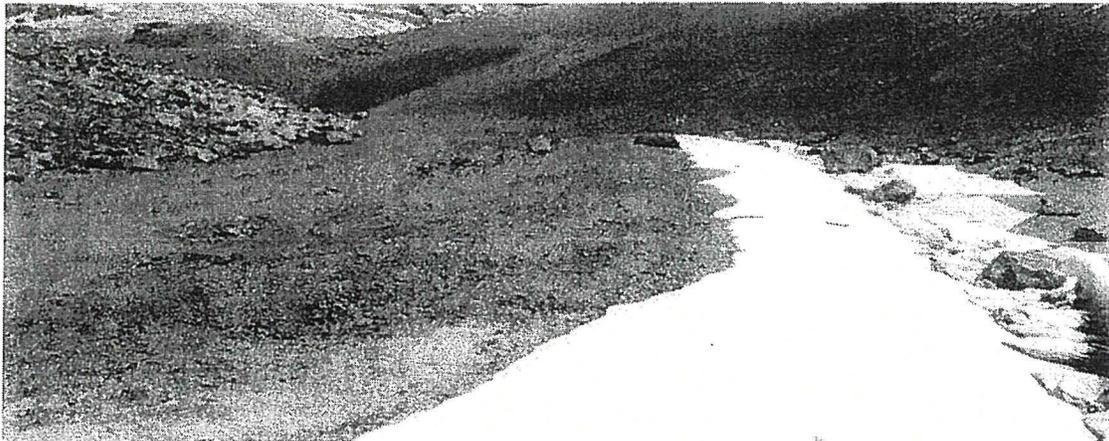
Photograph 14

Site Name: Waimanalo Gulch MSWLF and Ash Monofill
Location: 92-460 Farrington Highway, Kapolei, Hawaii 96707
Date Taken: September 29, 2006
Photographer: GSiu
Description: Composite liner under northwest berm.
