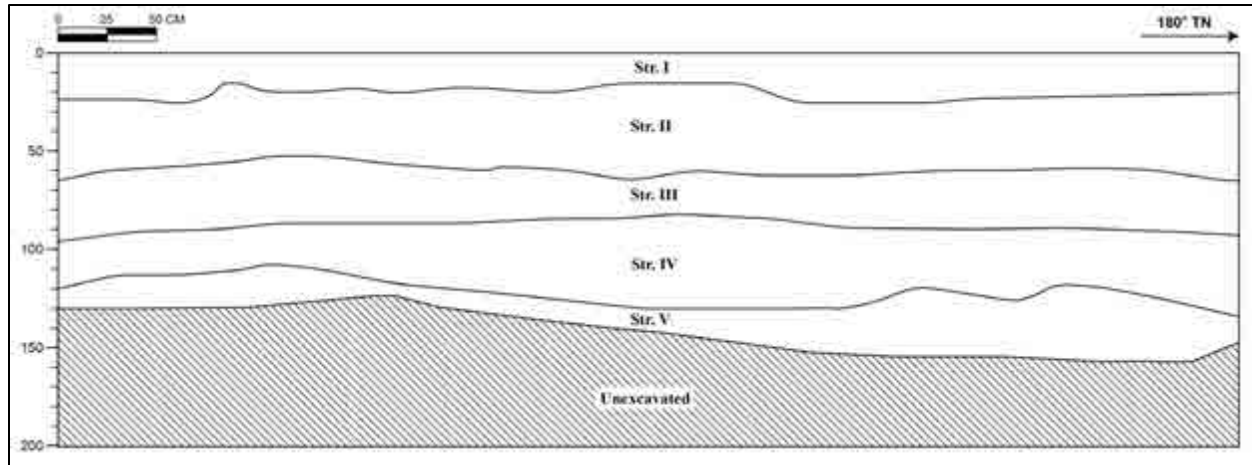
Figure 148. TE-34, stratigraphy of the east wall

Stratum	Depth (cmbs)	Description
I	0–23	Ap horizon; 10YR 3/6, dark yellowish brown; silt loam; moderate, fine granular structure; moist, friable consistence; no cementation; slightly plastic; terrigenous origin; fine roots common; clear, wavy lower boundary
II	12–65	Natural; 10YR 3/4, dark yellowish brown; loamy sand; weak, fine granular structure; moist, loose consistence; no cementation; non-plastic; terrigenous origin; few fine roots; abrupt, smooth lower boundary; contained fine to coarse mottles of 7.5YR 2.5/3, very dark brown, silty clay loam in the southern portion
III	55–95	Natural; 7.5YR 2.5/3, very dark brown; silty clay loam; moderate, fine platy structure; moist, friable consistence; no cementation; plastic; terrigenous origin; no roots; diffuse, smooth lower boundary
IV	83–130	Natural; 10YR 4/3, brown; silt loam; weak, fine granular structure; moist, friable consistence; no cementation; plastic; terrigenous origin; no roots; diffuse, wavy lower boundary; aeolian deposit; contained bands of 10YR 4/2, dark grayish brown, sandy loam cinder at the upper and lower interfaces

V	106–158	Natural; 7.5YR 4/3, brown; silt loam; weak, fine granular structure; moist, loose consistence; no cementation; plastic; terrigenous origin; no roots; lower boundary not observed; aeolian deposit

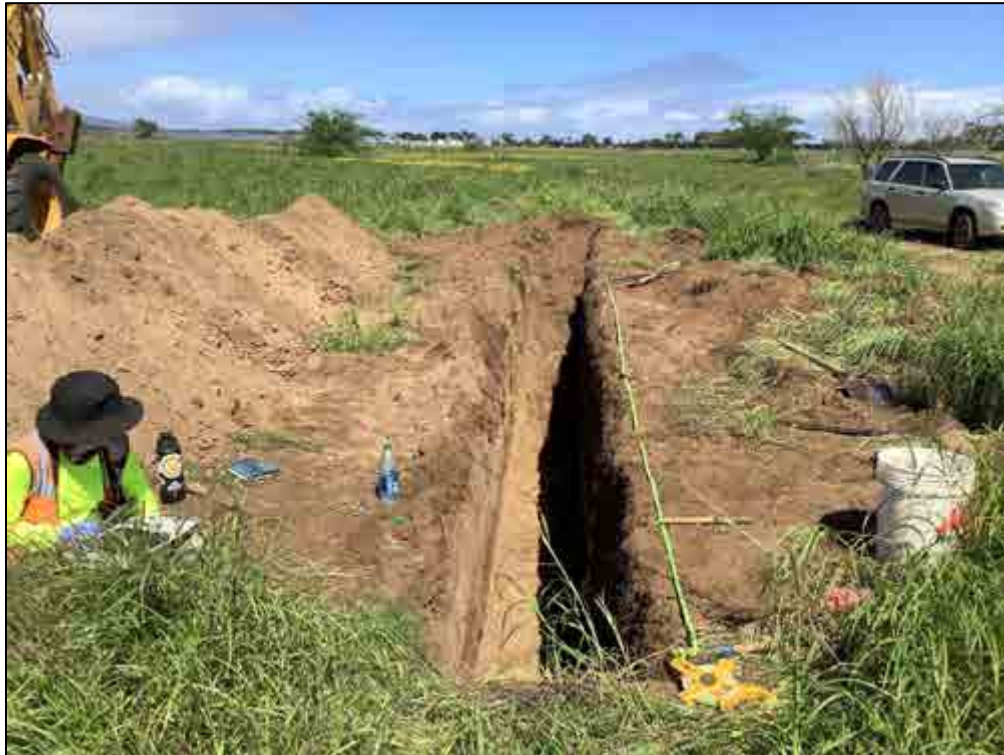
Figure 149. TE-35, overview of the general location, view to north

TE-35 was in the northeastern quadrant of the study area, approximately 4.0 m west of a field road (Figure 149). The excavation was 6.00 m long by 0.80 m wide with a maximum depth of 1.69 mbs. The stratigraphy of TE-35 consisted a dark brown, gravelly sandy loam Ap horizon (Stratum I); dark yellowish brown, sandy loam fill (Stratum II); and dark brown, sandy loam fill (Stratum III) overlying a dark brown, silt loam buried A horizon (Stratum IV); dark brown, natural sand (Stratum V); and brown, natural silt loam (Stratum VI) (Figure 150 through Figure 152 and Table 35). Samples of Stratum IV were screened in the field to determine whether the stratum contained cultural material. A total of approximately 5.0 L of sediment was screened yielding intact burnt vegetation, charcoal, and two natural waterworn pebbles. The material in Stratum IV indicated that the buried A horizon was likely related to historic or modern agricultural burning. No cultural material was encountered.

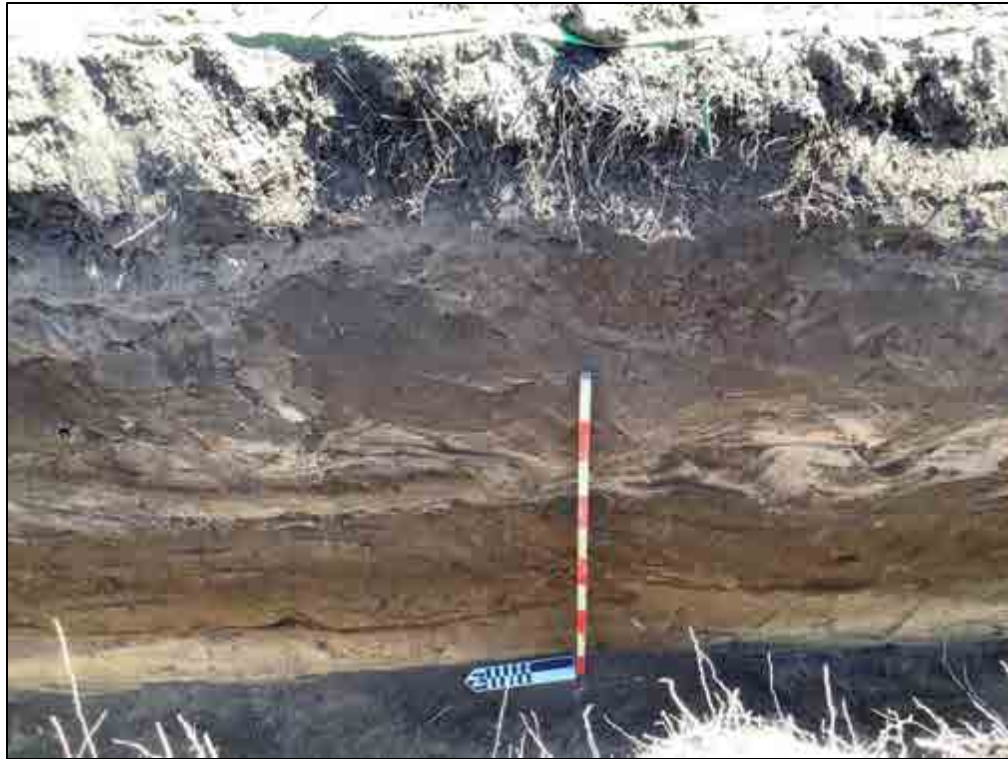
Figure 151. TE-35, close-up of the east wall, view to east

Stratum	Depth (cmbs)	Description
I	0–26	Ap horizon; 7.5YR 3/2, dark brown; gravelly sandy loam; moderate, fine granular structure; moist, friable consistence; no cementation; non-plastic; terrigenous origin; many fine roots; diffuse, wavy lower boundary
II	12–94	Fill; 10YR 3/6, dark yellowish brown; sandy loam; weak, fine granular structure; moist, loose consistence; no cementation; non-plastic; terrigenous origin; few fine roots; gradual, wavy lower boundary; contained common mottles of 10YR 4/3, brown, aeolian sand
III	56–94	Fill; 7.5YR 3/3, dark brown; gravelly silt loam; moderate, very fine granular structure; moist, friable consistence; no cementation; slightly plastic; terrigenous origin; few fine roots; clear, wavy lower boundary
IV	110–133	Buried A horizon; 10YR 3/3, dark brown; silt loam; moderate, fine granular structure; moist, loose consistence; non-plastic; terrigenous origin; few, fine roots; abrupt, smooth lower boundary; screened samples contained charcoal and burnt vegetation remnants and two water-rounded pebbles; no cultural material encountered

V	100–142	Natural; 10YR 3/3, dark brown; gravelly sand; structureless (single grain); moist, loose consistence; no cementation; non-plastic; marine origin; few, fine roots; gradual, smooth lower boundary; alluvial sand deposited from drainage to the east
VI	112–169	Natural; 10YR 5/3, brown; silt loam; weak, fine granular structure; moist, loose consistence; no cementation; slightly plastic; terrigenous origin; lower boundary not observed

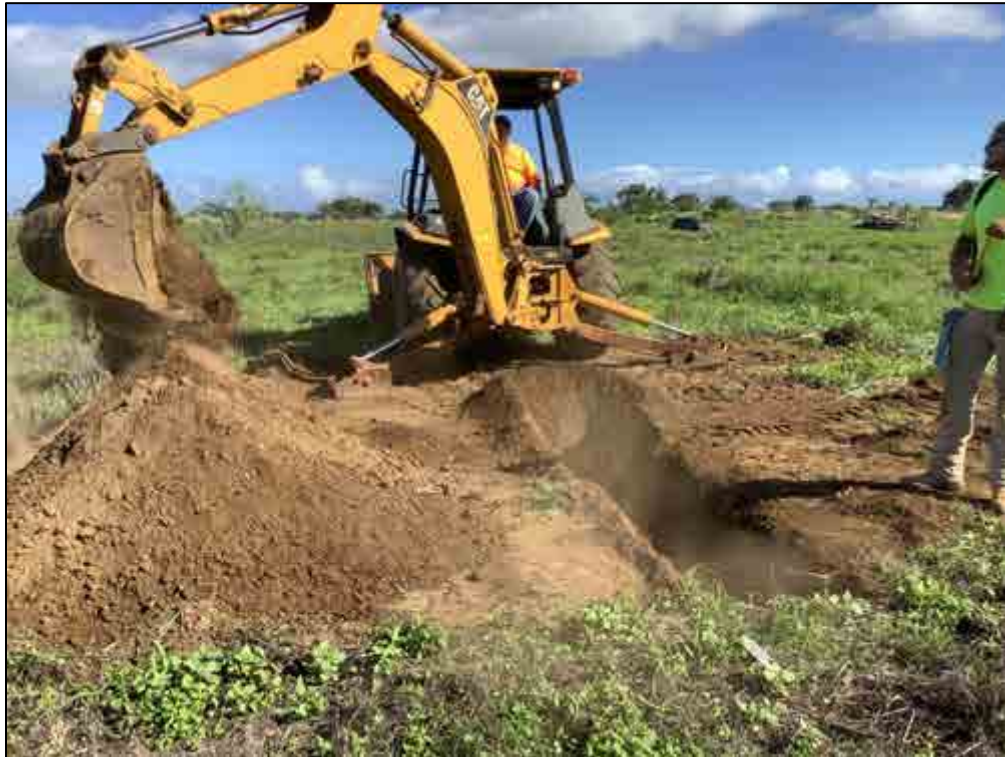
Figure 153. TE-36, overview of the general location, view to northeast

TE-36 was in the northeastern quadrant of the study area (Figure 153). The excavation was 6.00 m long by 0.80 m wide with a maximum depth of 1.70 mbs. The stratigraphy of TE-36 consisted of a very dark brown, gravelly sandy clay loam Ap horizon (Stratum I) overlying dark reddish brown, natural silty clay loam (Stratum II) and brown, natural silt loam (Stratum III) (Figure 154 through Figure 156 and Table 36). Stratum I contained a coarse inclusion of volcanic cinder at the lower interface. No cultural materials were encountered.

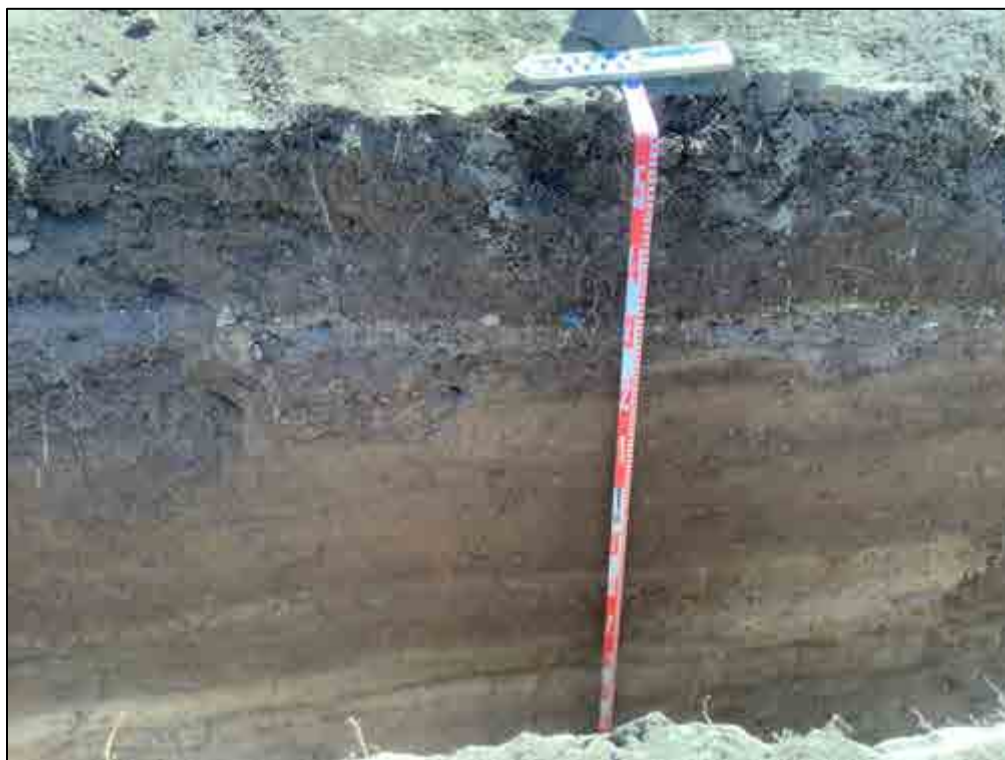
Figure 155. TE-36, close-up of the east wall, view to east

Stratum	Depth (cmbs)	Description
I	0–54	Ap horizon; 7.5YR 2.5/2, very dark brown; gravelly sandy clay loam; moderate, fine granular structure; moist, friable consistence; no cementation; plastic; terrigenous origin; many fine roots; clear, wavy lower boundary; contained a coarse inclusion of 7.5YR 3/3, dark brown, volcanic cinder at the lower interface
II	32–130	Natural; 5YR 3/3, dark reddish brown; silty clay loam; moderate, fine granular structure; moist, friable consistence; no cementation; plastic; terrigenous origin; no roots; clear, smooth lower boundary
III	93–170	Natural; 7.5YR 5/3, brown; silt loam; weak, fine granular structure; moist, friable consistence; no cementation; slightly plastic; terrigenous origin; no roots; lower boundary not observed

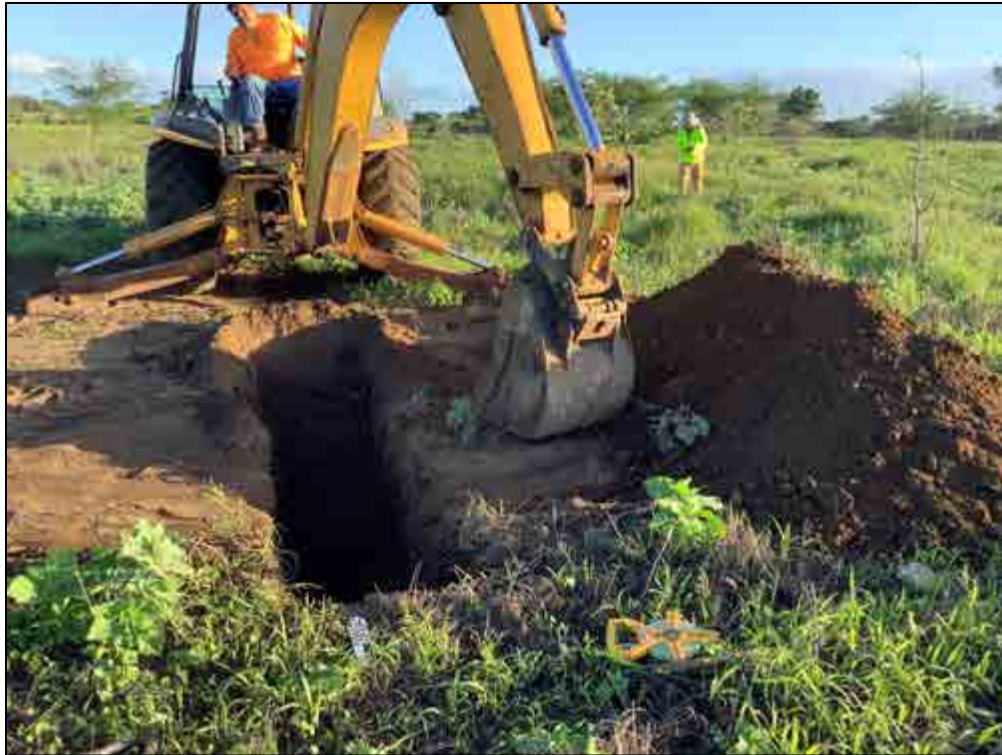
Figure 157. TE-37, overview of the general location, view to north

TE-37 was near the northeastern corner of the study area (Figure 157). The excavation was 6.00 m long by 0.80 m wide with a maximum depth of 1.70 mbs. The stratigraphy of TE-37 consisted of a very dark grayish brown sandy clay loam Ap horizon (Stratum I) overlying a dark yellowish brown A horizon (Stratum II) and dark reddish gray, natural silt loam (Stratum III) (Figure 158 through Figure 160 and Table 37). Stratum III contained two deposits of volcanic cinder inclusions. The agricultural plow zone (Stratum I) contained pieces of black plastic irrigation drip tape that were not collected. No other cultural materials were observed.

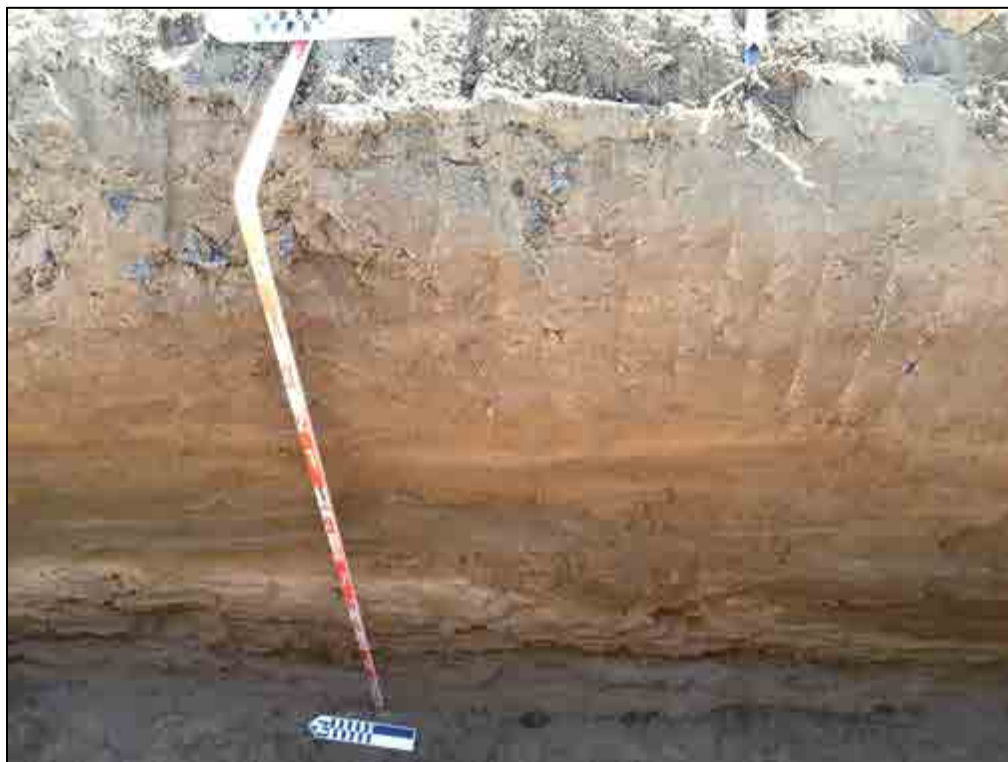
Figure 158. TE-37, oblique view of the east wall, view to south

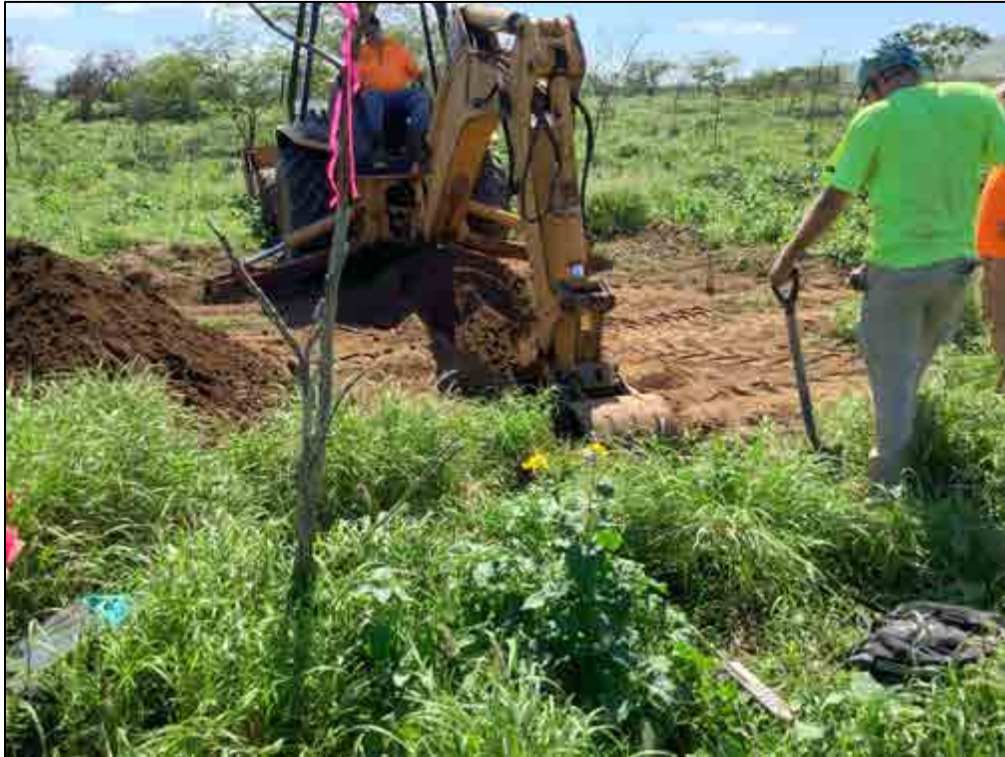
TE-38 was near the northeastern boundary of the study area (Figure 161). The excavation was 6.00 m long by 0.80 m wide with a maximum depth of 1.51 mbs. The stratigraphy of TE-38 consisted of a dark brown sandy loam Ap horizon (Stratum I) overlying natural dark reddish brown clay loam (Stratum II), natural brown silt loam (Stratum III), and natural pinkish gray silt loam (Stratum IV) (Figure 162 and Table 38). No other cultural materials were observed

Figure 161. TE-38, overview of the general location, view to south

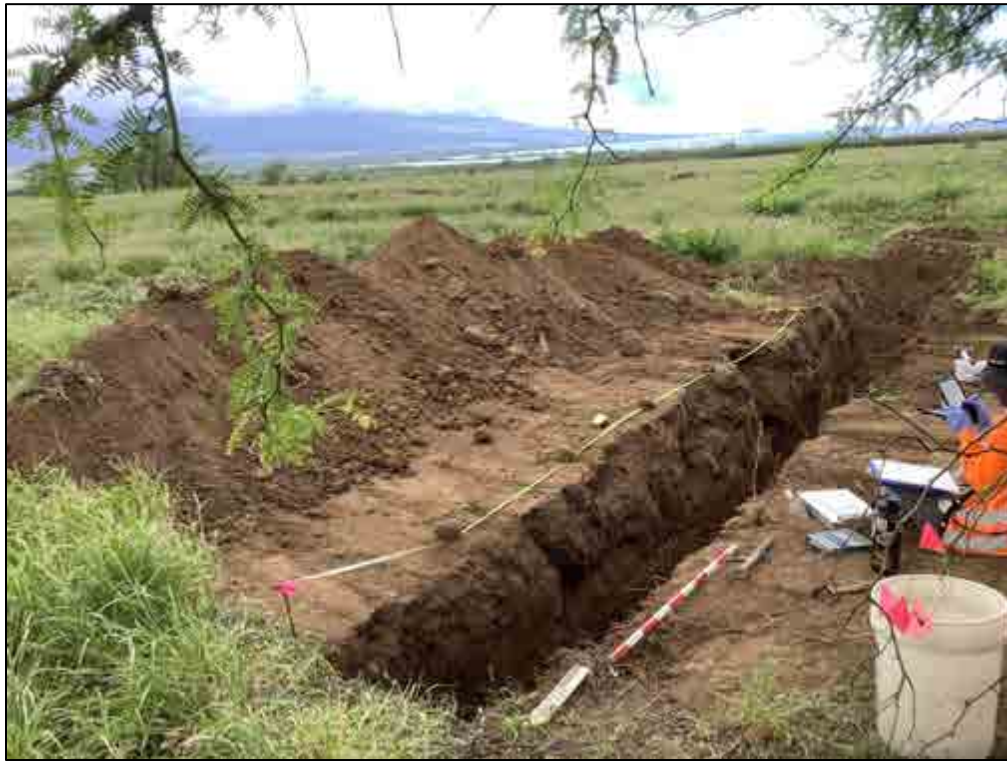
TE-39 was on the western boundary near the northwestern corner of the study area (Figure 163). The excavation was 6.00 m long by 0.80 m wide with a maximum depth of 1.66 mbs. The stratigraphy of TE-39 consisted of a dark brown, gravelly sandy loam Ap horizon (Stratum I) overlying dark brown, natural silty clay loam (Stratum II); a gray, natural sand stream deposit (Stratum III); and dark yellowish brown, natural silt loam (Stratum IV) (Figure 164 through Figure 166 and Table 39). No cultural materials were observed.

Figure 163. TE-39, overview of the general location, view to southeast

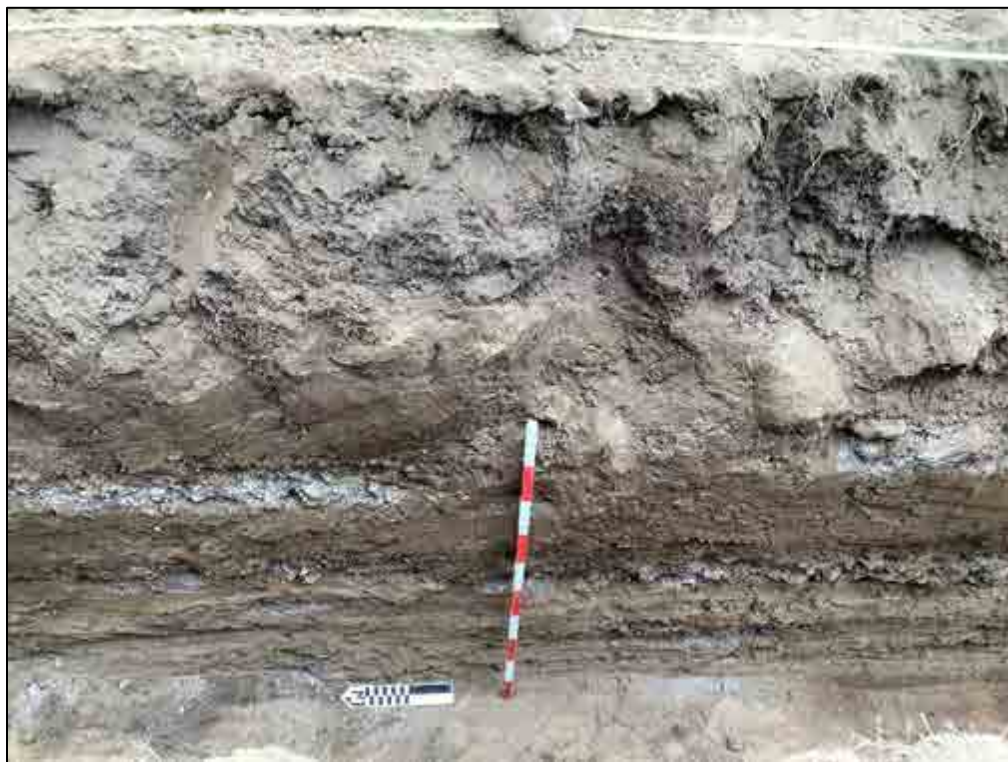
Figure 165. TE-39, close-up of the east wall, view to east

Stratum	Depth (cmts)	Description
I	0–76	Ap horizon; 7.5YR 3/2, dark brown; gravelly sandy loam; moderate, fine granular structure; moist, very friable consistence; no cementation; non-plastic; terrigenous origin; many fine roots; clear, wavy lower boundary; contained fine to coarse mottles of 10YR 3/3, dark brown; silt loam
II	47–113	Natural; 7.5YR 3/3, dark brown; silty clay loam; moderate, fine granular structure; moist, friable consistence; no cementation; plastic; terrigenous origin; clear, smooth lower boundary
III	90–124	Natural; 10YR 5/1, gray; extremely gravelly sand; weak, coarse granular structure; moist, loose consistence; no cementation; non-plastic; terrigenous origin; abrupt, broken lower boundary; stream deposit with basalt pebbles
IV	105–166	Natural; 10YR 4/4, dark yellowish brown; silt loam; weak, very fine granular structure; moist, friable consistence; no cementation; slightly plastic; terrigenous origin; lower boundary not observed; contained fine to coarse mottles of 10YR 3/4, dark yellowish brown, gravelly silt loam and fine mottles of 5YR 3/3, dark reddish brown, silty clay loam

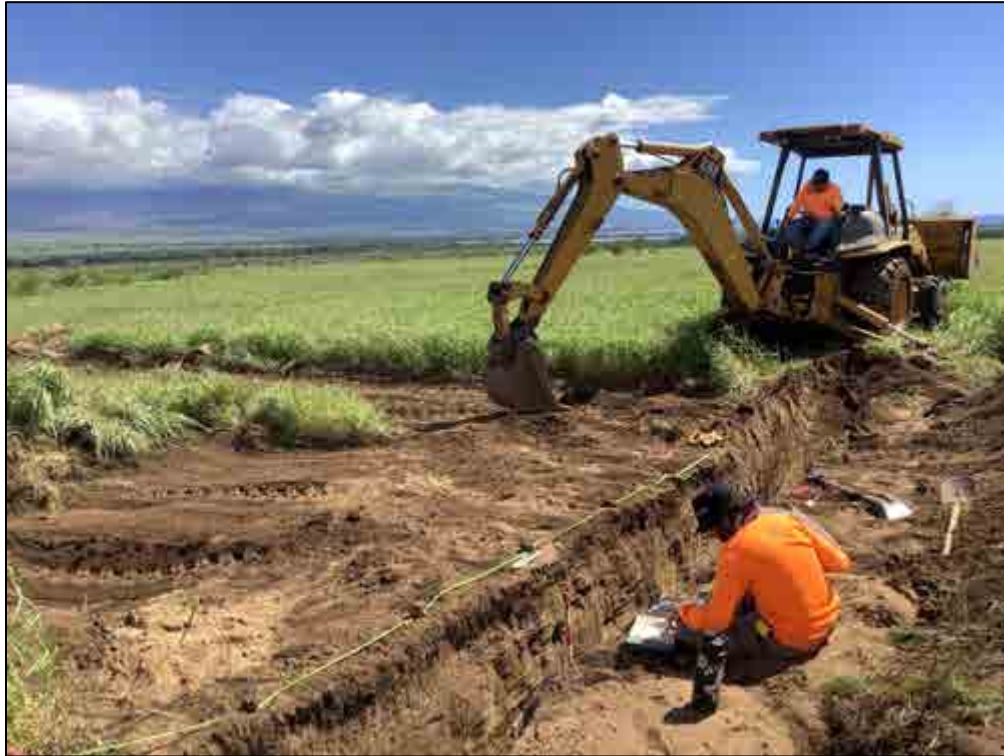
TE-40 was in the northwestern quadrant of the study area (Figure 167). The excavation was 6.00 m long by 0.80 m wide with a maximum depth of 1.26 mbs. The stratigraphy of TE-40 consisted of a very dark brown, silty clay loam Ap horizon mottled with dark yellowish brown, sand (Stratum I) and dark yellowish brown, sand fill (Stratum II) overlying dark brown, natural gravelly silty clay loam mottled with brown silt loam (Stratum III) (Figure 168 through Figure 170 and Table 40). No cultural materials were observed.

Figure 167. TE-40, overview of the general location, view to southeast

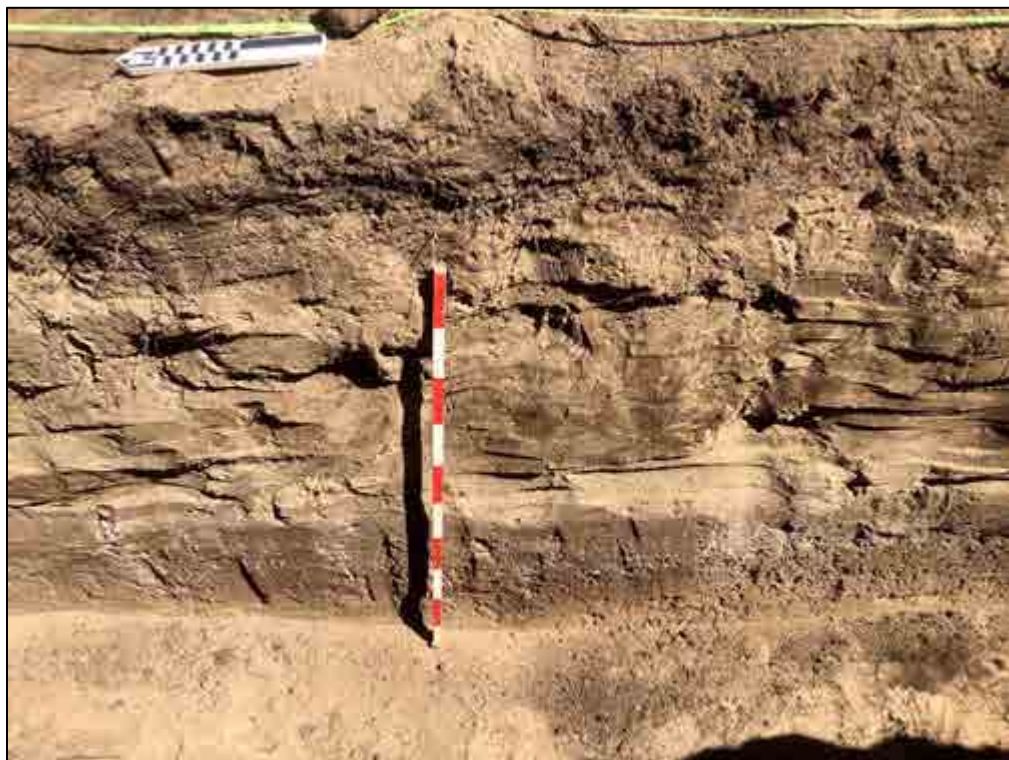
Figure 169. TE-40, close-up east wall, view to east

Stratum	Depth (cmbs)	Description
I	0–22	Ap horizon; 7.5YR 2.5/2, very dark brown; silty clay loam; moderate, fine granular structure; moist, friable consistence; plastic; terrigenous origin; many fine roots; gradual, smooth lower boundary; contained fine to coarse mottles of 10YR 4/4, dark yellowish brown, marine sand
II	15–90	Fill; 10YR 4/4, dark yellowish brown; sand; structureless (single grain); moist, loose consistence; weak cementation; mixed origin; few fine roots; abrupt, smooth lower boundary; contained fine to coarse mottles of 7.5YR 2.5/2, very dark brown, silty clay loam
III	70–126	Natural; 10YR 3/3, dark brown; gravelly silty clay loam; moderate, very fine granular structure; moist, friable consistence; terrigenous origin; plastic; lower boundary not observed; contained fine to coarse mottles of 10YR 4/3, brown, silt loam

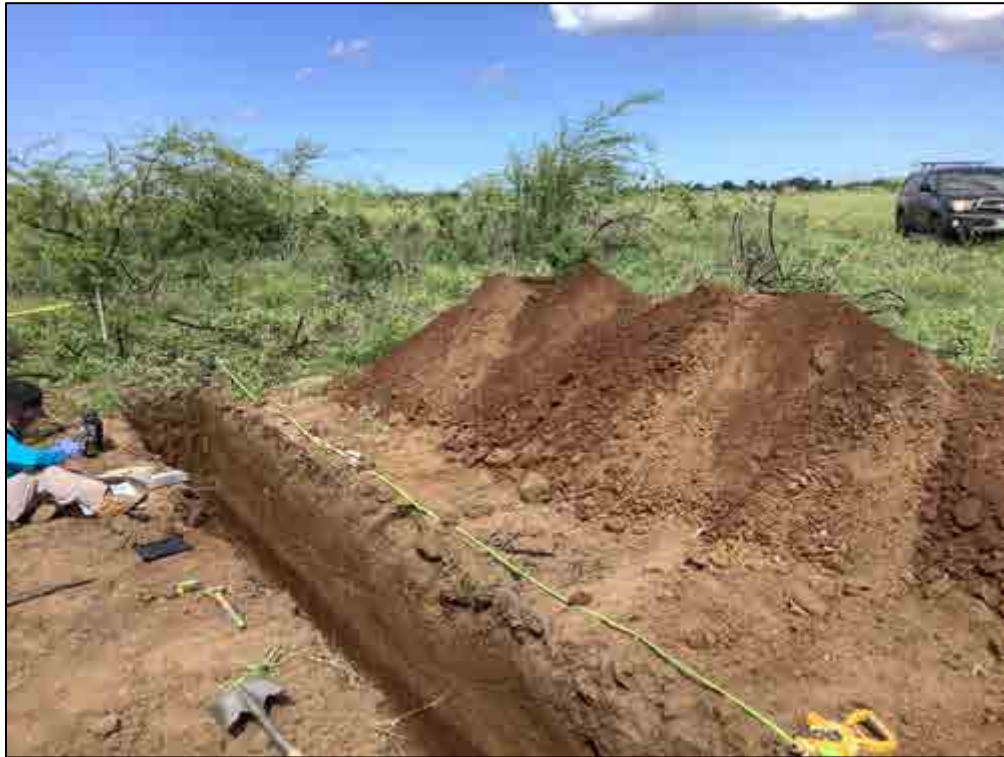
TE-41 was located in the northwestern portion of the study area (Figure 171). The excavation was 6.00 m long by 0.80 m wide with a maximum depth of 1.25 mbs. The stratigraphy of TE-41 consisted of a dark brown, gravelly sandy loam Ap horizon (Stratum I) overlying two layers of dark brown, natural silty clay loam (Strata II and III) and dark reddish brown, natural silty clay loam mottled with dark reddish brown, silt loam (Stratum IV) (Figure 172 through Figure 174 and Table 41). No cultural materials were observed.

Figure 171. TE-41, overview of the general location, view to northeast

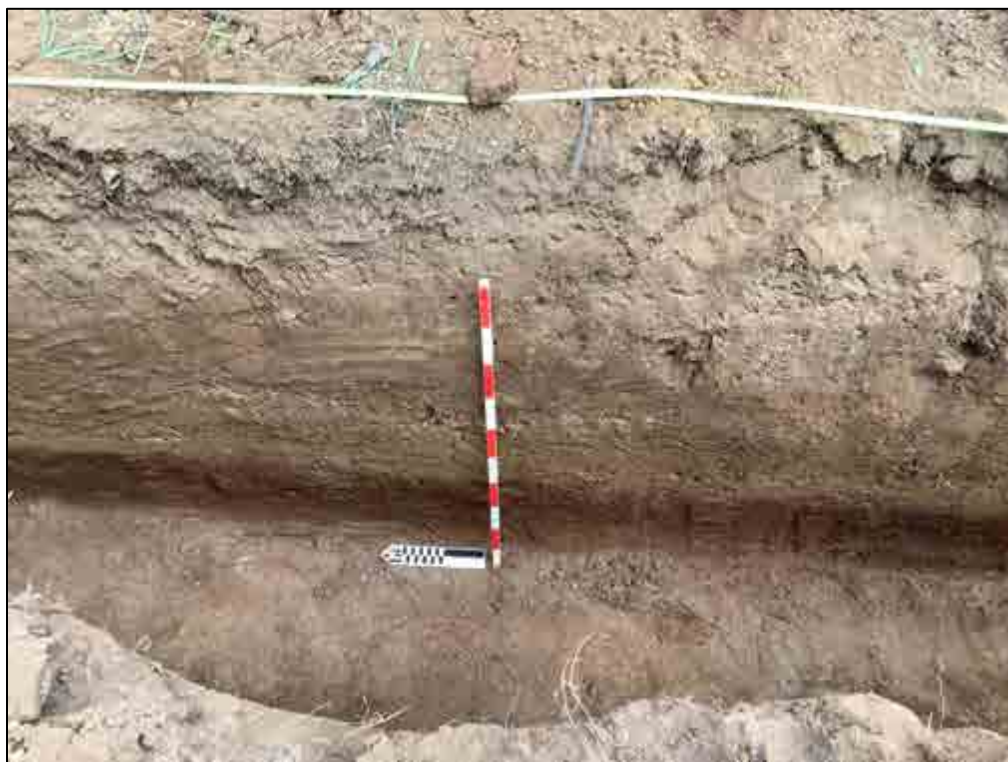
Figure 173. TE-41, close-up of the east wall, view to east

Stratum	Depth (cmbs)	Description
I	0–44	Ap horizon; 7.5YR 2.5/2, very dark brown; gravelly sandy loam; moderate, fine blocky structure; moist, friable consistence; no cementation; non-plastic; terrigenous origin; many fine to medium roots; clear, wavy lower boundary
II	20–75	Natural; 7.5YR 3/3, dark brown; gravelly silty clay loam; moderate, fine platy structure; moist, friable consistence; no cementation; plastic; terrigenous origin; few fine roots; gradual, smooth lower boundary
III	68–94	Natural; 10YR 3/3, dark brown; silty clay loam; moderate, very fine platy structure; moist, friable consistence; no cementation; plastic; terrigenous origin; abrupt, smooth lower boundary
IV	86–125	Natural; 5YR 2.5/2, dark reddish brown; silt loam; weak, fine granular structure; moist, friable consistence; terrigenous origin; slightly plastic; few fine roots; lower boundary not observed; contained common mottles of 5YR 3/3, dark reddish brown, silt loam in the southern half of the trench

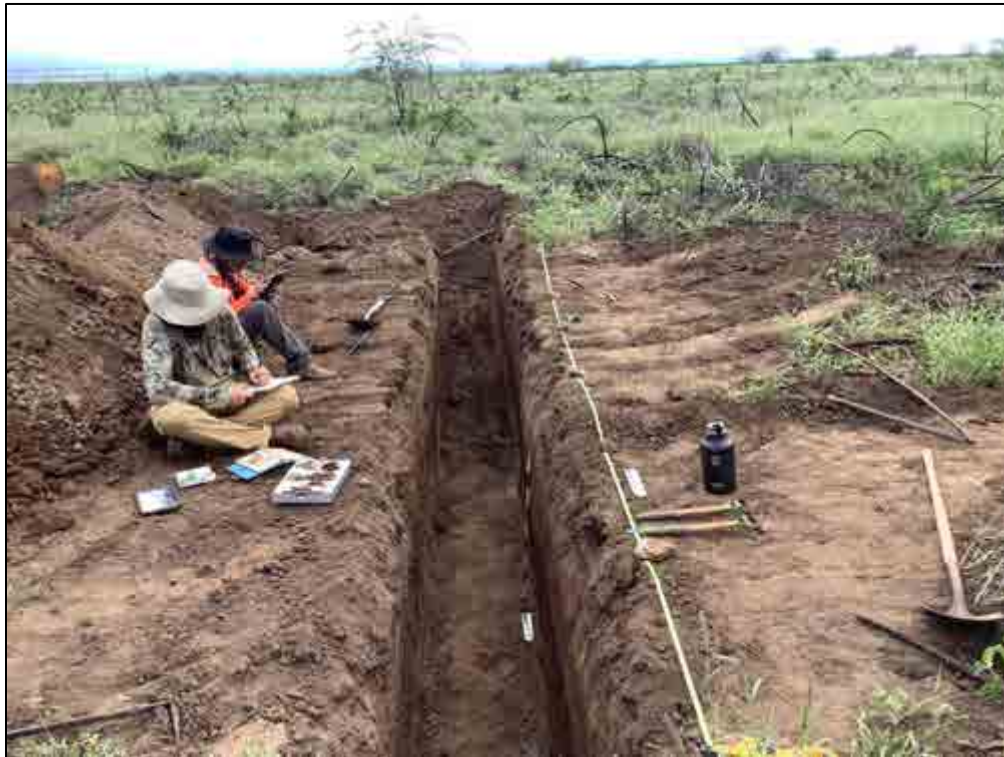
Figure 175. TE-42, overview of the general location, view to northeast

TE-42 was in the northwestern portion of the study area (Figure 175). The excavation was 6.00 m long by 0.80 m wide with a maximum depth of 1.53 mbs. The stratigraphy of TE-42 consisted of a very dark brown, gravelly sandy loam A horizon (Stratum I) overlying dark brown, natural gravelly silty clay loam mottled with dark yellowish brown, silt loam and dark gray stream deposited cobbly sand (Stratum II); dark reddish brown, natural silty clay loam (Stratum III); and gray, natural extremely cobbly stream deposited sand mottled with brown, very gravelly silt loam (Stratum IV) (Figure 176 through Figure 178 and Table 42). No cultural materials were observed.

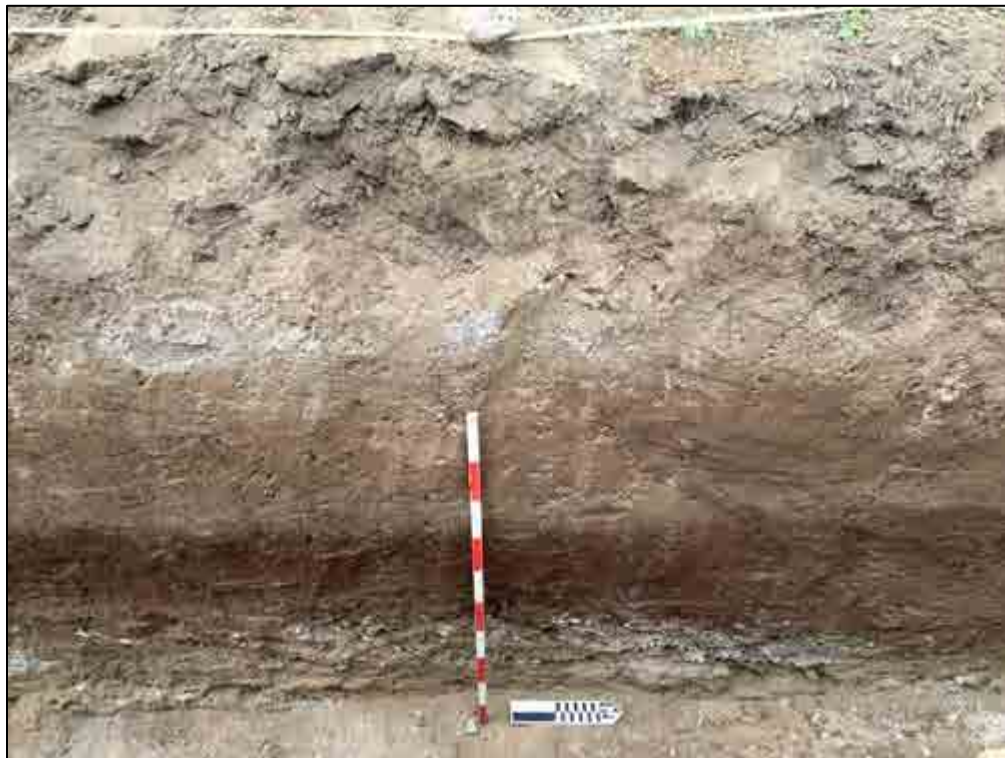
Figure 177. TE-42, close-up of the west wall, view to west

Stratum	Depth (cmts)	Description
I	0–29	Ap-horizon; 7.5YR 2.5/2, very dark brown; gravelly sandy loam; moderate, fine granular structure; dry, weakly coherent consistence; no cementation; slightly plastic; terrigenous origin; many fine roots; clear, smooth lower boundary
II	25–80	Natural; 7.5YR 3/4, dark brown; gravelly silty clay loam; moderate, fine platy structure; moist, friable consistence; no cementation; slightly plastic; terrigenous origin; few fine roots; clear, smooth lower boundary; contained common mottles of 10YR 3/4, dark yellowish brown, silt loam at lower boundary and pockets of 10YR 4/1, dark gray alluvial gravelly sand
III	70–137	Natural; 5YR 3/4, dark reddish brown; silty clay loam; moderate, fine platy structure; moist, friable consistence; no cementation; plastic; terrigenous origin; clear, smooth lower boundary
IV	103–153	Natural; 5YR 5/1, gray; extremely cobbly sand; structureless (single grain); moist, loose consistence; no cementation; non-plastic; terrigenous origin; no roots; lower boundary not observed; stream deposit with basalt pebbles and cobbles; contained bands of 10YR 4/3, brown, silt loam

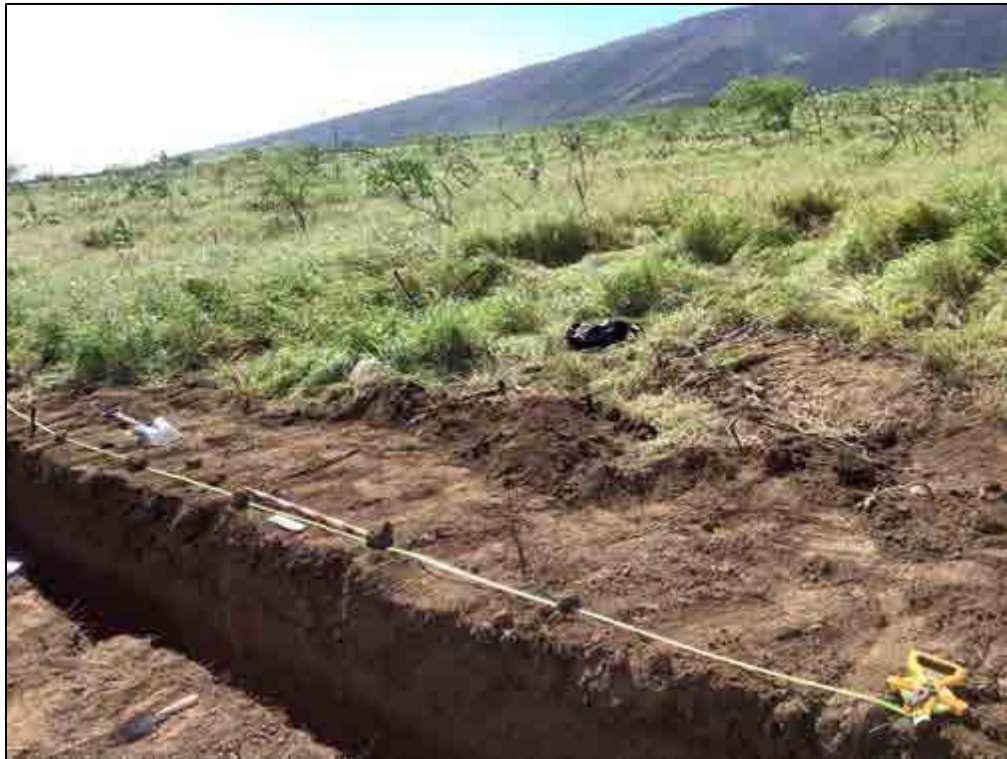
Figure 179. TE-43, overview of the general location, view to southwest

TE-43 was in the central-northern portion of the study area (Figure 179). The excavation was 6.00 m long by 0.80 m wide with a maximum depth of 1.46 mbs. The stratigraphy of TE-43 consisted of five strata: a very dark brown, gravelly sandy loam Ap horizon (Stratum I) overlying dark brown, natural very gravelly silt loam (Stratum II); brown, natural very gravelly silt loam (Stratum III); dark yellowish brown, natural gravelly silt loam with mottles of dark reddish brown, silt loam (Stratum IV); and dark brown, natural gravelly silt loam (Stratum V) (Figure 180 through Figure 182 and Table 43). No cultural materials were observed.

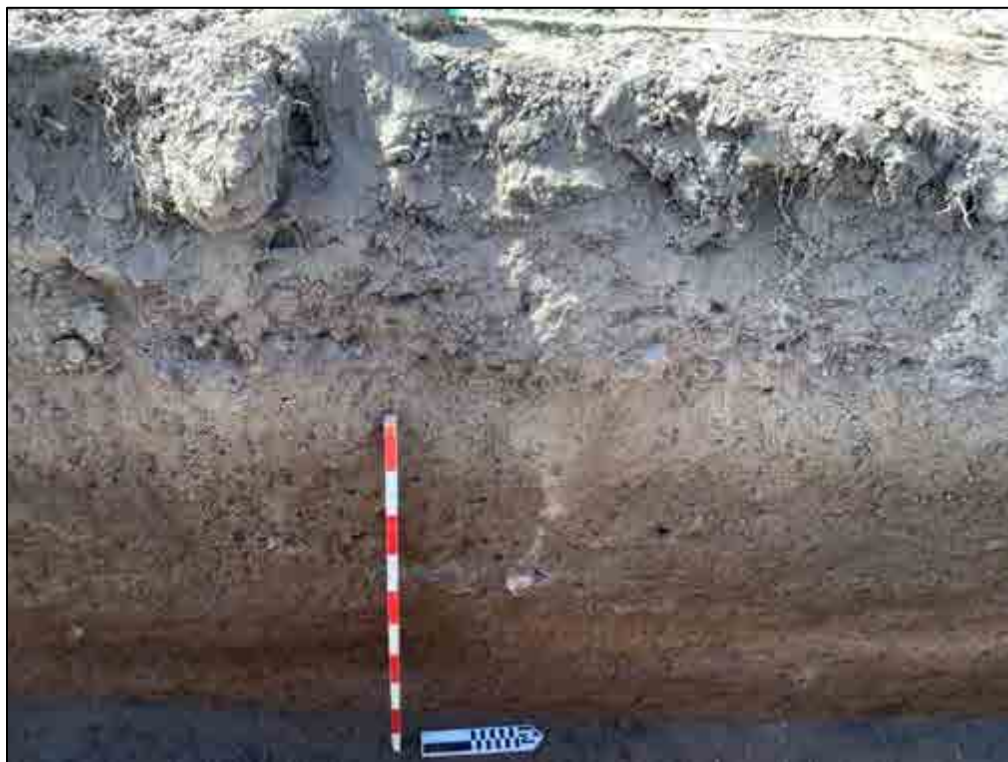
Figure 181. TE-43, close-up of the west wall, view to west

Stratum	Depth (cmbs)	Description
I	0–44	Ap horizon; 7.5YR 2.5/2, very dark brown; gravelly sandy loam; weak, fine granular structure; moist, loose consistence; no cementation; non-plastic; terrigenous origin; many fine to medium roots; clear, smooth lower boundary
II	37–60	Natural; 10YR 3/3, dark brown; very gravelly silt loam; weak, fine granular structure; moist, friable consistence; no cementation; slightly plastic; terrigenous origin; few fine roots; clear, smooth lower boundary
III	52–107	Natural; 7.5YR 4/4, brown; very gravelly silt loam; weak, fine granular structure; moist, friable consistence; no cementation; plastic; terrigenous origin; few fine roots; clear, smooth lower boundary
IV	86–140	Natural; 10YR 4/4, dark yellowish brown; gravelly silt loam; weak, very fine granular structure; moist, friable consistence; no cementation; slightly plastic; terrigenous origin; no roots; clear, smooth lower boundary; contains very coarse mottles of 5YR 3/3, dark reddish brown, silt loam

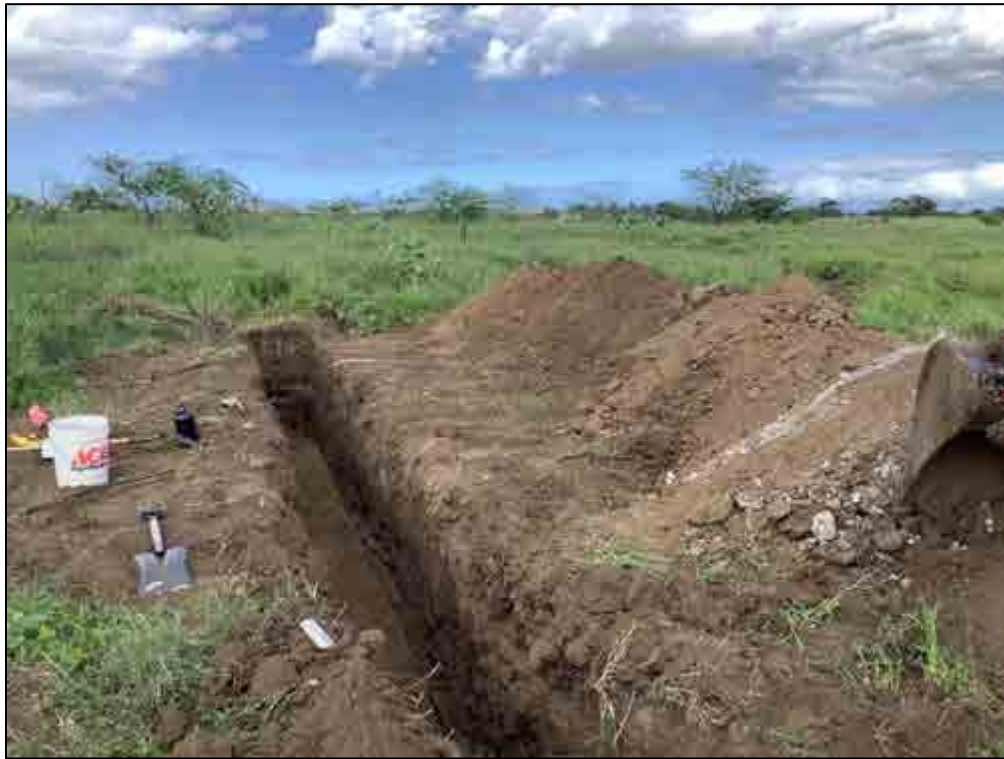
TE-44 was in the central-northern portion of the study area (Figure 183). The excavation was 6.00 m long by 0.80 m wide with a maximum depth of 1.50 mbs. The stratigraphy of TE-44 consisted of a very dark brown, gravelly sandy loam Ap horizon mottled with gray stream-deposited cobbly sand (Stratum I) overlying dark brown, natural gravelly silt loam mottled with gray stream-deposited cobbly sand (Stratum II) and a brown, natural gravelly silt loam (Stratum III) (Figure 184 through Figure 186 and Table 44). No cultural materials were observed.

Figure 183. TE-44, overview of the general location, view to northeast

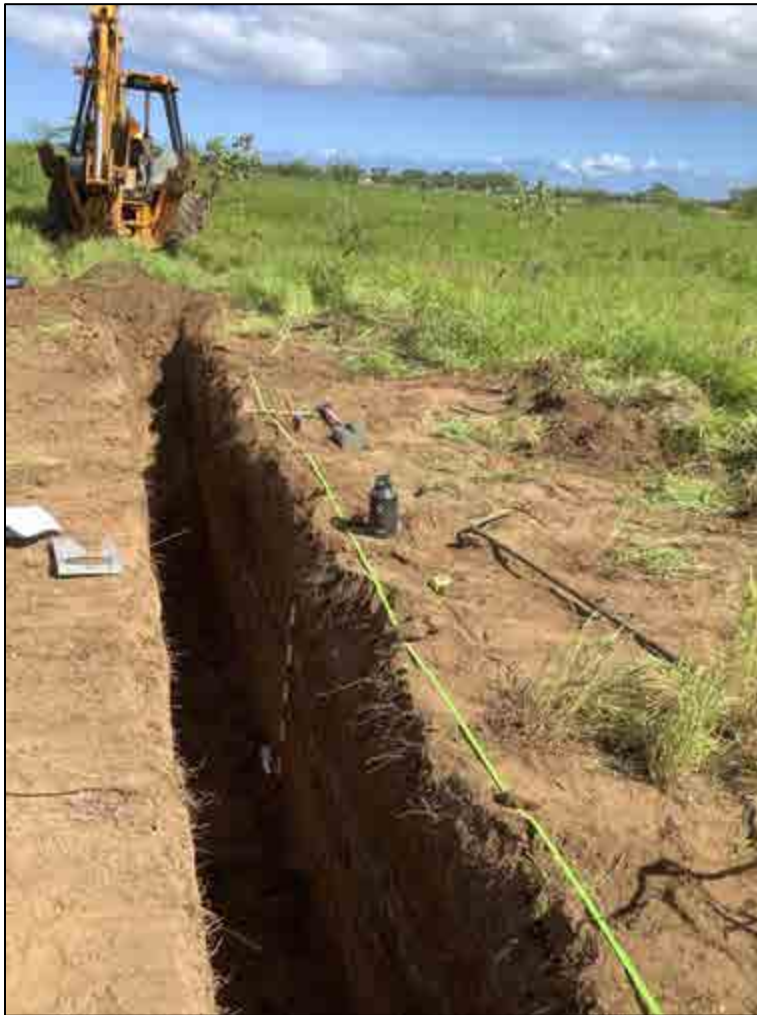
TE-45 was within the central-northern portion of the study area (Figure 187). The excavation was 6.00 m long by 0.80 m wide with a maximum depth of 1.60 mbs. The stratigraphy of TE-45 consisted of a very dark brown, very gravelly sandy loam Ap horizon (Stratum I) overlying brown, natural very gravelly silt loam mottled with gray stream-deposited extremely cobbly sand (Stratum II) and brown, natural very gravelly silt loam (Stratum III) (Figure 188 through Figure 190 and Table 45). No cultural materials were observed.

Figure 187. TE-45, overview of the general location, view to northeast

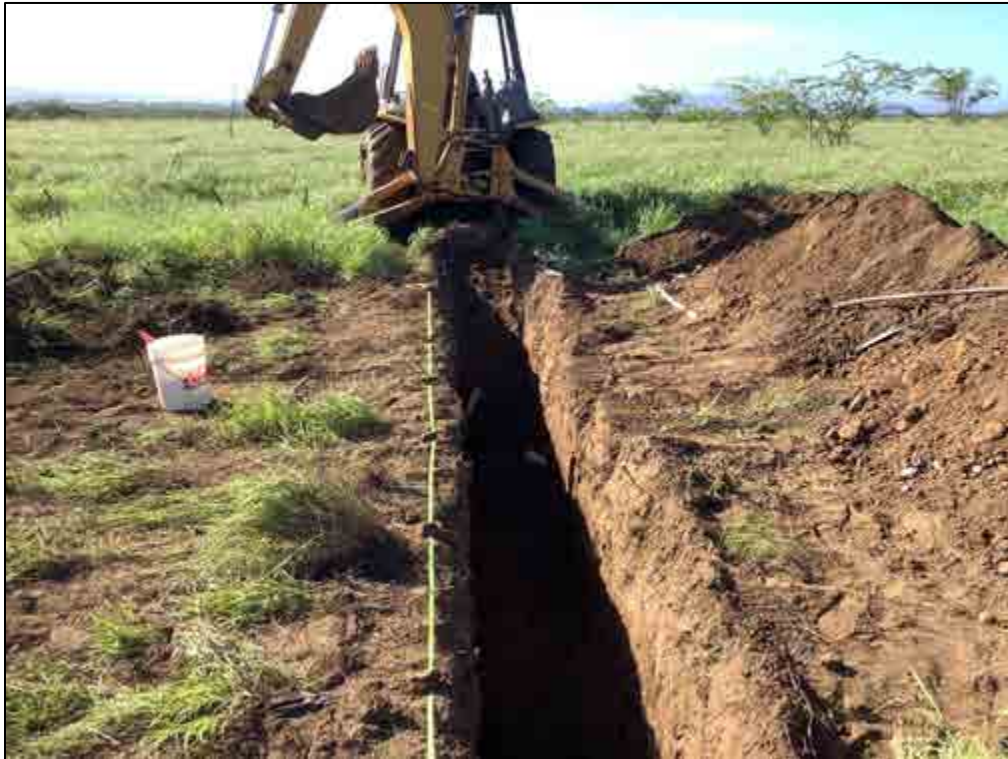
Figure 191. TE-46, overview of the general location, view to south

TE-46 was in the northeastern portion of the study area (Figure 191). The excavation was 6.00 m long by 0.80 m wide with a maximum depth of 1.28 mbs. The stratigraphy of TE-46 consisted of a dark yellowish brown, gravelly sandy loam Ap horizon mottled with dark yellowish brown sand (Stratum I) overlying a utility fill pit surrounding two pipes at the southern end of the trench (Stratum II); and brown, natural gravelly silty clay loam (Stratum III); gray, natural extremely gravelly stream-deposited sand (Stratum IV); and brown, natural silt loam (Stratum V) (Figure 192 through Figure 194 and Table 46). No cultural materials were observed.

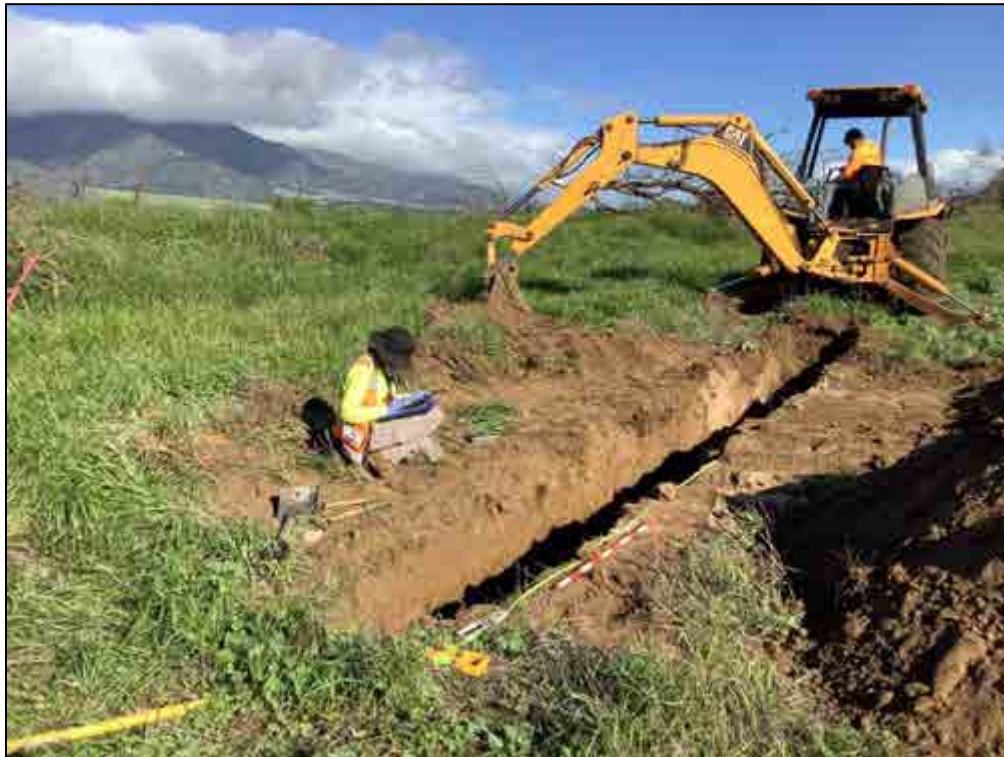
TE-47 was in the northeastern portion of the study area (Figure 195). The location is 10 m east of a drainage and soil berm. The excavation was 6.00 m long by 0.80 m wide with a maximum depth of 1.45 mbs. The stratigraphy of TE-47 consisted of four strata: a dark brown, sandy clay loam Ap horizon (Stratum I) overlying two layers of dark yellowish brown, natural silty clay loam (Strata II and III) and light brown, natural sand (Stratum IV) (Figure 197 through Figure 198 and Table 47). No cultural materials were observed.

Figure 195. TE-47, overview of the general location, view to northwest

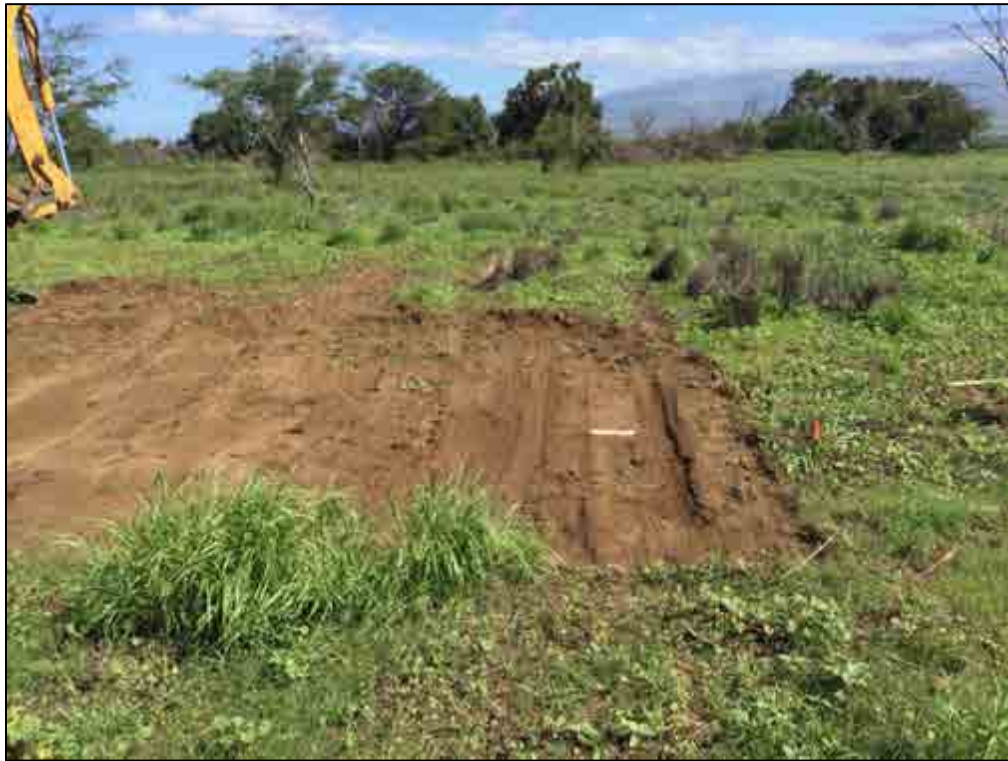
TE-48 was near the eastern border of the northern quadrant of the study area (Figure 199). The excavation was 6.00 m long by 0.80 m wide with a maximum depth of 1.62 mbs. The stratigraphy of TE-48 consisted of a dark reddish brown, sandy clay loam Ap horizon (Stratum I) and dark brown, previously disturbed natural silty clay loam (Stratum II) overlying brown, natural silt loam (Stratum III) (Figure 201 through Figure 202 and Table 48). Stratum II contained common inclusions of stream deposited pebbles and sand. No cultural materials were observed.

Figure 199. TE-48, overview of the general location, view to east
