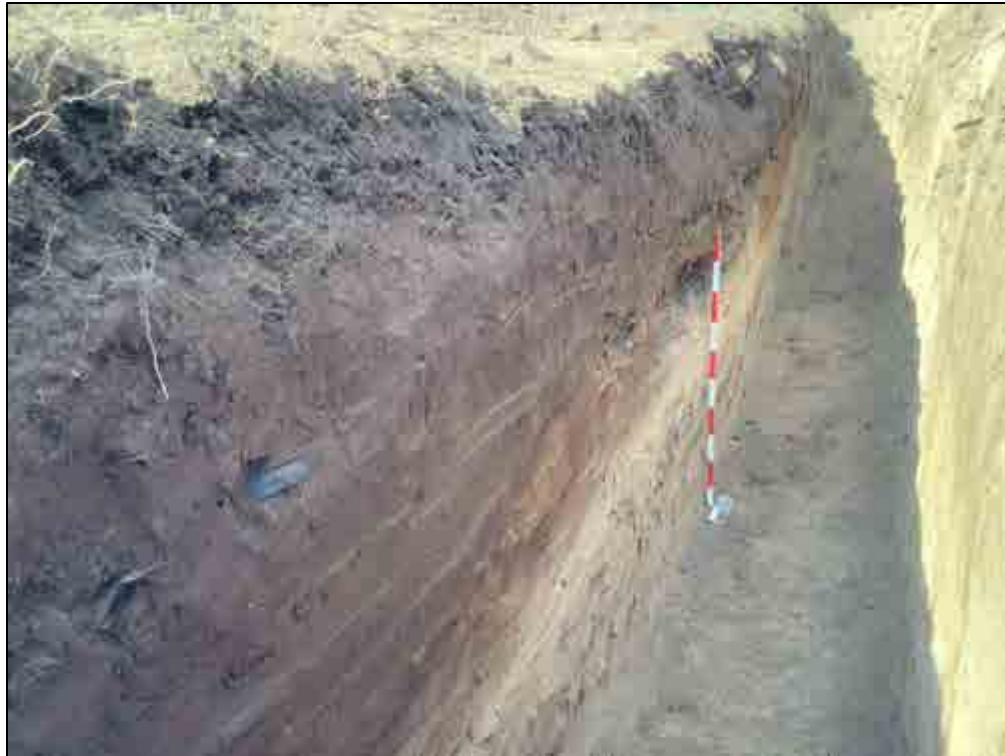
Figure 200. TE-48, oblique view of the west wall, view to northwest

TE-48 was near the eastern border of the northern quadrant of the study area (Figure 199). The excavation was 6.00 m long by 0.80 m wide with a maximum depth of 1.62 mbs. The stratigraphy of TE-48 consisted of a dark reddish brown, sandy clay loam Ap horizon (Stratum I) and dark brown, previously disturbed natural silty clay loam (Stratum II) overlying brown, natural silt loam (Stratum III) (Figure 201 through Figure 202 and Table 48). Stratum II contained common inclusions of stream deposited pebbles and sand. No cultural materials were observed.

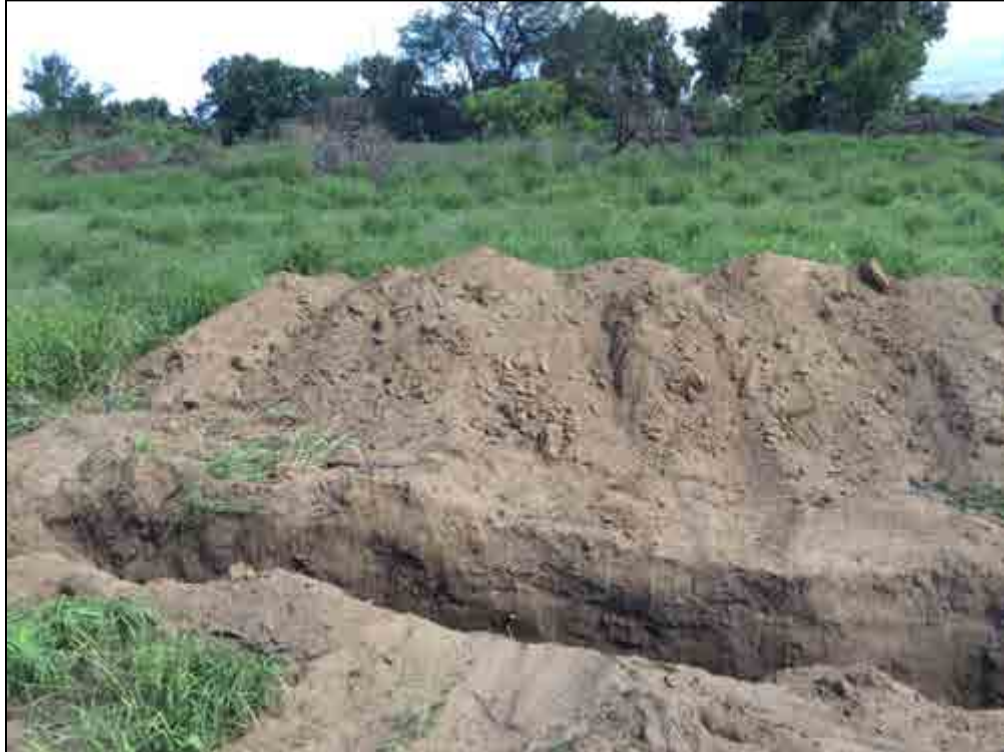
TE-49 was along the eastern border in the northeastern portion of the study area (Figure 203). The excavation was 6.00 m long by 0.80 m wide with a maximum depth of 1.85 mbs. The stratigraphy of TE-49 consisted of a brown, gravelly sandy clay loam Ap horizon (Stratum I) overlying dark brown, natural silty clay loam (Stratum II); and brown, natural silt loam (Stratum III) (Figure 205 through Figure 206 and Table 49). No cultural materials were observed.

Figure 203. TE-49, overview of the general location, view to northeast, Waikapu Stream in the background

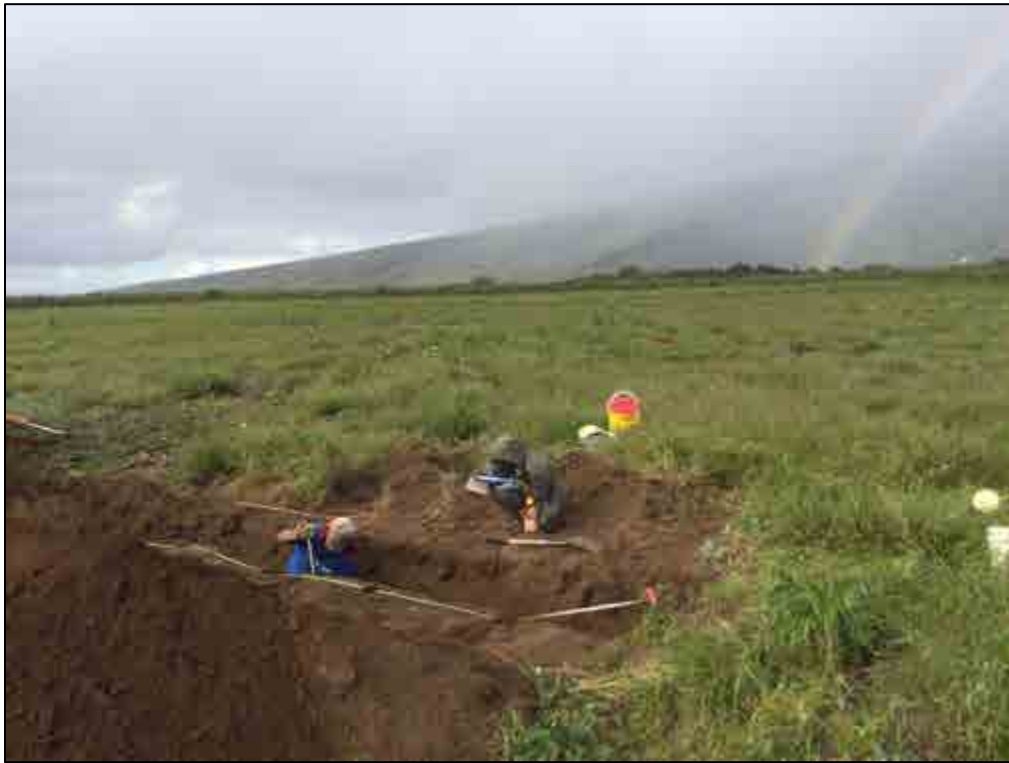
TE-50 is along the western border in the northwestern portion of the study area (Figure 207). The excavation was 6.00 m long by 0.80 m wide with a maximum depth of 1.35 mbs. The stratigraphy of TE-50 consisted of a dark brown, gravelly sandy clay loam Ap horizon (Stratum I) overlying dark reddish brown, natural gravelly silty clay loam (Stratum II); and dark reddish brown, natural gravelly silty clay loam (Stratum III) (Figure 208 through Figure 210 and Table 50). No cultural materials were observed.

Figure 207. TE-50, overview of the general location, view to southwest

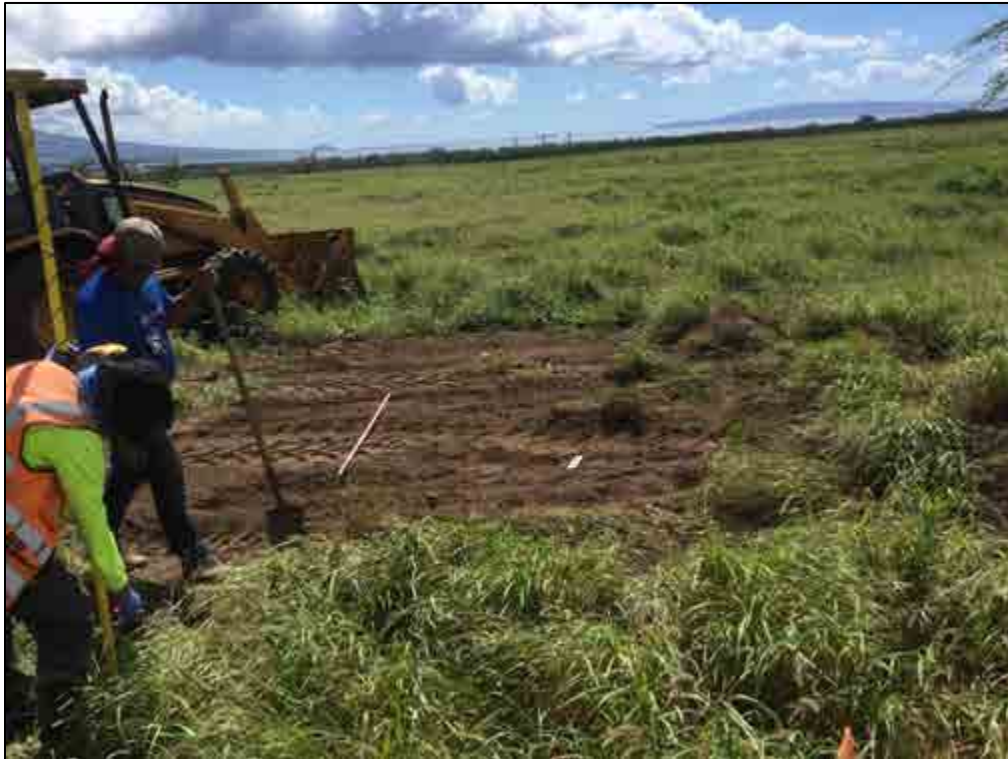
TE-51 was in the northwestern portion of the study area (Figure 211). The excavation was 6.00 m long by 0.80 m wide with a maximum depth of 1.56 mbs. The stratigraphy of TE-51 consisted of a very dark grayish brown, cobbly sandy loam Ap horizon (Stratum I) and gray, extremely cobbly sand fill (Stratum II) overlying dark brown, natural gravelly silty clay loam mottled with dark grayish brown extremely gravelly sand (Stratum III) and dark yellowish brown, natural gravelly silt loam (Stratum IV) (Figure 212 through Figure 214 and Table 51). No cultural materials were observed.

Figure 211. TE-51, overview of the general location, view to north

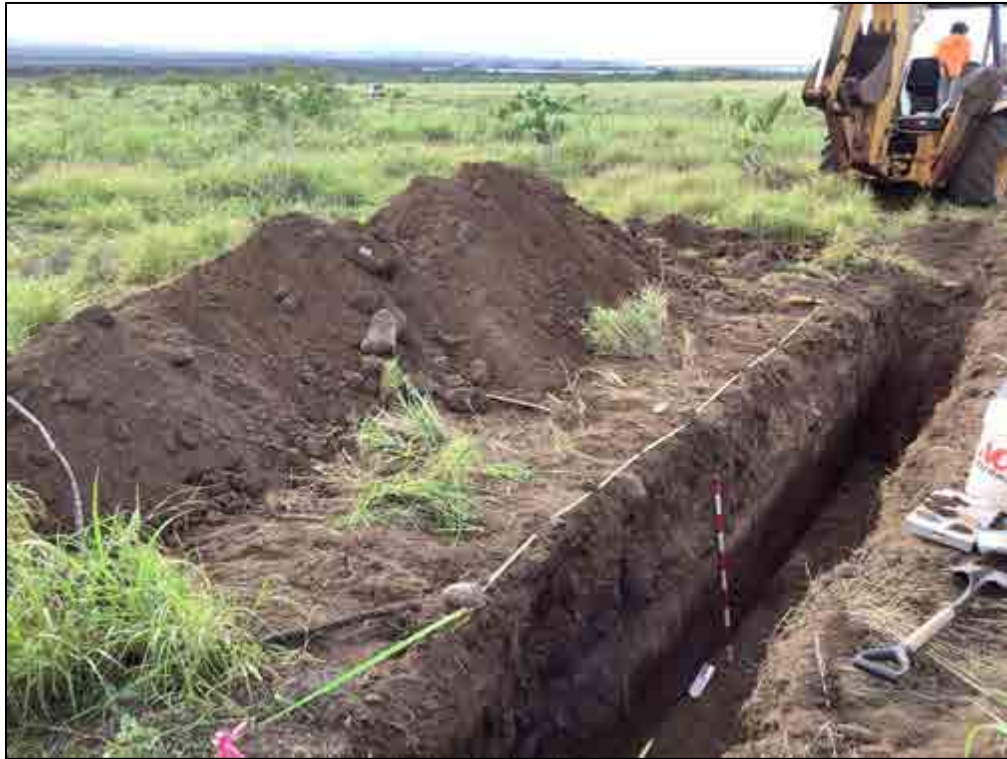
Figure 215. TE-52, overview of the general location, view to southeast

TE-52 was in the northwestern portion of the study area (Figure 215). The excavation was 6.00 m long by 0.80 m wide with a maximum depth of 1.28 mbs. The stratigraphy of TE-52 consisted of a dark yellowish brown, gravelly sandy loam Ap horizon (Stratum I) overlying dark brown, natural gravelly sandy clay loam mottled with dark yellowish brown sand (Stratum II); dark brown, natural extremely stony sandy loam (Stratum III); brown, natural sandy loam (Stratum IV); and dark brown, natural gravelly silty clay loam (Stratum IV) (Figure 216 through Figure 218 and Table 52). No cultural materials were observed.

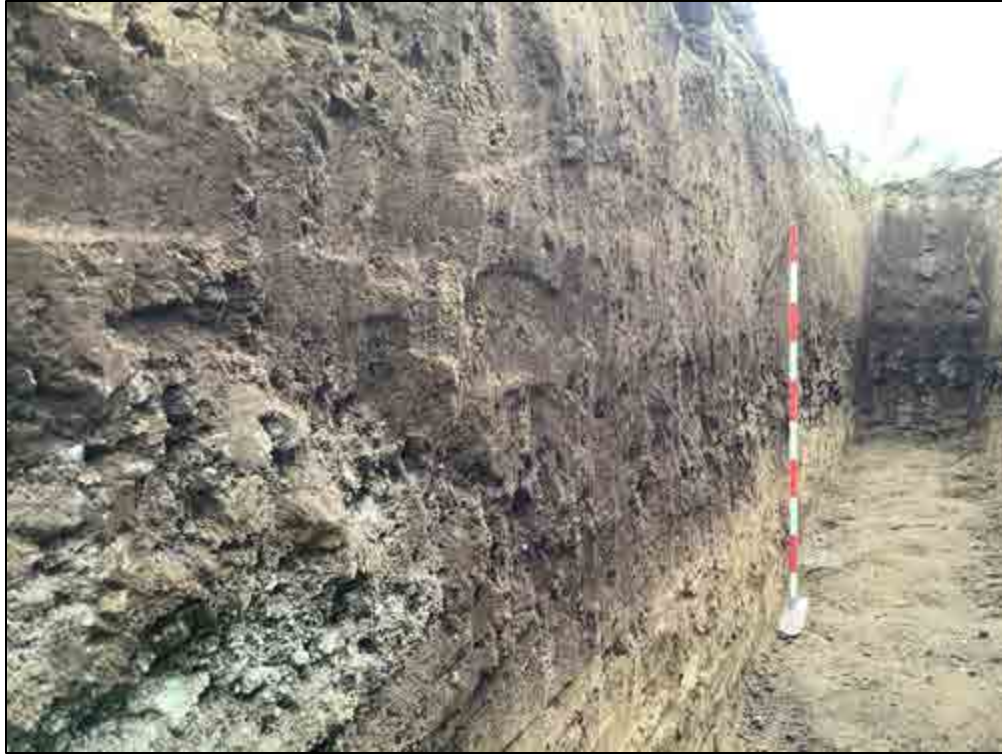
Figure 220. TE-53, oblique view of the east wall, view to southeast

TE-53 was in the northern-central portion of the study area (Figure 219). The excavation was 6.00 m long by 0.80 m wide with a maximum depth of 1.60 mbs. The stratigraphy of TE-53 consisted of a very dark brown, gravelly sandy loam Ap horizon (Stratum I) overlying dark brown, natural gravelly silty clay loam (Stratum II); dark reddish brown, natural gravelly silty clay loam with stream deposit inclusions (Stratum III); a gray, natural extremely cobbly sand stream deposit (Stratum IV); and dark yellowish brown, natural gravelly silt loam (Stratum V) (Figure 220 through Figure 222 and Table 53). No cultural materials were observed.

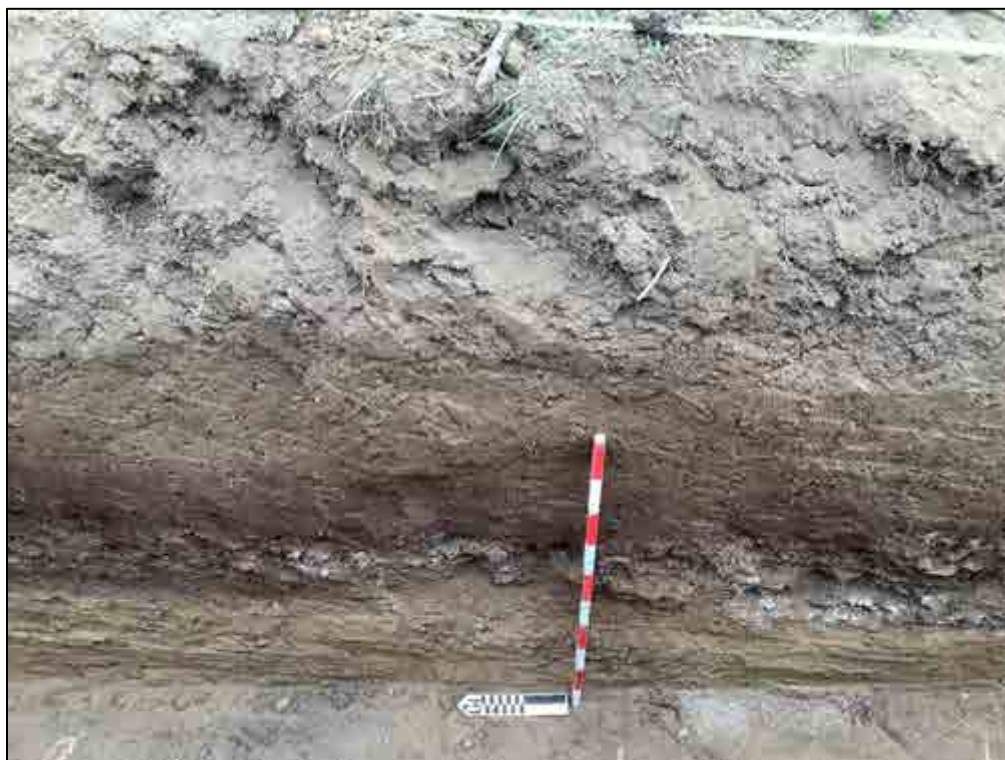
Figure 221. TE-53, close-up of the east wall, view to east

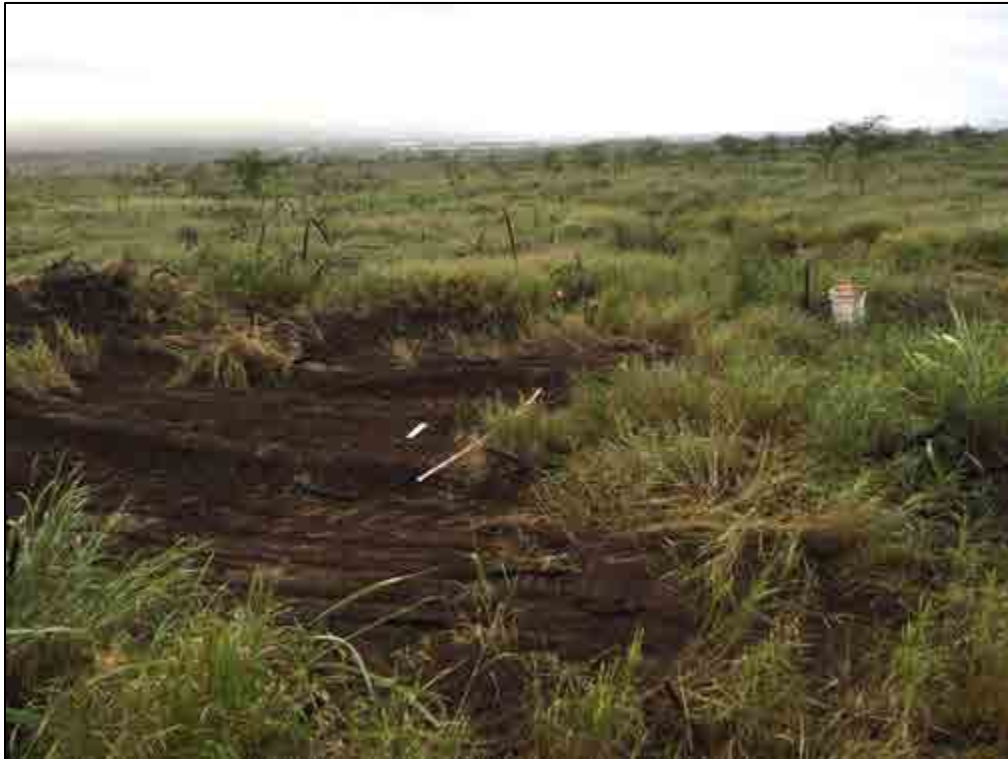
TE-54 was within the northern-central portion of the study area (Figure 223). The excavation was 6.00 m long by 0.80 m wide with a maximum depth of 1.50 mbs. The stratigraphy of TE-54 consisted of a dark brown, gravelly sandy clay loam Ap horizon (Stratum I) and brown, gravelly sand fill mottled with dark gray, gravelly clay loam (Stratum II) overlying dark brown, natural extremely gravelly clay loam (Stratum III); and dark yellowish brown, natural silt loam mottled with dark brown, silt loam (Stratum IV) (Figure 224 through Figure 227 and Table 54). No cultural materials were observed.

Figure 223. TE-54, overview of the general location, view to southwest

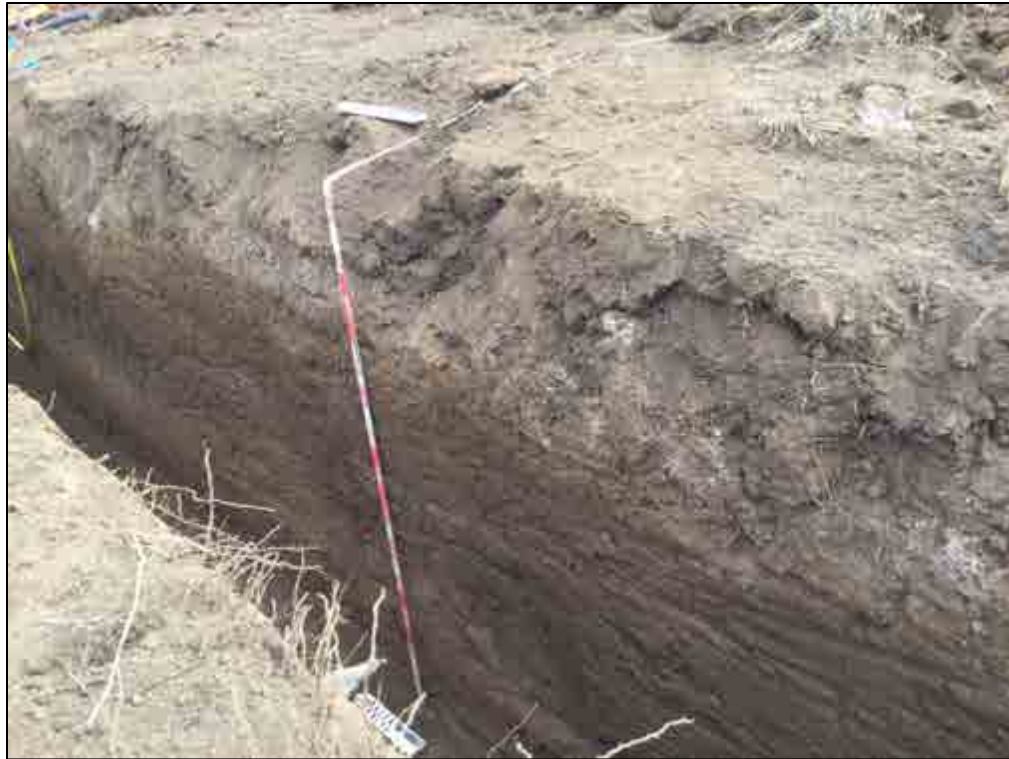
Figure 224. TE-54, oblique view of the east wall, view to northeast

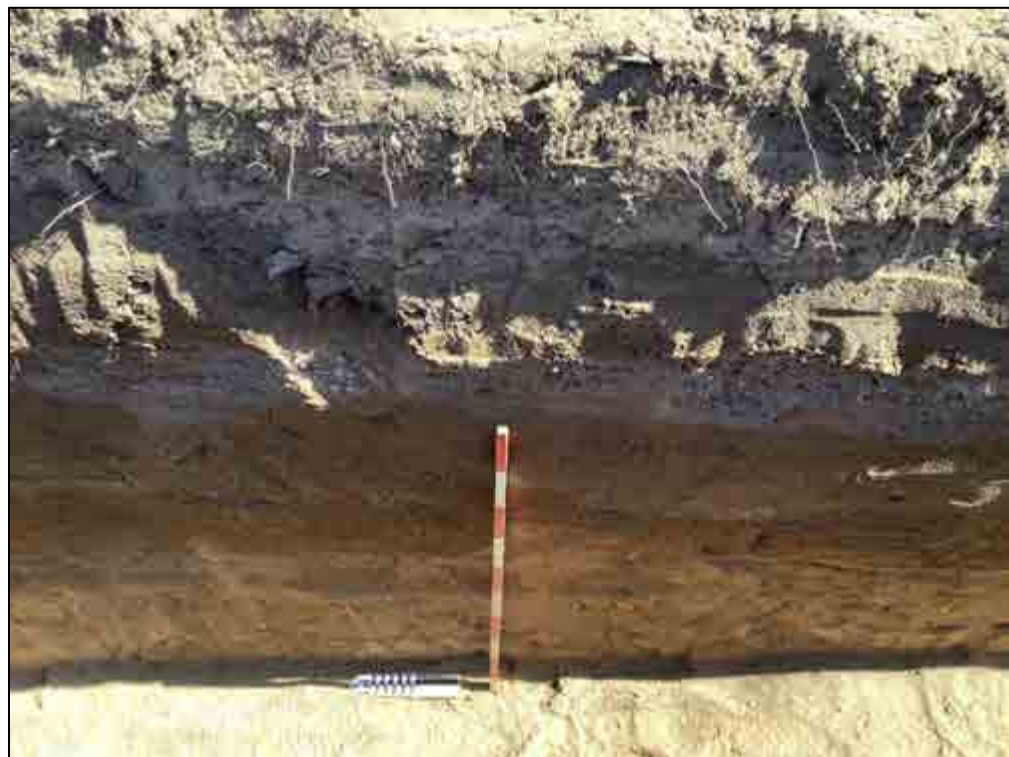
Figure 225. TE-54, close-up of the east wall, view to east

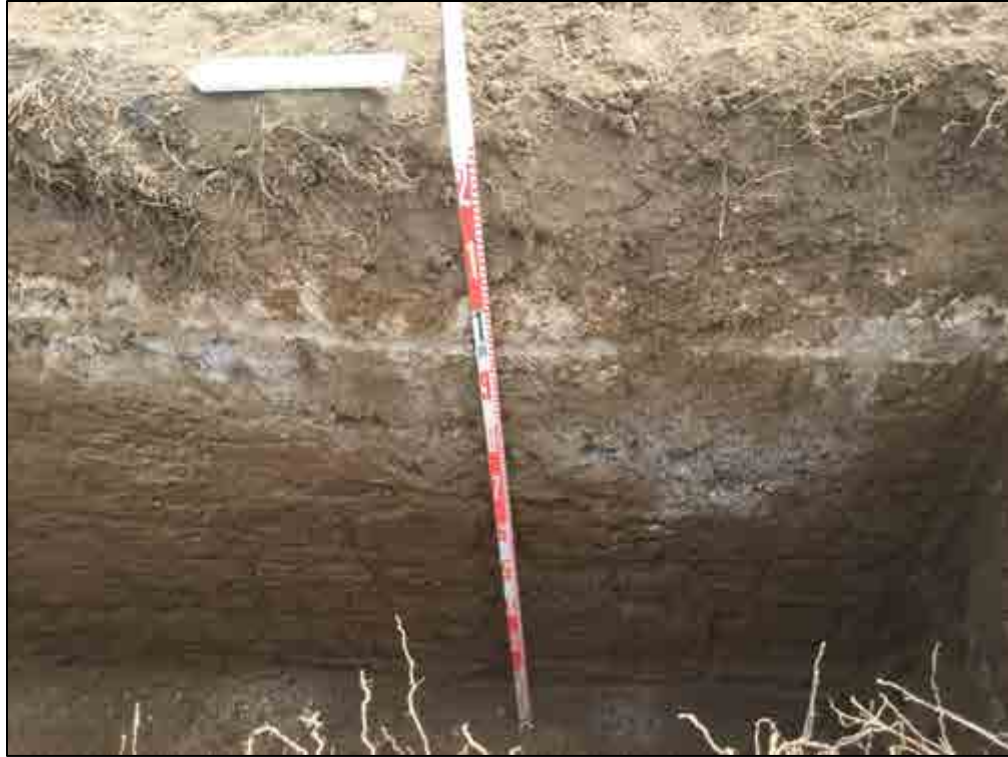
Figure 226. TE-54, close-up of the southern end of the trench, view to east

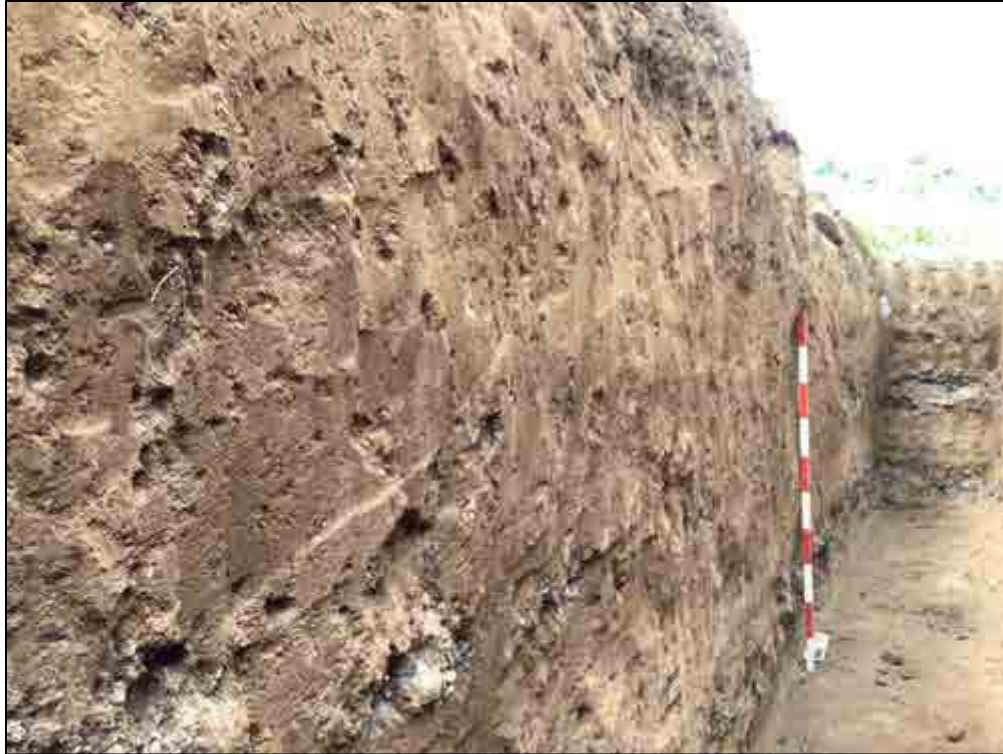
Figure 229. TE-55, oblique view of the east wall, view to north

TE-55 was near the northern-central portion of the study area. The excavation was 6.00 m long by 0.80 m wide with a maximum depth of 1.68 mbs. The stratigraphy of TE-54 consisted of a dark brown, gravelly sandy clay loam Ap horizon (Stratum I) overlying previously disturbed natural gravelly silty clay loam (Stratum II) and natural gravelly silt loam with a stream deposit inclusion (Stratum III) (Figure 229 through Figure 231 and Table 55). Stratum I contained multiple concrete pieces, which were not collected.

TE-64 was in the northern-central portion of the study area (Figure 266). The excavation was 6.00 m long by 0.80 m wide with a maximum depth of 1.50 mbs. The stratigraphy of TE-64 consisted of a very dark grayish brown, gravelly sandy clay loam Ap horizon (Stratum I) overlying dark brown, previously disturbed natural, gravelly silty clay loam (Stratum II) and brown, natural gravelly silt loam with stream deposit inclusions (Stratum III) (Figure 267 and Table 64). No cultural materials were observed. There are no stratigraphy photos available for TE-64. The location is in proximity to excavations TE-55 and TE-56 to the north and TE-65 to the east, which exhibit stratigraphic sequences that are relatively consistent and comparable to TE-64 (see Figure 229, Figure 230, Figure 233, Figure 234, Figure 269 and Figure 270).

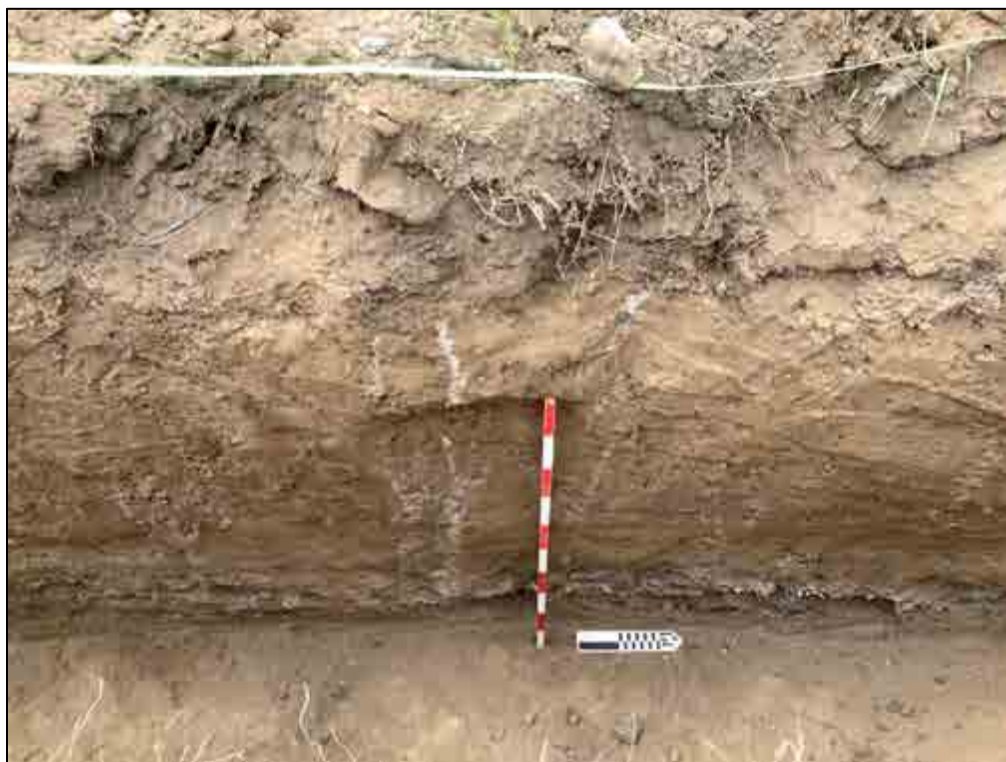
Figure 230. TE-55, close-up of the west wall, view to west

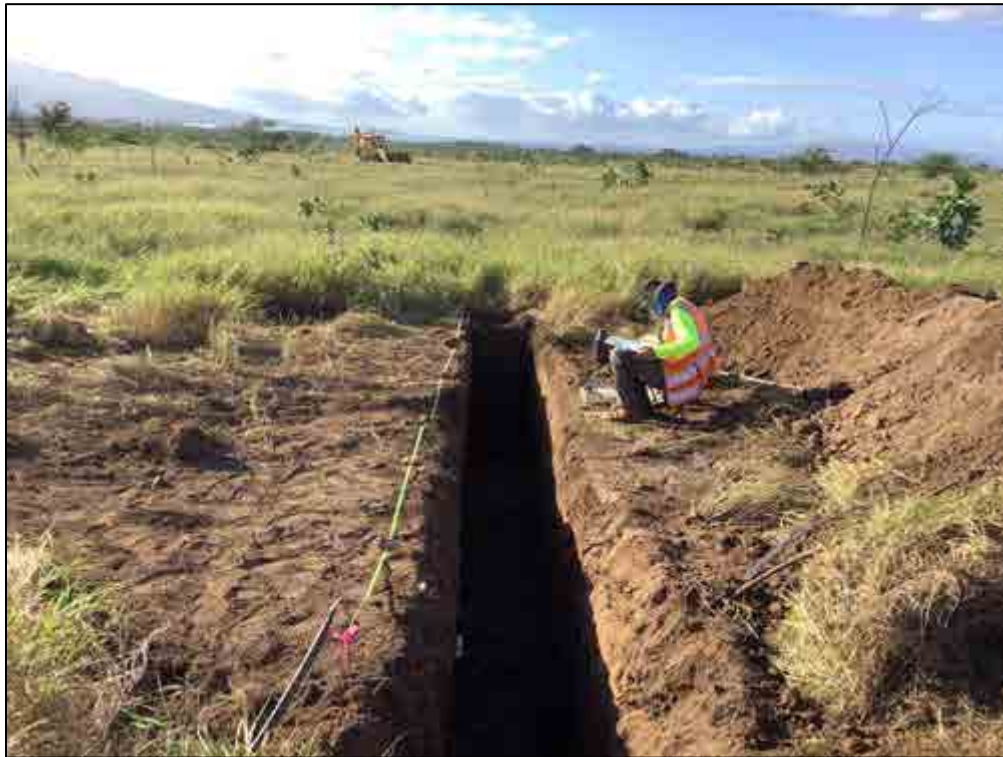
TE-56 was in the northeast portion of the study area (Figure 232). The excavation was 6.00 m long by 0.80 m wide with a maximum depth of 1.52 mbs. The stratigraphy of TE-56 consisted of a dark brown, gravelly sandy clay loam Ap horizon (Stratum I) overlying dark yellowish brown, natural gravelly silty clay loam (Stratum II) and brown, natural gravelly silt loam with gray, very gravelly sand stream deposit inclusions (Stratum III) (Figure 233 through Figure 235 and Table 56). No cultural materials were observed.

Figure 232. TE-56, overview of the general location, view to south

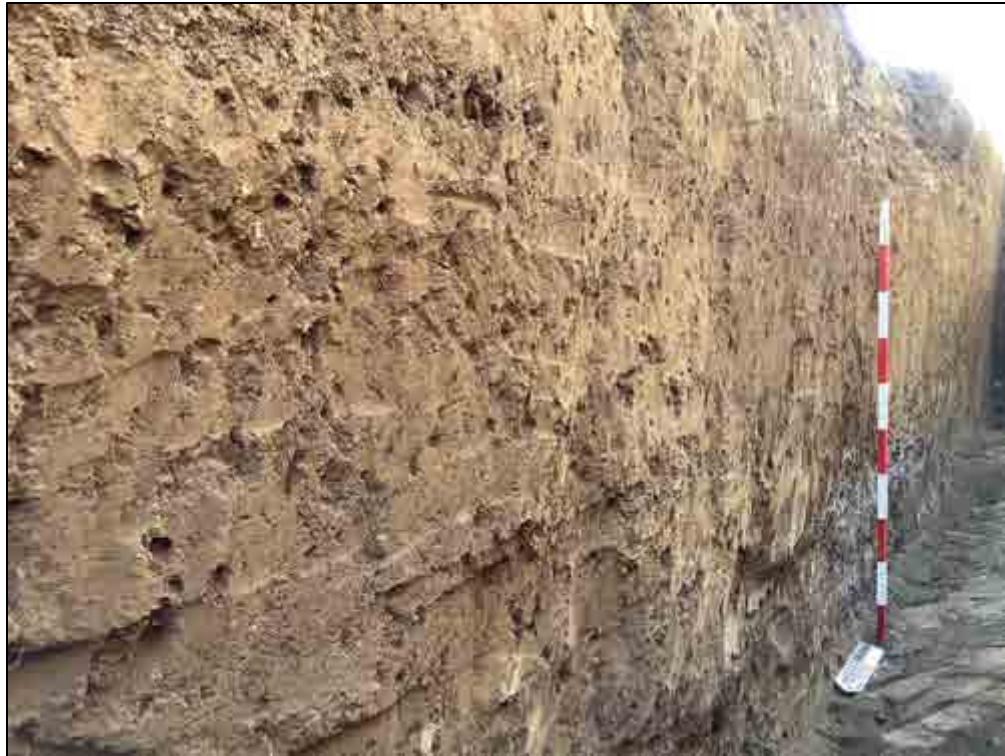
Figure 233. TE-56, oblique view of the east wall, view to south

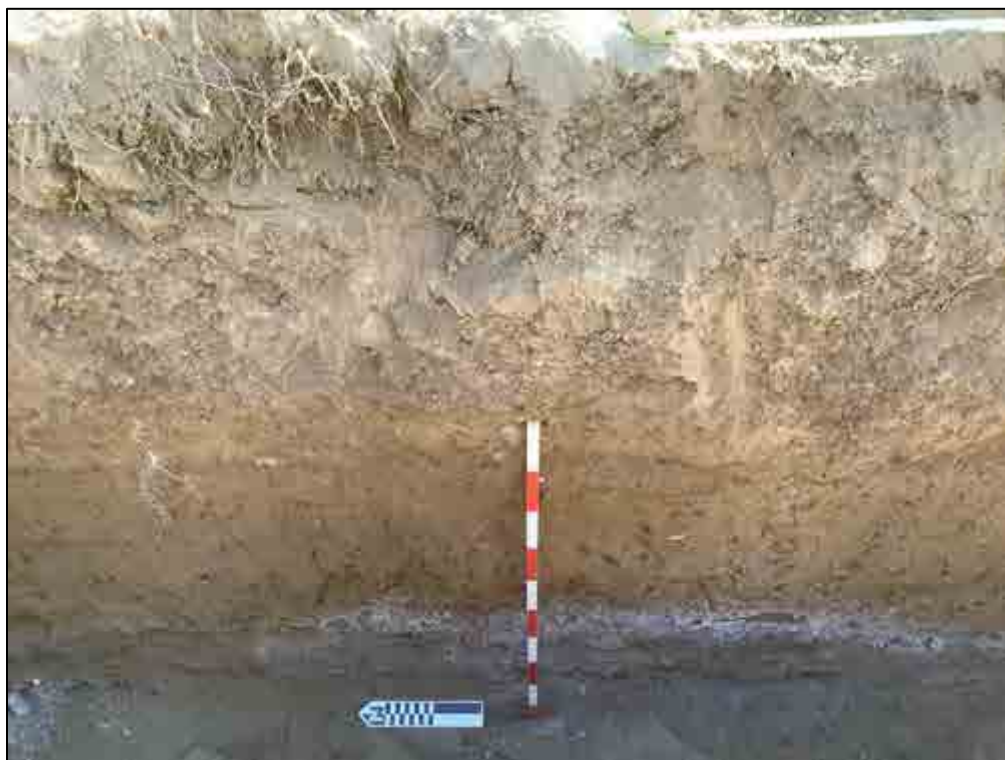
Figure 234. TE-56, close-up of the east wall, view to east

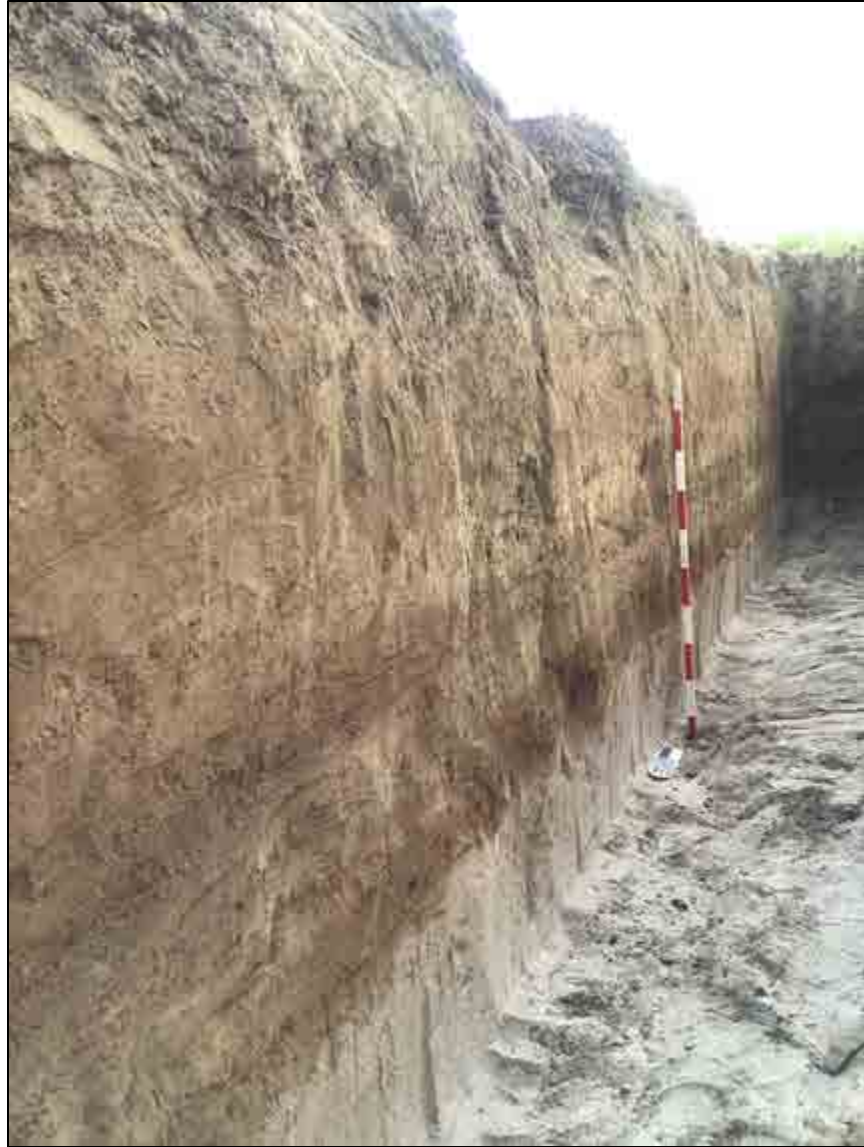
Figure 237. TE-57, oblique view of the east wall, view to southeast

TE-57 was in the northeastern portion of the study area (Figure 236). The excavation was 6.00 m long by 0.80 m wide with a maximum depth of 1.48 mbs. The stratigraphy of TE-57 consisted of a dark yellowish brown, gravelly sandy clay loam Ap horizon (Stratum I) overlying dark yellowish brown, natural silty clay loam (Stratum II); dark brown, natural silty clay loam (Stratum III); and brown, natural aeolian sand (Stratum IV) (Figure 237 through Figure 239 and Table 57). Sediment variations were included with Stratum II and described as two discontinuous bands of silty clay loam occurring at both the north and south ends of the trench. No cultural materials were observed.

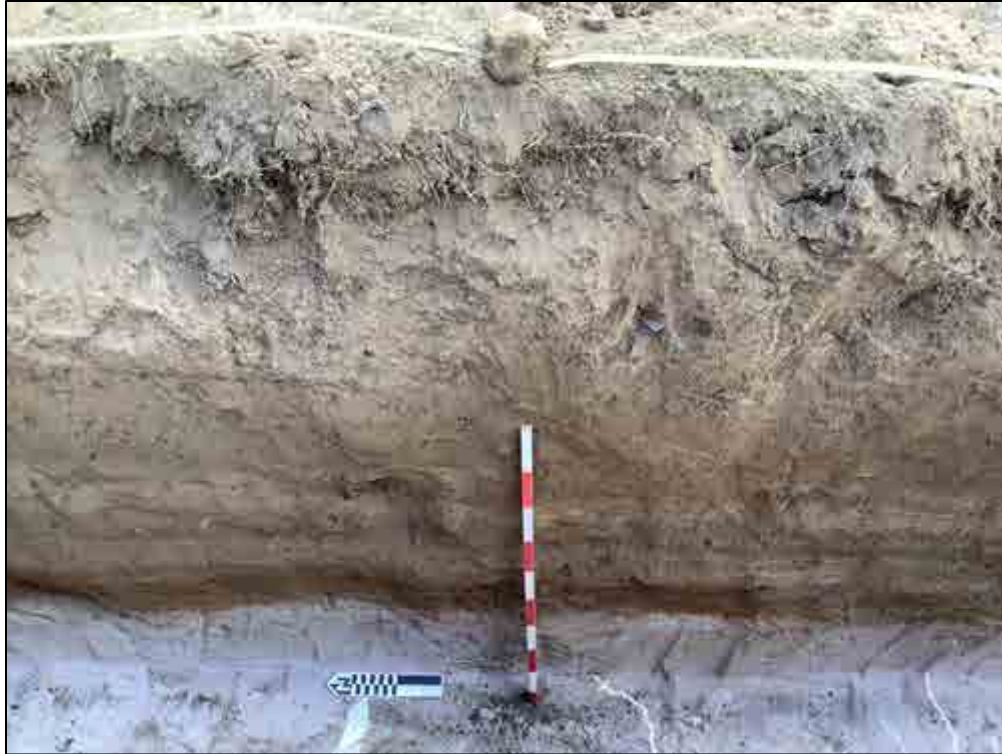
Figure 238. TE-57, close-up of the east wall, view to east

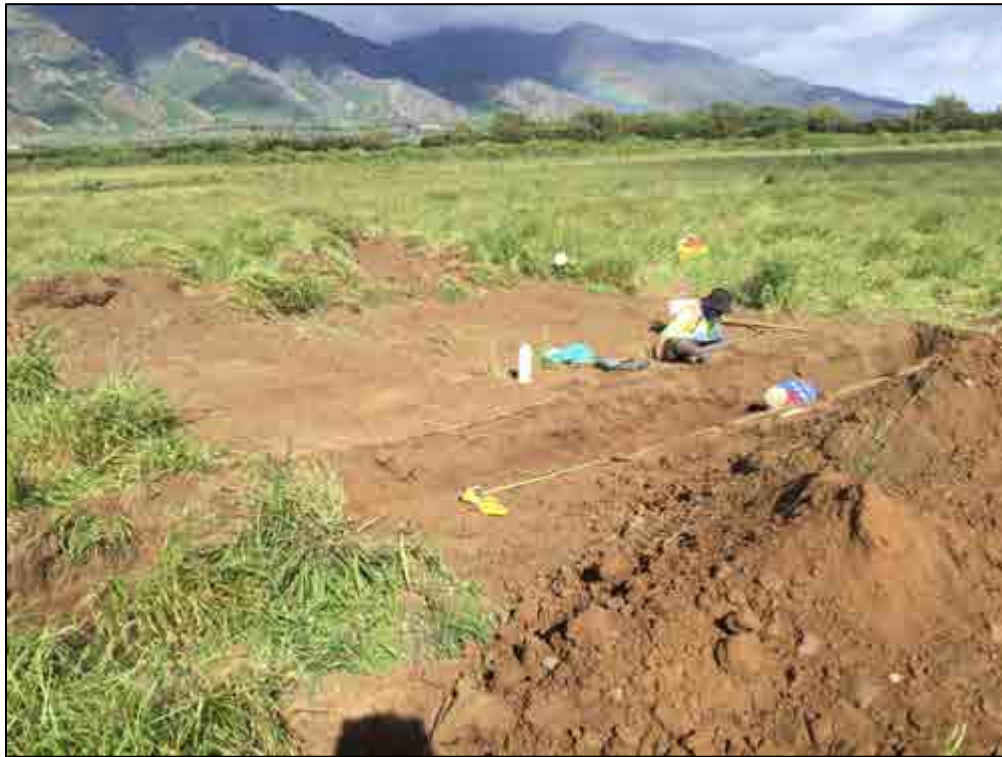
TE-58 was along the northwestern border of the study area (Figure 240). The excavation was 6.00 m long by 0.80 m wide with a maximum depth of 1.44 mbs. The stratigraphy of TE-58 consisted of a very dark brown, gravelly sandy clay loam Ap horizon (Stratum I) overlying dark reddish brown, natural gravelly silty clay loam (Stratum II) and dark brown, natural gravelly silty clay loam (Stratum III) (Figure 241 through Figure 243 and Table 58). No cultural materials were observed.

Figure 240. TE-58, overview of the general location, view to northwest

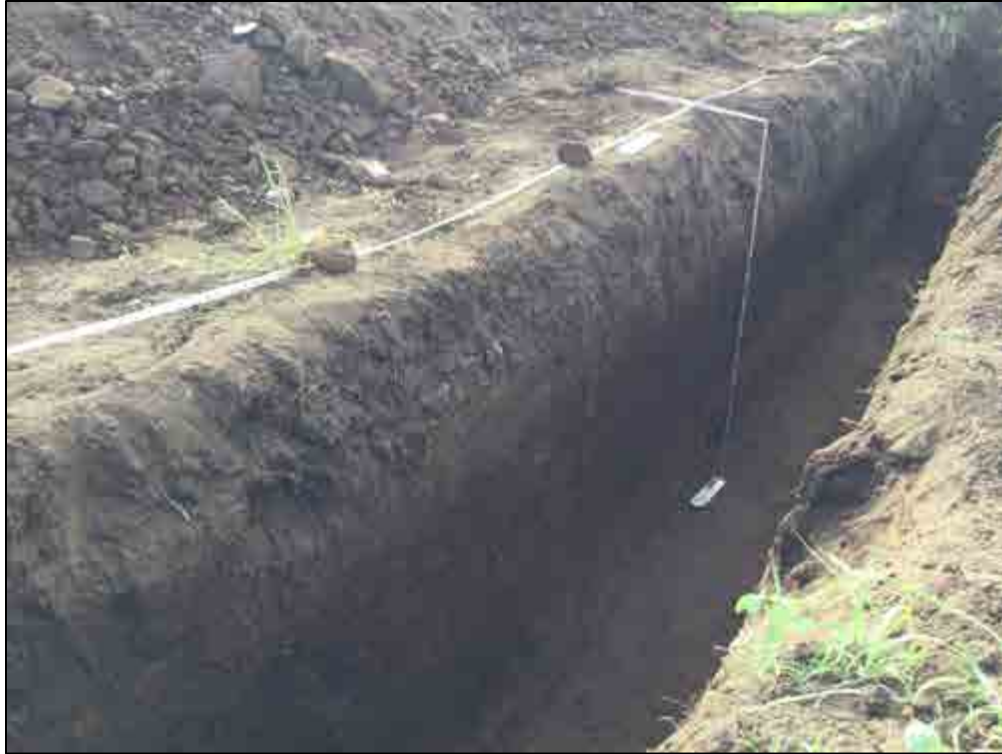
Figure 241. TE-58, oblique view of the east wall, view to southeast

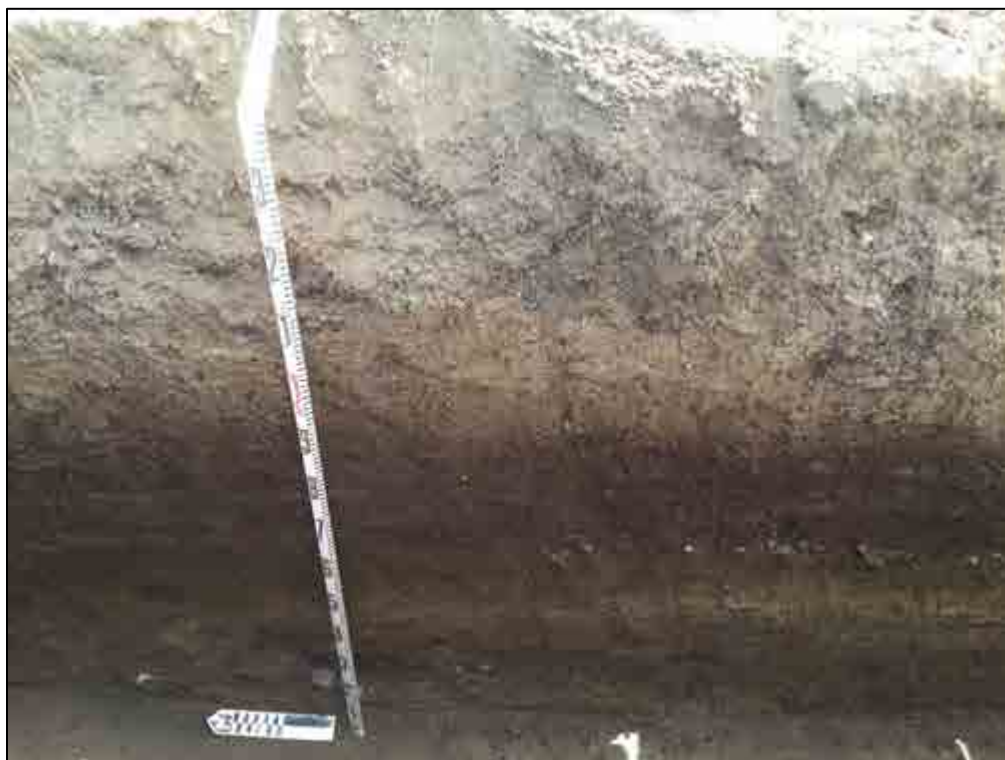
Figure 242. TE-58, close-up of the east wall, view to east

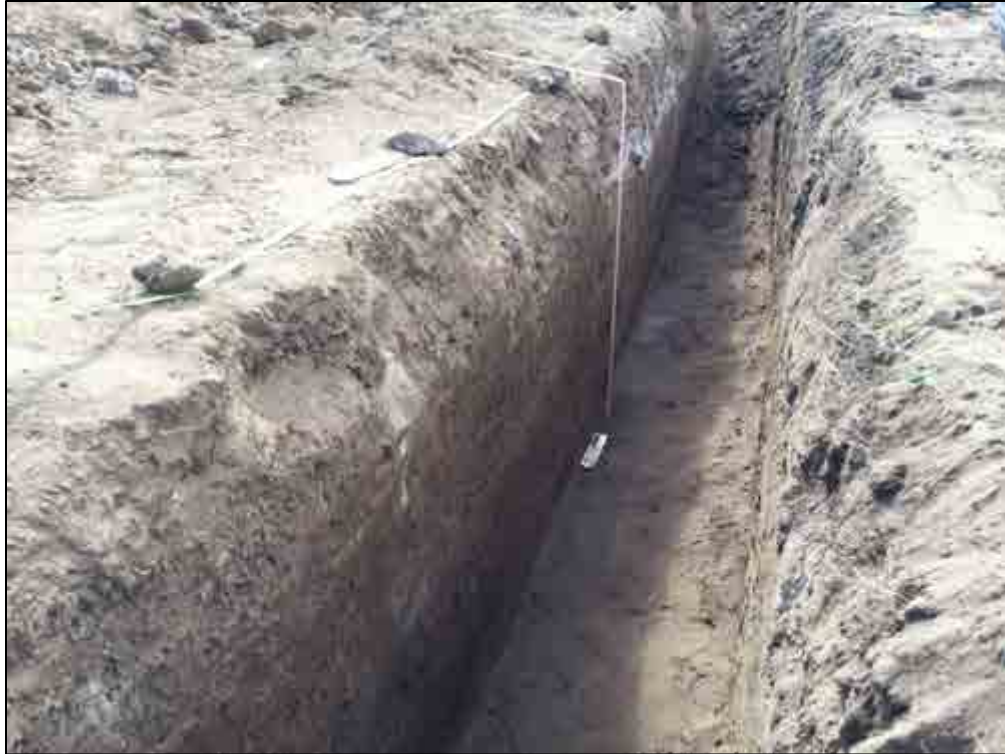
Figure 245. TE-59, oblique view of the east wall, view to southeast

TE-59 was near the northwestern border of the study area (Figure 244). The excavation was 6.00 m long by 0.80 m wide with a maximum depth of 1.40 mbs. The stratigraphy of TE-59 consisted of a very dark brown, gravelly sandy clay loam Ap horizon (Stratum I) overlying dark yellowish brown, natural gravelly silty clay loam (Stratum II); dark yellowish brown, natural silty clay loam (Stratum III); and dark reddish brown, natural gravelly silty clay loam (Figure 245 through Figure 247 and Table 59). The lower interfaces of Stratum I and Stratum II contained stream deposit inclusions. No cultural materials were observed.

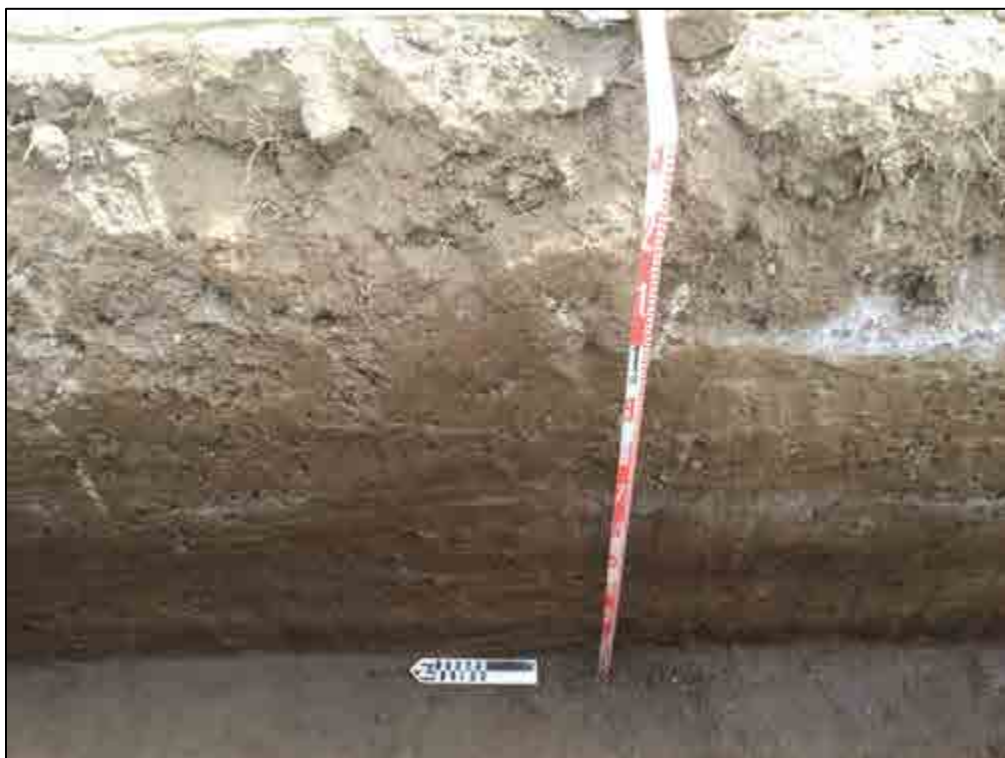
Figure 246. TE-59, close-up of the east wall, view to east

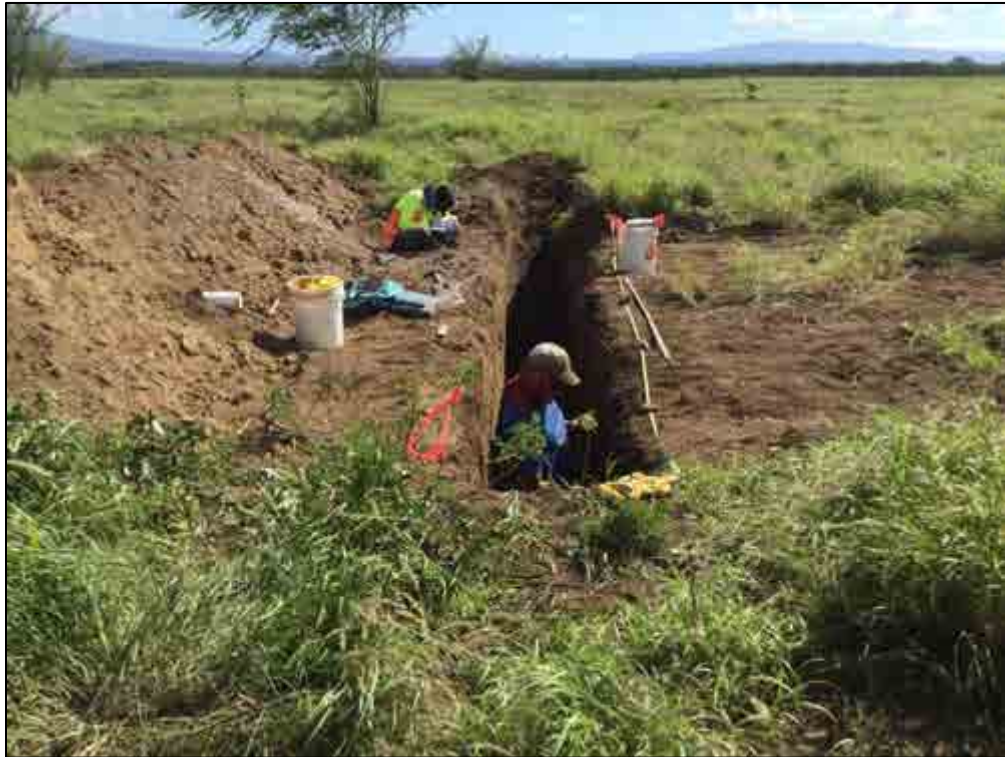
TE-60 was in the northwestern quadrant of the study area (Figure 248). The excavation was 6.00 m long by 0.80 m wide with a maximum depth of 1.63 mbs. The stratigraphy of TE-60 consisted of a very dark grayish brown, gravelly sandy clay loam Ap horizon (Stratum I) overlying dark brown, natural gravelly silty clay loam with extremely cobbly sand stream deposit inclusions (Stratum II) and brown, natural gravelly silt loam alluvium (Stratum III) (Figure 249 through Figure 252 and Table 60). A piece of concrete was observed (not collected) in Stratum I, and a bird (Aves) bone was collected from the stream deposited material within Stratum II.

Figure 248. TE-60, overview of the general location, view to south

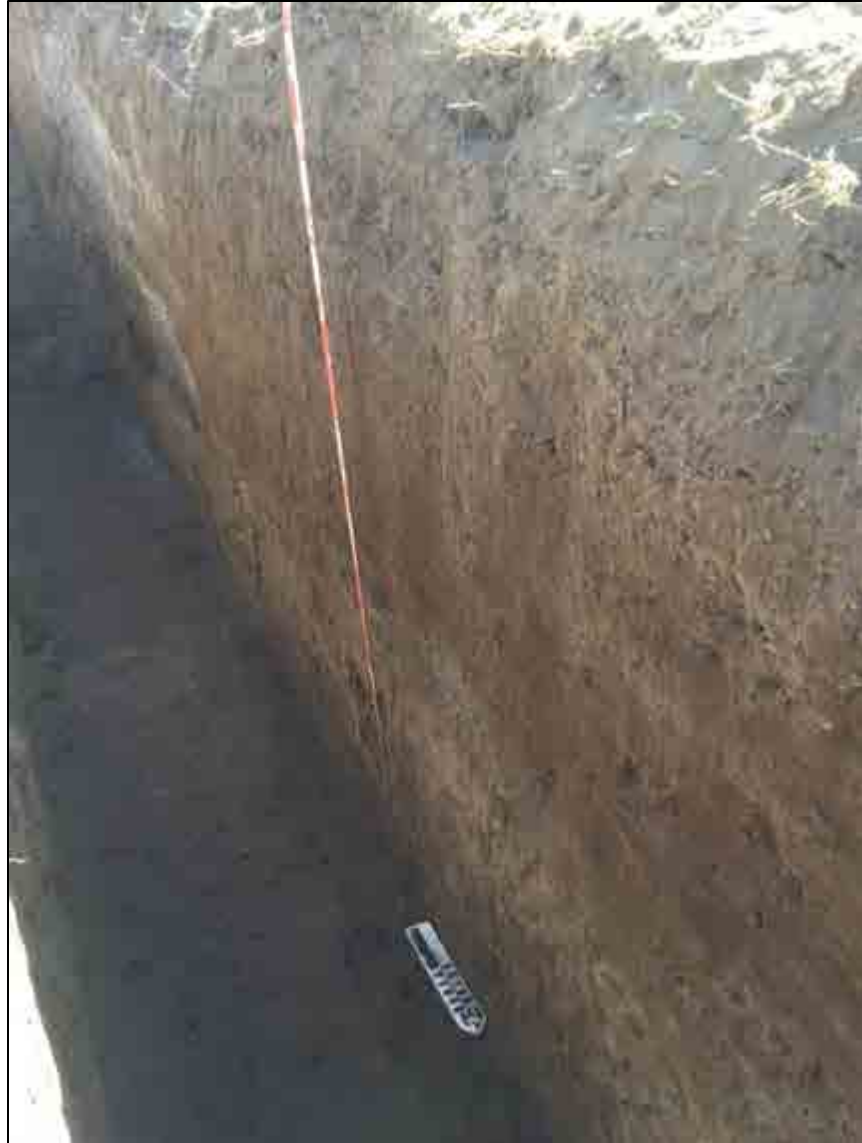
Figure 249. TE-60, oblique view of the west wall, view to southwest
