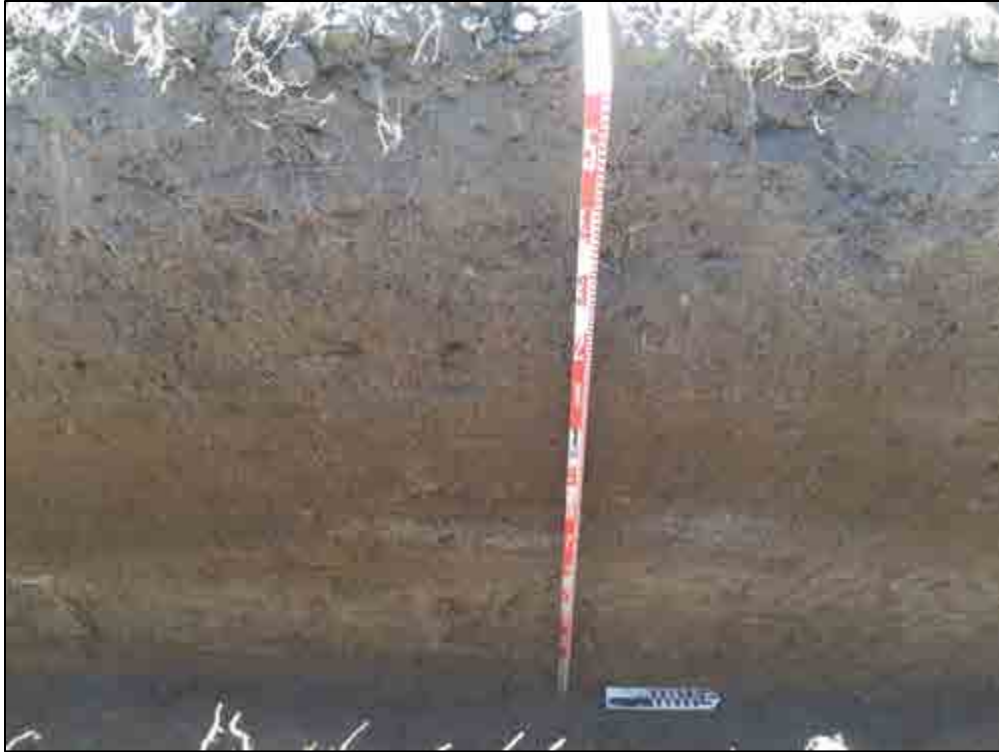
Figure 250. TE-60, close-up of the west wall, view to west

TE-60 was in the northwestern quadrant of the study area (Figure 248). The excavation was 6.00 m long by 0.80 m wide with a maximum depth of 1.63 mbs. The stratigraphy of TE-60 consisted of a very dark grayish brown, gravelly sandy clay loam Ap horizon (Stratum I) overlying dark brown, natural gravelly silty clay loam with extremely cobbly sand stream deposit inclusions (Stratum II) and brown, natural gravelly silt loam alluvium (Stratum III) (Figure 249 through Figure 252 and Table 60). A piece of concrete was observed (not collected) in Stratum I, and a bird (Aves) bone was collected from the stream deposited material within Stratum II.

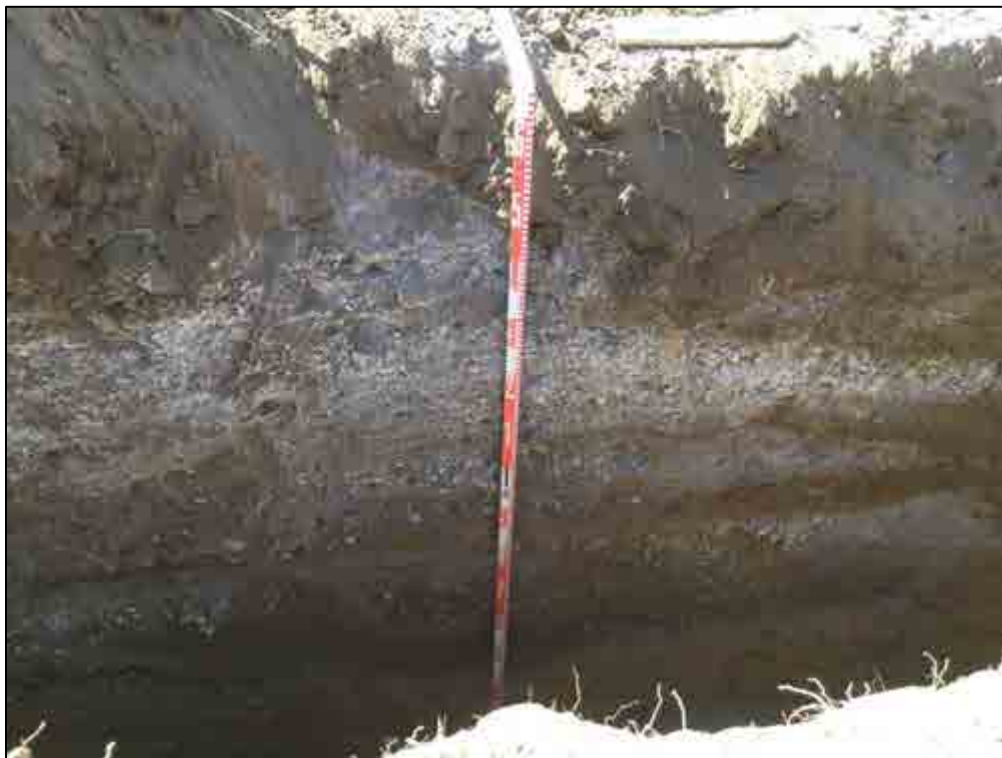
Figure 251. TE-60, close-up of a stream deposit inclusion in the west wall, view to west

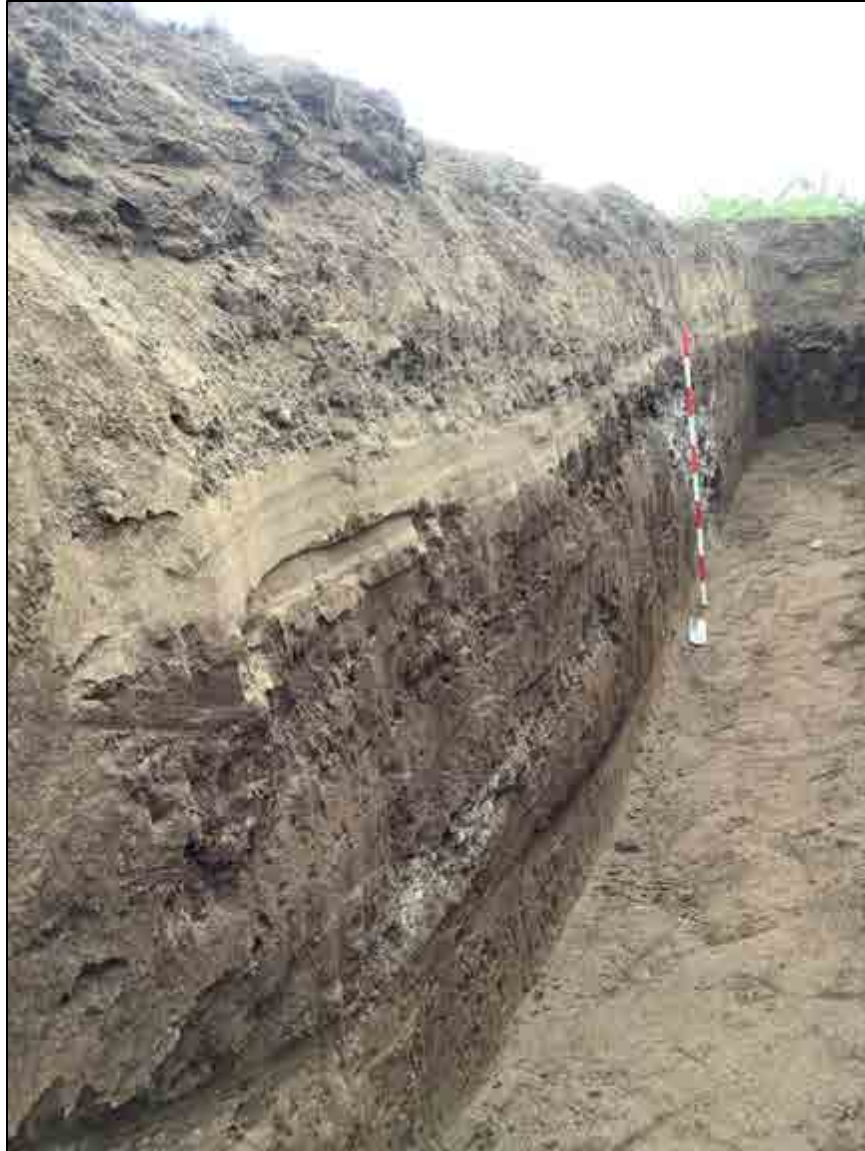
Figure 254. TE-61, oblique view of the east wall, view to south

TE-61 was in the northern-central portion of the study area (Figure 253). The excavation was 6.00 m long by 0.80 m wide with a maximum depth of 1.45 mbs. The stratigraphy of TE-61 consisted of a dark yellowish brown, gravelly sandy loam Ap horizon (Stratum I) overlying brown, previously disturbed natural extremely gravelly sand mottled with dark yellowish brown sandy loam (Stratum II); dark yellowish brown, natural sandy loam (Stratum III), a gray, natural extremely gravelly sand stream deposit (Stratum IV); very dark brown, natural gravelly silty clay loam mottled with dark brown silty clay loam (Stratum V); and dark yellowish brown, natural gravelly silty clay loam (Stratum VI) (Figure 254 through Figure 257 and Table 61). No cultural materials were observed.

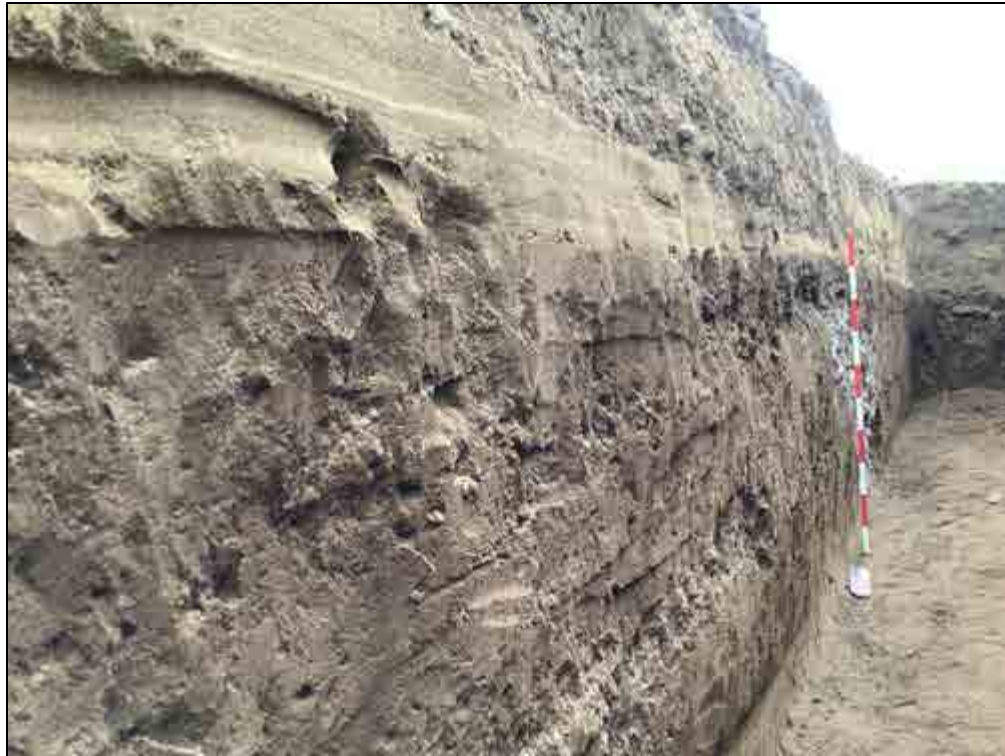
Figure 255. TE-61, oblique view of the east wall, view to south

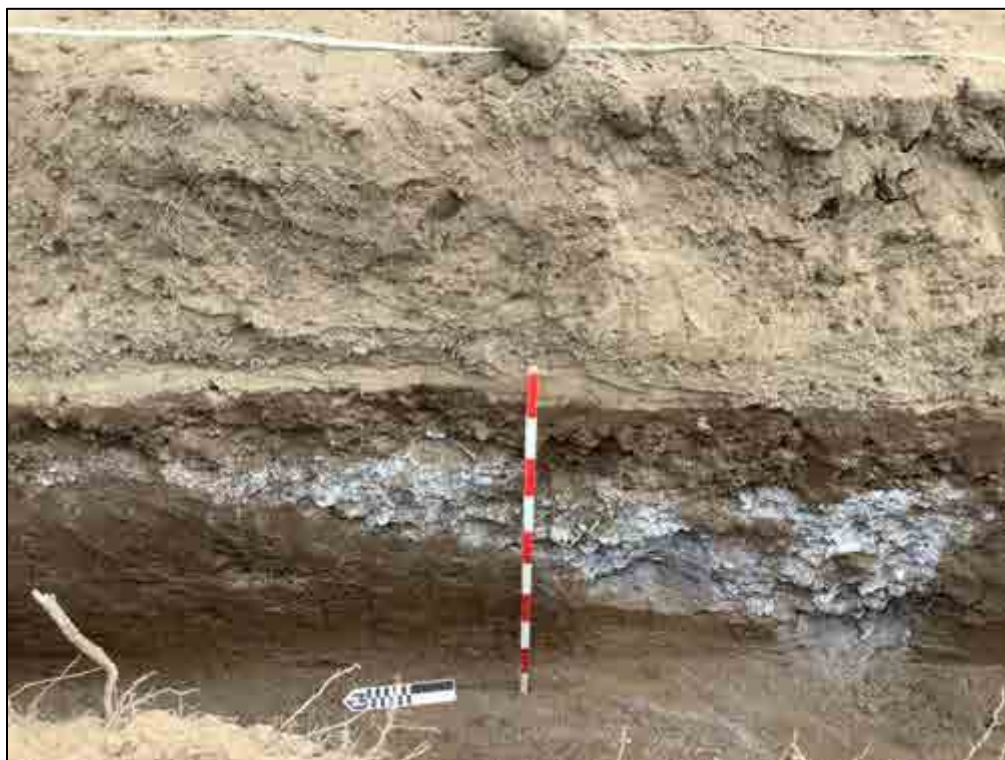
Figure 256. TE-61, close-up of a stream deposit inclusion in the east wall, view to east

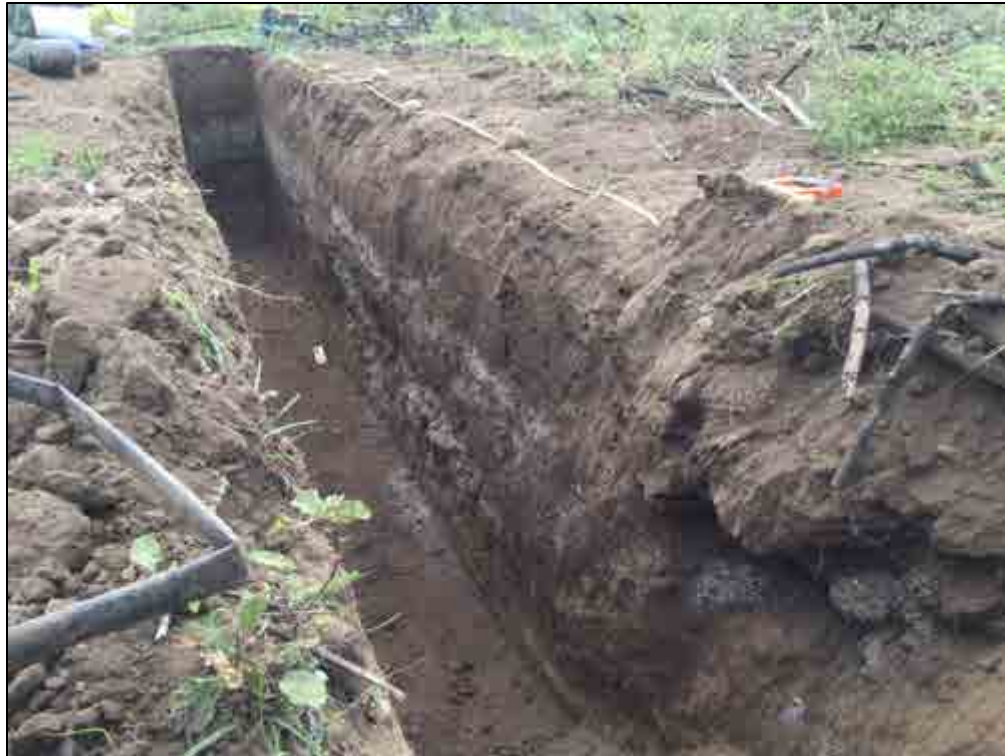
Figure 259. TE-62, overview of the east wall, view to southwest

TE-62 was in the northern-central portion of the study area (Figure 258). The excavation was 6.00 m long by 0.80 m wide with a maximum depth of 1.49 mbs. The stratigraphy of TE-62 consisted of a dark brown gravelly sandy clay loam Ap horizon (Stratum I), a very dark grayish brown, previously disturbed natural, gravelly clay loam with a concentration of gleyed sand near the lower interface (Stratum II); dark yellowish brown, natural clay loam (Stratum III), a gray, natural extremely cobbly sand stream deposit (Stratum IV); and dark yellowish brown, natural gravelly silty clay loam (Stratum V) (Figure 259 through Figure 261 and Table 62). No cultural materials were observed.

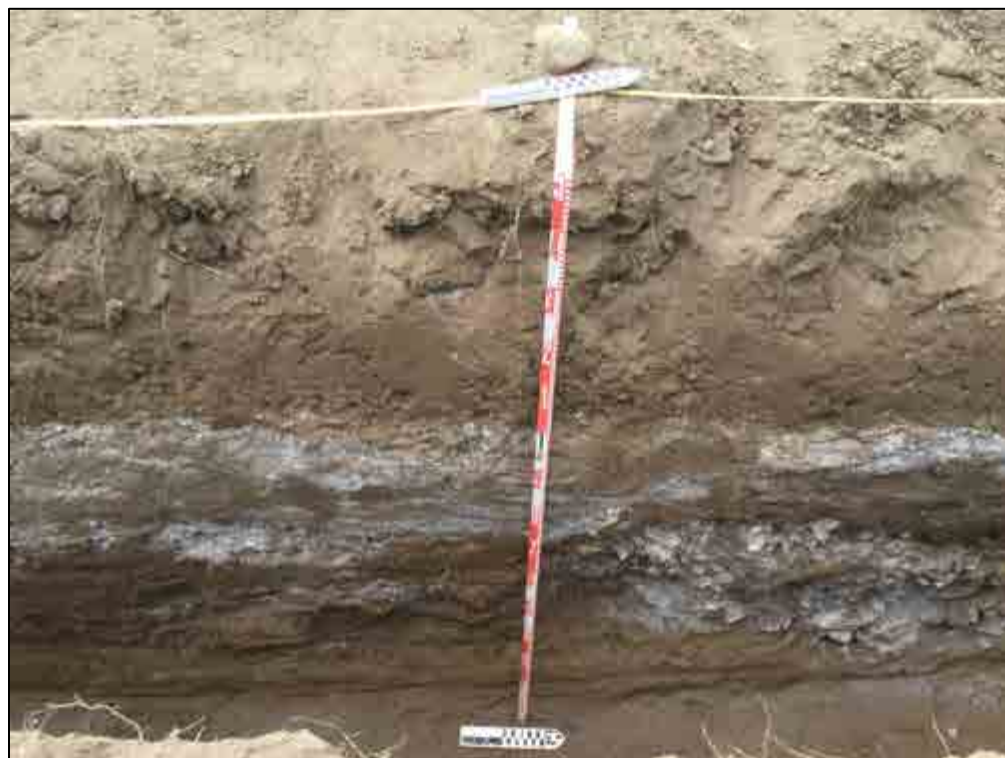
Figure 260. TE-62, close-up of the west wall, view to west

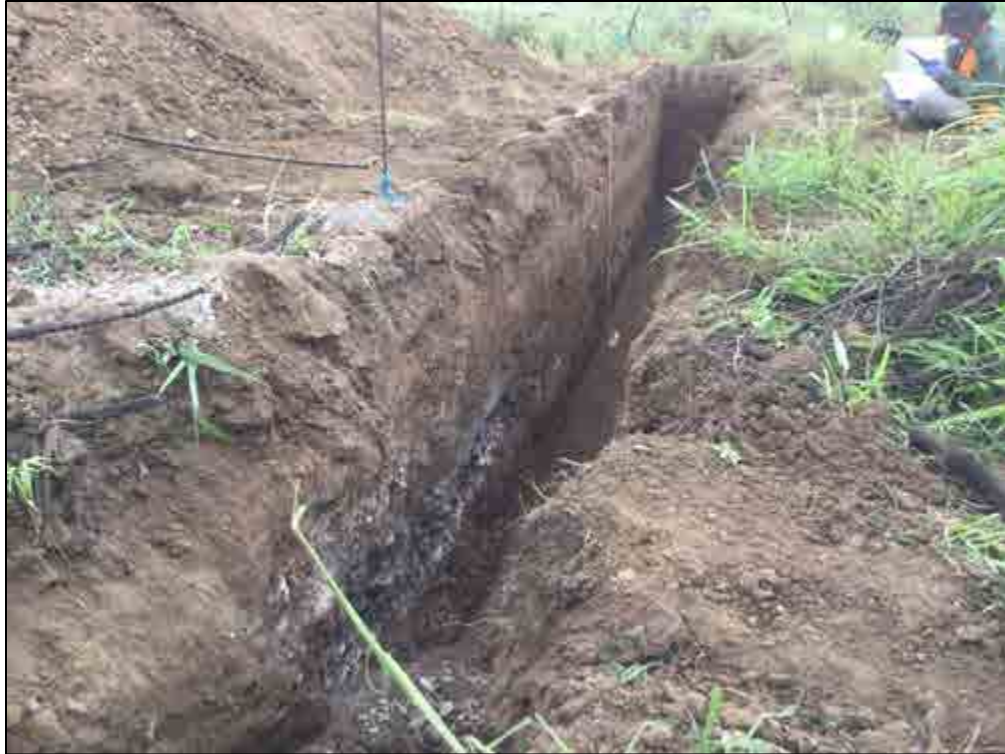
Figure 263. TE-63, overview of the east wall, view to southeast

TE-63 was in the central portion of the study area (Figure 262). The excavation was 6.00 m long by 0.80 m wide with a maximum depth of 1.72 mbs. The stratigraphy of TE-63 consisted of a very dark brown, gravelly sandy clay loam Ap horizon (Stratum I) overlying dark yellowish brown, natural gravelly clay loam (Stratum II); a dark gray, natural extremely cobbly sand stream deposit (Stratum III); dark yellowish brown, natural gravelly silt loam (Stratum IV); and dark brown, natural gravelly sandy clay loam with a stream deposit inclusion (Stratum V) (Figure 263 through Figure 265 and Table 63). No cultural materials were observed.

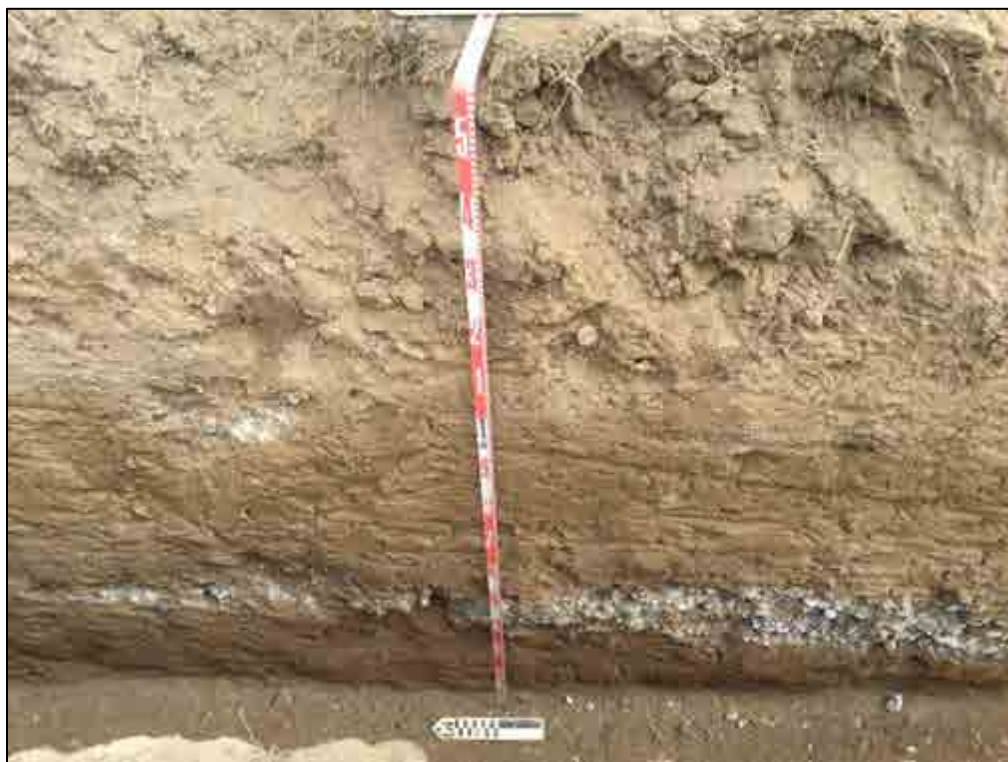
Figure 264. TE-63, close-up of the east wall, view to east

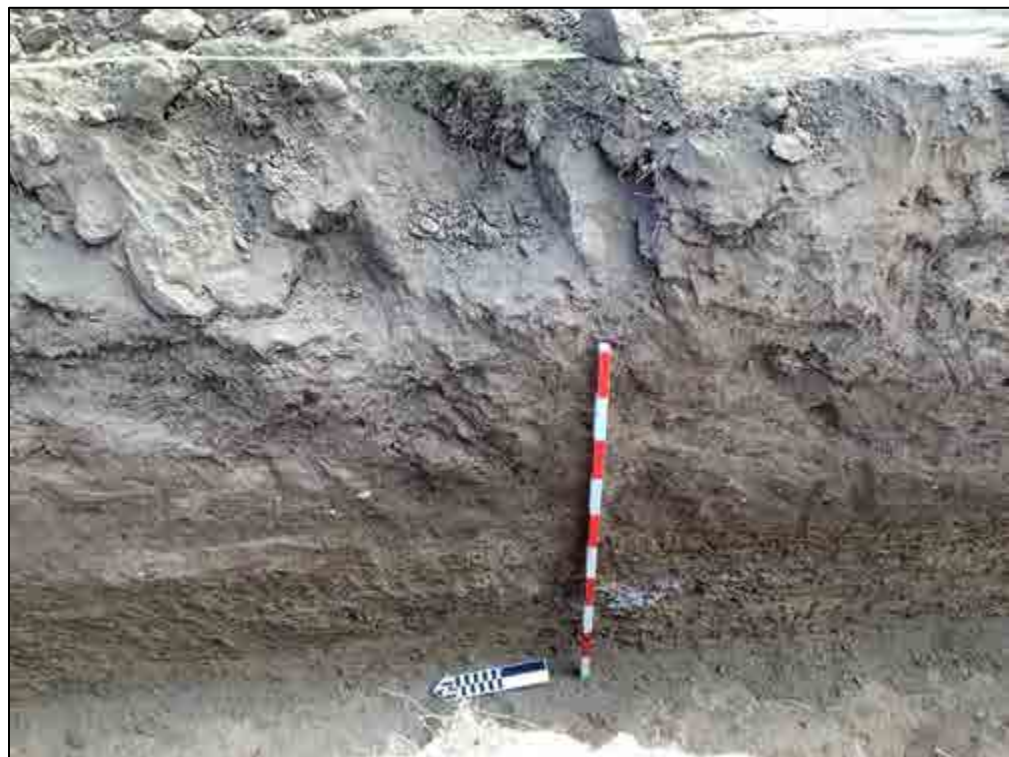
Figure 270. TE-65, close-up of the east wall, view to east

TE-64 was in the northern-central portion of the study area (Figure 266). The excavation was 6.00 m long by 0.80 m wide with a maximum depth of 1.50 mbs. The stratigraphy of TE-64 consisted of a very dark grayish brown, gravelly sandy clay loam Ap horizon (Stratum I) overlying dark brown, previously disturbed natural, gravelly silty clay loam (Stratum II) and brown, natural gravelly silt loam with stream deposit inclusions (Stratum III) (Figure 267 and Table 64). No cultural materials were observed. There are no stratigraphy photos available for TE-64. The location is in proximity to excavations TE-55 and TE-56 to the north and TE-65 to the east, which exhibit stratigraphic sequences that are relatively consistent and comparable to TE-64 (see Figure 229, Figure 230, Figure 233, Figure 234, Figure 269 and Figure 270).

TE-65 was near the southwestern of the A&B condo unit in the northeastern portion of the study area (Figure 268). The excavation was 6.00 m long by 0.80 m wide with a maximum depth of 1.46 mbs. The stratigraphy of TE-65 consisted of a dark brown, gravelly sandy clay loam Ap horizon (Stratum I) overlying dark brown, previously disturbed natural, very gravelly silty clay loam mottled with dark yellowish brown gravelly clay (Stratum II) and dark yellowish brown, natural gravelly silt loam (Stratum III) (Figure 269 through Figure 271 and Table 65). Several small concrete fragments were observed in Stratum I.

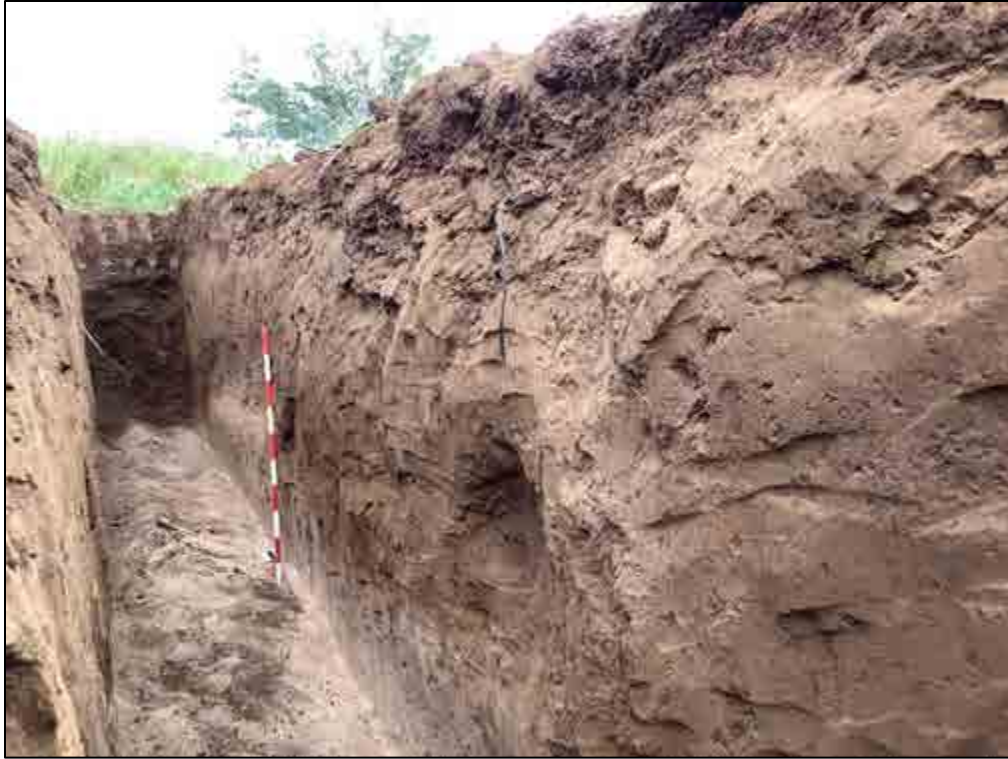
Figure 273. TE-66, overview of the east wall, view to northeast

TE-66 was near the southern edge of the A&B condo unit in the northeastern portion of the study area (Figure 272). The excavation was 6.00 m long by 0.80 m wide with a maximum depth of 1.63 mbs. The stratigraphy of TE-66 consisted of a dark reddish brown, gravelly silty clay loam Ap horizon (Stratum I) and dark brown, previously disturbed natural, gravelly sandy clay loam (Stratum II) overlying dark yellowish brown, previously disturbed natural gravelly silty clay loam (Stratum III) and natural aeolian sand (Stratum IV) (Figure 273 through Figure 275 and Table 66). Cane slag was observed in Stratum I, and black plastic irrigation drip tape was observed in Stratum III.

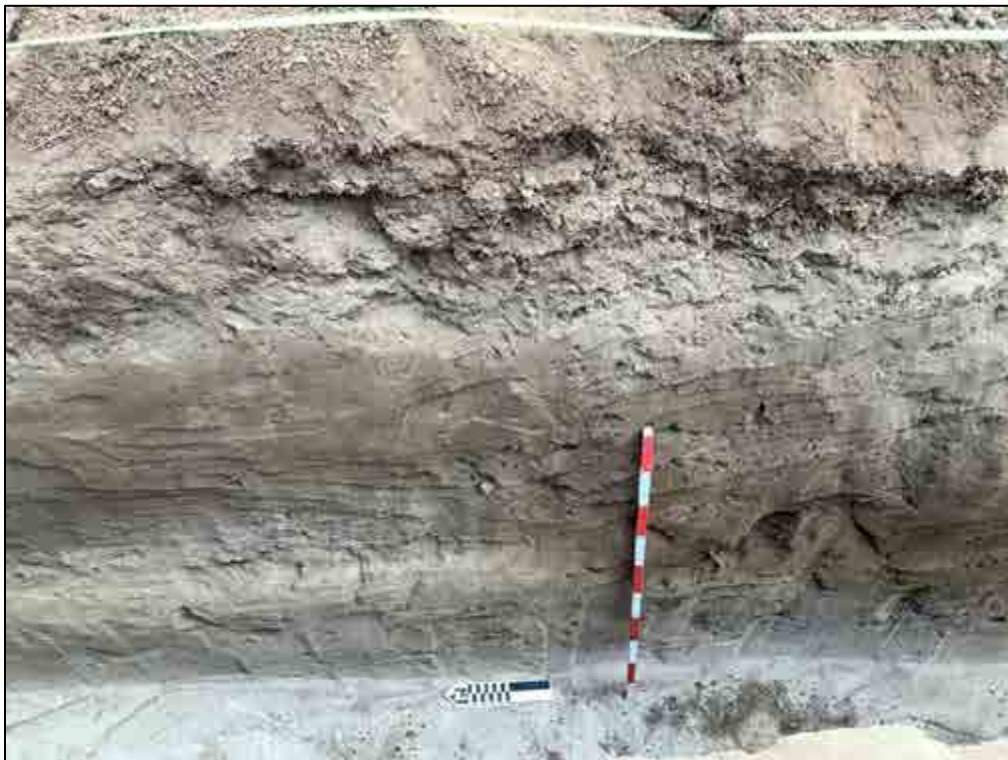
Figure 274. TE-66, close-up of the east wall, view to east

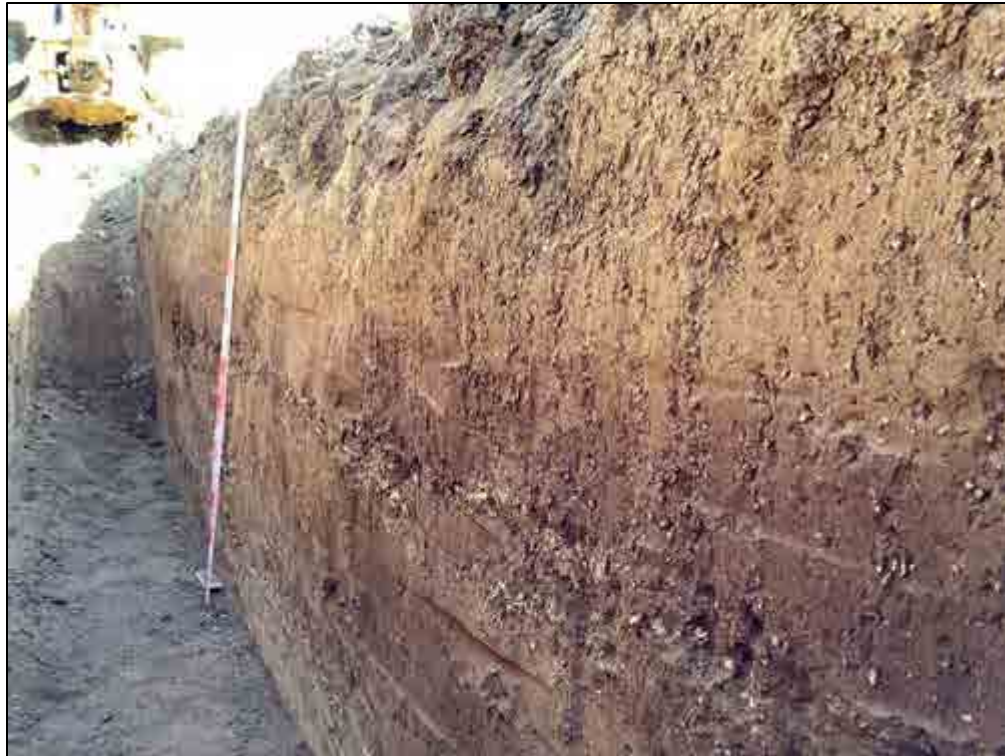
Figure 277. TE-67, overview of the east wall, view to northeast

TE-67 was along the western border in the northern half of the study area (Figure 276). The excavation was 6.00 m long by 0.80 m wide with a maximum depth of 1.65 mbs. The stratigraphy of TE-67 consisted of a dark brown, gravelly sandy loam Ap horizon (Stratum I) overlying dark brown, previously disturbed natural, very gravelly sandy clay loam (Stratum II) and dark yellowish brown, natural gravelly silt loam (Stratum III) (Figure 277 through Figure 279 and Table 67). Stratum III contained a gravelly stream deposit inclusion. No cultural materials were observed.

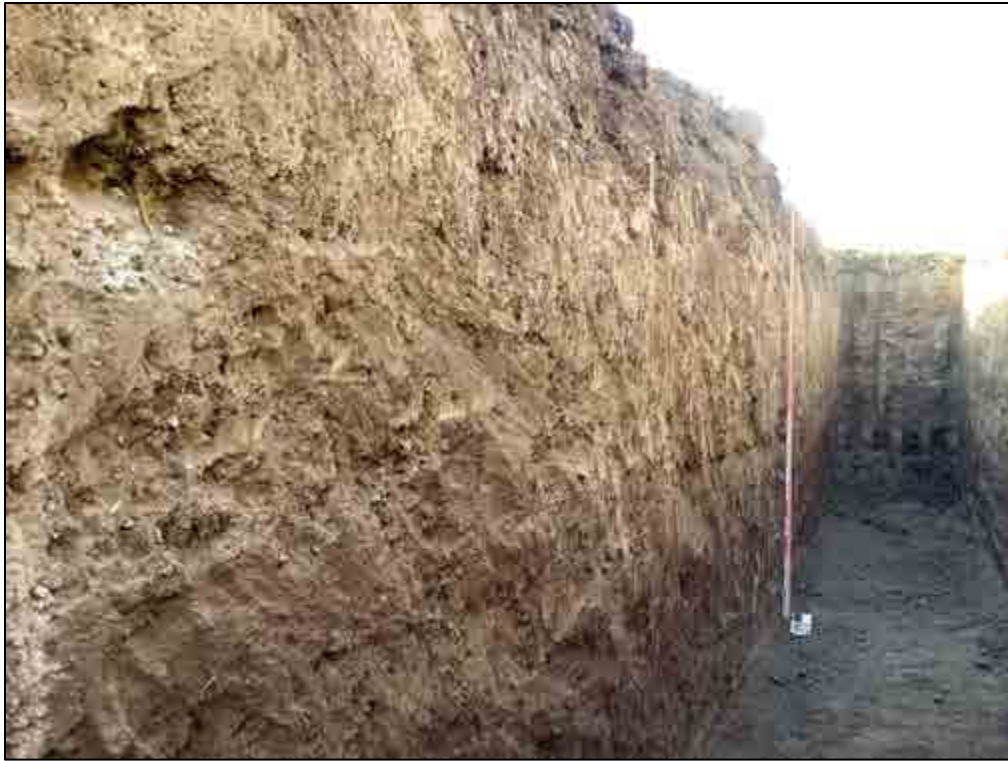
Figure 281. TE-68, overview of the east wall, view to southeast

TE-68 was near the western border in the northern half of the study area (Figure 280). The excavation was 6.00 m long by 0.80 m wide with a maximum depth of 1.57 mbs. The stratigraphy of TE-68 consisted of a dark brown, gravelly sandy loam Ap horizon (Stratum I) and a brown, previously disturbed natural, very gravelly silty clay loam (Stratum II) overlying dark brown, natural very gravelly silty clay loam (Stratum III) and natural gravelly silt loam (Stratum IV) (Figure 281 through Figure 283 and Table 68). Root moulds from Stratum II intruded through Stratum III and into Stratum IV. No cultural materials were observed.

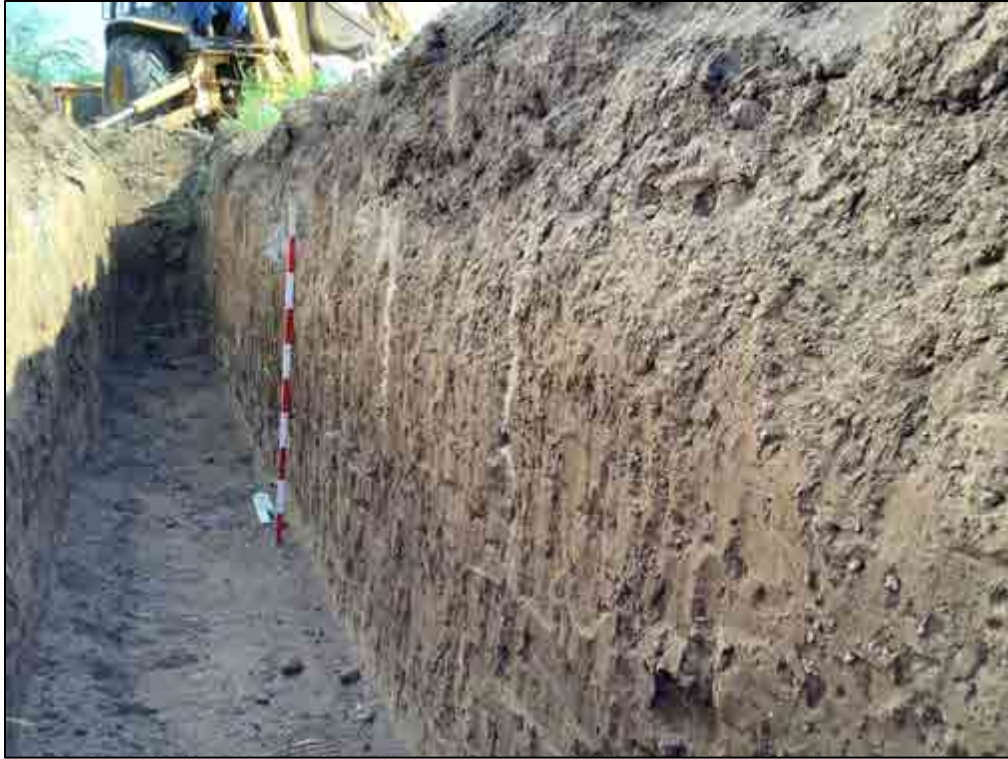
Figure 285. TE-69, overview of the east wall, view to northeast

TE-69 was in the western-central portion of the study area (Figure 284). The excavation was 6.00 m long by 0.80 m wide with a maximum depth of 1.43 mbs. The stratigraphy of TE-69 consisted of a dark brown, very gravelly sandy loam Ap horizon (Stratum I) overlying brown, natural gravelly silt loam (Stratum II) and brown, natural gravelly silt loam (Stratum III) (Figure 285 through Figure 287 and Table 69). Stratum I contained root moulds that intruded into Stratum II. No cultural materials were observed.

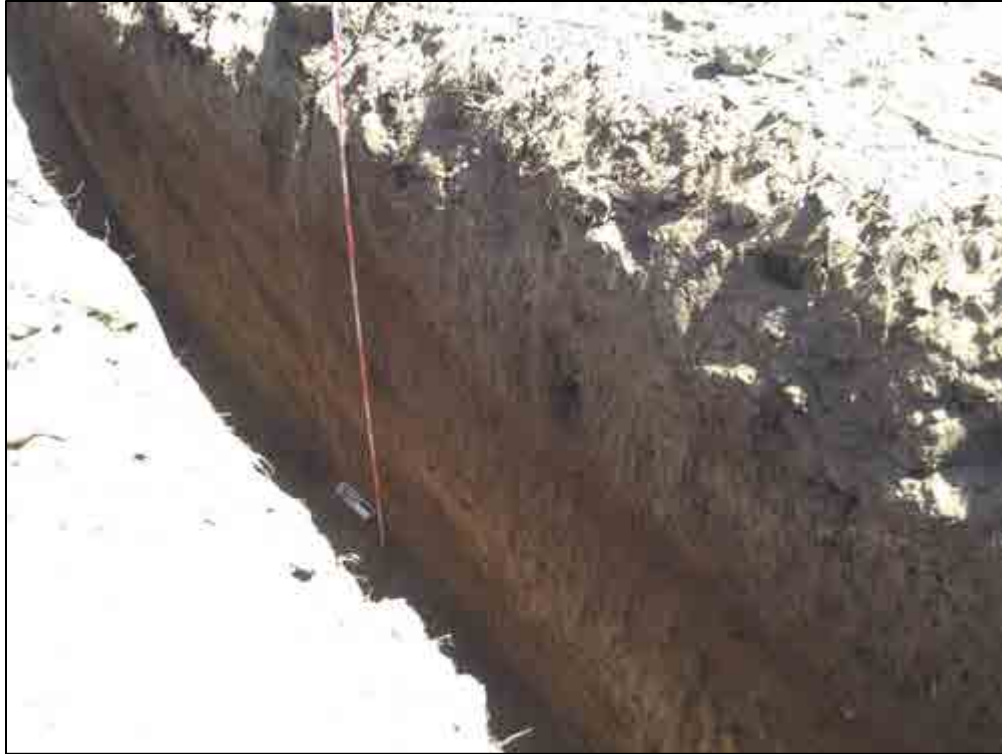
Figure 289. TE-70, overview of the east wall, view to northeast

TE-70 was in the central portion of the study area (Figure 288). The excavation was 6.00 m long by 0.80 m wide with a maximum depth of 1.73 mbs. The stratigraphy of TE-70 consisted of a very dark brown, gravelly sandy loam Ap horizon (Stratum I) overlying brown, natural gravelly silt loam (Stratum II) (Figure 289 through Figure 291 and Table 70). No cultural materials were observed.

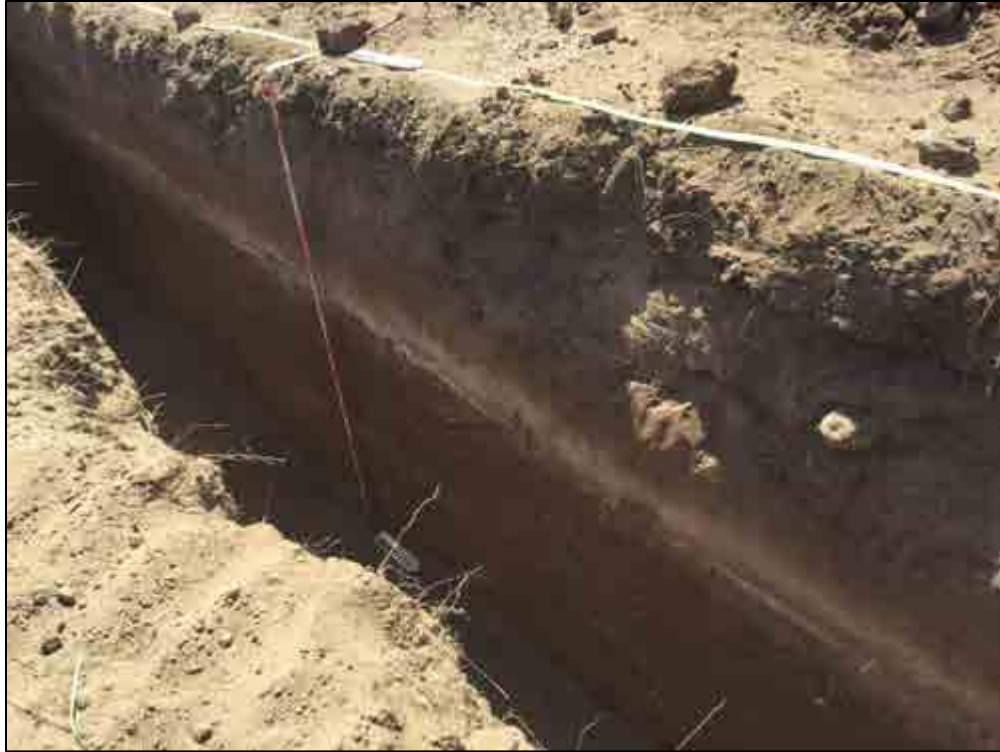
Figure 293. TE-71, overview of the west wall, view to southwest

TE-71 was in the central portion of the study area (Figure 292). The excavation was 6.00 m long by 0.80 m wide with a maximum depth of 1.68 mbs. The stratigraphy of TE-71 consisted of a dark yellowish brown, gravelly loamy sand Ap horizon (Stratum I) and dark brown, previously disturbed natural, gravelly silt loam (Stratum II) overlying reddish gray, natural gravelly loamy sand (Stratum III); dark brown, natural very gravelly silt loam (Stratum IV); and dark brown, natural gravelly silt loam (Stratum V) (Figure 293 through Figure 295 and Table 71). No cultural materials were observed.

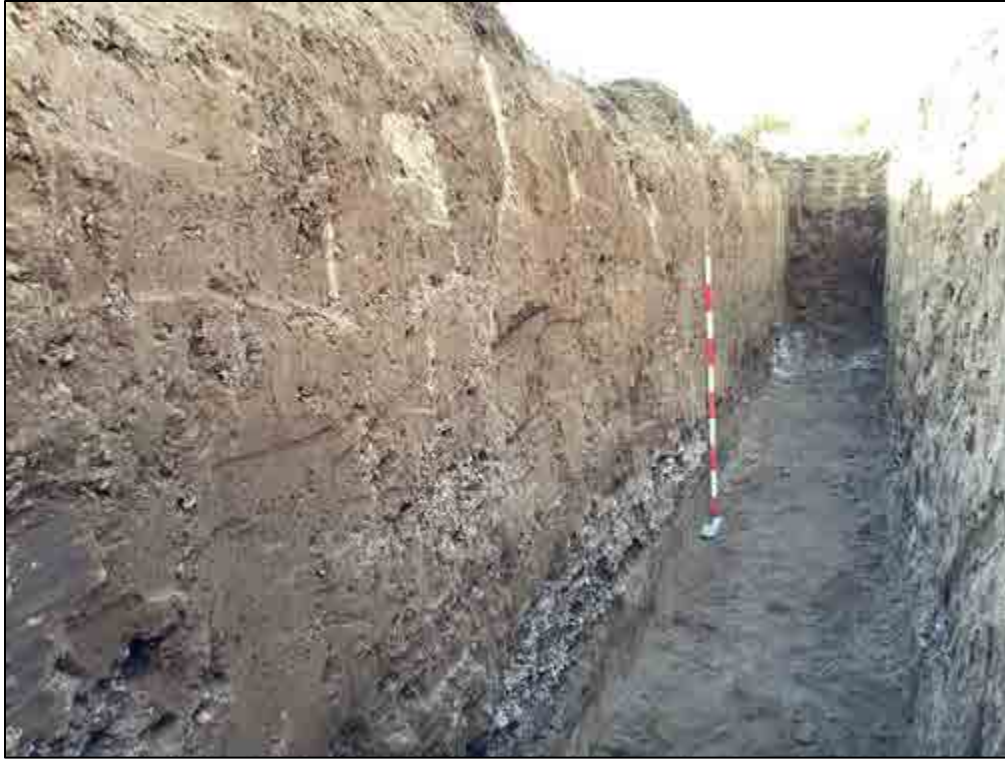
Figure 297. TE-72, overview of the east wall, view to southeast

TE-72 was in the central portion of the study area (Figure 296). The excavation was 6.00 m long by 0.80 m wide with a maximum depth of 1.59 mbs. The stratigraphy of TE-72 consisted of a very dark brown, gravelly sandy loam Ap horizon (Stratum I) overlying dark reddish brown, natural gravelly silty clay loam (Stratum II); a dark gray, natural extremely gravelly loamy sand stream deposit (Stratum III); and brown, natural gravelly silt loam (Stratum IV) (Figure 297 through Figure 299 and Table 72). The agricultural plow zone (Stratum I) contained pieces of black plastic irrigation drip tape that were not collected. No other cultural materials were observed.

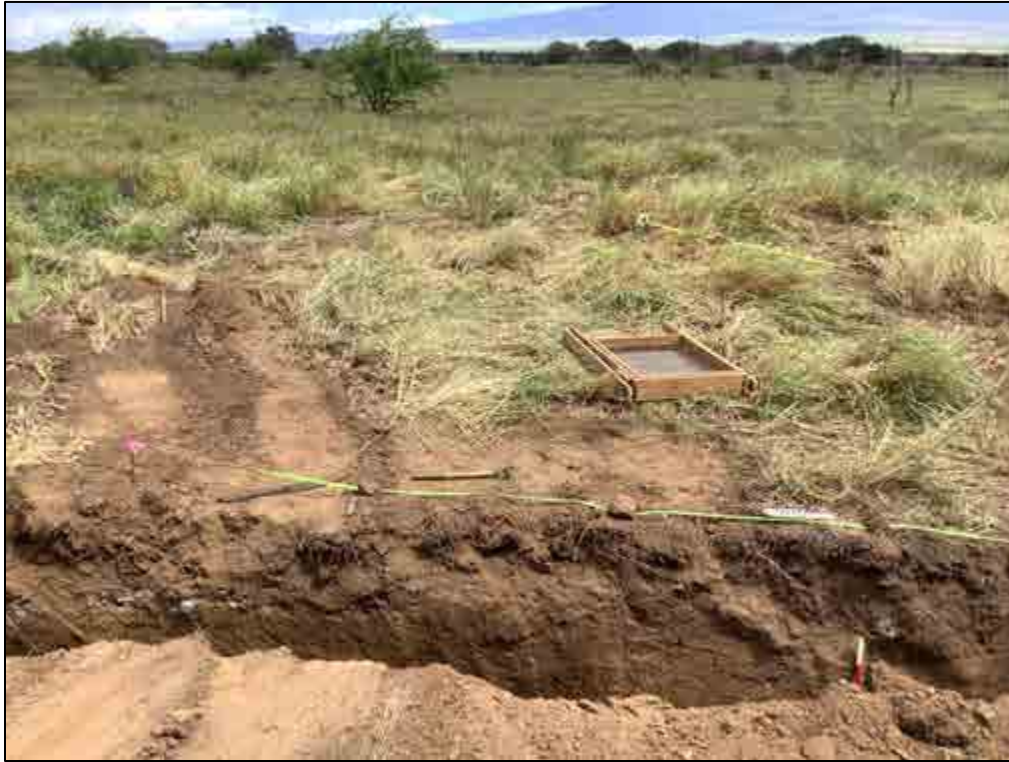
The newly identified SIHP # -08805 Feature C is a buried cultural deposit that was identified during subsurface testing within TE-73. The deposit included broken concrete rubble, seven metal artifacts including two nails (Acc. #s 6-11 and 17), five glass fragments (Acc. #s 2-5 and 18), a ceramic porcelain insulator spacer (Acc. # 12), one fragment of cane slag (Acc. # 1), and faunal remains representing terrestrial snail, pig, fish, and bird. All of the cultural material, with the exception of the concrete rubble, was collected for laboratory analysis.

Figure 300. TE-73, overview of the general location, view to east

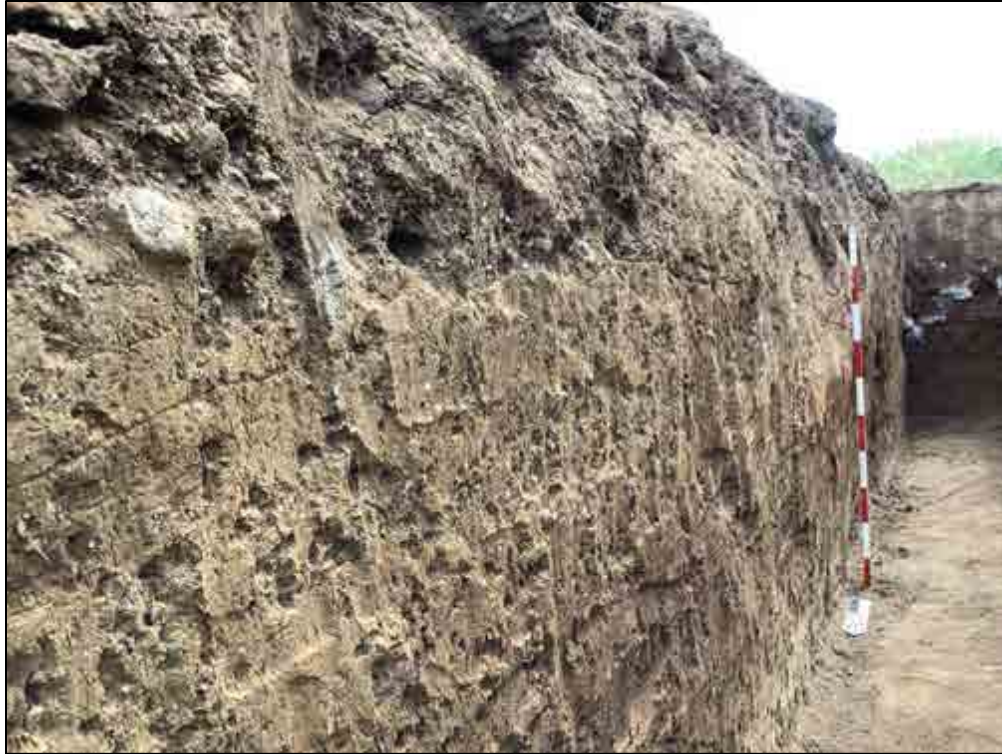
Figure 301. TE-73, overview of the east wall, view to southeast

TE-73 was in the northeastern portion of the study area (Figure 300). The excavation was 6.00 m long by 0.80 m wide with a maximum depth of 1.30 mbs. The stratigraphy of TE-73 consisted of a very dark brown, very gravelly sandy clay loam Ap horizon mottled with dark yellowish brown, sand (Stratum I) overlying dark yellowish brown, natural gravelly silty clay loam (Stratum II) and brown, natural gravelly silt loam (Stratum III) (Figure 301 through Figure 304 and Table 73).

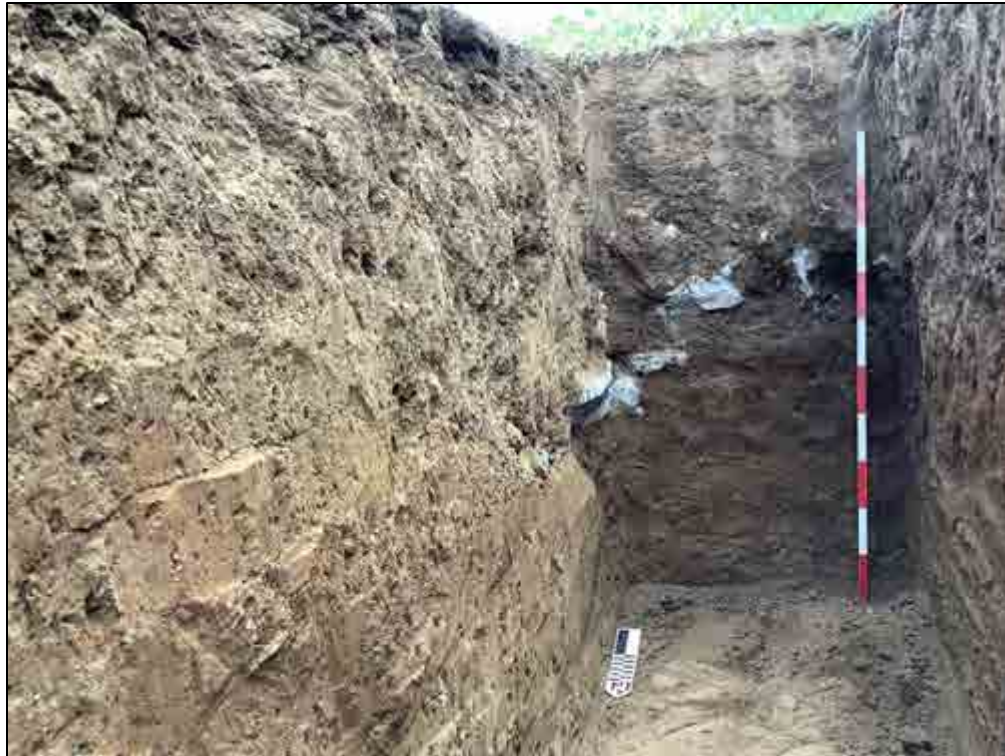
Figure 303. TE-73, close-up of concrete pieces in the southern end of the trench, view to south

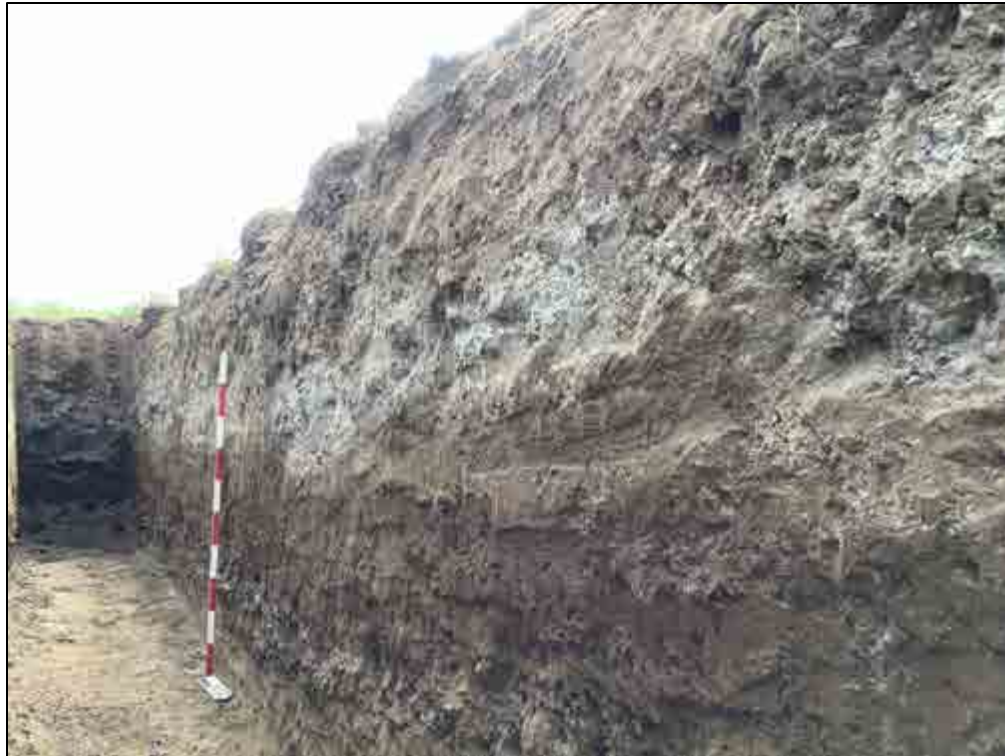
Figure 306. TE-74, overview of the west wall, view to southwest

TE-74 was located near the southern side of the A&B condo unit in the northeastern portion of the study area (Figure 305). The excavation was 6.00 m long by 0.80 m wide with a maximum depth of 1.46 mbs. The stratigraphy of TE-73 consisted of a dark brown, gravelly sandy clay loam Ap horizon (Stratum I) overlying gray, natural gravelly silt loam (Stratum II); dark yellowish brown, natural gravelly silty clay loam (Stratum III); a grayish brown, natural extremely gravelly sand stream deposit (Stratum IV); and dark brown, natural gravelly silt loam (Stratum V) (Figure 306 through Figure 308 and Table 74). The agricultural plow zone (Stratum I) contained pieces of black plastic irrigation drip tape that were not collected. No other cultural materials were observed.

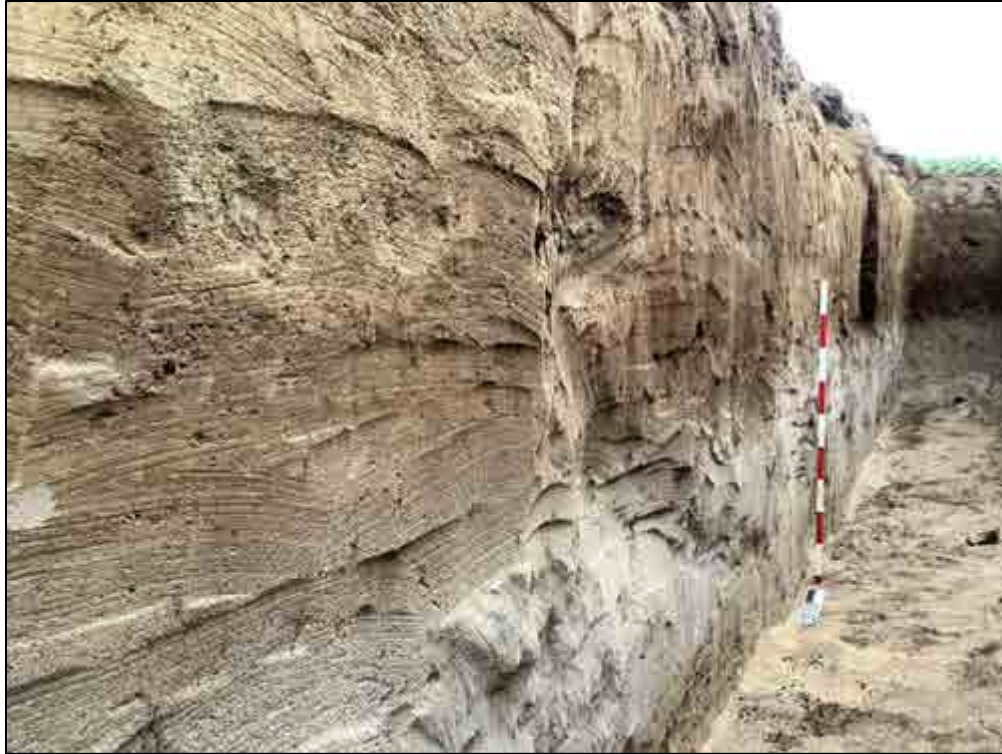
Figure 310. TE-75, overview of the east wall, view to southeast

TE-75 was near the eastern border in the central section of the study area, west of the Waikapu Stream (Figure 309). The excavation was 6.00 m long by 0.80 m wide with a maximum depth of 1.64 mbs. The stratigraphy of TE-75 consisted of a dark brown, gravelly sandy clay loam Ap horizon (Stratum I) overlying dark yellowish brown, previously disturbed natural, gravelly silty clay loam (Stratum II); dark yellowish brown, natural gravelly silty clay loam mottled with volcanic cinder and brown, silty clay loam (Stratum III); pale brown, natural sand (Stratum IV); and light yellowish brown, natural gravelly sand (Stratum V) (Figure 310 through Figure 312 and Table 75). No cultural materials were observed.

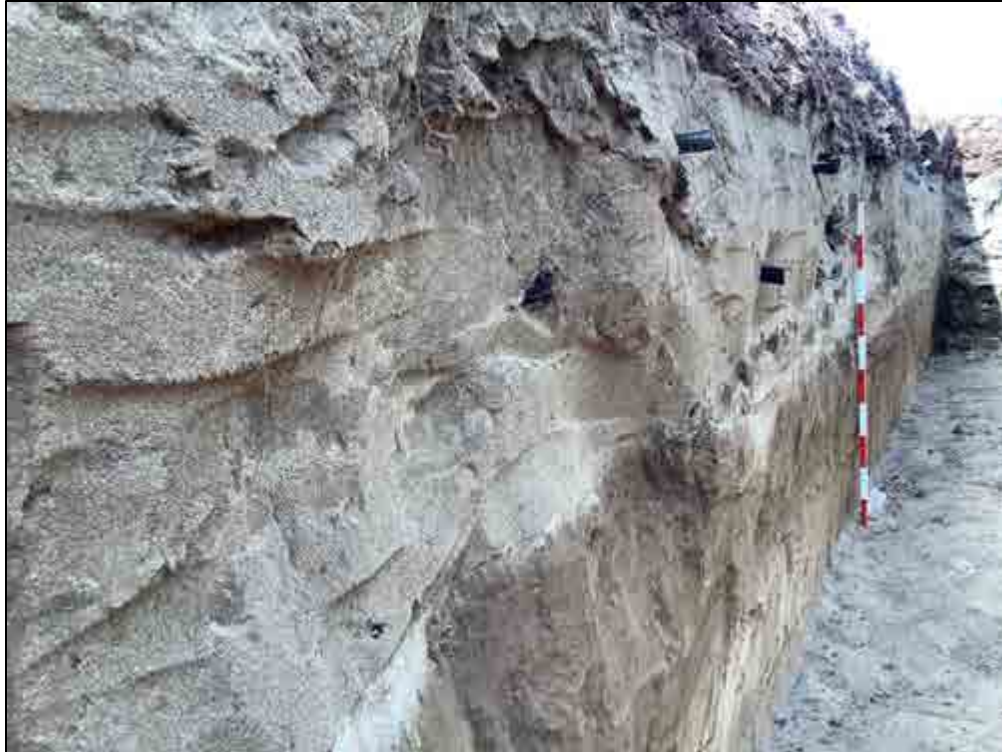
Figure 314. TE-76, oblique view of the west wall, view to northwest

TE-76 was along the eastern border in the central section of the study area, west of the Waikapu Stream (Figure 313). The excavation was 6.00 m long by 0.80 m wide with a maximum depth of 1.53 mbs. The stratigraphy of TE-76 consisted of dark reddish brown, gravelly silty clay loam fill (Stratum I) and a brown, sand Ap horizon mottled with brown silty clay loam (Stratum II) overlying brown, natural silty clay loam (Stratum III) (Figure 314 through Figure 316 and Table 76). The agricultural plow zone (Stratum II) contained many pieces of black plastic irrigation drip tape that were not collected. No other cultural materials were observed.
