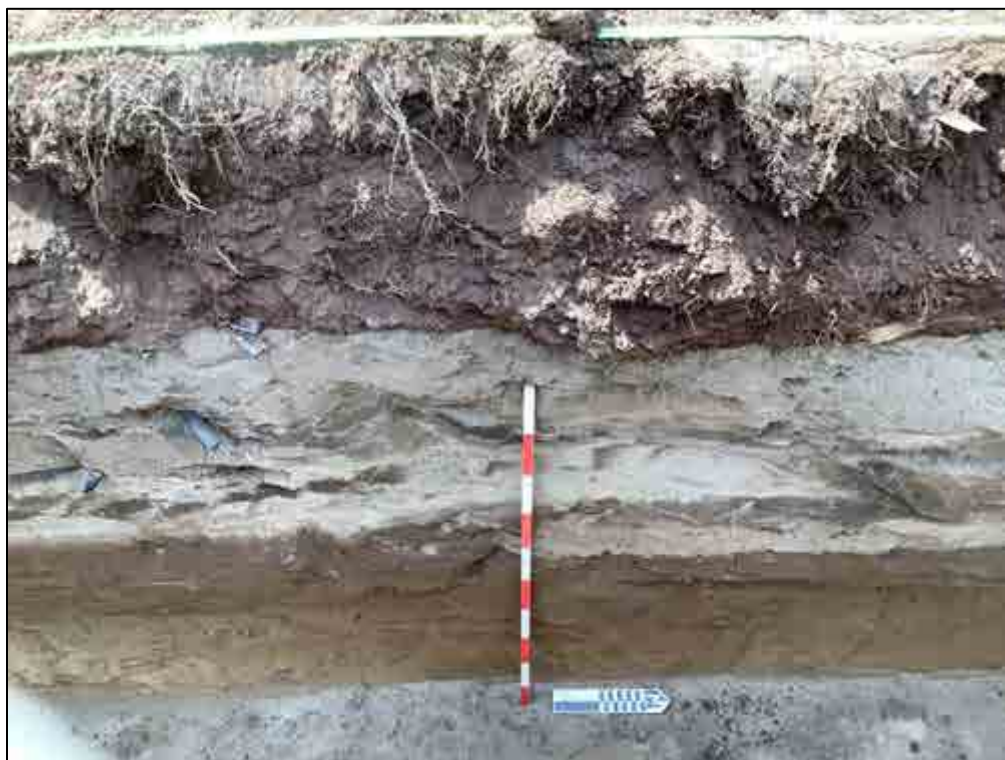
Figure 315. TE-76, close-up of the west wall, view to west

TE-76 was along the eastern border in the central section of the study area, west of the Waikapu Stream (Figure 313). The excavation was 6.00 m long by 0.80 m wide with a maximum depth of 1.53 mbs. The stratigraphy of TE-76 consisted of dark reddish brown, gravelly silty clay loam fill (Stratum I) and a brown, sand Ap horizon mottled with brown silty clay loam (Stratum II) overlying brown, natural silty clay loam (Stratum III) (Figure 314 through Figure 316 and Table 76). The agricultural plow zone (Stratum II) contained many pieces of black plastic irrigation drip tape that were not collected. No other cultural materials were observed.

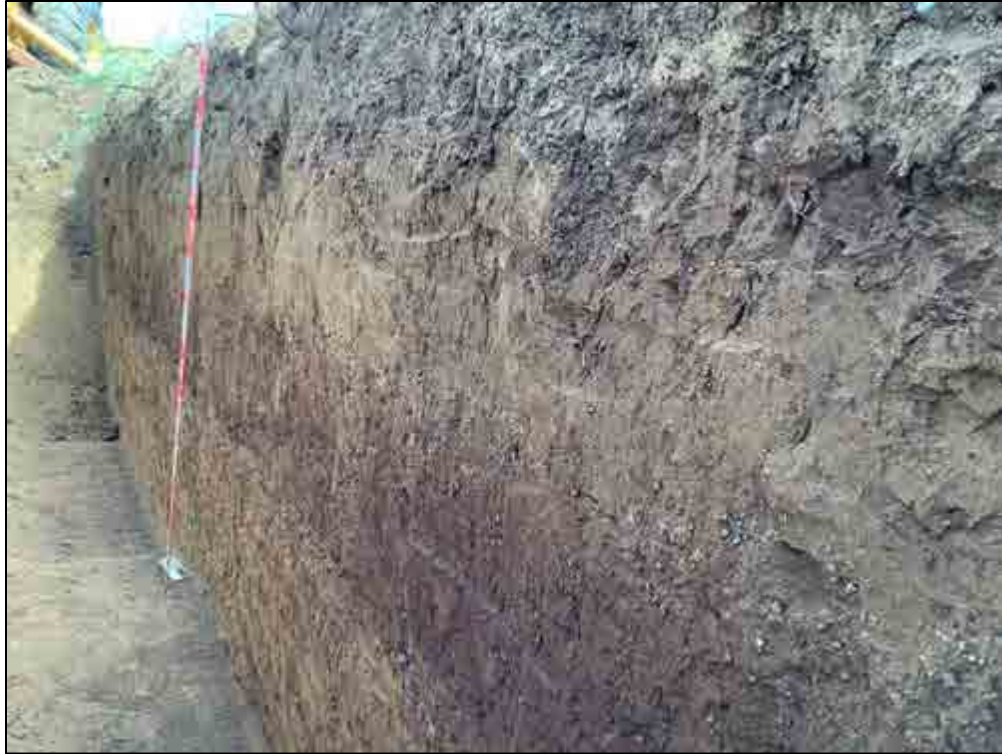
Figure 318. TE-77, oblique view of the east wall, view to northeast

TE-77 was along the western border in the central section of the study area (Figure 317). The excavation was 6.00 m long by 0.80 m wide with a maximum depth of 1.83 mbs. The stratigraphy of TE-77 consisted of a dark grayish brown, gravelly loam Ap horizon (Stratum I) overlying dark brown, previously disturbed natural, gravelly sandy clay loam (Stratum II); dark brown, natural very gravelly silty clay loam mottled with brown extremely gravelly sand (Stratum III); and dark yellowish brown, natural gravelly silt loam (Stratum IV) (Figure 318 through Figure 320 and Table 77). No cultural materials were observed.

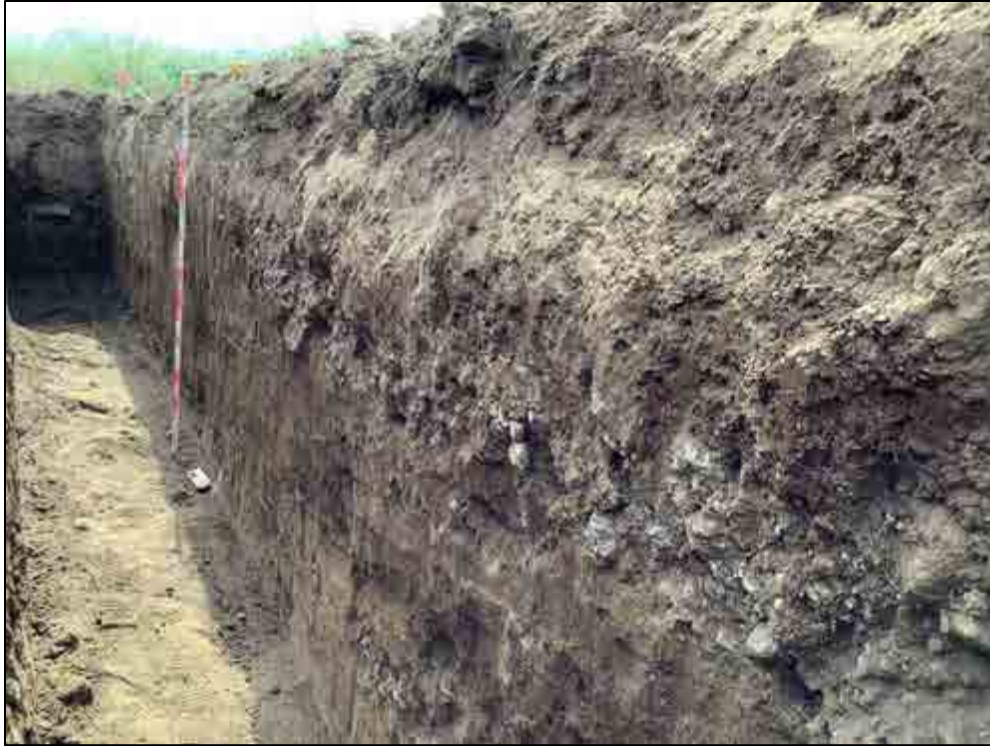
Figure 322. TE-78, oblique view of the west wall, view to southwest

TE-78 was near the western border in the central portion of the study area (Figure 321). The excavation was 6.00 m long by 0.80 m wide with a maximum depth of 1.60 mbs. The stratigraphy of TE-78 consisted of a very dark grayish brown, gravelly sandy loam Ap horizon (Stratum I) and dark brown, previously disturbed natural, very gravelly sandy clay loam mottled with gravel and dark brown sand (Stratum II) overlying brown, natural very gravelly silty clay loam mottled with grayish brown sand (Stratum III) (Figure 322 through Figure 324 and Table 78). No cultural materials were observed.

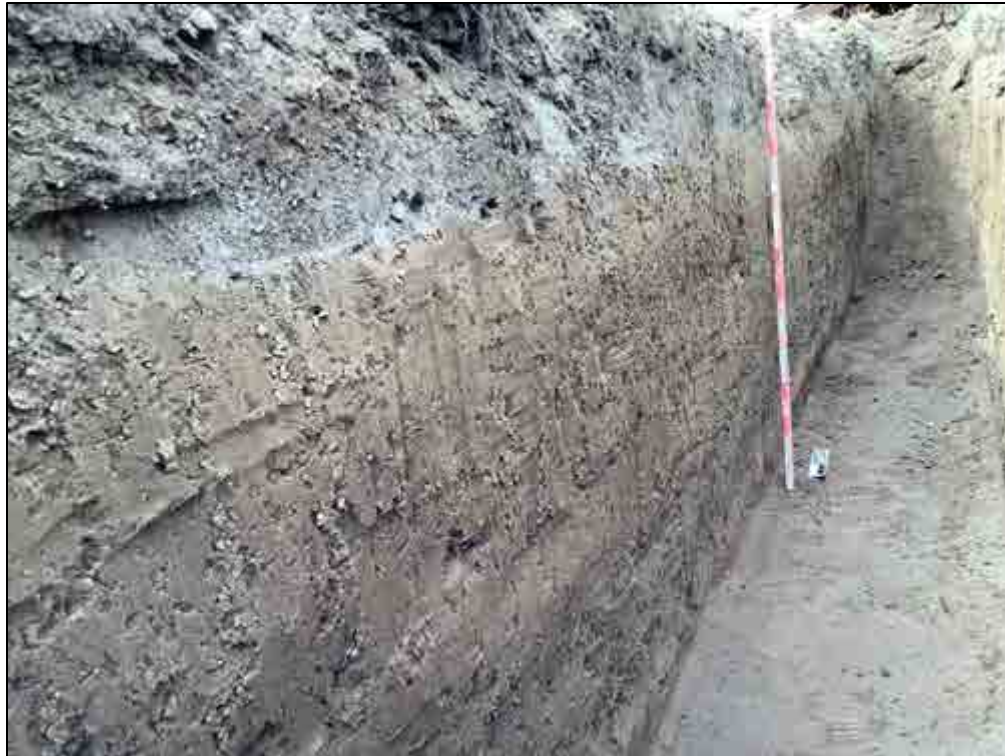
Figure 326. TE-79, oblique view of the west wall, view to northwest

TE-79 was near the western boundary in the central portion of the study area (Figure 325). The excavation was 6.00 m long by 0.80 m wide with a maximum depth of 1.50 mbs. The stratigraphy of TE-79 consisted of a very dark grayish brown, gravelly sandy loam Ap horizon (Stratum I) and brown, previously disturbed natural, gravelly silty clay loam (Stratum II) overlying dark brown, natural very gravelly sandy clay loam (Stratum III); dark grayish brown, natural sand (Stratum IV); brown, natural gravelly silt loam (Stratum V); and very dark brown, natural sandy clay loam (Stratum VI) (Figure 326 through Figure 328 and Table 79). No cultural materials were observed.

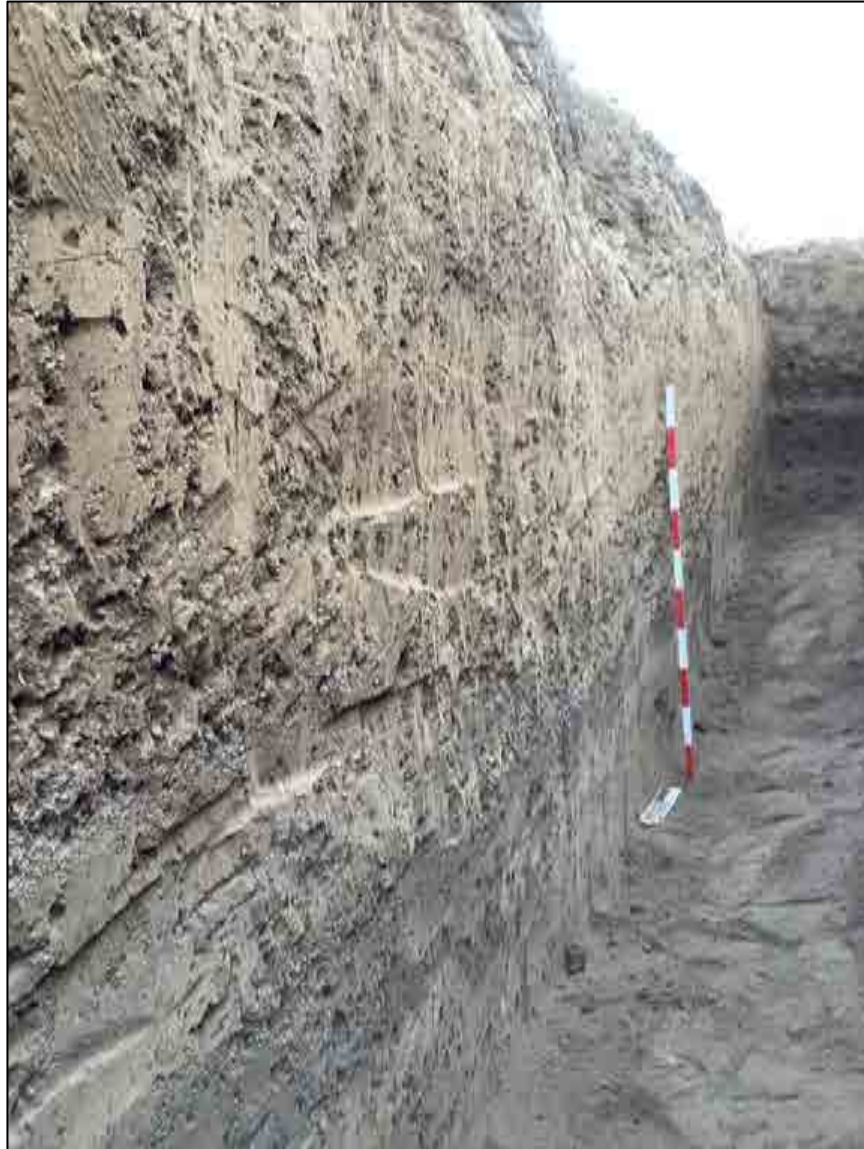
Figure 330. TE-80, oblique view of the east wall, view to southeast

TE-80 was in the central portion of the study area (Figure 329). The excavation was 6.00 m long by 0.80 m wide with a maximum depth of 1.73 mbs. The stratigraphy of TE-80 consisted of a dark brown, gravelly sandy loam Ap horizon (Stratum I) and brown, previously disturbed natural, gravelly silt loam (Stratum II) overlying dark yellowish brown, natural gravelly silty clay loam (Stratum III) and yellowish brown, natural gravelly silt loam with coarse mottles of very dark grayish brown sand (Stratum IV) (Figure 330 through Figure 332 and Table 80). No cultural materials were observed.

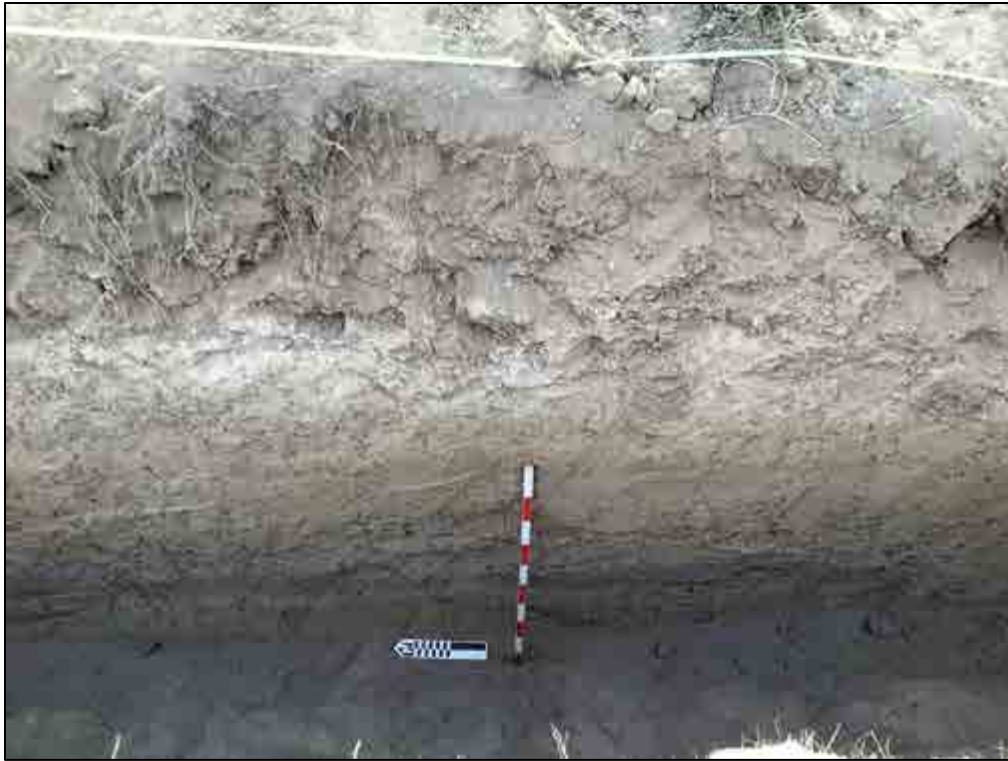
Figure 331. TE-80, close-up of the east profile

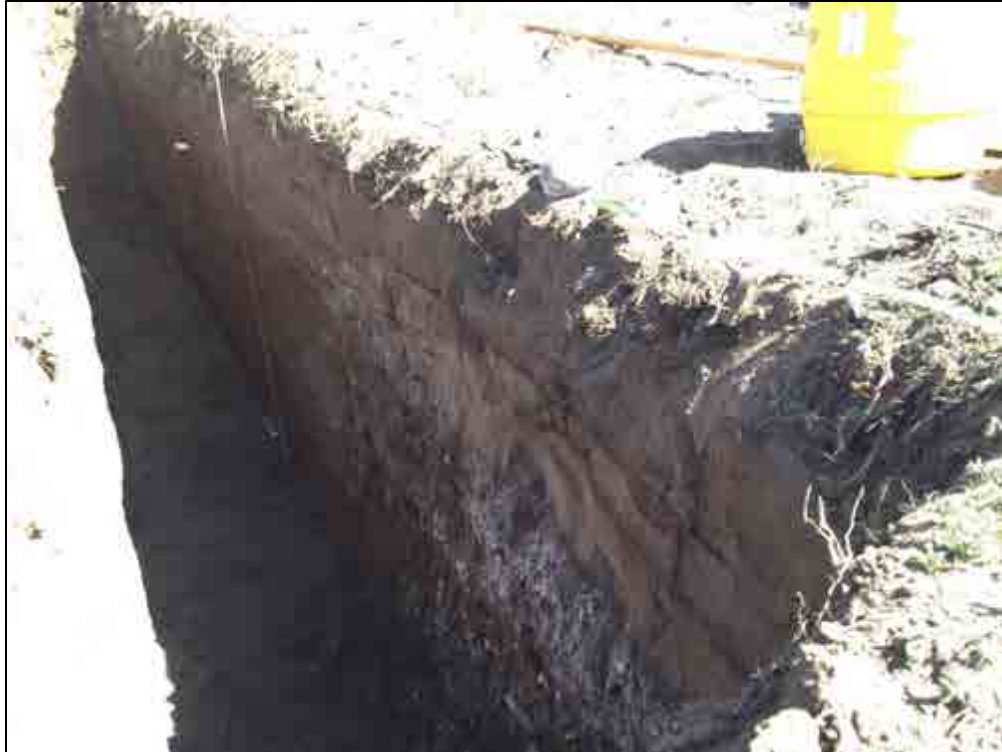
Figure 334. TE-81, overview of the east wall, view to northeast

TE-81 was located near the central portion of the study area (Figure 333). The excavation was 6.00 m long by 0.80 m wide with a maximum depth of 1.65 mbs. The stratigraphy of TE-81 consisted of a dark brown, gravelly loamy sand Ap horizon (Stratum I) overlying dark yellowish brown, previously disturbed natural, very gravelly silt loam (Stratum II); a dark gray, natural extremely cobbly sand stream deposit (Stratum III); and dark brown, natural gravelly silt loam (Stratum IV) (Figure 334 through Figure 336 and Table 81). The upper portion of Stratum II contained a 1-inch PVC pipe. No other cultural materials were observed.

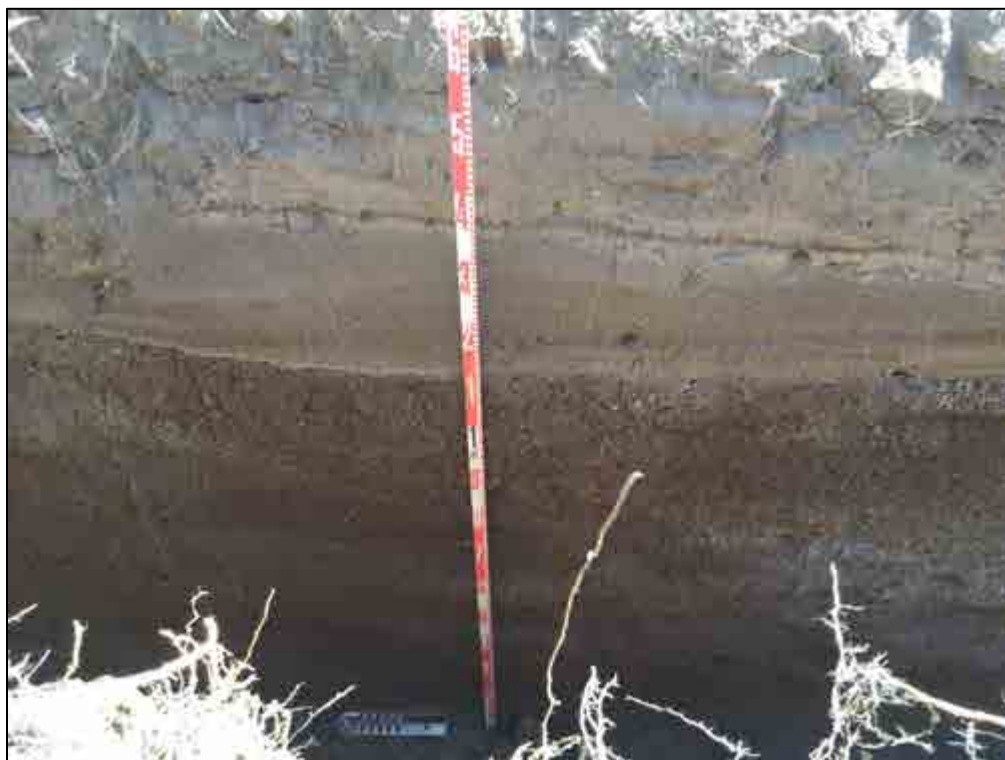
Figure 335. TE-81, close-up of the east wall, view to east

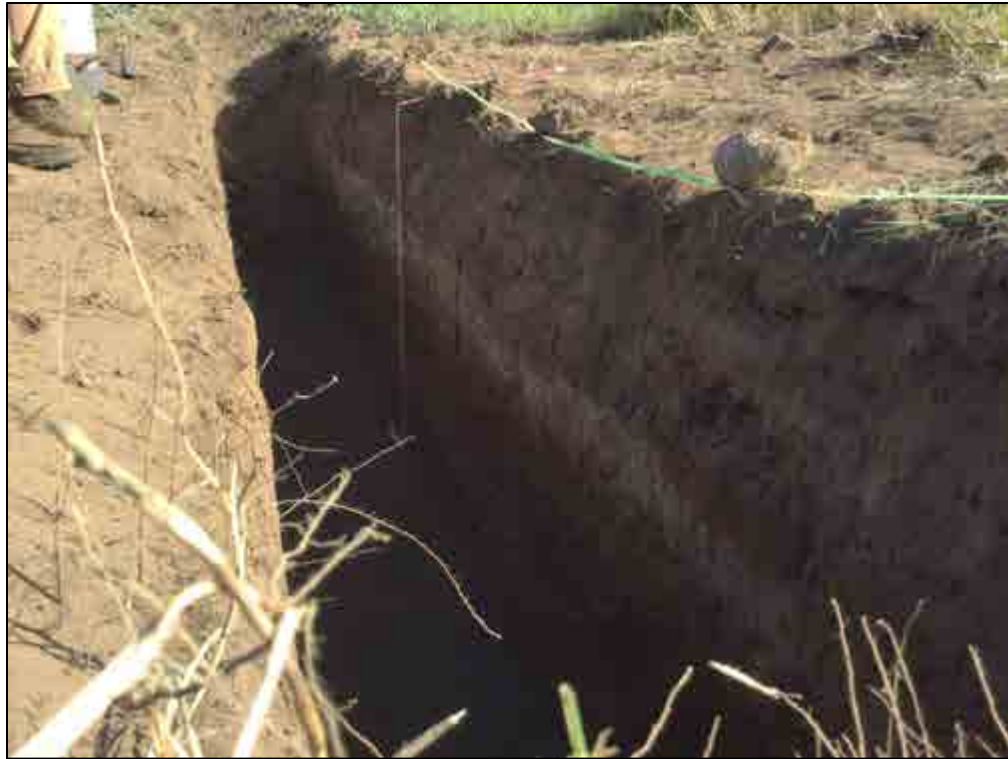
Figure 338. TE-82, overview of the east wall, view to northeast

TE-82 was in the central portion of the study area (Figure 337). The excavation was 6.00 m long by 0.80 m wide with a maximum depth of 1.50 mbs. The stratigraphy of TE-82 consisted of a brown loamy sand Ap horizon (Stratum I); dark brown, gravelly sandy clay loam fill (Stratum II); and a gray, previously disturbed natural, extremely gravelly loamy sand stream deposit (Stratum III) overlying dark reddish brown, natural gravelly silty clay loam (Stratum IV) and brown, natural gravelly silt loam (Stratum V) (Figure 338 through Figure 340 and Table 82). No cultural materials were observed.

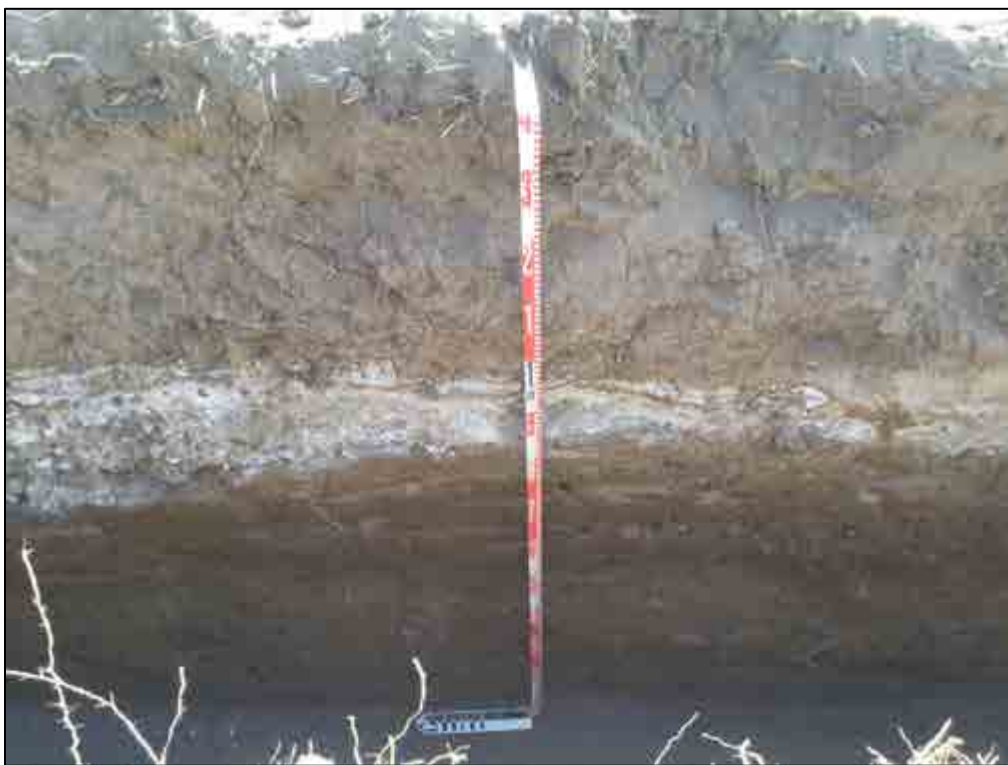
Figure 339. TE-82, close-up of the east wall, view to east

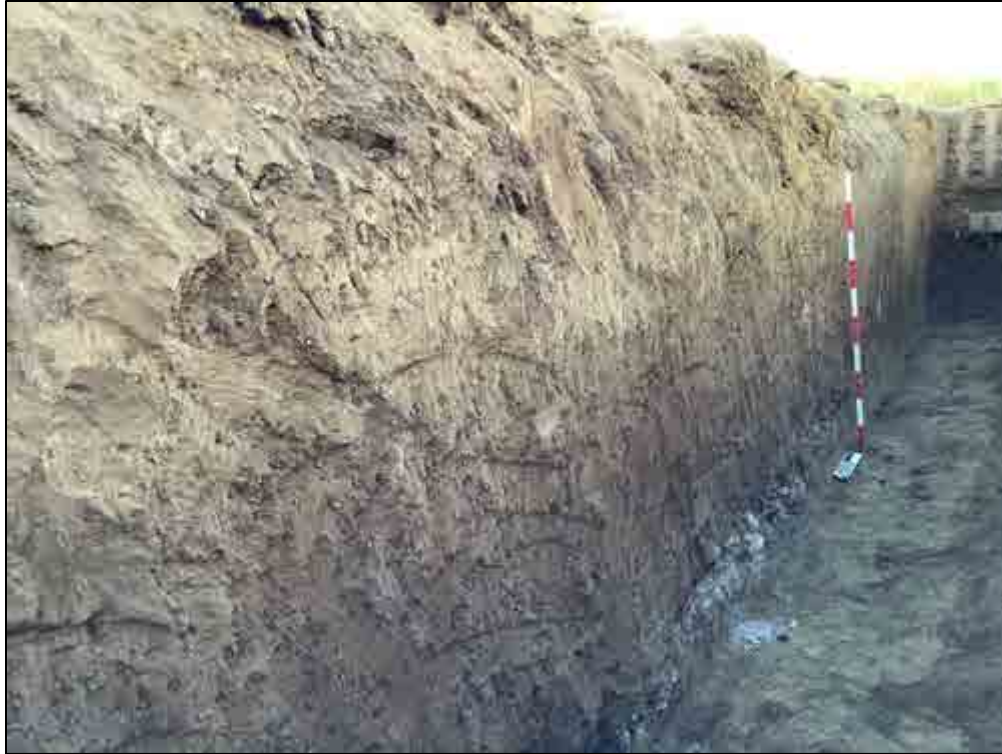
Figure 342. TE-83, overview of the east wall, view to southeast

TE-83 was in the central portion of the study area (Figure 341). The excavation was 6.00 m long by 0.80 m wide with a maximum depth of 1.46 mbs. The stratigraphy of TE-83 consisted of a dark brown, gravelly sandy loam Ap horizon (Stratum I) and dark reddish brown, previously disturbed natural, gravelly silty clay loam (Stratum II) overlying brown, natural gravelly silt loam (Stratum III) (Figure 342 through Figure 344 and Table 83). The agricultural plow zone (Stratum I) contained pieces of black plastic irrigation drip tape that were not collected. No other cultural materials were observed.

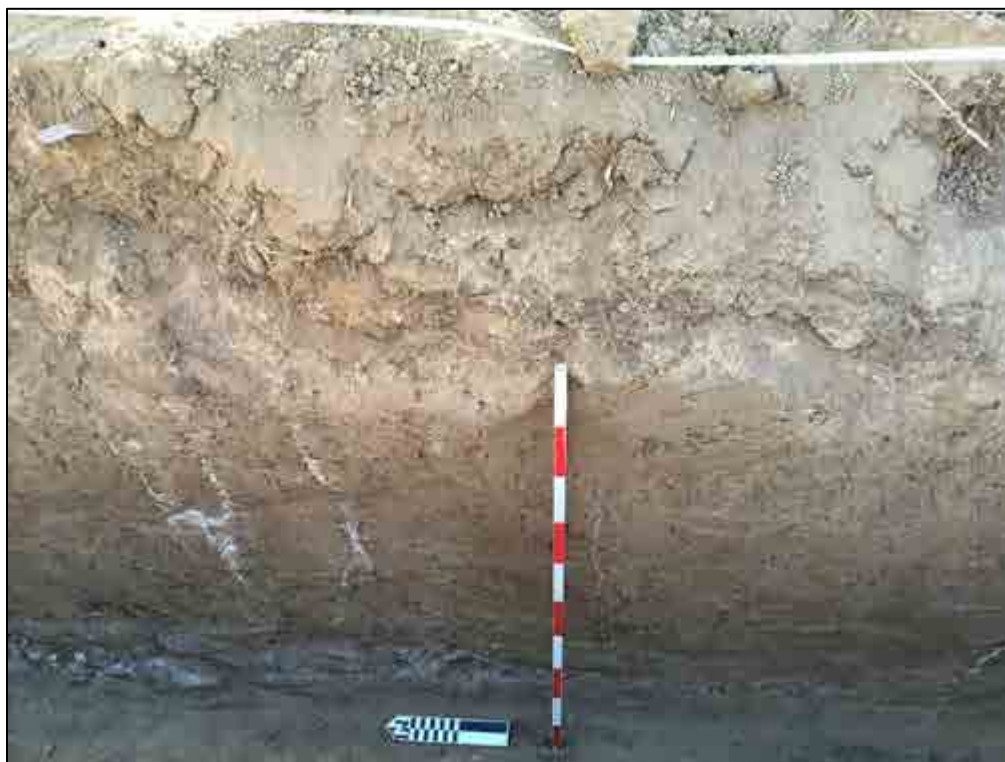
Figure 343. TE-83, close-up of the east wall, view to east

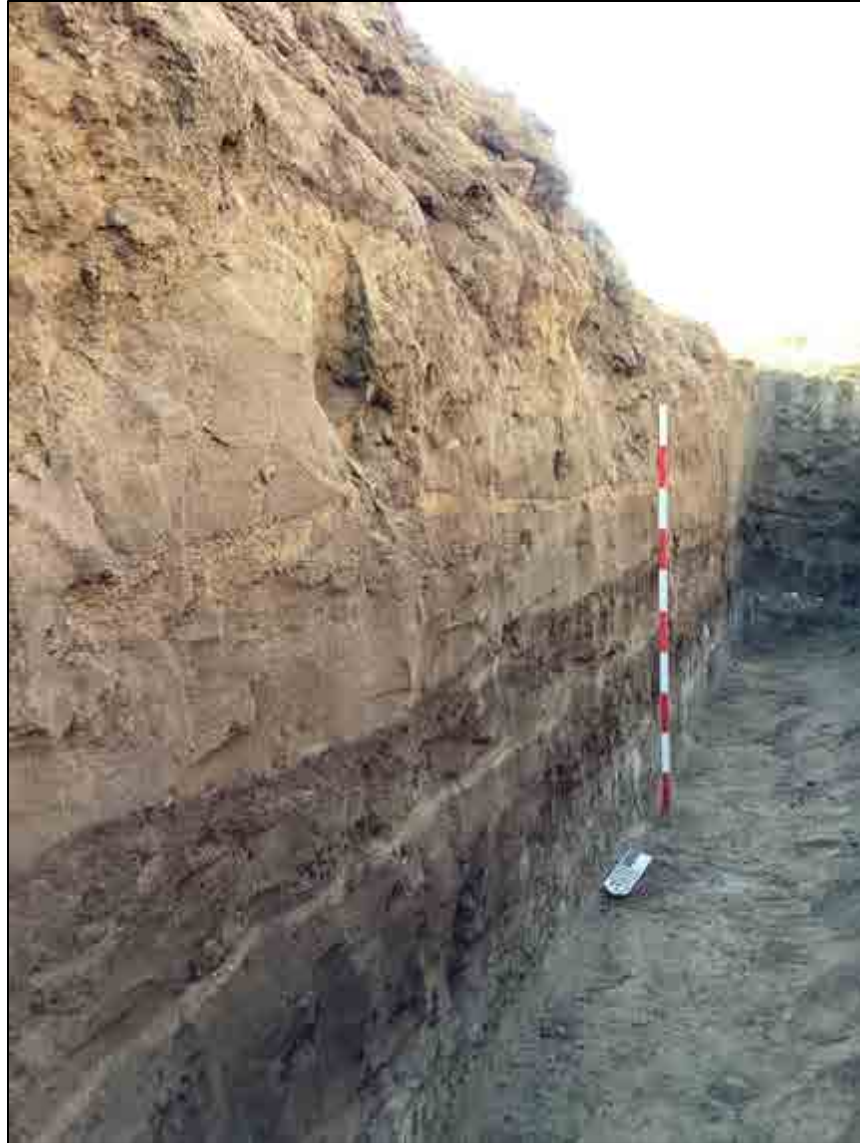
Figure 346. TE-84, oblique view of the east wall, view to southeast

TE-84 was located within the central portion of the study area (Figure 345). The excavation was 6.00 m long by 0.80 m wide with a maximum depth of 1.45 mbs. The stratigraphy of TE-84 consisted of a dark brown, gravelly sandy clay loam Ap horizon (Stratum I) and brown, previously disturbed natural, gravelly sand (Stratum II) overlying very dark brown, natural gravelly sandy loam (Stratum III); brown, natural gravelly sand (Stratum IV); dark brown, natural gravelly silty clay loam (Stratum V); and weak red, natural very gravelly silt loam containing concentrations of gray, very gravelly sandy loam stream deposits (Stratum VI) (Figure 346 through Figure 348 and Table 84). The agricultural plow zone (Stratum I) contained pieces of black plastic irrigation drip tape that were not collected. No other cultural materials were observed.

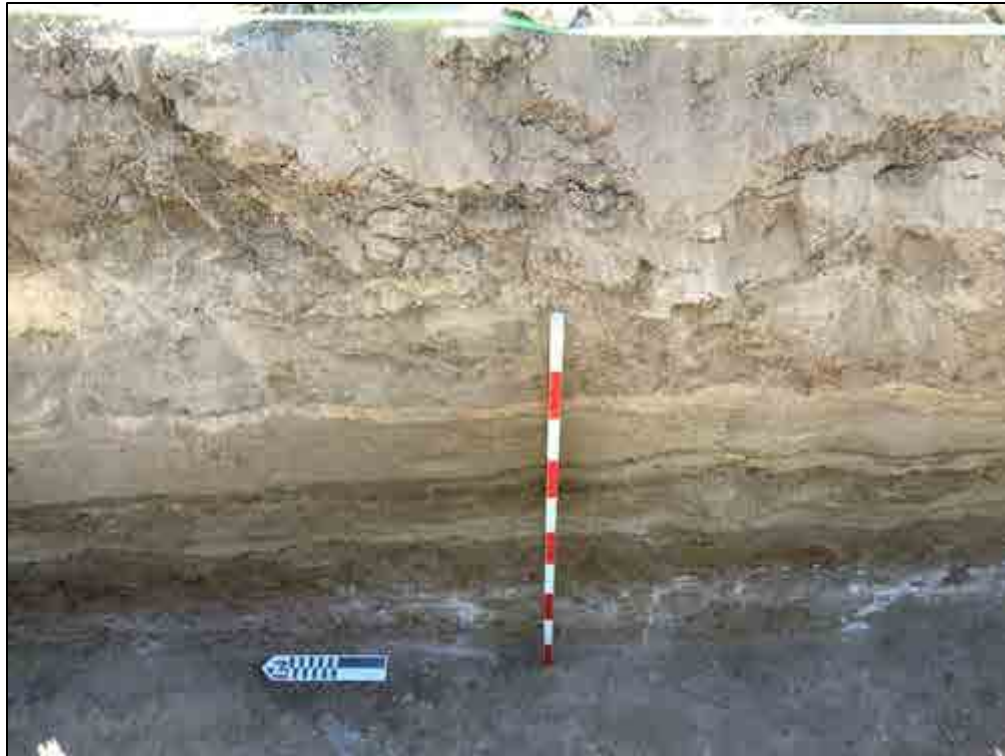
Figure 347. TE-84, close-up of the east wall

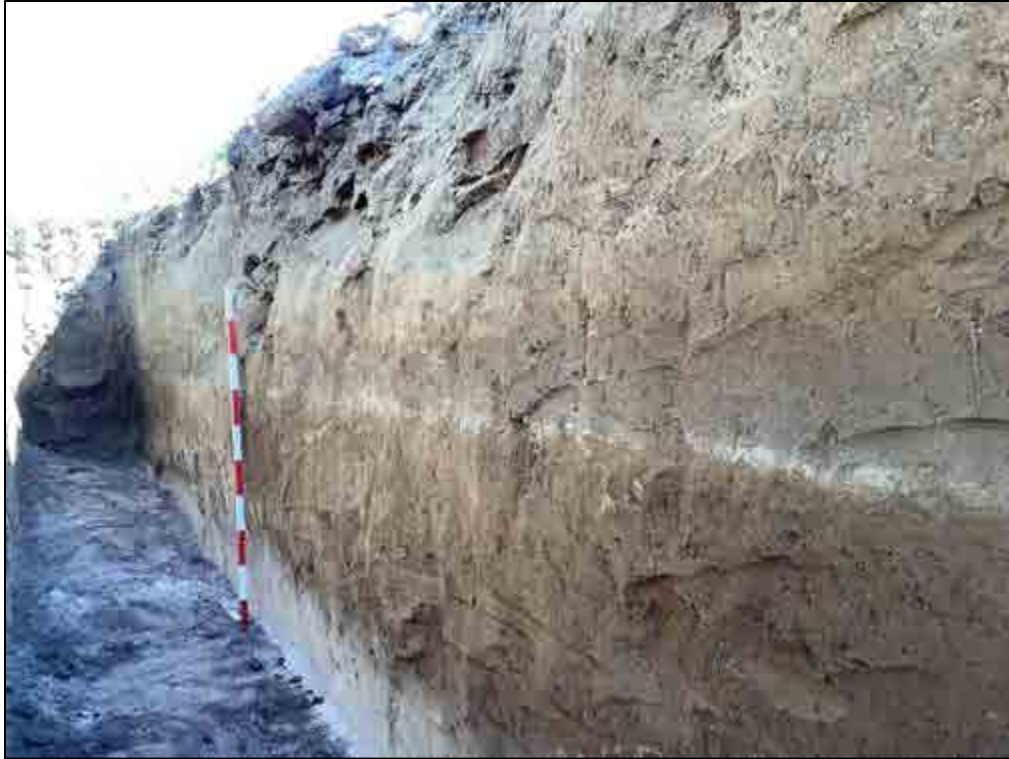
Figure 350. TE-85, oblique view of the east wall, view to northeast

TE-85 was in the eastern-central portion of the study area (Figure 349). The excavation was 6.00 m long by 0.80 m wide with a maximum depth of 1.60 mbs. The stratigraphy of TE-85 consisted of a dark brown, gravelly sandy clay loam Ap horizon (Stratum I) and dark brown, previously disturbed natural gravelly silty clay loam (Stratum II) overlying dark brown, natural silt loam (Stratum III); dark yellowish brown, natural silty clay loam (Stratum IV); pale brown, natural loamy sand (Stratum V) (Figure 350 through Figure 352 and Table 85). No cultural materials were observed.

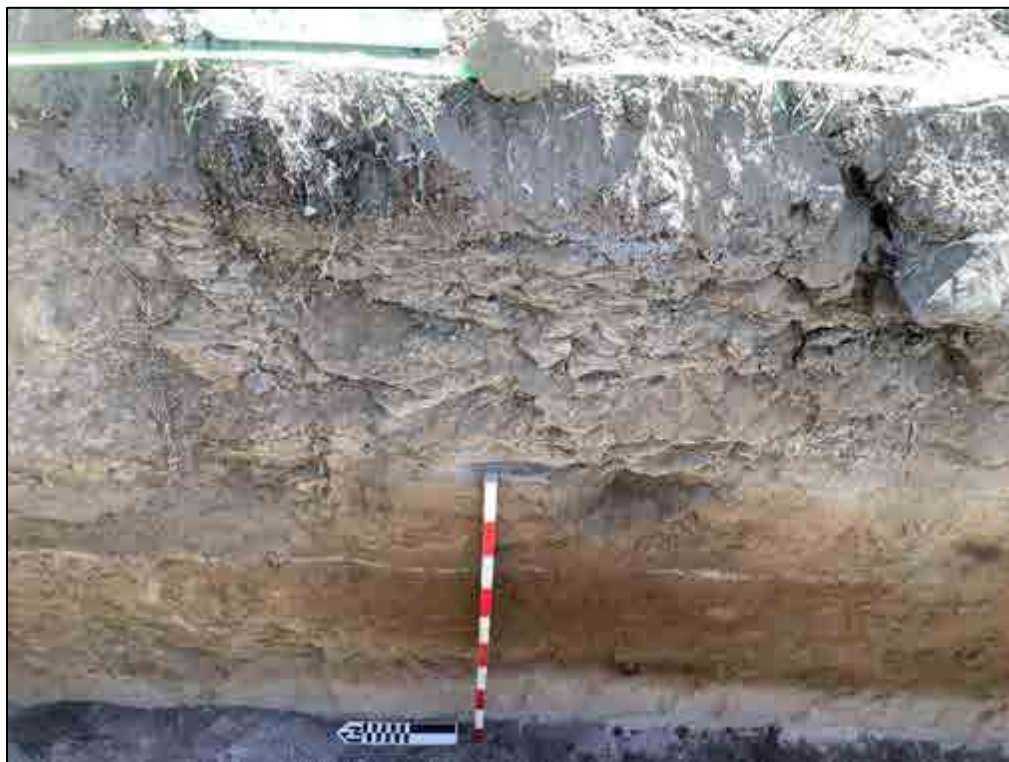
Figure 351. TE-85, close-up of the east wall, view to east

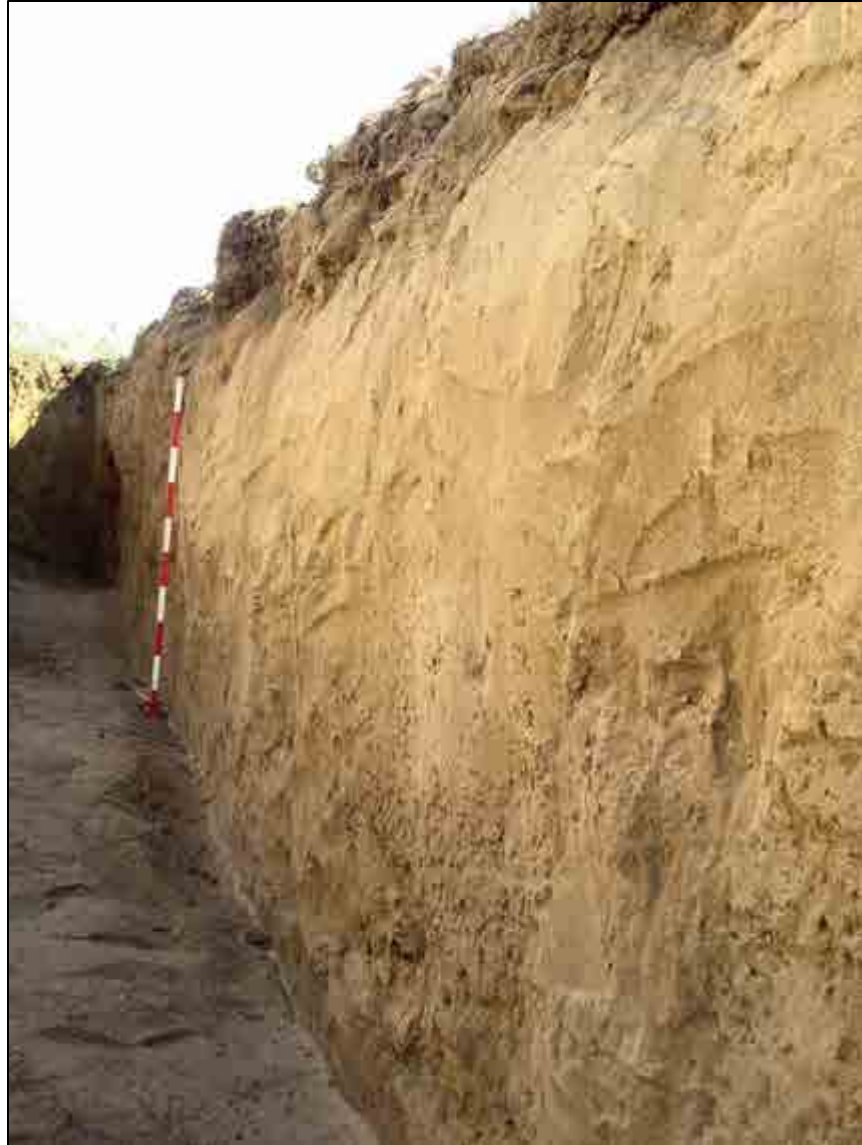
Figure 354. TE-86, oblique view of the east wall, view to northeast

TE-86 was in the eastern-central portion of the study area (Figure 353). The excavation was 6.00 m long by 0.80 m wide with a maximum depth of 1.37 mbs. The stratigraphy of TE-86 consisted of a dark brown, gravelly sandy clay loam Ap horizon (Stratum I) and dark yellowish brown, gravelly sandy loam fill (Stratum II) overlying brown, natural sand (Strata III and IV) and dark yellowish brown, natural loamy sand (Stratum V) (Figure 354 through Figure 356 and Table 86). No cultural materials were observed.

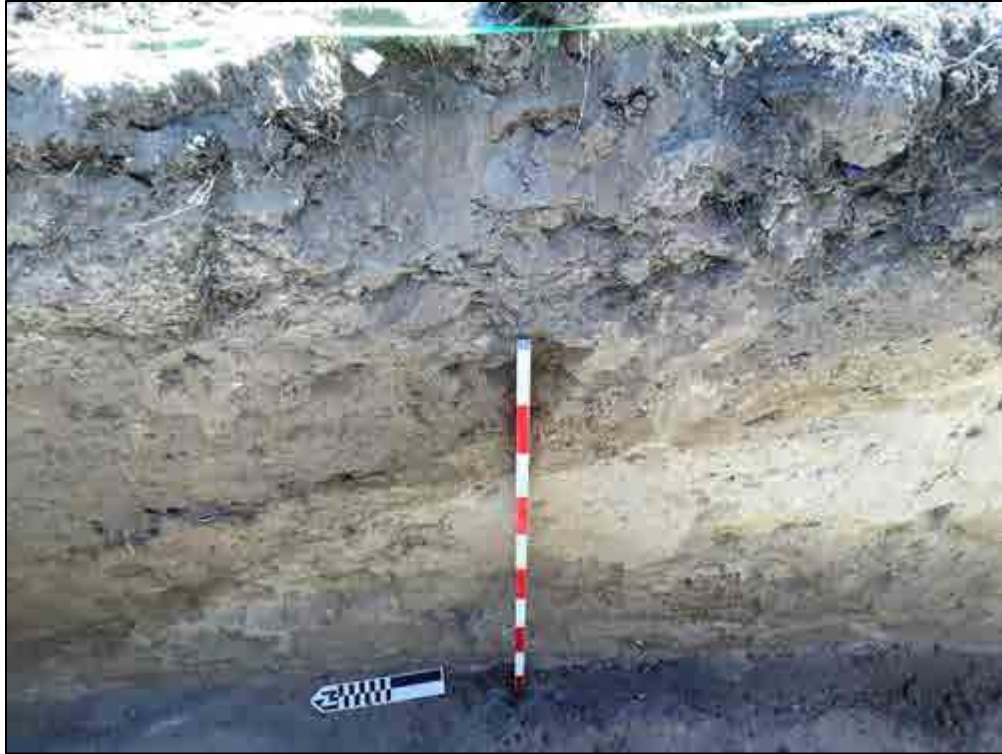
Figure 355. TE-86, close-up of the east wall, view to east

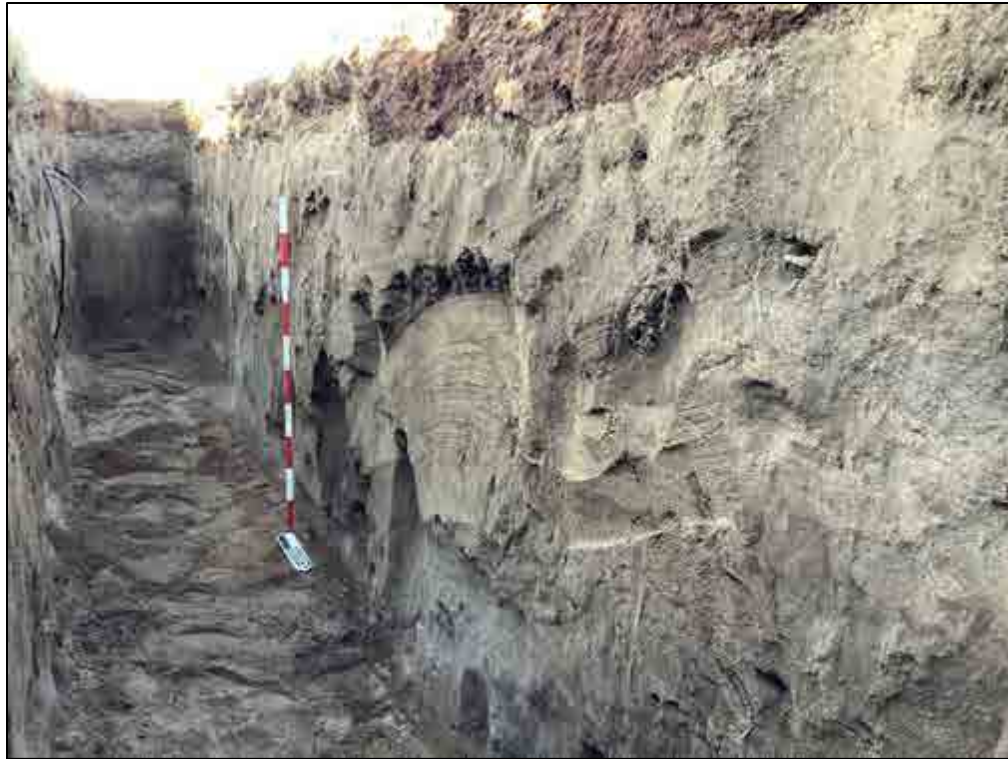
Figure 358. TE-87, oblique view of the west wall, view to southwest

TE-87 was near the eastern border in the central portion of the study area and west of Waikapū Stream (Figure 357). The excavation was 6.00 m long by 0.80 m wide with a maximum depth of 1.64 mbs. The stratigraphy of TE-87 consisted of dark reddish brown, gravelly silty clay loam fill (Stratum I) and a dark yellowish brown, loamy sand Ap horizon (Stratum II) overlying dark brown, natural silty clay loam (Stratum III) (Figure 358 through Figure 360 and Table 87). Strata I and II contained pieces of black plastic irrigation drip tape that were not collected. No other cultural materials were observed.

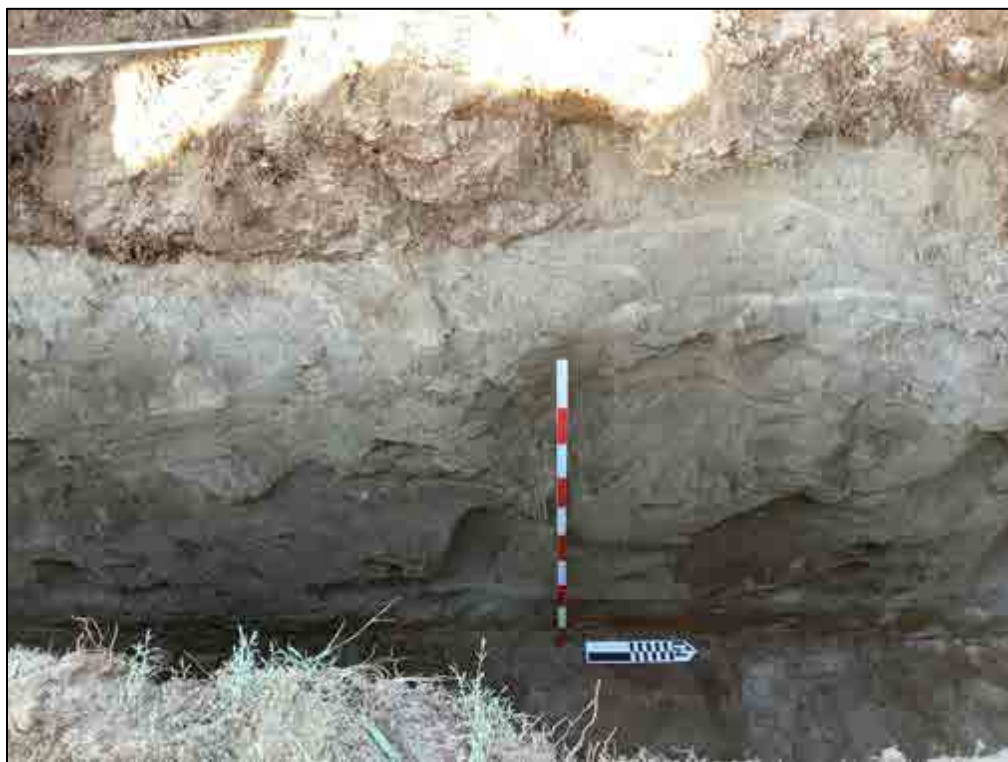
Figure 359. TE-87, close-up of the west wall, view to west

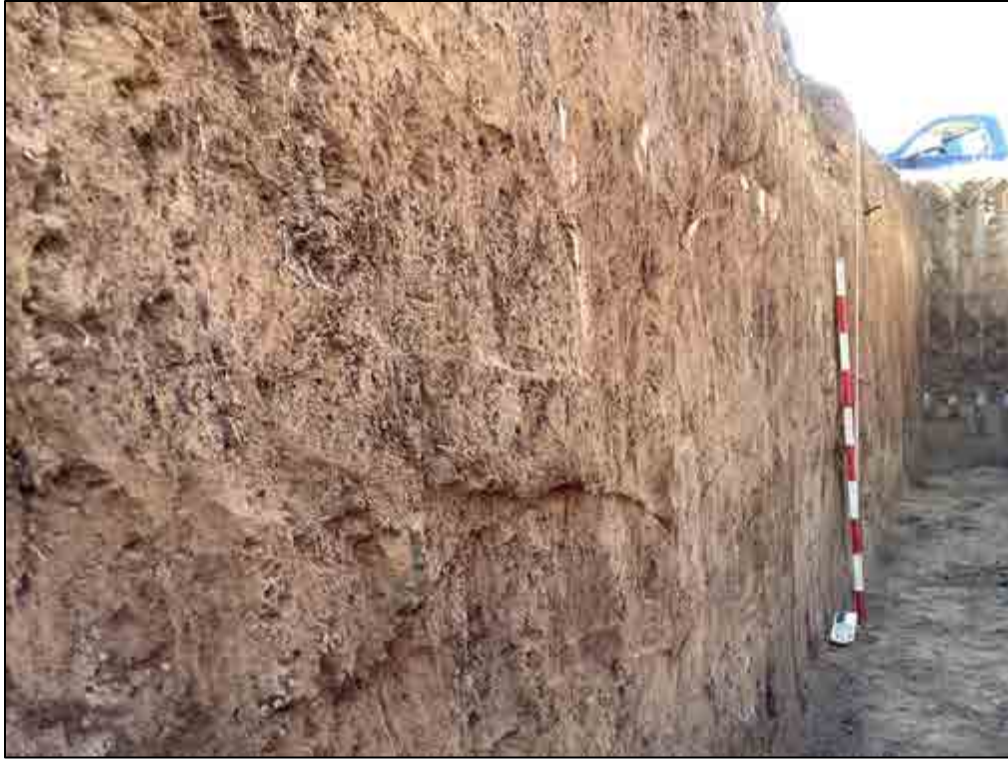
Figure 362. TE-88, oblique view of the east wall, view to south

TE-88 was near the western border in the central portion of the study area (Figure 361). The excavation was 6.00 m long by 0.80 m wide with a maximum depth of 1.63 mbs. The stratigraphy of TE-88 consisted of a very dark brown, gravelly sandy loam Ap horizon (Stratum I) and brown, gravelly sandy loam fill with concentrations of very dark brown, sandy loam (Stratum II) overlying dark brown, natural gravelly silty clay loam with small concentrations of brown sandy loam (Stratum III) and brown, natural gravelly silt loam with small concentrations of brown loamy sand and small gravels (Stratum IV) (Figure 362 through Figure 364 and Table 88). No cultural materials were observed.

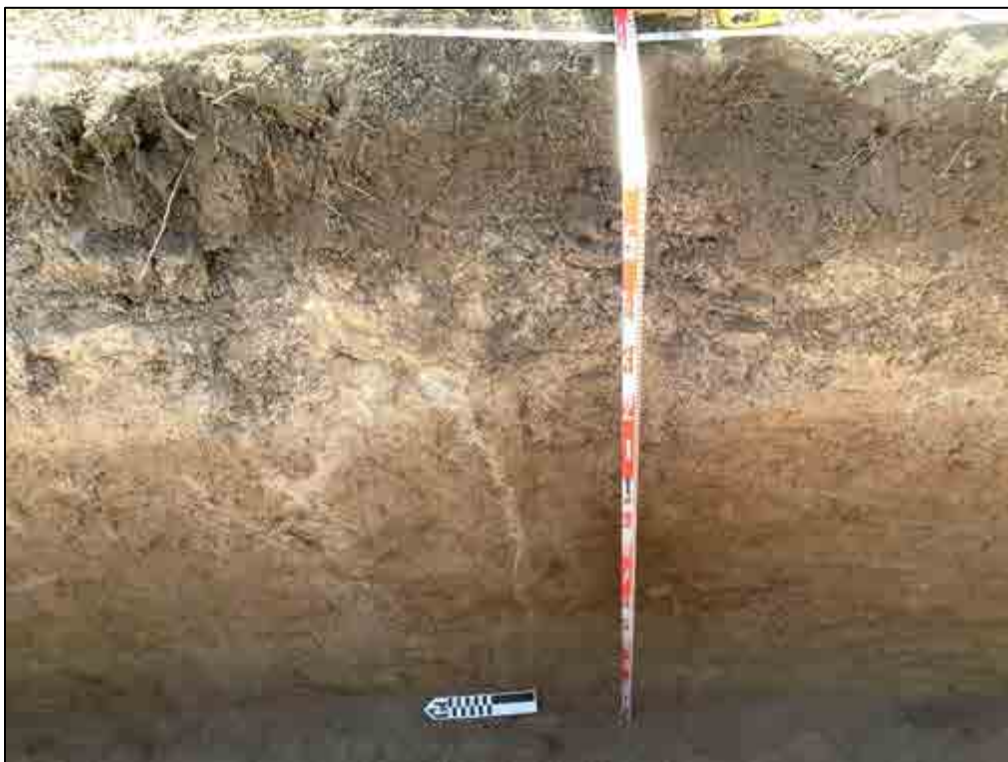
Figure 363. TE-88, close-up of the east wall, view to east

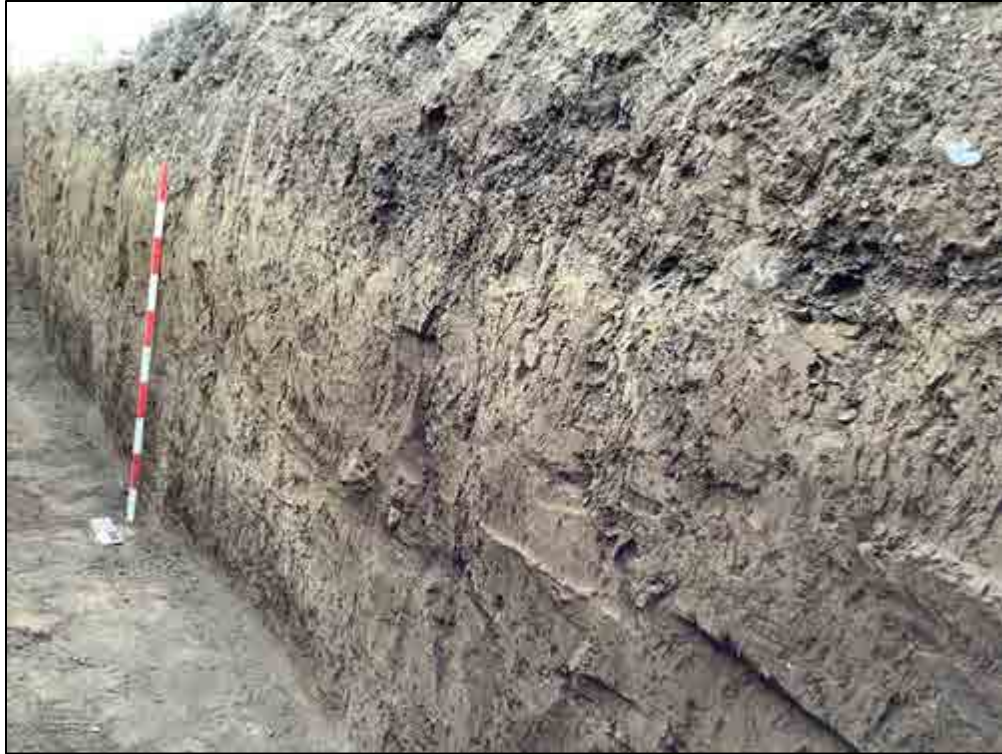
Figure 366. TE-89, oblique view of the east wall, view to northeast

TE-89 was near the western edge in the middle section of the study area, north of a drainage ditch (Figure 365). The excavation was 6.00 m long by 0.80 m wide with a maximum depth of 1.50 mbs. The stratigraphy of TE-89 consisted of a dark brown, gravelly sandy loam Ap horizon (Stratum I) and dark yellowish brown, previously disturbed natural, gravelly silty clay loam (Stratum II) overlying brown, natural gravelly silt loam (Stratum III) (Figure 366 through Figure 368 and Table 89). No cultural materials were observed.

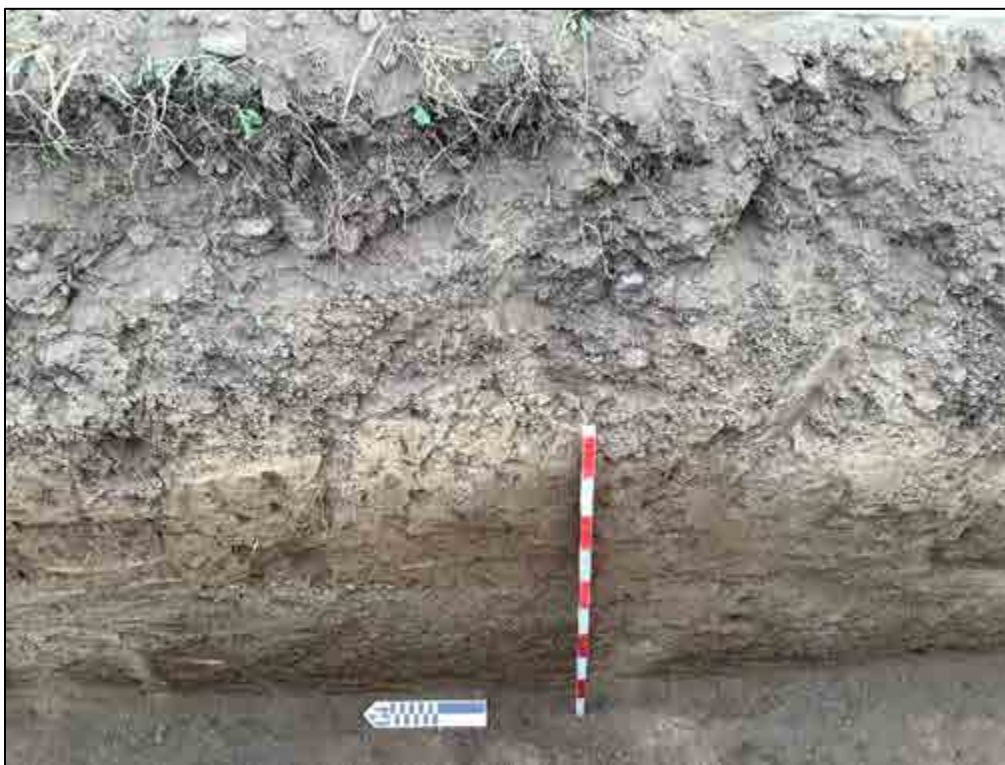
Figure 367. TE-89, close-up of the east wall, view to east

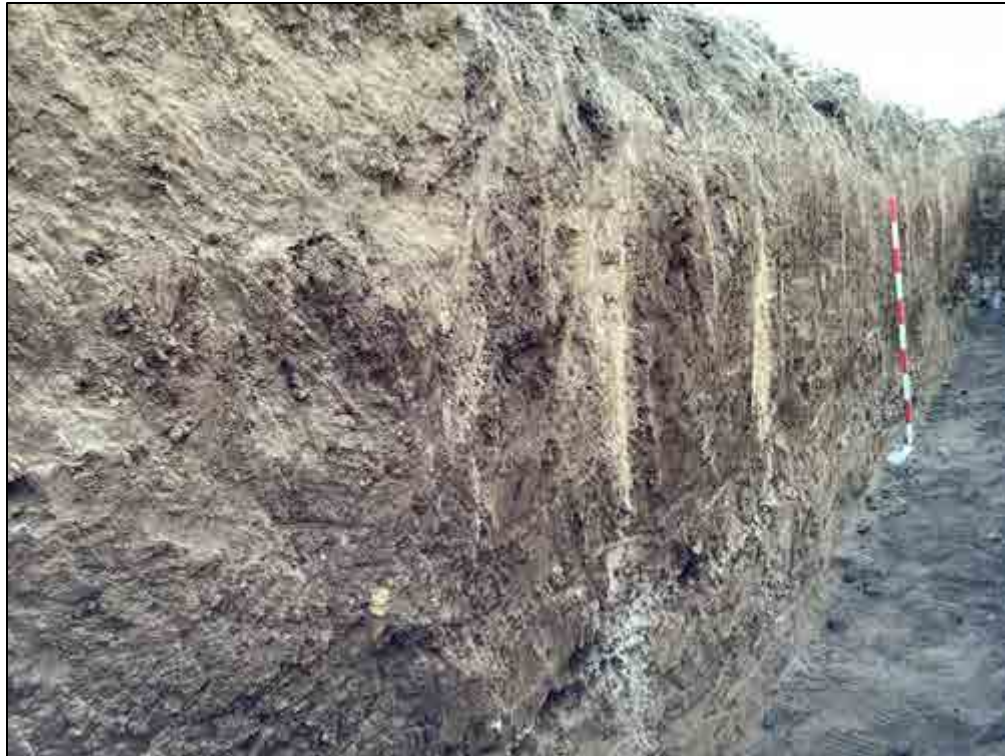
Figure 370. TE-90, oblique view of the east wall, view to southeast

TE-90 was near the western border in the central portion of the study area (Figure 369). The excavation was 6.00 m long by 0.80 m wide with a maximum depth of 1.73 mbs. The stratigraphy of TE-90 consisted of a dark brown, gravelly sandy loam Ap horizon (Stratum I) and dark reddish brown, previously disturbed natural, very gravelly silt loam (Stratum II) overlying dark yellowish brown, natural very gravelly silt loam with many inclusions of extremely gravelly loamy sand stream deposits (Stratum III) (Figure 370 through Figure 372 and Table 90). No cultural materials were observed.
