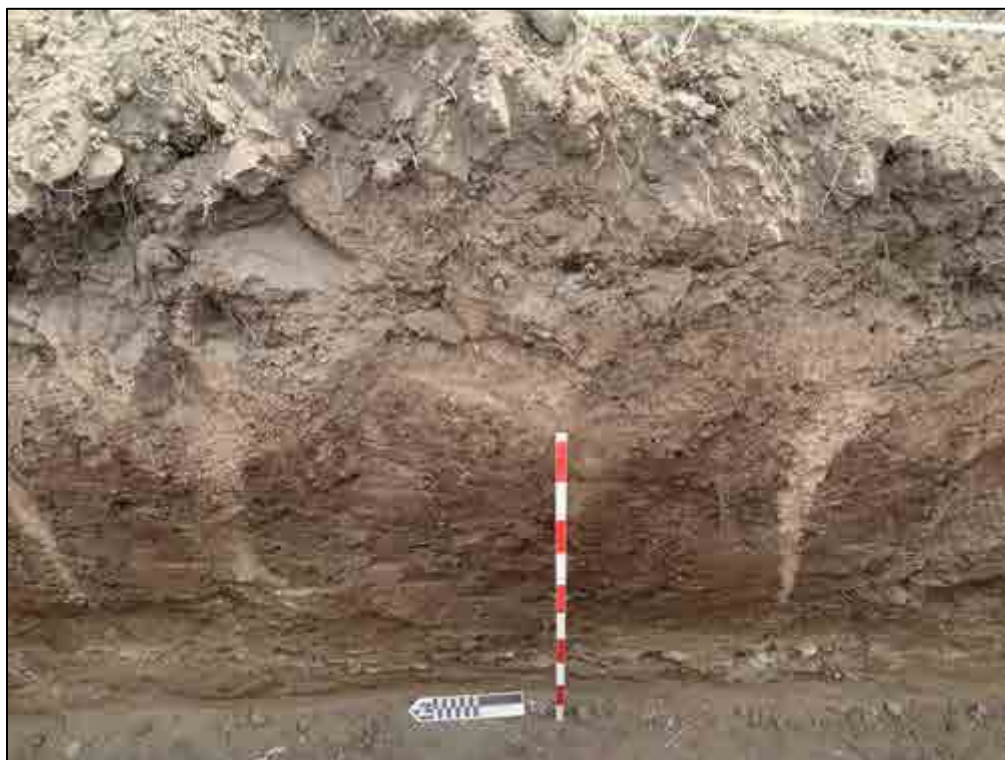
Figure 371. TE-90, close-up of the east wall, view to east

TE-90 was near the western border in the central portion of the study area (Figure 369). The excavation was 6.00 m long by 0.80 m wide with a maximum depth of 1.73 mbs. The stratigraphy of TE-90 consisted of a dark brown, gravelly sandy loam Ap horizon (Stratum I) and dark reddish brown, previously disturbed natural, very gravelly silt loam (Stratum II) overlying dark yellowish brown, natural very gravelly silt loam with many inclusions of extremely gravelly loamy sand stream deposits (Stratum III) (Figure 370 through Figure 372 and Table 90). No cultural materials were observed.

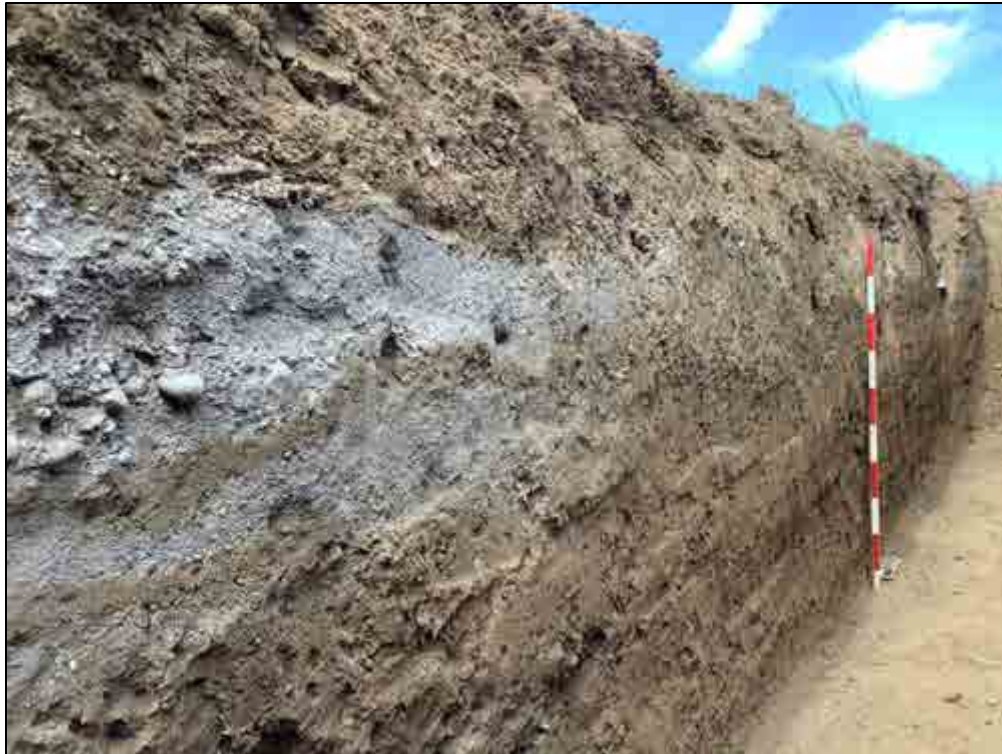
Figure 374. TE-91, oblique view of the west wall, view to northwest

TE-91 was in the western-central portion of the study area, north of a drainage ditch (Figure 373). The excavation was 6.00 m long by 0.80 m wide with a maximum depth of 1.55 mbs. The stratigraphy of TE-91 consisted of a dark brown, gravelly sandy loam Ap horizon (Stratum I) and dark yellowish brown, previously disturbed natural, very gravelly silt loam with many inclusions of extremely gravelly sand stream deposits (Stratum II) overlying brown, natural gravelly silt loam (Stratum III) (Figure 374 through Figure 378 and Table 91). Large pieces of concrete, possibly from a pipe, were encountered (not collected) in the west wall of Stratum I (see Figure 376 and Figure 377). No other cultural materials were observed.

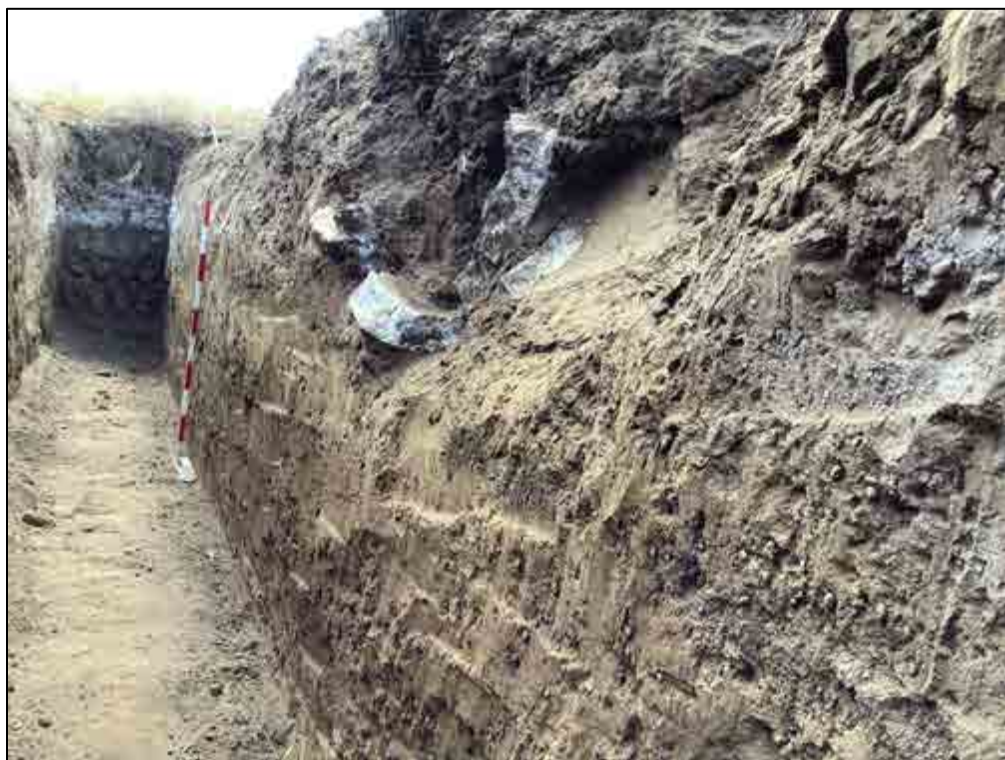
Figure 375. TE-91, oblique view of the west wall, view to southwest

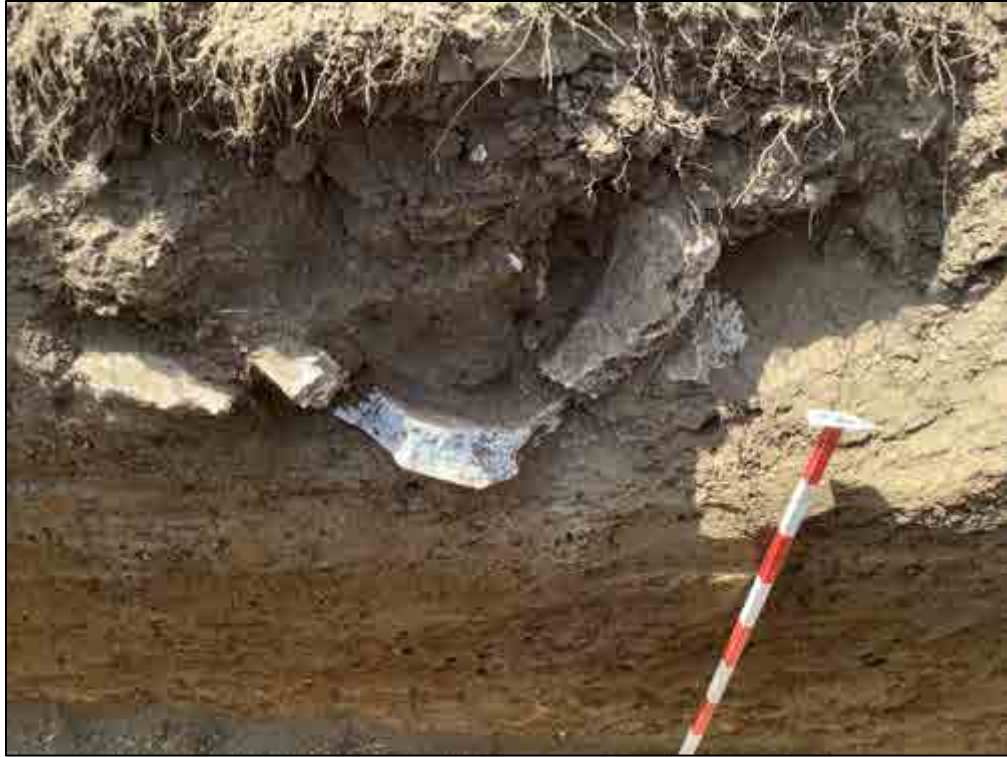
Figure 376. TE-91, close-up of the west wall showing concrete pieces in Stratum I, view to west

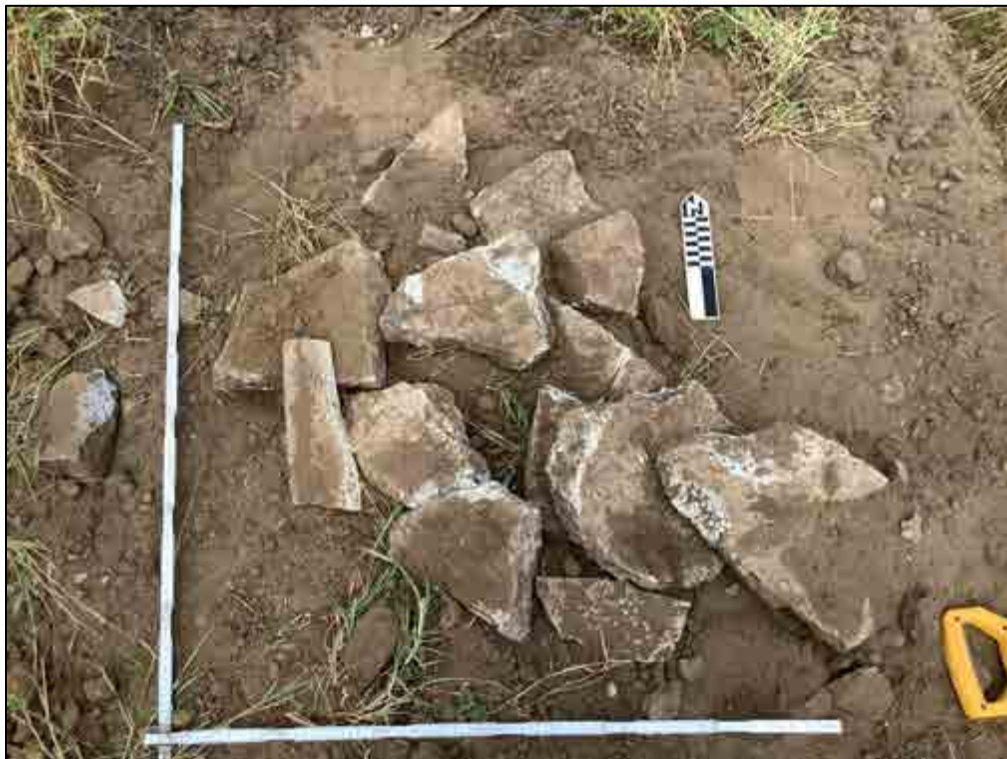
Figure 377. TE-91, overview of concrete pieces excavated from the west wall of Stratum I

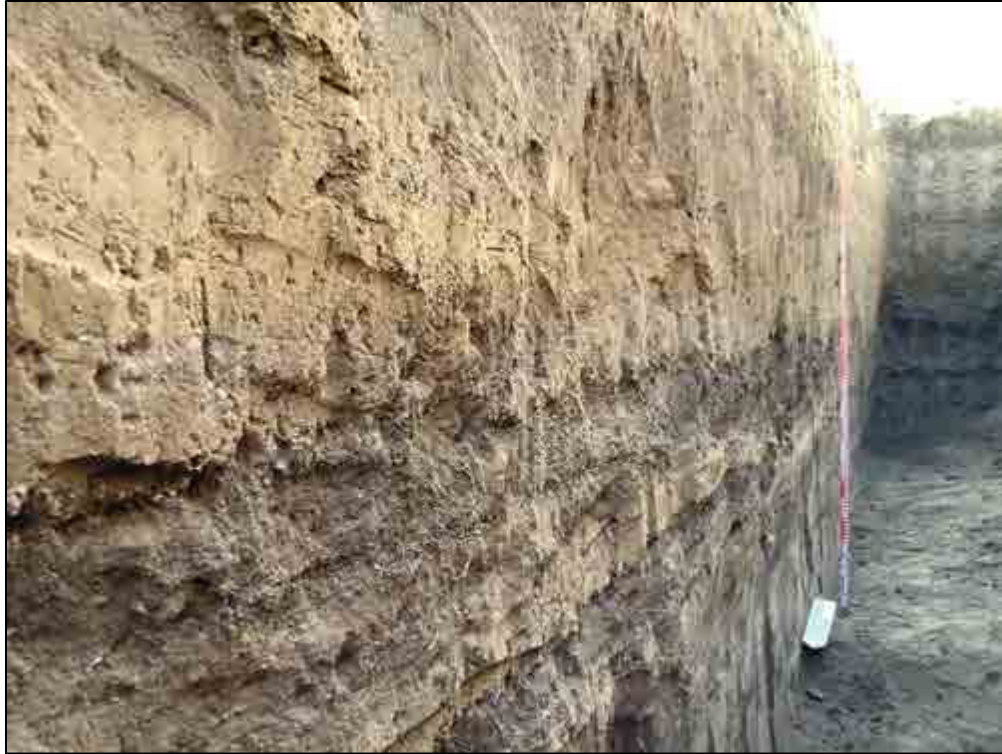
Figure 380. TE-92, oblique view of the east wall, view to southeast

TE-92 was in the central portion of the study area (Figure 379). The excavation was 6.00 m long by 0.80 m wide with a maximum depth of 1.75 mbs. The stratigraphy of TE-92 consisted of a very dark grayish brown, gravelly sandy loam Ap horizon (Stratum I) and dark brown, previously disturbed natural, gravelly silty clay loam with cinder sand inclusions (Stratum II) overlying natural brown, silt loam with cinder sand inclusions (Stratum III) (Figure 380 through Figure 382 and Table 92). No cultural materials were observed.

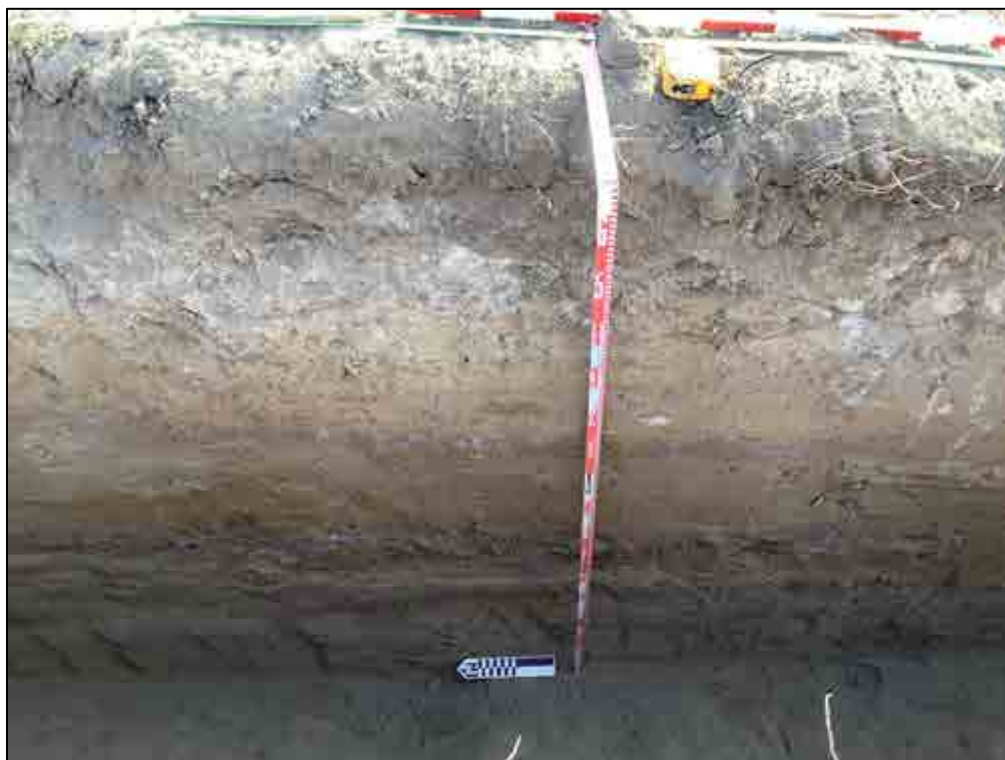
Figure 381. TE-92, close-up of the east wall, view to east

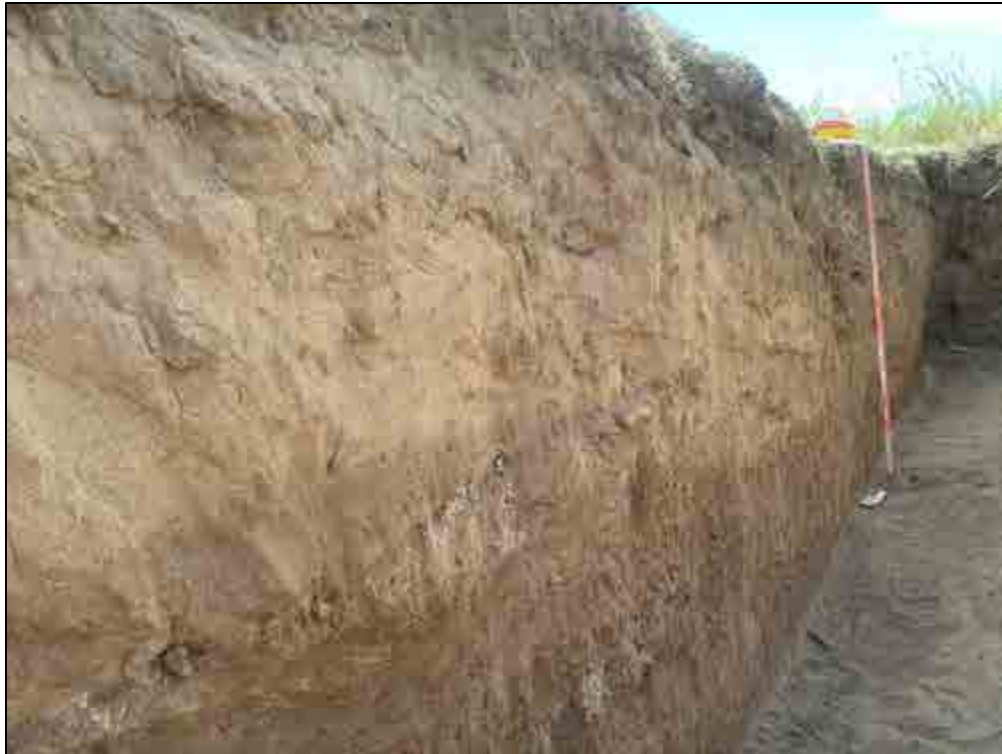
Figure 384. TE-93, oblique view of the east wall, view to southeast

TE-93 was in the central portion of the study area (Figure 383). The excavation was 6.00 m long by 0.80 m wide with a maximum depth of 1.62 mbs. The stratigraphy of TE-93 consisted of a very dark grayish brown, gravelly sandy loam Ap horizon (Stratum I) overlying brown, loamy sand fill mottled with brown marine sand (Stratum II) and natural dark brown, very gravelly sandy clay loam (Stratum III) (Figure 384 through Figure 386 and Table 93). Several pieces of concrete were scattered in the southern end of Stratum II and not collected.

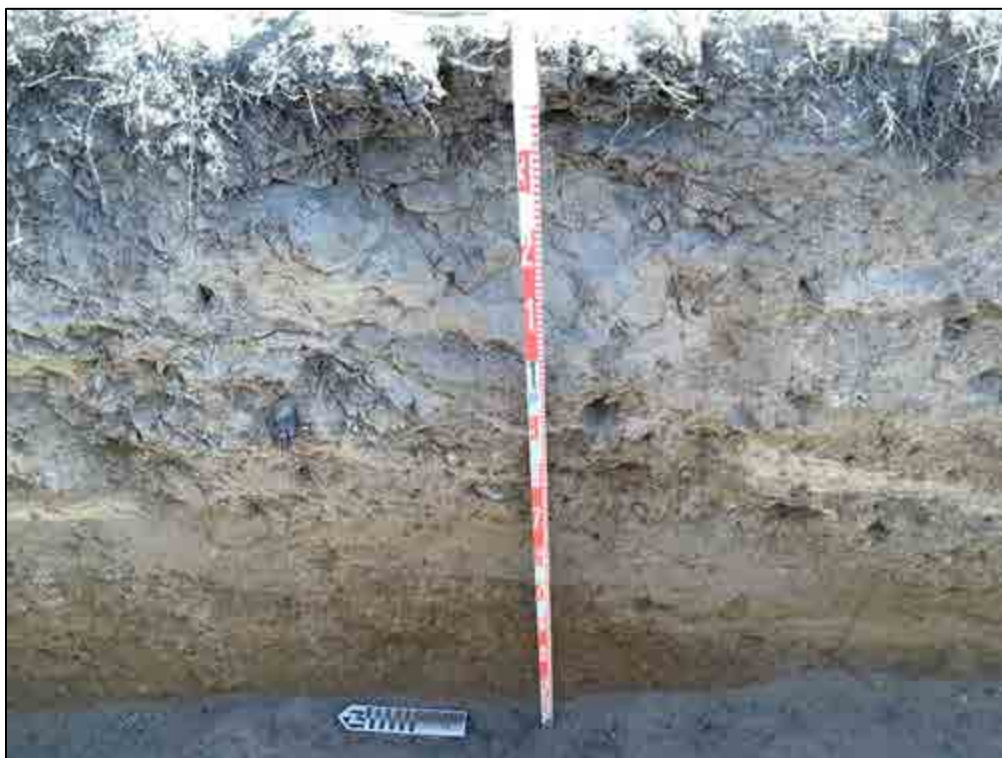
Figure 385. TE-93, close-up of the east wall, view to east

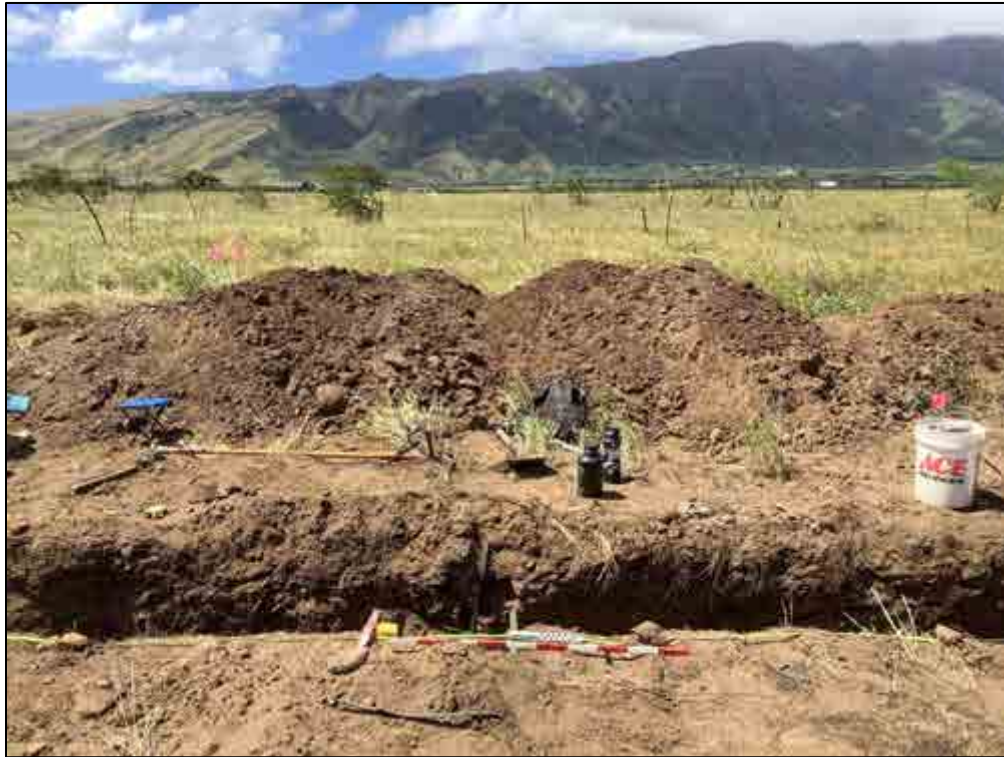
Figure 387. TE-94, overview of the general location, view to west

TE-94 was near the eastern-central portion of the study area (Figure 387). The excavation was 6.00 m long by 0.80 m wide with a maximum depth of 1.53 mbs. The stratigraphy of TE-94 consisted of a very dark grayish brown, gravelly sandy loam Ap horizon (Stratum I) and a brown, previously disturbed natural gravelly sandy loam (Stratum II) overlying dark brown, natural very gravelly silt loam with extremely gravelly sand stream deposit inclusions (Stratum III) and dark brown, natural very gravelly silt loam (Stratum IV) (Figure 388 through Figure 390 and Table 94). No cultural materials were observed.

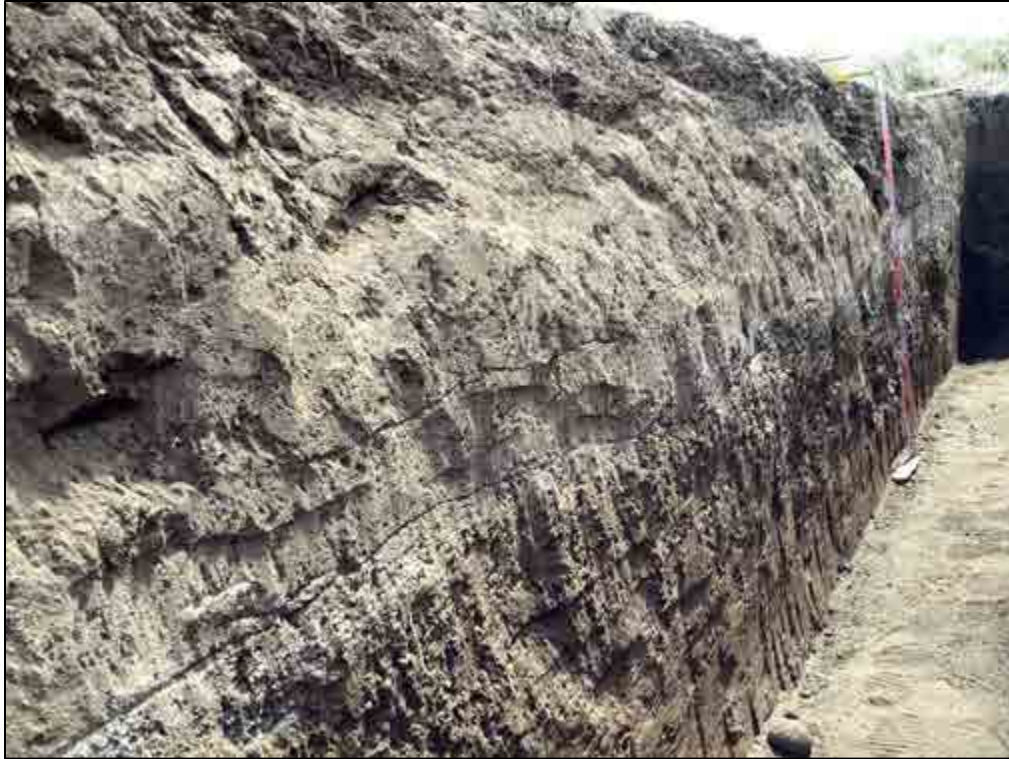
Figure 388. TE-94, oblique view of the east wall, view to southeast

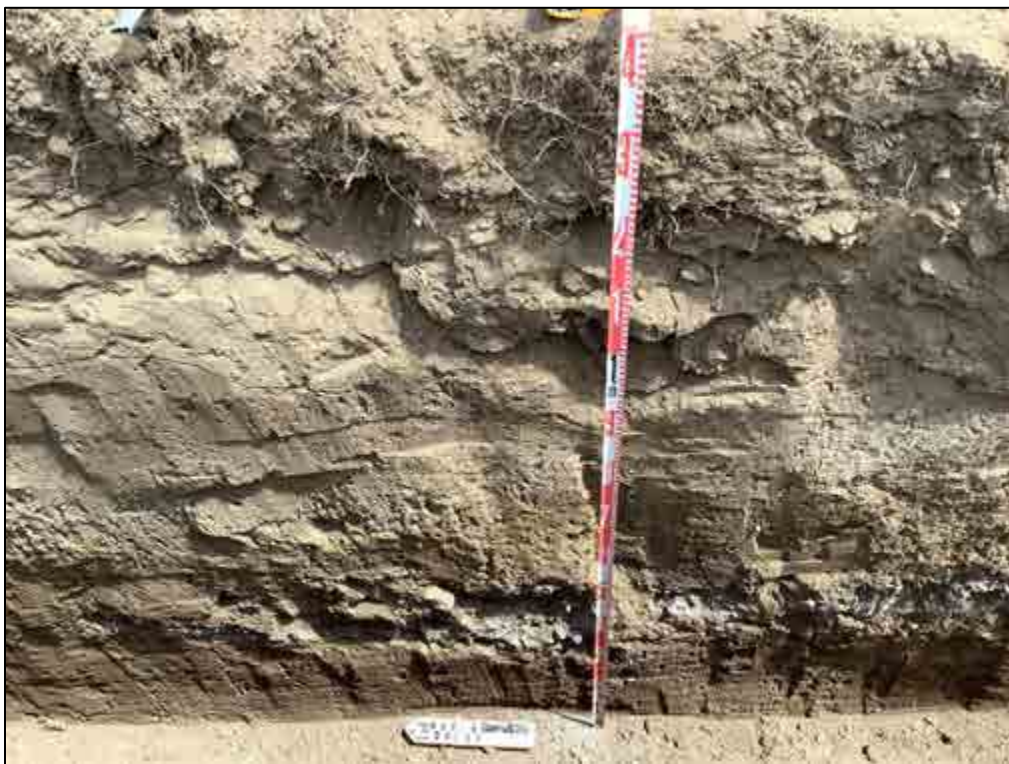
Figure 389. TE-94, close-up of the east wall, view to east

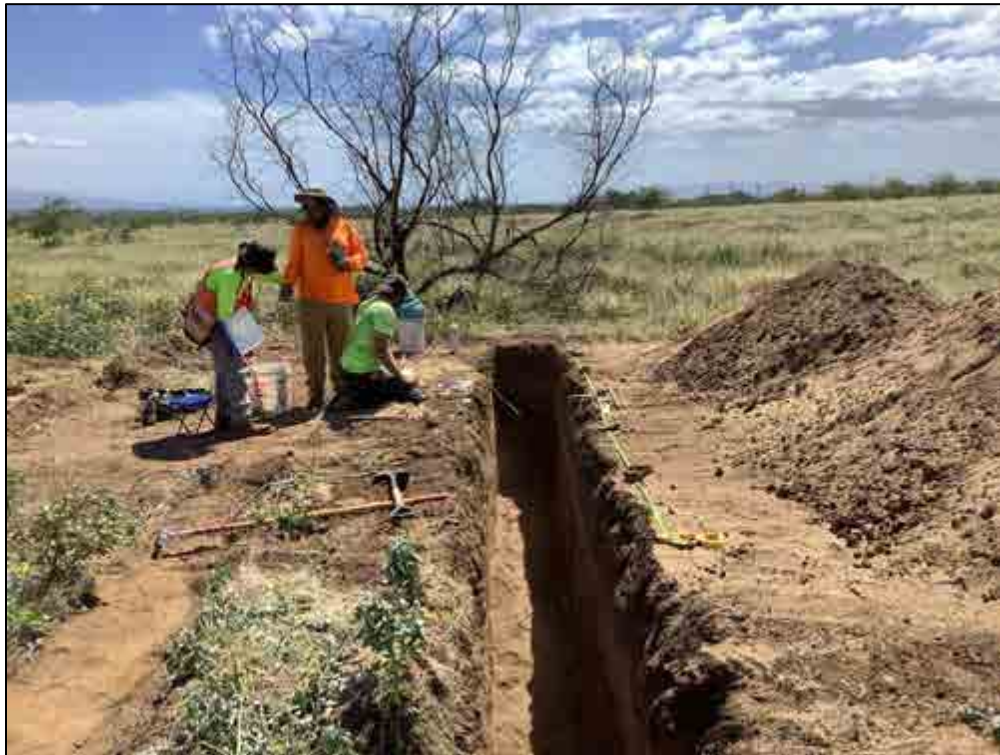
Figure 391. TE-95, overview of the general location, view to south

TE-95 was near the eastern-central portion of the study area (Figure 391). The excavation was 6.00 m long by 0.80 m wide with a maximum depth of 1.95 mbs. The stratigraphy of TE-95 consisted of a dark reddish brown, gravelly sandy loam Ap horizon (Stratum I) overlying yellowish brown, natural aeolian sand (Stratum II); dark brown, natural gravelly silt loam (Stratum III); and dark yellowish brown, natural gravelly silt loam (Stratum IV) (Figure 392 through Figure 394 and Table 95). No cultural materials were encountered.

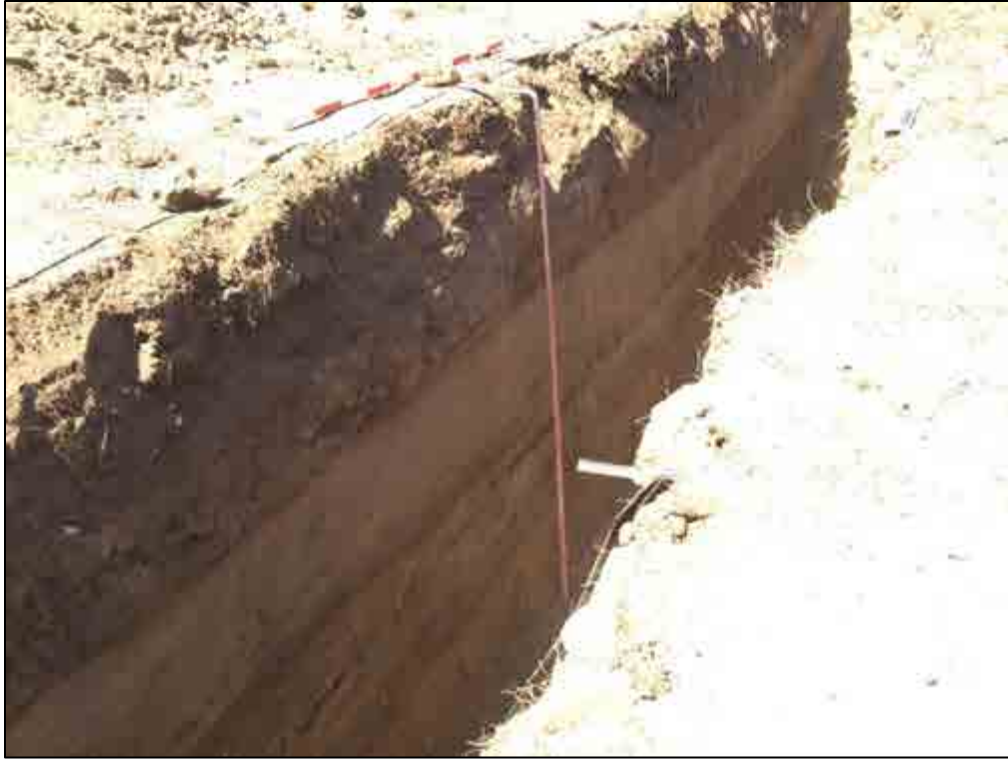
Figure 392. TE-95, oblique view of the west wall, view to northwest

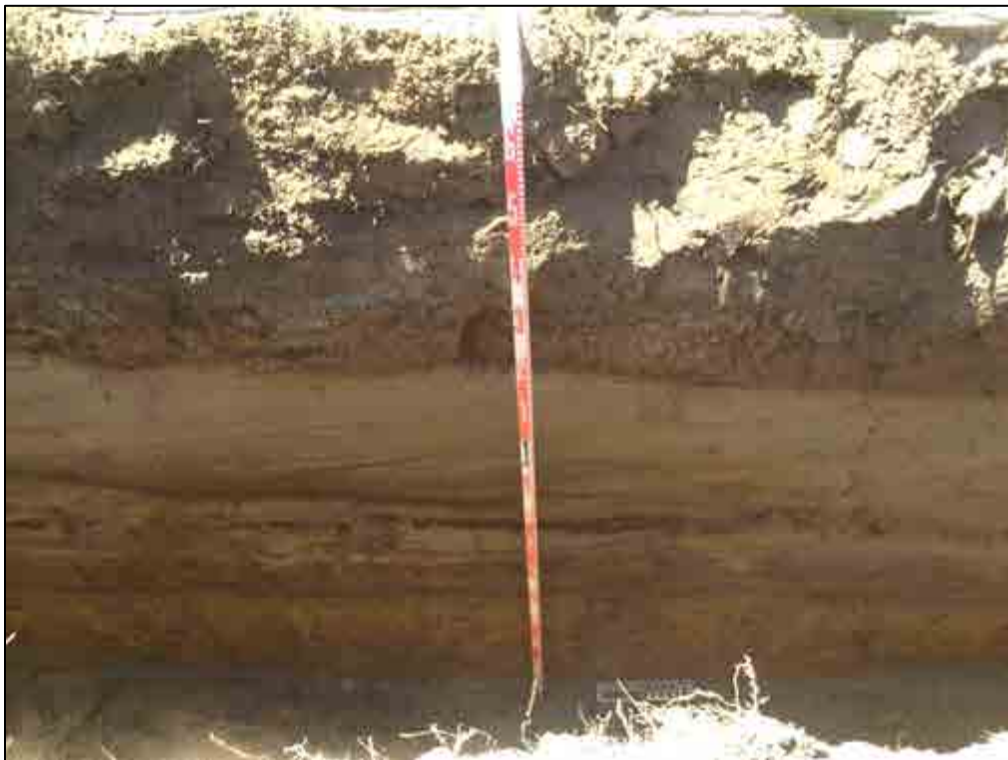
Figure 393. TE-95, close-up of the west wall, view to west

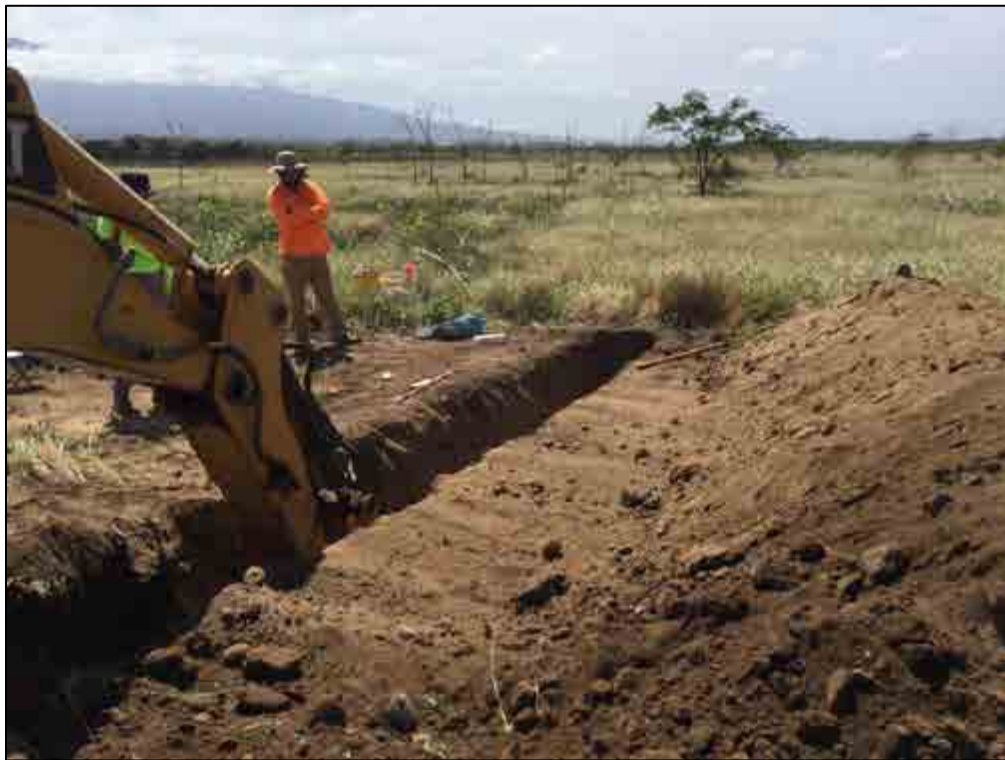
Figure 395. TE-96, overview of the general location, view to southeast

TE-96 was near the eastern-central portion of the study area (Figure 395). The excavation was 6.00 m long by 0.80 m wide with a maximum depth of 1.86 mbs. The stratigraphy of TE-96 consisted of a dark brown, gravelly sandy loam Ap horizon (Stratum I) and brown, previously disturbed natural, silt loam (Stratum II) overlying a dark gray, natural very gravelly sand alluvial deposit (Stratum III); brown, natural gravelly silt loam with loamy sand banding (Stratum IV); and brown, natural gravelly silt loam (Stratum V) (Figure 396 through Figure 398 and Table 96). The agricultural plow zone (Stratum I) contained pieces of black plastic irrigation drip tape that were not collected. No other cultural materials were observed.

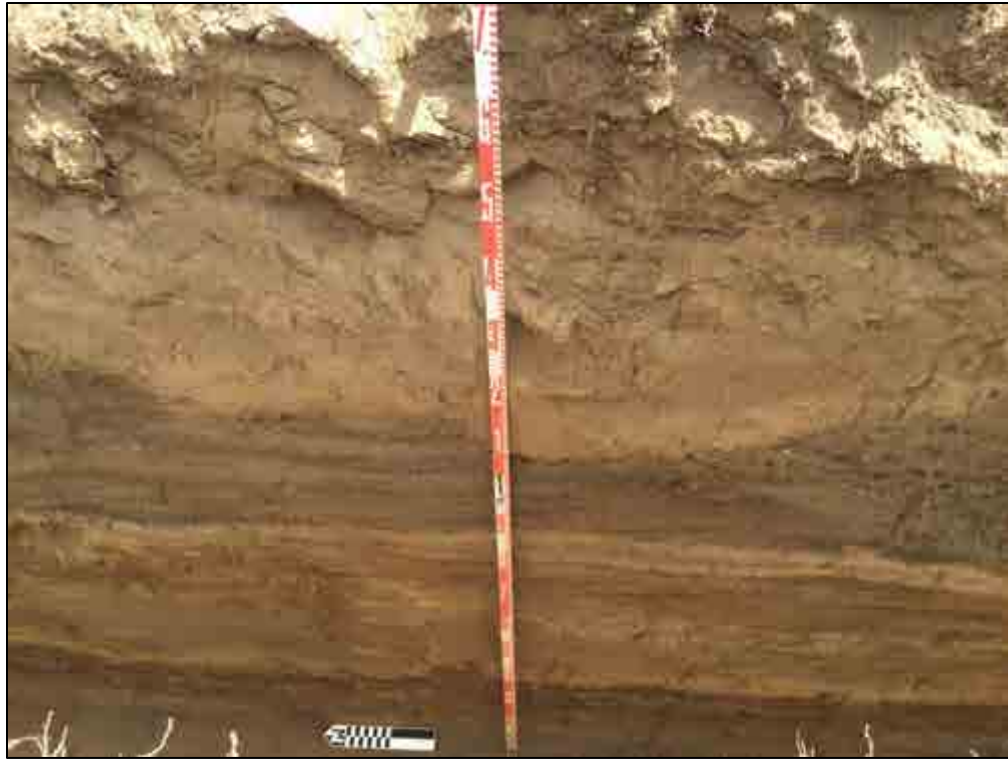
Figure 396. TE-96, close-up of the east wall, view to east

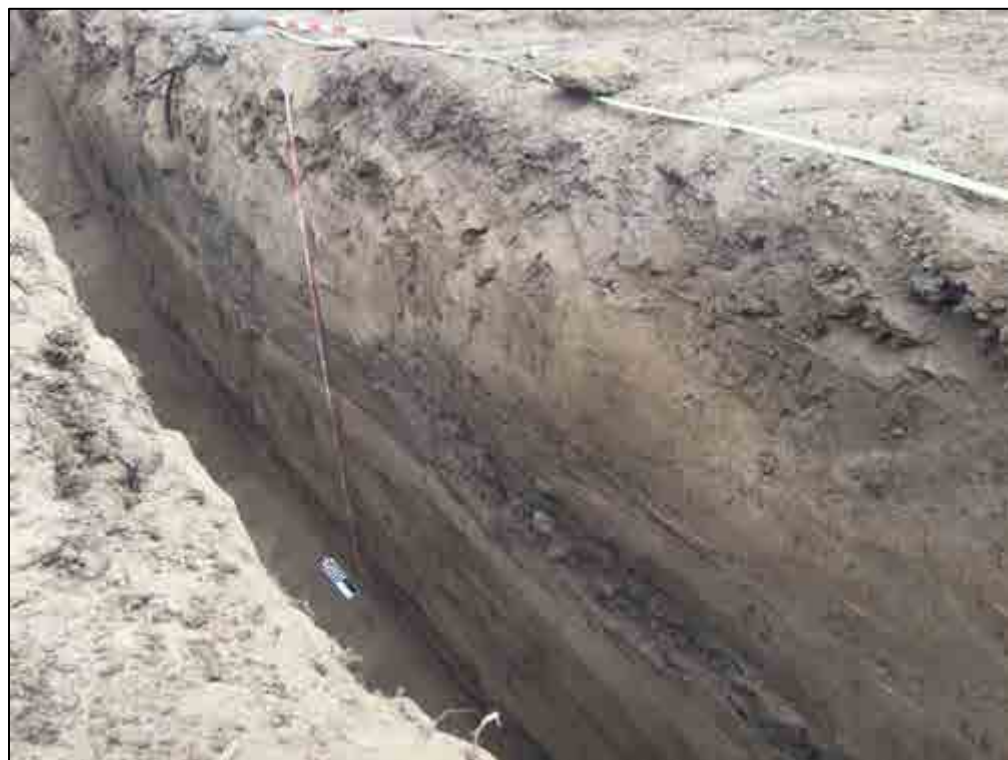
Figure 397. TE-96, overview of the east wall, view to northeast

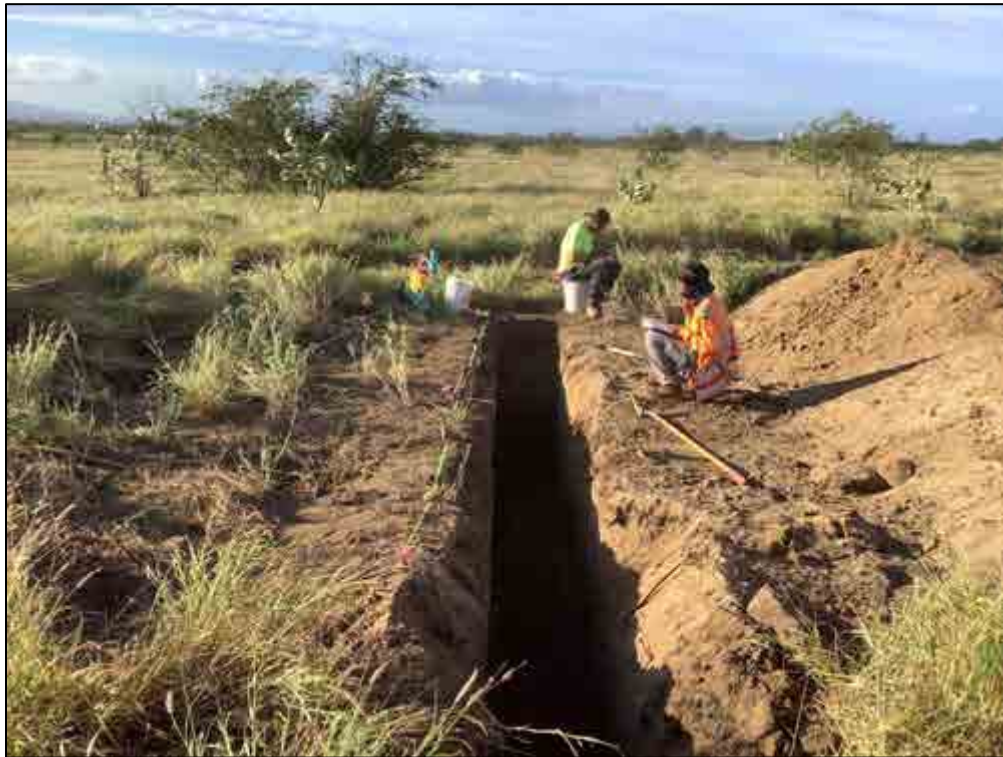
Figure 399. TE-97, overview of the general location, view to southeast

TE-97 was near the eastern border in middle section of the study area (Figure 399). The excavation was 6.00 m long by 0.80 m wide with a maximum depth of 1.70 mbs. The stratigraphy of TE-97 consisted of a dark yellowish brown, gravelly sandy loam Ap horizon (Stratum I) overlying brown, natural aeolian sand (Stratum II) and dark yellowish brown, natural gravelly silt loam (Stratum III) (Figure 400 through Figure 402 and Table 97). No cultural materials were encountered.

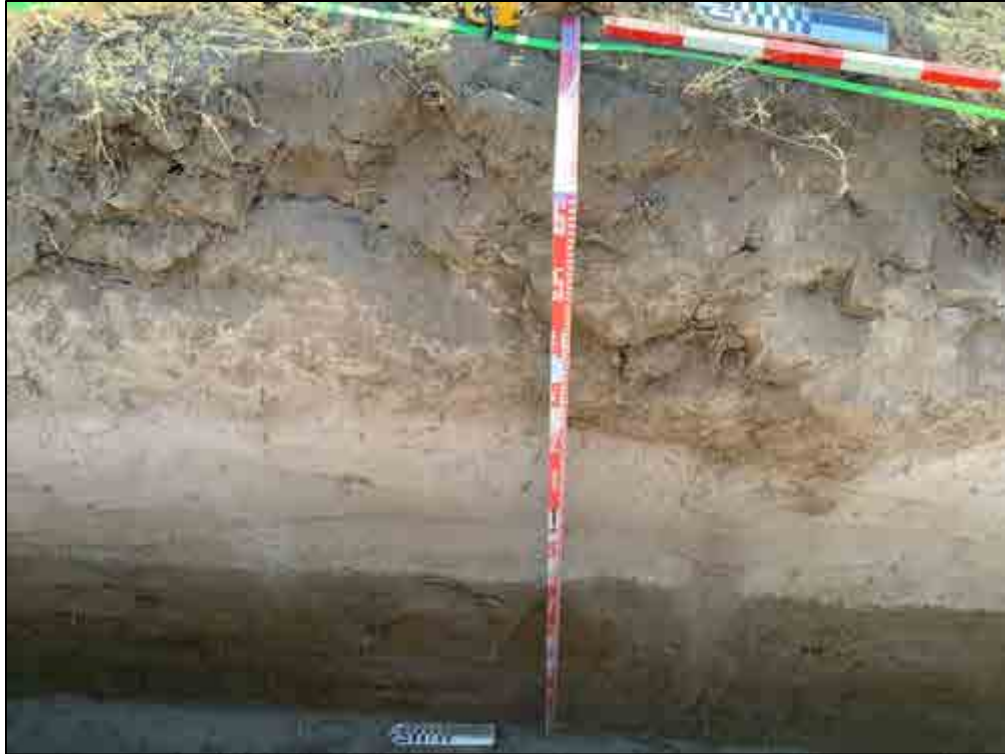
Figure 400. TE-97, close-up of the east wall, view to east

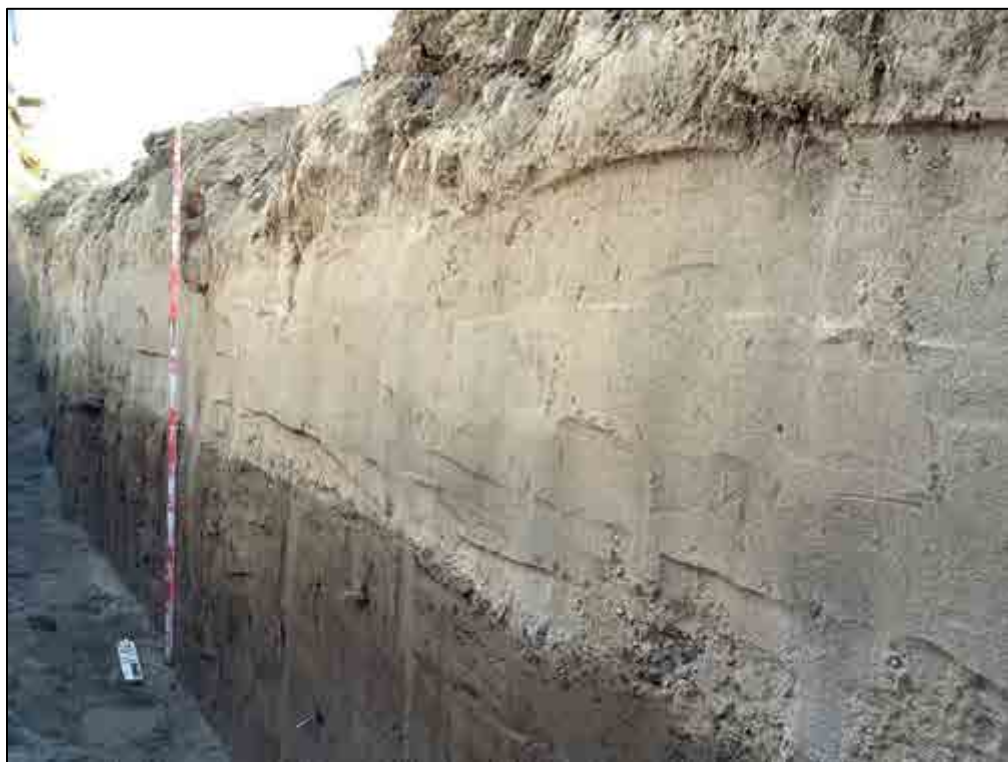
Figure 401. TE-97, overview of the east wall, view to northeast

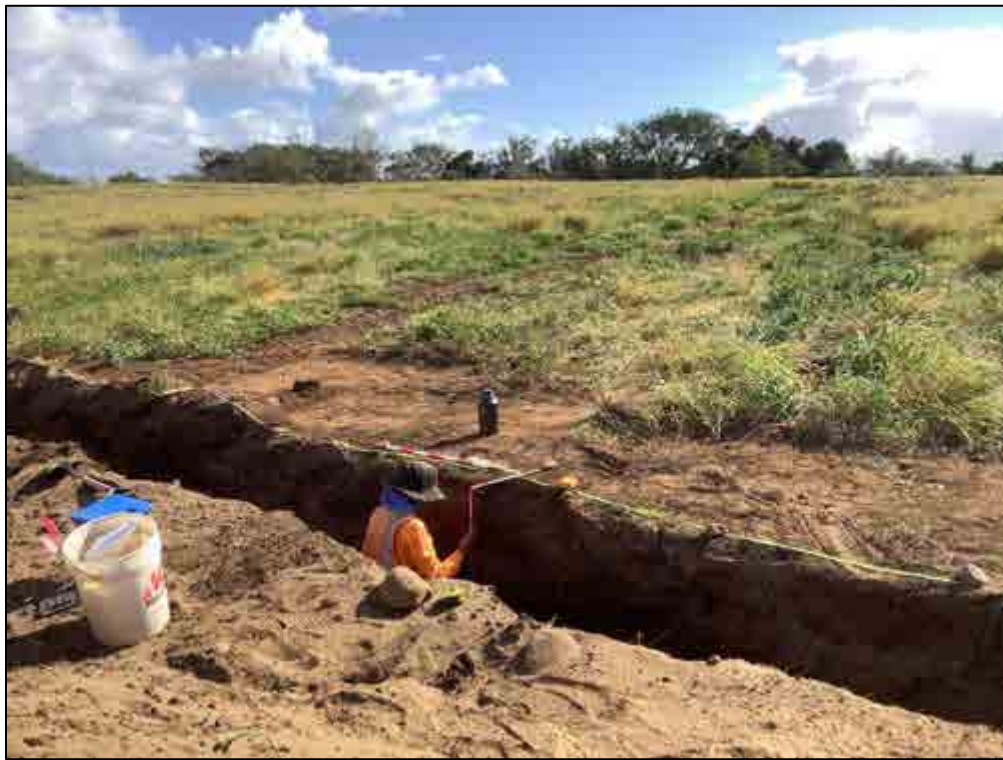
Figure 403. TE-98, overview of the general location, view to northeast

TE-98 was near the eastern border in the middle section of the study area (Figure 403). The excavation was 6.00 m long by 0.80 m wide with a maximum depth of 1.55 mbs. The stratigraphy of TE-98 consisted of a dark brown, sandy loam Ap horizon (Stratum I) and brown sand fill (Stratum II) overlying brown, natural extremely cobbly sand (Stratum III) (Figure 404 through Figure 406 and Table 98). The agricultural plow zone (Stratum I) contained pieces of black plastic irrigation drip tape that were not collected. Stratum II contained intact burnt logs and branches along with charcoal concentrations that appear to be modern and related to agricultural plowing and burning events.

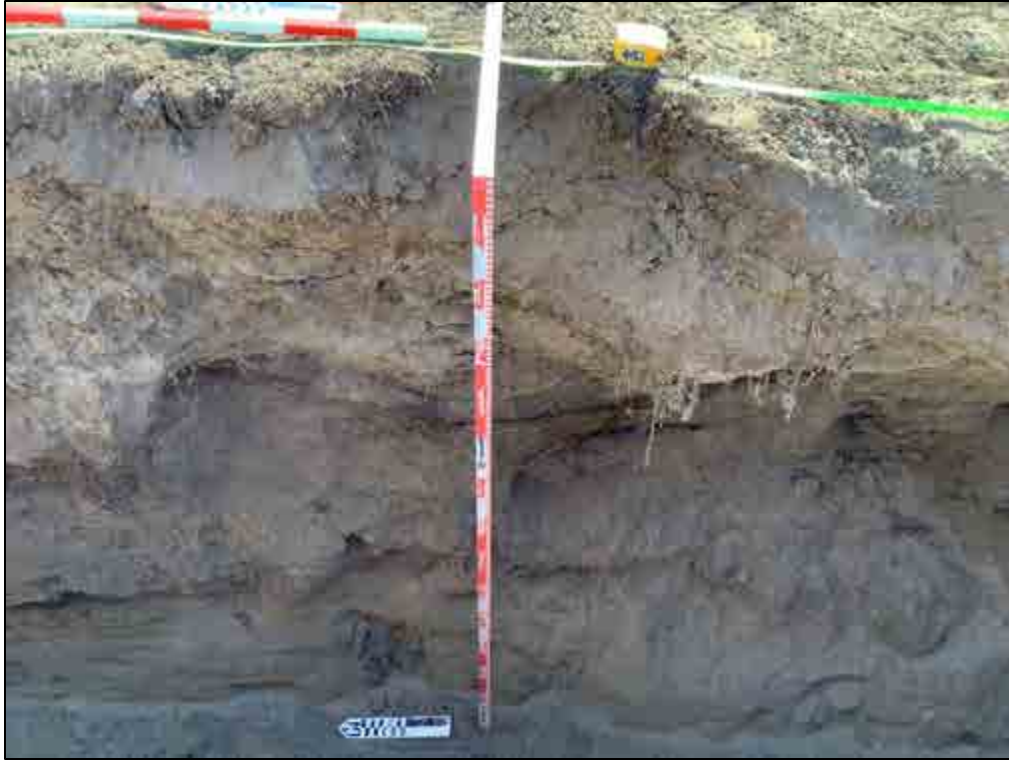
Figure 404. TE-98, close-up of the east wall, view to east

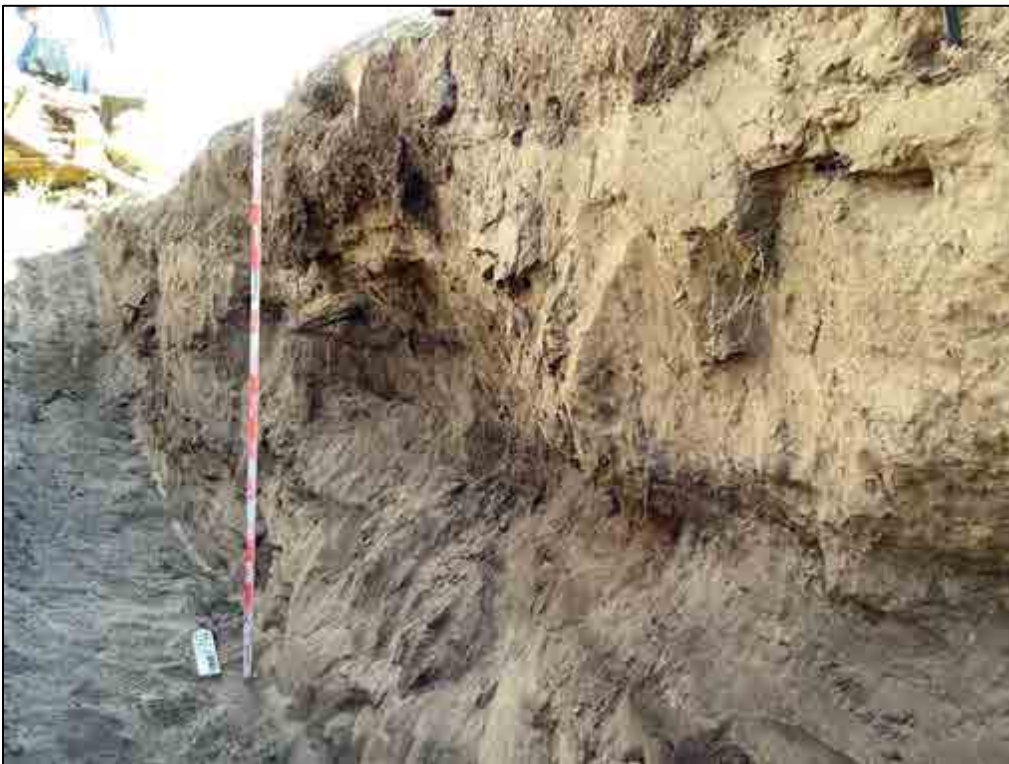
Figure 405. TE-98, overview of the east wall, view to northeast

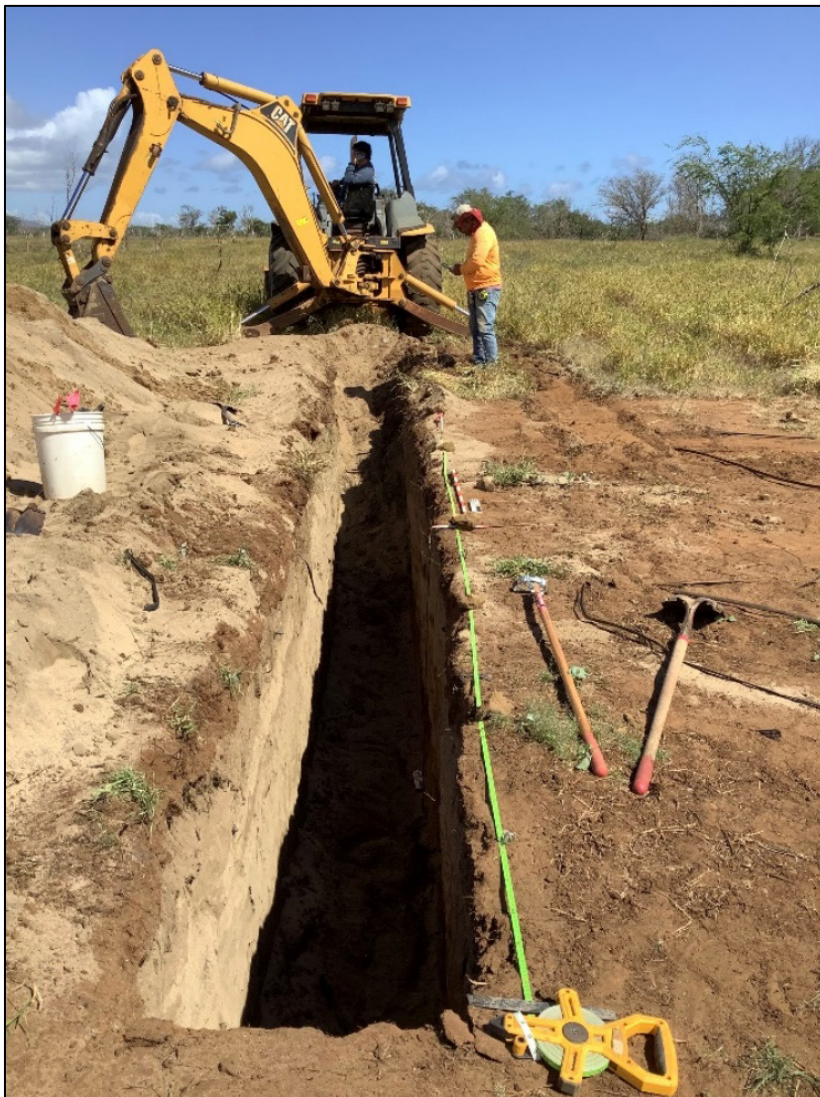
Figure 407. TE-99, overview of the general location, view to north

TE-99 was near the eastern border in the central portion of the study area (Figure 407). The excavation was 6.00 m long by 0.80 m wide with a maximum depth of 1.67 mbs. The stratigraphy of TE-99 consisted of a dark brown, gravelly sandy loam Ap horizon with mottles of brown sand and dark reddish brown clay particles (Stratum I) and brown gravelly sand fill with mottles of dark yellowish brown loamy sand (Stratum II) overlying brown, natural gravelly sand with a band of dark yellowish brown sand (Stratum III) and dark yellowish brown, natural silty clay loam with dark yellowish brown silt loam (Stratum IV) (Figure 408 through Figure 410 and Table 99). No cultural materials were encountered.

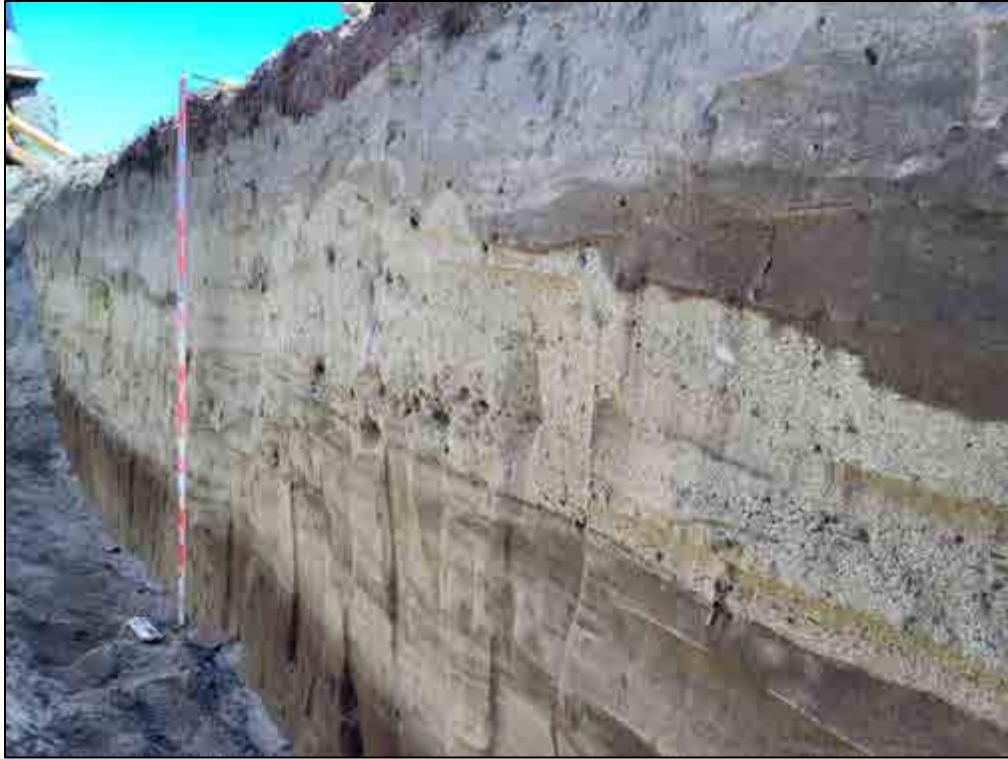
Figure 408. TE-99, oblique view of the east wall, view to northeast

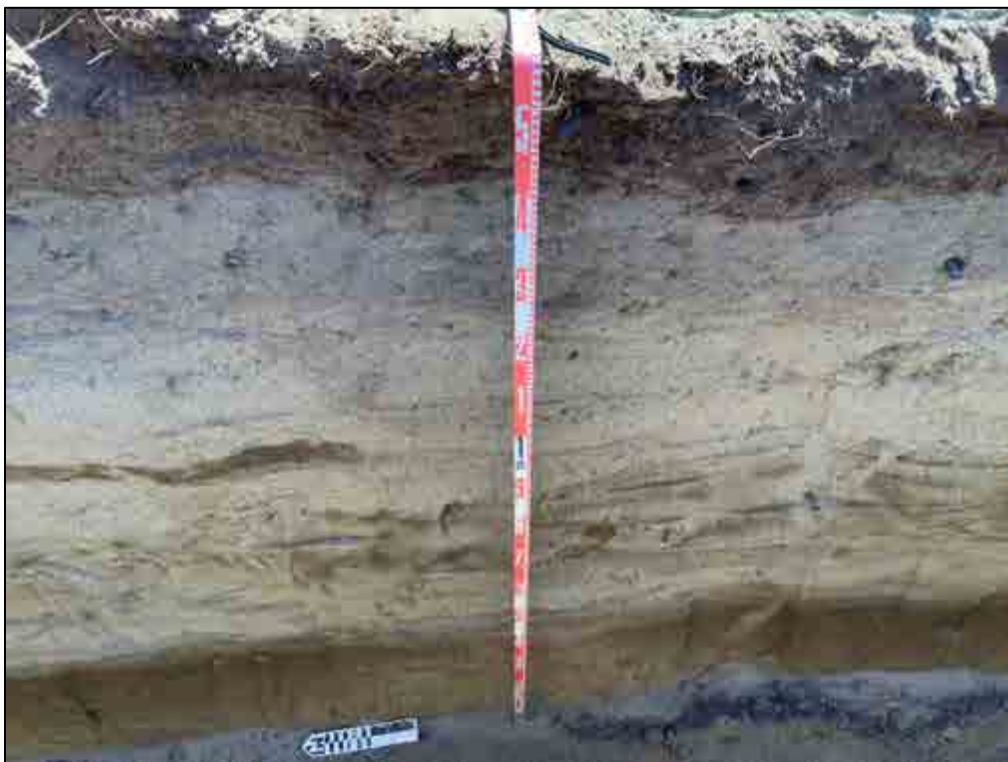
Figure 409. TE-99, close-up of the east wall, view to east
