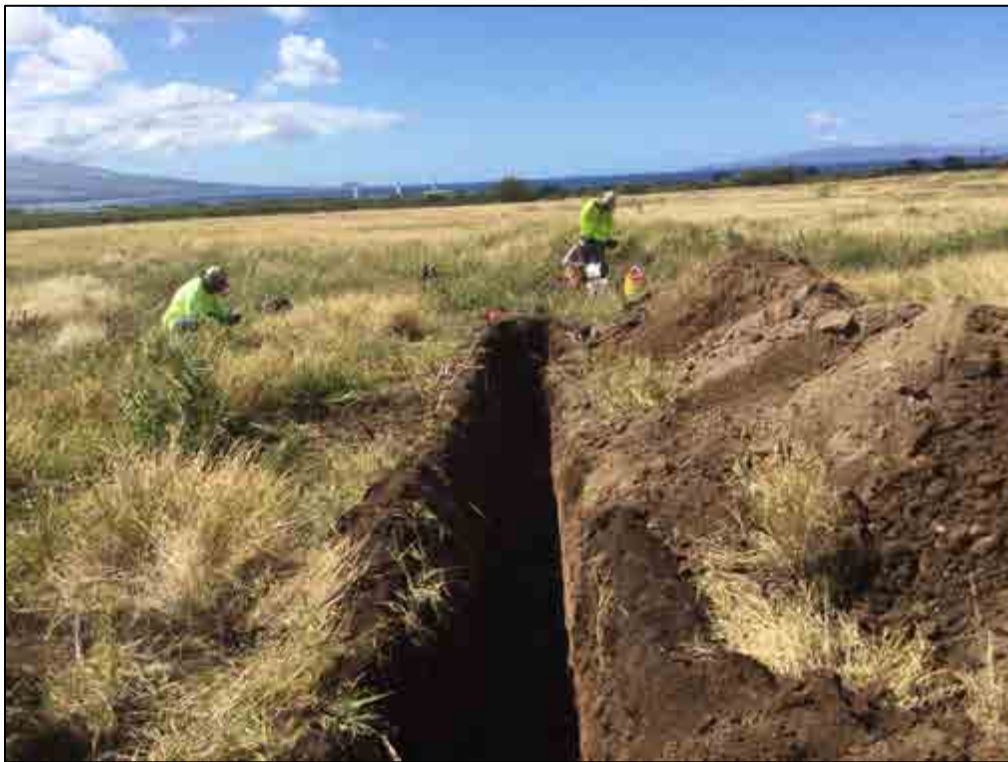
Figure 411. TE-100, overview of the general location, view to south

TE-100 was near the westernmost border in the southern half of the study area (Figure 411). The excavation was 6.00 m long by 0.80 m wide with a maximum depth of 1.67 mbs. The stratigraphy of TE-100 consisted of four strata: a very dark brown, gravelly sandy loam Ap horizon (Stratum I) and dark brown, gravelly sandy loam fill (Stratum II) overlying dark brown, previously disturbed natural, gravelly silty clay loam with small concentrations of brown, sandy loam and gravels (Stratum III) and brown, natural gravelly silt loam with large concentrations of gray loamy sand, gravels, and small cobbles from alluvial processes (Stratum IV) (Figure 412 through Figure 414 and Table 100). No cultural materials were encountered.

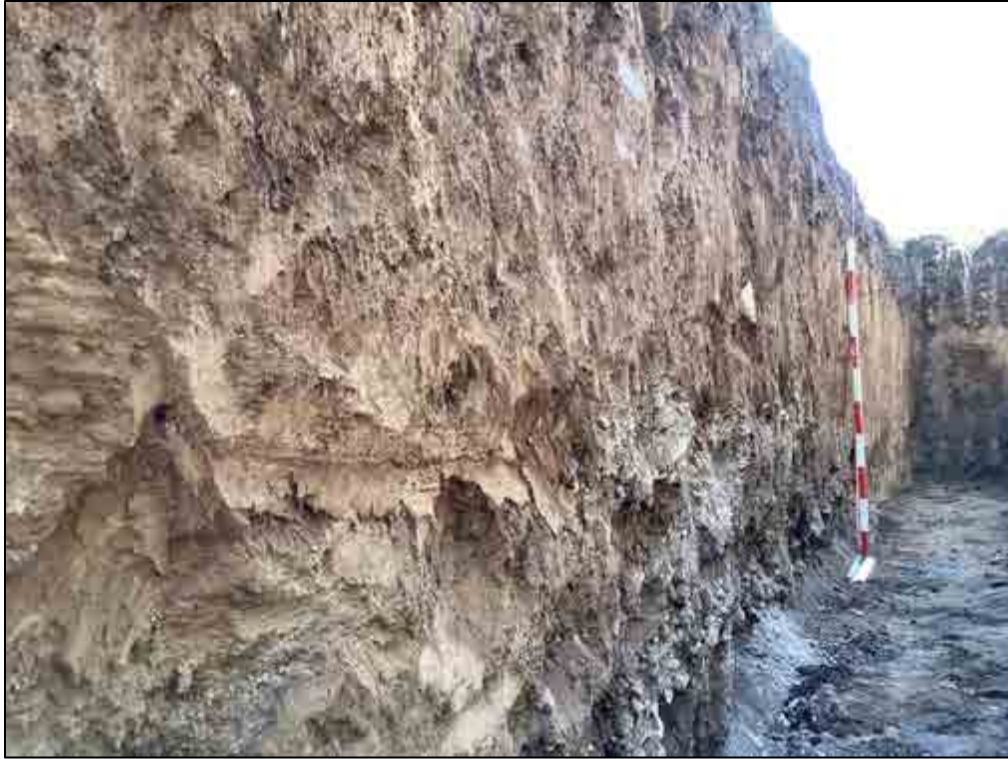
Figure 412. TE-100, oblique view of the east wall, view to southeast

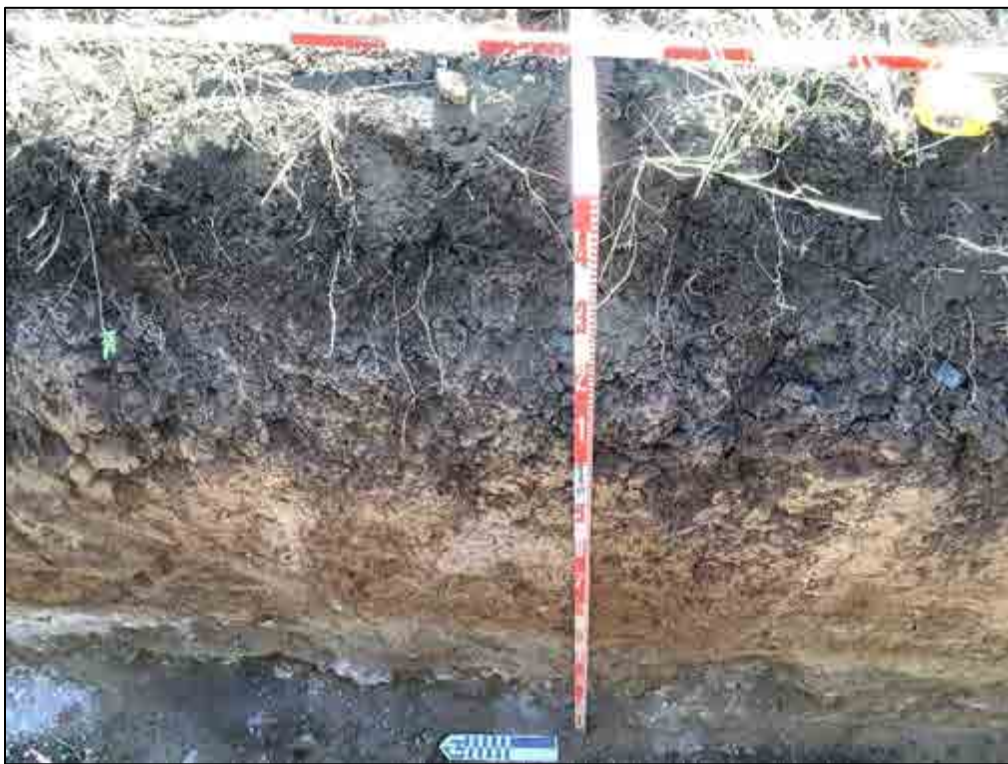
Figure 413. TE-100, close-up of the east wall, view to east
