ARCHAEOLOGICAL
ASSESSMENT
DATED MARCH 2020

**FINAL ARCHAEOLOGICAL ASSESSMENT REPORT
FOR HAWAIIAN CEMENT QUARRY EXPANSION
LOCATED AT TMK: (2) 3-8-004:001 portion
PŪLEHU NUI *AHUPUA'A*, KULA *MOKU*;
WAILUKU DISTRICT
ISLAND OF MAUI**

**ATLAS ARCHAEOLOGY
Mr. Reynaldo Nico Fuentes
POB 1368
WAILUKU, HI 96784**

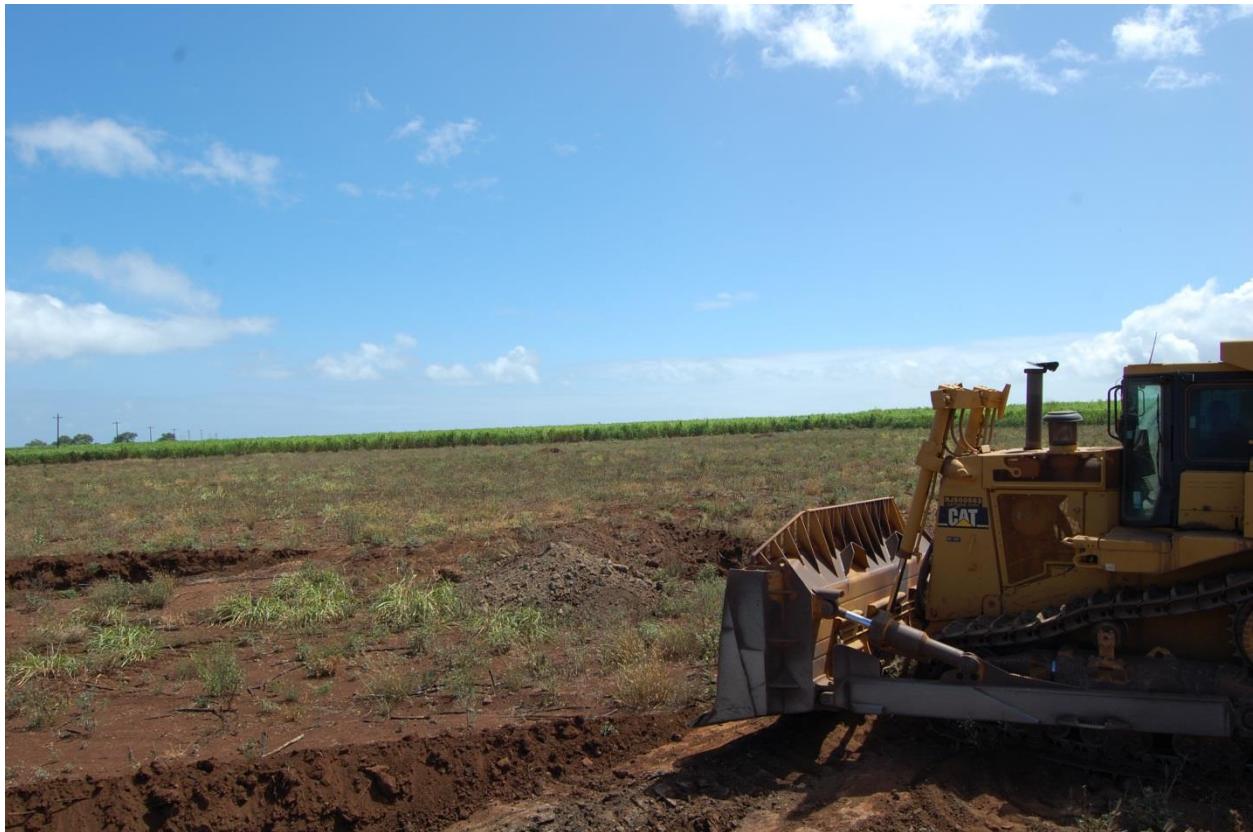
Figure 4. Overview from the south of 8.8 acre portion of Project Area

The subject parcel is presently under various stages of cultivation. The first test area comprised an 8.8-acre **section of land** in the southwest corner. This portion was previously harvested and a drainage basin was constructed. The area adjacent to the drainage contains large linear stockpiles for safety purposes, to prevent vehicular and pedestrian traffic from entering the drainage area. The remaining 33.0-acres of the project area was cultivated in sugar cane.

and located within the southwestern portion of the project area. The remaining section consists of over 33.0 acres that are currently cultivated in sugarcane (Figure 4).

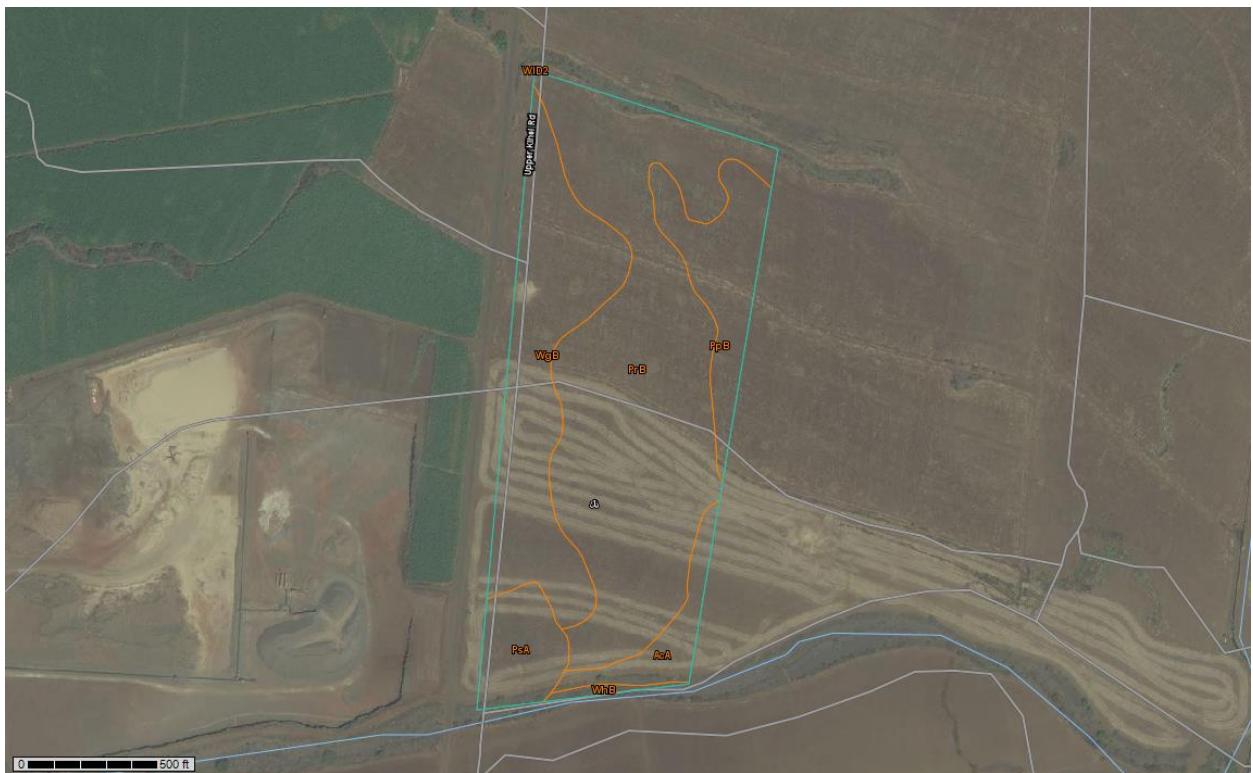
Figure 6. Location of Project Area on Web Soil Survey Map (outlined in blue)

Soils of the project area according to the USDA and Soil Survey Maps shows six soil zones within the project area; Alae cobbly sandy loam (AcA) 0 to 3% slope, Pulehu silt loam (PpB) 3 to 7%, Pulehu cobbly silt loam (PrB) 3 to 7%, Pulehu clay loam (PsA) 0 to 3% slope, and Waiakoa very stony silty clay loam (WgB) 3 to 7% slope, and Waiakoa extremely stony silty clay loam (WhB) 3 to 7% slope (Figure 6). The total area is occupied by 4.8% AcA, 10.8% PpB, 52.9% PrB, 6.5% PsA, 24.3% WgB, and 0.7% WhB. The Pulehu series consist of well-drained soils on alluvial fans and stream terraces around Maui. They developed in alluvium washed from basic igneous rock. The soils are nearly level to moderately sloping. Elevations range from nearly sea level to 300 feet. The Waiakoa series consist of well-drained soils on uplands of Maui. These soils developed in material weathered from basic igneous rock. The upper part of profile is influenced by volcanic ash. These soils are gently sloping to moderately steep. Elevations range from 100 to 1,000 feet.

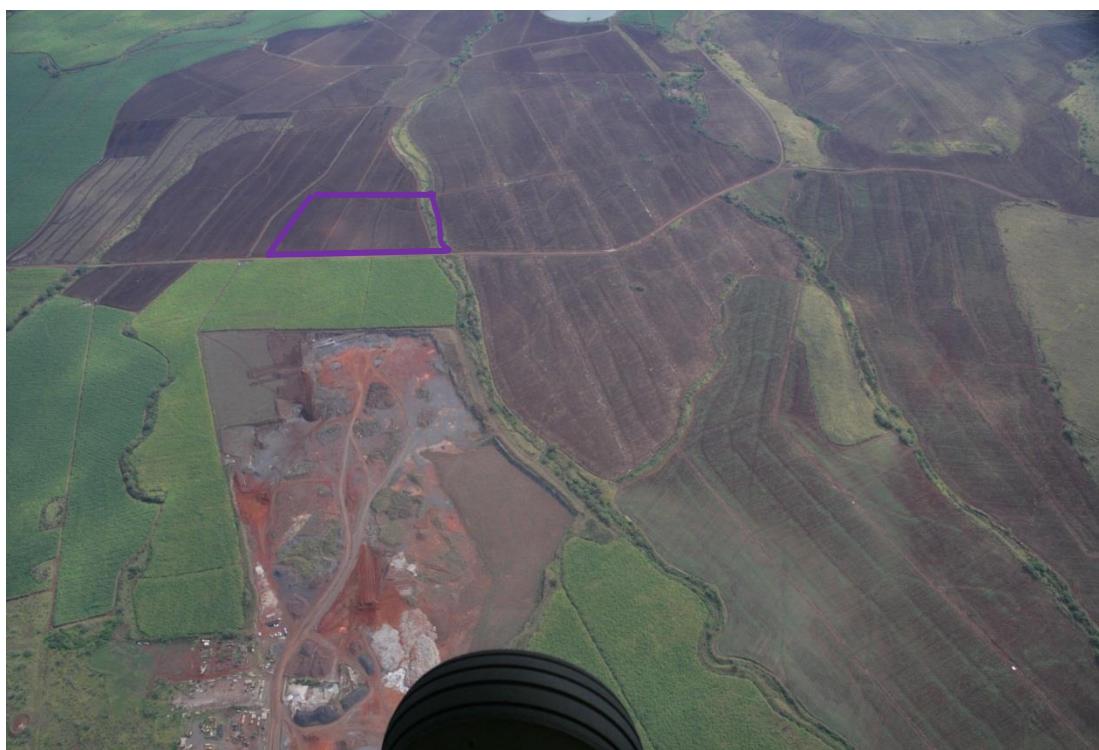
Figure 7. Aerial Photograph of Project Area (purple outline)

All soils can be utilized in multiple ways; truck crops, pasture lands, home sites and wildlife habitats, however in this instance the primary use was sugarcane cultivation and a rock quarry plant (Figure 7).

Vegetation within the project area consists of the cultivated sugarcane (*Saccharum officinarum*) and various other unidentified weeds and grasses. It was observed that concentrations of these unidentified weeds and grass were present within Kolaloa Gulch (see Figure 7).

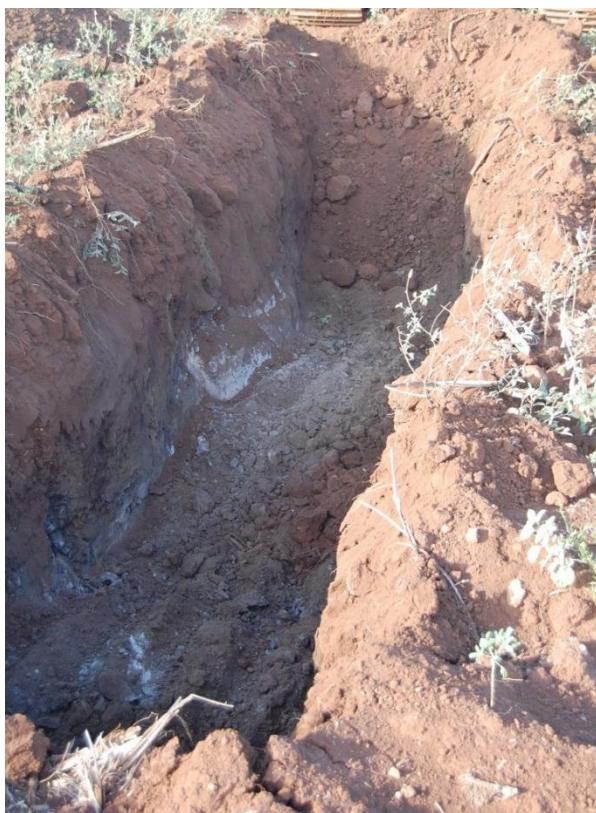
TR-1 was placed within the 8.8 acre area in the NE corner of the project area (see Figure 11, Table I and Appendix A). It measured 8.0 m long by 1.5 m wide by 1.60 m deep and was oriented 360° degrees. This section had been previously grubbed during the harvesting of the sugar cane. Testing revealed a four layer stratigraphic sequence (Figures 12 and 13). No cultural materials were observed.

Figure 12. Overview Photograph of Trench 1 (View to North)

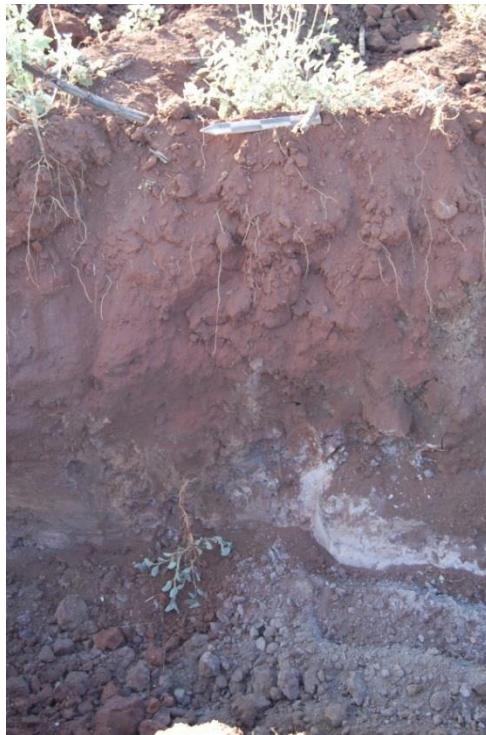
Layer III (88-140cmbs) is a yellowish brown (10yr5/4), silt loam, slightly plastic, slightly sticky, crumb, friable, with a high frequency of decomposing basalt. This layer is undisturbed and referred to as the "saprolytic layer".

Layer IV (136-160cmbs+) is a gray (10yr 5/1), basalt layer, non-plastic, non-sticky, massive, indurated. This layer is the bedrock layer.

Figure 13. Photograph of Trench 1 West Wall

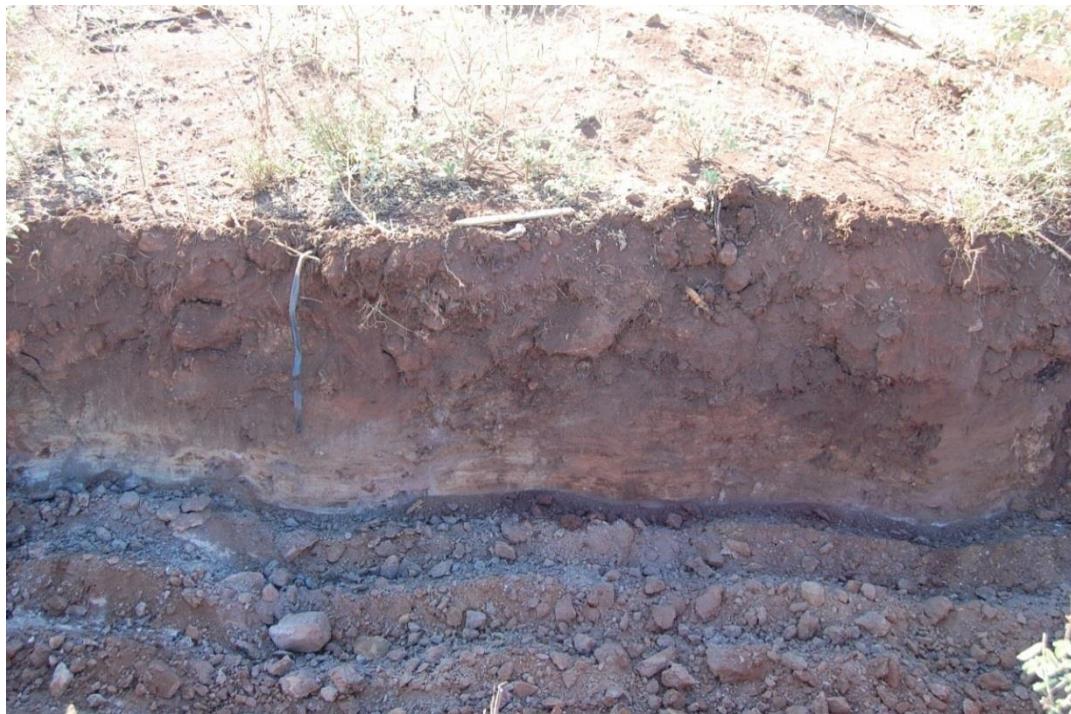
TR-2 was placed within the 8.8 acre area in the NW corner of the project area (see Figure 11, Table I and Appendix A). It measured 7.0 m long by 1.5 m wide by 1.60 m deep and was oriented 360° degrees. This section had been previously grubbed during the harvesting of the sugar cane. Testing revealed a four layer stratigraphic sequence (Figure 14). No cultural materials were observed.

Layer III (46-120cmbs) is a yellowish brown (10yr5/4), silt loam, slightly plastic, slightly sticky, crumb, friable, with a high frequency of decomposing basalt. This layer is undisturbed and referred to as the "saprolytic layer".

Layer IV (120-160cmbs+) is a gray (10yr 5/1), basalt layer, non-plastic, non-sticky, massive, indurated. This layer is the bedrock layer.

Figure 14. Photograph of Trench 2 East Wall

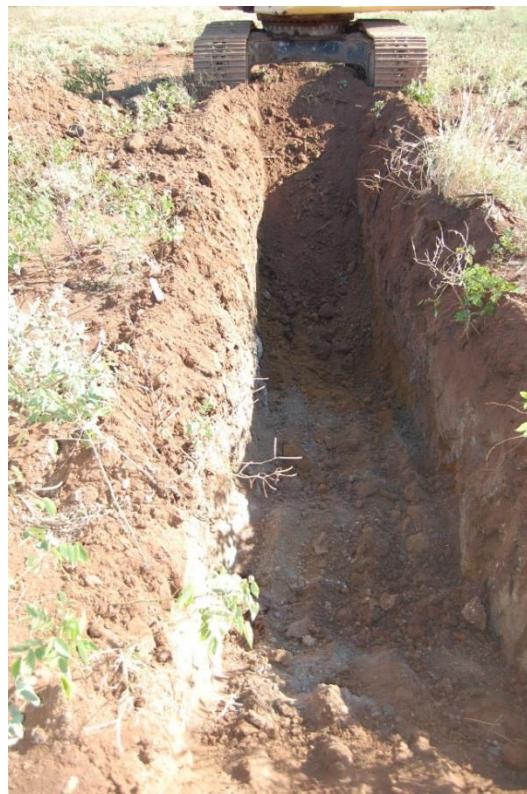
TR-3 was placed within the 8.8 acre area in the central portion of the project area (see Figure 11, Table I and Appendix A). It measured 9.0 m long by 1.5 m wide by 2.0 m deep and was oriented 360° degrees. This section had been previously grubbed during the harvesting of the sugar cane. Testing revealed a five layer stratigraphic sequence (Figures 15 and 16). No cultural materials were observed.

Figure 15. Overview Photograph of Trench 3 (View to East)

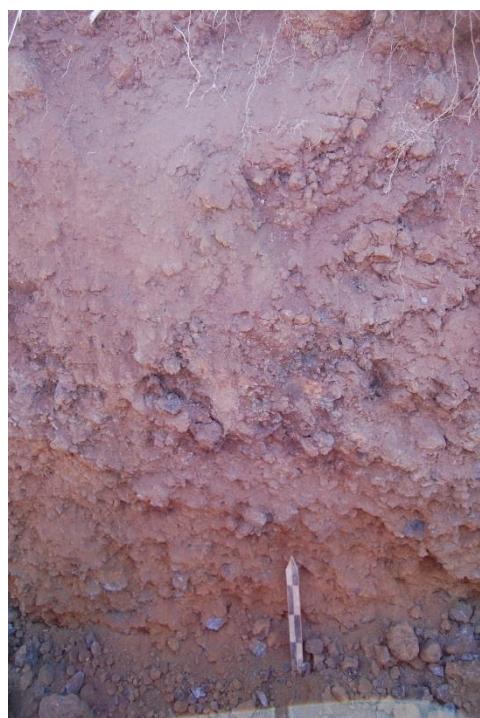
Lens/Layer IV (159-200cmbs+) is a yellowish brown (10yr 5/4), gravelly sub-angular layer, non-plastic, non-sticky, medium grain, firm. This layer occurs in pockets and in some cases as lenses throughout the region.

Layer V (160-200cmbs+) is a gray (10yr 5/1), basalt layer, non-plastic, non-sticky, massive, indurated. This layer is the bedrock layer and is the target material for the mining operations.

Figure 16. Photograph of TR-3 North Wall

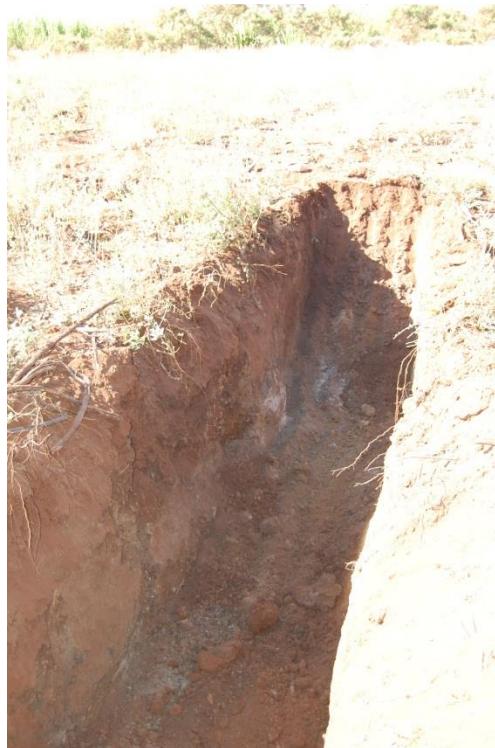
TR-4 was placed within the 8.8acre area in the central portion of the project area (see Figure 11, Table I and Appendix A). It measured 5.0 m long by 1.5 m wide by 2.0 m deep and was oriented 340° degrees (Figure 17). This section had been previously grubbed during the harvesting of the sugar cane. Testing revealed a four layer stratigraphic sequence (Figure 18). No cultural materials were observed.

Figure 17. Overview Photograph of Trench 4 (View to North)

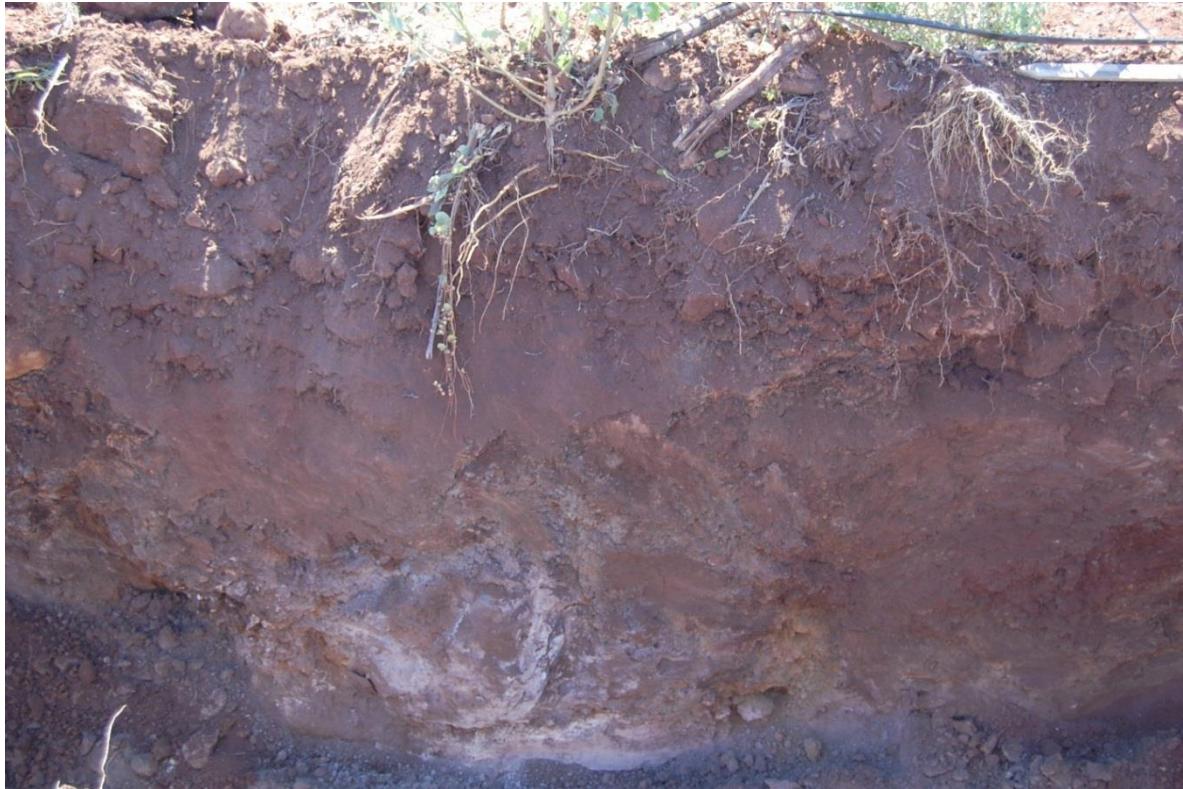
Layer III (98-142cmbs) is a yellowish brown (10yr5/4), silt loam, slightly plastic, slightly sticky, crumb, friable, with a high frequency of decomposing basalt. This layer is undisturbed and referred to as the "saprolytic layer".

Layer IV (138-180cmbs+) is a gray (10yr 5/1), basalt layer, non-plastic, non-sticky, massive, indurated. This is the bedrock layer.

Figure 18. Photograph of Trench 4 West Wall

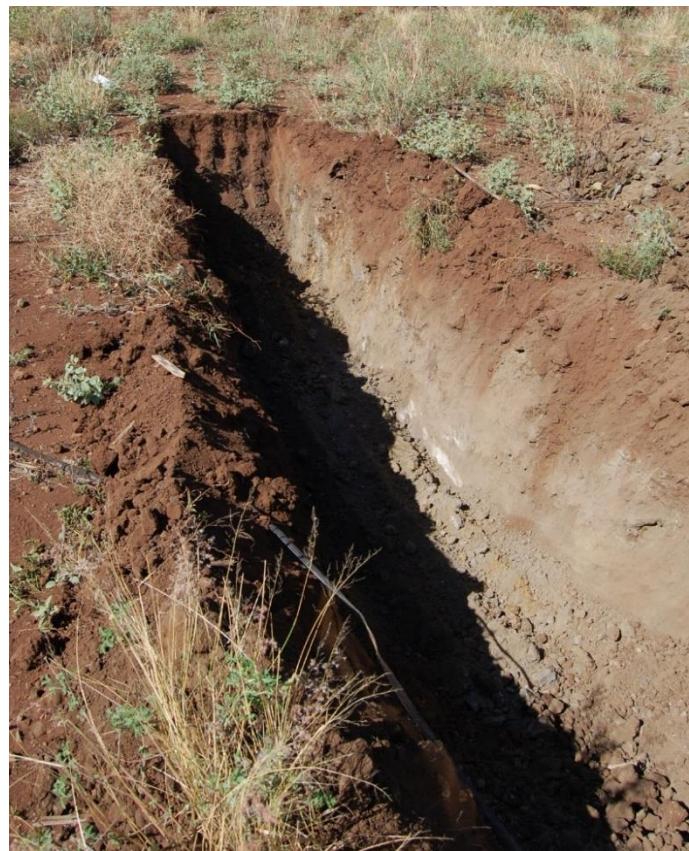
TR-5 was placed within the 8.8 acre area in the SE portion of the project area (see Figure 11, Table I and Appendix A). It measured 9.0 m long by 1.5 m wide by 2.0 m deep and was oriented 360° degrees. This section had been previously grubbed during the harvesting of the sugar cane. Testing revealed a four layer stratigraphic sequence (Figures 19 and 20). No cultural materials were observed.

Figure 19. Overview Photograph of Trench 5 (View to North)

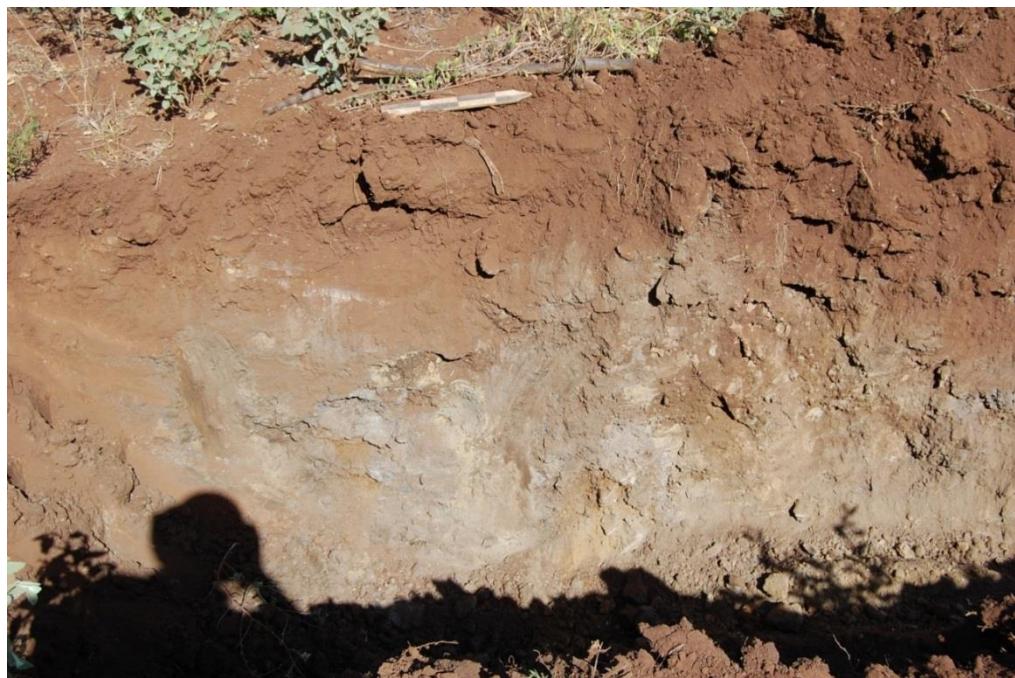
Layer III (98-174cmbs) is a greyish brown (10YR5/1) and yellowish brown (10YR5/4), silt loam, slightly plastic, slightly sticky, crumb, friable, with a high frequency of decomposing basalt. This layer is undisturbed and referred to as the "saprolitic layer".

Layer IV (170-180cmbs+) is a gray (10YR 5/1), basalt bedrock, non-plastic, non-sticky, massive, indurated. This layer is the bedrock layer and is the target material for the mining operations.

Figure 20. Photograph of Trench 5 West Wall

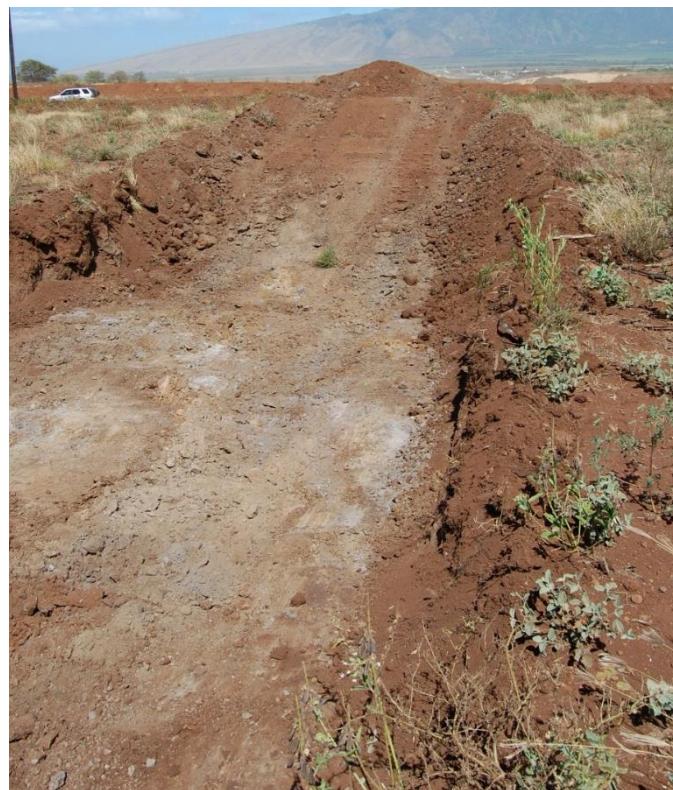
BD-1 was placed within the 8.8 acre area in the SW portion of the project area (see Figure 11, Table I and Appendix A). It measured 12.0 m long by 1.5 m wide by 1.4 m deep and was oriented 270° degrees (Figure 21). This section had been previously grubbed during the harvesting of the sugar cane. Testing revealed a four layer stratigraphic sequence (Figure 22). No cultural materials were observed.

Figure 21. Overview Photograph of Bulldozer Cut 1 (View to West)

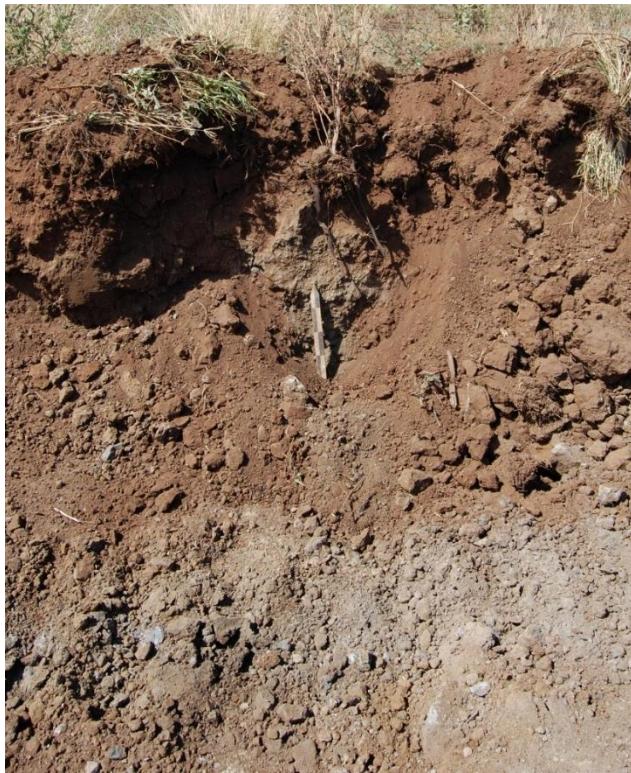
Layer III (50-136cmbs) is a yellowish brown (10yr5/4), silt loam, slightly plastic, slightly sticky, crumb, friable, with a high frequency of decomposing basalt. This layer is undisturbed and referred to as the "saprolytic layer".

Layer IV (136-140cmbs+) is a gray (10yr 5/1), basalt layer, non-plastic, non-sticky, massive, indurated. This layer is the bedrock layer and is the target material for the mining operations.

Figure 22. Photograph of Bulldozer Cut 1 North Wall

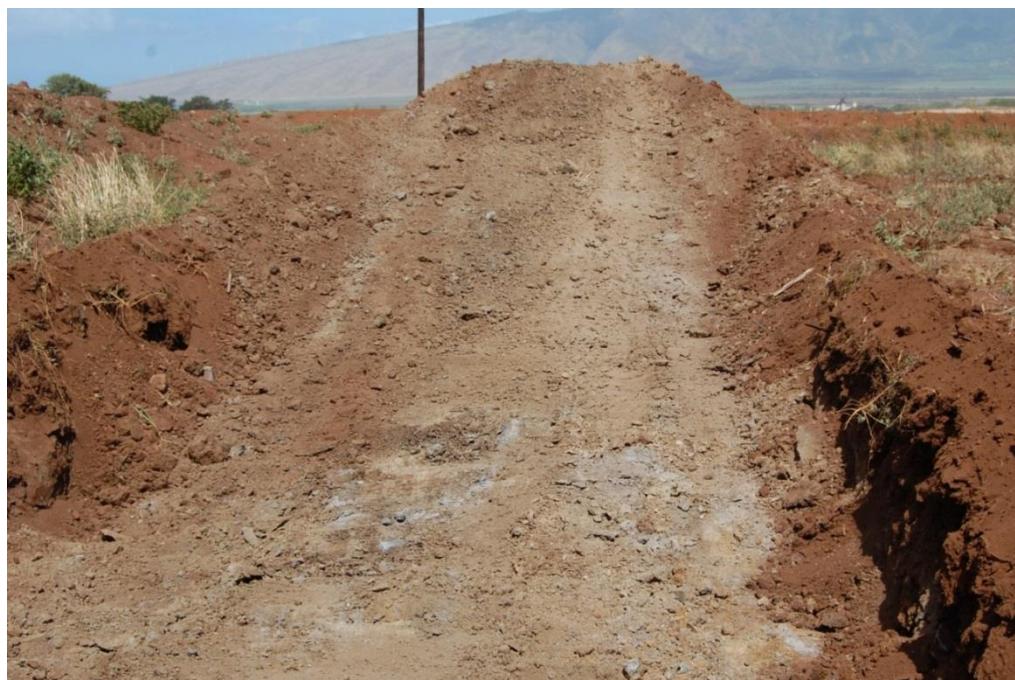
BD-2 was placed within the 8.8 acre area in the SW portion of the project area (see Figure 11, Table I and Appendix A). It measured 15.0 m long by 1.5 m wide by 1.6 m deep and was oriented 270° degrees. This section had been previously grubbed during the harvesting of the sugar cane. Testing revealed a four layer stratigraphic sequence (Figures 23 and 24). No cultural materials were observed.

Figure 23. Overview Photograph of Bulldozer Cut 2 (View to West)

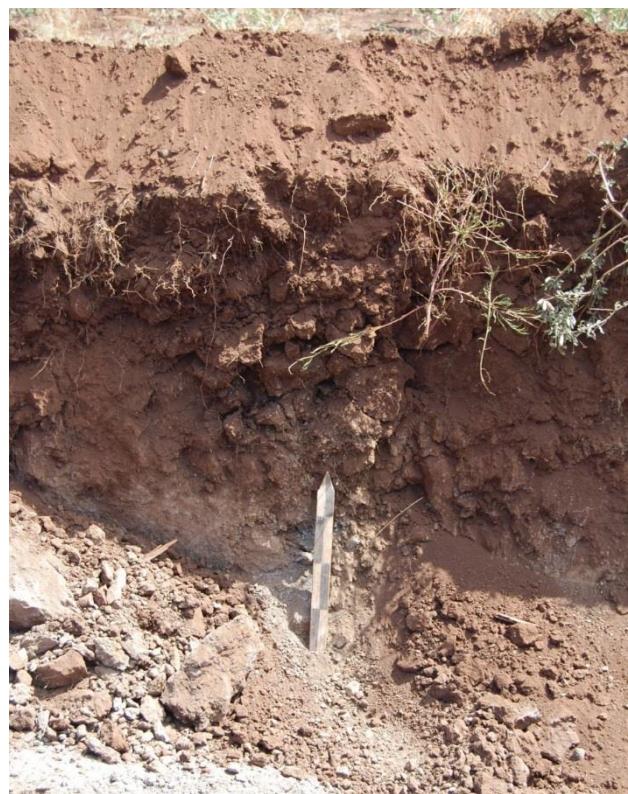
Layer III (98-139cmbs) is a yellowish brown (10yr5/4), silt loam, slightly plastic, slightly sticky, crumb, friable, with a high frequency of decomposing basalt. This layer is undisturbed and referred to as the "saprolitic layer".

Layer IV (136-160cmbs+) is a gray (10yr 5/1), basalt layer, non-plastic, non-sticky, massive, indurated. This layer is the bedrock layer and is the target material for the mining operations.

Figure 24. Photograph of Bulldozer Cut 2 North Wall

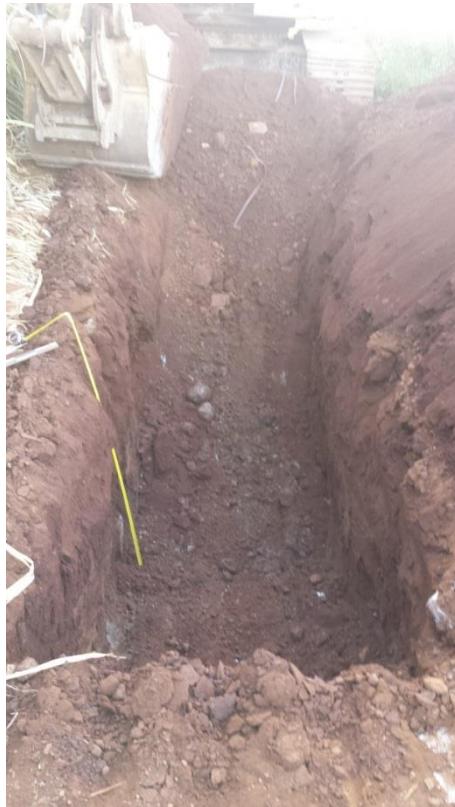
TR-6 was placed within the 33.0 acre area in the central portion of the project area (see Figure 11, Table I and Appendix A). It measured 4.1 m long by 1.5 m wide by 1.6 m deep and was oriented 270° degrees (Figure 25 and Table I). This section was an active cane fields and therefore the location of this trench was along a known haul rd. Testing revealed a three layer stratigraphic sequence (Figure 26). No cultural materials were observed.

Figure 25. Overview Photograph of Trench 6 (View to West)

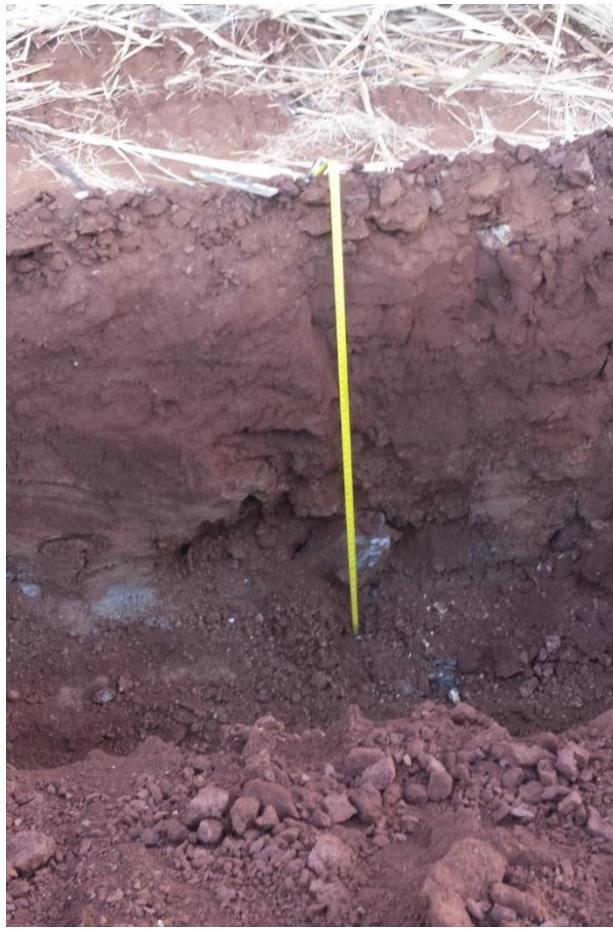
Layer II (18-90cmbs) is a dark reddish brown (5yr3/4), silt loam, slightly plastic, slightly sticky, crumb, friable. This layer does not appear to be disturbed.

Layer III (86-160+cmbs) is a yellowish brown (10yr5/4), silt loam, slightly plastic, slightly sticky, crumb, friable, with a high frequency of decomposing basalt. This layer is undisturbed and referred to as the "saprolytic layer".

Figure 26. Photograph of Trench 6 South Wall

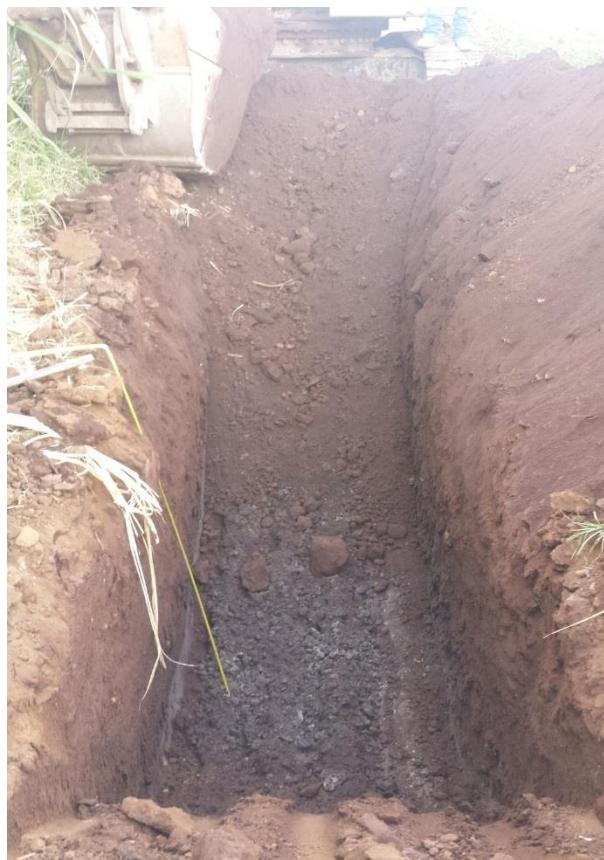
TR-7 was placed within the 33 acre area in the central portion of the project area (see Figure 11, Table I and Appendix A). It measured 3.9 m long by 1.5 m wide by 2.0 m deep and was oriented 270° degrees along the existing cane haul road (Figure 27 and Table I). Testing revealed a three layer sequence, where subangular, pyroclastic cobbles, similar to small cinder materials were observed in Layer III (Figure 28). No cultural materials were observed.

Figure 27. Overview Photograph of Trench 7 (View to North)

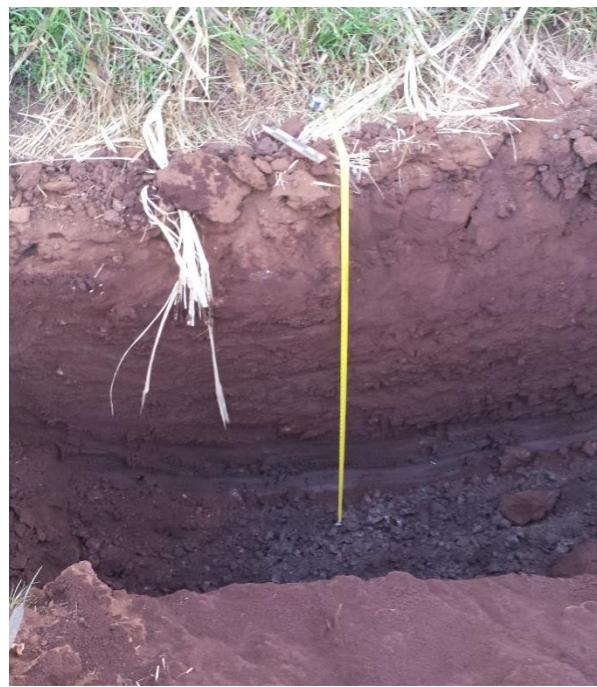
Layer II (18-170cmbs) is a dark reddish brown (5yr3/4), silt loam, slightly plastic, slightly sticky, crumb, friable. This layer does not appear to be disturbed.

Layer III (168-200cmbs+) is a black (7.5yr 2.5/1) coarse gravels and pyroclastic small cobbles with greyish black silty clay, moist, non-plastic, non-sticky, medium grain, firm. This layer was also observed in TR16.

Figure 28. Photograph of Trench 7 North Wall

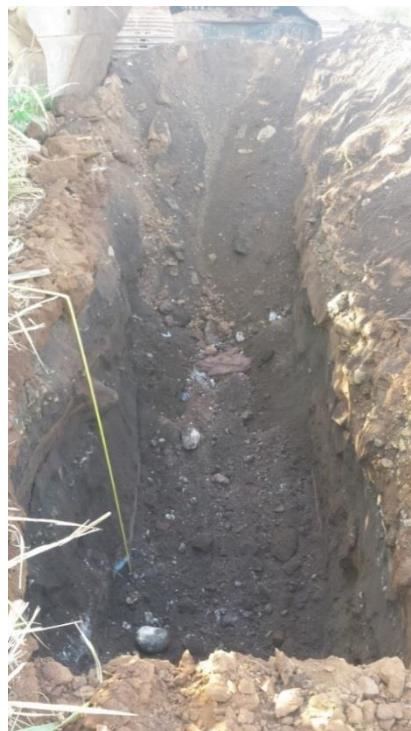
TR-8 was placed within the haul road in the central portion of the 33.0 acre area (see Figure 11, Table I and Appendix A). It measured 4.0 m long by 1.5 m wide by 1.8 m deep and oriented 270° degrees. TR-8 contained a five layer stratigraphic sequence indicative of alluvial and or flood plain deposits (Figures 29 and 30). No cultural materials were observed.

Figure 29. Overview Photograph of Trench 8 (View to East)

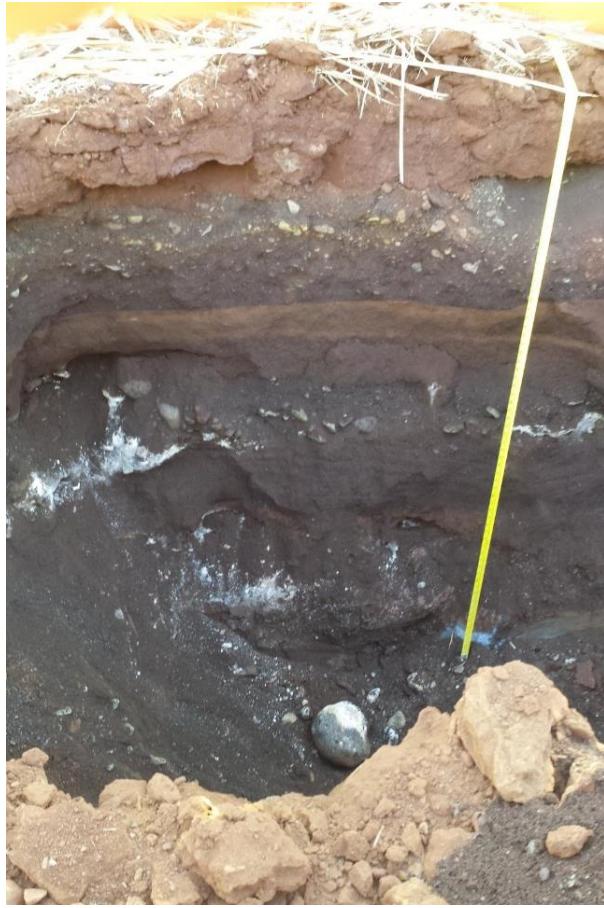
Lens/Layer II (21-80cmbs) is a very dark gray (7.5yr 3/1), gravelly silt, non-plastic, non-sticky, crumb, firm. This layer contained low frequencies of water worn basalt pebbles most likely associated with a former stream, or alluvial event.

Layer/Lens IV (110-146cmbs) is a very dark gray (7.5yr 3/1), gravelly silt, non-plastic, non-sticky, crumb, firm. This layer is the same as Lens/Layer II and contained low frequencies of water worn basalt pebbles. Since Layer III interrupts the alluvial deposits of Layers II and IV, this profile likely exhibits periodic flood events and subsidence.

Layer V (142-180cmbs+) is a yellowish brown (10yr5/4), silt loam, slightly plastic, slightly sticky, crumb, friable, with a high frequency of decomposing basalt. This layer is undisturbed and referred to as the "saprolytic layer".

Figure 30. Photograph of Trench 8 North Wall

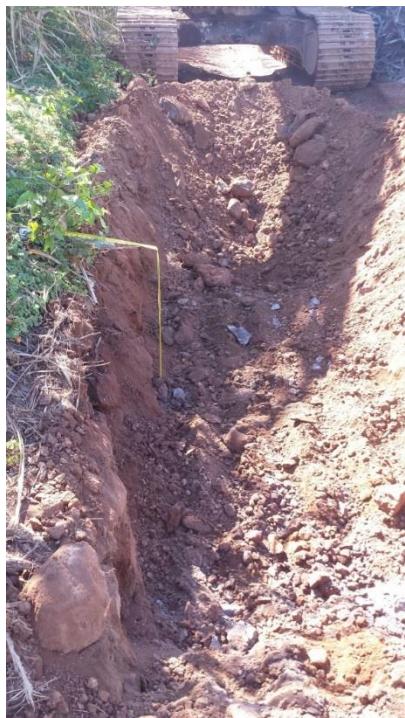
Figure 31. Overview Photograph of Trench 9 (View to East)

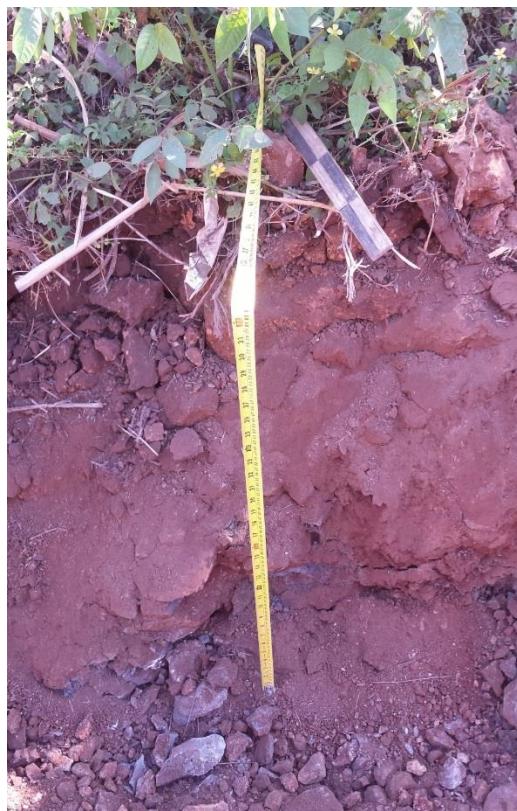
Layer I (0-80cmbs) is a yellowish brown (10yr 5/4), silty loam, slightly plastic, slightly sticky, crumb, friable, with moderate frequency of roots and rootlets. Inclusions consisted of black plastic irrigation indicating this layer was part of the "till zone".

Figure 32. Photograph of Trench 9 North Wall

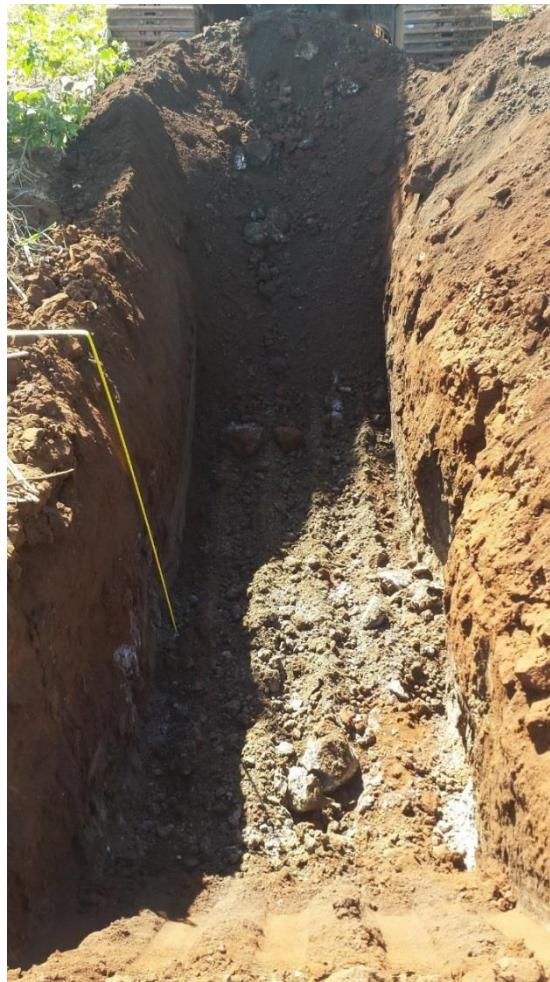
TR-10 was placed within the 33.0 acre area in the central portion of the project area (see Figure 11, Table I and Appendix A). It measured 4.0 m long by 1.5 m wide by 1.5 m deep, oriented 270° degrees and placed in the cane haul road. Testing revealed a three layer stratigraphic sequence (Figures 33 and 34). No cultural materials were observed.

Figure 33. Overview Photograph of Trench 10 (View to East)

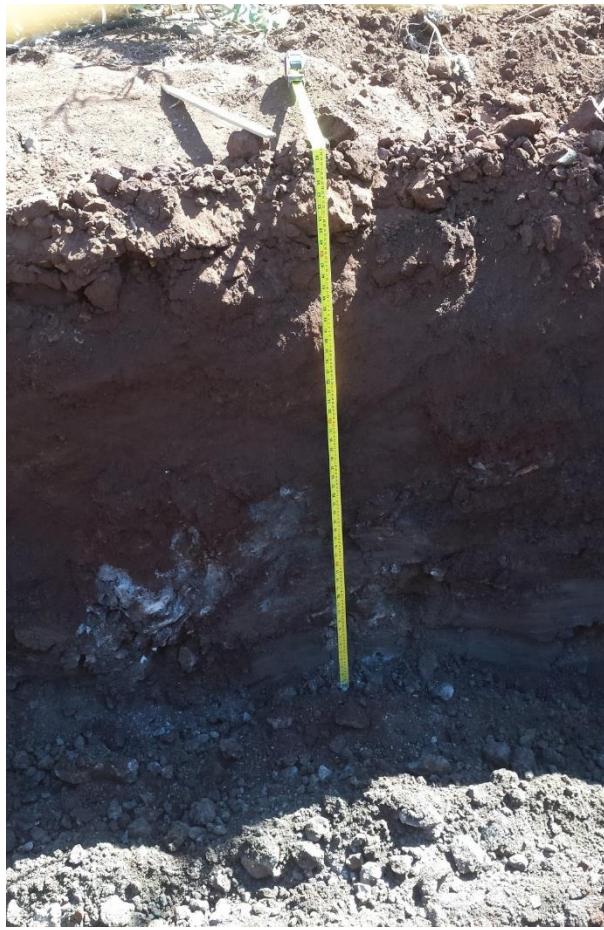
Layer III (60-150+cmbs) is a yellowish brown (10yr5/4), silt loam, slightly plastic, slightly sticky, crumb, friable, with a high frequency of decomposing basalt. This layer is undisturbed and referred to as the "saprolytic layer".

Figure 34. Photograph of Trench 10 North Wall

TR-11 was placed within the western portion of the 33.0 acre area within a cane haul road (see Figure 11, Table I and Appendix A). It measured 4.0 m long by 1.5 m wide by 1.2 m deep and was oriented 270° degrees. Testing revealed the same three layer stratigraphic sequence as observed within TR-10 (see Figure 34). No cultural materials were observed.

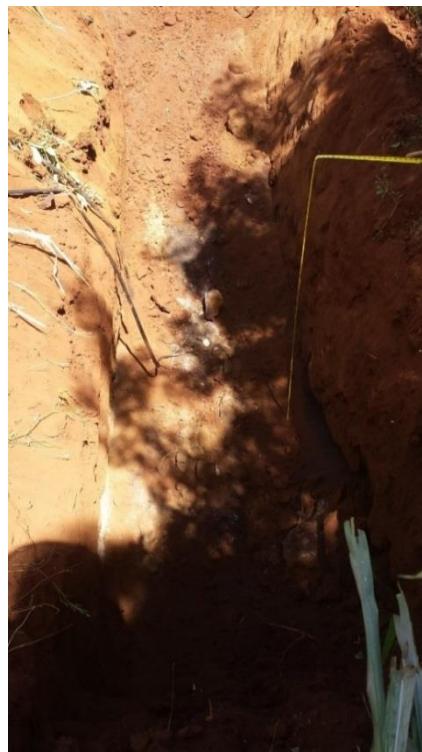
Figure 35. Overview Photograph of Trench 12 (View to West)

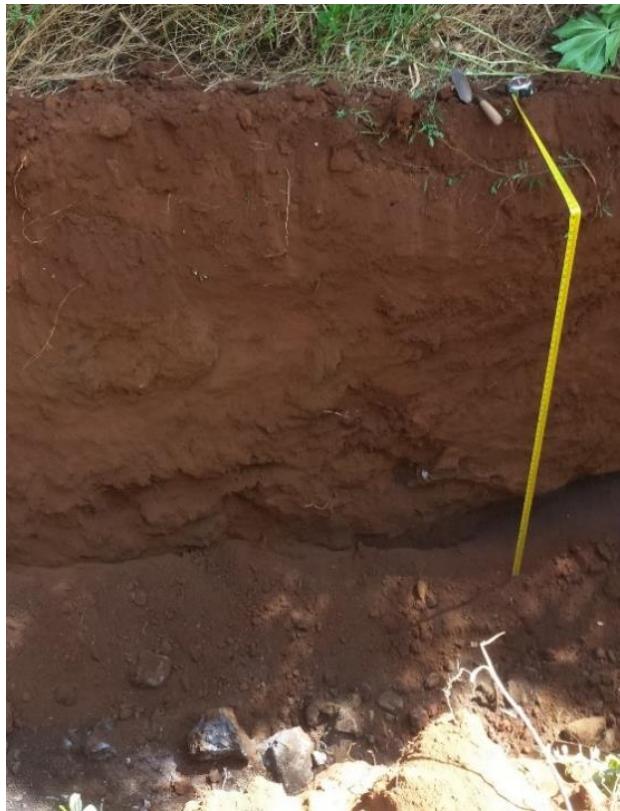
Lens/Layer III (158-186+cmbs) is a yellowish brown (10yr 5/4), gravelly silt loam, non-plastic, non-sticky, crumb, firm. This layer contained low frequencies of water worn basalt pebbles possibly associated with alluvial deposition.

Layer V (189-210 cmbs) is a gray (10yr 5/1), basalt layer, non-plastic, non-sticky, massive, indurated. This layer bedrock.

Figure 36. Photograph of Trench 12 North Wall

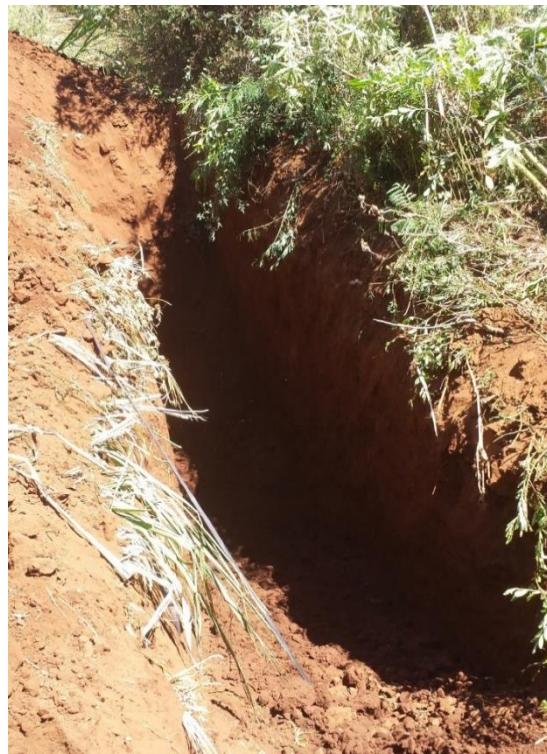
TR-13 was placed within the 33 acre area in the north central portion of the project area (see Figure 11, Table I and Appendix A). It measured 4.0 m long by 1.5 m wide by 3.0 m deep and was oriented 270° degrees. This section was an active cane fields and therefore the location of this trench was along a known haul rd. Testing revealed a three layer stratigraphic sequence (Figures 37 and 38). No cultural materials were observed.

Figure 37. Overview Photograph of Trench 13 (View to East)

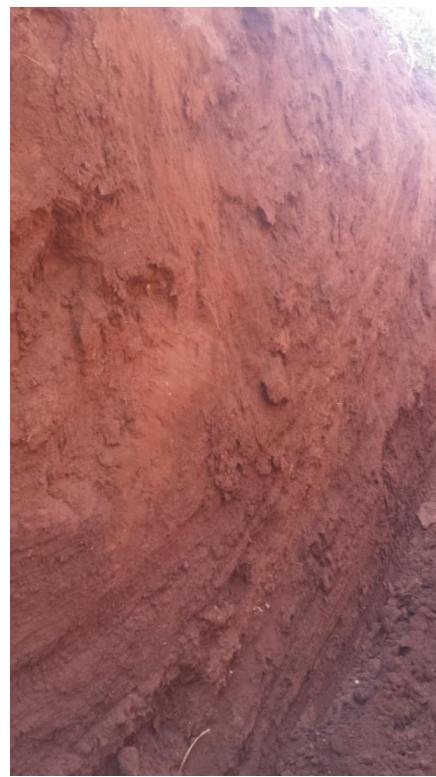
Layer III (295-305cmbs+) is a gray (10yr 5/1), basalt bedrock layer, non-plastic, non-sticky, massive, indurated.

Figure 38. Photograph of Trench 13 North Wall

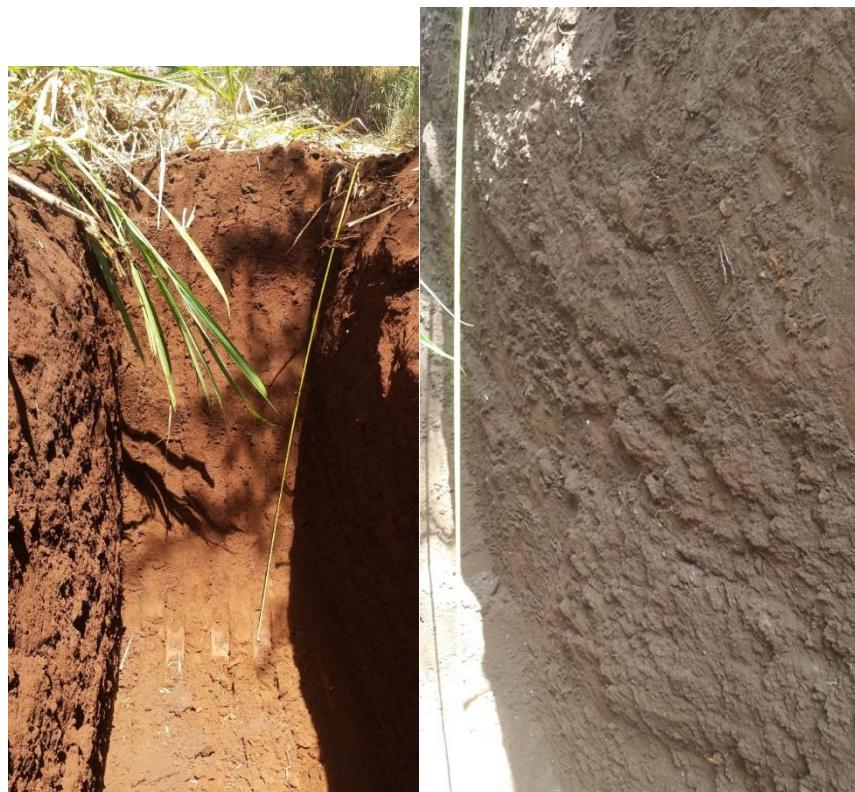
TR-14 was placed along haul road within the 33.0 acre area in the north central portion of the project area (see Figure 11, Table I and Appendix A). It measured 4.0 m long by 1.5 m wide by 2.05 m deep and was oriented 270° degrees. TR-14 contained a five layer stratigraphic sequence and no cultural materials were observed (Figure 39).

Lens/Layer III (160-1.85cmbs+) is a reddish brown (5yr4/6), pebbly silt loam, non-plastic, non-sticky, crumb, firm. This layer contained low frequencies of water worn basalt pebbles most likely associated with alluvial deposition.

Layer V (195-205cmbs+) is a dark yellowish brown (10yr5/4), gravelly silt loam, slightly plastic, slightly sticky, crumb, friable.

**Figure 39. (Left) Overview Photograph of Trench 14 (View to West);
(Right) Photograph of North Wall Trench 14 (View to Northwest)**

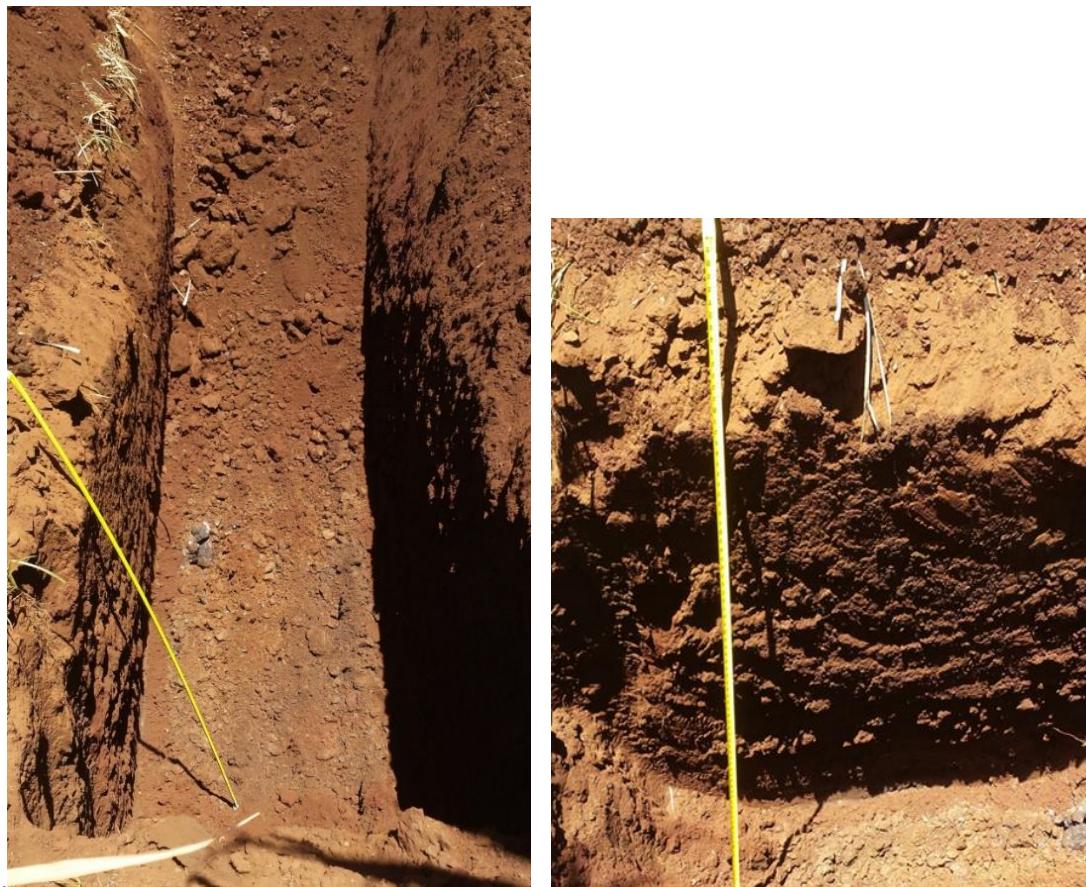
Layer III (81-120cmbs+) is a yellowish brown (10yr5/4), silt loam, slightly plastic, slightly sticky, crumb, friable, with a high frequency of decomposing basalt. This layer is undisturbed and referred to as the "saprolytic layer".

Figure 40. Photographs of TR-15 Overview (View to West) (left); and South Wall (right)

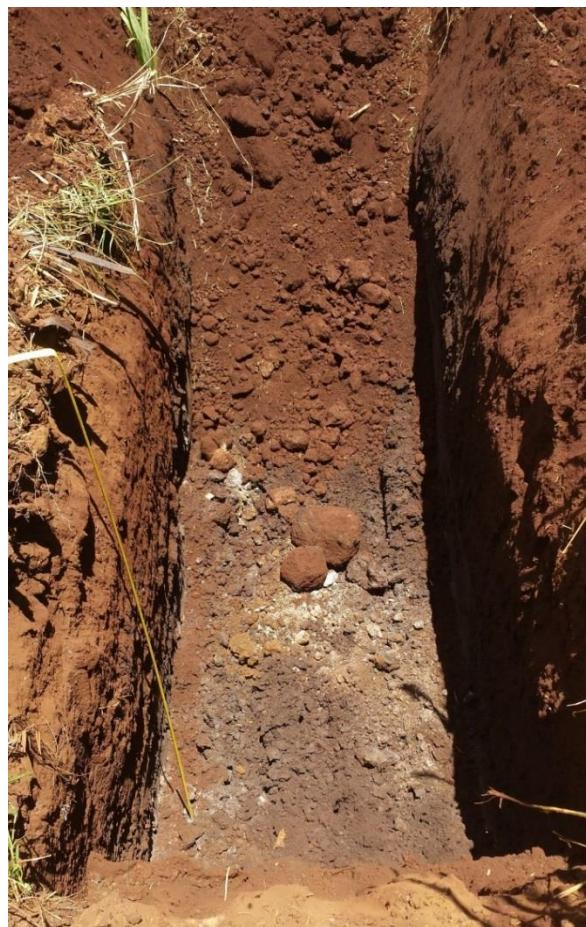
TR-16 was placed within the 33.0 acre area in the south central portion of the project area (see Figure 11, Table I and Appendix A). It measured 4.0 m long by 1.5 m wide by 1.45 m deep, oriented 270° degrees and situated within a haul road. TR-16 contained a three layer stratigraphic sequence with the pyroclastic cobbles observed in TR-7 (Figures 41 and 42). No cultural materials were observed.

Figure 41. Overview Photograph of Trench 16 (View to West)
