ARCHAEOLOGICAL
ASSESSMENT
DATED MARCH 2020

**FINAL ARCHAEOLOGICAL ASSESSMENT REPORT
FOR HAWAIIAN CEMENT QUARRY EXPANSION
LOCATED AT TMK: (2) 3-8-004:001 portion
PŪLEHU NUI *AHUPUA'A*, KULA *MOKU*;
WAILUKU DISTRICT
ISLAND OF MAUI**

**ATLAS ARCHAEOLOGY
Mr. Reynaldo Nico Fuentes
POB 1368
WAILUKU, HI 96784**

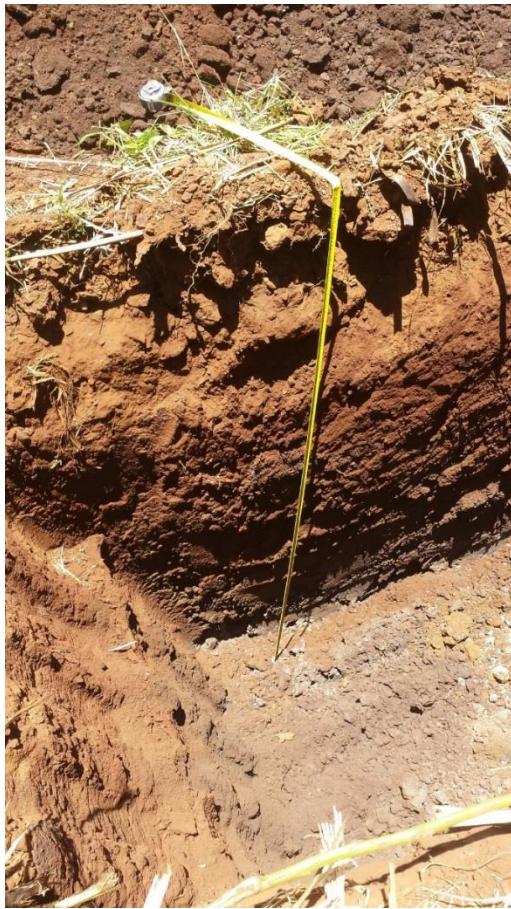
Layer III (68-150cmbs+) is a (7.5yr 2.5/1), greyish black silty clay with coarse gravels or small pyroclastic cobbles, non-plastic, non-sticky, medium grain, firm. This layer occurs in pockets and in some cases as lenses throughout the layer (similar to LIII in TR7).

Figure 42. Photograph of Trench 16 North Wall

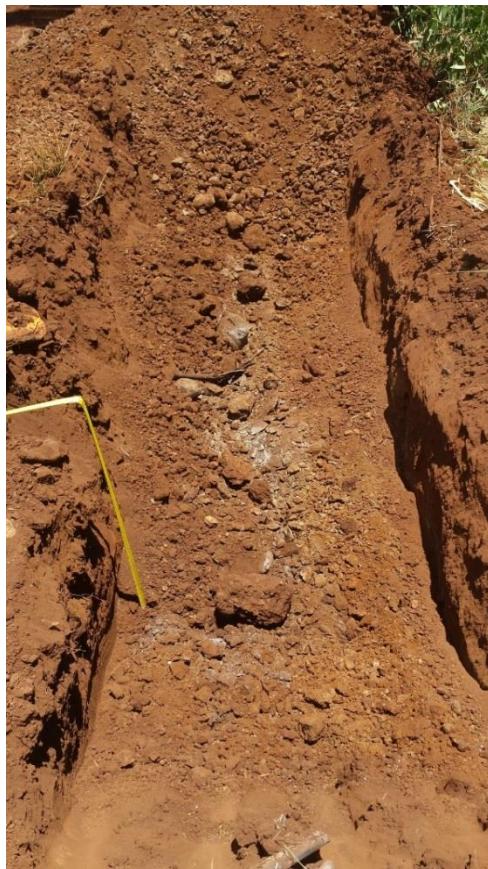
TR-17 was placed along the haul road within the 33.0 acre area in the south central portion of the project area (see Figure 11, Table I and Appendix A). It measured 4.0 m long by 1.5 m wide by 1.0 m deep and was oriented 270° degrees. Testing revealed a three layer stratigraphic sequence (Figures 43 and 44). No cultural materials were observed.

Figure 43. Overview Photograph of Trench 17 (View to West)

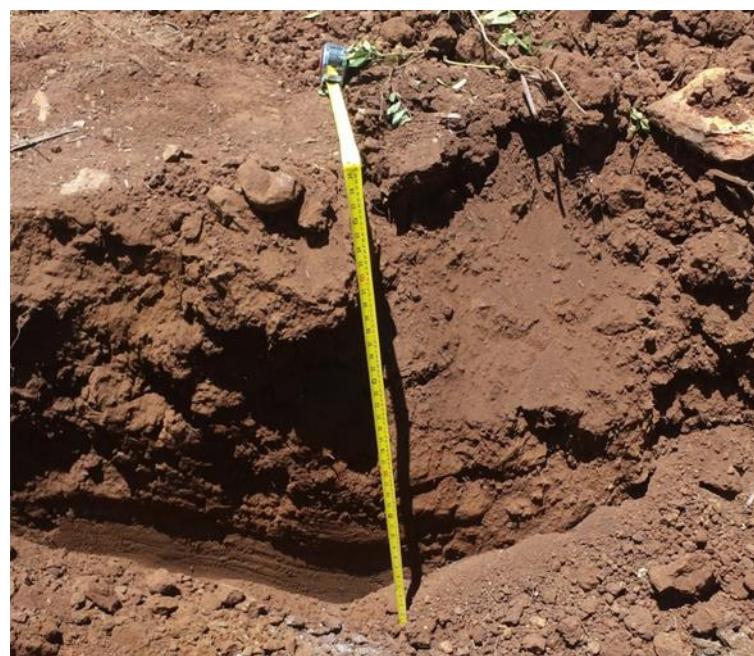
Layer III (85-105cmbs+) is a yellowish brown (10yr5/4), silt loam, slightly plastic, slightly sticky, crumb, friable, with a high frequency of decomposing basalt. This layer is undisturbed and referred to as the "saprolytic layer".

Figure 44. Photograph of Trench 17 South Wall
