HAZARDOUS MATERIALS SURVEY REPORT-REVISED

REPAIR AND/OR REPLACEMENT OF EXISTING CABINS 2 THRU 7, THE OFFICE/RESIDENCE, THE CARETAKER'S RESIDENCE (CRAIG CHAPMAN'S RESIDENCE), SECURITY HOUSE (ARON TUFAGA'S RESIDENCE), AND SECURITY RESIDENCE (GAME WARDEN'S RESIDENCE)
56-335 KAMEHAMEHA HIGHWAY
DEPARTMENT OF LAND & NATURAL RESOURCES, FRIENDS OF MALAEKAHANA BEACH PARK (DLNR-FOM)
OAHU, HAWAII

ETC Project No. 13-4014

September 13, 2013

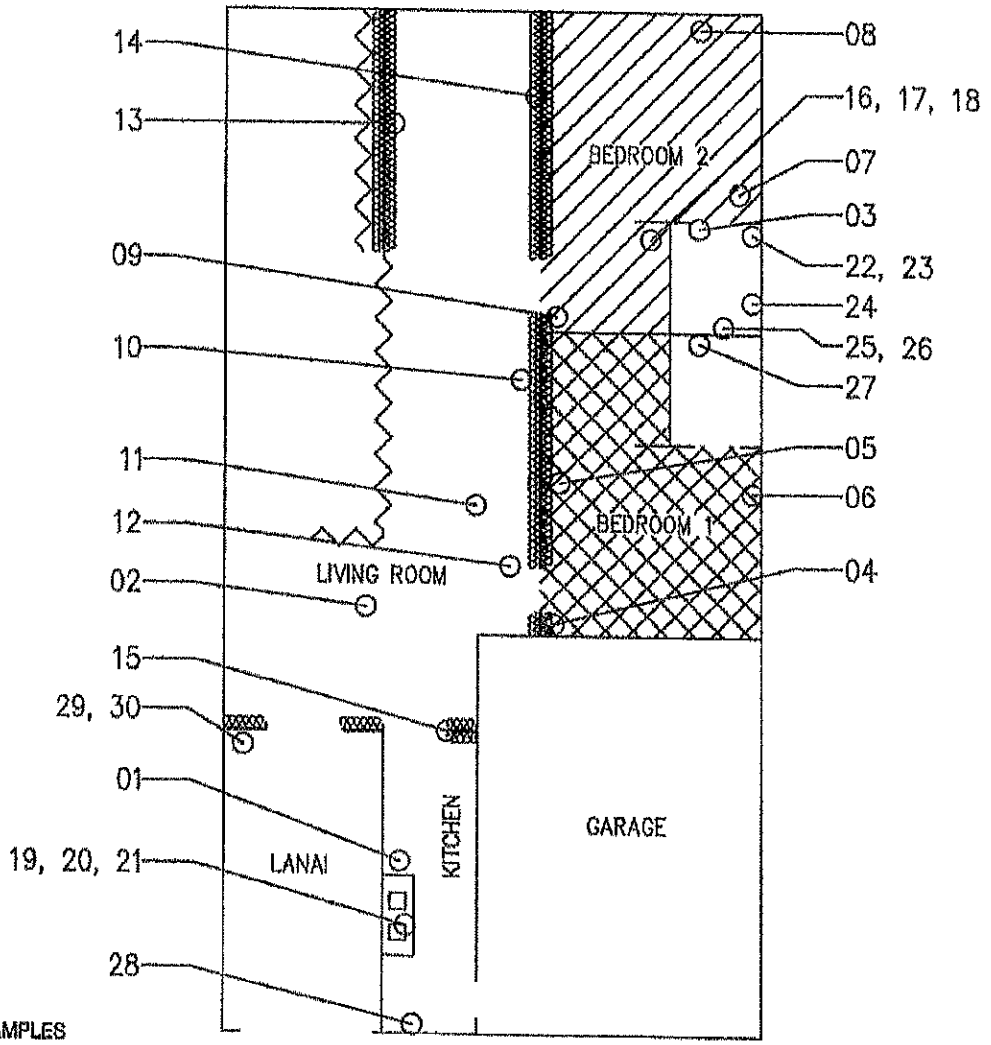
ETC JOB #13-4014
MAP 1 of 6

4014-CAB2-01 to -03	Ceramic Floor Tile with grout (various colors)
4014-CAB2-04 to -06	12" x 12" Black & White checkered pattern Vinyl Floor Tile (VFT) with replacement tiles and Mastic
4014-CAB2-07 to -09	12" x 12" White VFT with replacement tiles and Mastic
4014-CAB2-10 to -12	Grey Sheet Vinyl Flooring with mastic
4014-CAB2-13 to -15	Drywall Walls & Ceilings
4014-CAB2-16 to -18	Sink Counter Caulking
4014-CAB2-19 to -21	Kitchen Counter Caulking
4014-CAB2-22 to -24	Shower Caulking
4014-CAB2-25 to -27	Cementitious Shower Wall Panels
4014-CAB2-28 to -30	Black Asphaltic Roofing Material

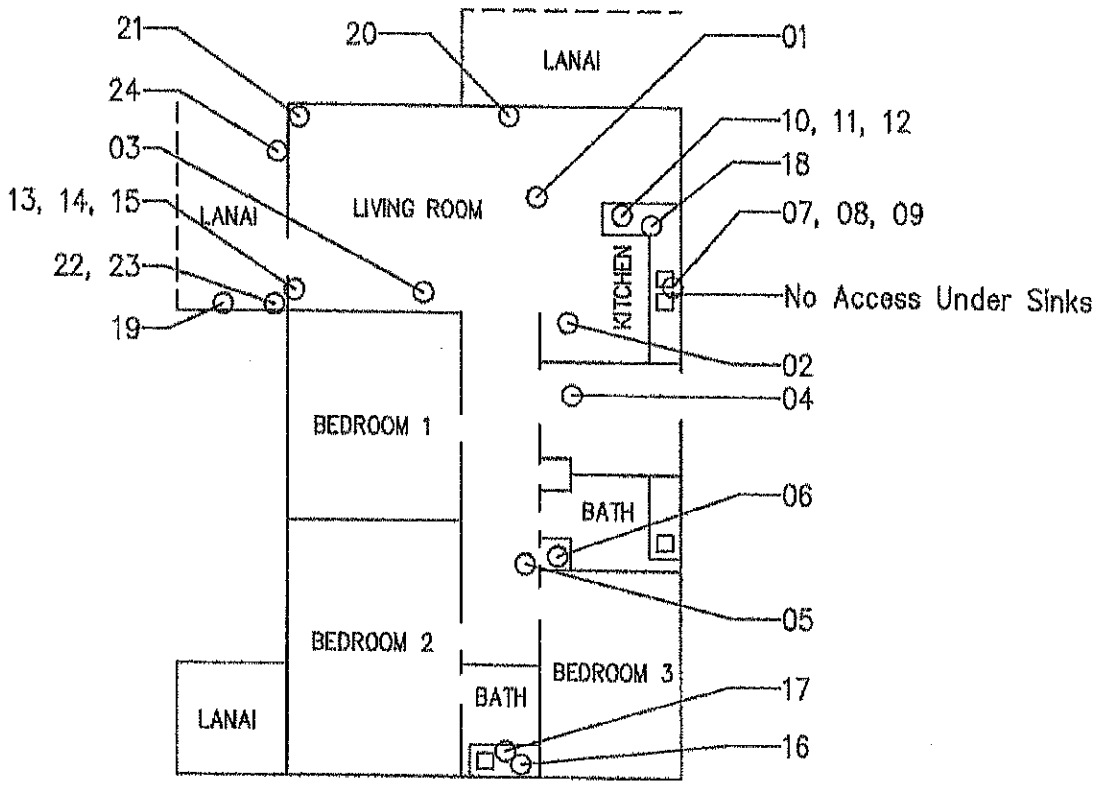
ETC JOB #13-4014
MAP 2 of 6

4014-CAB3-01 to -03	12" x 12" Green Vinyl Floor Tile (VFT) with Mastic
4014-CAB3-04 to -06	Brown Cementitious Flooring with Mastic
4014-CAB3-07 to -09	Kitchen Sink Caulking
4014-CAB3-10 to -12	Cementitious Wall Panels (Interior)
4014-CAB3-13 to -15	Drywall Walls
4014-CAB3-16 to -18	Ceramic Counter Tiles with Grout (various colors)
4014-CAB3-19 to -21	Black Asphaltic Roofing Material
4014-CAB3-22 to -24	Cementitious Wall Panels (Exterior)

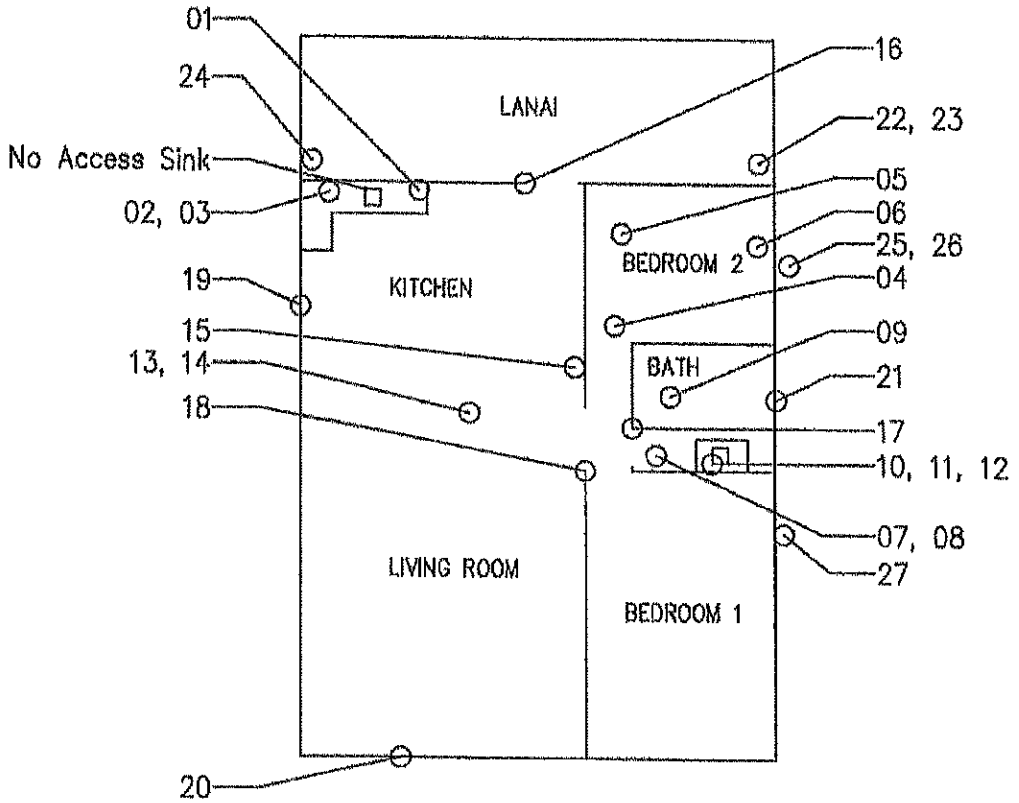
ETC JOB #13-4014
MAP 3 of 6

4014-CAB4-01 to -03	Kitchen Counter Caulking
4014-CAB4-04 to -06	Grey Sheet Vinyl Flooring
4014-CAB4-07 to -09	Multi-color Ceramic Floor Tiles with Mastic
4014-CAB4-10 to -12	Bathroom Sink Caulking
4014-CAB4-13 to -15	Grey Flooring Panels
4014-CAB4-16 to -18	Door Caulking
4014-CAB4-19 to -21	Window Caulking
4014-CAB4-22 to -24	Black Asphaltic Roofing Material
4014-CAB4-25 to -27	Cementitious Wall Panels (Exterior) (Exterior)

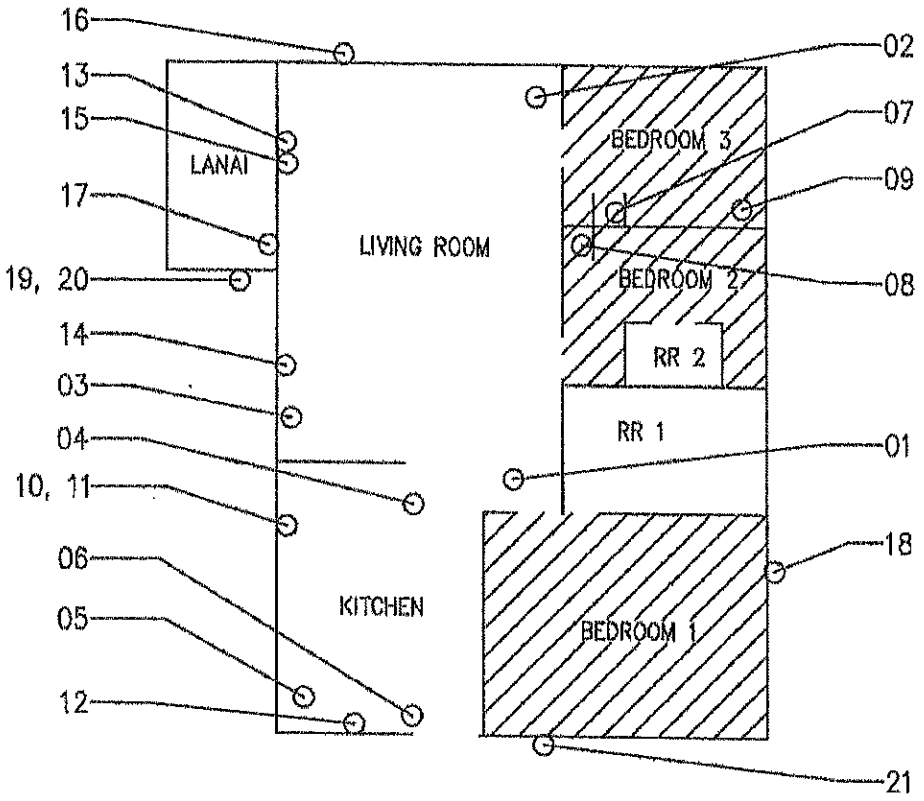
ETC JOB #13-4014
MAP 4 of 6

4014-CAB5-01 to -03	12" x 12" White with Black Specks Vinyl Floor Tile (VFT) and Mastic under carpet
4014-CAB5-04 to -06	12" x 12" Grey VFT with replacement tiles and Mastic
4014-CAB5-07 to -09	9" x 9" Black VFT and Mastic under carpet
4014-CAB5-10 to -12	Drywall Walls
4014-CAB5-13 to -16	Cementitious Wall Panels (interior)
4014-CAB5-17 to -18	Cementitious Wall Panels (exterior)
4014-CAB5-19 to -21	Black Asphaltic Roofing Material

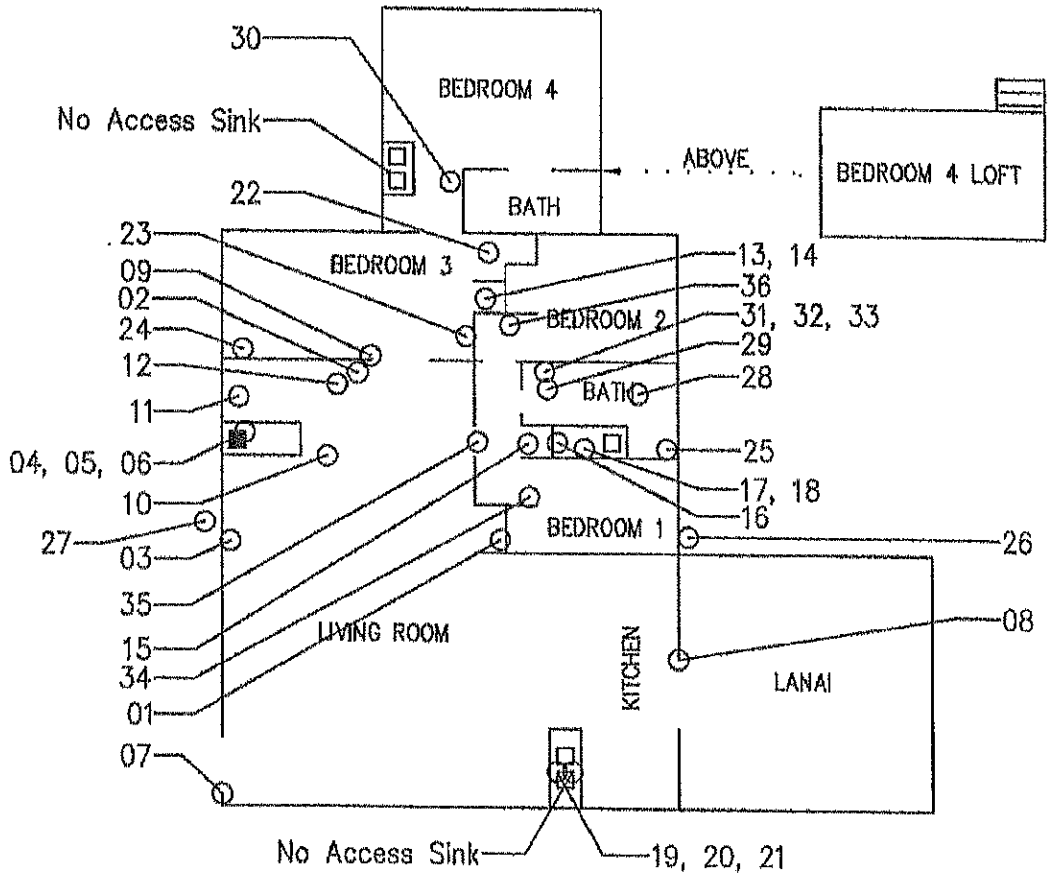
ETC JOB #13-4014
MAP 5 of 6

4014-AB-01 to -03	Drywall Walls
4014-AB-04 to -06	Grey Sink Undercoat
4014-AB-07 to -09	Door Caulking
4014-AB-10 to -12	12" x 12" Blue Textured Vinyl Floor Tile (VFT) and Mastic under ceramic tiles
4014-AB-13 to -16	12" x 12" Light Blue Textured VFT with Mastic
4014-AB-16 to -18	Counter Caulking
4014-AB-19 to -21	Counter Caulking
4014-AB-22 to -24	Blue Sheet Vinyl Flooring with Mastic
4014-AB-25 to -27	Black Asphaltic Roofing Material
4014-AB-28 to -30	Cementitious Flooring with Mastic
4014-AB-31 to -33	Shower Caulking
4014-AB-24 to -36	Multi-color Ceramic Floor Tile with replacement tiles

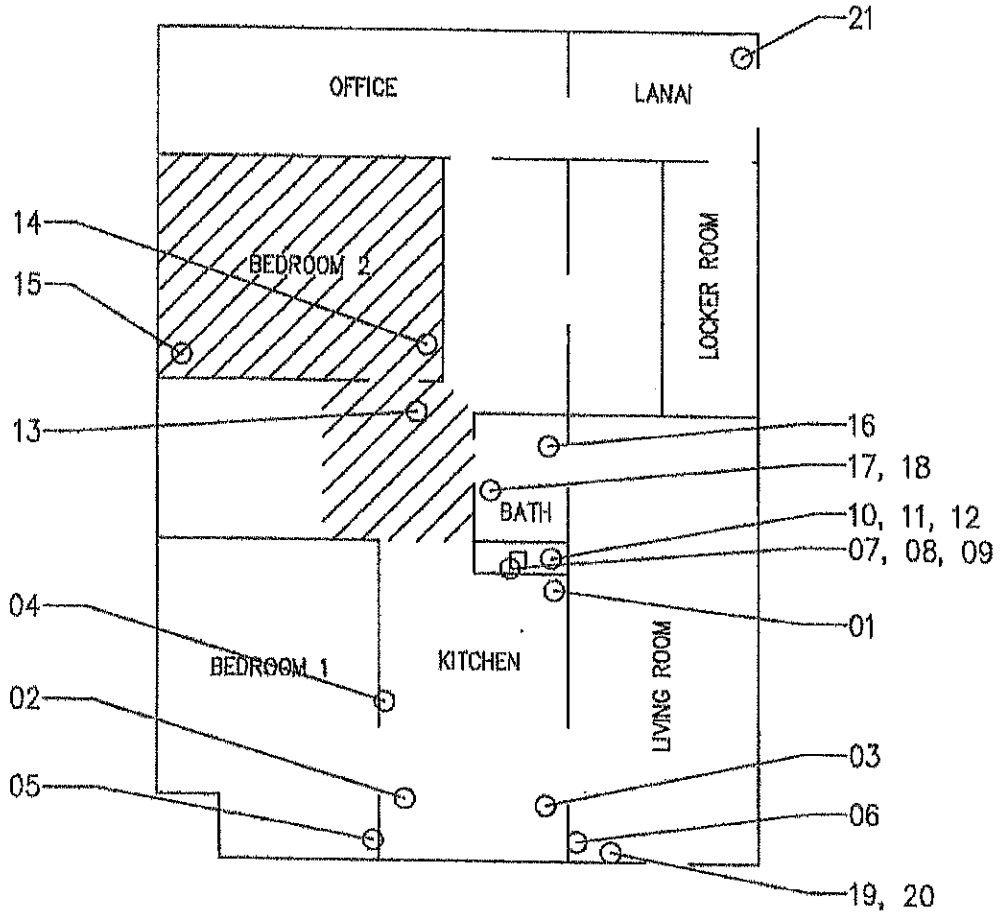
ETC JOB #13-4014
MAP 6 of 6

4014-OFFICE-01 to -03	12" x 12" White and Blue Checkered Pattern Vinyl Floor Tile (VFT) and Mastic
4014-OFFICE-04 to -06	Drywall Walls & Ceiling
4014-OFFICE-07 to -09	Kitchen Counter Caulking
4014-OFFICE-10 to -12	Ceramic Tile Counter with Grout
4014-OFFICE-13 to -15	12" x 12" White VFT and Mastic
4014-OFFICE-16 to -18	Ceramic Tile Counter with Grout
4014-OFFICE-19 to -21	Black Asphaltic Roofing Material

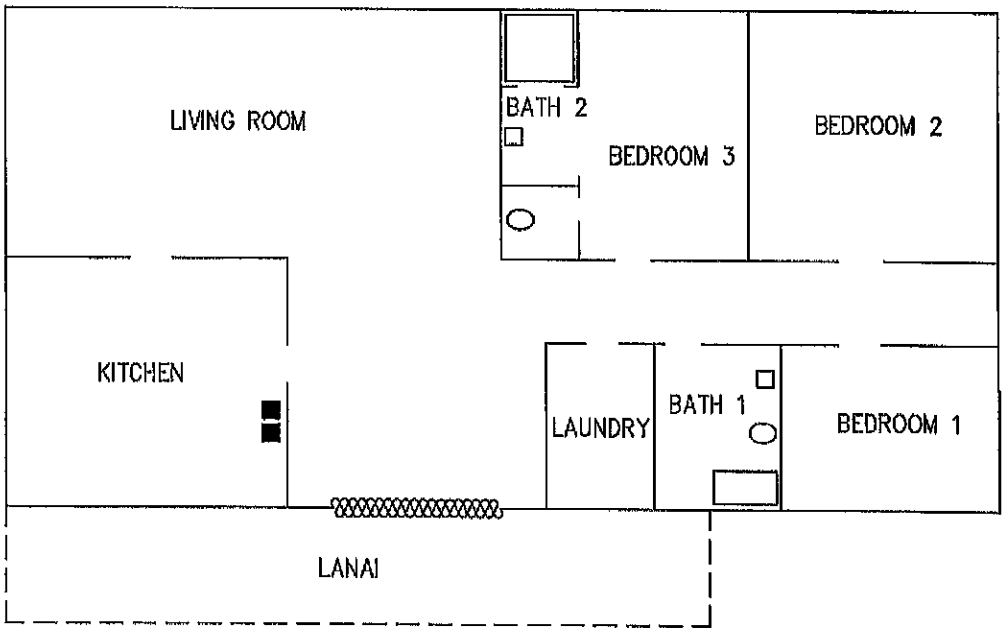
ETC JOB #13-4014
MAP 1 of 6

■ 4014-GWR-07 White Sink Undercoat

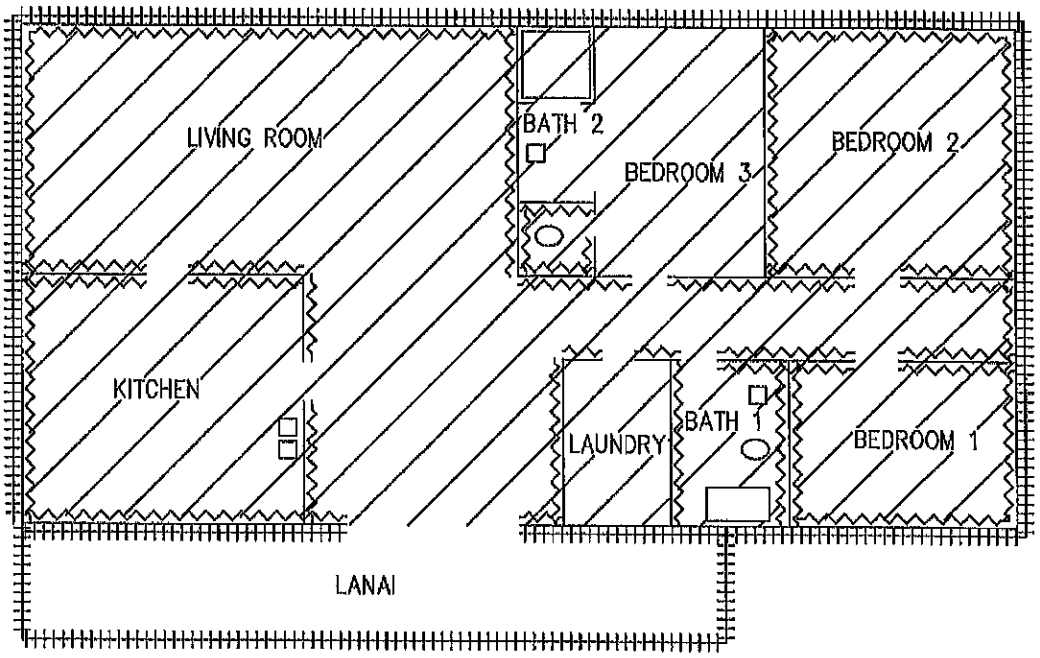
ETC JOB #13-4014
MAP 2 of 6

4014-PB-GWR-01 White Paint on Wood - Walls, Door Frame, Ceiling, Doors & Window Frame (poor condition)

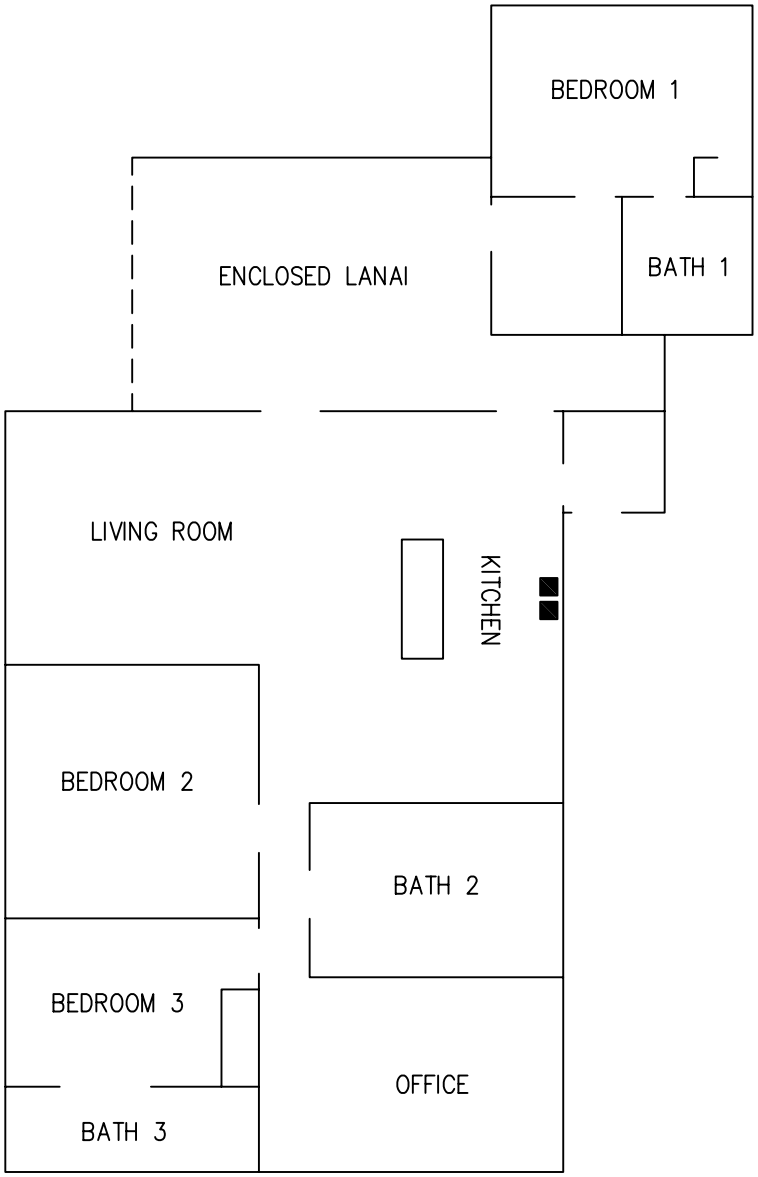
■ 4014-CCR-22 Black Sink Undercoat

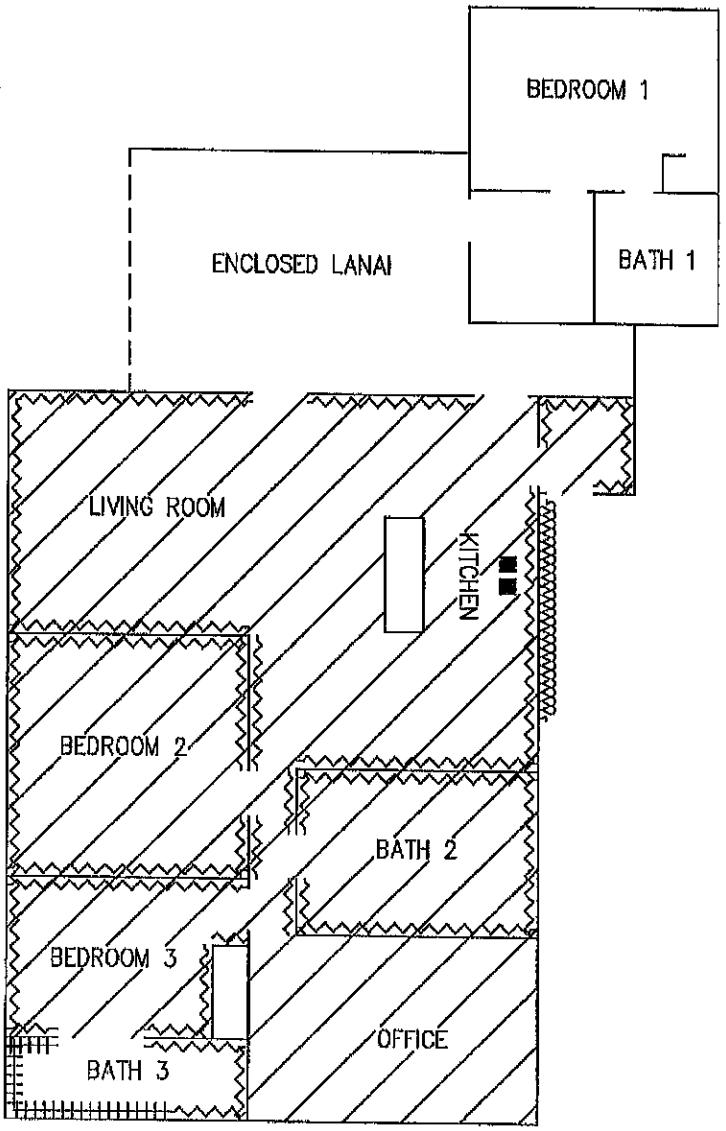
ETC JOB #13-4014
MAP 4 of 6

4014-PB-CCR-01 White Paint on Wood - Walls, Doors, Beams, Cabinets, Door Frames, Window Frames & Ceilings

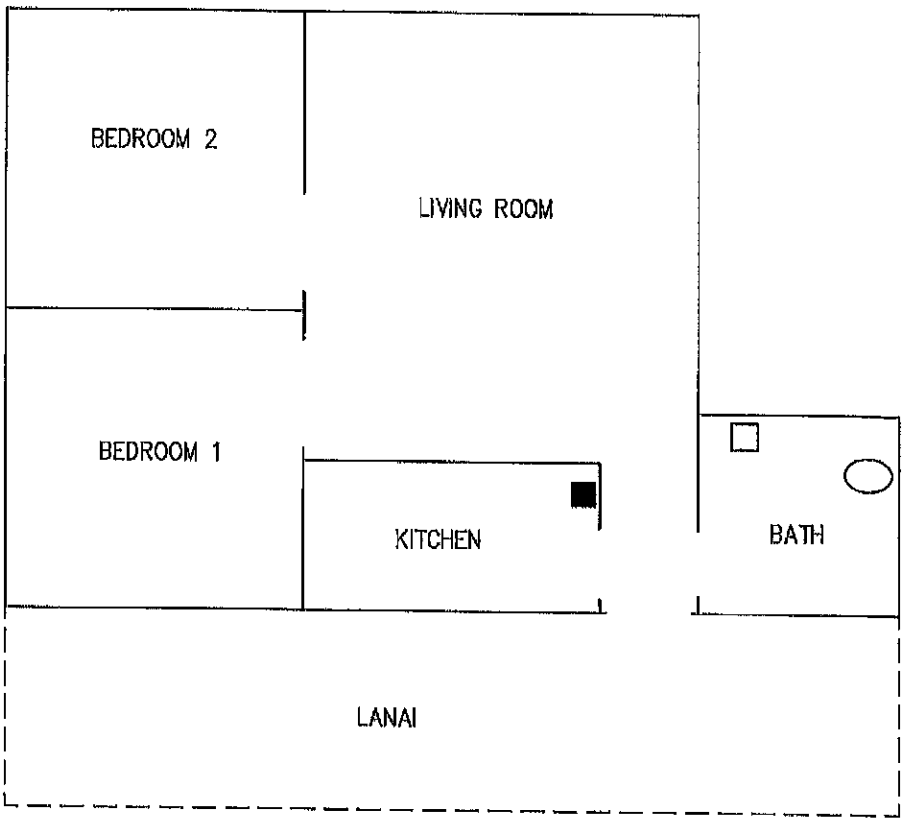
■ 4014-ASH-22 Black Sink Undercoat

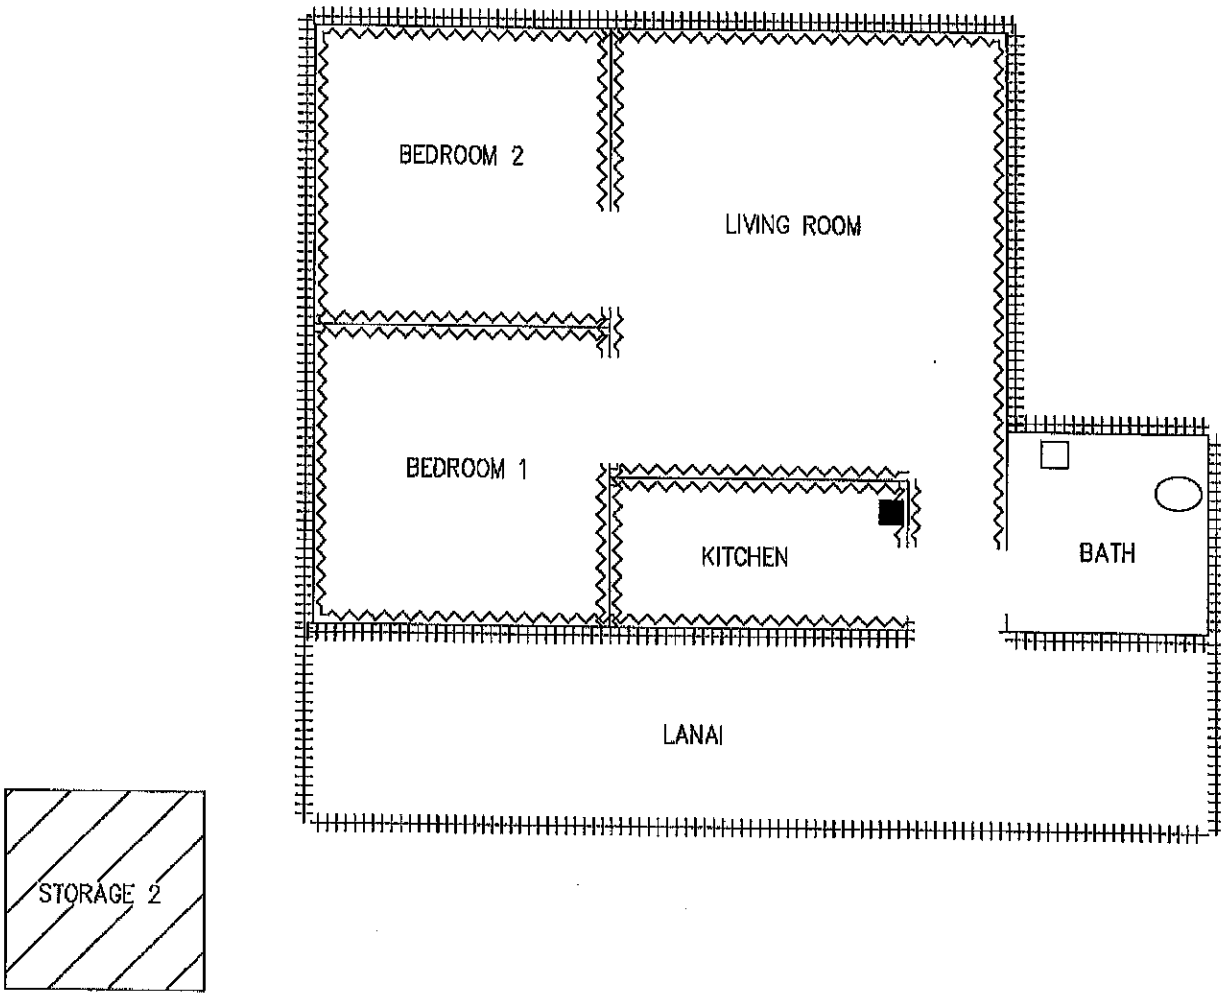
ETC JOB #13-4014
MAP 6 of 6

LEAD BASED PAINT (LBP) - Lead Content Greater Than 5000 mg/kg

4014-PB-ASH-01 White Paint on Wood - Walls, Ceilings, Beams, Doors & Window Frames (poor condition)
