STATE OF HAWAII  
DEPARTMENT OF LAND AND NATURAL RESOURCES  
COMMISSION ON WATER RESOURCE MANAGEMENT  
Stream Protection and Management Branch

**FIELD INVESTIGATION REPORT**  
FI2008120903 (East Maui, Waiokamilo Koolau Ditch)

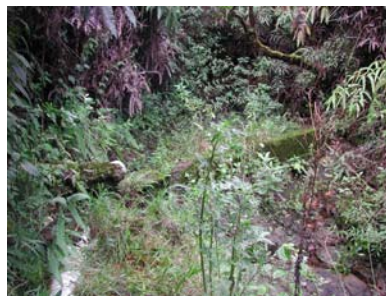
**20081209042.JPG**

20081209041	Minor diversion on a tributary of Waiokamilo Stream (K-22a). This section of the 6-inch aluminum PVC pipe is broken sever diversion of water from the stream.
20081209042	Minor diversion on a tributary of Waiokamilo Stream (K-22a). A 6-inch aluminum PVC pipe diverts water to a tributary of East Waiokamilo Stream, formerly known as Kualani Stream.
20081209043	Tributary of East Waiokamilo Stream upstream of the Koolau Ditch major diversion #10 intake (K-22).
20081209045	Koolau Ditch major diversion (K-22, #10 intake) on a tributary of East Waiokamilo Stream. Metal grate on the left streambank has been sealed with concrete.
20081209046	Koolau Ditch major diversion (K-22, #10 intake) on a tributary of East Waiokamilo Stream.
20081209047	Koolau Ditch major diversion (K-22, #10 intake) on a tributary of East Waiokamilo Stream.
20081209049	Koolau Ditch major diversion (K-22, #10 intake) on a tributary of East Waiokamilo Stream.

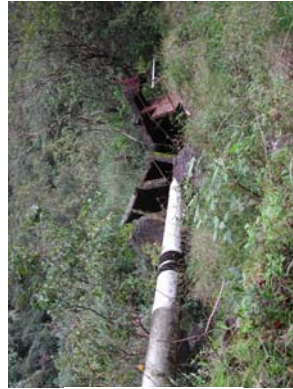
**20081209088.JPG**

8. Time: 1440 hours. Koolau Ditch major diversion (K-25, Kikokiko intake) on Waiokamilo Stream and the minor diversions. Water from Waiokamilo Stream would flow down a small waterfall and into the main intake structure on the left bank below the falls. A minor diversion (K-25a) is located on the left bank of the stream under the service road bridge. The diversion structure is a concrete catchment basin with a 2-inch pipe intake that would capture seepage and transported that water via a PVC pipe into another catchment basin below the service road. A second minor diversion (K-25c) begins mauka of the service road bridge on the left bank and then crossed over to the right bank. The diversion structure is a concrete catchment basin with a 6-inch pipe intake that would capture seepage and transported that water to Koolau Ditch. A third minor diversion (K-25d) is located further West along the service road. This diversion structure is a concrete catchment basin with a 4-inch PVC pipe that would capture seepage and transported that water to Koolau Ditch. A fourth minor diversion (K-25e) is located 20 feet West of minor diversion K-25d. This diversion structure is a concrete catchment basin with a 3-inch PVC pipe that would capture seepage and transported that water to Koolau Ditch. Based on staff's observation, the Kikokiko intake and the minor diversions are no longer functional because either the intakes were cemented and / or the pipes were severed. See photos 20081209088 and 20081209102.
