**URBAN PHASE III
ARCHAEOLOGICAL
INVENTORY SURVEY
(VOL. III)**

ARCHAEOLOGICAL INVENTORY SURVEY
OF URBAN PHASE III PARCEL
LILI'UOKALANI TRUST LANDS
IN KEAHUOLŪ, NORTH KONA
ISLAND OF HAWAII
[TMK: (3) 7-4-008:002 (por.)]

VOLUME III:
APPENDICES
(Newly Documented Sites, Table of Lava
Excavations, Isolated Finds,
GPS Site Locations)

Prepared by:
Rowland B. Reeve, M.A.
Paul L. Cleghorn, Ph.D.
Tanya Lizama, M.A.
and
Reid Yamasato, B.A.

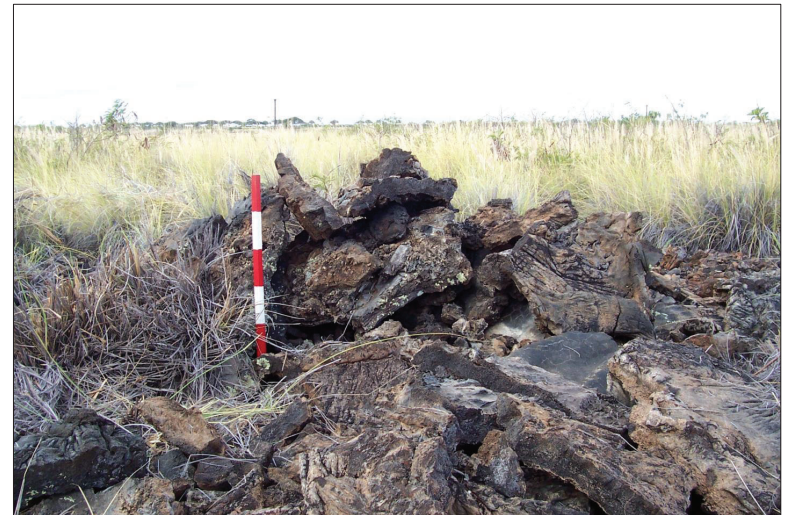
Small fragments of Porites coral were found scattered in the general area. These coral fragments may, however, be associated with the adjacent QLCC buildings rather than with the mound itself. The stone mound is in fair condition, with some tumble along its northwest end.

Figure C.2. Site 50-10-27-29088 stone mound (view southwest).

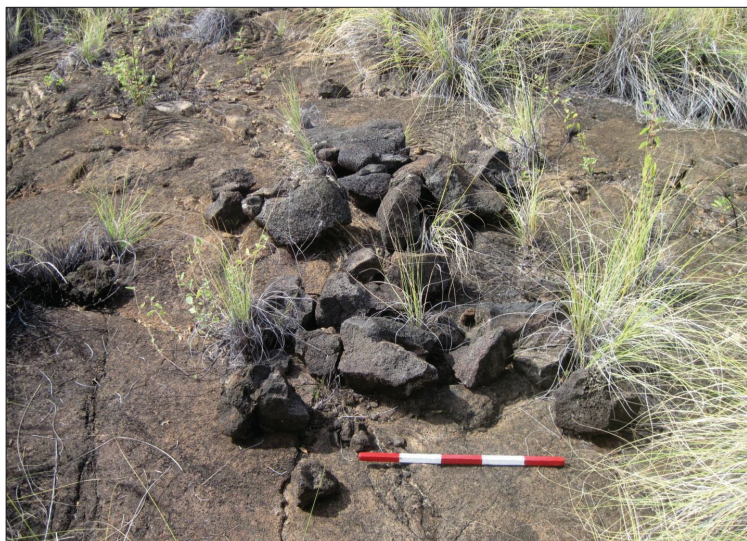
The remnants of the mound appear irregular in shape, comprising a scatter of small to medium sub-angular boulders and cobbles. The scatter of tumbled stones measures approximately 1.96 meters in length (north to south) by ca. 1.18 meters in width (east to west) with a maximum height of ca. 0.23 meters. No cultural material was observed in or around the site. The structure appears to be badly disturbed and its original shape indeterminate. Due to its disturbed condition, it is difficult to determine the mound's original function. It is likely, however, that it may have served as a marker. Site 29089 appears to be pre-Contact and/or early post-Contact in age.

Figure C.4. Site 50-10-27-29089 stone mound (view south).

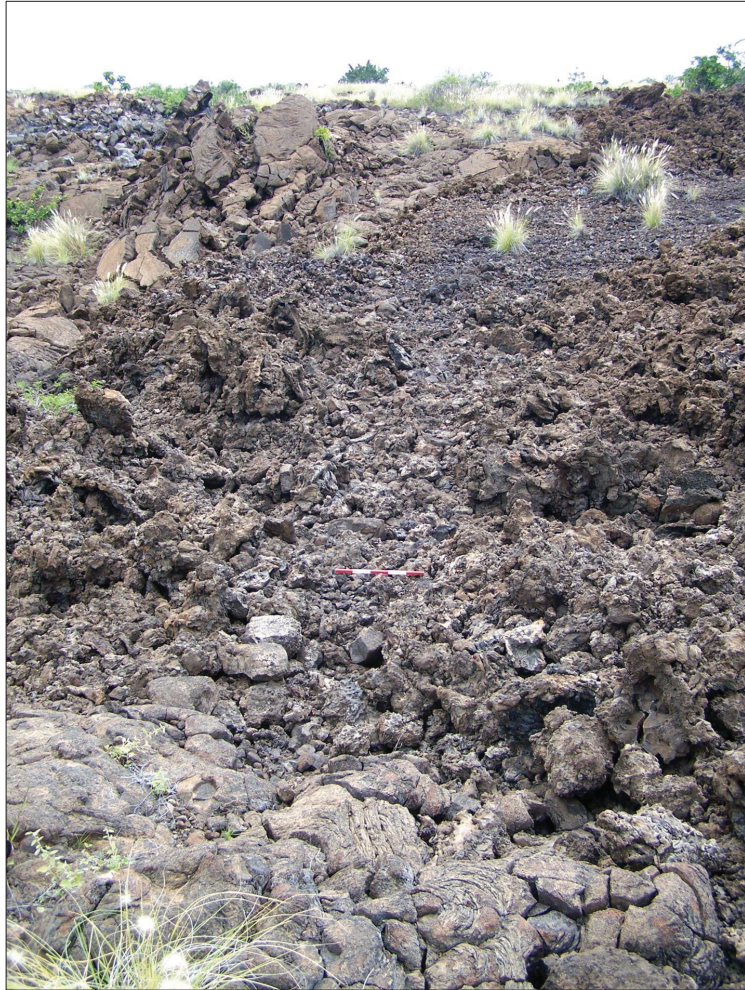
Description: Site 50-10-27-29090, Feature B consists of a trail segment extending over a stretch of rough 'a'ā lava that connects two patches of smoother pāhoehoe (Figure C.7). The northeast end of Feature B is situated approximately 3.3 meters from the northeast end of Feature A. The trail forms a shallow linear depression within the surrounding 'a'ā flow. Feature B runs roughly northeast to southwest and is paved with crushed 'a'ā clinkers. This trail bed of clinkers appears to have been created in part by the passage of foot traffic. Pāhoehoe slabs and sub-angular medium pāhoehoe boulders have been set into the surface of the trail at irregularly spaced intervals to serve as stepping stones. Feature B measures ca. 18.6 meters in length and ca. 0.66 meters in width. No cultural material was observed on or near the feature. The trail is in fair condition. However, a portion of the trail near its southwestern end has been partially destroyed by bulldozing.

Figure C.7. Site 50-10-27-29090, Feature B trail segment (view southwest).

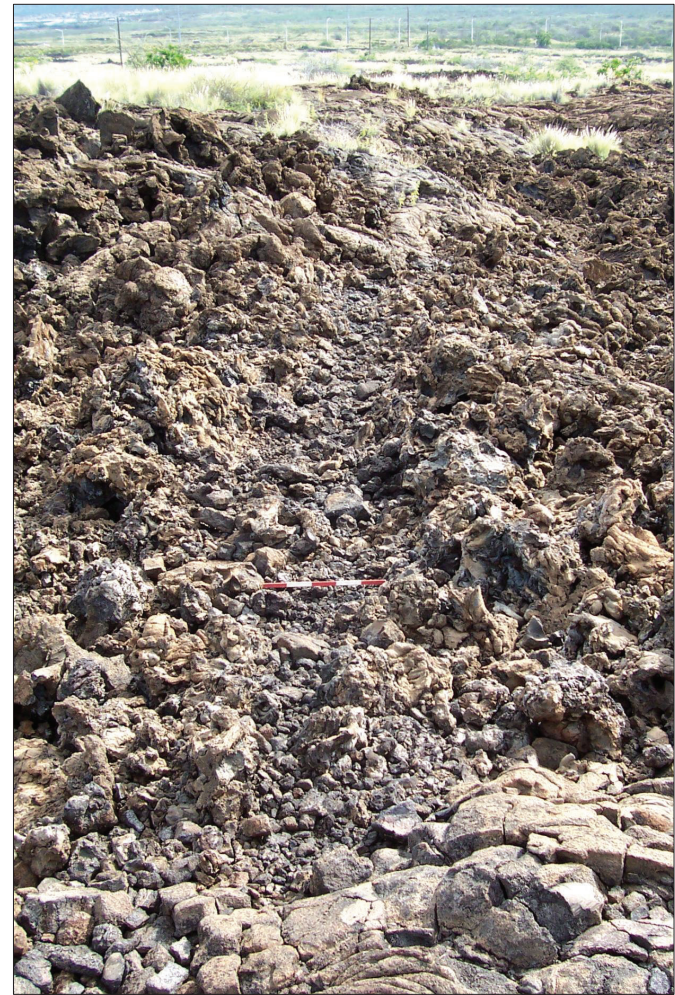
No surface cultural material was observed at or around the Site 29092 trails, which are both in good condition. The main Site 29092 trail appears to be aligned with the Site 29090 and Site 29091 trail segments, which are located to the northeast and southwest respectively. These three trail segments may form part of a single larger trail which is only visible where it crosses stretches of rougher 'a'ā lava. It appears that these trail segments were most likely constructed and utilized during the pre-Contact and/or early post-Contact periods for travel over rough sections of 'a'ā lava.

Figure C.12. Site 50-10-27-29092 trail segment (view to the northeast).

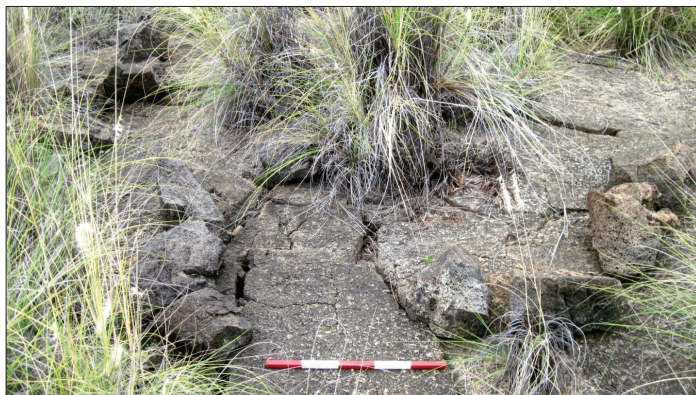
No cultural material was observed in or around the feature. Feature A is in poor condition and has been badly disturbed. Portions of the rock alignment have tumbled downslope to the east and south. The location of this feature, on a sloping and broken-up lava surface, would make the structure an uncomfortable shelter for temporary habitation. For this reason, the purpose of Feature A remains unclear. It is possible, however, that the fracturing of the underlying lava took place during seismic activities, which occurred after the abandonment of the feature. In this case, Feature A may well have served as a very crude windbreak shelter, possibly composing the base stones holding in place a shelter of matting or some other perishable material. Its construction style suggests that the feature may have been built and utilized during the pre-Contact and/or early post-Contact periods.

Figure C.15. Site 50-27-29-29094, Feature A C-shaped stone alignment (view west).

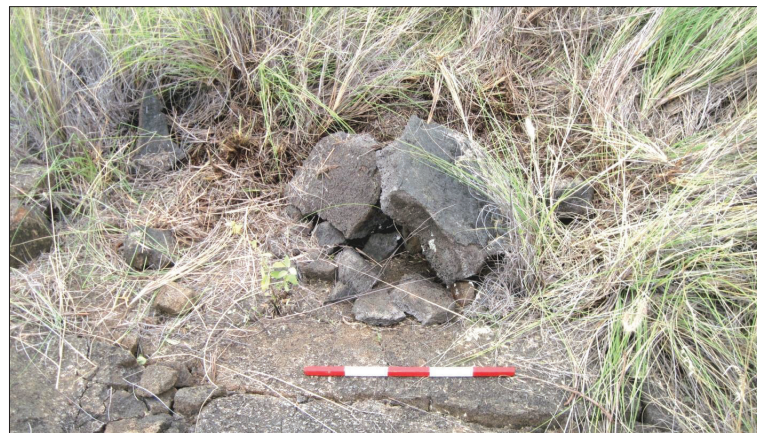
No cultural material was observed in or around the feature. Feature B is in poor condition and appears to have been badly disturbed. The mound is tumbled along all of its edges, making its original shape and construction style unclear. It is likely, that it served as a marker during the pre-Contact and/or early post-Contact periods. However, what the mound may have marked is unknown.

Figure C.16. Site 50-10-27-29094, Feature B stone mound (view east).

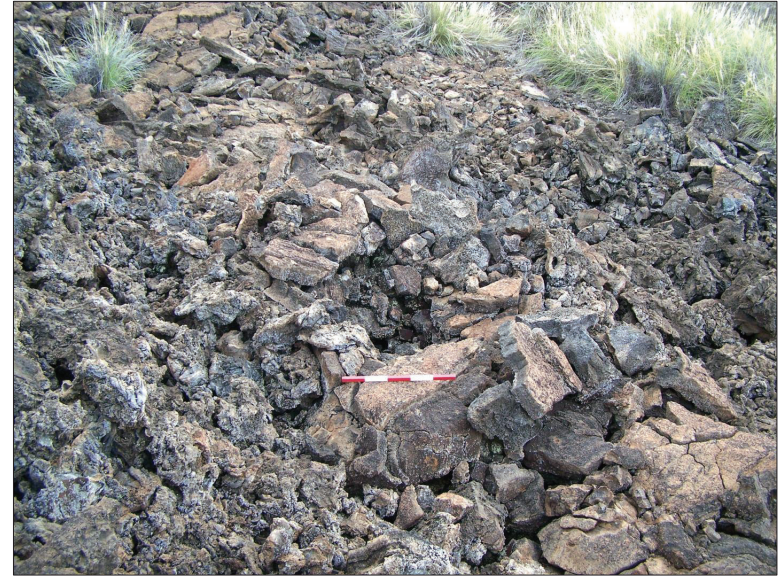
No cultural material was found in or around the site. Site 29096 is in fair condition with some of the edging stones having been disturbed.

Figure C.18. Site 50-10-27-29096 stone-edged depression (view south).

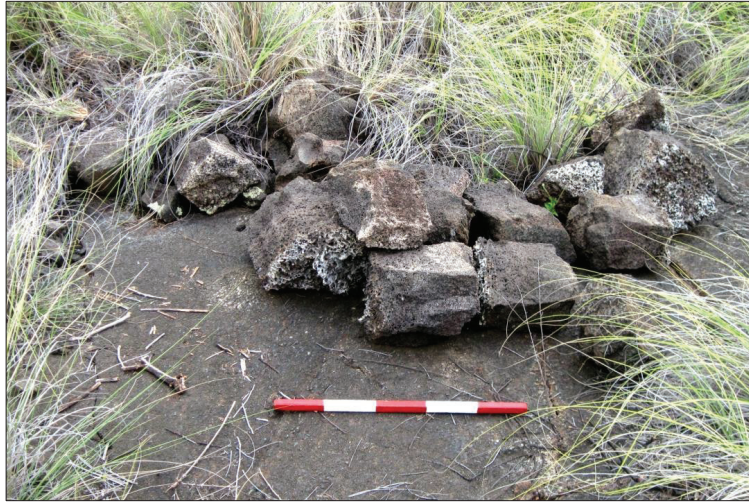
The Site 29097 stone mound is constructed of very loosely piled small to medium sub-angular basalt *pāhoehoe* boulders. The original shape of the mound could not be determined due to its poor condition. In its present condition, the mound measures approximately 0.90 meters in length (east to west) by ca. 0.87 meters in width (north to south) with a maximum height of ca. 0.33 meters. No cultural material was observed in or around the site. Site 29097 is in poor condition. The mound is badly disturbed, and many stones have tumbled to the south and southwest. The Site 29097 stone mound may have functioned as a marker that was built and utilized during the pre-Contact and/or early post-Contact period.

Figure C.20. Site 50-10-27-29097 stone mound (view south).

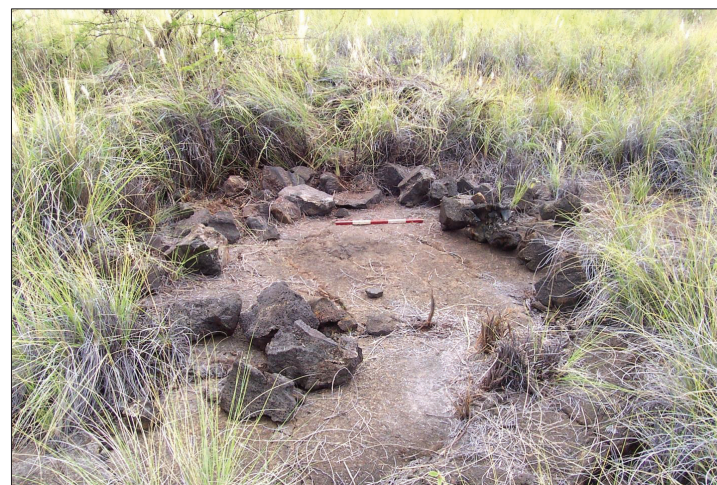
No cultural material was observed in or around the feature. Feature C is in fair condition with tumble located around all of its edges. Based on its construction style, Feature C was probably utilized as a temporary windbreak shelter (or the base of one) during the pre-Contact and/or early post-Contact periods.

Figure C.30. Site 50-10-27-29099, Feature C C-shaped wall (view west).

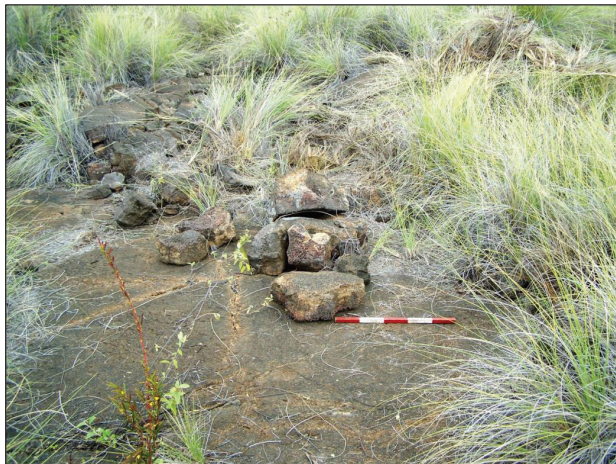
No cultural material was observed in or around the feature. This feature is in poor condition as stones have tumbled in all directions. The Feature E mound appears to be pre-Contact and/or early post-Contact in age and may have served as a marker, possibly to mark the location of the cluster of temporary habitation shelters.

Figure C.32. Site 50-10-27-29099, Feature E stone mound (view east).

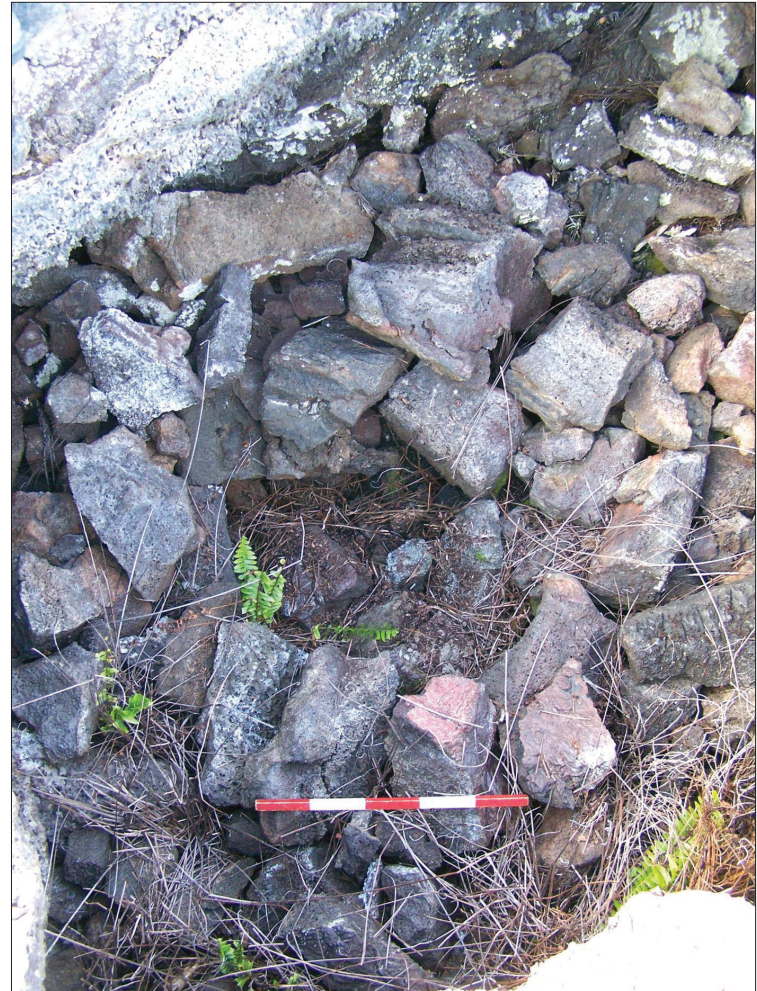
No surface cultural material was observed within or around the site. Site 29101 is in fair condition. The original function of this stone-edged depression is uncertain. It is possible that an object, such as a gourd calabash, could have been placed within the depression to catch and hold rainwater. The sides of the depression, and the sinkhole formed by the collapsed blister, would have sheltered the water container from the rays of the sun for much of the day and served to slow evapotranspiration. The natural shelving around the edges of the collapsed lava blister could have served as a good place for storage. It is probable that Site 29101 was modified and utilized during the pre-Contact and/or early post-Contact periods.

Figure C.35. Site 50-10-27-29101 stone-edged depression (view south).

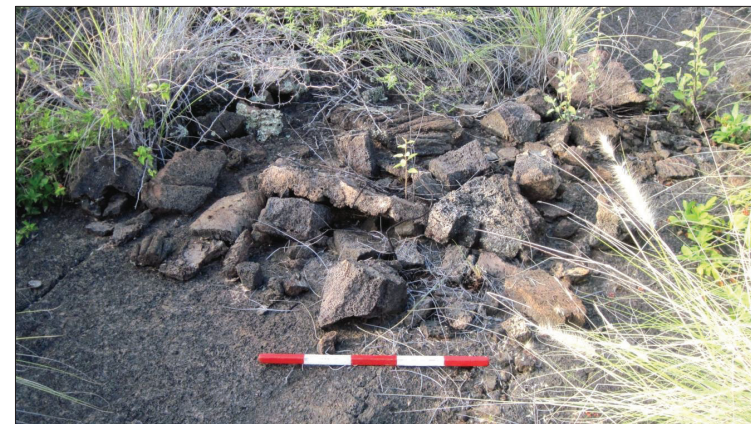
No cultural material was observed in or around the mound. Site 29102 is in poor condition and appears to have completely tumbled in all directions. Due to its disturbed condition it is difficult to determine the mound's original function. It is possible that Site 29102 may have served as a marker during the pre-Contact and/or early post-Contact periods. It is not clear, however, what the mound may have been intended to mark.

Figure C.37. Site 50-10-27-29102 stone mound (view south).

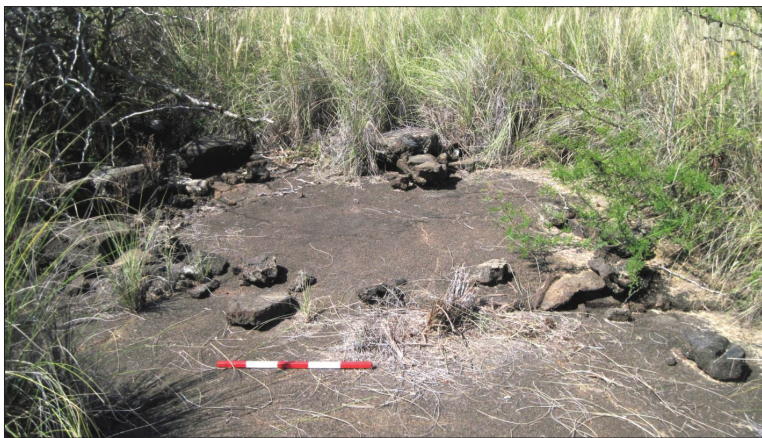
Description: Site 50-10-27-29104, Feature A is a collapsed C-shaped wall with a possible associated petroglyph image (Figure C.41). It is located in the southern portion of the site and is approximately 20.0 meters south (161°) from the Feature B C-shaped wall. Feature A is built directly on a level and smooth *pāhoehoe* surface and opens to the west. The C-shaped wall is constructed of loosely piled small to large *pāhoehoe* slabs and a few large sub-angular basalt cobbles. The stones along the eastern portion of the structure are larger in size. The interior of the C-shape measures ca. 2.1 meters in length (north to south) by ca. 1.6 meters in width (east to west). The overall exterior dimensions are ca. 2.5 meters in length (north to south) by ca. 2.7 meters in width (east to west). The maximum height of the wall is ca. 0.3 meters along its interior eastern edge. One possible petroglyph was noted on the center of the floor surface of Feature A. The petroglyph appears to be a rough "L" that may represent a torso and arm of a linear bodied human figure. This partial image, however, is too faint to determine its true shape. No surface cultural material was observed in or around the structure. Feature A is in poor condition and badly tumbled. Site 29104, Feature A was most likely built and used as a temporary shelter during the pre-Contact and/or early post-Contact periods.

Figure C.41. Site 50-10-27-29104, Feature A C-shaped wall (view southwest).

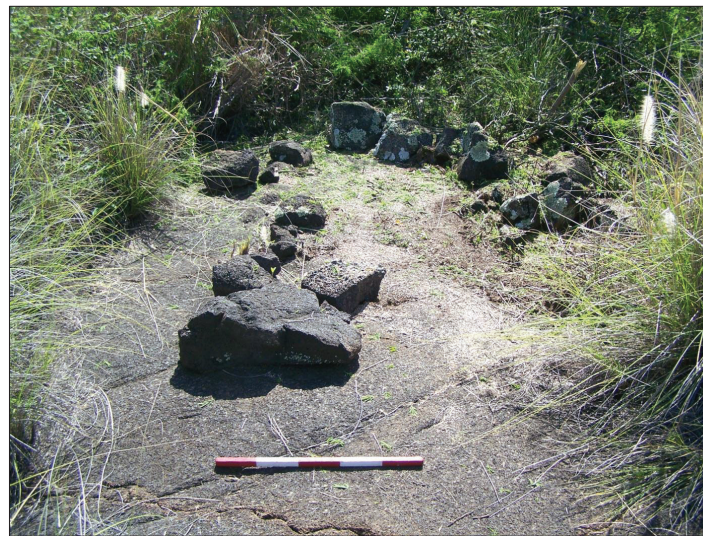
Feature B is in poor condition and has been badly disturbed. The eastern portion of the C-shaped alignment appears to have stones that are scattered and jumbled, impacting its true shape. It is likely that Feature B was used for temporary habitation, possibly as a windbreak during the pre-Contact and/or early post-Contact periods.

Figure C.42. Site 50-10-27-29104, Feature B C-shaped alignment (view north).

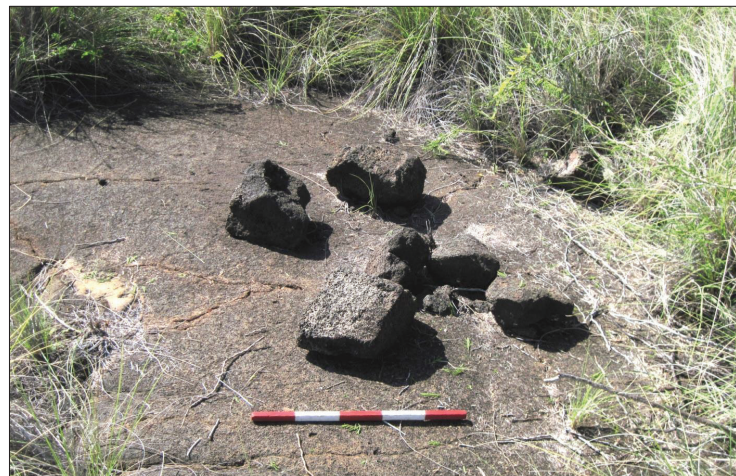
No cultural material was observed in or around Feature C. The mound is in poor condition and appears to be badly disturbed, possibly as a result of seismic activity. Due to its disturbed condition, it is difficult to determine the mound's original function. It is likely that it may have served as a marker. It is not clear, however, what the mound was intended to mark. The area of battering may have been associated with some form of processing activity. Feature C appears to have been constructed and utilized during the pre-Contact and/or early post-Contact periods.

Figure C.44. Site 50-10-27-29104, Feature C remnant stone mound (view southeast).

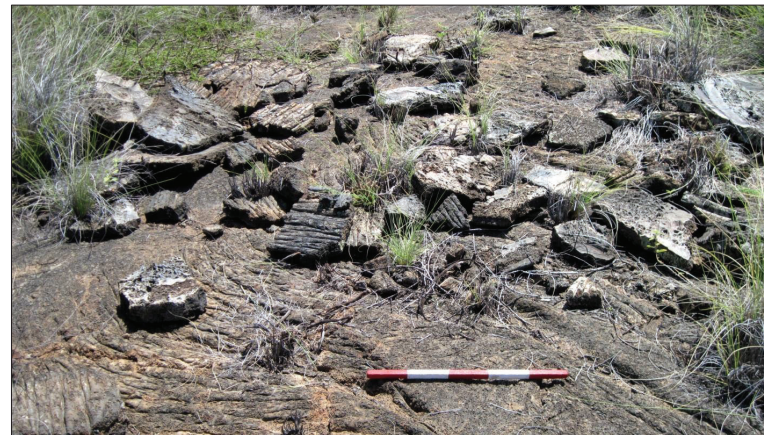
No cultural material was observed in or around the site. Site 29105 is in poor condition and is badly tumbled, possibly as a result of seismic activity. The enclosure was most likely constructed and utilized as a windbreak shelter during the pre-Contact and/or early post-Contact periods.

Figure C.46. Site 50-10-27-29105 remnant enclosure (view east).

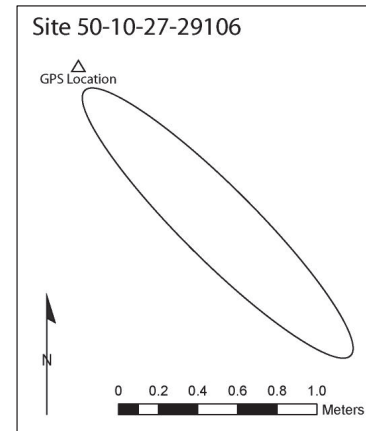
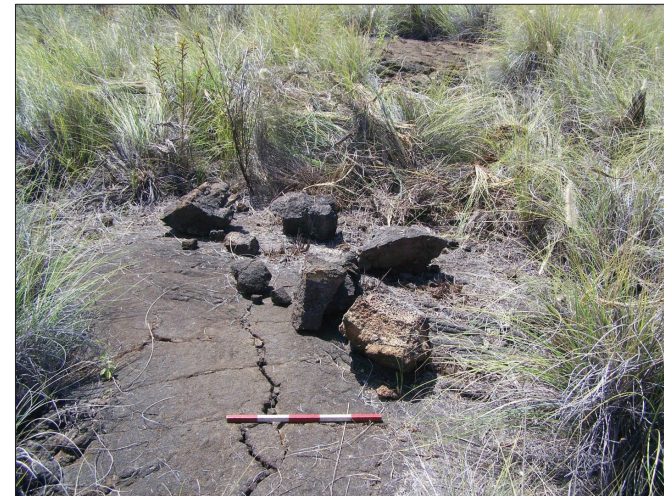
Description: Site 50-10-27-29106 consists of a single short and badly disturbed linear stone alignment (Figure C.47 and Figure C.48). The site is situated within the central portion of the project area, approximately 66.0 meters south (177°) of the Site 50-10-27-29105 enclosure. The terrain is a gentle undulating *pāhoehoe* lava flow covered with dense patches of fountain grass and scattered Christmasberry, *noni*, and *klu* trees. The stone alignment is constructed of five small sub-angular basalt boulders, two of which have been pushed aside. A few scattered small to large sub-angular basalt cobbles are also present but do not appear to be part of the alignment. The stone alignment is built on level, smooth, slightly ropy *pāhoehoe* bedrock. It measures ca. 1.91 meters in length (northwest to southeast) by ca. 0.37 meters in width (northeast to southwest) and has a maximum height of ca. 0.32 meters.

No surface cultural material was observed at this site. The Site 29106 stone alignment is in poor condition. It appears that this stone alignment most likely functioned as a temporary windbreak shelter during the pre-Contact and/or early post-Contact periods. The *pāhoehoe* surface on the northeast side of the alignment is very level and smooth, while the lava on the southwest side is ropy. This might suggest that the northeast side of the structure served as a more comfortable space for habitation.

Figure C.47. GPS-based map of Site 50-10-27-29106 stone alignment.

Figure C.48. Site 50-10-27-29106 stone alignment (view southeast).

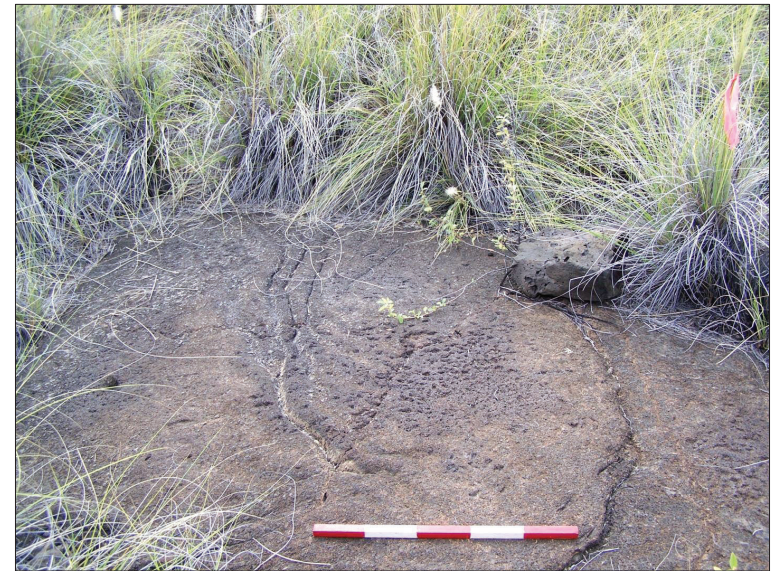
No cultural material was observed within the site area. However, fragments of fine-grained, dense, angular (fractured) basalt cobbles and small boulders that did not show any obvious evidence of battering were present in and amongst the battered *pāhoehoe* lava. Site 29107 is in fair condition. Bulldozing tracks have scarred the *pāhoehoe* bedrock within the central to southern site area. The former Swing Zone driving range has also impacted the southern portion of the area.

Figure C.50. Site 50-10-27-29107 area of heavy battering (view west).

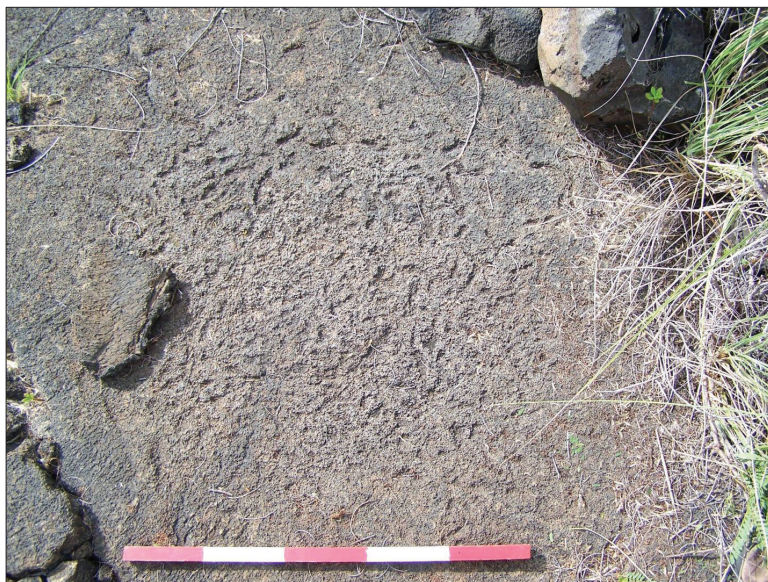
The more circular battering marks suggests that this site was utilized in the pre-Contact and/or early post-Contact periods, while the more linear tool marks indicate that it may possible have been in use up into the historic period. The substantial amount of battering present in the area suggests that Site 29107 was the focus of a relatively intense and concentrated processing activity, though what was being processed is unclear.

Figure C.51. Site 50-10-27-29107 area of linear battering (view west).

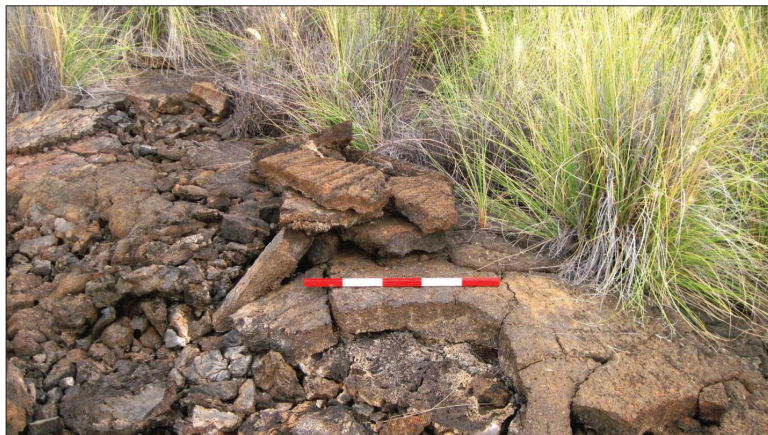
No cultural material was observed in or around the mound. Site 29108 is in good condition, with only slight tumble to the west. Its construction style and location suggest that the mound may have served as a marker during the pre-Contact and/or early post-Contact periods.

Figure C.53. Site 50-10-27-29108 stone mound (view west).

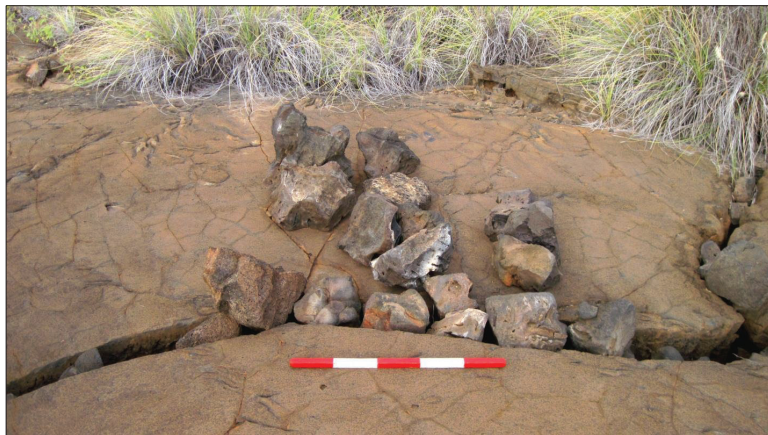
No cultural material was noted at this site. The mound is in poor condition and appears to be badly collapsed, possibly as a result of seismic activity. Some stones have tumbled downslope into a natural fissure that runs across the surface of the *pāhoehoe* lava. It is difficult to determine the mound's original function because of its collapsed state. Site 29109 may have possibly served as a marker due to its location atop of a lava ridge. It is not clear, however, what the mound was intended to mark. The mound appears to be pre-Contact and/or early post-Contact in age.

Figure C.55. Site 50-10-27-29109 rock concentration (view to the southwest).

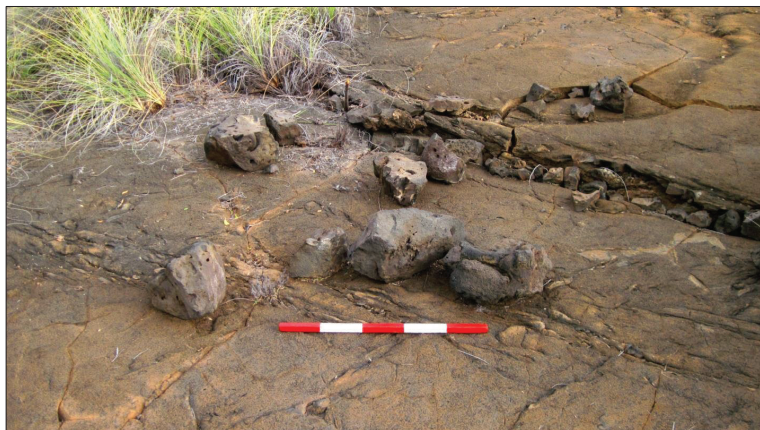
No cultural material was observed at this site. Site 29110 is in extremely poor condition. Due to its disturbed condition, it is difficult to determine either the original shape or function of the rock scatter. It is possible, however, that it may have once formed a stone mound, or a small C-shaped alignment that would have served as a temporary windbreak shelter during the pre-Contact and/or early post-Contact periods.

Figure C.57. Site 50-10-27-29110 rock concentration (view northwest).

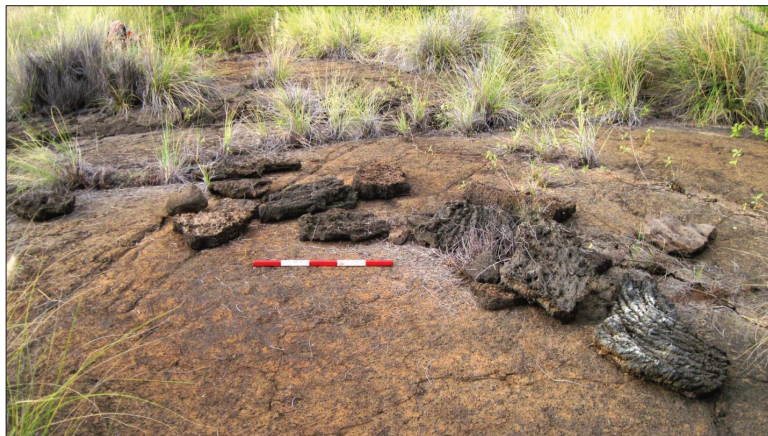
No cultural material was observed at this site. Site 29111 is in poor condition. The C-shaped wall was probably built during the pre-Contact and/or early post-Contact periods and utilized as a temporary windbreak shelter.

Figure C.59. Site 50-10-27-29111 C-shaped wall (view south).

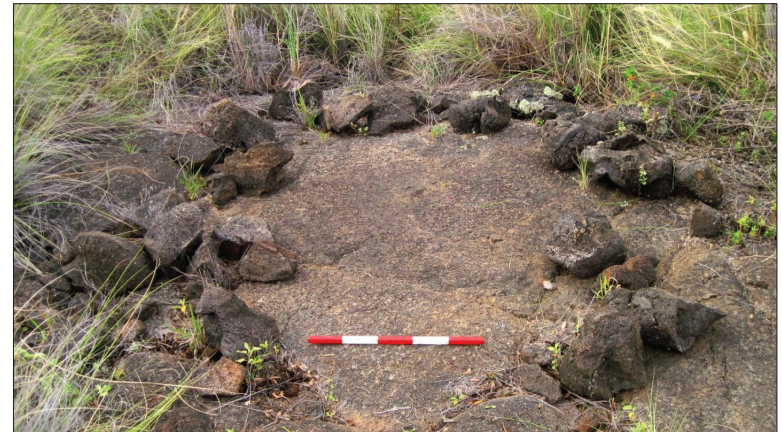
No cultural material was observed in or around the site. Site 29112 is in fair condition. The structure appears to be collapsed with possible tumble on its northwest edge.

Figure C.61. Site 50-10-27-29112 C-shaped wall (view southeast).

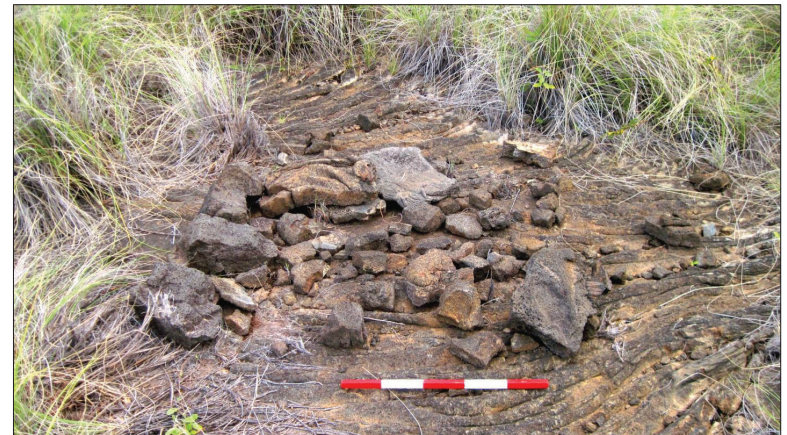
No cultural material was observed in or around Site 29113. The mound is in poor condition and appears complete collapsed, possibly as a result of seismic activity. Due to its disturbed condition, it is difficult to determine the mound's original function. It is likely, however, that it may have served as marker. Site 29113 appears to be pre-Contact and/or early post-Contact in age.

Figure C.63. Site 50-10-27-29113 stone mound (view northwest).

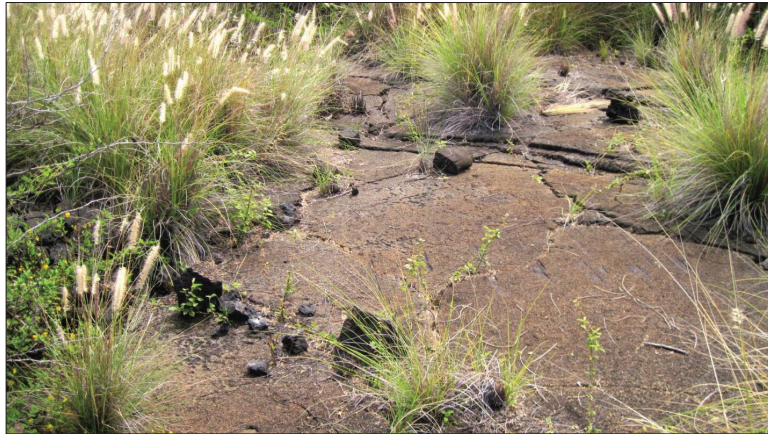
Site 29114 is in fair condition. Bulldozer tracks have scarred the *pāhoehoe* bedrock in the northeastern area of the site. The former Swing Zone driving range has also impacted the southeastern portion of the site. The presence of both circular battering and linear chisel tool marks suggests that Site 29114 was utilized during both the pre-Contact and/or early post-Contact and historic periods. The vast amount of battering and the presence of a boulder hammerstone suggest that the site may be associated with some processing activity. It is uncertain, however, what kind of processing took place here. It is possible that during the pre-Contact and/or early post-Contact periods, endemic plants used for fish poisoning grew in the vicinity, and this area served as a place for processing the fish poison plant by pounding it. This, however, would not appear to account for the linear chisel marks.

Figure C.65. Site 50-10-27-29114 area of battering (view east).

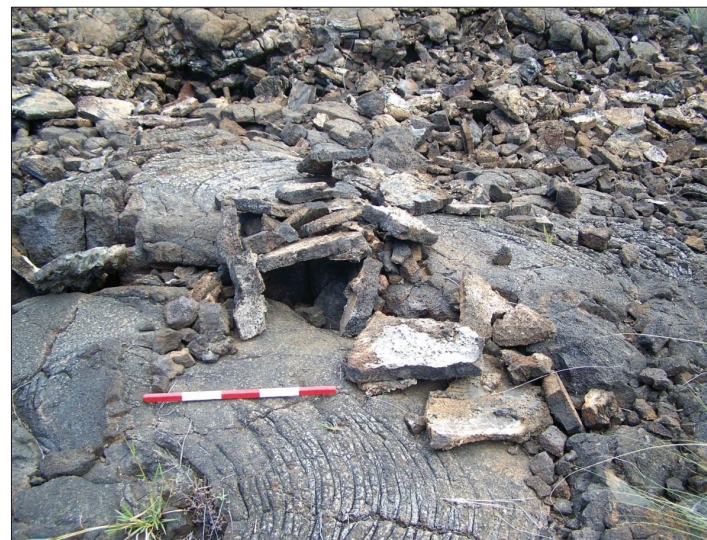
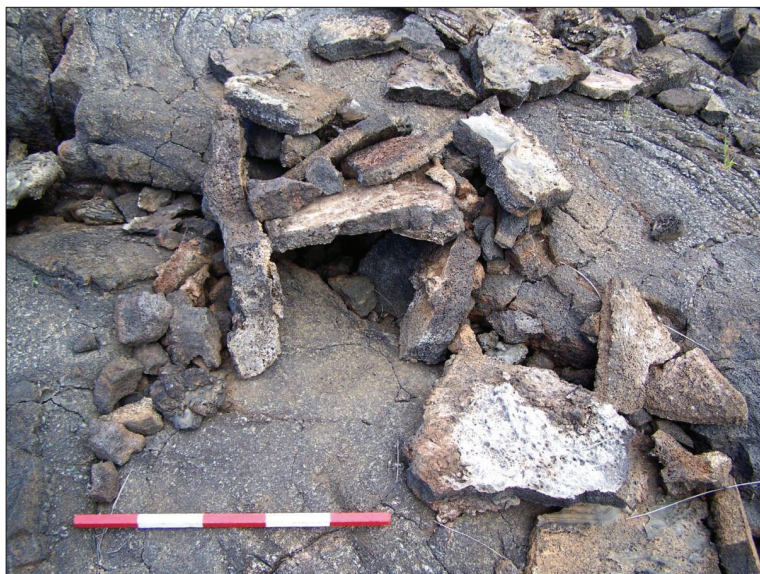
No cultural material was observed in or around the stone cist. Site 29115 is in fair condition. Some of the smaller cobble slabs that were stacked on top the cist appear to have tumbled. It is possible this stone cist may have served as a cupboard for storage that was built and utilized during the pre-Contact and/or early post-Contact periods.

Figure C.68. Site 50-10-27-29115 stone cist (view northwest).

Figure C.69. Site 50-10-27-29115 stone cist detail (view northwest).

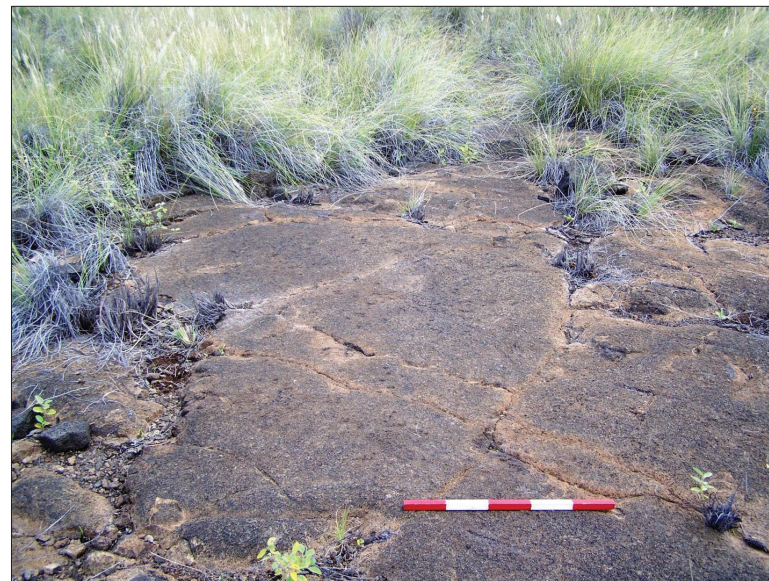
No cultural material was observed at the site. This site appears to be in fair condition, however, areas of the *pāhoehoe* lava exhibit scarring from bulldozer tracks.

Figure C.71. Site 50-10-27-29116 area of battering (view northeast).

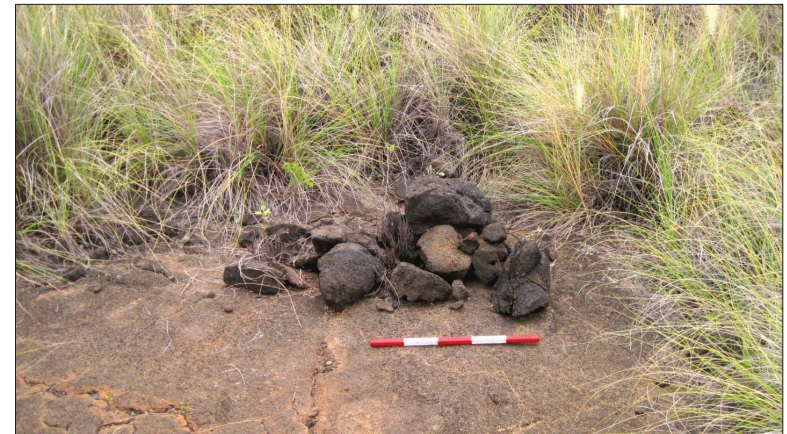
No cultural material was observed in or around the site. Site 29117 is in poor to fair condition. The mound is badly collapsed with tumbled in all directions.

Figure C.73. Site 50-10-27-29117 stone mound (view west).

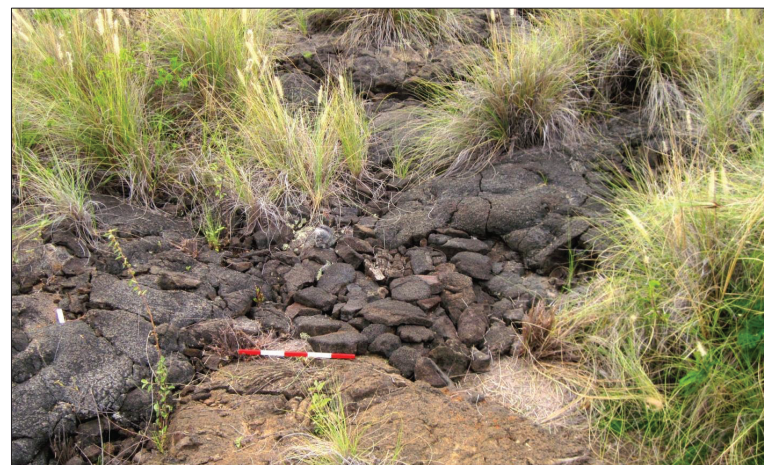
No cultural material was observed in or around the site. The site is in fair condition. There is evidence of modern disturbance. A piece of PVC pipe, some rubbish and dozer tracks are located south of the site. This disturbance may account for the presence of coral.

Figure C.75. Site 50-10-27-29118 stone-filled crevice (view southwest).

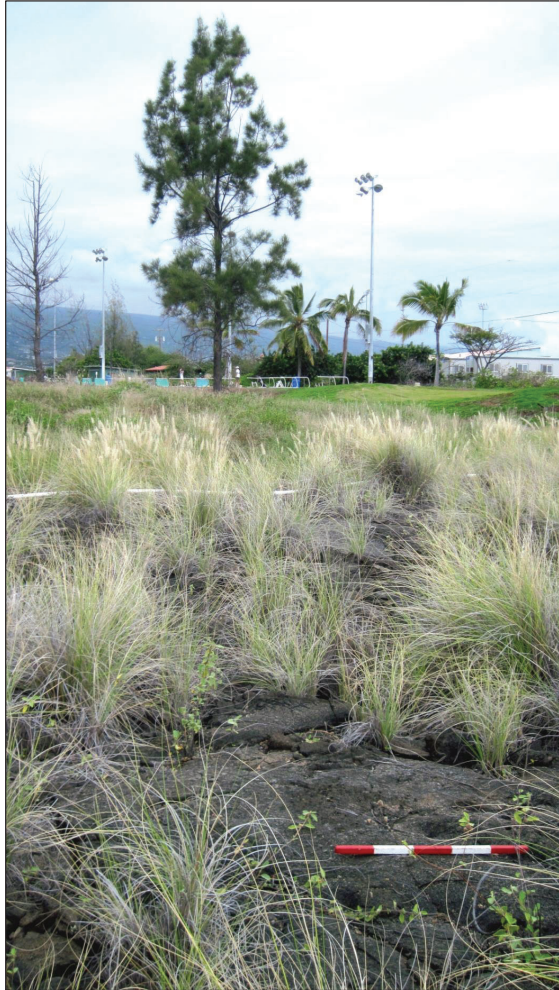
No cultural material was observed in or around the site. Site 29119 is in fair condition. Due to the presence of linear tool marks, Site 29119 was likely associated with a processing activity during the historic period. It is uncertain, however what kind of processing activity took place here.

Figure C.77. Site 50-10-27-29119 area of battering (view southeast).

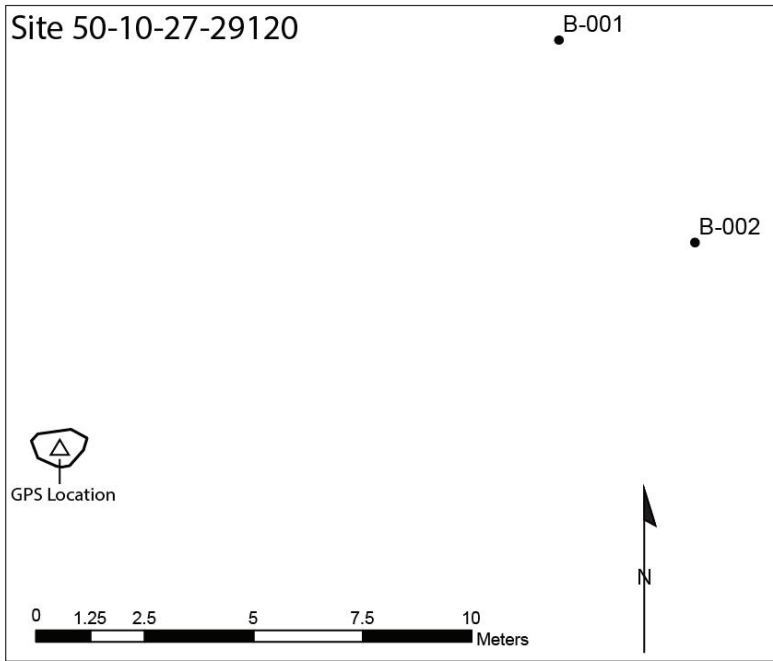
Figure C.78. GPS-based map of Site 50-10-27-29120 stone mound.

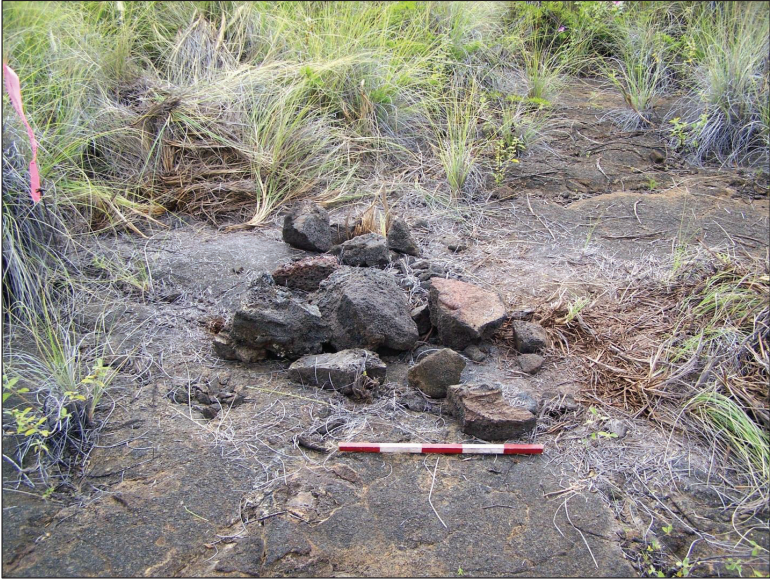
The stone mound is constructed of loosely piled large sub-angular basalt *pāhoehoe* cobbles and small sub-angular basalt *pāhoehoe* boulders on a level bedrock surface (Figure C.78, Figure C.79). Due to its poor condition, it is difficult to determine the original shape and size of the mound. It presently measures approximately 1.12 meters long (east to west) by ca. 0.90 meters (north to south) and ca. 0.25 meters in height.

No cultural material was observed in or around the site. Site 29120 is in poor condition. The mound appears to be collapsed and badly tumbled.

Figure C.79. Site 50-10-27-29120 stone mound.

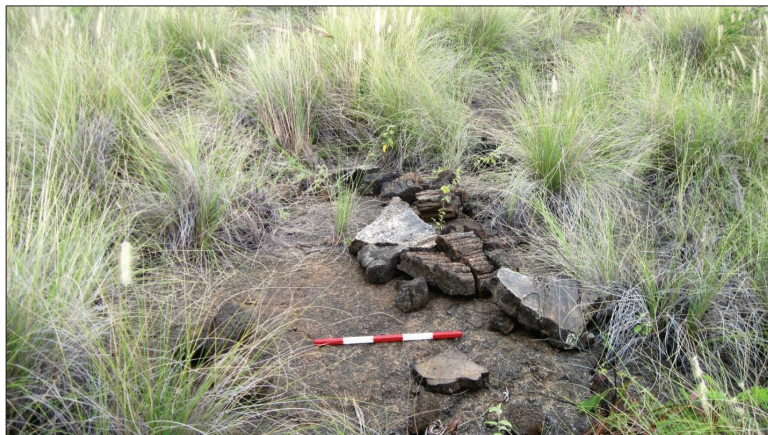
No cultural material was observed. Site 29121 is in poor condition and appears to have been badly disturbed. Due to its poor condition, it is difficult to determine the original shape of this structure. It is likely, however, that this linear alignment may have served as a temporary windbreak shelter during the pre-Contact and/or early post-Contact periods.

Figure C.81. Site 50-10-27-29121, stone alignment (view south).

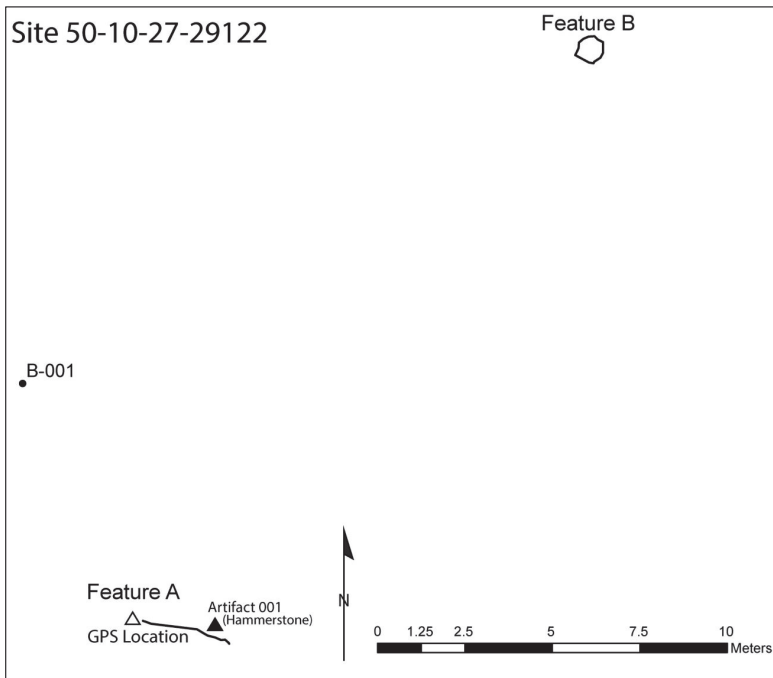
An area of battering, B-001, was located ca. 9.0 meters northwest (302°) of the Feature A wall segment. B-001 is irregular in shape and consists of heavy and dispersed battering marks made with a linear tool. The battered area measures ca. 0.60 meters in length (north to south) by ca. 0.30 meters in width (east to west). One small pebble of waterworn coral was observed in between Features A and B, just north of the naturally broken up areas of *pāhoehoe*. This coral pebble does not appear to be modified. A hammerstone (Artifact 001) was located at the northeast end of Feature A. It is a small, waterworn, fine-grained basalt boulder with battering at one end measuring ca. 25.0 centimeters in length by ca. 18.0 centimeters in width and ca. 17.0 centimeters in thickness. Site 29122 is in poor condition. The Feature A wall and the Feature B mound have collapsed and tumbled. The construction style and location of the features and presence of traditional artifacts/coral suggest that the site was built and utilized during the pre-Contact and/or early post-Contact periods. The linear marks found in B-001 suggest historic period battering. The wall segment may have served as a windbreak shelter, the mound may have functioned as a marker, and the battered area suggest that the site is associated with some kind of processing activity. It is uncertain, however, what kind of processing took place here.

Figure C.82. GPS-based map of Site 50-10-27-29122 complex.

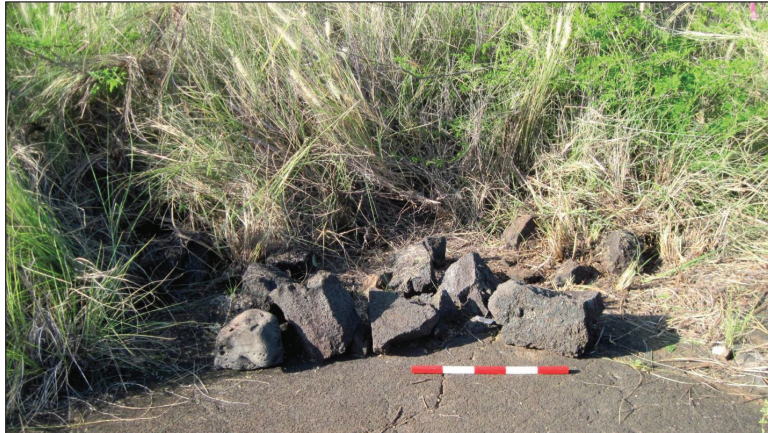
A hammerstone, Artifact 001 was located amongst the tumble of the northeastern end of the structure. Artifact 001 is a small, vesicular waterworn boulder that appears to have a small amount of battering at one end. It measures approximately 25.0 centimeters in length by ca. 18.0 centimeters in width and ca. 17.0 centimeters in thickness. No other cultural material was located in or around the feature. Feature A is in poor condition. The wall segment has tumbled in all directions and appears to be completely collapsed.

Due to its poor condition, it is difficult to determine its original function. Its location and size, however, suggest that the Site 29122 Feature A wall segment may have been utilized as a temporary windbreak shelter during the pre-Contact and/or early post-Contact periods.

Figure C.83. Site 50-10-27-29122, Feature A, wall segment (view south).

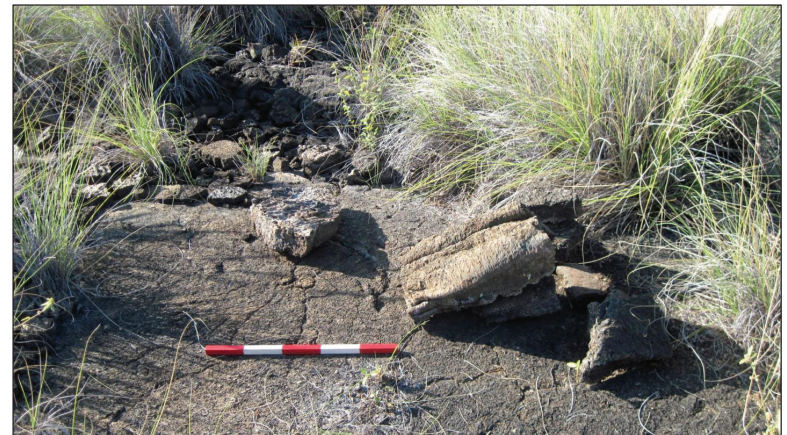
Description: Site 50-10-27-29122, Feature B is a collapsed stone mound (Figure C.84). It is approximately 21.0 meters northeast (33°) from the Feature A wall segment. The mound is irregular in shape and constructed of loosely stacked medium to large *pāhoehoe* basalt boulder and cobble slabs. It currently stands two to three courses high, and measures approximately 0.75 meters in length (northwest to southeast) by ca. 0.66 meters in width (northeast to southwest), and ca. 0.30 meters in height.

No cultural material was found in or around this feature. It is in poor condition and partially collapsed. Site 29122, Feature B may have possibly served as a marker during the pre-Contact and/or early post-Contact periods. It is not clear, however, what the mound was intended to mark.

Figure C.84. Site 50-10-27-29122, Feature B, stone mound (view southeast).

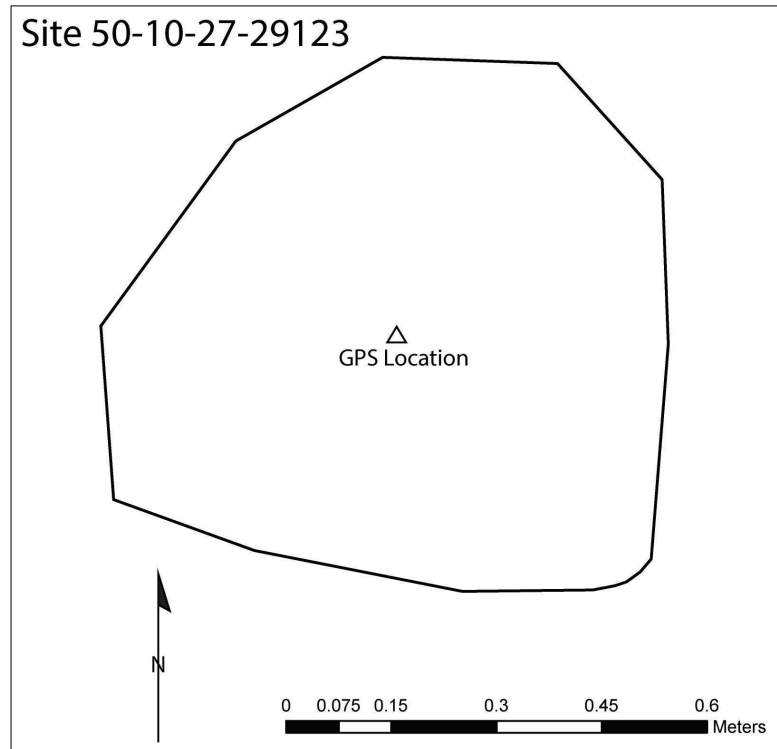
Figure C.85. GPS-based map of Site 50-10-27-29123 stone mound.
