**URBAN PHASE III
ARCHAEOLOGICAL
INVENTORY SURVEY
(VOL. III)**

ARCHAEOLOGICAL INVENTORY SURVEY
OF URBAN PHASE III PARCEL
LILI'UOKALANI TRUST LANDS
IN KEAHUOLŪ, NORTH KONA
ISLAND OF HAWAII
[TMK: (3) 7-4-008:002 (por.)]

VOLUME III:
APPENDICES
(Newly Documented Sites, Table of Lava
Excavations, Isolated Finds,
GPS Site Locations)

Prepared by:
Rowland B. Reeve, M.A.
Paul L. Cleghorn, Ph.D.
Tanya Lizama, M.A.
and
Reid Yamasato, B.A.

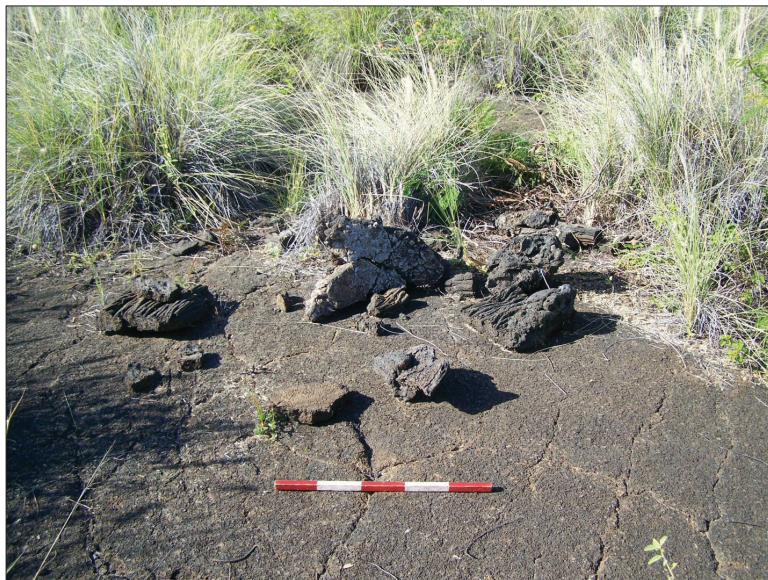
Located ca. 2.0 meters northeast of the mound, is a scatter of coconut shell fragments that appear to be relatively recent in age. No other cultural material was observed in or around the site. Site 29123 is in poor condition, being completely collapsed. Due to its poor condition, it is difficult to determine the mound's original function. It may, however, have served as a marker during the pre-Contact and/or early post-Contact periods.

Figure C.86. Site 50-10-27-29123 stone mound (view south).

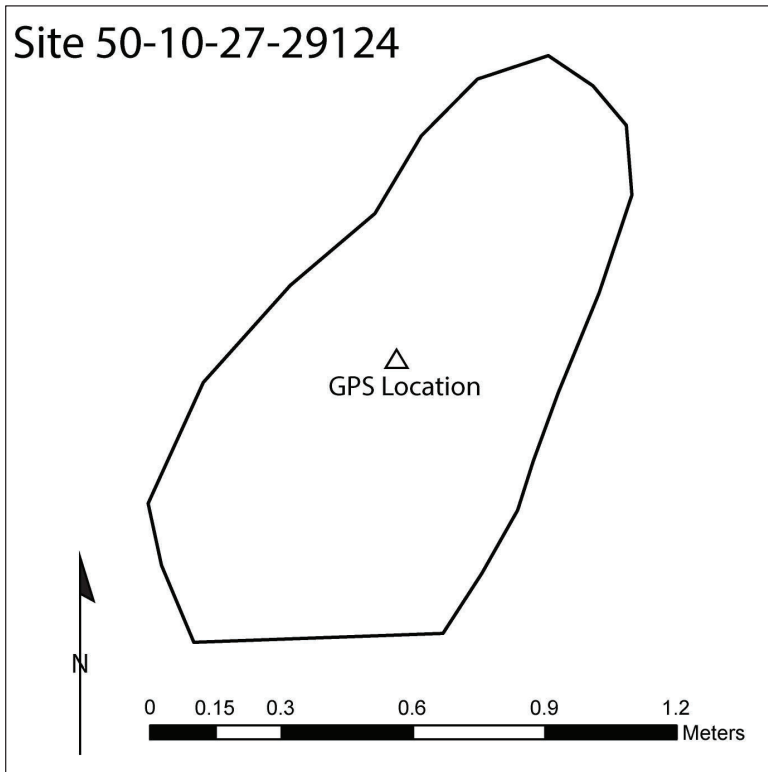
The mound is somewhat linear in shape (Figure C.87). It is constructed of small to medium sub-angular *pāhoehoe* boulders and slabs, which are loosely and neatly piled against each other. The structure measures approximately 1.60 meters in length (northeast to southwest) by ca. 0.81 meters (northwest to southeast) by ca. 0.39 meters in height.

Figure C.87. GPS-based map of Site 50-10-27-29124, stone mound.

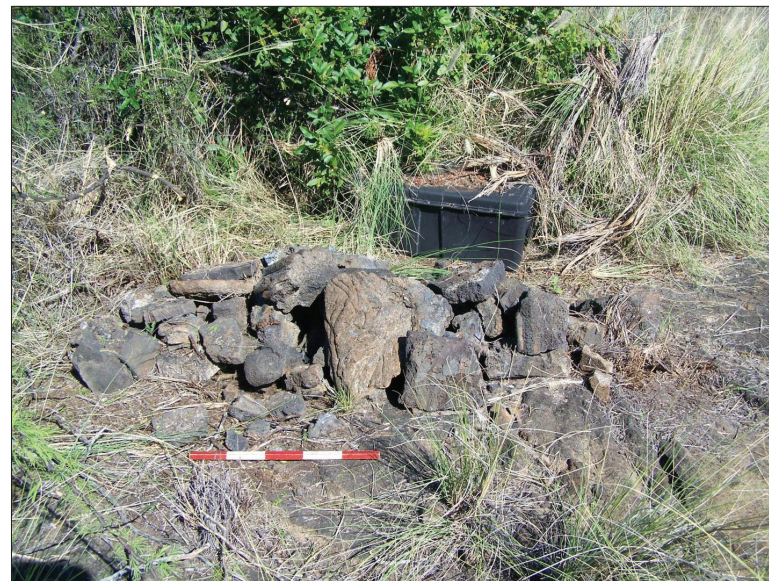
No traditional cultural material was observed in or around the site, though a modern plastic pest trap was observed next to and immediately northwest of the mound. Site 29124 is in fair condition. Some stones have tumbled along its northern and western edges, but the mound remains intact.

Due to its construction style and location, it is difficult to determine the possible age of this site. The mound appears too well-preserved to be a pre-Contact and/or early post-Contact structure. Its location near the historic fence line, as well as the presence of a plastic pest trap, may suggest it is modern in construction. The mound could possibly have served as marker, though this is also uncertain.

Figure C.88. Site 50-10-27-29124 stone mound (view northwest).

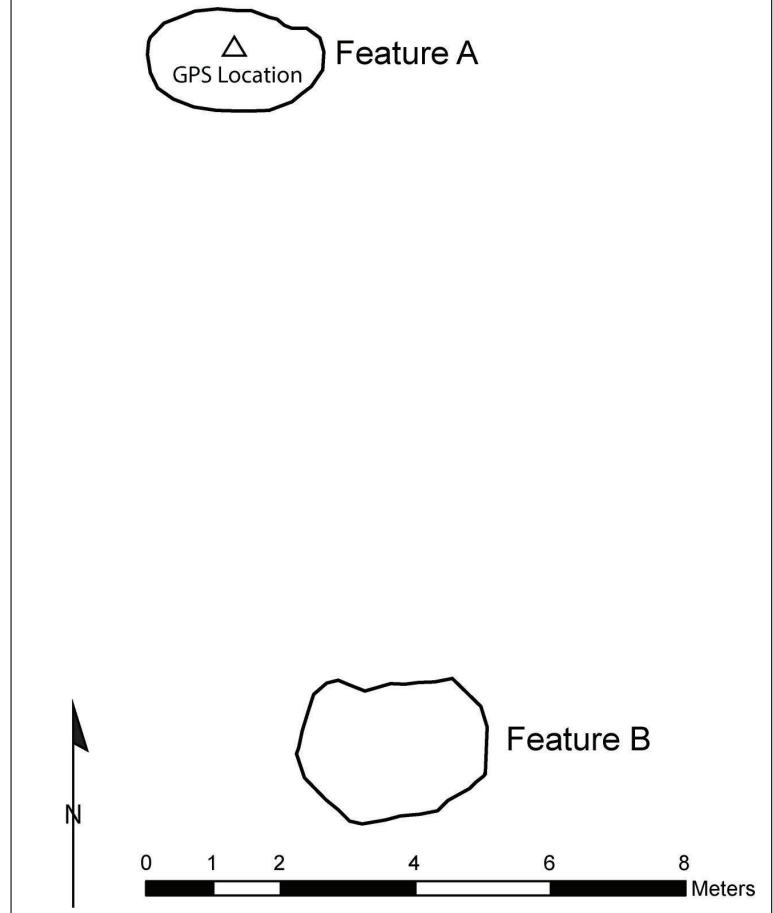
Site 50-10-27-29125

Feature B is a similar constructed mound, but smaller in size. It is situated ca. 10.0 meters south (150°) of Feature A (Figure C.89). Bulldozer tracks were observed adjacent to the feature.

Modern rubbish was also observed scattered around the site, including a large amount of glass and bottles and long strands of wires. Site 29125 is in good condition. The mounds are not necessarily tumbled but are jumbled in their construction.

Figure C.89. GPS-based map of Site 50-10-27-29185 complex.

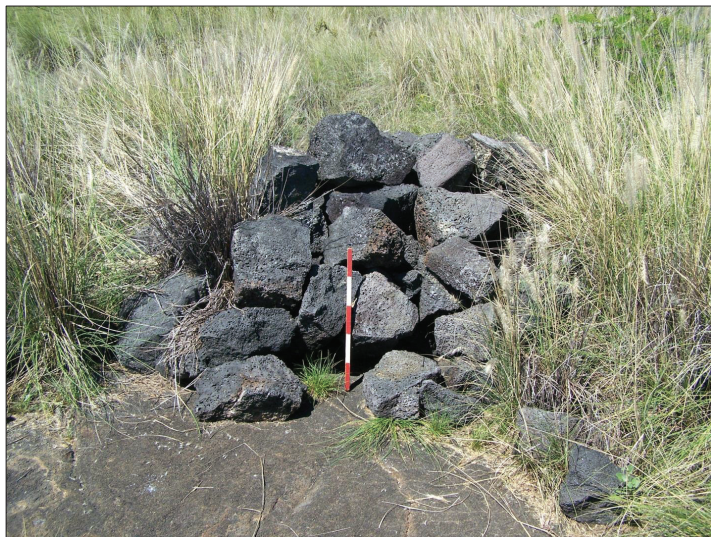
Description: Site 50-10-27-29125, Feature B is a modern mound (Figure C.91). It is located at the southern end of the site and approximately 10.0 meters south (166°) of the Feature A stone mound. The Feature B mound is loosely piled of large sub-angular basalt *pāhoehoe* boulders on level *pāhoehoe*. These stones appear to have come from an area outside of the complex of features. It measures ca. 3.1 meters in length (east to west) by ca. 2.5 meters in width (north to south) and ca. 0.85 meters in height.

No cultural material is present at this feature. This mound is in good condition. Feature B is in close proximity to a nearby jeep road and the lava surface surround the mound exhibits bulldozer tracks. This mound is more characteristic of a modern construction, perhaps the result of bulldozer push.

Figure C.91. Site 50-10-27-29125, Feature B, stone mound (view southwest).

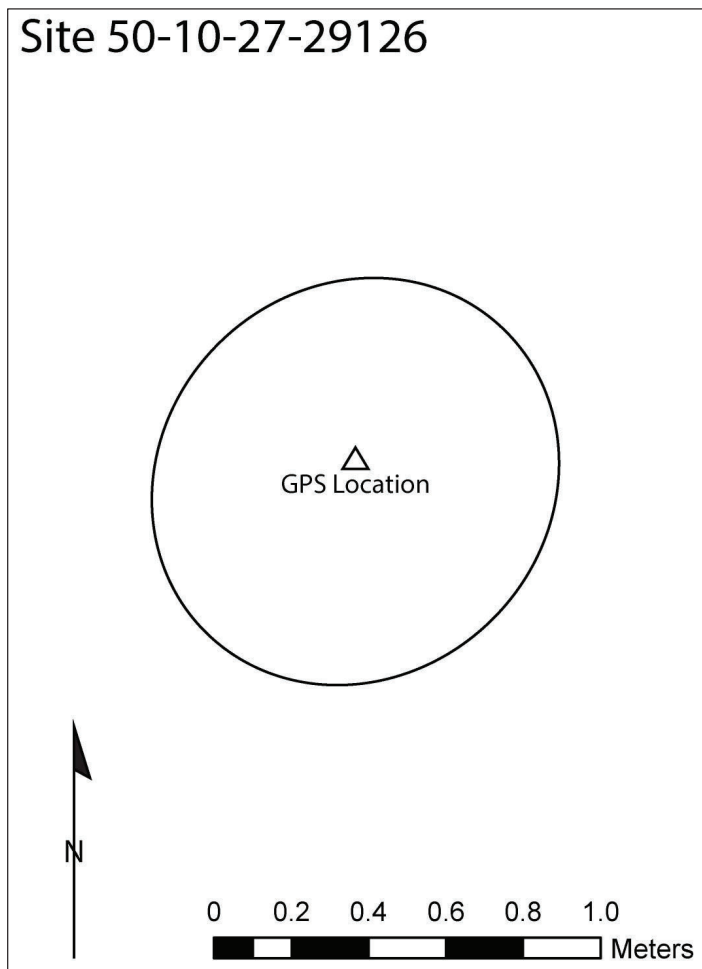
No cultural material was observed in or around the site. Site 29126 is in fair condition. The circular tool marks observed suggest that this site may have been associated with a processing activity undertaken during the pre-Contact and/or early post-Contact periods, though it is uncertain, however, what kind of processing activity took place here.

Figure C.92. GPS-based map of Site 50-10-27-29126 battering.

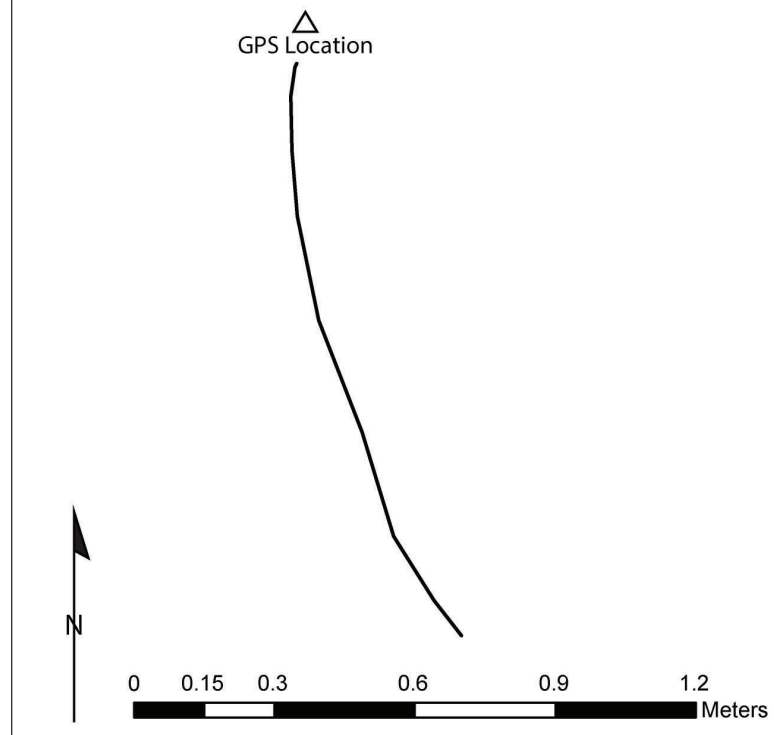
Figure C.93. GPS-based map of Site 50-10-27-29127 alignment.

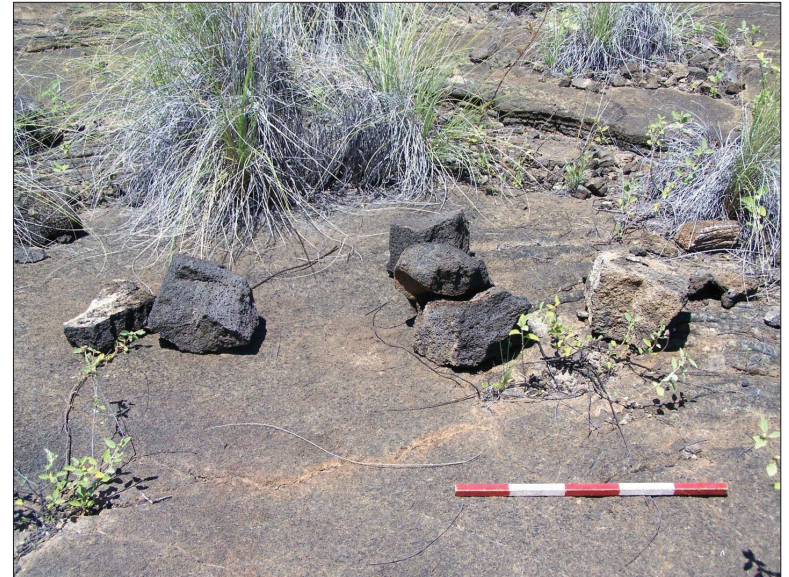
No cultural material was observed at this site. Site 29127 is in poor condition and appears to have been badly disturbed. Due to its poor condition, it is difficult to determine the alignment's original shape and function. It is likely, however, that it may have served as a temporary windbreak shelter, or as the anchor stones for a mat or other perishable shelter, utilized during the pre-Contact and/or early post-Contact periods.

Figure C.94. Site 50-10-27-29127 alignment (view west).

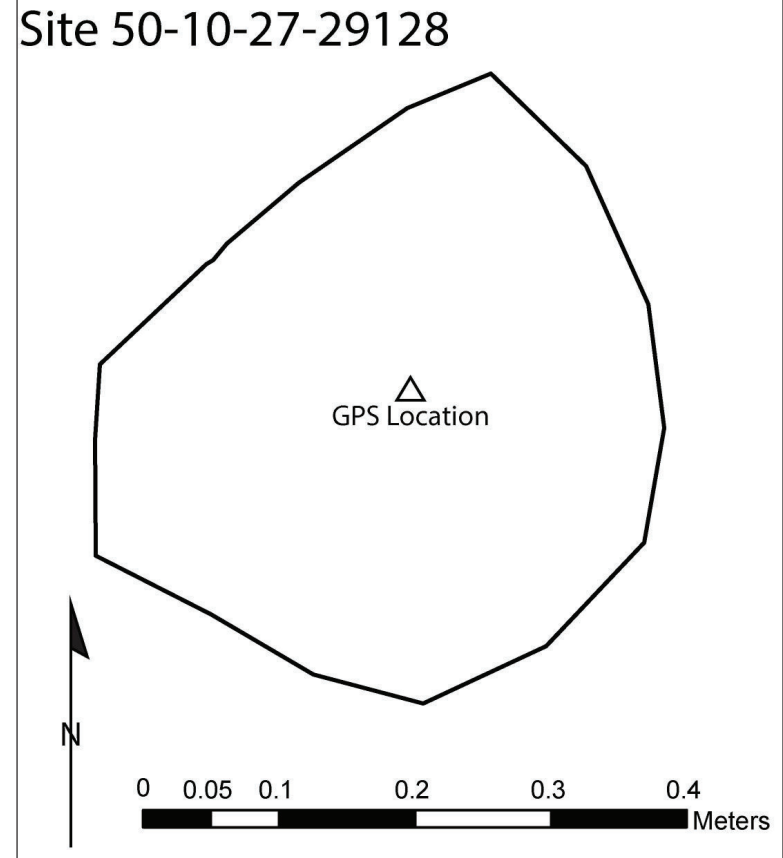
Description: Site 50-10-27-29128 consists of a single stone mound (Figure C.95 and Figure C.96). It is located in the southern central portion of the project area, approximately 19.0 meters west (249°) of Site 29127. The mound is situated on roughly level undulating *pāhoehoe* lava. The surrounding vegetation consists of a ground cover of fountain grass and a klu shrub.

Figure C.95. GPS-based map of Site 50-10-27-29128 stone mound.

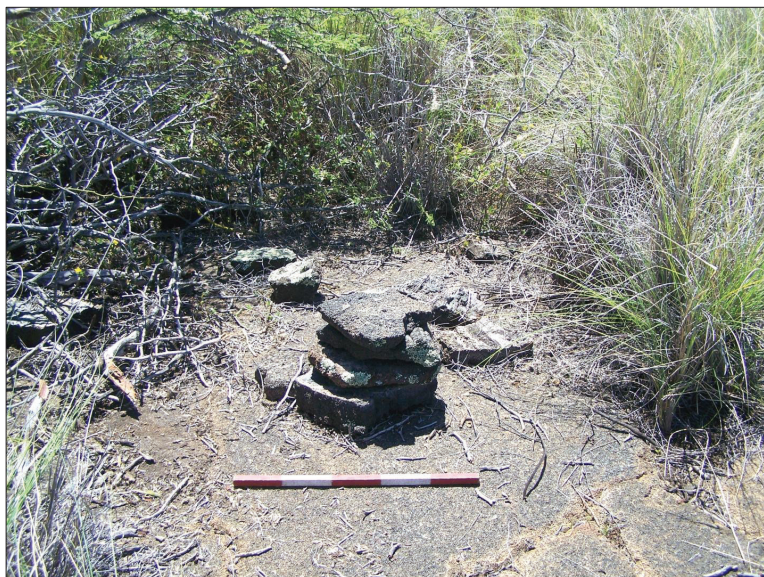
The mound consists of four small *pāhoehoe* boulder slabs that have been stacked atop each other to form a column. It measures ca. 0.28 meters in length (northwest to southeast) by ca. 0.23 meters in width (northeast to southwest), and ca. 0.25 meters in height. No cultural material was observed at the site. The mound is in fair condition. Four small boulder slabs appear to have tumbled to the southeast of the mound, which suggests that the mound may have originally been a taller column. The somewhat unstable construction style of the Site 29128 mound suggests that it may have been constructed during the more recent period. It likely served as a marker, though it is not clear what the mound was intended to mark.

Figure C.96. Site 50-10-27-29128, stone mound (view south).

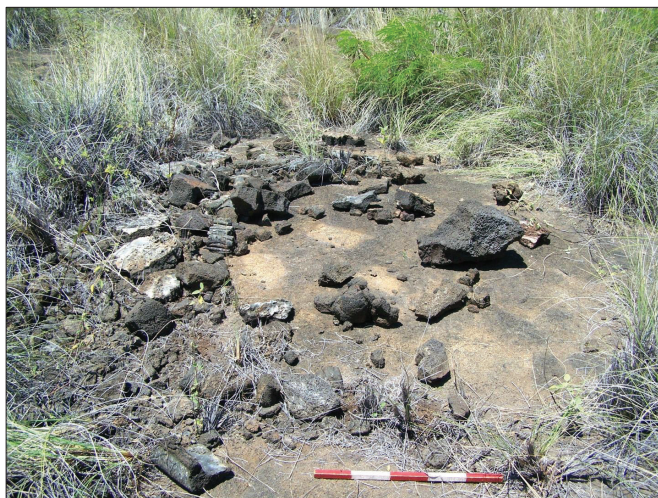
No cultural material was observed in or around the site. Site 29129 is in poor condition. The enclosure wall is collapsed, and stones have tumbled in all directions. The construction style of this site suggests that it may have been built and utilized during the pre-Contact and/or early post-Contact periods. The enclosure could have served as a temporary windbreak shelter, and the battered area suggest that the site may be associated with a processing activity. It is uncertain, however, what kind of processing activity took place here.

Figure C.97. Site 50-10-27-29129, enclosure (view west).

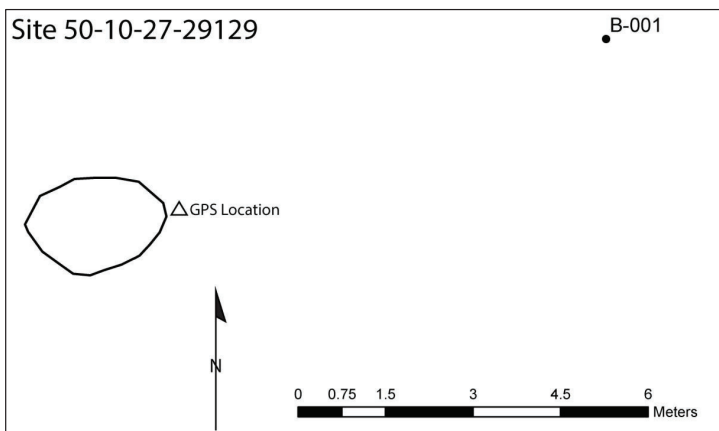
An area of battering, B-001, was located approximately 10.0 meters east (70°) of the enclosure (Figure C.98). B-001 consists of an irregular-shaped area of heavy, concentrated battering marks made with a circular tool. The battered area measures ca. 0.96 meters long (east to west) by 0.42 meters wide (north to south).

Figure C.98. GPS-based map of Site 50-10-27-29129 enclosure and area of battering.

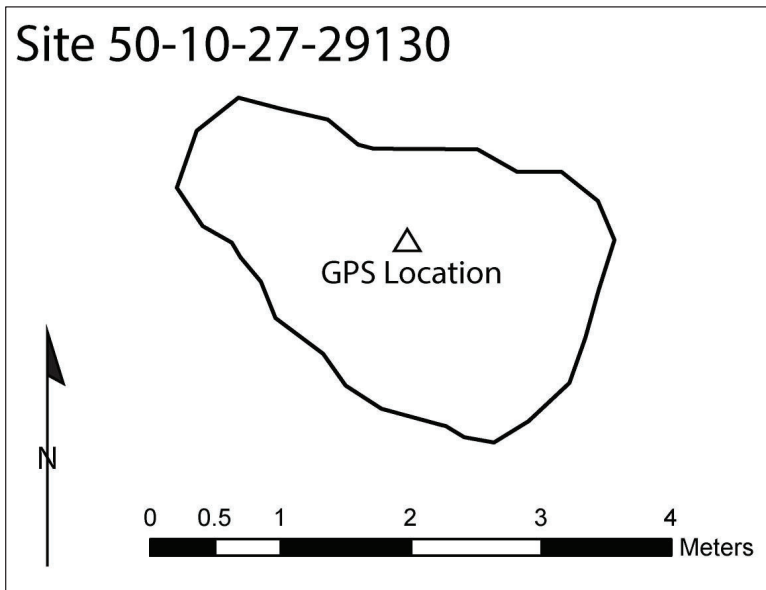
The mound consists of a jumbled pile of small to large sub-angular boulders. The boulders appear to be brought in from another location, as the material used in the mound is not found in the area surrounding the site. The mound measures ca. 3.2 meters in length (east to west) by ca. 2.6 meters in width (north to south) (Figure C.99), its maximum height is ca. 0.7 meters.

Figure C.99. GPS-based map of Site 50-10-27-29130 stone mound.

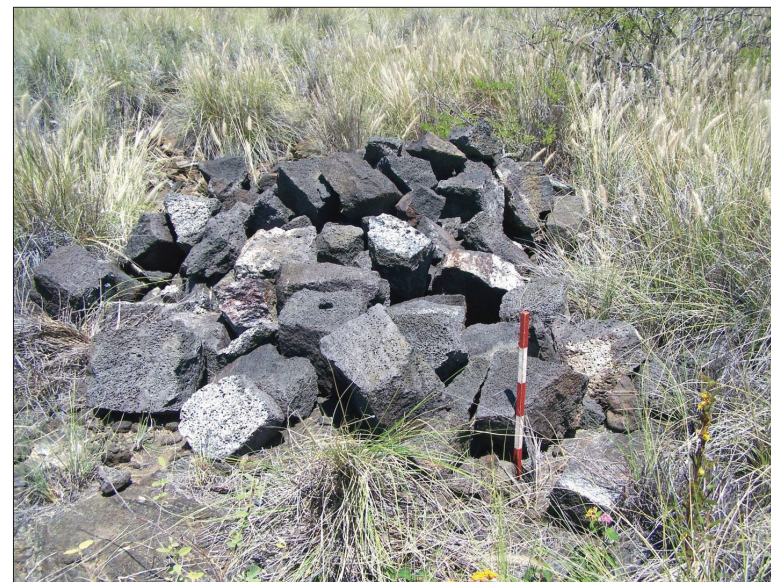
Located at the southeastern end of the mound is a medium sized sub-angular boulder that has a core sample drilled through it. This also suggests that the boulders were brought in from a different location. Many bulldozer tracks were located immediately east of the mound, which further suggests that the rock material may have been brought in from a bulldozer.

No cultural material was observed in or around the site. The mound is in fair condition and has not suffered that much tumble. The presence of bulldozer tracks and the mound's proximity to the road, as well as its jumbled appearance, suggest that the Site 29130 mound may have been created in modern times. It likely served as some sort of marker, though this is uncertain.

Figure C.100. Site 50-10-27-29130 stone mound (view northwest).

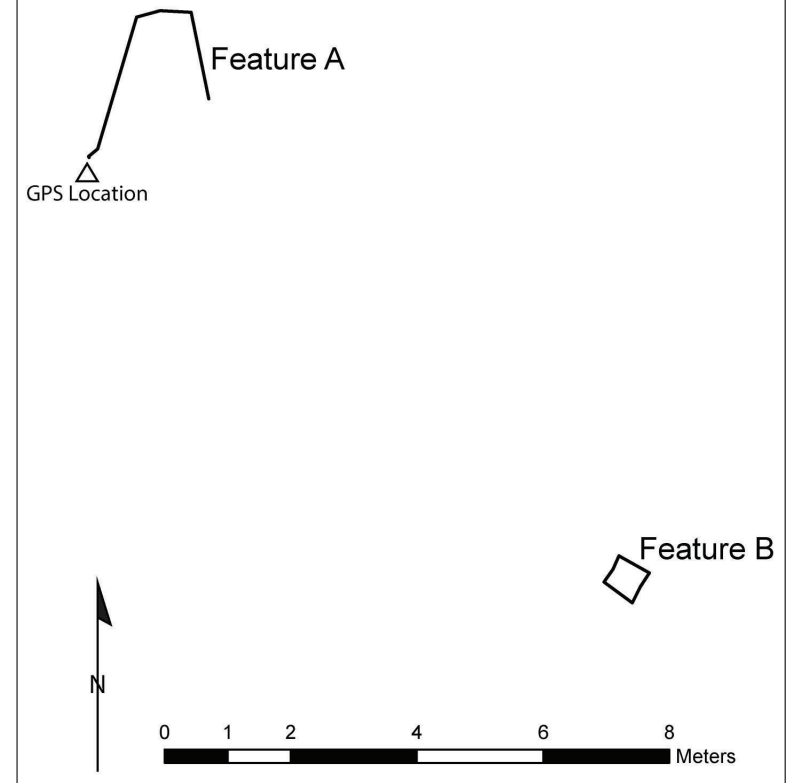
The site is in poor condition; both features are badly tumbled and collapsed, possibly due to seismic activity. No cultural material was observed in or around the site. It is difficult to determine the site's original function due to its collapsed state. Feature A's construction suggests that it may have functioned as a C-shaped windbreak, while Feature B may have functioned as a marker. The site appears to have been constructed during the pre-Contact and/or early post-Contact periods.

Figure C.101. GPS-based map of Site 50-10-27-29131 complex.

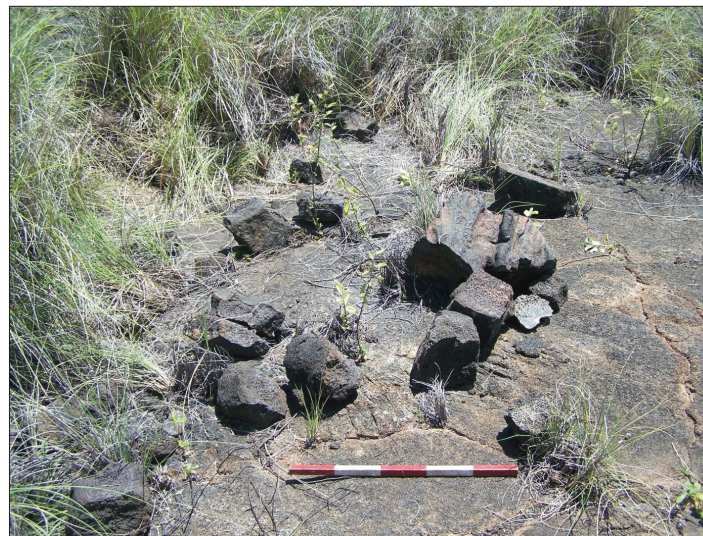
No cultural material was observed in or around the feature. Feature A is in poor condition. This C-shaped wall is collapsed, and some stones have tumbled downslope to the southeast and east. No cultural material was observed in or around the feature. In its present condition, it appears that Feature A was a C-shaped wall, possibly constructed during the pre-Contact and/or early post-Contact periods, which could have served as windbreak shelter. The ground surface within the C-shape, however, is rough and sloping, making it an uncomfortable area for a shelter.

Figure C.102. Site 50-10-27-29131, Feature A, C-shape wall (view south).

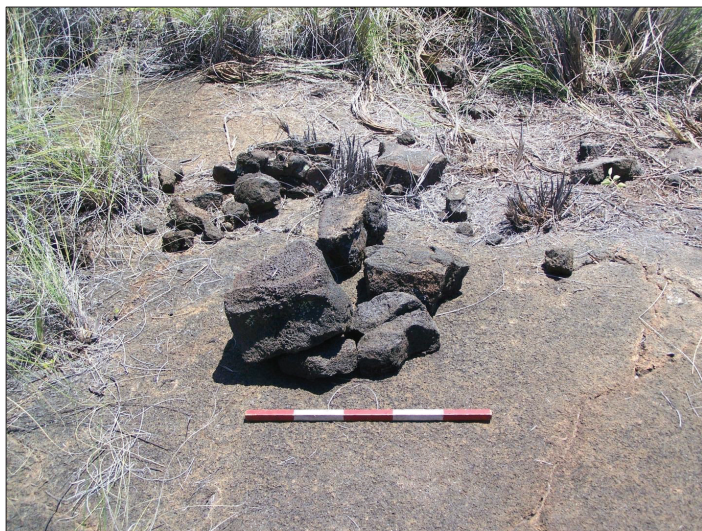
Description: Site 50-10-27-29131, Feature B is a possible collapsed mound (Figure C.103). It is located on the southeastern end of the site, approximately 9.0 meters southeast (144°) of the Feature A collapsed C-shape wall.

Feature B is comprised of medium to large basalt boulders and one large basalt cobble, with some boulders scattered to the south. The mound is irregular in shape, and measures roughly ca. 0.7 meters in length (north to south) by ca. 0.45 meters in width (east to west) and is ca. 0.24 meters in height. No cultural material was found at this feature. Feature B is in poor condition and has been badly tumbled. Due to its poor condition and scattered state, it is difficult to determine the mound's original function. It is likely, however, that it may have served as a marker constructed and utilized during the pre-Contact and/or early post-Contact periods.

Figure C.103. Site 50-10-27-29131, Feature B, stone mound (view south).

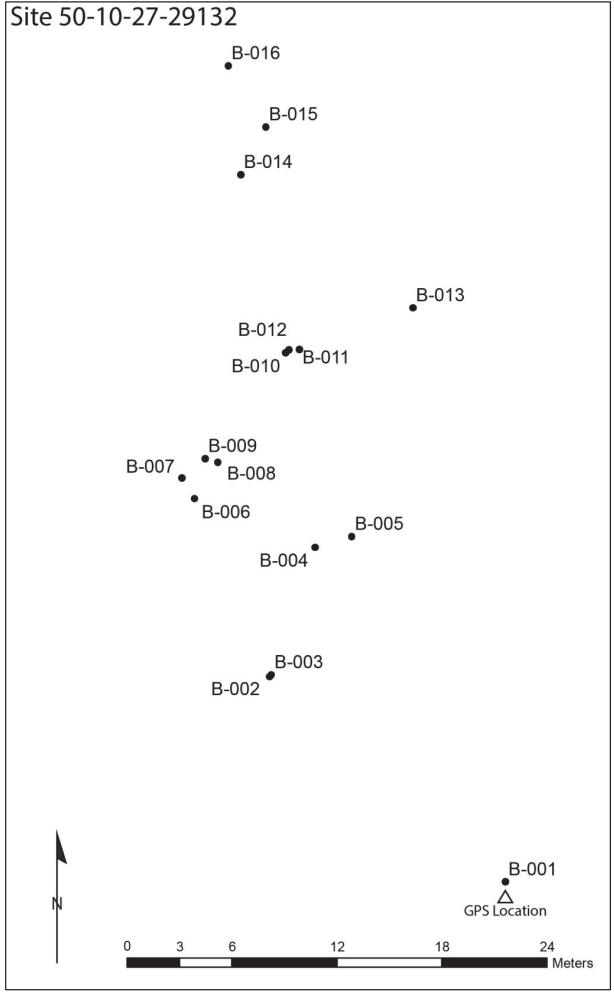
No cultural material was observed in or around the site area. Small basalt boulders of varying densities and grains are spread throughout the site area and may have been used as hammerstones, but no obvious battering was observed on these stones. This site is in poor to fair condition. A modern homeless camp is located in the southwestern portion of the site with modern trash spreading from the camp to the rest of the site area. It is possible that the homeless camp is situated on and obscuring more areas of battering.

Figure C.104. GPS-based map of Site 50-10-27-29132 battering.

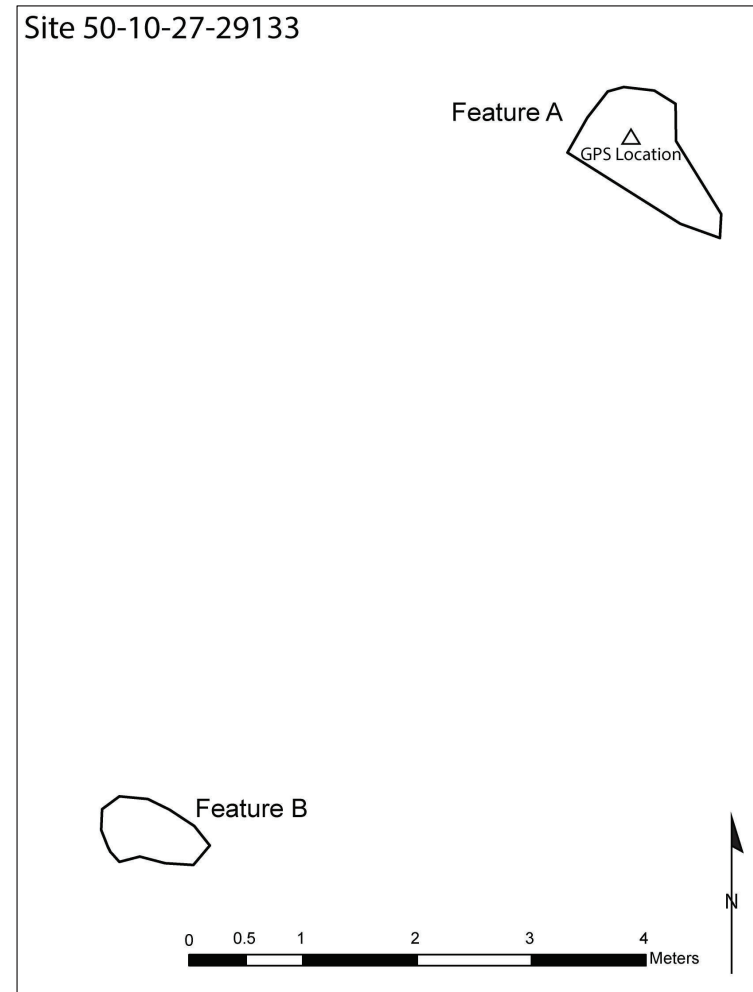
The site runs roughly northwest to southeast and measures a total length of ca. 8.6 meters (Figure C.105). Feature A and B are both collapsed and appear to be constructed of loosely piled small to medium sub-angular basalt boulders, as well as some small *pāhoehoe* boulder slabs and cobbles. Feature A is located at the northern portion of the site and measures ca. 1.0 meters in length (east to west), ca. 0.92 meters in width (north to south), and ca. 0.3 meters in height. Feature B is located approximately 6.8 meters south (212°) of Feature A. This mound measures ca. 1.30 meters in length (east to west), by ca. 0.60 meters in width (north to south) by ca. 0.28 meters in height.

No cultural material was observed in or around the site. Site 29133 is in poor condition. Due to its disturbed condition, it is difficult to determine either mound's original shape or exact function. It is likely, however, that the mounds served as markers, possibly constructed during the pre-Contact and/or early post-Contact periods.

Figure C.105. GPS-based map of Site 50-10-27-29133 complex.

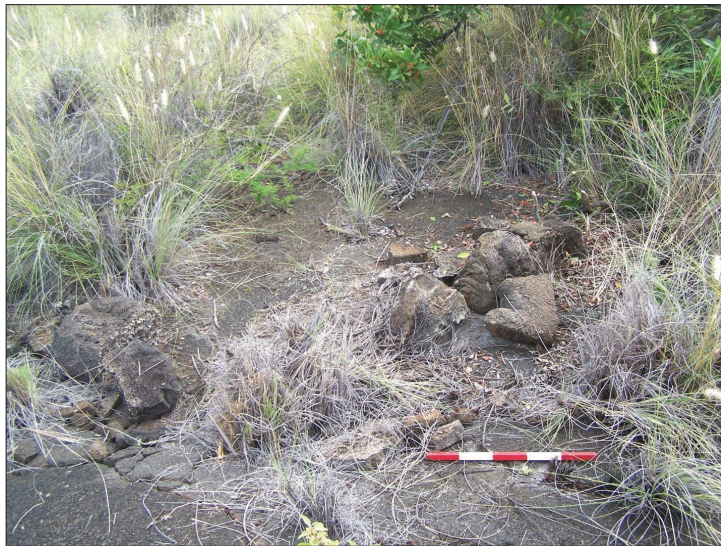
Description: Site 50-10-27-29133, Feature A is a possibly collapsed mound (Figure C.106). It is located approximately 8.6 meters to the northeast (32°) of the Feature B stone mound. Feature A is constructed of medium to large sub-angular *pāhoehoe* basalt boulders and few *pāhoehoe* cobble slabs. It measures approximately 1.0 meter in length (east to west), ca. 0.92 meters in width (north to south), and ca. 0.3 meters in height.

No cultural material was observed in or around this feature. It is in poor condition with a few boulders and cobbles tumbled to the side. The Feature A mound may have served as a marker constructed during the pre-Contact and/or early post-Contact periods. It is not clear, however, what the mound was intended to mark.

Figure C.106. Site 50-10-27-29133, Feature A, stone mound (view northeast).

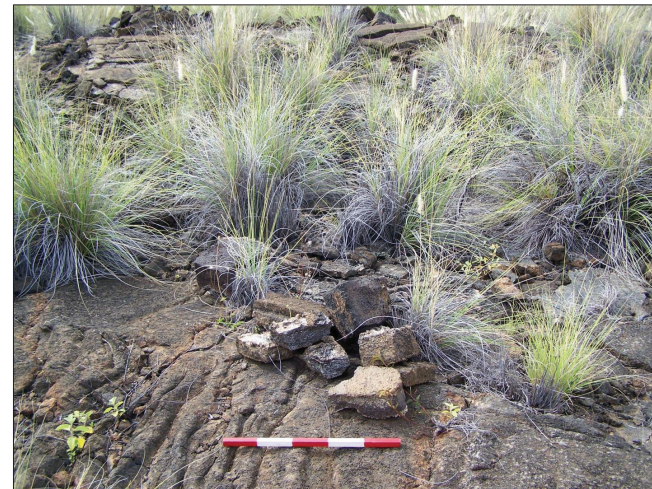
Description: Site 50-10-27-29133, Feature B consists of a collapsed stone mound (Figure C.107). This feature is located in the western portion of the site, approximately 8.6 meters southwest (212°) of the Feature A stone mound. The stone mound is constructed of large sub-angular basalt *pāhoehoe* cobbles and small sub-angular basalt *pāhoehoe* boulder slabs that have been loosely piled on to a relatively flat *pāhoehoe* surface. Due to its poor condition, the original shape of the mound could not be determined. In its present condition, the mound measures approximately 1.30 meters in length (east to west), by ca. 0.60 meters in width (north to south) by ca. 0.28 meters in height.

No cultural material was observed in or around the mound. Feature B is in poor condition, as it is collapsed with tumble to the east and west. It is likely that the Feature B mound served as a marker, possibly constructed during the pre-Contact and/or early post-Contact periods. It is unclear, however, what the mound was intended to mark.

Figure C.107. Site 50-10-27-29133, Feature B, stone mound (view south).

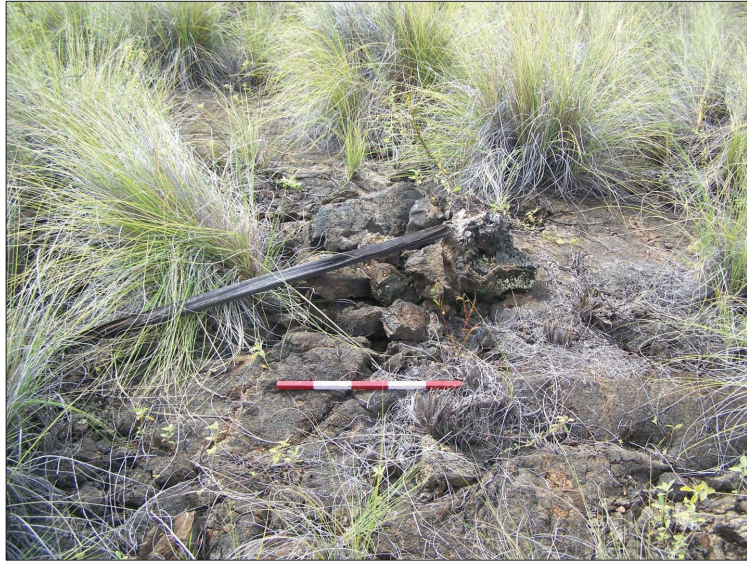
The mound is roughly circular in shape and is constructed of loosely piled small to medium sub-angular *pāhoehoe* boulders (Figure C.108). A small area of lava in the center of the mound is exposed where an iron nail has been hammered in the bedrock. A tall wooden stake that appears to have originally been set vertically within the mound has fallen and now rests partially atop the northwest side of the mound. The mound measures approximately 1.00 meters in length (northwest to southeast) by 0.90 in width (northeast to southwest), and ca. 0.23 meters in height.

No cultural material was observed. This site is in fair condition. Although the stake has collapsed and the nail has rusted, the mound itself remains fairly intact. Bulldozer tracks are noted east of the northeastern portion of the site. The construction style of the Site 29134 mound, the presence of the wooden stake, and the iron nail all indicate that it was built and utilized during the modern period. The site likely functioned as a survey marker.

Figure C.109. Site 50-10-27-29134, stone mound (view southwest).

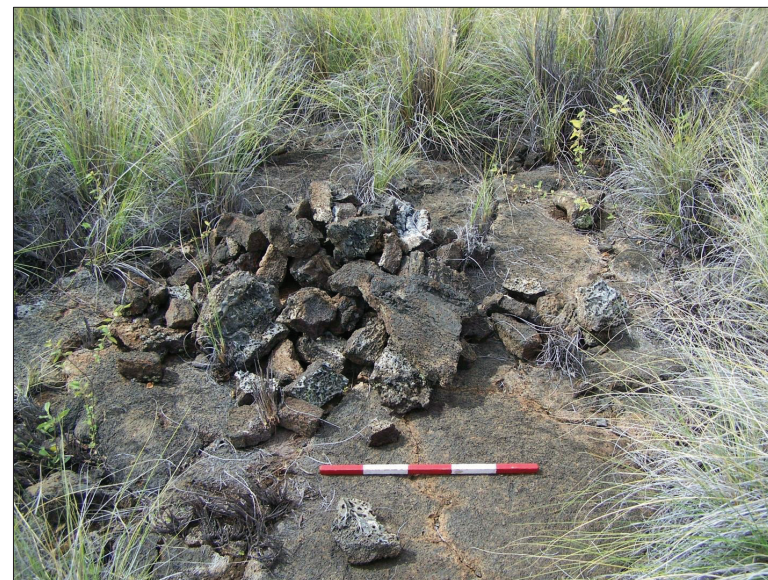
Description: Site 50-10-27-29135 is a stone mound (Figure C.111). This site is located near the central portion of the project area approximately 34.0 meters northeast (46°) of Site 29134. It is situated on slightly undulating broken up *pāhoehoe* lava. The surrounding vegetation consists of dense patches of fountain grass and scattered klu, Christmasberry, and *koa haole* trees.

A modern wooden fence post with an attached metal strip was found roughly 6.3 meters north of the site. Also, a small waterworn pebble was found less than 1.0 meter from the northeast end of the mound. The structure is in fair condition, with some stones scattered to the north.

Figure C.111. Site 50-10-27-29135, stone mound (view southeast).

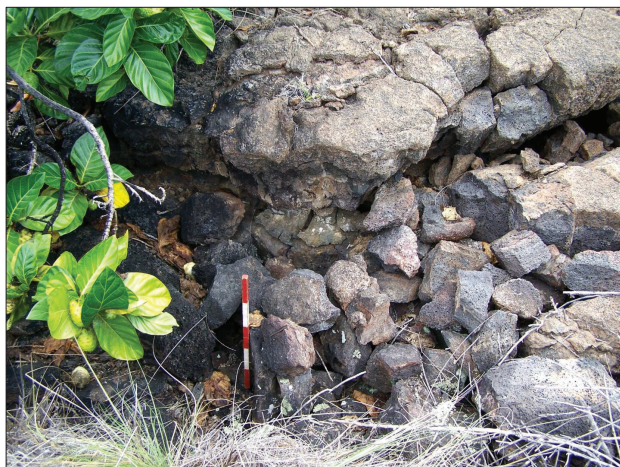
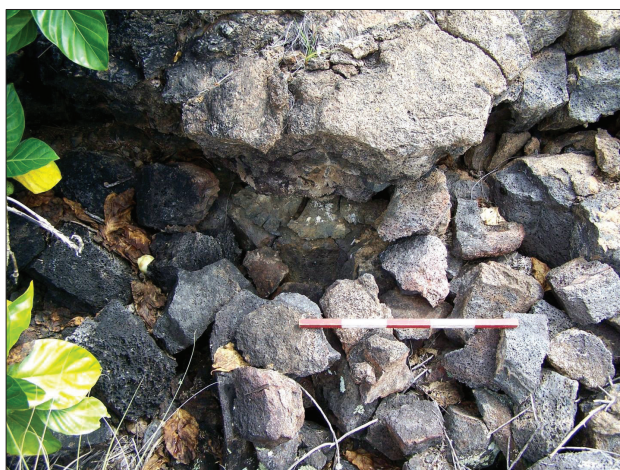
The site is constructed primarily of large sub-angular basalt boulders, and a few small sub-angular basalt cobbles that have been loosely piled to form the east, south, and west edges of a roughly circular depression that abuts a natural *pāhoehoe* bedrock outcrop/ridge to the north. This outcrop forms the northern edge of the depression. The narrow interior of the depression is floored with uneven bedrock and few small sub-angular basalt cobbles. No soil is present. The depression measures approximately 0.33 meters in length (north to south) by ca. 0.32 meters (east to west) and is ca. 0.64 meters deep (Figure C.113, Figure C.114, Figure C.115).

No cultural material was observed in or around the site. This site appears to be in fair condition with a small presence of tumble to the south. The construction style of this site suggests it may have been built and utilized during the pre-Contact and/or early post-Contact periods, though its function is uncertain.

Figure C.114. Site 50-10-27-29137, stone-edged depression (view north).

Figure C.115. Site 50-10-27-29137 stone-edged depression, close-up (view north).

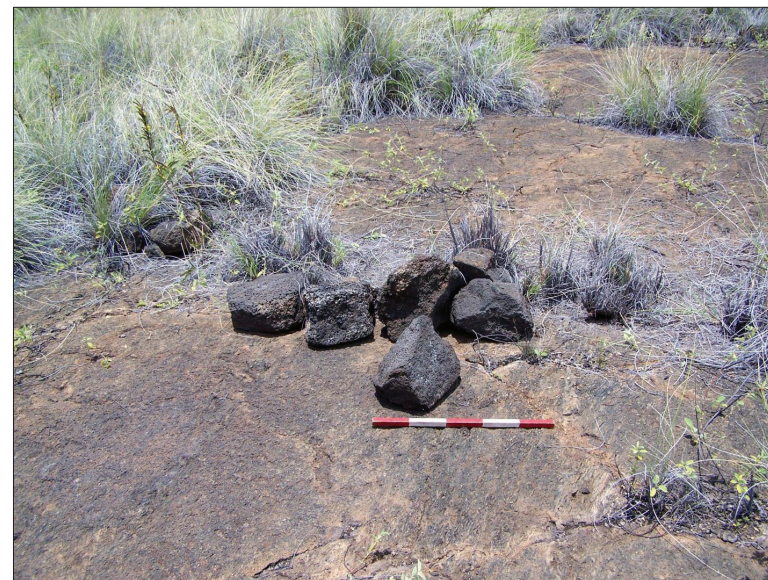
One piece of cowry shell was found ca. 3.84 meters north (340°) from the mound. The mound is in poor condition, and fully collapsed. This collapsed mound may possibly have served as a marker during the pre-Contact and/or early post-Contact periods.

Figure C.117. Site 50-10-27-29138, badly collapsed stone mound (view north).

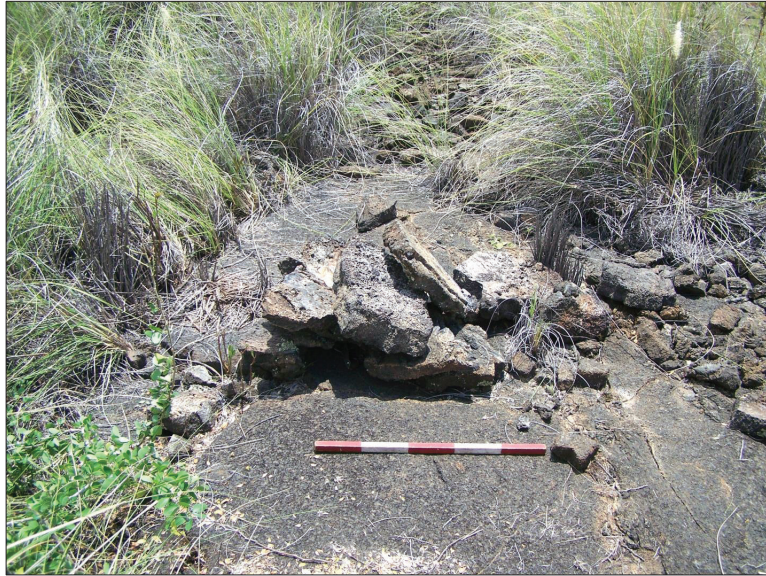
Description: Site 50-10-27-29139 consists of a single stone mound (Figure C.118, Figure C.119). This site is located in the central portion of the project area, approximately 61.0 meters west (281°) of Site 29138. The mound is situated on an area of level *pāhoehoe* lava, surrounded by a ground cover of fountain grass with *kū* shrubs. The mound is constructed of small sub-angular *pāhoehoe* boulder slabs, which have been loosely piled atop bedrock and have tumbled to the northwest. Due to its poor condition, it is difficult to determine the mound's original shape. It currently measures ca. 1.00 meters in length (northwest to southeast) by ca. 0.57 meters in width (northeast to southwest), and ca. 0.33 meters in height. A dispersed rock scatter of *pāhoehoe* slabs are located roughly 10.0 meters northwest (312°) of the site. It appears too dispersed to determine any age, function, or dimension.

No cultural material was observed in or around the site. The site is in poor condition, as stones have tumbled from the mound. Modern wire fencing and wood scraps are located just to the east of the site, suggesting a possible modern homeless habitation. The construction style of the mound suggests that Site 29139 may have served as a marker during the pre-Contact and/or early post-Contact periods. It is not clear, however, what the mound was intended to mark.

Figure C.119. Site 50-10-27-29139 stone mound (view southwest).

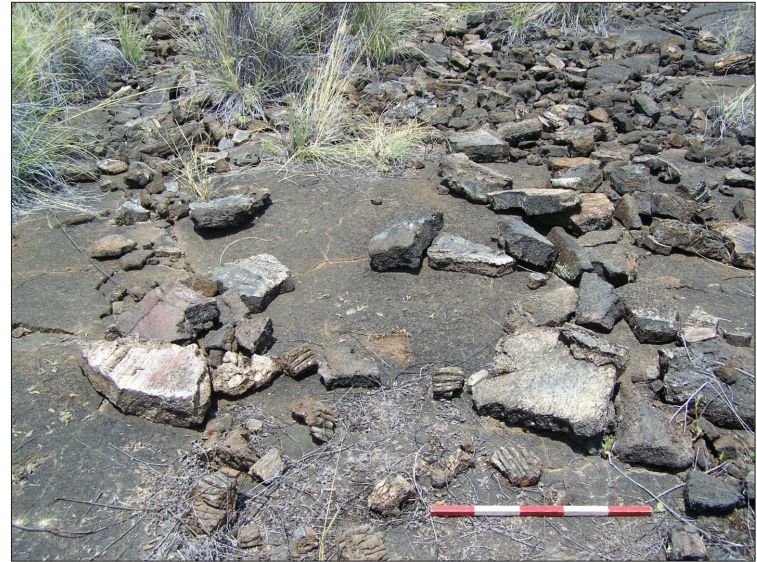
Description: Site 50-10-27-29140 is a badly disturbed C-shaped wall (Figure C.120, Figure C.121). The site is located in the central portion of the project area, approximately 30.0 meters west (267°) of Site 29139. The surrounding terrain consists of roughly level *pāhoehoe* lava and areas of naturally broken up *pāhoehoe*. The vegetation is comprised of a ground cover of fountain grass with a scatter of Christmasberry shrubs.

No cultural material was observed in or around this site. Site 29140 is in poor condition. The structure is heavily impacted, possibly as a result of seismic activity. It presently appears to be collapsed and scattered. Site 29140 may possibly have served as a temporary windbreak shelter, built and used during the pre-Contact and/or early post-Contact periods. Several of its slab wall stones were likely originally set on edge.

Figure C.121. Site 50-10-27-29140, badly collapsed C-shaped wall (view east).

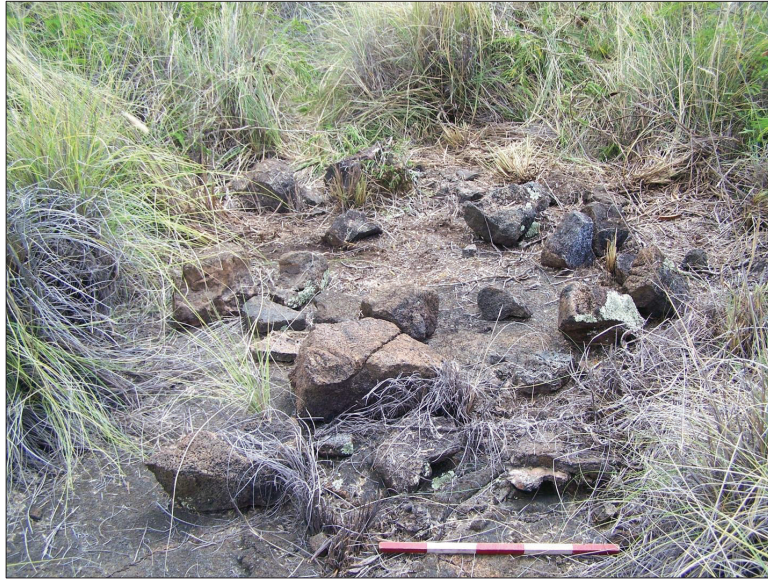
The site appears to be constructed of small sub-angular boulders and cobbles that have been roughly set into a low C-shape. The wall has collapsed and is presently only one course high. Based on the amount of material present, however, the wall may have originally been built to form a two-course high wall. Its collapsed and scattered state makes it unclear as to what its internal measurements would have been. The C-shape currently opens to the southeast. The site's overall exterior length is ca. 2.05 meters (northwest to southeast) by ca. 1.89 meters in width (northeast to southwest).

No cultural material was observed in or around the site. The site is in poor condition and is collapsed, possibly as a result of seismic activity. Site 29141 may have possibly served as low windbreak shelter due to its location atop level *pāhoehoe* lava. The construction style of the C-shape suggests that it may be pre-Contact and/or early post-Contact in age.

Figure C.123. Site 50-10-27-29141, collapsed C-shaped wall (view southwest).

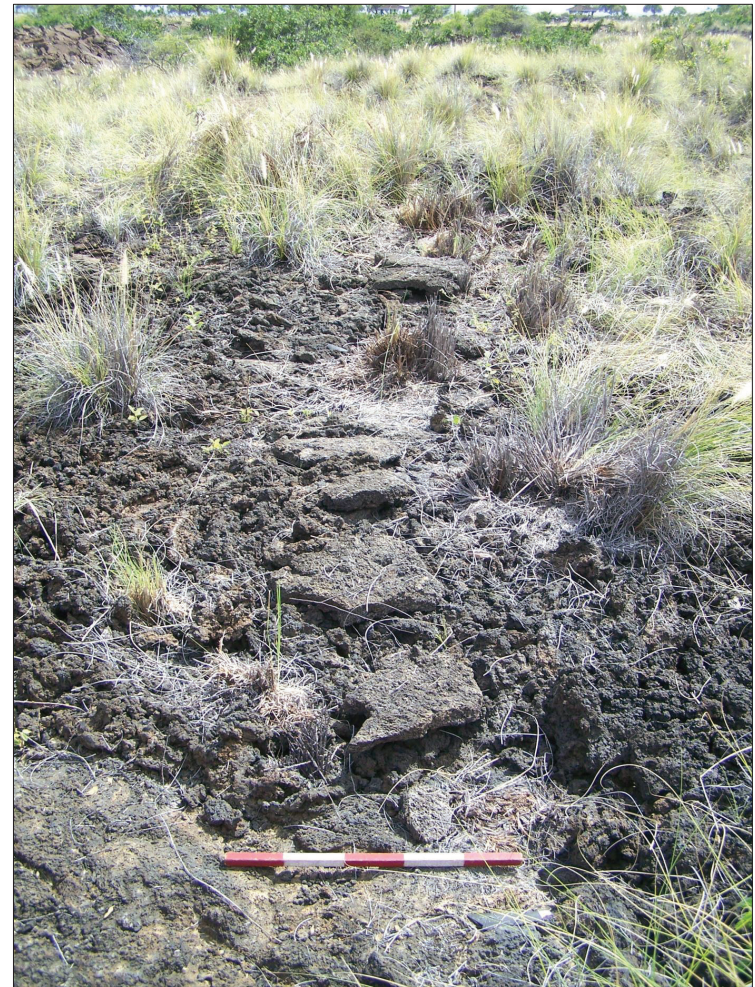
No cultural material was observed in or around the site area. Site 29142 is in fair condition. The stepping stone trail follows a defined path, but its course is not visible on the smoother *pāhoehoe*.

Figure C.125. Site 50-10-27-29142, trail segment (view to the southwest).

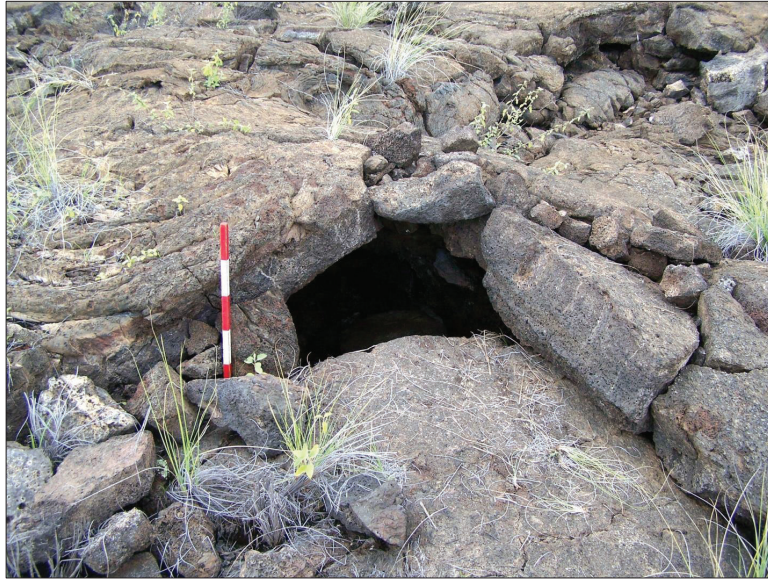
Description: Site 50-10-27-29143, Feature A is a modified overhang that was created from a natural opening in a collapsed lava blister (Figure C.127). This feature is located at the southern end of the site area, approximately 1.8 meters north (337°) of the Feature B modified overhang. The overhang of Feature A opens to the north and is relatively shallow in height. Modifications have been made to its eastern and western exterior edges. These modifications consist of loosely piled small sub-angular boulders and cobbles that appear to have been placed to fill a narrow crevice extending off the overhang's exterior edges. The interior of the overhang has been cleared of rocks, however, its floor consists of exposed bedrock and some small *pāhoehoe* boulder slabs. These slabs may have been used to help level the floor. Atop the overhang on its eastern edge, small cobbles and pebbles appear to have been loosely piled to possibly seal a small skylight into the overhang.

No cultural material was observed in or around the feature. Site 29143, Feature A is in good condition, and does not appear to be tumbled. The construction and location of Feature A suggest that the overhang was modified to possibly have functioned as a storage area. One small boulder slab is located in the feature's interior below the dripline. This suggests that the feature may have also been utilized for water catchment, although it remains unclear. Feature A was most likely built and utilized during the pre-Contact and/or early post-Contact periods.

Figure C.127. Site 50-10-27-29143, Feature A, modified overhang (view northeast).

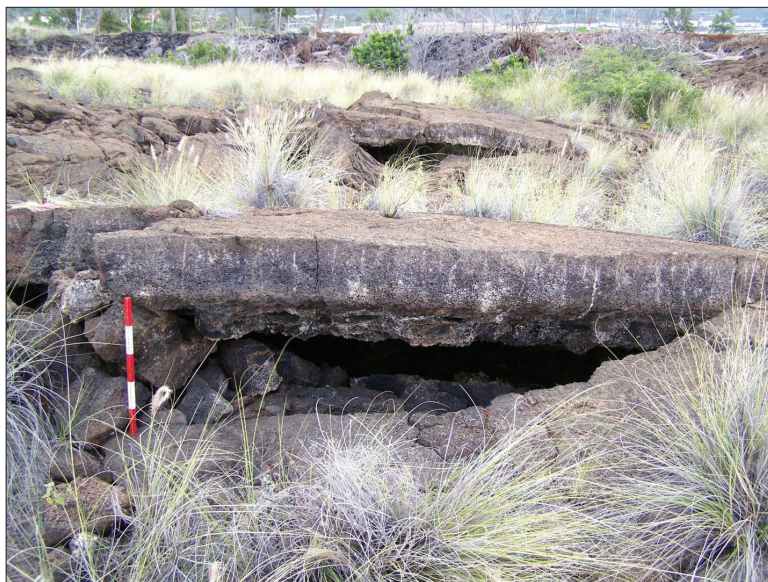
Description: Site 50-10-27-29143, Feature B is a modified overhang (Figure C.128). The feature is located within a collapsed lava blister, approximately 1.8 meters south (157°) of the Feature A modified overhang. Feature B consists of a natural overhang that opens to the east, with modifications along its northern end. These modifications consist of some loosely piled small sub-angular basalt boulders that appear to be sealing a crevice at the northern edge of the overhang. No other modifications were observed. Natural collapse from the roof of the overhang has narrowed the entrance, however, further back, the interior widens, and the floor of the overhang is cleared of rock. Feature B measures ca. 2.1 meters in length (north to south) by ca. 0.4 meters in width (east to west). The overhang's depth is ca. 2.0 meters.

Located at the entrance of Feature B is a badly degraded, possible condensed milk tin can. The can measures ca. 9.84 centimeters in length, and ca. 7.47 centimeters in diameter. It has stamped ends and a crimped side seam and a "hole-in-one" filing method (ca. 2.54 centimeters in diameter) and a punch hole opening. According to the "Simonis Milk Can Guide" by Jamie Palmer (http://www.academia.edu/4810446/Simonis_Milk_Can_Guide), this type of can was manufactured either between 1917 and 1929 or 1935 and 1945, the latter only if embossing is present. Due to the can's degraded state, it is impossible to read the embossing. No other cultural material was observed at the site. Site 29143, Feature B is in fair condition, it does not appear to have suffered tumble besides the natural roof collapse.

Figure C.128. Site 50-10-27-29143, Feature B, modified overhang (view east).
