**URBAN PHASE III
ARCHAEOLOGICAL
INVENTORY SURVEY
(VOL. III)**

ARCHAEOLOGICAL INVENTORY SURVEY
OF URBAN PHASE III PARCEL
LILI'UOKALANI TRUST LANDS
IN KEAHUOLŪ, NORTH KONA
ISLAND OF HAWAII
[TMK: (3) 7-4-008:002 (por.)]

VOLUME III:
APPENDICES
(Newly Documented Sites, Table of Lava
Excavations, Isolated Finds,
GPS Site Locations)

Prepared by:
Rowland B. Reeve, M.A.
Paul L. Cleghorn, Ph.D.
Tanya Lizama, M.A.
and
Reid Yamasato, B.A.

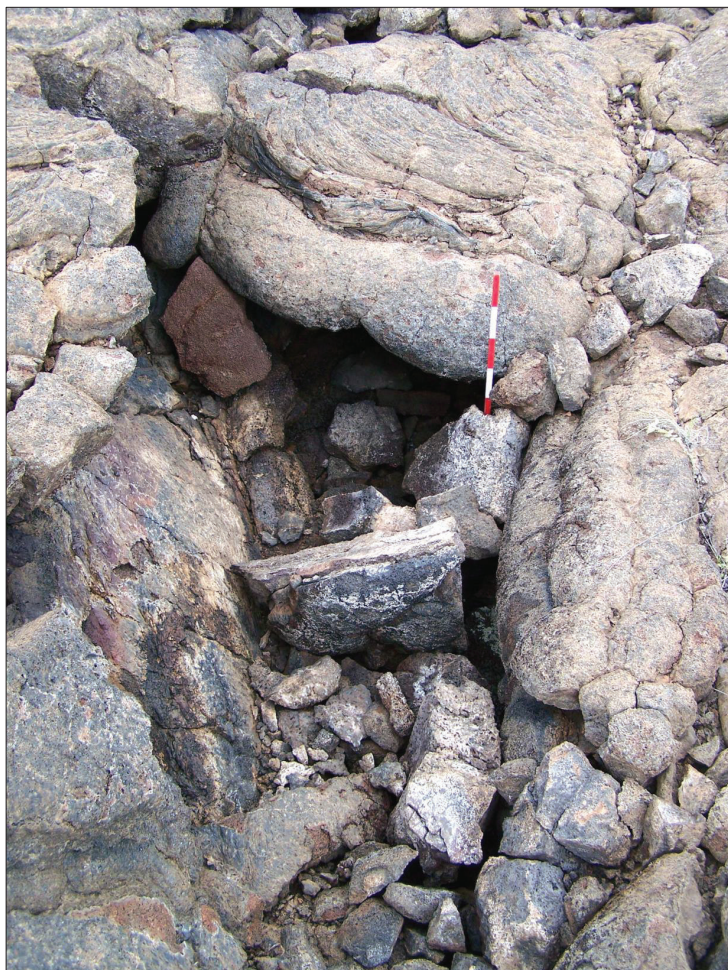
Description: Site 50-10-27-29143, Feature C consists of a modified overhang (Figure C.129). This feature is located in the southeastern portion of the site area, approximately 2.5 meters north (340°) of the Feature D modified overhang. The Feature C overhang opens to the northeast and is the result of a naturally collapsed and opened lava blister. The floor of the blister is filled and leveled with small to medium sub-angular *pāhoehoe* slabs. The northwestern end of the opening has a medium sub-angular *pāhoehoe* slab set into it, narrowing the opening size. Small to large sub-angular basalt boulders are present to the southwest but appear to be natural collapse and tumble of the bedrock. The opening of the modified overhang measures ca. 0.80 meters in length (northwest to southeast) by ca. 0.6 meters in height. The internal depth is ca. 1.35 meters (northeast to southwest), ca. 1.2 meters in internal width and ca. 0.6 meters in internal height.

No cultural material was observed in or around this feature. Site 29143, Feature C is in good condition. Its construction style and location of Feature C in a natural overhang, suggests that it was built and utilized during the pre-Contact and/or early post-Contact periods for storage.

Figure C.129. Site 50-10-27-29143, Feature C, modified overhang (view northeast).

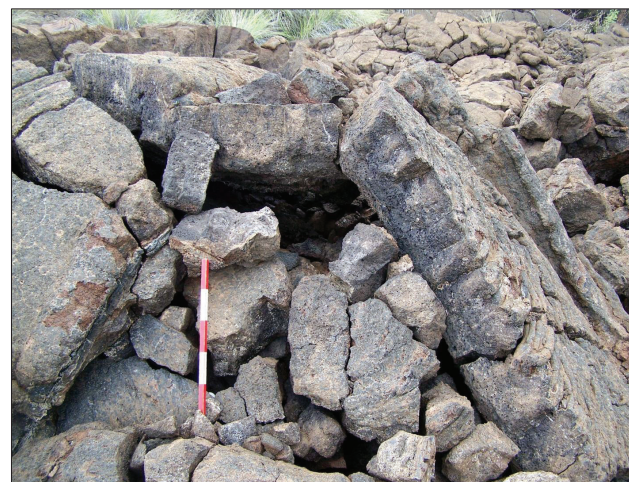
Description: Site 50-10-27-29143, Feature D consists of a modified overhang (Figure C.130). The feature is located in the southwestern portion of the site area, approximately 5.1 meters northwest (303°) of the Feature A modified overhang. The Feature D overhang is set in to a *pāhoehoe* lava ridgeline and opens to the north. Modifications have been made to its western and eastern edges. This consists of two small sub-angular boulders that have been placed on the eastern edge, and two small sub-angular boulders have also been placed on the western edge. These modifications have narrowed the entrance of the overhang. The floor of the overhang's interior consists of exposed bedrock and some small boulder slabs that may have been placed to level the floor. The opening of the overhang measures ca. 0.6 meters in length (east to west) by ca. 0.46 meters in width (north to south) with a depth of ca. 1.6 meters. No cultural material was observed in or around the feature. Feature D is in good condition, it does not appear to have tumbled. The construction of the Feature D modified overhang suggests that it may have functioned as a storage area during the pre-Contact and/or early post-Contact period.

Figure C.130. Site 50-10-27-29143, Feature D modified overhang (view north).

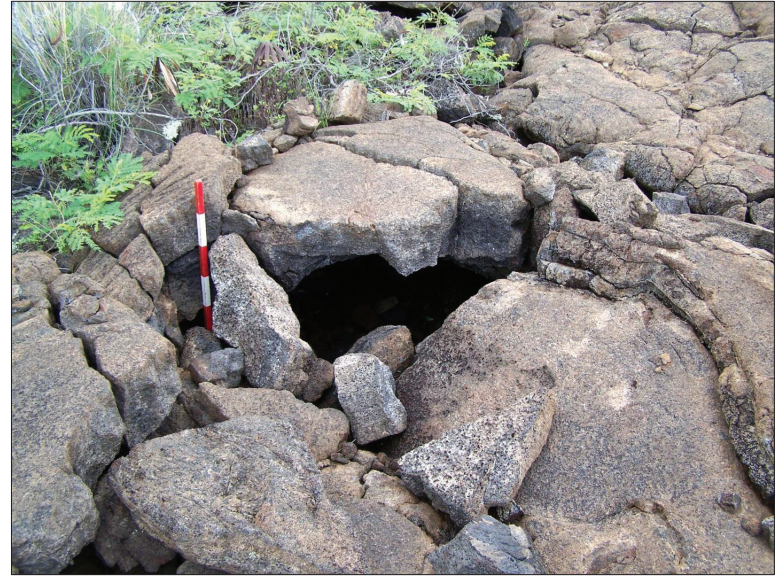
Description: Site 50-10-27-29143, Feature E consists of a modified overhang (Figure C.131). It is located in the northeastern portion of the site area, approximately 30.0 meters northeast (51°) of the Features C overhang. The overhang is set at the base of a low *pāhoehoe* ridge and opens to the southwest. It appears to be a naturally collapsed lava blister that naturally opened into an overhang. Modifications have been made to the overhang entrance and its interior floor. Small sub-angular boulders and cobbles appear to have been loosely piled along the overhang's western edge, narrowing the opening. Small *pāhoehoe* boulder slabs and cobbles appear to have been placed in the interior of the overhang along its floor and may have been used to form a rough paving along the floor. The feature measures ca. 1.0 meter in length (east to west) by ca. 0.4 meters in width (north to south), and ca. 1.1 meters in depth.

Feature E is in good condition; it appears to have suffered some tumble along its western edge. The construction of Feature E is similar to that of the other modified overhangs in the area, suggesting that it was likely used as a storage area during the pre-Contact and/or early post-Contact periods.

Figure C.131. Site 50-10-27-29143, Feature E, modified overhang (view southeast).

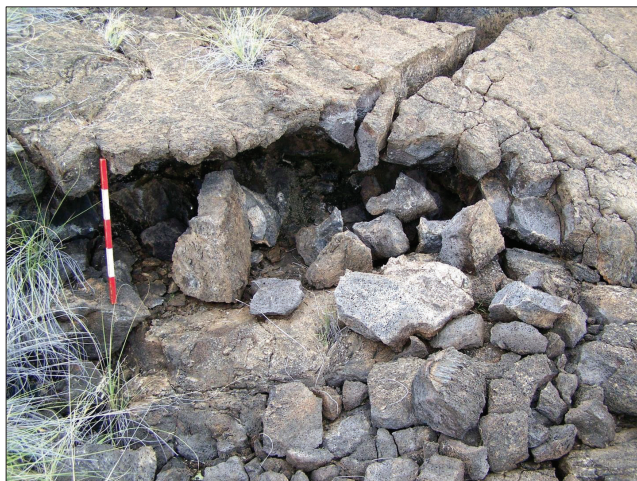
Description: Site 50-10-27-29143, Feature F consists of a modified overhang (Figure C.132). This feature is located in the northeastern portion of the site, approximately 9.0 meters northeast (53°) of the Feature E modified overhang. Feature F is a collapsed lava blister that naturally opened into an overhang. The overhang opens to the north and has very slight modifications. Two medium to large sub-angular *pāhoehoe* boulders are set on end onto the level bedrock floor in a line perpendicular to the opening and beneath the overhang, effectively dividing it into two distinct areas. The opening of the overhang measures approximately 1.9 meters east to west by ca. 0.57 meters in height, with a depth of ca. 1.1 meters. The placed boulders exist 0.8 to 1.05 meters in from the west end of the opening. No cultural material was observed in or around the feature. Feature F is in fair condition. Small to medium boulders have collapsed and tumbled into the eastern end of the overhang. Due to its construction, and its location in a natural overhang, Feature F appears to have been built and utilized in the pre-Contact and/or early post-Contact periods, possibly for storage.

Figure C.132. Site 50-10-27-29143, Feature F, modified overhang (view northeast).

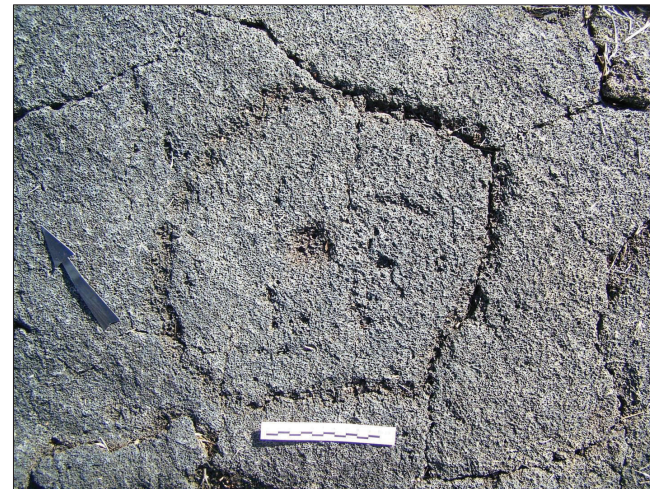
Description: Site 50-10-27-29144, Feature A consists of a petroglyph (Figure C.134). Feature A is located in the eastern portion of the site, approximately 3.0 meters east (112') of the Feature B mound and the Feature C petroglyph. Feature A is a clearly defined broad oval-shaped petroglyph with a large pecked dot in the center. The petroglyph is located on a level area of a roughly east to west running flow of undulating *pāhoehoe* lava. The eastern portion of the petroglyph ellipse follows a natural crack. In addition to the defined petroglyph, some battering is present between the petroglyph's ellipse line and the central dot, and it appears to be made with circular tool marks, and likely predates the petroglyph. The petroglyph measures approximately 0.33 meters on its long axis (east to west), and ca. 0.30 meters along its short axis (north to south). The central, circular dot measures ca. 0.04 meters in diameter. No cultural material was observed in or around the site. The Feature A petroglyph is in good condition. The petroglyph appears to have been created during the pre-Contact and/or early post-Contact periods.

Figure C.134. Site 50-10-27-29144, Feature A petroglyph.

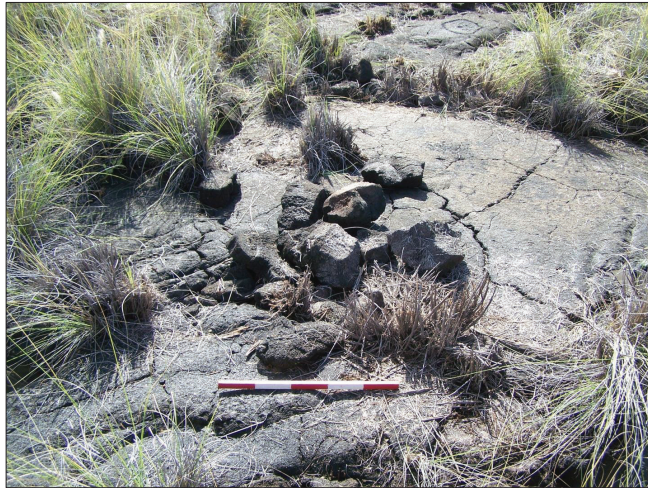
Description: Site 50-10-27-29144, Feature B consists of a disturbed stone mound (Figure C.135). It is situated atop relatively level *pāhoehoe* lava, approximately 3.0 west (292°) of the Feature A petroglyph. The mound is constructed of small sub-angular basalt boulders and cobbles that at present lie scattered on the ground surface. The mound measures approximately 1.4 meters in length (east to west) by ca. 0.76 meters in width (north to south). It has a maximum height of ca. 0.25 meters.

No cultural material was observed in or around the feature. The mound is in poor condition and appears badly disturbed, possibly due to seismic activity or other natural causes. The Feature B mound may have served as a marker, most likely built during the pre-Contact and/or early post-Contact periods. Its close proximity to Features A and C may indicate that the mound served to mark the location of the petroglyphs.

Figure C.135. Site 50-10-27-29144, Feature B stone mound (view east).

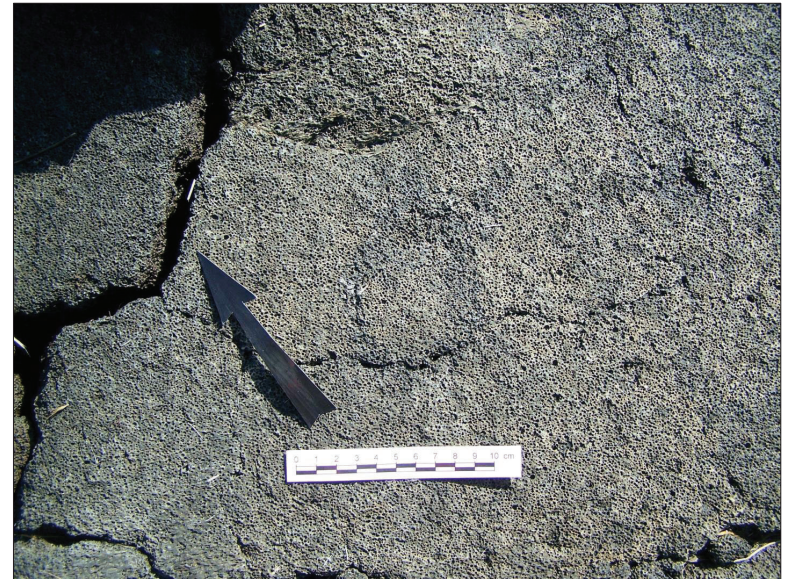
Description: Site 50-10-27-29144, Feature C consists of a single petroglyph (Figure C.136). It is situated approximately 2.5 meters west (281°) of the Feature A petroglyph, and adjacent of the Feature B mound. Feature C consists of a small oval-shaped petroglyph that is shallowly pecked and relatively faint. It measures 8.5 centimeters (east to west) along its long axis, and ca. 7.0 centimeters (north to south) along its short axis.

No cultural material was observed in or around the feature. Feature C is in fair condition, though somewhat naturally weathered. The Feature C petroglyph appears to have been created during the pre-Contact and/or early post-Contact periods.

Figure C.136. Site 50-10-27-29144, Feature C, petroglyph.

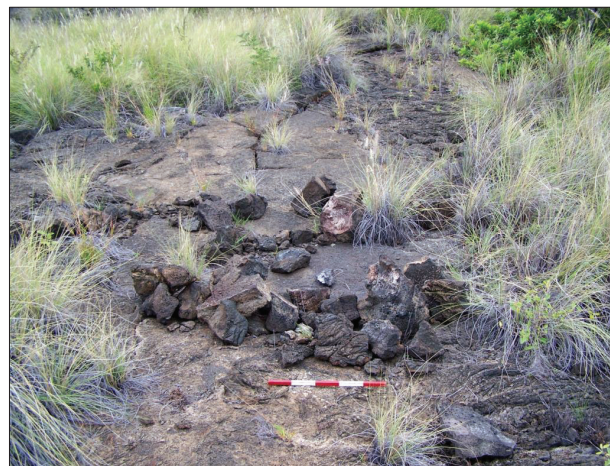
Description: Site 50-10-27-29146, Feature A is a badly disturbed, roughly oval enclosure (Figure C.141). It is located 15.0 meters northeast (54°) of the Feature B enclosure, towards the center of the shallow *pāhoehoe* bedrock depression in which the site is located. The enclosure is built on roughly level *pāhoehoe* bedrock and is constructed of a rough alignment of small to large sub-angular basalt cobbles and boulders. The structure has been disturbed on its western, northern and eastern edges, making the original dimensions of the enclosure obscure. In its present condition, the mound's exterior measures ca. 2.9 meters in length (east to west), by ca. 2.0 meters in width (north to south). It is impossible to determine the interior length but the present interior width measures ca. 1.0 meters. The maximum height of the enclosure measures ca. 0.35 meters in height along the southern edge.

No surface cultural material was observed at this feature. Site 29146, Feature A is in poor condition. The Feature A enclosure most likely served as a temporary habitation shelter during the pre-Contact and/or early post-Contact periods.

Figure C.141. Site 50-10-27-29146, Feature A enclosure (view northwest).

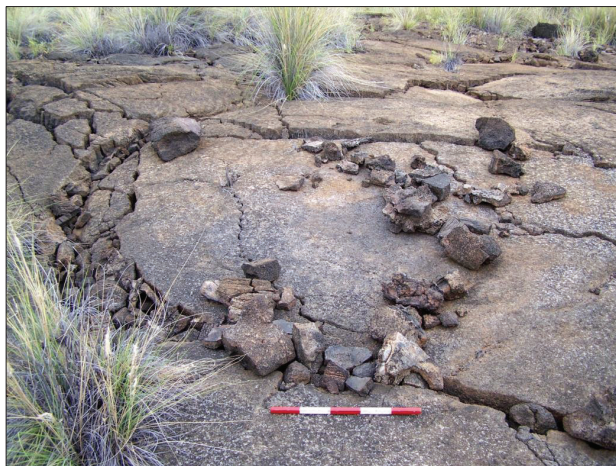
Description: Site 50-10-27-29146, Feature B consists of a badly disturbed remnant of what appears to have been a small oval-shaped enclosure (Figure C.142). It is located toward the southwestern edge of the *pāhoehoe* lava depression. The enclosure is approximately 15.0 meters southwest (234°) from the Feature A enclosure. The enclosure is formed by a rough alignment of small to large basalt cobbles and some small basalt boulders, resting directly on a roughly level *pāhoehoe* bedrock surface. Due to its poor condition, it is difficult to determine the original dimensions of the enclosure. In its present condition, the overall exterior dimensions appear to be ca. 2.3 meters in length (northeast to southwest), by ca. 1.4 meters in width (northwest to southeast). The internal dimensions may have been ca. 1.7 meters in length, by ca. 0.9 meters in width. The maximum height of the enclosure is ca. 0.2 meters. No surface cultural material was observed at this feature. Site 29146, Feature B is in poor condition. The northern and western edges of the enclosure appear to have tumbled into a narrow crack to the west, possibly due to seismic activity. Although heavily disturbed, it appears that Feature B may have served as a temporary habitation shelter during the pre-Contact and/or early post-Contact periods.

Figure C.142. Site 50-10-27-29146, Feature B enclosure (view east).

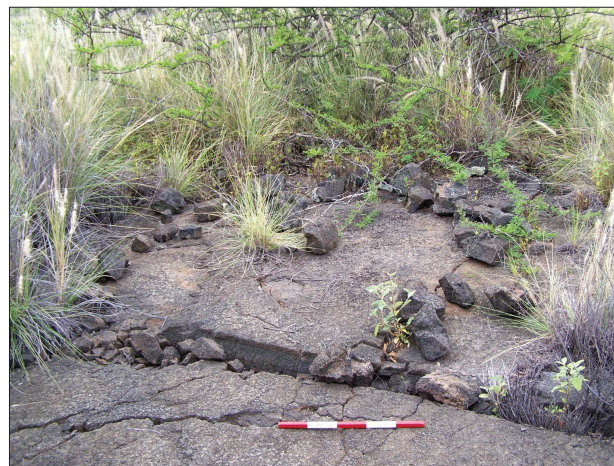
Description: Site 50-10-27-29146, Feature C is a badly disturbed, small, roughly oval-shaped enclosure (Figure C.143). It is located toward the western edge of the shallow *pāhoehoe* depression. This enclosure is ca. 16.0 meters northwest (324°) from the Feature B enclosure. Feature C is constructed of a rough alignment of small to large sub-angular basalt cobbles and small basalt boulders. The stones are resting directly on a slightly sloping *pāhoehoe* bedrock surface. Due to its poor condition, the overall original dimensions of the enclosure are difficult to determine. The original exterior may have measured ca. 1.8 meters in length (north to south), by ca. 1.7 meters in width (east to west). The original interior may have measured ca. 1.5 meters in length (north to south) by ca. 1.3 meters in width. The maximum height of this enclosure currently measures ca. 0.24 meters along its interior southern edge. Site 29146, Feature C is in poor condition. Portions of the northern and western edges of the enclosure have tumbled into a narrow crack just to the northwest, possibly due to seismic activity. No surface cultural material was observed at this feature. It appears that Feature C most likely functioned as a temporary habitation shelter during the pre-Contact and/or early post-Contact periods.

Figure C.143. Site 50-10-27-29146, Feature C enclosure (view northeast).

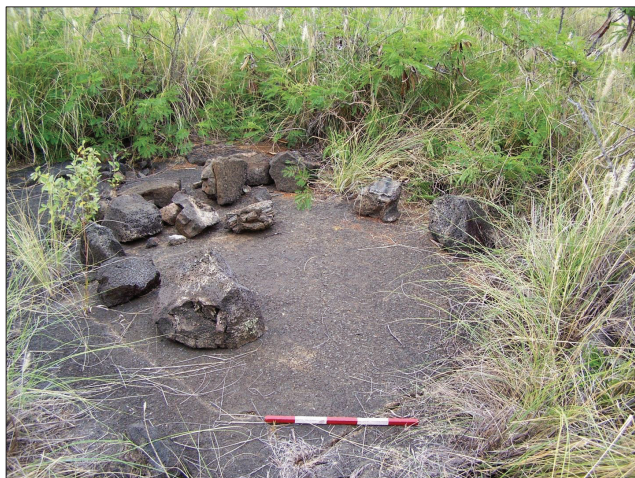
Description: Site 50-10-27-29146, Feature D consists of a badly disturbed roughly oval-shaped enclosure (Figure C.144). It is situated approximately 31.0 meters north (338°) from the Feature C enclosure. The Feature D enclosure is located along the exterior northwest edge of the *pāhoehoe* depression. It is constructed of an alignment of small sub-angular basalt boulders and some small to large sub-angular basalt cobbles. The stones are resting directly on top of slightly sloping *pāhoehoe* bedrock surface. Due to its poor condition, the overall original dimensions of the enclosure are difficult to determine. The original exterior may have measured ca. 2.5 meters in length (northeast to southwest) by ca. 1.8 meters in width (northwest to southeast). The original interior may have measured ca. 1.7 meters in length by ca. 1.1 meters in width. The maximum height of the enclosure measures ca. 0.27 meters. Site 29146, Feature D is in poor condition. The northeast edge appears to have tumbled slightly to the north, probably due to seismic activities. It appears that Feature D most likely functioned as a temporary habitation shelter during the pre-Contact and/or early post-Contact periods.

Figure C.144. Site 50-10-27-29146, Feature D enclosure (view southwest).

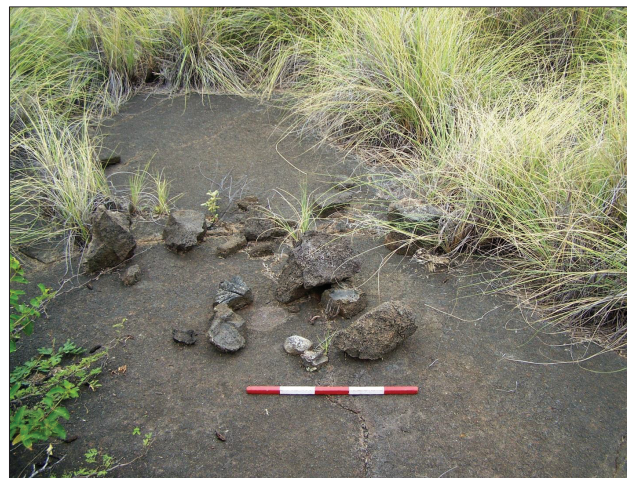
Description: Site 50-10-27-29146, Feature E is a small rock concentration (Figure C.145). The concentration of stones is located along the northern edge of the shallow *pāhoehoe* depression. It is located ca. 20.6 meters southeast (114°) from the Feature D enclosure. This small rock concentration consists of small to large sub-angular basalt cobbles and small sub-angular boulders. The stones are resting directly on top of roughly level *pāhoehoe* bedrock surface. The structure is so badly disturbed that it is impossible to determine its original shape and dimensions. The overall present dimensions of this rock concentration are ca. 1.5 meters in length (northeast to southwest) by ca. 1.1 meters in width (northwest to southeast), and it has a maximum height of ca. 0.25 meters. No surface cultural material was observed at this feature. Site 29146, Feature E is in poor condition. It is unclear exactly what structure this rock concentration may have originally formed, a short stone alignment or a low, stone mound. Site 29146, Feature E was most likely built and utilized during the pre-Contact and/or early post-Contact periods.

Figure C.145. Site 50-10-27-29146, Feature E, rock concentration (view southeast).

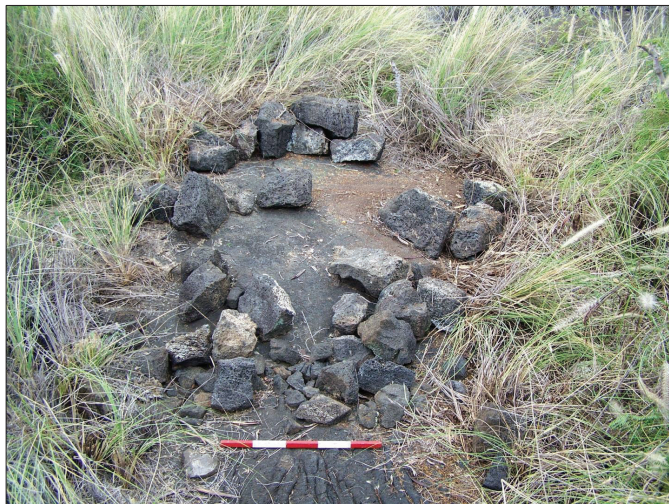
Description: Site 50-10-27-29146, Feature F is a badly disturbed, roughly oval-shaped enclosure (Figure C.146). It is located just outside the southern edge of the shallow *pāhoehoe* depression. This enclosure is situated approximately 26.0 meters southeast (144°) from Feature B enclosure. Site 29146, Feature F is constructed of small to large sub-angular basalt cobbles and small sub-angular basalt boulders. The enclosure is built on slightly sloping *pāhoehoe* bedrock. The northern edge is the most intact, where one boulder is actually stacked on top of another. The stones along the southern and western edges appear to have tumbled and are slightly scattered. The overall exterior dimensions of this enclosure are ca. 1.7 meters in diameter. The overall interior dimensions are ca. 1.2 meters in length (north to south) by ca. 1.0 meter in width (east to west). No surface cultural material was observed at this feature. Site 29146, Feature F is in poor condition. It appears that Feature F was most likely built and utilized during the pre-Contact and/or early post-Contact periods and may have functioned as a temporary habitation shelter.

Figure C.146. Site 50-10-27-29146, Feature F, enclosure (view northeast).

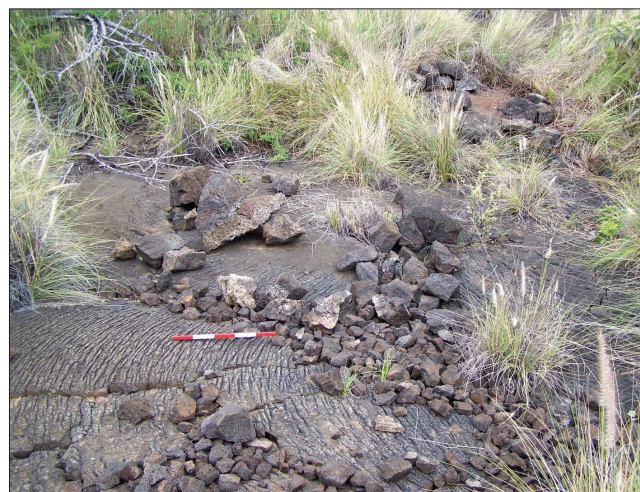
Description: Site 50-10-27-29146, Feature G consists of a badly disturbed, roughly oval-shaped enclosure (Figure C.147). It is situated ca. 5.0 meters south (182°) from the Feature F enclosure. The enclosure is located just outside the southern edge of the shallow *pāhoehoe* depression. Site 29146, Feature G is constructed of small to large sub-angular basalt cobbles and small to medium-sized basalt boulders. The stones are placed on top of slightly sloping *pāhoehoe* bedrock. Due to its poor condition, it is difficult to determine the enclosure's original dimensions. The exterior may have originally measured ca. 1.9 meters in length (east to west) by ca. 1.6 meters in width (north to south). Its interior may have originally measured ca. 1.2 meters in length (east to west) by ca. 1.0 meter in width (north to south). The maximum height of this enclosure is ca. 0.40 meters. No surface cultural material was observed at this site. Site 29146, Feature G is in poor condition. The enclosure is heavily tumbled along its northern and western edges. It is most likely that this enclosure functioned as a temporary habitation shelter during the pre-Contact and/or early post-Contact periods.

Figure C.147. Site 50-10-27-29146, Feature G, enclosure (view northwest).

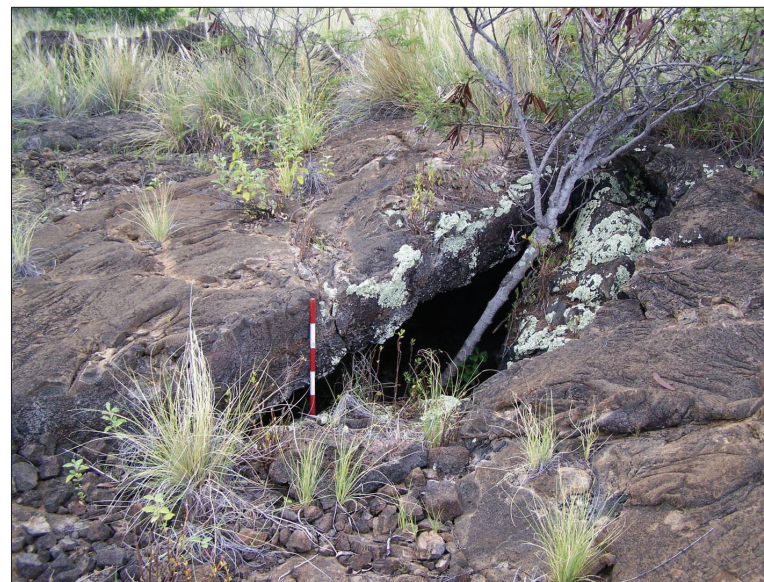
Description: Site 50-10-27-29146, Feature H is a small, unmodified lava tube, which contains one artifact, a small waterworn boulder hammerstone with battering on one end (Figure C.148). The lava tube is situated ca. 5.3 meters southwest (192°) from Feature G enclosure. It is located along the southern edge of the shallow *pāhoehoe* depression. The lava tube and its entrance are quite small, and the entrance of the lava tube measures ca. 1.0 meter in width, by ca. 0.90 meters in height. Just within the entrance is the main chamber, which measures ca. 4.3 meters in length, by ca. 2.9 meters in width, and ca. 0.7 meters in maximum height. The floor of the main chamber is fairly level and consists of bedrock with some scattered roof fall. A second chamber contains no cultural material. It extends to the northwest and measures ca. 6.7 meters in length, by ca. 2.0 meters in width and ca. 0.9 meters in maximum height. The floor of this chamber is steeply sloping and consists of bedrock with some roof collapse.

The only cultural material noted within the tube is a hammerstone with one battered end. It is located just within the dripline of the main chamber. This artifact measures ca. 26.0 centimeters in length by ca. 12.0 centimeters in diameter. No additional cultural material was observed. Site 29146, Feature H is in fair condition. Given its small size and the limited accessibility into its two chambers, the lava tube would not have provided a comfortable shelter. Instead, this small tube may have functioned as a storage area utilized by the occupants of the multiple enclosures located nearby. Site 29146, Feature H was most likely utilized during the pre-Contact and/or early post-Contact periods.

Figure C.148. Site 50-10-27-29146, Feature H, lava tube (view southeast).

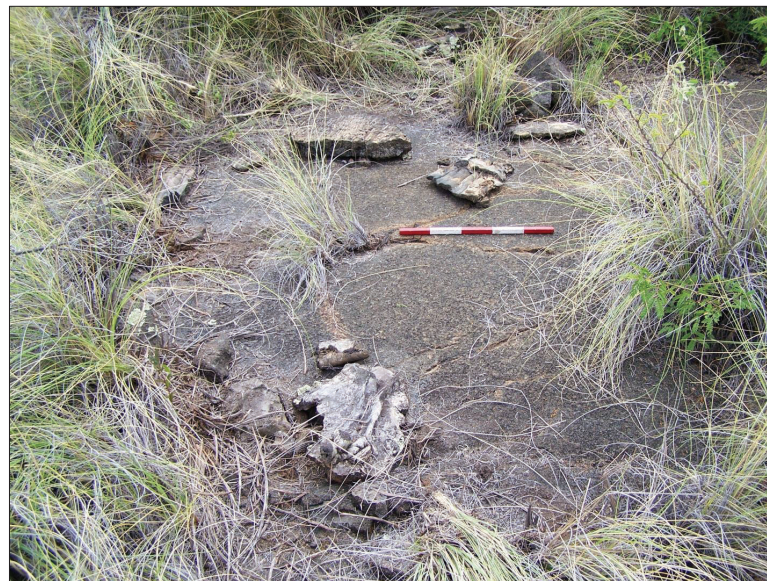
Description: Site 50-10-27-29147, Feature B consists of a rock concentration (Figure C.151). This feature is located ca. 7.3 meters south (180°) from the Feature A enclosure. The rock concentration consists of both small *pāhoehoe* slabs and small sub-angular basalt boulders. The stones are placed directly on top of slightly sloping *pāhoehoe* bedrock. It is not possible to determine the original shape or size of this concentration of stones. It may originally have been a possible stone alignment or a possible C-shape. This enclosure is in close proximity to the Feature A enclosure but does not incorporate as many stones. Currently the area of stones measures ca. 3.0 meters in length (north to south), by ca. 2.5 meters in width (east to west).

No surface cultural material was observed in or around this feature. Site 29147, Feature B is in poor condition. Due to the feature's disturbed condition, it is impossible to determine the original shape or function of the structure. Given its similarity to similar and more intact structures within the survey area, it appears to have most likely been built and utilized during the pre-Contact and/or early post-Contact periods.

Figure C.151. Site 50-10-27-29147, Feature B, rock concentration (view northwest).

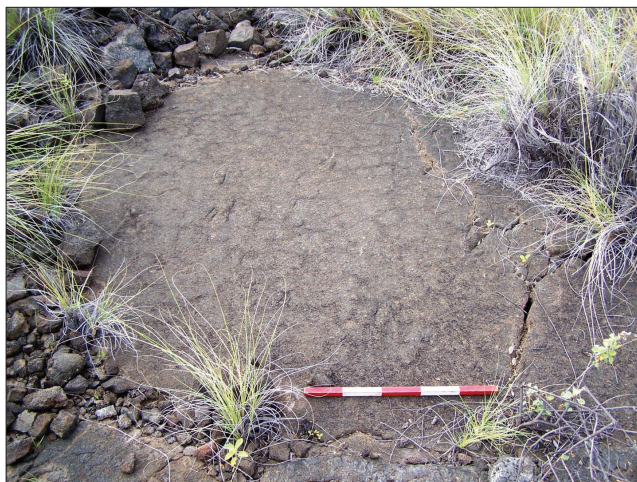
No cultural material was observed at the site. The Site 29148 petroglyphs are in fair condition. Bulldozing push piles are situated on the western edge of the site area and may have impacted the original extent of the site. The site requires additional investigation to determine the exact number and shape of the images. The style of the petroglyphs suggests that they were created during the traditional period. Site 29148 does not appear to have been recorded by the Stasacks during their survey of petroglyphs in coastal Keahuolū (Stasack and Stasack 2012).

Figure C.153. Site 50-10-27-29148 petroglyph panel (view southeast).

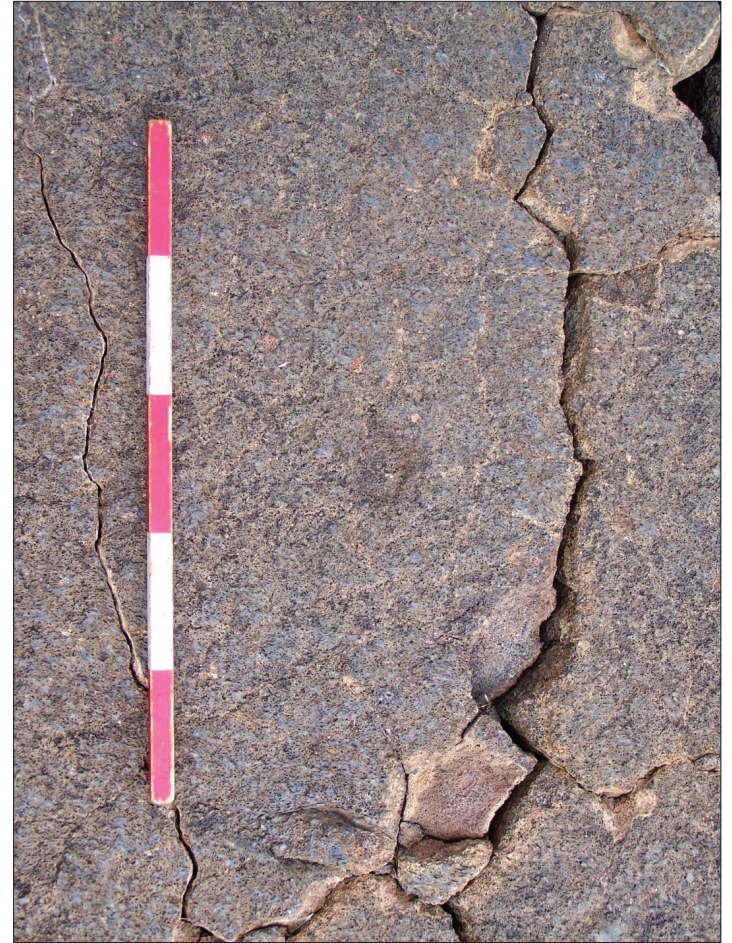
No surface cultural material was observed at the site. The Site 29149 petroglyph is in good condition. It appears that this shallow circular depression (*poho*) may possibly represent a repository for a baby's *piko*, but this is uncertain. The image at Site 29149 was most likely created during the pre-Contact and/or early post-Contact periods.

Figure C.156. Site 50-10-27-29149, petroglyph (view northwest).

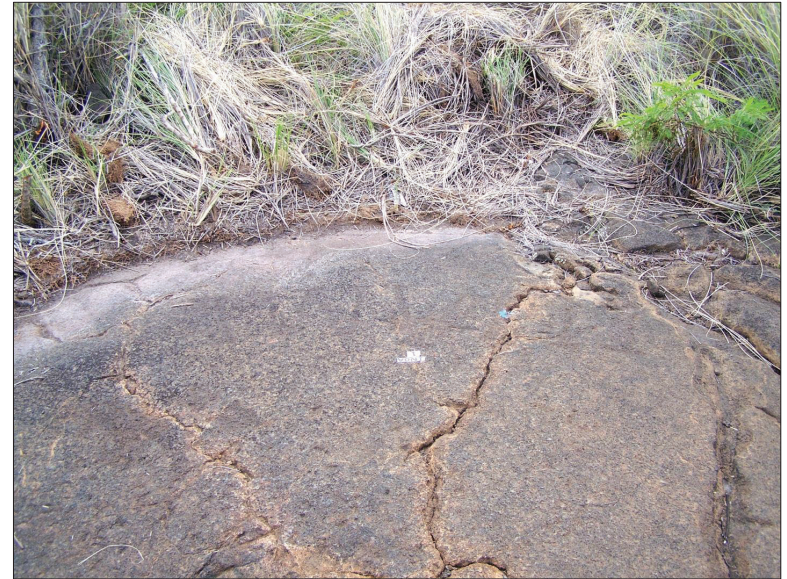
No cultural material was observed in or around the site. Site 29150 is in fair condition. The style of the single petroglyph suggests that this site dates to the early historic period. The presence of circular battering marks, however, suggest a traditional component to the site. The petroglyph may have functioned as art and the battering may have been associated with a processing activity of some kind. It is uncertain, however, what that processing activity may have been.

Figure C.157. Site 50-10-27-29150, petroglyph (view east).

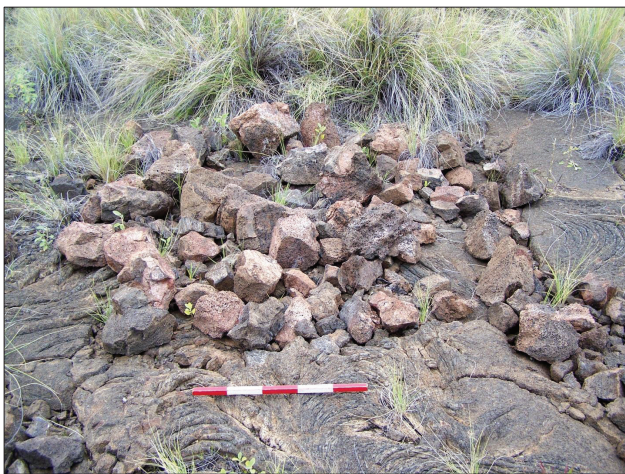
Site 29151 is in poor condition and has tumbled in all directions. Based on its construction style, location, and its proximity to traditional artifacts, Site 29151 may have been built and utilized during the pre-Contact and/or early post-Contact periods. It is likely that it served as a marker, possibly for the Site 29152 petroglyphs located just southwest of the mound.

Figure C.160. Site 50-10-27-29151, stone mound (view southwest).

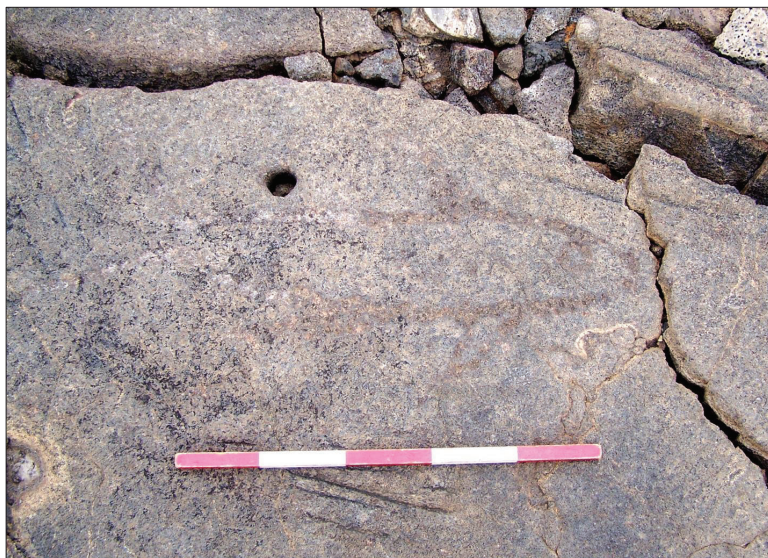
No cultural material was observed around the feature. The petroglyph fish is in fair condition. A modern core hole has been drilled adjacent to the fish's southeastern end but appears not to have directly impacted the petroglyph itself. Due to the unusual style of the image, it is difficult to determine the age of Feature A.

Figure C.162. Site 50-10-27-29152, Feature A petroglyph (view to the west).

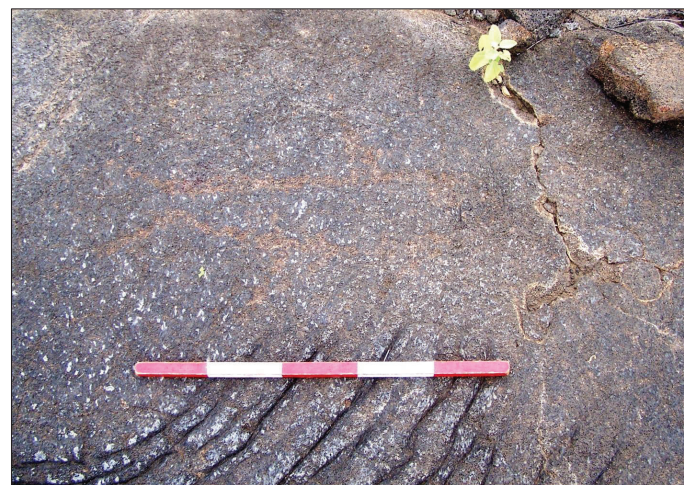
No cultural material was observed at the feature. The Feature B petroglyph is in good condition and remains well-defined and visible. Due to the unusual style of the image, it is difficult to determine the age of Feature B.

Figure C.163. Site 50-10-27-29152, Feature B petroglyph (view to the west).

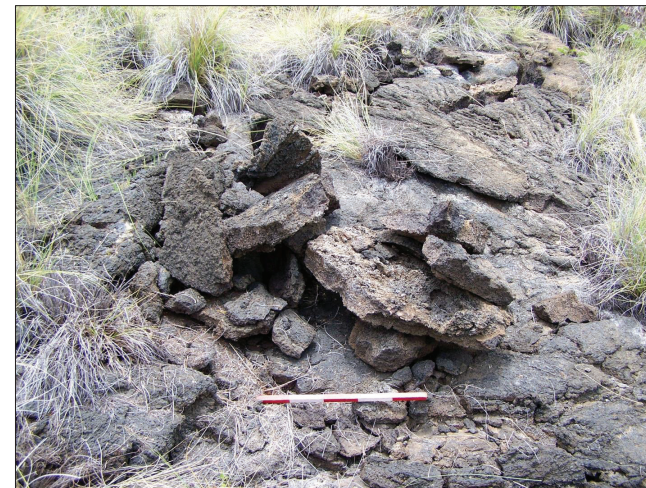
The stone mound is constructed of loosely piled small to large *pāhoehoe* slabs some of which are stacked on edge. The mound is built directly on the *pāhoehoe* bedrock, and tumbled downslope on its east end. The original size of the mound is difficult to determine, in its present condition the mound measures ca. 1.35 meters in length (east to west), by ca. 0.90 meters (north to south) and it is ca. 0.55 meters in maximum height. A small concentration of small to medium *pāhoehoe* slabs are located ca. 28.0 meters west (286°) from the site. This concentration of slabs may have once formed a low stone mound similar to the intact stone mound at Site 29153. The area of stones measures ca. 1.4 meters in length (north to south) by ca. 1.1 meters in width (east to west) and it has a maximum height of ca. 0.15 meters. No surface cultural material was observed at this site. Site 29153 is in poor condition. It appears that the Site 29153 stone mound may have served as a marker. It is not clear, however, what the mound was intended to mark. Due to its rough construction, the age of the mound cannot be determined.

Figure C.165. Site 50-10-27-29153, stone mound (view north).

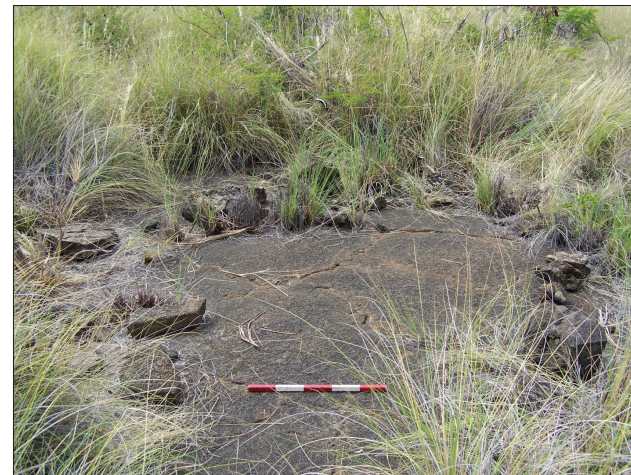
No cultural material was observed in or around the site. Site 29154 is in poor condition and badly collapsed in all directions. The construction style and location on level *pāhoehoe* bedrock, suggests that Site 29154 may have served as a traditional windbreak shelter during the pre-Contact and/or early post-Contact periods.

Figure C.167. Site 50-10-27-29154 enclosure (view northwest).

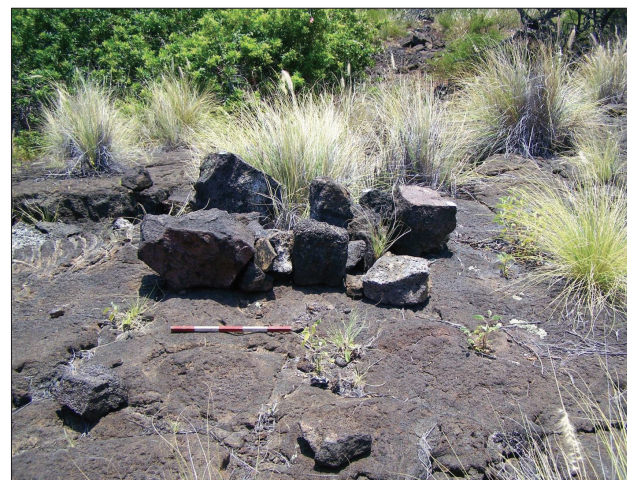
No cultural material was observed in or around the mound. Site 29155 is in fair condition. The structure has suffered some tumble yet has retained some of its original edging. The mound's location atop a ridgeline and its proximity to the Site 13287 complex suggests that it may have served as a marker for the habitation site. Site 29155 was likely constructed during the pre-Contact and/or early post-Contact periods.

Figure C.169. Site 50-10-27-29155, stone mound (view northeast).

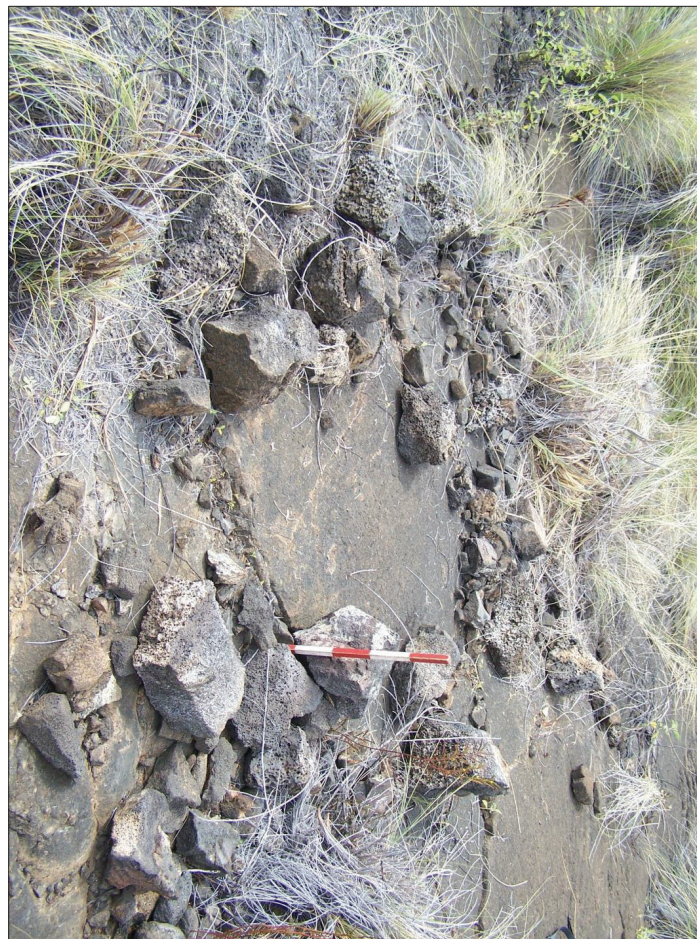
No cultural material was observed in or around the site. The enclosure is in poor condition, and badly tumbled. Site 29156 may have been built and utilized during the pre-Contact and/or early post-Contact periods as a windbreak shelter for temporary habitation. The nearby petroglyphs could possibly be associated with it.

Figure C.170. Site 50-10-27-29156, enclosure (view north).
