RE: PUBLICATION OF THE ENVIRONMENTAL ASSESSMENT TITLED ADAPTATION PATHWAYS: SEAWALL REMOVAL AND DUNE RESTORATION

Adaptation Pathways: Seawall Removal and Dune Restoration

Draft environmental assessment and anticipated finding of no significant impact (DEA-AFNSI)

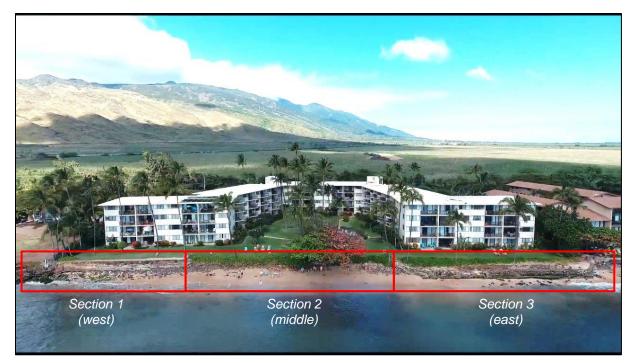
Figure 4-1 KAN shoreline sections

- *Section 1* consists of a 90-foot-long CRM seawall along the west end of the shoreline.
- Section 2 consists of 150 feet of unarmored shoreline along the middle of the property.
- *Section 3* consists of a 130-foot-long CRM seawall along the east end of the shoreline.

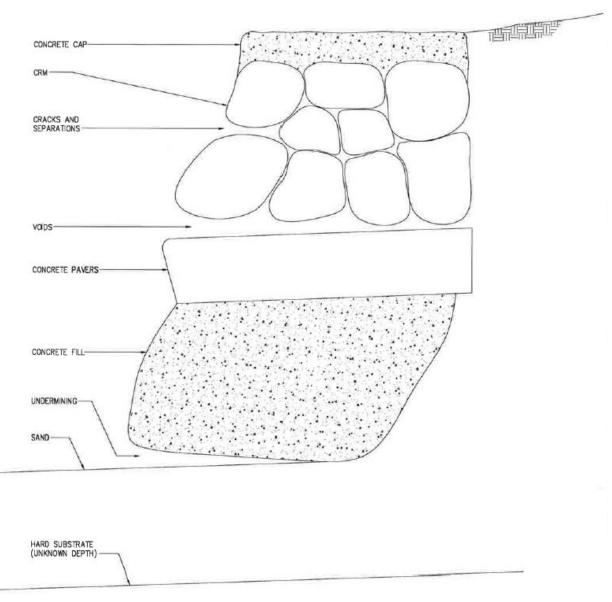
Figure 4-3 Section 1 (west) existing seawall section

- Erosion and loss of mortar due to weathering and wave action.
- Undermining and void formation due to erosion of loose sandy material.
- Wall displacement and settlement due to loss of subgrade support.
- West adjacent seawall is damaged and appears to be failing.

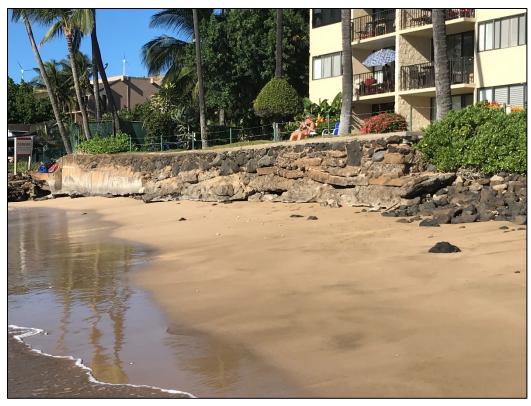
Figure 4-4 CRM seawall in Section 1 (west)

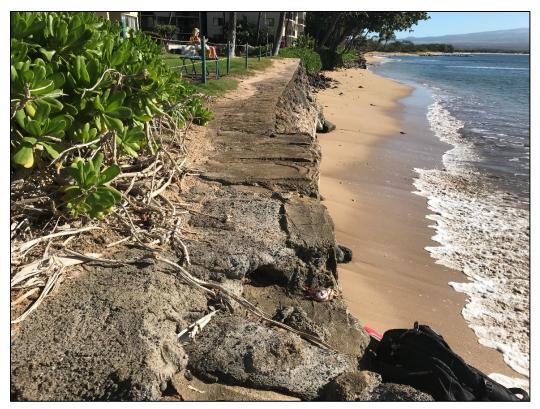
Figure 4-5 Concrete cap on top of seawall

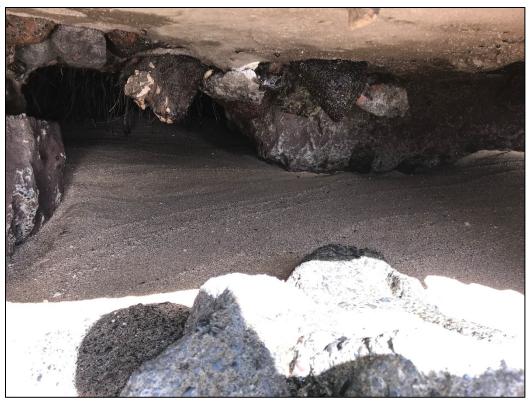
Figure 4-8 Void under seawall due to undermining

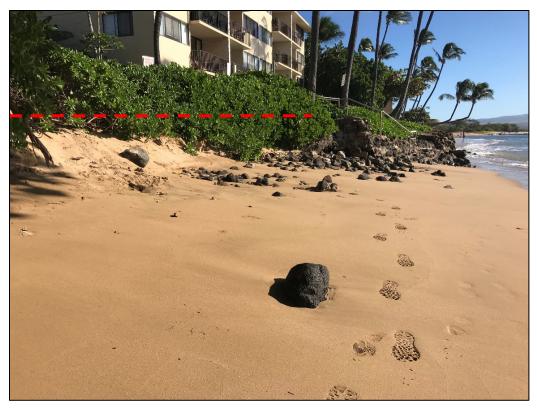
Section 2 consists of approximately 150 linear feet of unarmored shoreline. A continuous erosion scarp extends from the CRM seawall at the east end of *Section 1 (west)* to the CRM stair at the west end of *Section 3 (east)* (Figure 4-10 and Figure 4-11). The erosion scarp roughly follows the landward edge of the Naupaka hedge and is approximately 30 feet seaward of the KAN pool.

Figure 4-11 Approximate location of erosion scarp (dashed line)

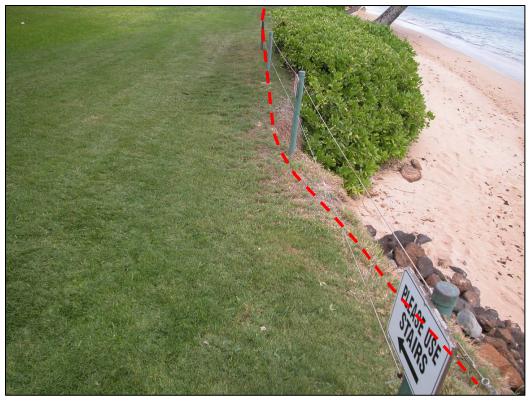
The erosion scarp is approximately 4 to 5 feet above the current sand elevation. There is evidence of undermining, particularly around the tree root structures. In some areas, the undermining extends 4 to 6 feet landward of the edge of the erosion scarp (Figure 4-12). There is evidence of active erosion (Figure 4-13) and several of the trees located along the edge of the scarp appear to be leaning in a seaward direction, which suggests they are at risk of falling. A pile of loose cobble and debris material is accumulated along the base of the erosion scarp.

Figure 4-12 Erosion scarp along edge of lawn

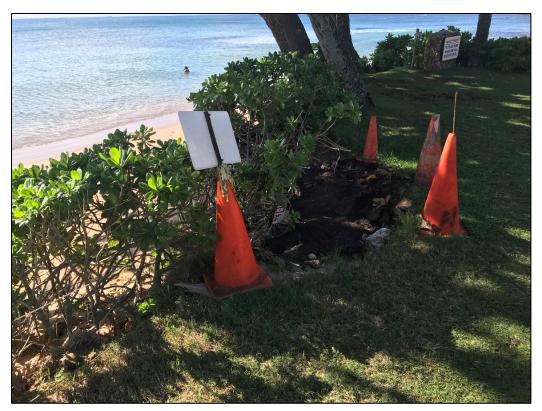
Figure 4-13 Evidence of active erosion

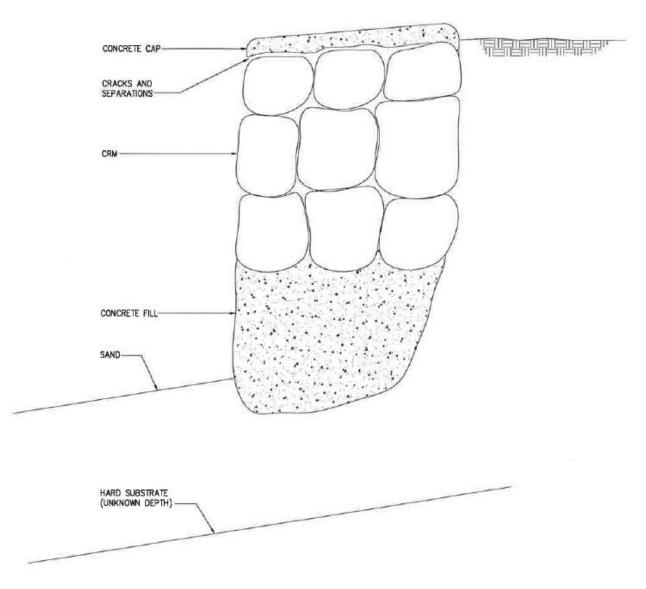
Figure 4-16 Section 3 (east) existing seawall section

Section 3 consists of approximately 130 linear feet of shoreline that is fronted by a CRM seawall. The seawall is approximately 35 to 45 feet seaward of the east wing of the KAN building. A typical section view of the seawall based on field observations is shown in Figure 4-16.

- Erosion of mortar, cracking, and dislodged stones due to weathering and wave action.
- Vertical and lateral displacement of portions of the wall.
- Undermining due to erosion of the loose sandy material.
- Outward rotation of the seawall.
- East adjacent seawall is damaged and appears to be failing.

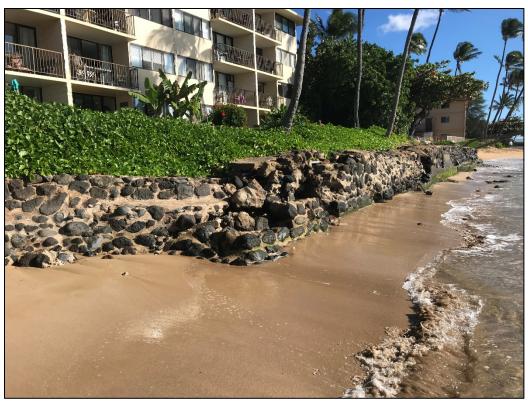
The seawall is about 5 to 6 feet high and appears to be constructed of mortared stone for the top 3 to 4 feet of wall height with concrete fill at the lower 1 to 3 feet (Figure 4-17). It appears that the concrete fill may have been added later to address undermining of the original stone wall as well as missing stones. The thickness of the wall is unknown. A CRM stair leading to the ocean is located at the west end of the wall (Figure 4-18). Portions of the stair are undermined.

Figure 4-17 CRM seawall in Section 3 (east)

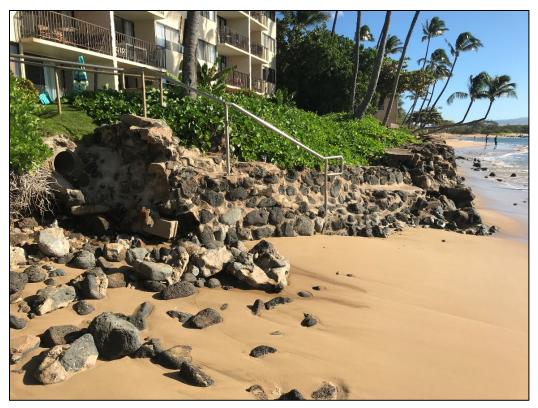
Figure 4-18 CRM stair at west end of seawall
