# AERIAL PHOTOGRAPHY ANALYSIS OF COASTAL EROSION ON THE ISLANDS OF KAUAI, MOLOKAI, LANAI, MAUI AND HAWAII

JUNE, 1991

**PREPARED BY:**  
**MAKAI OCEAN ENGINEERING, INC**  
**and**  
**SEA ENGINEERING, INC.**  
**Honolulu, Hawaii**

**PREPARED FOR:**  
**STATE OF HAWAII**  
**OFFICE OF STATE PLANNING**  
**COASTAL ZONE MANAGEMENT**  
**PROGRAM**

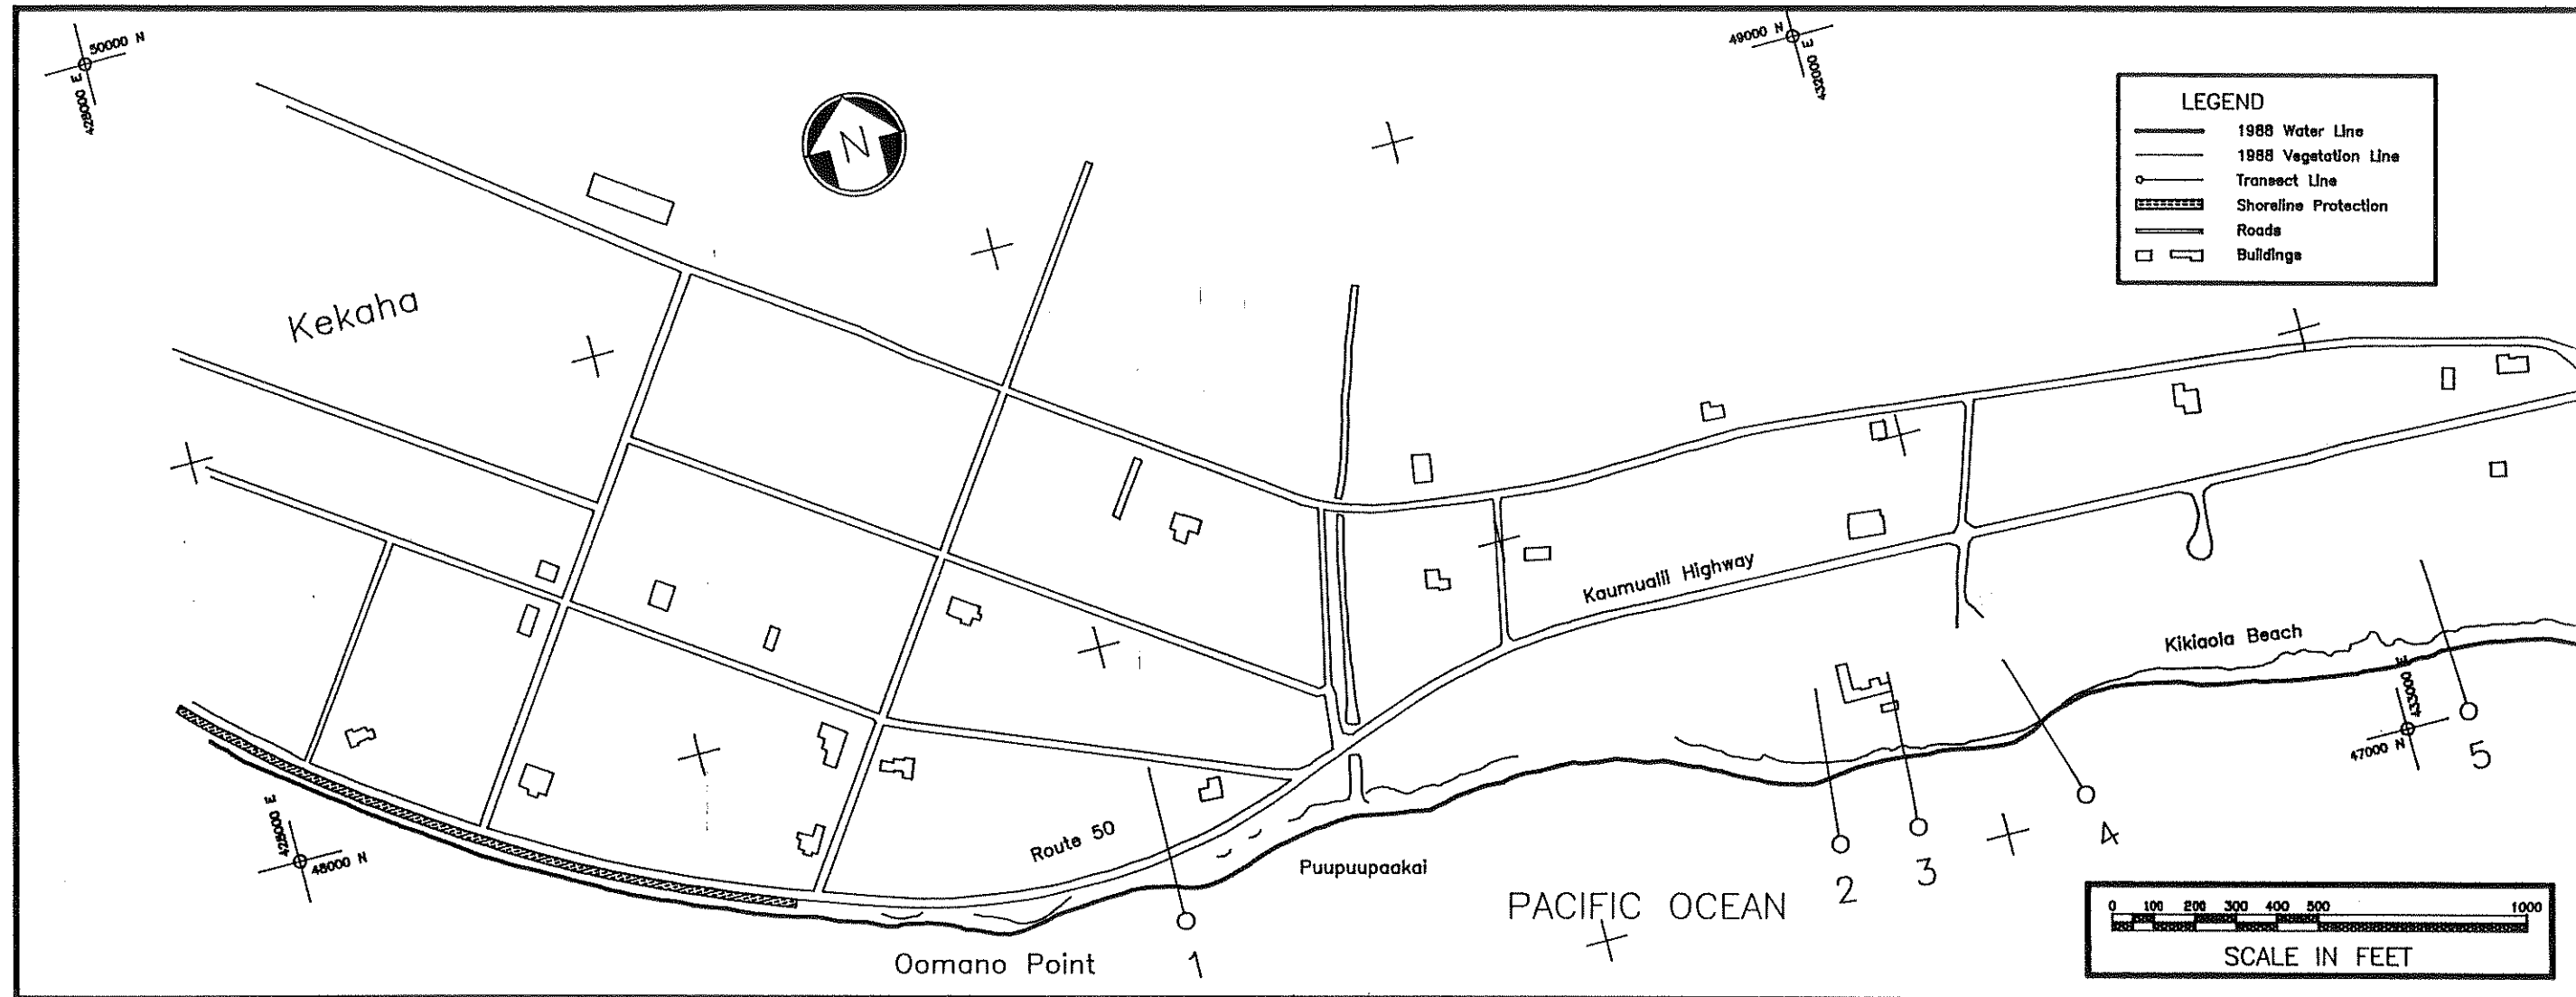
**FIGURE KA-1**

- Kikiaola Beach has eroded severely since the construction of the small boat harbor, which interrupted the predominant westward littoral drift. This resulted in the construction of the massive revetment at Oomano Point.
- The beach in front of the houses is eroding, and this is a potential problem area.

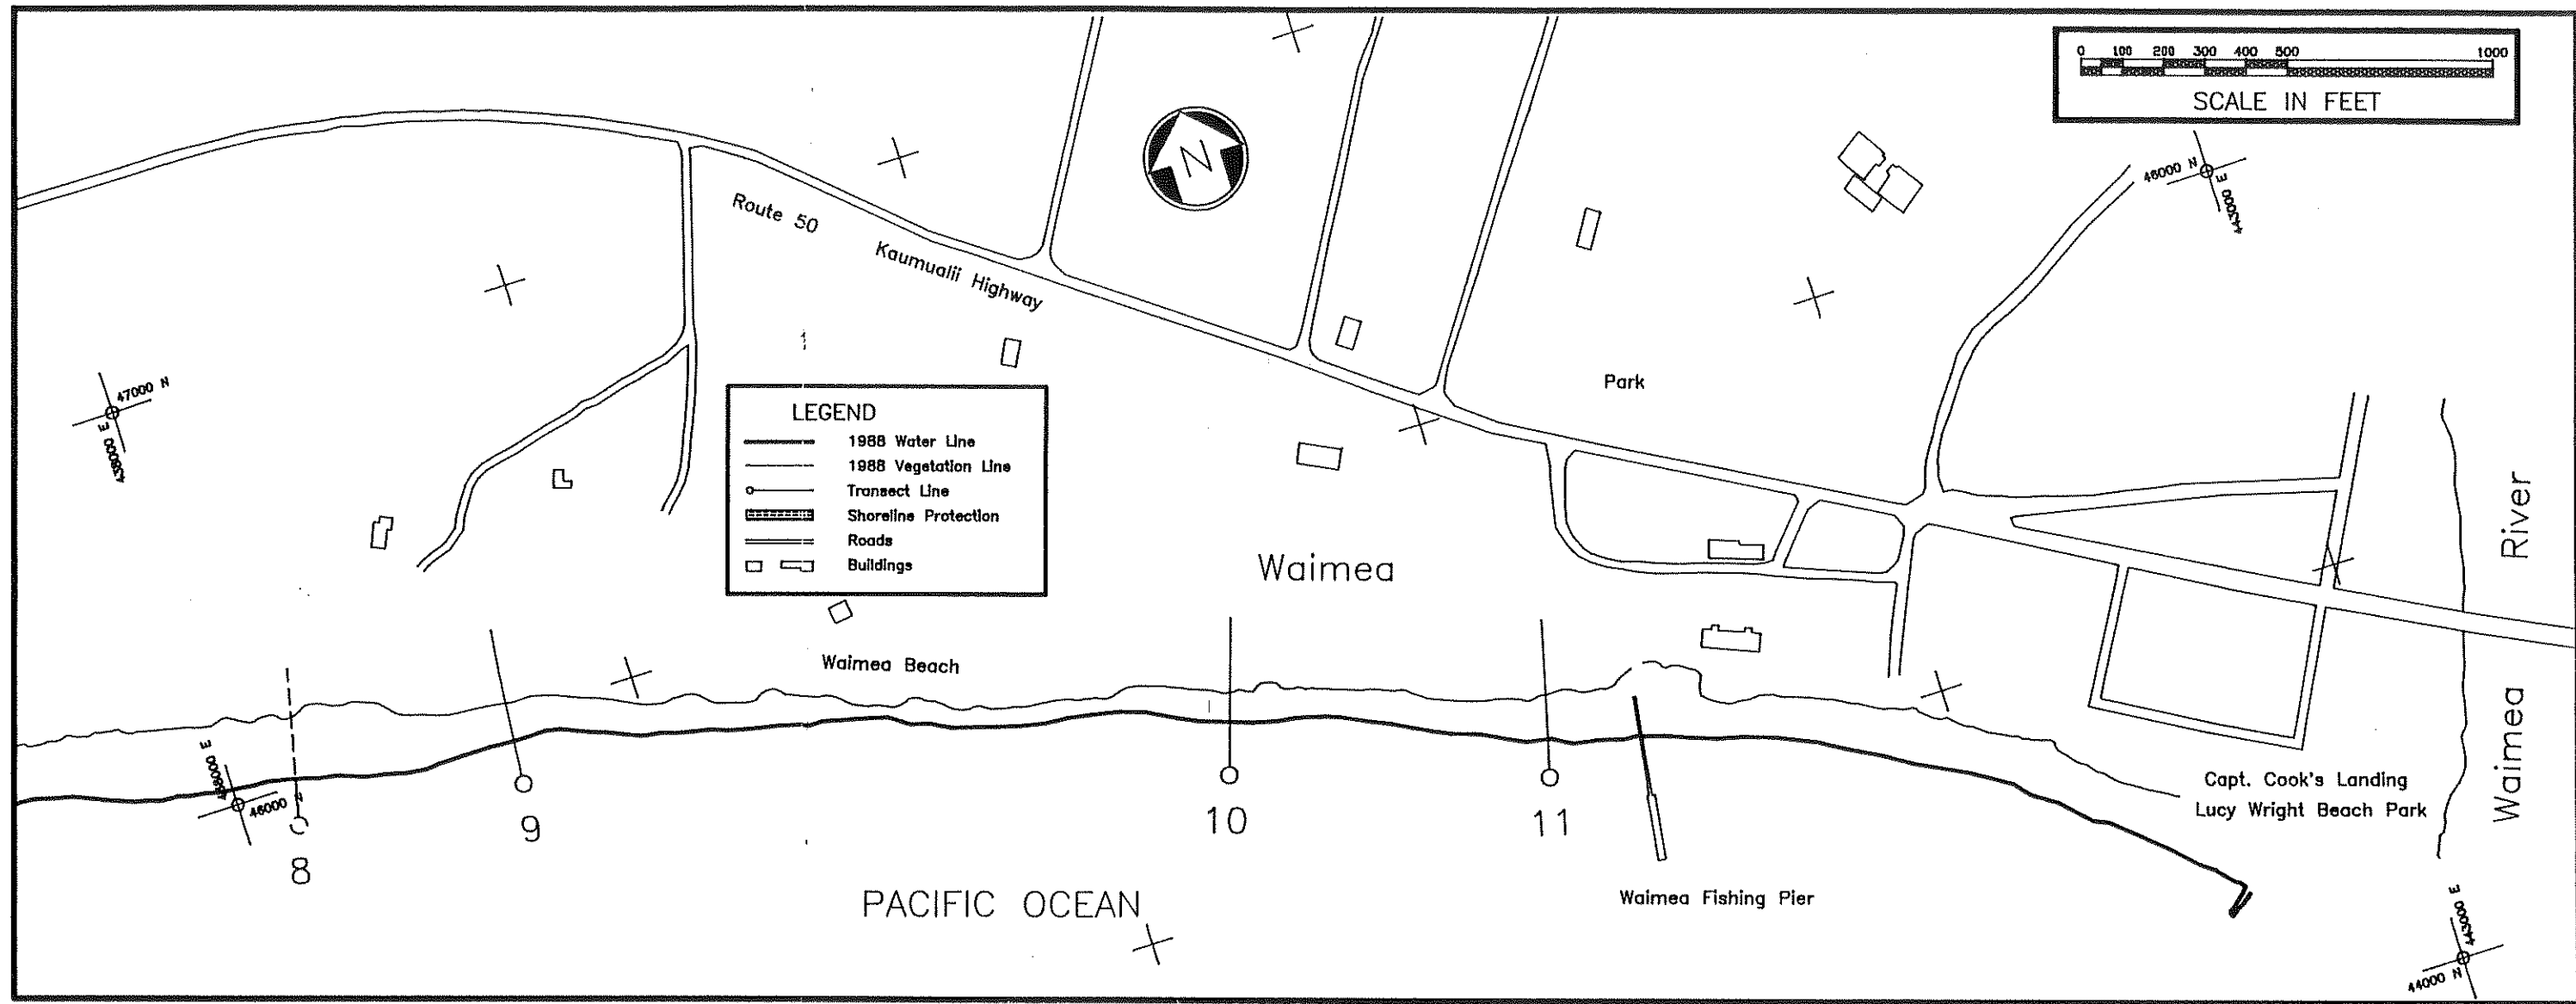
**FIGURE KA-3**

- Severe erosion in this subsector was reversed by construction of the Kikiaola Small Boat Harbor in 1959.

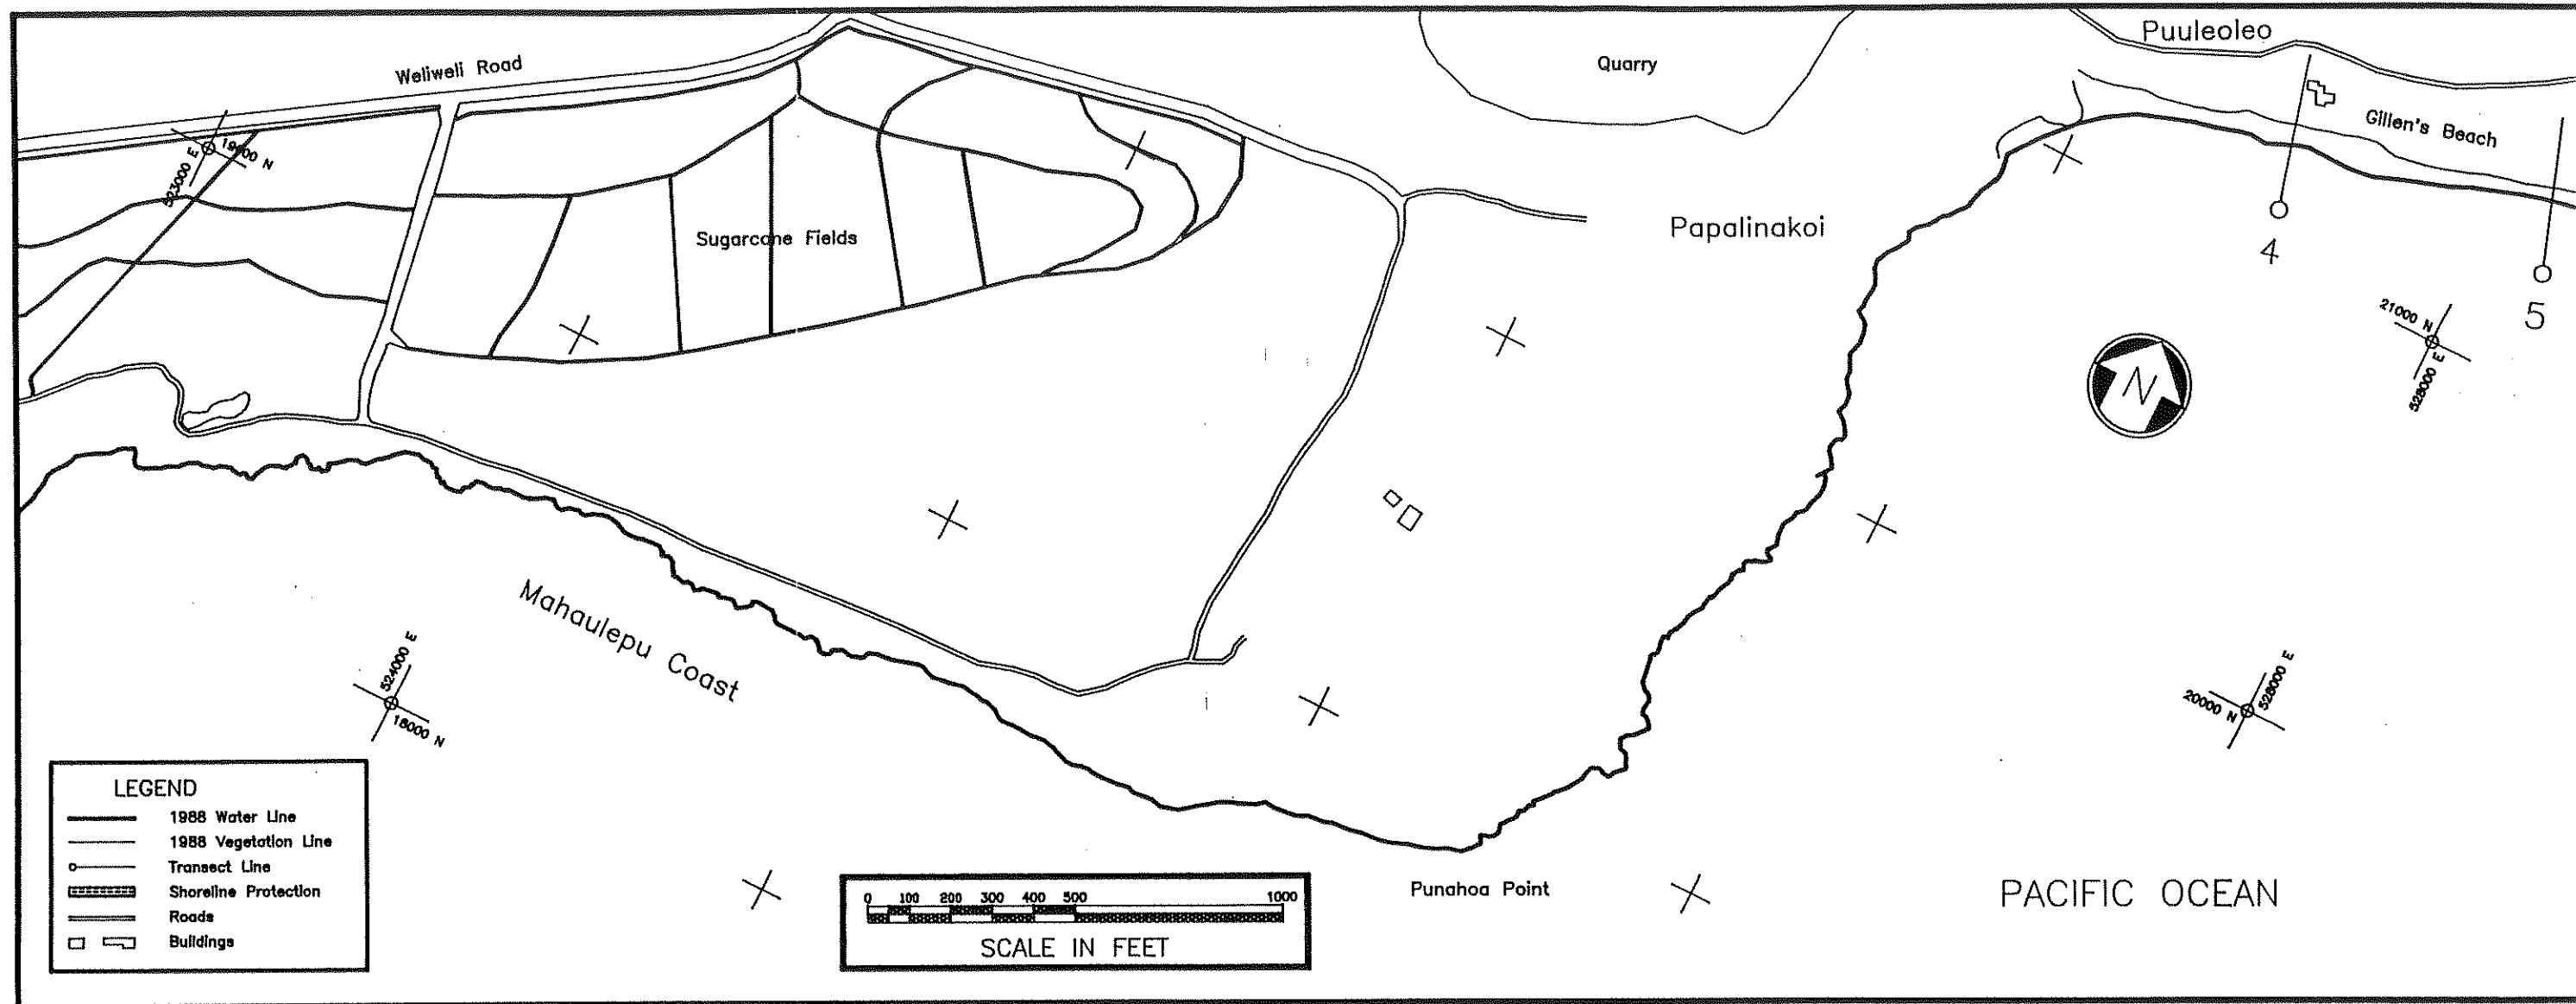
**FIGURE KB-2**

- Gillen's Beach is the only sandy beach in this subsector. The beach has eroded slightly since 1963.

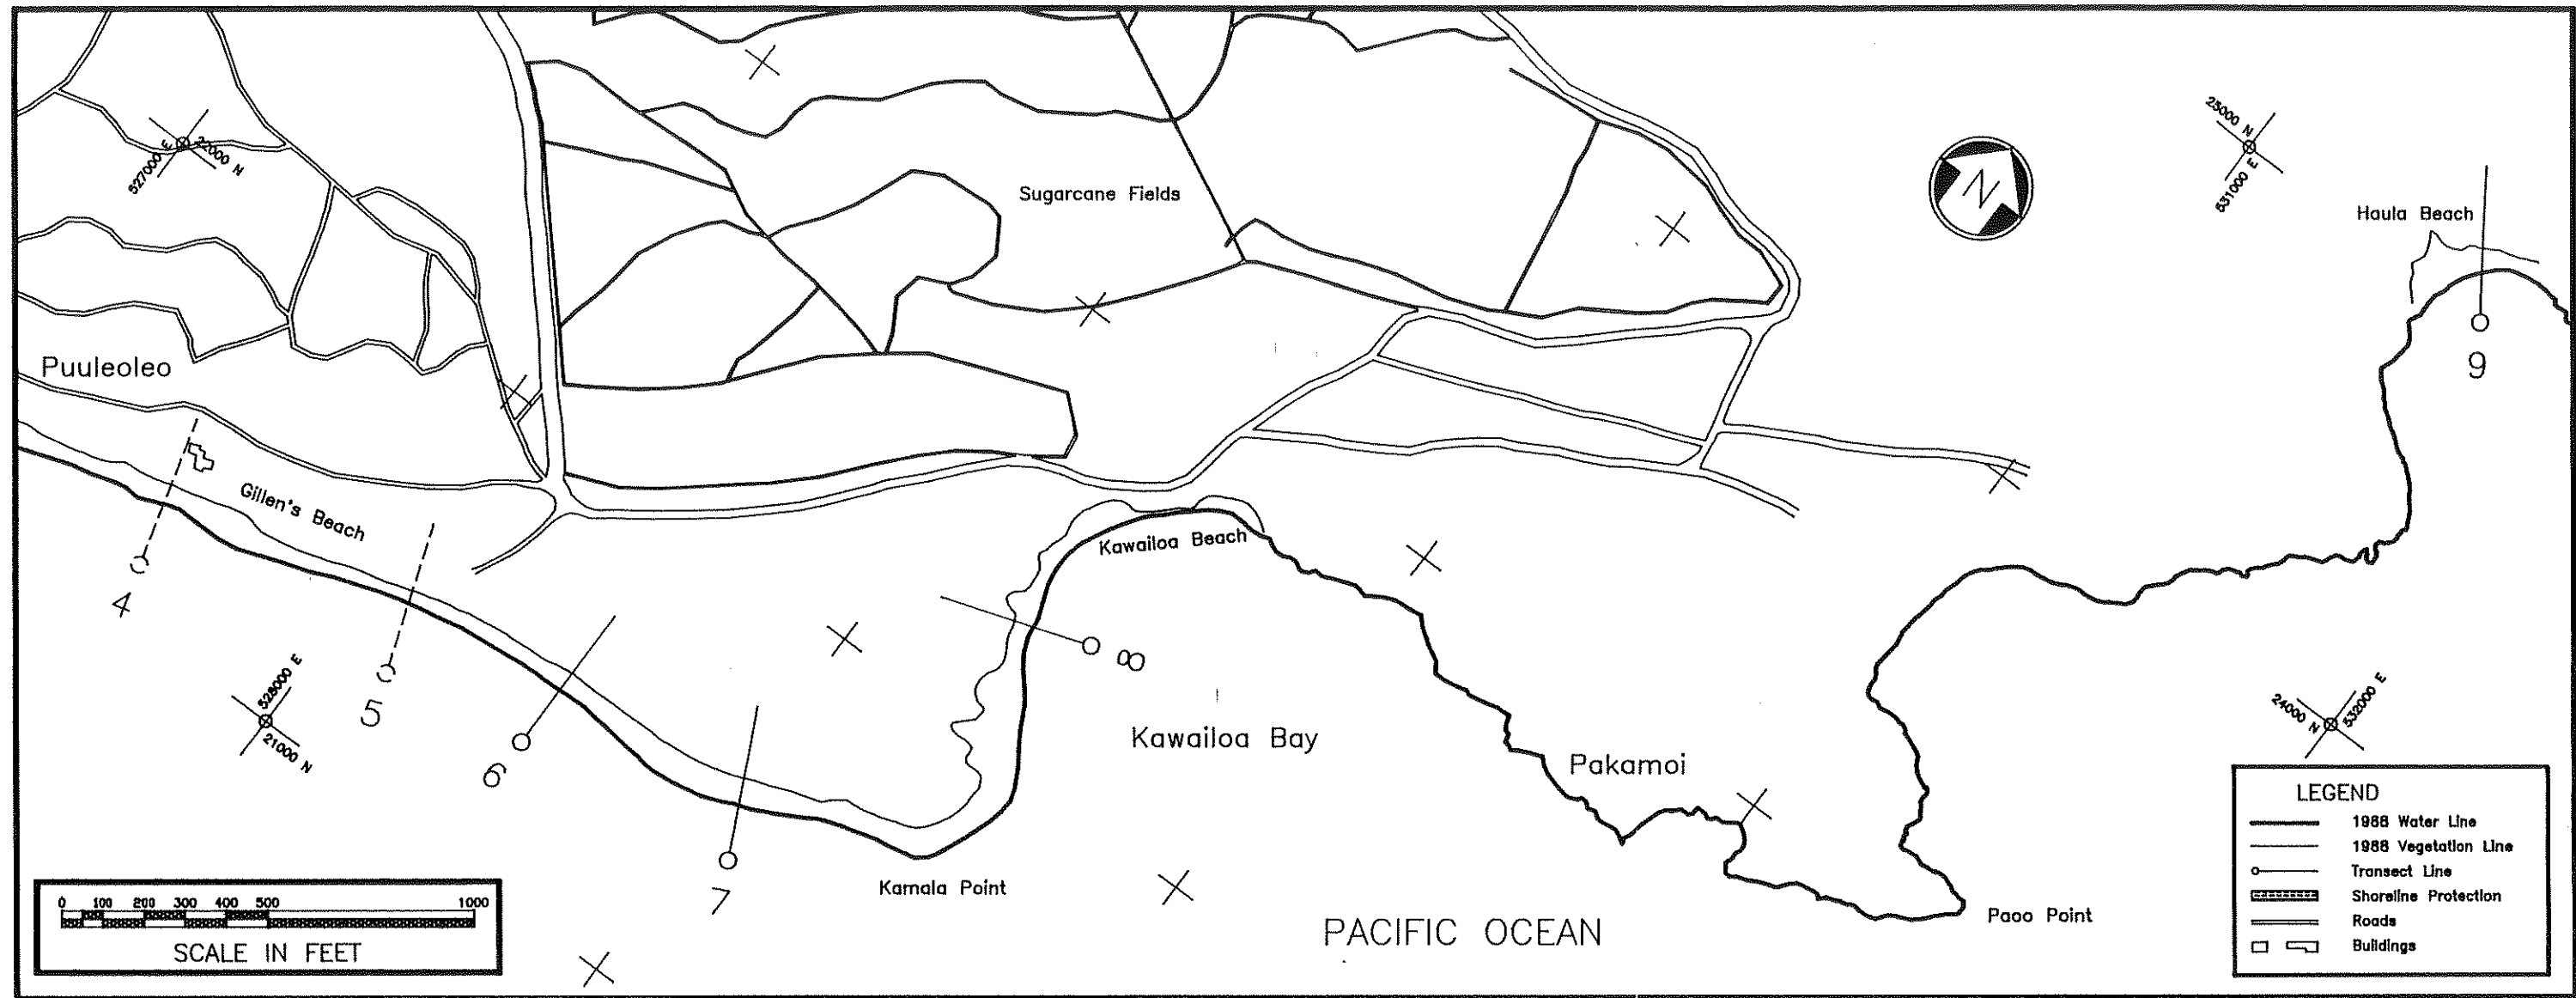
**FIGURE KB-3**

- The backshore in this subsector is undeveloped. the beaches are stable, although they are exposed to Kona storm waves.

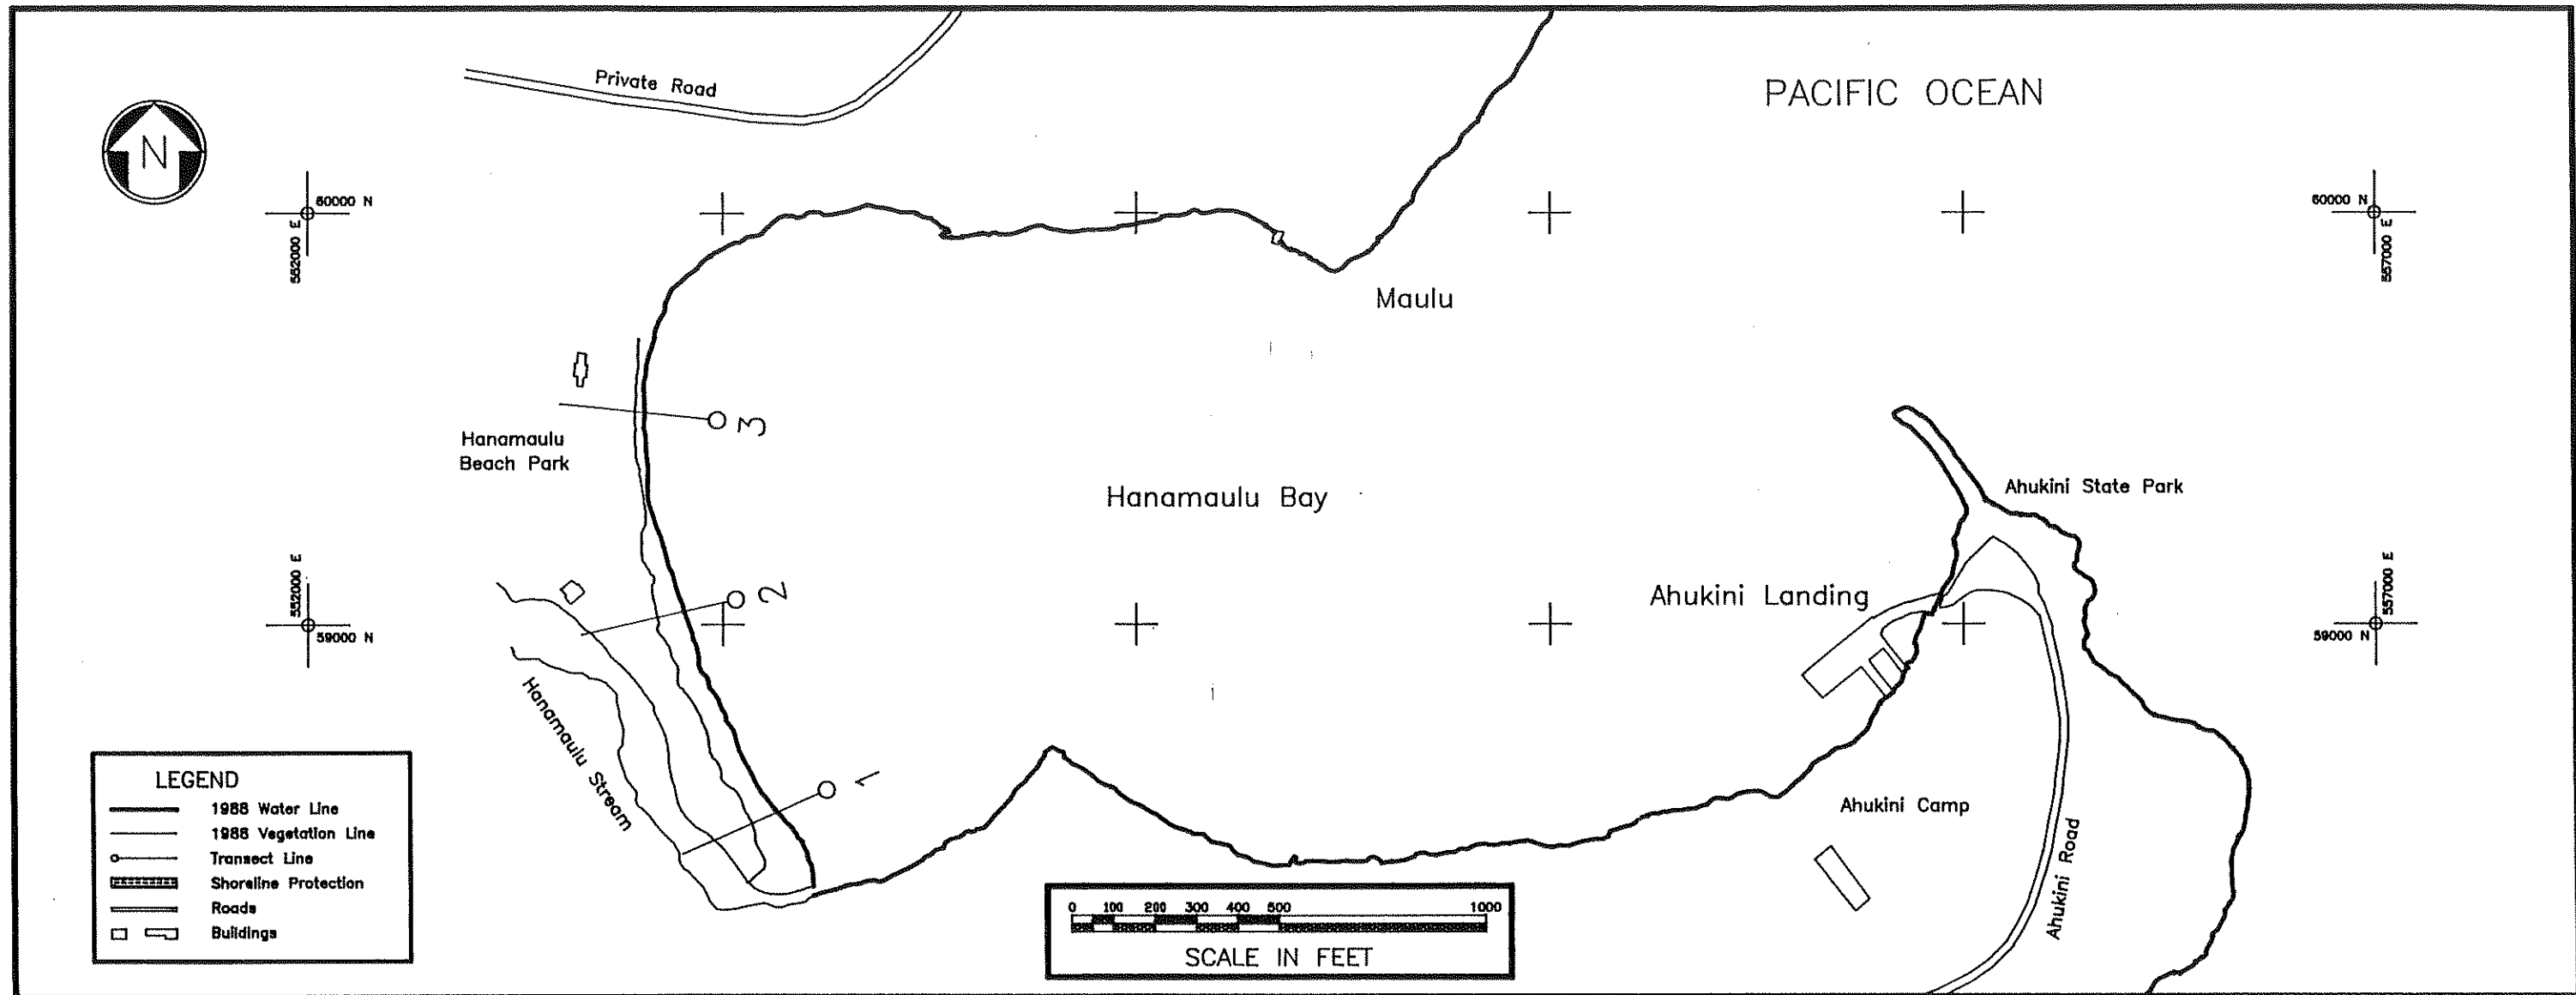
**FIGURE KC-1**

- The south end of the beach is relatively dynamic, and probably affected by the river discharge. The erosion of the middle section of the beach, although relatively steady, does not pose a threat to structures or park facilities at this time. No significant erosion was apparent at the time of the site visit.

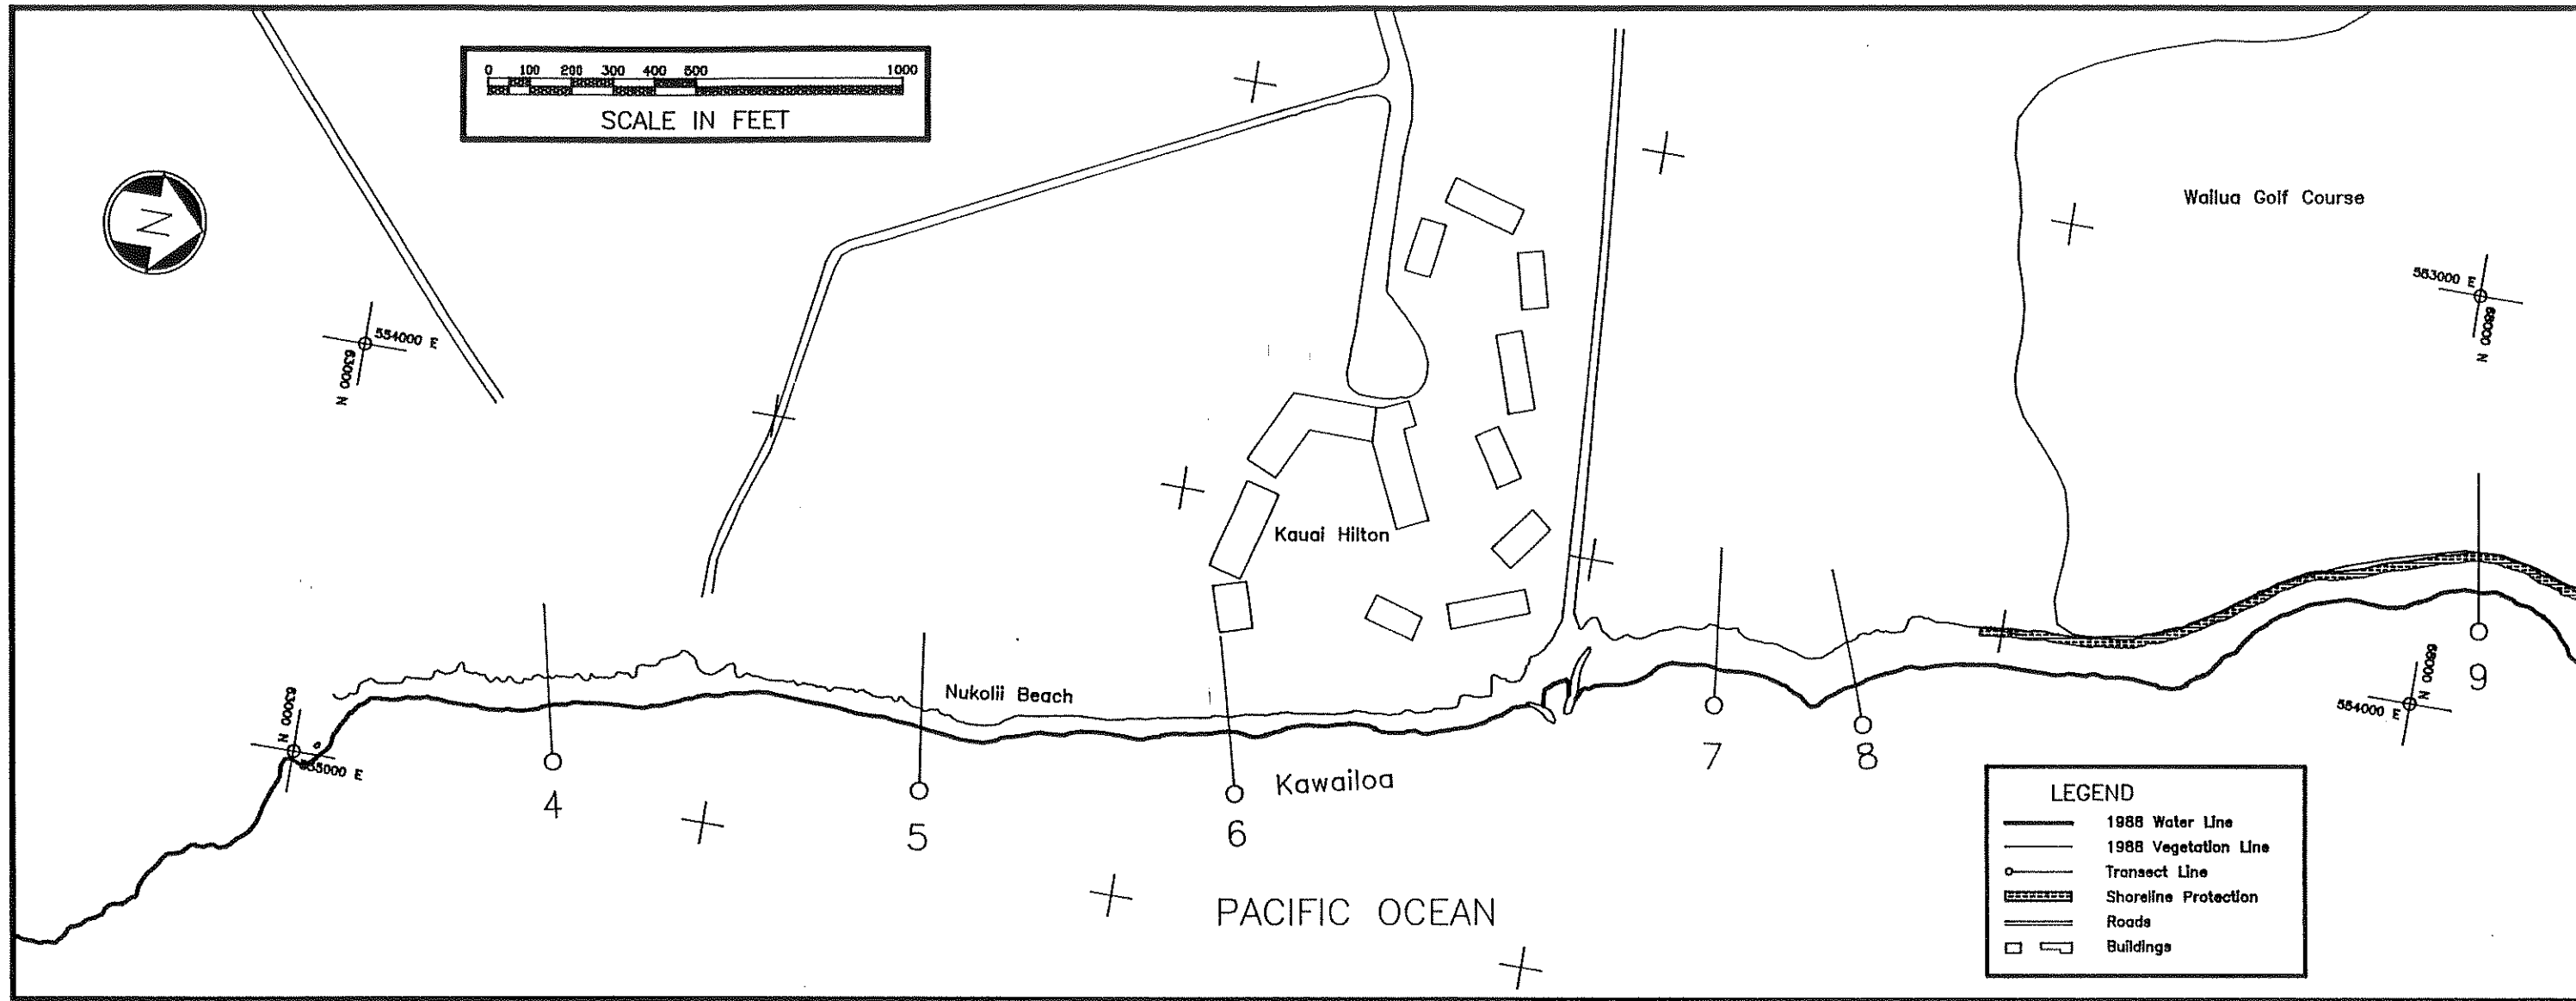
**FIGURE KC-2**

- The southern half of this subsector is relatively stable, due to the extensive beachrock outcroppings at the waterline. Erosion is ongoing in front of the Kauai Hilton. No structures are threatened. The northern half of the subsector has been subject to severe, chronic erosion since 1950.

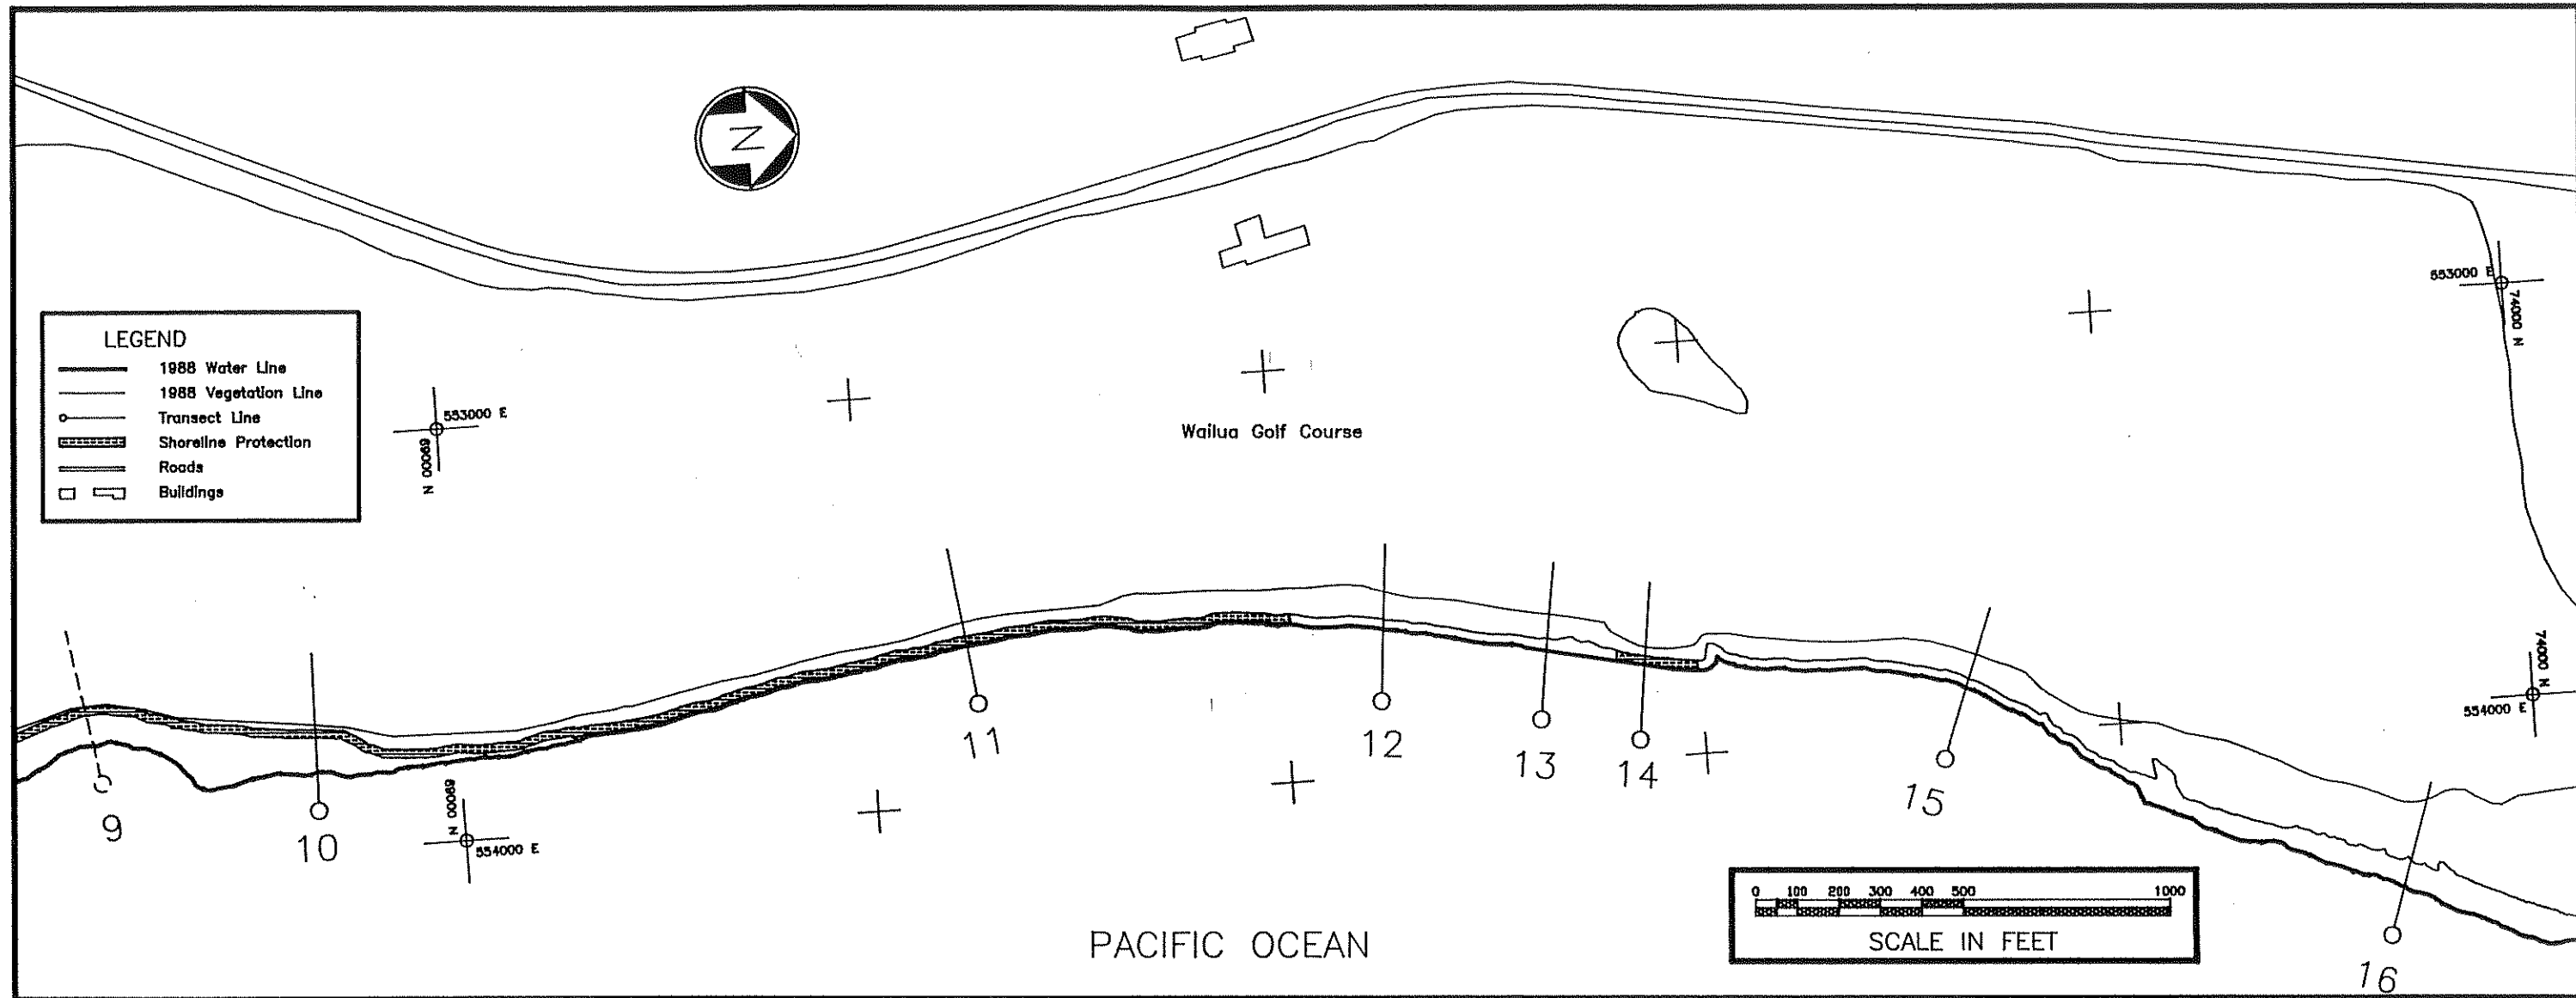
**FIGURE KC-3**

- The southern half of the beach in this subsector has been subject to chronic, long term erosion. Part of the golf course was built very close to the unstable vegetation line, and a revetment was built to protect the course. Most of Subsector KC-3 is now committed to shore protection, and the littoral processes for most of this shoreline length have probably been affected by the shore protection.

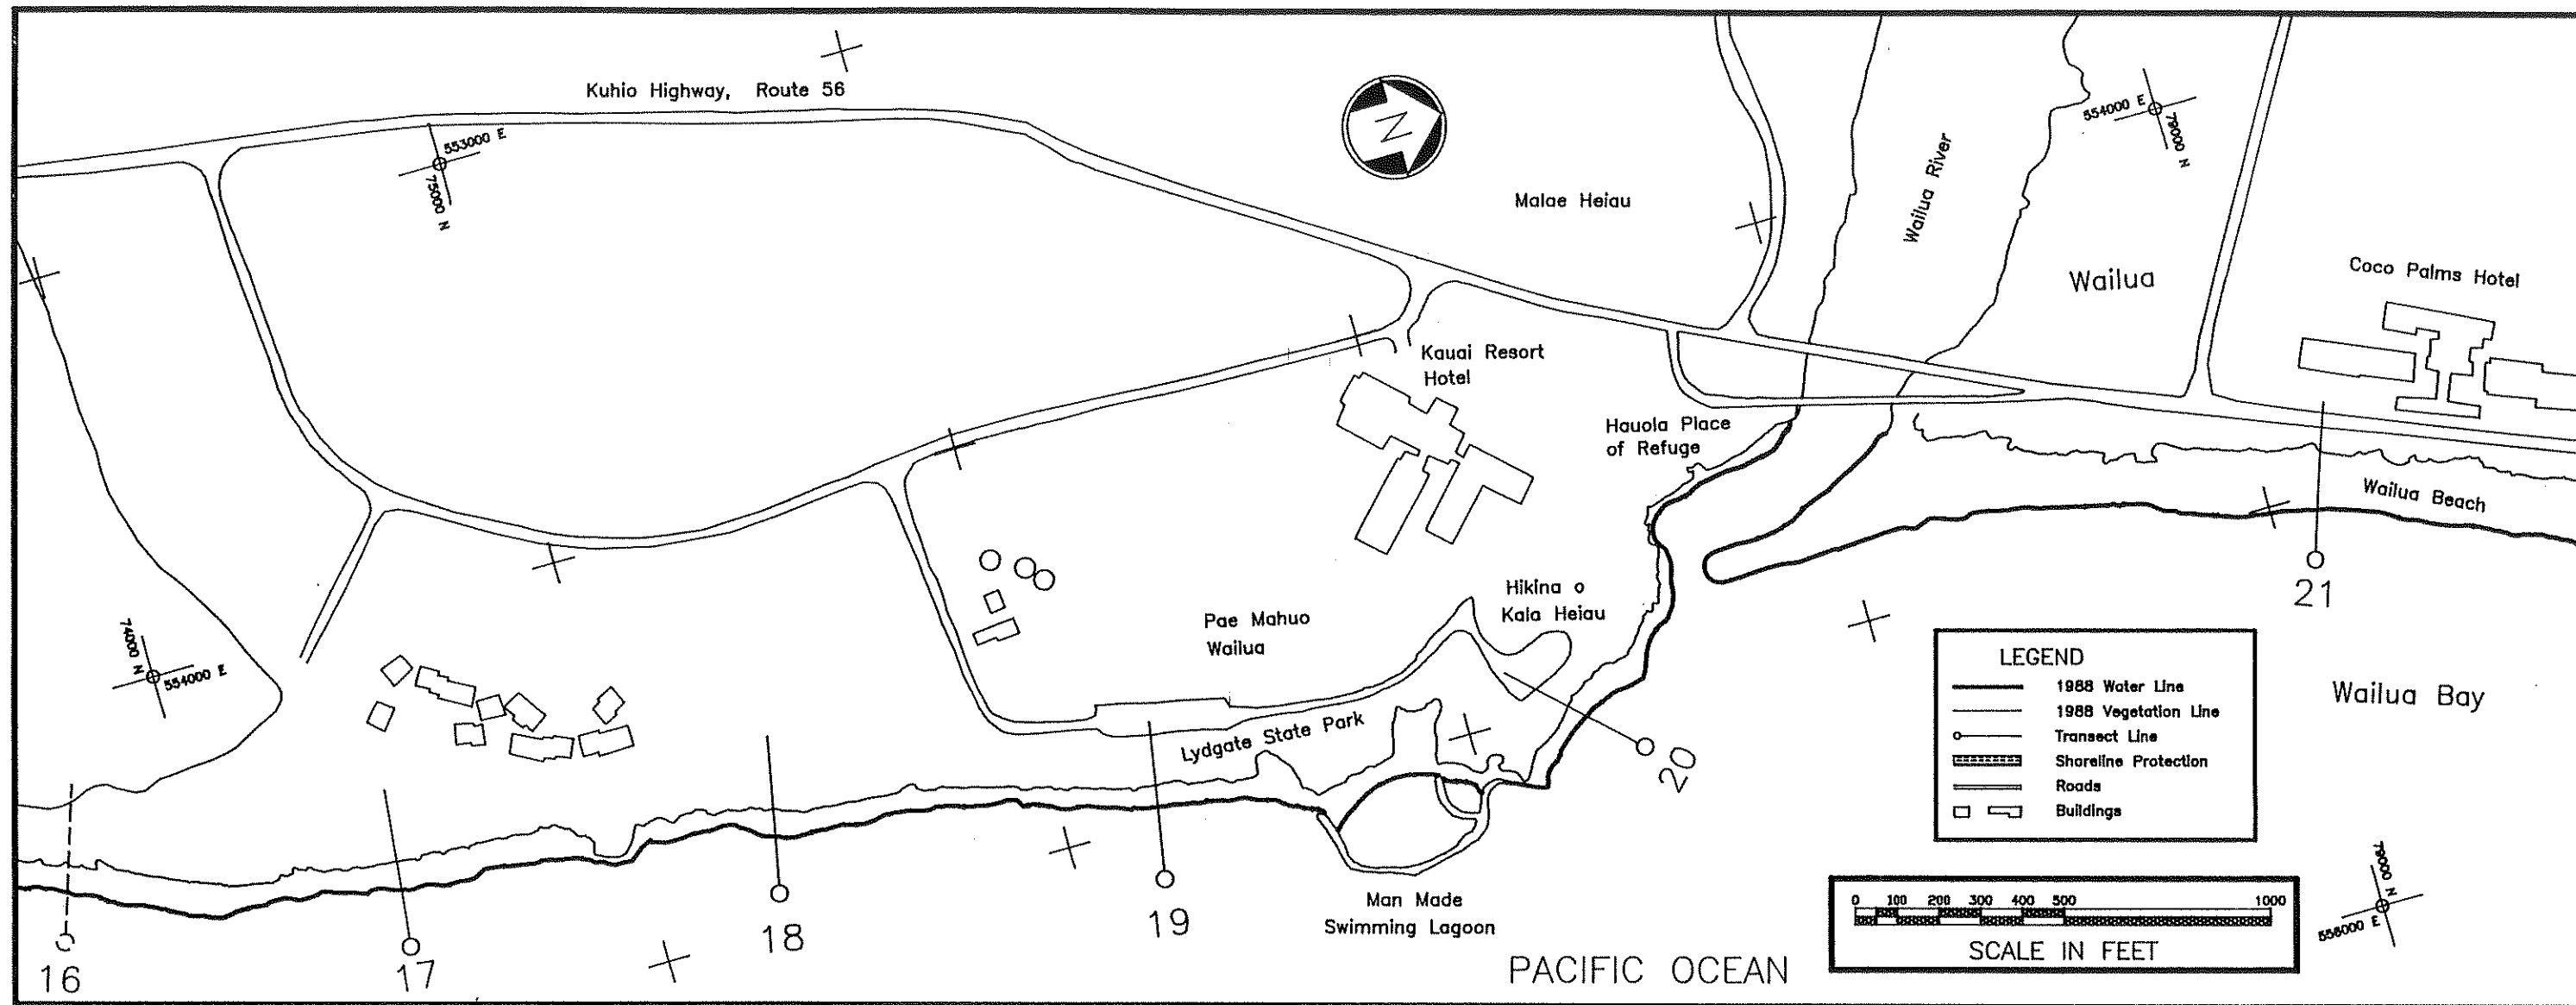
**FIGURE KC-4**

- This beach subsector is relatively stable, except for the area between the Wailua River and Lydgate State Park. Except for the man-made swimming area at Lydgate State Park, all structures are set well back from the vegetation line.
