# AERIAL PHOTOGRAPHY ANALYSIS OF COASTAL EROSION ON THE ISLANDS OF KAUAI, MOLOKAI, LANAI, MAUI AND HAWAII

JUNE, 1991

**PREPARED BY:**  
**MAKAI OCEAN ENGINEERING, INC**  
**and**  
**SEA ENGINEERING, INC.**  
**Honolulu, Hawaii**

**PREPARED FOR:**  
**STATE OF HAWAII**  
**OFFICE OF STATE PLANNING**  
**COASTAL ZONE MANAGEMENT**  
**PROGRAM**

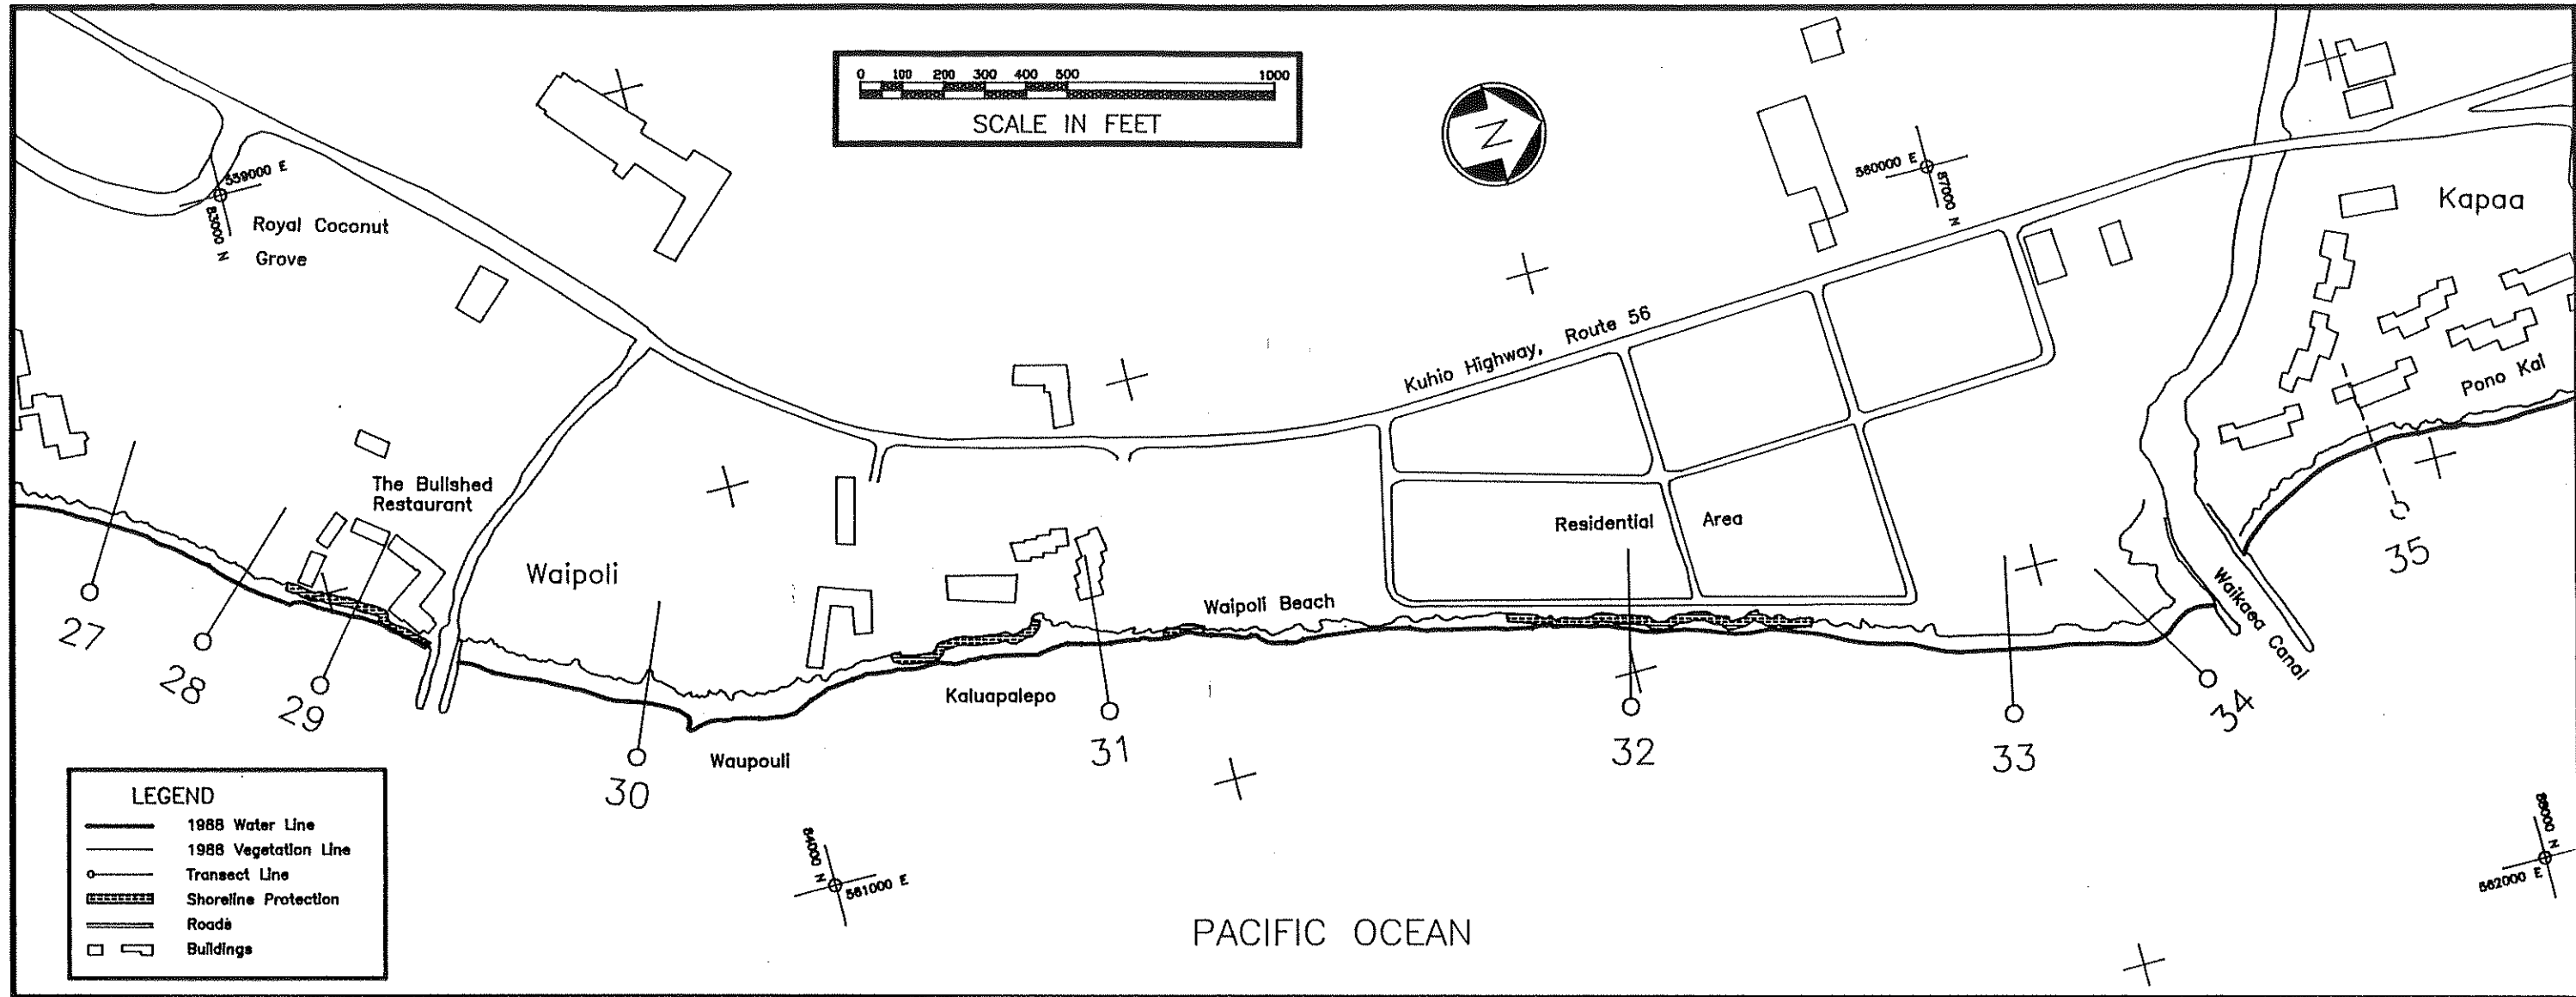
**FIGURE KC-6**

- The beach south of the small drainage canal (Regions 28 and 29) is eroding, and a vertical seawall protects the foundation of The Bullshed, a popular restaurant.

- Waipoli Beach has been extensively modified by the jetties, groins, revetments and seawalls that have been constructed over the past years. The developments have been placed very close to the vegetation line, and any recession of the vegetation line presents a threat to the structures; shore protection is then constructed.
- Severe erosion is occurring in front of the residential area. The houses are set back but the road along the beach crest may be threatened. This is an area where the data from the photographs do not indicate the actual erosion. Overhanging ironwood trees preclude digitizing an accurate vegetation line.

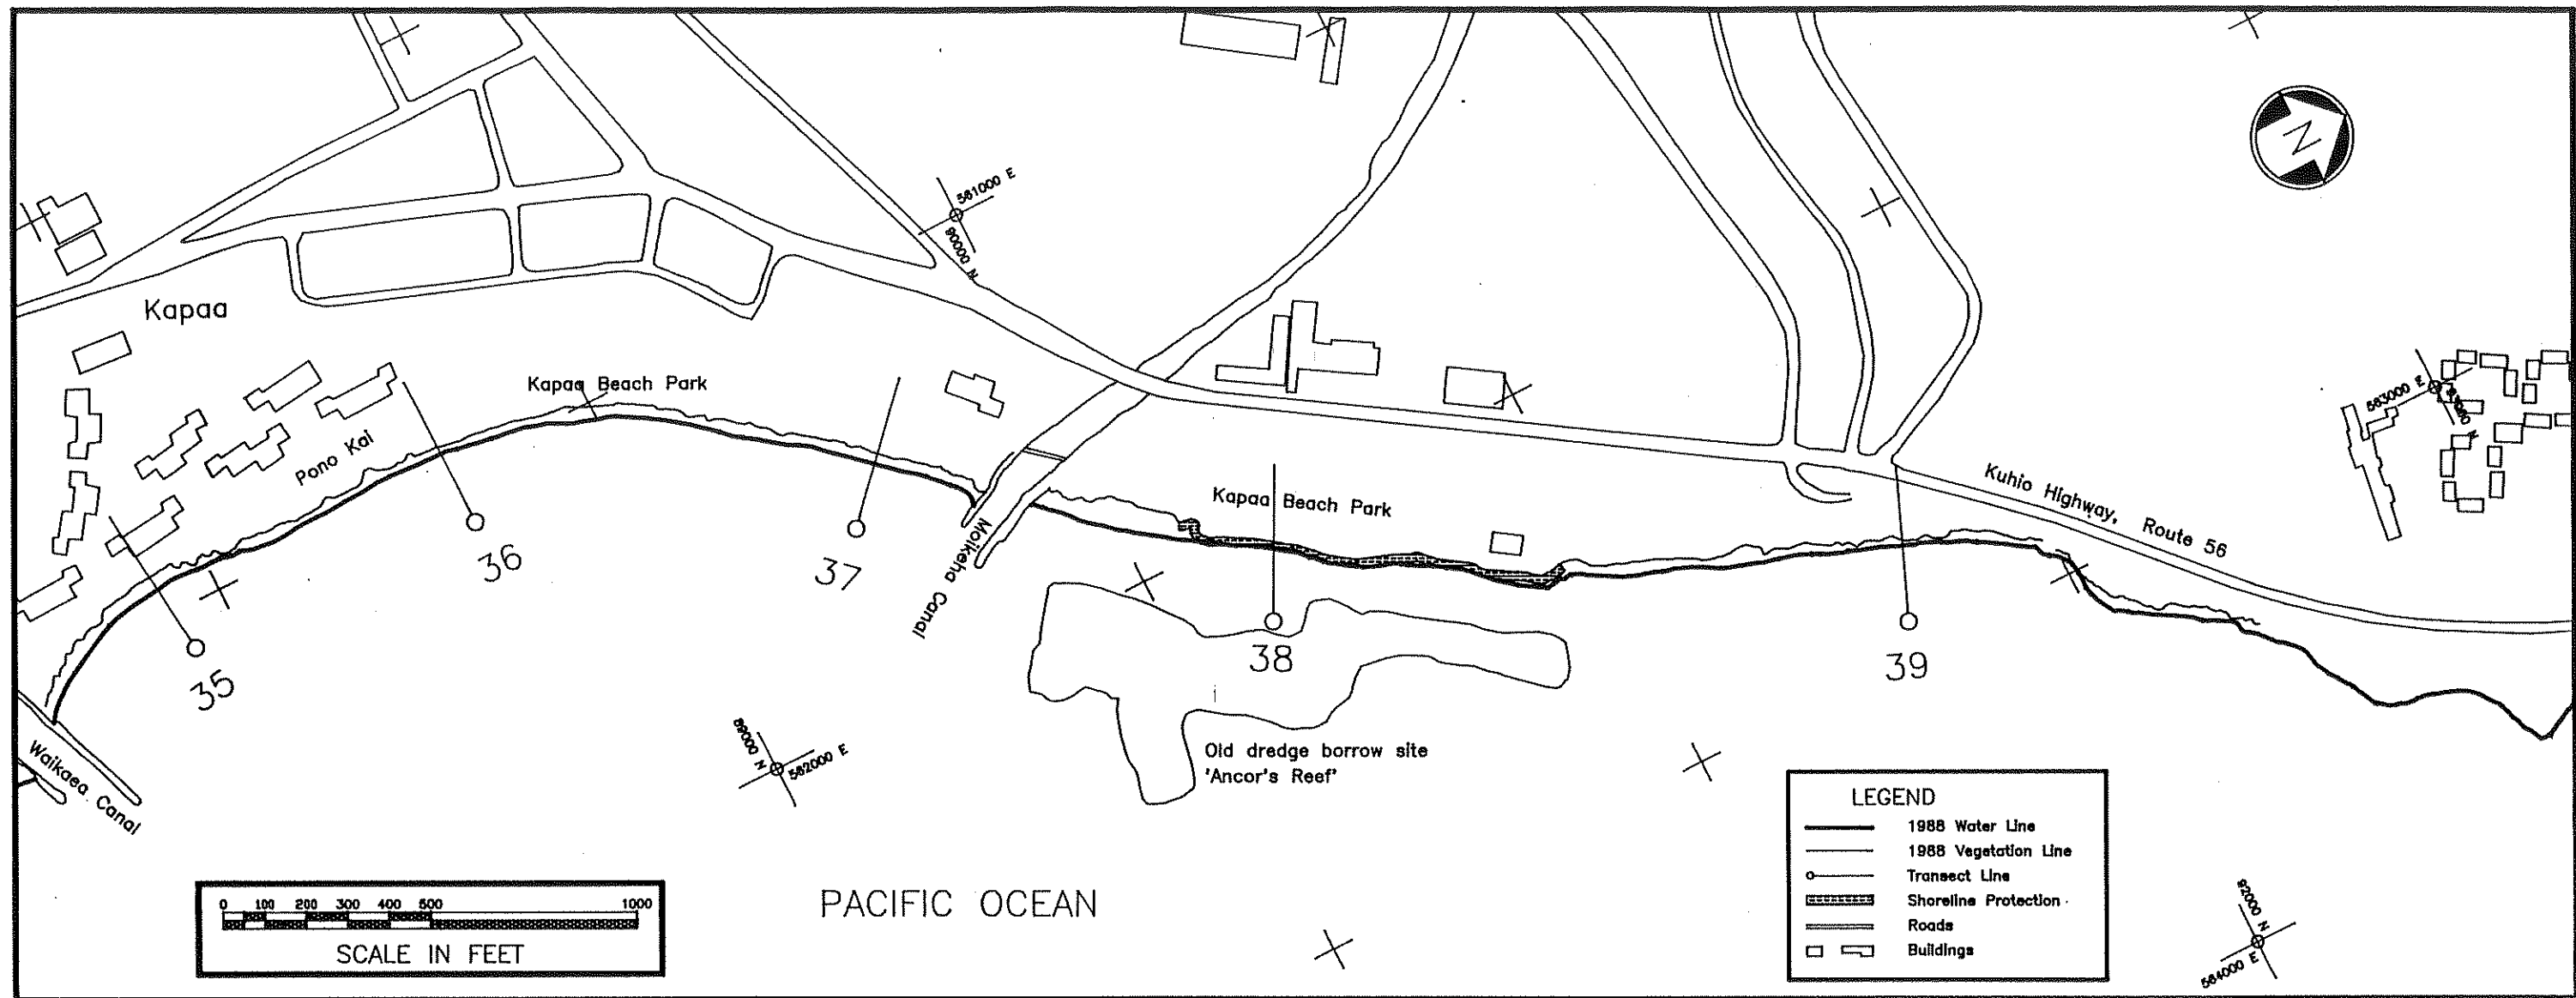
**FIGURE KC-7**

- Kapaa Beach is similar to Waipoli Beach to the south in that it has been extensively modified by man's activities. The most notable modification was the dredging of the borrow pit on the Kapaa Reef, which resulted in severe shoreline erosion. Fortunately, most of the development in this area is set back from the vegetation line.
- Severe erosion is also occurring at the Pono Kai Resort, but the buildings are set back from the vegetation line.

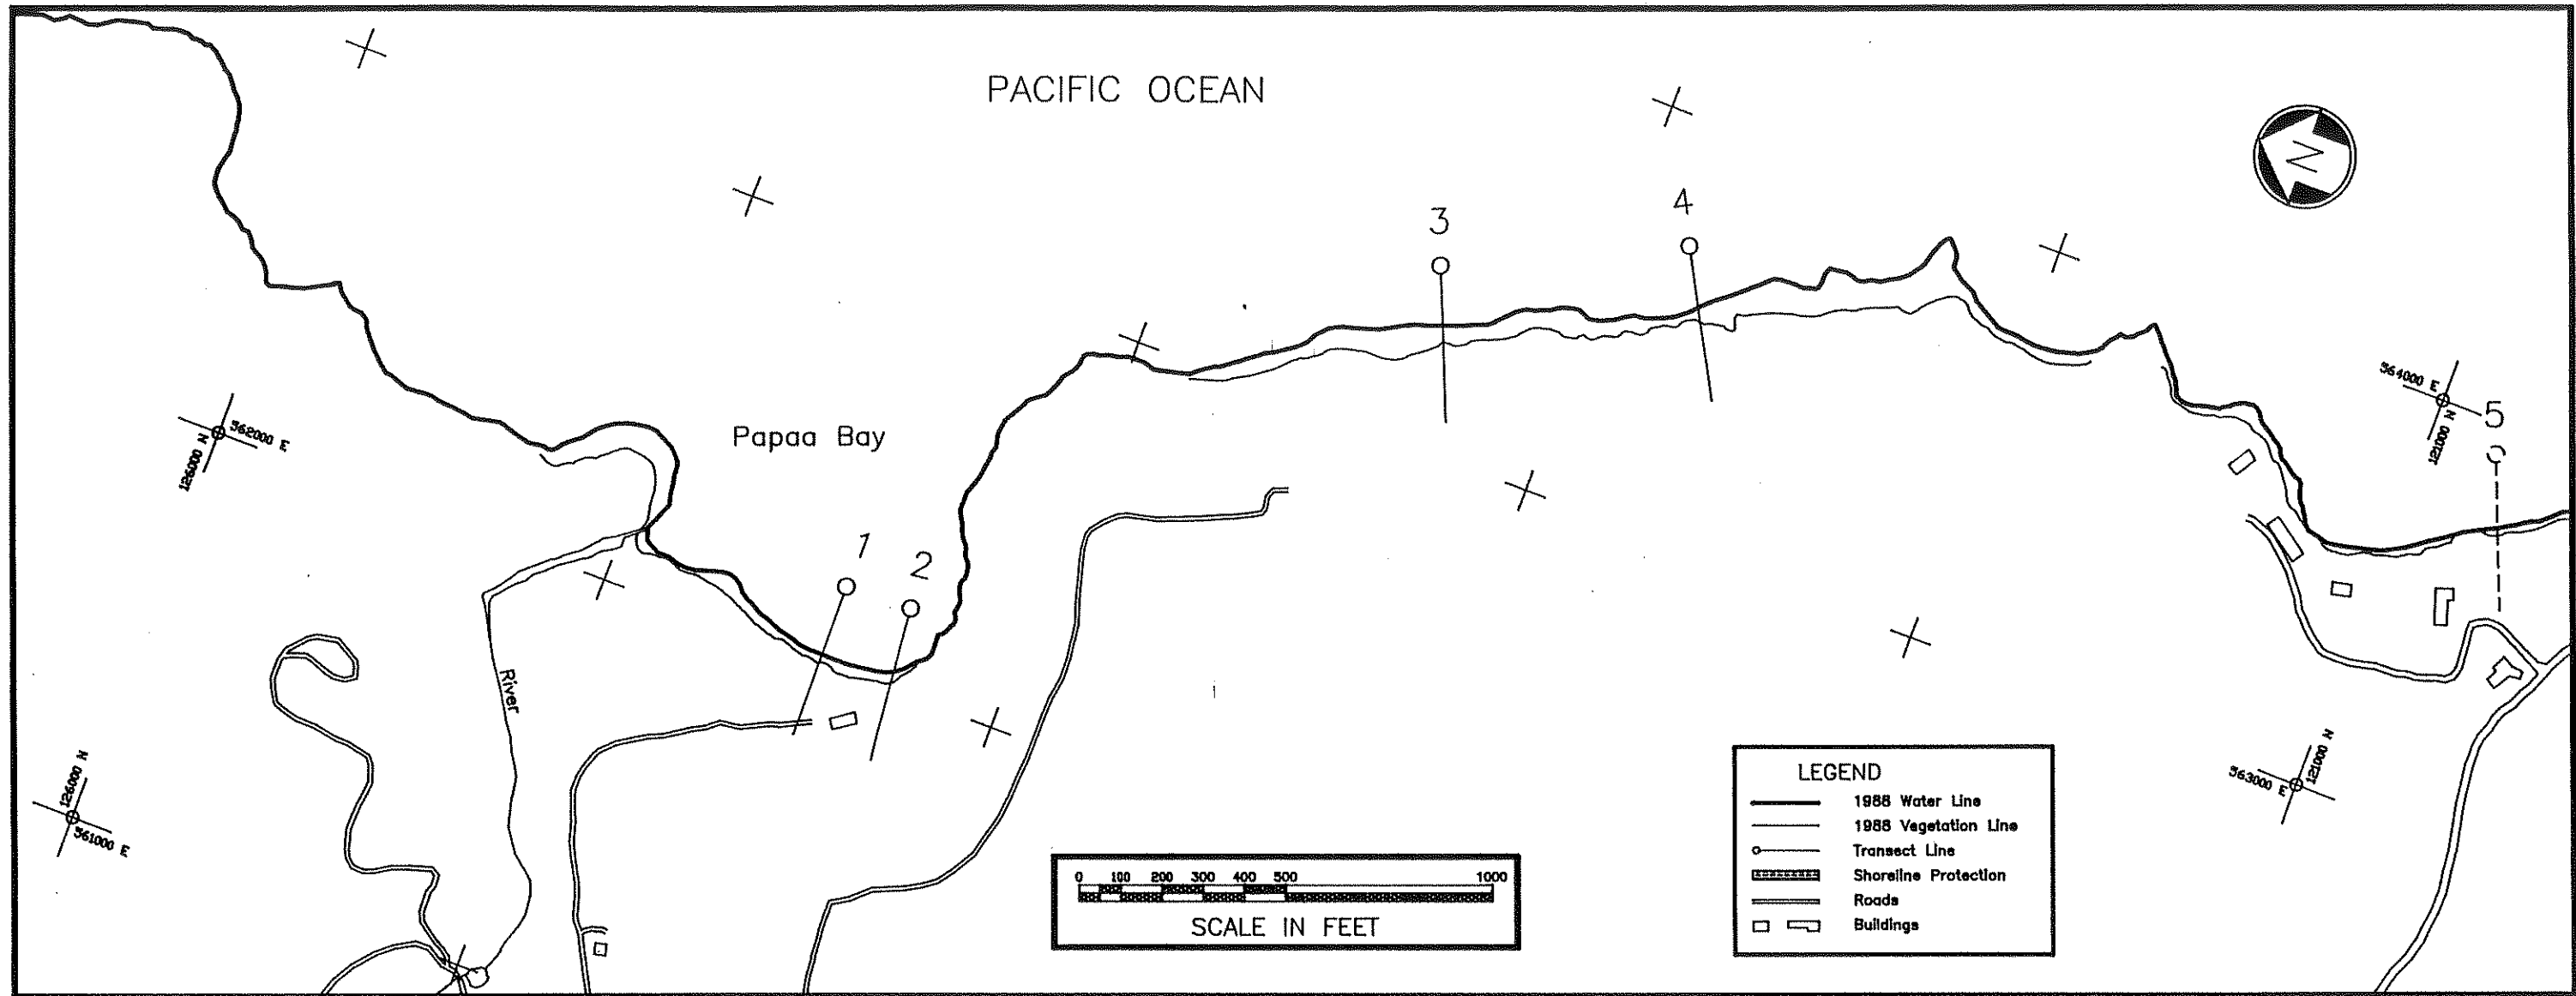
FIGURE KD-1

- Both beaches in this relatively undeveloped subsector are stable. Any development at Papaa Bay should be sited conservatively, particularly at the north end.

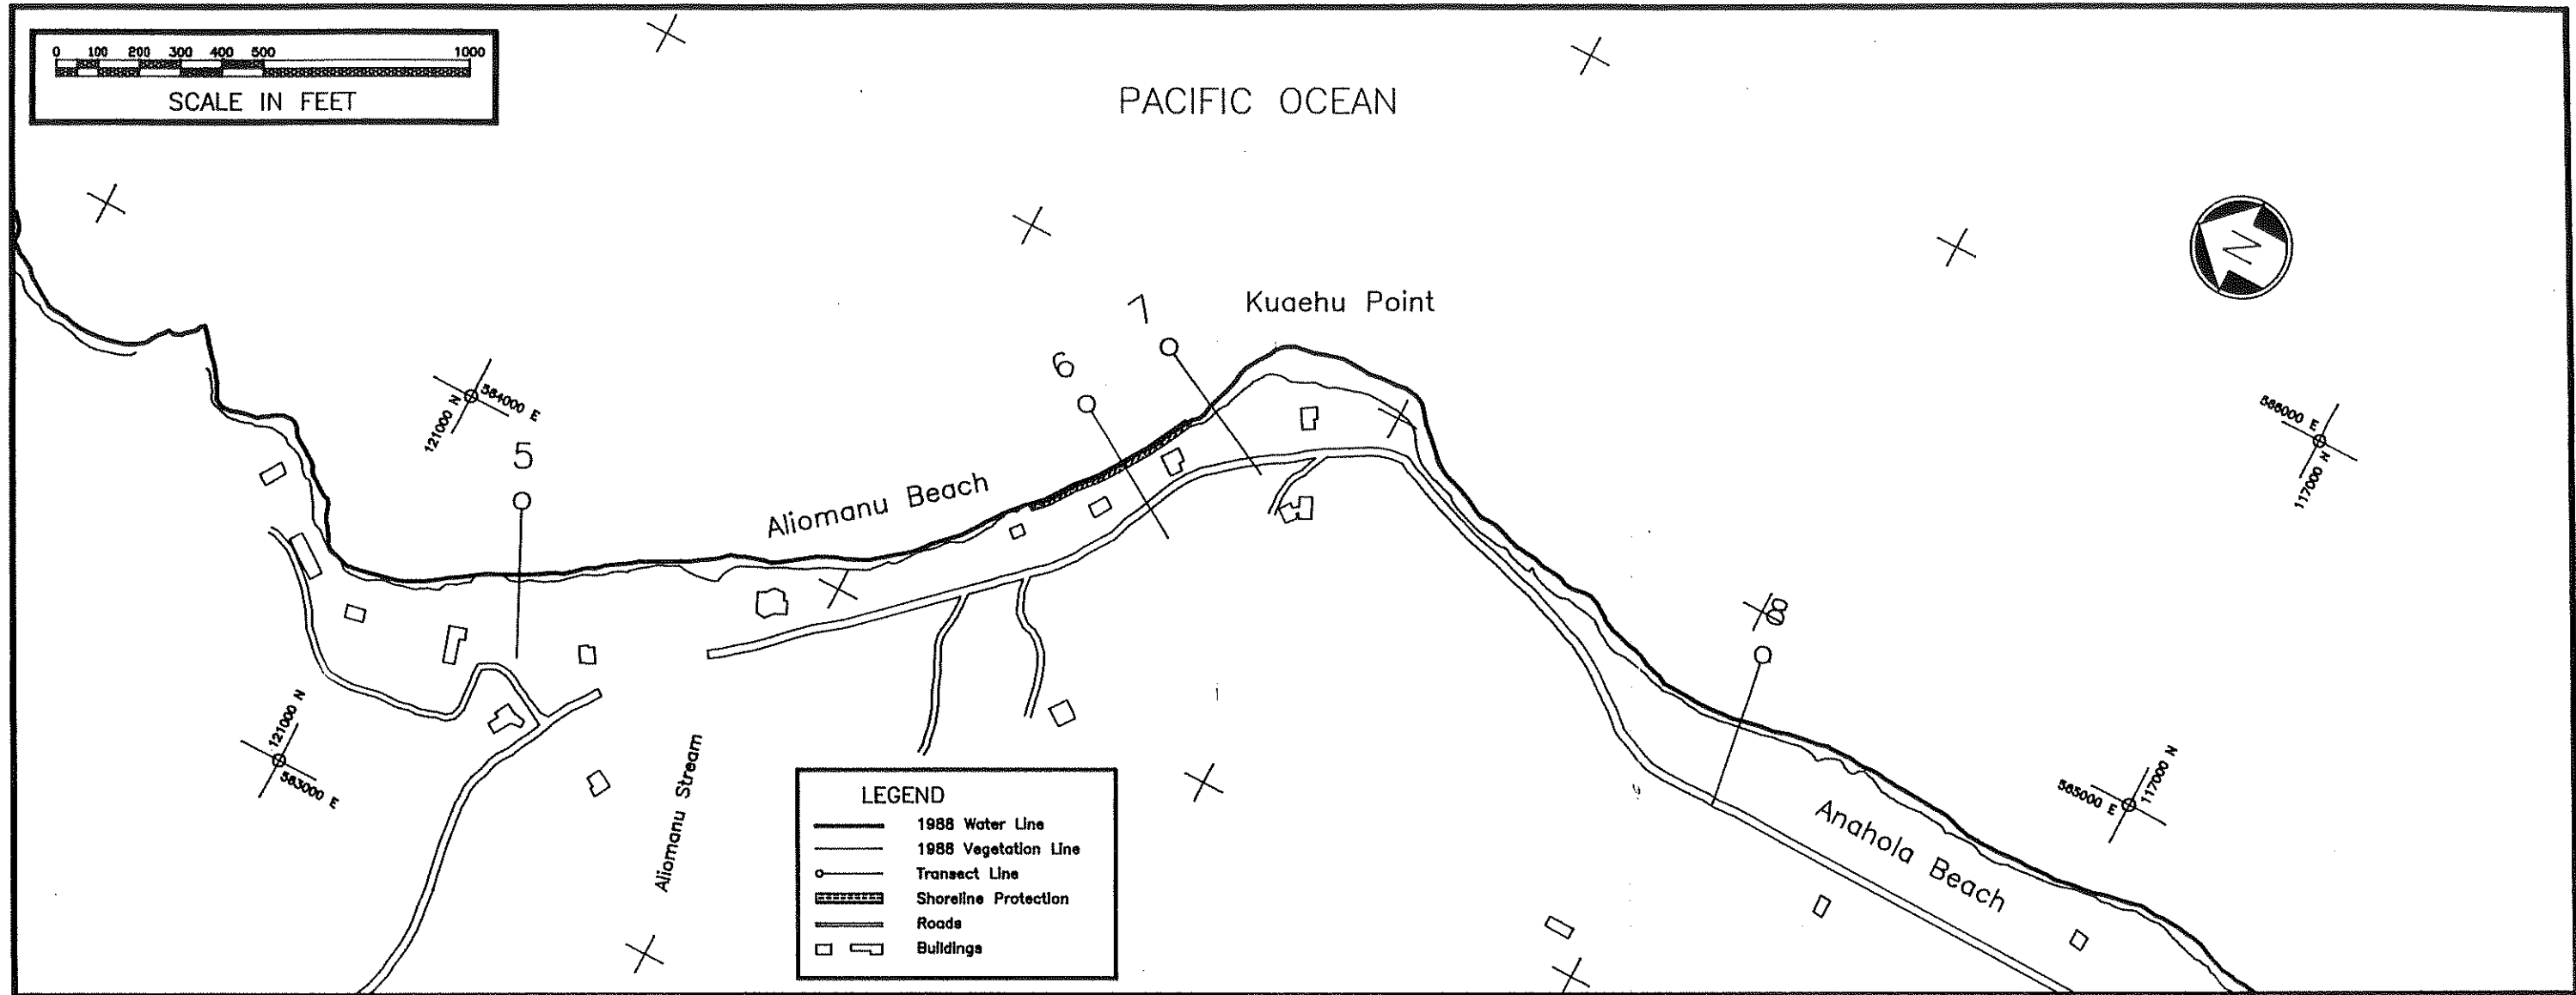
FIGURE KD-2

- The Aliomanu residential area, north of Kuaehu Point, was developed after 1975, and several houses were constructed close to the vegetation line. The south end of this beach is eroding (Regions 6 and 7) and there is now a 450 foot long seawall. There is no dry beach in front of the seawall.
- During the site visit, it was observed that the shoreline is now eroding both north and south of the wall. North of the wall, there is no erosion scarp, but the vegetation overhangs the beach. Tree trunks have been placed along the vegetation line as a temporary revetment. A wave cut erosion scarp, 2 to 3 feet high, extends south of the wall for 200 feet.
- The Anahola residential area was developed prior to 1960, and the slight accretion of the shoreline (Region 8), is similar to that occurring at the north end of subsector KD-3 (Region 9).

- The beaches in this subsector have a relatively small sand volume, making them sensitive to any changes in the sand budget. The shoreline south of Kuaehu Point is stable or slightly accreting.
- The southern part of Aliomanu Beach has a history of erosion and some shore protection has been built. The beach along the entire Aliomanu residential area appears to be stressed and is a potential problem area.

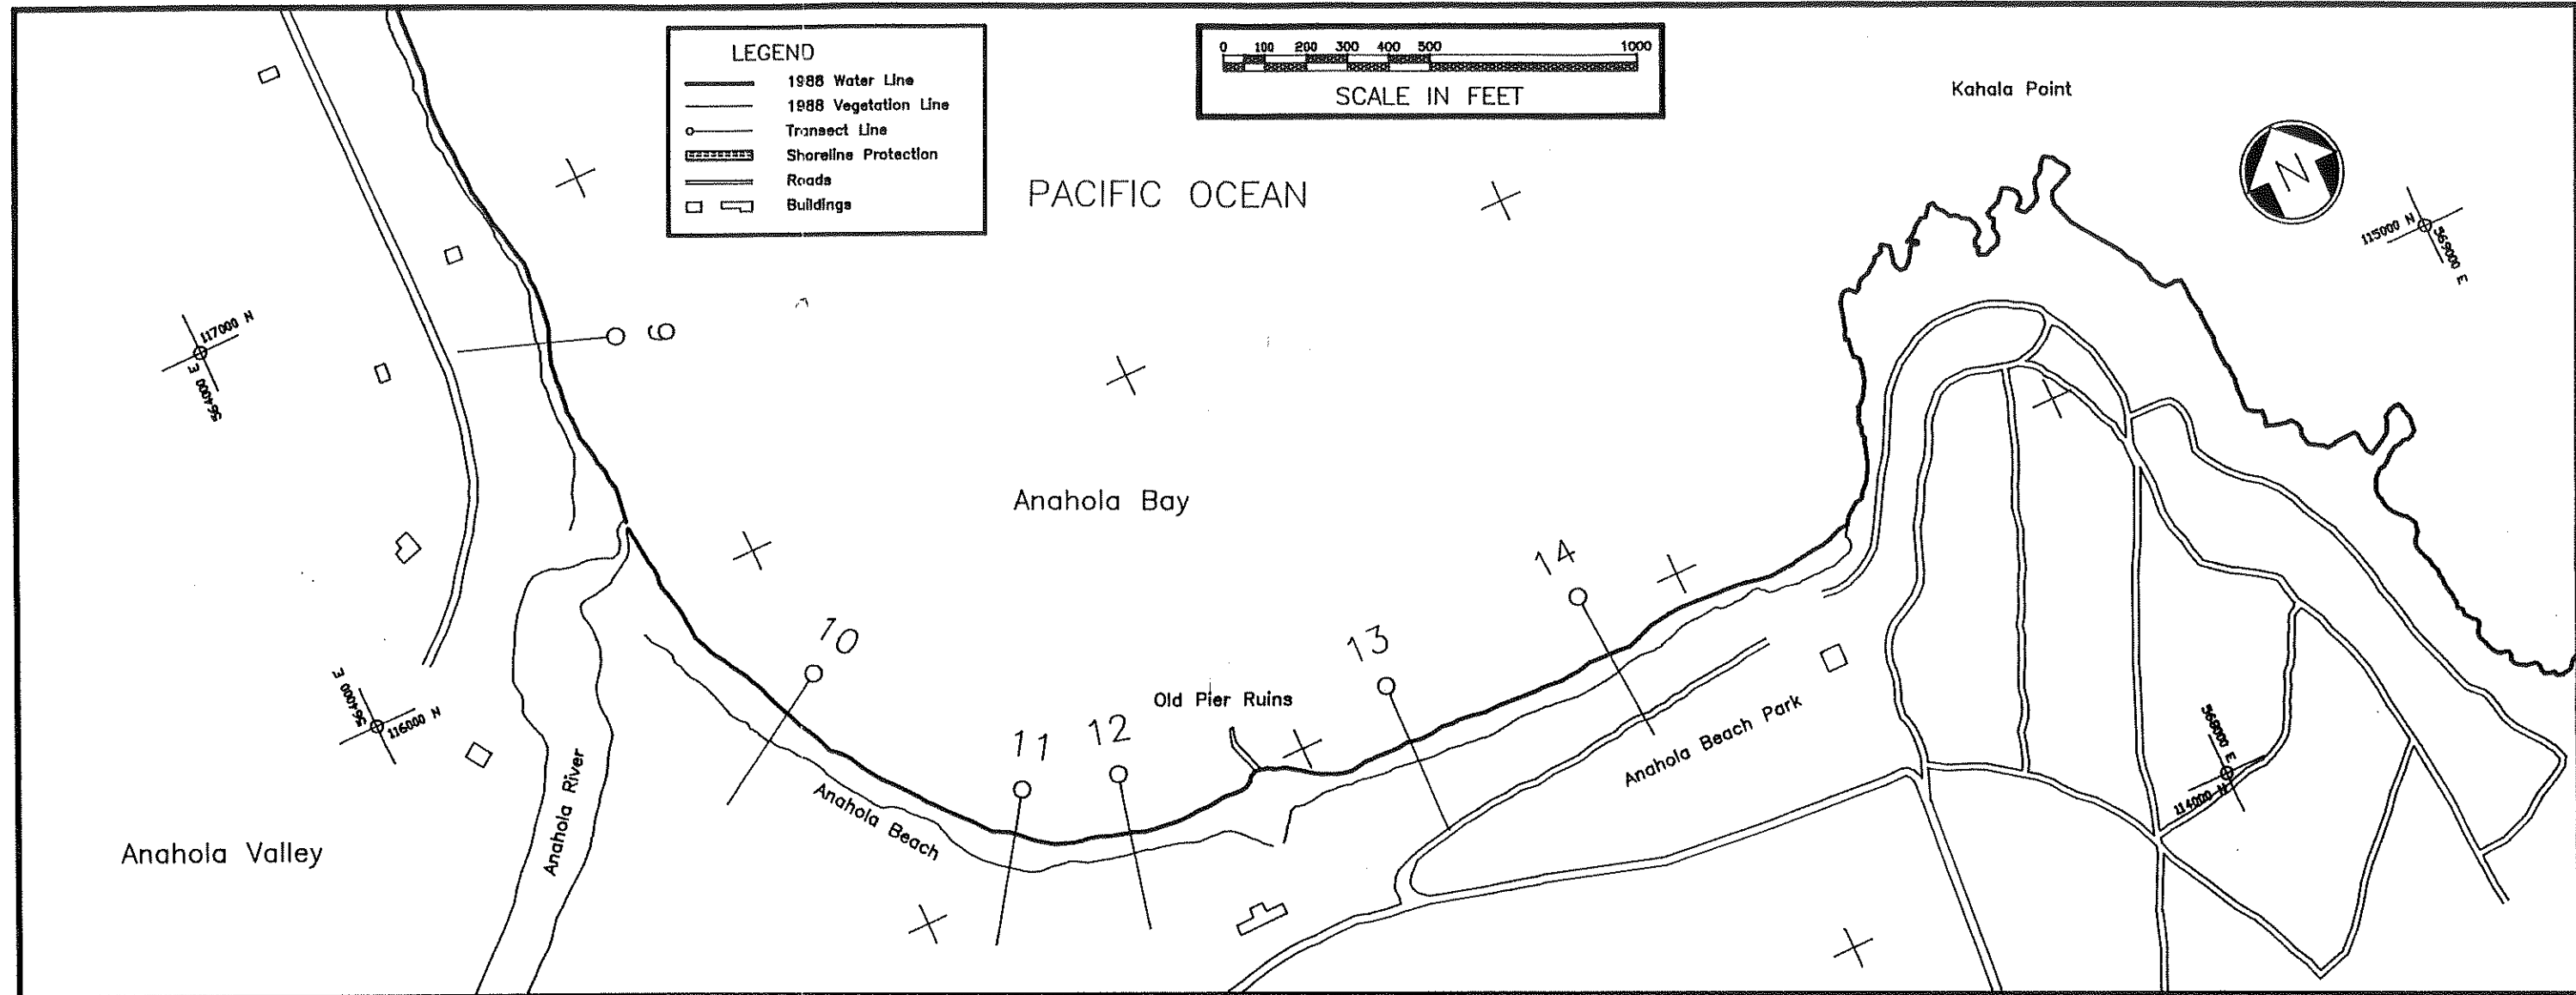
**FIGURE KD-3**

- The center of the beach is dynamic, and park facilities should be kept well back from the shoreline. The residential areas are set back from the shoreline, and there are no apparent erosion problems. There is no shore protection in this subsector.

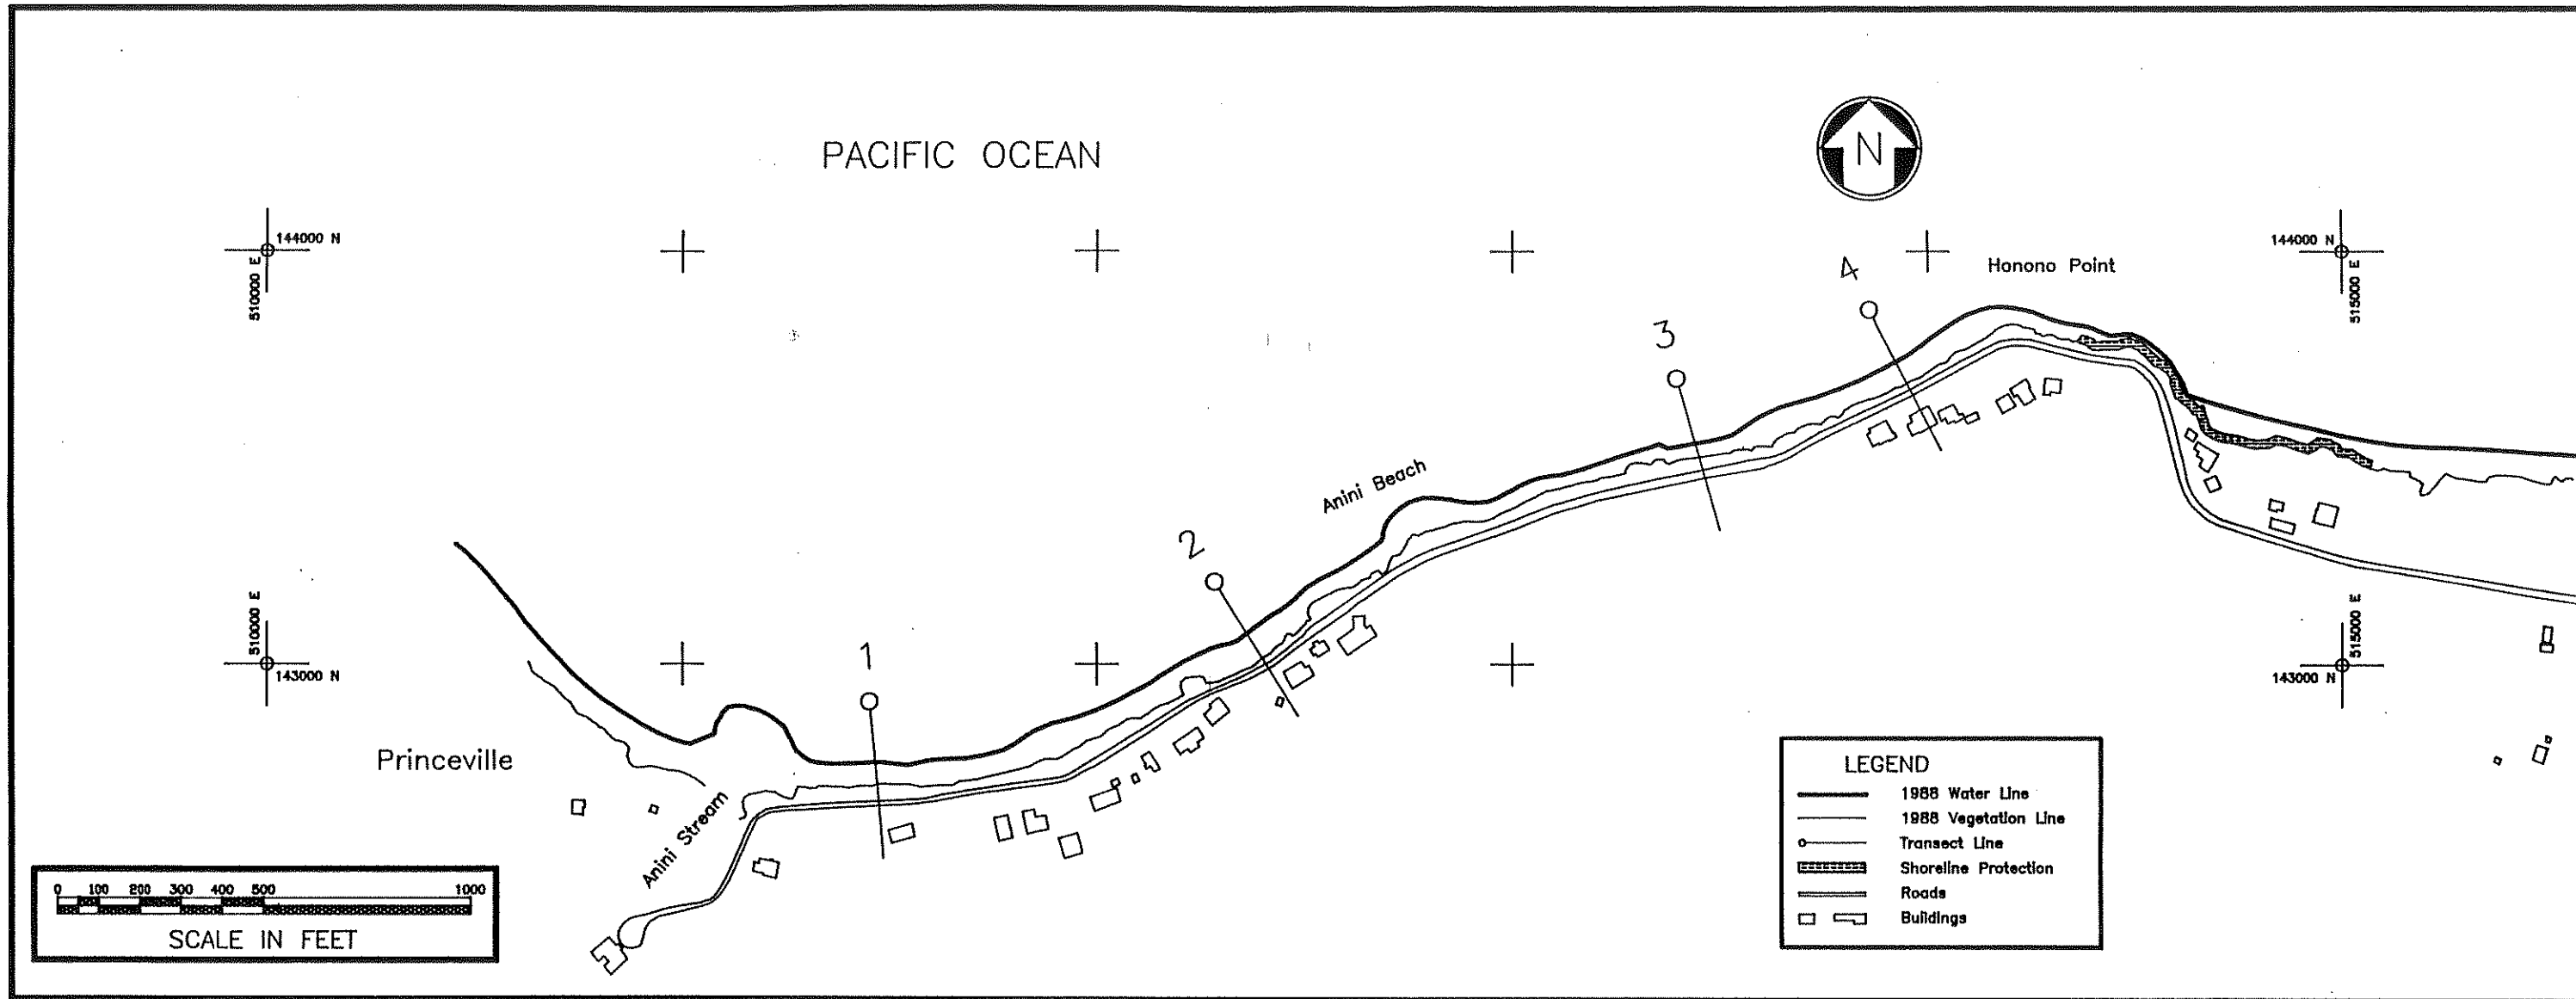
FIGURE KE-1

- This western segment of Anini Beach is stable, and there are no apparent erosion problems. There is no shore protection along the coast.
- All development is landward of the road through this subsector.

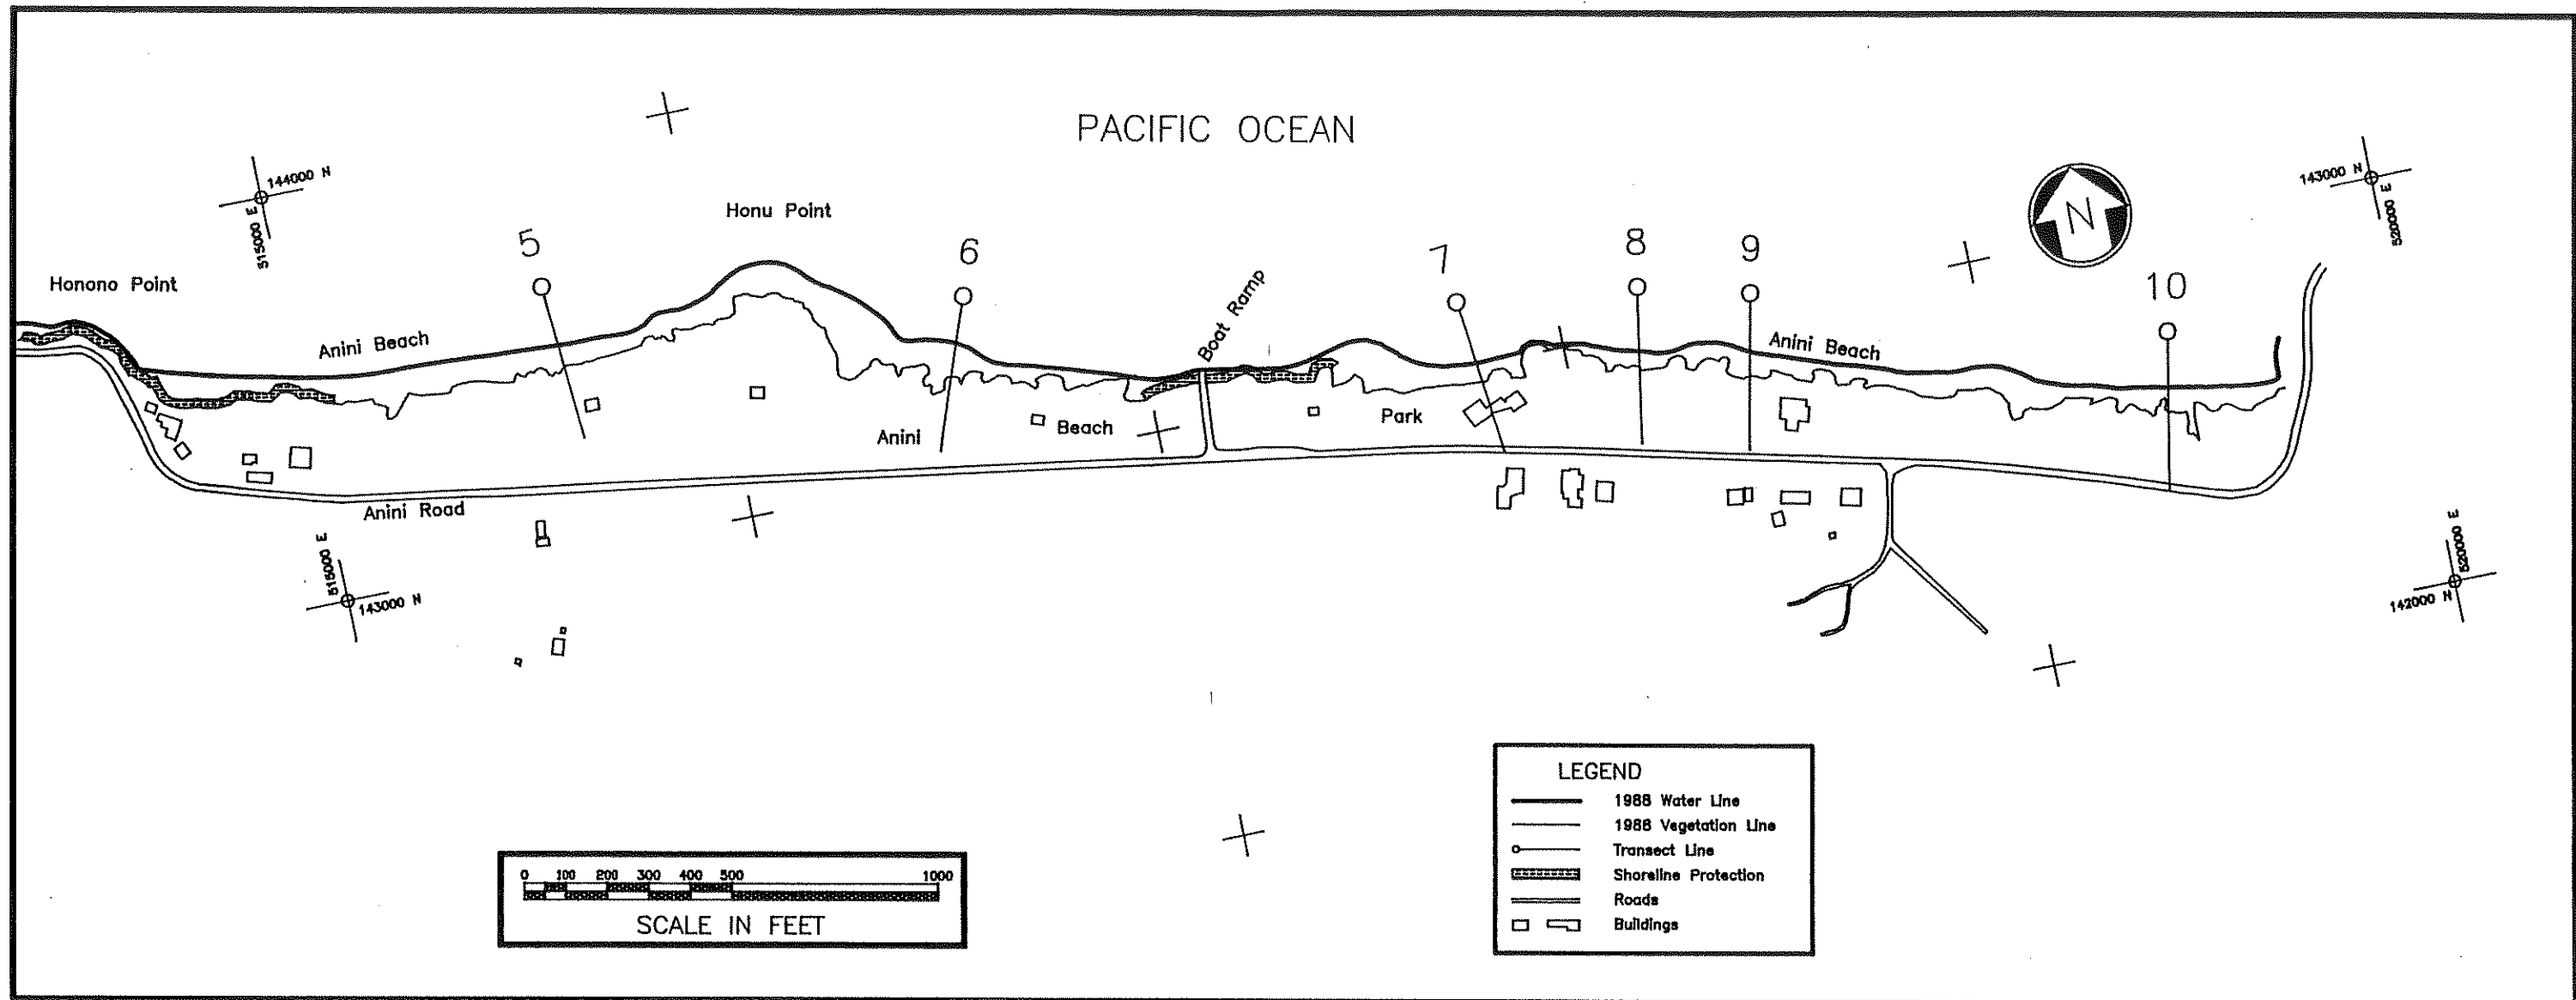
**FIGURE KE-2**

- This beach, particularly the residential area east of the park (Regions 7 to 10), is a potential problem area. Erosion is occurring, and given the narrow beach and the proximity of the houses to the vegetation line, permit applications for seawalls should be anticipated.
- The data from the aerial photographs should be considered as approximate due to the ironwood trees overhanging and obscuring the actual vegetation line.

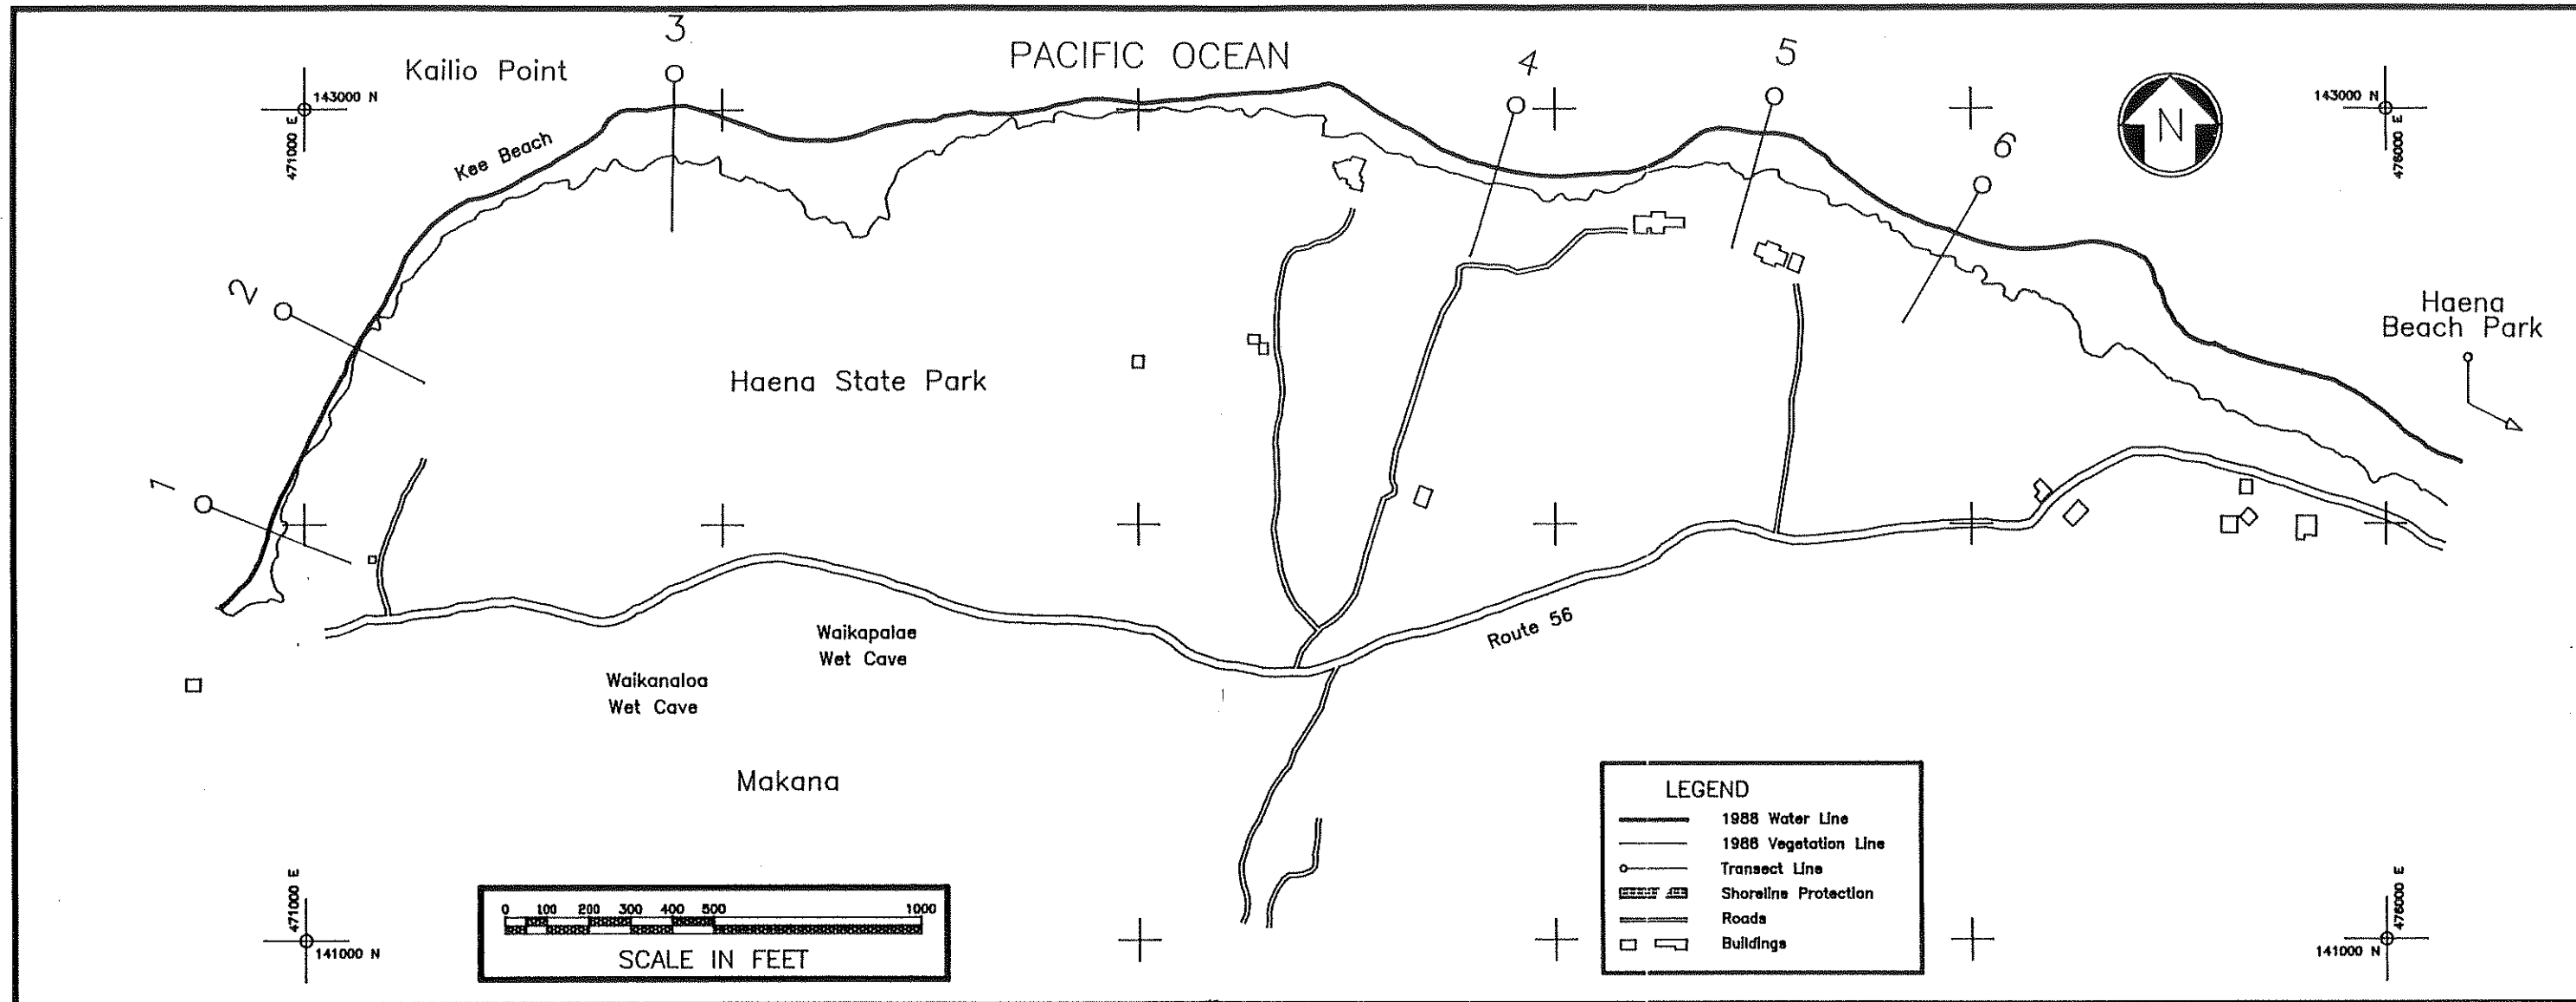
FIGURE KF-1

- The vegetation line of this subsector was difficult to pinpoint due to ironwood trees overhanging the beach. The 1960 photo series also had shadows of the trees on the beach, making the process even more difficult. As a result, the 1960 series was not used. The data in graph KF-1 should be considered as approximate, indicative of general trends and overall beach dynamics, but not as precise records of shoreline change.
- The vegetation line changes in this subsector follow no consistent trend. This is also typical of the beaches to the east studied by DHM (1990). Due to the locally varying reef and shoreline configurations, the nearshore wave heights and approach directions vary greatly through the subsector, resulting in varying shoreline response.
