# AERIAL PHOTOGRAPHY ANALYSIS OF COASTAL EROSION ON THE ISLANDS OF KAUAI, MOLOKAI, LANAI, MAUI AND HAWAII

JUNE, 1991

**PREPARED BY:**  
**MAKAI OCEAN ENGINEERING, INC**  
**and**  
**SEA ENGINEERING, INC.**  
**Honolulu, Hawaii**

**PREPARED FOR:**  
**STATE OF HAWAII**  
**OFFICE OF STATE PLANNING**  
**COASTAL ZONE MANAGEMENT**  
**PROGRAM**

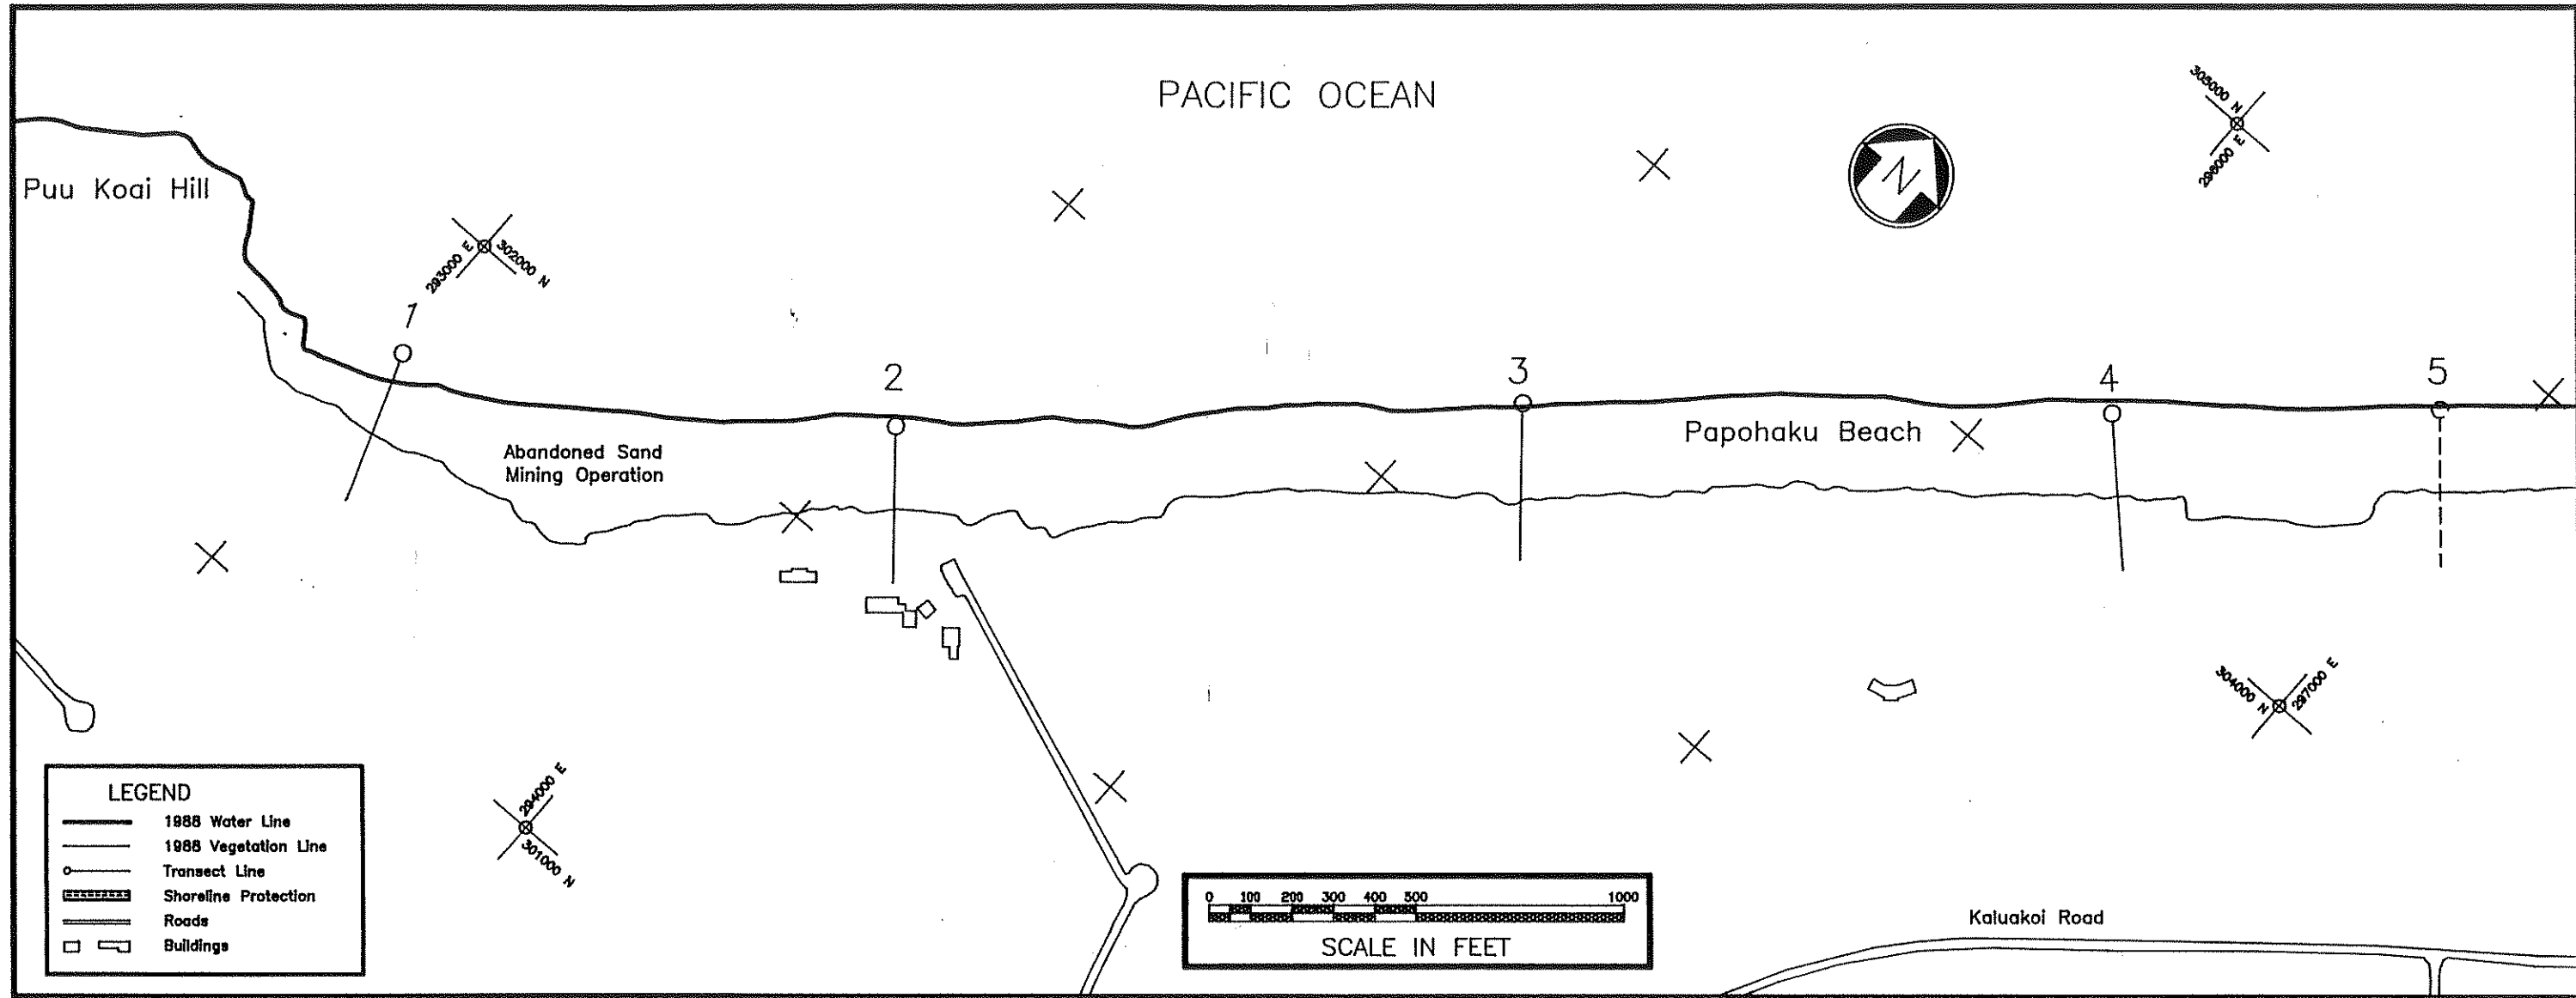
**FIGURE OA-1**

- Analysis of the vegetation lines does not show the total effect of sand mining on this beach. Comparing the aerial photos of January 1955 and those of either July 1987 or March 1988, it is apparent that a large amount of sand has been lost to the beach system.
- In 1950, the beach was 250 feet wide at the north end and 450 feet wide at the south end; the 1987 and 1988 photos show widths of 200 feet and 300 feet respectively.

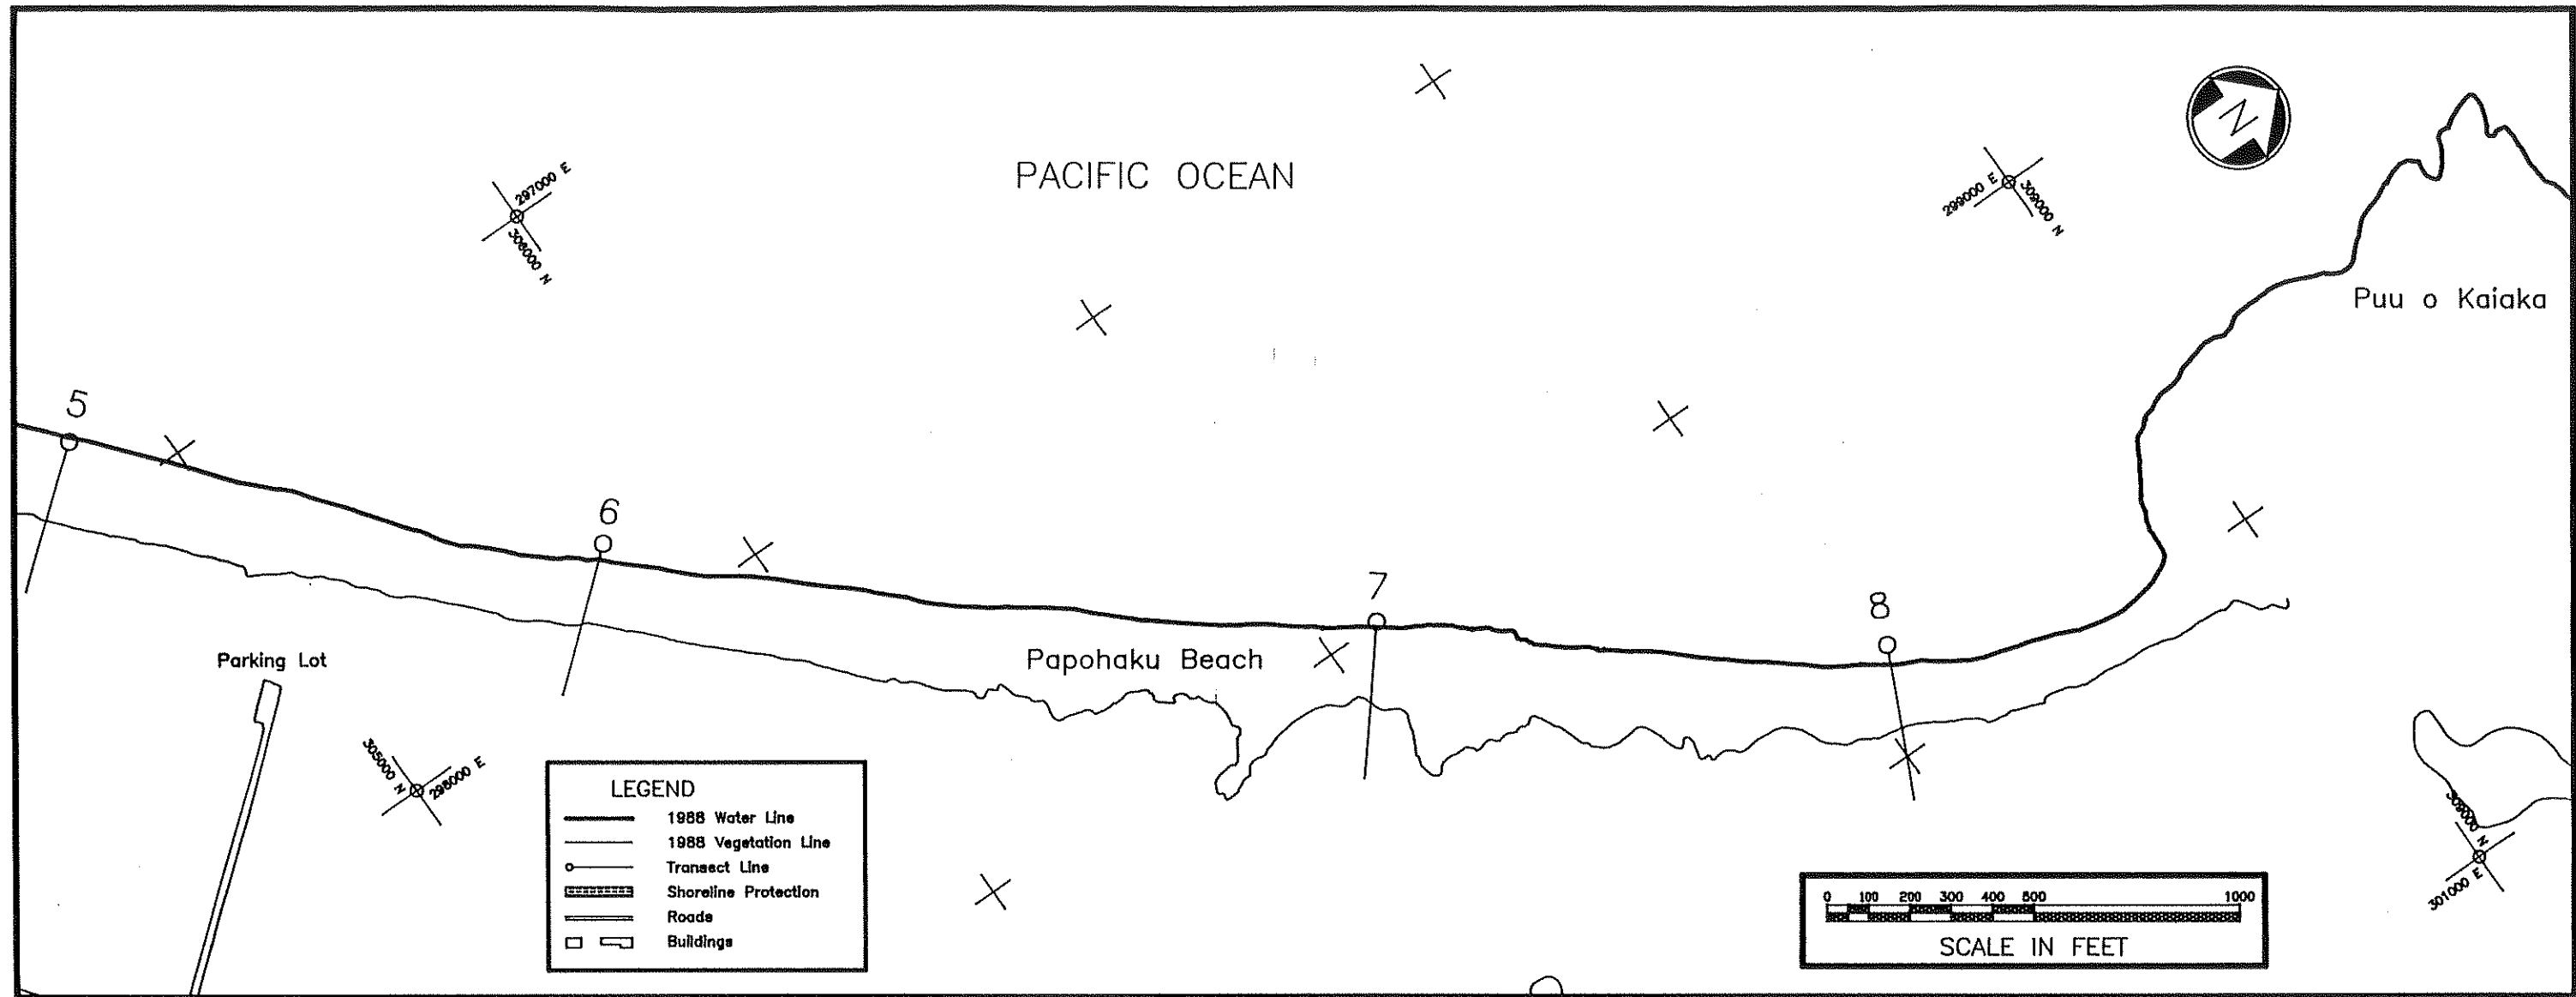
FIGURE OA-2

- The northern half of Papohaku Beach was not affected by the sand mining to nearly the same extent as the southern half.
- The seasonal variations in wave climate, and the direct exposure to the North Pacific swell, combine to make this a dynamic beach, potentially subject to large vegetation line changes. This should be considered as houses are built along the beach.

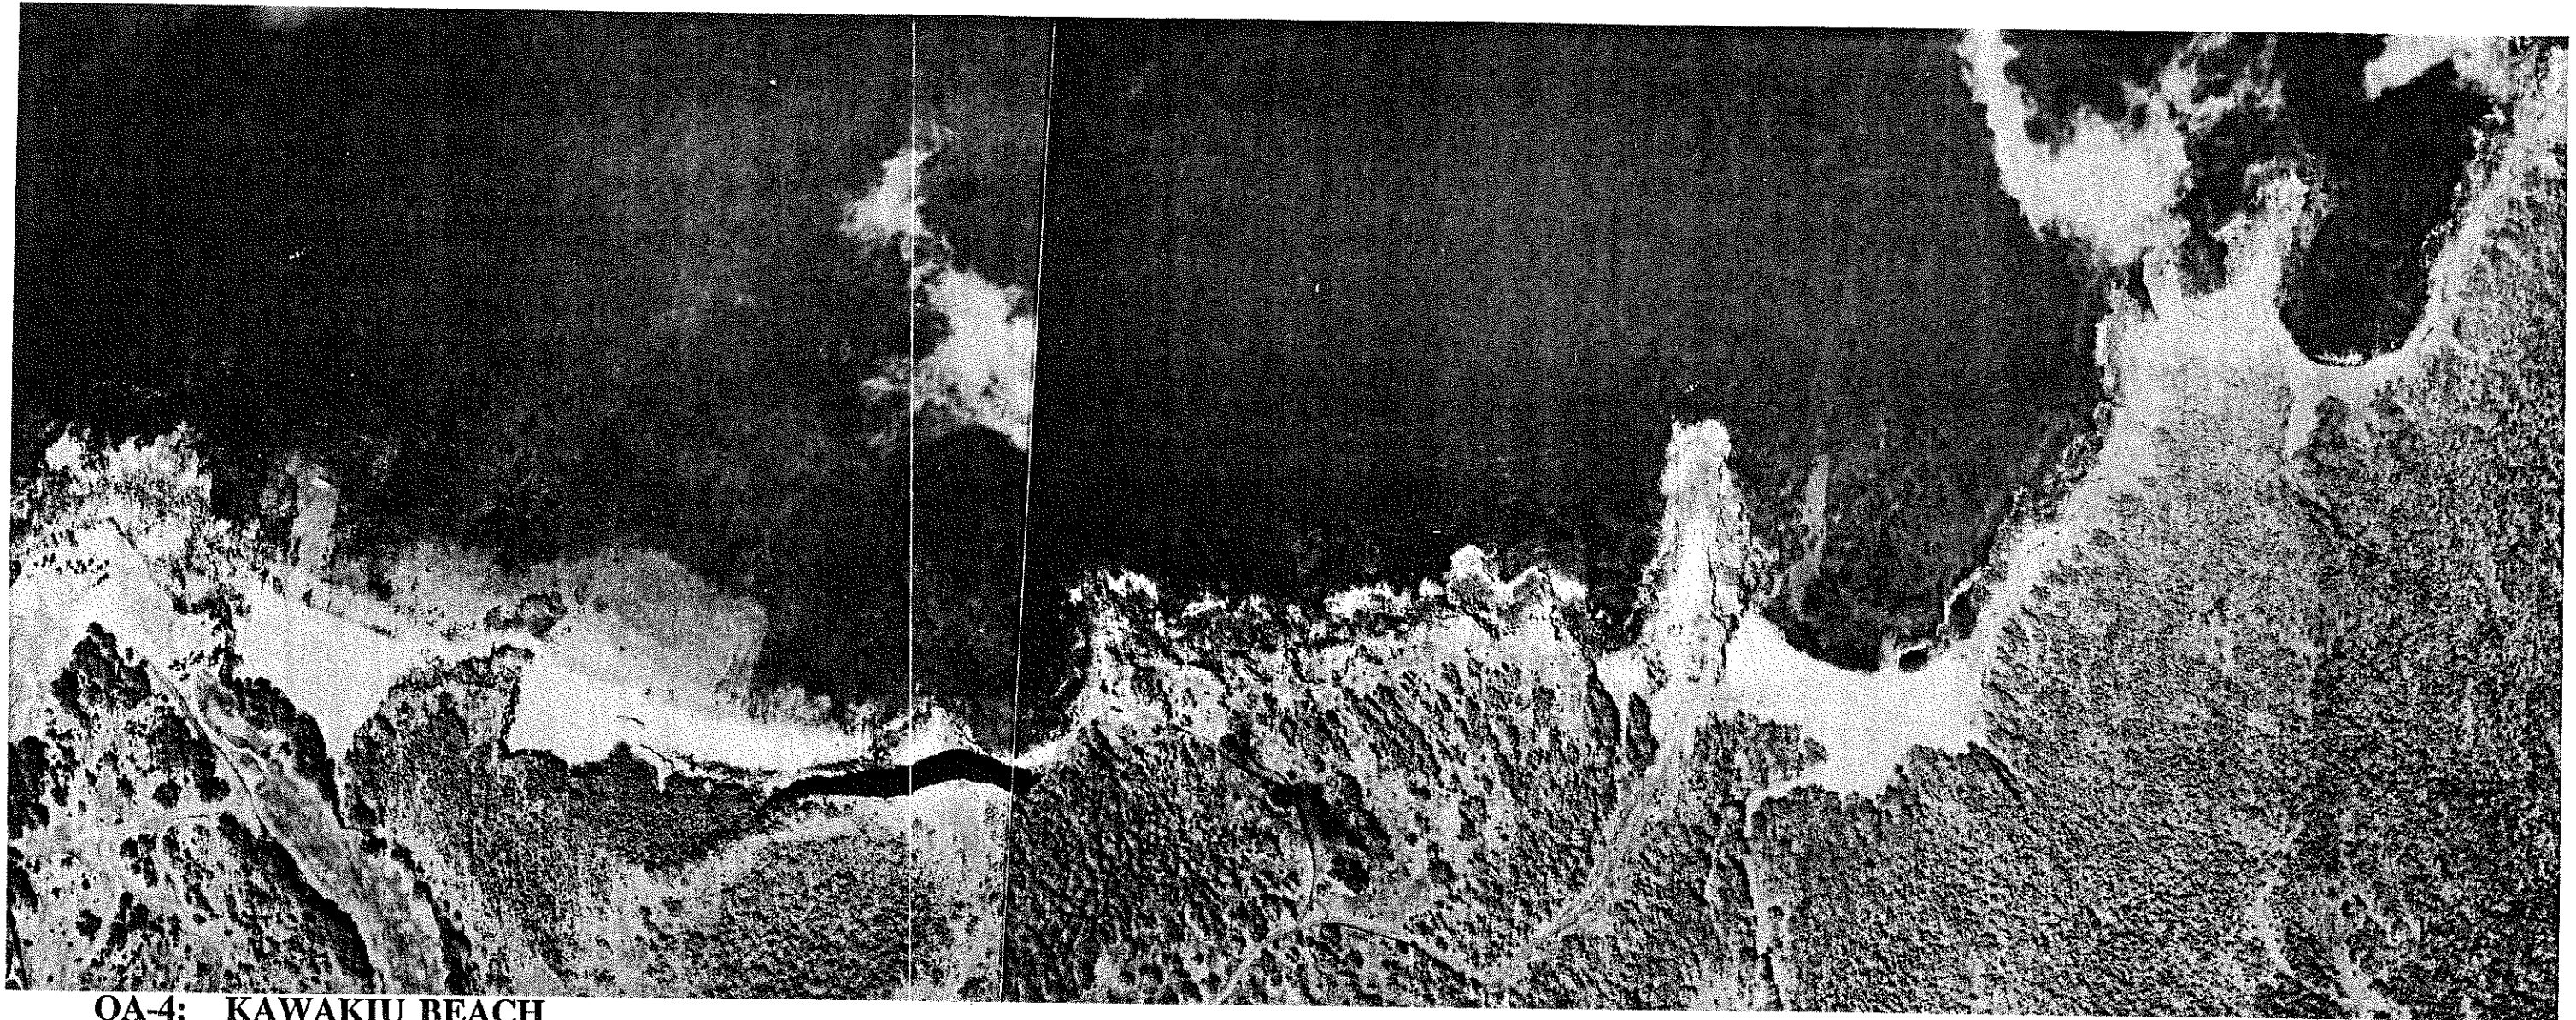
- Kawakui Beach is somewhat protected from wave attack by the rock headlands on each side. Given its location at the head of the bay, it should be relatively stable.

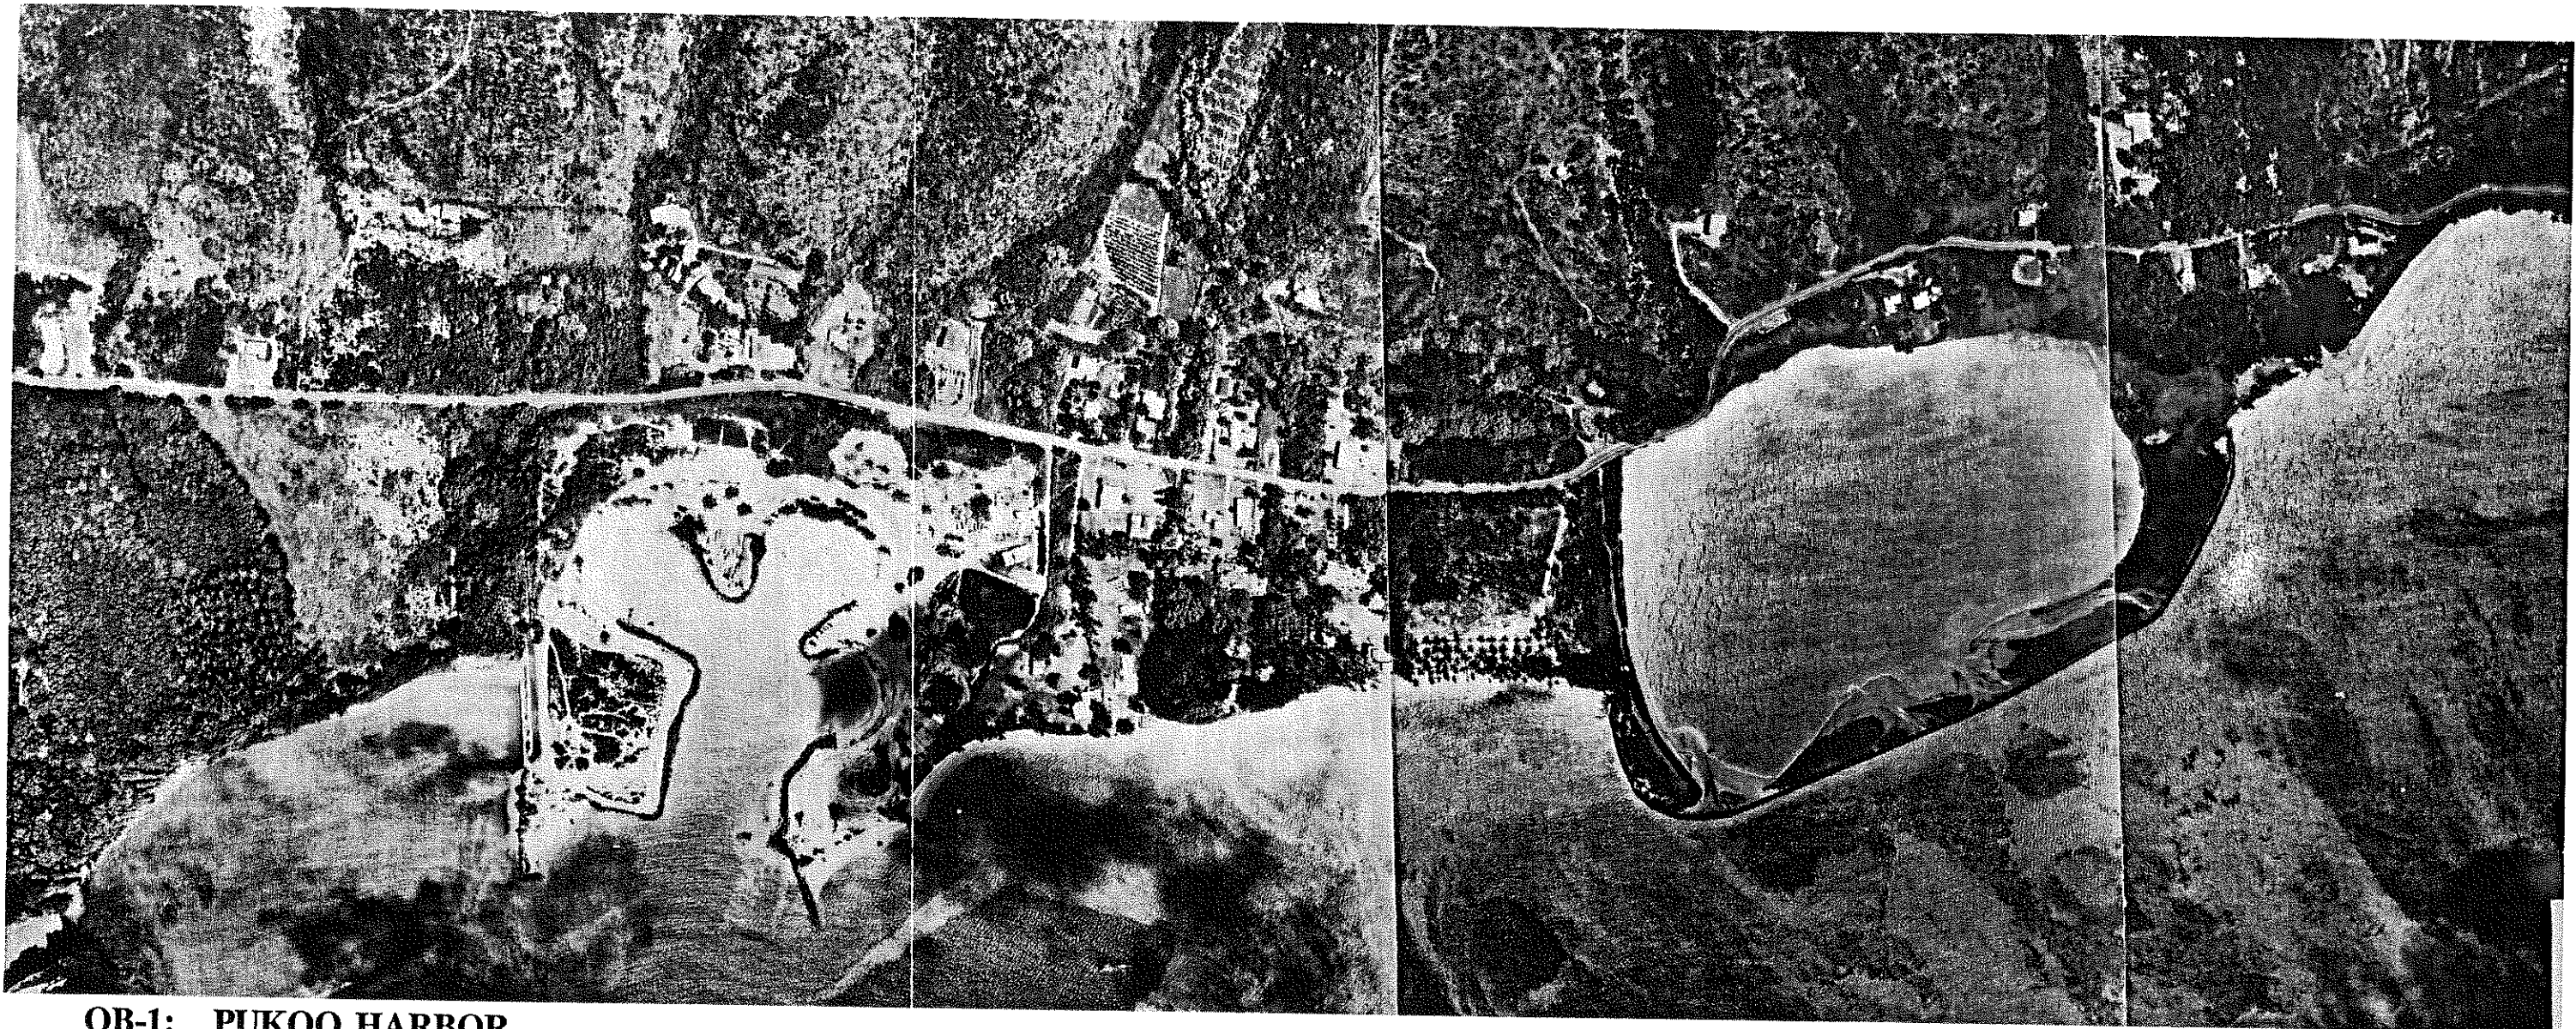
**FIGURE OB-1**

- There is no vegetation line history for Pukoo Harbor, but the small beach areas appear stable.
- The beach between the harbor and Kupeke fishpond eroded significantly (up to 30 feet) between 1949 and 1961. The reason is not known. Since construction of Pukoo Harbor, the south end of the beach has been relatively stable, while the north end has eroded slightly.

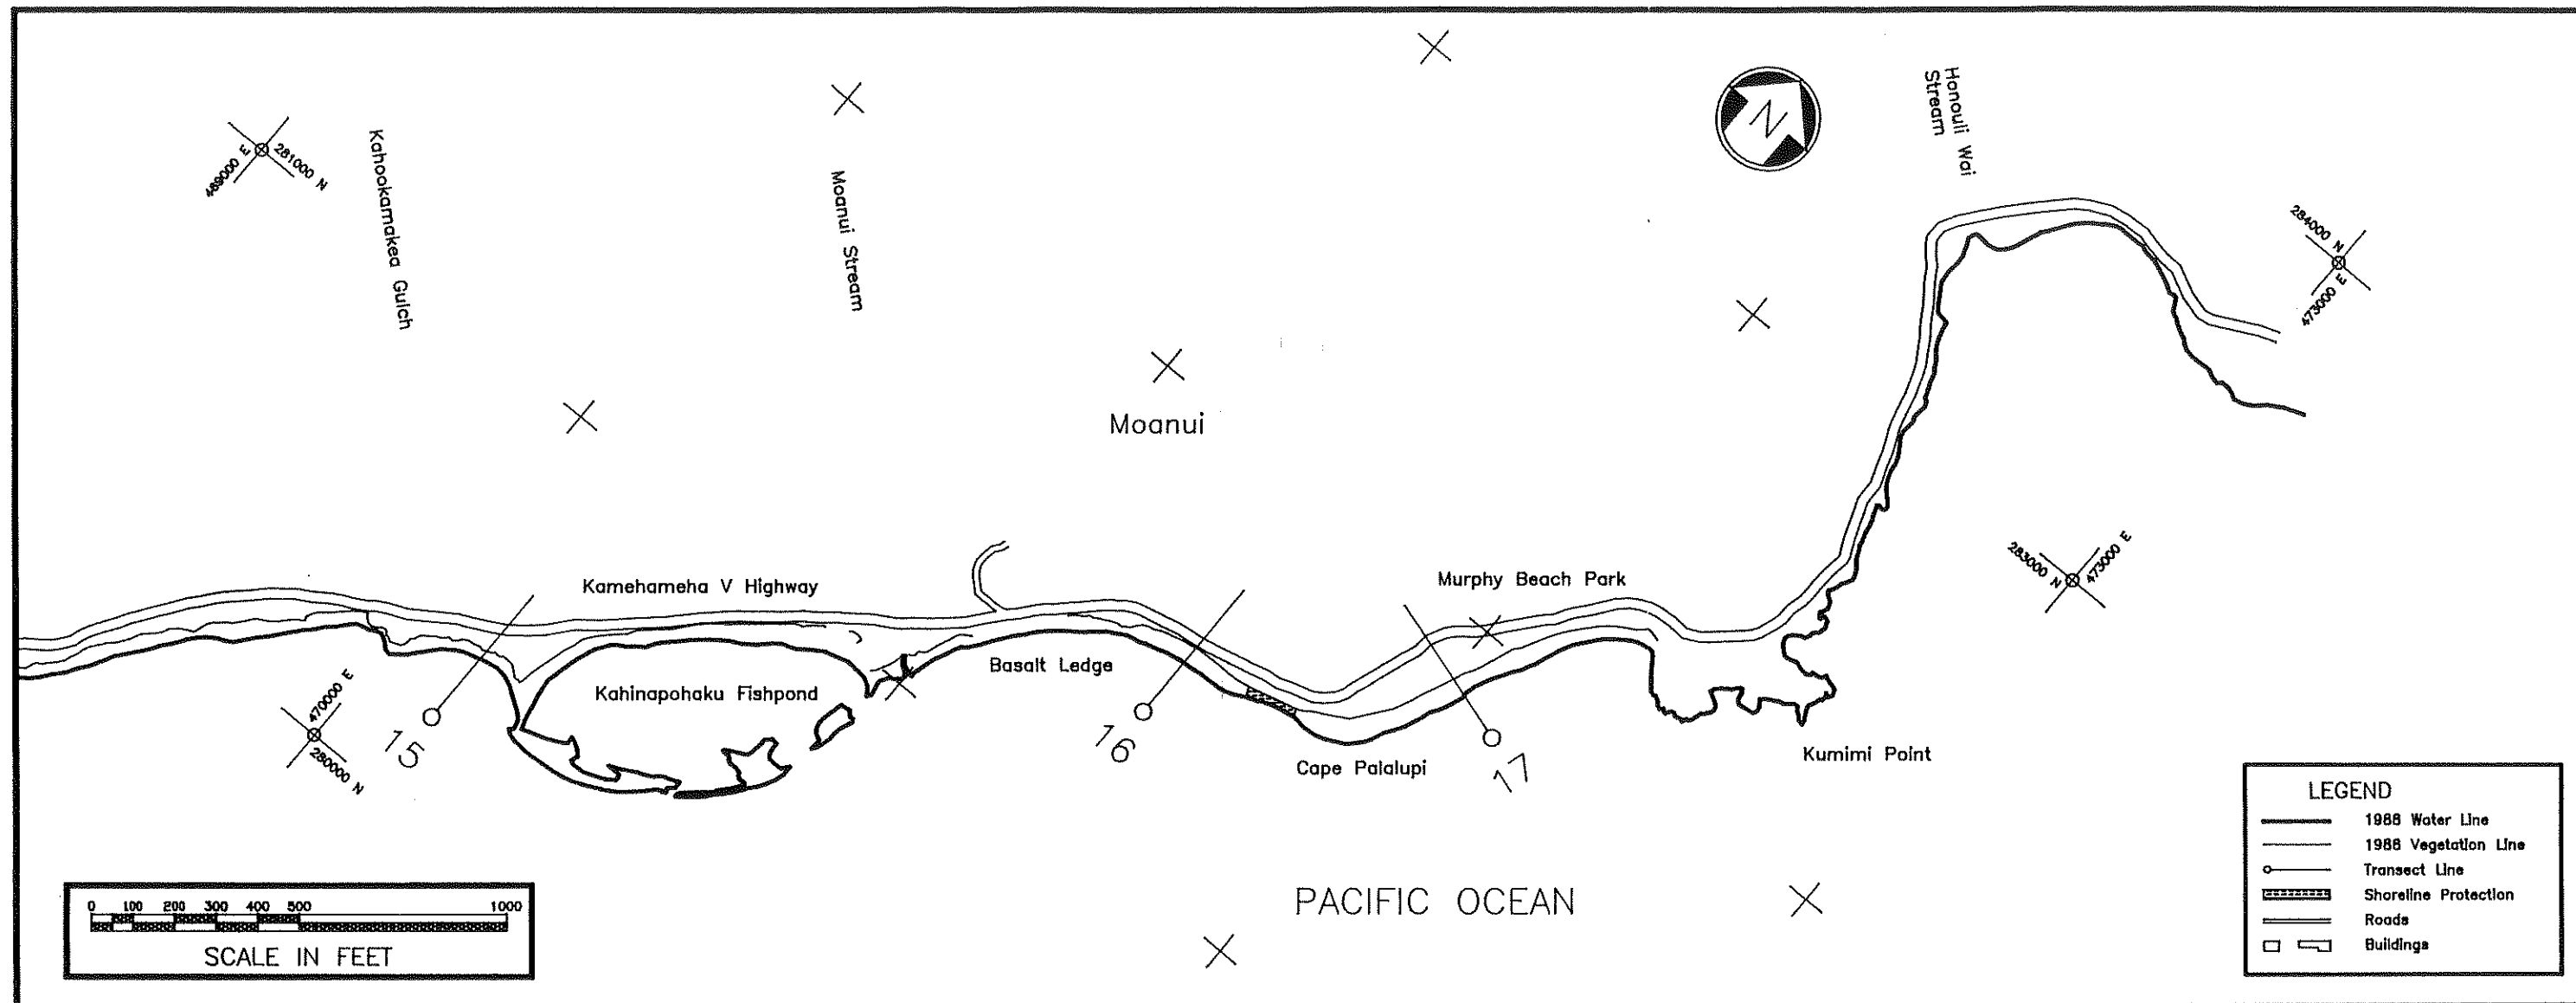
FIGURE OB-4

- The aerial photographs from 1961 were not available for this sector.
- The vegetation line has accreted in the vicinity of Region 15, probably due to the accumulation of silt in the lee of the fishpond.

- At the south end of Kahinapohaku Fishpond, there is a scarp in the dirt embankment. The high waterline is within five feet of the embankment.
- The highway in the vicinity of Region 16 is located right at the beach crest and there is only a narrow beach between the waterline and the highway. The aerial photographs show that this has been the case since some time prior to 1949.
- The shoreline at Murphy Beach Park is slowly accreting, with a net gain of 29 feet.

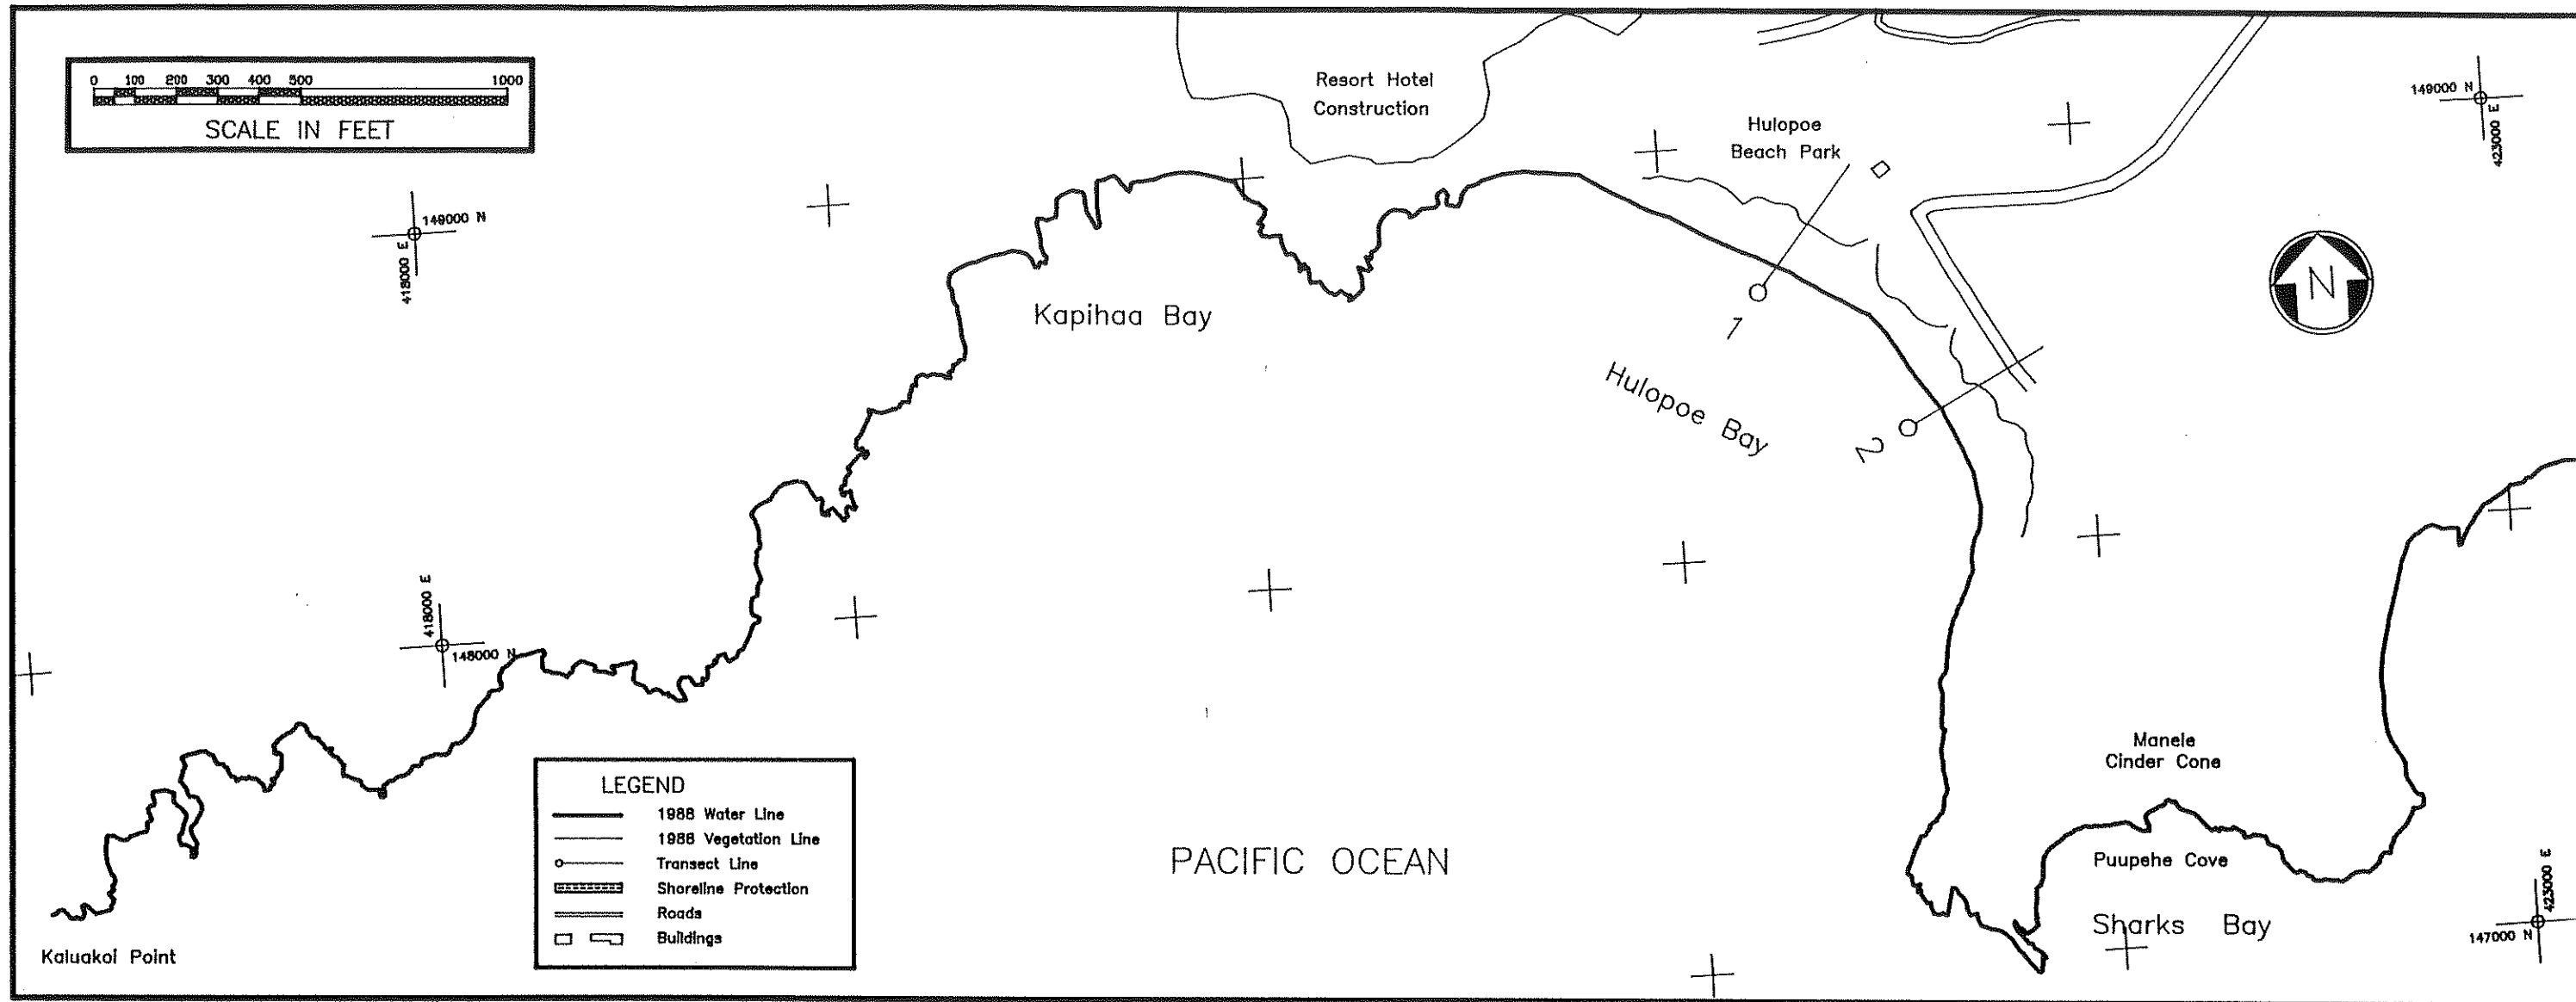
**FIGURE LA-1**

- Huloepoe Beach has been stable over the time interval of this study.
- A large resort hotel has been constructed recently on the rocky point at the northwest end of the beach.

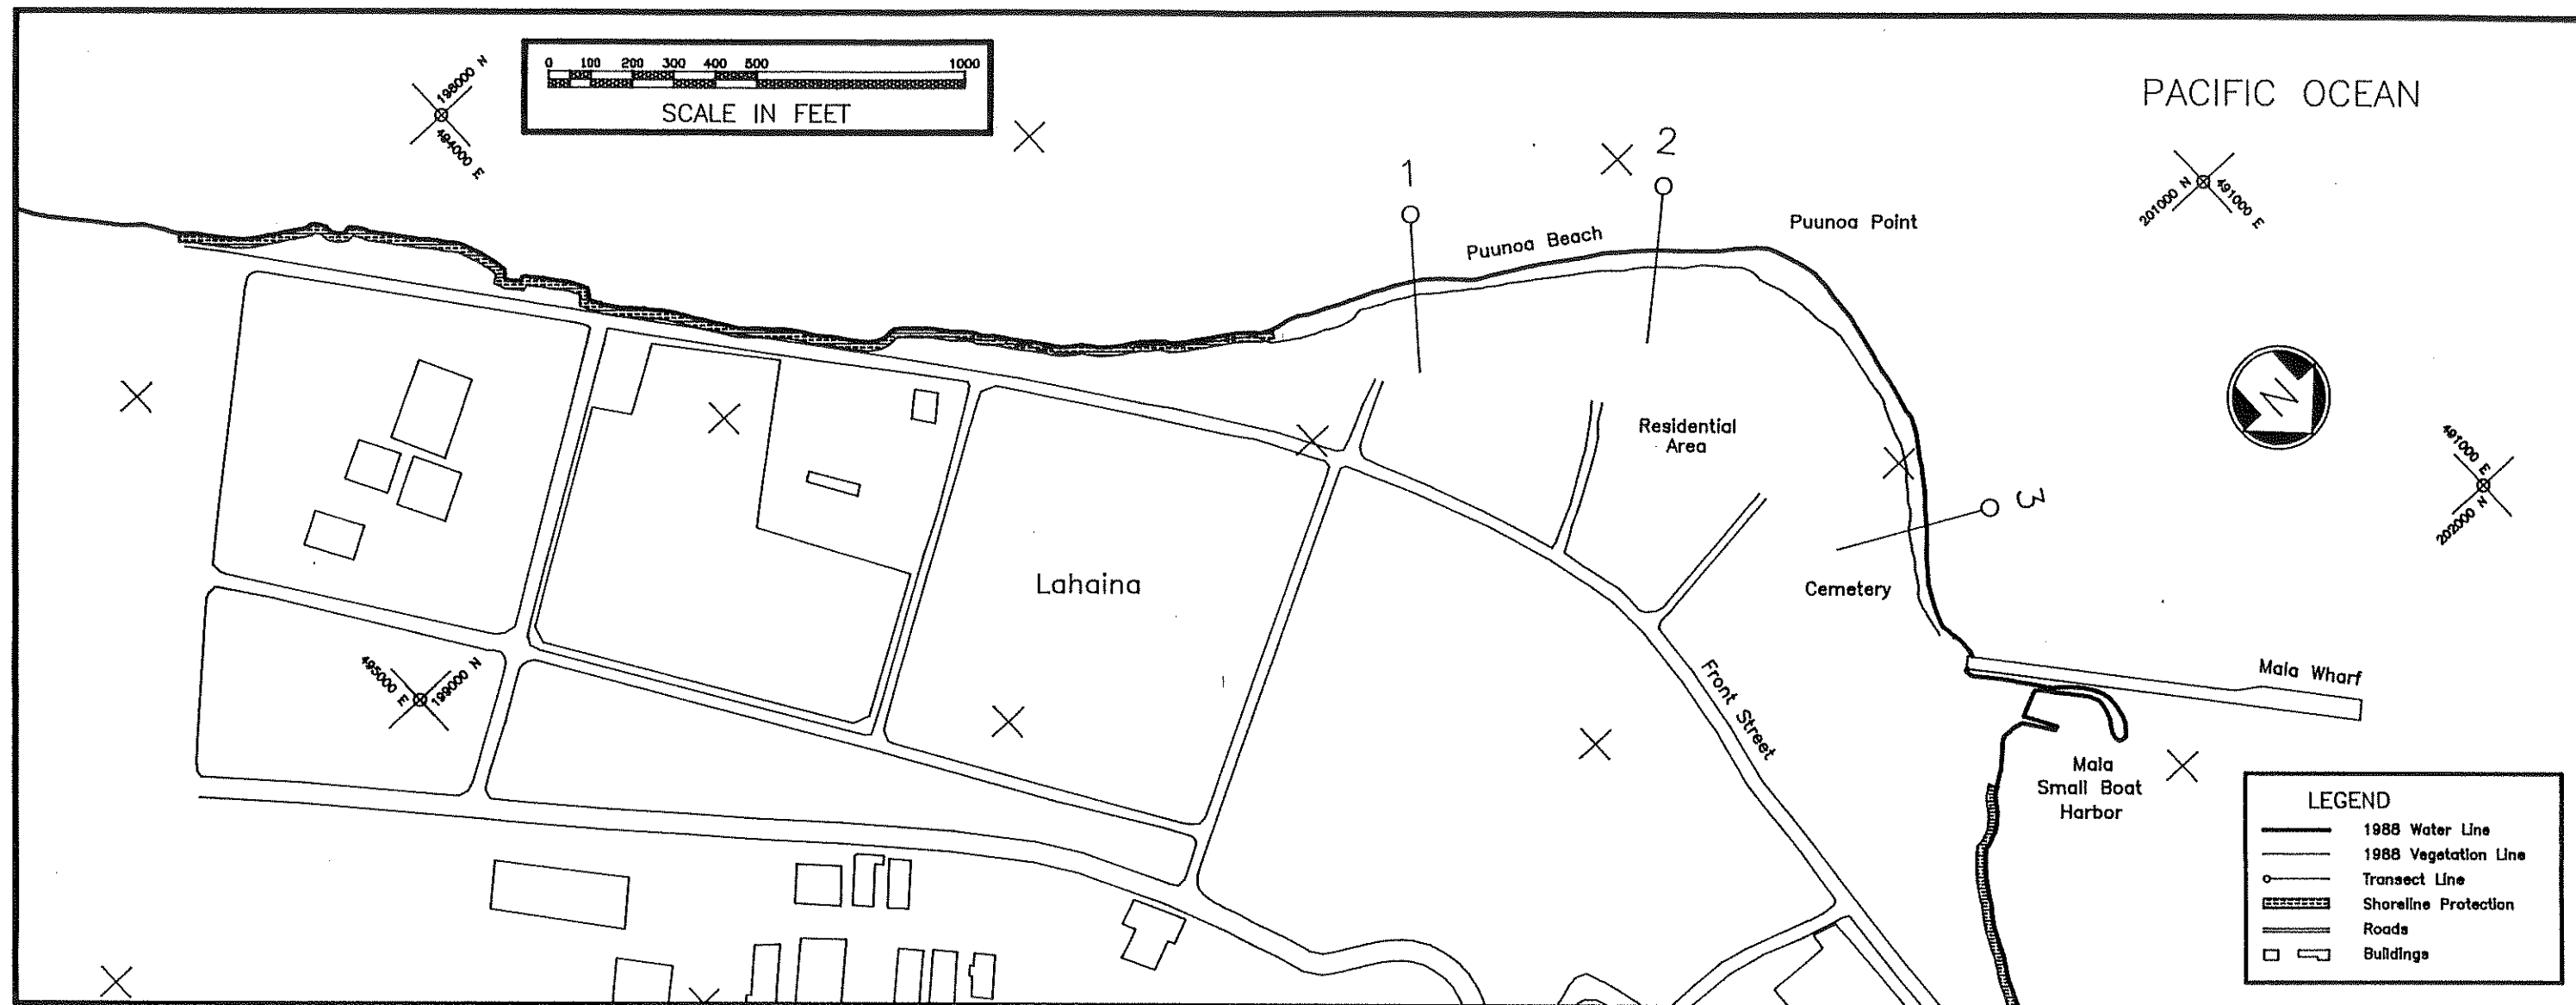
**FIGURE MA-1**

- The beach at Puunoa Point and to the south is accreting; that to the north is eroding. The shoreline at the point and in the immediate vicinity is dynamic.

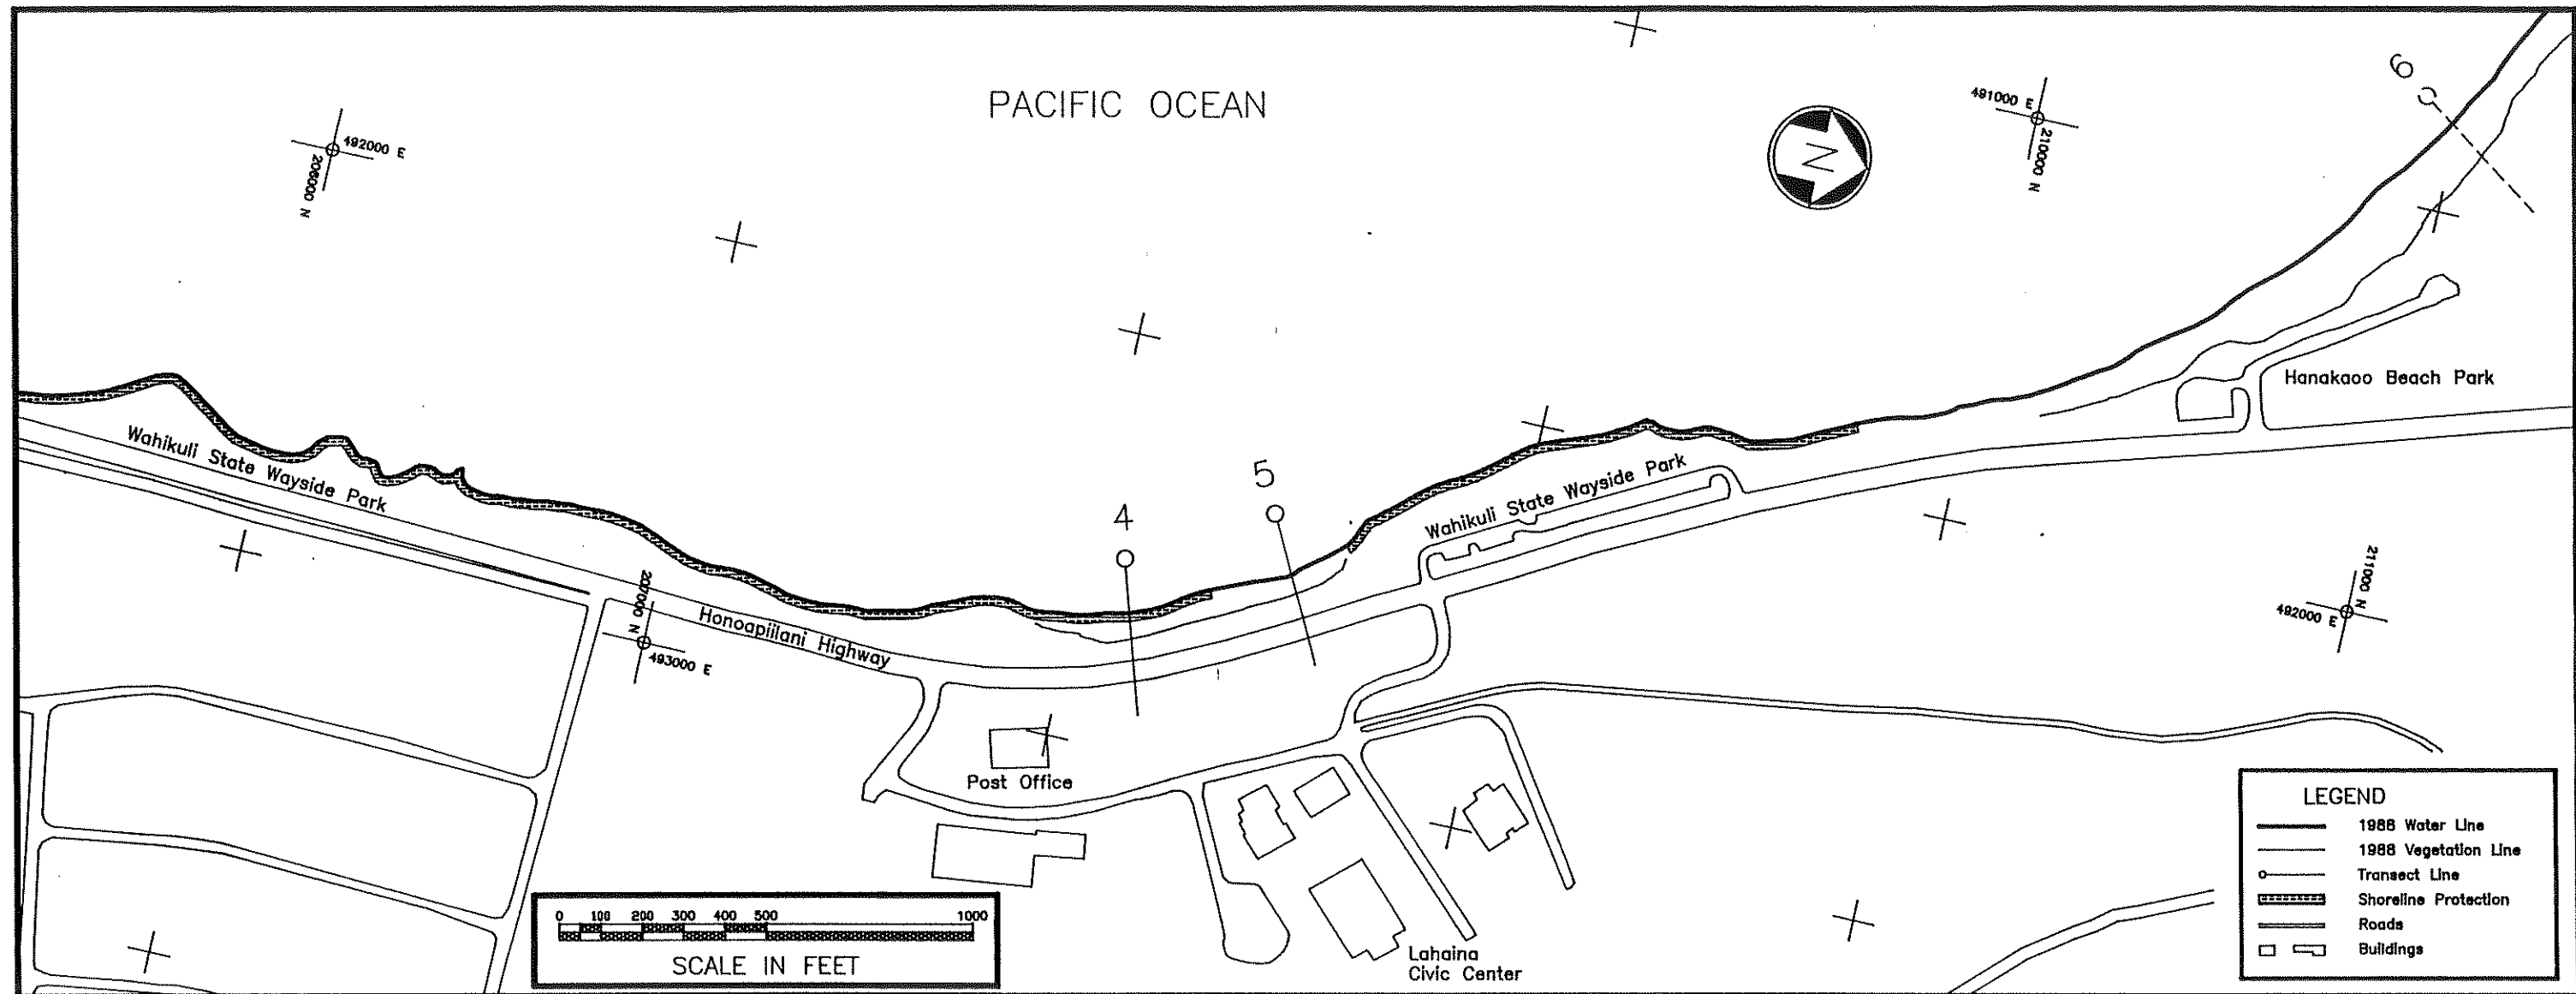
FIGURE MA-3

- Wahikuli State Wayside Park is a popular park and swimming beach due to its proximity to Lahaina. The south end was subject to slow, steady erosion.
