# AERIAL PHOTOGRAPHY ANALYSIS OF COASTAL EROSION ON THE ISLANDS OF KAUAI, MOLOKAI, LANAI, MAUI AND HAWAII

JUNE, 1991

**PREPARED BY:**  
**MAKAI OCEAN ENGINEERING, INC**  
**and**  
**SEA ENGINEERING, INC.**  
**Honolulu, Hawaii**

**PREPARED FOR:**  
**STATE OF HAWAII**  
**OFFICE OF STATE PLANNING**  
**COASTAL ZONE MANAGEMENT**  
**PROGRAM**

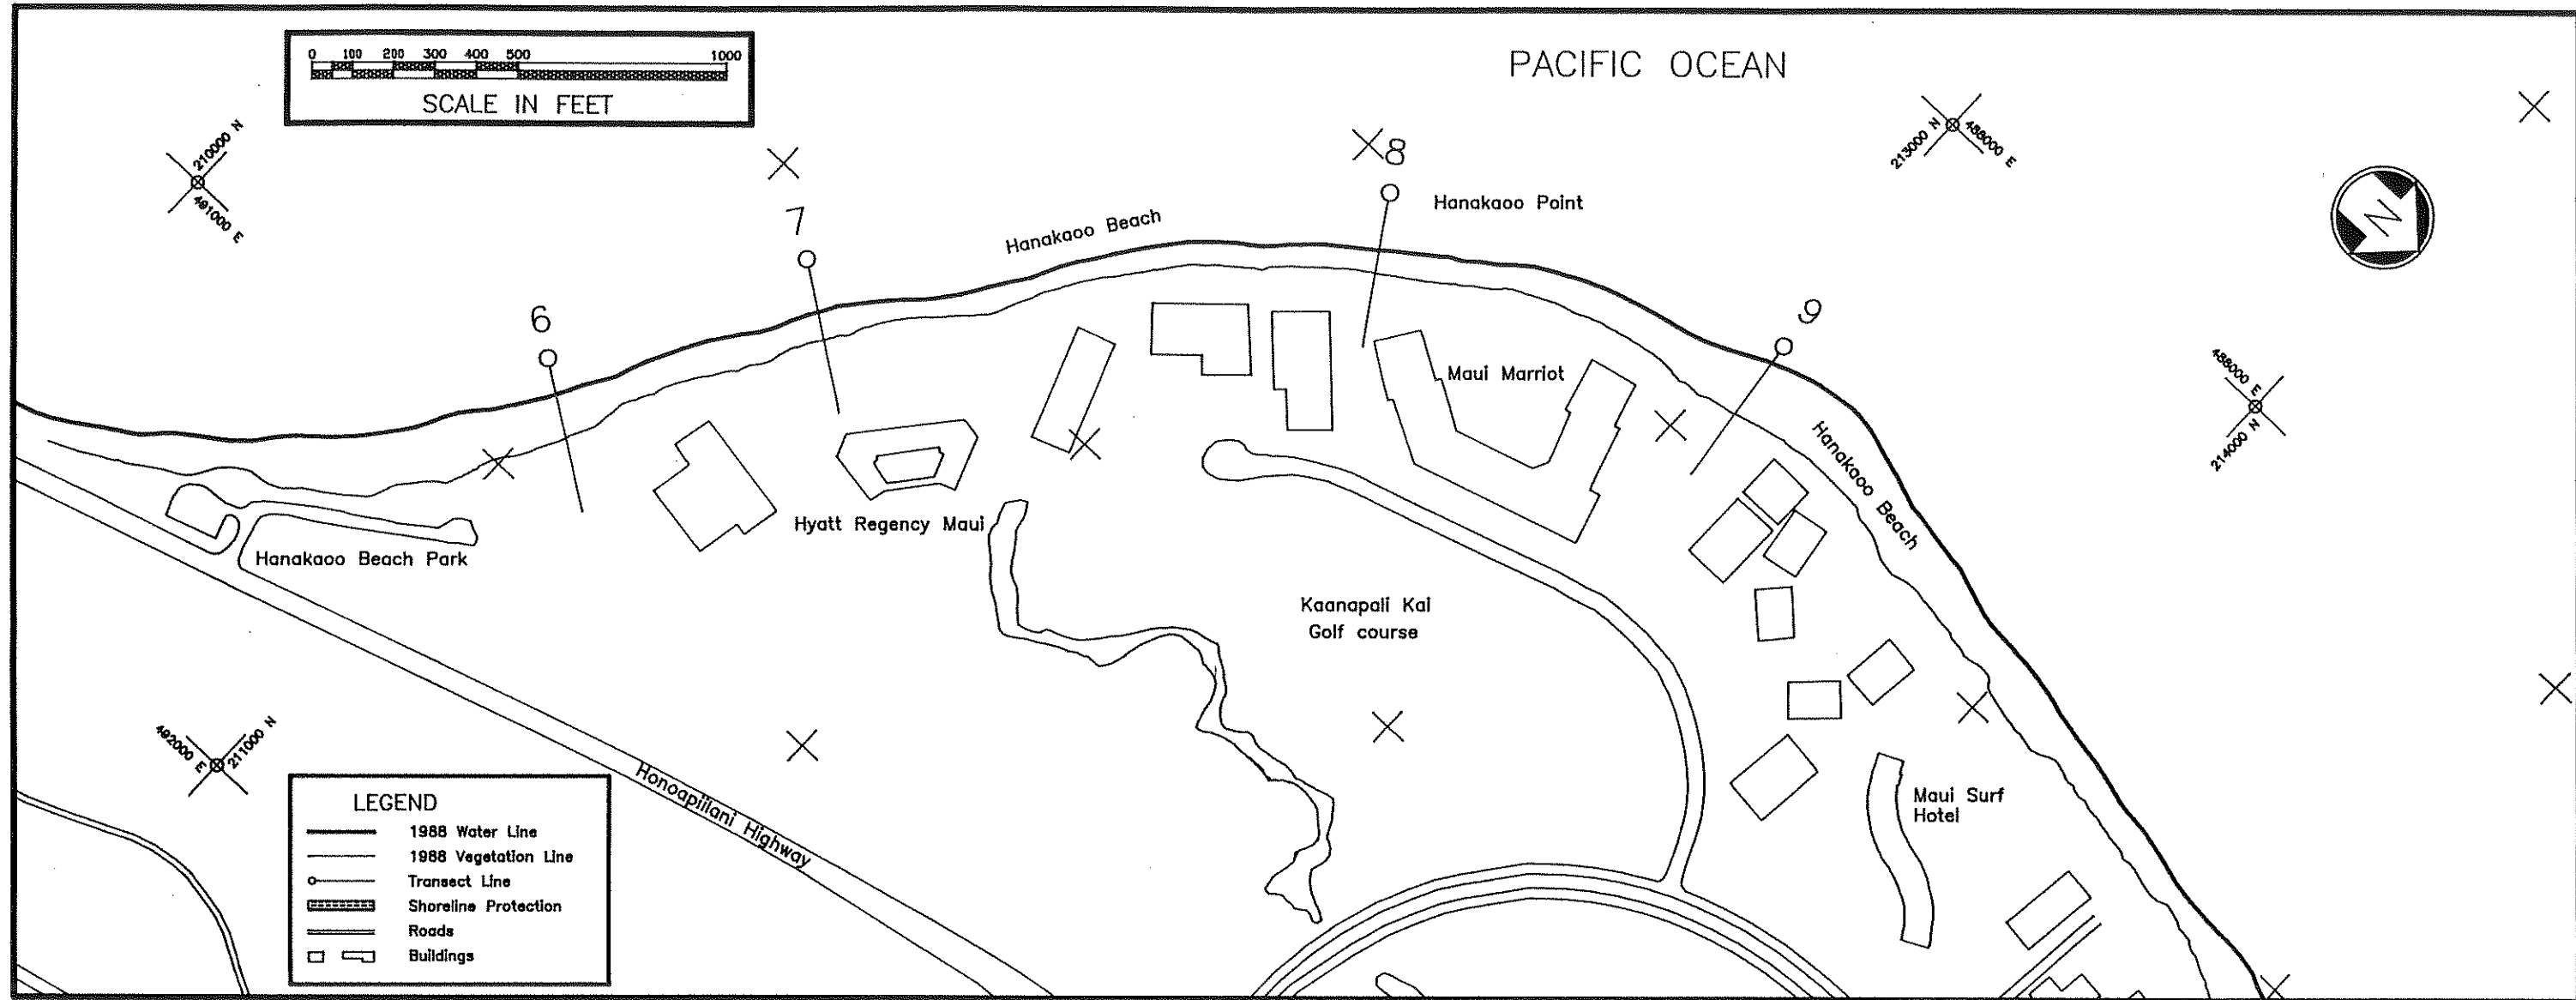
**FIGURE MA-4**

- According to Moberly and Chamberlain (1964), Hanakao Point is seasonally unstable. During the summer, the south swell moves the sand to the north; the point erodes and the north end of the beach accretes. The opposite occurs when the winter north swell moves the sand to the south. The erosion occurs to the extent that a 15 foot wave cut scarp at the point was noted in 1963.
- This subsector is also directly exposed to Kona storm waves, and severe erosion occurred during the January 1980 storm.
- The measurements from the aerial photographs indicate that the beach south of Hanakao Point (Regions 6 and 7) have a tendency toward erosion, and the point (Regions 8 and 9) while dynamic, has a tendency toward overall accretion.

- Although there are no major shore protection structures in this subsector, the vegetation line is no longer a natural line, but is part of the landscaped grounds of the hotels.
- Many of the hotels and related facilities were built very close to the vegetation line. Although the vegetation line is not highly dynamic, there is now little area to accommodate naturally occurring vegetation line changes, either long term or storm related. As a result, this subsector is a potential problem area.

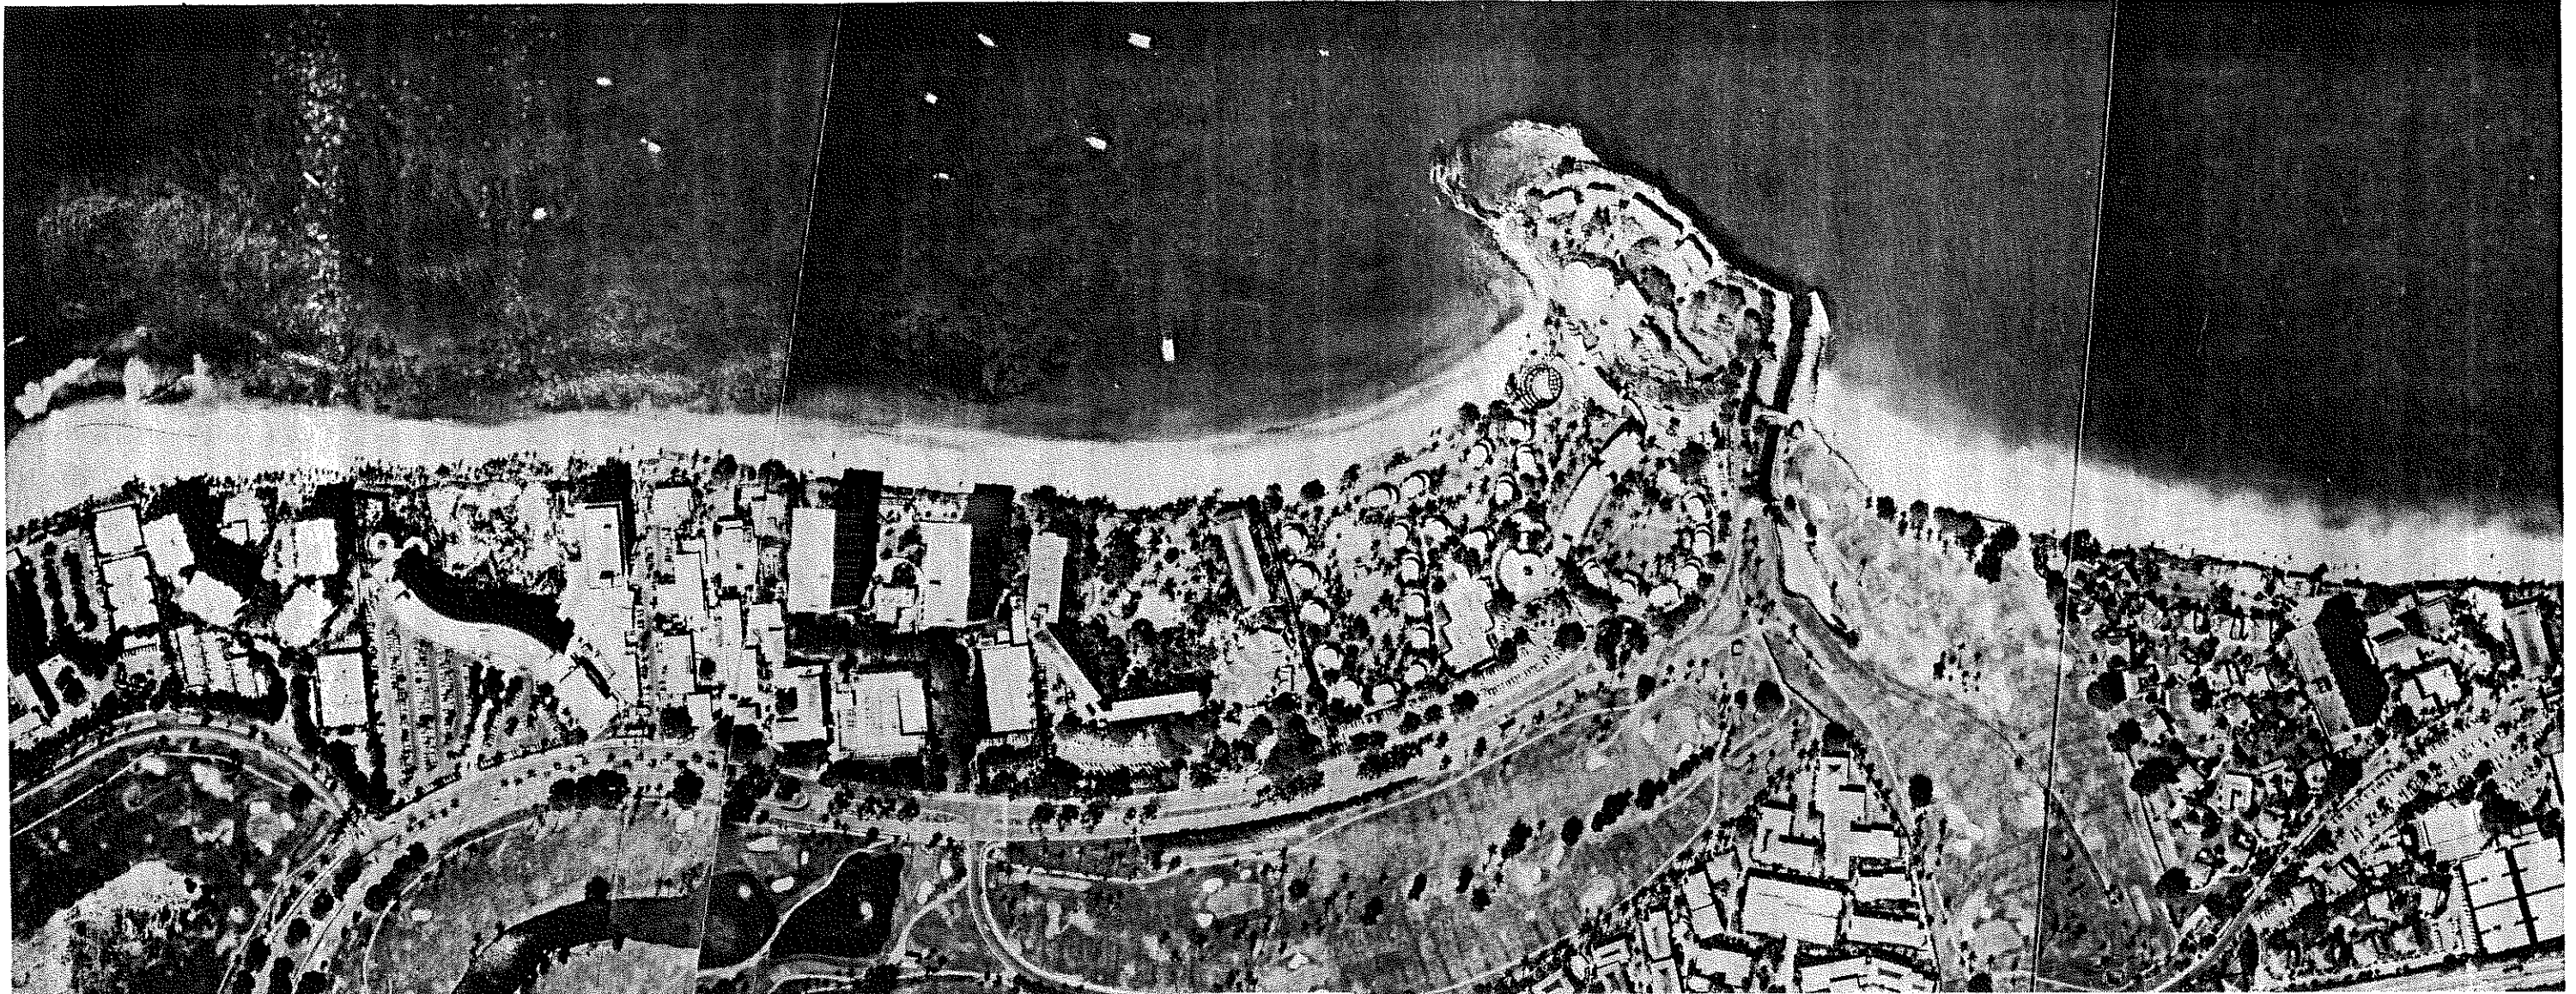
**FIGURE MA-5**

- As in subsector MA-4, some of the hotels and related facilities have been built very close to the vegetation line. It appears that the beach is stable during typical conditions, but has a history of erosion during severe Kona storms. After the January 1980 Kona storms, at least some of the hotels considered building protective revetments. This is a potential problem area, due to proximity of the structures to the vegetation line.

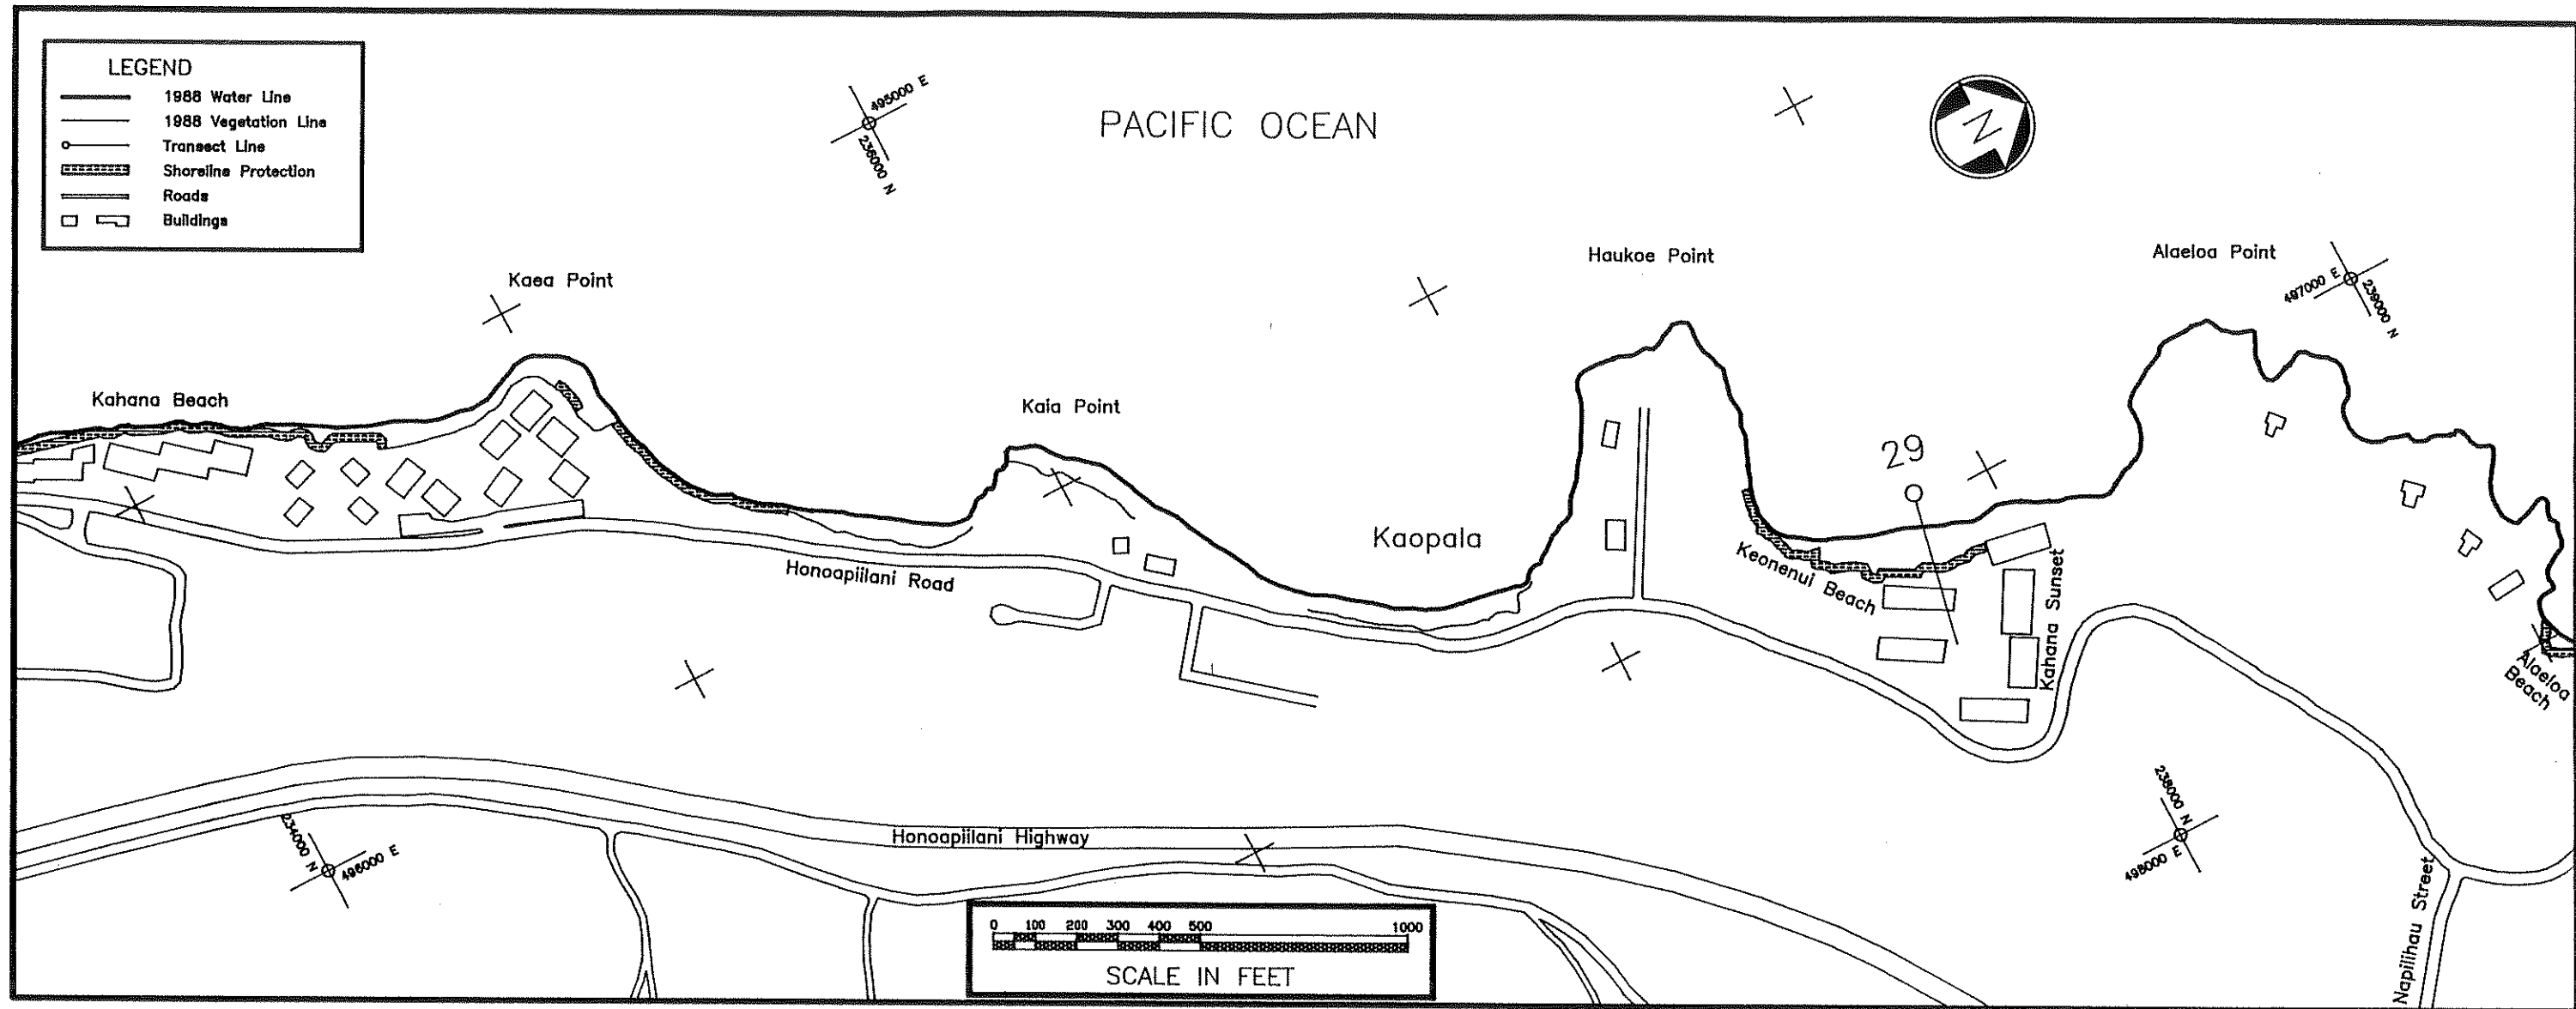
**FIGURE MA-9**

- This subsector has very small reaches of sandy beach, separated by extensive seawalls, revetments and rocky points.

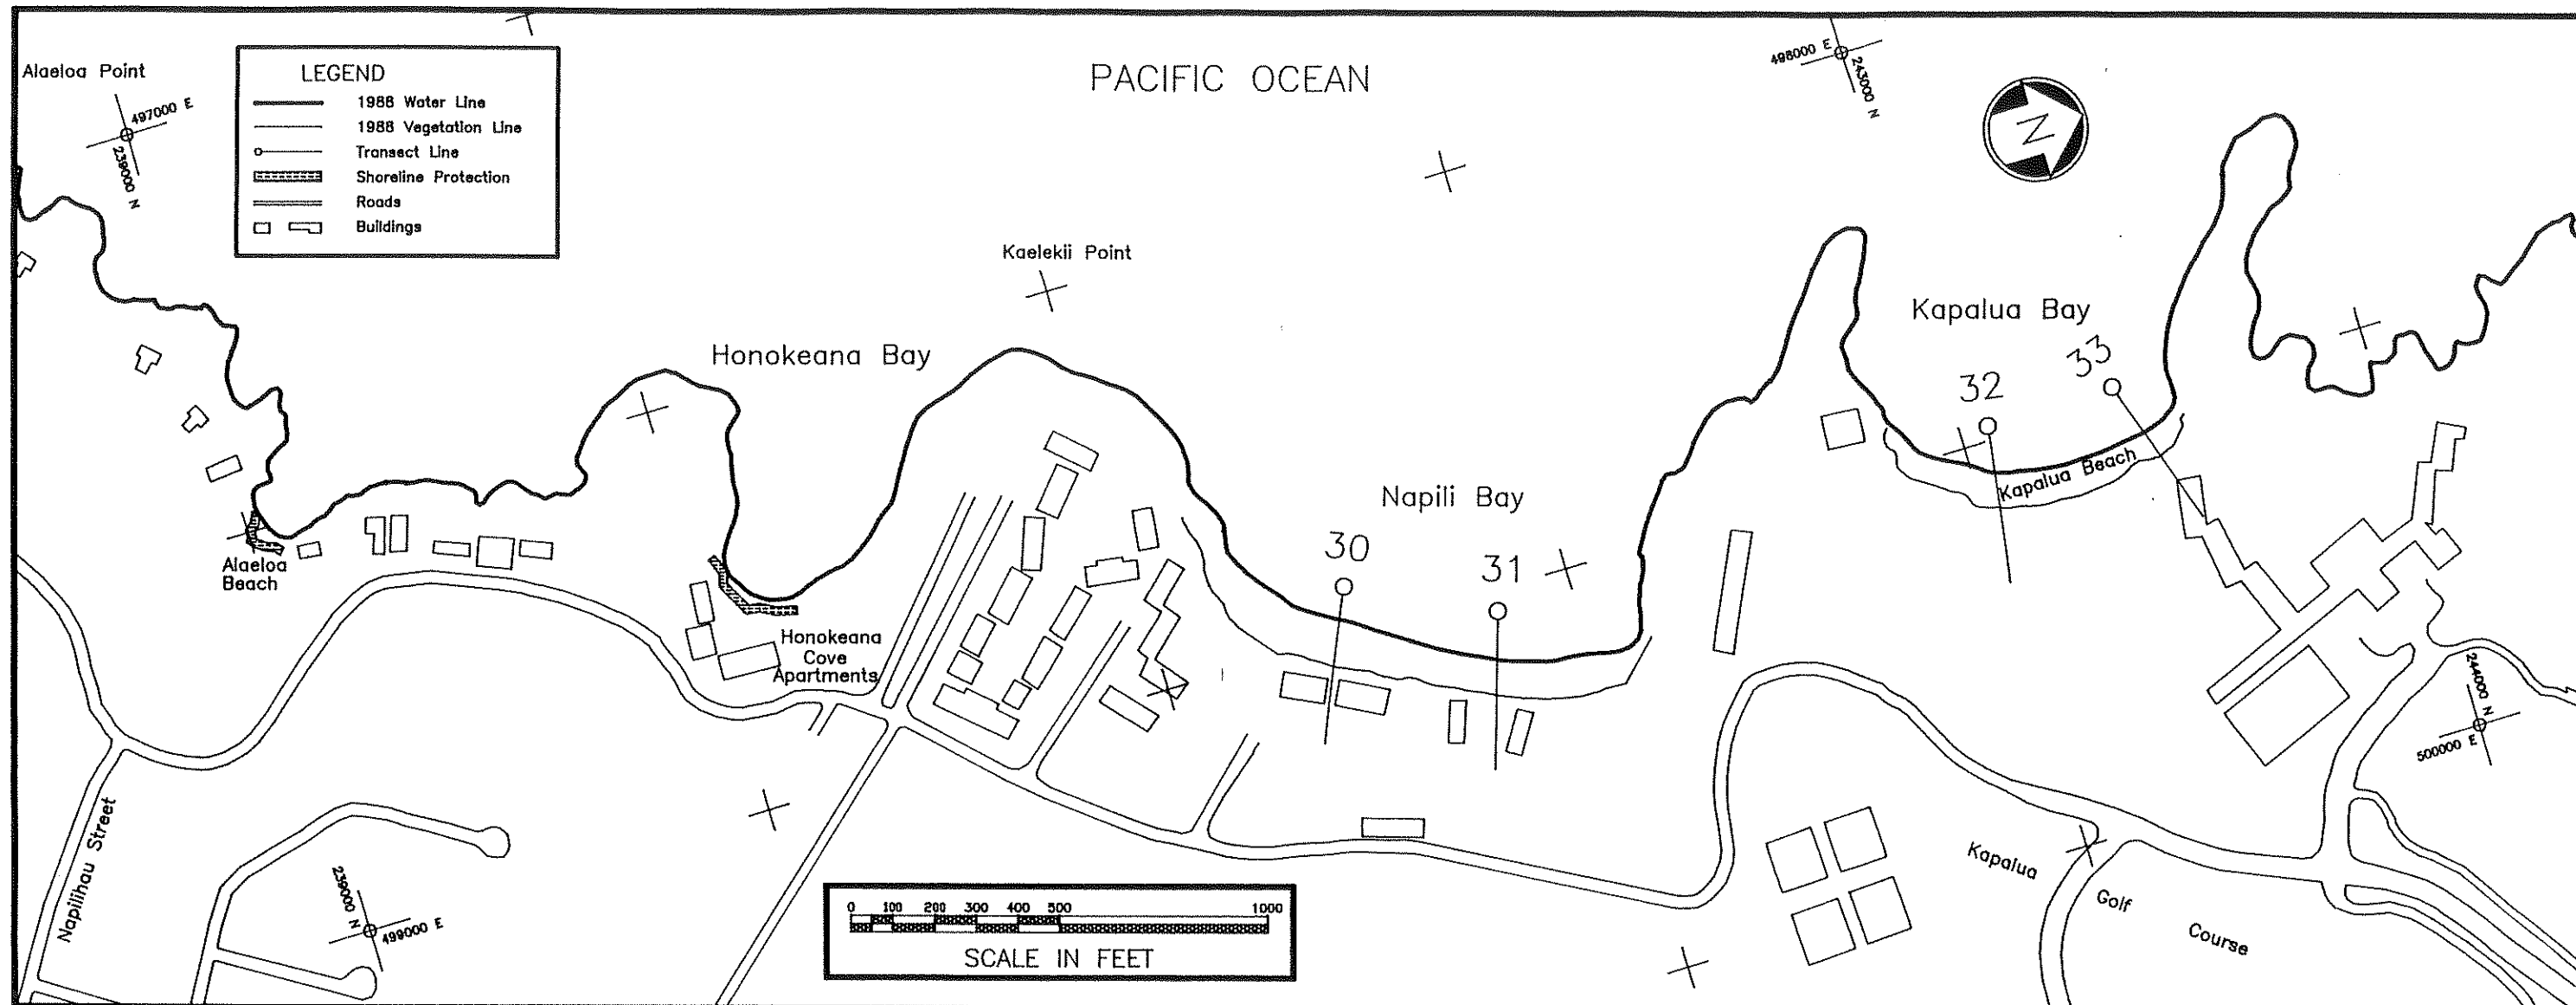
**FIGURE MA-10**

- Four small pocket beaches are located in this subsector. Although some erosion is occurring there are no structures threatened at present.

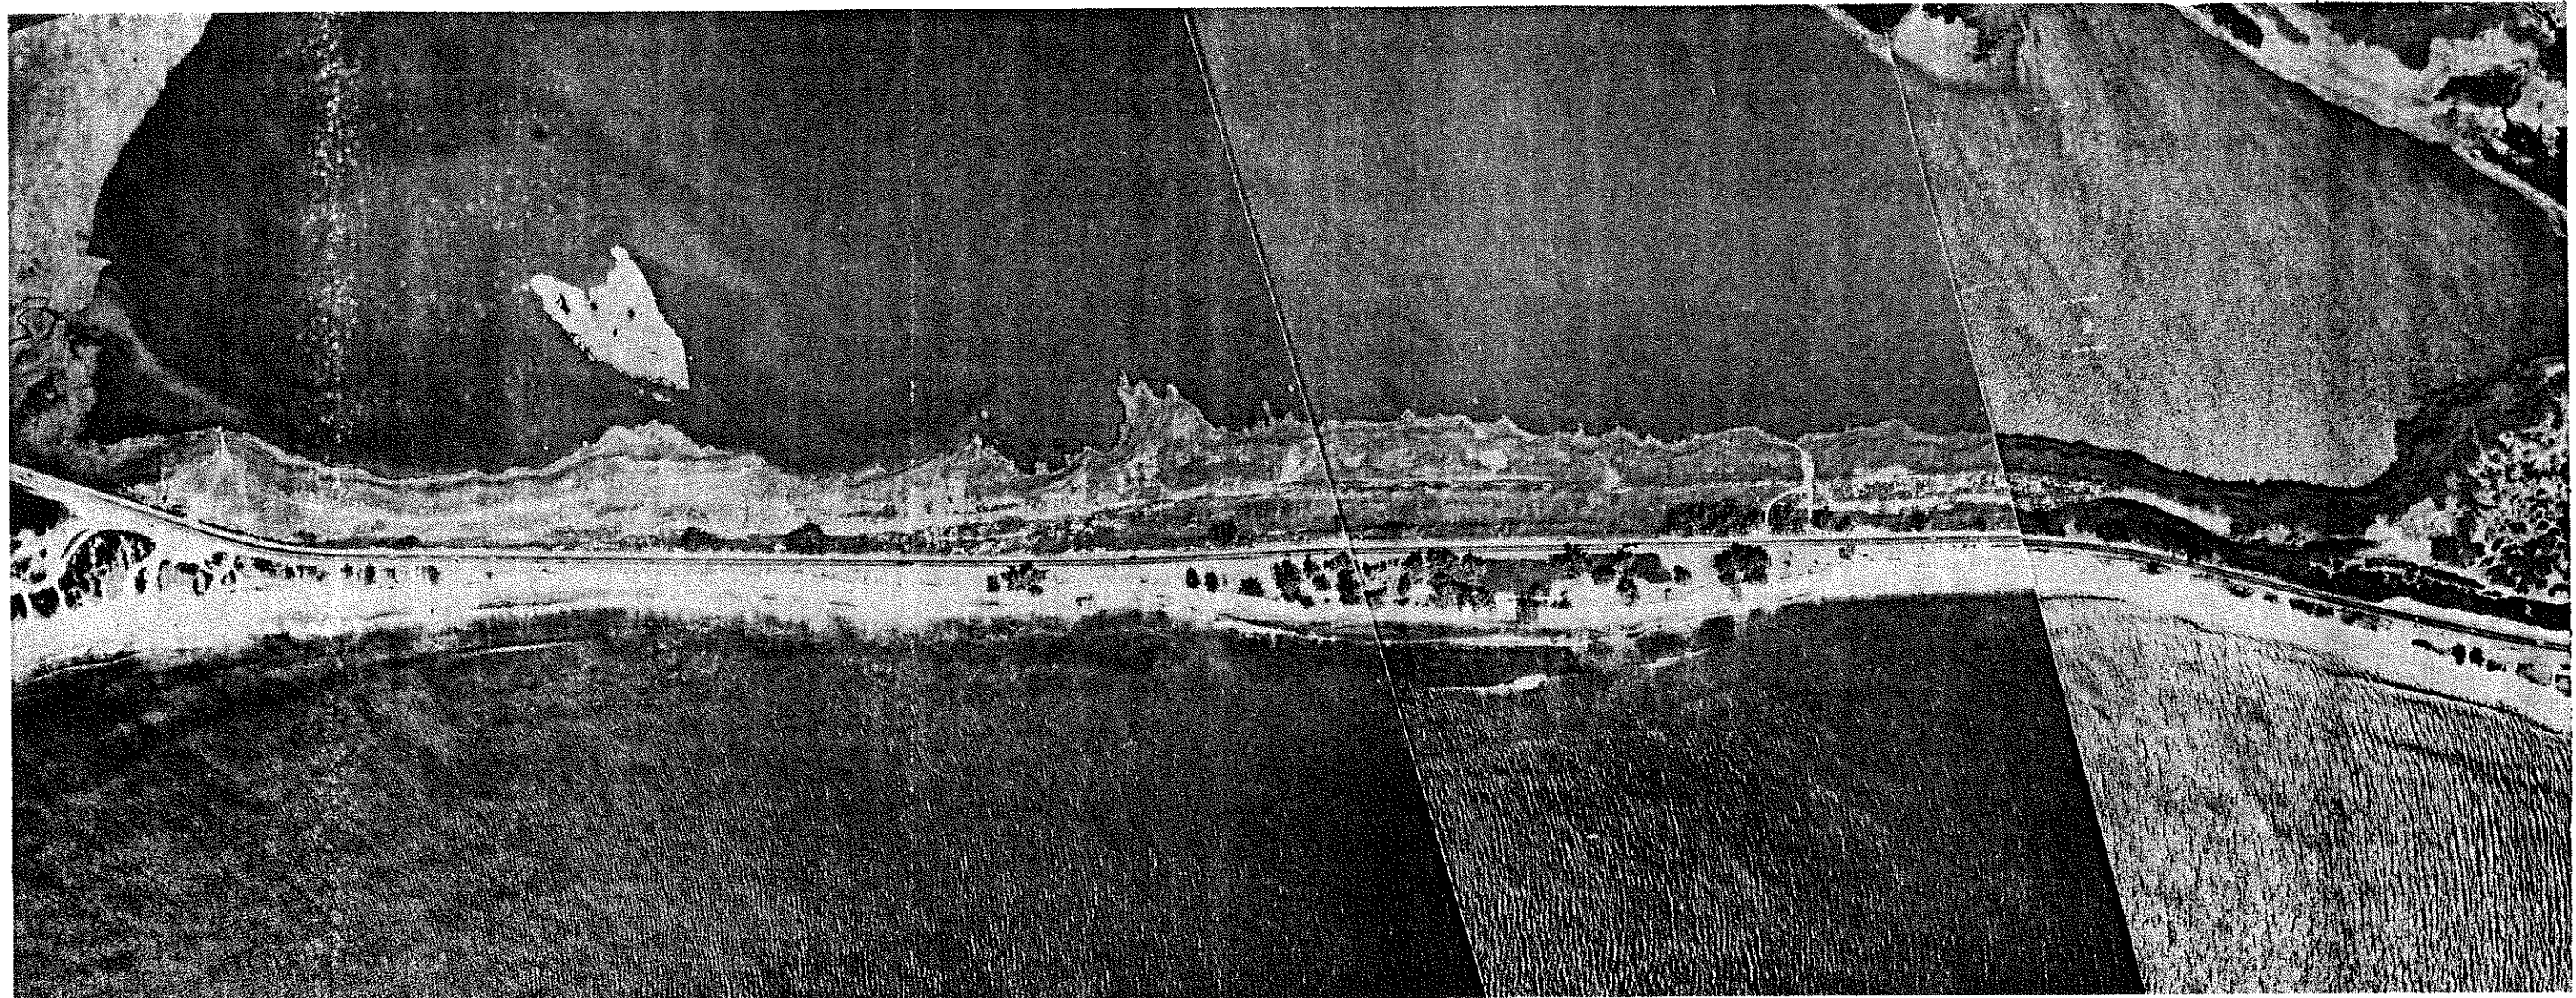
**FIGURE MB-3**

- The entire length of Maalaea Beach along Kealia Pond has eroded.
- Net erosion between 1949 and 1988 ranged from 25 to 55 feet.
- Continued erosion could damage North Kihei Road near Region 6, where trees lining the road are already being undercut by waves.

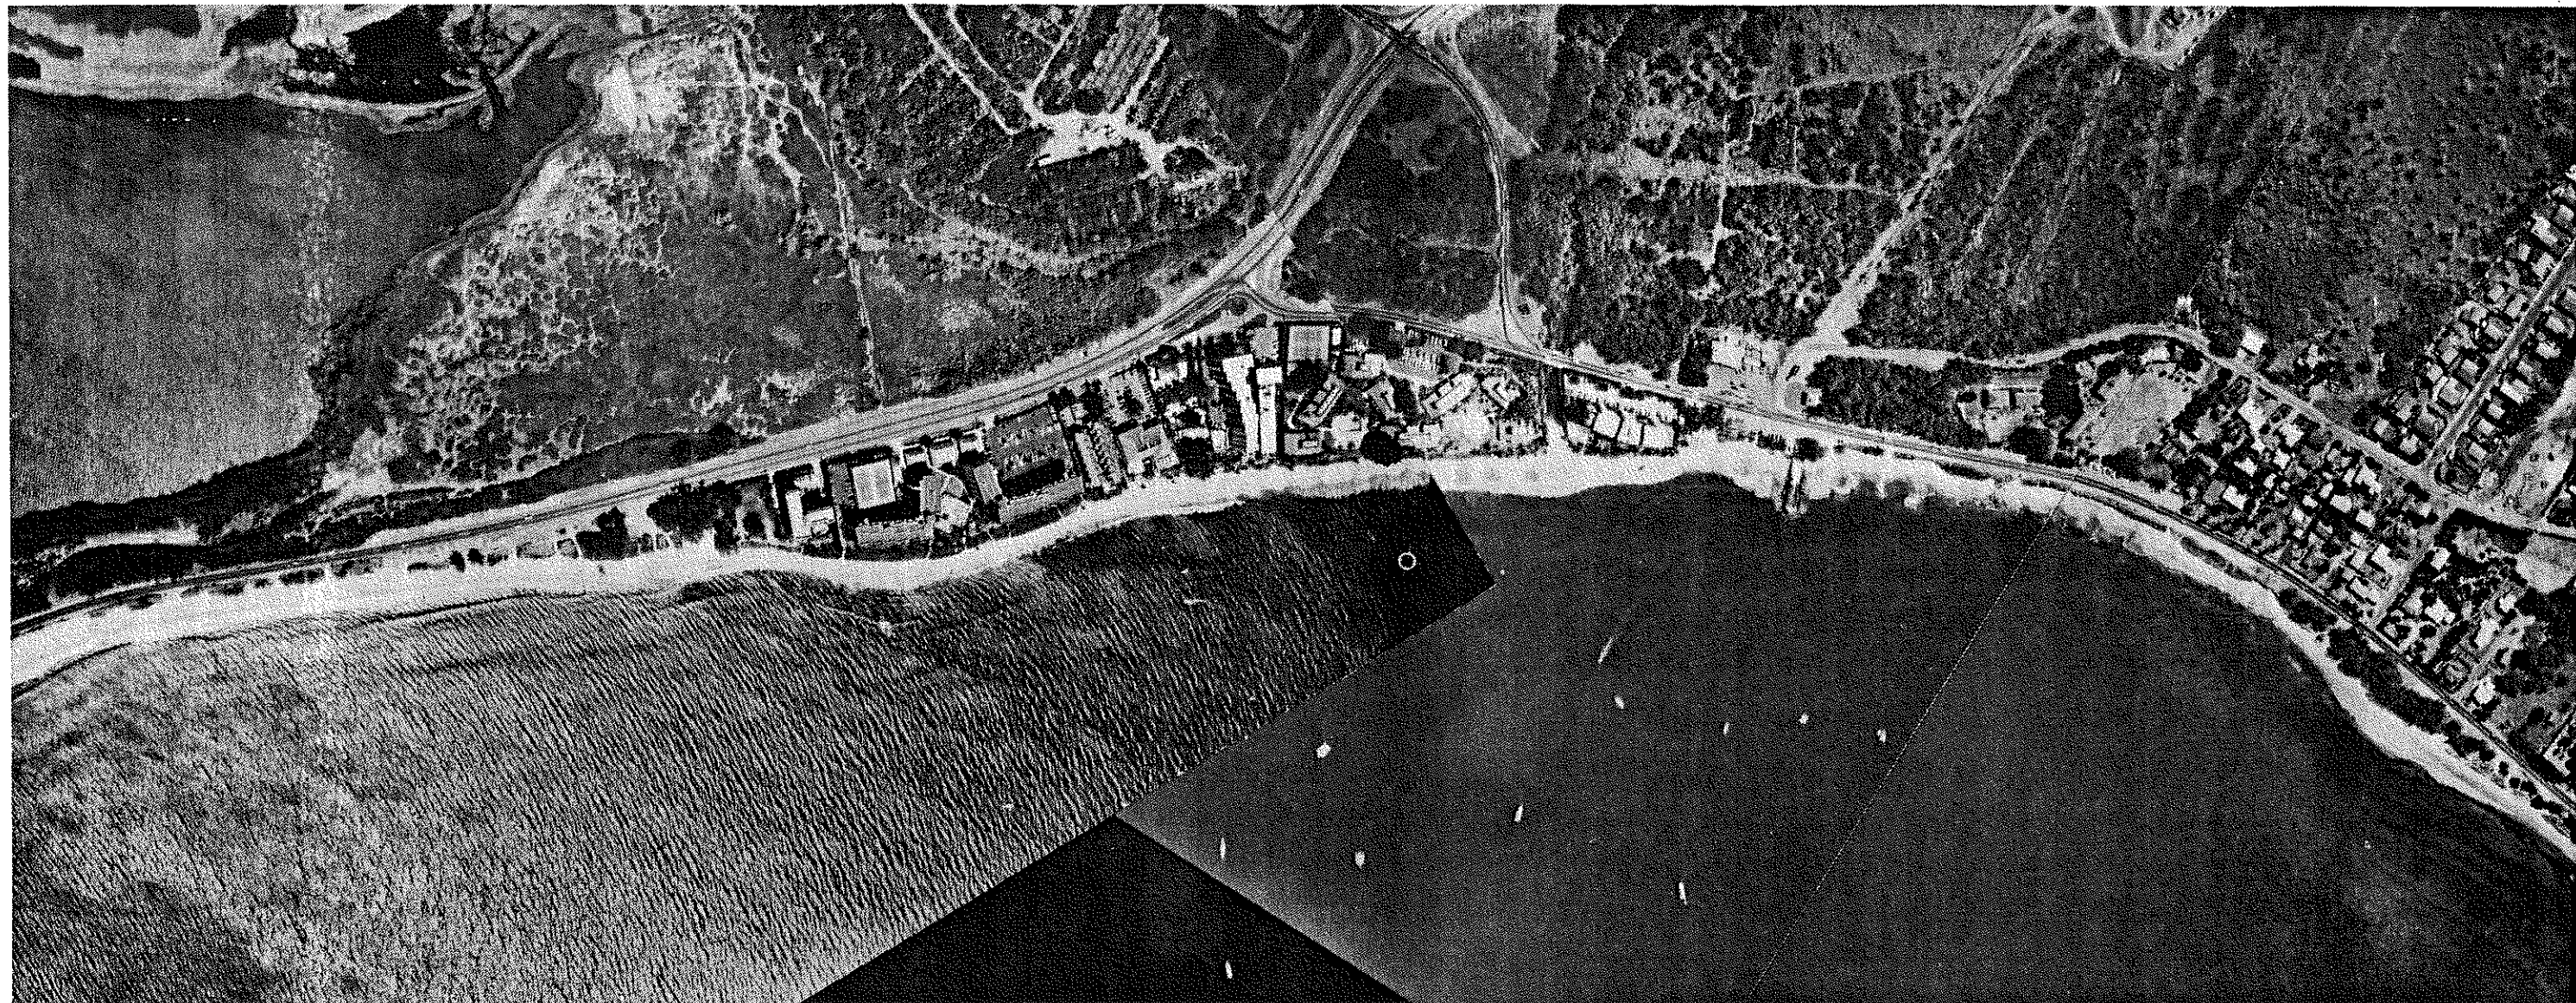
FIGURE MB-4

- Beach history has not been consistent throughout this subsector.
- Region 9 has been dynamic; the beach was eroded 45 feet in 1964, but has since accreted. Net erosion between 1949 and 1988 was 17 feet.
- Net accretion of 37 feet has occurred in Region 10. Despite the accretionary trend, shore protection structures have been constructed. This is because the resort hotels were constructed in the dynamic zone of the beach, seaward of the 1949 vegetation line. They are, therefore, subject to erosion damage.
- Region 11 has been relatively stable. The vegetation line accreted 8 feet between 1949 and 1975, and was unchanged between 1975 and 1988.
- Extensive accretion of sand was reported in the early 1900's around Kihei Pier. Evidence of this accretion was not visible in the aerial photos used in this study. Conversely, along the 60 feet of coast

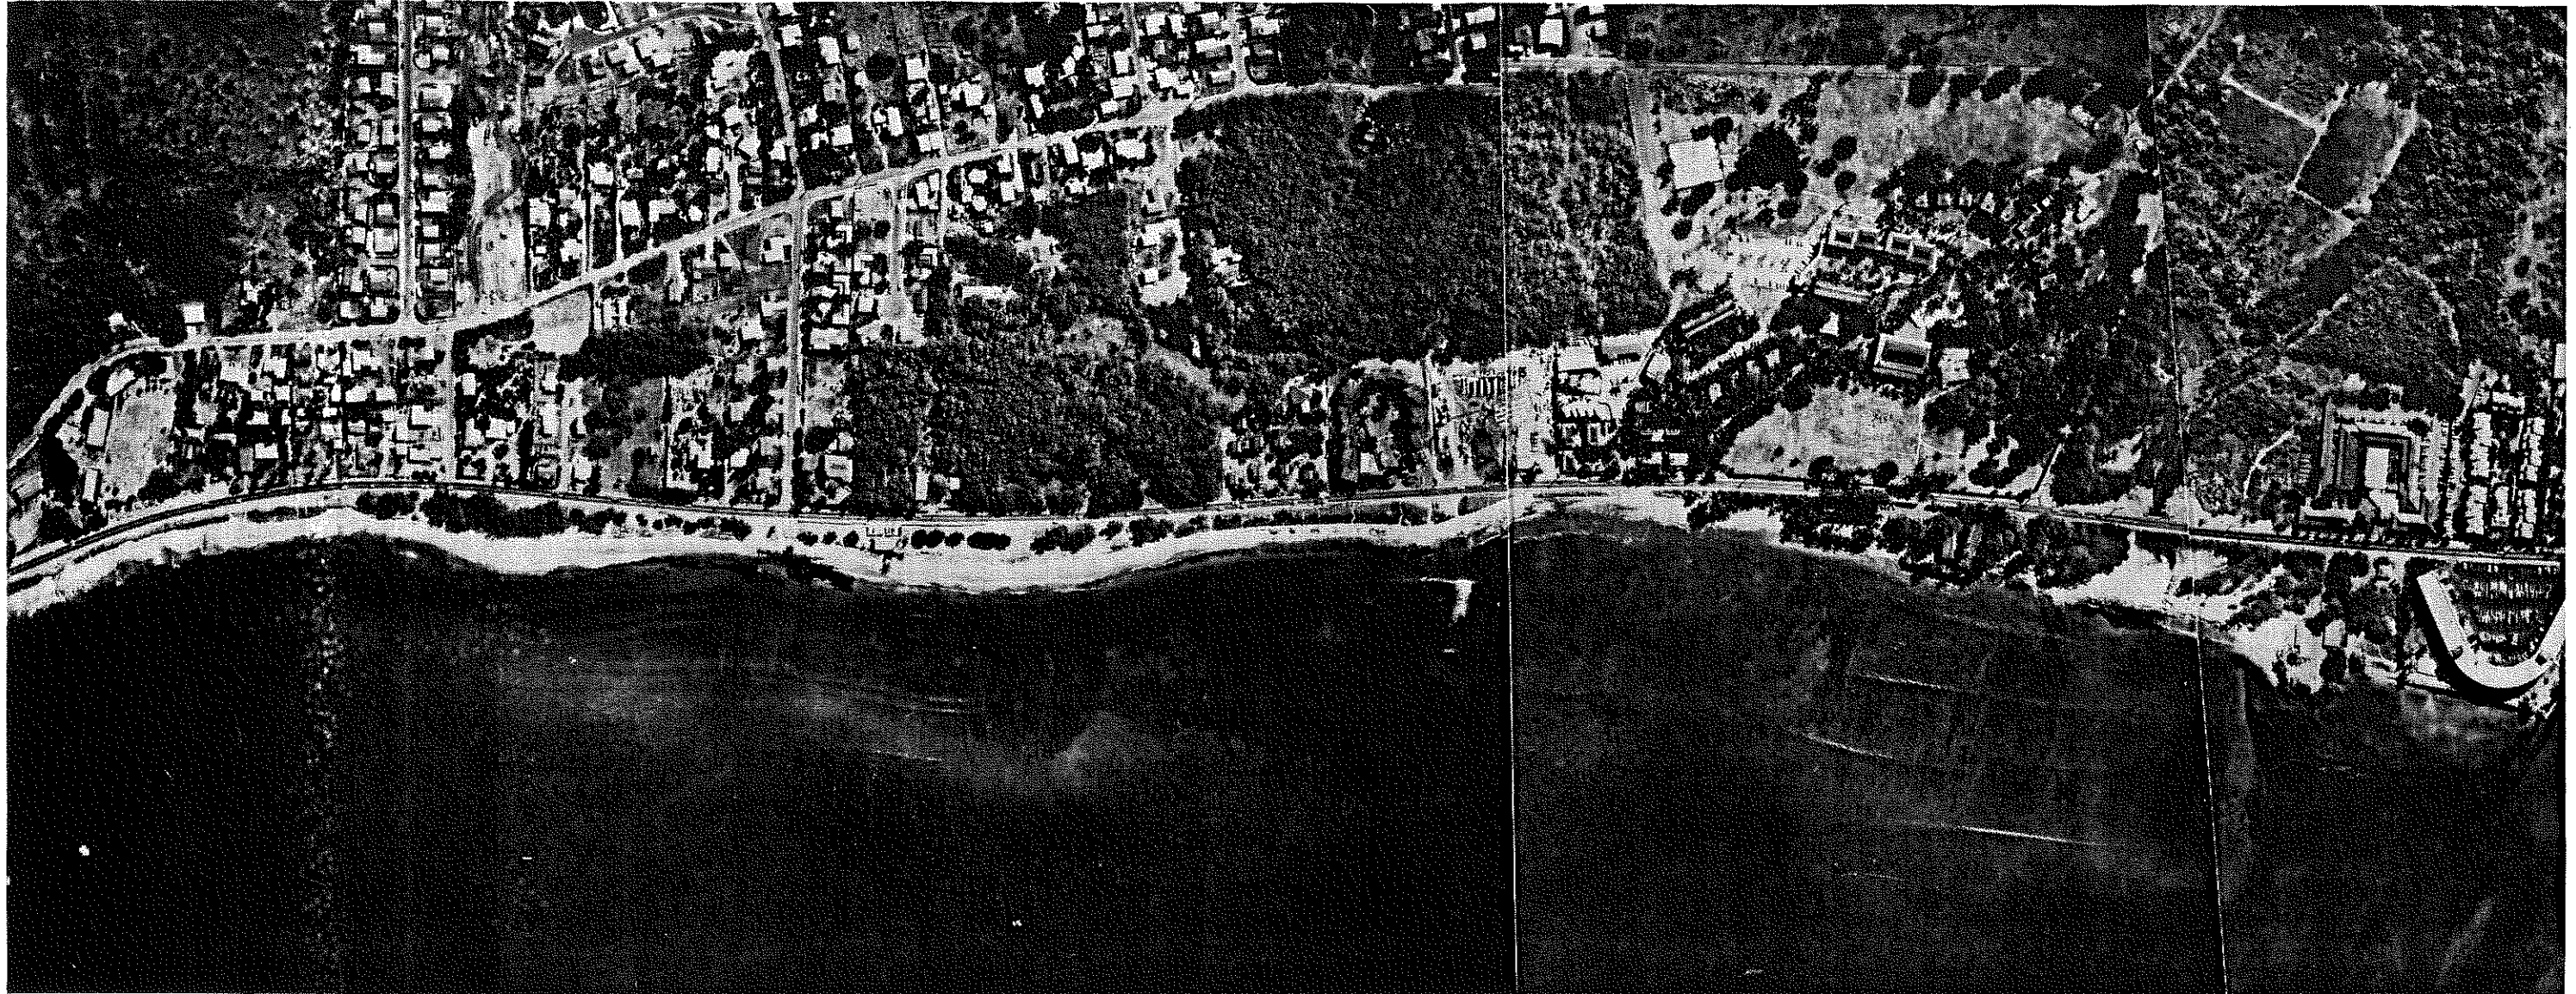
FIGURE MB-5

- Although a protective, fringing reef is present offshore, the road and buildings have been subject to erosion damage because they were constructed too close to the water.
- The oblique aerial photos show that erosion is continuing north of Kulanihakoi Gulch, south of the revetment. A scarp has been cut into the vegetation line exposing roots and causing trees to fall into the beach.

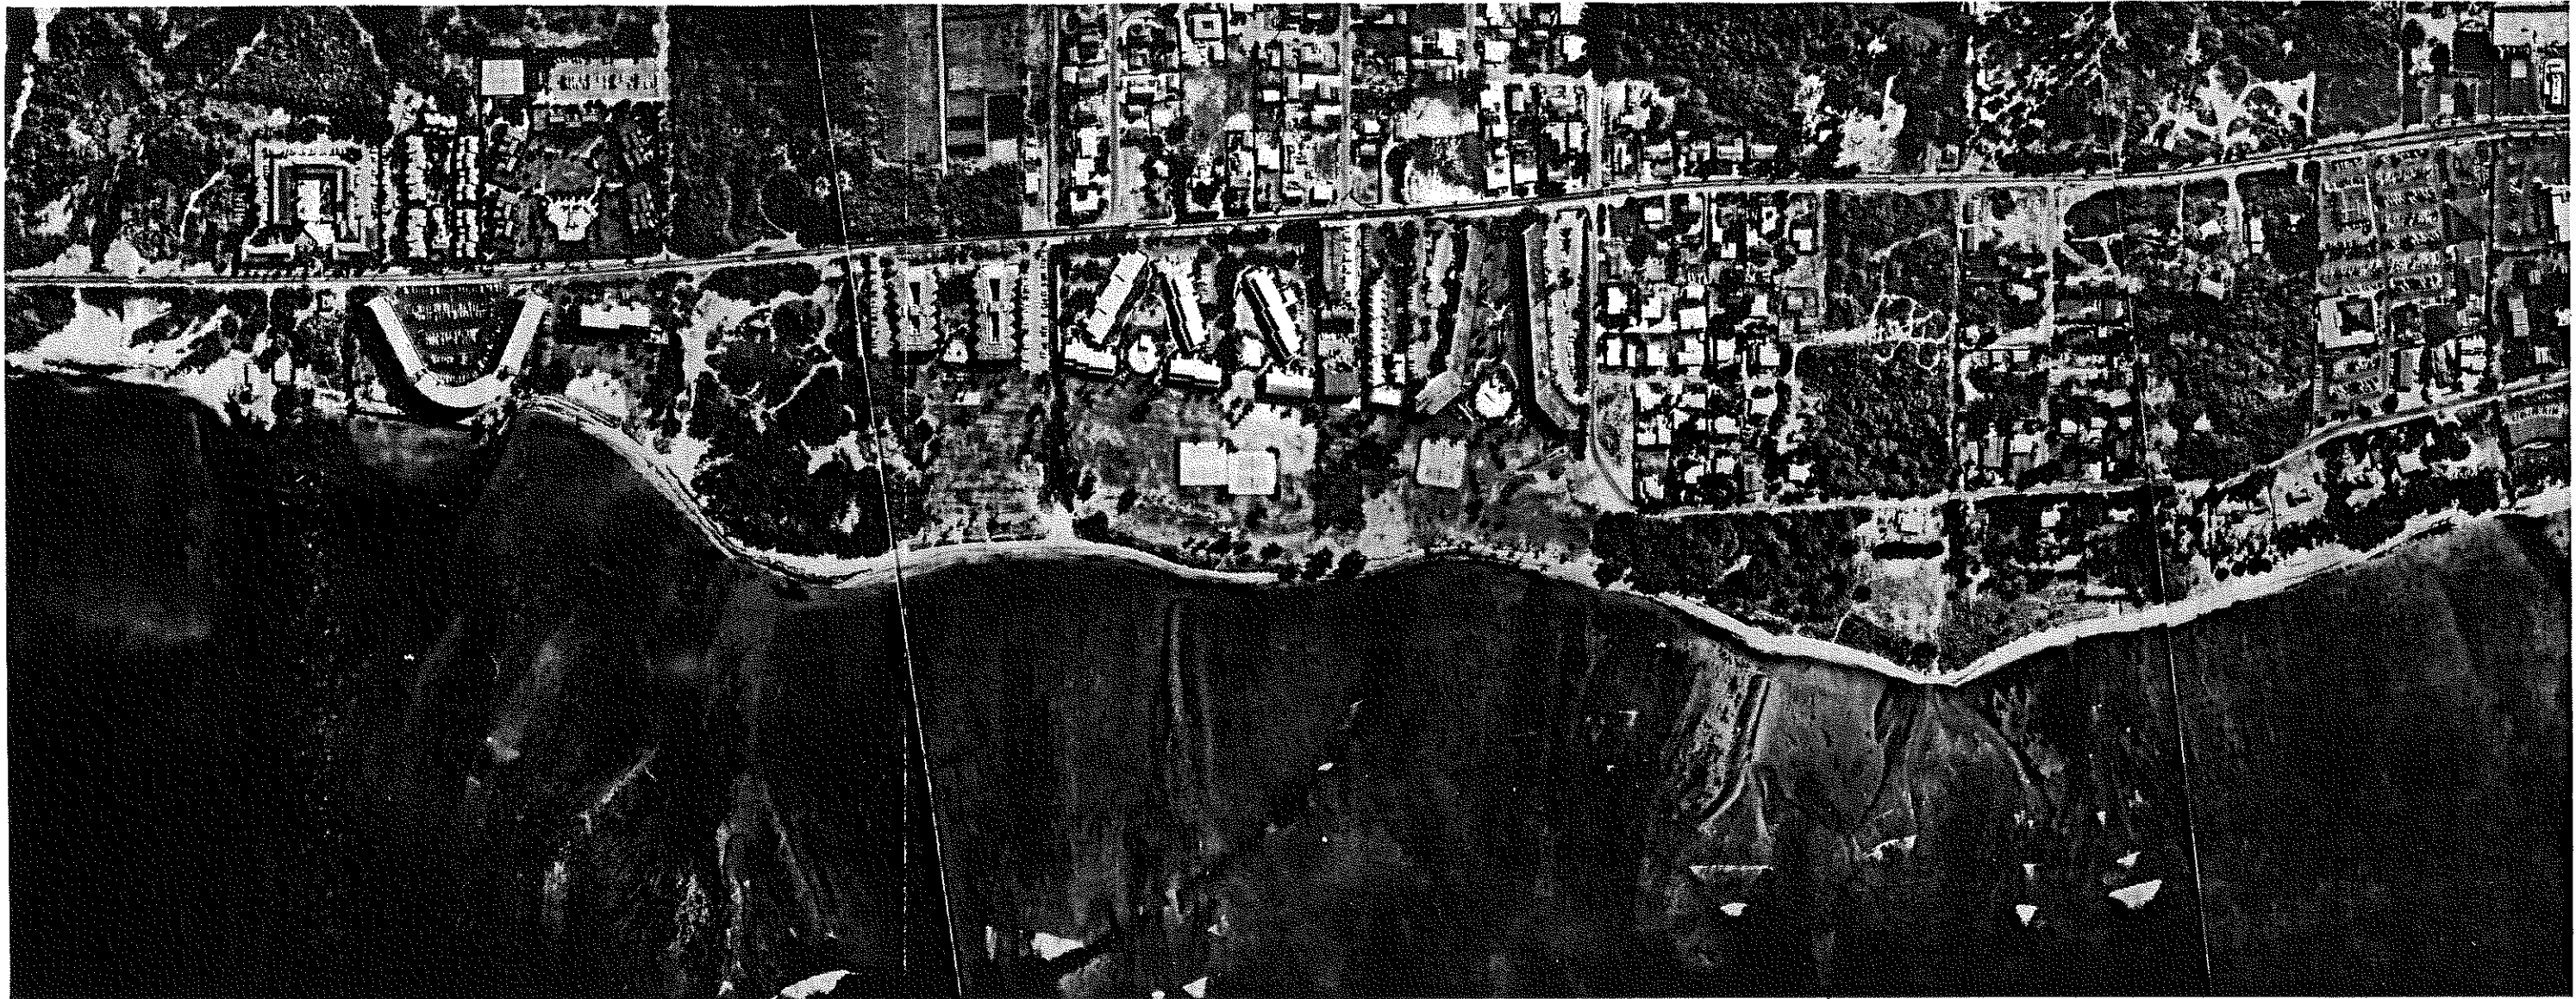
FIGURE MB-6

- The beach in this subsector has experienced dramatic changes since 1949. From 1949 to 1988, the beach has accreted 115 feet, eroded 92 feet, and accreted 284 feet in Regions 15, 16 and 17 respectively.
- These changes are likely due to a regional shift in longshore currents that has caused currents from the south and from the north to converge and deposit sand around Region 17.
- Erosion in Region 16 has cut a scarp into the vegetation, exposing roots and undercutting trees. The erosion, however, is not causing problems because the backshore is a grassy lawn of the state beach preserve.
